TECHNICAL PAPER 29

REVIEW OF HOT-MIXED EXTERNAL LIME
COATINGS IN SCOTLAND 1997-2016

HISTORIC
ENVIRONMENT
SCOTLAND

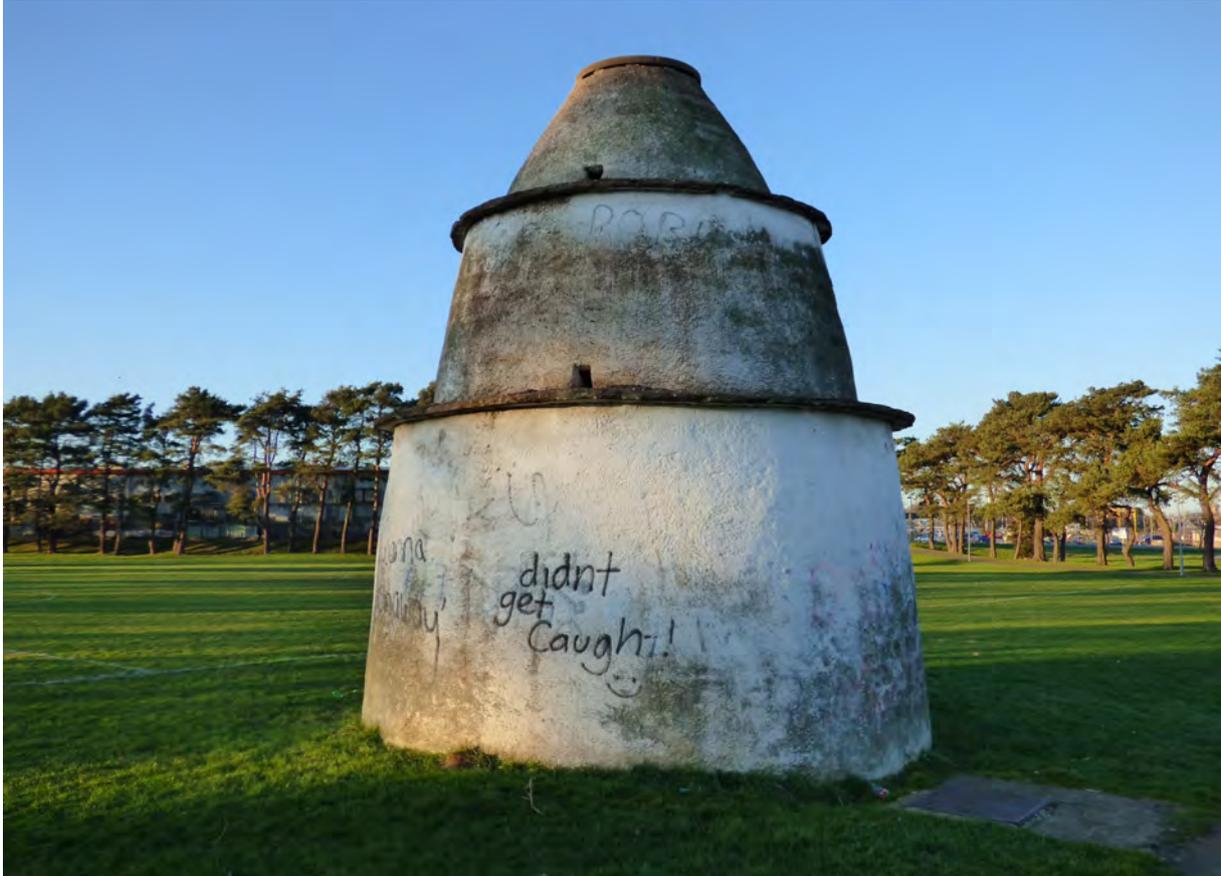
Figure 17.1 South side of the doocot, with intact harl, viewed from the south.

This late-medieval doocot was refurbished c.1999 when a hard, external cement render was removed and the structure was re-harled in lime mortar, with a limewash finish. It is understood that the harling was an NHL gauged hot-mixed mortar. The doocot is currently used by wild birds.

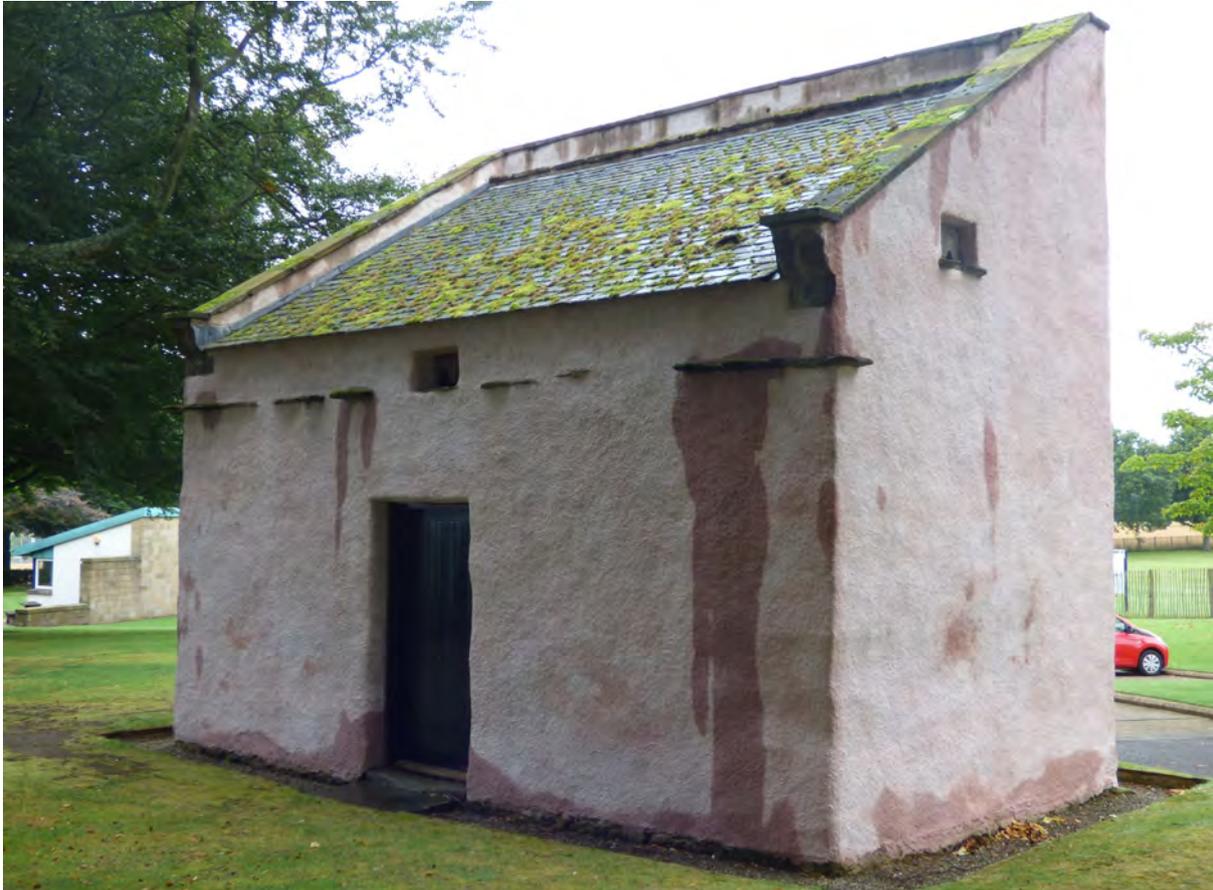
Figure 18.1 General view showing the front (south) elevation; photo taken after heavy rain.

The harling on this structure appears to be a hand-cast finish, limewashed. It was inspected immediately after a spell of heavy rain, which allowed easy identification of areas of run-off and staining. It is understood that the existing harling is an NHL gauged hot-mixed mortar and was applied in 2011, replacing an earlier defective lime harling. The harling and limewash are in generally good condition. Roof copes to the rear (north) wall seem to have open joints allowing water to drain into the parapet upstand. The perpend joints to the copes on the side (gable) elevations appear to have open joints leading to water accessing the wall head and channelling water flow over the harled surface below.

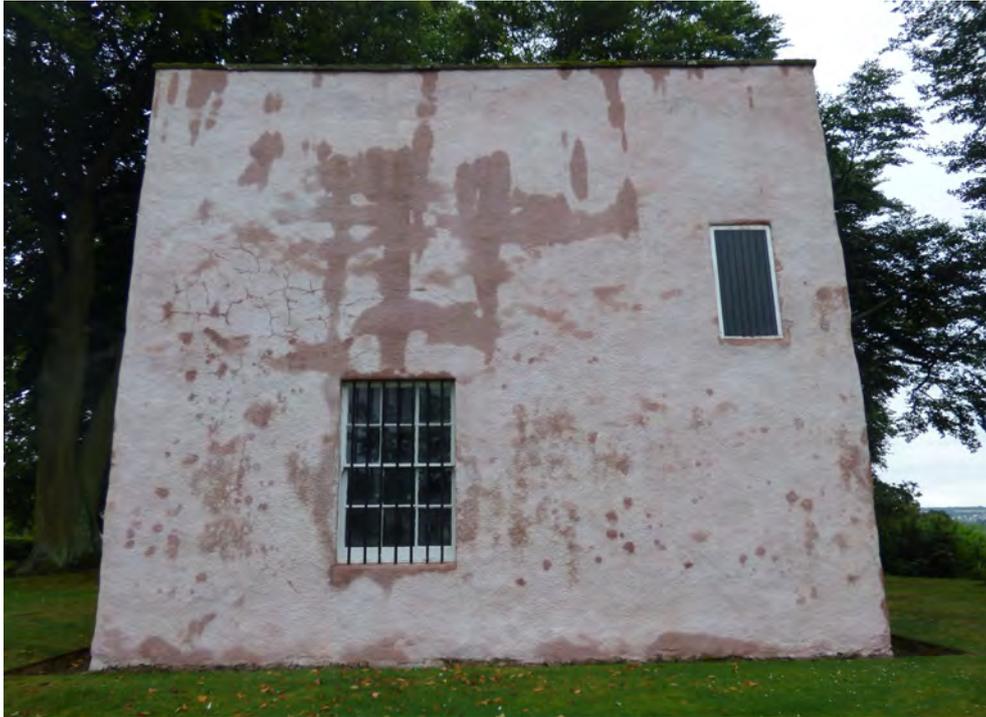
Figure 18.3 Rear (north) elevation, where the narrow overhang on the wall head cope is insufficient to keep water off the wall.

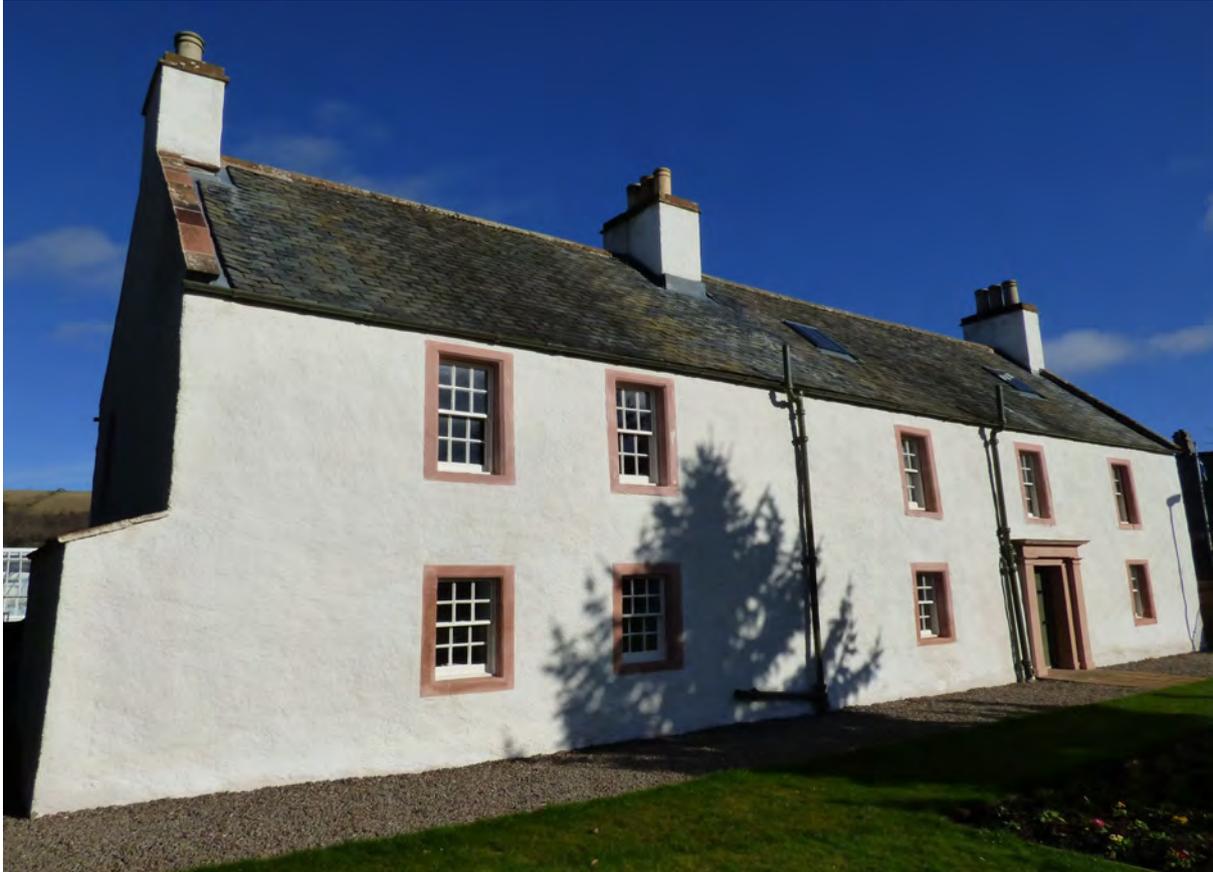
Figure 19.1 View of the front elevation from the south-west.

The harling is a traditional hand-cast finish throughout, finished with a limewash. These are both relatively consistent in appearance across the external walls. The harling is an NHL gauged hot-mixed mortar and limewash made on site from freshly slaked quicklime, applied whilst hot/warm. The harling appears to be well bonded to its rubble stone substrate with no visible cracking observed and, except for the details below, it is doing well.

On the front elevation there are sections of rising damp at low level, with areas of recent patching. This was particularly noticeable by the front door, where there appears to be a blocked drain, with repair to the harl at ground level continuing to extend from the doorway westwards. The east gable looks sound except, again, for localised damp patches at high level and indications of rising damp at ground level. The west gable shows some evidence of damp, particularly at the skews and below the sloping stone flag roof to the extended wall section. In addition, there was localised evidence of rising damp at ground level, affecting the wall up to 100mm above the ground surface.

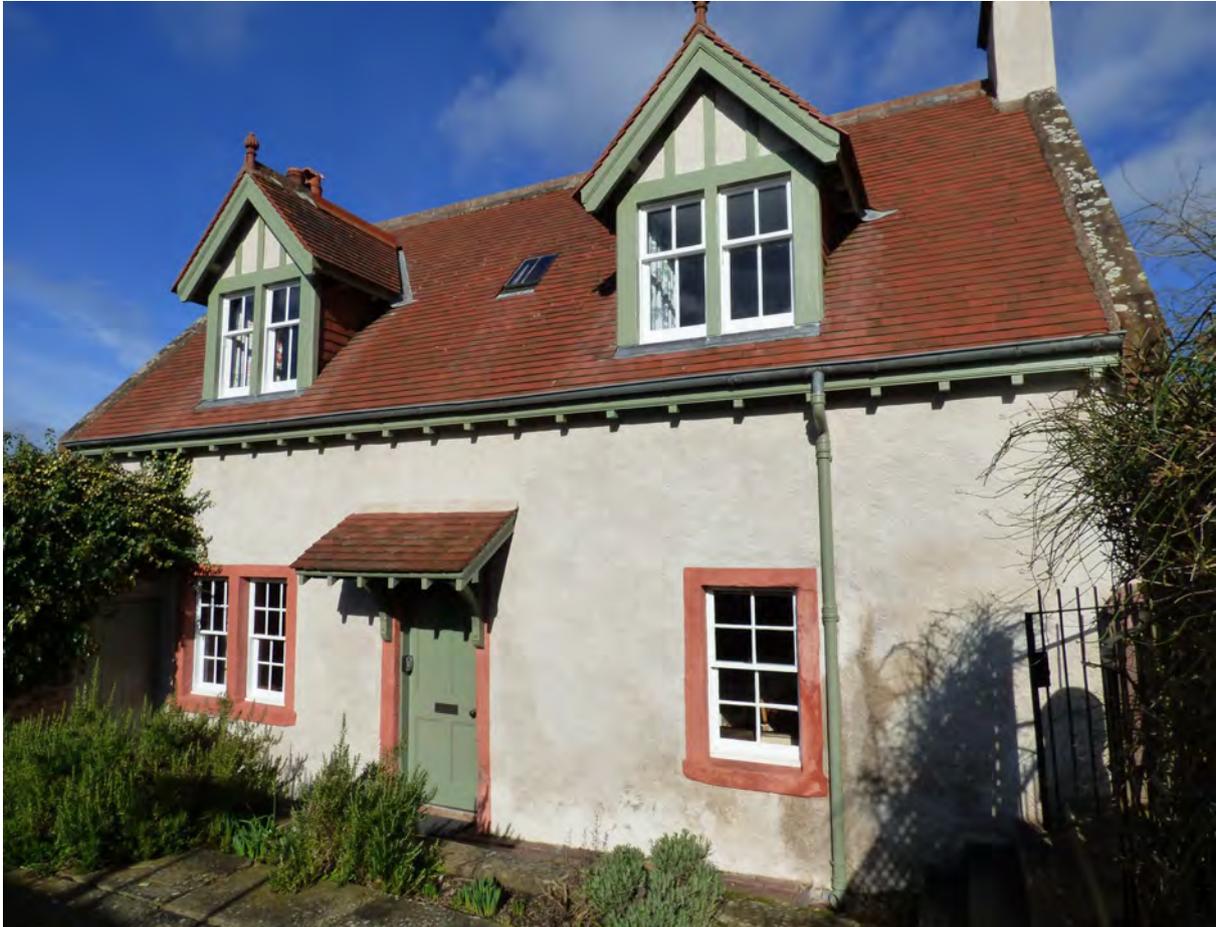
Figure 20.1 Front elevation of the cottage.

The cottage's harling is a traditional hand-cast finish with a subtly pigmented limewash applied over it. It is understood that an NHL gauged hot-mixed mortar harling was used. Generally the harling and limewash are doing well. At the base of the front elevation there are indications of rising damp up to 300mm from ground level. Moisture was also observed in the harl adjacent to the east downpipe, possibly indicating a current or past blockage in the downpipe.

On the east gable the lower 1.2m to 1.4m seems to have been recently coated over. It is not known what materials were applied or the reason for their application. This has given the wall an uneven colouration. Further investigation would be required to confirm the repair history, materials used and reasons for the harl repairs to this gable.

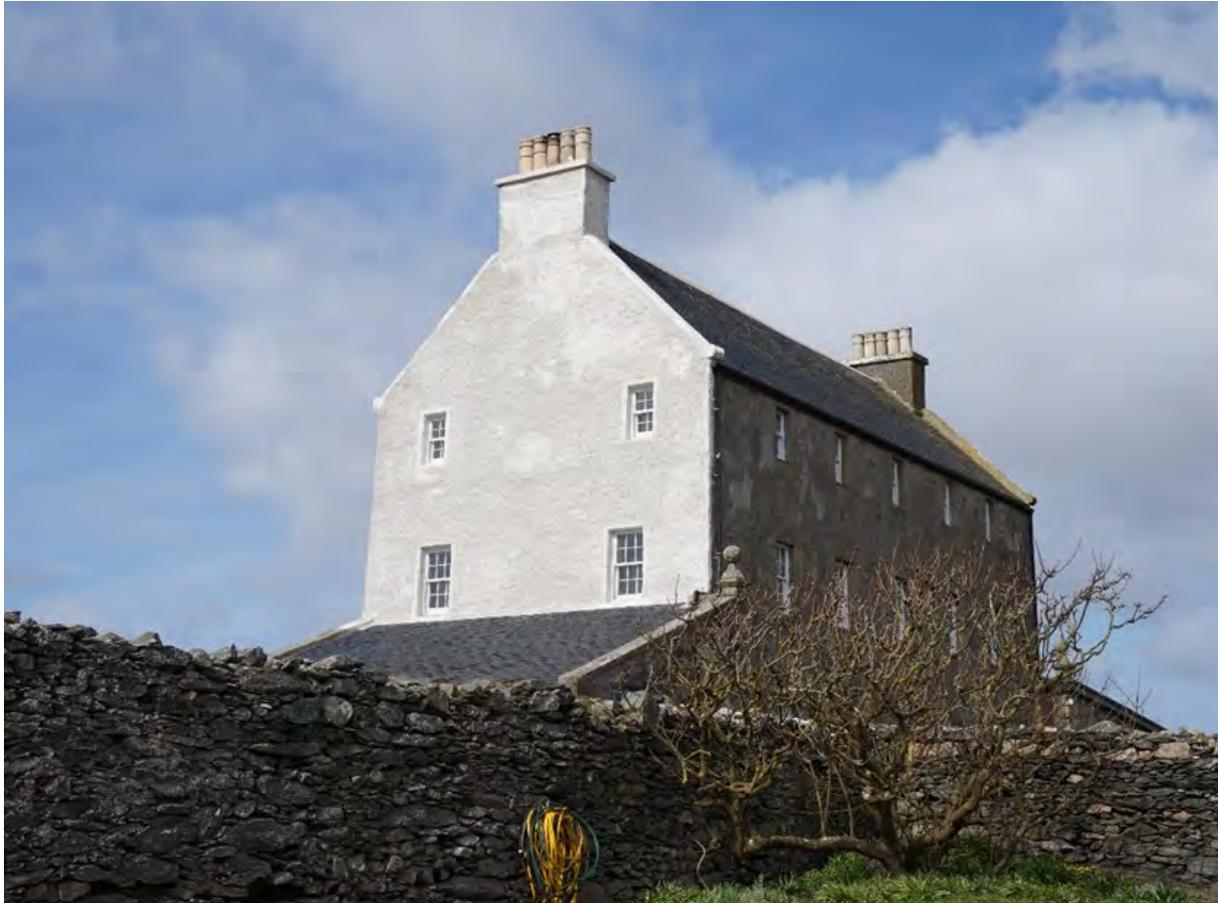
Figure 21.1 South-east gable and north-east principal (front) elevation.

The lime harling is a single coat NHL gauged hot-mixed mortar containing a relatively low proportion of NHL relative to the CL90 quicklime. A proportion of crushed seashell was added to the aggregate. The harling was then limewashed using a gauged mix of CL90 quicklime and NHL5 to protect the harl.

The harl finish is somewhat vernacular in appearance, being fairly coarse and hand-cast using traditional methods. As would be expected with a single coat application of harl, the plane of the wall undulates with the underlying rubble masonry, though the texture and character of the finish are relatively consistent across the whole gable. Three years after completion, the gable wall is continuing to perform well.

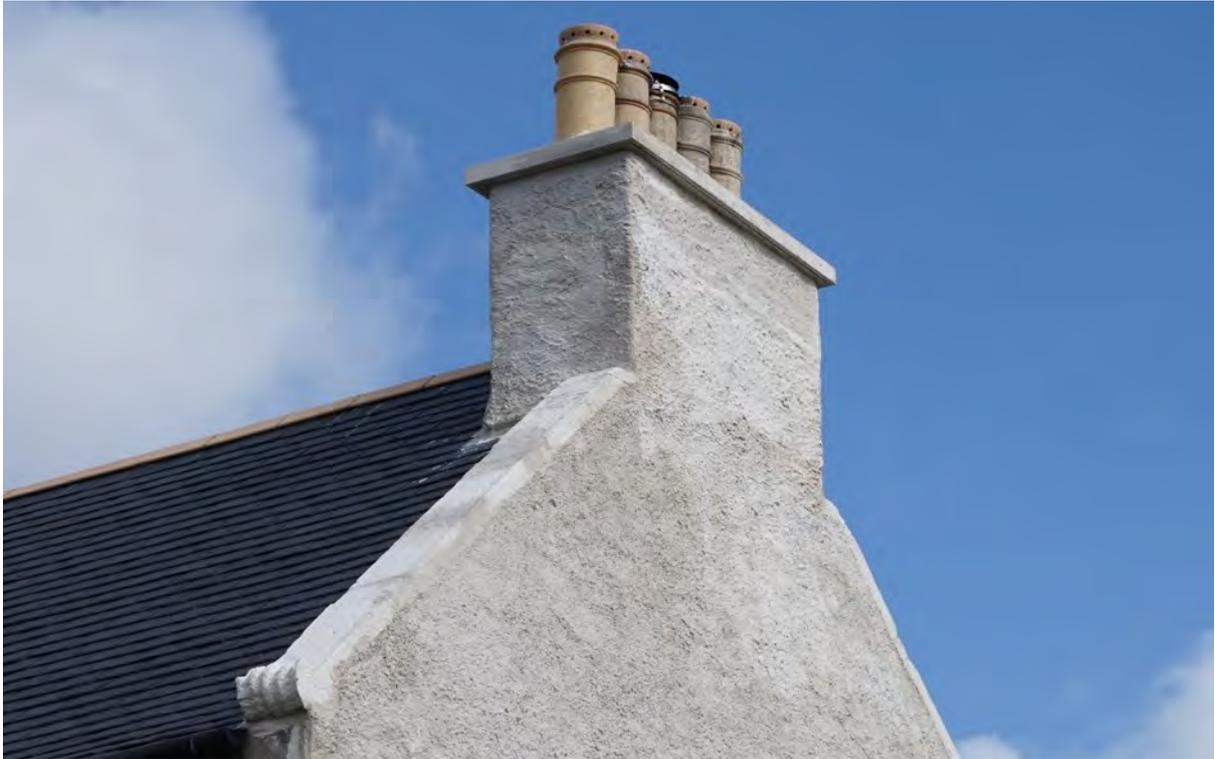
Figure 21.2 Detail of the chimney stack and upper gable, illustrating the harling and the limewash, the latter having been taken over the stone skewes.

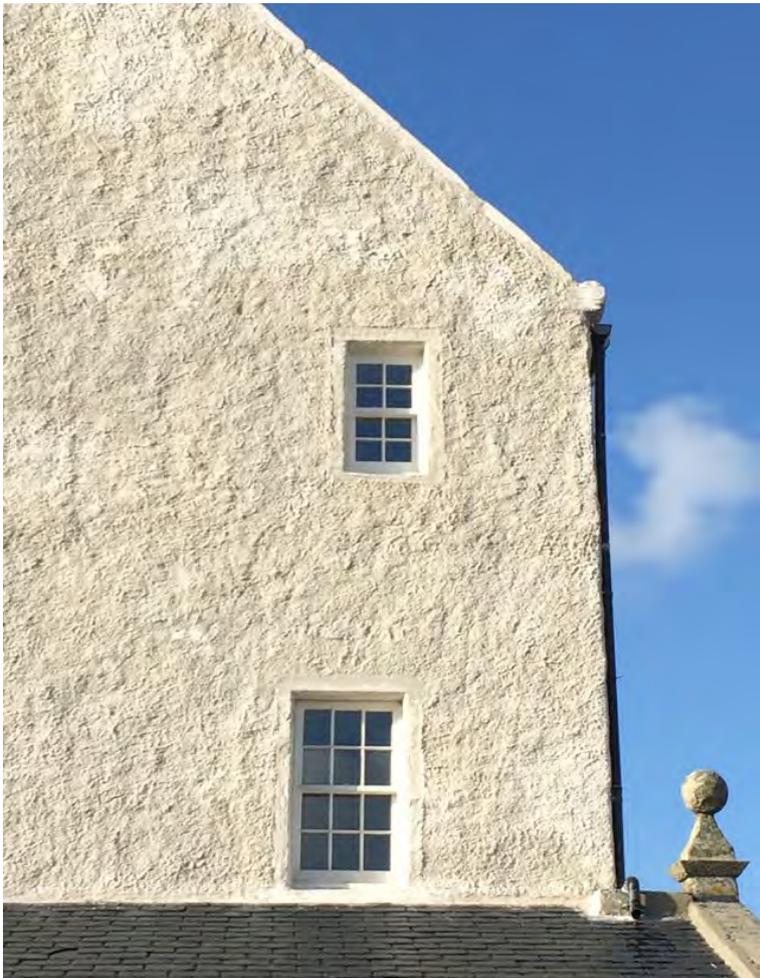
Figure 21.3 Detail of harling and limewash finish to south-east gable elevation, illustrating the textural effect of the harl in direct sunlight and the colour variation due to wetting and drying.

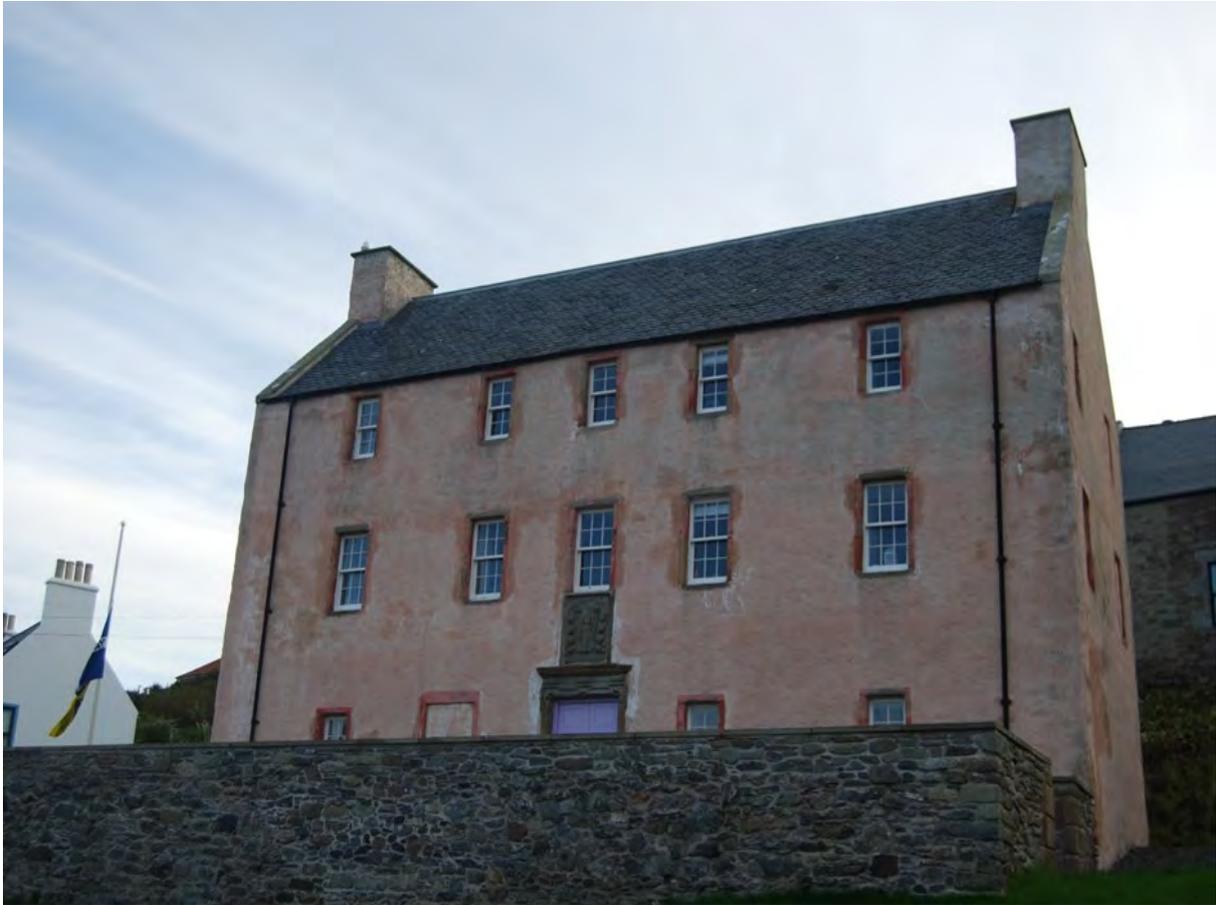
Figure 22.1 Front (west) elevation of Haa of Scalloway.

Haa of Scalloway is constructed of rubble masonry (mixed stone types), bedded in earth/clay based mortar and finished with a protective harling.

Some 15 years after the work was carried out, the harling remains largely intact, with the exception of an area below the skews to the south-west corner which is cracked and shows localised detachment. It is understood that the building has not been re-limewashed, or the harling otherwise maintained, since the work was completed in c.2002.

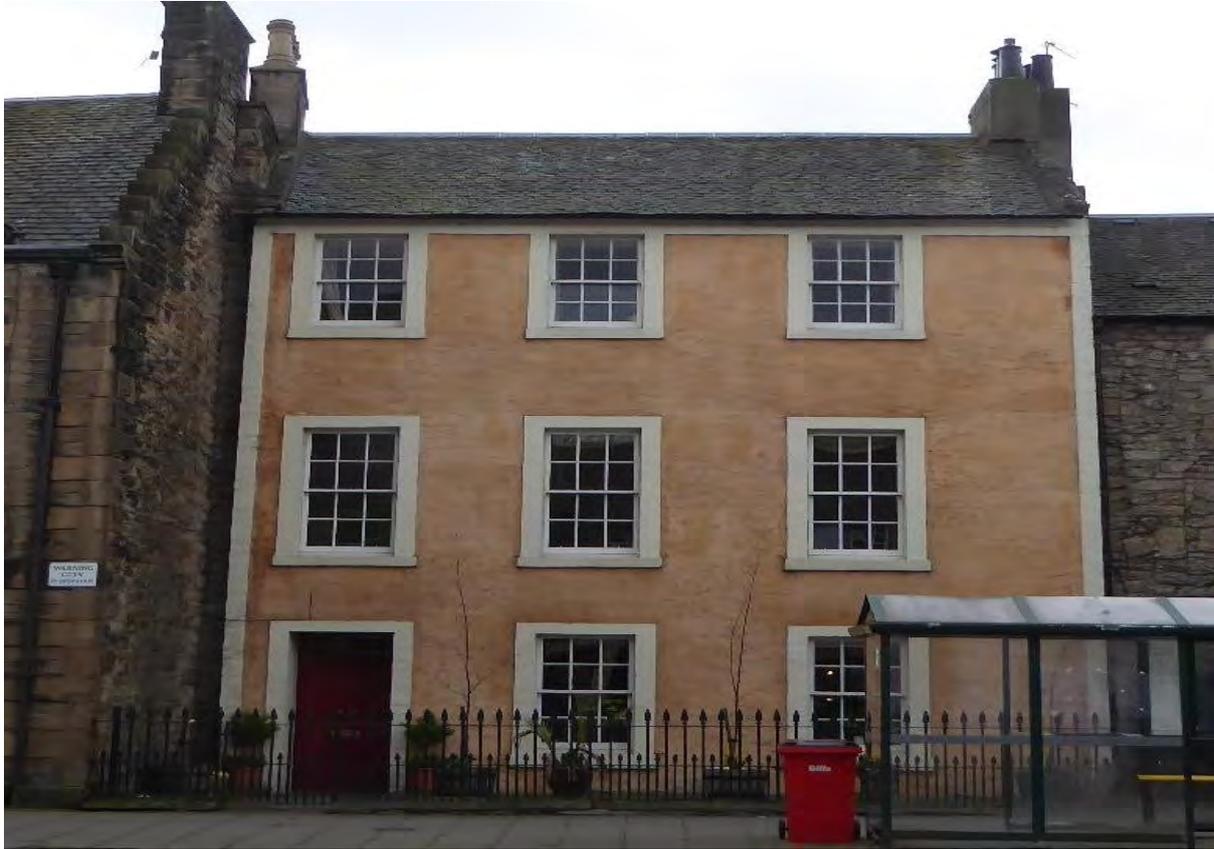
Figure 23.1 View of the front (north) elevation.

The front (north) elevation of this building has been harled and limewashed. The harling is reported to be an NHL gauged hot-mixed lime mortar. The harling has been finished with a pigmented limewash and the window margins appear to have been painted with a mineral paint. From the appearance of the harl, and the regular horizontal pattern apparent, it is considered that the harl had either been applied with a harling gun or sprayer. There are also features apparent that may suggest some localised flattening or re-spreading of the harl whilst still plastic at the time of application, with the mortar being applied relatively wet (workable).

The elevation is in good condition and all areas of the harling appear sound. There is no evidence of rising damp affecting the lower levels of the harl, with only very localised indications of retained moisture within the harl, or the underlying wall fabric, with this at the upper west (right) side. The limewash does not seem to have been re-done since the harling works and the only noticeable effect is a washing out of the colour and minor staining from urban pollution.

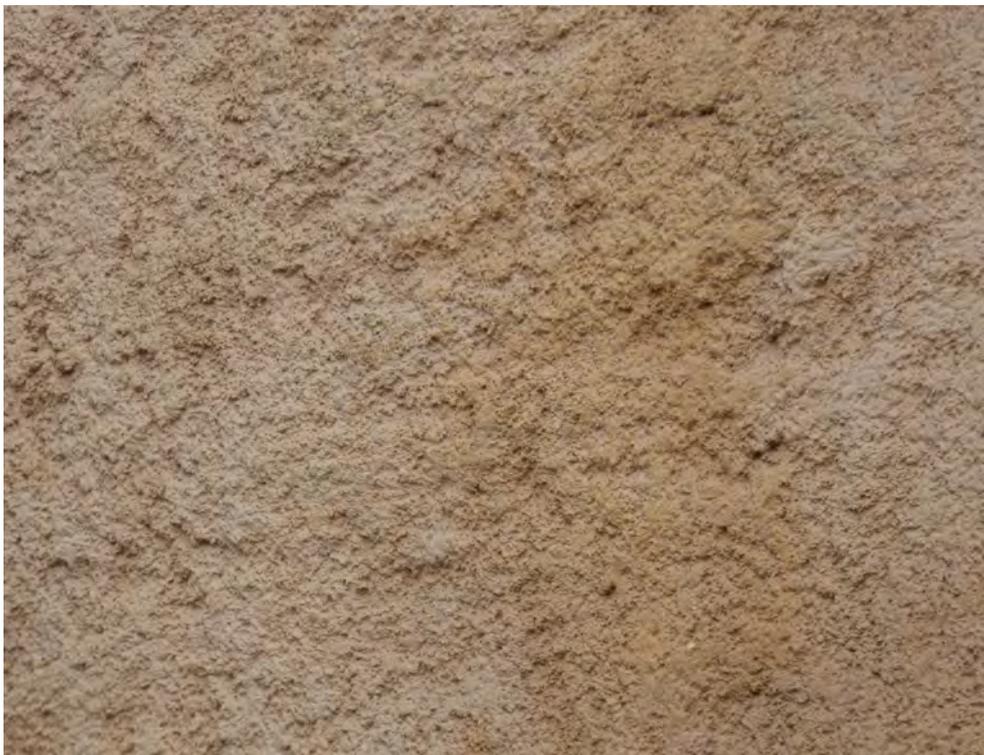
Figure 23.3 A close-up of the harl and limewash finish showing the aggregate distribution across its surface. The more open texture may be indicative of a mechanically applied harling.

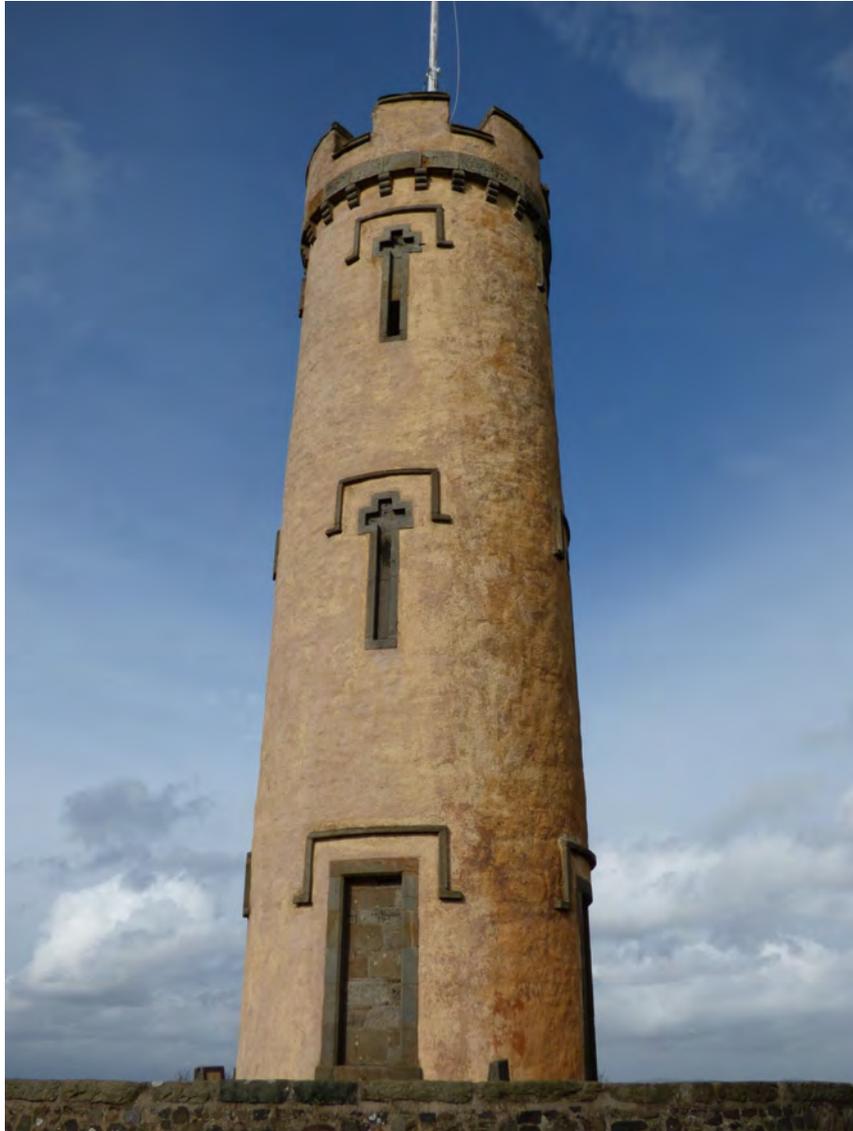
Figure 24.1 View of the tower from the east.

The tower of the House of the Binns is a round tower constructed of rubble with sandstone dressings. The tower was repointed and harled with an NHL gauged hot-mixed lime mortar as part of major repair scheme. The scheme was supported by Historic Environment Scotland's Annual Repair Grant to the National Trust for Scotland. The limewash used at this stage was mixed with linseed oil and later coats have been added. The limewash is pigmented and there were at least four coats of various colours observed in areas where the limewash and the surface of the harl have been locally eroded. It was also noted that the aggregate used in the harl contained shell and it is understood that this was added as part of the aggregate component of the mortar.

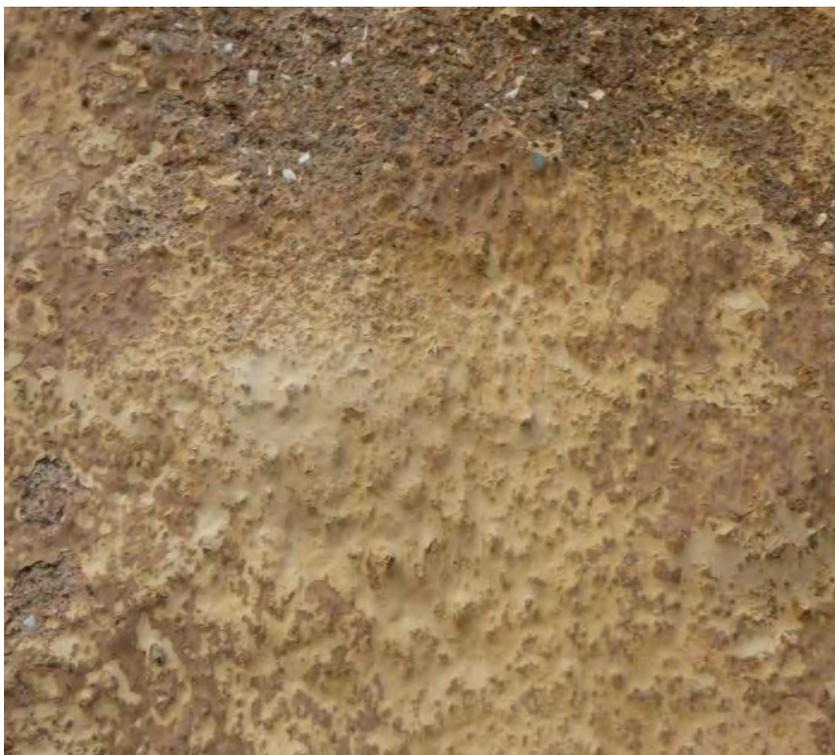
Figure 24.3 Close-up of an area of harl which has suffered from localised erosion, showing the range of limewash coats and the crushed shell.
