REFURBISHMENT CASE STUDY 29

FALKLAND HOUSE STABLES FIFE

MAINTENANCE AND ADAPTION WORKS

MAINTENANCE AND ADAPTATION WORKS

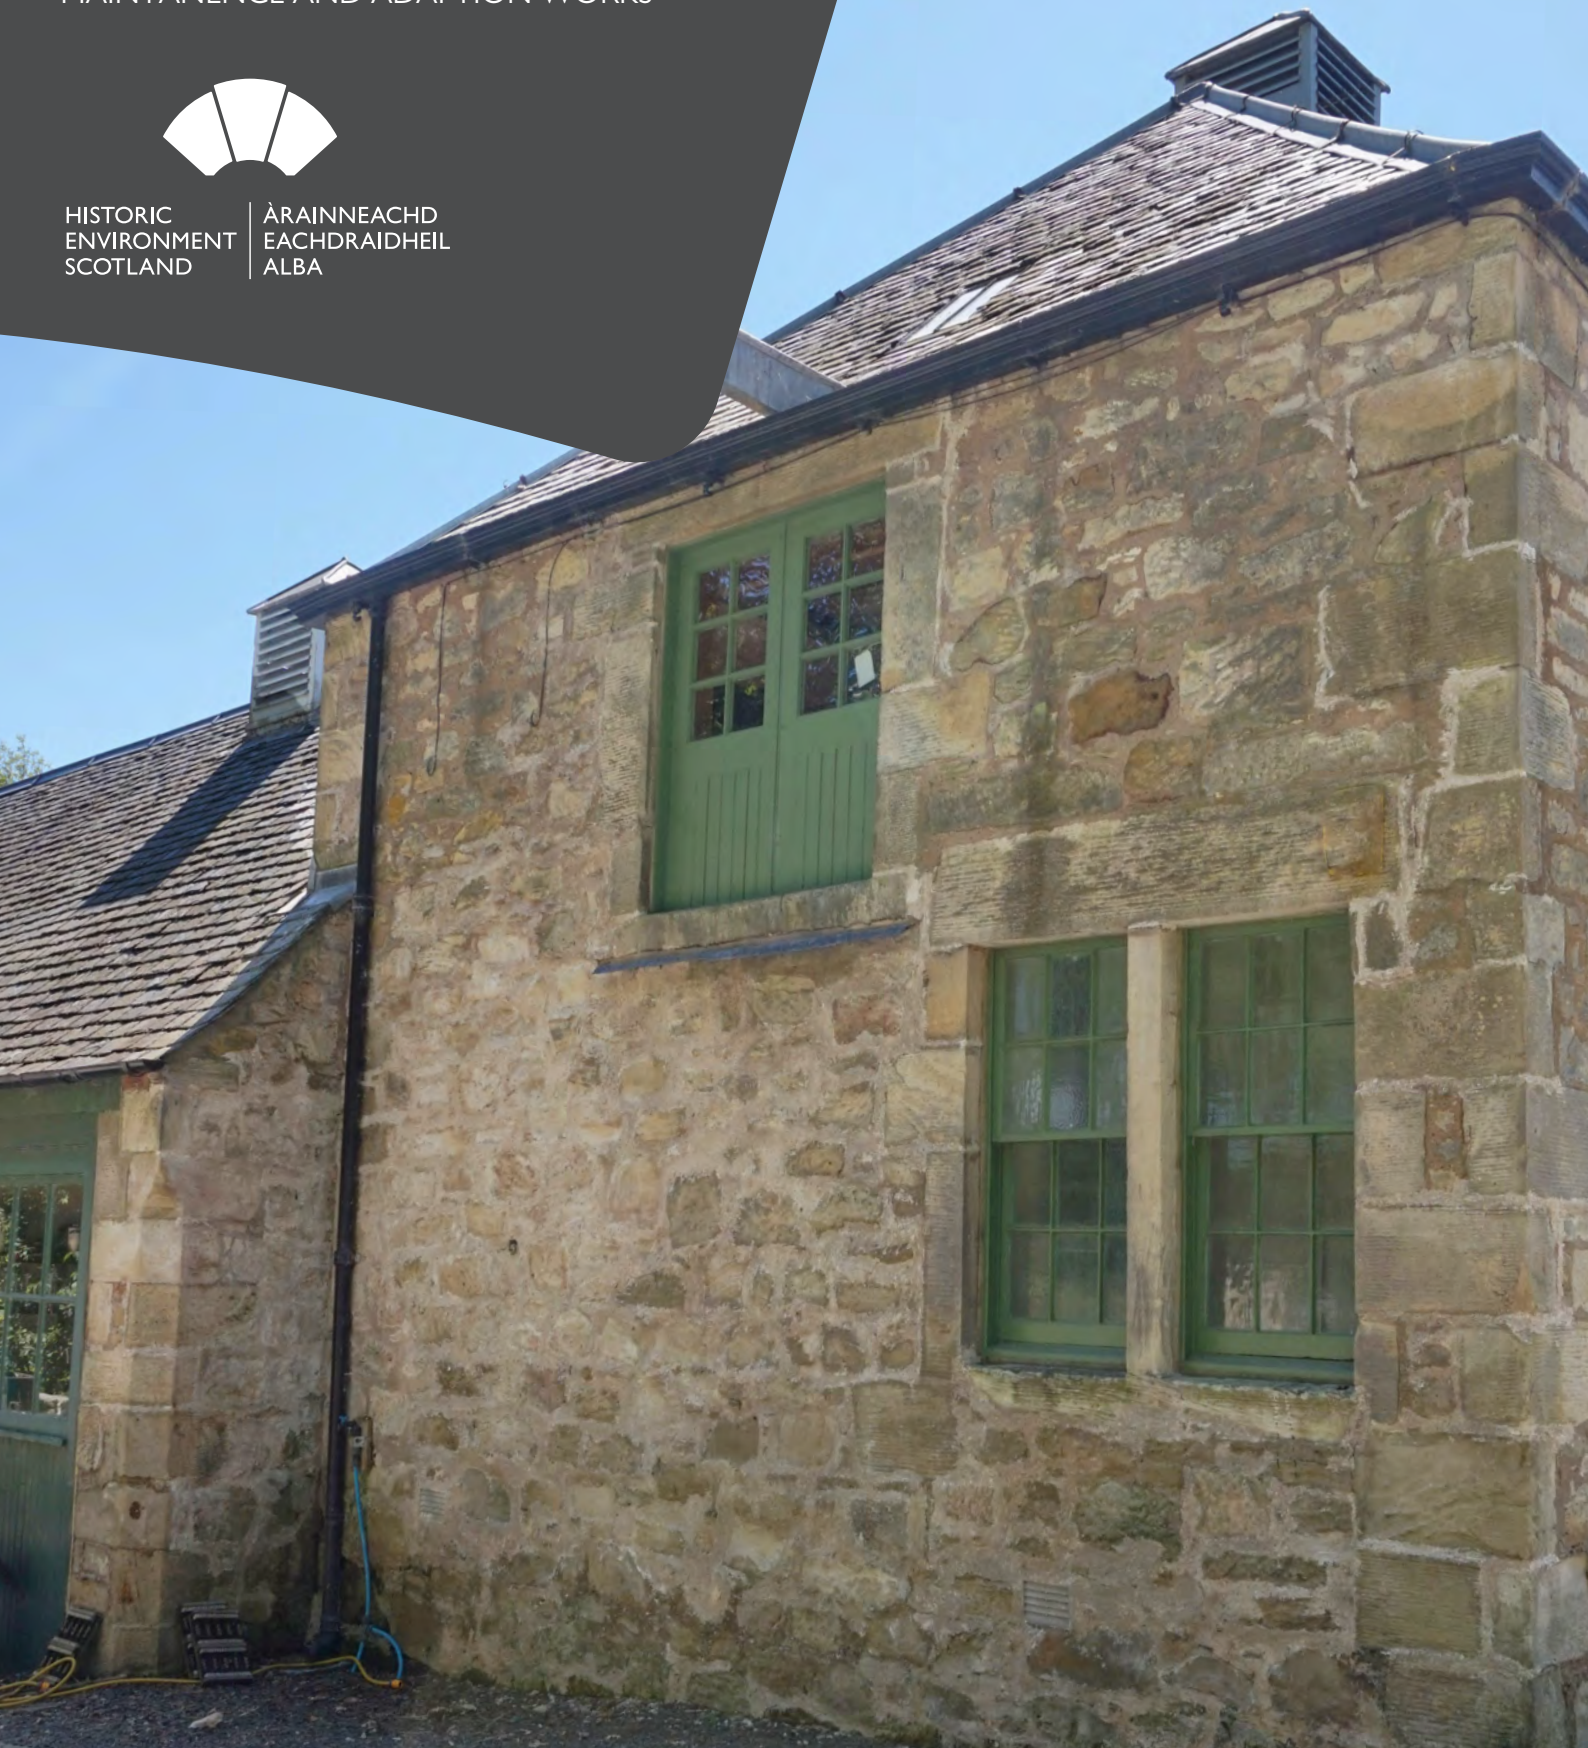
Figure 1. View of the north elevation of the stable block where the works took place. Note the poor condition of the stonework at lower levels.
