FIVE TENEMENT FLATS, EDINBURGH

WALL & WINDOW UPGRADES

This publication should be quoted as:
Historic Scotland Refurbishment Case Study 1

Historic Scotland Refurbishment Case Study 1

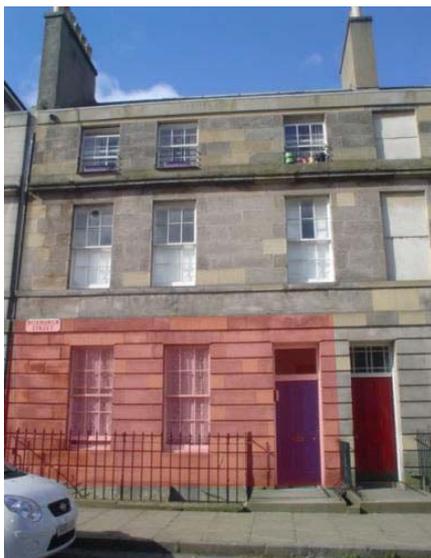
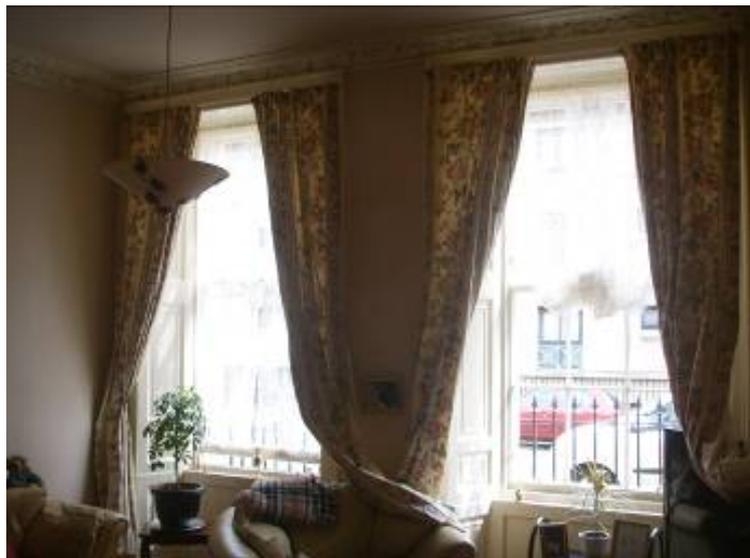
Fig. 1. Views of 16 Roxburgh Street prior to works

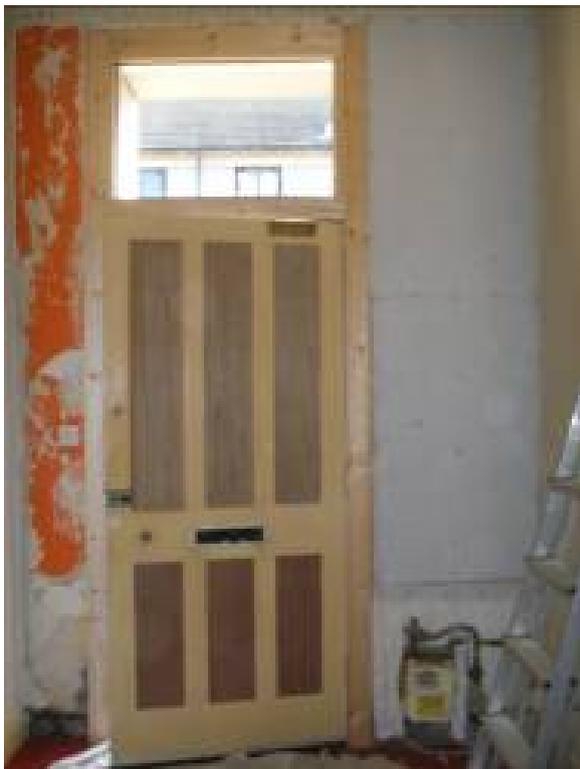
Fig. 8. Insulation of the front door

- Existing wallpaper removed
- Existing skirting removed and set aside
- Existing door facings in entrance removed and set aside
- 10 mm thick timber rail fixed to the head of the wall in the hall, below the cornice, with 15 mm stainless steel plasterers stop-end bead
- 25 mm thick dressed packing timbers fixed to the existing skirting grounds and door frame
- Light switches and sockets removed and made safe. Back boxes fitted with 25 mm extension pieces, and fittings replaced on completion of insulation/plaster works

- 10 mm thick Proctor Spacetherm insulation blanket fitted to external walls, and held in place with stainless steel expanded metal lath, fixed with proprietary 'mushroom headed' plugs drilled into masonry
- 12 mm bonding coat of Limelite plaster applied to the metal lath, and finished with a 3 mm Limelite skim coat
- Skirting and facings reinstated
- New plasterwork painted with clay based paint, in three coats
- All new joinery work painted one primer / undercoat and two coats gloss. All existing, reinstated woodwork was prepared, with any filling / making good painted with one undercoat / primer and one coat gloss, and a complete top coat

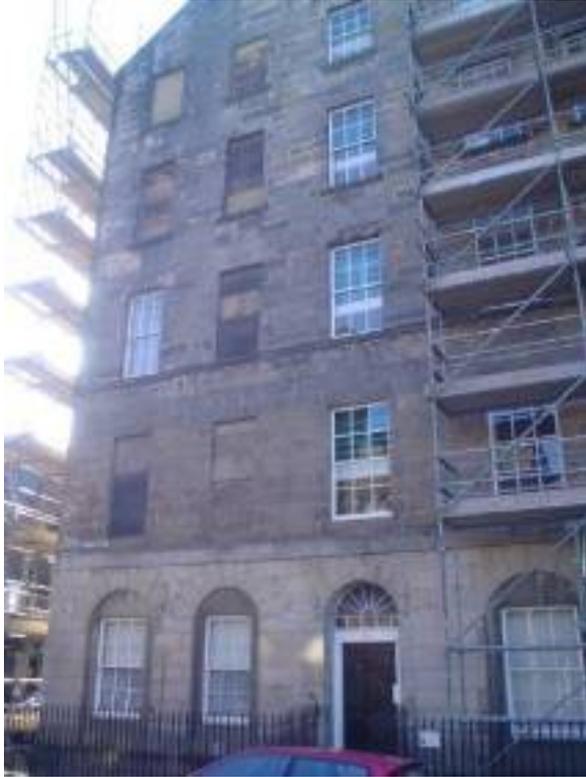
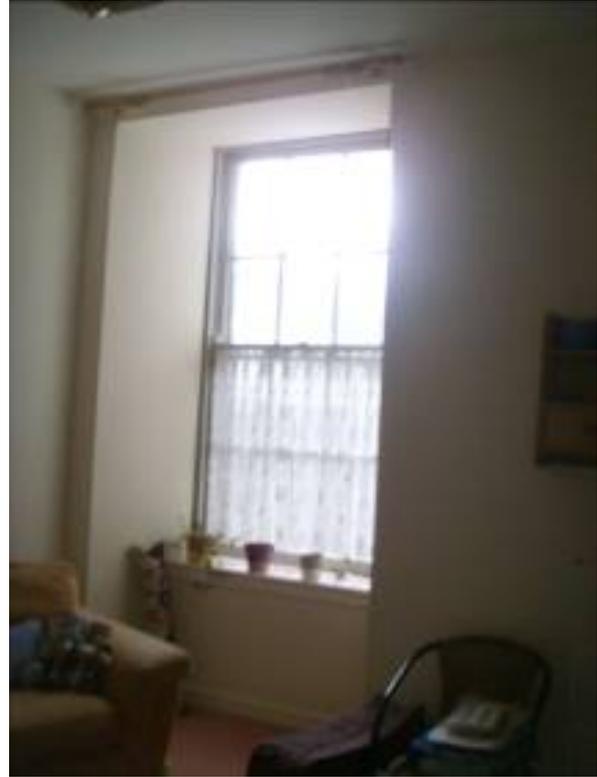
Fig. 11. The Drummond Street flat before the works

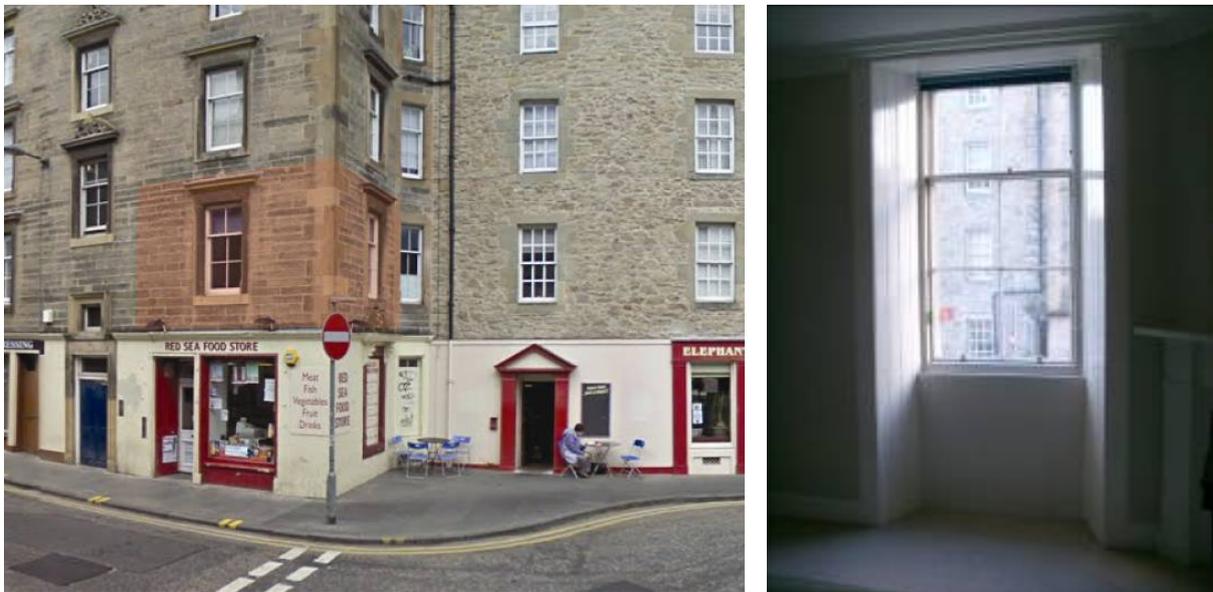
Fig. 15. The Marshall Street flat prior to the works

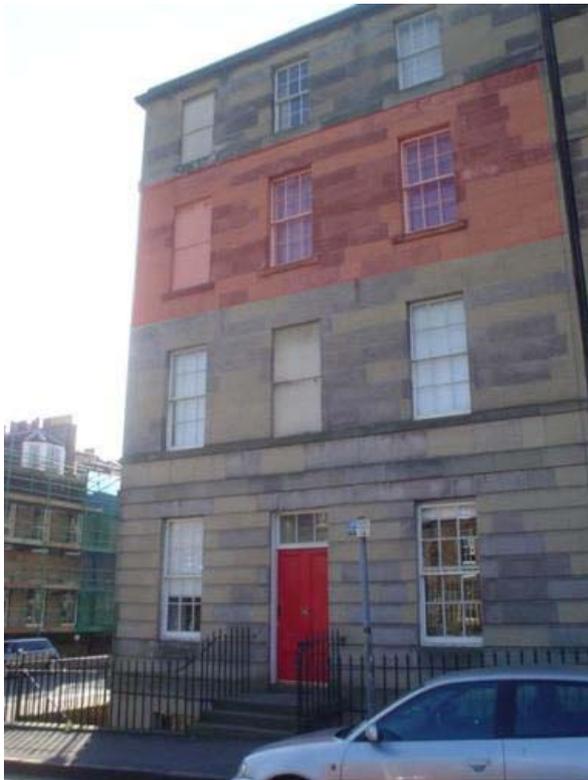
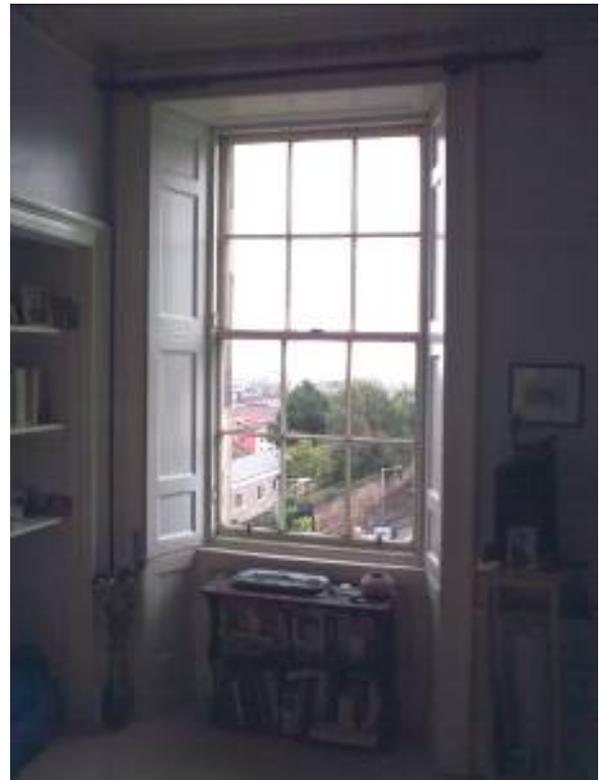
Fig. 19. The Roxburgh Street flat prior to the works

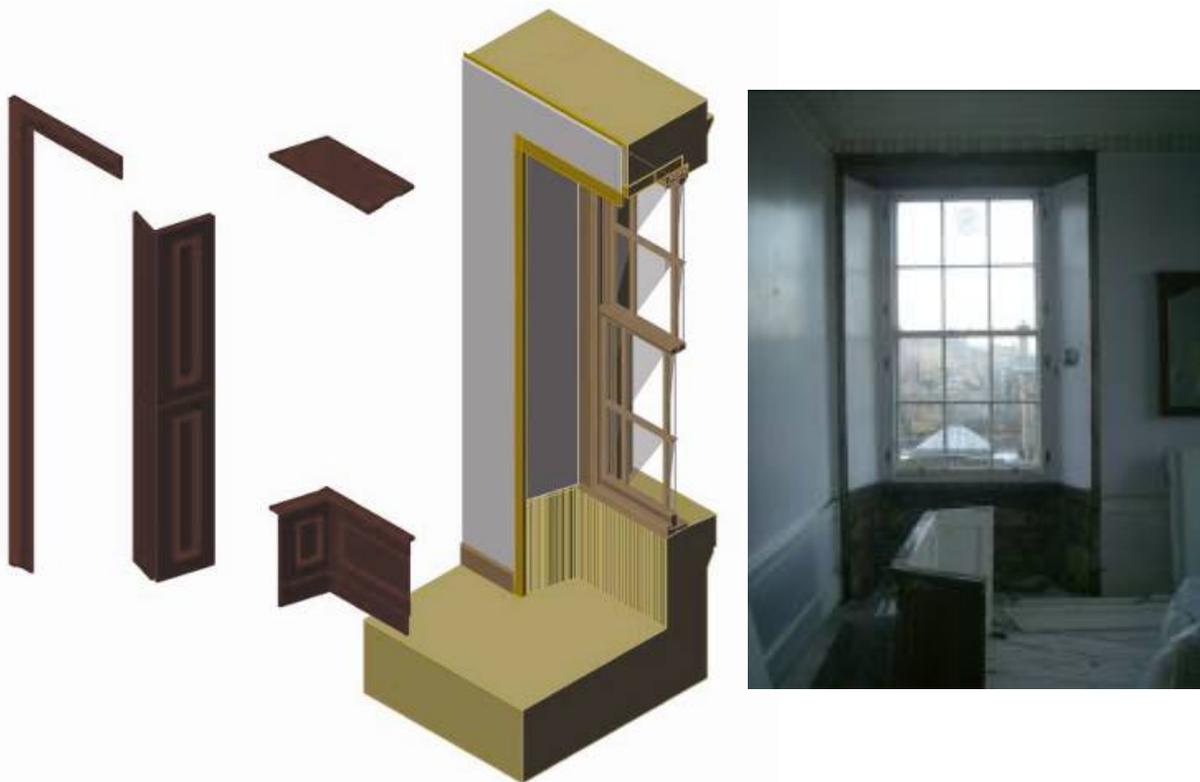
Fig. 20. Diagram and photograph showing downtakings

- Shutters / hinges were unscrewed from case lining, leaving the plaster 'on the hard' to the shutter pocket exposed
- Architraves and skirting blocks were carefully prised away from timber grounds, taking care not to disturb the decoration or plasterwork
- Soffit panels were prised away from timber packers / timber safe lintels, exposing the cavity at the head of the window opening
- Window elbows and backs were removed in one piece, exposing the cavities between the architrave / lath ground each side of opening, below cill level (the cavities above cill level being otherwise covered by the plaster to the shutter pockets)

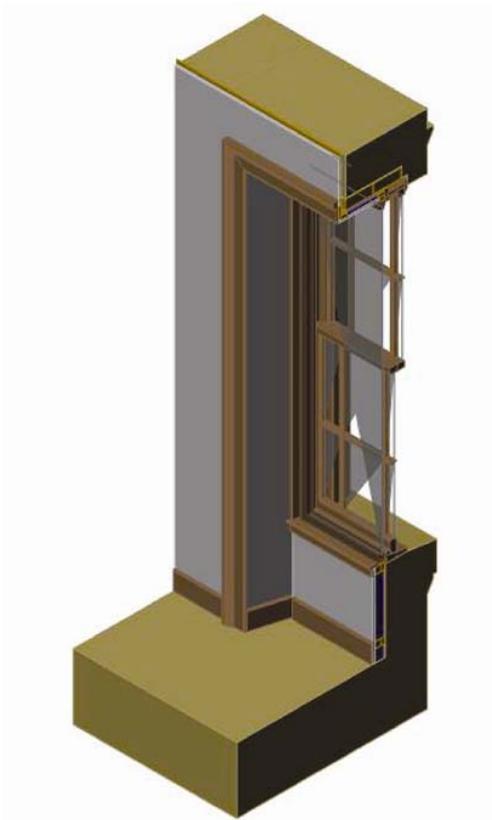
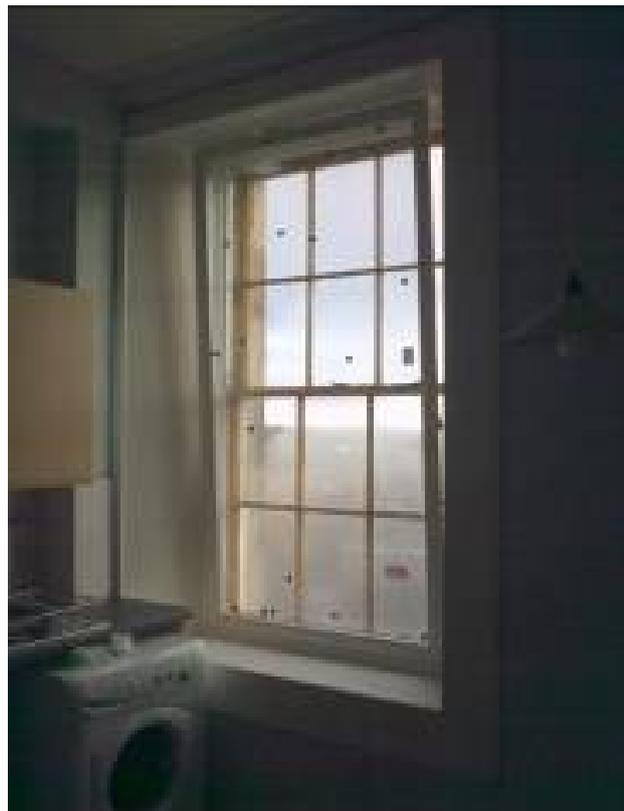
Fig. 27. Completed works to window opening showing tilting secondary glazing

- Salvaged skirting, cill board and apron refitted to small bedroom. Salvaged deep cill re-fitted to kitchen
- All new woodwork was painted with one primer / undercoat, and two coats gloss, and the final top coat applied to the timber secondary glazed units. All existing, reinstated woodwork was prepared, with any filling / making good painted with one undercoat / primer and one coat gloss, and a complete top coat

- All faced-drilled holes for the blown insulation were repaired with a bonding coat and finishing plaster
- The existing wallpaper was stripped from the external walls, and re-papered in 800 gauge lining paper and painted with clay based paint, in three coats. The remaining walls were painted in standard emulsion, to match, simply for continuity

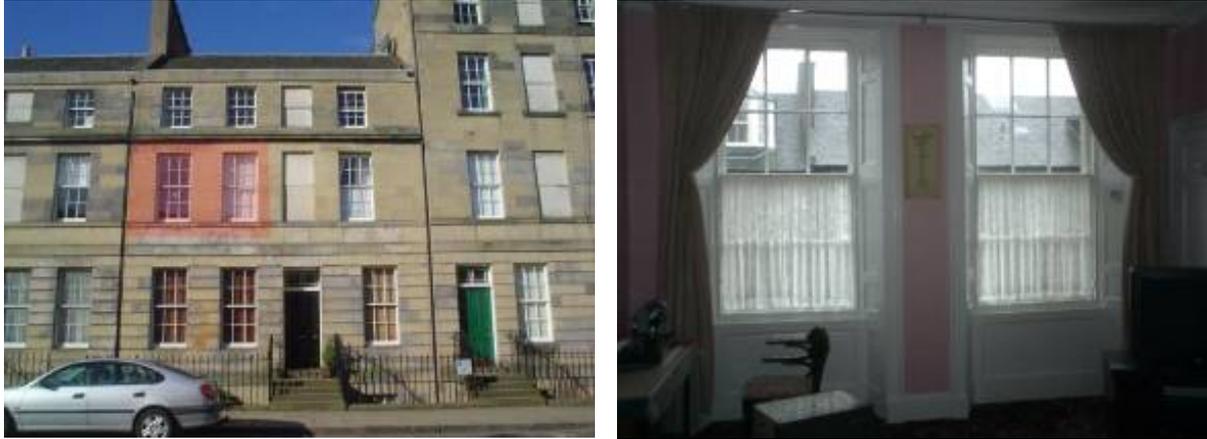
Fig. 28. The flat prior to the works

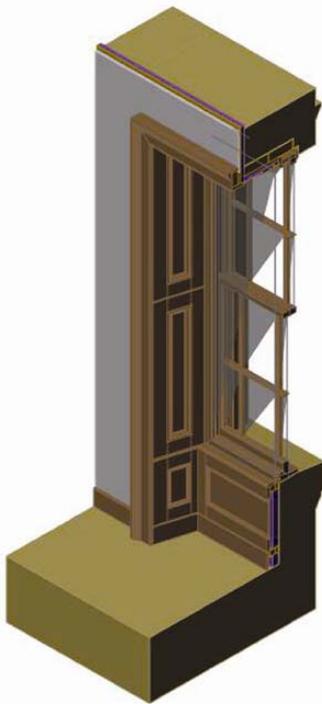
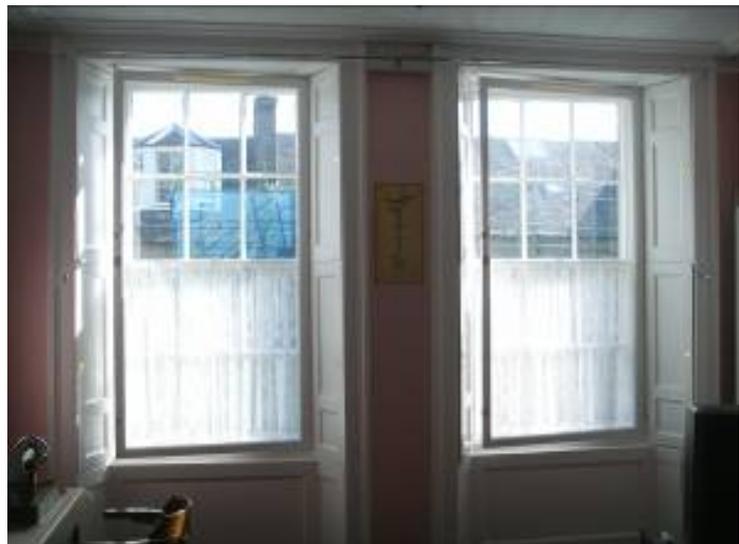
Fig. 32. Diagram and photographs showing completed works

- All new woodwork to the window linings was painted with one primer / undercoat, and two coats gloss, and the final top coat applied to the timber secondary glazed units. All existing, reinstated woodwork was prepared, with any filling / making good painted with one undercoat / primer and one coat gloss, and a complete top coat

- New plasterboard wall lining re-papered in 800 gauge lining paper and painted with three coats emulsion
- Fitted carpets were trimmed and refitted, to suit the new line of the window linings and architraves / skirting blocks

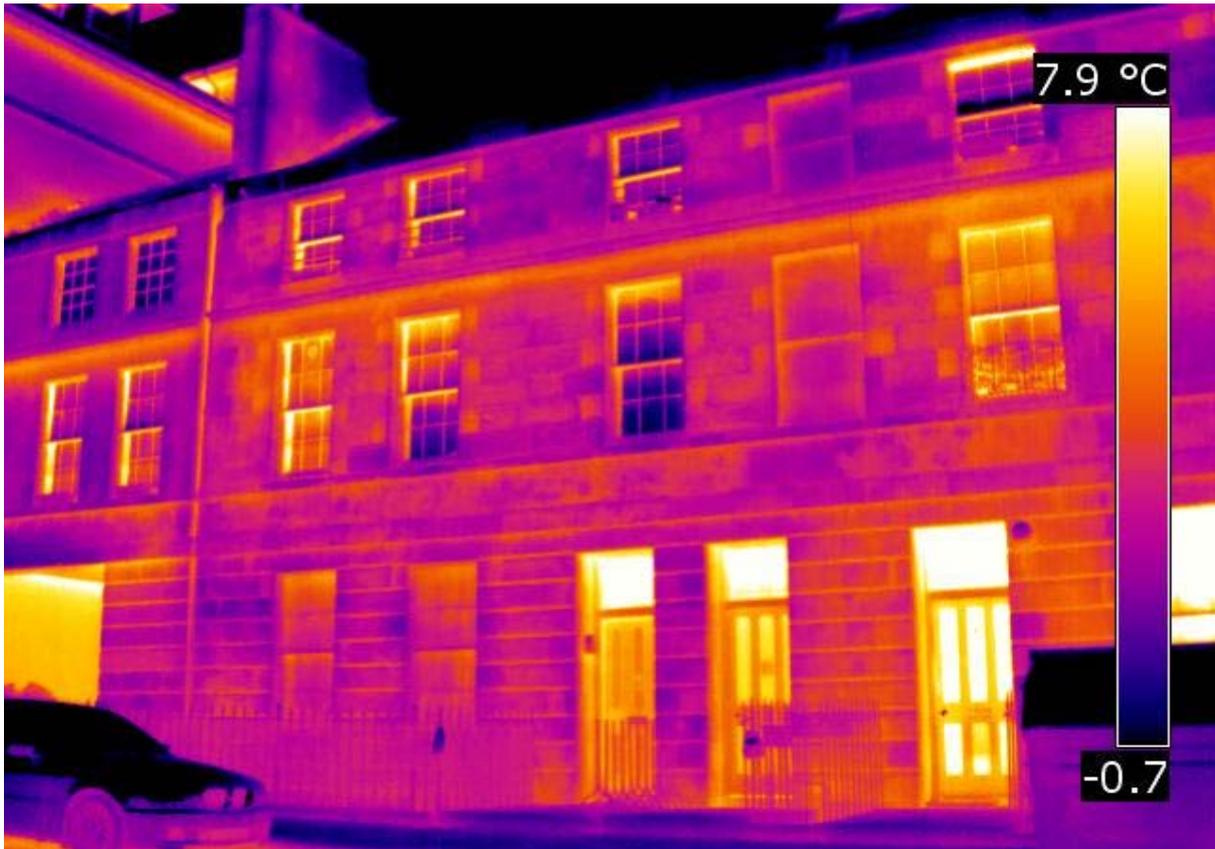
Fig. 35. Thermographic image of 16 Roxburgh Street, showing the thermal improvements to the ground floor windows on the left © Crown copyright (Historic Scotland)
