ST PETER'S SEMINARY Cardross

CONSERVATION ASSESSMENT

Main Report

FEBRUARY 2008

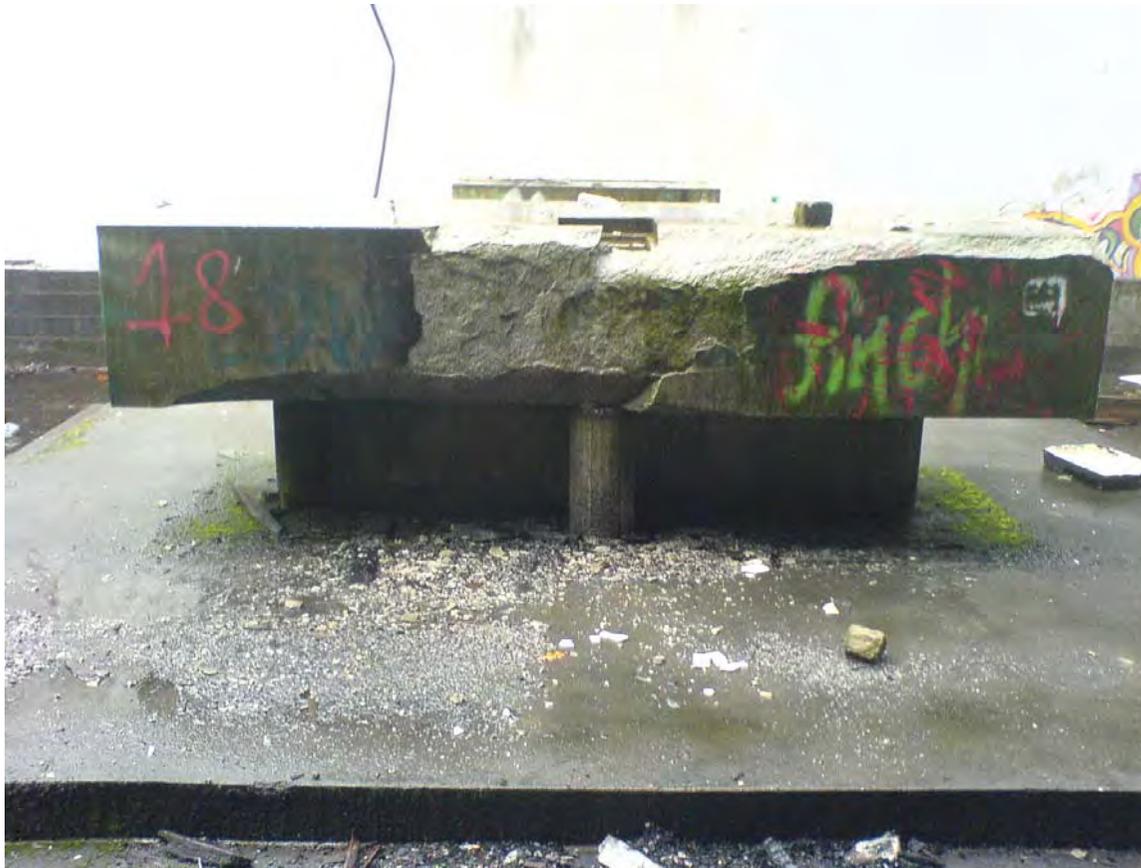
The altar in its current state, 2007

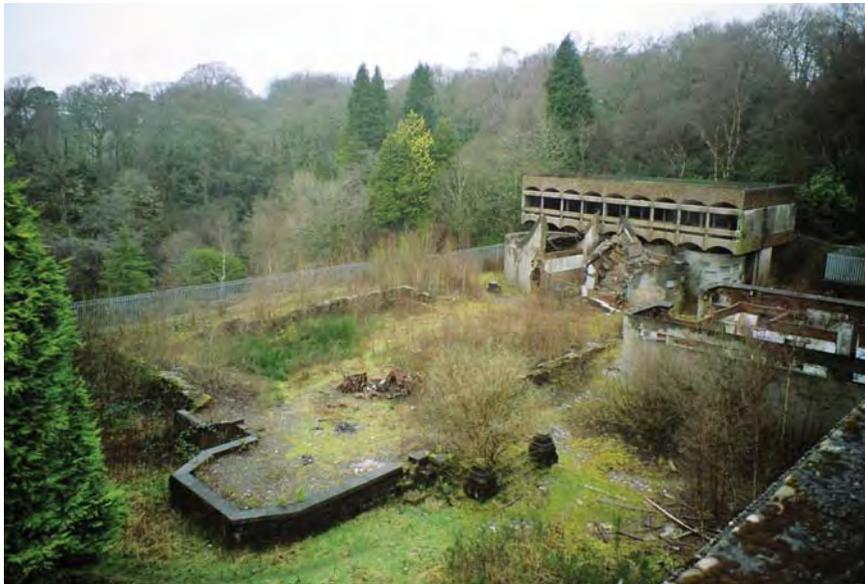
Current view of the remains of Kilmahew House

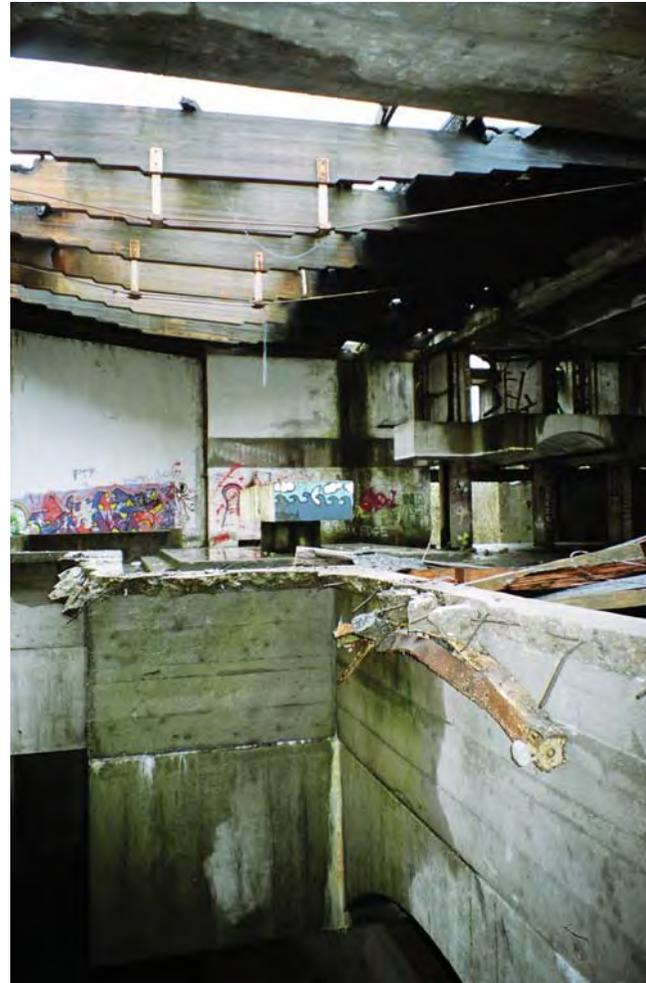
Current view of sanctuary

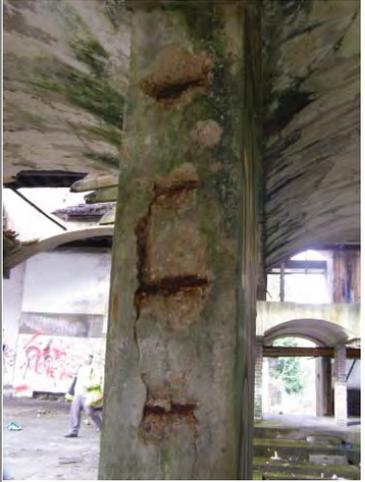
Insitu Frame/ Primary Structure	5 storey structure comprising of in situ reinforced concrete columns, walls, beams, slabs and retaining walls.	The in situ reinforced concrete elements are generally in a structurally robust condition with signs of localized durability issues which have led to localized areas of spalled, delaminated, missing, cracked and honeycombed concrete, exposed reinforcement and defective shutter ferrule plugs. The areas of deterioration are related to the ongoing corrosion of embedded steel reinforcement close to the surface of the concrete elements. If remedial work is not undertaken to the concrete the problems will continue and will begin to have implications on the structural integrity of the structure. Urgency: Medium	P1	The use of insitu concrete has significance both architecturally and structurally. The placing of columns was carefully considered within the ground floor plan, to help define space whilst supporting the structure above.	Modification to the in situ frame including over painting should be prevented. Ensure that all boardmarking and shuttering patterns are retained, and replicated where repairs have been carried out. All repairs should be squared off in outline leaving a light but not unsightly manifestation.

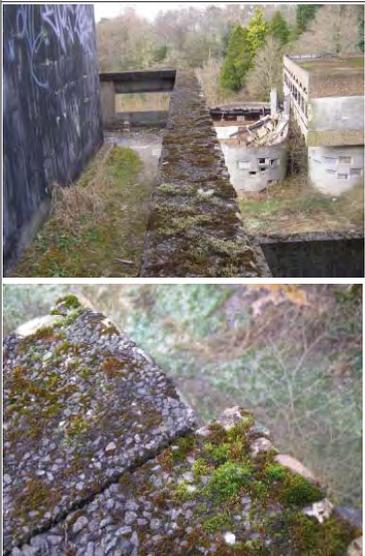
Pre-Cast exposed aggregate parapet handrail panels to galleries	Pre cast concrete slender handrail panels are bolted to pre cast concrete posts.	The bolted connections between handrail posts have severely corroded in places. Where the corrosion has reached an advanced state local collapse of the handrail could happen. Also the facing panels have moved out of alignment as a result of corroding shims which have expanded between the panels and the posts. This damage is progressive and requires intervention now. Urgency: High	P1	These parapet panels form a significant part of the overall elevational composition, and should be regarded as an important conservation item. But whilst the panels are of high architectural significance, their fixings are not so, and these could be replaced with secure, state of the art alternatives.	The pre-cast cladding handrail panels should be retained unless the condition is so deteriorated that replacement is required, in which case, all new sections should closely match the original in all respects. Method of securely re-fixing of parapet handrail panels should be improved by ensuring all metal fixings/plates/bolts are either stainless steel, or galvanized mild steel, and are of sufficient strength and detail to withstand current design loads. Careful consideration would be required if the height of the handrail needs to be increased when reinstated to comply with current legislation.

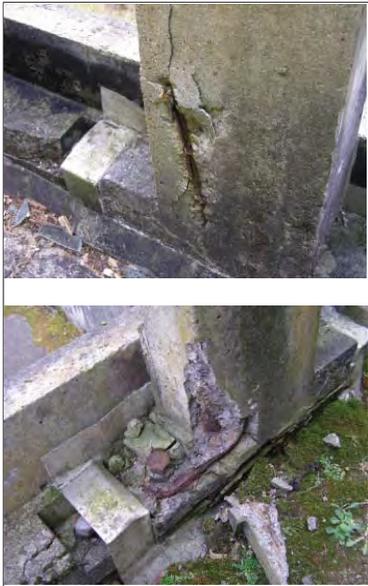
<p>Pre-cast post supports to handrail panels.</p>	<p>The concrete posts are slender, heavily reinforced, inverted 'T' shaped elements with uncoated smooth faced finish to all surfaces. The lower horizontal member of the post sits on top of the cladding panels and straddles the vertical joint between lower panels. Each leg of the T is bolted to the top of the cladding panels. A preformed zinc flashing tray is located within the joints between the post and cladding panels.</p>	<p>Extensive spalling/cracked concrete and corroding reinforcement to the concrete pockets is occurring around the bottom leg fixings of the post. Spalling and corroding reinforcement is evident to all posts. Severe corrosion is occurring to the bolt fixings in the bottom leg of the posts. Certain posts are leaning or lifting due to corroded shims between the posts and cladding. Urgency: High</p>	<p>P1</p>	<p>These posts support the pre cast handrail panels and form a significant part of the overall elevational composition, and whilst significant are less so, than the pre cast handrail elements as these smooth faced pre-cast concrete posts could be readily replicated and in doing so provide a beneficial opportunity to improve the detail to safeguard the long term future of the original pre-cast elements. The fixings themselves are not significant and could be replaced with secure, state of the art alternatives.</p>	<p>The condition of the posts and fixings have deteriorated significantly due to uneven workmanship, the use of ungalvanized metal fixings and lack of cover on the reinforcement. These posts can be renewed offering an opportunity to improve details and fixings. Method of securely re-fixing the supporting concrete posts could be improved by ensuring all new metal fixings are either stainless steel, or galvanized mild steel, and are of sufficient strength and detail to withstand current design loads. Base detail to be re-considered to improve weathering at the junction of balcony and post. The material used to renew the posts could be either pre-cast re-inforced concrete or galvanized mild steel provided that the overall profile, colour, and size matches the original post.</p>

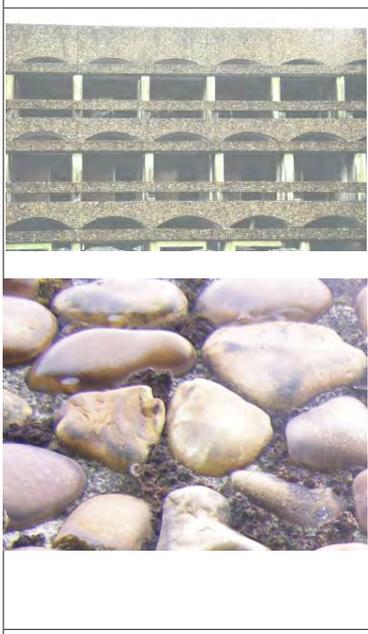
<p>Pre-cast exposed aggregate concrete cladding panels with vaulted profile.</p>	<p>Light brown in colour, external large soft rounded exposed pebble aggregate. The slabs are 4" thick and span 8ft bays in the form of an arch, gallery or handrail unit.</p>	<p>The exposed aggregate panels appear to be in sound condition with little evidence of defects or past repairs. The large aggregates cast into the external faces of the panels appear to be firmly embedded in mortar, with no significant bowing or distortion noted. The galvanized brackets appear to be intact. However all bolt fixing to the cladding panels are severely corroded. The bolts will continue to rust and will eventually fail causing the pre-cast units to fall off the substrate resulting in a severe health and safety risk and material loss. Urgency: High</p>	<p>P1</p>	<p>The choice of aggregate is of key significance to the character of the building and was selected to 'harmonise with the stone of the existing house.' The finish is also suitably vigorous in what is a rugged setting. The pre cast work is similar to the pre cast panels used at the Roehampton Estate. It is reported that the architects asked that the shuttering be similar to the exposed concrete work at the Roehampton 11-storey maisonettes. But whilst the panels are of high architectural significance, their fixings are not so, and could be replaced with secure, state of the art alternatives.</p>	<p>The pre-cast cladding panels should be retained unless the condition is so deteriorated that replacement is required, in which case all new sections should closely match the original in all respects. Any new fixings should be inserted without any visible manifestation to the exterior of the pre cast panels. All new fixings to be stainless steel or galvanized mild steel. All repair work required to the pre cast concrete panels should match the original, pattern, aggregate type, colour and texture. If panels need to be removed, care should be taken to ensure that the vaulted plastered ceiling behind is not damaged. The insertion of sacrificial anodes or corrosion inhibitors should be kept to the non visible rear face of all pre cast panels.</p>

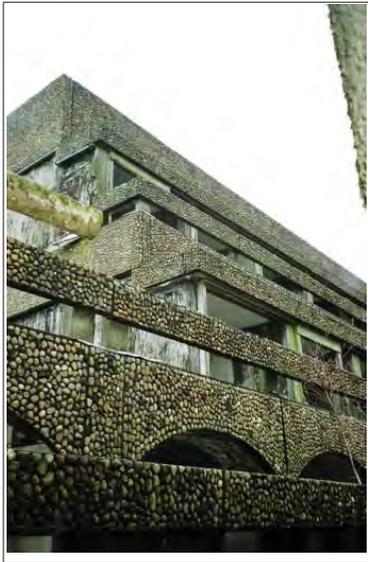
<p>Pre-cast exposed aggregate concrete cladding panels to the roof edges of the study rooms</p>		<p>The exposed aggregate panels appear to be in sound condition with little evidence of defects or past repairs. Urgency: Medium</p>	<p>P1</p>	<p>As above</p>	<p>The pre-cast cladding panels should be retained unless the condition is so deteriorated that replacement is required, in which case all new sections should closely match the original in all respects.</p> <p>Any new fixing should be inserted without any visible manifestation to the exterior of the pre cast panels. All new fixings to be stainless steel or galvanized mild steel. All repair work required to the pre cast concrete panels should match the original. Care will be needed when replacing waterproofing to the roofs of the study rooms, not to affect the visible profile.</p>

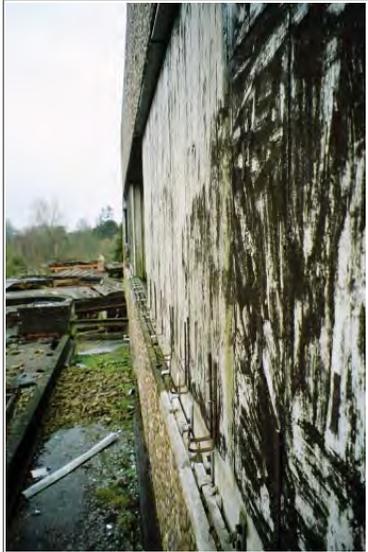
<p>Pre-cast exposed aggregate concrete cladding panel to the South gable of the main block above sanctuary roof.</p>	<p>Light brown in colour, external large soft rounded exposed pebble aggregate. The slabs are located above and below rendered blockwork to the south end of the main block</p>	<p>These panels have been installed with galvanized steel lugs and mild steel bolts. The mild steel bolts have severely corroded and will fail eventually resulting in the panels falling from the structure. Urgency: High</p>	<p>P1</p>	<p>As above</p>	<p>The pre-cast cladding panels should be retained unless the condition is so deteriorated that replacement is required, in which case all new sections should closely match the original in all respects.</p> <p>Any new fixings should be inserted without any visible manifestation to the exterior of the pre cast panels. All new fixings to be stainless steel or galvanized mild steel. All repair work required to the pre cast concrete panels should match the original, pattern, aggregate type, colour and texture. If panels need to be removed, care should be taken to ensure that the vaulted plastered ceiling behind is not damaged. The insertion of sacrificial anodes or corrosion inhibitors should be kept to the non visible rear face of all pre cast panels.</p>

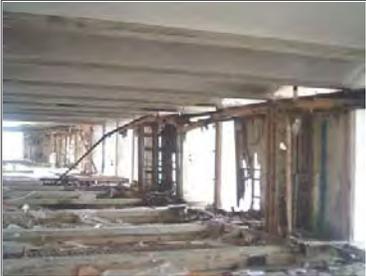
Upper Floors	22mm dressed end grain white pine boards on suspended timber joists spanning between timber runners bolted to in-situ concrete beams The vaulted ceilings are as described below with services located within the floor void.	All floors (where surviving) are covered in debris and potentially hazardous and dangerous so it is difficult to inspect their condition. Much of the flooring is no longer in place, exposing the metal vault formers. The upper floors are dangerous and access should be prevented except where secured and defined as a maintenance access route. Urgency: Medium provided unauthorized access is prevented.	P1	The type of timber flooring provides the warmth of colour to the upper floor spaces, and is an important part of the architectural vocabulary.	Timber flooring should be reinstated to the upper floor spaces, but additional floor coverings such as carpet, sheet materials or alternative timbers, such as a hardwood could be accommodated if colour, texture and details are carefully considered. The addition of thermal insulation to the external envelope could be integrated within the floor void above the vaults. New services may need to be fed beneath the floor and above the ceiling vaults.

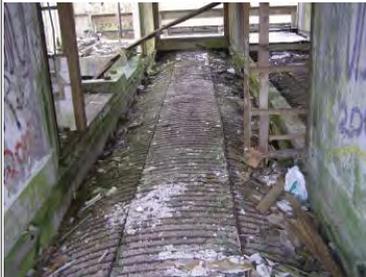
Non structural ceiling vaults	Ceiling construction is vaulted between the primary cross walls with the vaults being constructed with Hy-Rib metal formers coated with cement plaster.	75% of vaults remain mostly intact. They all show signs of water ingress, possibly from the moist environment and water ingress from above but also through the structure. The HyRib pre-formed steel curved lath is corroding which can be seen from above and will eventually fail and the vaults will fall, resulting in significant health and safety issues. Urgency: High	P1	Form, scale and colour are all of significance. Size is a constant reminder of the visual dimensions of the single cell rooms above. The method of construction is also of historical architectural interest due to the use of the patent Hy-Rib technology.	All original barrel vaults should be retained where still viable and repaired/restored, all missing vaults to be re-instated. Reinstatement of missing barrel vaults can adopt new modern method of construction provided that the end result matches original profile and detail. Service voids will need to be carefully threaded below the upper floors and above the ceiling vaults and care will need to be taken to avoid damaging original vaults to be restored.

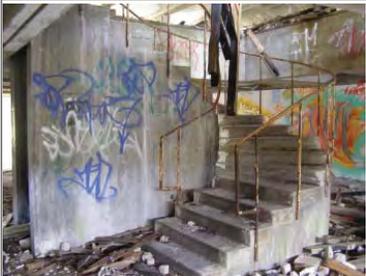
Entrance stair up from cloister level	In situ curved concrete staircase with tubular steel rod handrails surrounded originally with a perimeter timber glazed entrance screen.	Steps still in situ and appear to be largely sound with local areas of spalling evident and local patches of mechanical damage due to vandalism. Metal handrail is rusting and is damaged and bent in places. Urgency: Medium	P2	The controlled entry to the upper level main hall is an important feature and method of direct access up into the principal spaces. The loss of the screen removes the significance of the entry configuration, as the visitor was effectively directed to cross beneath the building towards the angled steps, leading the visitor up to the administrative reception point in Kilmahew House.	The extent of the enclosure to the staircase can accommodate change in areas and detail provided that it does not interfere with the circulation flow under the building and around the cloister. The design of any new screen should adopt a style sympathetic to the original character. Upgrading to new fire regulation compliance should be assimilated within the original design intent.

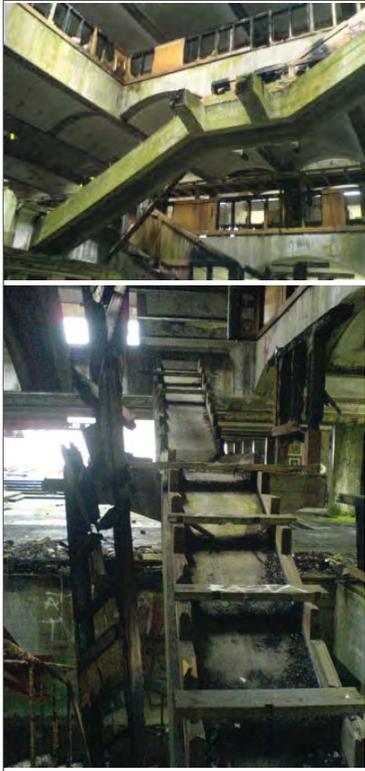
Central staircase and handrail	<p>Main stair comprised of a concrete spine with timber treads and timber handrail supported off mild steel supports.</p> <p>Bespoke cubic light fittings were fixed to projecting concrete arms either side of each landing.</p>	<p>The treads are missing but the concrete spine is largely intact. Remnants of the handrail are visible in parts, but have been severely vandalized. A few treads survive.</p> <p>Urgency: Medium provided unauthorized access is prevented.</p>	P1	<p>The internal staircase in the main hall is located between the two principal spaces offering efficient circulation but more importantly a social meeting place within the main block.</p> <p>Timber was used for the treads and handrails to contrast with the concrete surfaces and provided warmth, colour to the touchable surfaces. The design of the handrail is of particular interest as the string runner above the stair becomes the handrail further up the staircase. Light switches were incorporated into the handrail.</p> <p>The rod and plate internal fixings of the handrail are of interest as a pragmatic solution, but could be readily replaced as necessary to suit more stringent compliance requirements.</p>	<p>The central staircase provides the central vertical circulation to the upper levels and its location and arrangement should be retained.</p> <p>The fixing details of re-newed balustrade may need to be improved to accommodate updated legislation and current Building Regulations. This should be incorporated within the original design intent.</p> <p>Any fire enclosure should be resisted to the central staircase and alternative means of escape identified to remove the pressure for change on what is a key element in the spatial organization of the main block.</p>

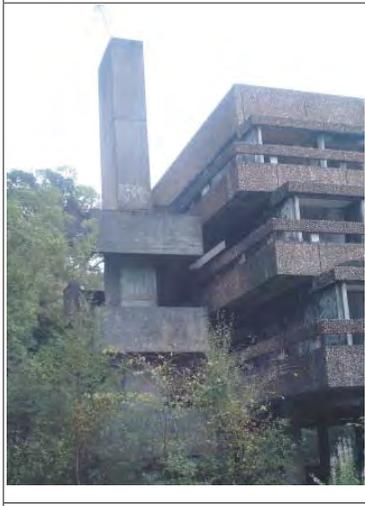
External Fire Escape Stair	<p>Insitu board marked reinforced concrete external fire escape stair serving ground to third floor levels cantilevered from central boiler house chimney.</p>	<p>Local areas of spalling concrete and corroding reinforcement are evident. The metal grid bridges between the stair landings and the main building are in place, but show signs of corrosion and therefore connections should be checked.</p> <p>Urgency: Medium</p>	P1	<p>The escape stair cantilevers from the chimney and is deliberately structurally separate from the main block and is reached over metal grid bridges. The verticality of this staircase offers a closing volumetric counterpoint to the horizontality of the main ziggurat block and should be retained. This element also loosely resembles that at Le Corbusier's Millowners' Association Building</p>	<p>The staircase should be retained as an alternative fire escape from all levels.</p> <p>All repairs should adopt the shutter board marking of the surrounding concrete surface. Careful consideration should be given if corrosion inhibitors/sacrificial anodes are to be inserted, so as to limit the visual impact of new repairs work in contrast to aged concrete surfaces.</p>

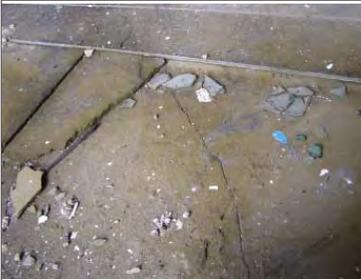
Floor finish	Patent screed of a dark grey colour laid in large panels	The condition is difficult to assess due to the amount of debris on the floor, Urgency: Medium	P2	This choice of the patent screed material, scale and size of panels is of definite architectural interest. The choice of material was neither precious, nor expensive and provided a robust hard wearing surface. Its joints could be carefully designed to fit within the plan form of the principle spaces. The acoustic properties of the floor finish were a factor deliberately intended according to Andy MacMillan.	New flooring could be laid to match the original if required, ensuring all flush threshold details retained similar relationship to one another and all skirting details were carefully detailed. It is important to retain the uniformity of floor surface throughout the ground floor and the scale and layout of the floor panel sizes in any new flooring.

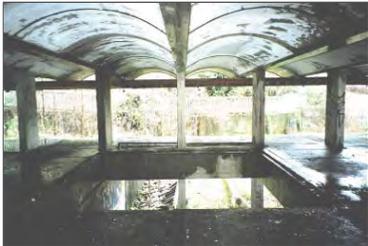
External timber screen windows	Redwood full height timber external screen with randomly spaced mullions to the west, east and north side of the main block and either side of the side chapels.	These screen are largely missing, only small pieces of timber remnants are visible in areas. Urgency: Medium	P1	The random spacing between the mullions offers a significant counterpoint to the regular rhythm of the barrels and was a significant reference to the 'ondulatoires' used by Le Corbusier at La Tourette.	The visible width of all new mullions and transoms should be kept as close to the original size when incorporating double glazing. Solar control glass should be as clear a possible avoiding use of tinting. The material used for the glazed frames, could be polyester powder coated aluminum or steel if low maintenance is a priority. All original colours and mullion transom patterns should be restored to match original fenestration patterns. Consideration should be given to eliminate cold bridging at reveals.

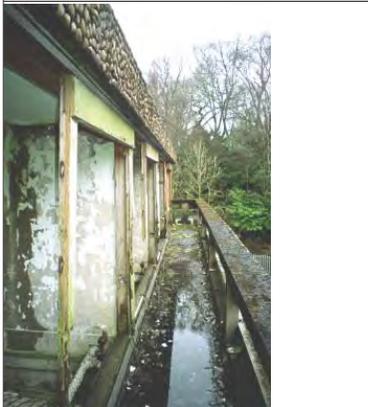
External timber screens to student rooms	Full room width painted green (although historical references describe the original colour as being dark brown) redwood timber screen window with single outward opening door to access external gallery. Concealed lighting was incorporated above window.	All glass is missing. 90% of all timber window framing and doors are missing. Remnants of the perimeter framing is still in place in parts, particularly where the wc, bathrooms are located on each upper floor. Urgency: Medium	P1	The timber detail, paint colour, section sizes and mullion, transoms locations are all important. The timber type is paint covered and therefore can be revised to suit if required.	The visible width of all new mullions and transoms should be kept close to the original size when incorporating double glazing. Solar control glass should be as clear a possible avoiding use of tinting. The material used for the glazed frames, could be polyester powder coated aluminum or steel if low maintenance is a priority. All original colours and mullion transom patterns should be restored as original. Consideration should be given to eliminate cold bridging at reveals.

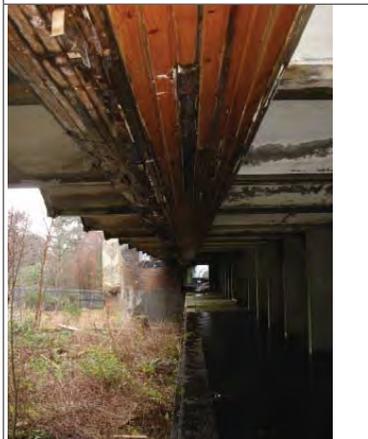
Soffit cradle head detail above external timber screening and below the barrel vaults	Clear finished slatted t&g pine profiled curved cradle fixed to underside of first floor soffits and above the timber window mullions	50% of this profile soffit cradle detail is still in situ, but the timber has suffered weather damage and vandalism. Urgency: Medium	P2	Particular detail located below the barrel vault and above the external window screens. This provided a profiled and horizontal element below the arched form to support the head of the window screens and the cill of the arched clerestory window to each barrel vault. Concealed uplighting appears to have been fixed within the cradles.	The cradle detail provides an important device to conceal services and possibly lighting and provides a horizontal head to fix the perimeter external glazed screens. Adaptation of the installation details may be necessary to avoid cold bridging. Where original sections are being re-used these should be contained in distinct and whole section pieces to avoid any problems with matching new timber next to aged timber. New lighting to current standards may be incorporated without difficulty where light source is concealed.

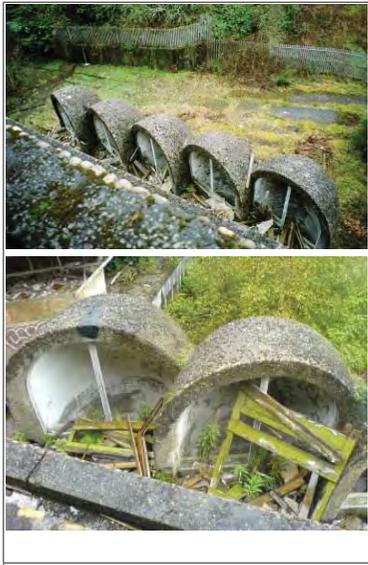
Side Chapels	10 silo shaped chapels; constructed of 19mm thick harled roughcast on 305mm cavity load bearing brick structures supporting insitu concrete semi domed roof tops invisibly lit from semi circular windows at a splayed angle to the west and east side of main chapel	Sections of harling have fallen off and areas are blown and delaminating away from the brick surface. The exposed brickwork is showing signs of deterioration with the exfoliation of the brick face and deterioration of the mortar jointing is evident. Staining to tops of the silos has occurred. All glass and most of the timber high level window framing is missing or damaged. Internal plaster finish is damaged in places mostly due to water ingress. Urgency: Medium	P1	The form, harling surface finish, location, concealed slanted high level windows are all important key elements of the overall composition. These silos evoke the work of Le Corbusier by suggesting an image of clasping fingers pioneered by Corbusier at the Ronchamp Chapel. The material used in construction other than the texture and colour of the harling to the external face of the silos are merely appropriate to their form and functional in detail.	The chapels and their relationship with the main chapel space should be maintained. All surfaces and structures should be repaired. The visible width of all new mullions and transoms should be kept as close to the original size when incorporating double glazing. Solar control glass should be as clear a possible avoiding use of tinting. The material used for the glazed frames, could be polyester powder coated aluminum or steel if low maintenance is a priority. All original colours and mullion transom patterns should be restored to match original. Consideration should be given to eliminate cold bridging at reveals.

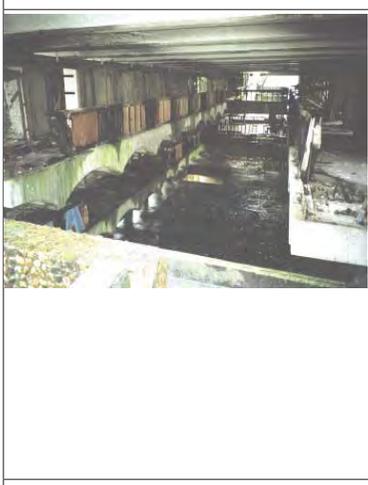
Internal timber screens and doors	Partitions dividing the hall and upper internal galleries from the chapel were made of pine and translucent glass. The double doors to the chapel and refectory were all of gridded timber detail	All missing Urgency: Low	P3	These internal screens defined the space and controlled the connection between principal spaces. The loss of these destroys the legibility of the plan and definition of use. The warmth of the timber and the detailing were all important in providing the intended contrast with the concrete surfaces. The internal doors were grid-like in detail and references have been made to CR Mackintosh.	Timber species to closely match original wherever possible. Location of doors may be re-considered provided that this does not compromise the significant aspects of the internal layout. Contemporary timber coatings can be used to enhance durability. Upgrading to new fire regulation compliance should be assimilated within original design intent.

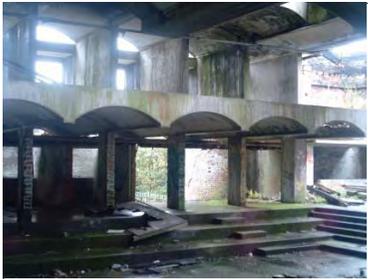
Internal timber partitions dividing upper galleries and void over chapel	Partitions constructed in 16mm red pine tongued and square channeled vertical boarding on 75x50mm timber framing.	All appear to be missing. Urgency: Low	P2	These internal screens defined the space and controlled the connection between principal spaces and the priests cells on the upper levels. The loss of these destroys the legibility of the plan and definition of use. The warmth of the timber and the detailing were all important in providing the intended contrast with the concrete surfaces.	Alteration in the location of the screens may be considered provided that this does not compromise the significant aspects of the internal layout. Timber species to closely match original wherever possible. Contemporary timber coatings can be used to enhance durability. Upgrade to the construction of the partitions may be required to comply with current Fire and Building Regulations.

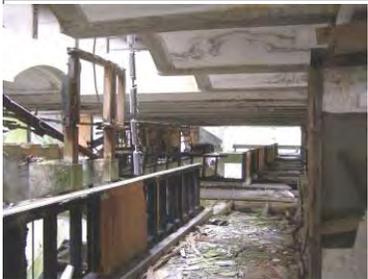
Timber handrail and guardings to internal upper floor galleries	Pine timber solid handrails spaced slightly above the cantilevered galleries floors. Baluster members are secured by mild steel tie rods with square flanged plates.	20% remain insitu but are largely in very poor condition from vandalism, fire and water ingress. Urgency: Medium	P1	These provide an obvious warmth of material to the upper levels of the section. They register as longitudinal timber bands which alternate with the projecting concrete vaults up the triple height space. The rod and plate internal fixings of the handrail are of interest as a pragmatic solution, but could be readily replaced as necessary to suit more stringent compliance requirements.	The detail and location of the guarding should be maintained. Upgrade of fixings may be required to meet current Structural Loadings and Building Regulations. Timber species to closely match original wherever possible. Contemporary timber coatings can be used to enhance durability.

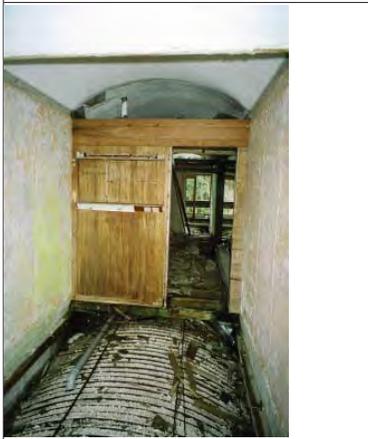
Student room interior	8ft wide single vaulted room with built in wardrobes, wash hand basin Plastered vaulted ceiling painted white. Concealed lighting within the joinery details. Evidence of low level heating.	Many cells have no floor covering exposing the Hy-rib metal formers of the vaults below. Most have large areas of plaster intact. Several have the entrance partition still in place but in most cases have been damaged and most have the fittings removed. The vaulted ceilings of the higher levels are more in tact than the lower vaults. Urgency: Medium	P2	These cells are structurally, and architecturally, important. The 8ft width cell provides the initial conceptual basis for the main ziggurat structural concept and this dimension filters through the plan of the building. Little of the interior fittings have survived but would have been significant in demonstrating the degree of architectural thought which was undertaken to tailor the interiors to the needs of the students.	Original 8' wide cells to be retained. Wash hand basin, wardrobe, paneling, desk and shelving details could be re-instated, adapted, or omitted depending on, and, if necessary to allow for future re-use. The individual rooms should not be knocked through but a discrete interconnecting door might be considered to offer more flexibility of use. One original student cell could be selected as a representative 'heritage room/s' and reinstated to original design and detail with salvaged and/or replacement fabric.

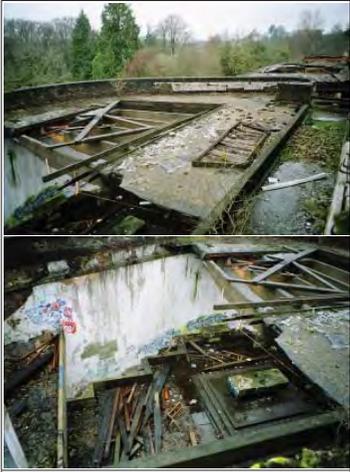
Roof Covering	3 layers of asbestos based built up roofing felt on 25mm of insulation on 22mm timber sarking on 100x25mm joists	Roof has been almost entirely destroyed by fire and vandalism. Areas of felt, sarking and roof timbers are still in place. Evidence of the location and size of the large roof light still visible. Urgency: High	P1	Roof covering material is purely functional and out of sight. No rainwater goods are visible.	Any new roof covering material should be chosen to meet the required design life. Built- up roofing felt, single ply membrane, asphalt are all acceptable alternatives to the original asbestos based felt. When re-roofing, improve drainage falls and insulation thickness provided that the outcome does not affect the roof line and profile. All maintenance fall arrest equipment should be installed out of sight. Any new plant room or equipment at roof level should be located well back from roof edges, out of view.

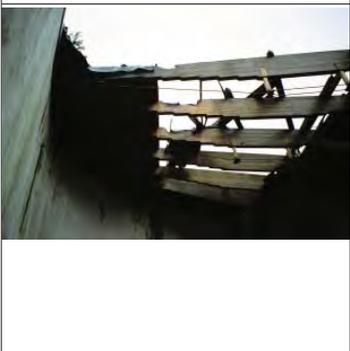
Roof light	Wedge shaped stepped rooflight. Originally constructed in timber frame covered with 24g copper on 22mm t & g sarking and 25mm insulation	Missing Urgency: High	P1	Shafts of sunlight and shadows filter through the glulam beams providing natural daylight illuminating the altar sanctuary below. The timber added a rich hue to the light which filtered through the beams and this light also reflected off the white apse. This feature was highly significant to the original reading of the sanctuary.	The size, location and profile of the roof light should match original. Modifications may be required to improve thermal, solar and weathertightness.

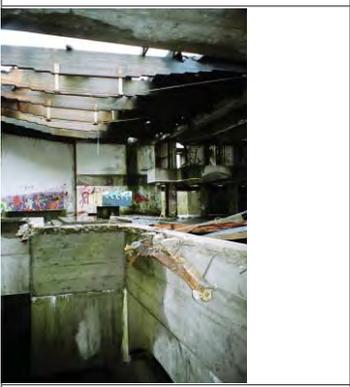
Roof Beams	Oregon pine laminated timber roof beams, with a serrated bottom tapered edge and tie rods slung below metal spacers, the composite member being supported on an in situ concrete ring beam.	Approximately 6 of the original beams remain in place but are in danger of collapse. Parts of other beams lie on the floor below in very poor condition. Urgency: High	P1	The material, profile, layout and design of the glulam beams are all of high architectural significance. These are now the only unique timber components remaining in the building. The beams added a richness and colour to the daylight which filtered through the grid like structure into the sanctuary.	It may not be possible to structurally prove and restore the remaining original beams and therefore they may need to be re-newed. They should match original in all aspects, colour, timber, detail, profile, size and layout. The connection details could however be discreetly updated to meet current codes of practice and standards as required.

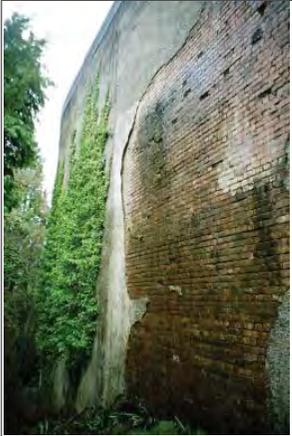
Curved external load bearing wall	White wet dashed harled external masonry curved wall with deep recesses in the outer wall and a insitu concrete flush coping. The internal face of the load bearing wall is plastered and painted white.	The harling has fallen off in large sections and is blown and delaminating in large sections and dangerously still loosely attached to the substrate. Water is now penetrating both sides of the wall. The condition of the brickwork is suspect. SE to confirm. Urgency: High	P1	The form of the sanctuary external wall is significant as it is a break from the controlled regularity of the main block and forms the backdrop to the processional movement from the lower church to the sanctuary. The shape is reminiscent of the curved shape of the crypt of La Tourette. Harling on load bearing masonry is one of the principal materials in the GKC's palette of materials used at St Peter's wherever non-orthogonal plan geometry occurs.	All materials should be retained, restored or replaced to match original. Care must be taken to reinstate reveal details to small windows and to reinstate parapet condition. When repairing in situ concrete coping, ensure the top side is benched inwards to shed rainwater away from the external wall face, to avoid unnecessary staining to the external harling render coat.

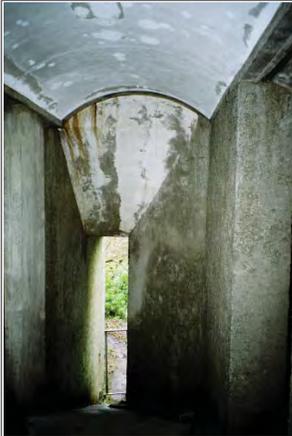
Entrance to sanctuary	Angled stepped entrance approach to cloister level. The entrance is narrow at the low entry point and splays out towards as you ascend up to the cloister level.	Steps appear to be in sound condition but covered in debris, with the exception of the first two steps at the beginning of the flight where the concrete is broken away. The walls are sound but have suffered from damp and water penetration. Manhole covers have been removed to cloister level. Urgency: Medium	P1	This entry is monastic and medieval in feel creating a unique space in the complex. This was a 'secret' connection to the gardens, but is now incorrectly used as an access to the building.	All materials should be retained, restored or replaced to match original.

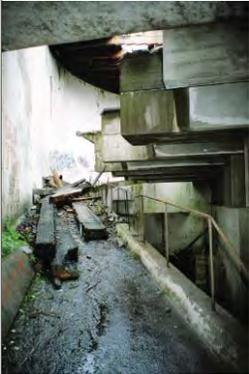
Internal Ramp	Insitu concrete curved ramp which leads up from the crypt and sacristy at lower level to the altar. Tubular metal handrail sits on top to upstand edge of ramp.	Insitu concrete ramp is covered in fallen debris and very wet due to the loss of roof covering, so difficult to inspect its condition. Handrail is bent and rusting and sections are missing. Urgency: Medium	P1	Movement within the sanctuary is generally highly formalized and ritual was signified in the grand processional movement from the lower church to the sanctuary, via the sinuous curved ramp.	Additional balustrade protection may be required to meet current Building Regulations. Care should be taken to limit the visual impact of additional balustrade protection.

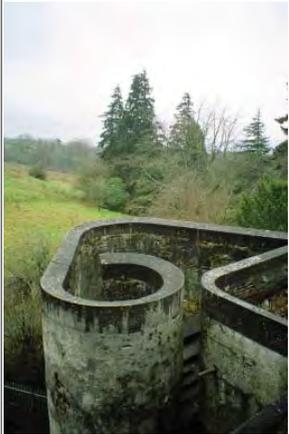
Outside Chapel	Curved load bearing cavity brick wall forming walled enclosure to outdoor chapel. No roof	Harling has fallen off in places and is blown and delaminating in areas. The coping is wet and discoloured. Pointing to brickwork is loose in exposed areas. Urgency: High	P1	A reflective semi- enclosed chapel where solitary prayer could be undertaken. No views out of the space were available other than upwards towards the heavens. This was an important sacred space within the seminary.	This space is currently external and could be enclosed if required provided that any roof construction is kept below parapet level. Drainage of any new roof would need to ensure that no rainwater pipes were visible. A use that enabled it to remain unroofed would of course be preferable.

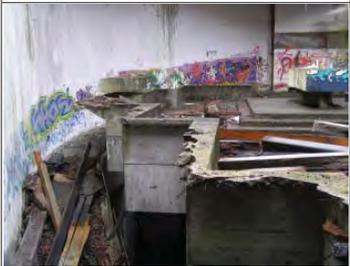
Stepped cantilevered back platform of sanctuary	Board marked in situ reinforced concrete stepped profiled balcony overlooking the sanctuary ramp. Concealed fluorescent lights fitted to back edge of projecting balcony to illuminate the rear curved white wall of the sanctuary.	Covered in graffiti. The corners and edges of the balcony edge have been vandalized, resulting in broken corners visible reinforcement in places. Concrete is wet and green with algae growth due to the missing roof covering. Urgency: High	P1	The stepped profile of the balcony is of architectural interest as is the board marking. The structural system of the principal building has been turned through 90 degrees to terminate the main floor.	All materials should be retained, restored or replaced to match original. Additional balustrade protection may be required to meet current Building Regulations. Care should be taken to limit the visual impact of additional balustrade protection.

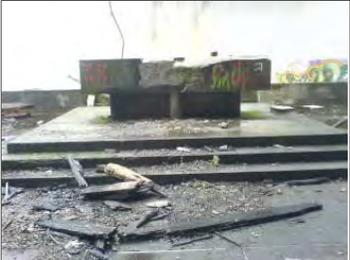
Altar	Large rectangular section of granite stone resting on a smaller granite base. The altar stone cantilevers from central support.	Altar has been graffitied and damaged, chipped and is significantly cracked. Urgency: Medium	P2	The altar is the focal element within the space and has considerable significance to the religious function of the chapel.	This element could be relocated if necessary out of the chapel space, to alternative safe store or the altar stone could be retained as an emblem of the building's history (graffiti et al).

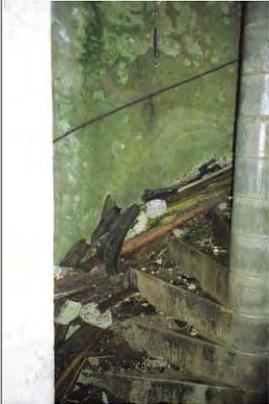
Public access Staircase to Chapel	Pre-cast circular staircase leading from outside up to the external chapel and organ loft.	Staircase covered in fallen debris, but appears to be generally sound and passable. Concrete is wet and green and has suffered from water ingress from above. Urgency: Medium	P2	The entrance is deliberately discreet. The circle forms the tight spring point for the sweeping curve of the sanctuary wall.	All materials should be retained, restored or replaced to match original.

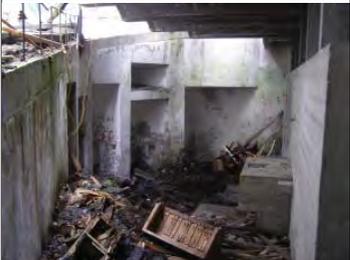
Crypt	Steps down the natural fall of the site. The serial altars are placed in deep recesses in the outer wall	Full of debris, access was difficult. Urgency: Medium	P2	The depth of the wall is used to full effect i.e the 'inhabited' wall common in GKC work. The crypt is also a key part of the sacred spaces, training and functions of the seminary.	The crypt space could be adapted/ altered in layout to accommodate new uses, provided that the recessed niche windows in the external curved walls are retained and not obscured. White wall finishes should also be retained wherever possible.

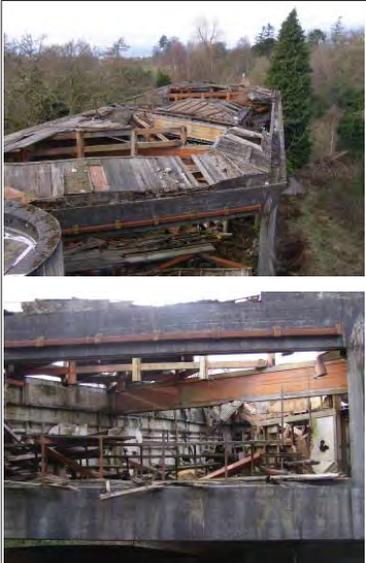
Roof	<p>The roof of the lecture room is of heavy laminated Oregon pine and comprises a double grid of structural and tie trusses, braced by short stalactite posts. There were triangular pyramidal roof lights providing top light. The roof covering was copper laid on sarking. Natural vents to be checked?</p>	<p>Partially collapsed. A good deal of the original roof material still exists with the exception of copper which has all been removed. The location, size and shape of triangular roof lights can be clearly seen.</p> <p>The main deep glulam or laminated main timber beams appear to remain, these act as bracing to the concrete beam walls. The bracing framed beams are in varying states, their condition being difficult to assess due to the roof debris above them.</p> <p>Urgency: High</p>	P1	<p>The roof was a lattice construction of Oregon timber of considerable structural interest providing an intricacy of detail and warmth in contrast to the massiveness of the insitu concrete structure. The material evidence is of importance and should be retained or collected and stored wherever possible for reference.</p> <p>The top coverings in copper were elaborately worked in patterns reflecting the geometry of the roof and were an integral part of the architectural expression.</p>	<p>The roof covering should match original in detail, layout and copper material. Re-roofing will offer the opportunity to improve roof drainage details if necessary.</p> <p>Insulation values should be improved to comply with Building Regulations which may increase the overall depth of the roof structure. Ensure that any increase does not affect the original roof line and level and any increase is accommodated internally.</p> <p>Light fittings could be replaced with new contemporary fittings that closely resemble originals but not necessarily purpose made.</p> <p>Rooflights should be reintroduced.</p>

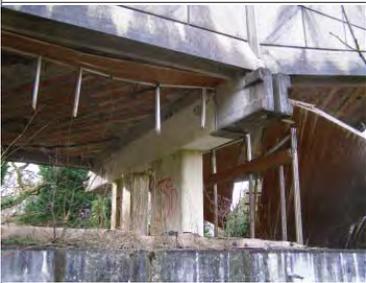
Structure: Insitu reinforced concrete.	<p>The classroom level is supported on 4 columns. These supports two 4ft deep beams which in turn support two longitudinal beam walls spanning 58ft and cantilevering 40ft at each end of block</p>	<p>Refer to S.Eng Urgency: Medium</p>	P1	<p>The scale, massiveness and hand-crafted qualities of the in situ concrete structure are structurally and architecturally significant.</p>	<p>The structure is expressed within the common room space and every effort should be taken to maintain the clarity of the visible structure. Work may be required to reduce the effect of cold bridging and this should be accommodated and concealed within the floor and ceiling voids if possible.</p>

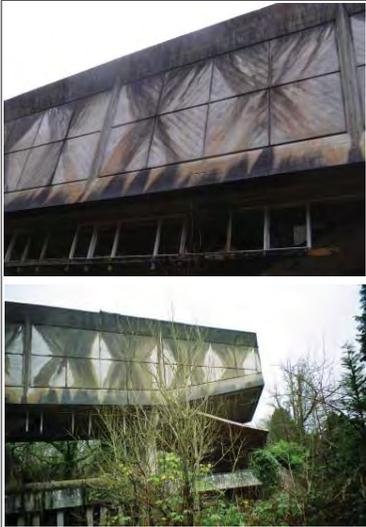
Herringbone board marked in situ concrete beam walls	<p>Beam walls are tapered inwards at the top and base of the wall. The wall is constructed from in situ reinforced concrete board marked with a diagonal herring-bone pattern.</p> <p>There are 7 bays to the north and south elevation of the classroom, 5 bays are rectangular and are divided into 8 panels. The joints are recessed. The bays are then divided by triangular concrete vertical struts. The end bays are splayed and comprise of 6 panels.</p>	<p>No visible spalling. Staining due to weathering has occurred mimicking the herringbone pattern. Water is penetrating down from the unprotected top edge of the wall due to the lack of roof membrane and gutter lining.</p> <p>Urgency: Medium</p>	P1	<p>The boardmarked herringbone pattern to the in situ concrete provides an intricate hand worked level of detail and texture to the surface of the concrete, and is a significant aspect of the architectural expression of the complex.</p>	<p>No alteration to the surface, texture, detail of the concrete should be undertaken unless it can be demonstrated the intervention will improve the long term durability and performance of the concrete structure i.e introduction of drip grooves to prevent water staining to overhangs, parapets etc.</p> <p>External walls should be insulated internally with for example; foil backed insulated plasterboard or be inserted within cavities behind new internal wall finishes.</p>

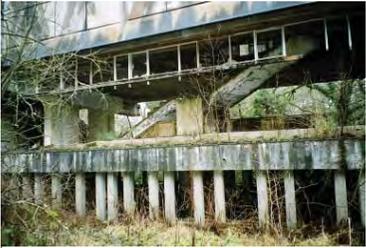
External glazed screen to common room	<p>The perimeter of the common room was enclosed with a full height glazed screen comprising a large lower glazed panel, and a random timber-mullioned recessed glazed panel above a horizontal trough shaped profile located beneath the two beams which in turn becomes the roof below the main westward cantilever.</p>	<p>Small sections of timber framing are precariously still attached to the soffit of the upper classroom level, indicating the rhythm of the mullions.</p> <p>Urgency: Medium</p>	P1	<p>The transparency of the glazed screen allows the solid mass of the classroom to read strongly whilst providing a generous and open connection with the outside.</p>	<p>The visible width of all new mullions and transoms should be kept to the original size when incorporating double glazing. Solar control glass should be as clear as possible avoiding the use of tinting. The material used for the glazed frames, could be polyester powder coated aluminum or steel if low maintenance is priority. All original colours, mullions and transom patterns should be restored as original.</p>

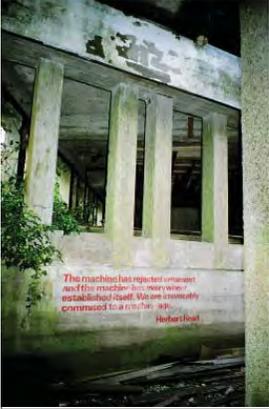
Concrete Mullions	Randomly spaced pre cast concrete mullions to the library level, originally infilled with full height timber glazed panels.	All mullions appear to be present and intact. The timber glazed infill screens are all missing. For condition of concrete refer to S.Eng. Urgency: Medium	P1	The library level is partially sunken. The randomness of the mullions is a clear reference to La Tourette's 'undulating windows' and is a significant element forming the elevational composition of the classroom block. The mullions are set back from the original retaining wall of the old house.	The visible dimension of the mullions and transoms should be kept close to the original size when incorporating double glazing. The material used for the glazed frames, could be polyester powder coated aluminum or steel if low maintenance is a priority. All original colours, mullion and transom patterns should be restored as original.

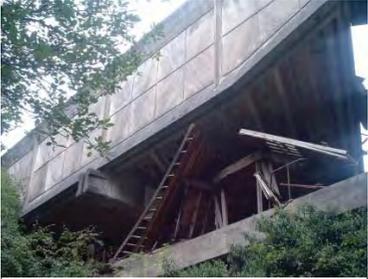
Floors	The floors of the classroom are constructed from beam and block construction	The beam and block floors appear to be in sound condition probably as they have until recently been covered by finishes. Urgency: Medium	P1	Terracotta pot and beam was used extensively to reduce the dead weight of the floor structure. The design and materials are typical of the period.	The floors may require upgrading to meet Building Regulations: Fire and/or acoustic separation. This should be considered carefully so as to maintain flush threshold details and ceiling, glazed screen relationships. Any additional insulation required to meet current Building regulation should not alter the profile of the cantilevered soffits.

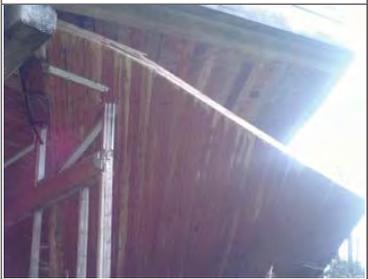
Timber external soffits	The classroom top level cantilevers 40ft tapering upwards at each end forming an external covered area with varnished timber soffits.	The timber soffit to the west end has become detached as a whole from the substrate. A large amount of the original timber is still in reasonable condition albeit in a precarious state of collapse. Urgency: High	P1	The timber cladding to the soffit of the lecture rooms adds warmth and colour to the cantilevers and the canopy soffit above the west facing terrace.	Timber profile, size and pattern should be restored to match original, however the timber type, method of fixing and clear coating can be updated to improve long term performance of soffit. Any additional insulation required to meet current Building Regulations should not alter the profile of the cantilevered soffits.

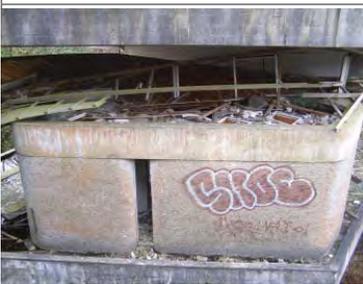
Toilet pod	Harled curved brickwork single storey structure, with insitu concrete coping. located beneath the underside of the main insitu concrete classroom structure. Natural light is provided by way of a full height thin slot with splayed reveals.	External walls and harling remain largely intact probably because of its sheltered location. although its surface has been graffitied. Urgency: Medium	P2	The toilet pod is a self contained and enclosed form in an otherwise open and glazed enclosed space. It deliberately sits beneath but does not touch the main structural soffit of the upper classroom.	The toilet pod space could be adapted for new uses, provided that the external envelope, window fenestration, curved reveals and external curved walls are retained.

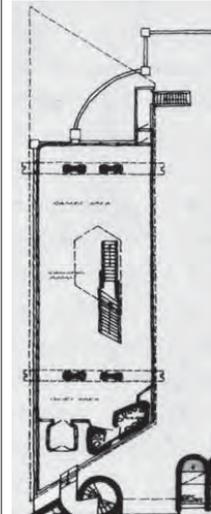
Internal plan layout	Refer to plans	The external envelope of the library and common room are missing. Access to the upper classroom level was not possible as the roof has fallen in on the internal spaces. Urgency: Medium	P2	The single open plan glazed common room space sits below and emphasizes the solid massive classroom volumes above. Views are available through this space from the external courtyard out towards the trees and landscape beyond on the south side of the teaching block. The clever use of adaptable partitions was adopted in the upper level to provide flexibility of classroom numbers. The lecture rooms at either end are expressed externally by the upward canted cantilevers to the east and west ends of the block.	The single open plan space of the common room should be retained. The subdivision and use of the upper classroom space could be adapted for new uses, provided the south and eastern glazed screens are retained. The layout and use of the library space could also withstand adaptation for new uses.

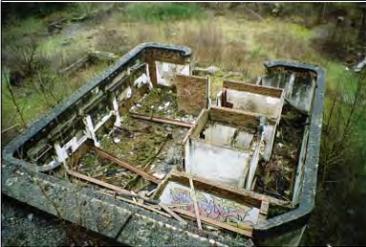
Kitchen Block	<p>Single storey load bearing harled semi curved rectangular block with a narrow timber glazed linking corridor to the existing house. The space was lit by small irregularly placed windows with splayed external reveals. There were two rectangular copper clad rooflights with a swept curved section. The disposition of the windows was determined by the arrangement of the kitchen. Internally, timber ceilings were employed and the walls were covered in glazed white tiling. Quarry tile to floors.</p>	<p>The building is in derelict condition with just the shell remaining. Remnants of the high level windows are left in places. Sections of internal brick partitions are still intact and have original white tile finishes still adhered to them. Flooring is covered in debris but the original quarry tile floor is still evident in places. Urgency: Medium</p>	P2	<p>The position of this kitchen building is significant to the original buildings use as it acts as a social valve dividing the convent from the college buildings and students' accommodation. The only direct contact between the students and the sisters being through the servery at meal times. Its position also allowed the reuse of the existing service access route to the original Kilmahew House and the building helped screen deliveries from the courtyard.</p>	<p>The building should ideally be retained in any proposal for new use as its location is critical to the understanding of the original design and composition of the complex. Its use however and internal layout can accommodate alteration to suit a new use. It might also be removed if this was <u>essential</u> to the fulfillment of a new use for the main building.</p>

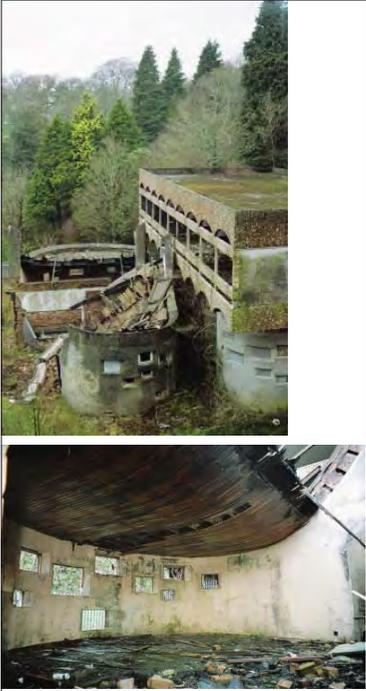
Sisters' refectory and common room	<p>Two single storey load bearing harled curved forms, with roofs in section that sweep up dramatically towards each other. These forms were bisected by a corridor which linked the main convent block. The internal walls were painted white and the curved ceilings were clad with varnished curved timber. Small differing sized windows were arranged randomly in the external wall and have splayed external reveals.</p>	<p>Both structures are in poor condition. The roofs of both are in a state of collapse, although it is still possible to see the timber clad swept form of the common room roof. A good deal of the white painted timber window frames are in place, some opening lights exist but all glass appears to be missing. The interior plaster is still intact on those walls that are still in place. All material has suffered due from water ingress due to damage to roofs. Urgency: High</p>	P1	<p>These structures are free form enclosing the social spaces of the convent linking the convent block to the original house providing intermediate spaces for social activity before entering the convent block itself. The formal inter-dependency between the small units and large volumes reflects the concept of the 'ideal religious community in that every part speaks to every other part.' The dramatic swept sections and the warm timber curved cladding to the ceiling are all of architectural significance. The ceiling still in situ provides important documentary material evidence of the detail, material and colour of the timber used internally within the buildings.</p>	<p>Both structures should ideally be retained, including the roof, form and external envelope. The internal spaces should be retained whole and not sub divided. The missing links to the convent block and the now demolished house can be altered to suit new proposals and use provided the new design retains the overall design intent.</p>
