ST PETER'S SEMINARY Cardross

CONSERVATION ASSESSMENT

Main Report

FEBRUARY 2008

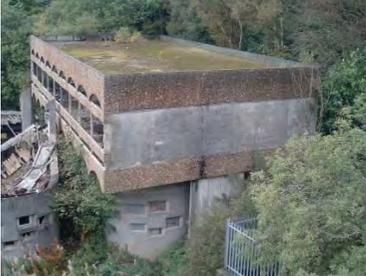
Roof	3 layer asbestos based roofing felt, assumed to be of similar construction to main block.	Roof covering appears to be intact, but the surface has silted up and algae, moss etc have established resulting in a green cover to the felted surface. Rainwater outlets were not visible and are possibly obstructed. Urgency: Medium	P2	Roof material and detail are of purely functional importance as not visible, except from upper levels of the seminary.	Any new roof covering material should be chosen to meet the required design life. Built-up roofing felt, single ply membrane, asphalt are all acceptable alternatives to the original asbestos based felt. When re-roofing, improve drainage falls provided that the outcome does not affect the roof line and profile. All maintenance fall arrest equipment should be installed out of sight from ground level. Any new plant room or equipment at roof level should be located well back from roof edges, out of view. Decision regarding possible installation of solar energy collectors/pv' cells should be taken in conjunction with design and detailing of new roof covering.

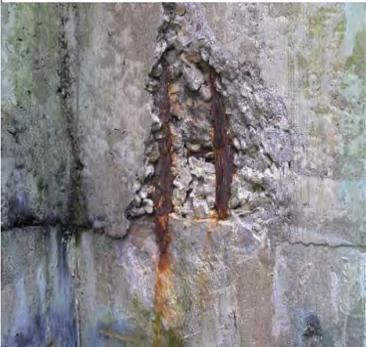
Insitu Frame/ Primary Structure	2 storey structure comprising of in situ reinforced concrete columns, walls, beams and slabs	Access was not gained, assumed to be same as the main block. The in situ reinforced concrete elements are generally in a structurally robust condition with signs of localized durability issues which have led to localized areas of spalled, delaminated, missing, cracked and honeycombed concrete, exposed reinforcement and defective shutter ferrule plugs. The areas of deterioration are related to the ongoing corrosion of embedded steel reinforcement close to the surface of the concrete elements. If remedial work is not undertaken to the concrete the problems will continue and will begin to have implications on the structural integrity of the structure. Urgency: Medium	P1	The use of insitu concrete has significance both architecturally and structurally.	Ensure that all boardmarking and shuttering patterns are retained, and replicated where repairs have been carried out. All repairs should be squared off in outline leaving a light but not unsightly manifestation.

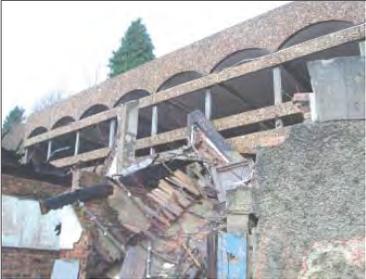
Pre cast cladding	Light brown in colour, external large soft rounded exposed pebble aggregate. The slabs span 8ft bays in the form of an arch, gallery or handrail unit in 4inch thick.	As main block Urgency: Medium	P1	The choice of aggregate was selected to 'harmonise with the stone of the existing house.' The finish is also suitably vigorous in what is a rugged setting. The pre cast work is reported to be similar to the pre cast panels used at the Roehampton estate.	Any new fixings should be inserted without any visible manifestation to the exterior of the pre cast panels. All repair work required to the pre cast concrete panels should match the original, pattern, aggregate type, colour and texture. If panels need to be removed, care should be taken to ensure that the vaulted plastered ceiling behind is not damaged. The insertion of sacrificial anodes or corrosion inhibitors should be kept to then non visible rear face of all pre cast panels.

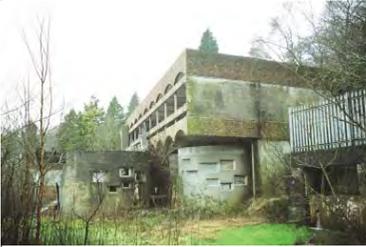
Rendered blockwork walls	Rendered non load bearing blockwork walls to the east and west end external first floor walls of convent block	Render appears to have remained insitu but is suffering from water damage at the junction with the cladding panels above and discoloration from algae. Urgency: Medium	P1	Render surface should be retained as significant	Any new render work required to match original texture, detail and colour.

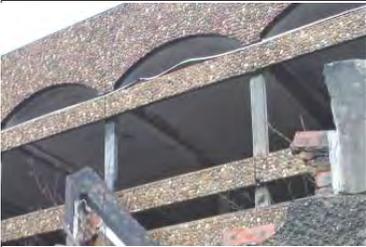
Convent bedroom windows	Painted timber glazed windows, one opening side hung casement, one fixed pane. Above the horizontal pre-cast dividing panel, within the vault was a curved glazed fixed slender framed panel. Beneath the cill level externally there is a horizontal pre cast panel above a painted timber panel divided it from a curved pre cast panel below.	All timber components are missing. Urgency: Low	P1	The timber detail, paint colour, section sizes and mullion, transoms locations were all of architectural importance and formed part of the building language adopted.	The visible width of all new mullions and transoms should be kept close to the original size when incorporating double glazing. Solar control glass should be as clear a possible avoiding use of tinting. The material used for the glazed frames, could be polyester powder coated aluminum or steel if low maintenance is a priority. All original colours and mullion transom patterns should be restored as original. Consideration should be given to eliminate cold bridging at reveals.

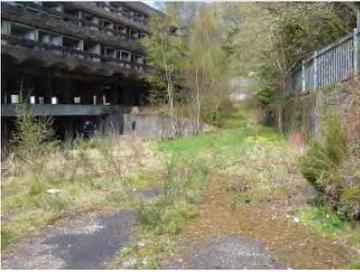
Paving	Bands of macadam subdivided by lines of granite setts running parallel to the service road.	Macadam and setts still exist but overgrown with rank grass and scrub vegetation. Urgency: Medium	P1	Part of GKC (Gillespie Kidd and Coia) landscape scheme	Bands of macadam and setts express the geometry of the the entrance sequence and should be retained.

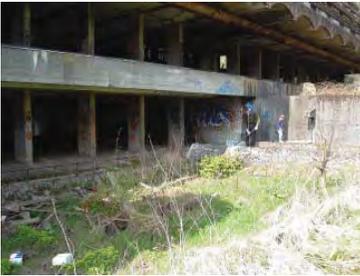
Pool	Sunken pool c. 500mm deep. Sloped edge, laid to setts. Base of pool surface unknown. Two trip rails, 300mm high approx. – east one made from tubular steel sections, west one from steel flats – both painted black- Latter probably original	Pool full of debris and scrub vegetation. Safety rails showing signs of corrosion. Urgency: High	P1	Integral element in GKC scheme. Water symbolises the seminary's separation from the outside world.	Pool is of high significance to the entry sequence and symbolic of the notion of retreat.

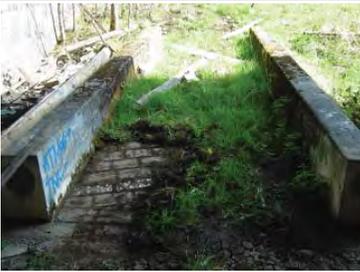
Entrance Bridge	Sett paving, lying parallel to sett bands in forecourt. Couple of cast metal setts substituted near end of bridge, with raised bumps similar to impaired visibility paving. Setts possibly shallow depth to traditional setts as one was chipped in uncharacteristic way.	Urgency: Medium	P1	The bridge is symbolic in how the students 'retreat' over the threshold away from everyday life into the religious world.	The bridge is an key element of the expression of retreat and separation.

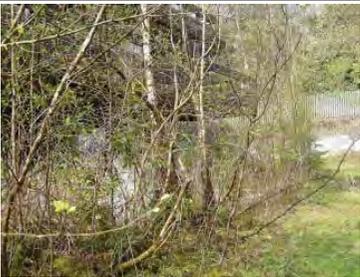
Dry Moat	Described as a dry moat in GKC drawings. The moat mirrors the pool layout, however elevated at height of retaining wall which houses water spout and chain. Could be part of device of connecting water source to pool.	Moat full of debris, rank grass and scrub vegetation. In addition invasion by saplings, suggesting deeper soil conditions. Urgency: Medium	P2	Part of GKC landscape scheme. Demonstrates hierarchical design intent, as visitor would not appreciate water from bridge at this higher level. Moat, in conjunction with pool symbolises segregation from outside world and more practically the service area.	Important in negotiating the level change from the higher ground and retaining walls and entry level.

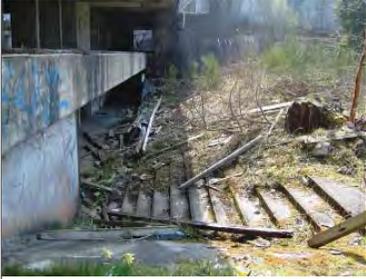
Main Block Steps	Battered concrete berm, with two flights of steps at 45 degree angles, leading to paths that connect cloister to mansion house and 19 th century steps to lower terrace and classroom block. Steps to mansion house broader than steps to path, signifying main entrance.	Appear sound, but covered in debris and some vegetation. Urgency: Medium	P1	Integral element of GKC scheme. Demonstrates functional and hierarchical design approach. This solution much emulated in contemporary landscape schemes.	Steps should be restored to match original.
Quadrangle

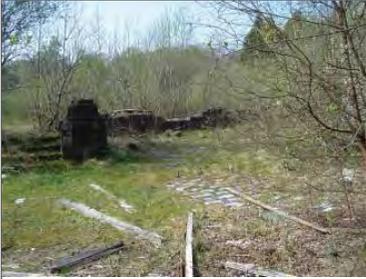
Paving	Two areas of coursed setts connecting the Main block steps to the mansion house and 19 th century steps to the lower terrace and classroom block both relating to desire lines	Setts still exist but overgrown with scrub vegetation Urgency: Medium	P2	Part of GKC landscape scheme. Demonstrates functional, economical but durable design intent.	Paving should be restored to original layout

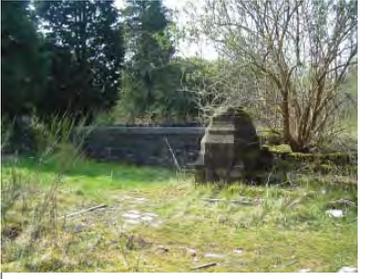
Grass Lawn	Grass lawn in areas where access is recreational.	Overgrown with rank grass and scrub vegetation. In addition invasion by saplings. Urgency: Medium	P2	Part of GKC landscape scheme. An inner sanctuary of soft landscape is in keeping with monastic tradition and also softens the built form.	Grass should be reformed and kept trim.

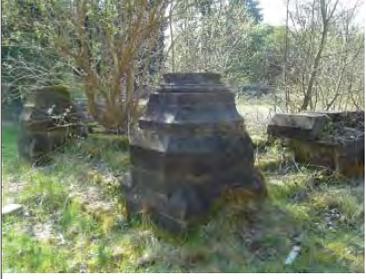
Mansion House Walls and Steps	Mansion house demolished. All that remains is the masonry base course, approximately 1m high. Inside the void has been filled with gravel and crushed stone laid level to original internal ground level.	Walls to east and south and main steps still extant and in relatively sound condition. Only remnants survive of the west and north walls. Urgency: Medium	P2	Footings indicate location of 19 th century mansion house which was integral to GKC scheme and influenced the layout. It is vital to understanding this. Important to maintain height of internal ground level in order appreciate views and relationship with other buildings.	Outline base of original should be retained and ideally restored where missing.

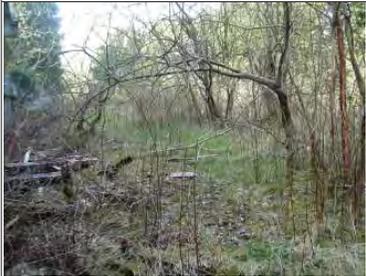
Paving	Random coursed setts, running parallel to building facades and connecting 19 th century terrace steps with steps to west of Classroom Wing.	Setts still exist but overgrown with rank grass and scrub vegetation Urgency: Medium	P2	Part of GKC landscape scheme. Demonstrates functional, economical but durable design intent.	Should be restored and maintained.

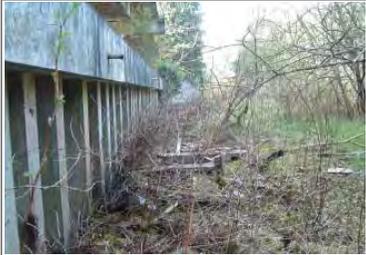
Edging to Classroom Wing	Contemporary photographs suggest 1m wide (approx.) gravel/cobble strip with sett edge.	Overgrown with debris, rank grass and scrub vegetation. Sett edging visible but former gravel/cobble strip looks like it sloped down to the building – therefore unlikely material unless the gravel was set and exposed in concrete. Urgency: Medium	P2	Sett edge is part of GKC landscape scheme. Gravel strip status unknown. Further inspection required.	Should be restored and maintained.

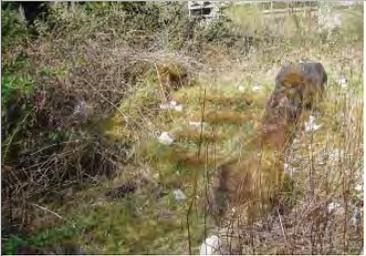
Terrace Steps	Original steps to 19 th century formal terraced garden. Dressed stone steps with raised retaining wall and coping	Overgrown with moss and rank grass but appear relatively sound. Urgency: Medium	P2	The steps are remnants of 19 th century landscape that were consciously retained as part of GKC scheme. Reveals that GKC incorporated 19 th century elements where possible, presumably for economical reasons and also because they valued them.	Should be restored and maintained.

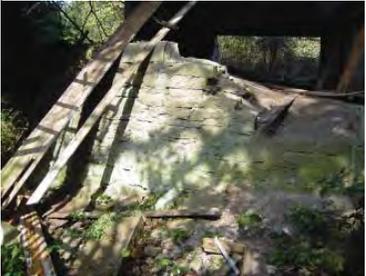
Masonry Retaining Walls	Southwest and northwest sections of 19 th and early 20 th century retaining wall supporting formal garden terrace. Now appears to support Classroom wing at terrace level. Southern section as high as 5m approx. Curved profile beneath elevated building section. Part dressed stone, part rubble wall.	Southwest section covered in debris, scrub vegetation and ivy but appears sound. Rubble sections and around curved buttress to northwest sections appear to be crumbling. Structural Engineer to inspect and assess. Urgency: Medium	P2	Retaining walls are remnants of 19 th century landscape. Incorporated by GKC as integral element, which influenced the seminary layout. Appears to support Classroom Wing and vital to the understanding of the GKC layout.	Should be restored and maintained.

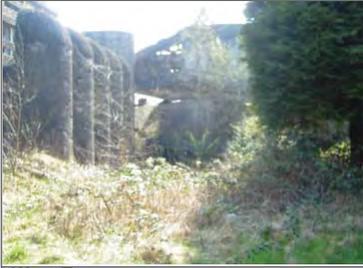
Grass Lawn and Bank	Grass lawn and grass bank with three relatively mature cypress trees visible in contemporary photographs.	Overgrown with rank grass, scrub vegetation. Also invasion of self-regenerating saplings. Bank profile still visible and cypresses mature and over dominant. Urgency: Medium	P2	Remnants of 19 th century landscape that were consciously retained and incorporated in GKC scheme, including the cypress trees. Evidence of how GKC incorporated 19 th century elements where possible, presumably for economical reasons and also because they valued them.	Should be restored and maintained.
West Terrace

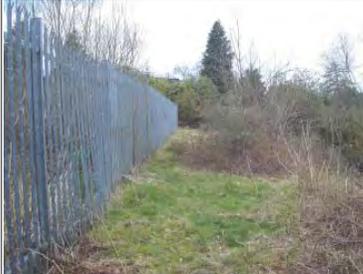
Terrace	West terrace for 19 th century mansion house, with two curved 'belvederes' at both ends, and views over the pleasure grounds, in particular to the lake. Southern buttress larger than the north. Overlaid with macadam and sett path to Convent block when incorporated into GKC scheme. Contemporary GKC photographs show two low-clipped yew and rhododendrons either side of southern steps retained in GKC scheme.	Macadam still exists but overgrown with rank grass and scrub vegetation. Security fencing subdivides terrace, obstructs views of 19 th century pleasure grounds (lake obscured by vegetation) to west and also access to the gardens. Sett path still relatively sound. Ornamental vegetation is overgrown and obstructs view of steps. Urgency: Medium	P1	The terrace is a remnant of the 19 th century landscape. Incorporated by GKC as integral element, which influenced the seminary layout. Vital to understanding GKC layout and for enjoying views of the pleasure grounds and lake. Ornamental vegetation is remnant of 19 th century planting scheme.	Should be restored and maintained.

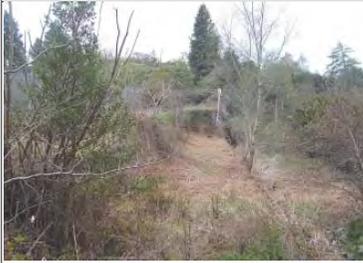
Masonry Retaining Wall and Balustrade	Retaining wall erected to support west terrace to 19 th century mansion house, with two curved curved buttresses at both ends supporting 'belvederes'. Rubble wall with dressed stone balustrade, up to 5m high approx. Balustrade retained and visible in contemporary photographs of GKC scheme.	The balustrade has been removed. Straight sections covered in ivy and difficult to assess. Rubble sections and around curved buttress to south appears to be crumbling. Structural Engineer to inspect and assess. Urgency: Medium	P1	Retaining walls and balustrade are remnants of 19 th century landscape. Integral element of GKC scheme, which influenced the seminary layout. Vital to understanding GKC layout.	Should be restored and maintained. Any requirement for raised guarding should be resisted if possible, or designed with minimum visual impact.

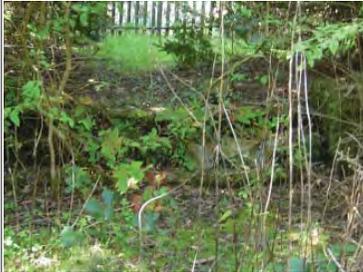
Terrace Steps and Low Walls	Three sets of original steps. Two flights of steps led to 19 th century pleasure grounds: a flight at the southern end of the terrace consisting of dressed stone inset between retaining walls; and a narrow flight of steps further south, parallel to west retaining wall. In addition three steps along the east boundary of west terrace were also recessed. Low walls between steps defined extent of west terrace.	The retaining walls of the southern flight exist, but treads are missing. The narrow steps still visible but crumbling. The steps along east boundary of west terrace are overgrown with moss and rank grass but appear sound. Urgency: Medium	P2	The steps are remnants of 19 th century landscape, consciously retained as part of GKC scheme and continued to provide main link to 19 th century pleasure grounds.	Should be restored and maintained.

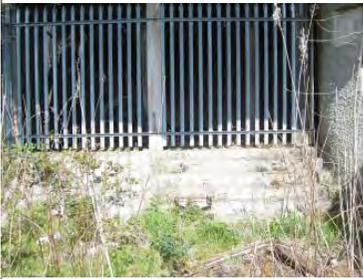
Undercroft to Convent Block		Security fence beneath block at top of steps. Access not possible . Urgency: Medium	P2		Generally restore to original character
Service Access and Court

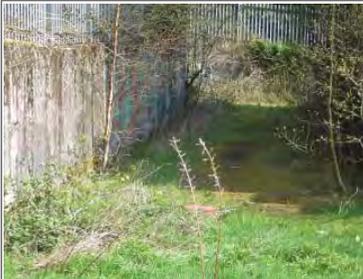
Paving	Access road laid to macadam and edged with setts. Service court laid to bands of macadam subdivided by lines of granite setts at right angles to buildings.	Macadam and setts still exist but overgrown with rank grass and scrub vegetation. Urgency: Medium	P2	Part of GKC landscape scheme	Generally restore to original character

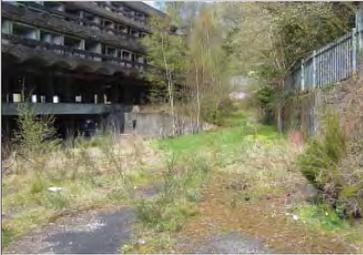
Retaining Wall	Concrete retaining wall	Appears sound, but some vegetation, including saplings growing in walls. Security fence erected above it. Also burn seeping through central section of western wall. Urgency: Medium	P2	Boundary of GKC landscape scheme, which redefined relationship with 19 th century pleasure grounds to north. Necessary in order to construct seminary buildings.	Consider ways of minimising impact of security fence

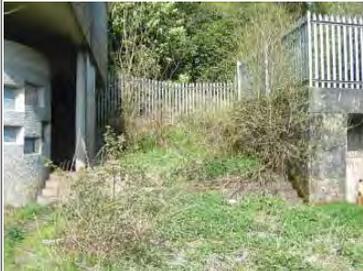
Steps to Gardens	Two flights of steps and a landing between Convent Block and bunker? South of access road retaining wall. Southern flight spans the whole area, northern ones much narrower and built against bunker, providing a connection with the 19 th century path to north woodland pleasure grounds, albeit to the west of it.	Appear sound, but covered in debris, rank grass and scrub vegetation. Urgency: Medium	P2	Part of GKC landscape scheme. Demonstrates functional and hierarchical design intent.	Generally restore to original character

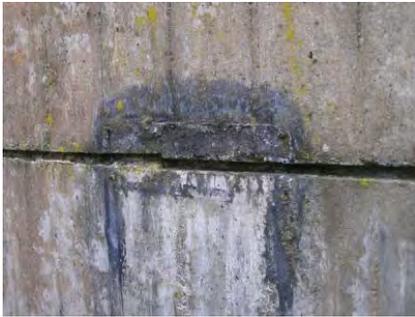
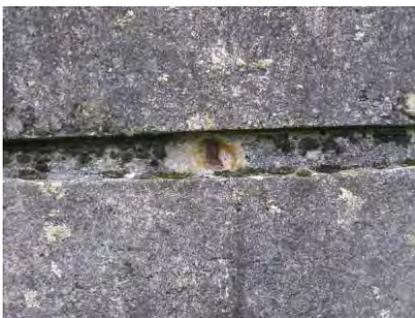
Inadequate cover to expressed day joints

- 4.6.8 Evidence of poor detailing and construction was also noted in a number of locations e.g. inadequate cover generally, inadequate cover at expressed daywork joints (grooves), honeycombed concrete, etc. These defects are prevalent on the external staircase at the north end of the Main Block

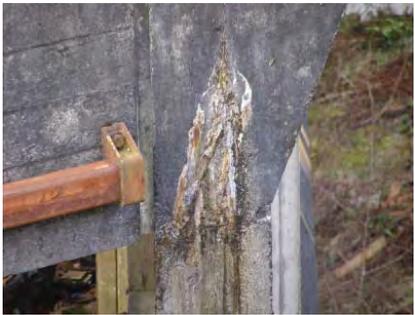
Exposed corroded reinforcement

4.6.4 It is apparent that this process is now at a relatively advanced stage in isolated locations and the cause of the most recent deterioration is related to ongoing corrosion of embedded steel reinforcement close to the surface of the concrete elements. It is also clear that if effective remedial repairs are not executed further corrosion and spalling will occur in the future possibly exacerbated by frost action in cold weather.

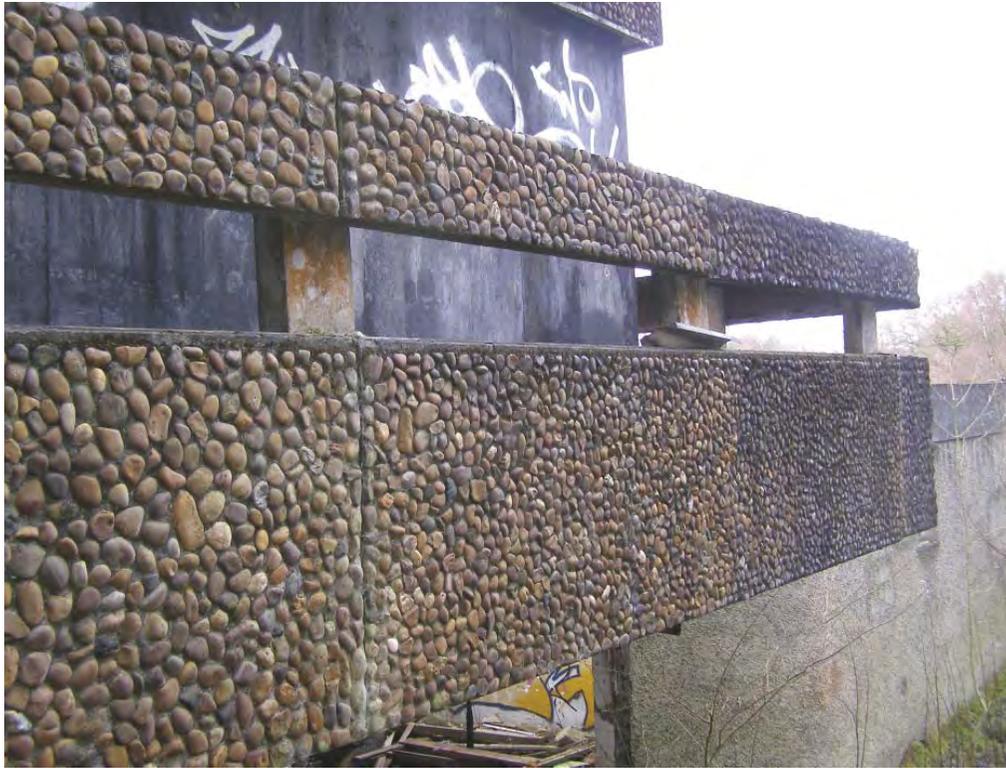
Exposed aggregate pre cast concrete cladding

The pre cast concrete cladding panels to the ends of the Main Block generally appear to be in a sound condition with little evidence of defects or past repairs noted. The large aggregates cast into the external faces appear to be firmly embedded in mortar no significant bowing or distortion was noted.

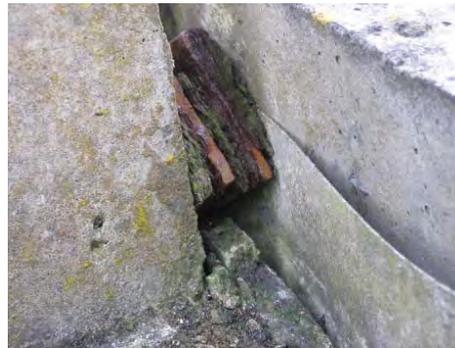
Corroded shims between handrail post and facade forcing panels out of alignment

- g. Isolated spalling/cracked concrete and corroding reinforcement to handrail surfaces.
- h. Severe corrosion to metal shims between vertical joints between posts and cladding panels in isolated locations.

- j. Distortion, leaning and lifting of posts and handrails as a result of g and h above.
- k. Missing and loose/slack bolt fixings to all components in isolated locations.

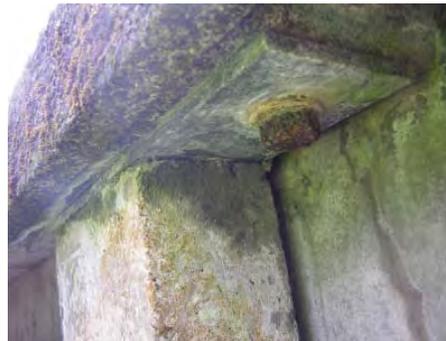
Corroded bolt fixing to underside of handrail panels

- e. Severe corrosion to bolt fixings into underside of handrails.
- f. Extensive spalling/cracked concrete and corroding reinforcement to vertical post members.

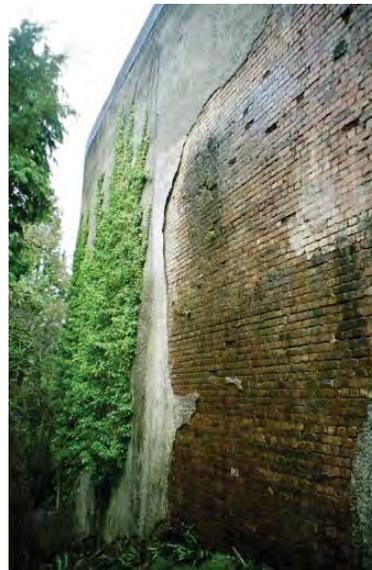
4.6.30 There are extensive areas of missing, cracked and delaminated render on all walls. Where bricks are exposed significant numbers of bricks have delaminated. In the limited time available it was not possible to undertake a wall tie survey although limited inspection within the cavities did reveal the presence of flat twisted metal wall ties. It is pertinent to note that where areas of rendered blockwork has fallen away from the concrete walls to the ends of the Main Block, galvanised triangular wire wall ties were found. The ties were fixed to the concrete walls and the outer parts of the ties (i.e. the section of tie originally embedded in the blockwalls) were actively corroding whereas the remaining tie (i.e. the section originally within the open cavity between the block and concrete walls) were in good condition with no rusting noted. We may therefore deduce that the

Delaminating/missing render leading to saturated brickwork

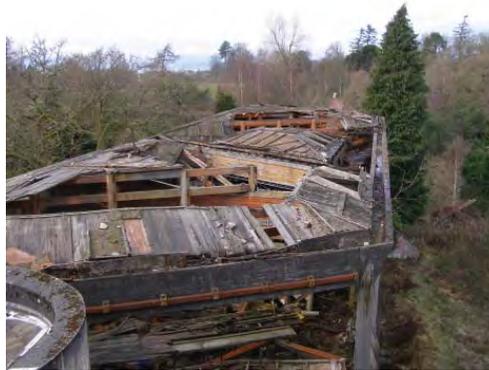
Damaged timber roof of teaching block all original copper roof covering missing

4.6.34 The timber roof construction over the Classroom Block is in a state of partial collapse and only remote inspection from a safe distance was undertaken. No fire damage was visible. Two large diagonal tie beams appear to be in place albeit the bearings could not be seen and therefore the effectiveness of any restraint offered by these members to the slender external wall/beams could not be assessed.

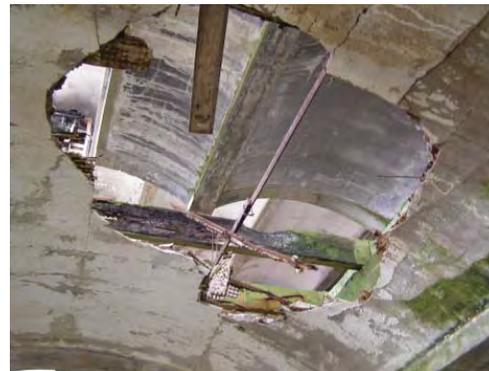
Damaged plastered vault

4.6.35 The vaulted ceilings are constructed in plastered Hi – Rib metal lathing. The arch springers are located on projecting nibs on the side of the main in situ reinforced concrete beams. Many ceilings are completely missing or in a state of partial collapse and are strewn with debris. The upper surfaces of the exposed Hi – Rib are visibly corroding but it was not possible to undertake close up investigations to assess the severity of the rusting.

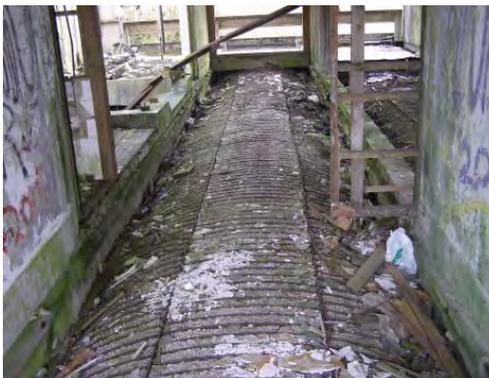
Floor missing vault viewed from above showing metal Hi-Rib lath support structure

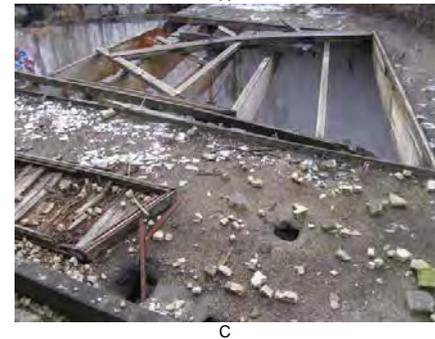
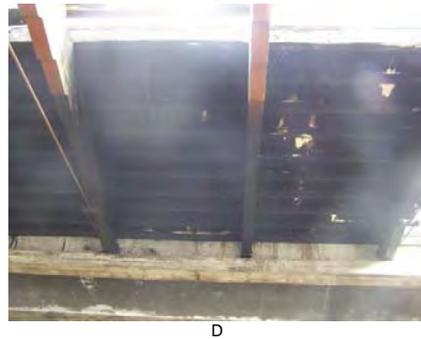
Plates T2: Unsafe, rotten and partially collapsed roofs.

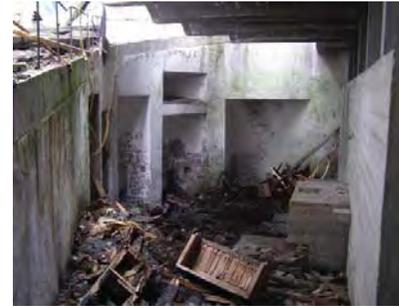
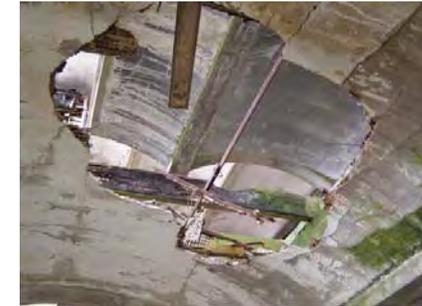
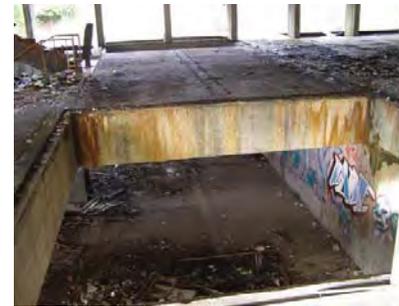
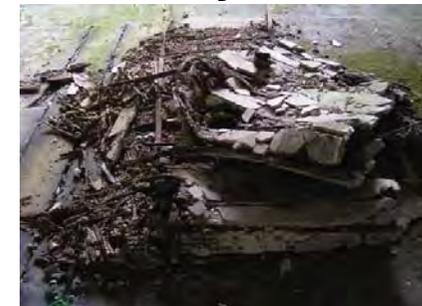
Plates T3: Collapsed roofing materials, debris and unprotected edges.

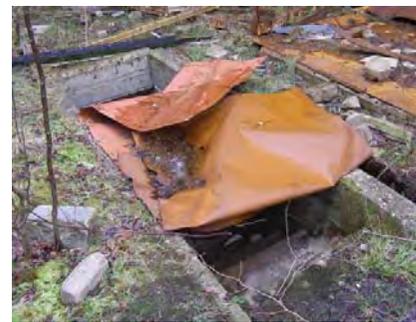
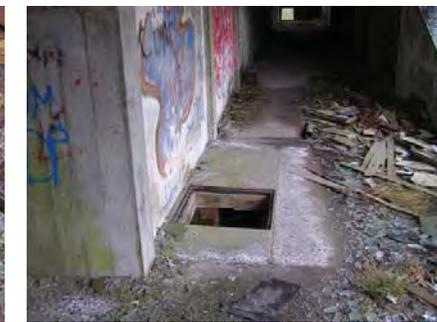
Plates T4: Blocked entrances to a basement and an open access into an under-floor or basement area. These areas would need to be investigated and would probably, at least initially, be classified as confined spaces.

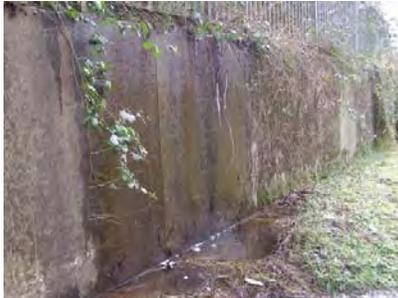
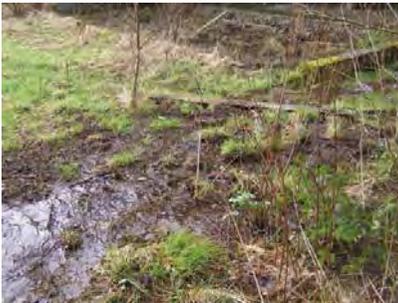
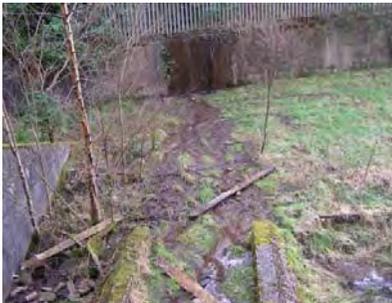
Plates T5: Water from stream and groundwater entered the site on the up-slope sides of the site, in some areas overtopping retaining walls. In the former cases the water had been directed into channels, but in others the ground had become waterlogged. Streams exited the site, from beneath the buildings, on the down-slope sides. This would suggest that, at least in some cases, the basement and under-floor areas could be waterlogged / flooded, increasing the risk categories of any 'confined spaces'.

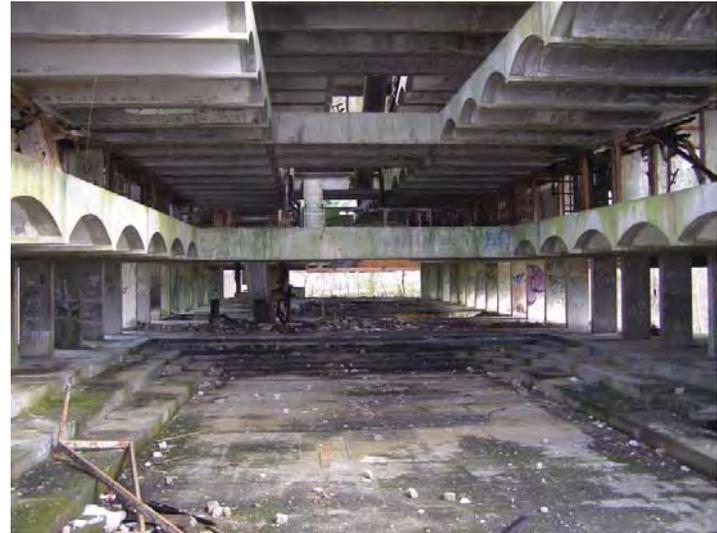
Plate T6: General view of the main building looking down from the High Alter. The structures generally comprised two rows of 'internal' in-situ cast reinforced concrete columns, with in-situ cast reinforced concrete crossbeams supporting the floors and roof. Most of the crossbeams forming the first and second floors were truncated, internally to create an 'atrium', with the internal cantilever sections supporting peripheral 'balcony' floors and external cantilever sections supporting open walkways, with pre-cast concrete cladding panels, supported on in-situ cast 'stub' columns, forming the parapet edge protection.

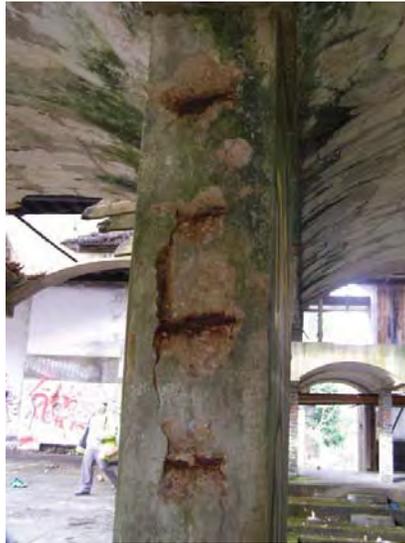
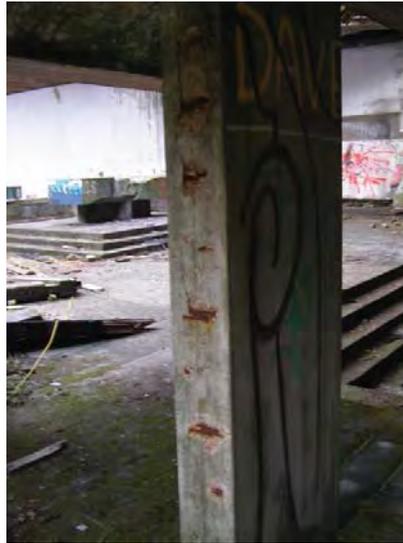
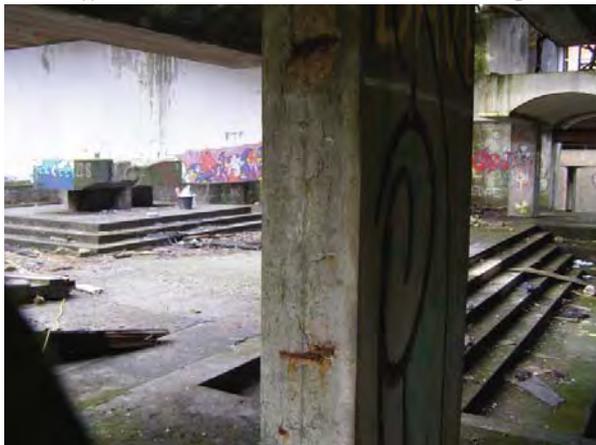
Plates T8: In-situ columns exhibiting surface spalling associated with corroded reinforcement.

In these, and many other cases, surface spalling generally occurred where the original depths of cover to the reinforcement were less than 25mm.

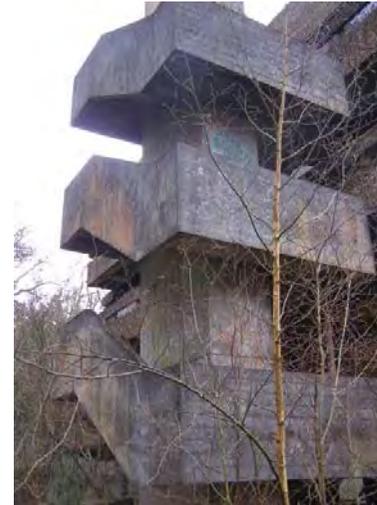
Plates T9: An external, in-situ cast staircase exhibited widespread surface spalling associated with corroded reinforcement.

In these, and many other cases, surface spalling generally occurred where the original depths of cover to the reinforcement were less than 25mm.

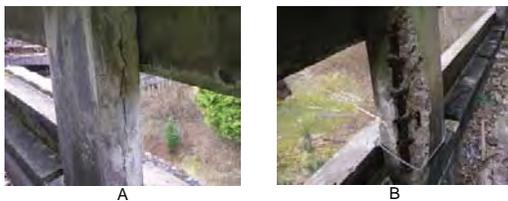
The stub columns were probably pre-cast and as illustrated below many exhibited cracking and spalling associated with corrosion of the encapsulated reinforcement.

Plates T11: Typical cracking and spalling to a stub columns.

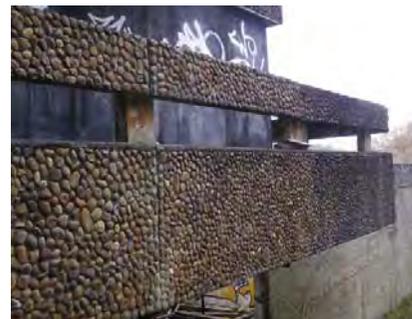
Plate T13: Closer view showing the panels in good visual condition.

Note: Rust staining emanating from the fixings.

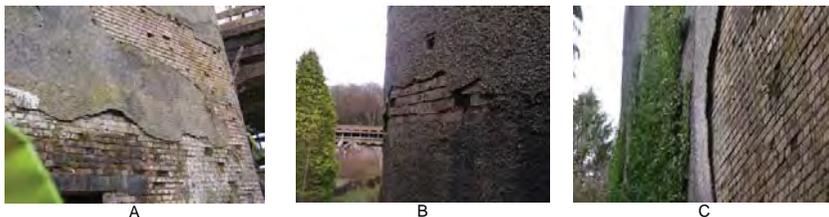
Various 'details' around the site comprised rendered and dashed brickwork. As illustrated below the render and dash were variably de-bonded and detached with some remnant portions clearly blistered and about to fall.

Plates T15: Deteriorated brickwork details, with delaminated render and dash. The brickwork surfaces beneath were showing signs of deterioration, with exfoliation of the brick surfaces and degradation of the mortar jointing. In some cases this latter deterioration could, at least partially, be the result of wildlife (birds and insects) activity.

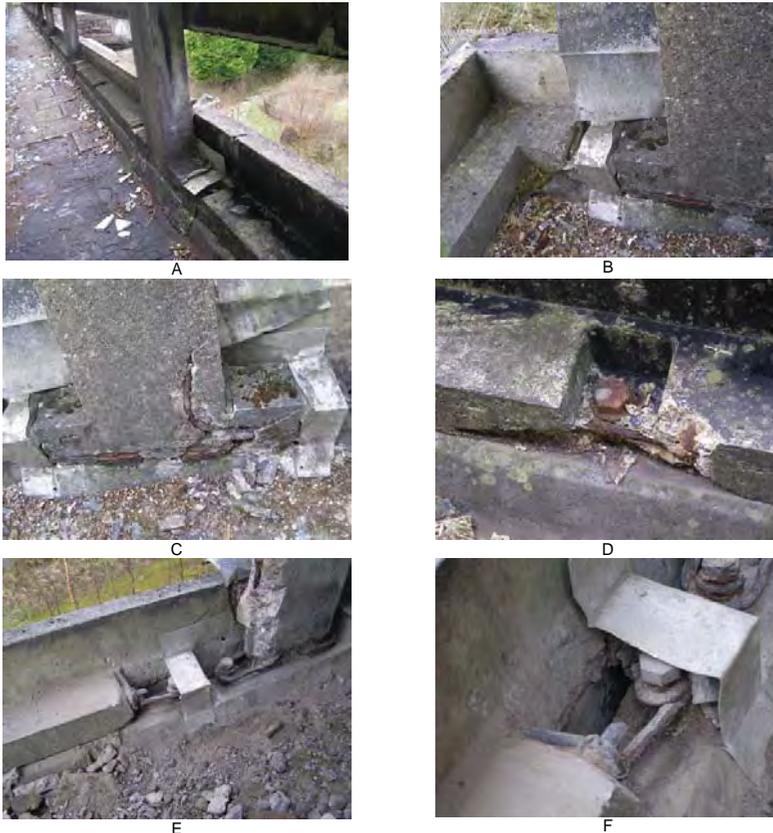
Plates T16: In our opinion, the lower panel units were probably installed first, pre-cast with a 'foot' on the back, to sit on and bolt down to a small upstand detail along the edge of the structure. The panels were bolted down, through the foot and into the upstand, at centre and end positions, the latter via reinforcement bar extensions bent around the bolts. A profiled metal sheet had then been installed, separating panel from stub column connections, with the stub columns then 'dropped' into place and bolted down, on each side, via reinforcement bar extensions bent around the bolts. The fixings pockets had been packed with a protective packing of mortar.

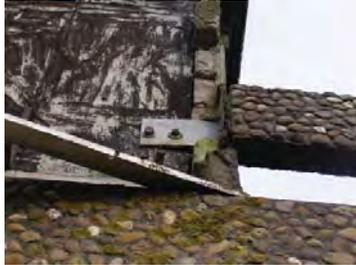
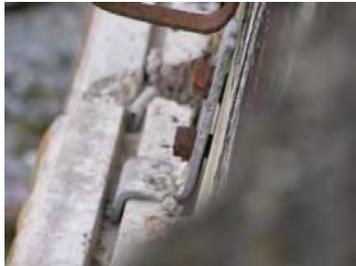
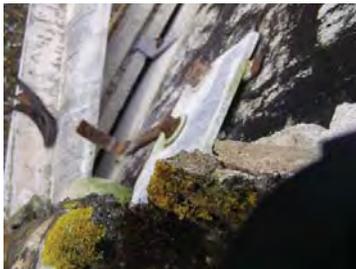
Plate T21: At other locations pre-cast panels had been installed and fixed via galvanised steel plates and mild-steel bolts. The mild-steel bolts were variably corroded.

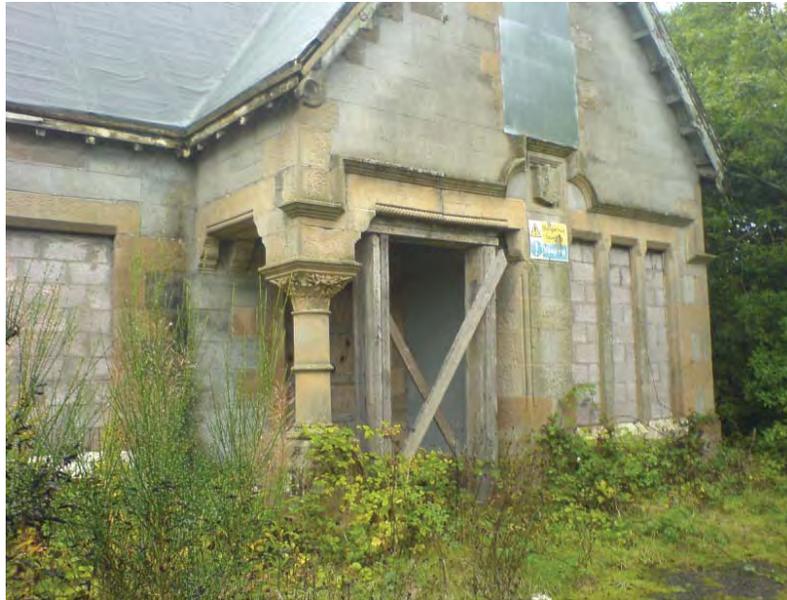
South Lodge, 2007

4.8.3.1 South Lodge and Approach Drive
 South Lodge is now derelict and the gates have been removed. A red sandstone wall in a variable condition extends south from the lodge connecting with the boundary wall for Bloomhill, a property also owned by the Burns family. It stops at the lodge. A modern security fence now prevents access, although it is possible to enter the site via a gap to the side that has been left unsecured.

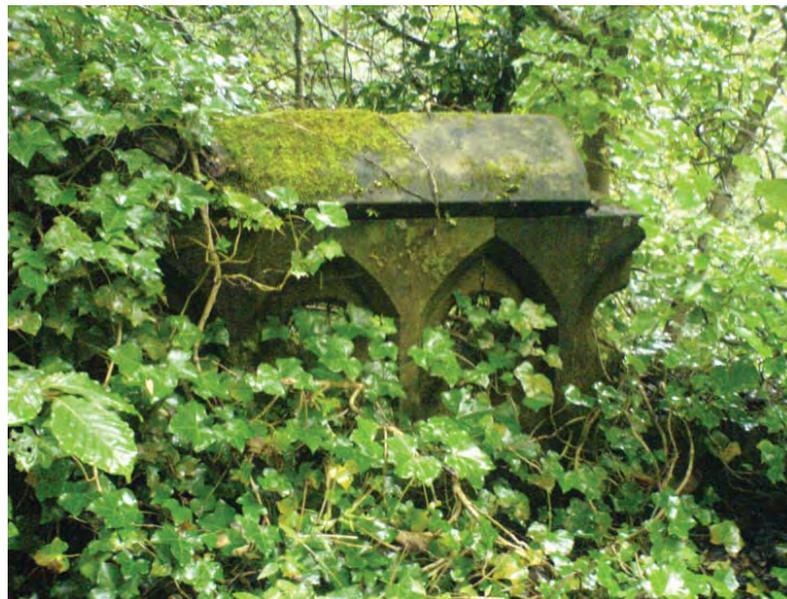
Remnant of gothic bridge balustrade, 2007

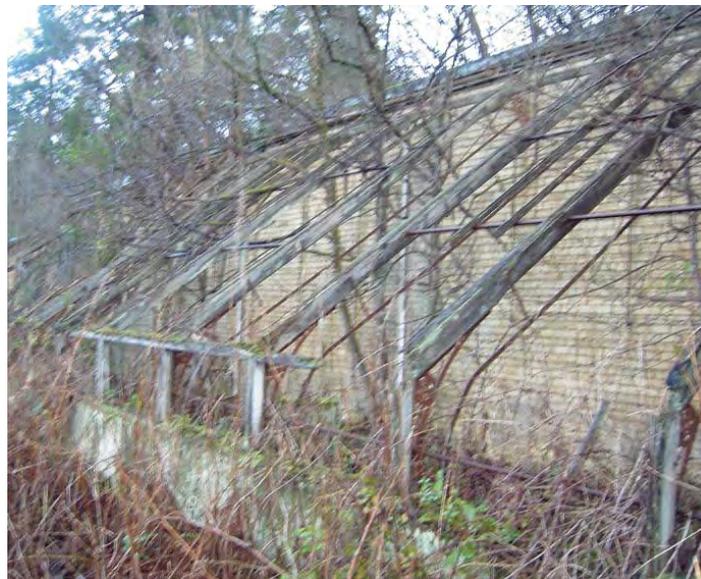
Dilapidated glass houses, 2007

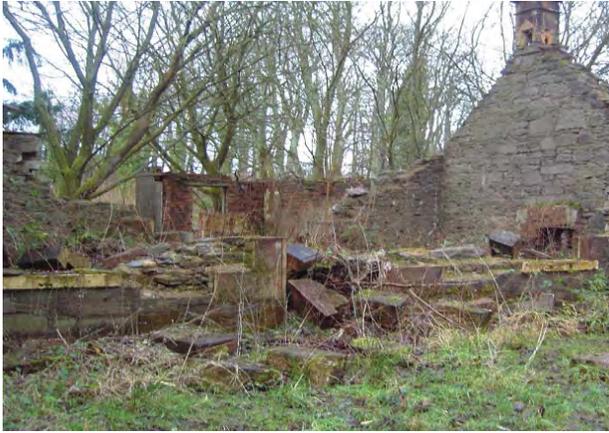
4.8.5.1 Over the last fifteen years West Lodge has deteriorated rapidly and it is now a pile of rubble with only a couple of standing walls. The stone

West Lodge, 2007

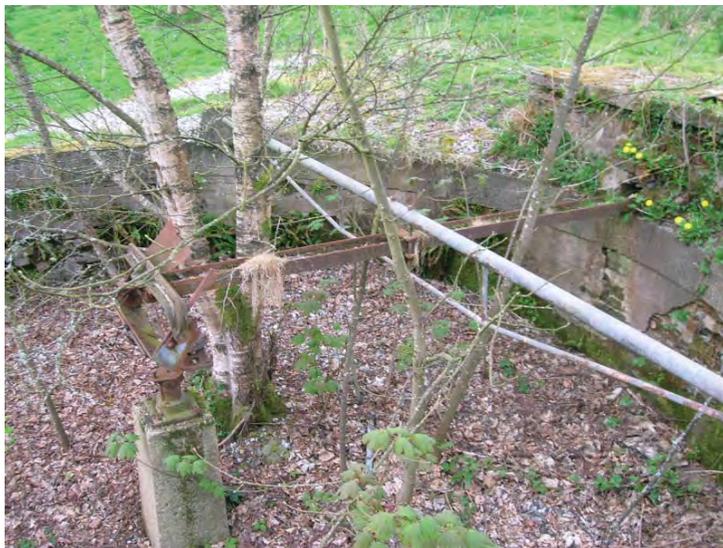
Trees growing in filter bed of existing sewage treatment plant

We are not confident that if the existing sewage treatment plant was restored the effluent from it would meet current discharge standards.

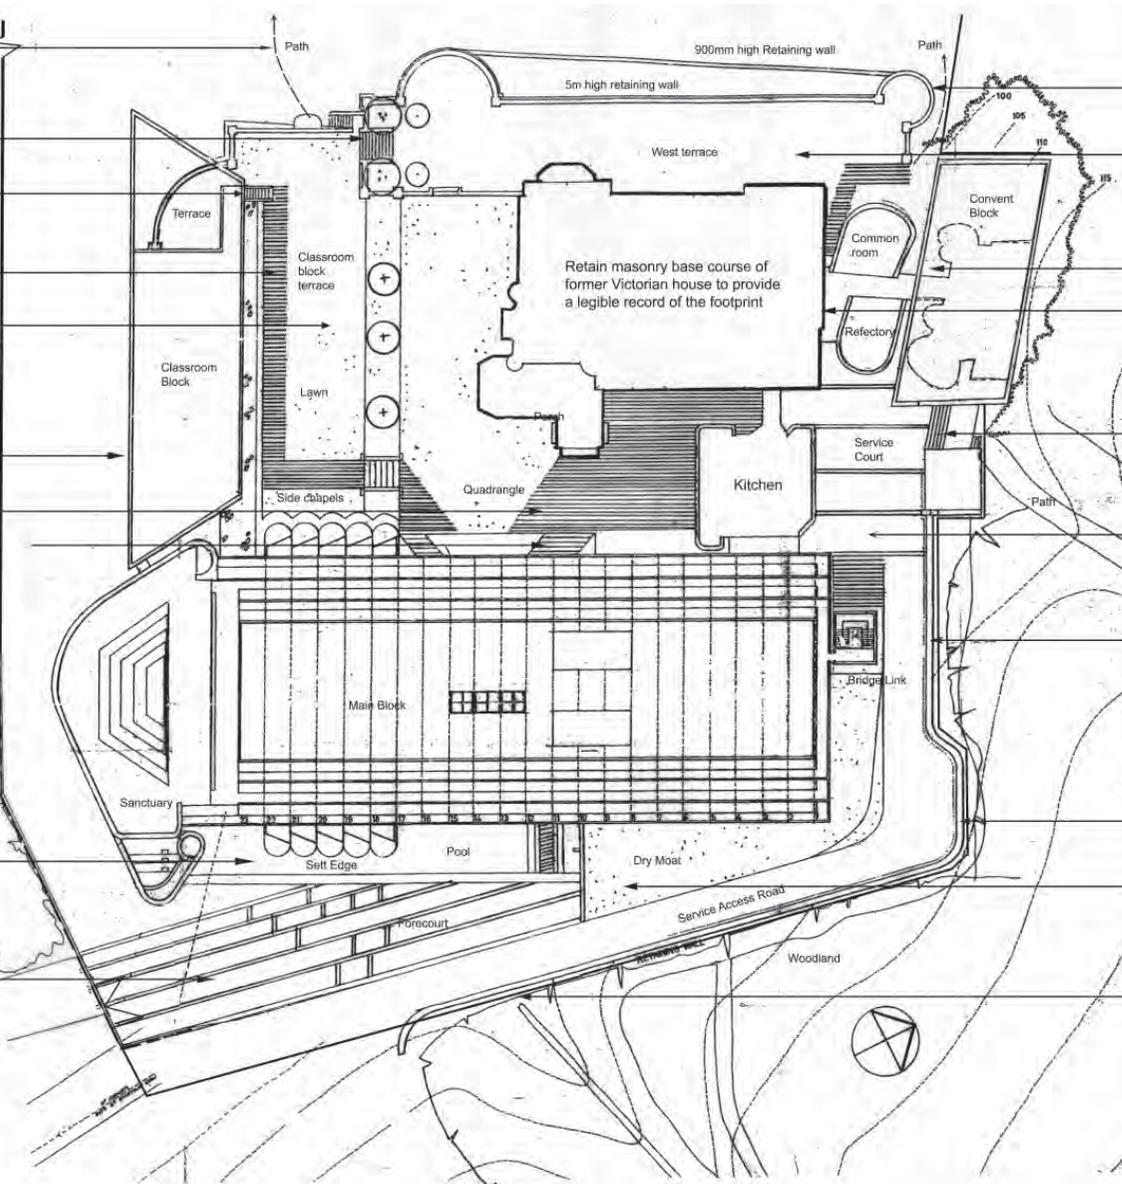
Water flowing over retaining wall probably from original stream diverted into a culvert. Culvert may be blocked. Investigate and repair/replace as necessary.

Retain and restore paths, locate a single gate in security line to allow access to the surrounding landscape
 Remove moss and grass to expose steps. For southern flights, inspect, repair and reinstate replicas of original treads to ensure safety. For steps along east boundary inspect, repair as necessary to ensure safety.

Remove moss and grass to expose steps. Inspect, repair as necessary to ensure safety.

Remove grass to expose paving scheme and gravel strip with sett edging to classroom wing terrace. Inspect, repair as necessary to ensure safety.

Clean down retaining walls. Remove debris and scrub vegetation. Inspect, repair as necessary to ensure safety, subject to Structural Eng.

Remove grass and expose paving scheme. Inspect, repair as necessary

Remove debris, rank grass and scrub vegetation to expose concrete slope and steps. Inspect, repair and reinstate as necessary to restore.

Remove debris and vegetation to expose sett edge and pool surface. Inspect, repair waterproofing features as necessary and re-instate water supply from local spring/stream source. Clean knee rails, repair and paint.

Remove grass to expose paving scheme, inspect, repair and reinstate original pattern. Apply bituminous tack coat and chippings to achieve uniform appearance.

Extend original pattern and install new security fence line parallel to the sanctuary wall, with lockable access gates

Remove vegetation to expose masonry. Inspect and repair masonry as necessary, to ensure safety, subject to S.Eng specification. Re-align security fence to restore views looking west to former 19th century pleasure grounds.

Remove security fence-see chapter 8 for alternative security arrangements. Cut yew trees right back to restore shape and reduce rhododendrons but allow to re-sprout. Cut out all *ponticum* shoots. Restore views from terrace.

Remove grass to expose paving scheme, and maintain to prevent further degradation.

Remove debris, rank grass and scrub vegetation. For steps, east and south walls inspect, repair as necessary to ensure safety. For west and north walls, conserve wall remnants, and erect low wall using reclaimed masonry to restore perimeter wall of house. Lay gravel to original floor level of house.

Remove debris and rank grass to expose concrete steps. Inspect, repair as necessary for safety.

Remove grass to expose paving scheme. Inspect, repair as required

Remove debris and scrub vegetation grass to expose concrete walls. Inspect, repair as necessary to ensure safety.

Remove debris, rank grass, scrub vegetation and saplings to expose bank profiles and re-establish geometry and construction of moat. Inspect, repair as necessary to ensure safety.

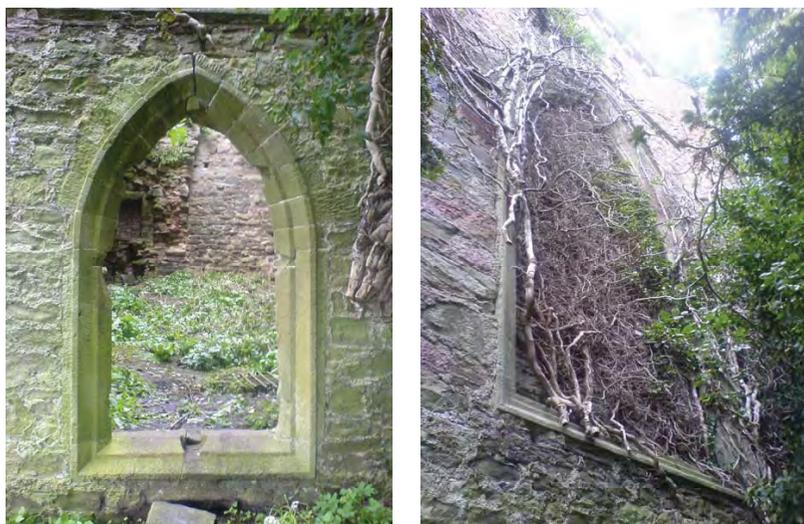
S frontage – gothic windows at ground and first floor

Generally the S elevation appears stable although there is slight structural cracking on the centre line of the arch headed windows and some particular distortion of the head of the uppermost window, with the crack running up through the parapet. A number of the parapet stones (in particular the copings) are clearly loose.

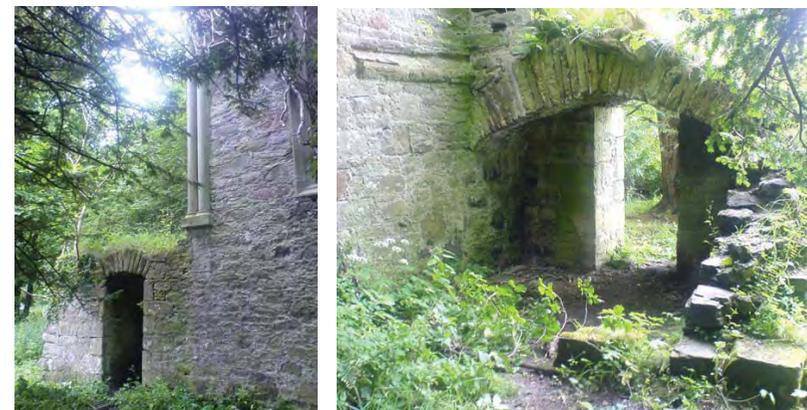
The unfinished western extension to the S frontage

At the W end of the S frontage the ground floor remains appear relatively stable, the arching still performing its structural function supporting the first floor projecting masonry of the intended mansion entrance. Of the ashlarwork of the entrance itself some individual stones are loose and it appears that one or two have fallen, perhaps still recoverable on the ground below, otherwise generally in good condition.

At its W end the ground floor masonry though in stable condition, has been impacted by a tree that has grown out of the rubblework, this now appears to be dead.

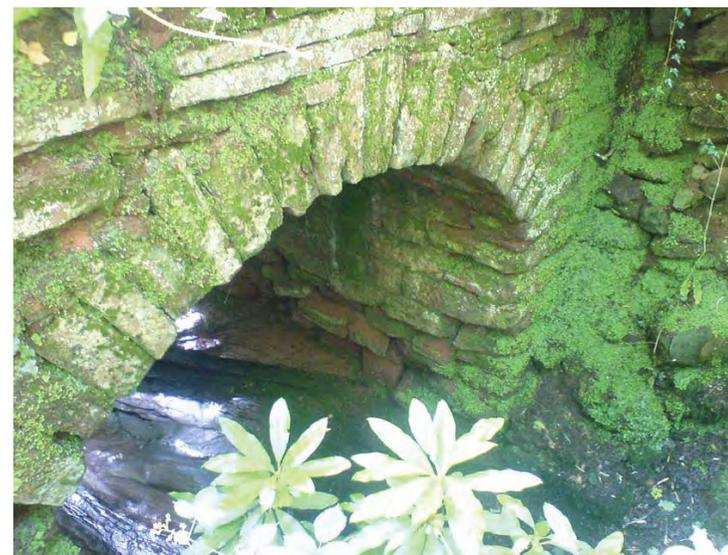
Upstream side of the bridge

While the arch of the bridge is intact and structurally undistorted it is clear that the lower part of the western abutment has been considerably eroded by water action and the masonry beginning to become loose.

As the bridge and the abutments cross over the burn itself, both parapets have been pushed in.

The down-stream side of the bridge appears to be in somewhat better condition than the upstream side.

This bridge, though in poor general condition now, seems to be wholly repairable.

It is important for a number of reasons, not least in terms of practical circulation and public safety, that this bridge be assessed by a conservation-trained structural engineer, be cleared of vegetation and made safe in the short term, and a suitable repair programme planned for to fully reinstate it as a functioning structure, employing appropriate materials (including lime-based mortars) and techniques of construction, detailing, etc. to match the original.
