TECHNICAL PAPER 33

MASONRY POINTING AND JOINT FINISHING

PART 2 - GAZETTEER

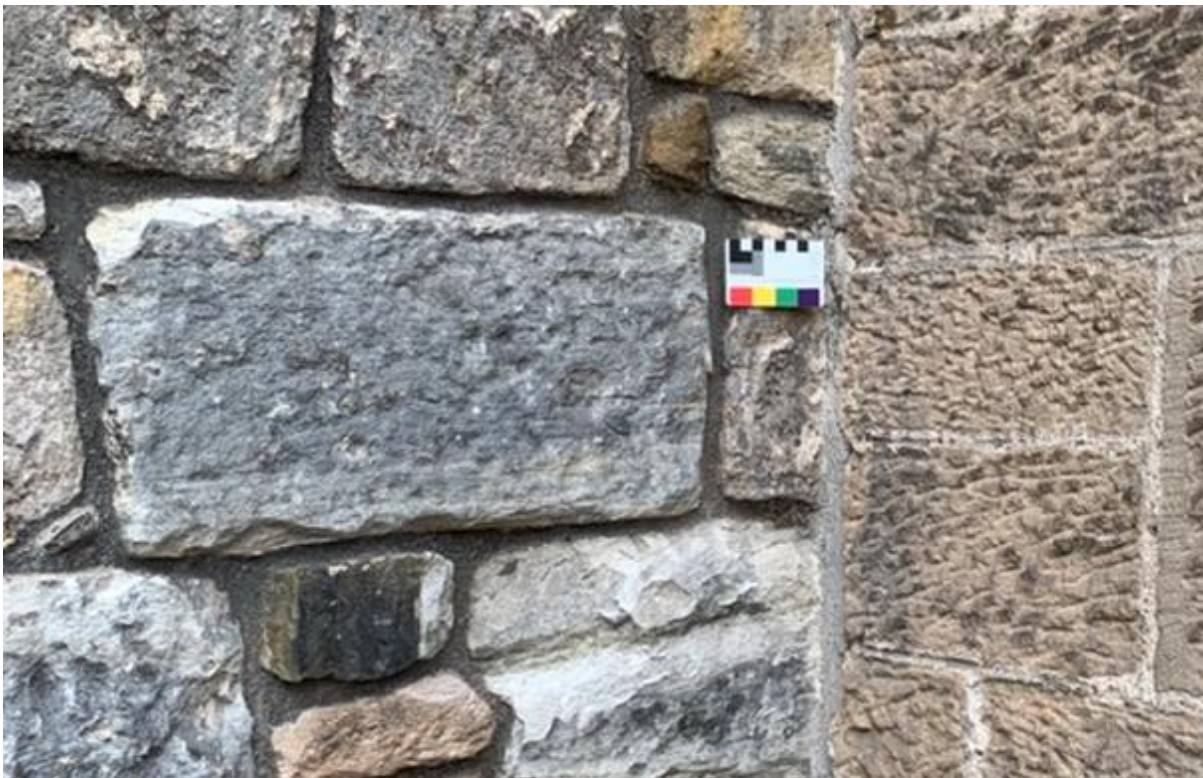
The King's Old Building, (Figure 001.1) was built for James the IV in around 1497 as part of the Royal Complex at Stirling Castle. Masonry work in the 20th century now presents a bare stone façade with a heavily recessed cement joint between the blocks of masonry. However, upon scrutiny of masonry lower down, there are traces of lime harl in some areas (Figure 001.2). Archive images from the 19th century show that the finish was a lined out flush point, and it is likely that the original harl was removed as part of this work. This lined out pointing may have been associated with the repair works after the fire and the rebuilding of the Officers Mess by Robert Billings in 1857. Later activity by the Ministry of Works resulted in the recessed pointing style (Figure 001.3) seen today.

Figure 001.3. 20th century recessed pointing on the 15th century masonry of the Kings Old Building. To the right is 19th century masonry and lined out pointing; work done following the fire.

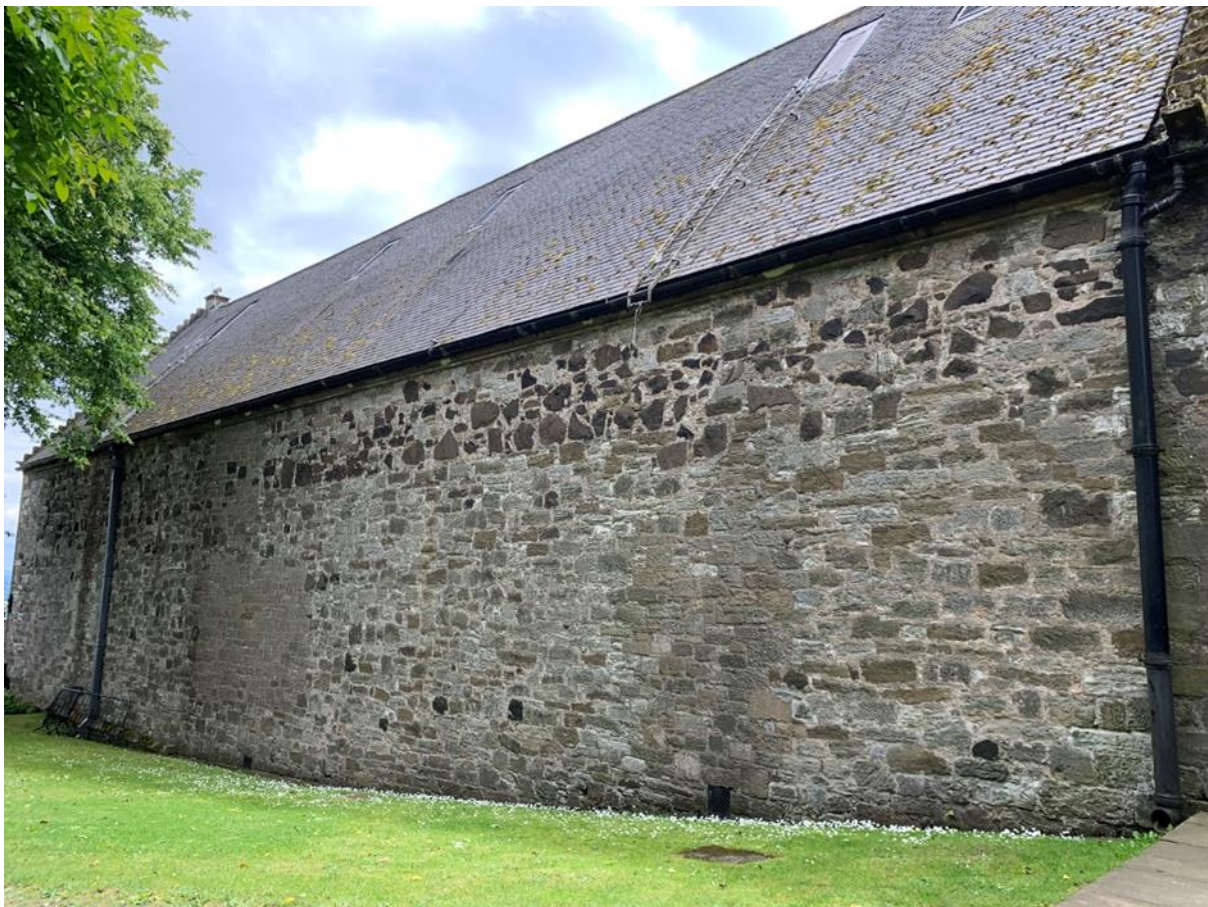
Figure 002.1. The rear elevation of the Chapel Royal.

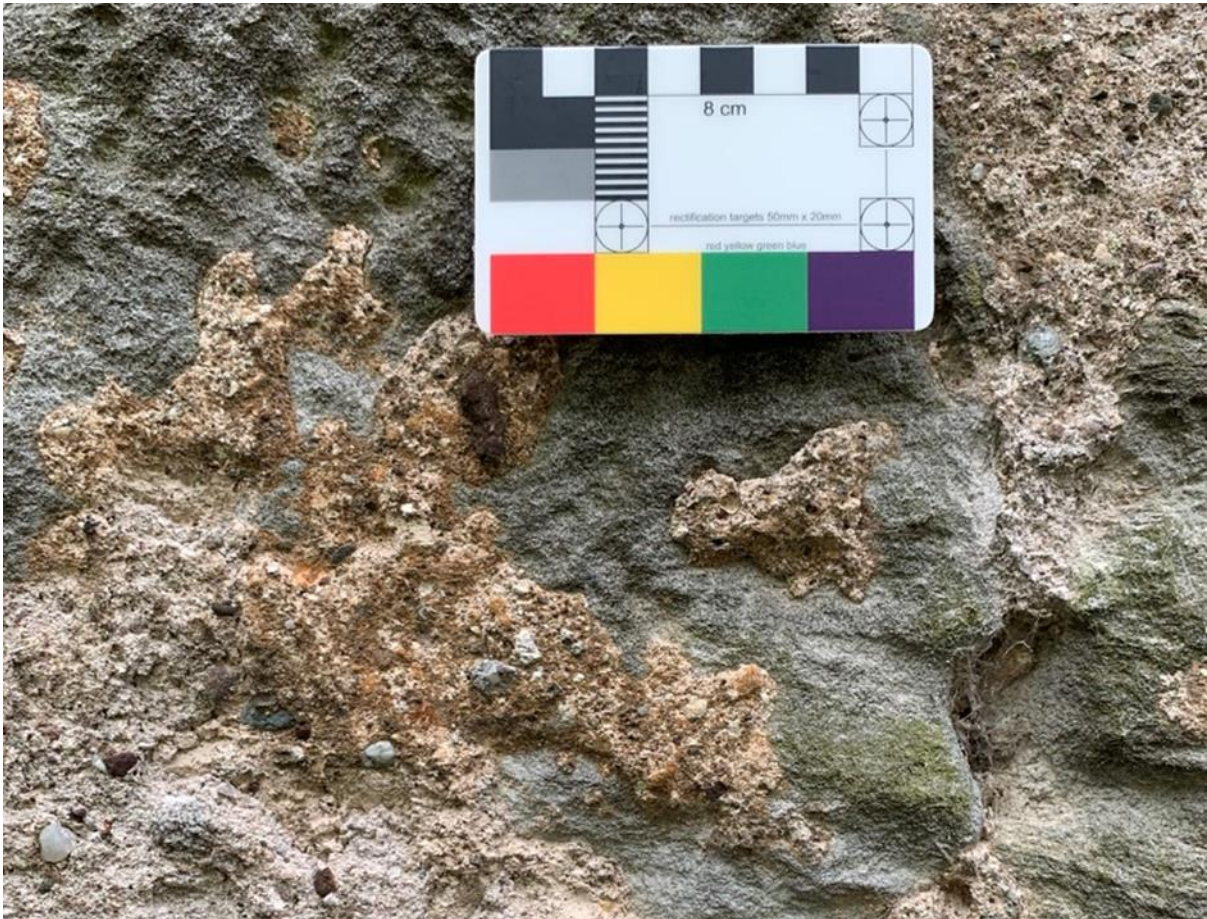
Figure 002.2. Surviving orange coloured harl in the centre, overlain with a later white pointing bottom left. This harl could be part of the original finish matched to the Great Hall close by.

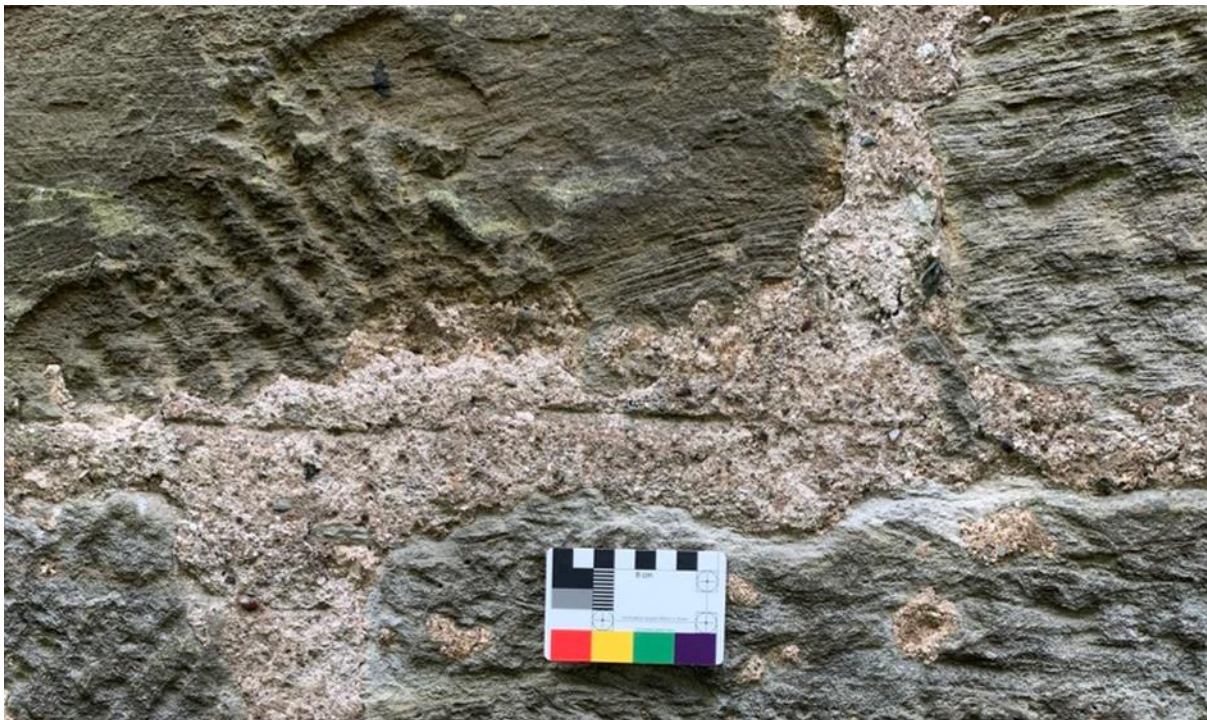
Figure 002.3. Overlying white pointing with horizontal ruling out, probably dating from the 19th century.

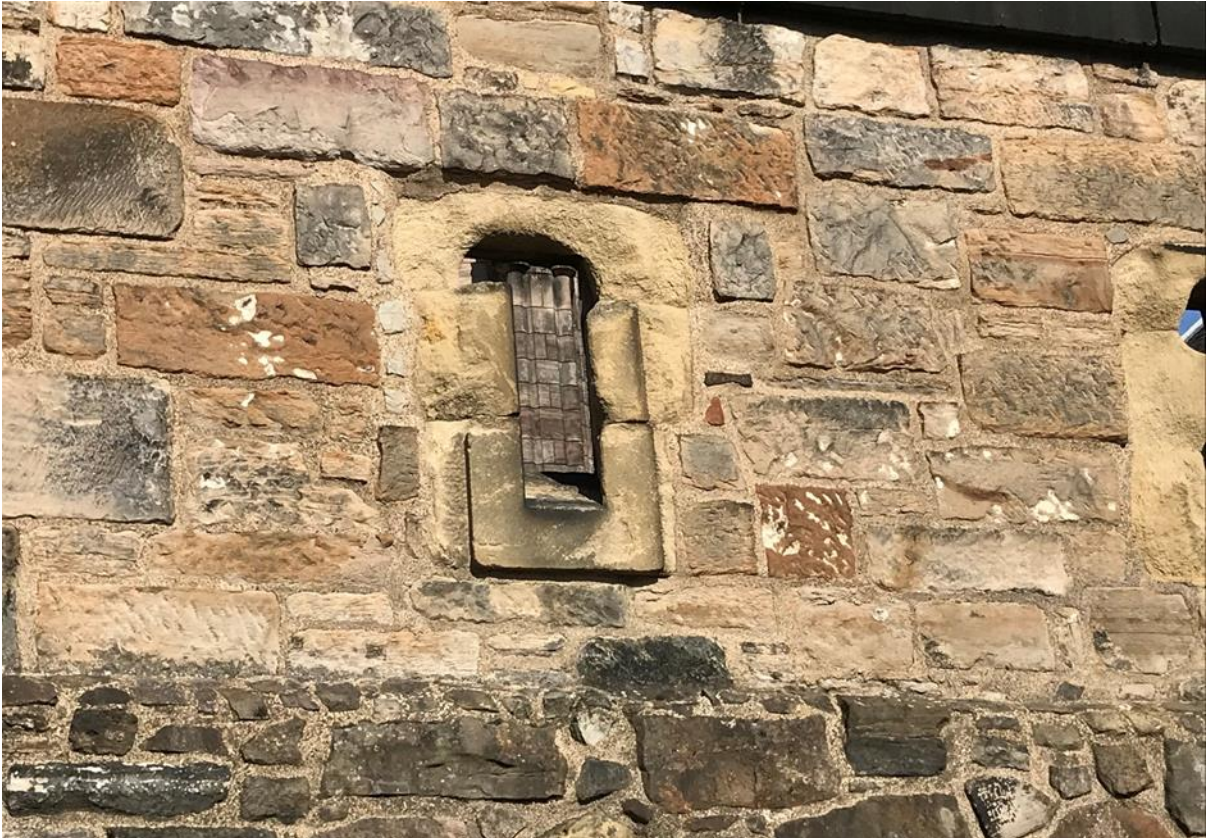
Figure 003.2. The Foogs Gate forework masonry probably dating from the mid-18th century. Several masonry units either side of the lancet show limewash surviving in the tooling marks suggesting that this area was flush pointed and limewashed.

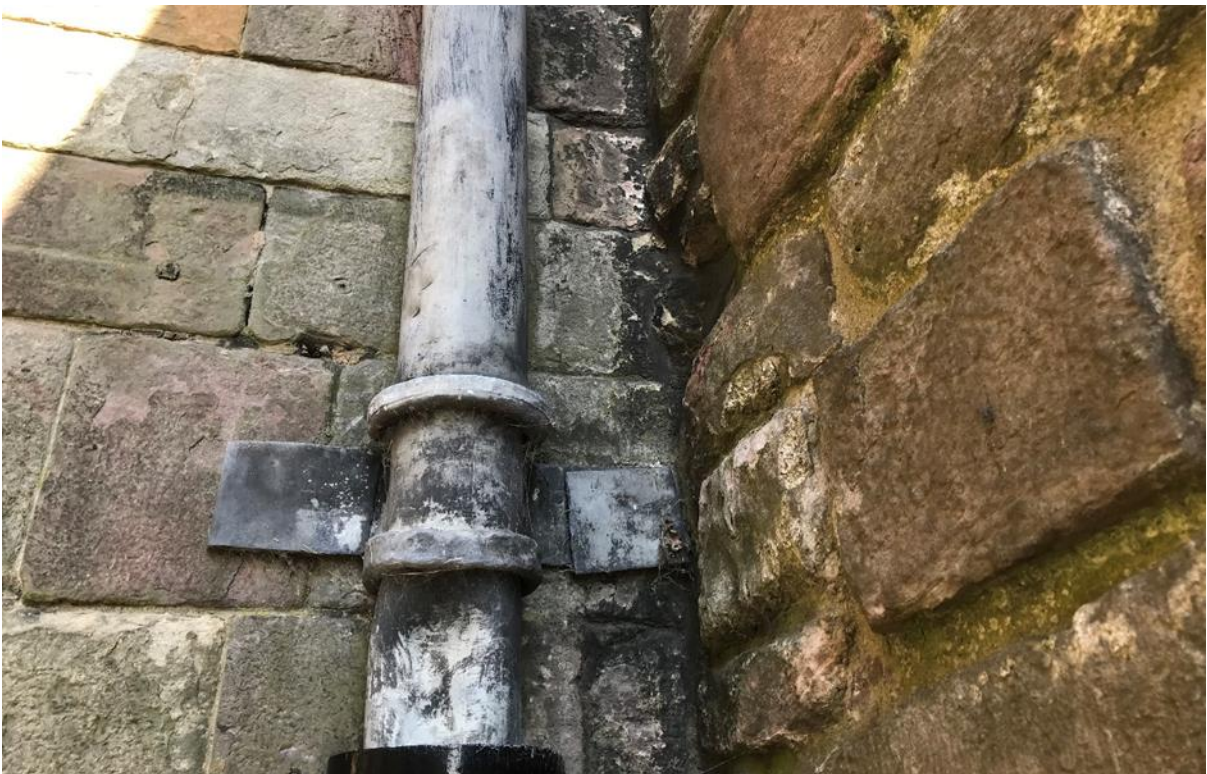
There are some other areas around the castle where historic finishes survive, notably on the 16th century ashlar work of the Portcullis Gate (Figure 003.3), and on the adjacent retaining wall to the North.

Figure 003.3. Ashlar work of the Portcullis Gate dating from the 16th century. Limewash fragments visible to the left and right of the downpipe.

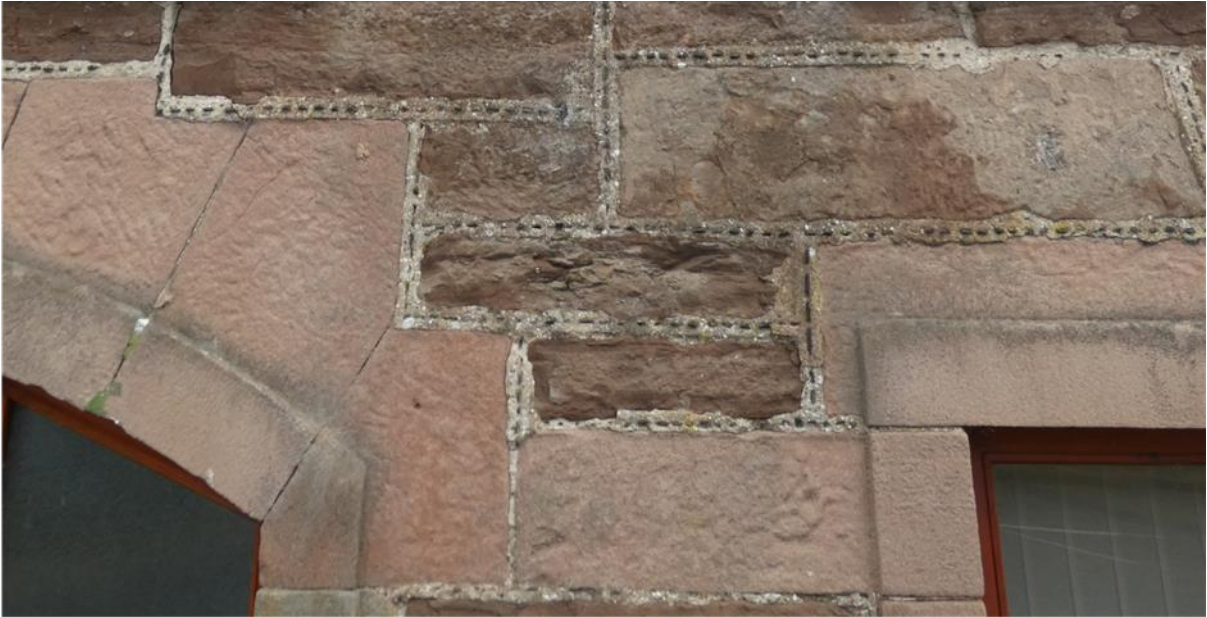
Figure 004.2. Finely detailed masonry and precise cherry-stoning.

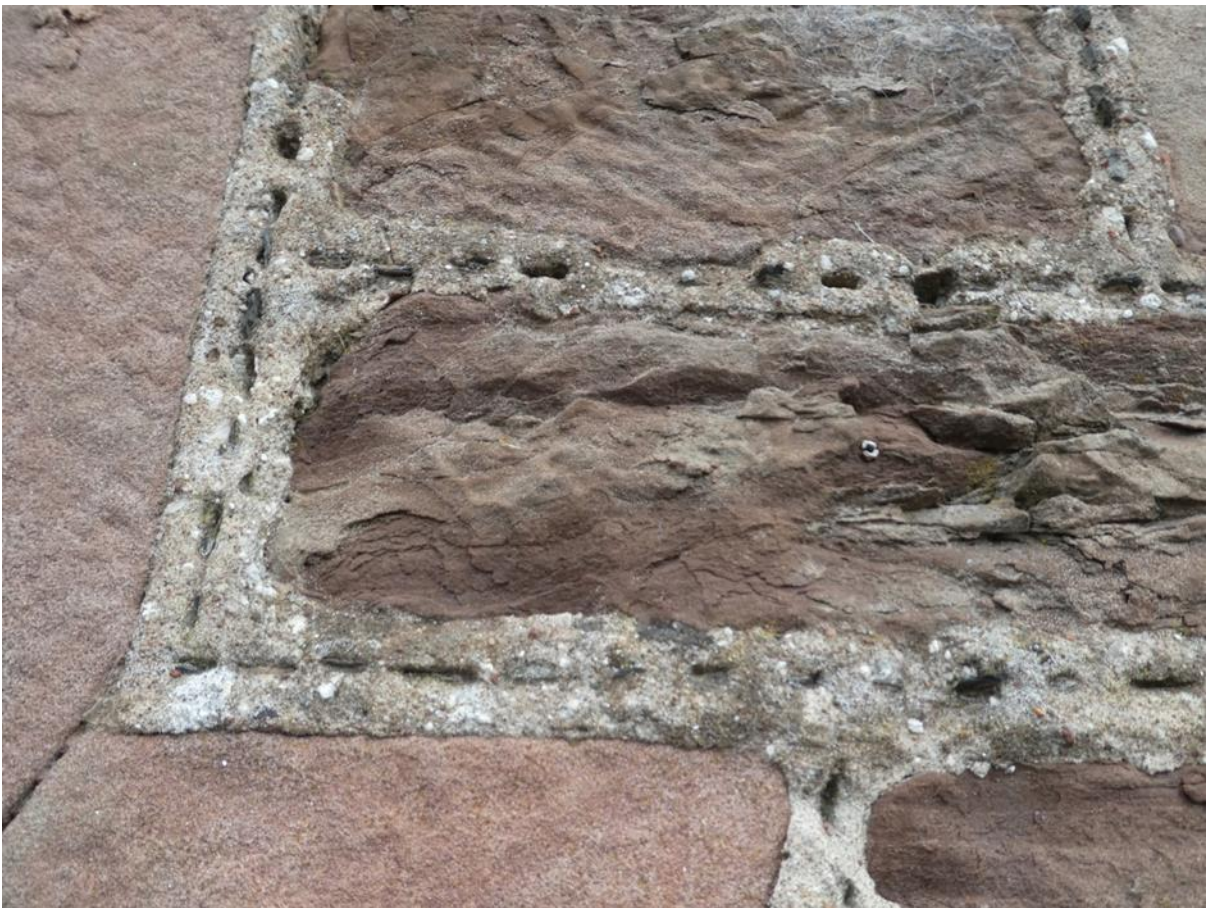
A two storey sandstone building at the junction of the High Street and Hawkhill Road (Figure 004.1). Formerly part of a terrace the adjacent building to the left has been demolished. The north elevation is compromised by the raised pavement. Given the care taken at the raised details around the openings it is possible that the building was once harled. Currently, the joints are cherry-stoned with Scotch slate (Figures 004.2). If the building was once harled, then the cherry-stoning is a post-construction change. The mortar consists of fine marine sand with shells with what appear to be late slaked lime inclusions (Figure 004.3). It is interesting to note the level of sandstone decay even with lime mortar.

Figure 004.3. Fine sand with shell and lime inclusions.

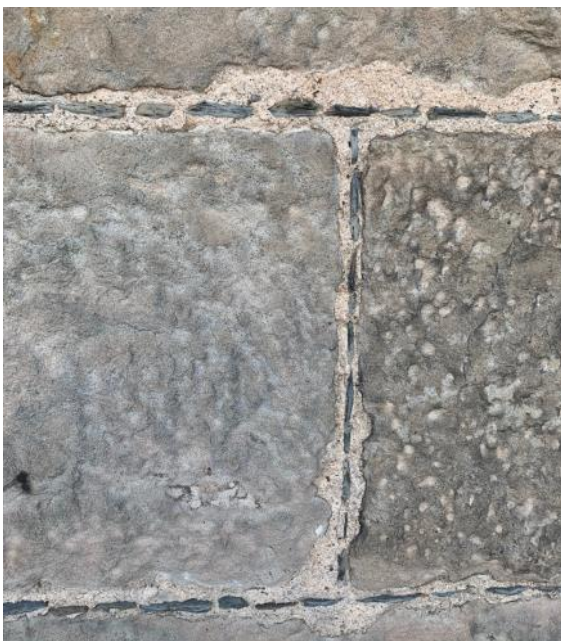
A three bay, two and half storey Georgian house. The house is constructed with sandstone with raised margin at the quoins, doors and windows (Figure 005.1). It is flush finished with very fine Scotch slate cherry-stoning (Figures 005.2). The mortar is made of fine angular sand in the range of 1-5mm. There is no trace of former harl despite the raised margins.

Figure 005.2. Detail of the cherry-stoned finish.

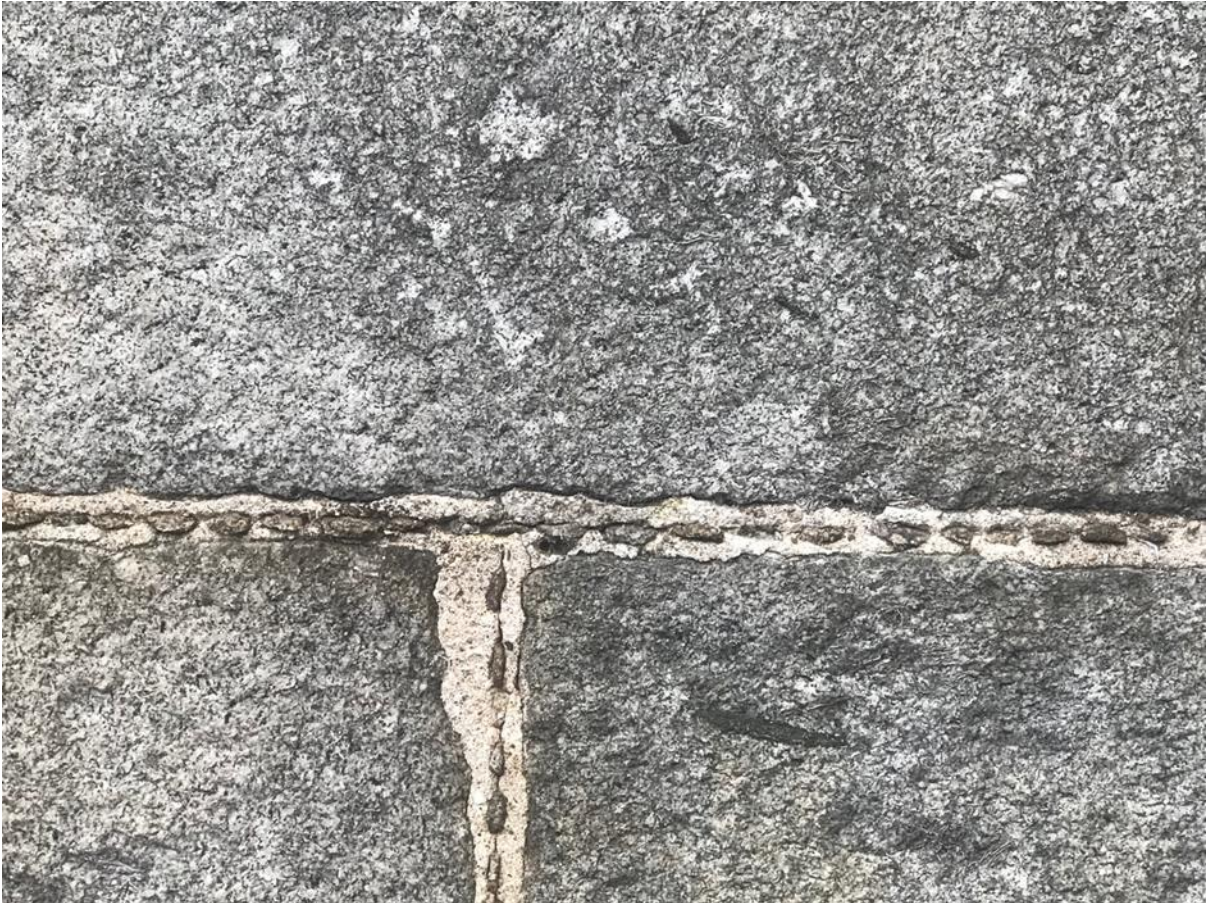
A simple late Georgian house (Figure 006.1). Presumably altered in the Victorian/Edwardian period given the changes to the ground floor right window and former door opening. The masonry is flush finished and cherry-stoned with small pieces of granite (Figure 006.2). It is tempting to suggest that the cherry-stones are a byproduct of the squaring of the blocks of granite used in the construction of the house, however, the style of the building suggests that it may have been harled. If this was the case, then the pointing and correlating cherry-stoning would have been a later addition and one that is possibly coeval with the window and door alterations. It has been demonstrated that, despite the robustness of granite, Aberdeenshire did have a tradition of lime harling and the Balgownie area was no exception, even in the 19th century.

Figure 006.2. Granite built and cherry-stoned with what appear to small granite chips.

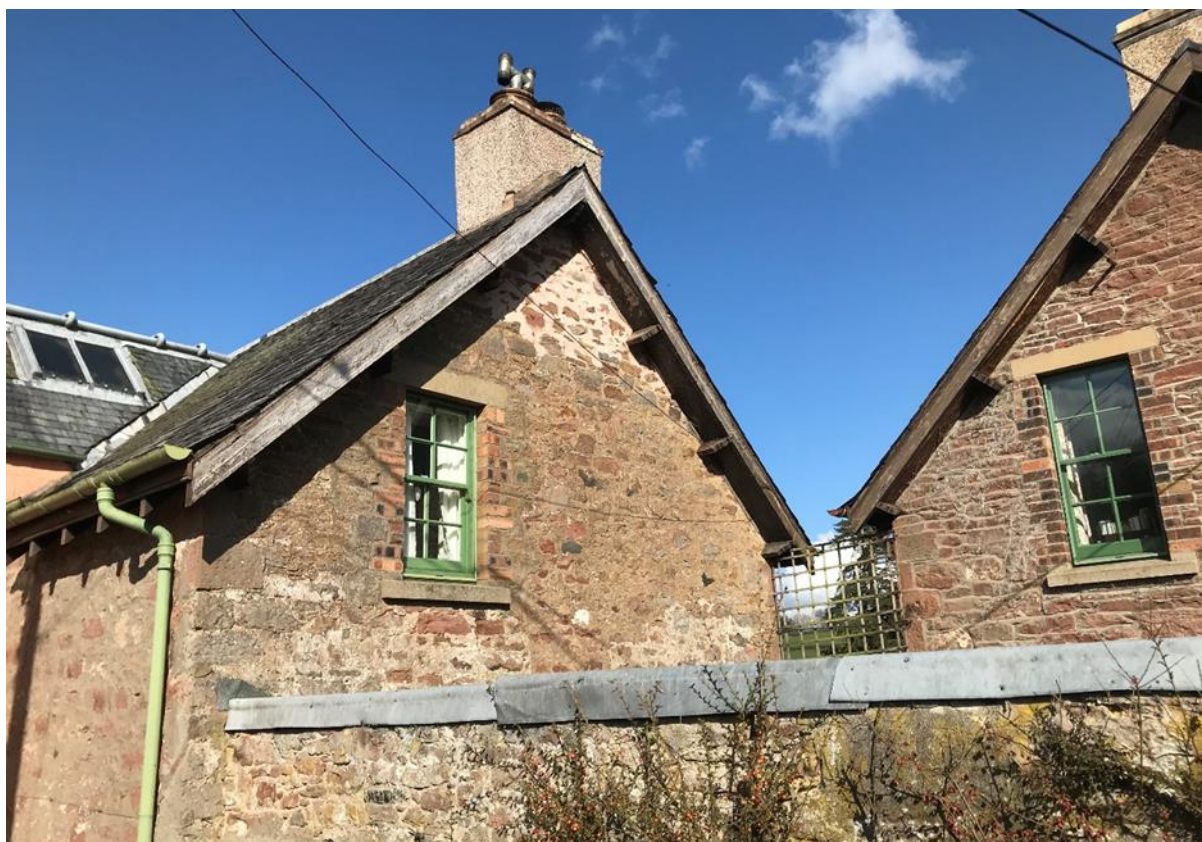
Figure 007.1. The Gable end of one of the stable cottages.

At the former stables for Weens House near Hawick, formerly for Estate staff. The south west gable of one shows an interesting sequence of building and masonry finishing styles over the main periods of the building's evolution to a private house. It is believed that the stables were built or reconfigured in the late 18th century when Sheriff Oliver built the mansion house close by. The courtyard buildings were constructed from clay bonded sandstone rubble, flush pointed with lime and limewashed (described in TP 31). Evidence for this survives in many areas including the lower parts of the gable end middle left of Figure 007.1.

About 1905 the cottages were largely rebuilt with additional height to the walls, new dormers on the first floor and new masonry gables replacing the pien end roof. The masonry of the new gable shows clearly above the line of the window cill. While it is a traditional flush point, it was never limewashed. This shows as a light brown coloured mortar (Figure 007.2) above the 18th century material, surviving below (Figure 007.3). The older finish was limewashed, with some traces remaining. This gable faces south west, and exposed elevation in this district, and the durability of both

pointing types is of interest. By way of contrast, the gable of the adjacent cottage was re-pointed in 1958 in a semi strap style which can be seen on Figure 007.1, giving a very different presentation to the building.

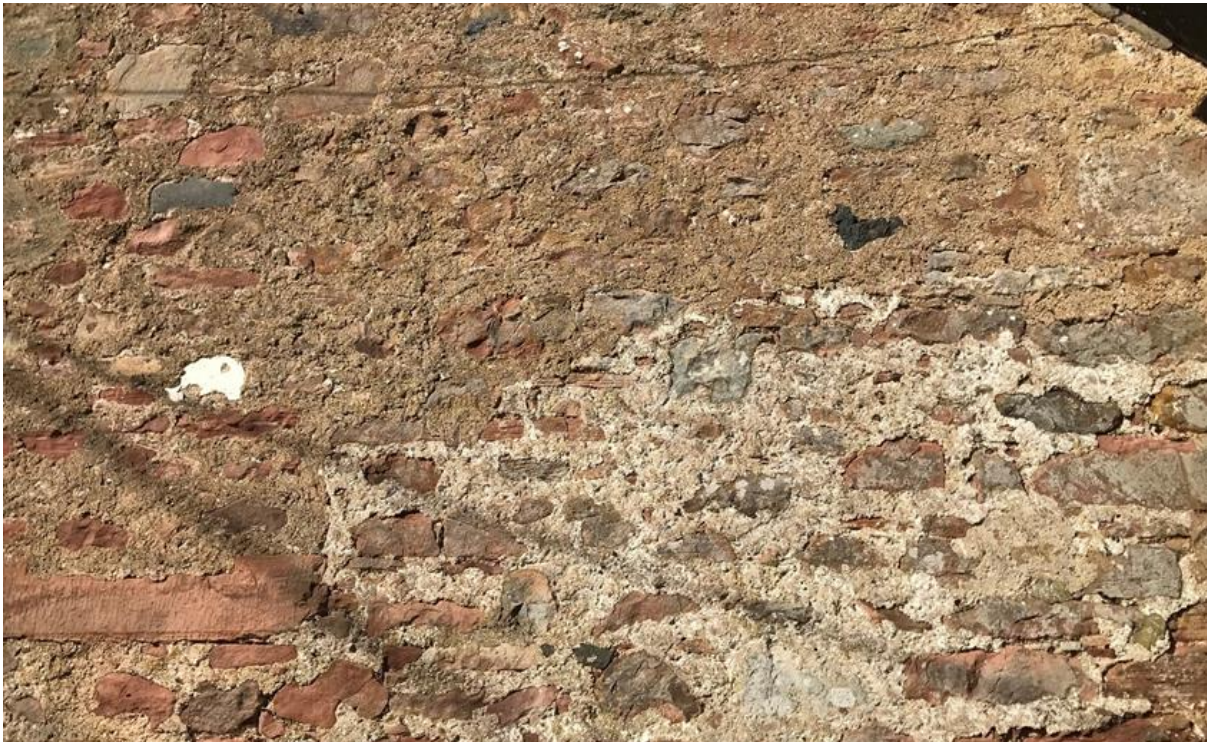
Figure 007.2. Wall finish from the 18th century showing as a whiter flush point, with a similar mortar finish from the 1906 work.

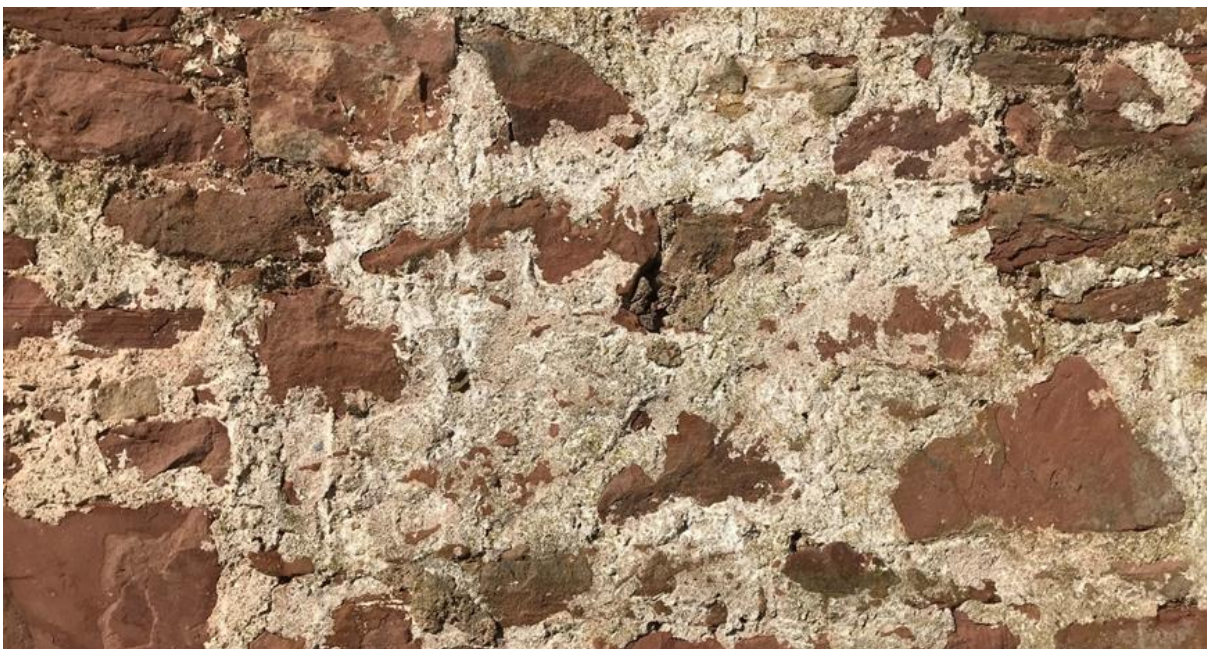
Figure 007.3. Flush pointing and limewash traces on the lower part of the gable dating from the 18th century.

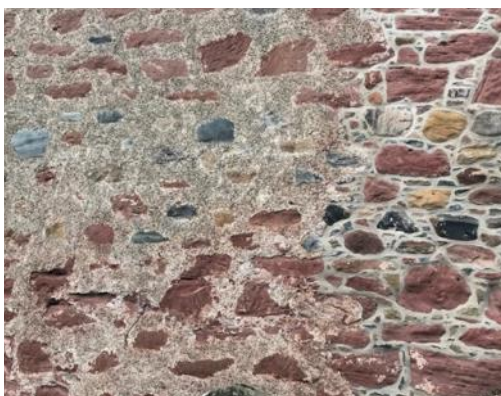
Figure 008.2. Sneck harl with recent lime pointing.

A late 18th or early 19th century house built with red and yellow/buff sandstone and field boulders. The gable is plastered and the rear elevation that abuts the Cromarty East Kirk is sneck harled (Figure 008.1). The mortar is of marine aggregate in the range of 1-12mm. There is also evidence of recent lime pointing in a contrasting modern style (Figure 008.2).

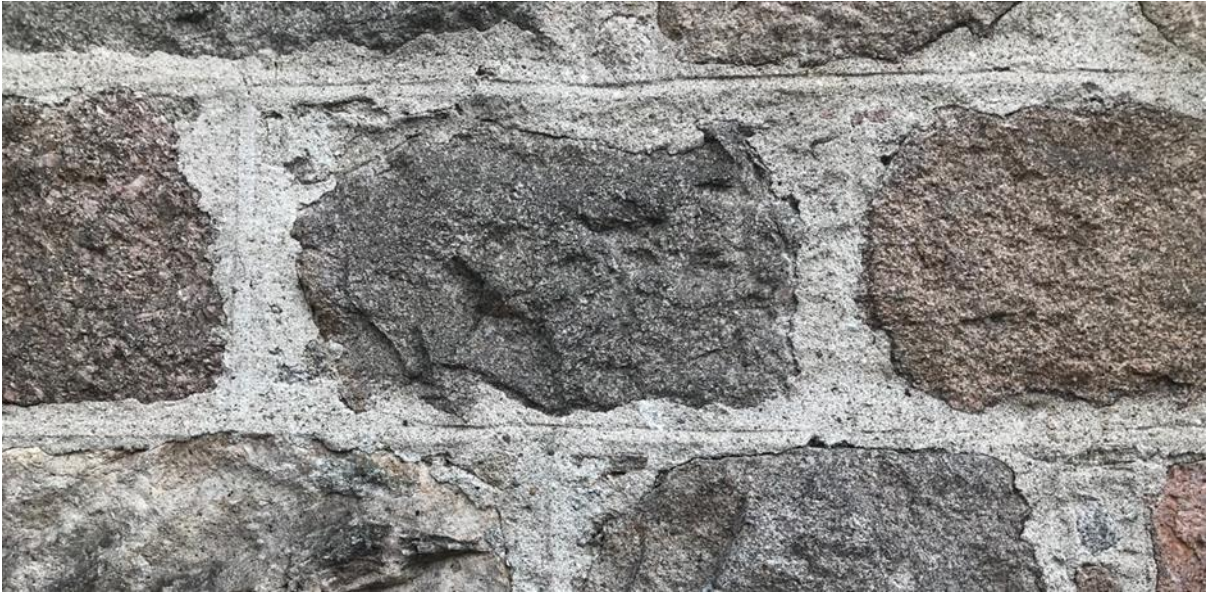
A three bay two and a half storey building (Figure 009.1). The pointing is fully flush finish and has a raised band measuring 20mm applied to both the horizontal and perpendicular joints (Figures 009.2). The sand and aggregates are sharp and well graded with no sign of inclusions. The most likely source of lime for the mortar would be Parkmore at Portsoy. The extant finish is generally intact though worn in some areas, resulting in the raised band becoming faint. In other areas, repairs have been made with a cement mortar (Figure 009.3). Other buildings in the area demonstrate a similar pointing tradition. It is possible that mortar was applied liberally over the whole joint and then flattened with the back of a trowel. Two parallel lines might have been struck using rod or level and the lines made by using something similar to a carving fork. Once the lines were struck, the mortar on the outer edges of marks could be teased away, leaving the raised band prominent of the wider surface. There are no indications of limewash.

Figure 009.2. Worn raised band pointing.

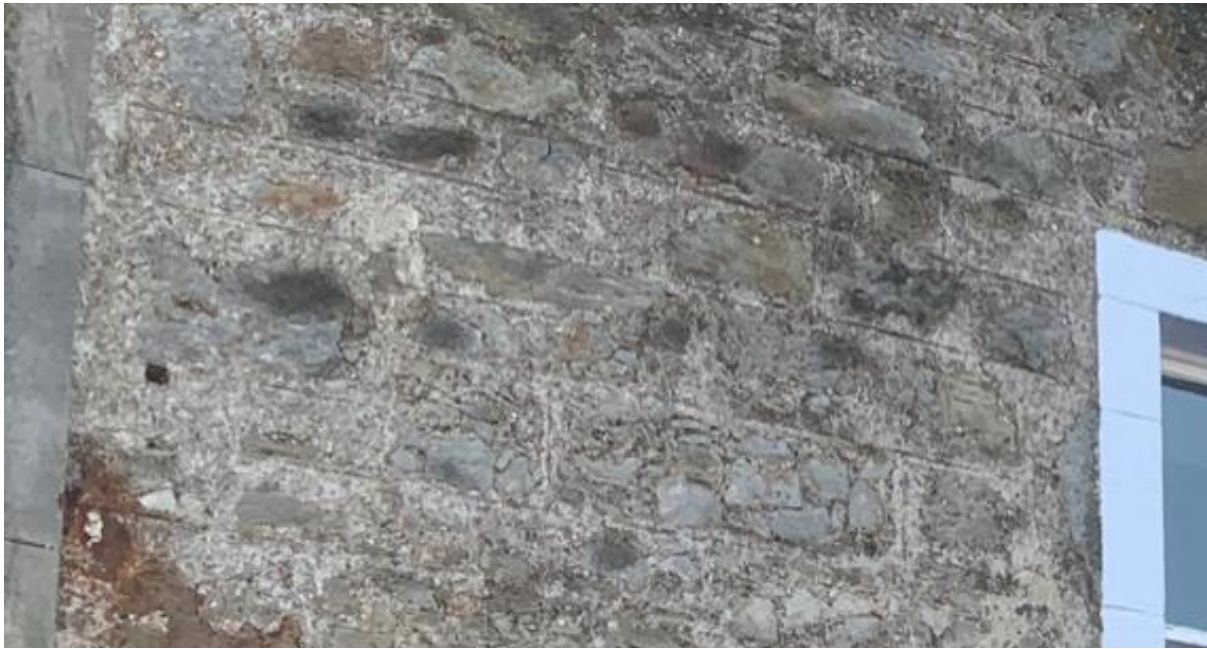
Figure 010.2. Change in masonry above close entrance.

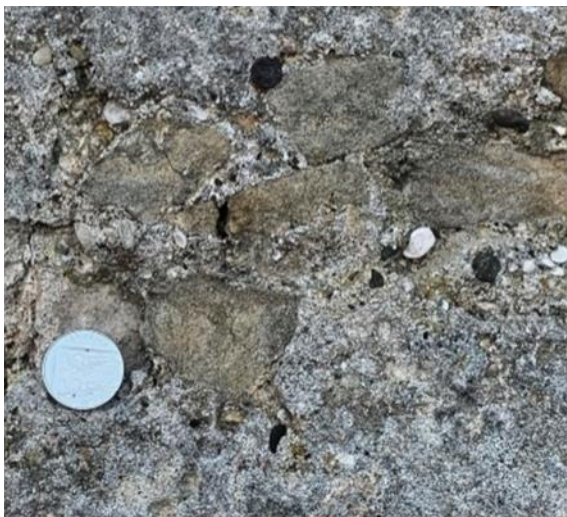
The mortars are varied but feel binder rich to touch. Given South Queensferry's proximity to the Charlestown lime works, it would seem likely that the burnt lime came from there. The lime is feebly hydraulic. The aggregates are rounded with lime, shell and small quantities of burnt coal inclusions in the range of 1-15mm (Figure 010.3). The sneck finish is horizontally and perpendicularly ruled out (Figure 010.4).

Figure 010.3. Coal inclusions in the aggregate.

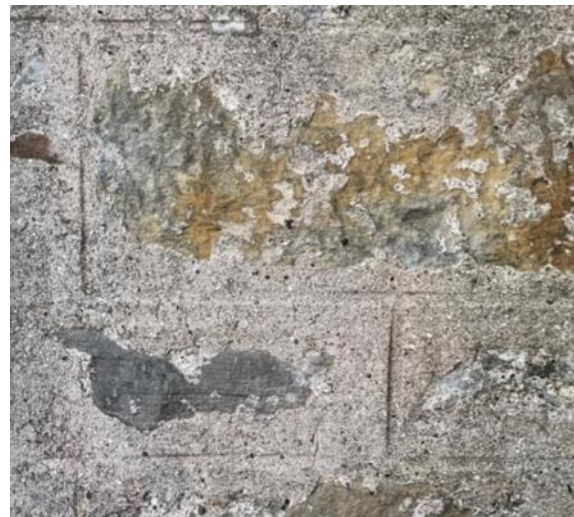
Figure 010.4. Horizontally and perpendicularly ruling out on the sneck finish.

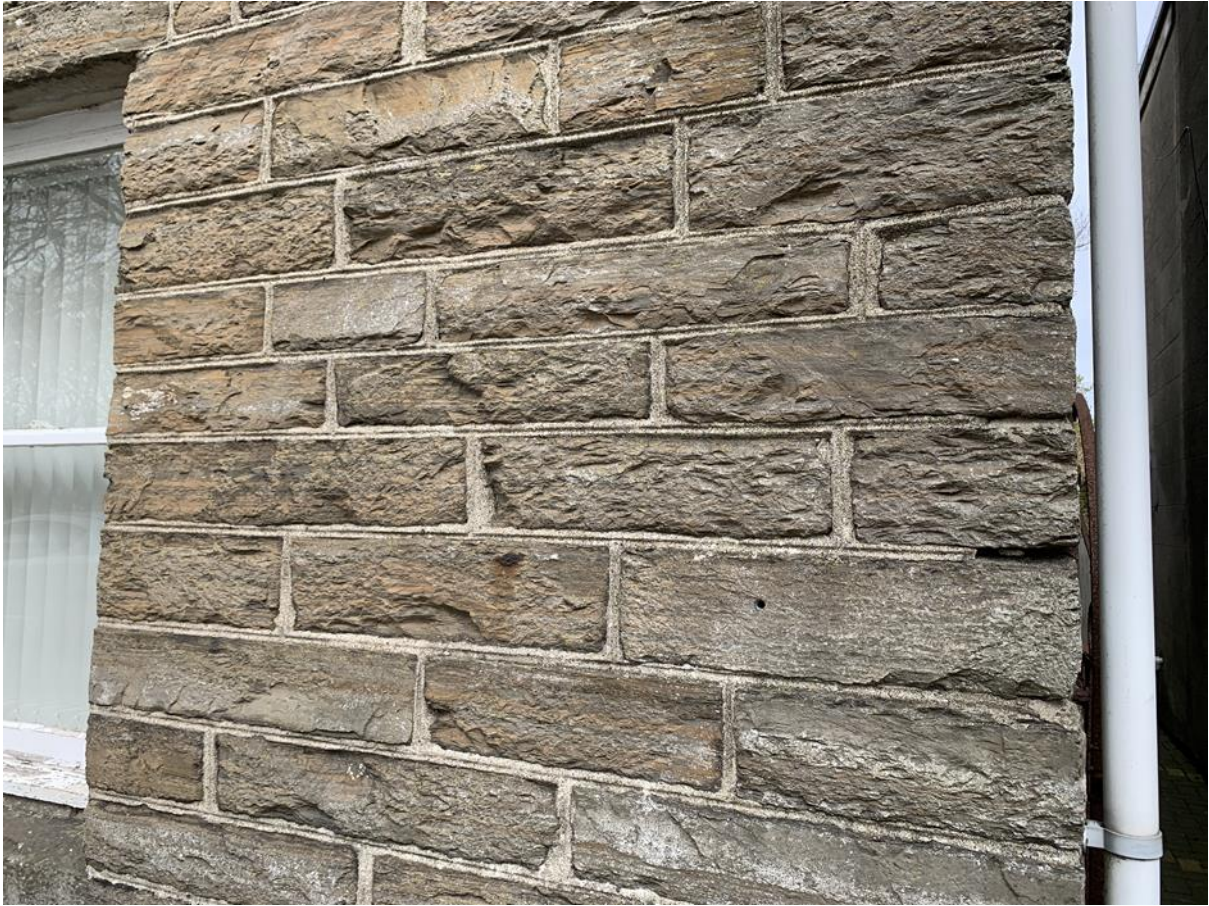
This building is an early Victorian period end terrace, in the centre of the part of Wick called Pultneytown. This square was part of a scheme designed by Thomas Telford in the early 19th century for the British Fisheries Society; this property and many others are Category B Listed. It is constructed in the local sandstone with evenly laid coursed masonry. The nature of the stone means that the normal approach to masonry construction for opening and edges was not needed, so courses are built through to the margins. The mortar is a fine graded lime, with what appears to be original perpendicular and horizontal ruling out (Figure 011.2).

Figure 011.2. Coursed masonry with horizontal and vertical lining out on the pointing. The mortar appears to be original.

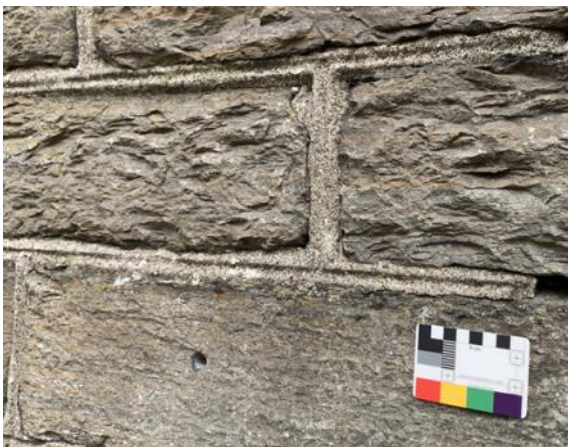
Figure 012.2. Flushed and ruled out mortar on the front façade.

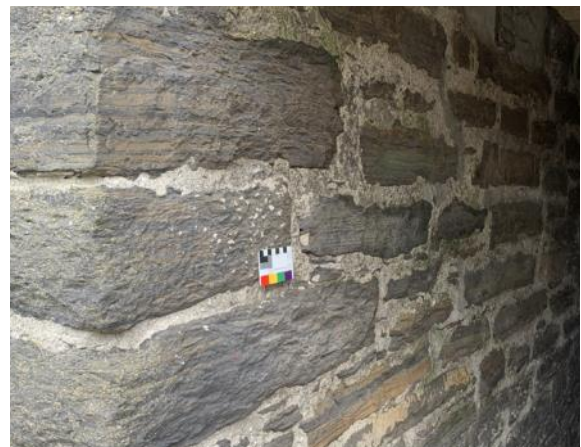
Figure 012.3. The flush pointed masonry finish in the close on the right hand side of the building, showing the hierarchy of finishes.

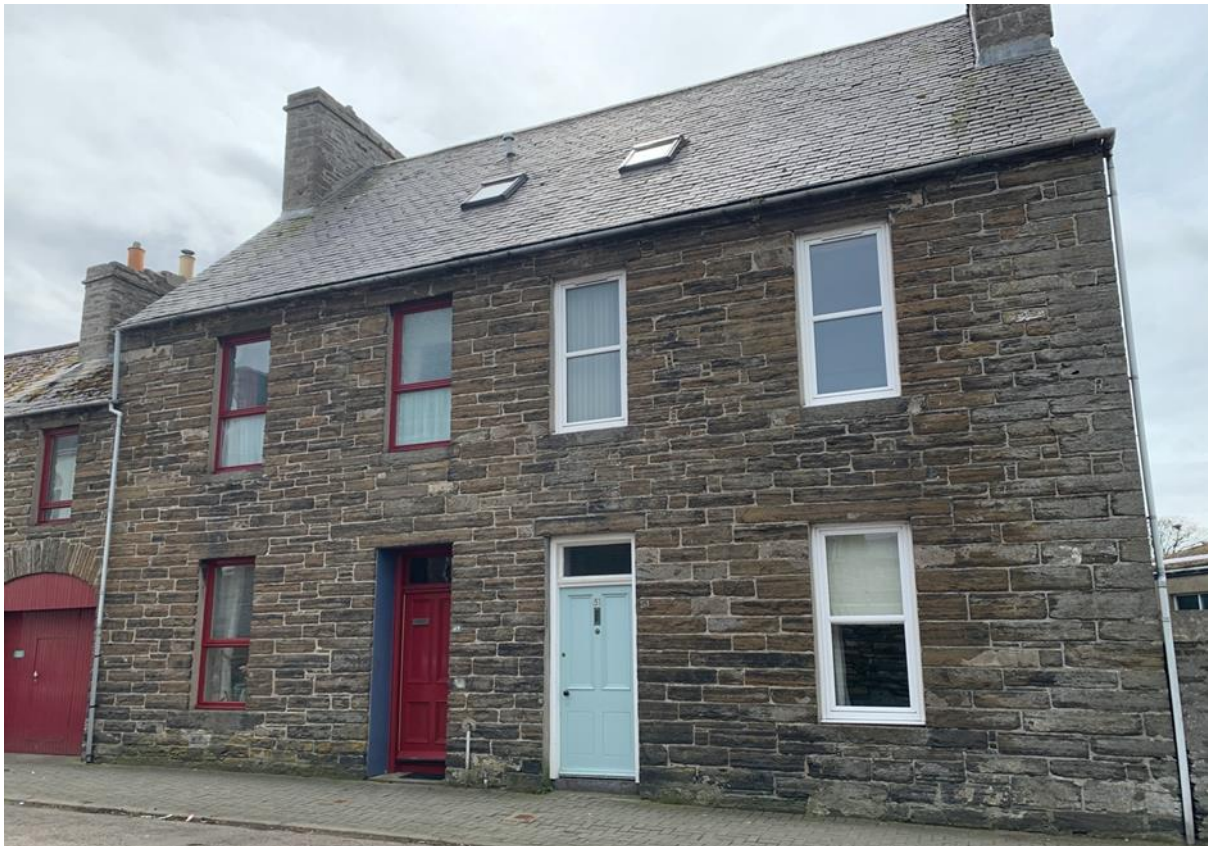
Figure 013.1. Semi-detached houses with earlier (left) pointing and later (right) finer version.

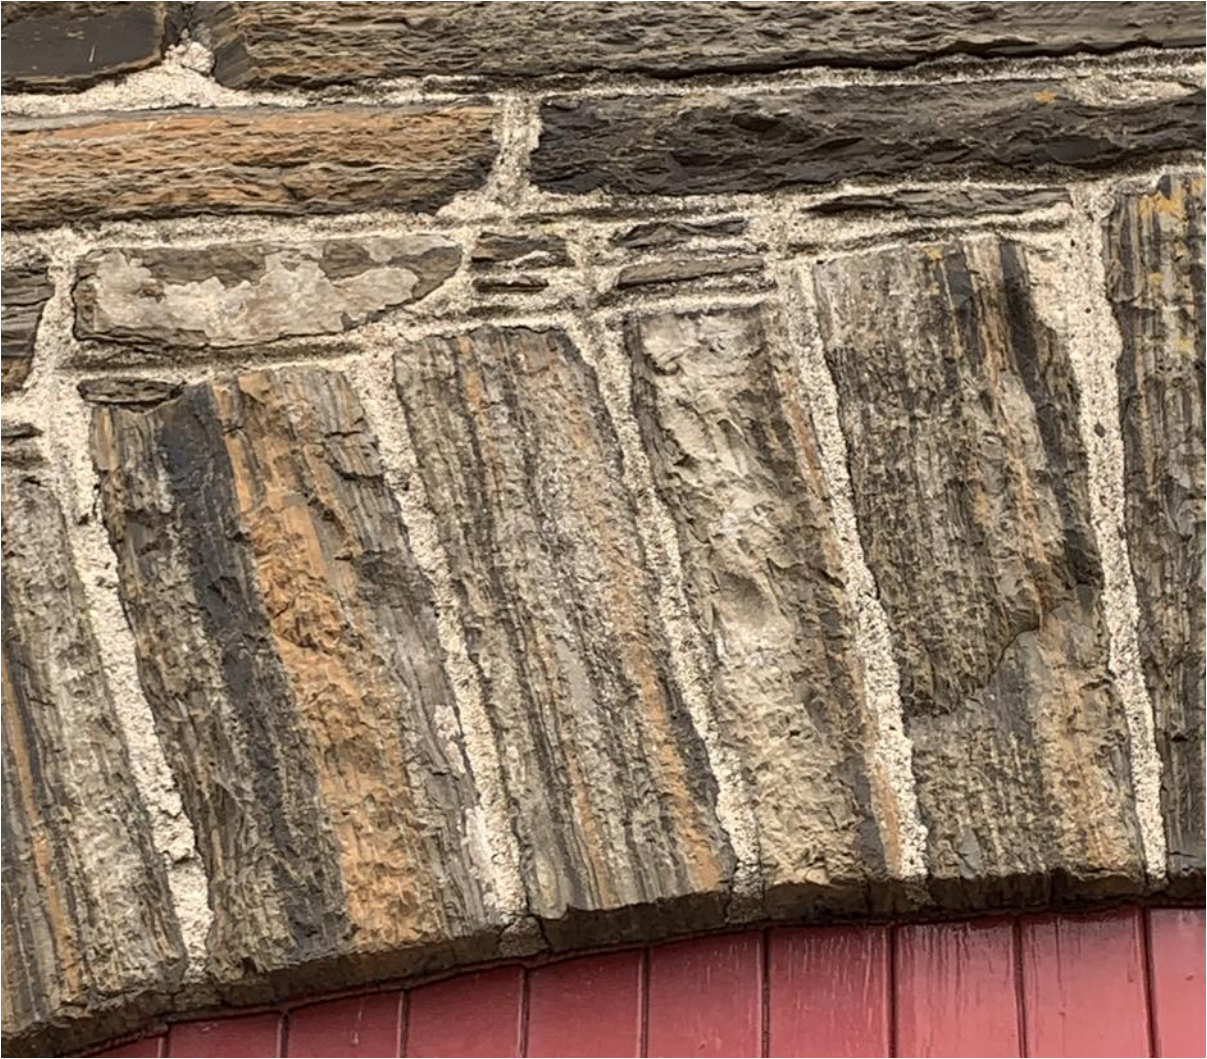
Figure 013.2. Broad ruled buff pointing.

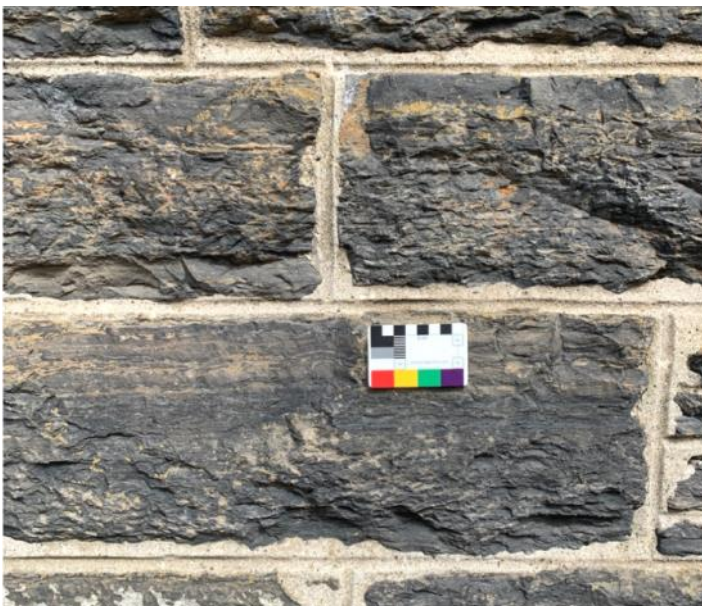
Figure 013.3. House to the right with later, finer sand pointing.

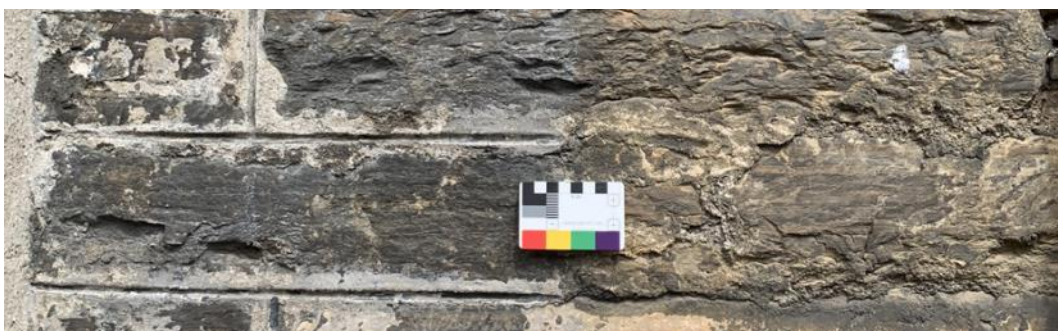
This group of buildings is part of an uncompleted terrace, built in the early 19th century as two dwellings, but with the intention of a longer terrace (Figure 014.1). On the right-hand side, the masonry is flush pointed with medium coarse sand with lime and shell inclusions and ruled out in a fairly rough fashion. On the left-hand side is what seems to be later work. This finish is flush pointed as well but much smoother with vertical and horizontal lining out giving greater formality. Close inspection of the lined areas shows signs of white paint. At the junction of the two buildings, in the closed-up doorway the two finishes can be seen close up (Figure 014.2).

Figure 014.2. A close up of the elevation at the junction of the two buildings, showing the rougher finish to the right, and the more formal work, lined out and whitened, to the left.

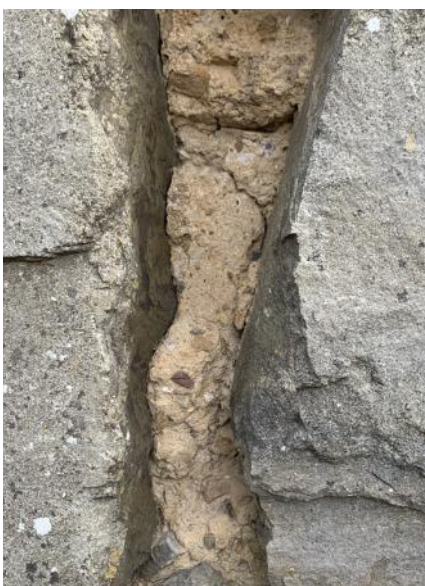
Figure 015.2. Historic earth/lime bedding mortar, showing the coarse aggregate.

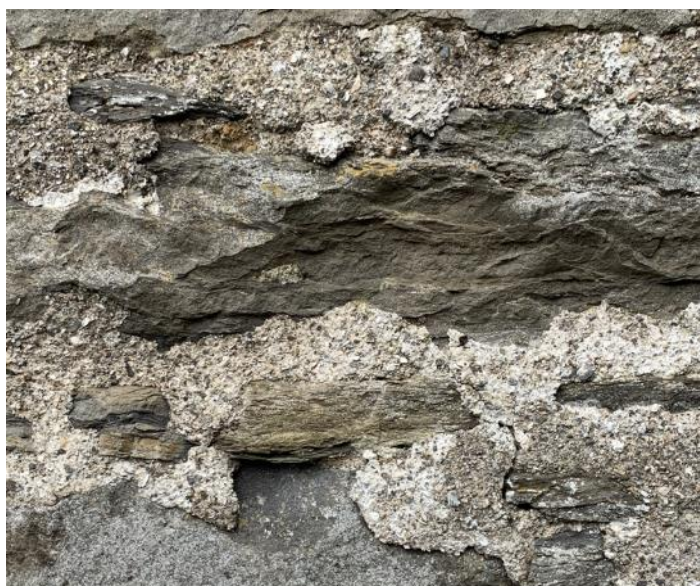
An industrial building from the early nineteenth century (Figure 015.1), probably a warehouse for traded goods connected with the fishing. Likely to have been part of the construction work in Wick by Thomas Telford in the Town in the 1820's. It is constructed from local stone with an earth/lime core (Figure 015.2), pinning's and cherry-cocks. Currently not in use. The pointing finishes are very worn in most areas (Figure 015.3), but the more sheltered rear elevations show a flush finish, with no lining out or limewash.

Figure 015.3. Sneck pointing surviving on the more sheltered rear elevation, showing finer aggregate compared to the bedding mortar.
