TECHNICAL PAPER 33

MASONRY POINTING AND JOINT FINISHING

PART 2 - GAZETTEER

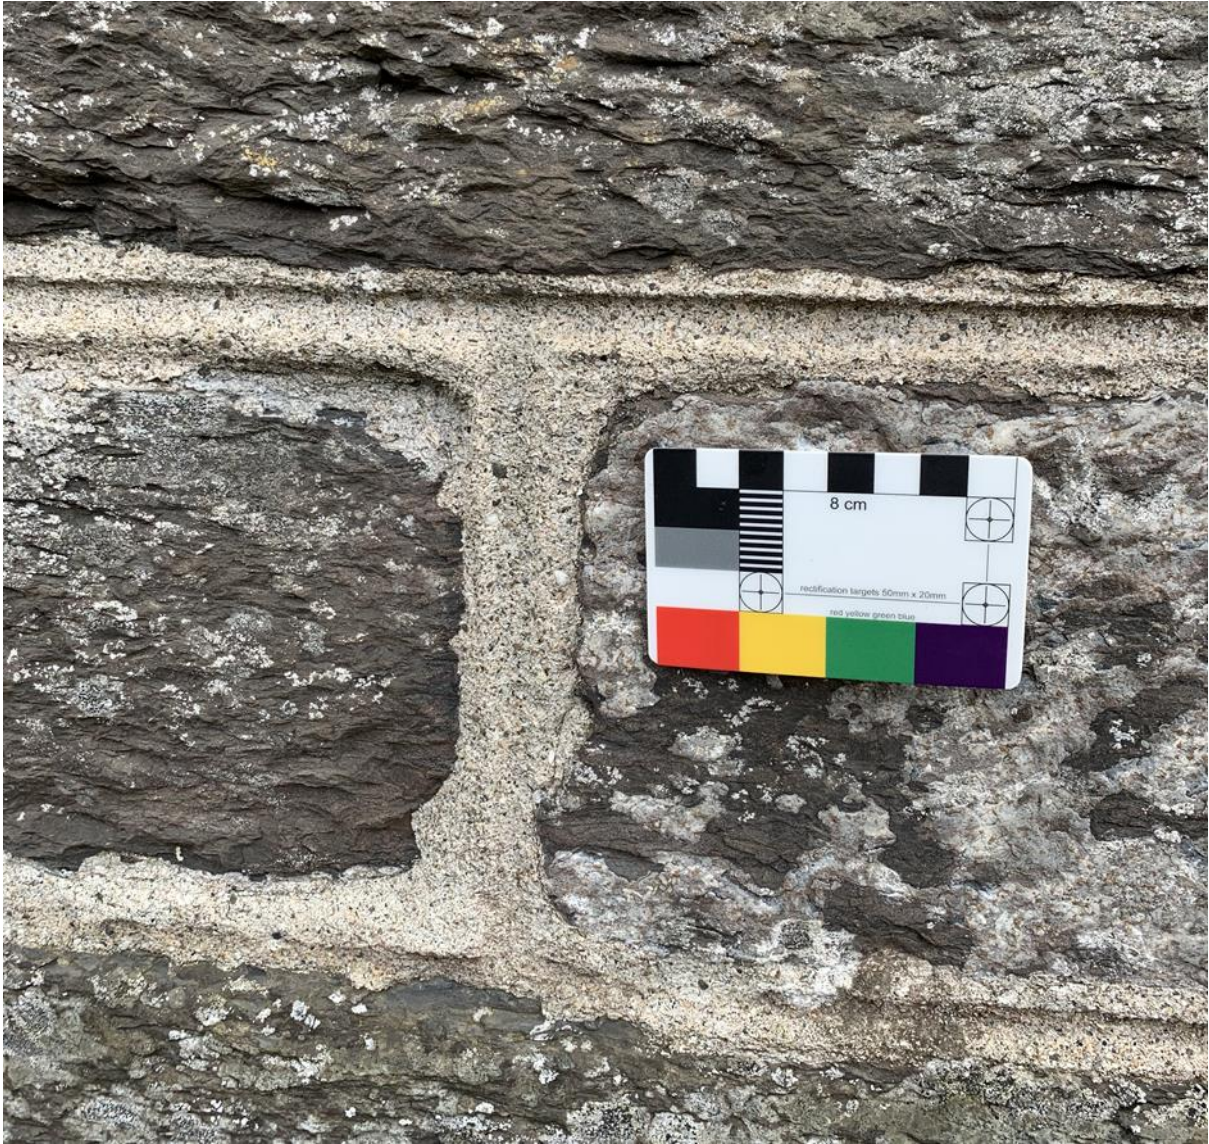
Figure 017.2. Detail of the flush point with horizontal and vertical lining out. The tool used has given a slightly wider line than is normal.

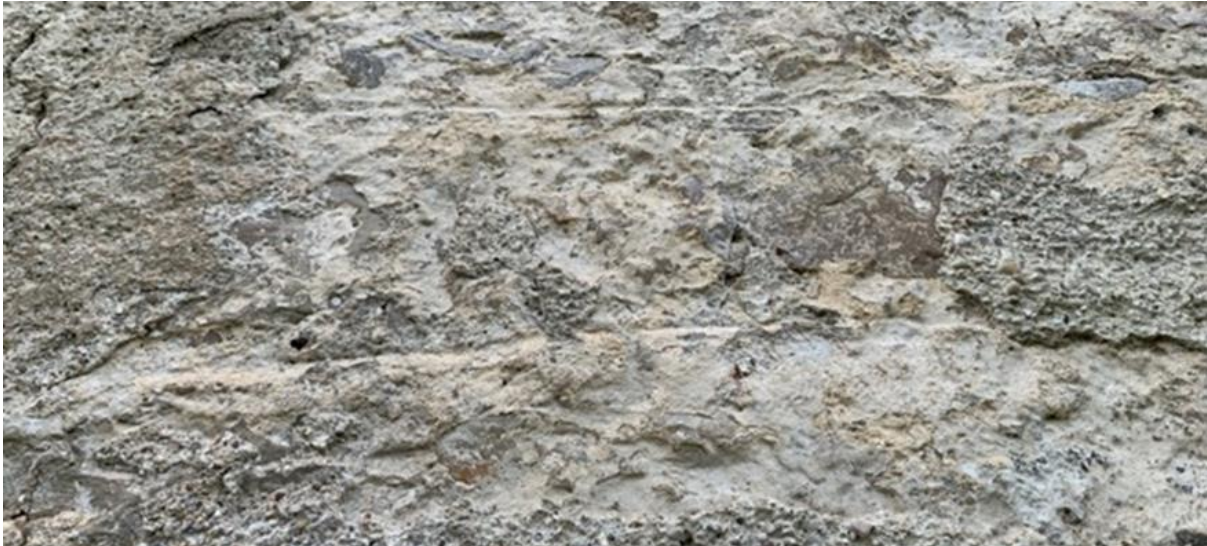
Inspection of the elevations on the house have shown that there are four phases of lime finishes on the house. Phase one, harl integrated with the building mortar was informally/crudely horizontally lined out (Figure 018.2). This harl was limewashed with pale cream coloured limewash, possibly as response to the need for maintenance on the front elevation (Figure 018.3). In a third phase, the cream limewash was again over coated with a whitewash. In the fourth phase the front elevation was reharled over all the previous works also seen in Figure 020.3. The sides and rear elevations show no signs of having been limewashed and the harling resembles the overlayer on the front. Only minor cement repair interrupt an otherwise complete lime finish narrative.

Figure 018.2. The lined out flush pointing from Phase one of the building, probably around 1830.

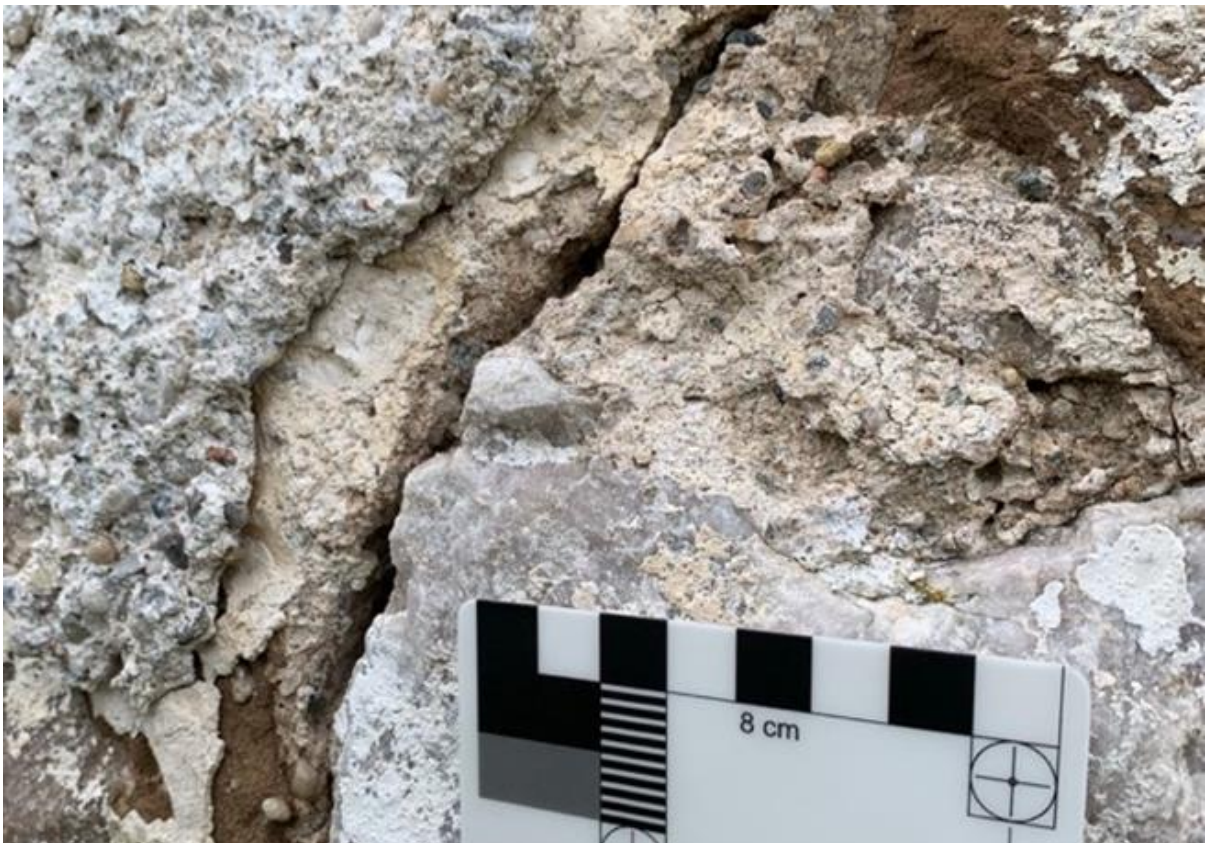
Figure 018.3. The first coat of integrated harl, with cream limewash overlay and final coat of harl.

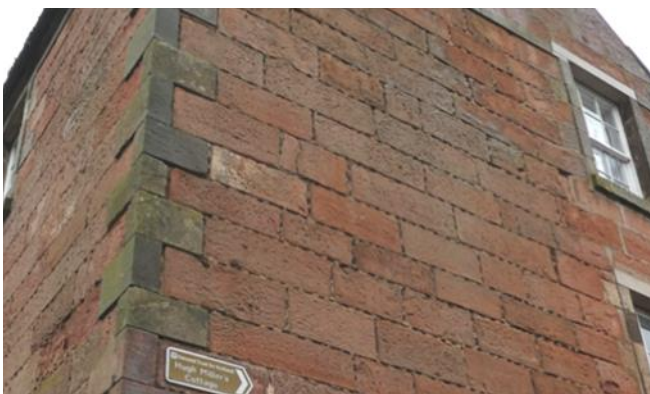
A 19th century, three-storey house on the edge of Cromarty built with soft red sandstone and buff coloured details (Figure 019.1). Although the details are raised, the slate cherry-stoned joints initially suggest that the finished joint is decorative as well as functional and intended to be seen (Figure 019.2). This is, however, not necessarily the case in the area previously covered by a shopfront. The cherry-stoning here has small mortar spills and some joints have been packed with sandstone rather than slate, suggesting the building may have originally been harled (Figure 019.3).

Figure 019.2. The decorative, yet functional cherry-stoning is visible from street level.

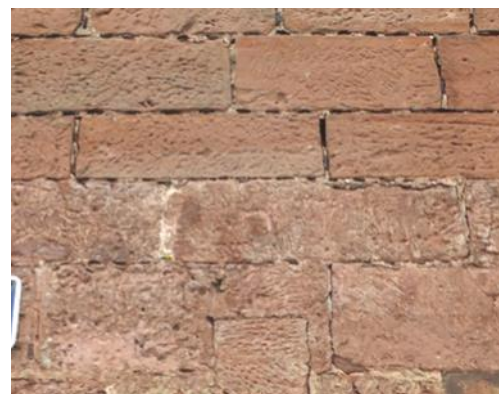
Figure 019.3. Some of the joints are filled with sandstone chips.

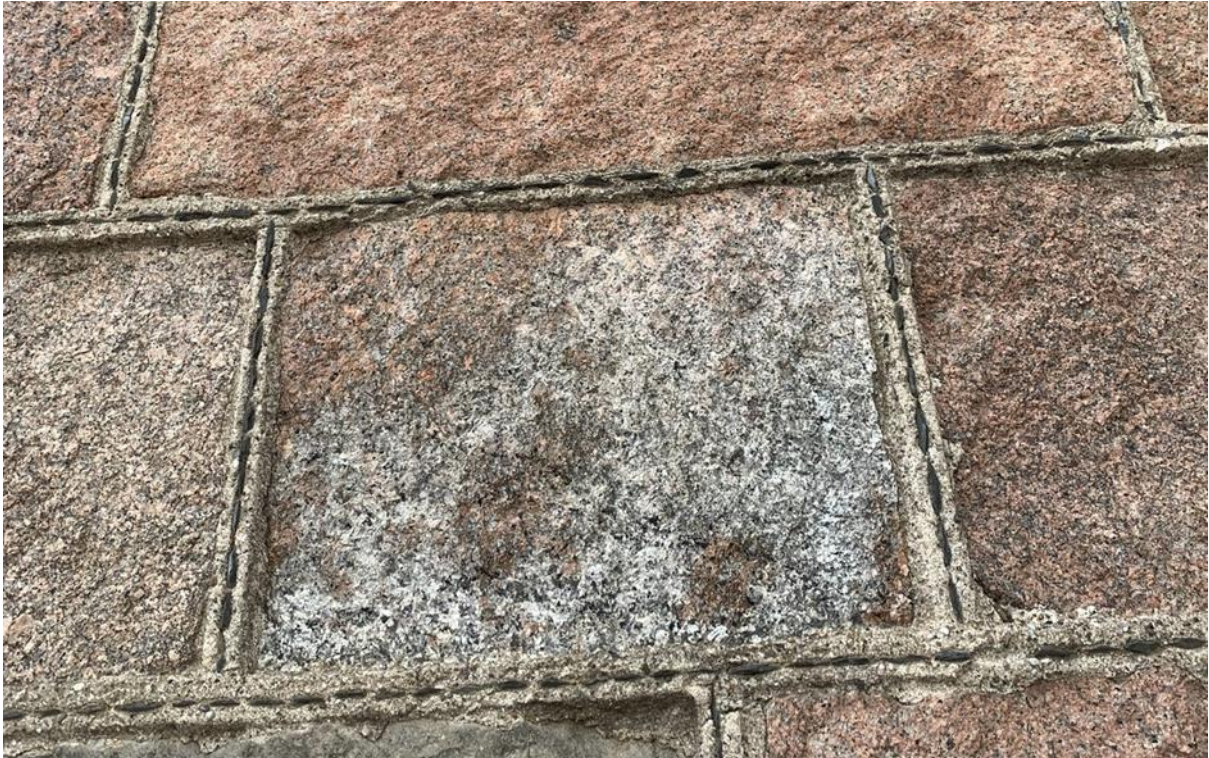
Figure 021.2. Raised ribbon lime finish with slate cherry-cocking.

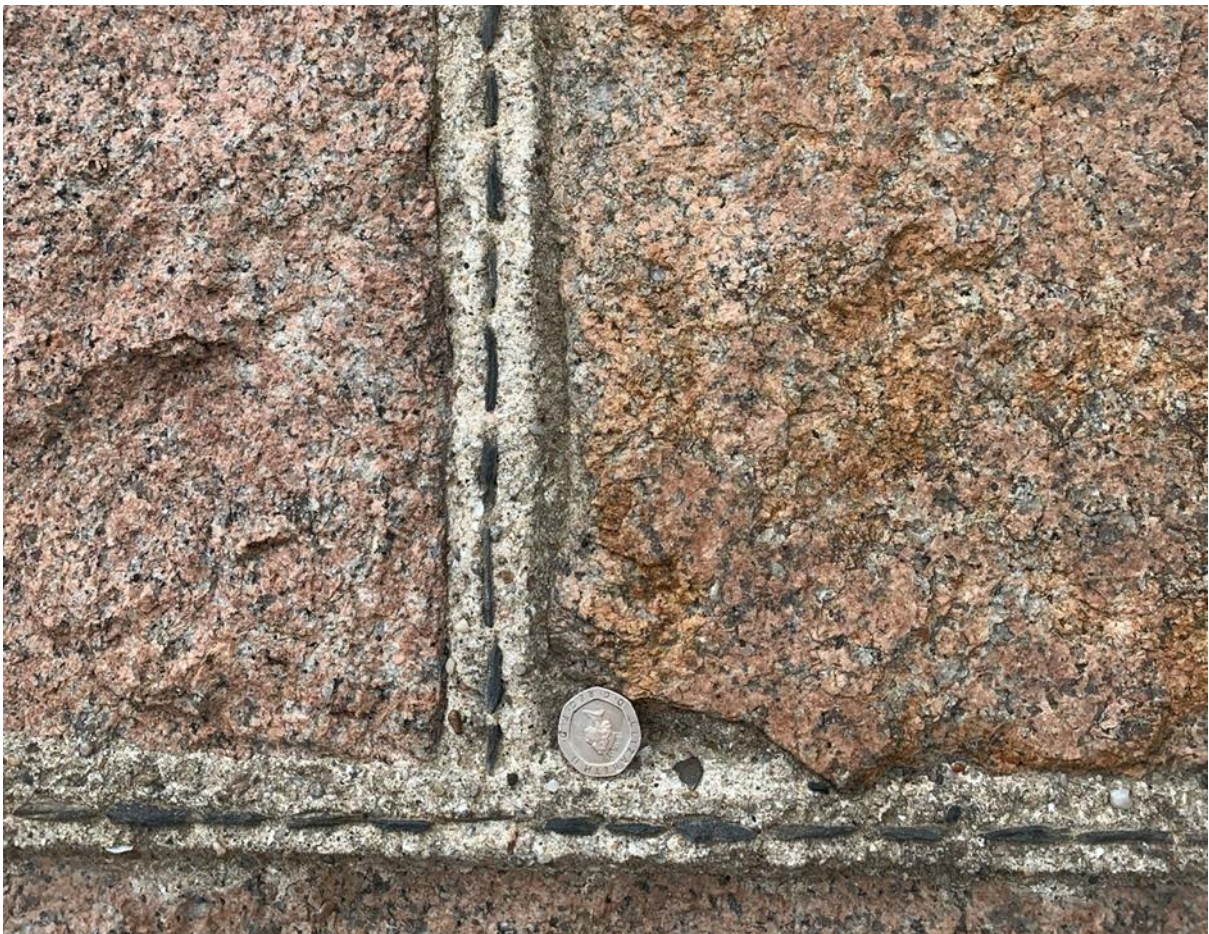
Figure 021.3. Raised ribbon and cherry-cocking with the background mortar slightly graded away.

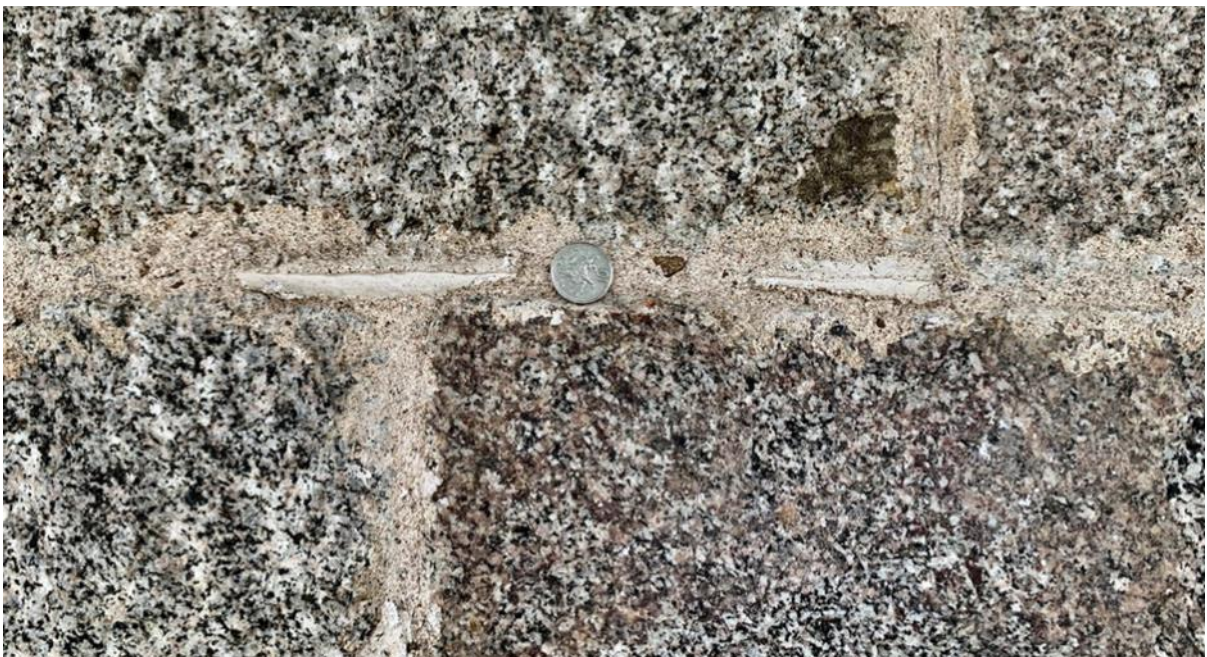
This lodge has an overhanging roof detail that shelters the granite masonry wall face (Figure 023.1). Because the wall face has been protected, fragmentary remains of the of the joint finish have been retained. The flush ruled pointing has been highlighted with limewash (Figure 023.2). An examination of the squared blocks of the regular granite blocks revealed no trace of limewash anywhere other than the joint.

Figure 023.2. Flush ruled pointing with overlaying whitewash.

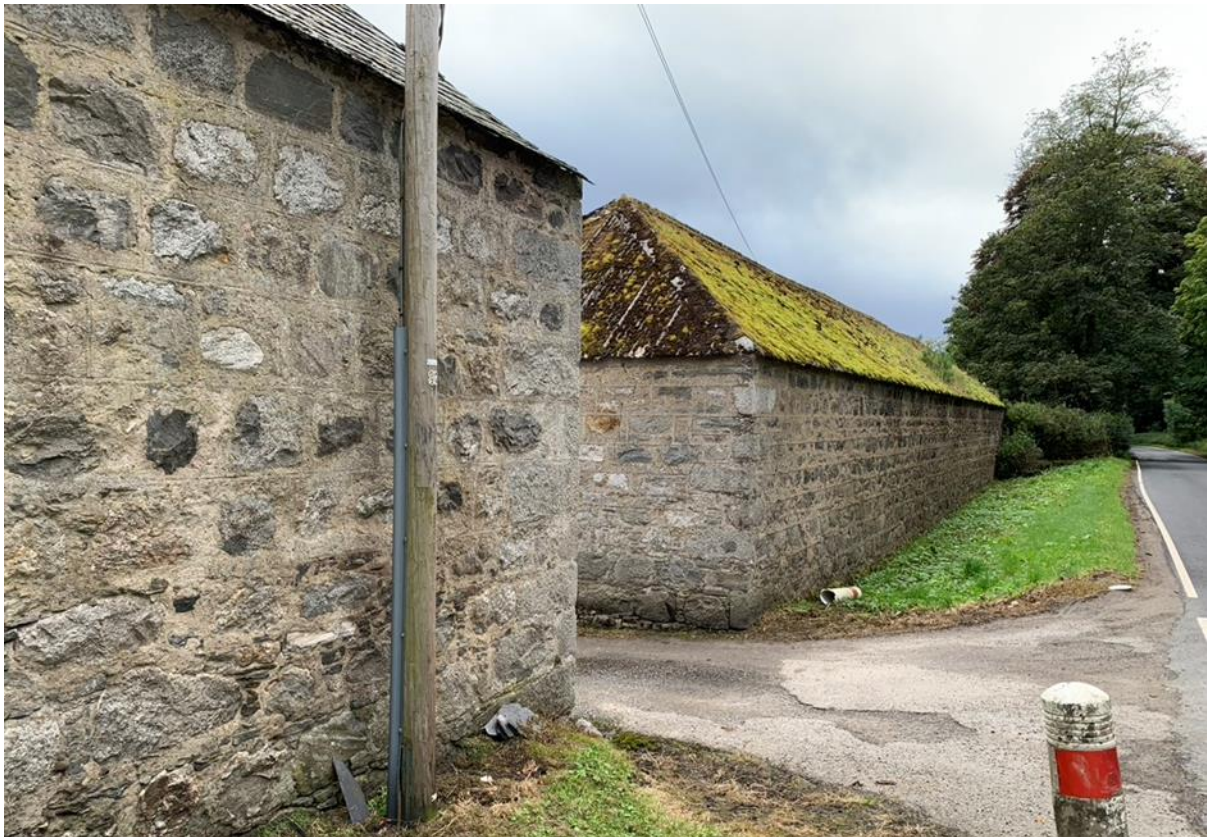
Figure 024.1. Two periods of construction with two different point styles.

This farm steading is part of the Cluny Estate and has a range of buildings constructed in phases after the main house in the early 19th century. The phased construction of buildings is represented by differing pointing styles (Figure 024.1).

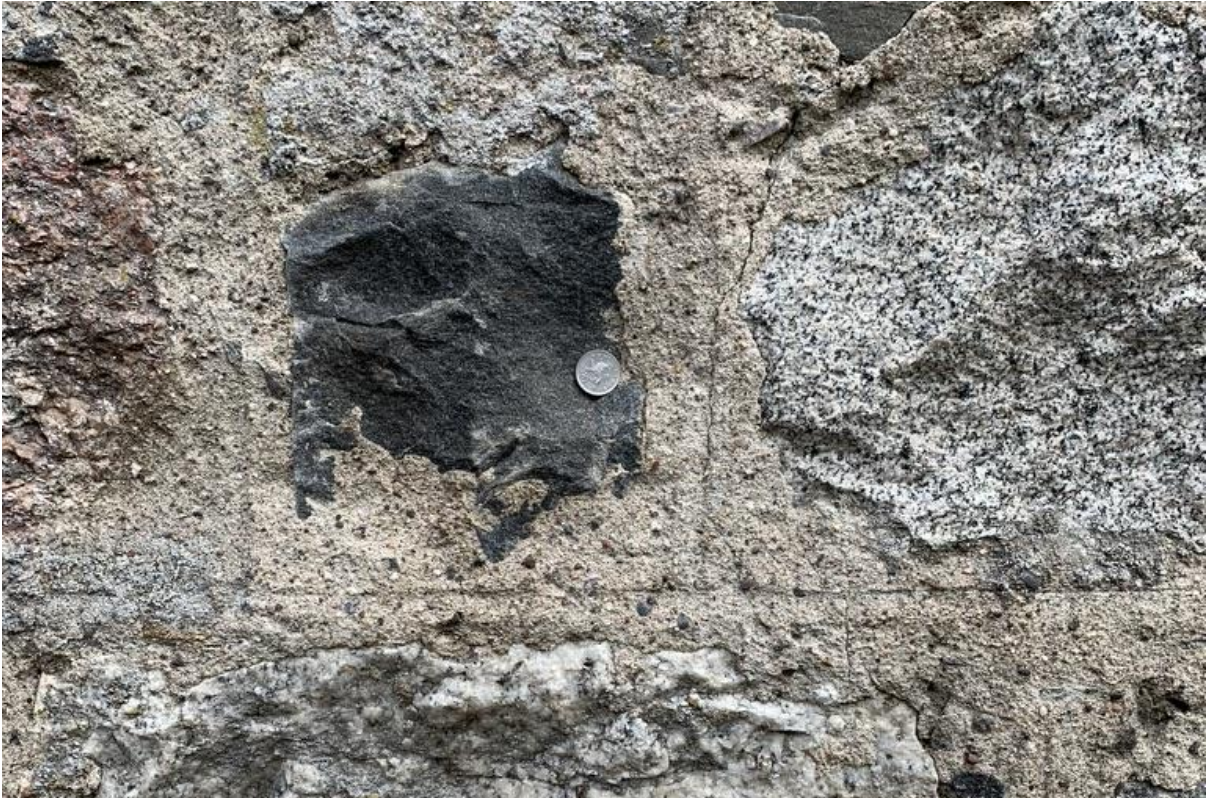
The first, to the left of Figure 024.1, is sneck pointed and horizontally and perpendicularly ruled out with the edge of a trowel. The horizontal ruling is weather shot with the impression greater at the top of the rule than at the bottom (Figure 024.2). The pointing extends to the front and rear of the building, but the gable is harled (Figure 0024.3). Aggregates are sharp and angular in the range 0.5mm – 6mm.

Figure 024.2. Sneck, ruled weather-shot point.

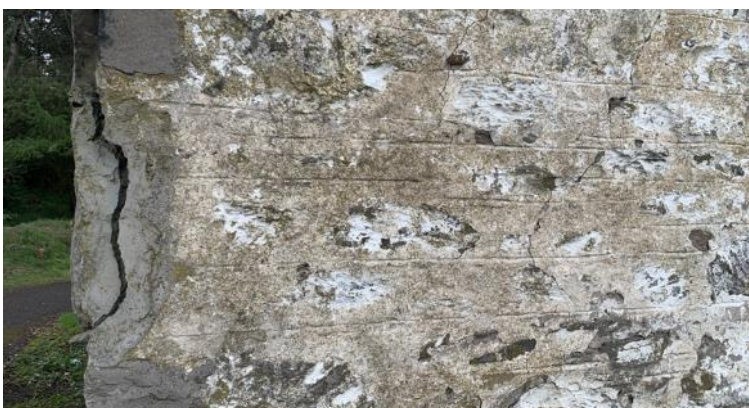
This appears to be an early 19th century steading associated with Ballechin Farm. The roof arrangement has been altered and there are various modern configurations of roofing materials (Figure 026.1). The rubble masonry of the walls however shows a flush point and informal ruling out with limewash (Figure 026.2). The limewash, as might be expected, survives well in areas free of water from defective roof drainage.

Figure 026.2. Flush pointing and informal ruling out with limewash.

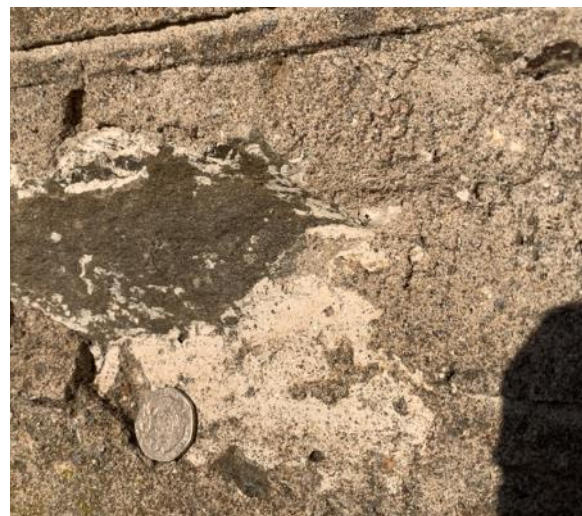
Figure 027.3. Traces of limewash.

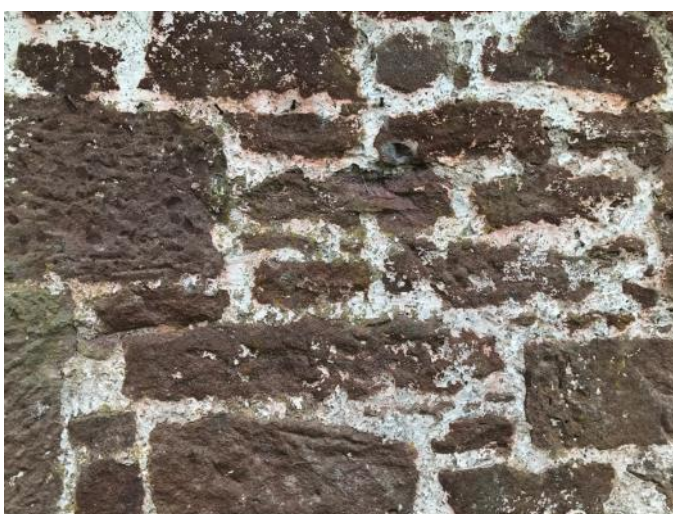
Figure 028.2. Close up of the pointing on the north east elevation. Limewash shows on the joints and in the broaching of the rubble.

rubble and dressed margins (Figure 028.1). There is a lime rich mortar with large aggregate finished flush with limewash surviving on sheltered elevations (Figure 028.2). On the exposed south west elevation, it has all but gone. Inspection of the limewash shows only a few layers, suggesting that the practice was discontinued in the mid-19th century.

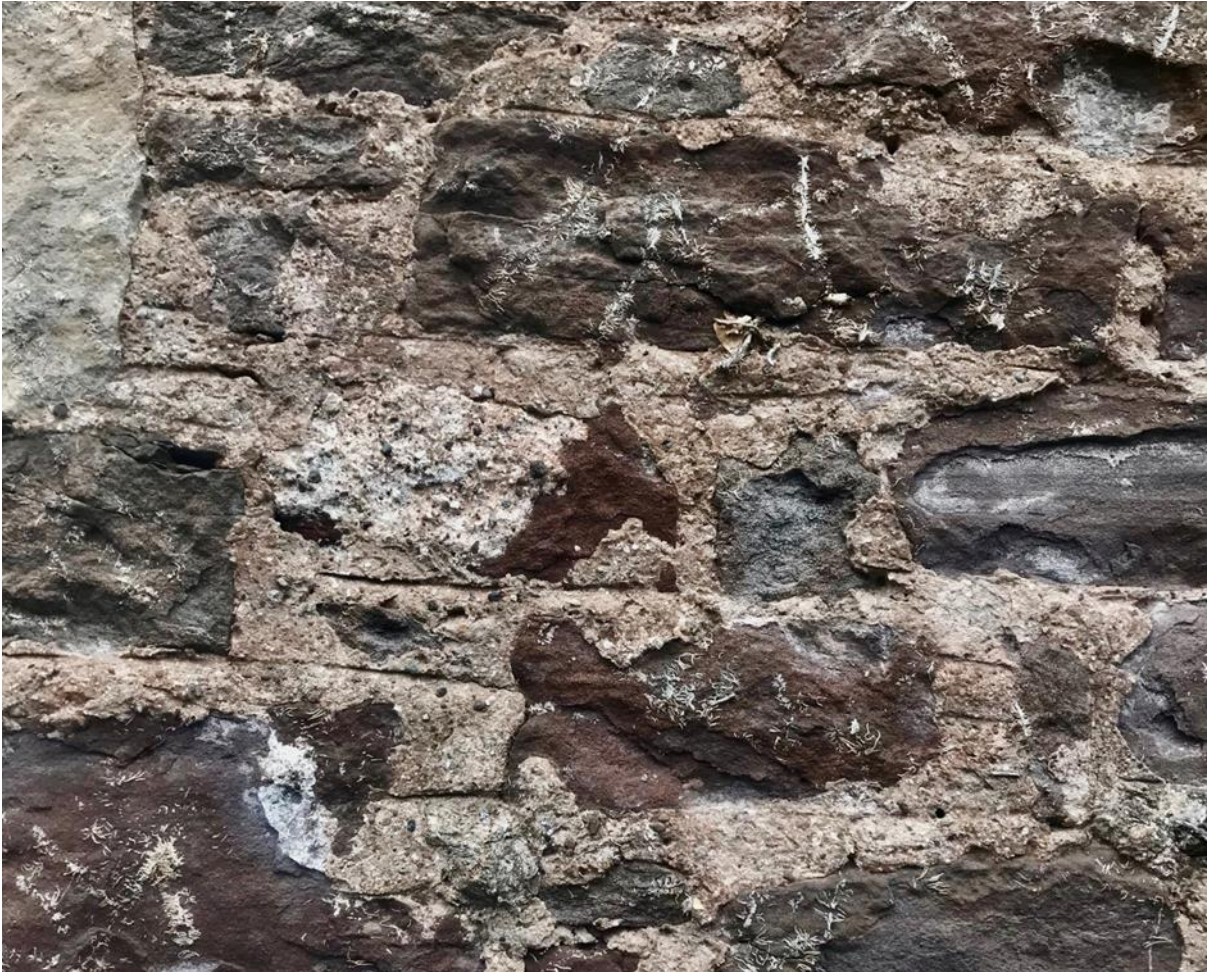
Figure O31.2. Informally ruled, flush lime pointing of modest quality. The lighter patch of harl on some of the stones indicates that the building may once have been fully harled.

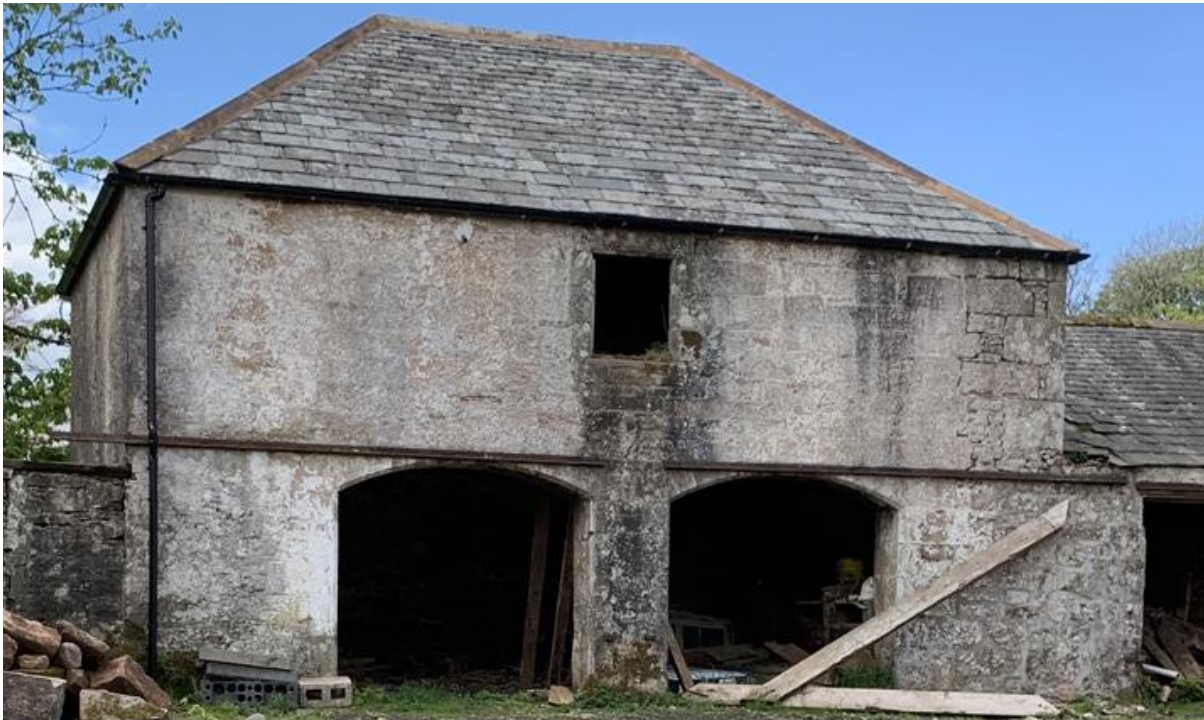
Figure 032.1. The south west corner of the steading complex at Muiryhill.

This farm steading is set out on traditional lines as a four-sided complex of buildings. The cart shed and granary above (Figure 032.1) are on the south west corner and show a well-preserved rubble build with flush pointing and areas of limewash surviving. It appears to date from the early 19th C. Some areas have had multiple coats of limewash and occasionally a hint of colour (Figure 032.2). In two areas the pointing was raised to a ribbon (Figure 032.3). The location is on a hillside exposed to the SW, and the survival of the limewash on exposed elevations can show the durability of such finishes.

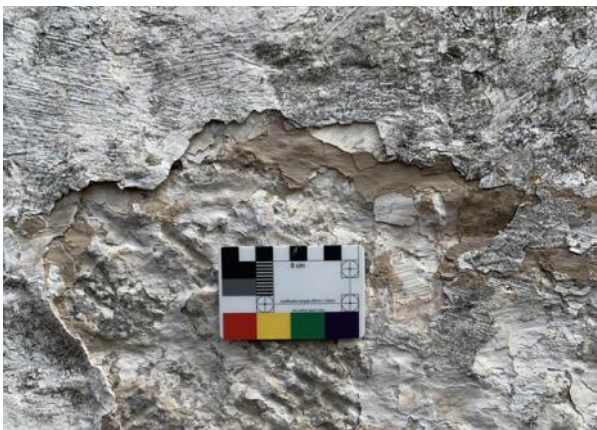
Figure 032.2. Multiple layers of limewash.

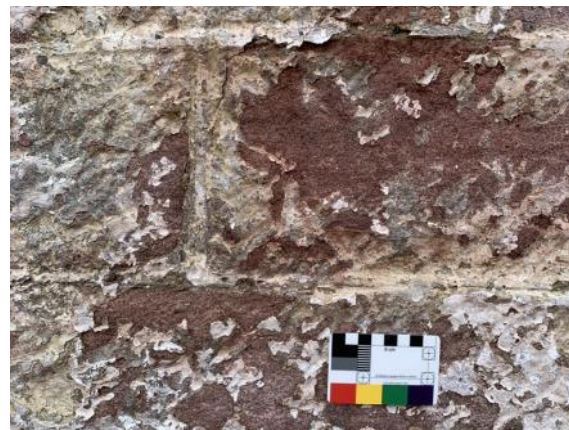
Figure 032.3. The raised ribbon pointing with limewash finish.

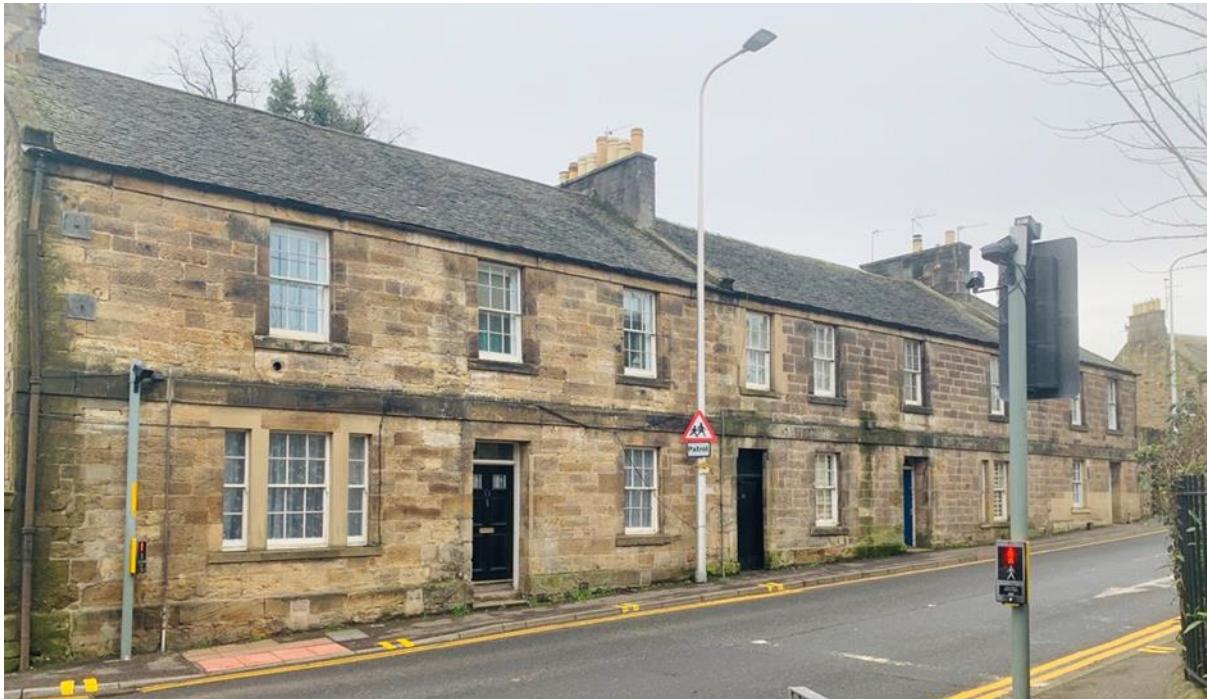
Figure 033.1. The terrace viewed from the north-west.

A relatively well preserved late Georgian Terrace built in c.1827 (Figure 033.1). The joints are flush, with horizontal and perpendicular ruling (Figure 033.2). The mortar is lime rich with many lime inclusions. Angular sand and aggregates in the range of 1-5mm produce a buff coloured mortar. Given its robustness to the touch and the buildings proximity to the road, the mortar may be feebly hydraulic.

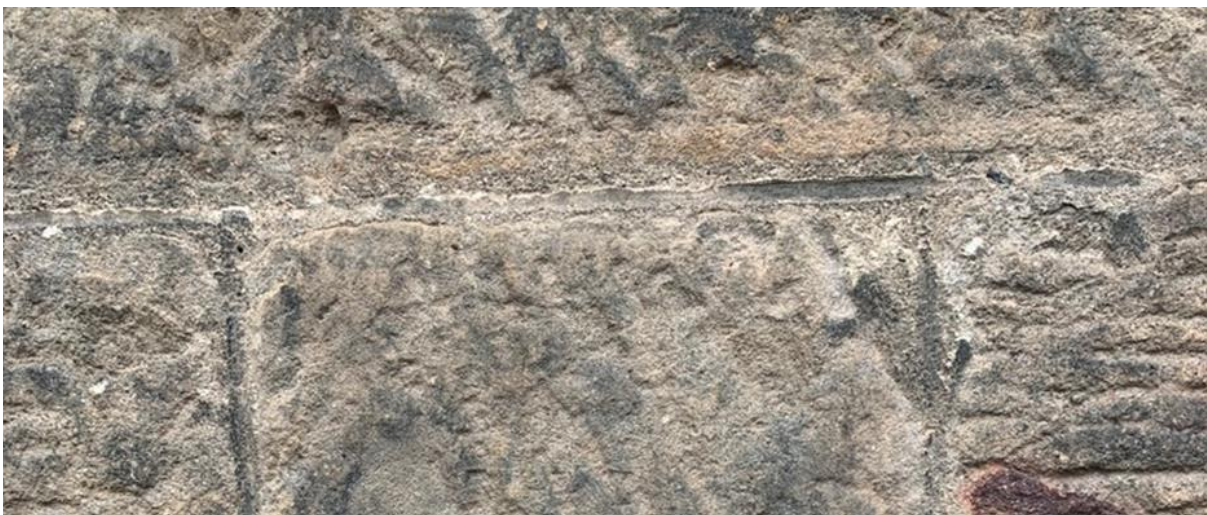
Figure 033.2. Horizontally and perpendicularly ruled flush joints.

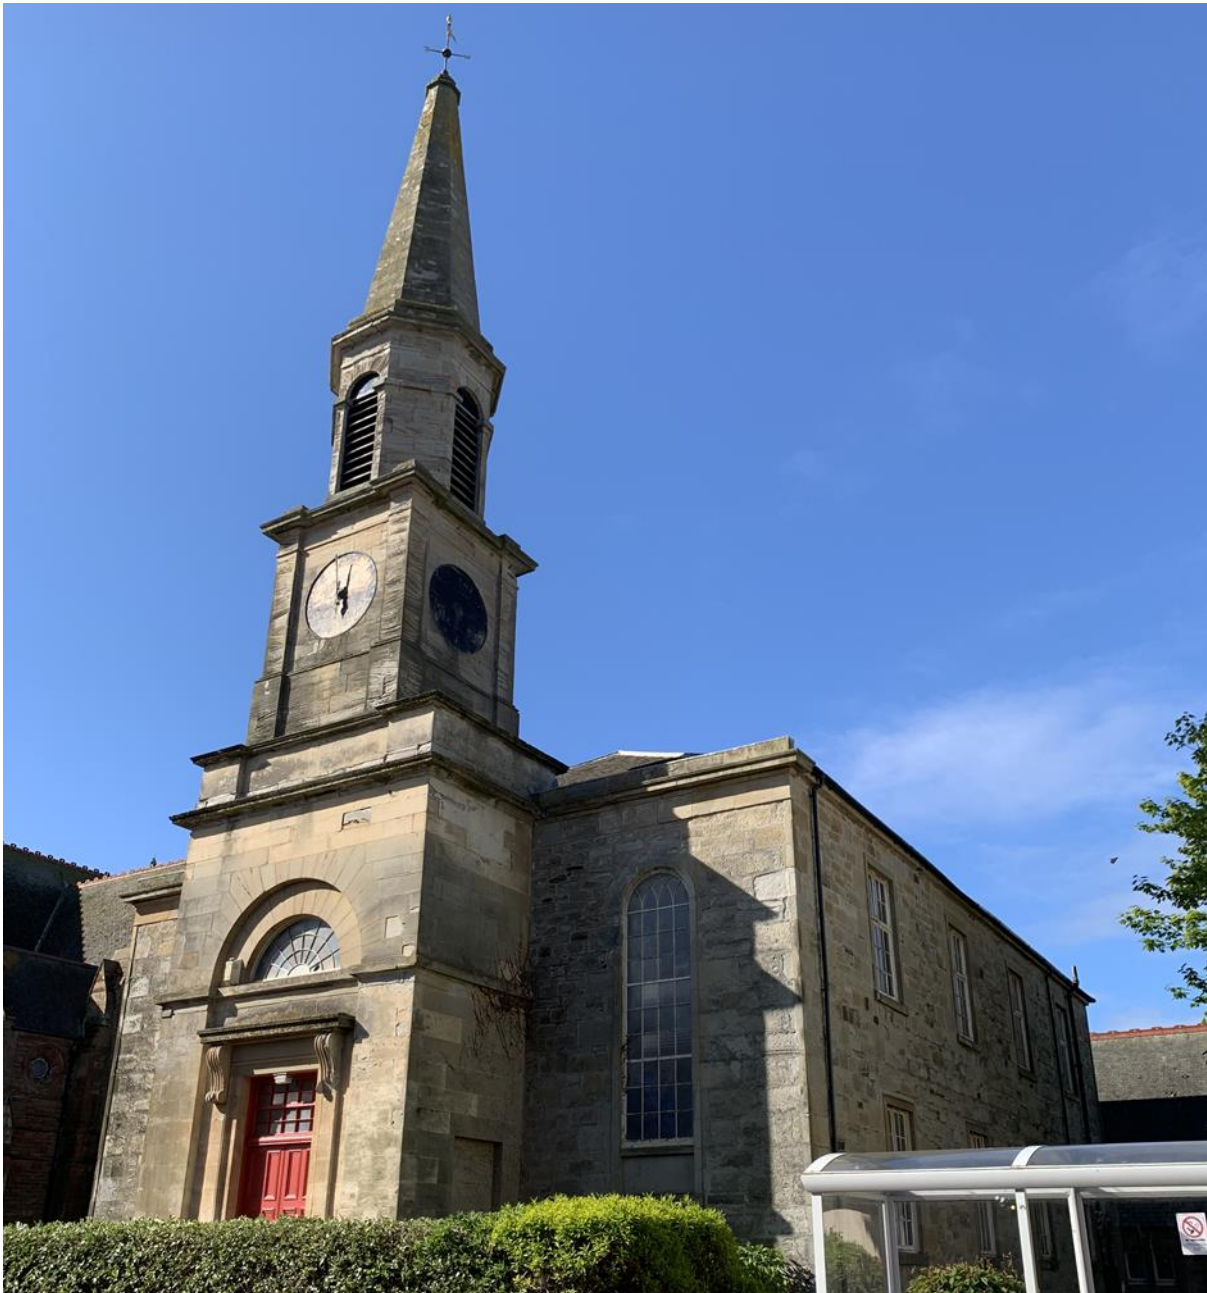
Figure 034.1. Troon Old Parish Church, main elevation. The later church is to the left.

This was the former parish church for Troon and was built for the Church of Scotland in 1837 (Figure 034.1). By the late 19th century it became too small for the congregation and a new gothic style church was built close by in 1897, when it was adapted for use as a church hall. The building is constructed from buff to blonde ashlar sandstone on the principal elevation, with coarsely squared rubble used on the sides and rear. The pointing on the side walls is made up of fine aggregates and the mortar survives well behind cast iron downpipes (Figure 034.2). The pointing is

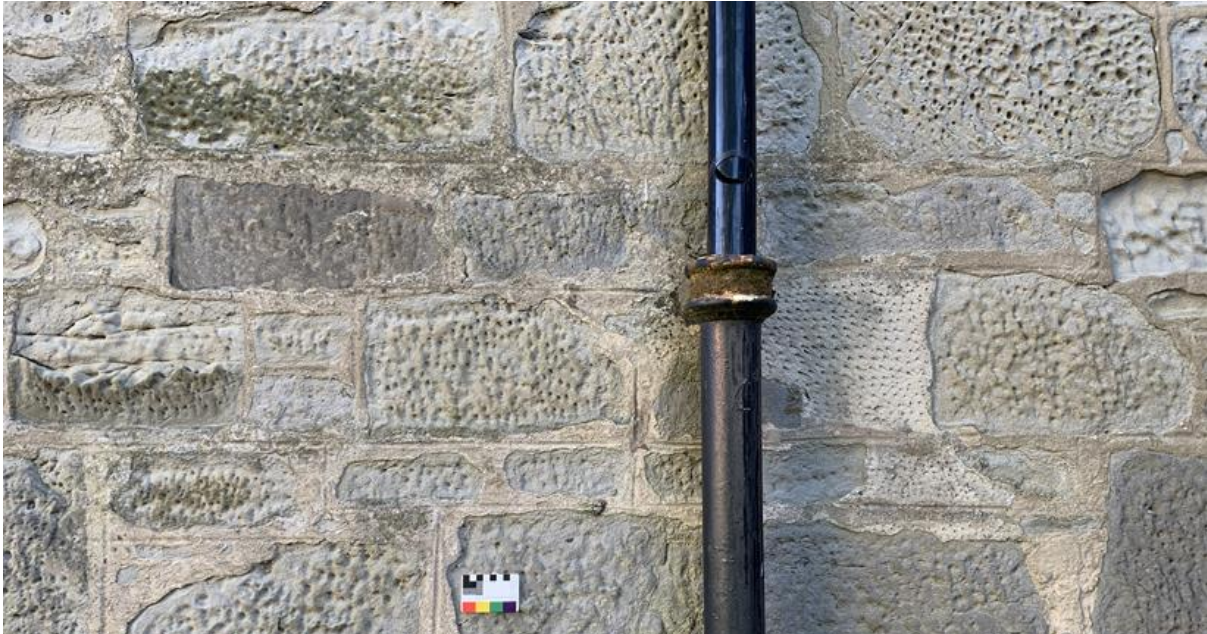
Figure 034.2. Side elevation with some remaining lime pointing.

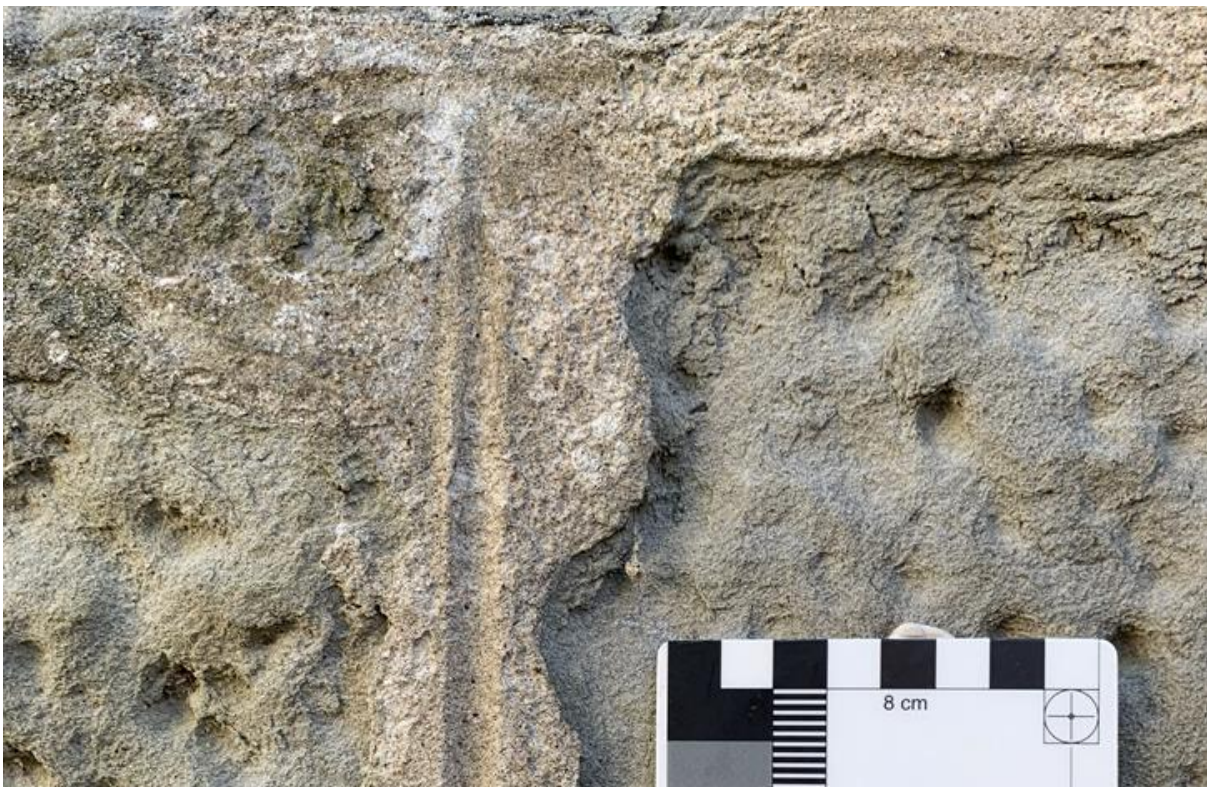
flush and ruled out horizontally and perpendicularly. There is no evidence of limewash. The sandstone is soft, and decay is evident in all areas, and in many areas the pointing sits proud of the masonry (Figure 034.3). Some areas have been repointed with a cement mortar that appears to have exacerbated the problem.

Figure 034.3. Flush lime pointing, ruled out with fine sand mortar containing lime inclusions.

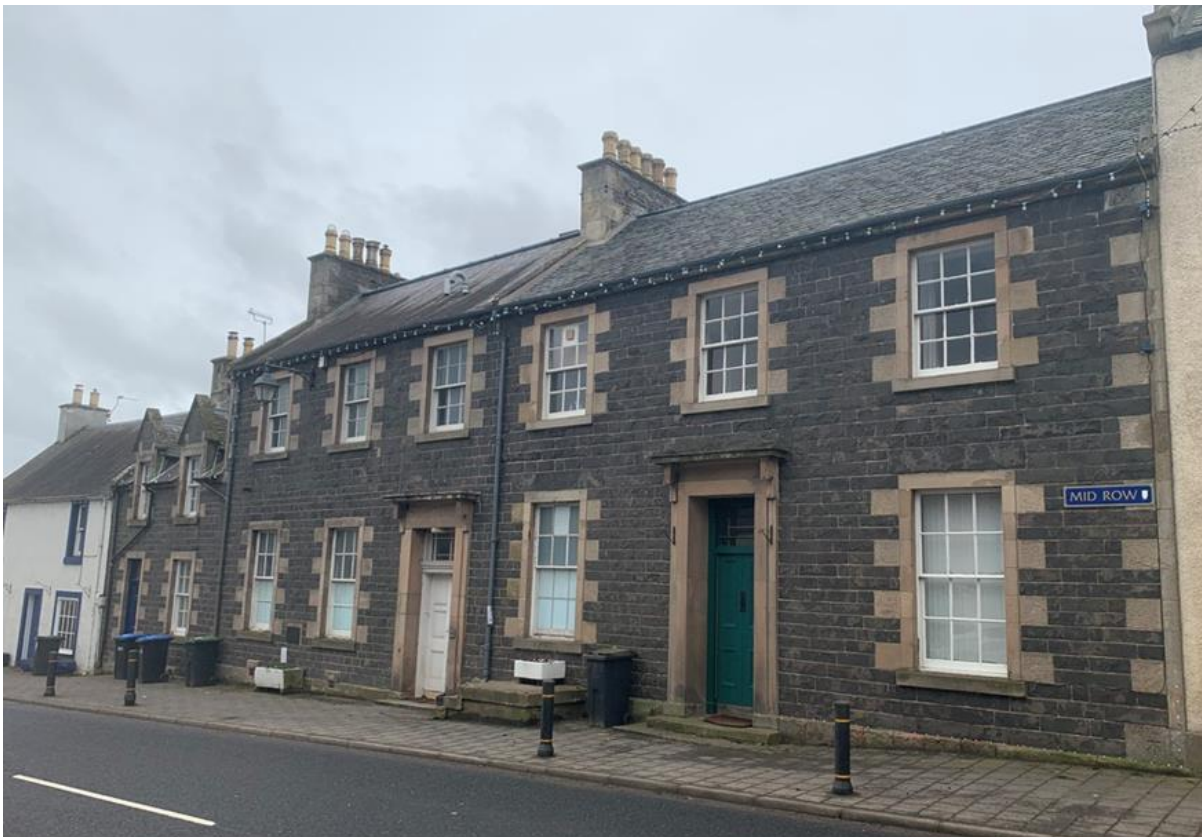
Figure 035.1. A pair of houses on Mid Row, Lauder, viewed from the north-east.

A pair of 19th century houses, constructed of squared, coursed whinstone with fine joints (Figure 035.1). The stone is dark and hard to dress to a square face, resulting in ledges being formed at the junction between courses. The whinstone is also largely impervious; thus, the ledge has the potential to attract water into the body of the wall through the porous lime mortar. To combat this difficulty the mortar has been raised to the rear of the ledge and then 'feathered' out to the front edge to push the water away from the joint (Figure 035.2). The mortar is coarse and angular in the range of 1-5mm. The rear of the building is also built with whinstone but in smaller random sections (Figure 035.3). All traces of the finish here had worn away.

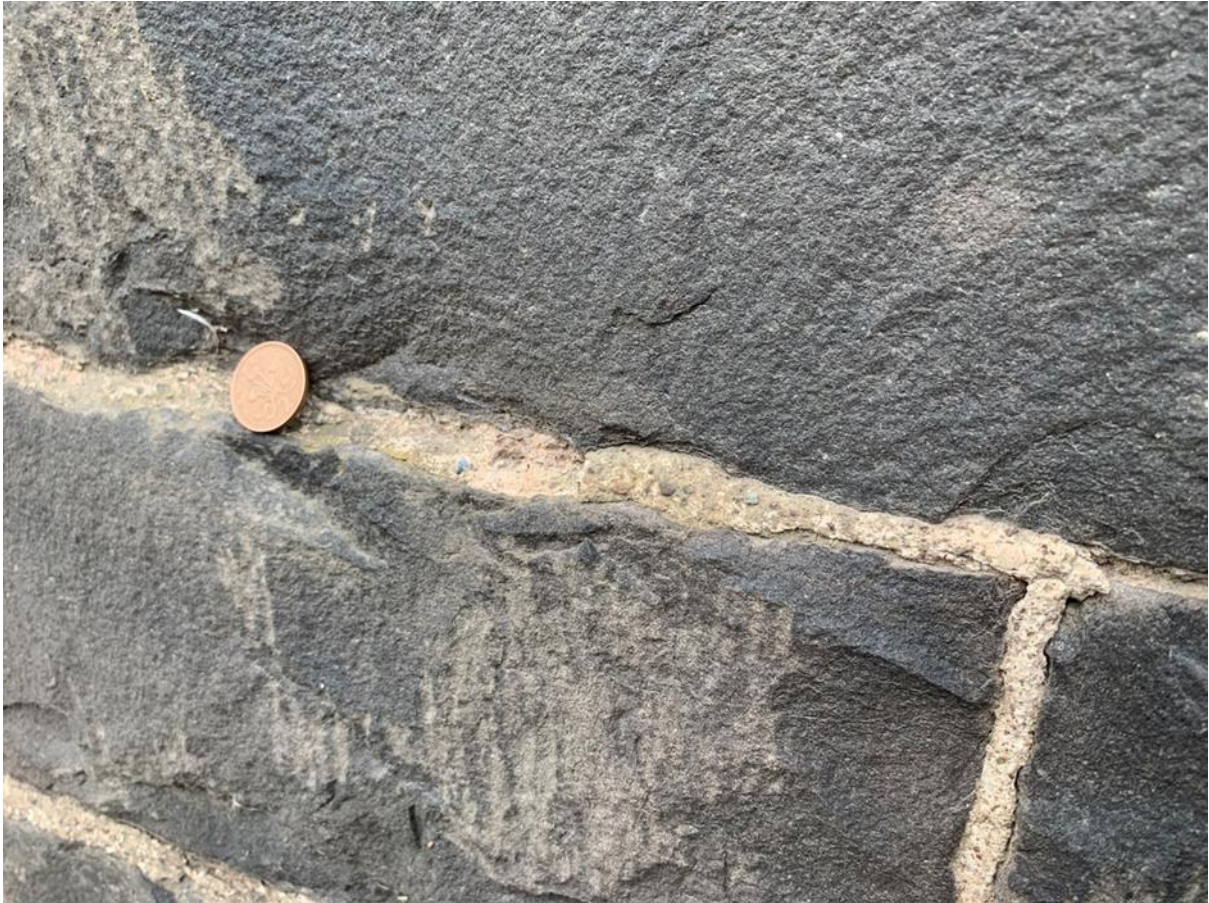
Figure 035.2. Ramped mortar to combat water absorption.

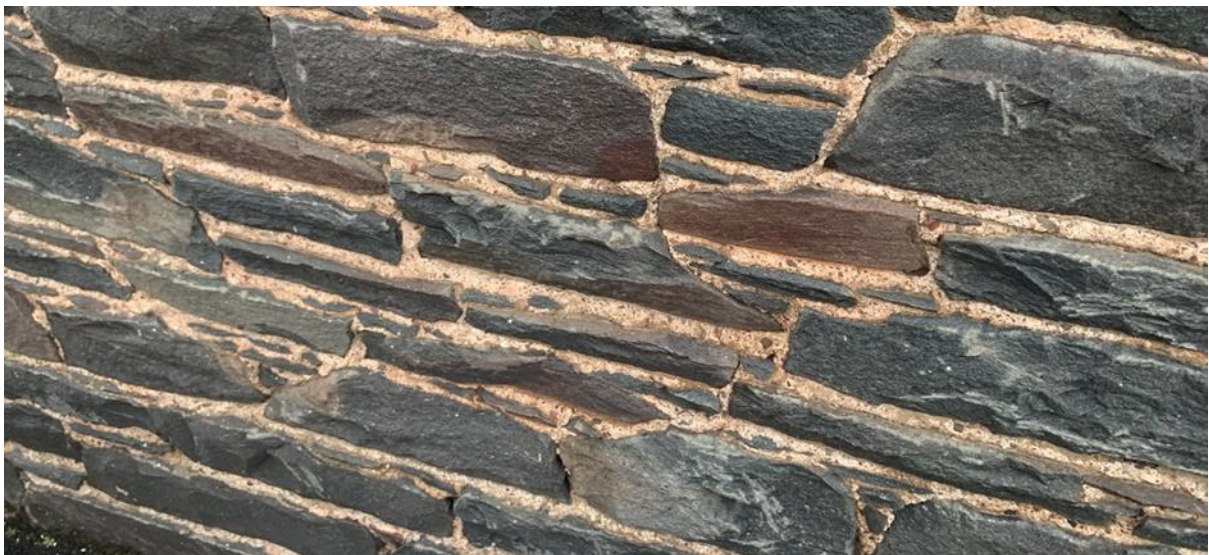
Figure 035.3. Random whinstone masonry.

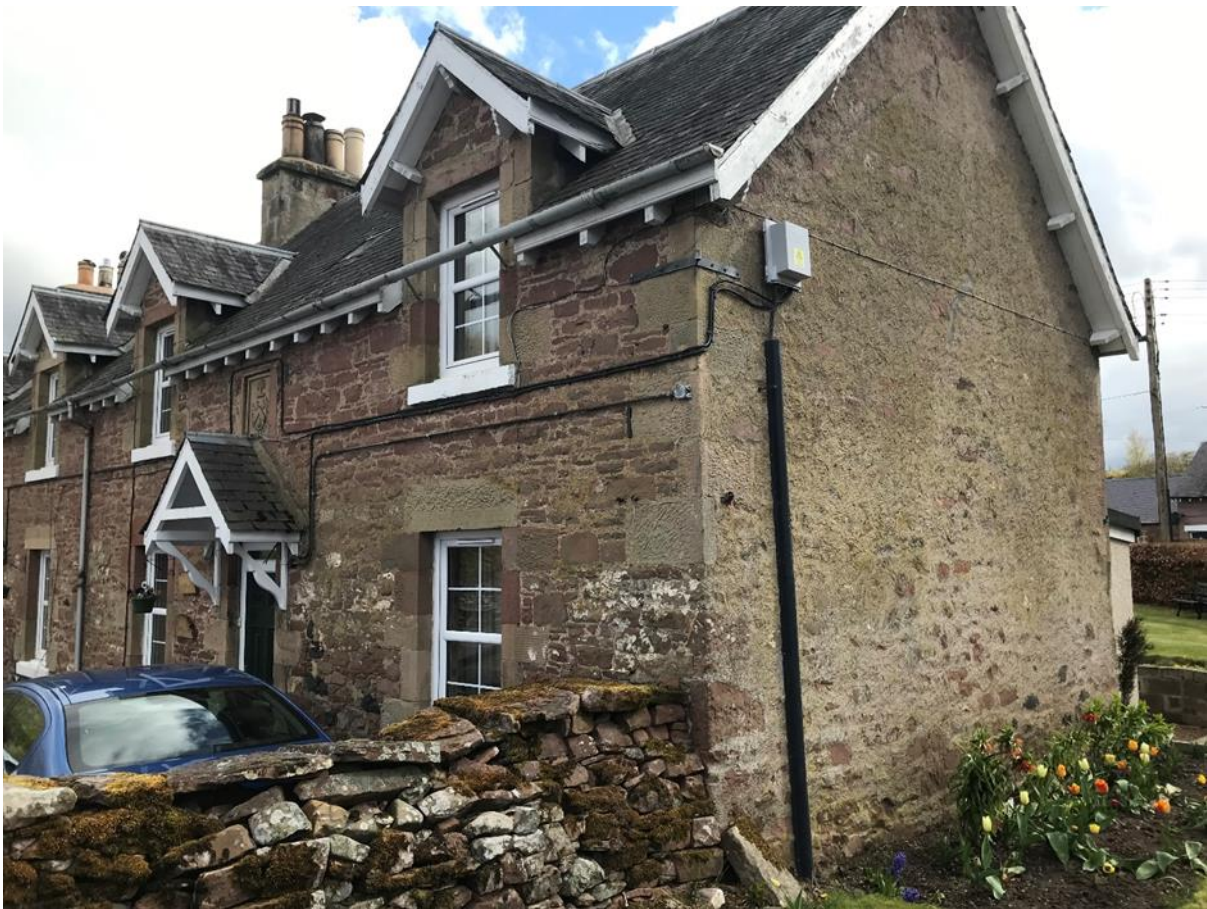
Figure 036.1. Carter Road, Bonchester, a 2 story cottage with a later Victorian first floor and post war sneck harl in a cement based mortar to the gable. Note limewash on original ground floor.

This cottage dates from the 1820's, originally a single-story thatched building, it was upgraded in 1897 by the proprietor of the Weens Estate (Figure 036.1). This is recorded on the date stone over the front door. It is interesting as it shows three phases of masonry treatments or approaches. The original finish of a flush pointed limewash can be seen in several areas to the right of the front door which probably dates from its construction in the early 19th century (Figure 036.2). The new masonry on the first floor from the 1897 work is in the local red sandstone with a narrow flush point. At a later point the gable end has been given a slightly different treatment, with a cement based thin sneck harl, leaving some of the stones uncovered (Figure 036.3). While the cement-based mortar used is modern, the technique and style is traditional.
