TECHNICAL PAPER 33

MASONRY POINTING AND JOINT FINISHING

PART 2 - GAZETTEER

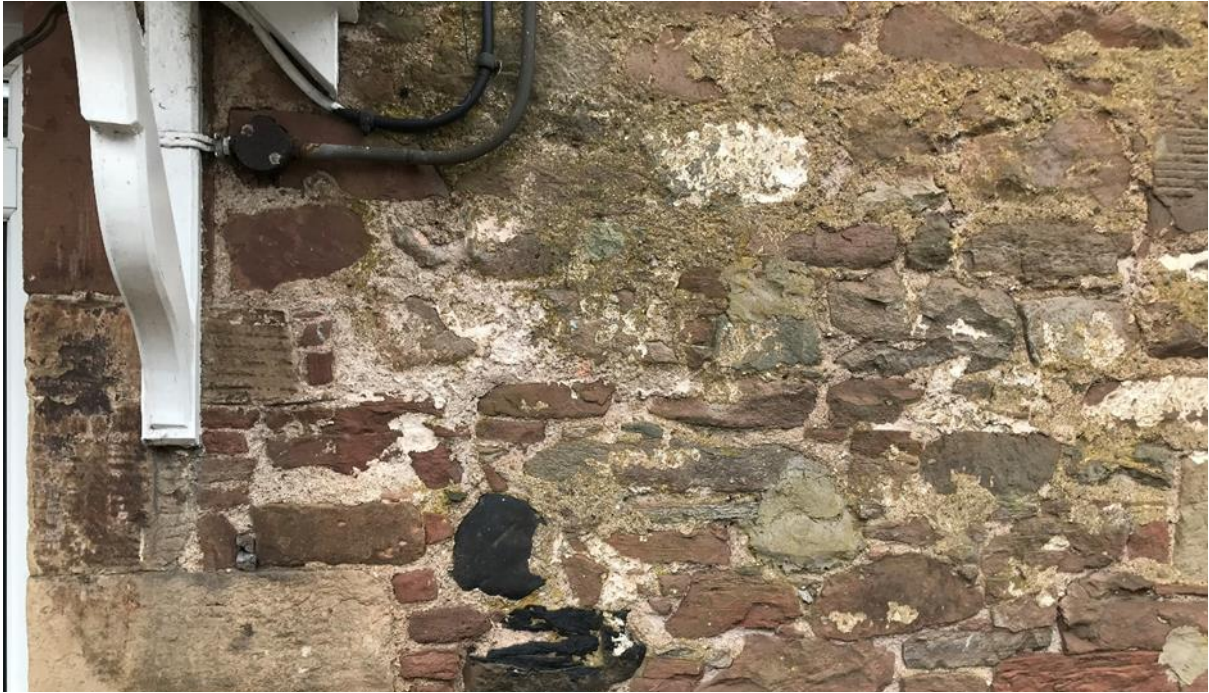
Figure 036.2. A close up of the original cottage wall at ground floor level, showing flush pointing and layers of limewash.

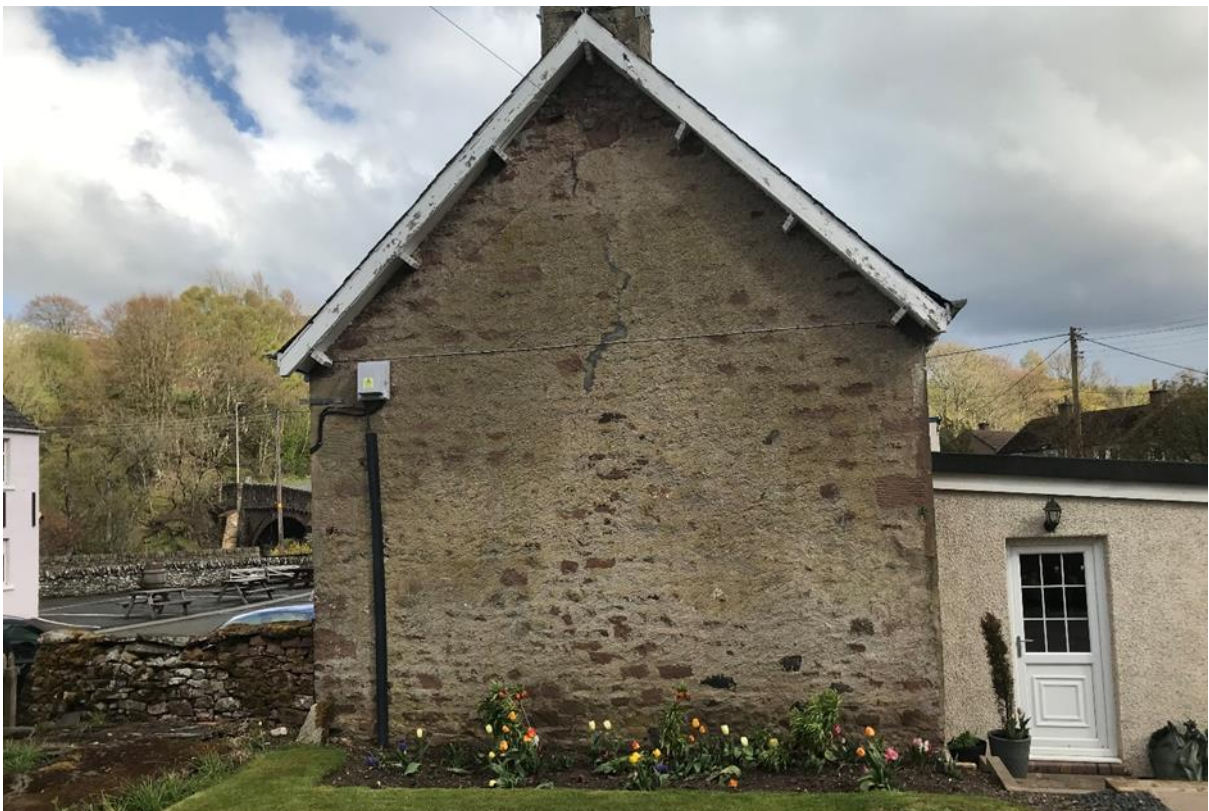
Figure 036.3. The East Gable, showing the later sneck harl using cement, but applied in a traditional fashion.

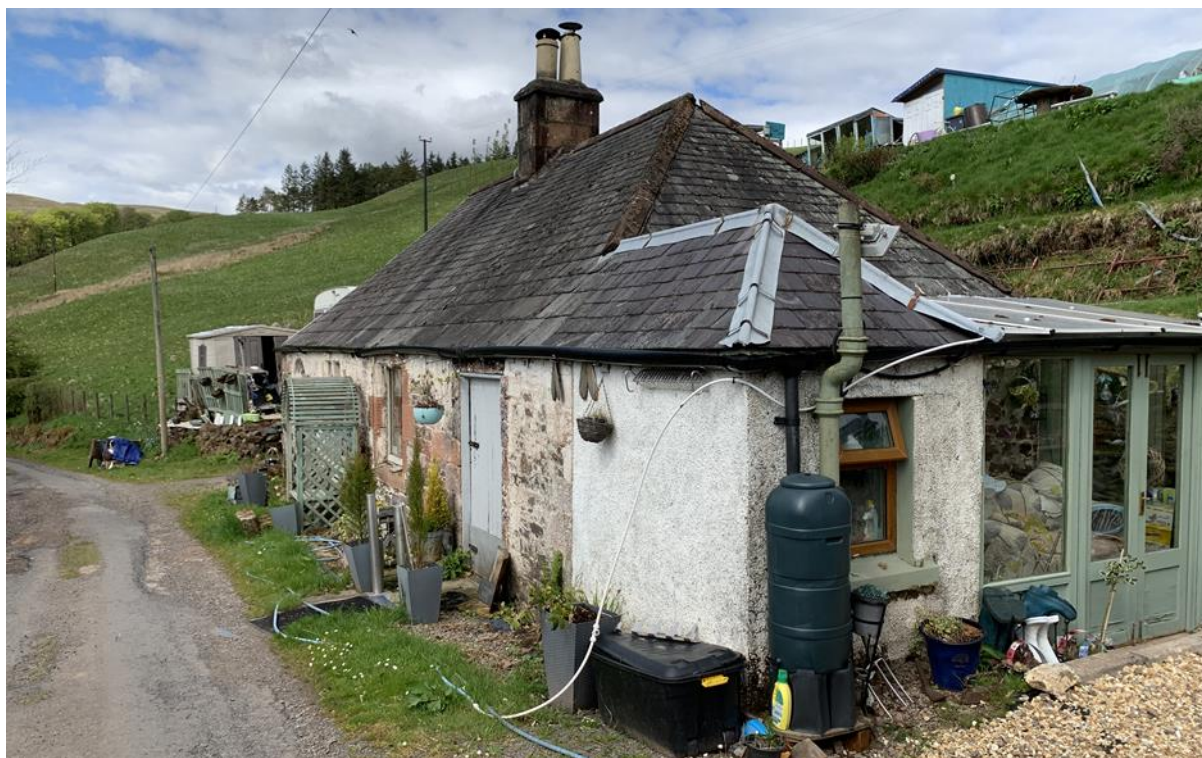
Figure 037.1. The bothy building from the south west.

This small narrow building, consisting of two halves, was bothy accommodation for seasonal labour at Coshogle farm (Figure 037.1). It is believed to have been built in the early 19th century and has recently been re-occupied after a long period of being vacant. The left hand bothy has a reused 16th century door surround from Coshogle Castle built in the 16th century. (Figure 037.2). The rubble masonry on both cottages is flush pointed, informally ruled and limewashed (Figure 037.3). The limewash shows as several layers in some areas. The colour is the same ginger-pink tint as noted on the farm buildings and Coshogle farmhouse.

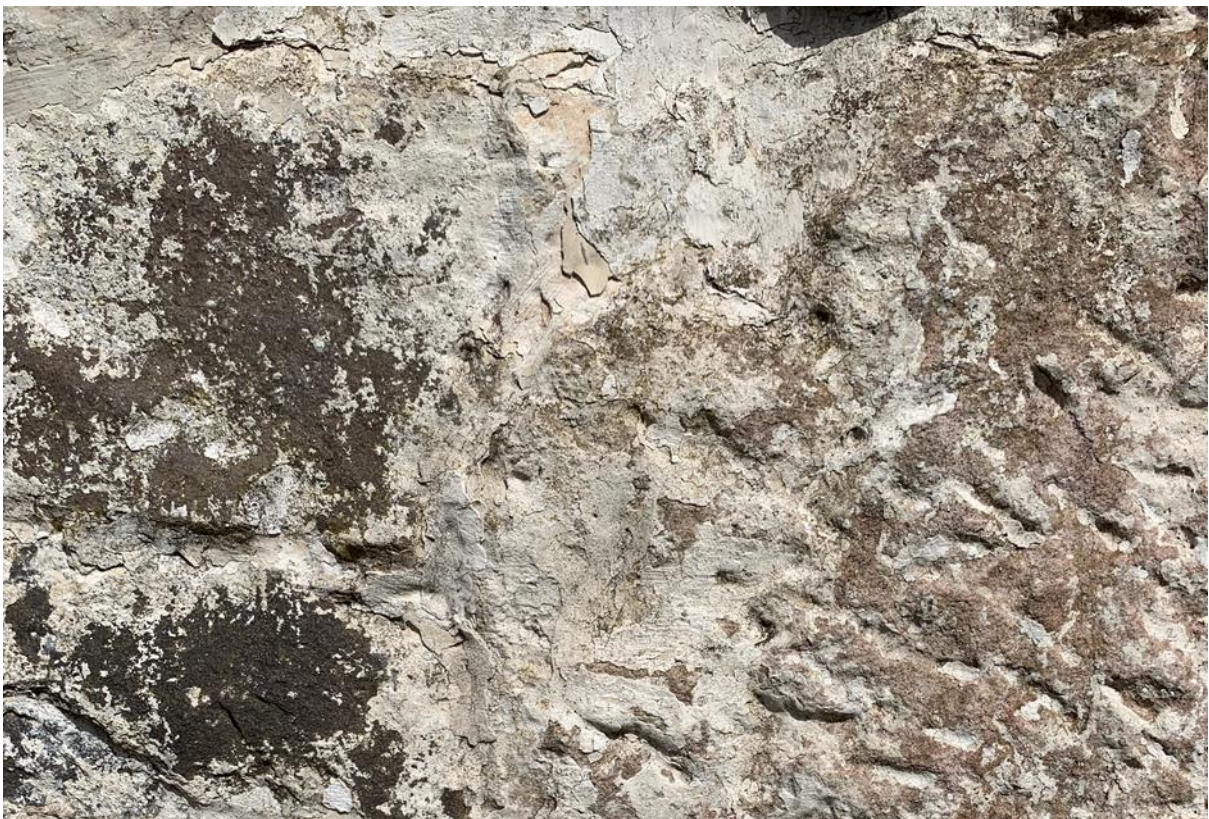
Figure 037.3. The many layers of limewash surviving in some areas.

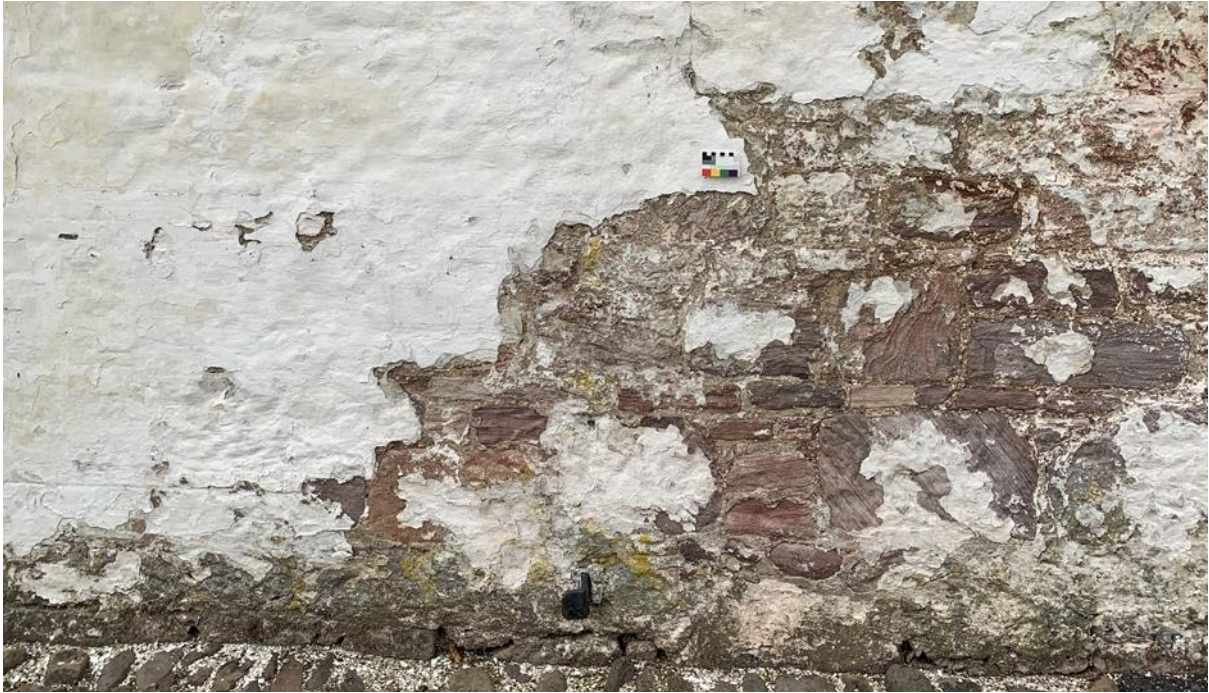
Figure 038.2. The flush pointed elevation with multiple layers of limewash.

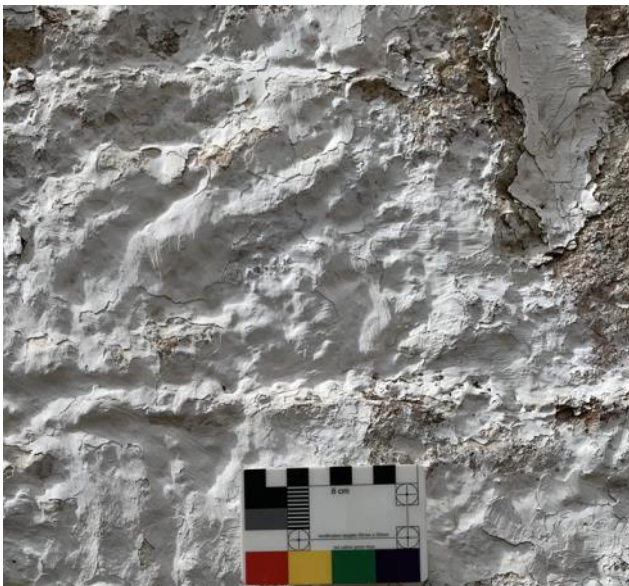
Figure 038.3. Detail of the masonry with vertical and horizontal lining out, nearly obscured by the many layers of limewash.

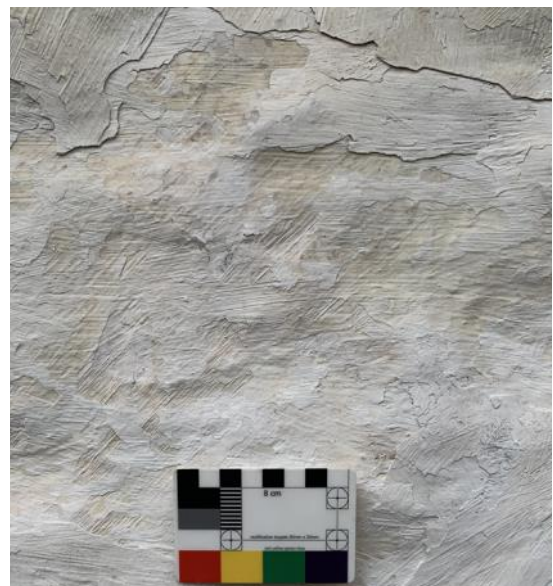
Figure 038.4. Flush pointed masonry with no lining out and multiple layers of limewash surviving in good condition.

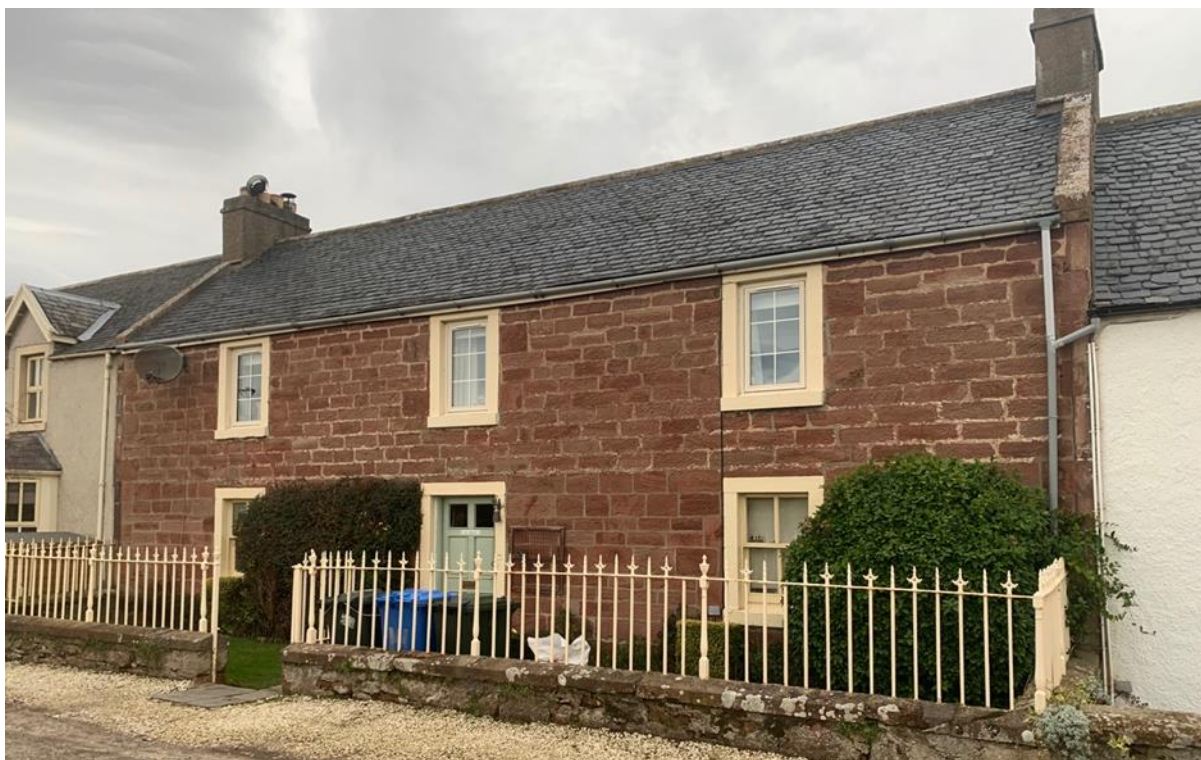
Figure 039.1. Southern elevation.

A two-story house with red squared sandstone blocks (Figure 039.1). The first floor retains a full flush finish, ruled both horizontally and perpendicularly. This is, however now worn and faint (Figure 039.2). The mortar is lime rich with inclusions. The house had restricted access, so no estimate could be made of the aggregate size. The ground floor repairs are ruled but have been made in a cement mortar (Figure 039.3).

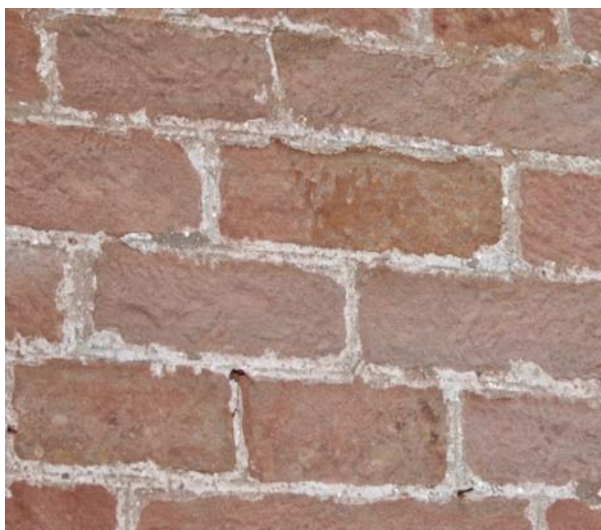
Figure 039.2. Full flush finish with faint horizontal and perpendicular ruling out.

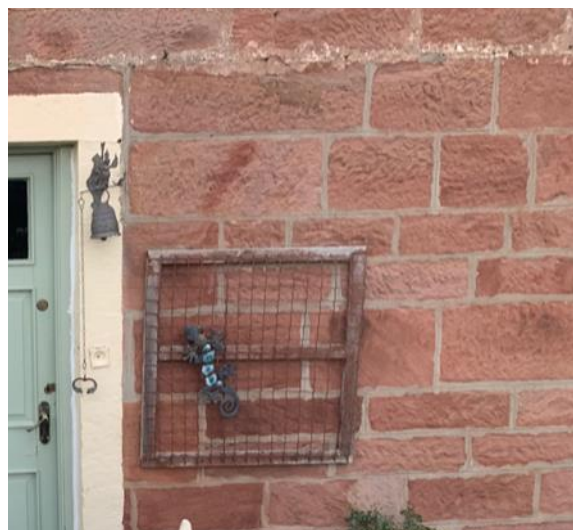
Figure 039.3. Ruled out cement mortar repairs made to the ground floor.

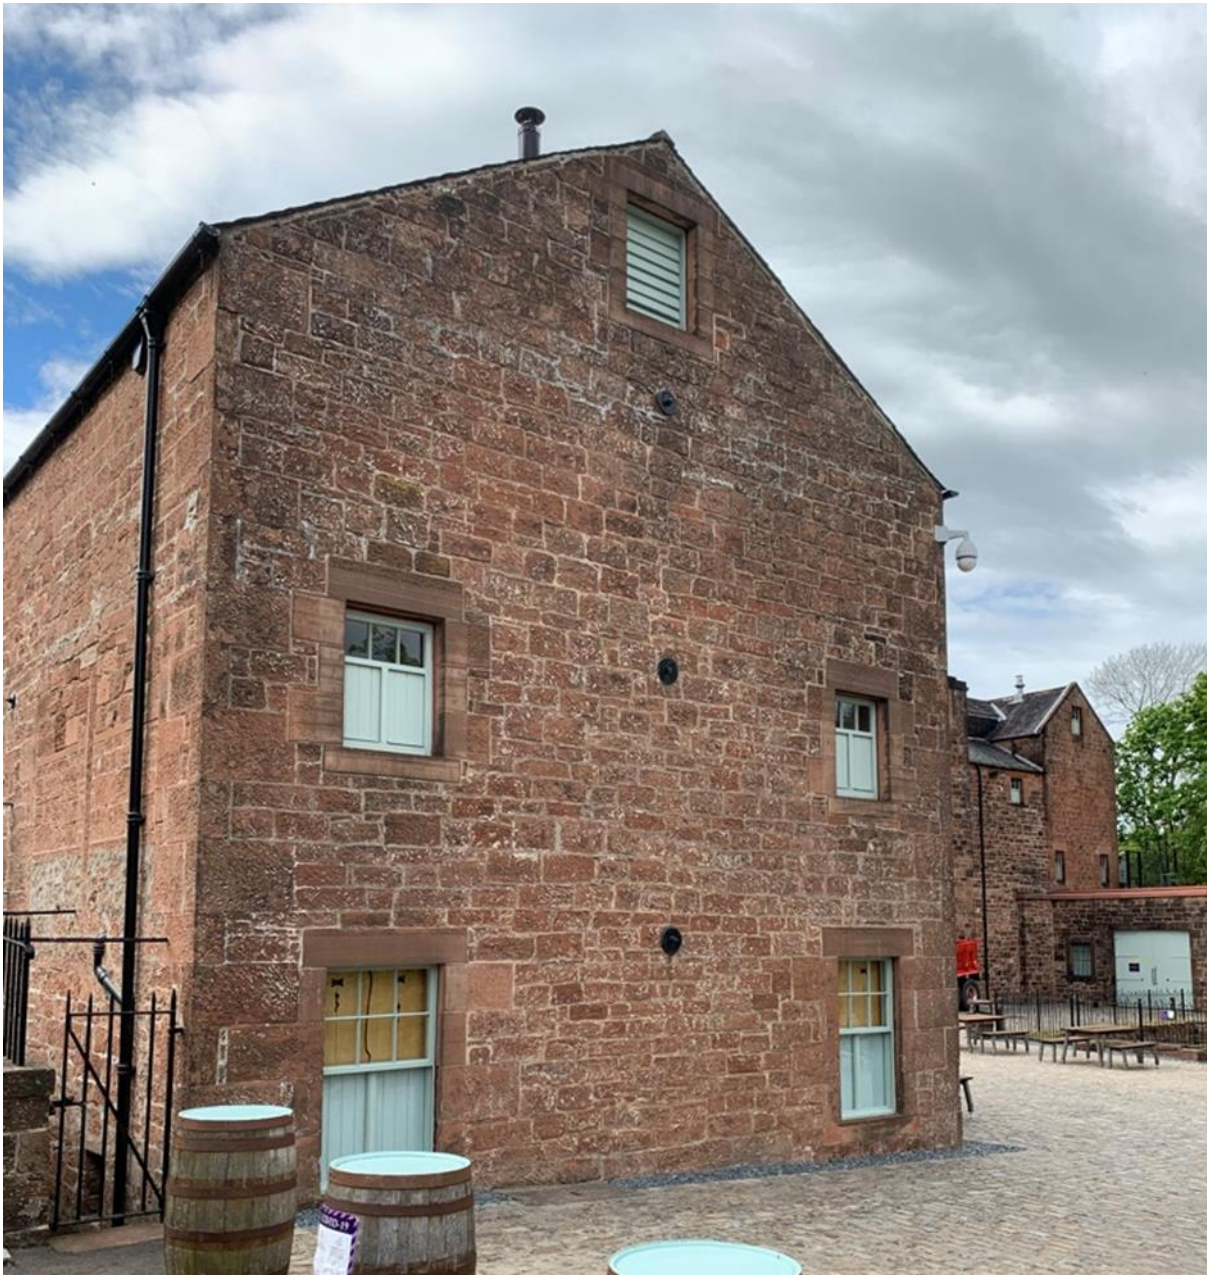
Figure 040.1. The SW gable of the Annan Distillery.

The Annan Distillery dates in stages from 1836 with work in 1893 and an extensive repair scheme in 2007. In the large complex there is a range of pointing styles. The walls of the earlier buildings are constructed with a mixture of sawn and random rubble and flush pointing (Figure 040.1). From the evidence surviving on the roughly coursed blocks it can be assumed that this building was flush pointed and limewashed (Figure 040.2). In later parts of the complex are also flush points, possibly from the 1893 works, but appear to have been without limewash (Figure 040.3).

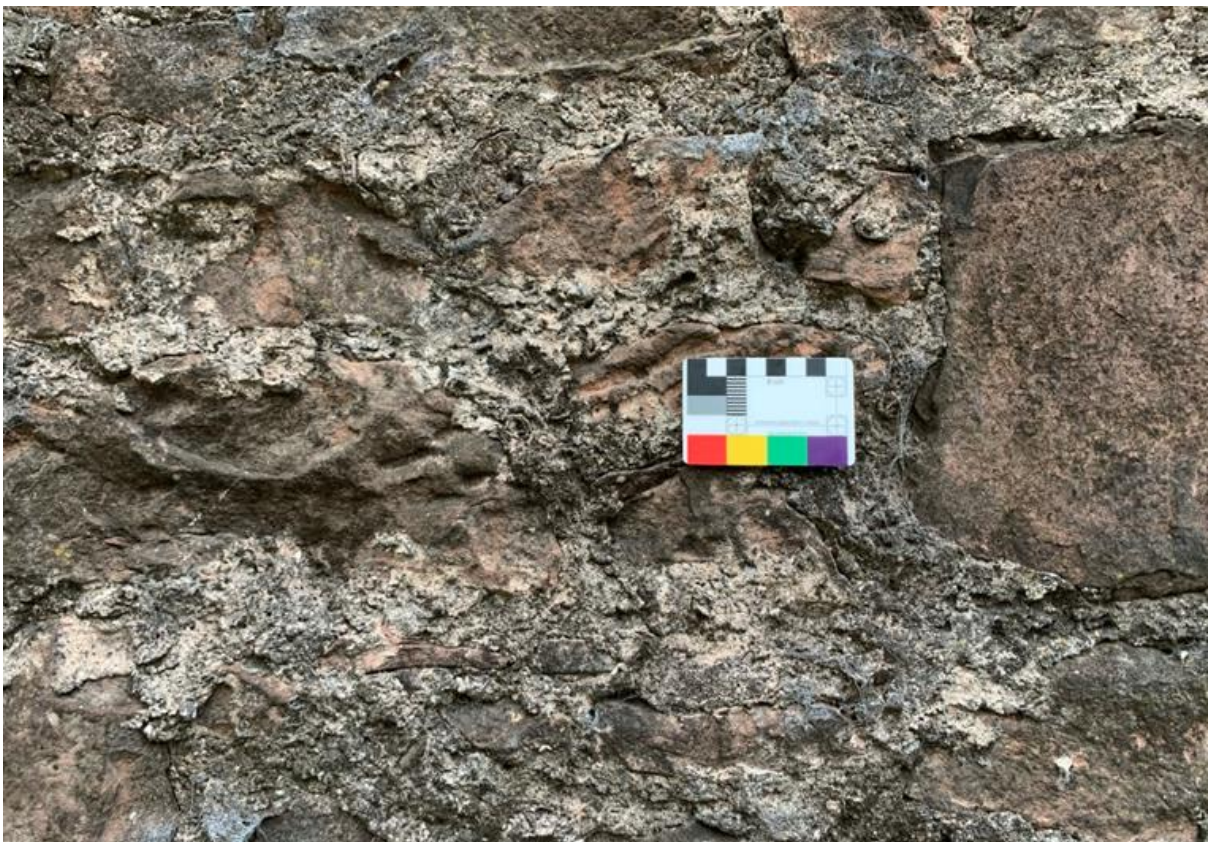
Figure 040.3. Remains of a coarser sneck harl or flush finish on a rear building in the complex.

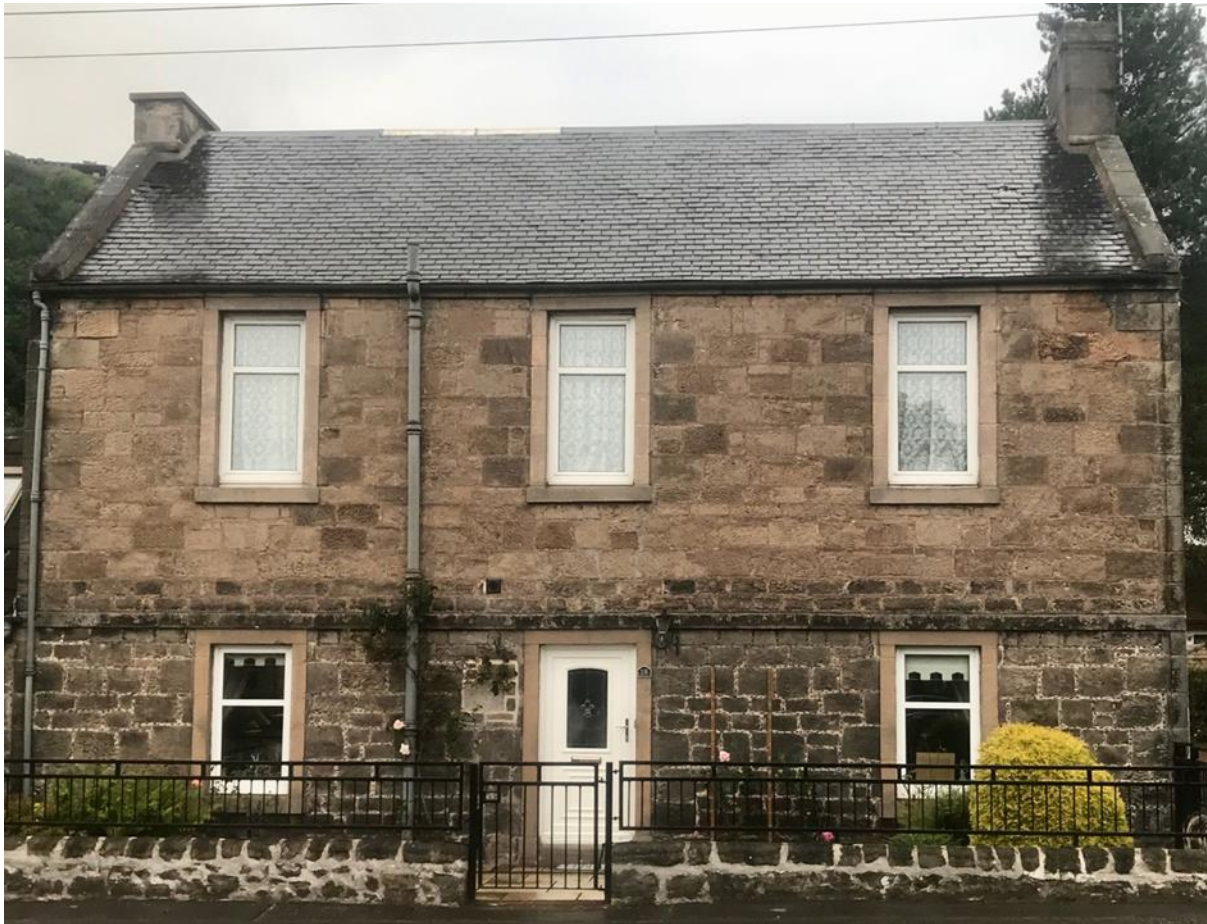
Figure 041.1. Southern view of a house on Main Street West, Menstrie.

A two-storey house with the ground floor constructed in one type of sandstone and the first floor in another (Figure 041.1). This, along with the difference in window sizes, suggest that the building was raised and altered, thus representing two separate building phases. Each of the floors are finished differently; the first floor is simply flush pointed while the ground floor is cherry-stoned (Figure 041.2) with small sections of basalt. The fact that the cherry-stones are basalt confirms that the process is not a byproduct from the squaring of the building blocks, but a deliberate decorative inclusion. There is no trace of harl on either floor.

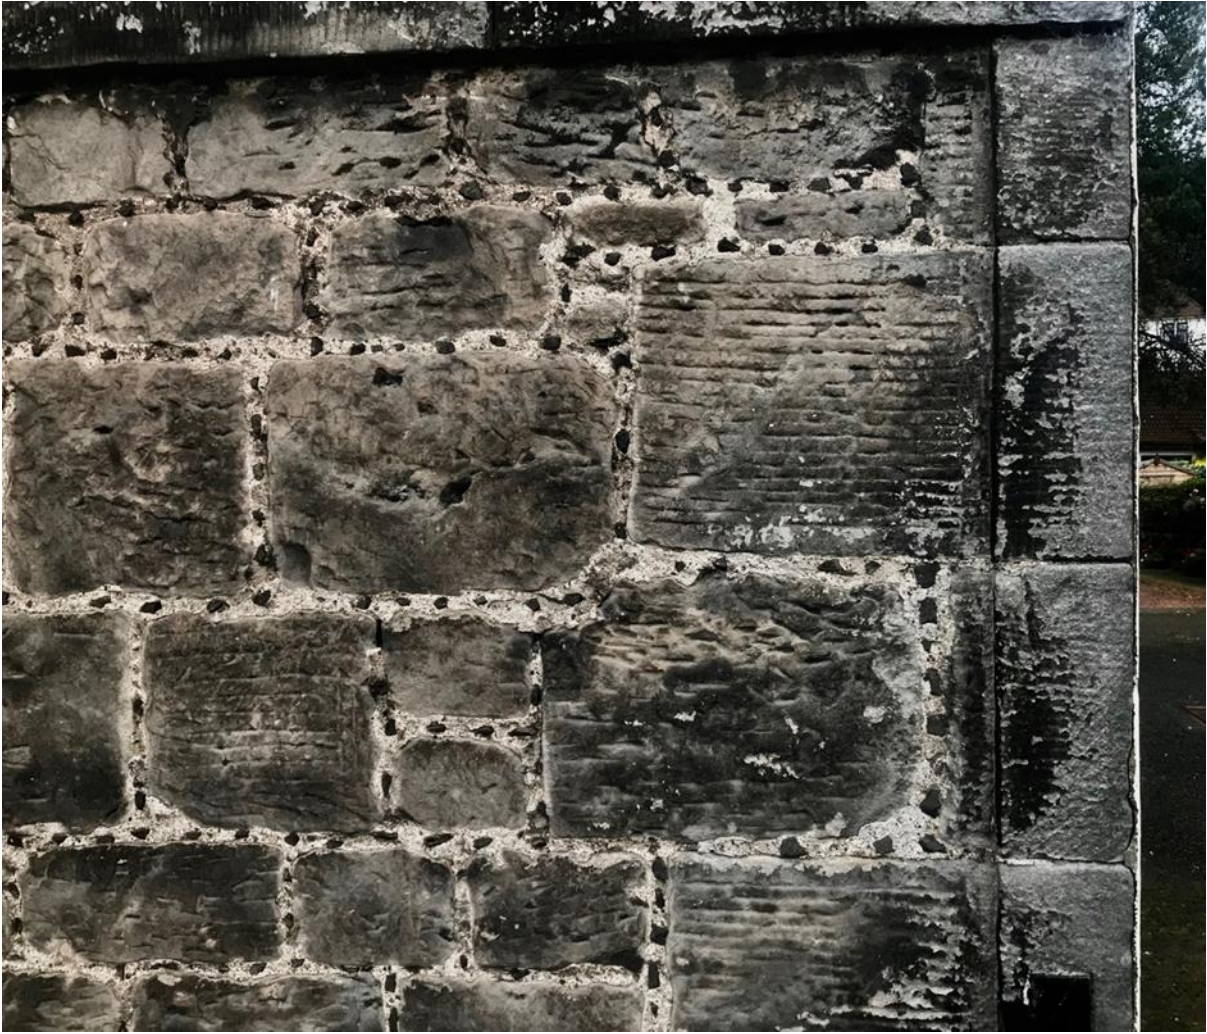
Figure 041..2. Sandstone ground floor, cherry-stoned with basalt.

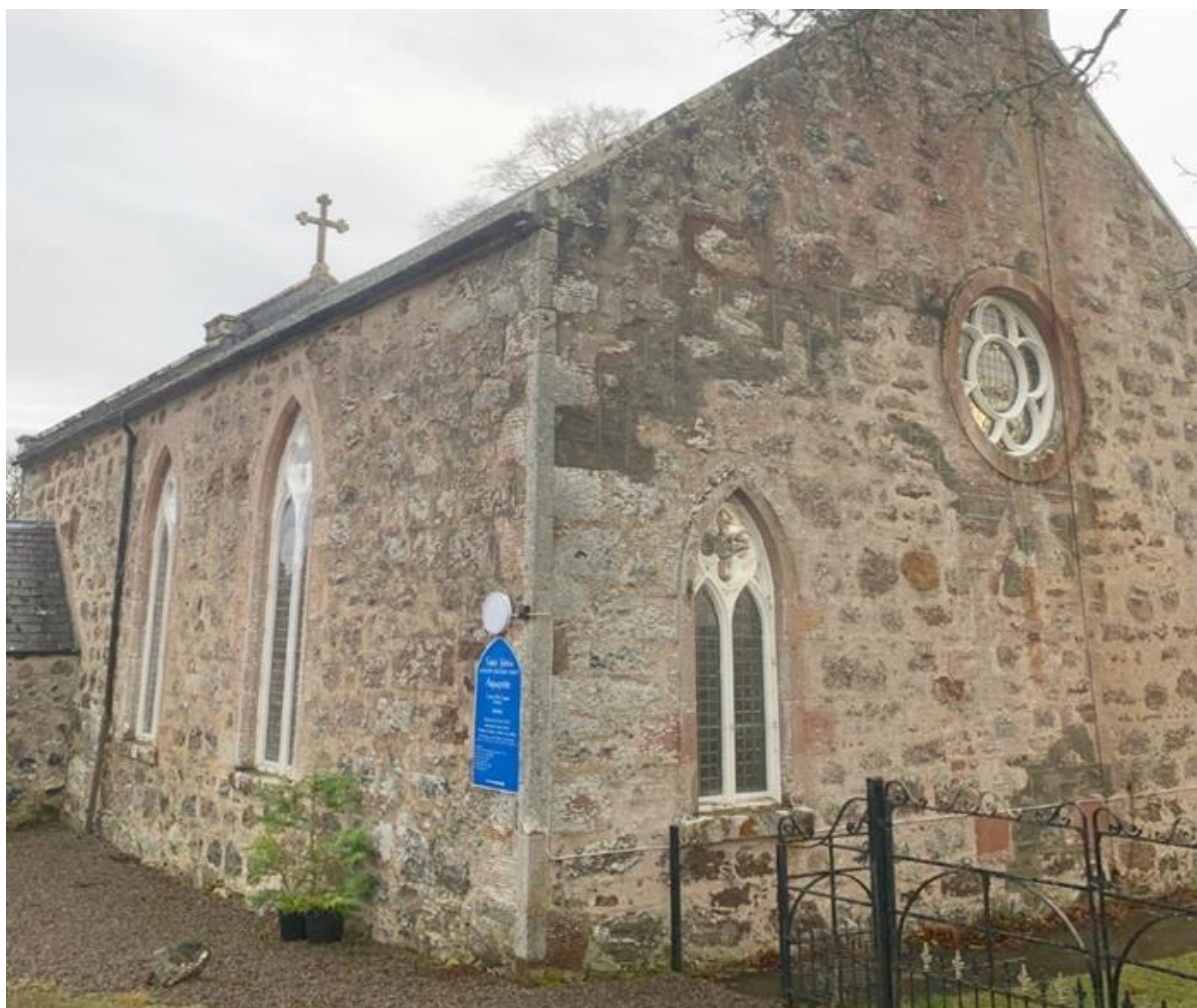
Figure 042.1. St John the Evangelist Church, viewed from the southwest.

This Episcopalian church (Figure 042.1) was originally built between 1810 and 1816 and was later remodeled by Alexander Ross in 1879. Because of the poor-quality local sandstone and agglomerate stone used in construction, it is suggested here that it was originally full harled, with fragmentary traces of the complete finish found in the deeper recesses of some stones (Figure 042.2). The horizontal and perpendicular ribbon pointing probably dates from the late 19th century reconstruction (Figure 042.3). The inscribing of the lines on the raised ribbon is of variable quality but the mortar generally survives well. The aggregates range in size from 1-10mm and are generally mixed - some are rounded and others, angular. There are lime inclusions on all elevations.

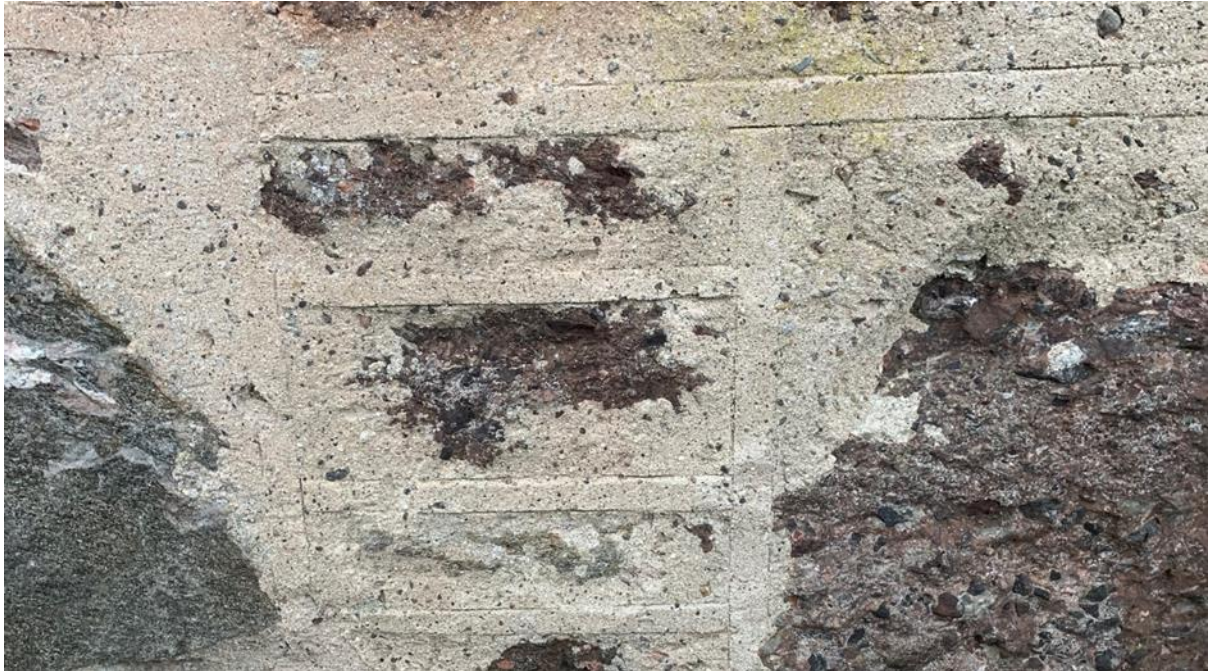
Figure 042.3. Horizontal and perpendicular ribbon pointing.

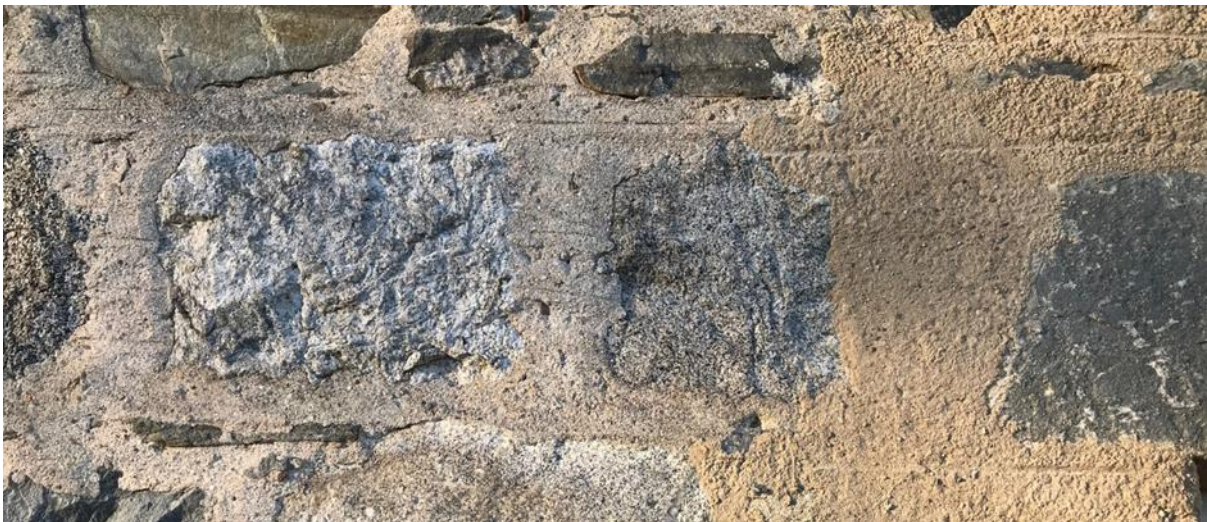
Figure 043.3. Semi-formal ruling out of the original sneck harl to the left and recent lime mortar repair to the right.

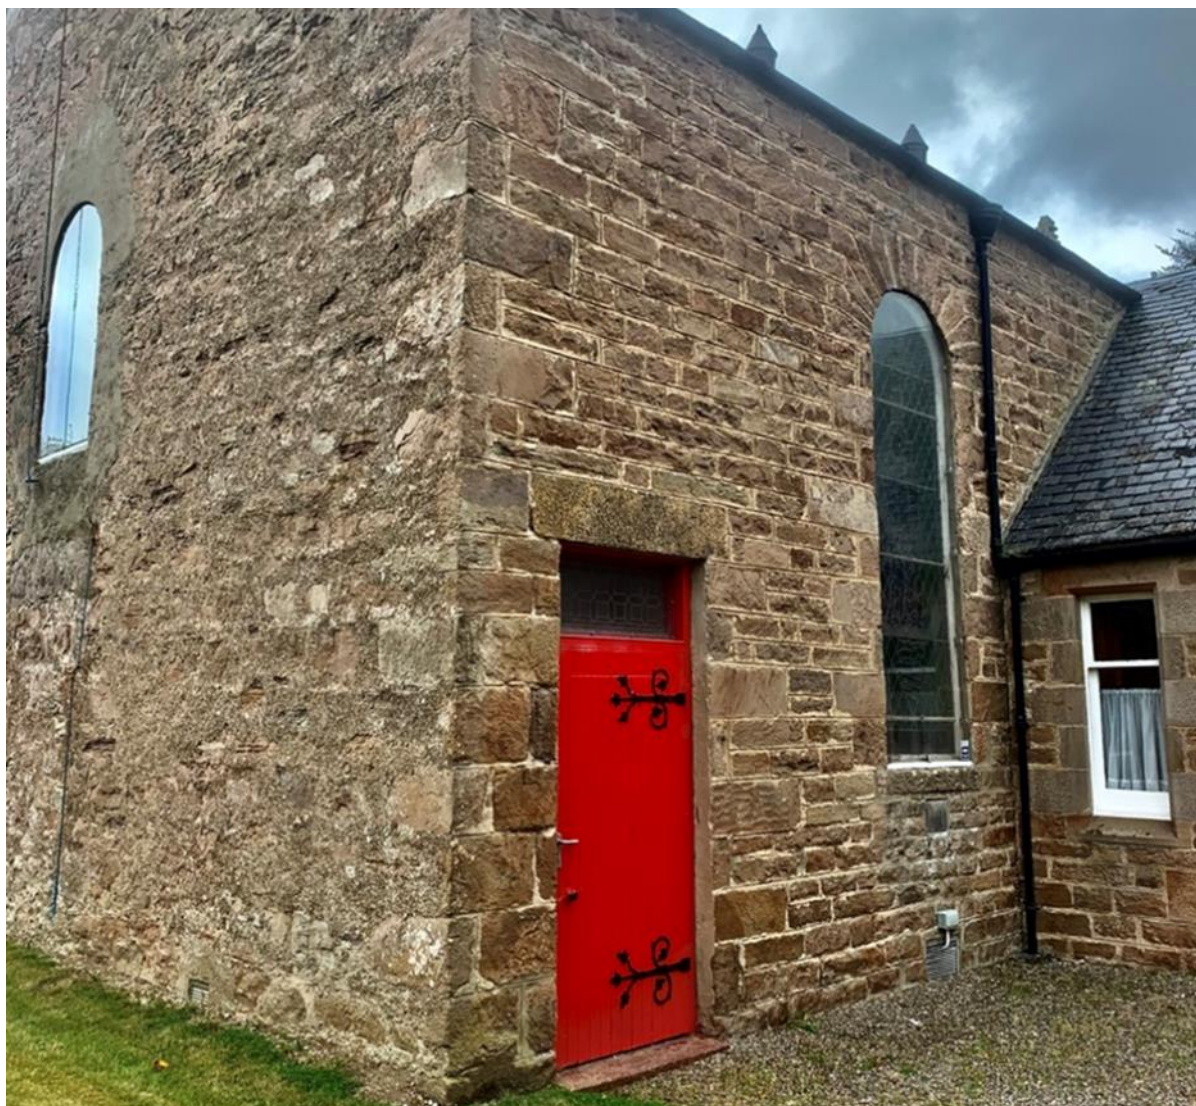
Figure 044.1. The Petty Church, Tornagrán, showing gable and front.

A sandstone church built in c.1839 (Figure 044.1). Squared blocks of local poor quality flush pointed sandstone on the front elevation and sneck harl on the gables and rear. The pointing is horizontally and perpendicularly ruled with a tool that left a half round profile. The work is crude and relatively inaccurate and exhibits many shrinkage cracks. There are signs that the pointing was delivered at the point of construction rather than later (Figure 044.2). The aggregates are in the general range of 0.5mm – 7mm and vary from fine rounded to larger angular and contain multiple, large and small lime inclusions.

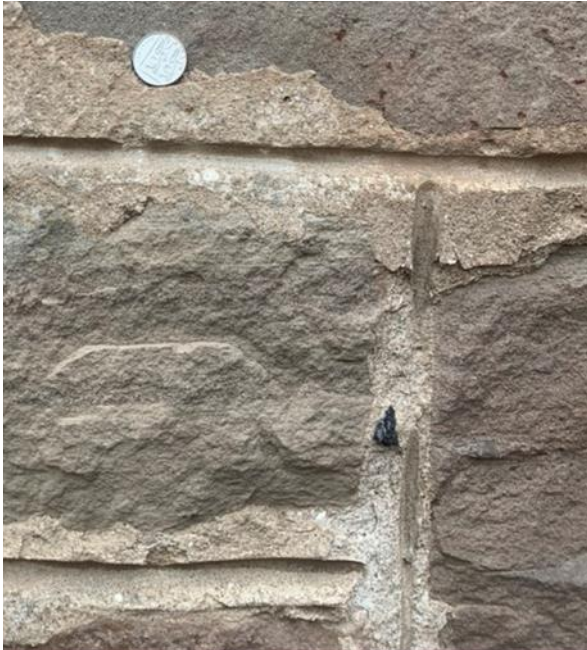
Figure 044.2. Flush pointed with half round informal ruling out. Possible integrated mortar and lime inclusion visible.

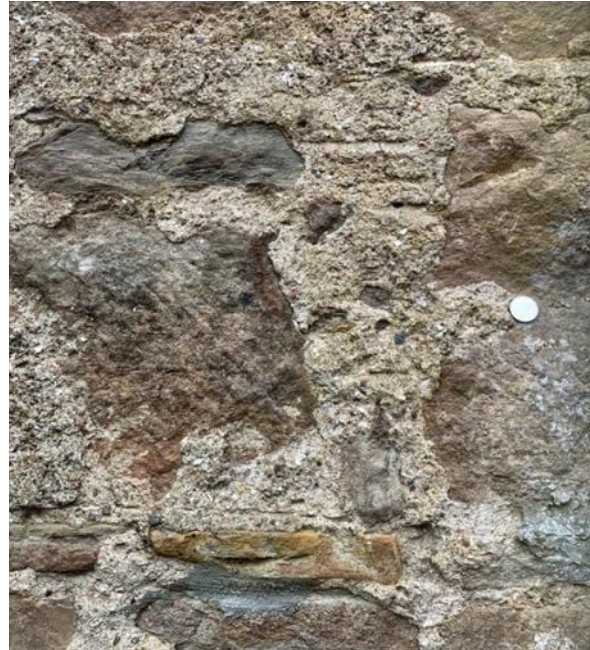
On the gable an earlier finish emerges where the marine sneck harl has graded away (Figure 044.3). This was a full sneck harl, without marine material and has been informally horizontally ruled out, with the edge of a trowel. This finish, like the pointing on the front elevation appears to be integrated with the building process.

Figure 044.3. Later marine sneck harl (left) overlaying earlier mortar without marine inclusions.

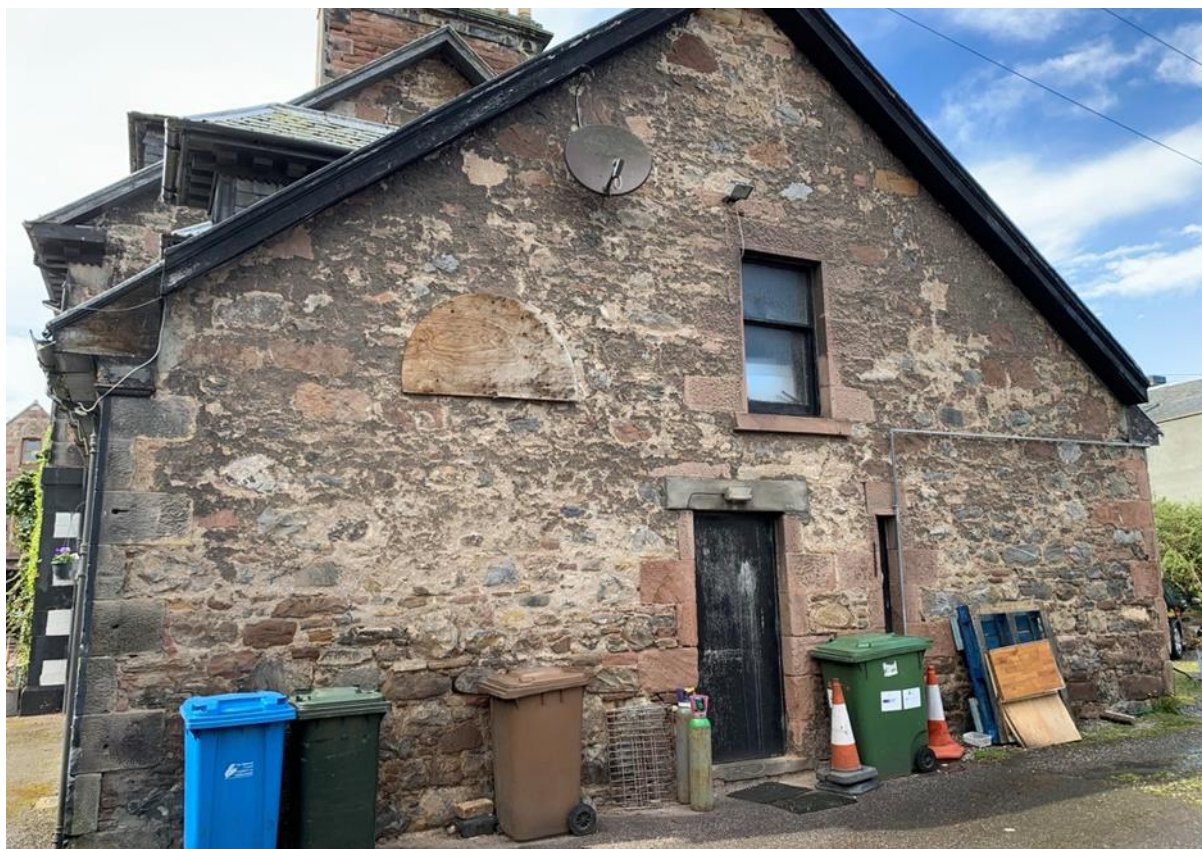
Figure 045.1. The Anderson Hotel, rear elevation.

The rear of this large Victorian hotel (Figure 045.1) still retains extensive remains of a sneck point; with traces of horizontal ruling out (Figure 045.2). The sneck point finish is best preserved in the sheltered areas under the overhanging eaves. The mortar is made with a medium fine sand and contains shell fragments and unslaked lime inclusions (Figure 045.3). The masonry does not appear to have been limewashed. Like many examples within the gazetteer, the principal elevations are sawn sandstone (in this case, now painted) while the rear elevations were finished less formally with the simple lined out sneck point.

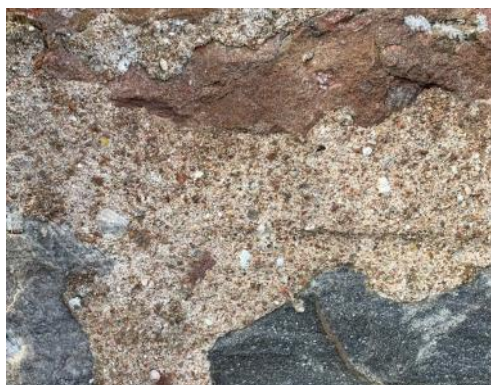
Figure 045.2. Extant ruled sneck pointing made with medium fine shell sand

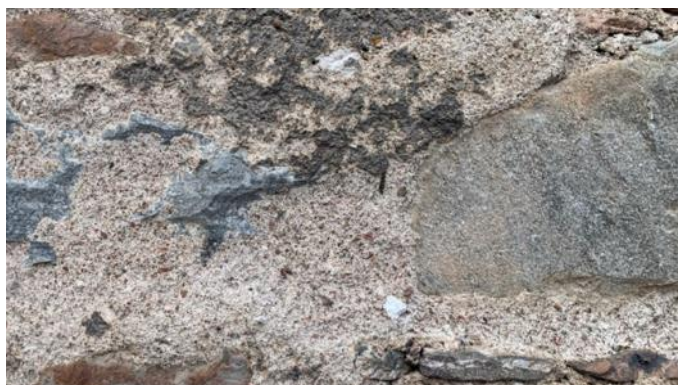
Figure 045.3. Mortar with lime inclusions.

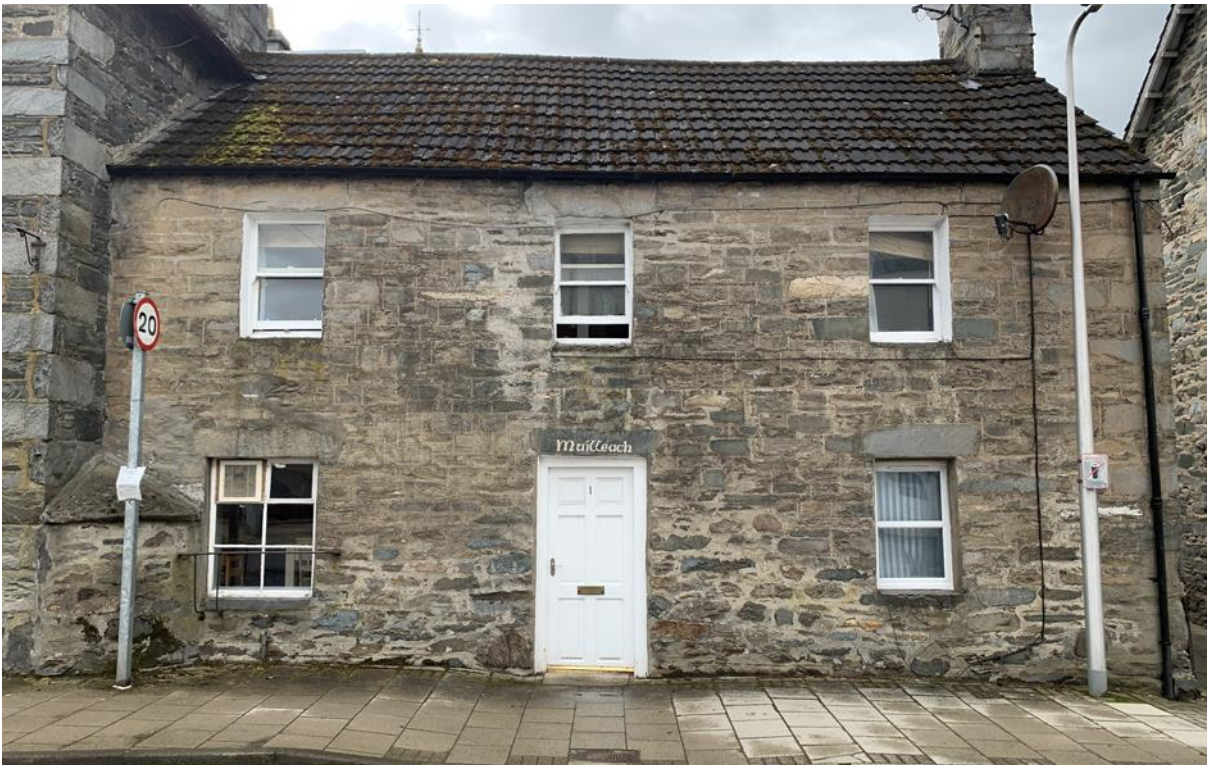
Figure 046.1. The house on Chapel St, Aberfeldy. Flush point with horizontal and vertical ruling out, the pattern of which can still be discerned on the upper levels.

Early to mid-nineteenth-century house built with random rubble but given a sense of formality by the application of a slaistered, sneck point with horizontal and perpendicular ruling out (Figure 046.1). The ruling out was subsequently white line lined into the incisions (Figure 046.2). The mortar is made with medium buff coloured sand and aggregates, containing many lime inclusions. The relative shelter of the location means that the pointing has survived well, and the pattern of the lining out can still be seen on the upper levels.

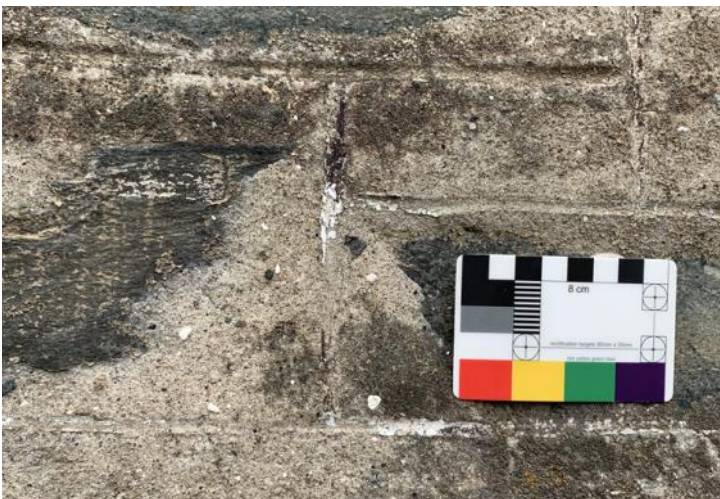
Figure 046.2. Detail of the flush point showing the horizontal and vertical lining out, with traces of white coloring to the incised lines.

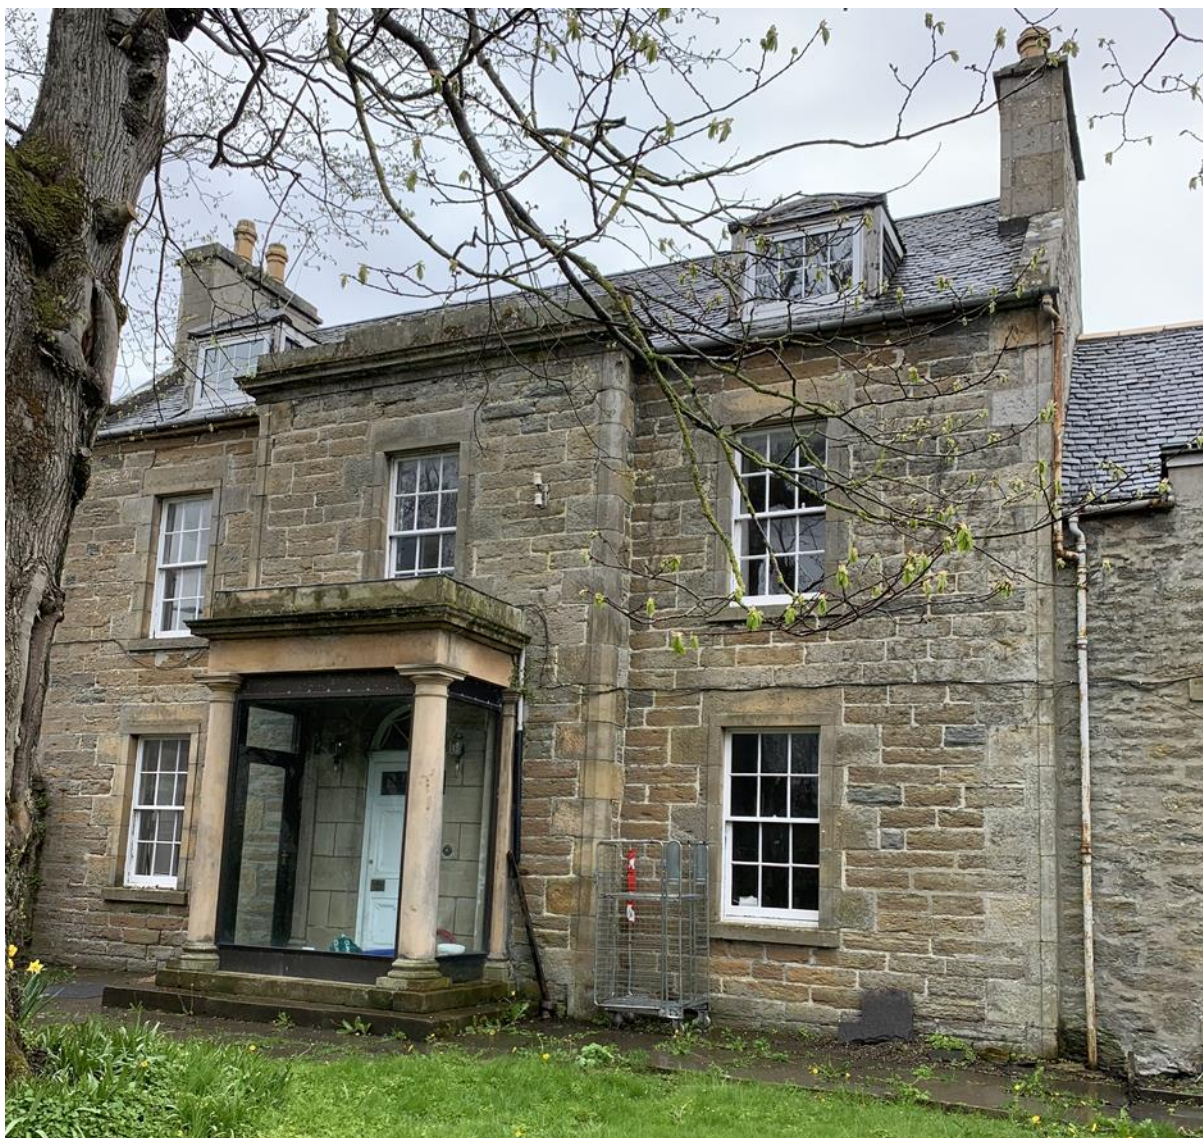
Figure 047.1. Front elevation of building.

Constructed with local Caithness stone and pale sandstone details at the quoins, doors, and windows with additional formal entrance porch (Figure 047.1). The details are raised as if to accommodate a full finish but instead the masonry has formal pointing. The mortar is made with medium fine sand and has lime inclusions. The joints are perpendicularly and horizontally ruled out with a broad half round tool (Figure 047.2). In general, the pointing survives well and may have been executed at the time the walls were built.
