TECHNICAL PAPER 33

MASONRY POINTING AND JOINT FINISHING

PART 2 - GAZETTEER

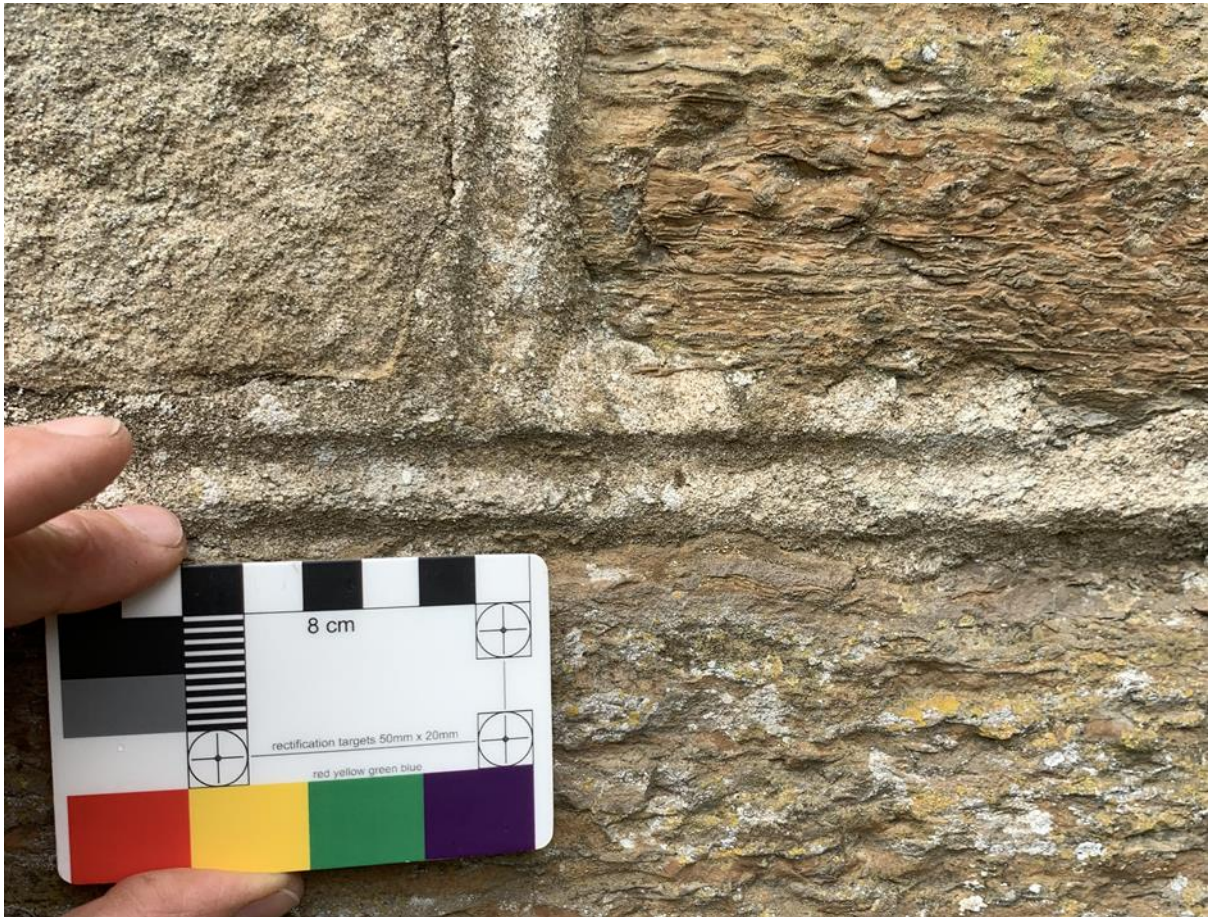
Figure 047.2. Flush pointing lined horizontally and vertically.

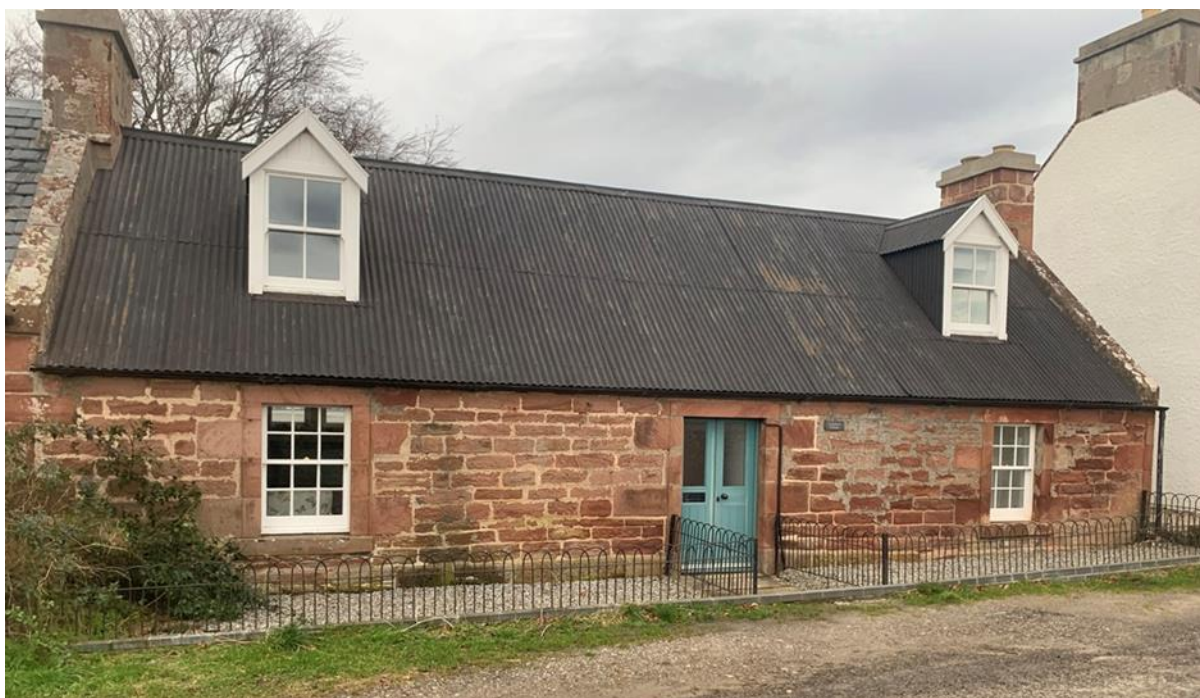
Figure 048.1. Southern elevation of the cottage.

A mid-19th century, tin roofed single-story cottage with flush lime pointing (Figure 048.1). It is likely that this tin replaced a thatch roof. The mortar is horizontally and perpendicularly ruled out (Figure 048.2). The mortar is comprised of marine sand with shell and lime inclusions (Figure 048.3). The masonry is built with clay and pointed with lime.

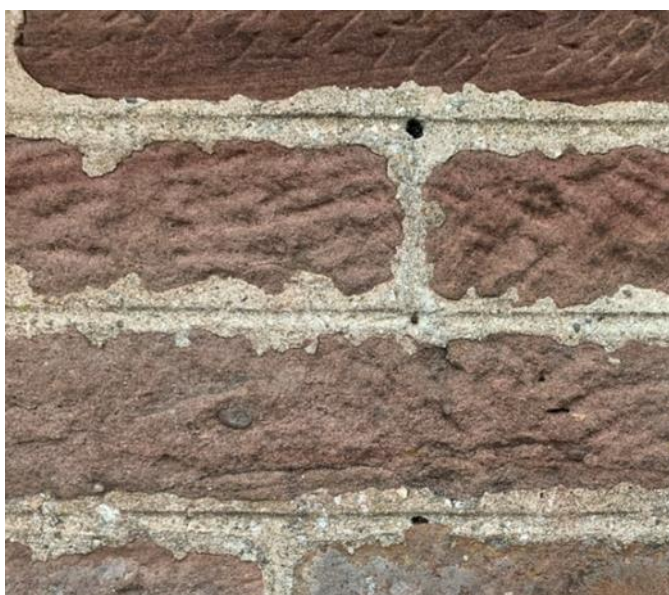
Figure 048.2. Horizontal and perpendicular ruling out.

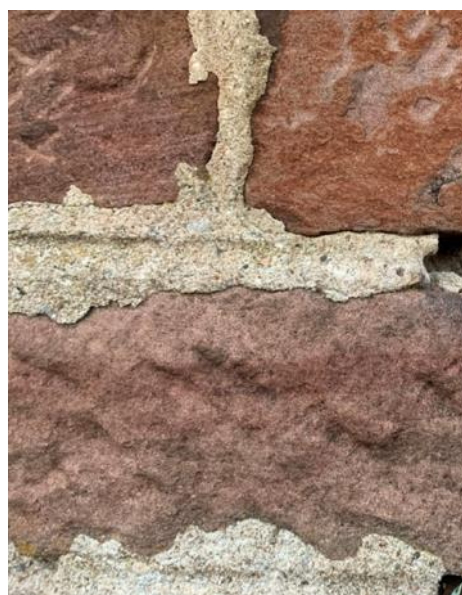
Figure 048.3. Marine sand with shell and lime inclusions.

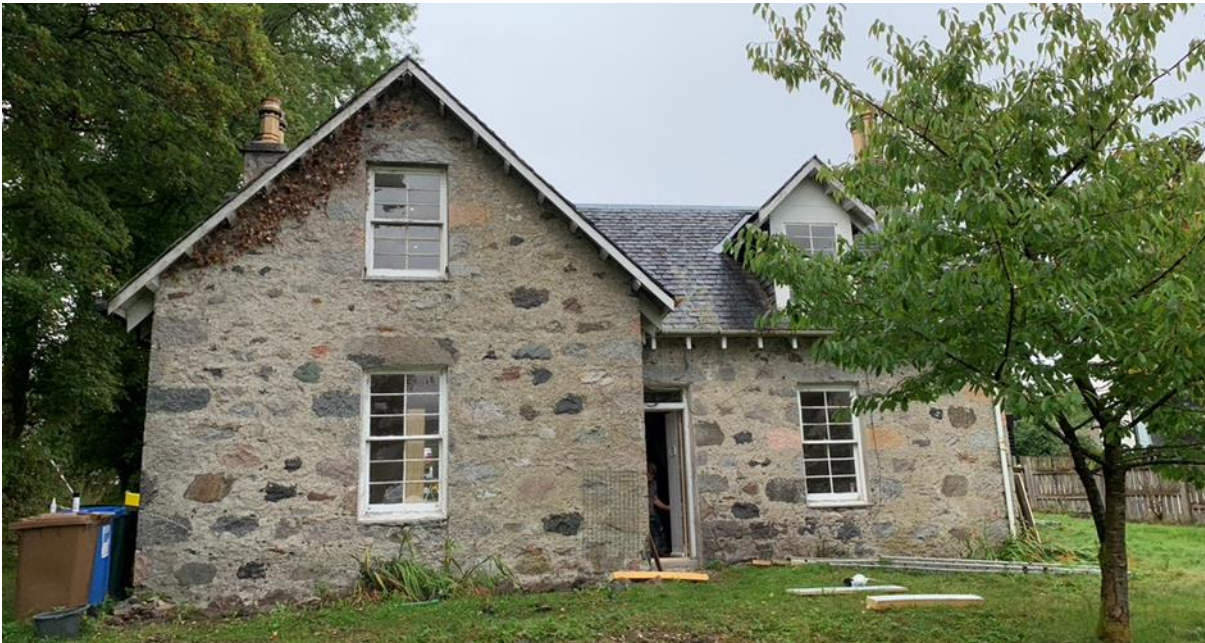
Figure 049.1. Sneck harled cottage at Spean Bridge.

An 'L' plan Victorian cottage c. 1850 (dated by the horizontally arranged windows) with sneck harled finish (Figure 049.1). The sneck harl (Figure 049.2) remains extensive on all elevations and is made with a very coarse angular sand with a particle size in the range 0.5mm – 15mm and has extensive large lime inclusions. The extant evidence suggests that the covering of stone was once greater than it now is but given the evenness of the wear pattern on all elevations it is unlikely to have been fully harled.

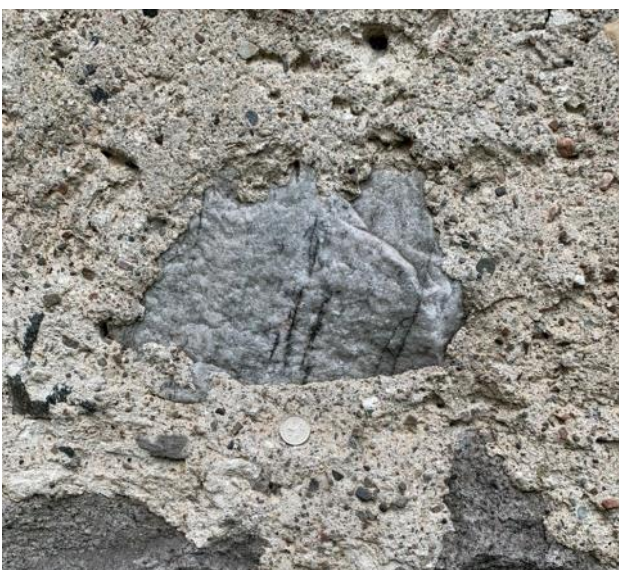
Figure 049.2. Very coarse angular sneck harl.

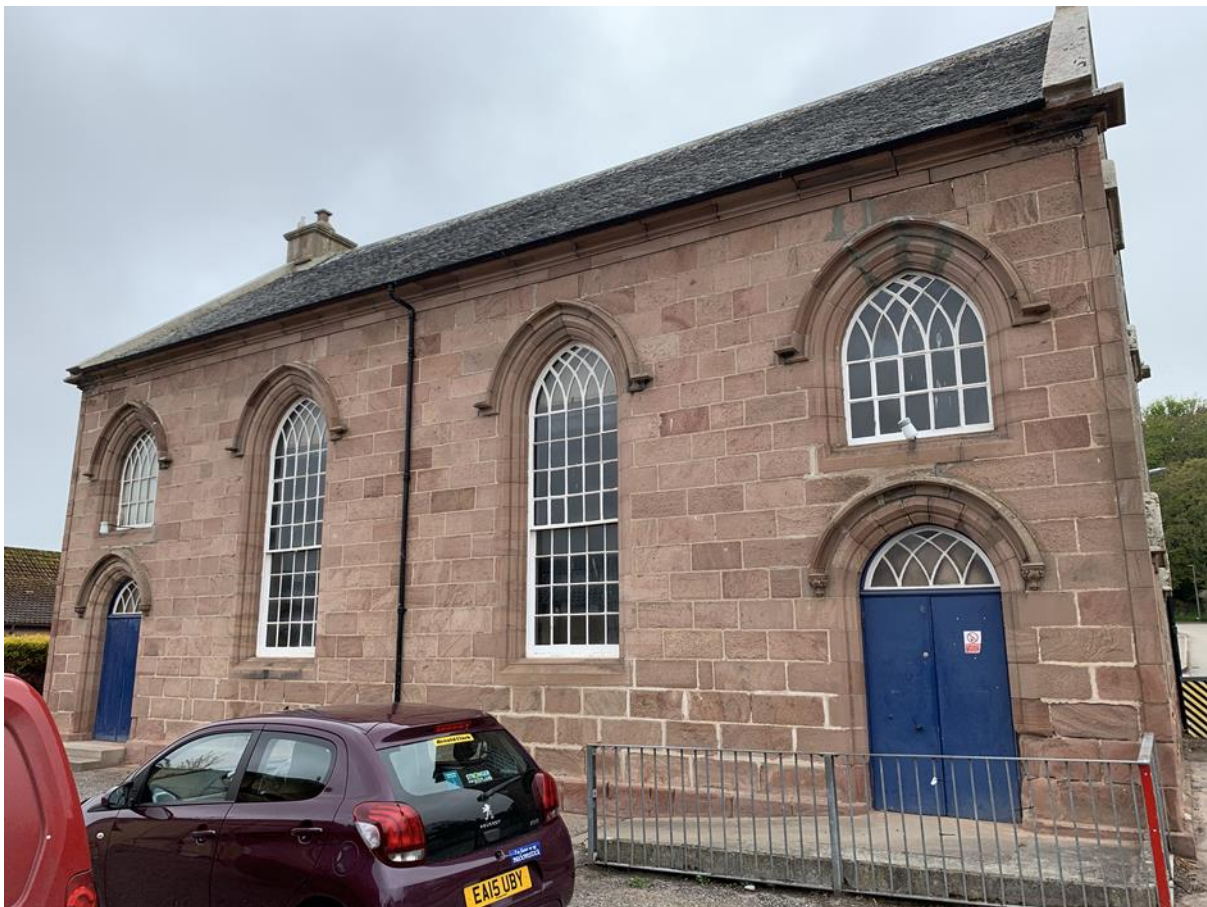
Figure 050.1. The principal elevation of the former Town Hall.

This building was built as a chapel of ease for Fortrose between 1839- 41 and latterly as a Parish Church (Figure 050.1). In 1931 its religious function ceased, and it became the Town Hall. It is Category B Listed. It is built from a local red -brown sandstone and is flush pointed and ruled horizontally and vertically on all elevations. This contrasts with the side elevations which have a masonry with a rougher finish, sneck pointing and cruder lining out (Figure 050.2), showing a hierarchy of finishes. The mortar is lime rich with a medium - coarse sand in the range of -0.5 - -13mm with lime inclusions. The tooling on the sandstone is multi directional and may reflect local practice (Figure 050.3).

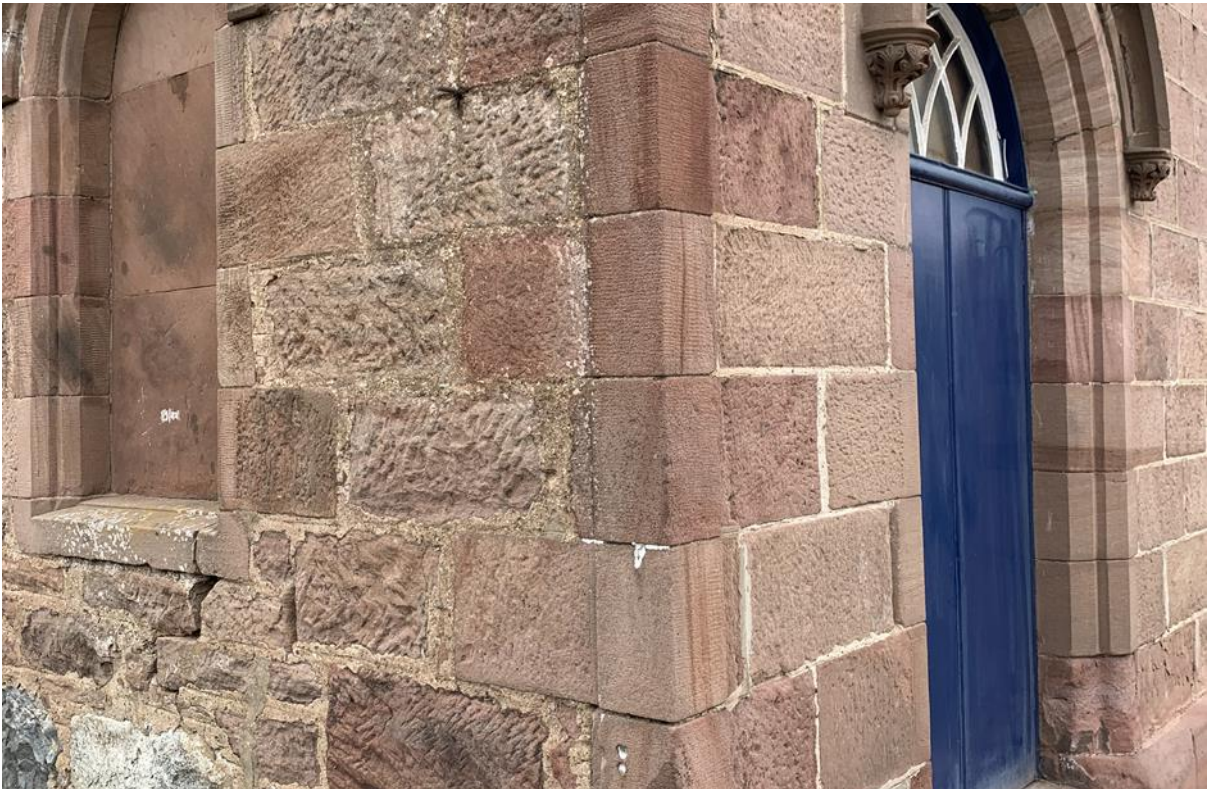
Figure 050.2. The corner of the building showing the hierarchy of finishes - smoother cut blocks with lined out pointing on the principal elevation, with the coarser finishes for rear elevations showing on the left.

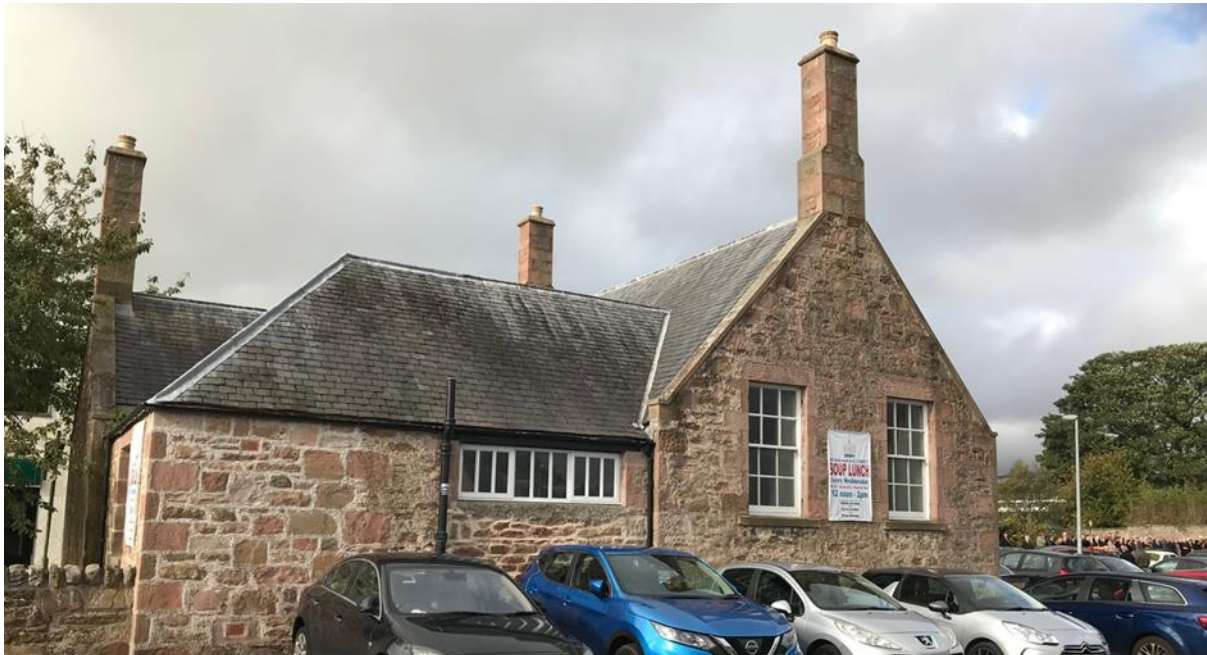
Figure 051.1. St Clement's Church Hall, eastern elevation.

This church hall most likely dates from the mid-19th century. The tall chimneys are, in all probability, a later addition. The rear elevation of the church hall is one of rubble masonry (Figure 051.1). There have been several attempts to repair and re-point the rear elevation (Figure 051.2) and this gives an interesting sequence. There are surviving examples of the original pointing (Figure 051.3).

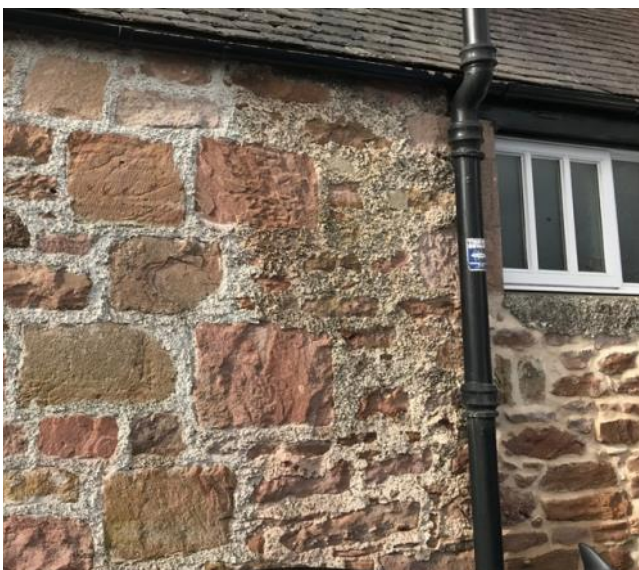
Figure 051.2. Three samples of pointing: 1 (left) recent lime mortar sneck harl; 2 (middle) original sample; 3 (right) earlier re-pointing.

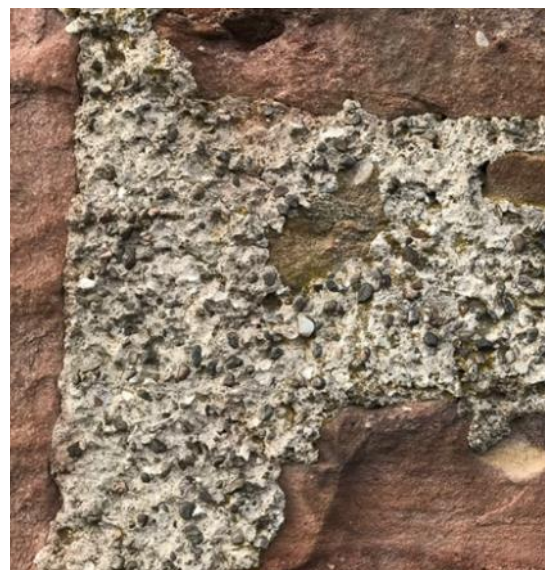
Figure 051.3. Original extant pointing sample.

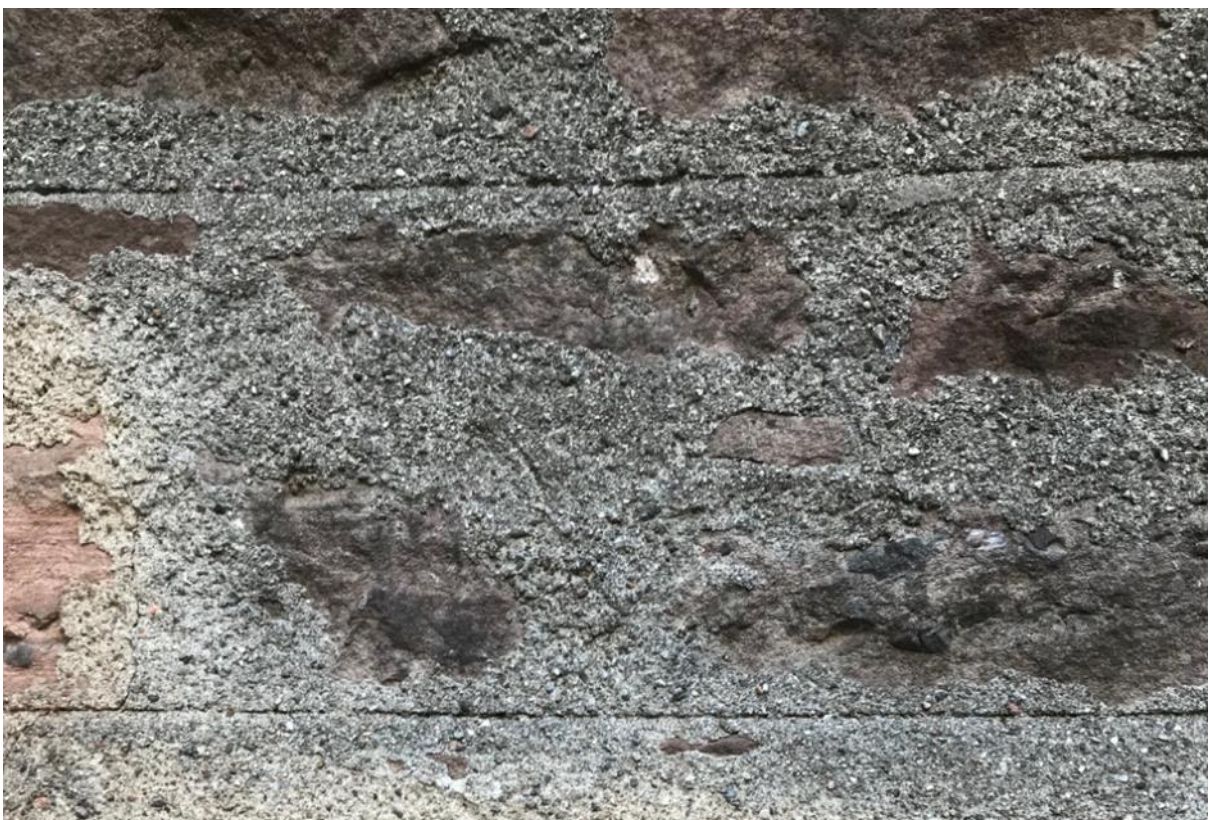
Figure 052.3. Sneck harl with ruling out.

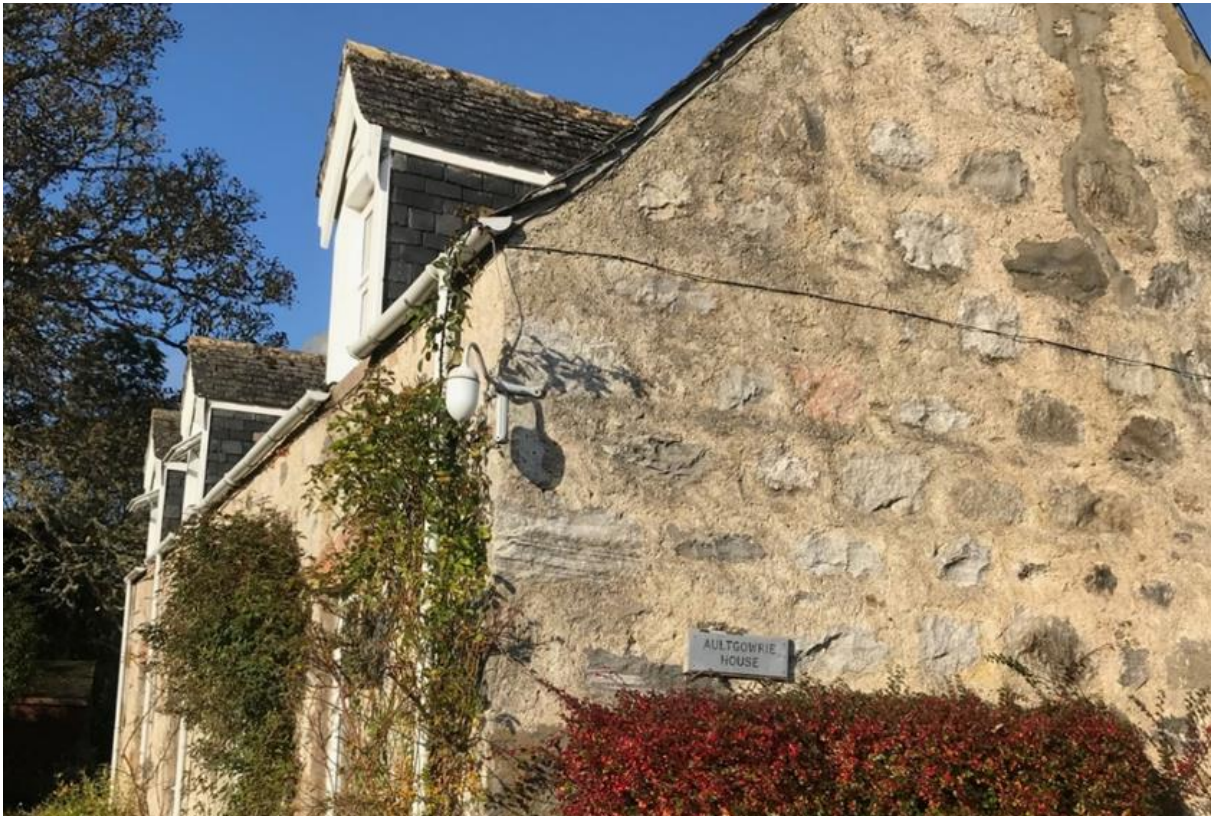
Figure 053.1. View of the west gable of the cottage.

A Victorian, two-storey, three bay cottage built with mixed whinstone, granite and sandstone with a lime sneck harl (Figure 053.1). The high points of the various stones protrude through the mortar. The sneck harl is generally intact and appears to be original (Figure 053.2).

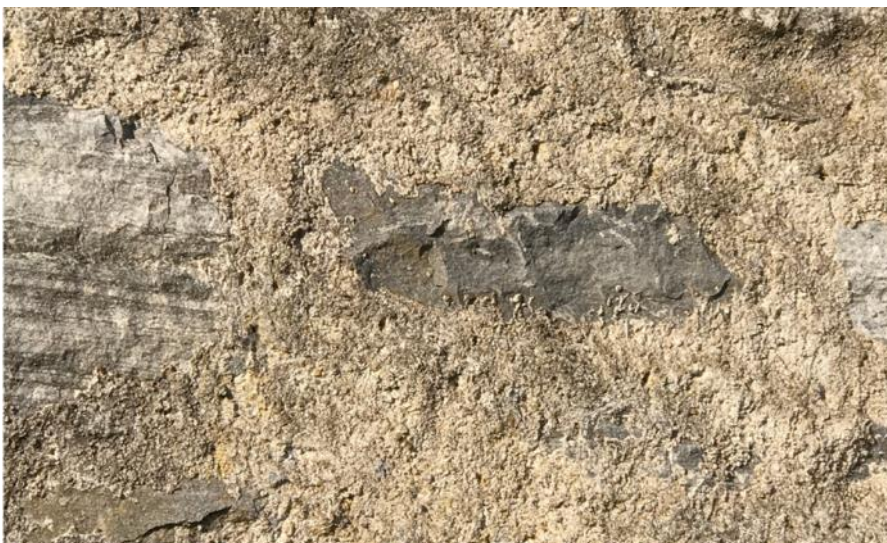
Figure 053.2. Detail of the flush finish on the west gable.

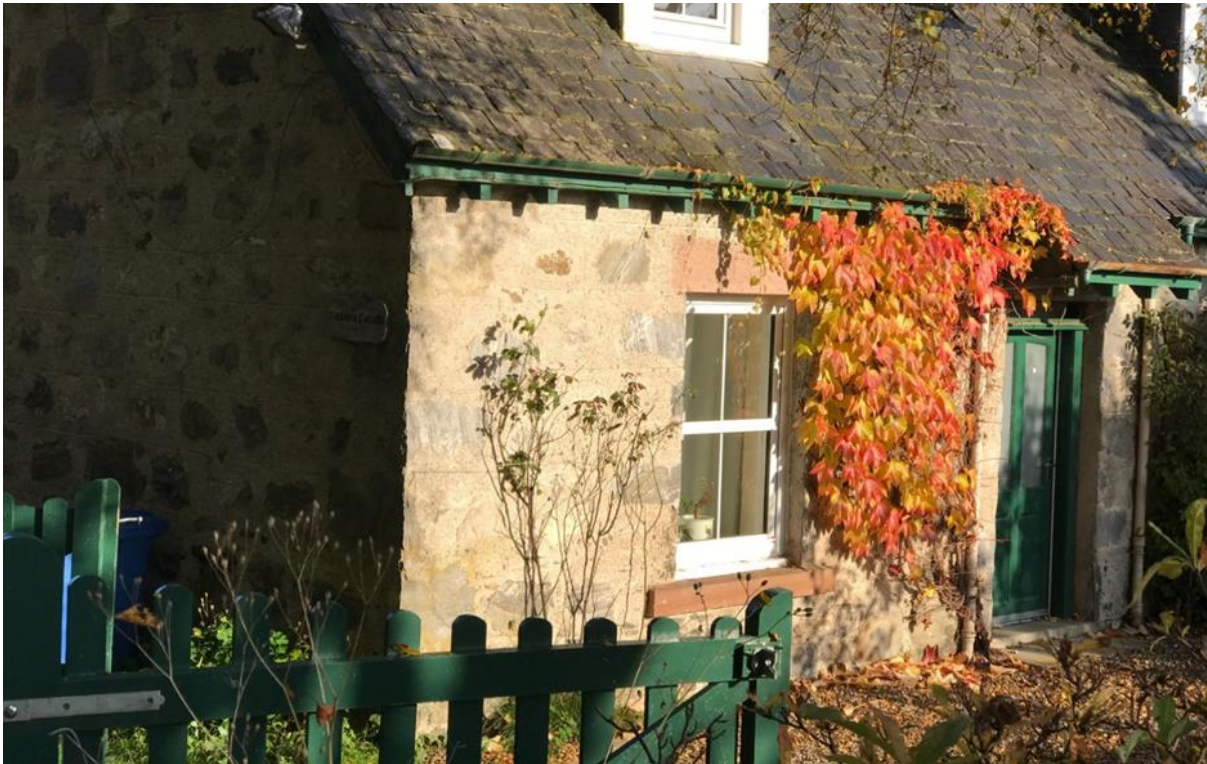
Figure 054.1. Front elevation of the cottage at Fairburn.

A Victorian cottage that forms part of the Fairburn estate (Figure 054.1). The building is one and half storeys with mixed rubble and sandstone sills and details. The masonry is sneck harled and horizontally ruled out. The mortar is coarse with aggregates in the range of 1-8mm (Figures 054.2).

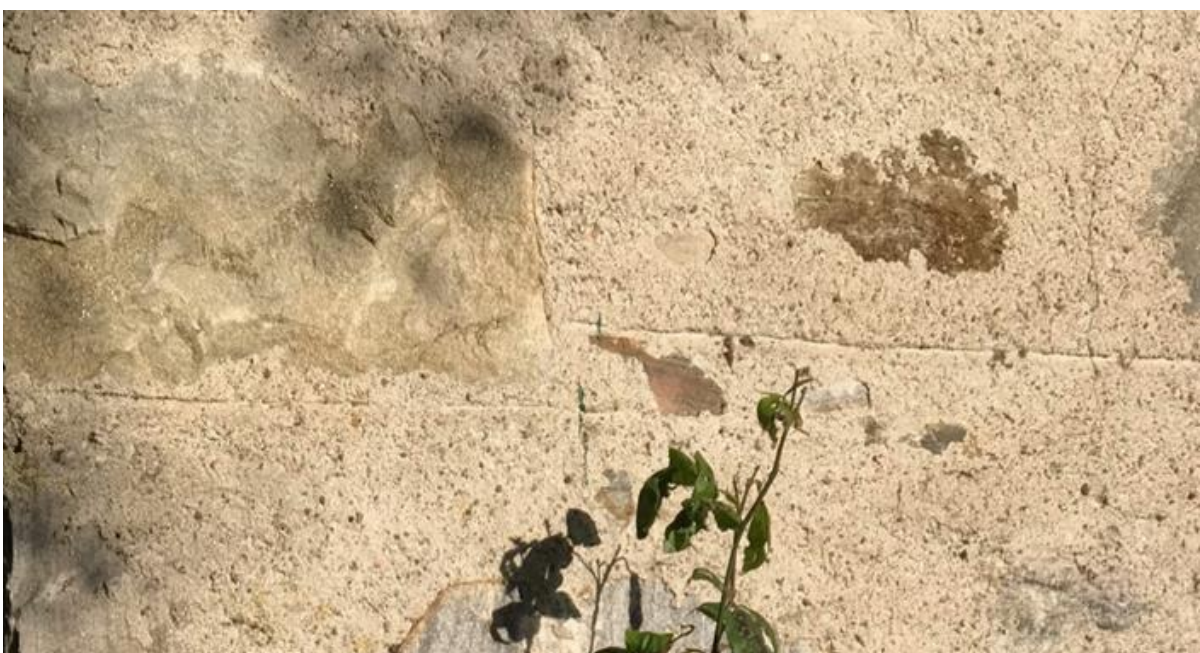
Figure 054.2. Example of horizontally ruled out sneck harling.

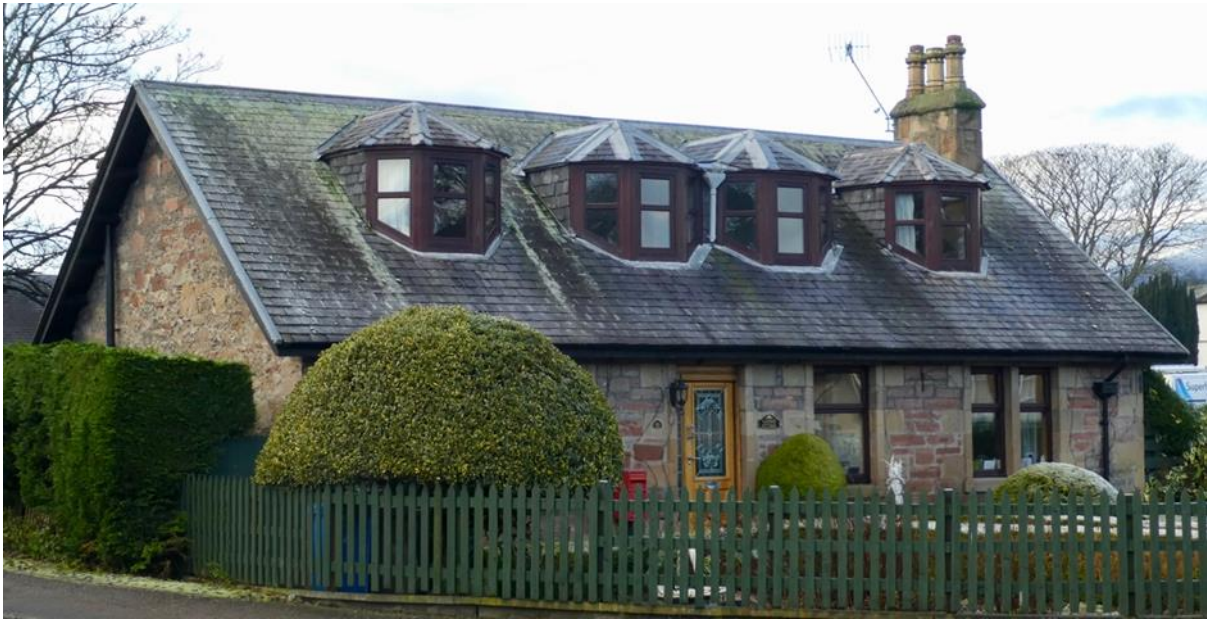
Figure 055.1. General prospect from south east.

A Victorian one and half storey cottage with dormer windows; heavily modernised. The front elevation is re saw sawn rubble with buff sandstone dressings (Figure 055.1). The gables are random rubble with a mix of the two types of sandstone (Figure 055.2). The left hand gable has had the chimney removed, but both gables retain much of the remains of a sneck harled, ruled finish (Figure 055.3). Although access was limited, the harl is clearly coarse and lime rich, with aggregates in the range of 1-7mm.

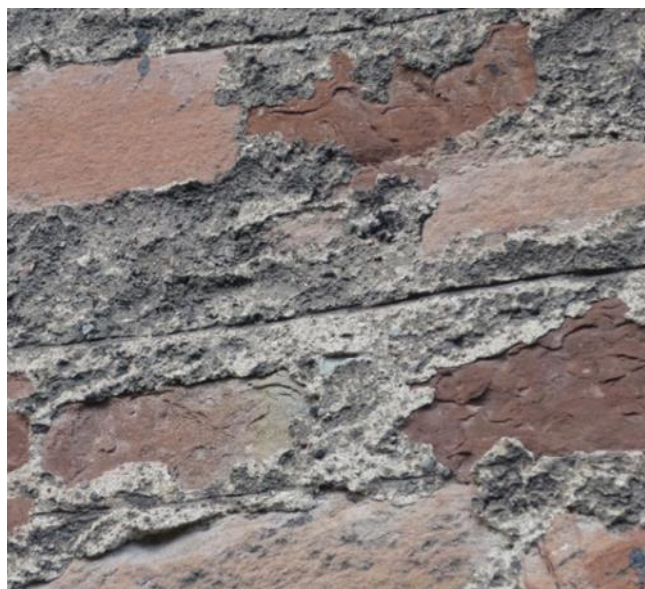
Figure 055.3. West gable, harling and ruled finish.

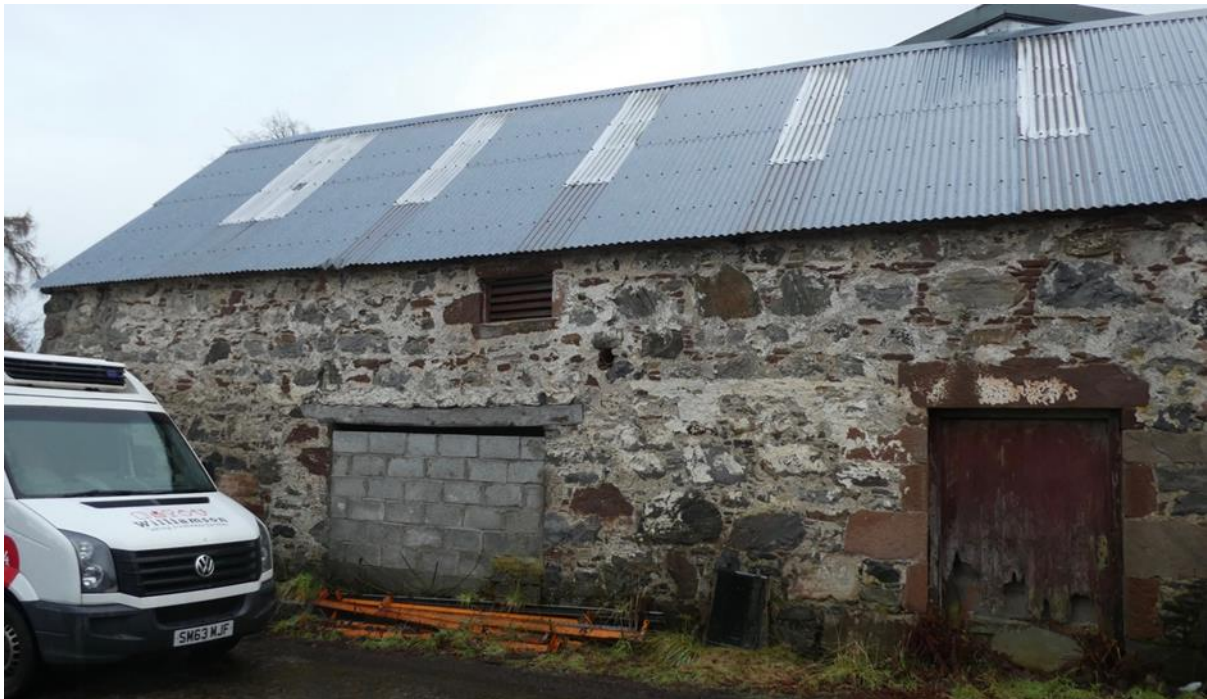
Figure 056.1. Warehouse elevation.

An unprepossessing rear elevation of a neglected warehouse (Figure 056.1) with vestigial remains of a ruled sneck harl and with additional coats of limewash (Figures 056.2). As with many buildings, it is the neglected areas that often tell us the most about original finishes. Here, an authentic vernacular finish remains, where in more prominent areas it would have been removed.

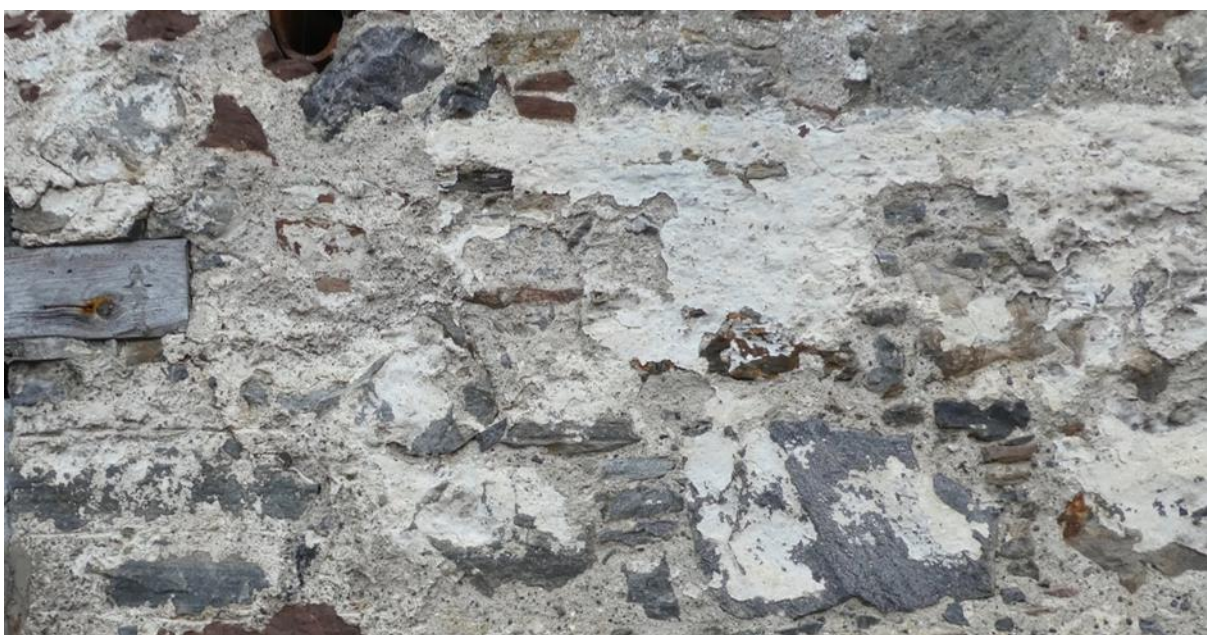
Figure 056.2. Remains of ruled sneck harl and limewash coats.

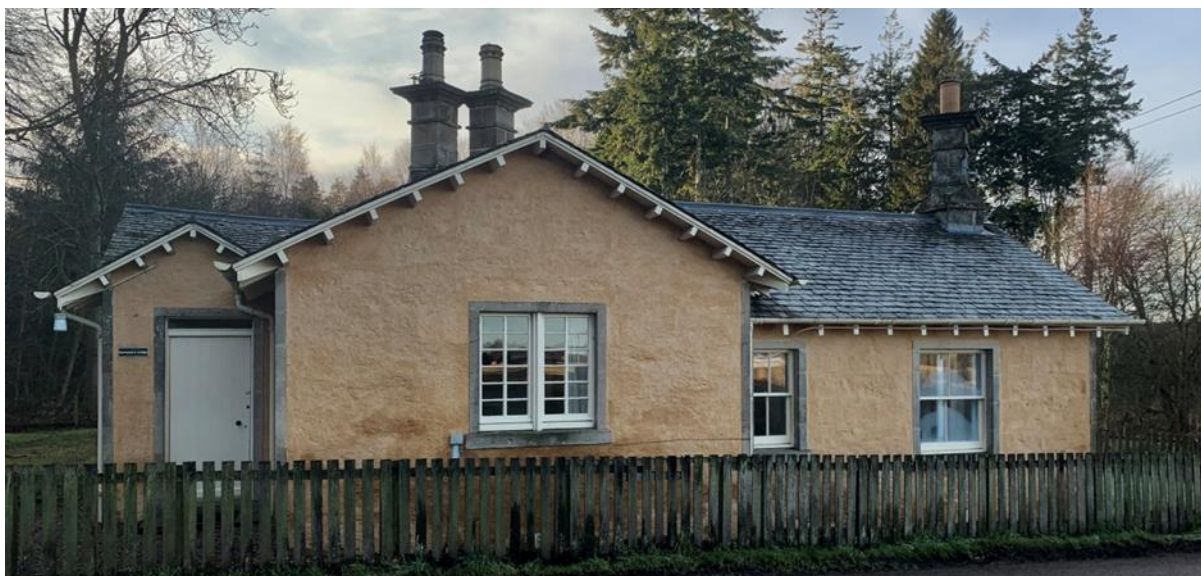
Figure 057.1. General view of the cottage.

A Victorian estate cottage associated with Brodie Castle near Forres, Moray (Figure 057.1). Flush/sneck finished and limewashed (Figure 057.2). To some degree this is an outlier in the survey, in that it is a fairly recent repair or re-instatement of a traditional surface finish. As such it deserves mention, as an indicator of how many buildings in this survey might have appeared when built and maintained.

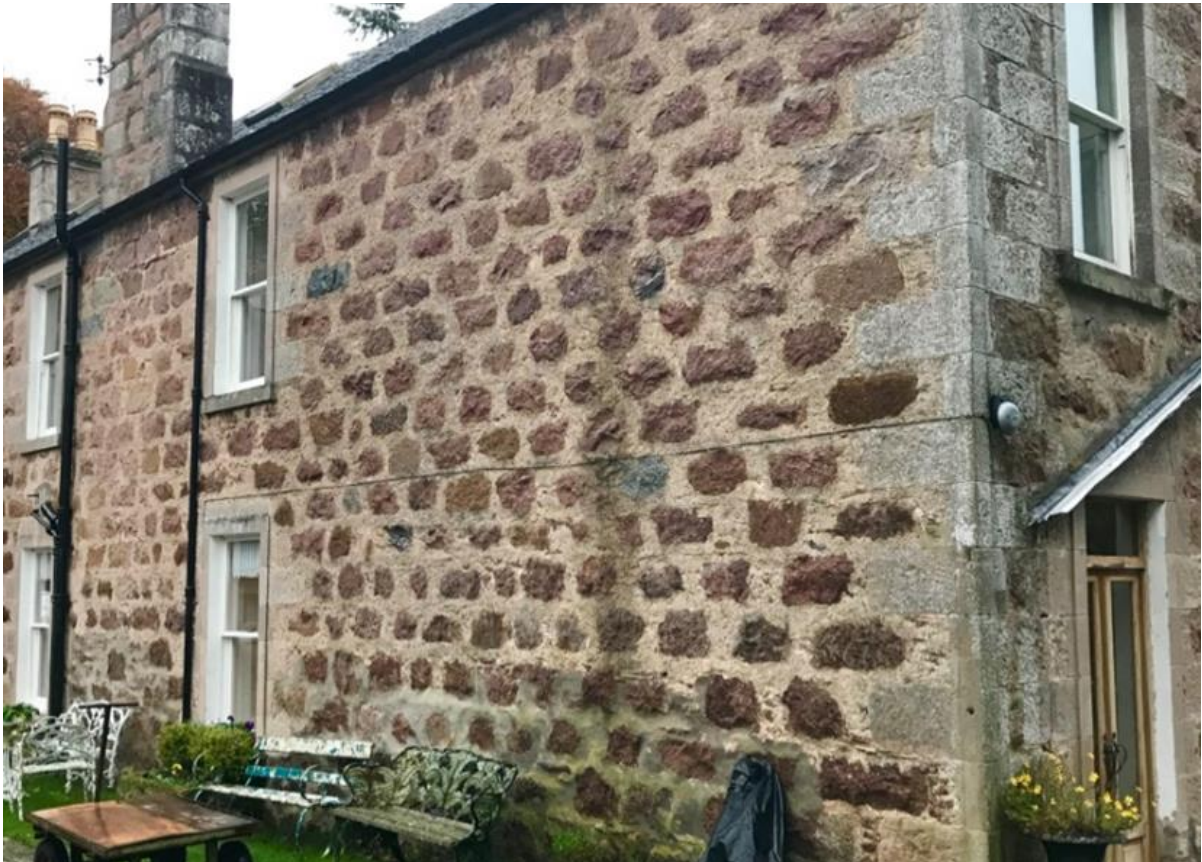
Figure 058.1. Elevation of building.

This former manse of the Free Kirk probably dates from the mid 19th century (Figure 058.1). It is fully flush finished (Figure 058.2), though now worn, with traces of horizontal ruling out. The mortar is still robust to touch but has sustained water and salt damage at ground level. There is water staining down the wall face due to a defective rhone. The mortar comprised well graded sands and aggregate with a mix of angular and sub-rounded particles. There are no visible inclusions.

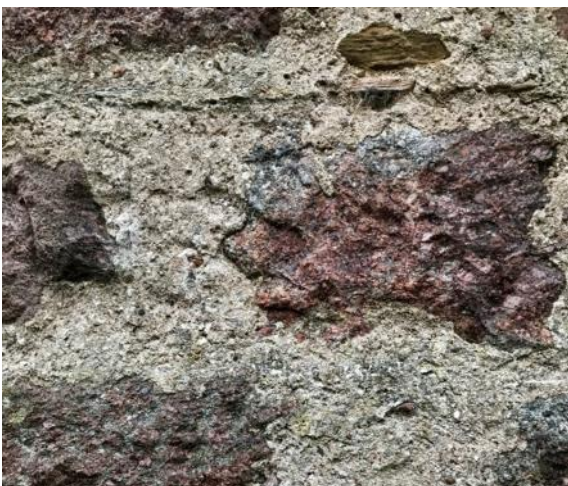
Figure 058.2. Flush finish detail., with traces of lining out.

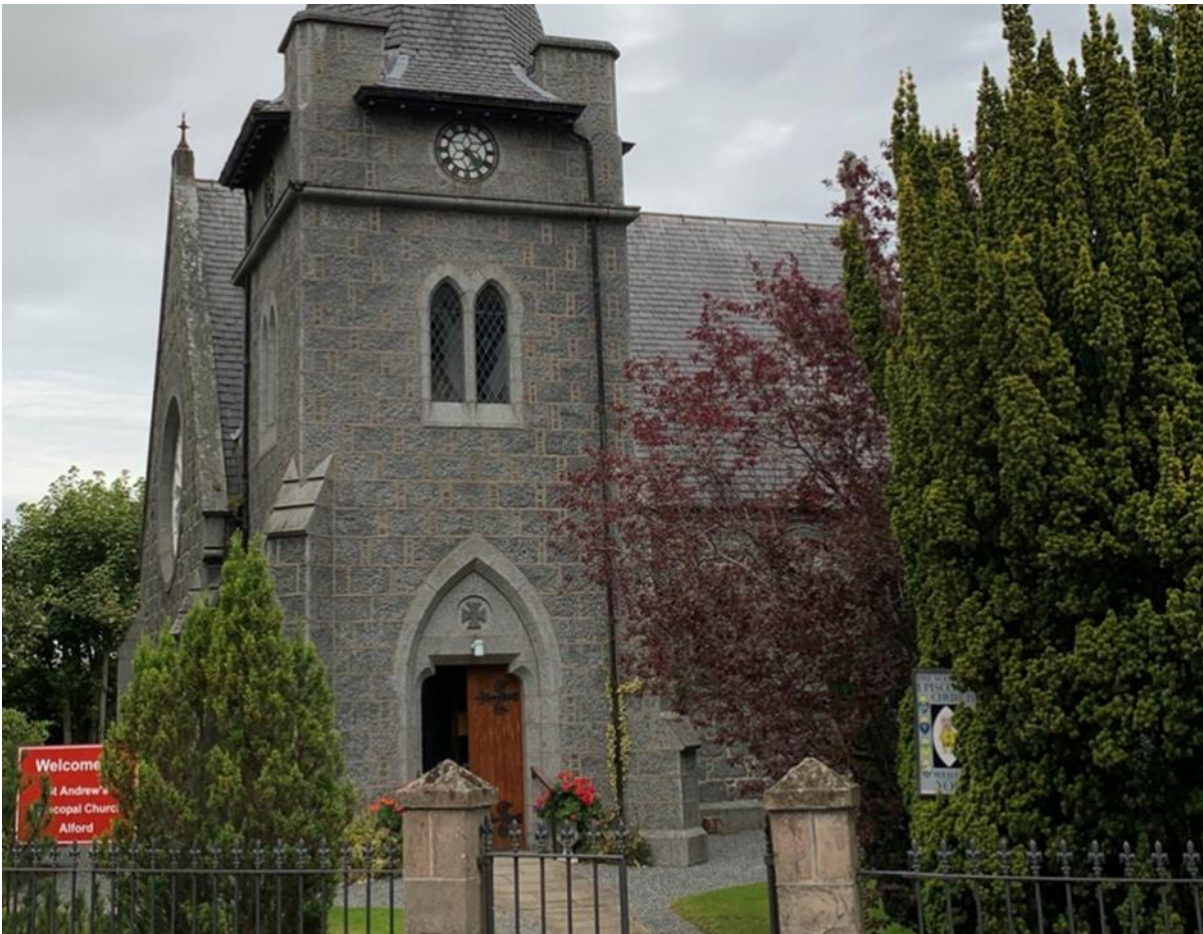
Figure 059.1. St Andrew's, Alford.

This church was designed by Matthews architects of Aberdeen in 1860. The masonry is formed of coursed tooled granite blocks and pinnings with finer tooled details at the doors and windows (Figure 059.1). The church has been altered and repaired over time and this is reflected in the pointing. The nave still retains much of its raised ribbon lime pointing (Figure 059.2). The mortar for the pointing uses aggregates in the range 0.5mm - 5mm and they are angular in profile. Some recent repairs to the ribbon work have been made to the nave that seem clumsy and appear to be cement based. However, the tower has been repointed entirely with a cement ribbon. Although lacking in an understanding of the nature of the original lime mortars, the quality and dexterity of the new work is very good (Figure 059.3).

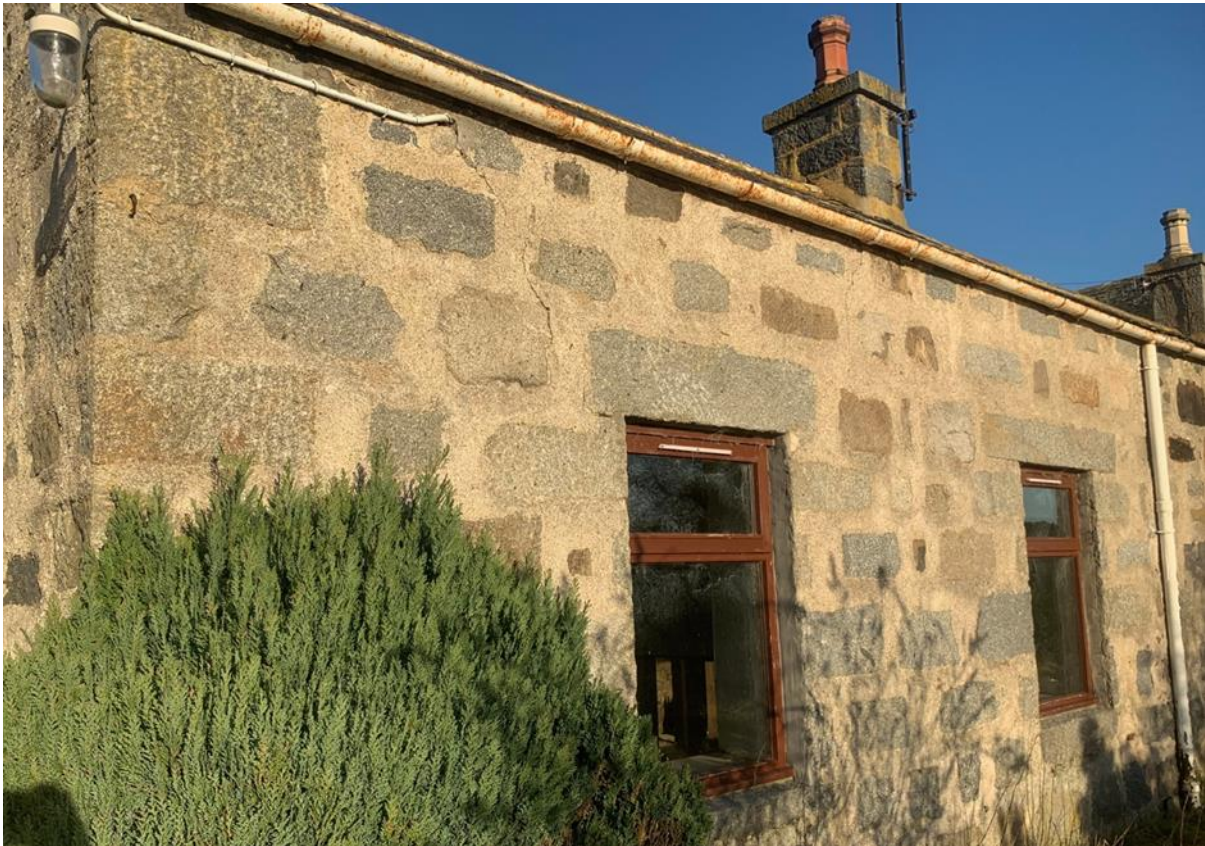
Figure 060.1. Cottage, front elevation.

A single-storey cottage that forms part of a larger farm complex (Figure 060.1) at the hotel, probably dating from the mid 19th century. The pointing is a squared sneck harl in the range of 1-5mm containing sharp angular aggregates and lime inclusions (Figure 060.2).

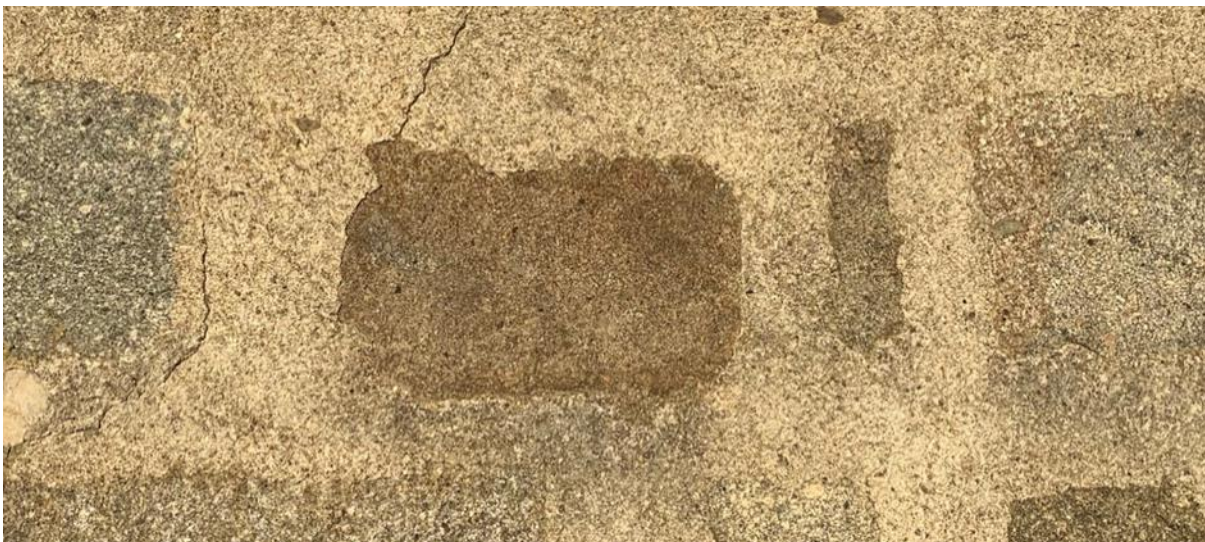
Figure 060.2. Squared sneck harl with sharp, angular aggregates.

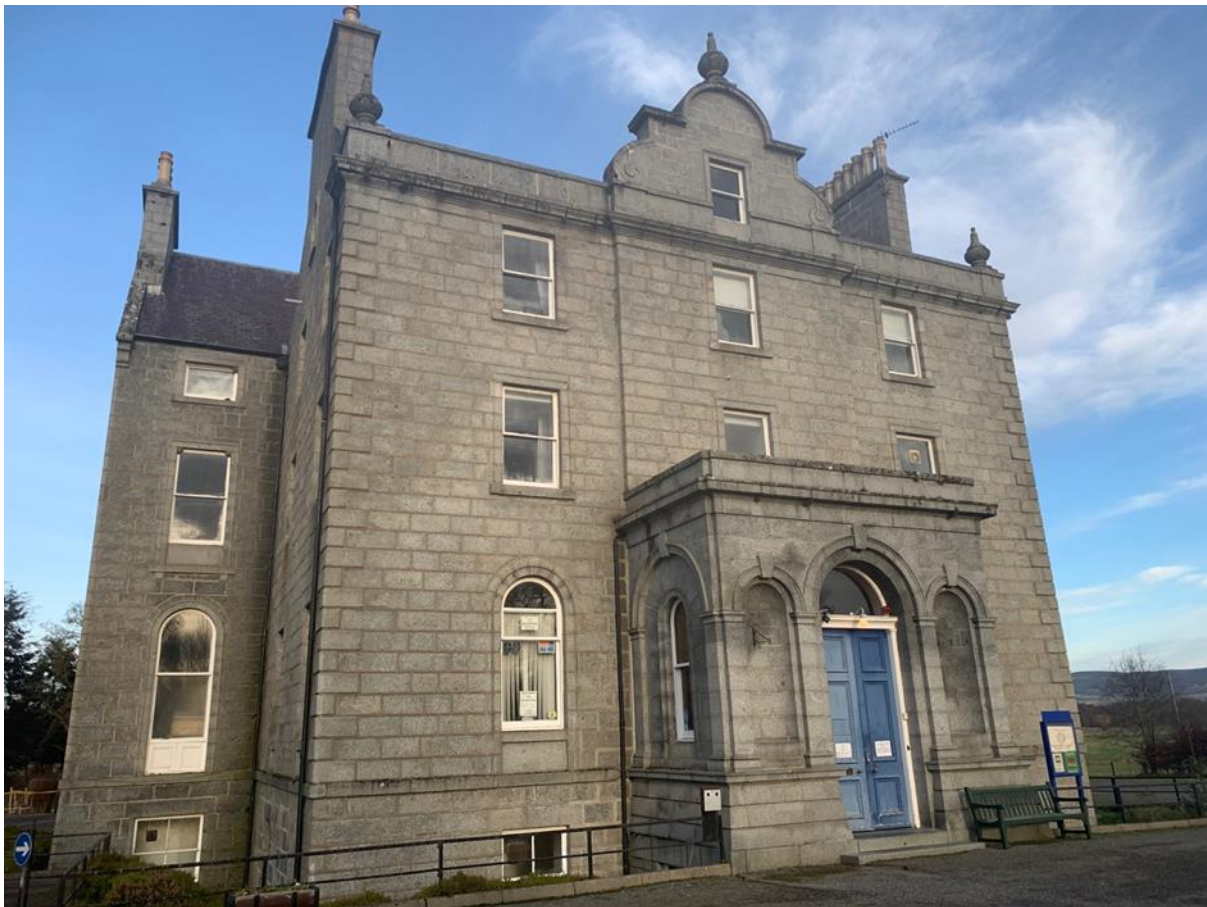
Figure 061.1. South elevation.

This house was built in 1854 (Figure 061.1) and is now in institutional use. It is constructed in granite with flush and ribbon finish (Figure 061.2). The majority is a lime and cement mortar, however, at the rear of the building there are the remains of what appears to be the original raised ribbon (Figure 061.3). The aggregates are well graded and sharp (but finer in size than many others found in the locality), in the range of 1-4mm. The extant mortars indicate that the original finish was spread more extensively over the stone but has graded away.

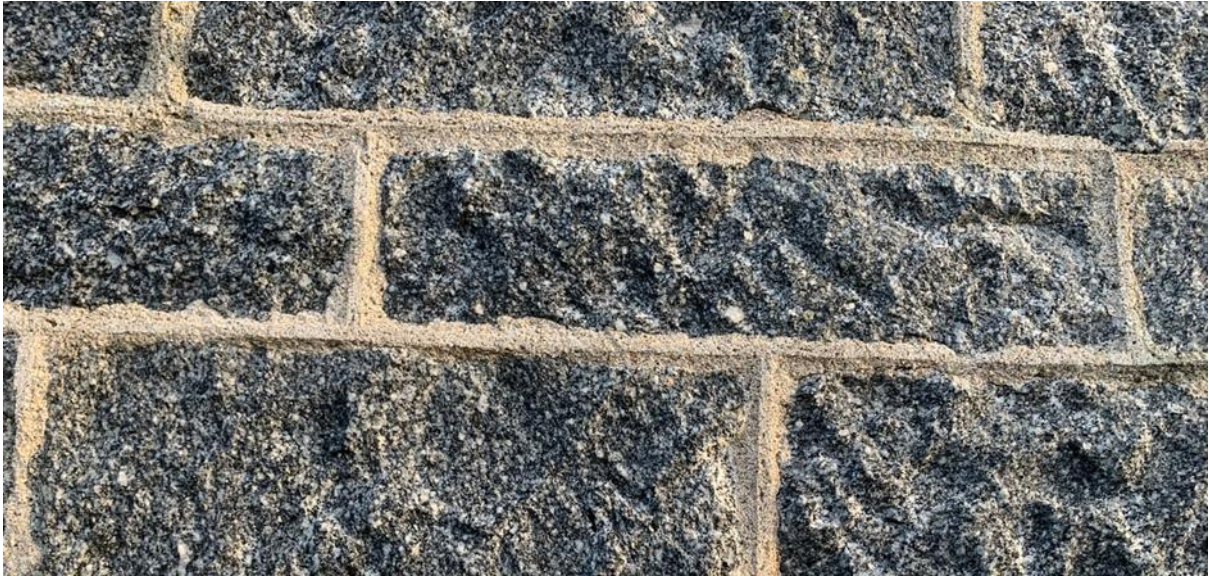
Figure O61.2. Flush point with raised ribbon.
