TECHNICAL PAPER 33

MASONRY POINTING AND JOINT FINISHING

PART 2 - GAZETTEER

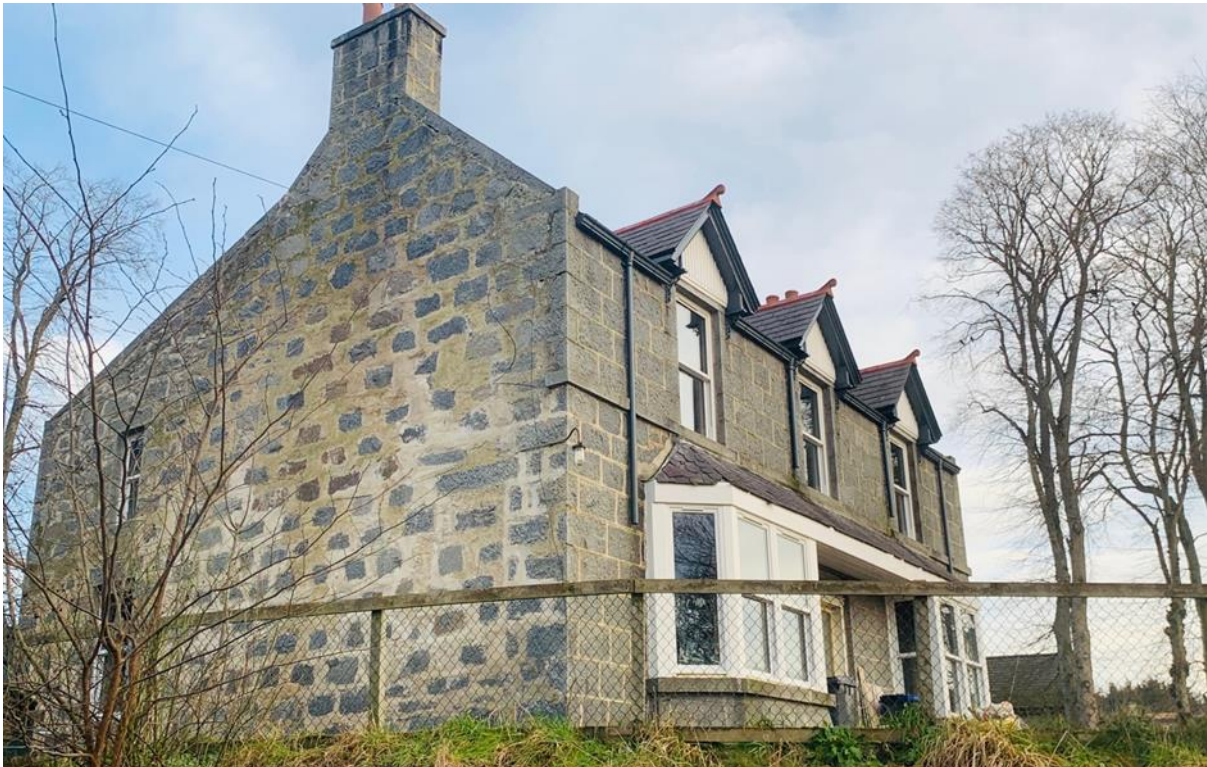
Figure 062.1. View of Miller's House from the southwest.

The Miller's House forms part of the Montgarrie Mill complex (Figure 062.1), and is most likely a slightly later building than the mill. The front elevation is flush finished with a raised ribbon. The gables are sneck harled (Figure 062.2) and the ribbons are absent, denoting a hierarchy in finishes. The mortar includes finer sand than the mill, in the range of 1-7mm. Some shrinkage and structural cracking occurs in the formal ribbon pointing (Figure 062.3.), but generally the mortar has survived well.

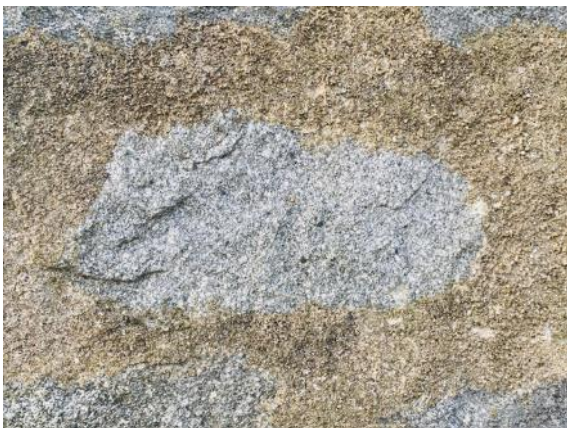
Figure 062.2. Sneck harling on the west gable.

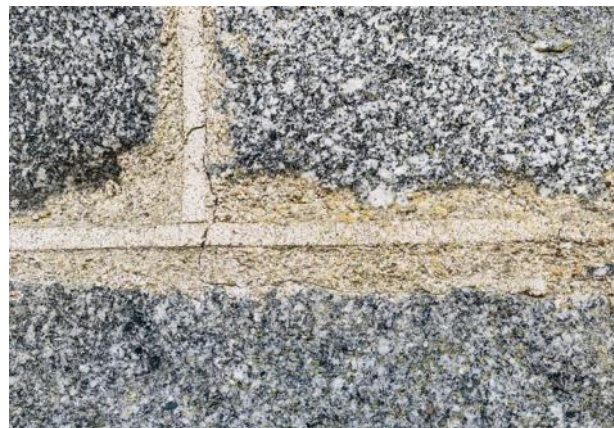
Figure 062.3. Ribbon pointing on the south front.

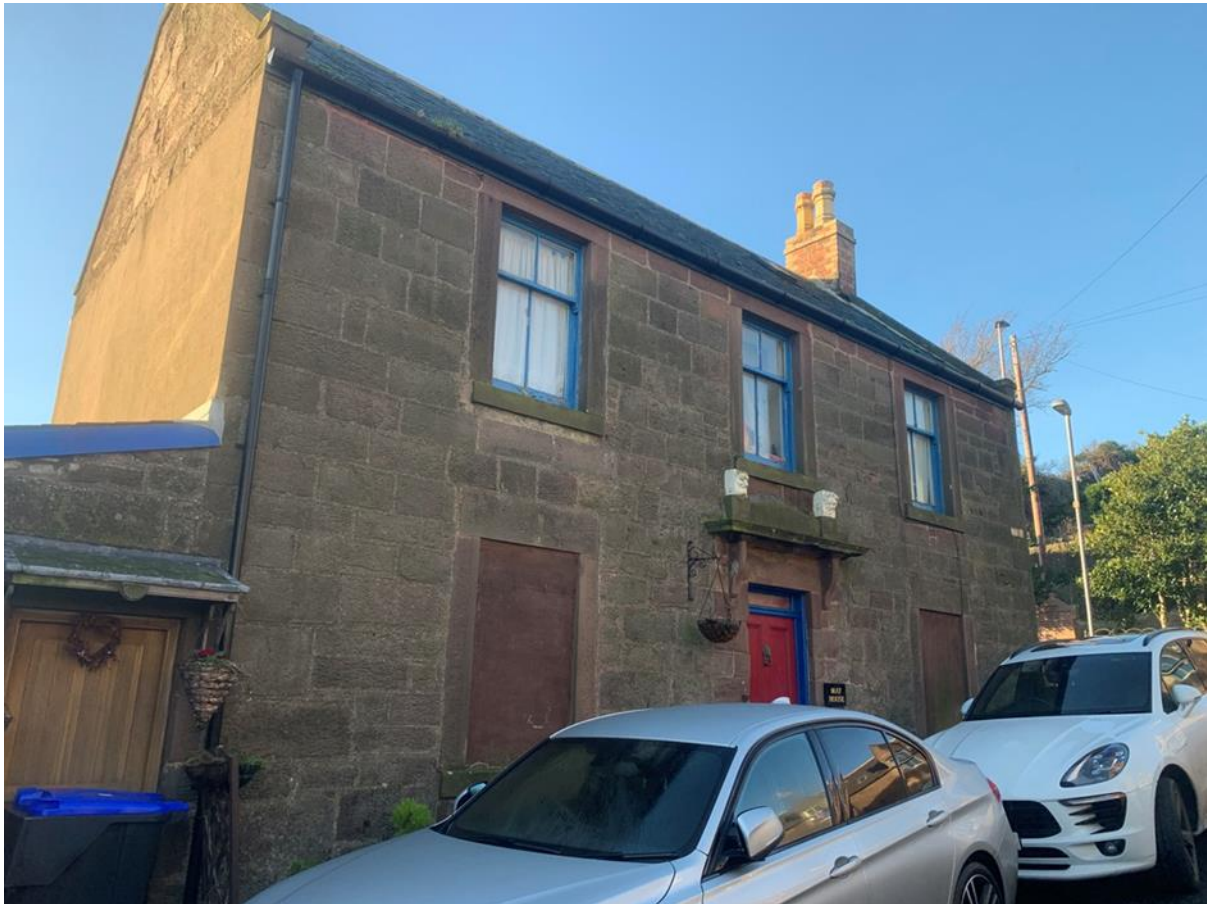
Figure 063.1. House on Mid Street, northeast elevation.

A two-storey house built in local sand and agglomerate stone (Figure 063.1). The flush finish has been ruled out. The mortar comprises coarse, rounded marine aggregate in the range of 1-5mm with lime inclusions (Figure 063.2). There is evidence that the finishing material was integrated with the bedding mortar and that the ruling out was executed while the mortar was still plastic. This supposition is supported by several shrinkage cracks in areas where the full extent of the final finish has survived well (Figure 063.3).

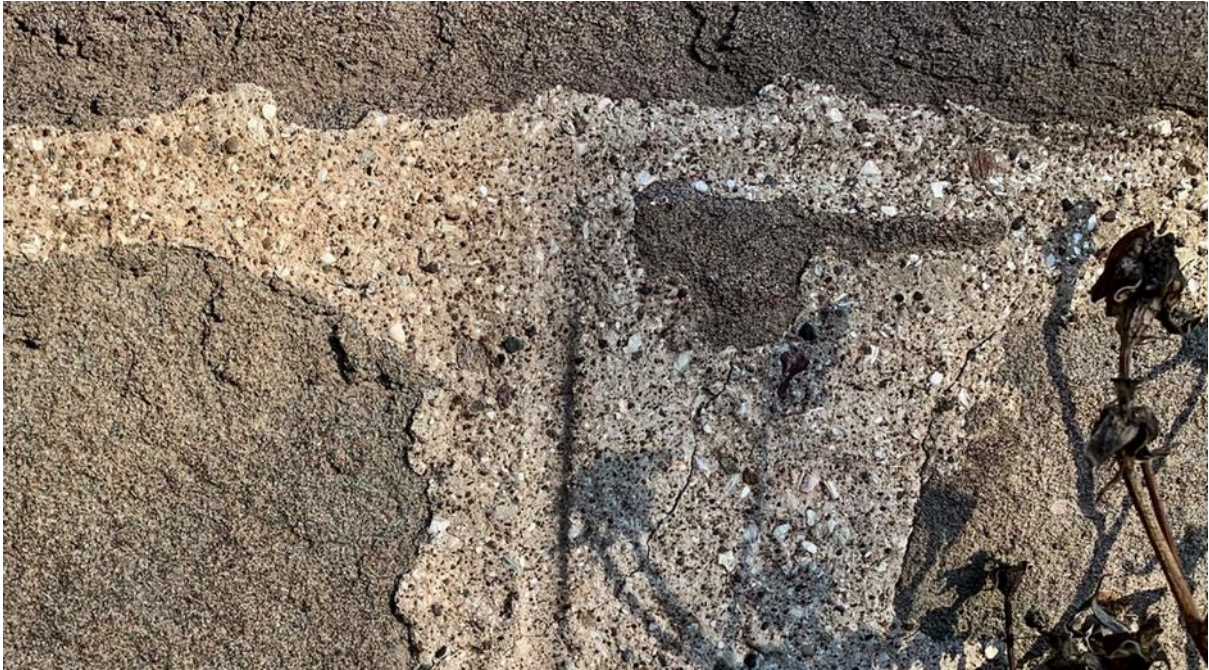
Figure 063.2. Flush finishing with horizontal and vertical ruling out.

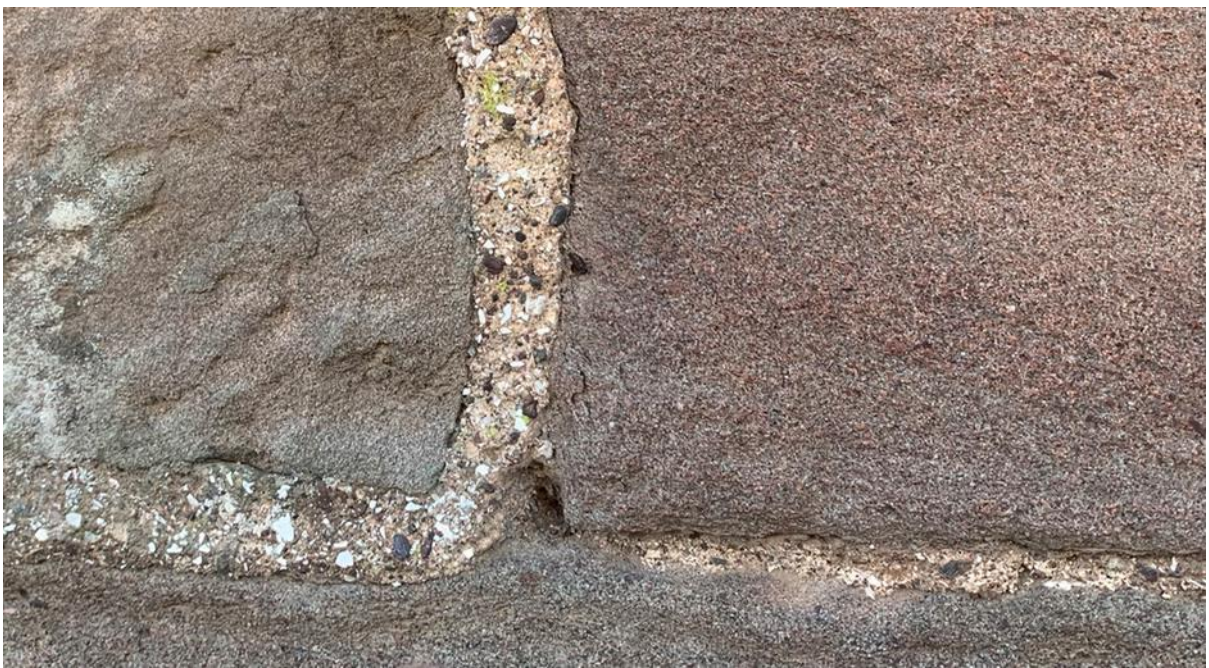
Figure 063.3. Shrinkage cracks.

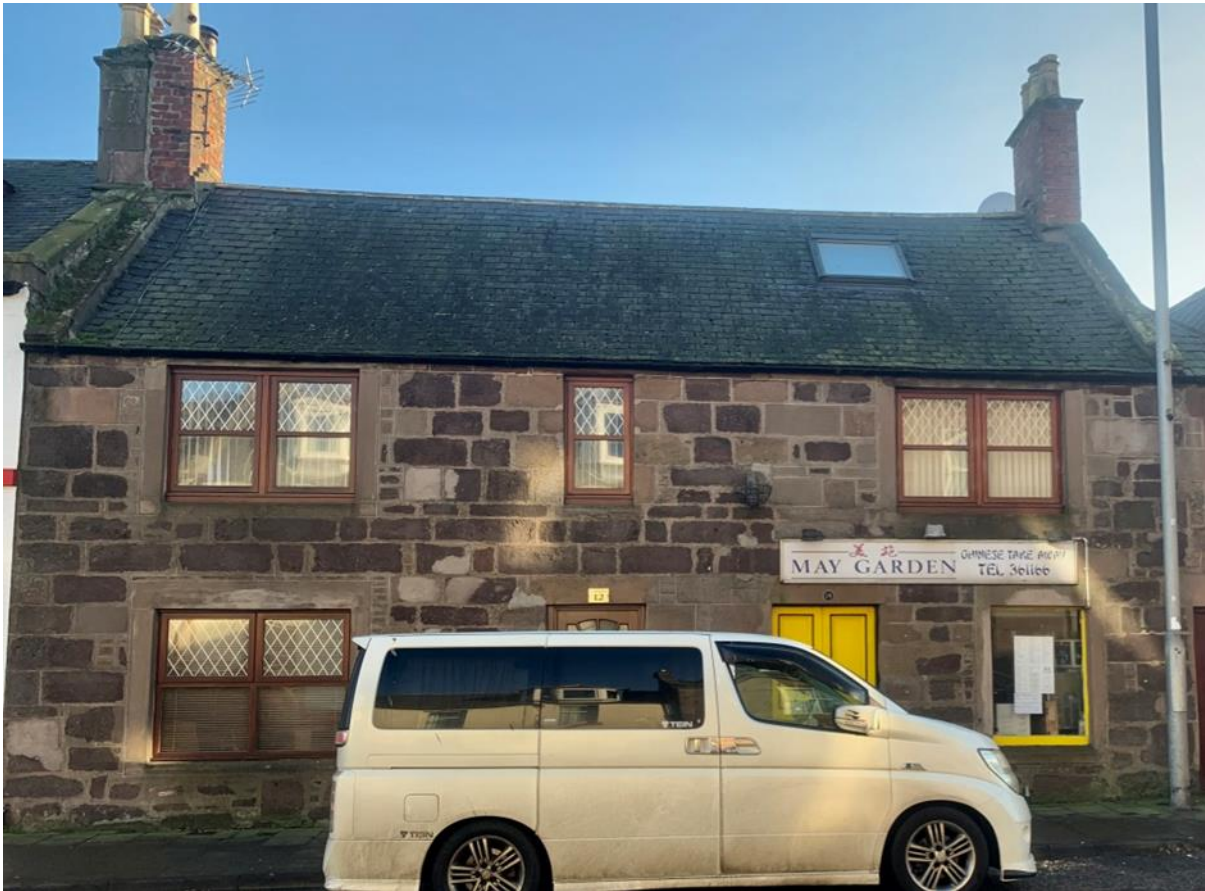
Figure 064.1. King Street, northeast elevation.

A two-storey house and shop (Figure 064.1.) built with local sand and agglomerate stone that is flush pointed with horizontal and perpendicular ruling out (Figure 064.2). The ruling out has been accentuated by adding limewash into the ruled groove (Figure 064.3). This is best seen under the eaves where it has been afforded some protection from the weather. The mortar is robust and may have a hydraulic component. The aggregates are marine, and in the range of 1-5mm.

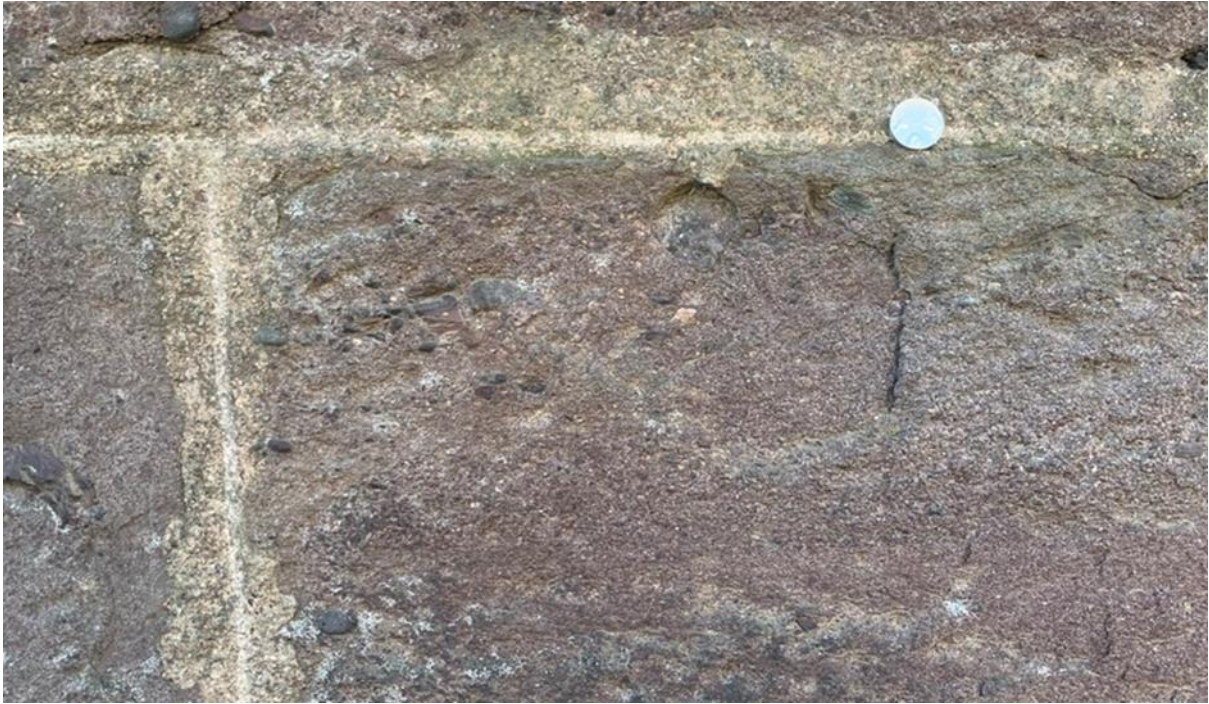
Figure 064.2. Horizontal and perpendicular ruling out.

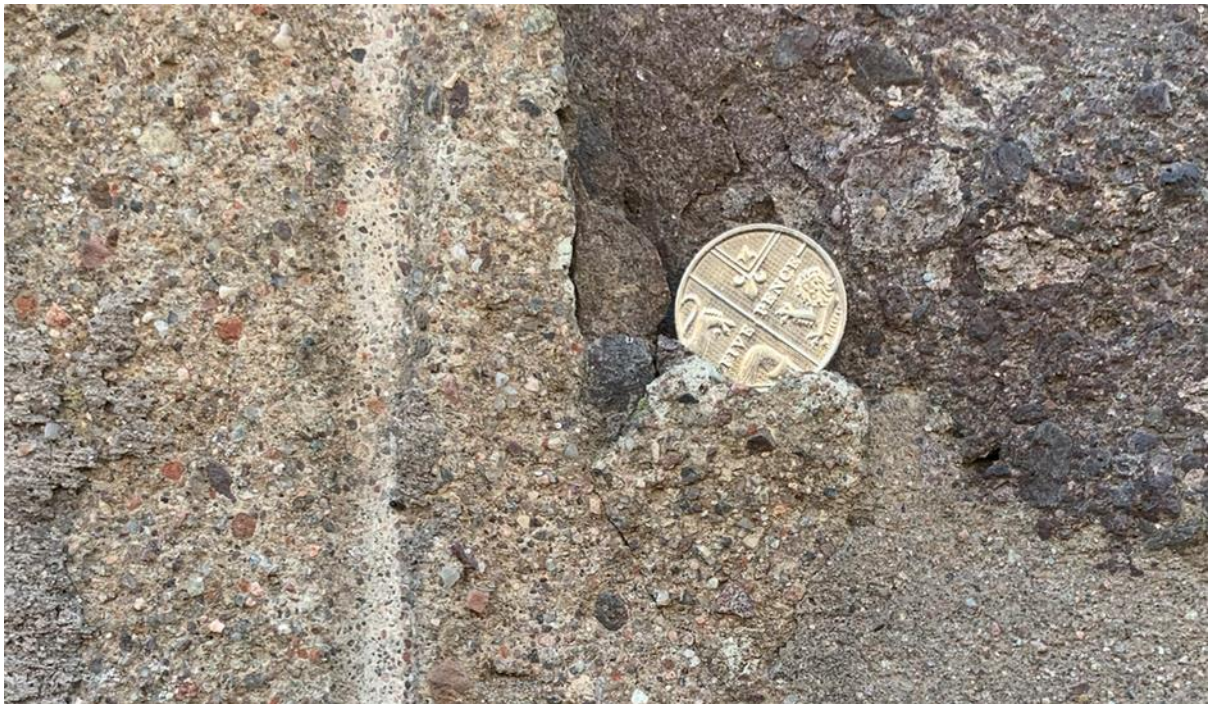
Figure 064.3. Limewash to accentuate the ruling out.

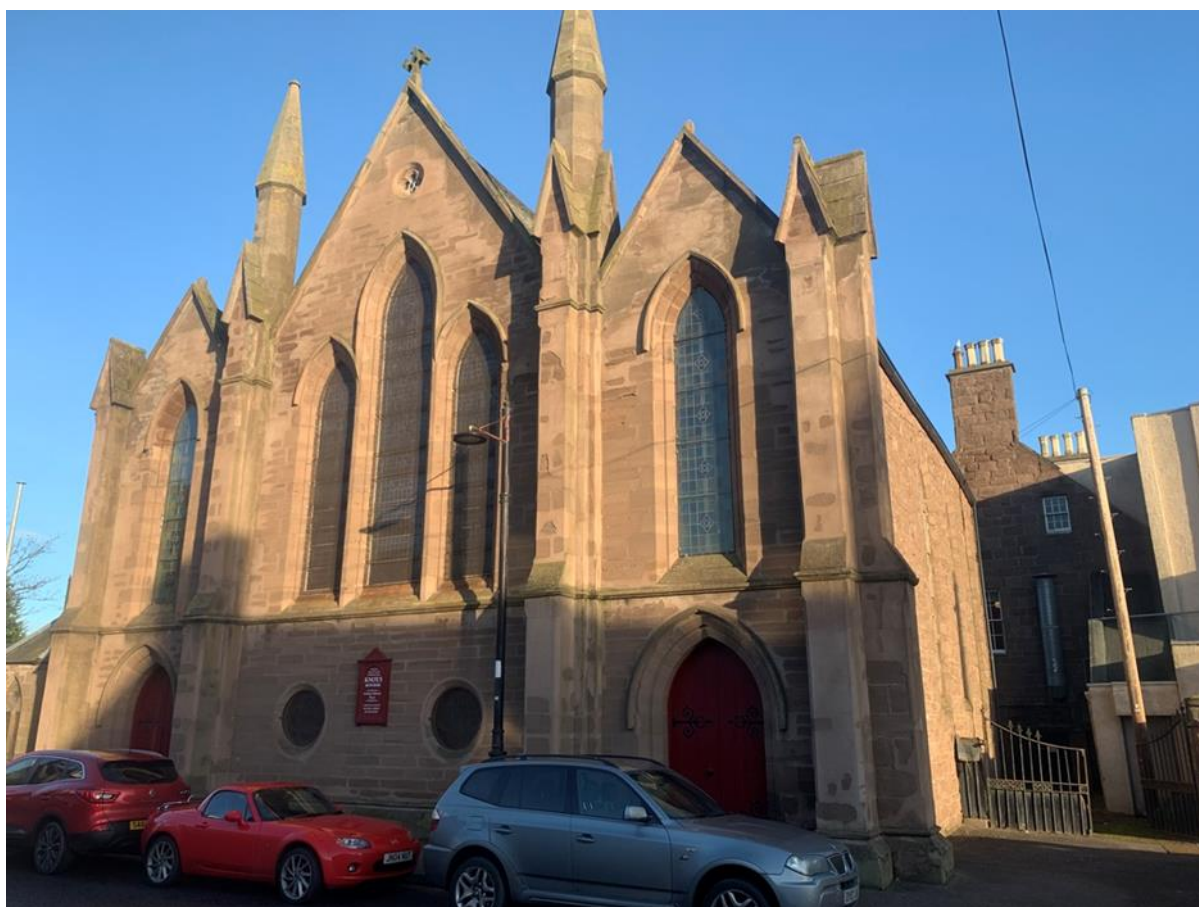
Figure 065.1. Knox Church, east front.

This church was designed in 1851 in the centre of Montrose by the architect John Peddie (Figure 065.1). The church is ashlar fronted, with sawn rubble masonry on the sides and rear. The church experiences all the sandstone issues of the region with ongoing delamination and exfoliation. The ashlar front has been extensively re-pointed, making the side elevations the relevant part for this study. The sawn rubble walls are built with lime mortar (Figure 065.2). The extant flush finish is an overlay, and distinct from the construction mortar. This finish appears to be trowel applied, buff in colour with orange/buff coloured aggregate in the range of 1-7mm (Figure 065.3). Both mortars have lime inclusions, but it is possible that the finish has a hydraulic component. It is not possible to ascribe a date to the finish.

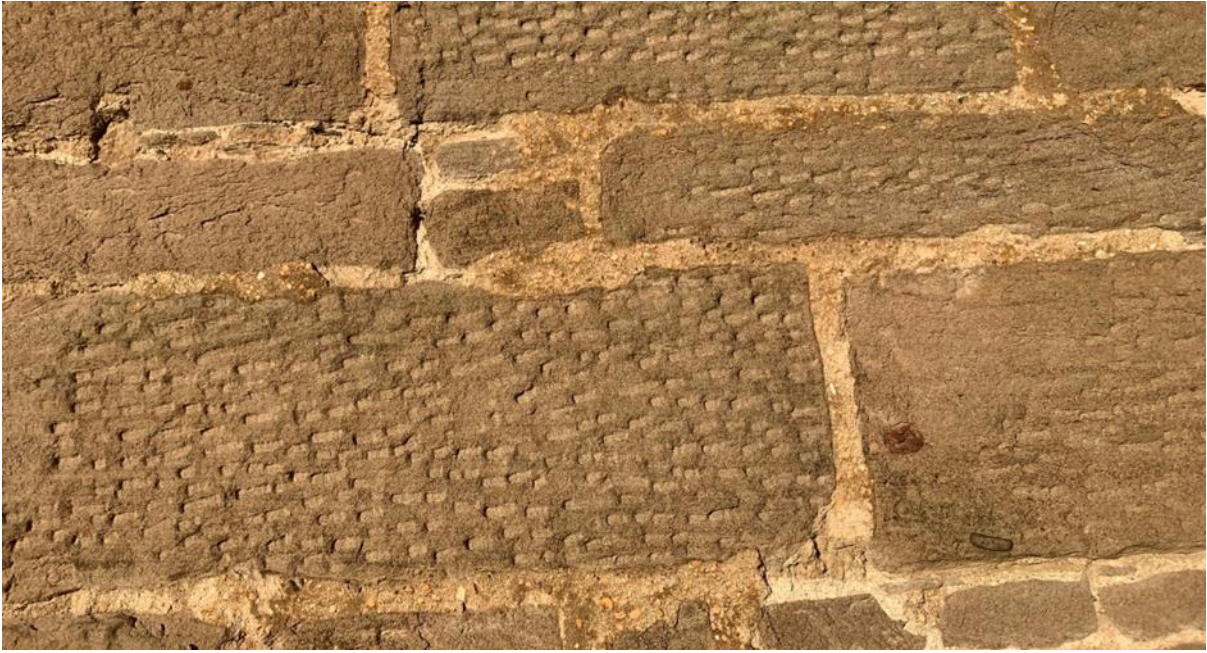
Figure 065.2. Sawn rubble walls with lime mortar.

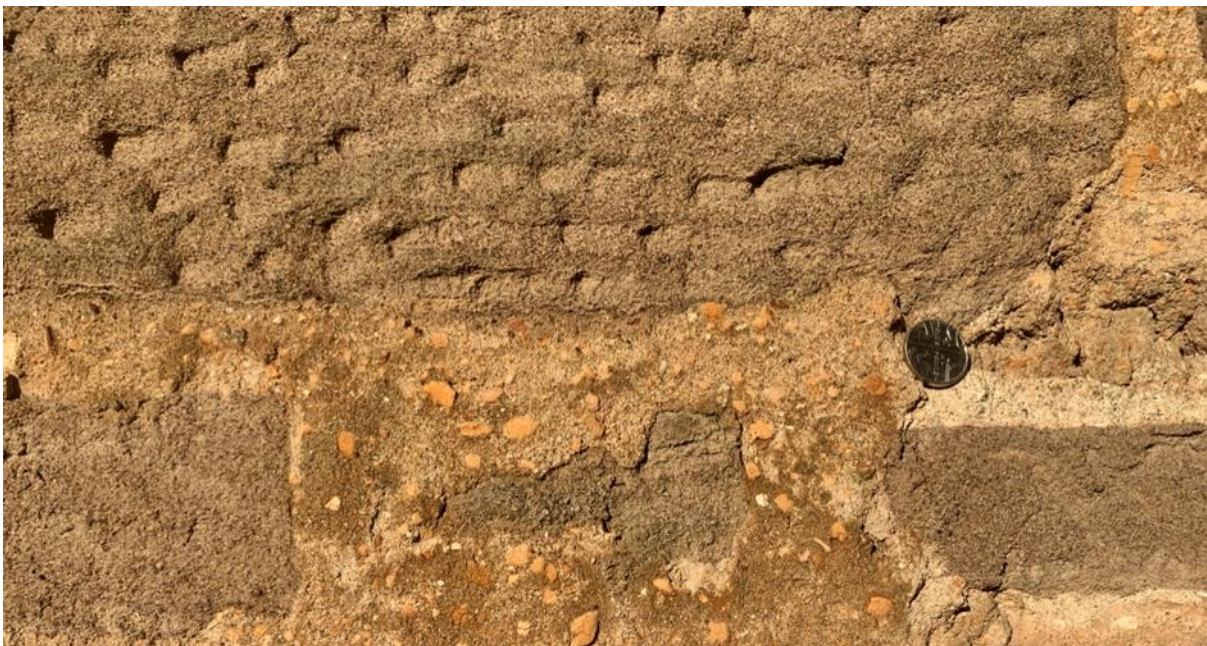
Figure 065.3. Later buff pointing finish overlaying the construction mortar.

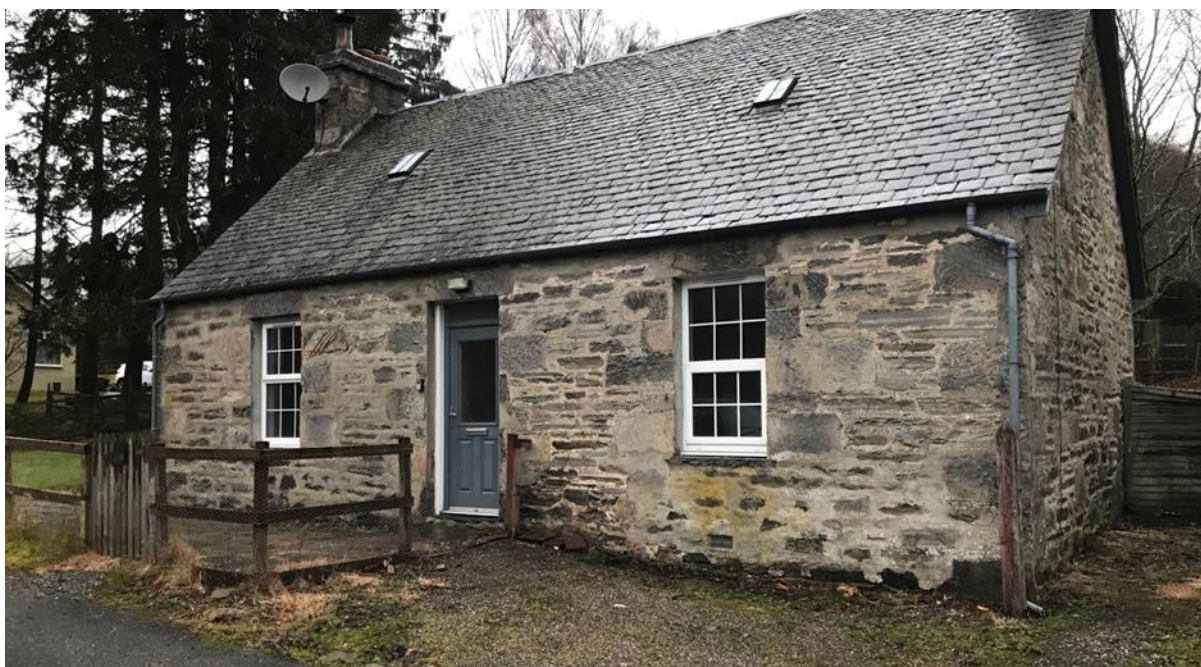
Figure 066.1. Single bay stone cottage with flush pointing and a crude attempt at ruling out.

This single-storey cottage has recently had some upgrading but manages to retain most of the flush finish on all elevations (Figure 066.1). The cottage is built with dense whinstone, basalt and other glacial erratics, some of which are split into flat bedding planes. Generally, the pointing remains in good condition despite having many shrinkage cracks. The mortar is waxy in appearance suggesting it was high in lime binder. It may have a natural hydraulic component given the proximity of the Shierglass limestone outcrop at Blair Atholl. The finish has very informal horizontal ruling out (Figure 066.2).

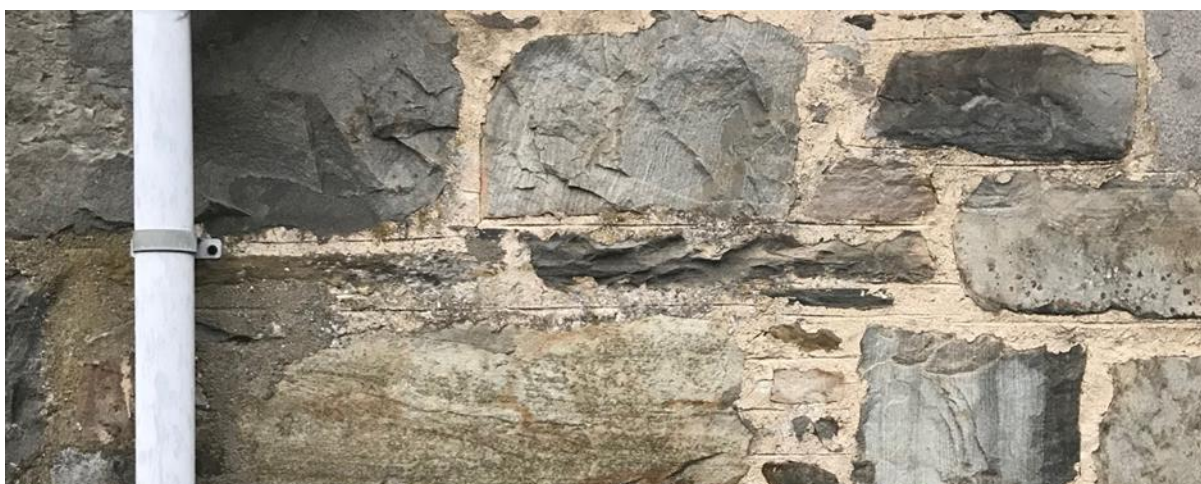
Figure 066.2. The crude flush and informal lining out finish.

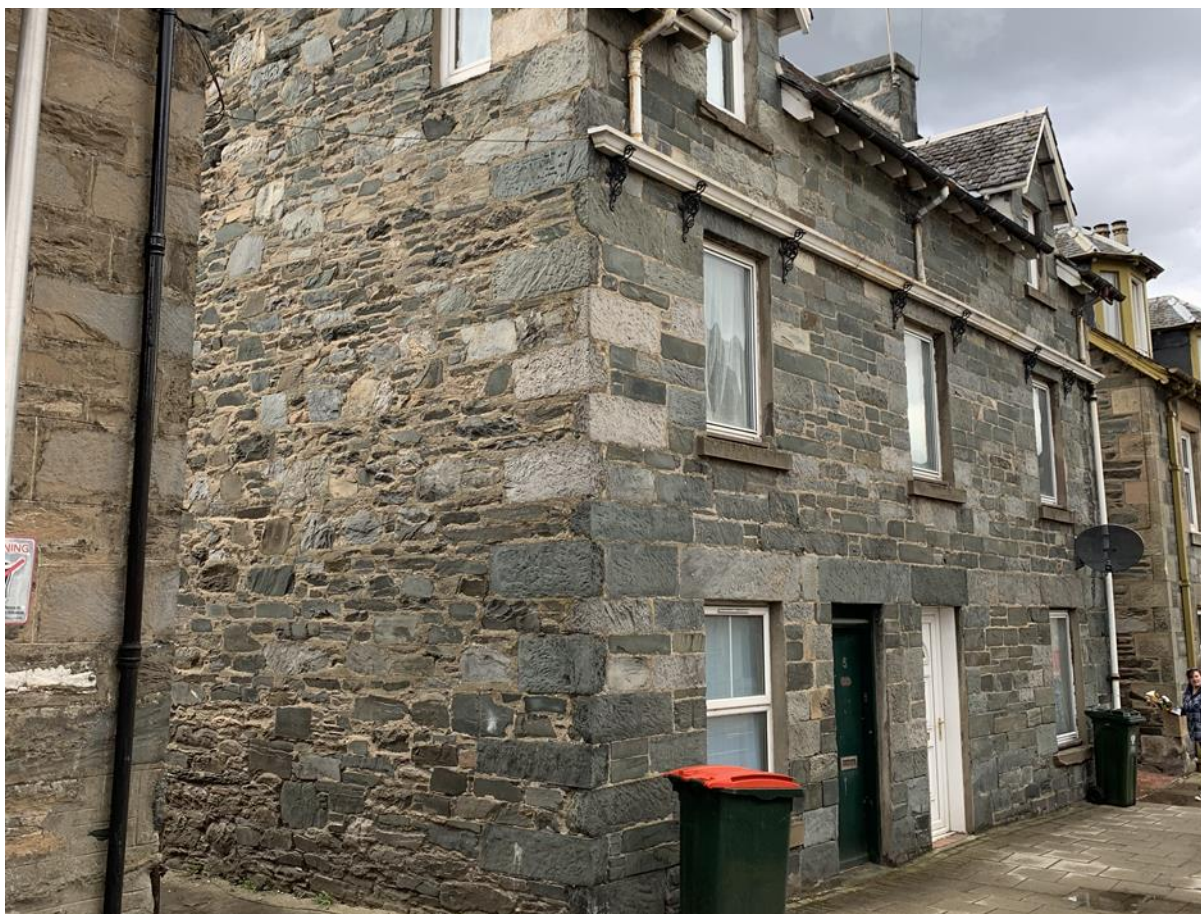
Figure 067.1. Gable and front elevation of the house on Chapel Street.

A nineteenth century, semi-detached house with sawn, squared, coursed stone on the front street elevation and semi-coursed, random rubble at the gable (Figure 067.1). All the pointing is worn, however the remains on the gable reveal an extensive weather-shot point with horizontal ruing out (Figure 067.2). On the front elevation the work is more carefully executed, respecting the joints of the sawn stone. The mortar is made with a medium fine buff coloured sand and contains many lime inclusions.

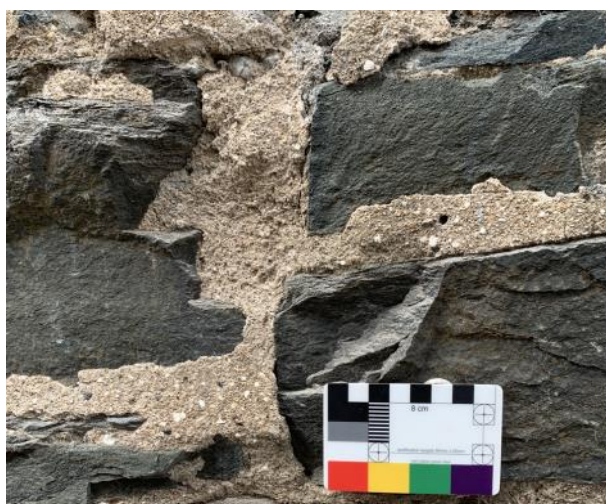
Figure 067.2. The weather struck pointing on the gable end.

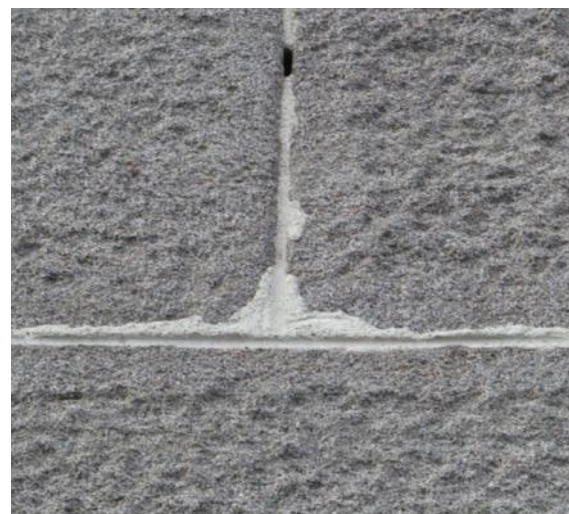
Figure 068.3. Fine, ruled aggregate in the joints.

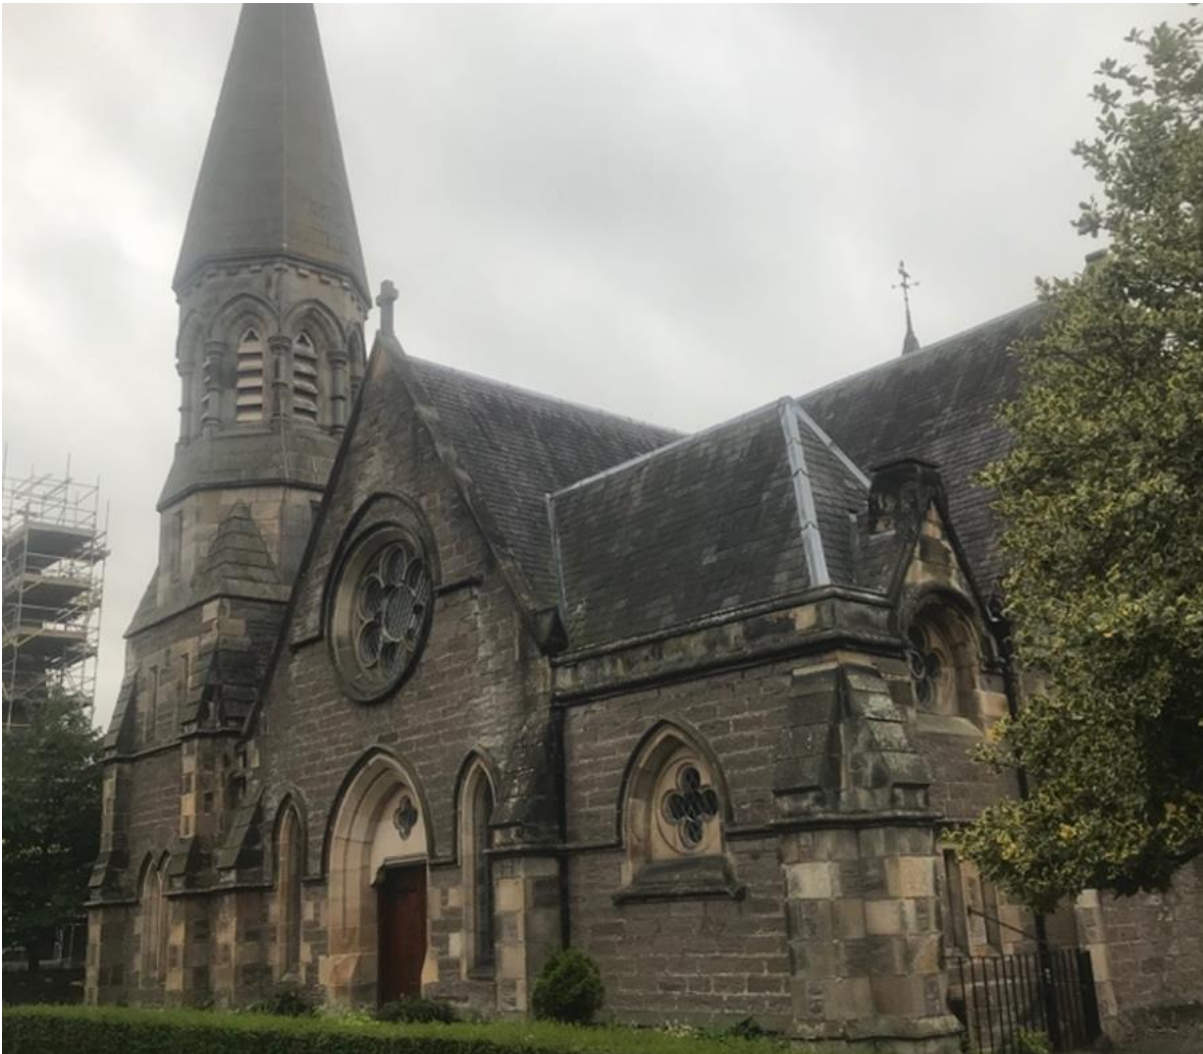
Figure 069.1. Holy Trinity Church, view from northwest.

The church was designed by James Henderson of Glasgow in 1858-59 with local Bridge of Allan sandstone that now exhibits signs of delamination (Figure 069.1). This is flush finished in lime with both horizontal and perpendicular ruling out (Figure 069.2). The aggregates are both variable and angular with what appears to be lime inclusions.

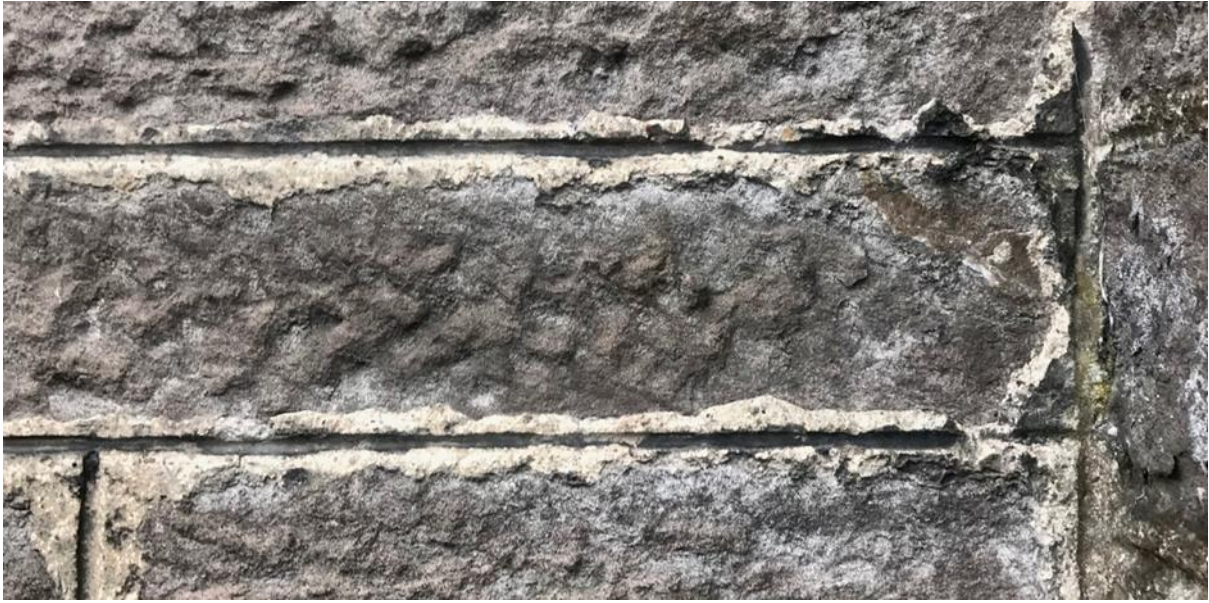
Figure 069.2. Flush lime finish with horizontal and perpendicular ruling out.

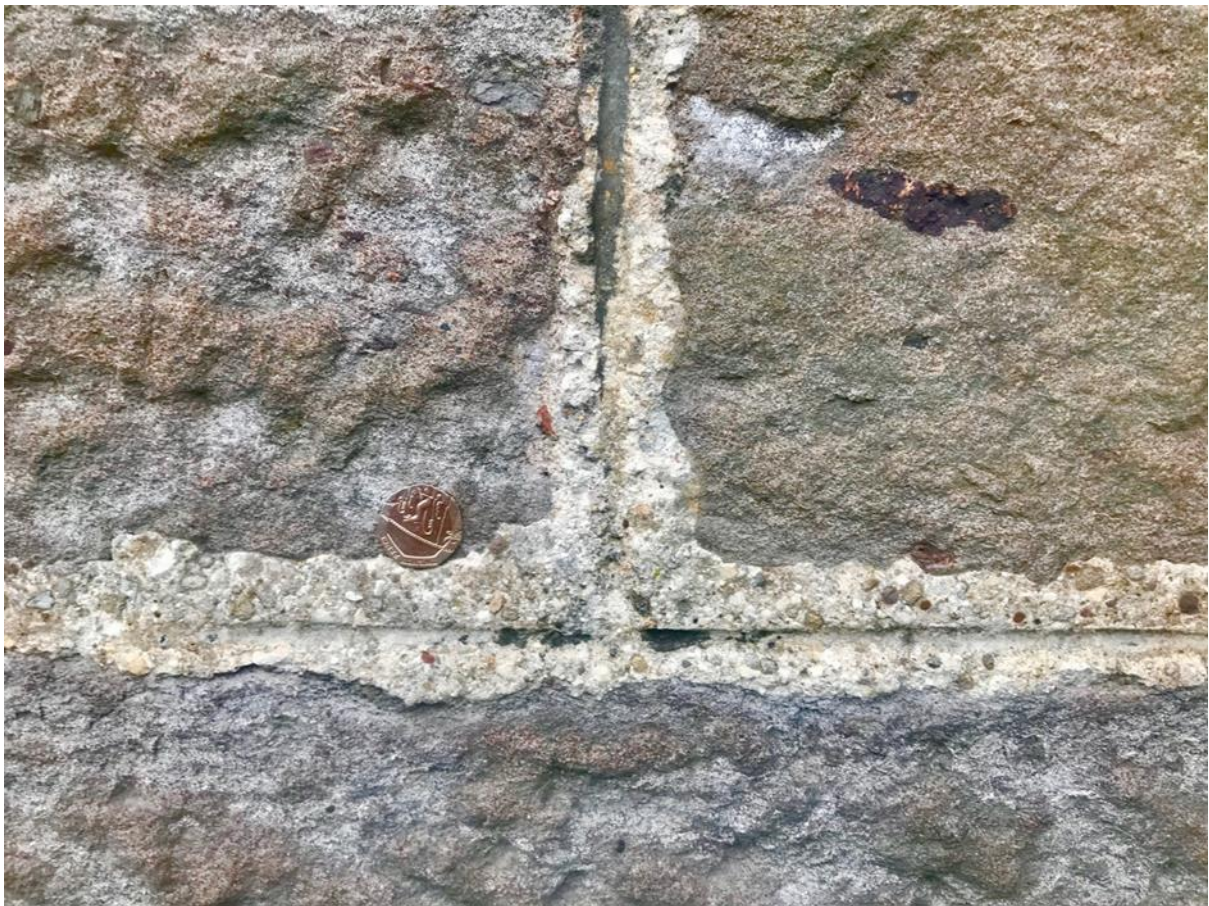
Figure 069.3. Angular and variable aggregates.

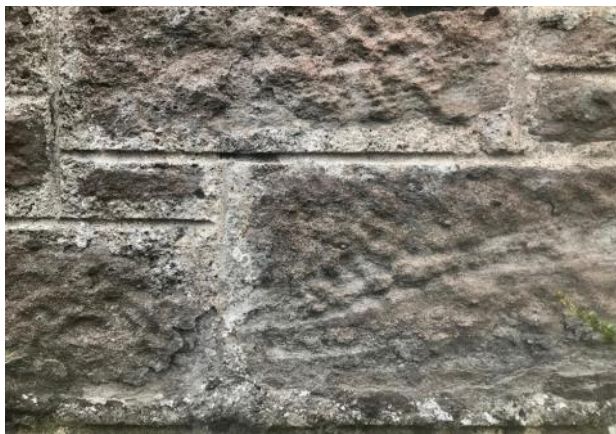
St. Savior's Church (Figure 070.1), was built in the mid-19th century with local Bridge of Allan red-brown sandstone and buff coloured details. The pointing style is flush finished, with horizontal and perpendicular ruling out (Figure 070.2). The mortar is comprised of medium to coarse sand with dark flecks and is seemingly lime rich. This mortar is robust to the touch but does rub down when extended pressure is brought to bear.

Figure 070.2. Detail of the flush finish and ruling out.

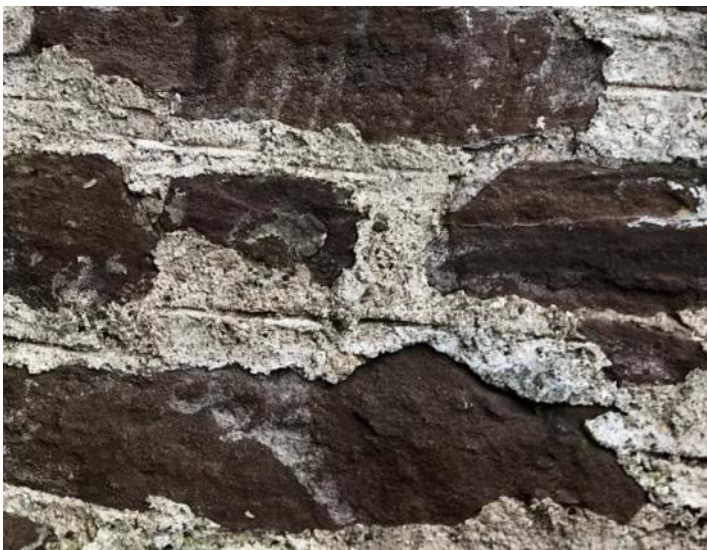
In an unprepossessing corner, at the roundabout end of the High Street (Figure 071.1) normally used for storing waste bins, there are the remains of this flush finish sample (Figure 071.2). It survives possibly because the area is of low status and there have, as a result, been minimal renovations in the area. The mortar is trowel applied rather than thrown with informal ruling out; perhaps with a small stick or the edge of thickly bladed trowel. Judging from the shrinkage cracks, the mortar has a high lime binder content. The aggregate is sharp and variable in the range of 1-5mm.

Figure 071.2. Detail of the flush finish with informal ruling out.

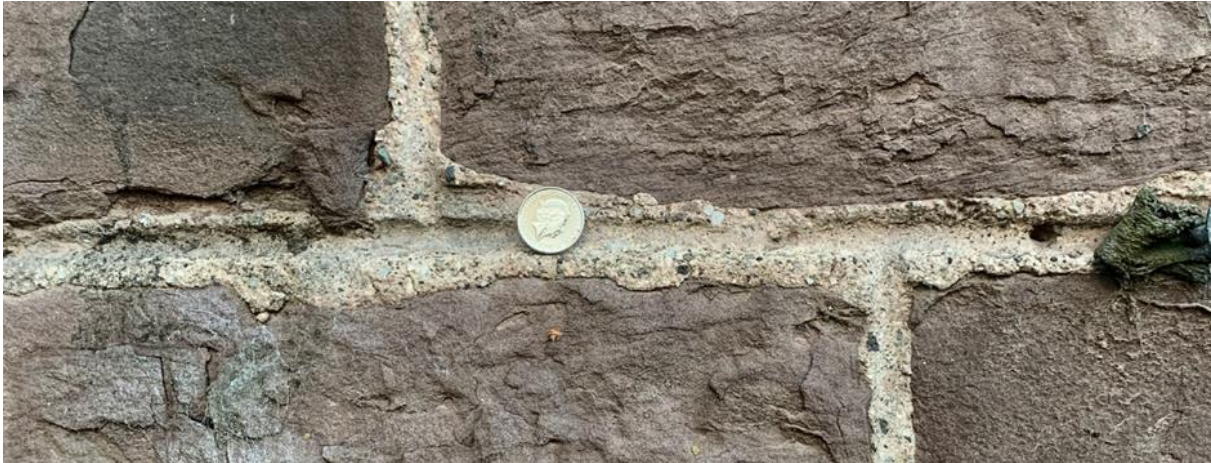
The formal front elevation has, at ground level, the same squared local sandstone blocks. Here, however the finishing differs. The mortar resembles that of the rear in its waxy appearance (Figure 072.2). It is lime rich but with less shrinkage.

Figure 072.2 Waxy mortar on front elevation with ruling out.

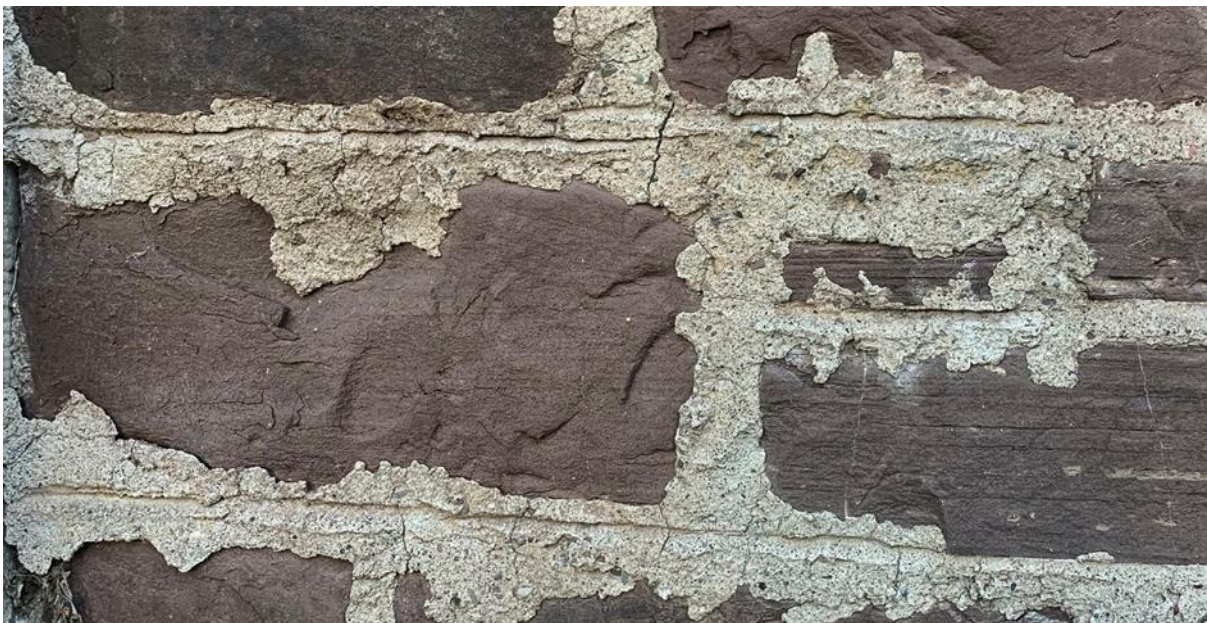
The rear elevation is constructed informally with rubble. The joint finish is flush and ruled with the edge of an angled trowel. This is high in binder content and is riddled with shrinkage cracks (Figure 072.3). However, this

Figure 072.3. Informally ruled out flush pointing on rear elevation.

does not seem to have had any negative effect on the robustness of the mortar. The aggregate is medium to coarse, with sizing in the range of 1-4mm.

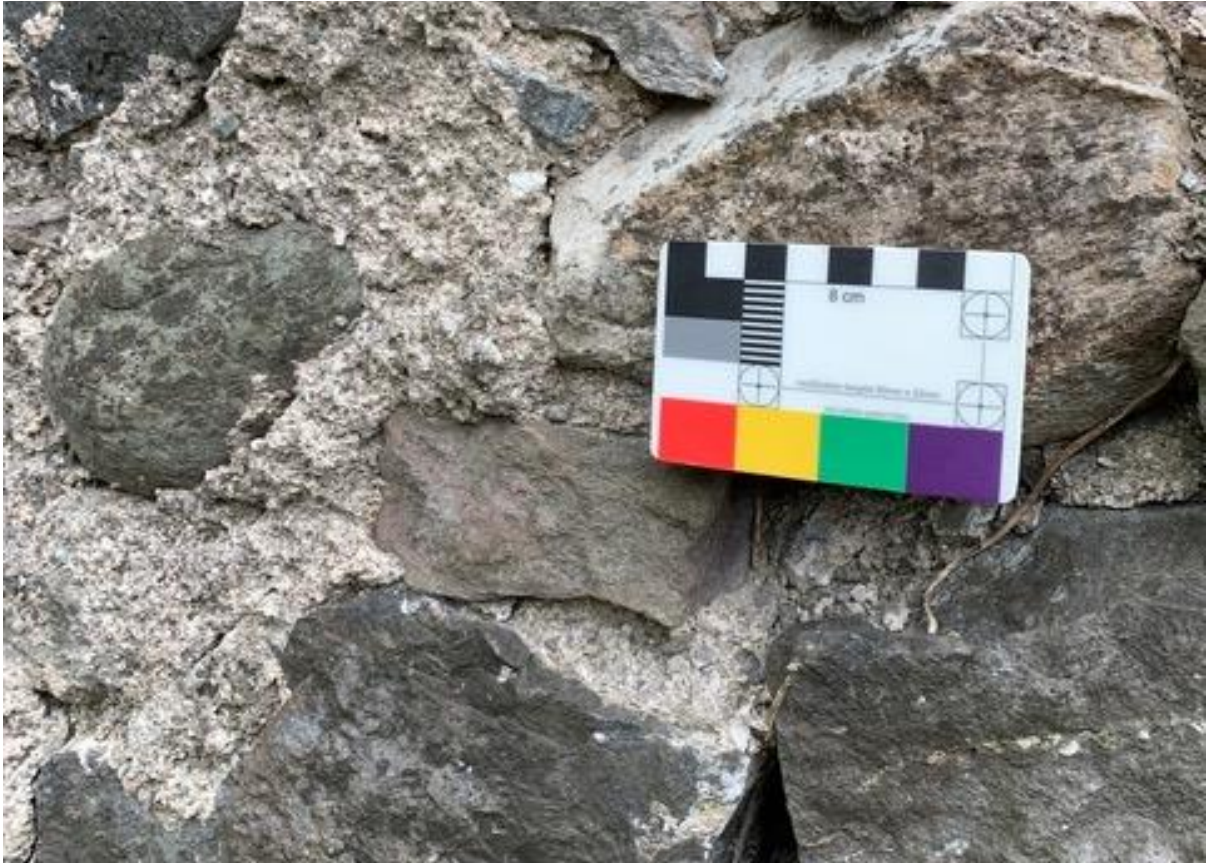
Figure 073.2. Integrated bedding and harling mortar.

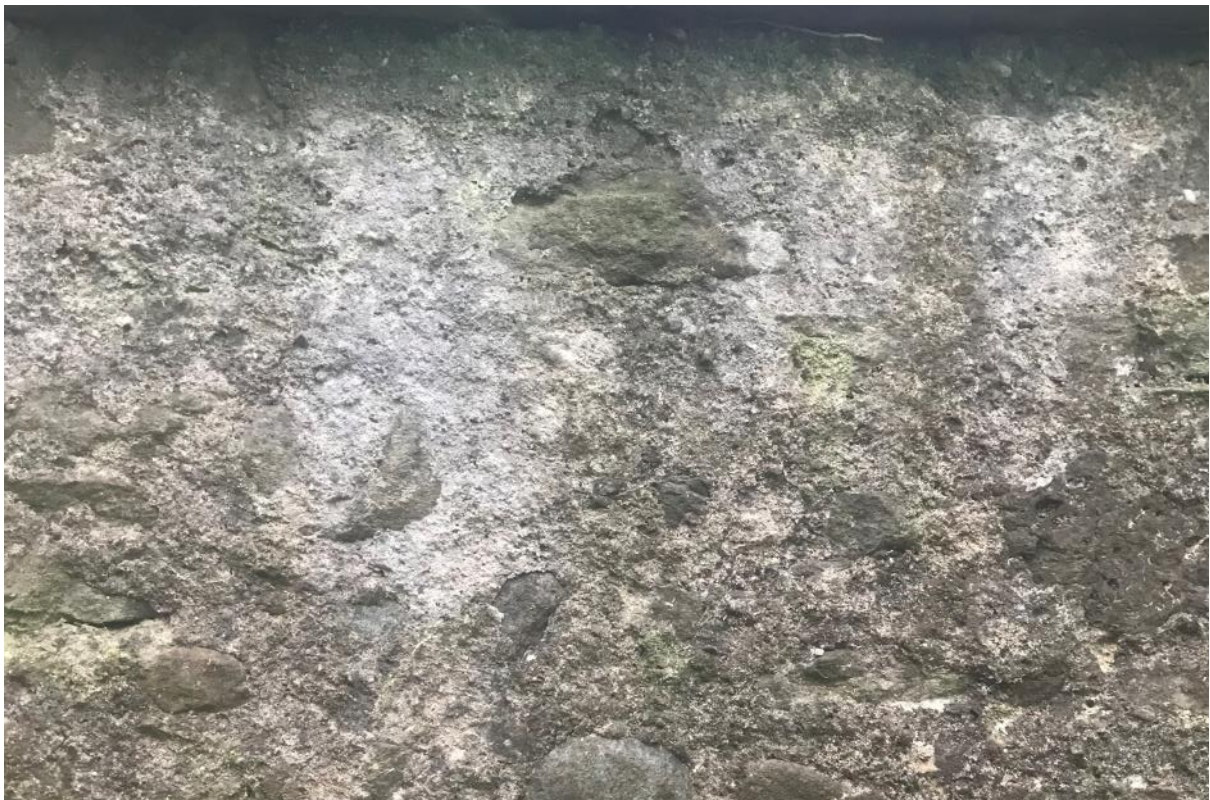
Figure 073.3. Extensive remains of flush finish.

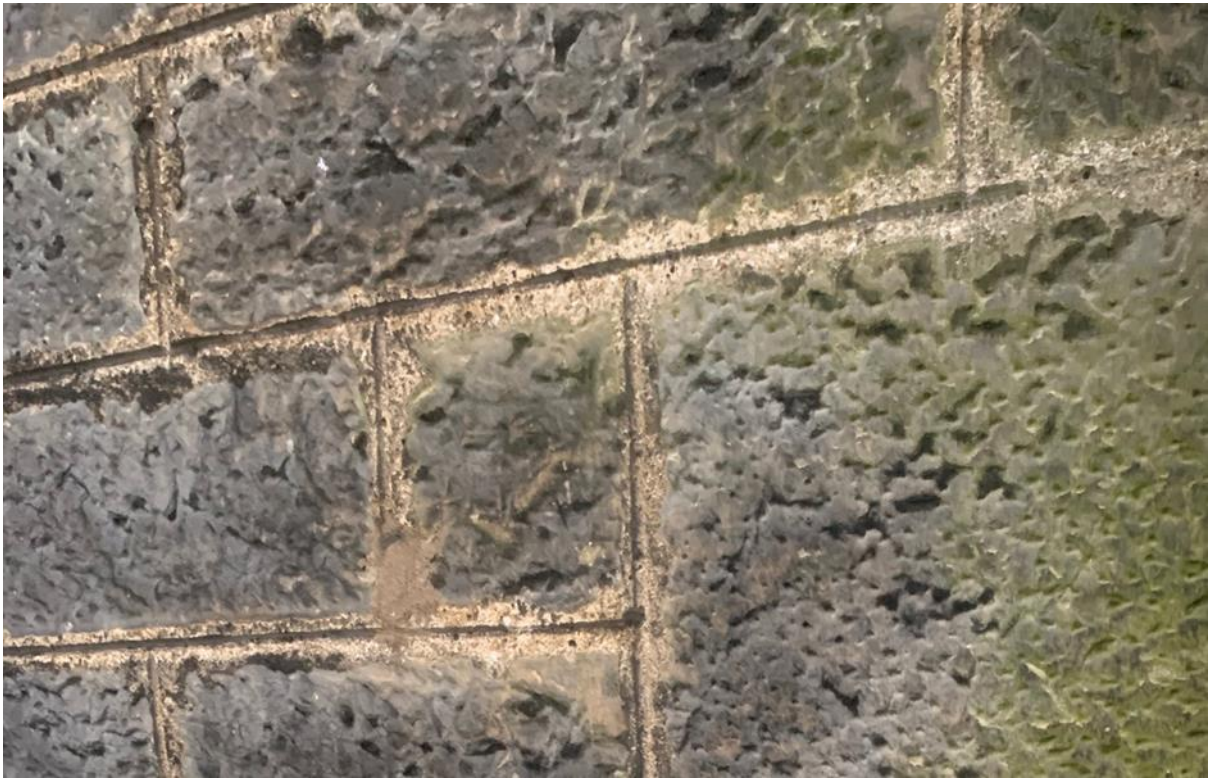
Figure 074.2. Horizontal and perpendicular ruling out.
