TECHNICAL PAPER 33

MASONRY POINTING AND JOINT FINISHING

PART 2 - GAZETTEER

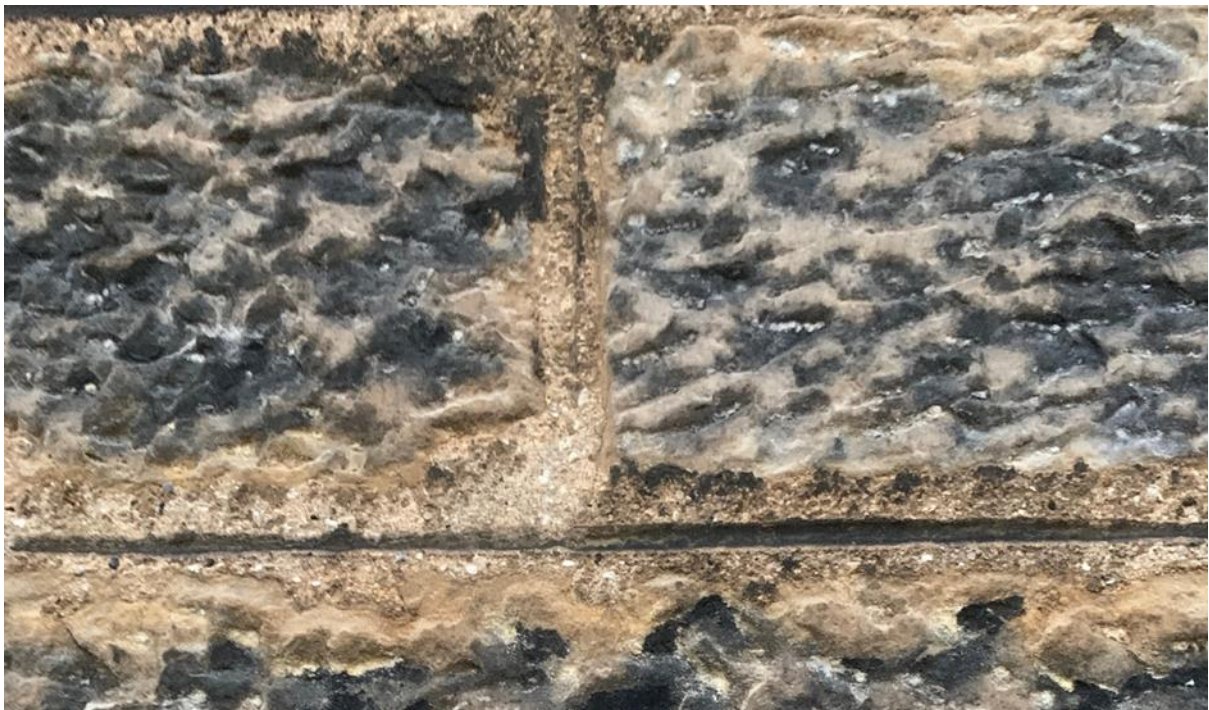
Figure 074.3. Sharp and angular sand with lime inclusions.

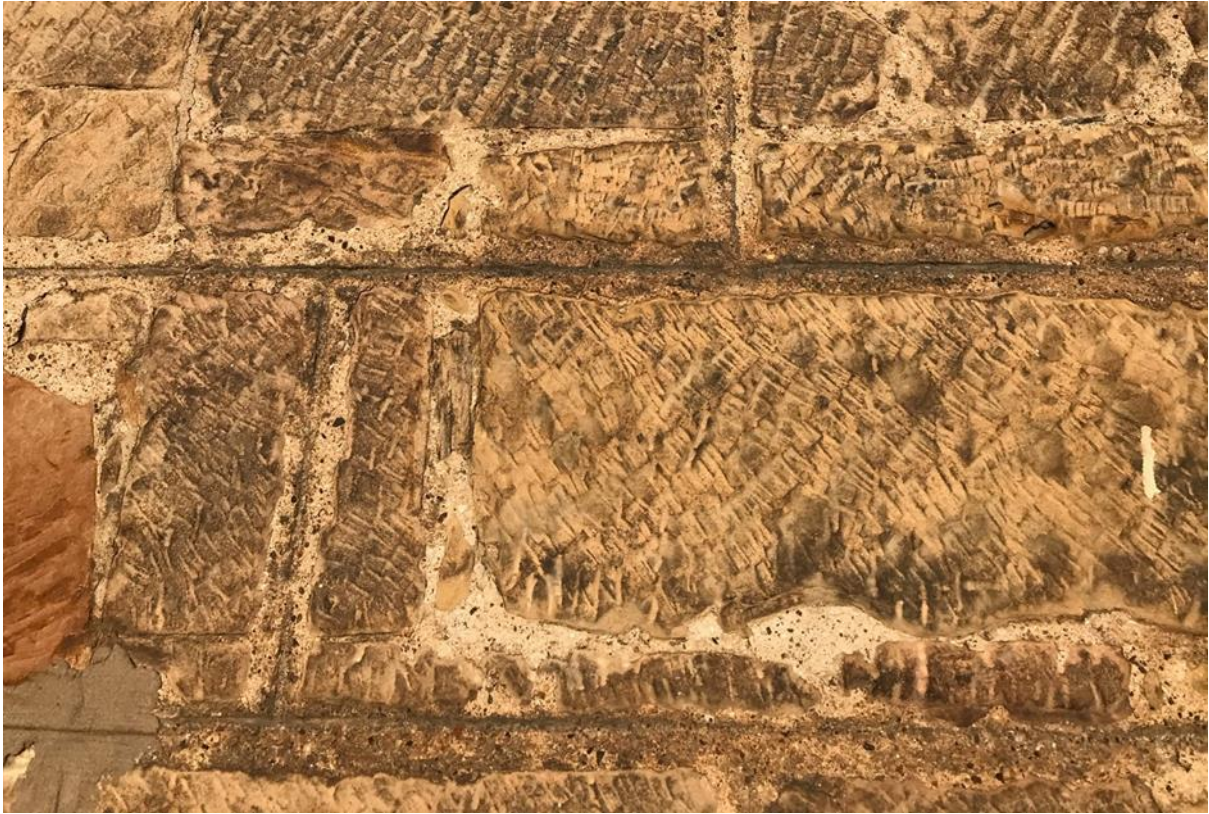
Figure 075.2. Horizontal and perpendicular ruling out with traces former lime harl.

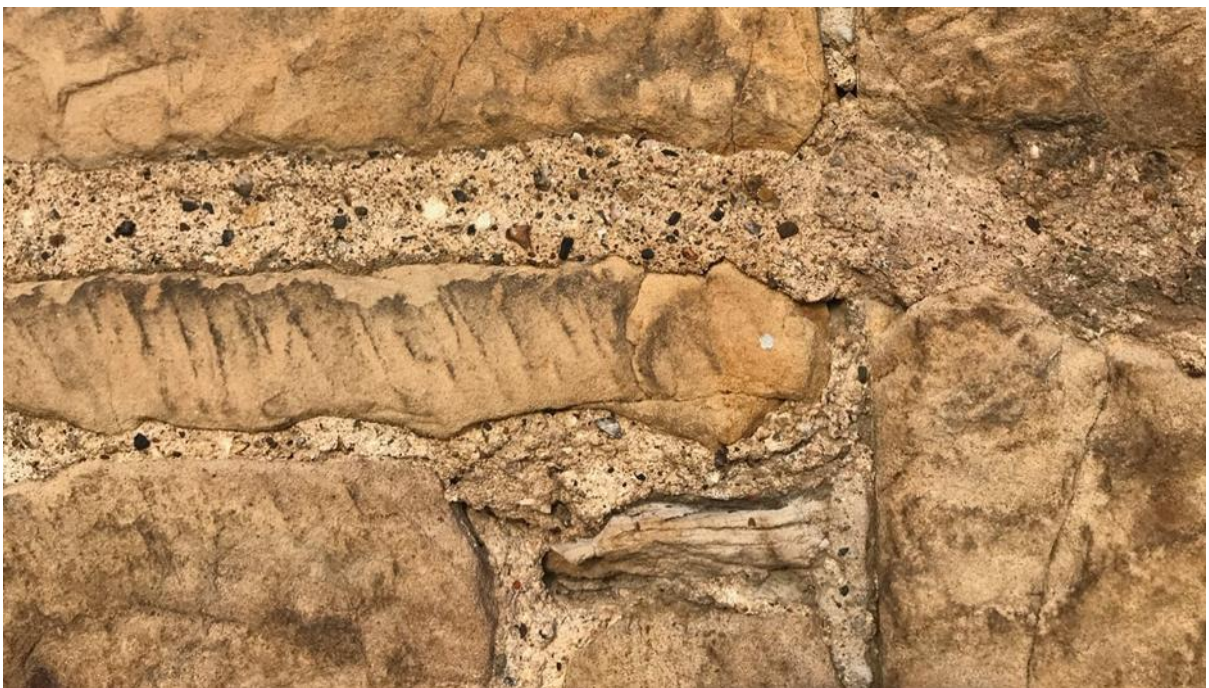
Figure 075.3. Coal, lime and shell inclusions.

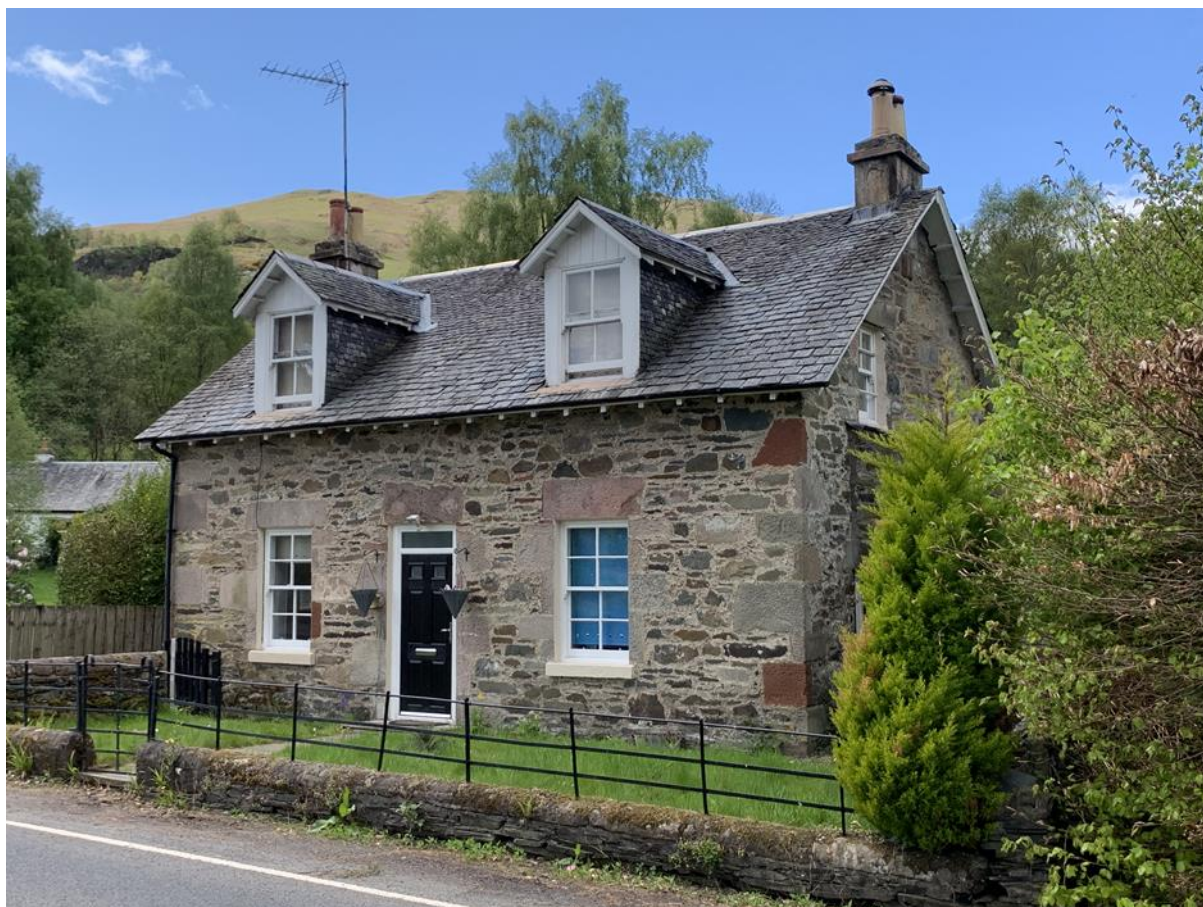
Figure 076.1. Front elevation of fully lime sneck pointed cottage, Luss.

A one and a half storey cottage with two dormer windows, formerly part of the Luss Estate (Figure 076.1). It probably dates from the mid 19th century. This building is a rare in that the lime pointing appears to survive complete on all elevations, protected by the overhanging eaves. The random rubble walls are pointed with sneck pointing using medium course, rounded aggregate (Figure 076.2). The treatment is the same on the gable side. The building does not appear to have been limewashed.

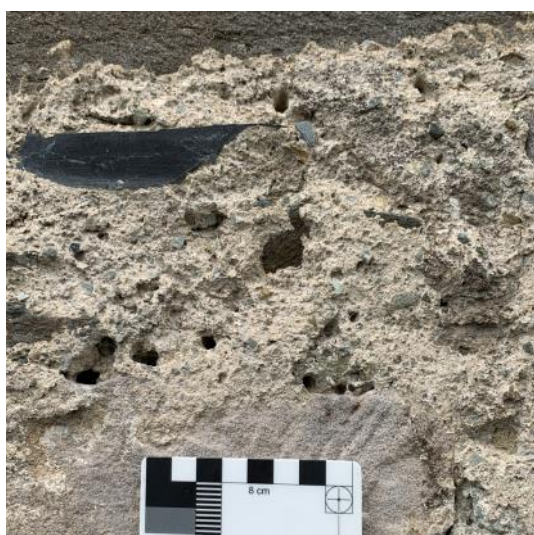
Figure 076.2. Detail of snecked pointing, showing the aggregate.

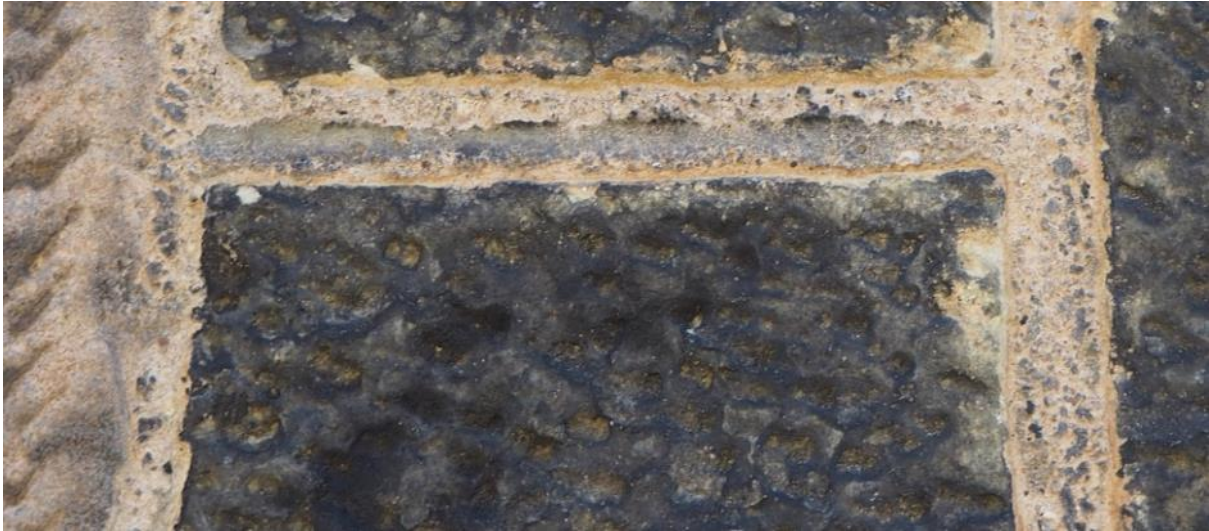
Figure 078.2. Lime mortar on the front elevation of the farmhouse. Image © Sweyn Ross)

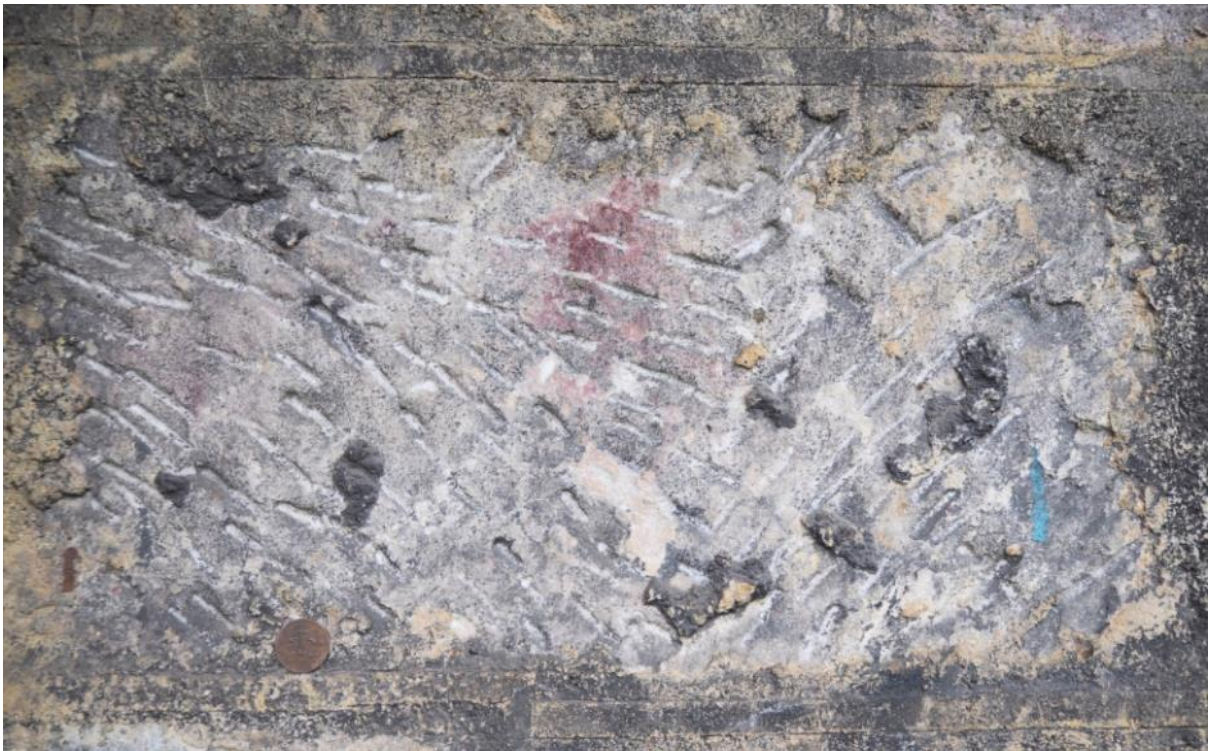
The rear of the building is constructed with informal sawn sandstone. A large section retains what might be sneck harling with a broad, polished band, possibly made by pressing in a purpose made, flat bladed tool. This band is both horizontal and perpendicular. There is evidence of a former full lime covering (Figure 078.3) and an interesting section on the face of several larger blocks of stone where the ruling out does not correspond with the underlying masonry joints. The mortar is robust to the touch, but crumbles when pressure is added. It uses fine to medium aggregate similar to the front of building, however it appears to be more orange in colour under the soot.

Figure 078.3. Evidence of full lime covering on face of stone, with later ribbon pointing. Image © Sweyn Ross

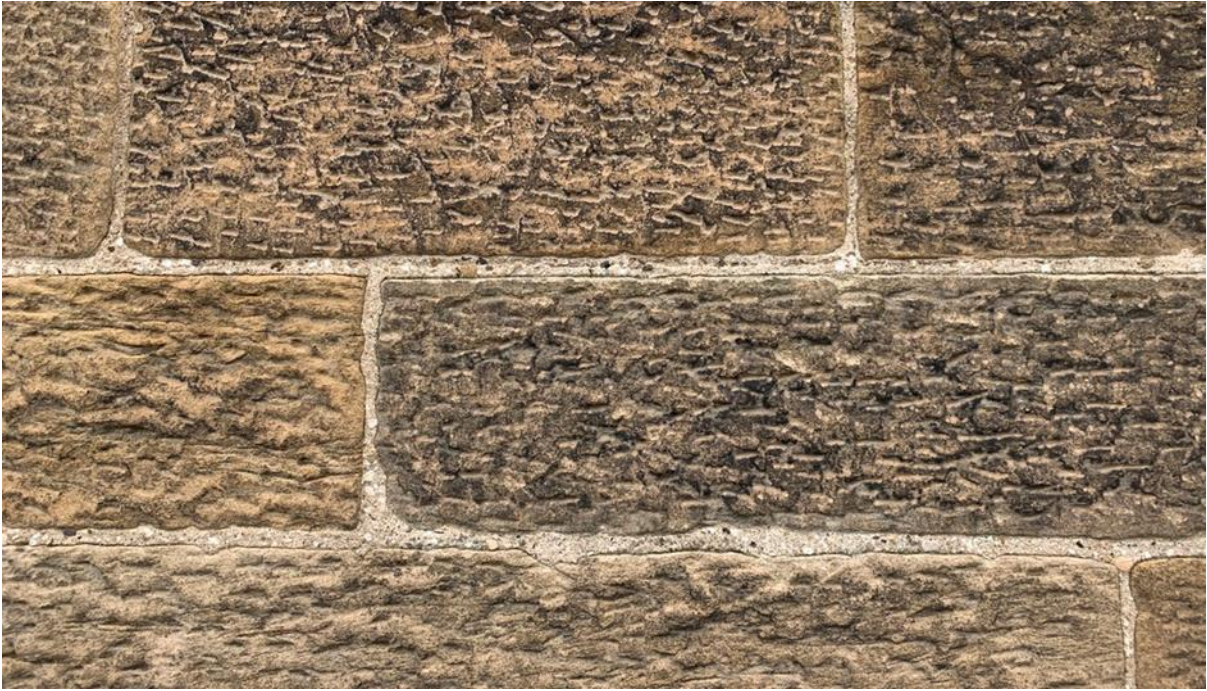
Figure 079.2. Fine lined out joints with gritty mortar.

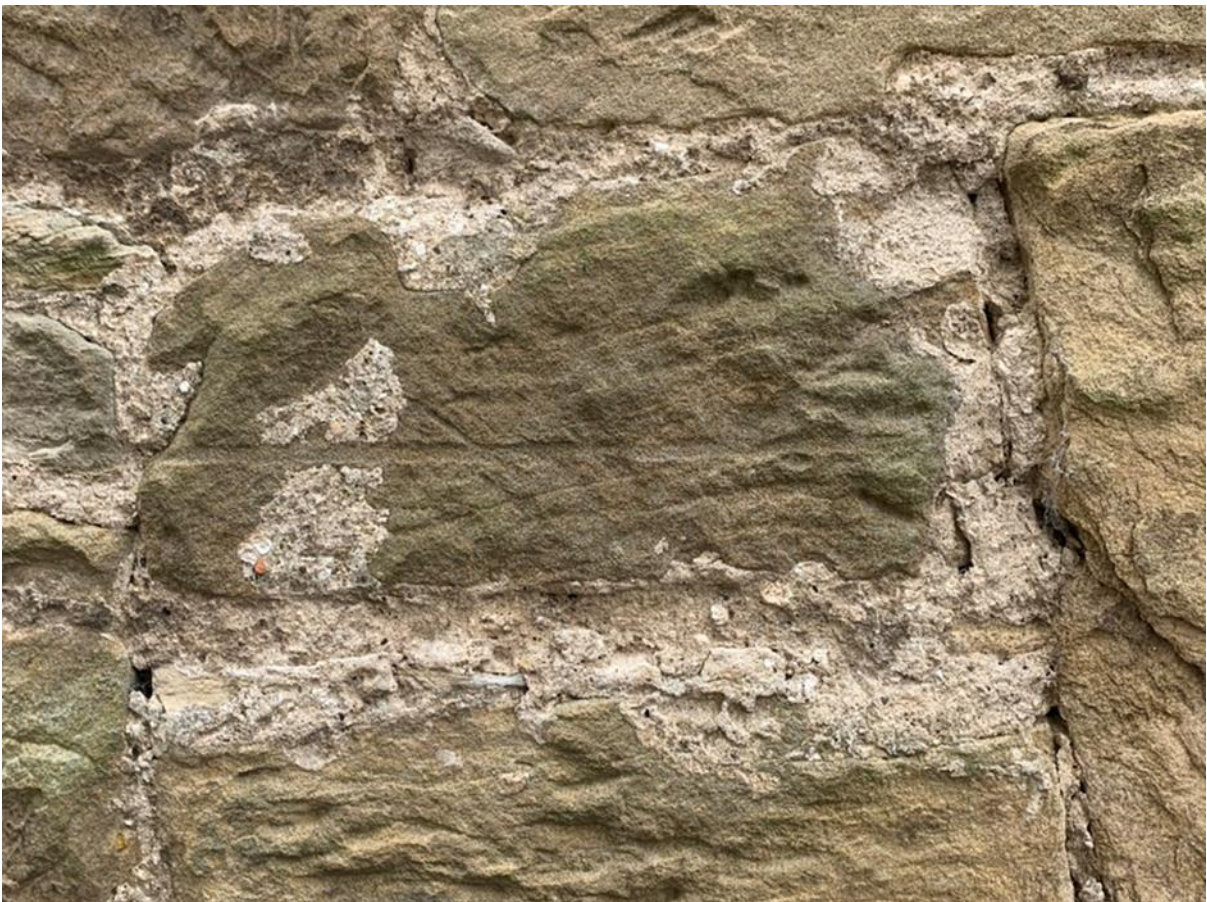
Figure 079.3. Fragmentary remains of an extensive flush finish and covering.

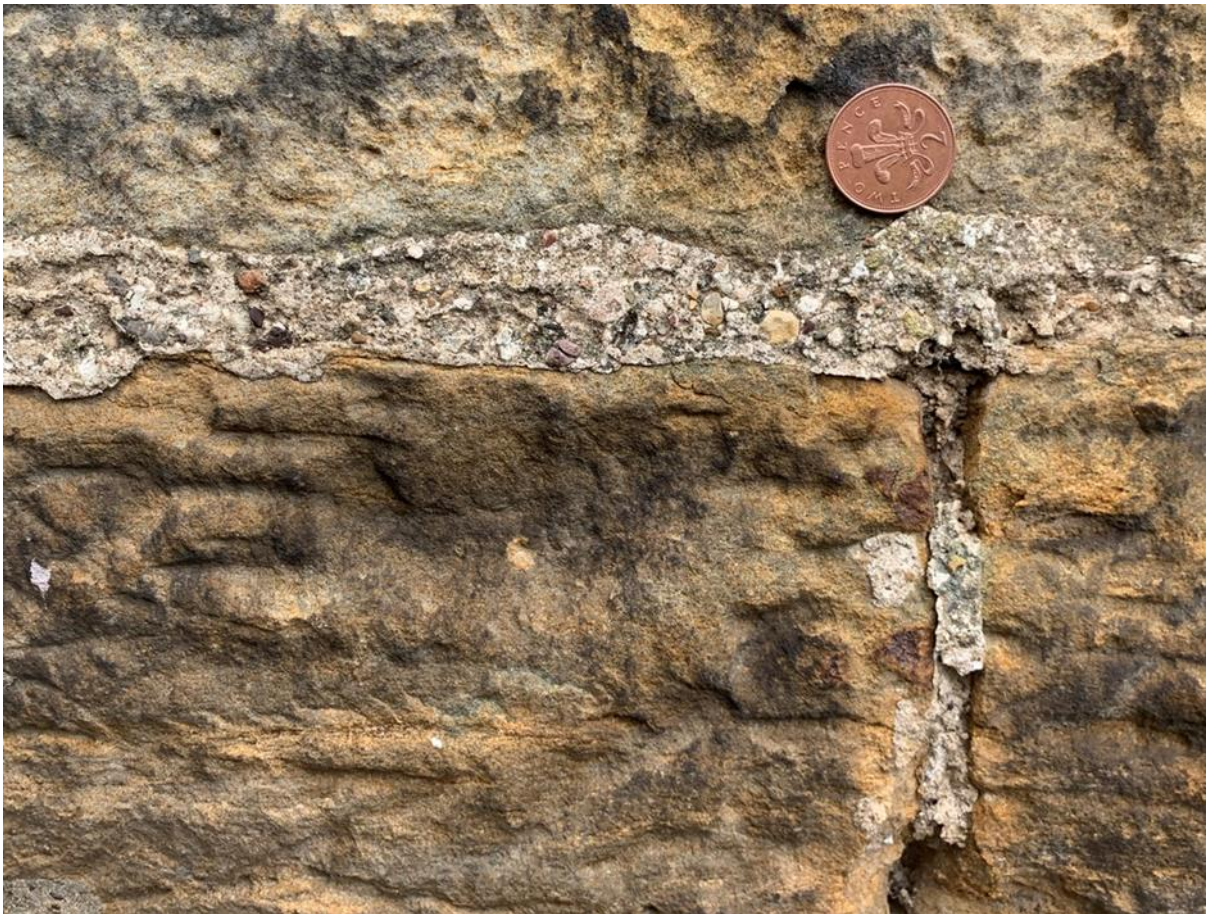
Figure 080.3. Coarse angular and rounded aggregate.

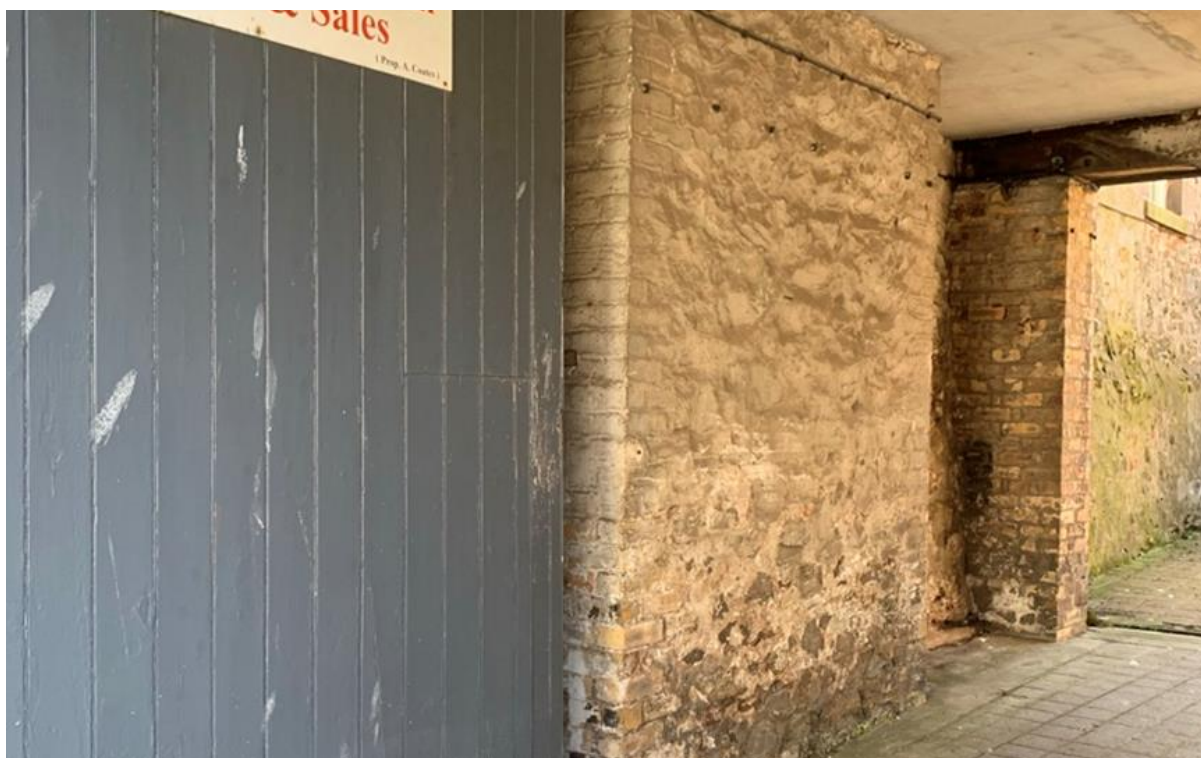
Figure 081.1. The close off Church Street, showing limewashed finish.

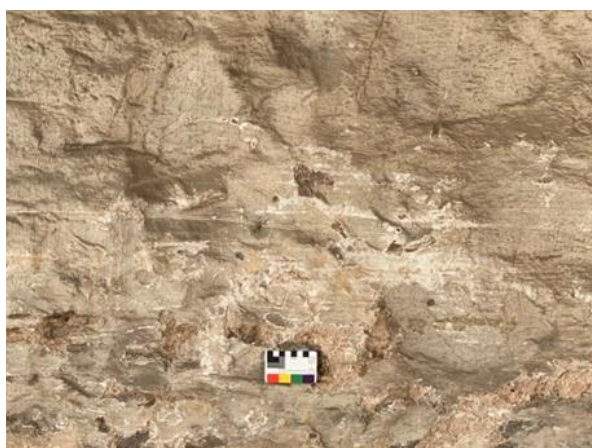
Figure 081.2. A view of the close wall, showing the overall finish.

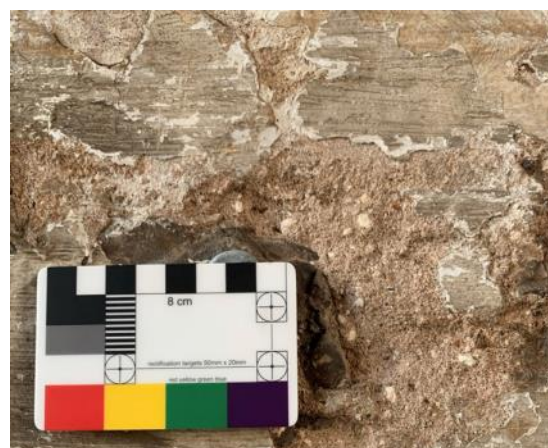
Figure 081.3. The mortar showing through where the limewash has come away.

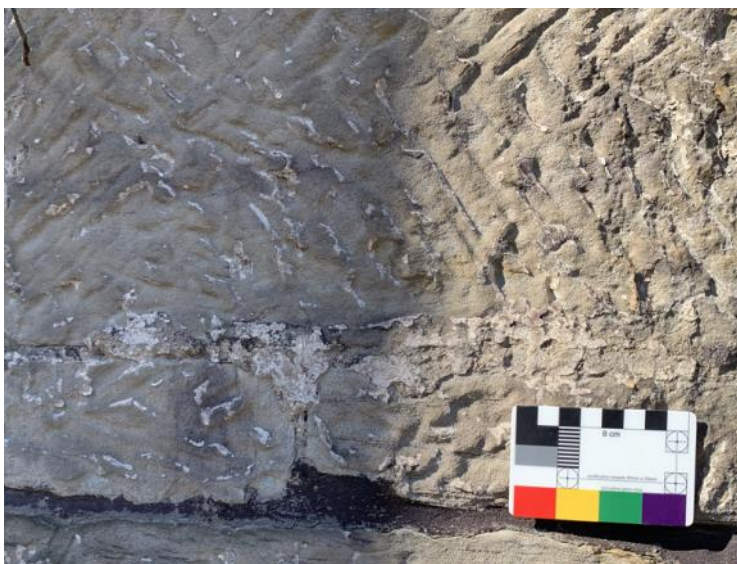
A large one and a half storey house built with a coursed buff coloured sandstone, stugged and broached (Figure 082.1) built in the mid 19th C. The masonry is flush pointed with evidence on the whole front elevation that this work had previously been covered with limewash. The droving on the masonry is deep enough to trap pockets of limewash (Figure 082.2). There has been no lining out as is common on masonry of this type, which supports the likelihood that it was limewashed. Strands of vegetation on the façade indicate that the limewash may have been protected by ivy growth, hence its partial survival.

Figure 082.2. Showing pointing and limewash remains over mortar and in the stugging and broaching cuts.

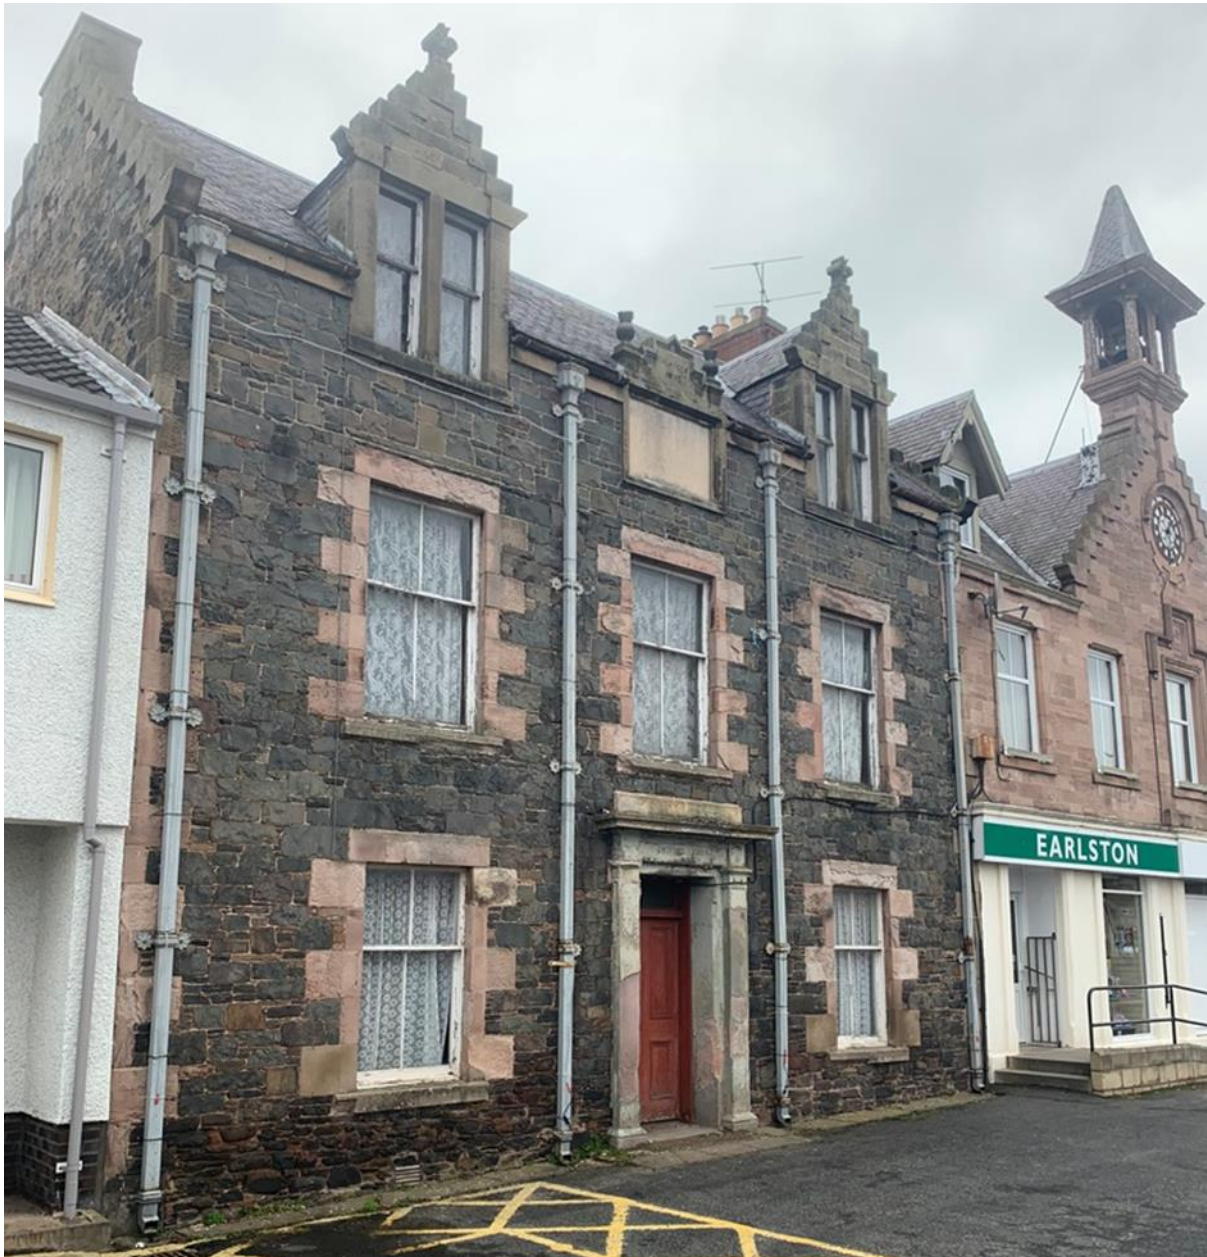
Figure 083.1. South front of the house, The Square, Earlston.

A three-storied, mid-terrace house, built in random whinstone rubble (Figure 083.1). The joint finish is distinct from the bedding mortar in binder content. The bedding mortar is made from a fine angular aggregate in the range of 1-4mm. The finishing mortar, while fragmentary, has a higher lime content. The profile of the finish follows the contour and shape of the random rubble masonry and has a slightly raised and rounded profile (Figure 083.2).

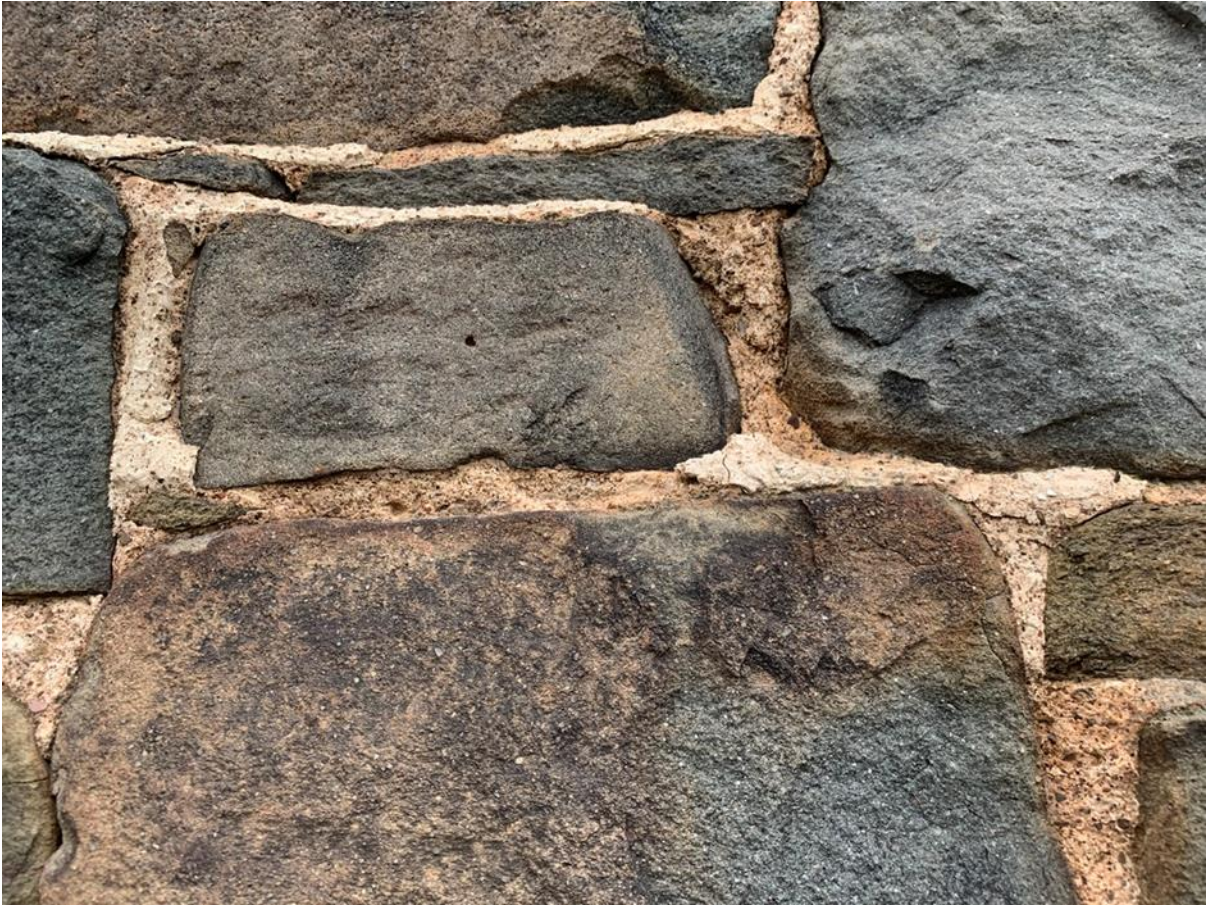
Figure 083.2. Raised and rounded finish, following the contours of the masonry.

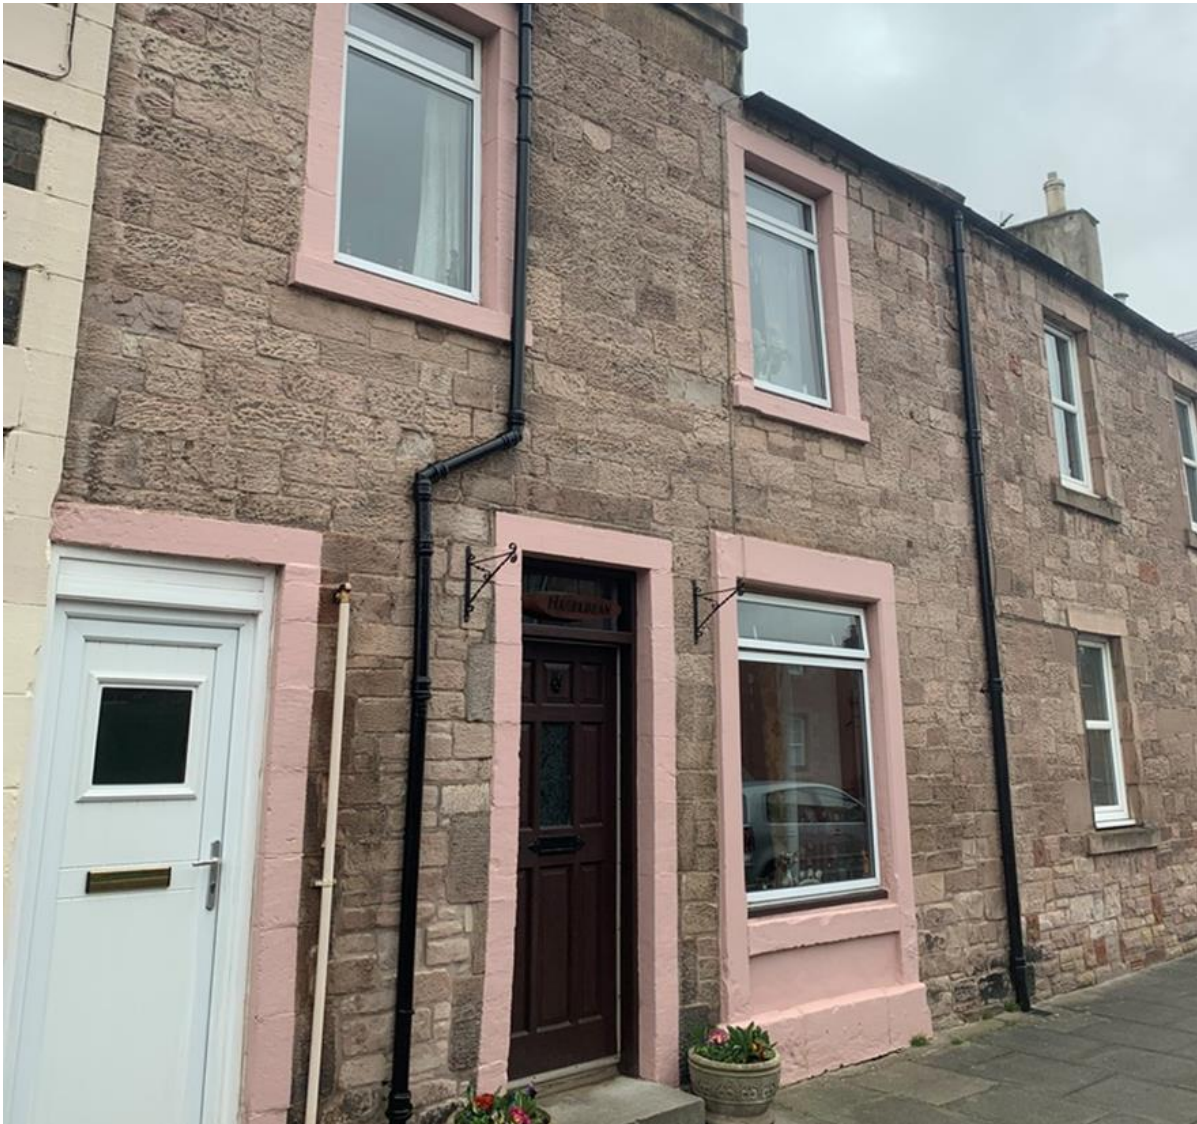
Figure 084.1. The property on the High Street, viewed from the south.

A three-storey house with squared sandstone blocks (Figure 084.1). The joints are flush finished with a convex and rounded profile (Figure 084.2). It is worth noting the decay of the sandstone even when flush finished with a lime mortar.

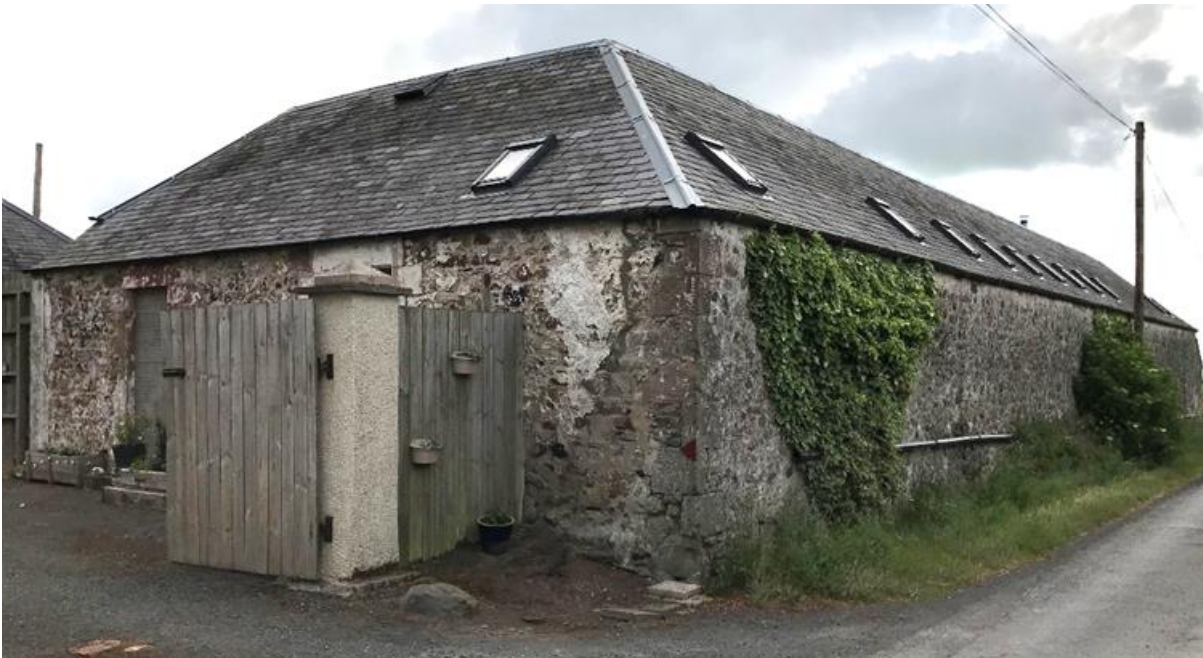
Figure 085.1. The north range of the former steading at Ladyrigg.

This steading complex (Figure 085.1) is close to the village of Heiton and was part of Ladyrigg Farm until agricultural operations were transferred elsewhere. The masonry is a lime bonded whinstone rubble with sandstone dressings and probably dates from the mid-19th century. It was converted to housing in the mid 2000's. This conversion work, while extensive, did not affect the northern elevation of the steading courtyard adjacent to the road where there is extensive evidence of traditional masonry finishes. The flush pointing is starting to wear back, but the mortar and limewash survive well under the rhones on the upper part of the wall (Figure 085.2). The pointing style appears to have been a flush or sneck point with a limewash finish (Figure 085.3). The does not appear to have been any lining out. This northern elevation is sheltered from prevailing winds and this will account for its survival.

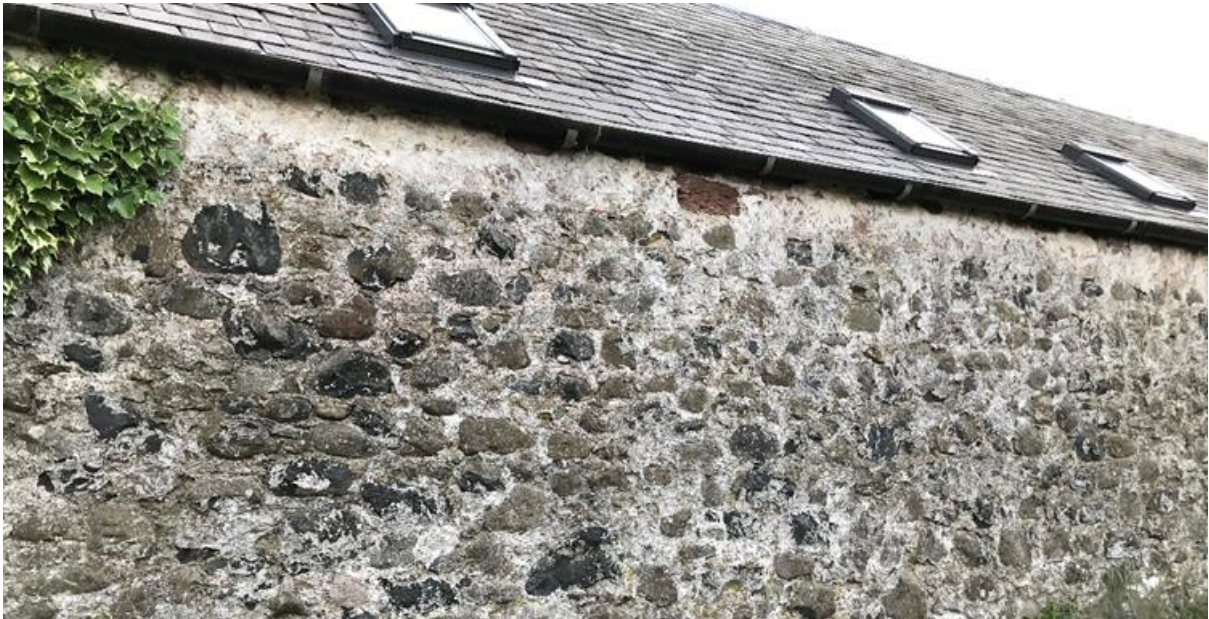
Figure O85.2. The roadside elevation of the steading with what appears to be original finishes. Note the better survival of limewash and pointing under the rhone.

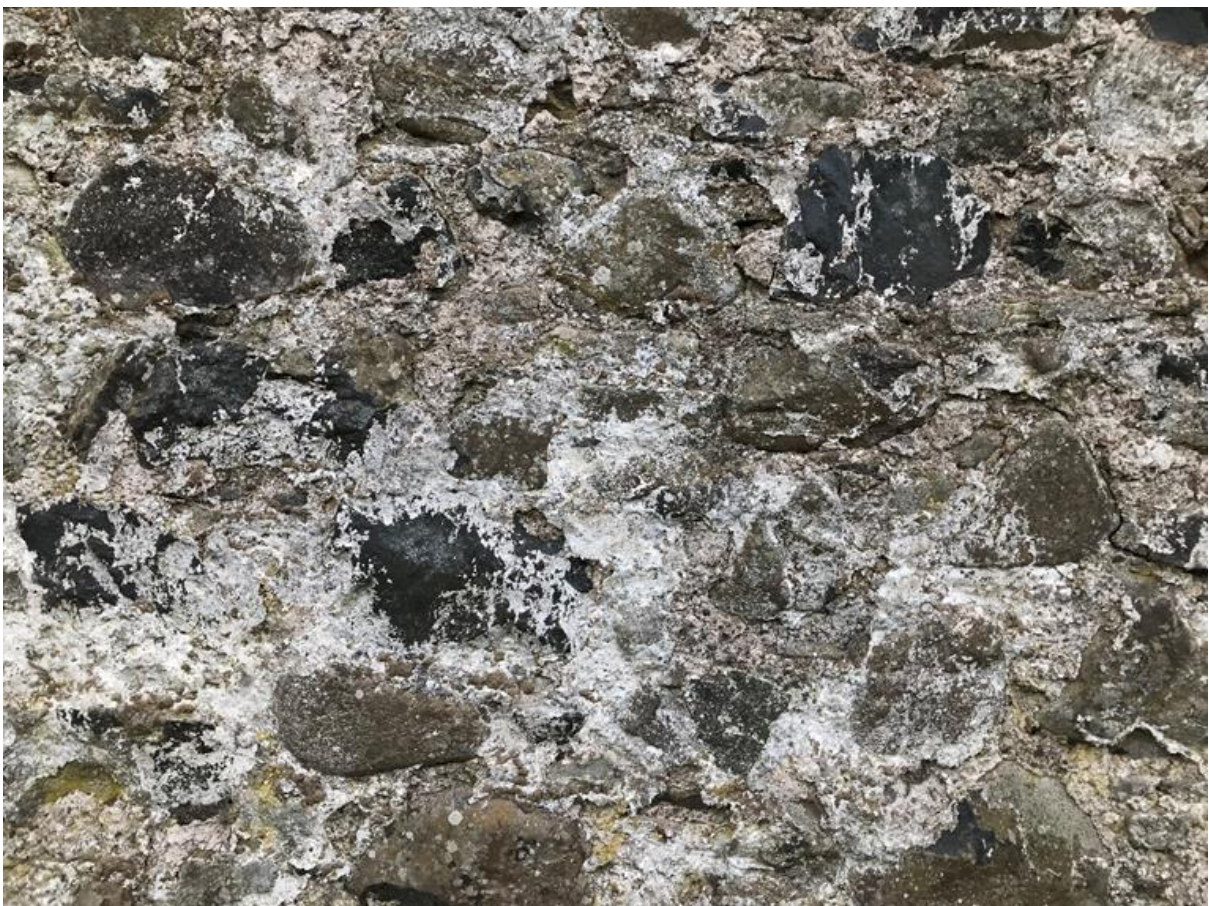
Figure O85.3. Detail of the masonry finish at Ladyrigg, showing the flush or sneck point and the surviving limewash.

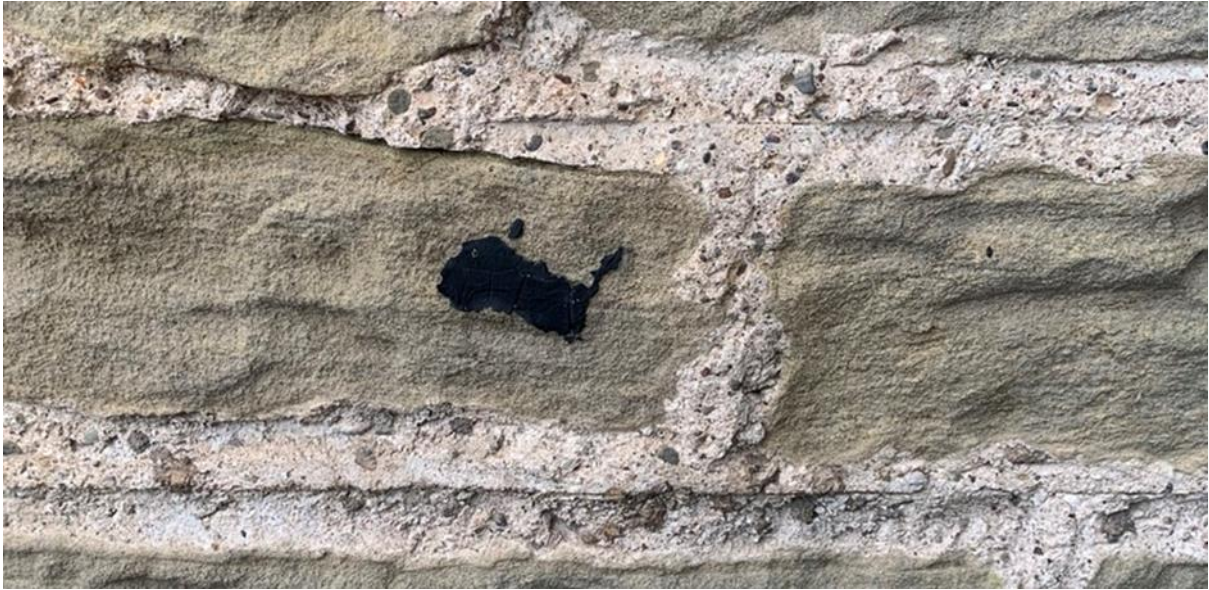
A mid-19th century sandstone church (Figure 086.1). The masonry is squared and sawn rubble with a flush and ruled out finish. Much of the surface has degraded but fragments of the ruling remain (Figure 086.2). The mortar has coarse angular and rounded aggregates in the range of 1-6mm (Figure 086.3).

Figure 086.2. Remnants of ruling out.

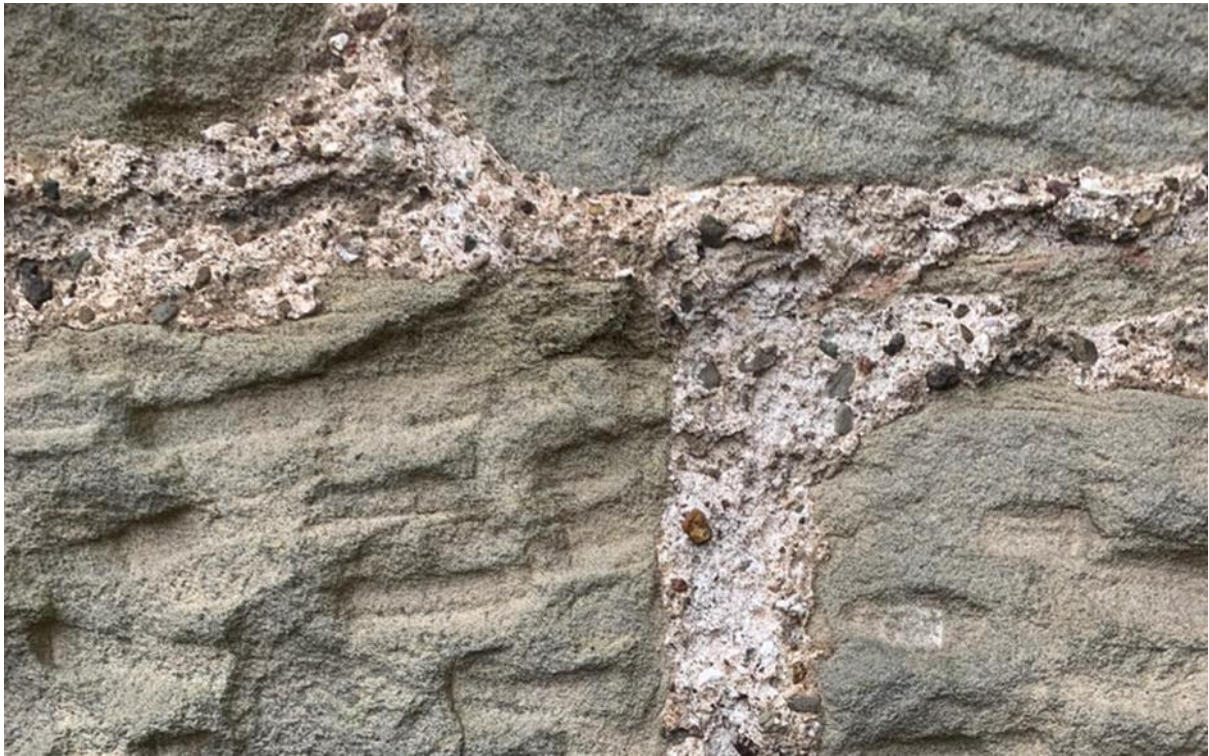
Figure 086.3. Coarse angular and rounded aggregates.

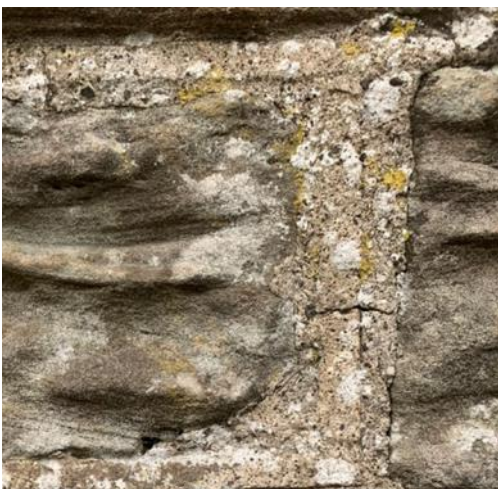
Figure 087.2. Flush finish with the raised ribbon.

The boundary wall (Figure 087.1) that surrounds Floors Castle and the Roxburghe Estate forms part of a range of improvements initiated in the 19th century. The finish mortar is a post construction application consisting finer sands and aggregates (in the range of 1-5mm) than the bedding mortar. The completed finish is flush and raised to a ribbon. This is applied to both the horizontal and perpendicular joints of the squared sandstone (Figure 087.2). There is extensive cracking of this pointing although still adhering well.

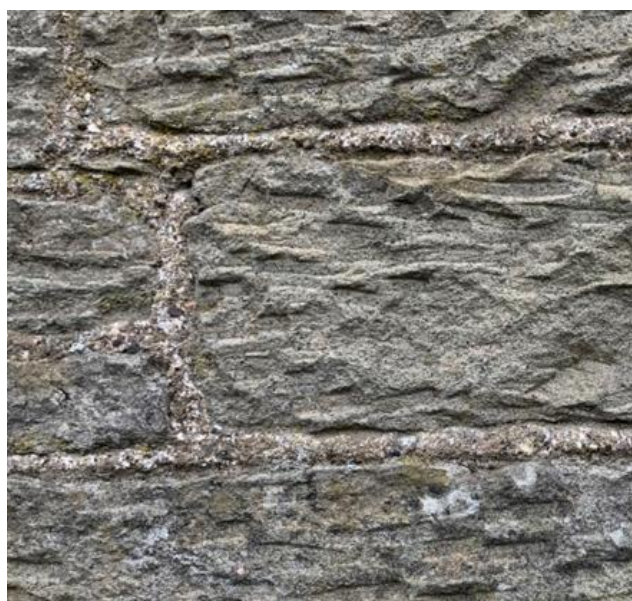
The farm buildings (Figure 088.1), built in 1848, are constructed with roughly squared pale sandstone, which is in turn flush finished with a raised convex ribbon (Figure 088.2). The 'ribbons' follow the contours of the stone rather than imposing a rigidly horizontal or perpendicular form. Very coarse mortar has been used with rounded aggregates in the range of 1-9mm (Figure 088.3).

Figure 088.2. Raised convex ribbon.

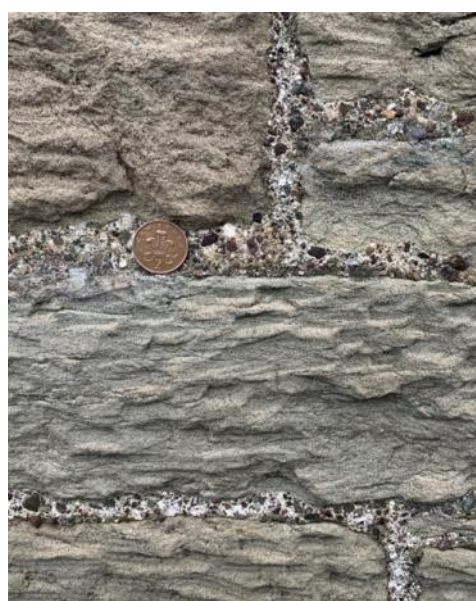
Figure 088.3. Very coarse mortar with large, rounded aggregate.

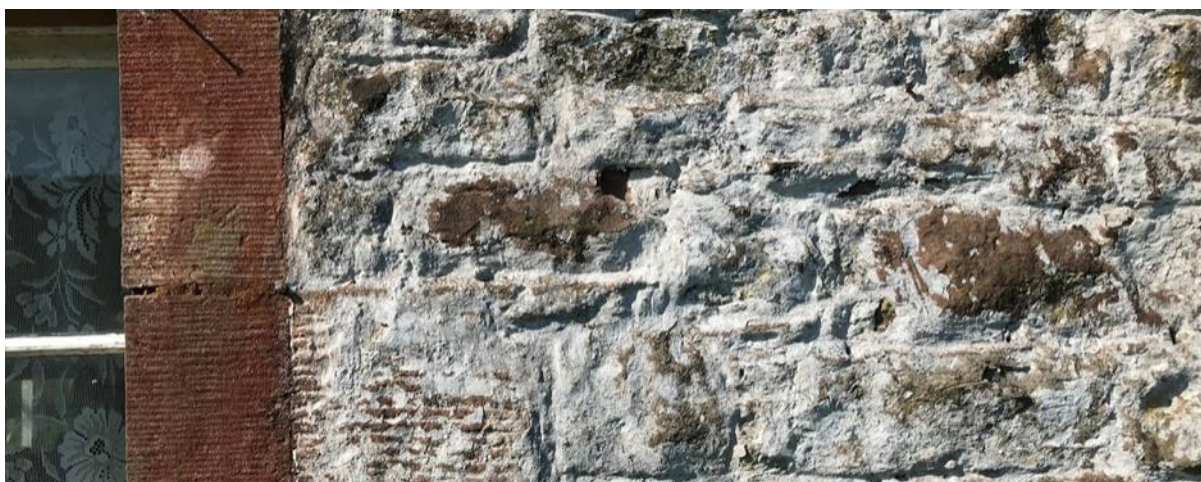
Grange cottage is now a single dwelling, although it was built in the mid-19th century for two households on the Abbottrule Estate (Figure 089.1). The masonry is local old red sandstone pointed with a lime mortar. The northern end of the building retains a narrow point which is limited to the joints, and not flush to the high points. There is a covering of limewash surviving in several areas, but it is thin and appears to be a single coat (Figure 089.2). This suggests that it is a later addition.

Figure 089.2. Detail of the pointing and limewash at Grange Cottage. The limewash appears to be a single coat.

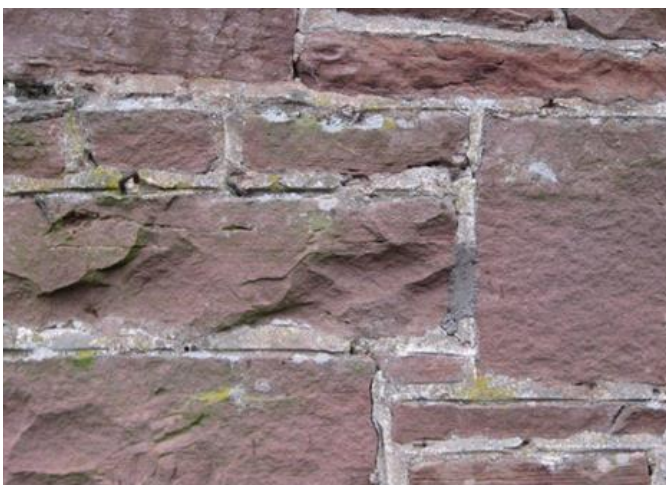
This small mid-19th century building was built in 1863 as the cottage for the Gardener at Weens (Figure 090.1). While altered inside its external finish appears to be more or less original apart from some work to the chimneys. The masonry is old red sandstone rubble, lime bonded with a shaped finish to the pointing, which is restricted to covering the joints only, sloped outwards in a style sometimes called 'weatherstruck', and following the joints of the rubble (Figure 090.2). The mortar appears to be lime rich with a fine aggregate, necessary to be able to form the lower edge. The pointing seen today appears to be either original, or certainly from before the 20th century. The front elevation is fairly sheltered, and this may explain its good condition. The survival of the mortar may also be due to a covering of climbing plants on a wooden framework seen in older photographs.

Figure 090.2. The pointing on the front elevation showing the weatherstruck finish, it appears to be original.
