TECHNICAL PAPER 33

MASONRY POINTING AND JOINT FINISHING

PART 2 - GAZETTEER

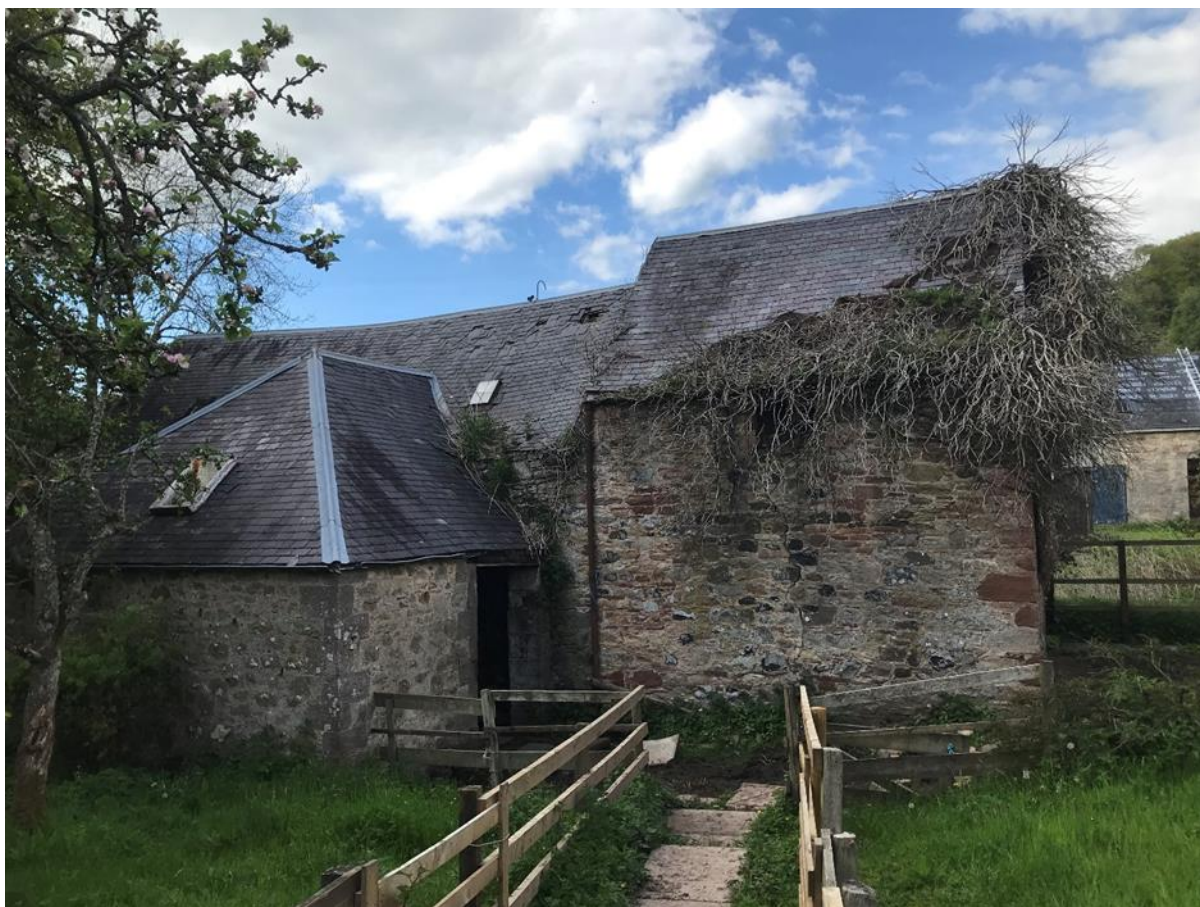
Figure 091.1. Ferniehurst Mill from the south.

There has been a mill on the site since the 16th century or earlier, and a date stone over the wheel pit shows '1683', but most of the masonry seems to be later. The mill building is in poor condition, with all mill machinery removed at some point in the 20th century, and the north side opened up as tractor bays. However, on many elevations of this multi-phased building are good examples of traditional flush pointed rubble. The annex to the south wall of the main building, shown on the left-hand side of Figure 091.1 appears to be mid-19th century and has a well preserved traditional mortar finish (Figure 091.2) that appears to have been applied with a trowel, not thrown (Figure 091.3). There are no traces of limewash.

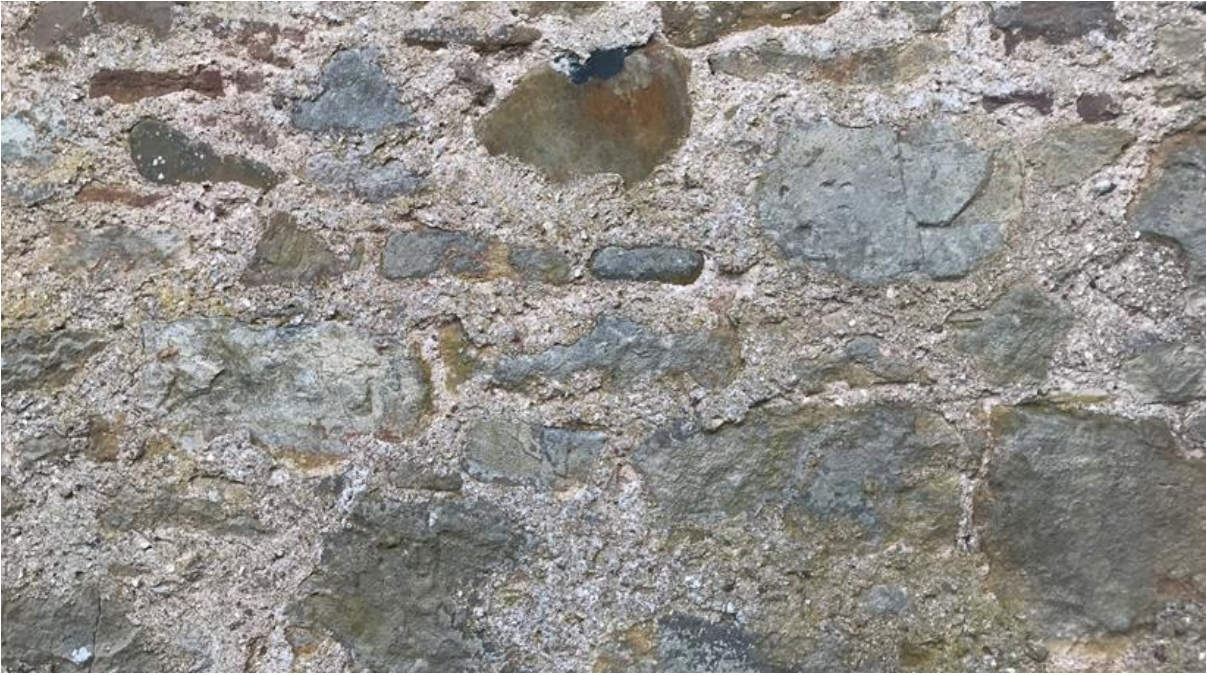
Figure 091.2. The sneck pointing on the south extension of the mill.

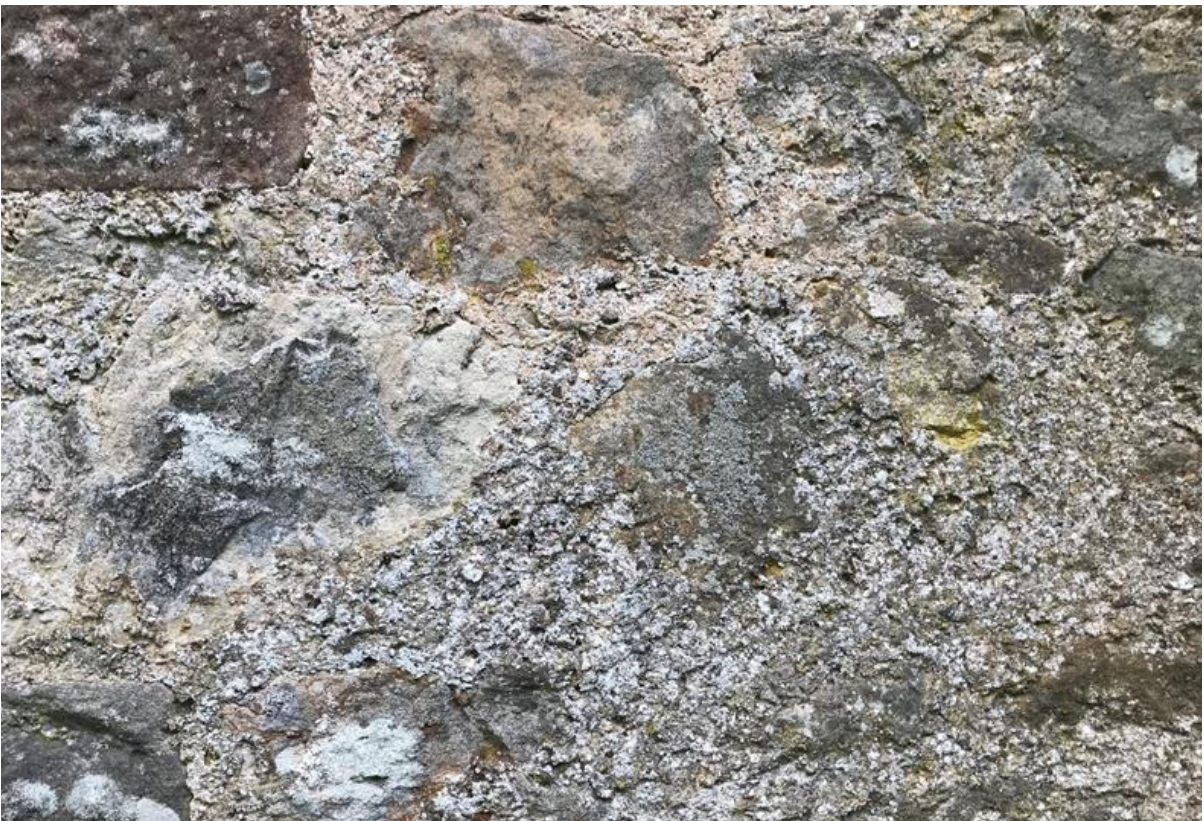
Figure 091.3. A close view of the pointing on the 19th century extension.

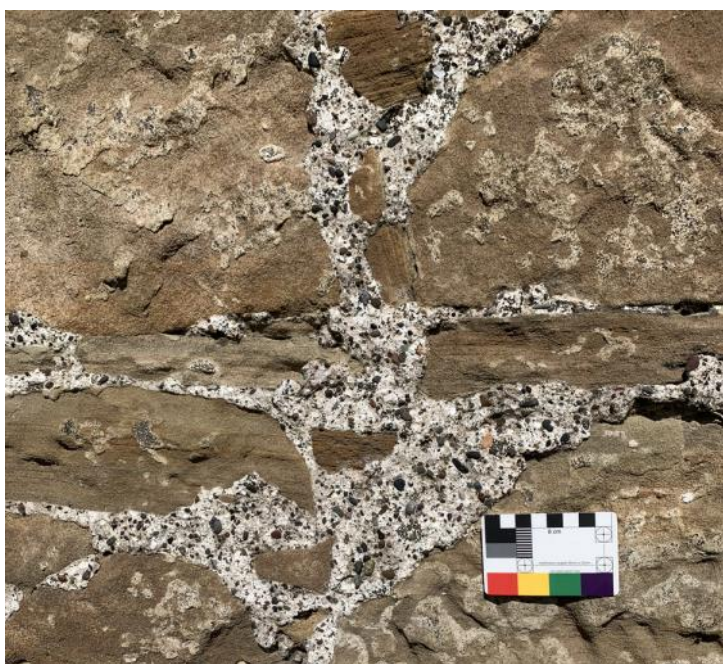
This sandstone building, probably a granary, dates from the mid nineteenth century (Figure 092.1). There are extensive remains of snick pointing and traces of a further surface covering. The mortar is lime rich with extensive large rounded black aggregates which resemble coal, with lime inclusions (Figure 092.2). This entry represents the difficulty in differentiating between a very worn full harl and a snick harl. The mortar appears to be integral to the building mortar.

Figure 092.2. Close up of the remaining snick pointing. Traces of a surface covering are showing on the sandstone blocks.

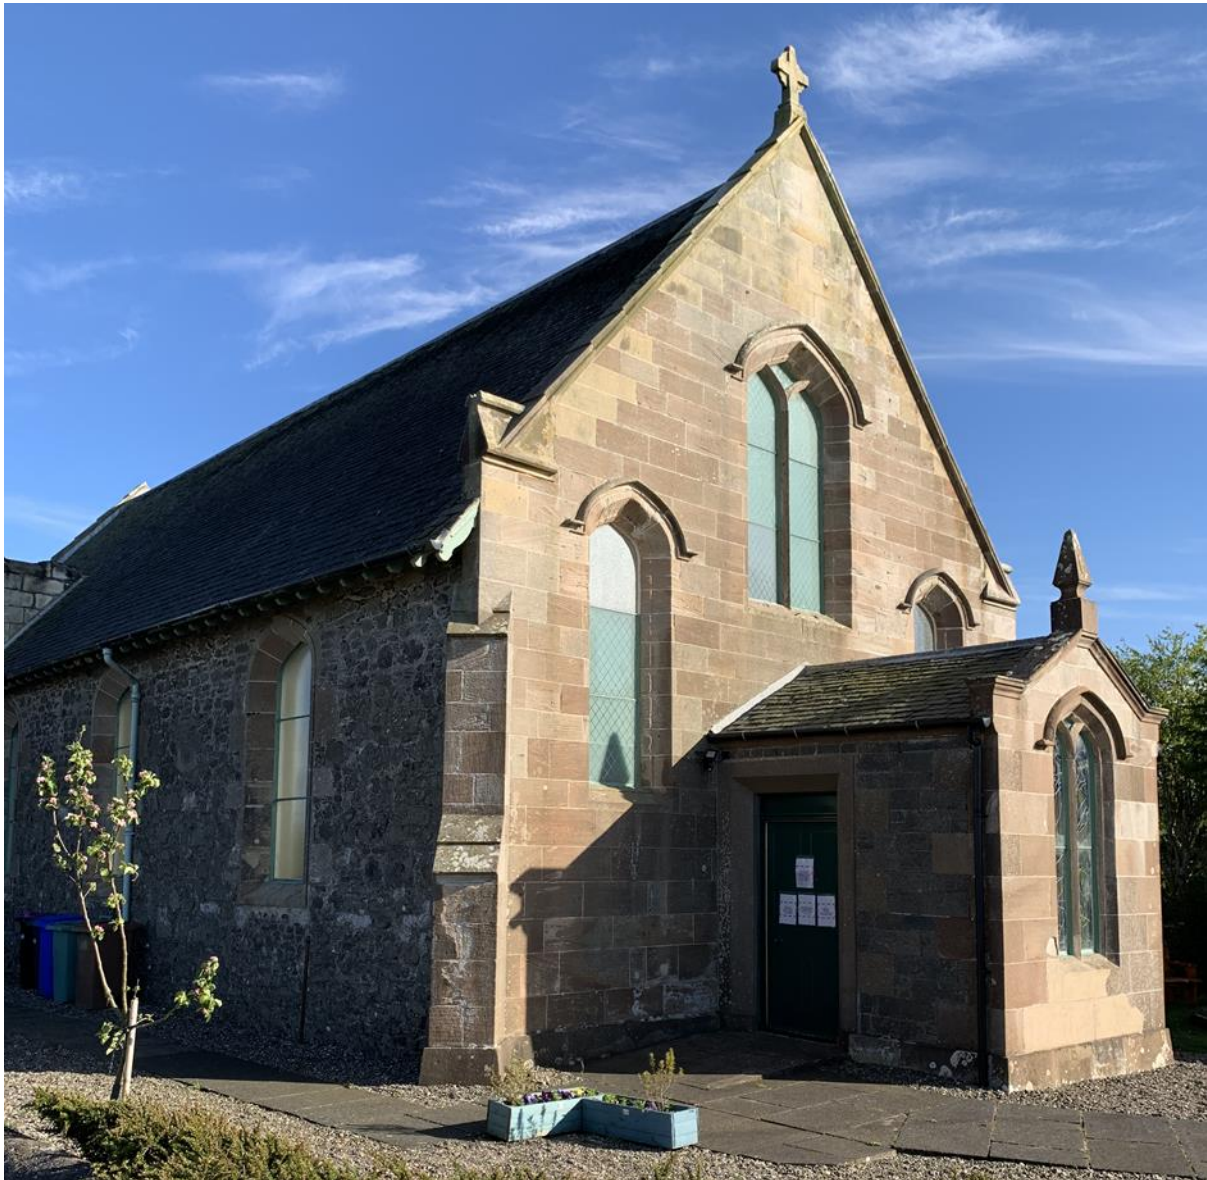
Figure 093.1. Fisherton Church, front and east elevations.

Fisherton Church, dating from 1843, demonstrates hierarchy in building with more refinement given to the front of the church than the sides and rear (Figure 093.1). The principal elevation of the church is built with a sandstone ashlar, while the sides are built with rough whinstone. The whinstone is crudely sneck harled and quite decayed, revealing open joints. The mortar for the sneck harl is coarse, has large, rounded aggregates with lime inclusions (Figure 093.2). A porch has been added and this is also ashlar fronted. However, the sides are built with sawn whinstone. This whinstone has medium fine joint. The mortar employed in the construction of the squared whinstone is less coarse than the sneck

The western elevation has recently been plastered suggesting that water ingress through the sneck harl has been an issue.

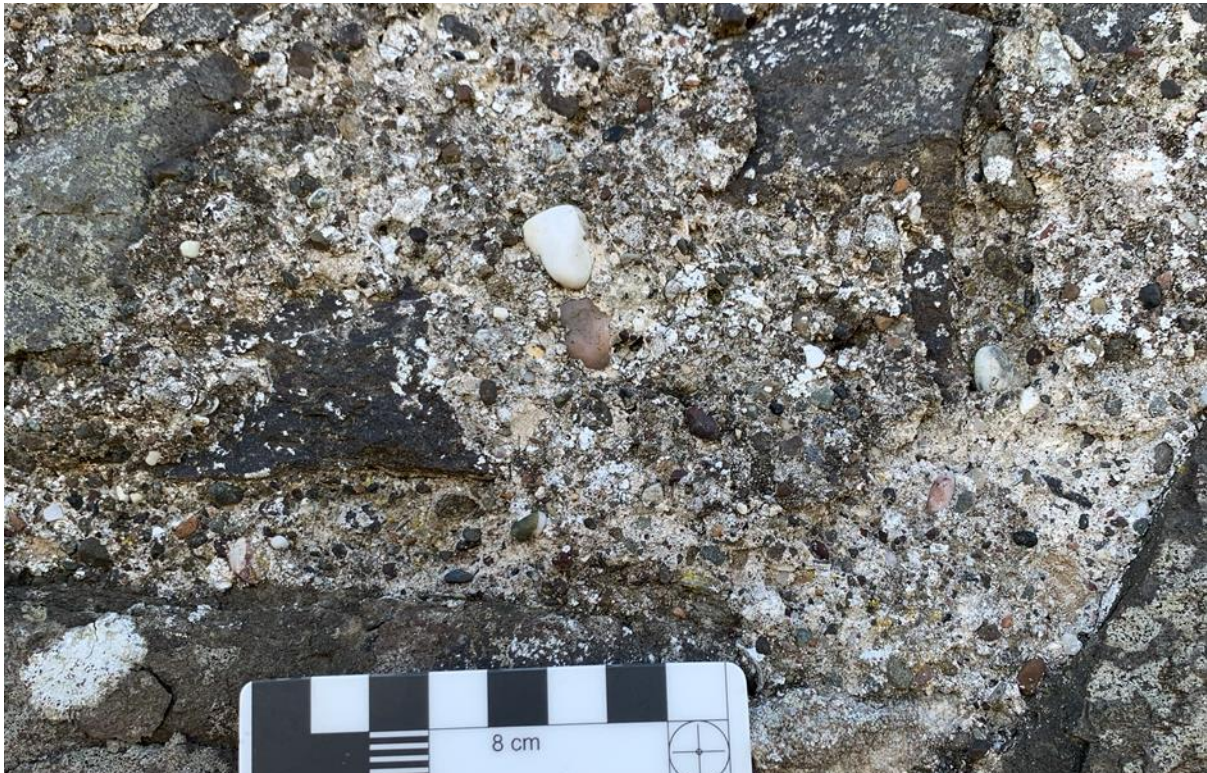
Figure 093.2. Large, rounded aggregates with lime inclusions.

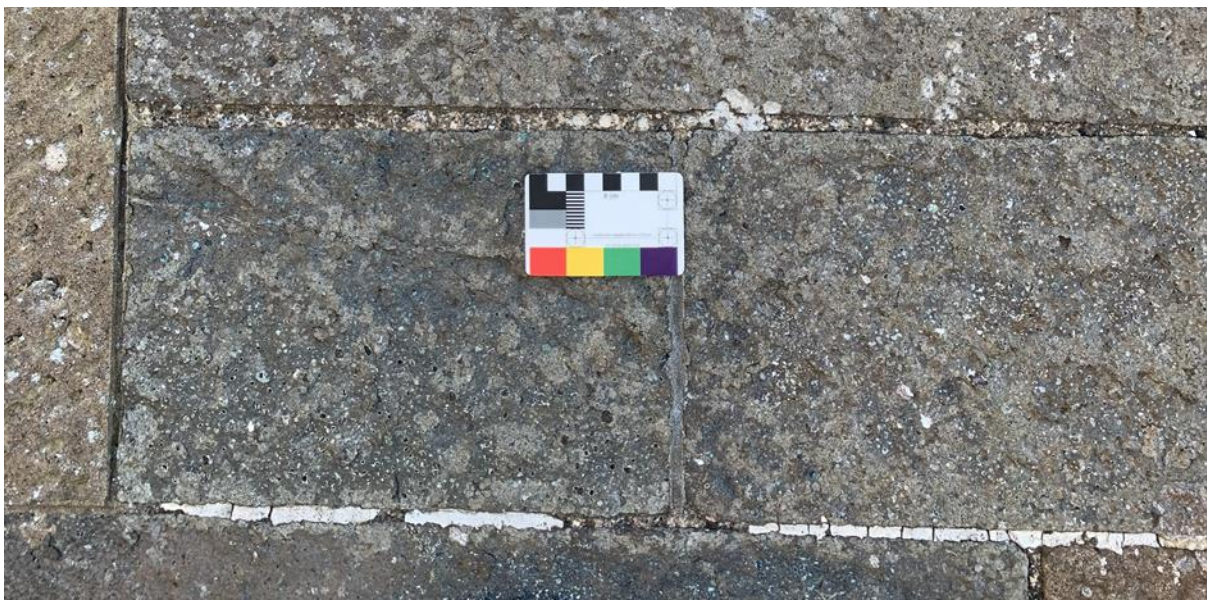
harl but similarly contains lime inclusions. Significantly, this masonry has been 'piped' with a finer putty mortar (Figure 093.3).

Figure 093.3. East elevation of the porch with the remains of white putty pointing.

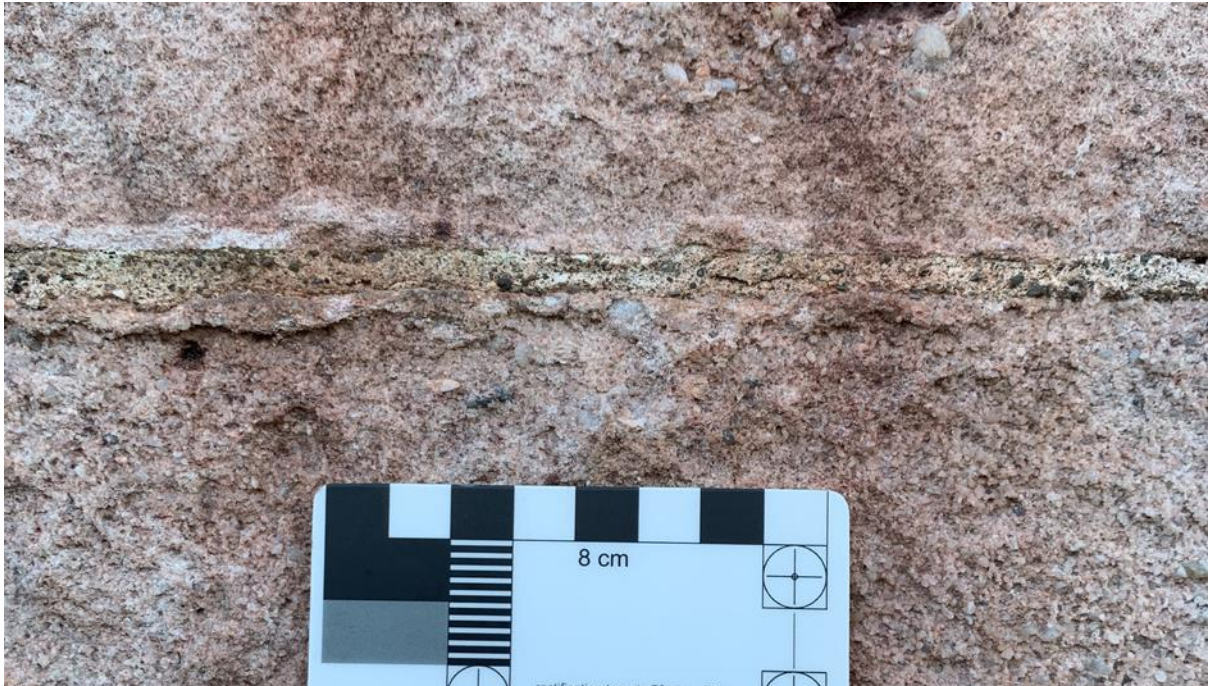
The Buccleuch Hotel is a two and a half storey building from the mid-19th century (Figure 094.1), with decorated dormers matching the five bays. It is constructed with broached, rusticated ashlar with contrasting droved work in the main doorway. The main body of the hotel has medium fine joints that were ruled out (Figure 094.2). This pointing is best preserved in the close between the hotel and the adjacent building where it is sheltered and has been limewashed (Figure 094.3 and 094.4). There are faint traces of the ruling out on the front elevation, but the pointing is worn. This

Figure 094.2. Worn, ruled pointing on the main body of the hotel.

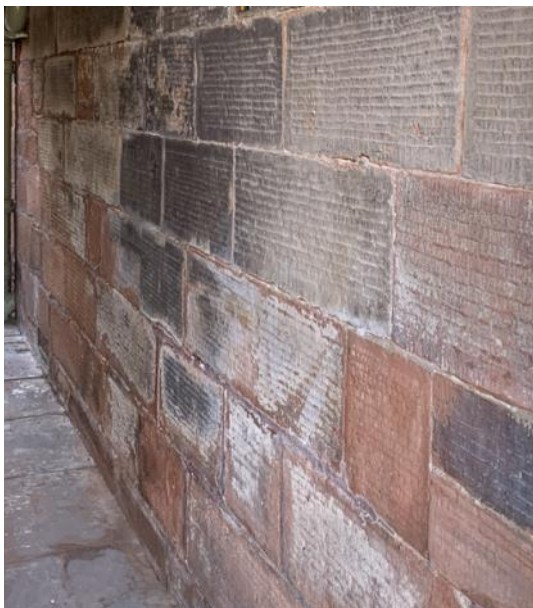
Figure 094.3. The close to the left of the hotel, showing signs of original masonry finishes.

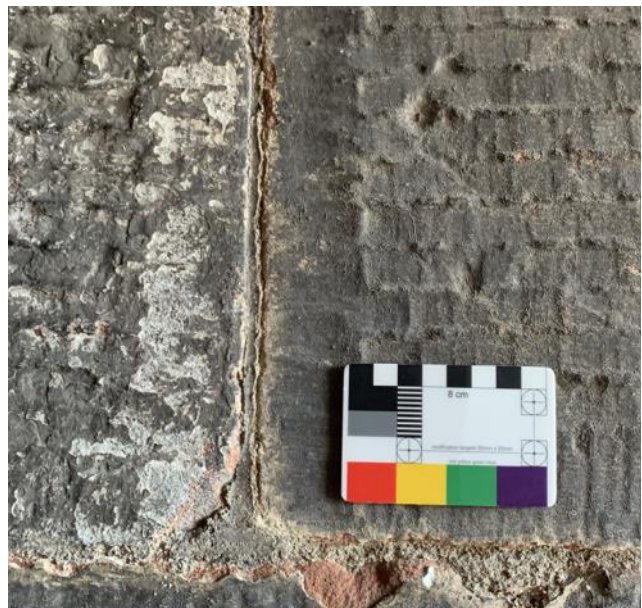
Figure 094.4. Masonry finishes in the adjacent close, showing fine pointing and discoloured layers of remaining limewash.

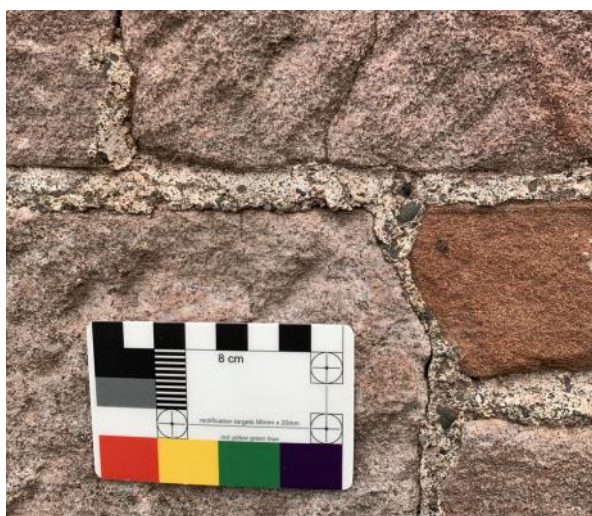
Figure 095.2. The lime rich mortar with large aggregate showing. The angle of the pointing, called 'weather struck', can be seen.

dates from the mid-19th century and is Category B Listed. The masonry is coursed rubble with a flush, weather-struck finish to the pointing. The top of the pointing tucks into bottom arris of the upper stone while the bottom is flush with the top edge of the lower stone as can be seen in Figure 095.2. In the mortar can be seen large angular and rounded aggerate in the range ~ 10mm – ~0.5mm.

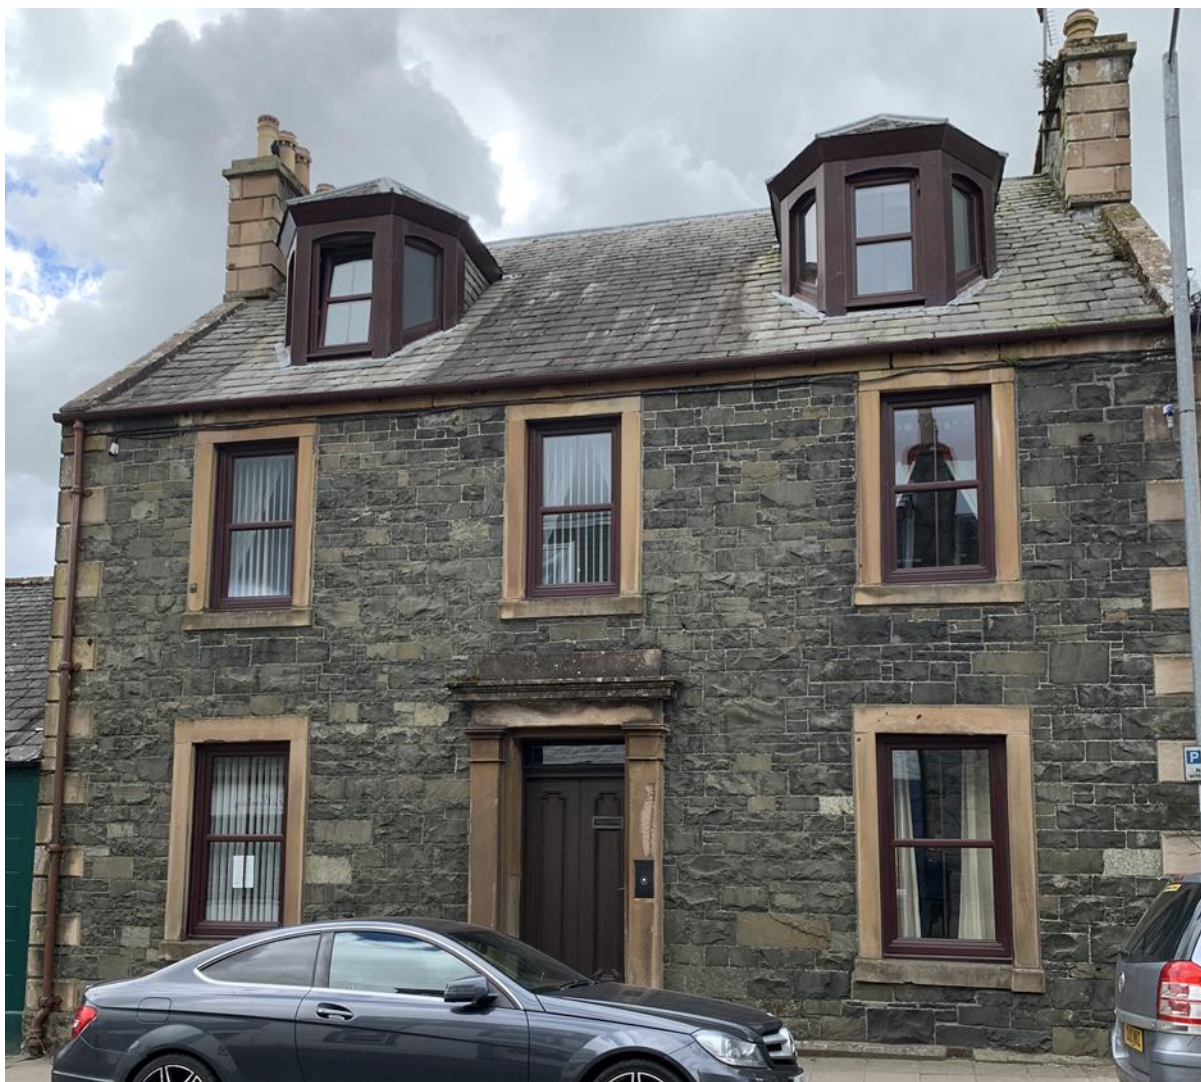
Figure 096.1. Front elevation of house in Albert Street.

This 19th century house 2 1/2 story house is constructed with a squared whinstone rubble and sandstone dressings. It is pointed with a coarse mortar with rounded aggregate and lime inclusions (Figure 096.1). The mortar appears to have been left crudely finished, simply spilling out of the joint. There has been no further finish to the masonry, and the pointing appears to be original. Some hint of lining out (Figure 096.2).

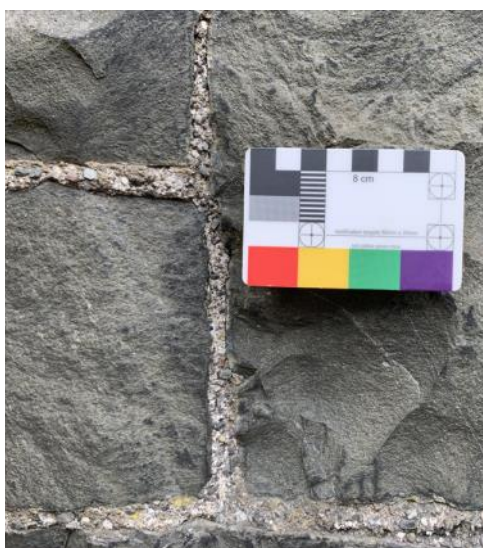
Figure 096.2. Mortar with coarse aggregate and some hints of lining out.

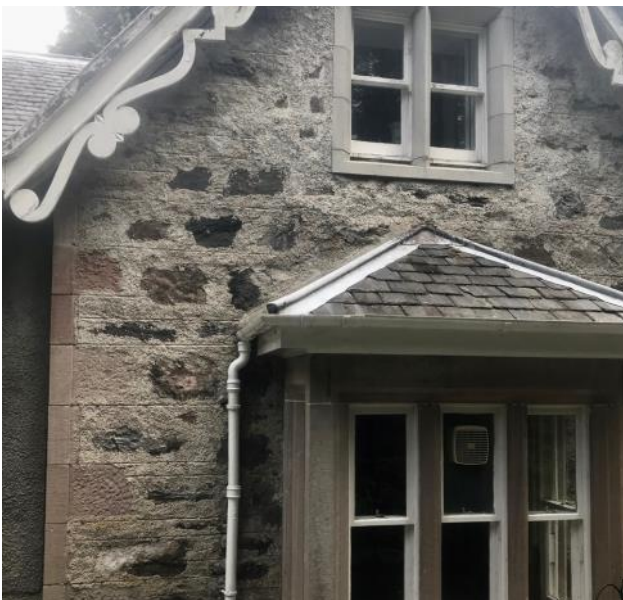
Figure 097.2. Ruled sneck harl.

A Victorian gate lodge built in local whinstone with dressed and raised sandstone quoins, windows and door details (Figure 097.1). The mortar is sneck harled with horizontal ruling out (Figure 097.2). The sneck harl remains largely intact with exception of the recent window alterations.

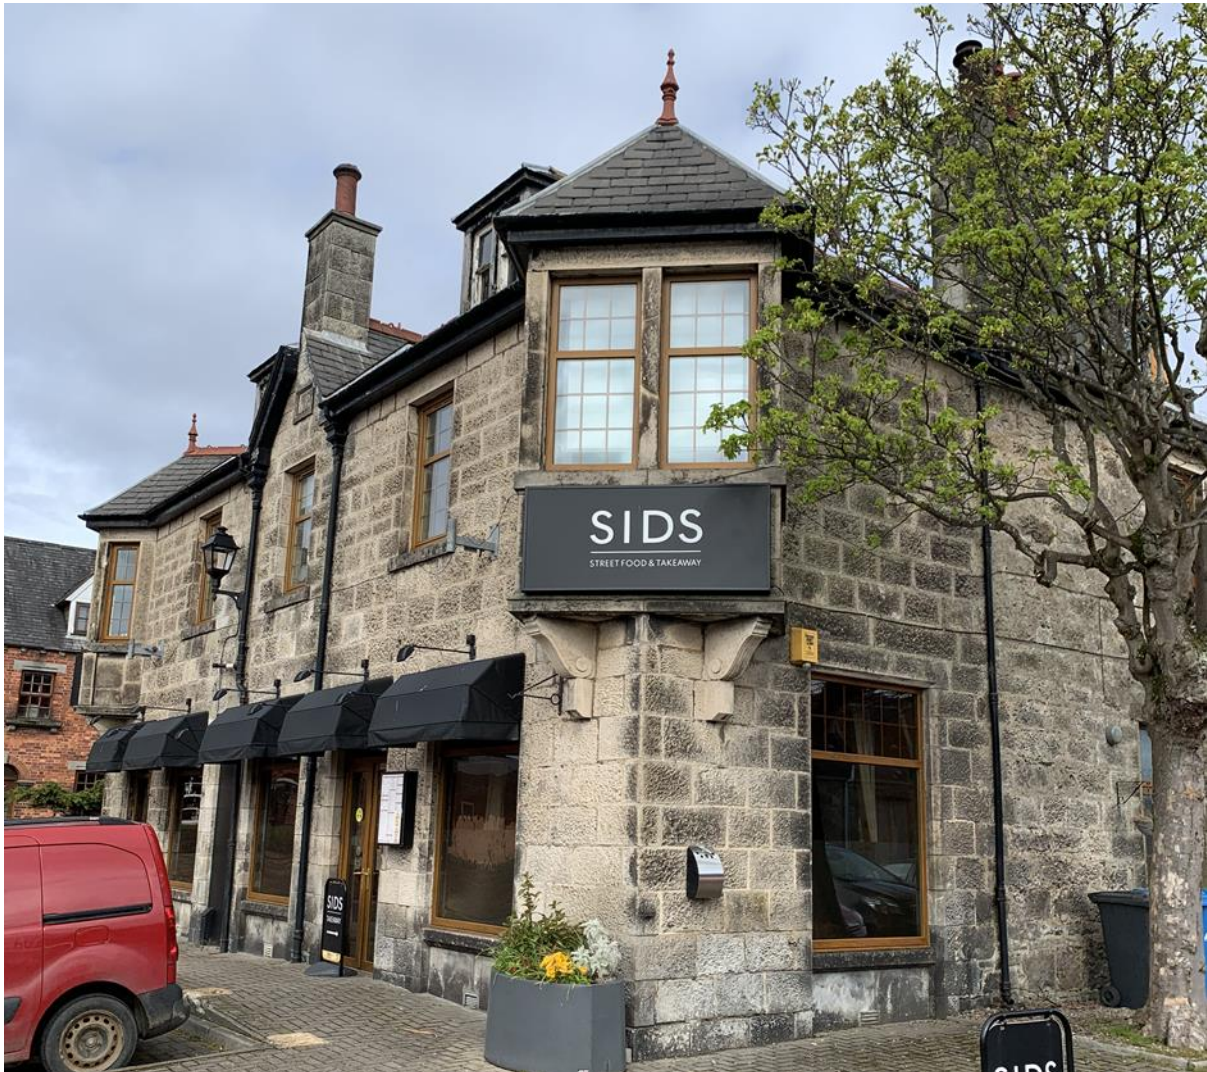
Figure 098.1. The south and east elevations of the building.

This nineteenth century two storey building to the north of the station quadrangle represent a complex narrative of construction with different phases of lime harl and pointing (Figure 098.1). It is likely that the building was altered in the late 19thc with additional windows on the corners. The east and south elevations, over-looking the square and Brora railway station, are constructed with a pale blonde sandstone. The square, regular blocks of stone are broached, flush pointed and ruled out. The mortar is made with medium fine aggregates in the range ~0.5mm - ~5mm and there are lime inclusions (Figure 098.2). The west elevation, overlooking the A9 road, is built with the same regular blocks of stone but have been lime harled (Figure 098.3); recent work is being done in a different style. The evidence suggests that the whole building was previously harled and that on the west elevation the harl was protected and retained by an ivy cover.

At some time harl was removed from the south and east elevations and the joints were pointed.

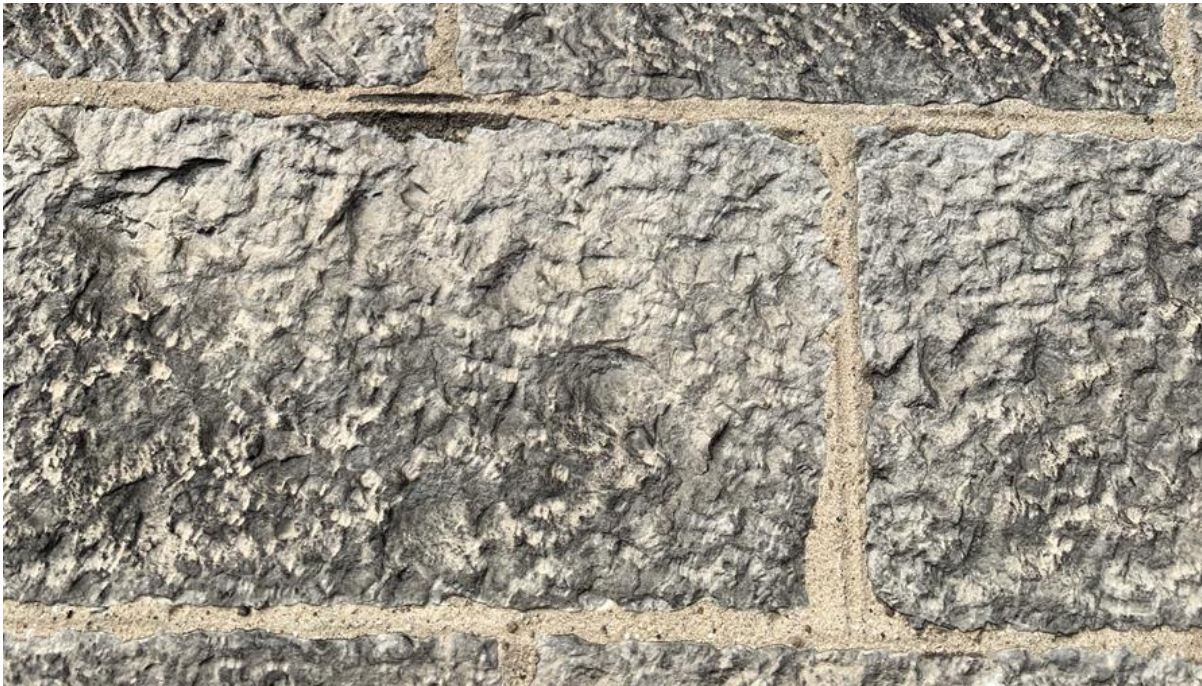
Figure 098.2. Flush ruled lime pointing, also showing aggregate and lime inclusions.

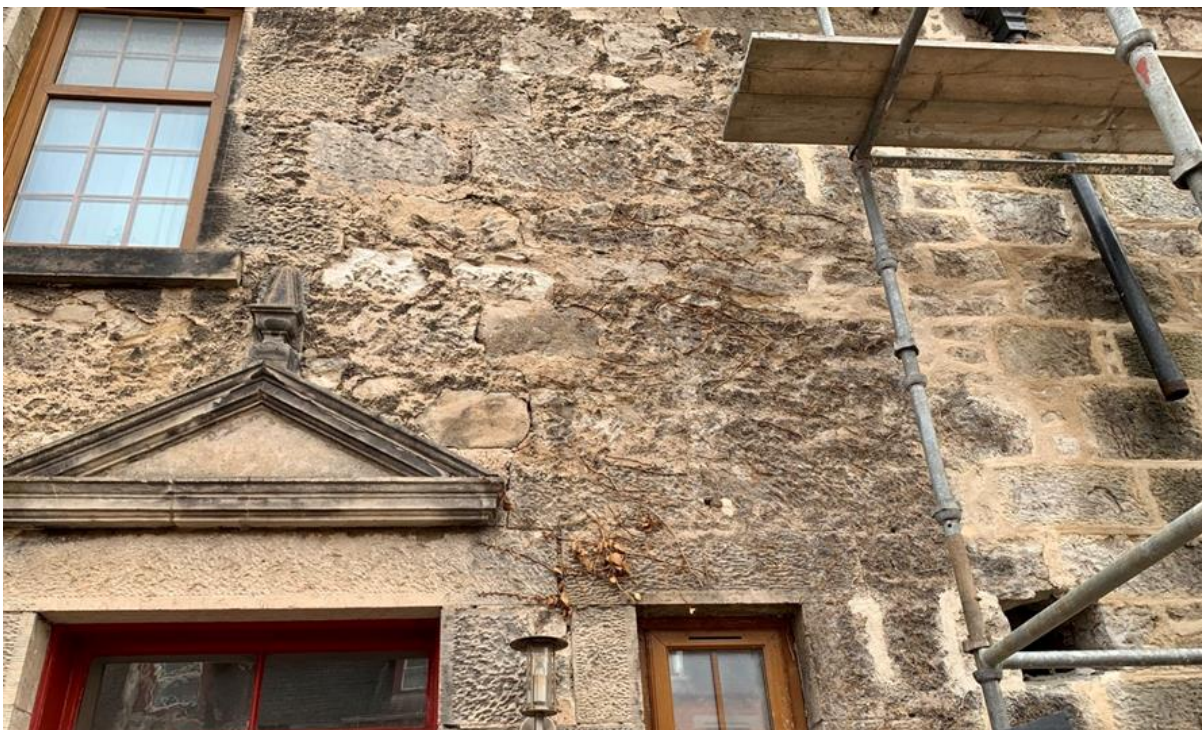
Figure 098.3. West elevation with extant harling to the left and new pointing work to the right, in a modern style.

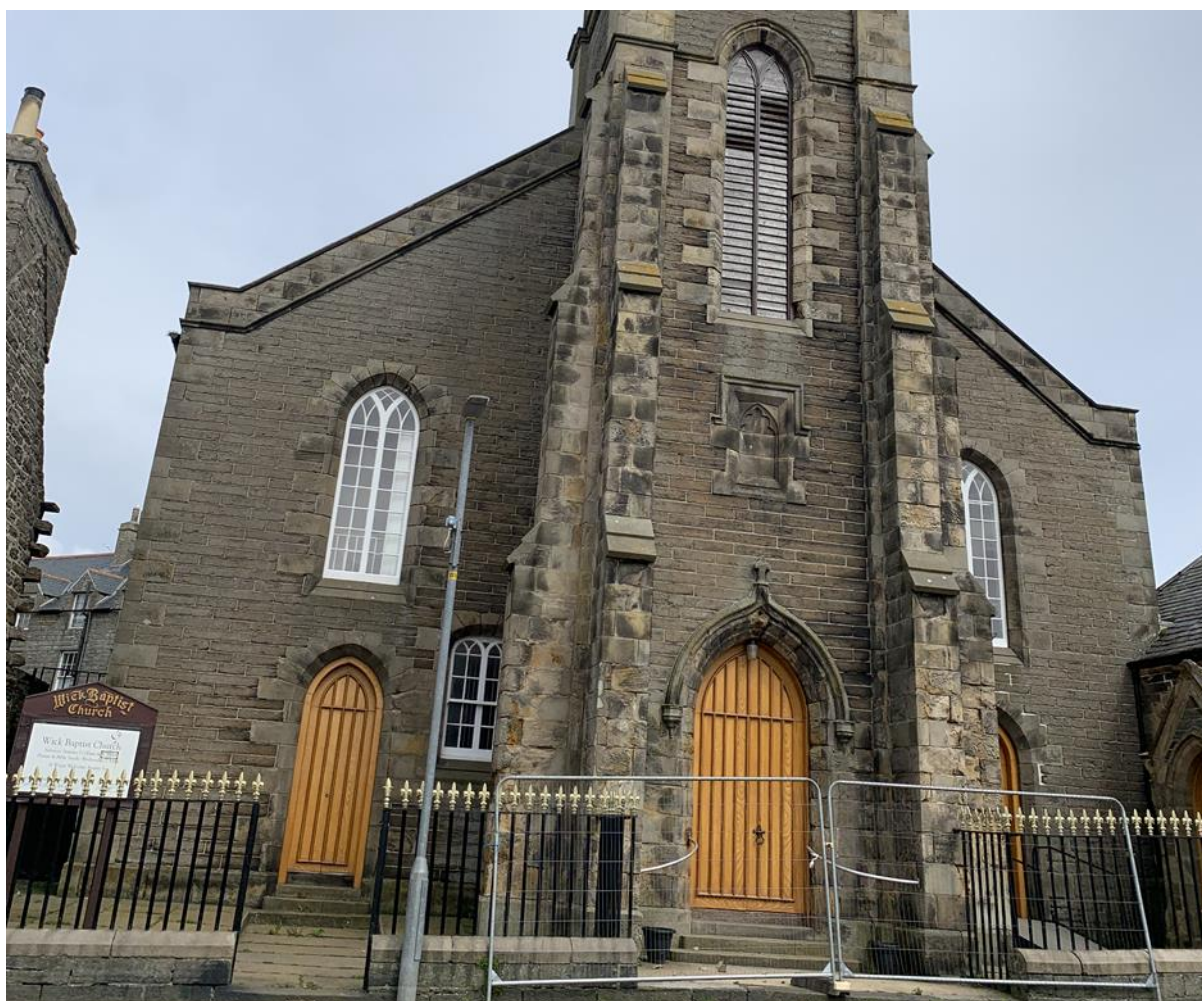
Figure 099.1. Baptist Church, Wick. The main façade on Dempster Street.

The main body of the church (Figure 099.1) was constructed in 1853 for the Free Church of Scotland and the spire was added in 1862. It is Category B Listed. The building was closed for a period before being purchased and refurbished by the Baptist Church in 1998. The masonry is sawn Caithness stone and contrasted with a fine ashlar tower. The sawn blocks were finished flush with a fine and ruled out mortar which for the greater part remains without repair. The pointing was carefully done and even now the ruling out of the junction between the horizontal and perpendicular joints remains crisp and sharp (Figure 099.2). The ashlar, which is very decayed, has a white lime putty 'pencil line' joint that now stands proud of the worn ashlar block (Figure 099.3).

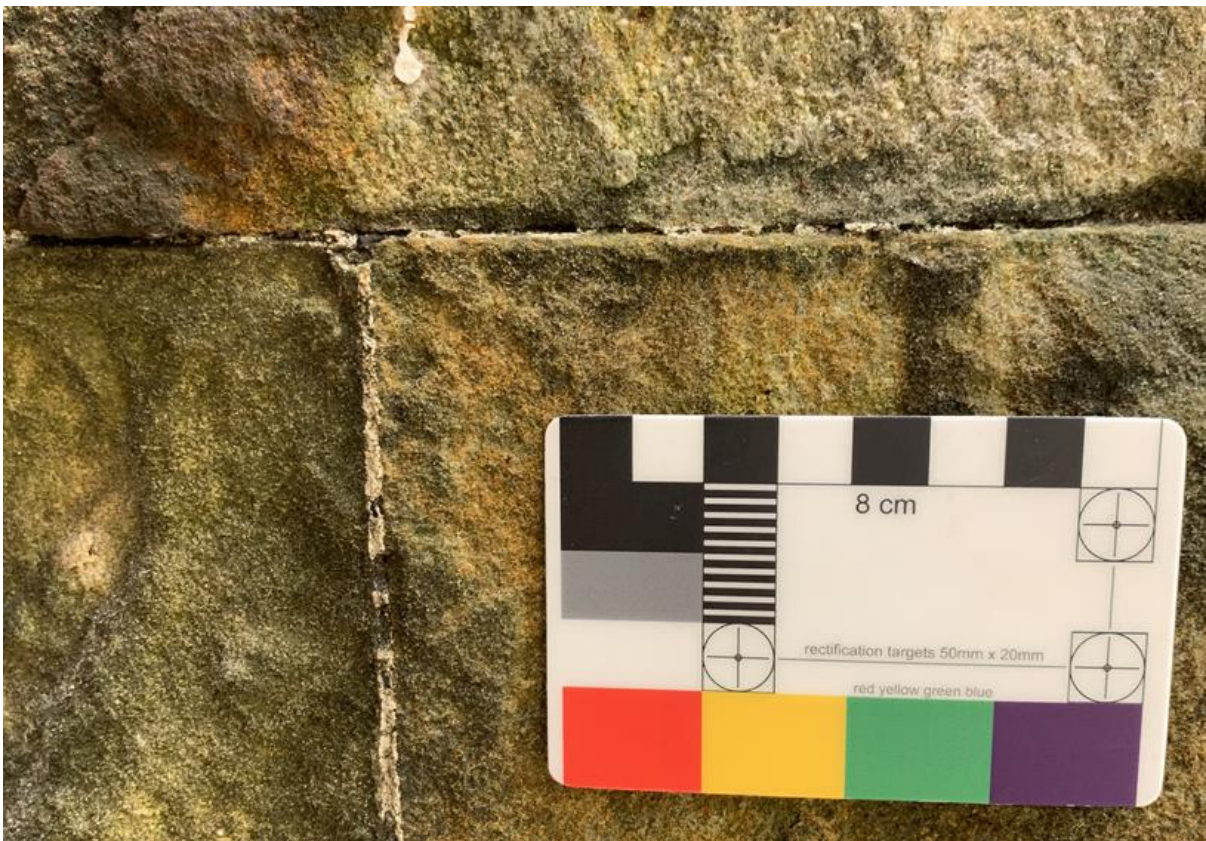
Figure 099.3. Fine ashlar pointing made with a lime putty.

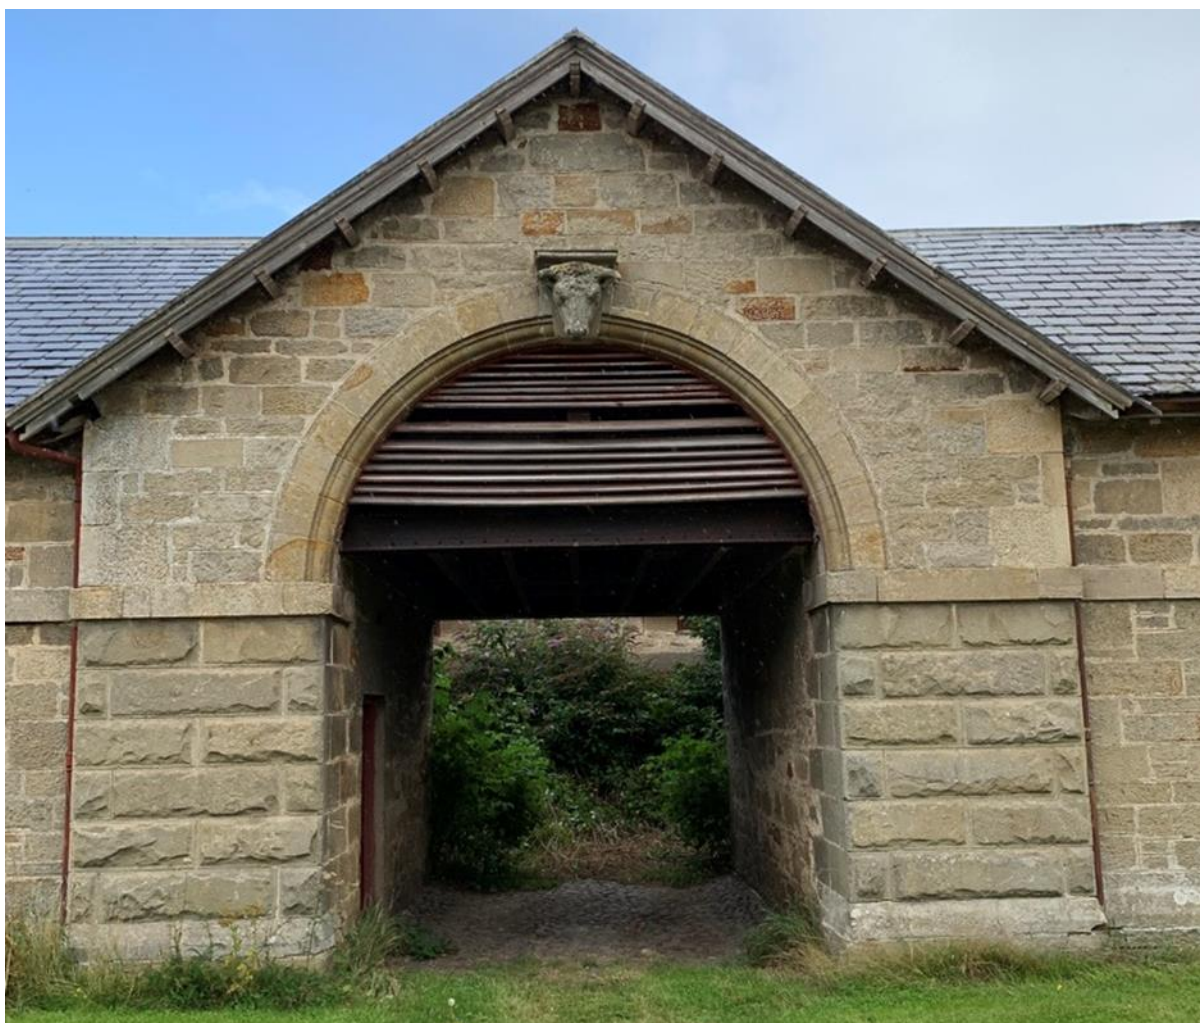
Figure 100.1. The main steading complex facing Kinloss House. Rusticated ashlar blocks containing semi-coursed, sawn-squared blocks of sandstone.

The principal elevation of the steading complex faces Kinloss House (Figure 100.1) and is constructed of sawn, unevenly coursed sandstone

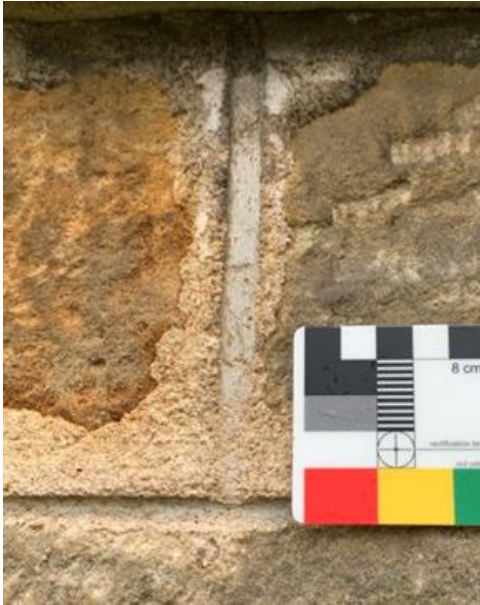
Figure 100.2. Flush pointing ruled out and white lined on the principal elevation.

blocks contained within large, rusticated ashlar blocks with fine ~1 - ~3mm joints. This sawn coursed work was flush pointed, ruled out with a white line applied to the ruled groove, a decorative motif (Figure 100.2), a finish more closely associated with the Scottish central belt.

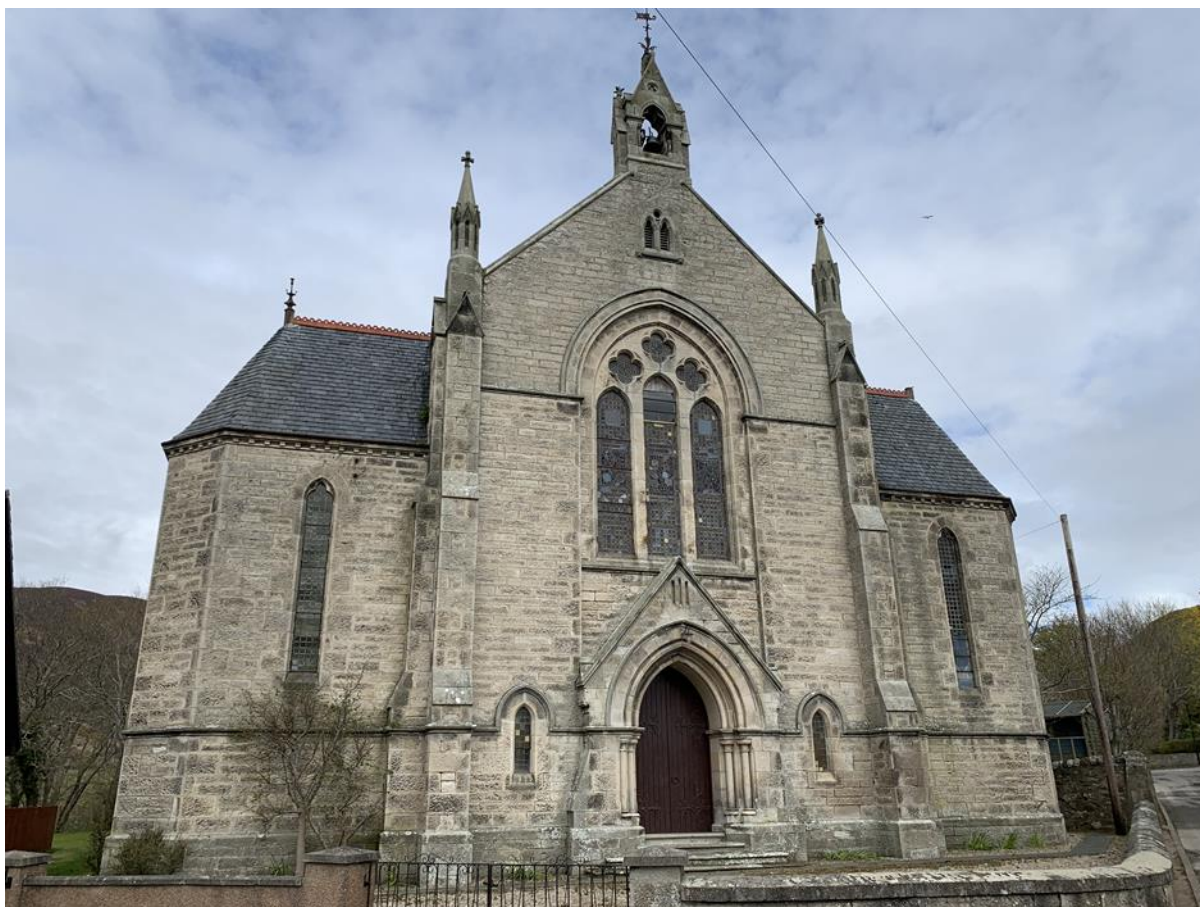
Figure 101.1. The principal elevation of the church.

This Church was built for the Free Church of Scotland between 1890 – 1892. The approach to masonry finishes on this building shows a three-stage hierarchy. The principal elevation and octagonal flanking isles are built with squared, coursed, sawn and stugged blocks of blonde sandstone that are flush pointed and ruled out. The ruling has been applied to the horizontal and perpendicular joints in a mortar made with coarse angular sand and contains lime inclusions (Figure 101.2). Where some of the mortar has broken down in exposed areas it is noticeable that the building and pointing mortar are indistinguishable. The pointing appears to have been undertaken as the building was constructed, referred to as ‘point as you go’.

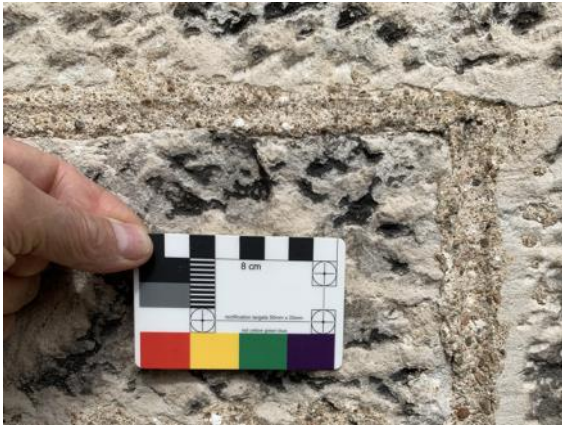
Figure 101.2. Formal mortar on the front elevation, ruled out horizontally and vertically. Also showing coarse aggregate and lime inclusions.

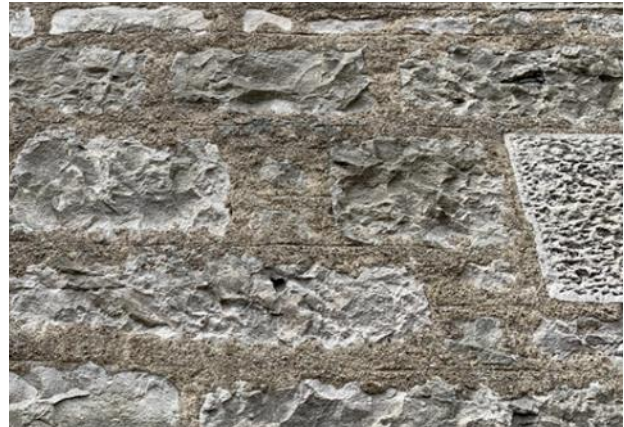
The masonry treatment for the side elevations is less formal with squared roughly dressed coursed blocks of stone. They are sneck pointed and ruled, however the ruling out is horizontal only (Figure 101.3). The associated buildings at the rear of the church may be later additions, constructed in a similar manner to the side but the sneck pointing is more

Figure 101.3. Flush and partly rule horizontal pointing on the side elevations.

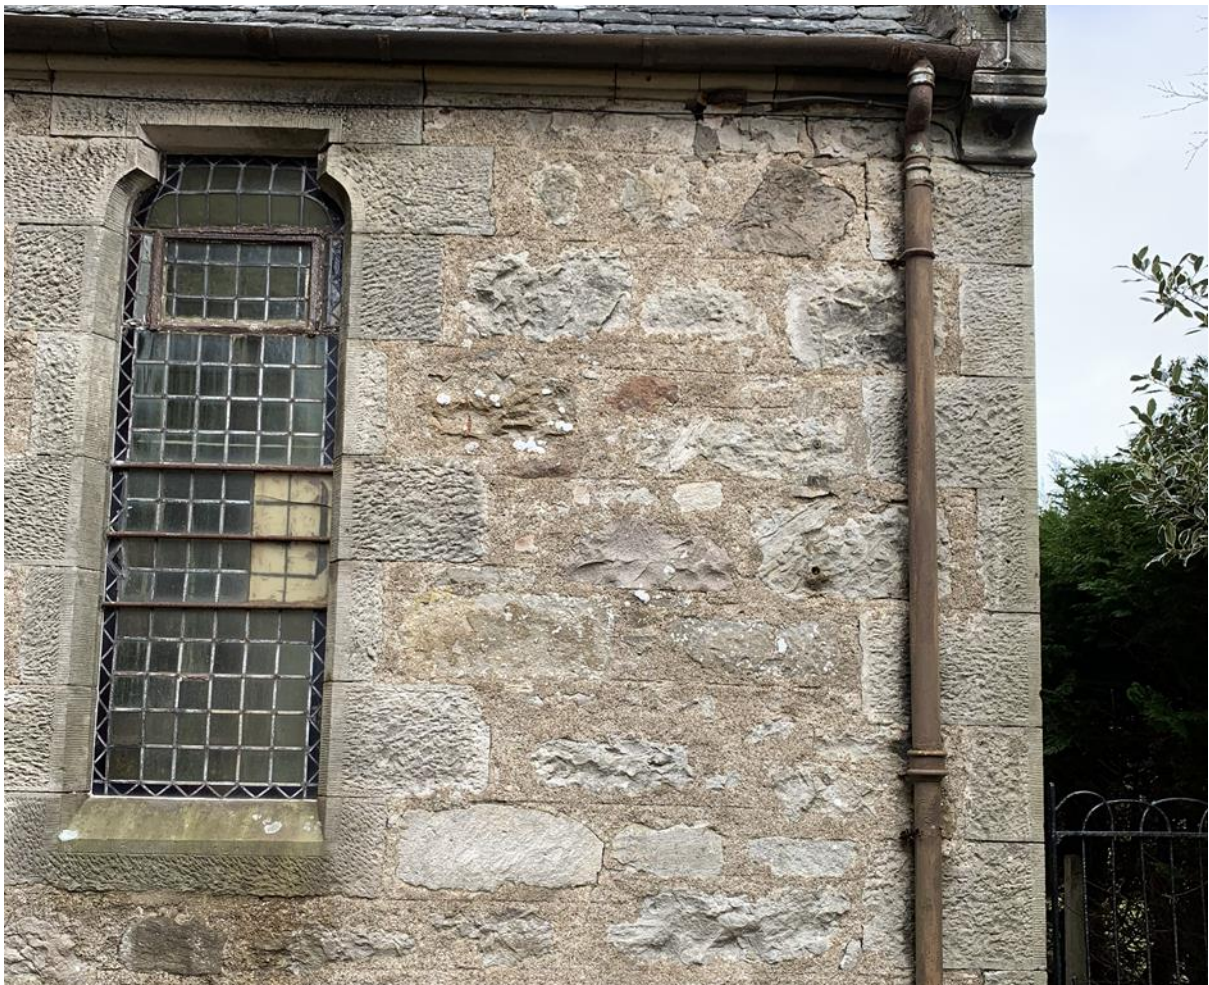
extensive. This also has horizontal ruling out, and as seen in other locations with the ruling out aligned to the course levels between the window jambs and quoins (Figure 101.4).

Figure 101.4. Associated building, wider sneck-pointed rubble, ruled out horizontally aligned with the sandstone dressings.
