TECHNICAL PAPER 33

MASONRY POINTING AND JOINT FINISHING

PART 2 - GAZETTEER

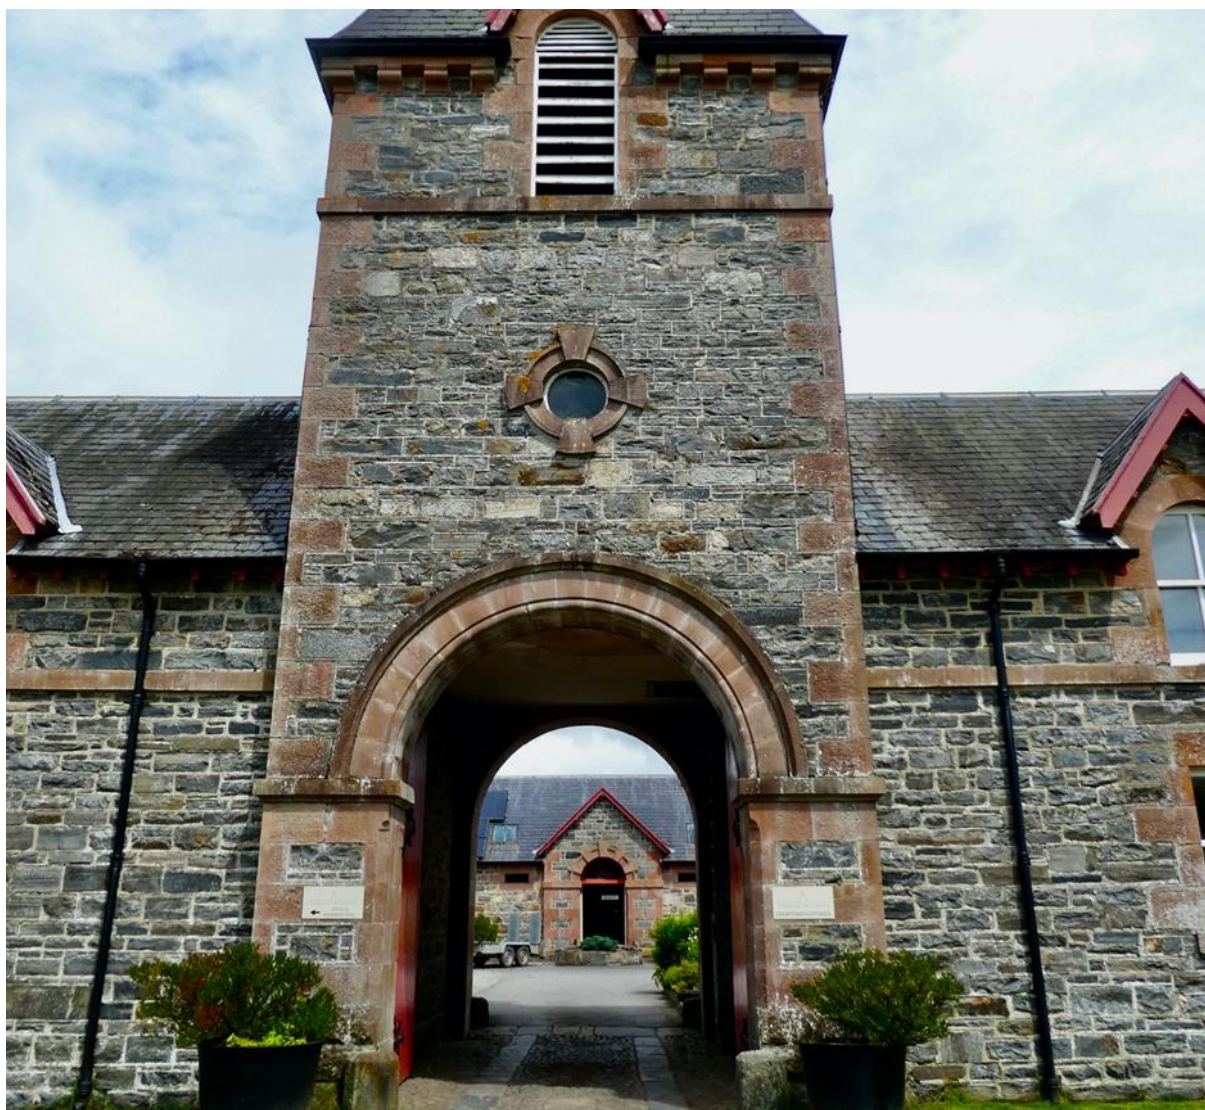
Figure 102.1. Guisachan Farm complex, external elevation of entrance arch.

This farm complex is part of the larger Guisachan Estate and the enclosed quadrangle (Figure 102.1) was unique within the survey for several reasons. Firstly, because of survival of so much of the raised ribbon finish and secondly because of the hierarchy of the different finishes between the outer walls, the inner courtyard and finally because of the associated lime works on the cottages that make up the village of Tomich.

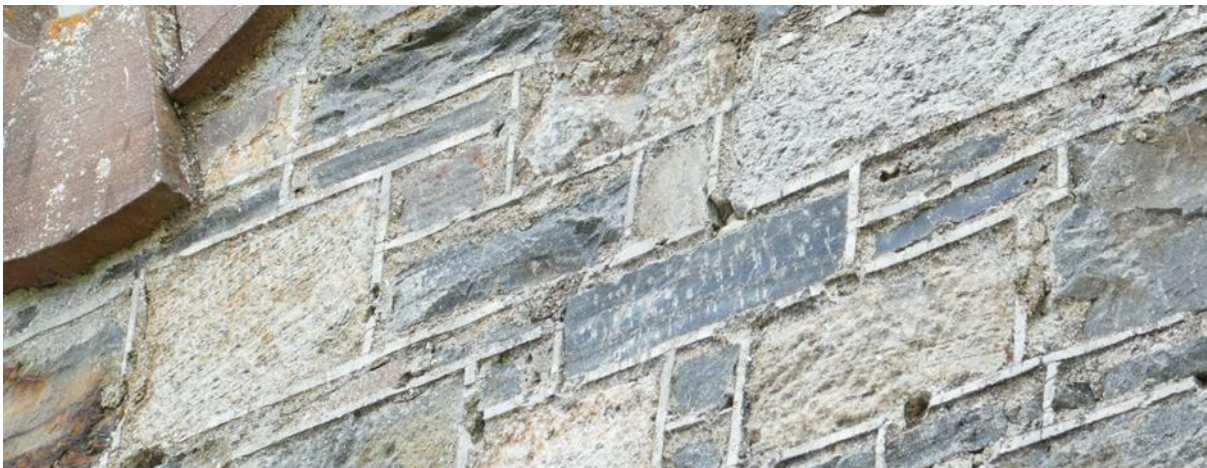
The outer walls of the quadrangle are flush lime finished with a horizontal and perpendicular raised band (Figure 102.2). The inner courtyard is similarly worked but differs in that the raised band is horizontal only (Figure 102.3). The cottages in Tomich are flush finished on the front elevation and ruled out while gables are sneck harled and ruled out (Figure 102.4).

Figure 102.2. Horizontal and perpendicular ribbon work on the front elevation.

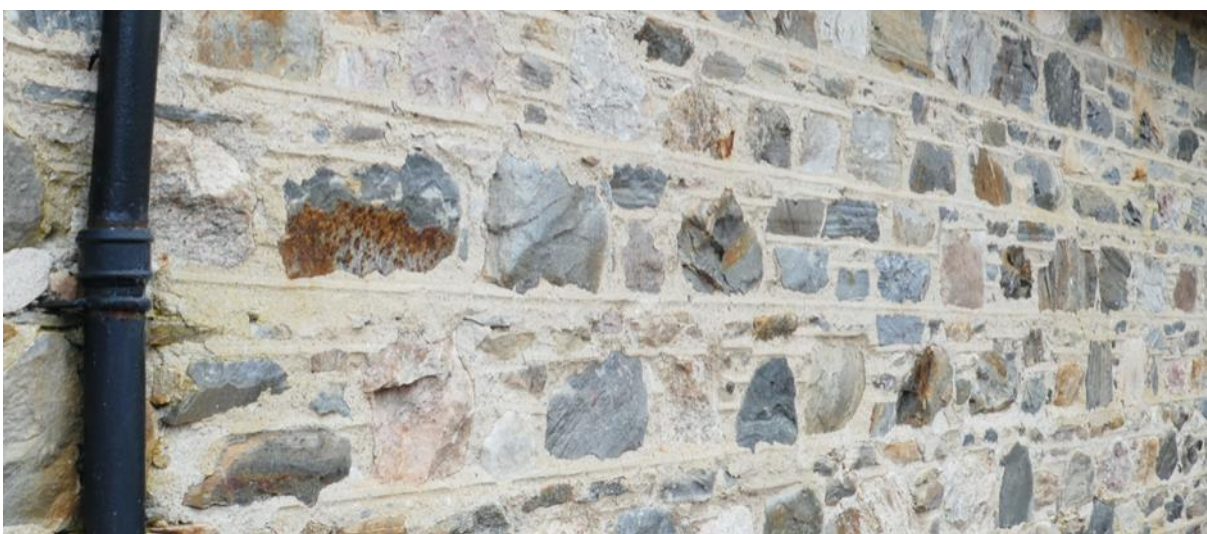
Figure 102.3. Flush ribbon work applied horizontally only on the inner courtyard.

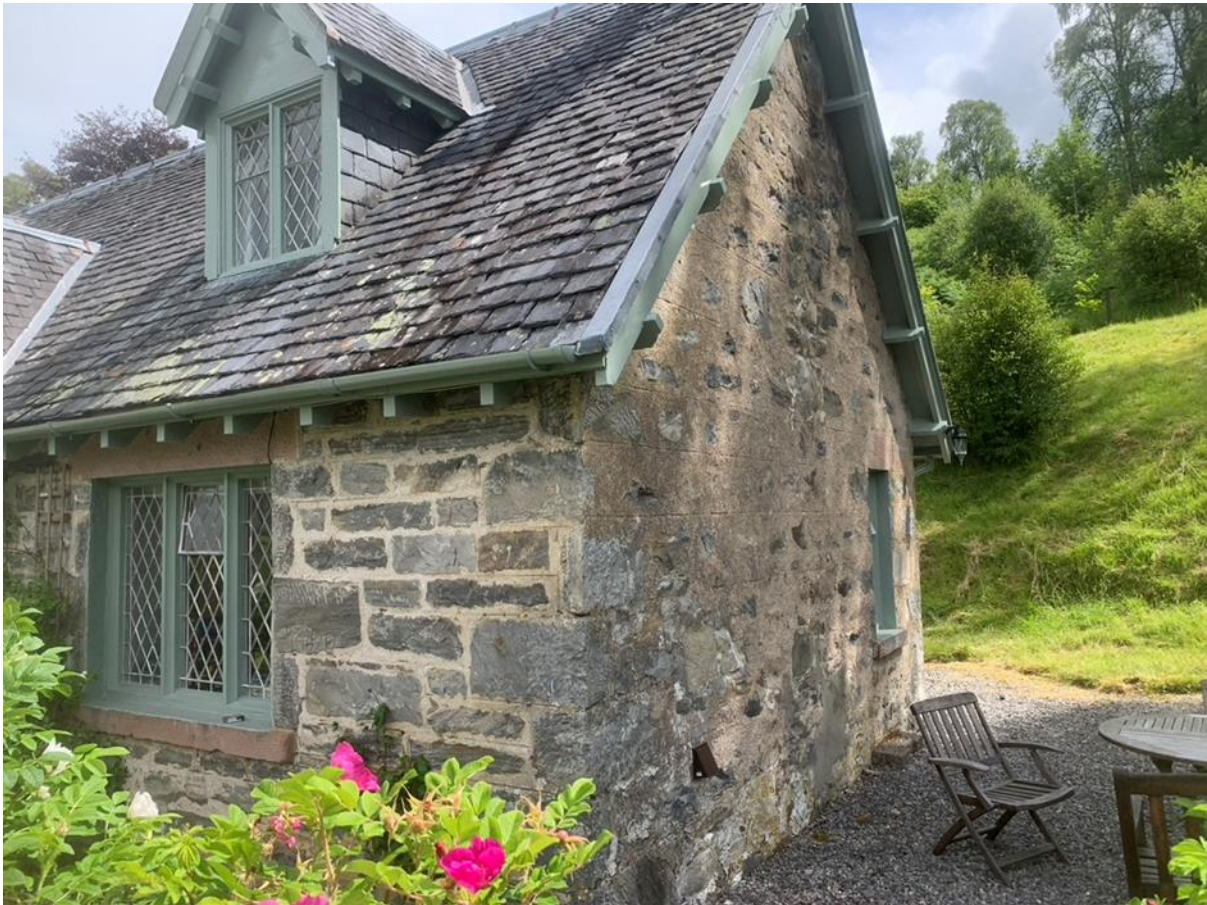
Figure 102.4. Tomich estate farm cottage with ruled flush finish on the front elevation and ruled sneck harl on the gables and rear.

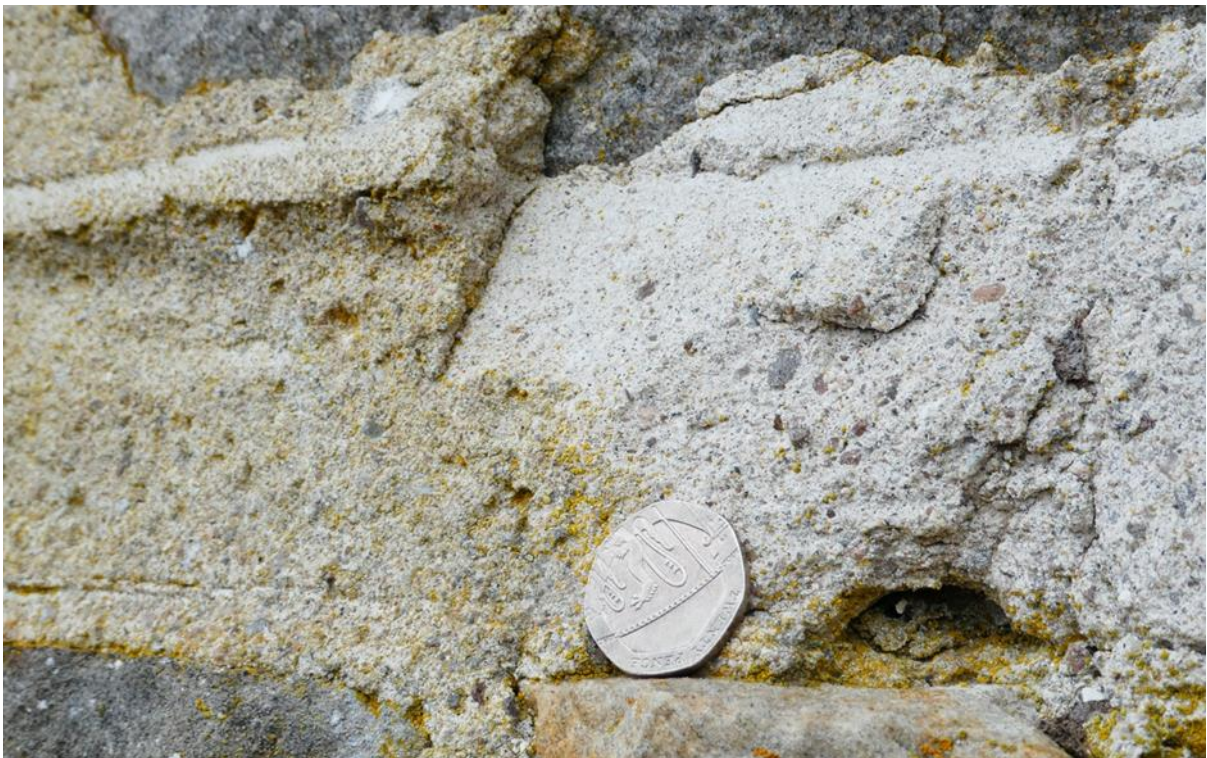
The methods employed were to construct the walls and incorporate a primary finish at the time of building, so the bedding mortar and preliminary straightening of the wall surface are integrated (Figure 102.5). On examination the bond between the ribbon mortar and the preparatory work is good and the finished work is robust suggesting that the straightening work was firm but not without some water content. There is slight difference in appearance in the ribbon work and it may have a hydraulic component.

Figure 102.5. The first flush finish was integrated with the construction work. The final coat was applied once the building work was complete.

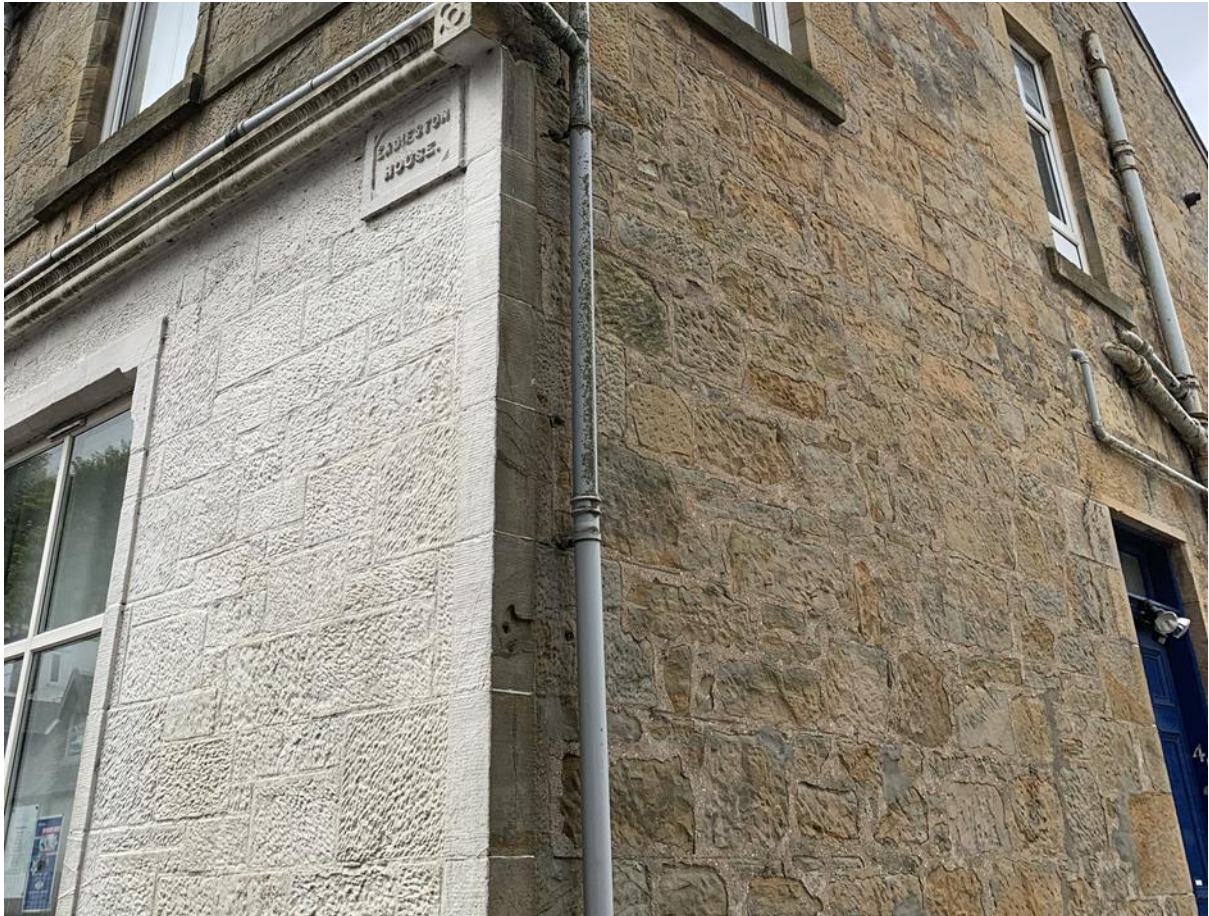
Figure 103.1. Corner of what is now the Semple Centre in Fairlie, showing broad ruled flush pointing to the gable.

This former shop probably dates from the late 19th century (Figure 103.1). The lower part of the front elevation has been painted, but on the gable end the original pointing survives with a broad ruled flush point (Figure 103.2). The aggregates are rounded and contain marine material with lime inclusions. As this elevation is relatively sheltered the pointing is likely to be original.

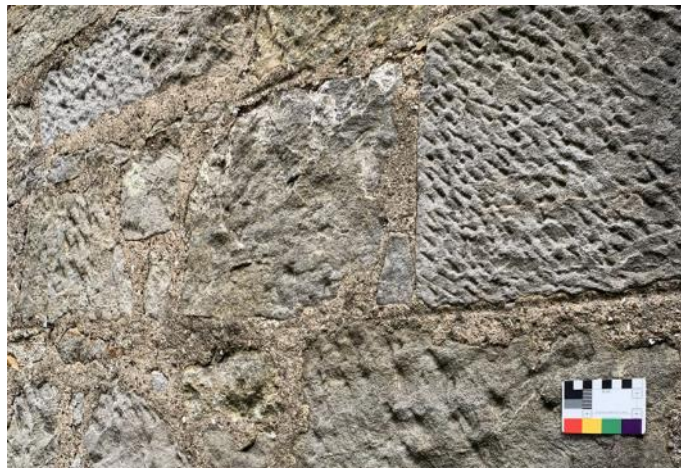
Figure 103.2. Horizontal ruling out on the gable side.

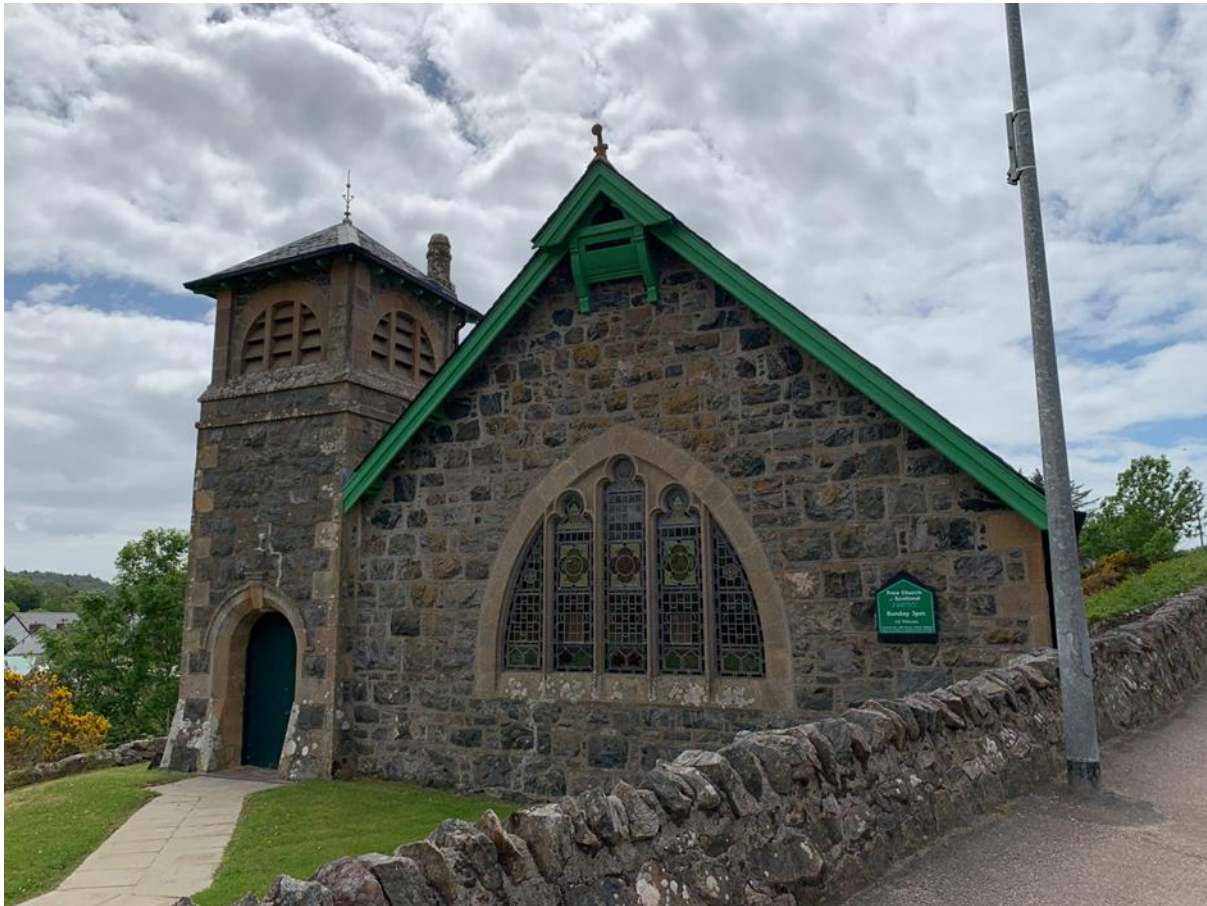
Figure 104.1. The principal elevation of the church.

The Free Church building in Lochinver (Figure 104.1) is located above the town and represents a mid-period Arts and Crafts church built in 1893. Squat in appearance with the main doorway located within the asymmetric tower and it is presented as a whinstone building with sandstone details. The building has been covered extensively with cement slaisterd, raised ribbon pointing, yet with careful scrutiny ample evidence of the former flush lime pointing was located on several elevations (Figure 104.2). The earlier mortar made with fine sand and lime with multiple inclusions (Figure 104.3) was soft and friable and this is likely to have been a contributor to the harder cement mortar replacement. The extant evidence reveals a more extensive cover of the masonry rather than the expression of the bare stone seen today.

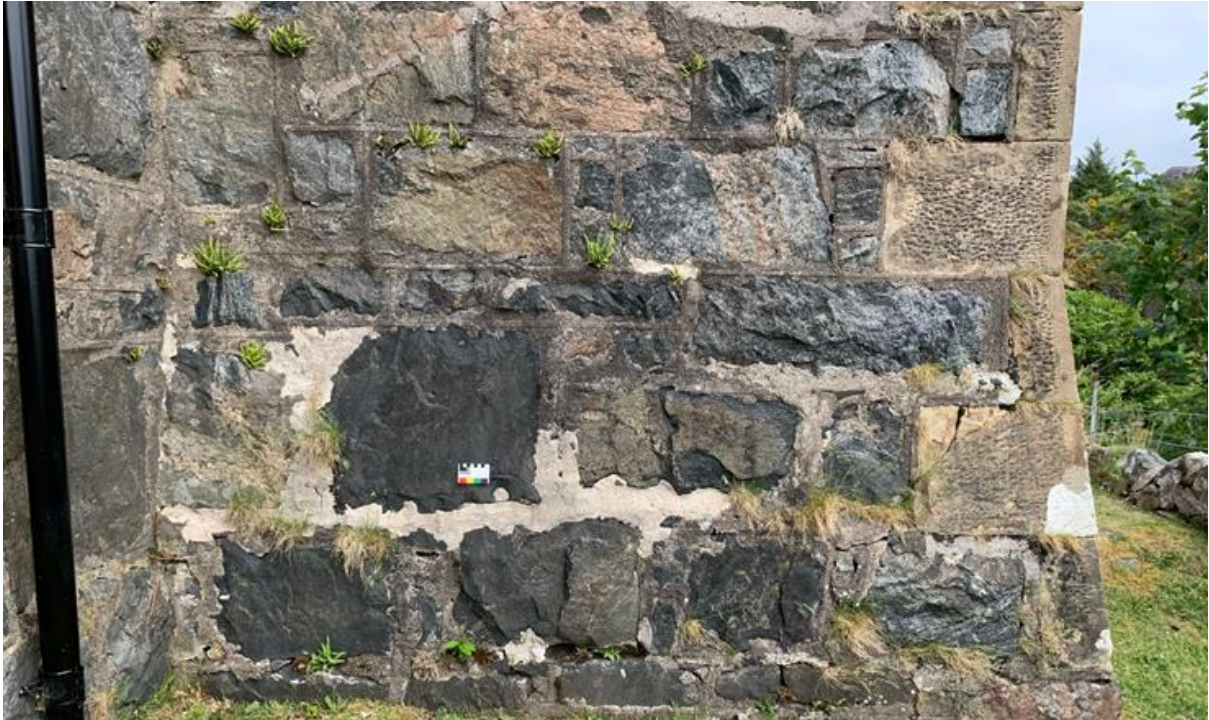
Figure 104.2. Later raised ribbon pointing seen in the upper part of the image, with earlier flush pointing seen lower down, showing much brighter.

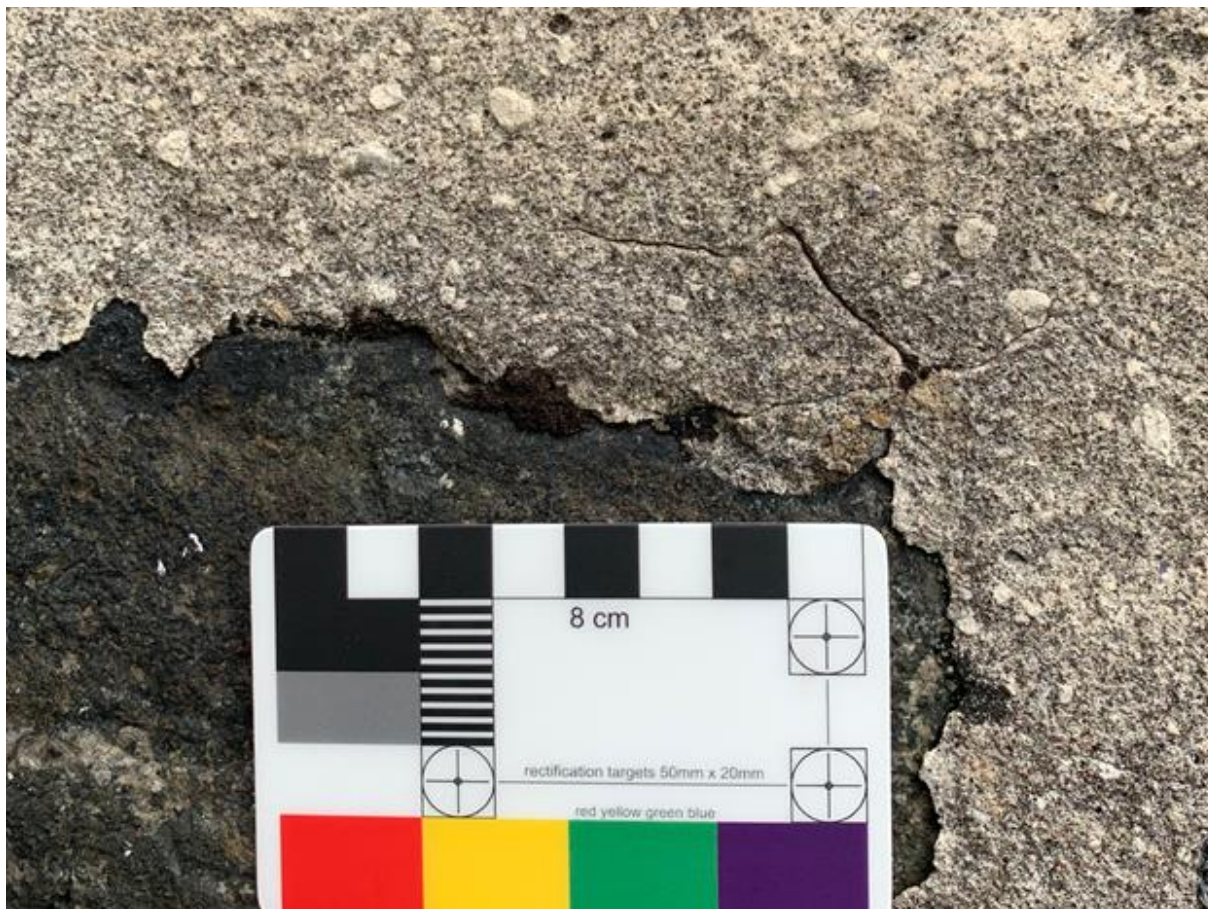
Figure 104.3. Soft lime pointing with multiple lime inclusions. This earlier style covered much more of the whinstone than the later pointing.

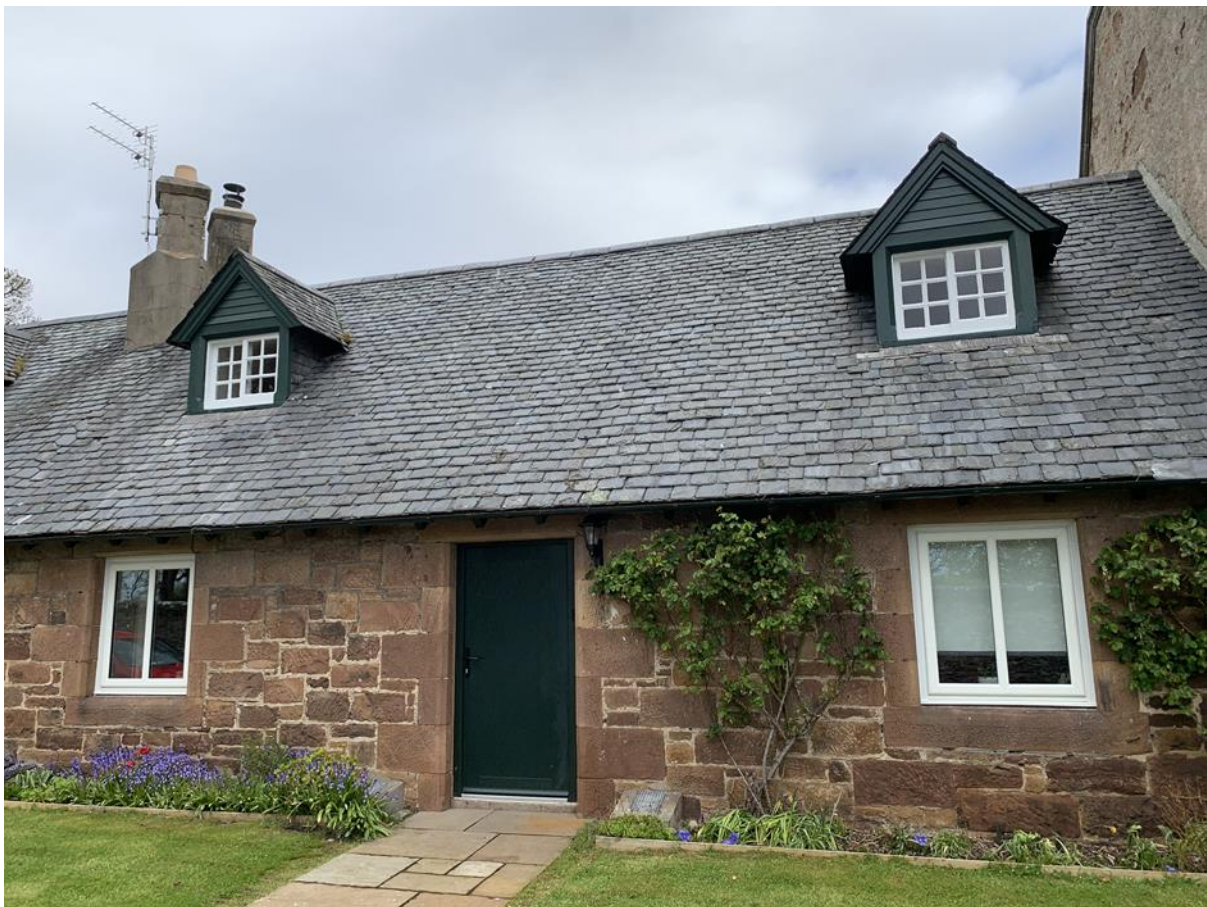
Figure 105.1. Front façade of the cottage.

This cottage is one of three estate cottages contained within a terrace at Golspie. They probably date from the late nineteenth century. The cottage is one and a half storeys, with two dormers (Figure 105.1). It is constructed with squared red sandstone, flush pointed and ruled out horizontally and vertically. The mortar made with fine to medium sharp aggregates and containing lime inclusions (Figure 105.2).

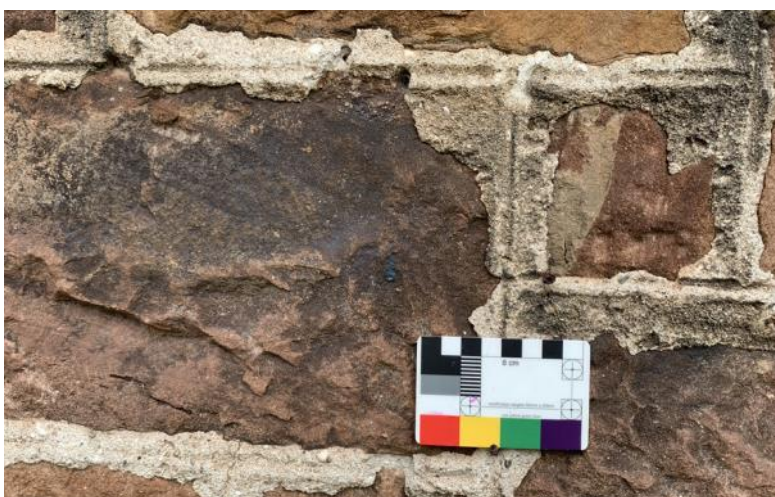
Figure 108.5. Flush-pointed and ruled out mortar, showing the aggregate and lime inclusions.

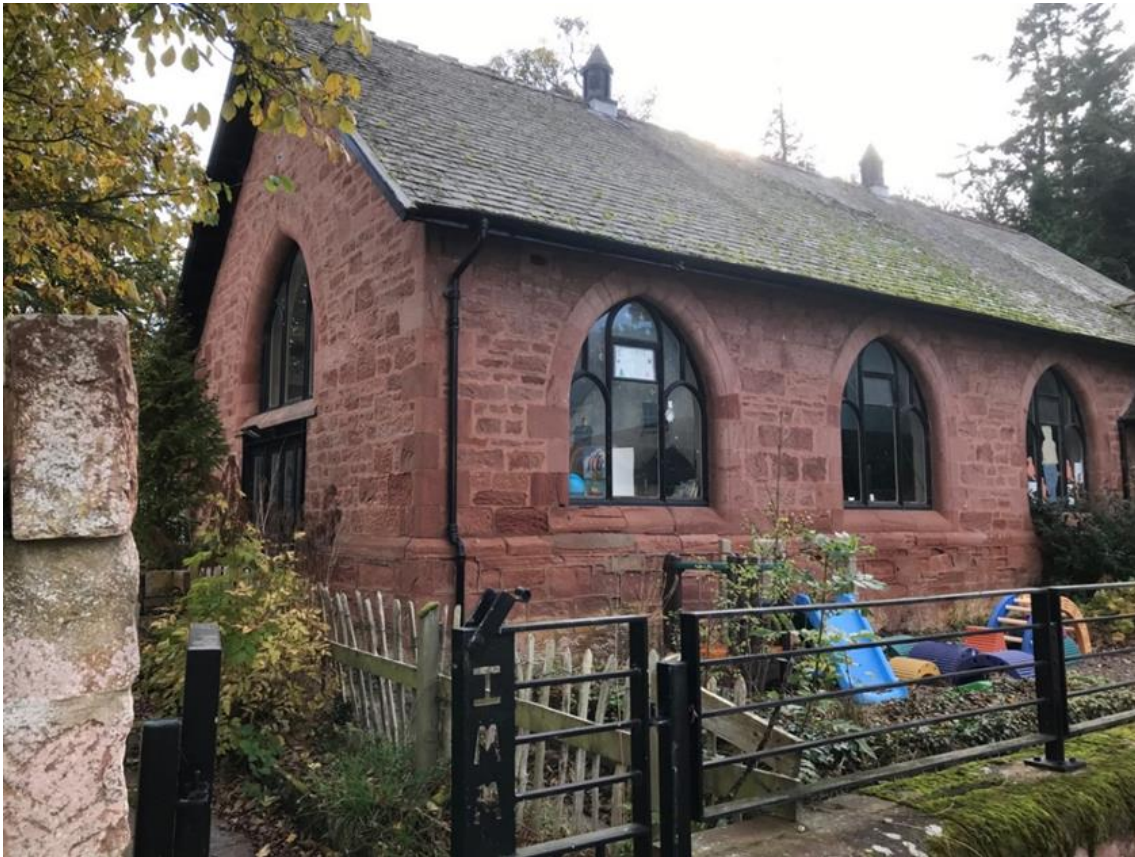
Figure 106.1. View of hall from the northwest.

Single storey 4 bay hall built in c. 1898 of red sandstone rubble with broached ashlar dressings (Figure 106.1). The Hall is flush finished with horizontal and perpendicular ruling out (Figure 106.2). This was achieved with a broad half round tool, possibly a metal bucket handle. The mortar is pigmented to appropriate the colour of the local sandstone. The sand grading ranges sub 1-6mm and has rounded aggregate with shell inclusions (Figure 106.3). Cromarty is a marine environment, making this unsurprising. The pointing and stonemasonry above the scarcement remains in good condition with no apparent repairs. This is robust to touch but will abrade with pressure from the fingers. On and below the scarcement there is considerable decay of the stone and the pointing.

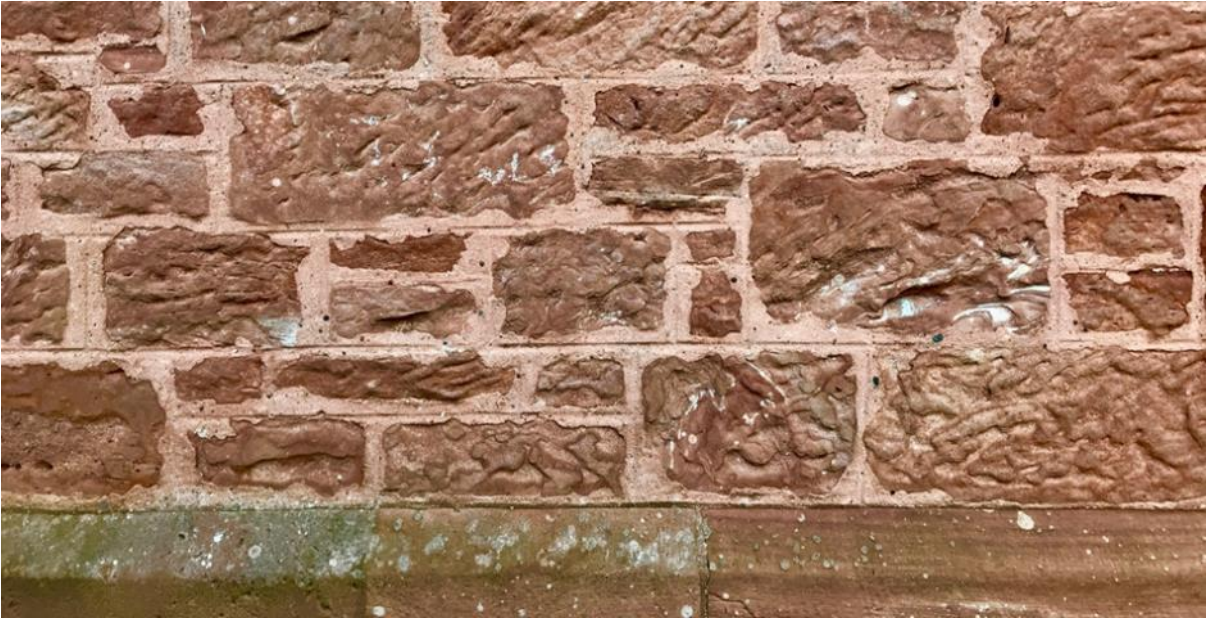
Figure 106.2. Pink flush finish with horizontal and perpendicular ruling out.

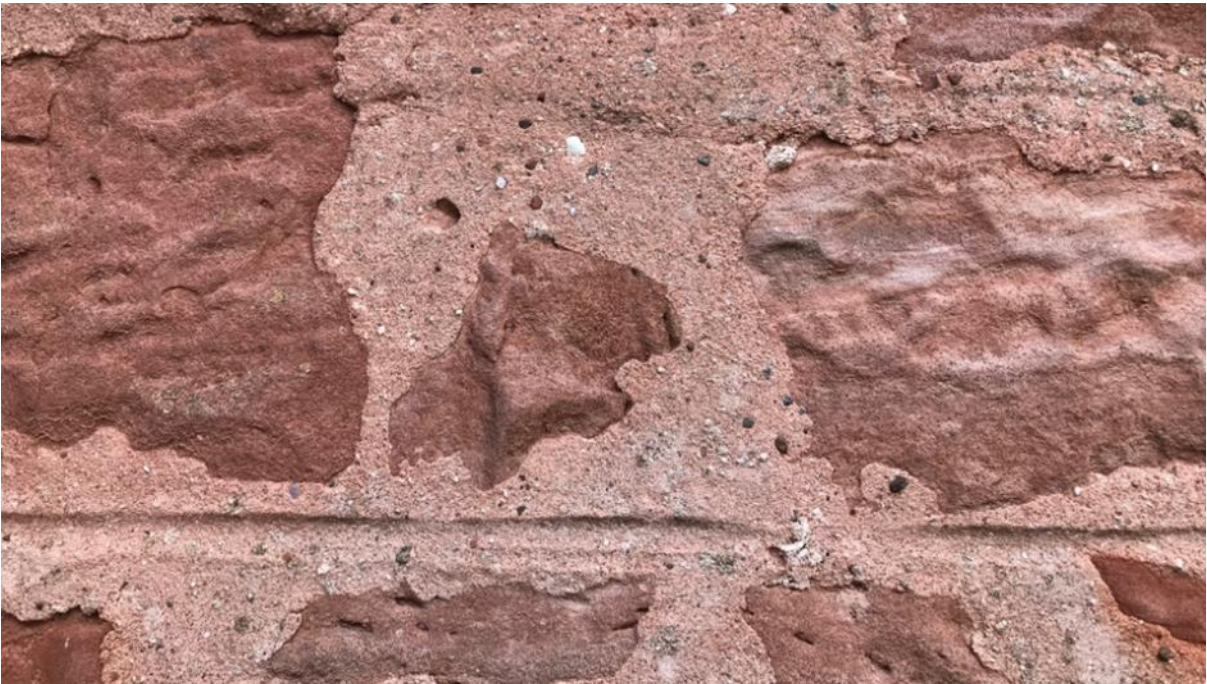
Figure 106.3. Fine and coarse sand with shell inclusions.

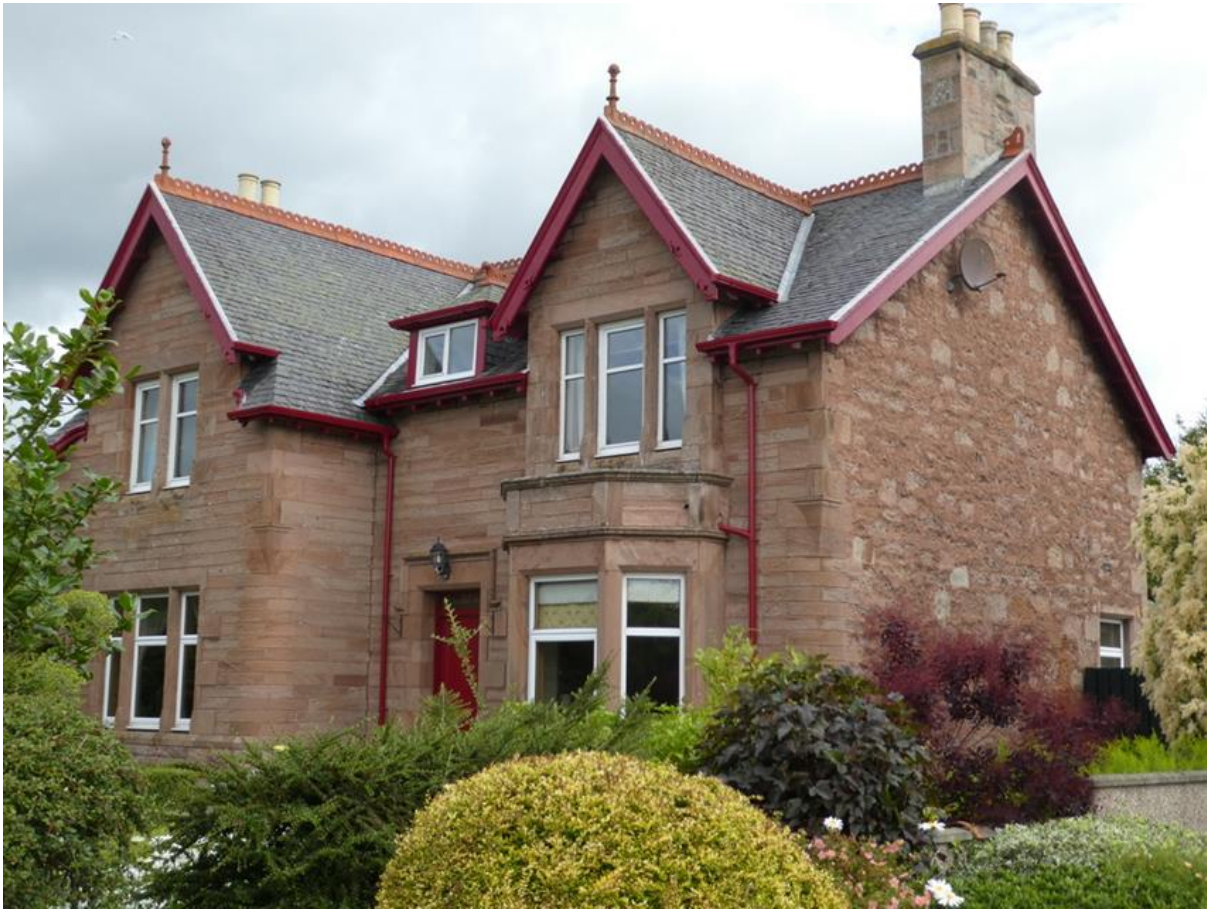
Figure 107.1. The villa main elevation with red tinted mortars for finishing.

Late Victorian villa c.1890 constructed of local, buff/red sandstone (Figure 107.1). Ashlar front with rubble gable and rear linked by a round-to-square on the southern corner (Figure 107.2). The ashlar has a pink coloured mortar with half round rule, much as bricklayer would make today. The gable is sneck harled, also with a coloured mortar (Figure 107.3). This was likely to have been one of the last major buildings constructed with lime on the Black Isle. The aggregates are sharp and angular in the range 1mm – 8mm.

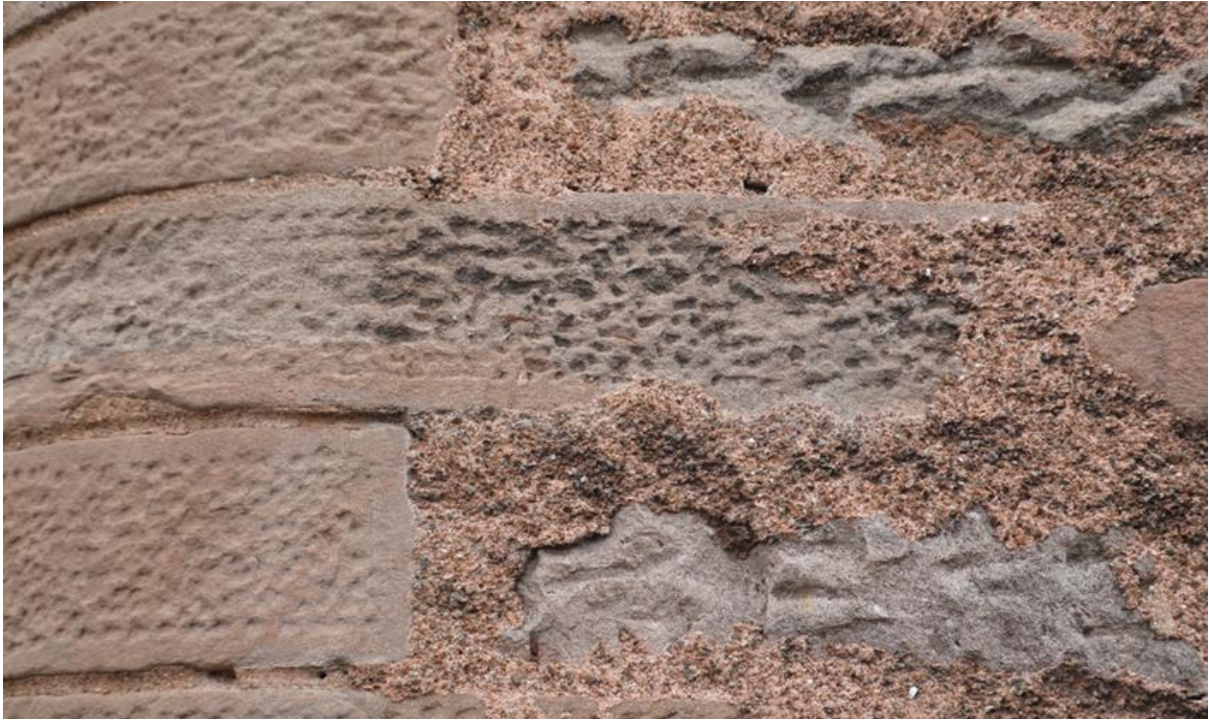
Figure 107.2. Coarse pink mortar used for both the ashlar work and the sneck harl.

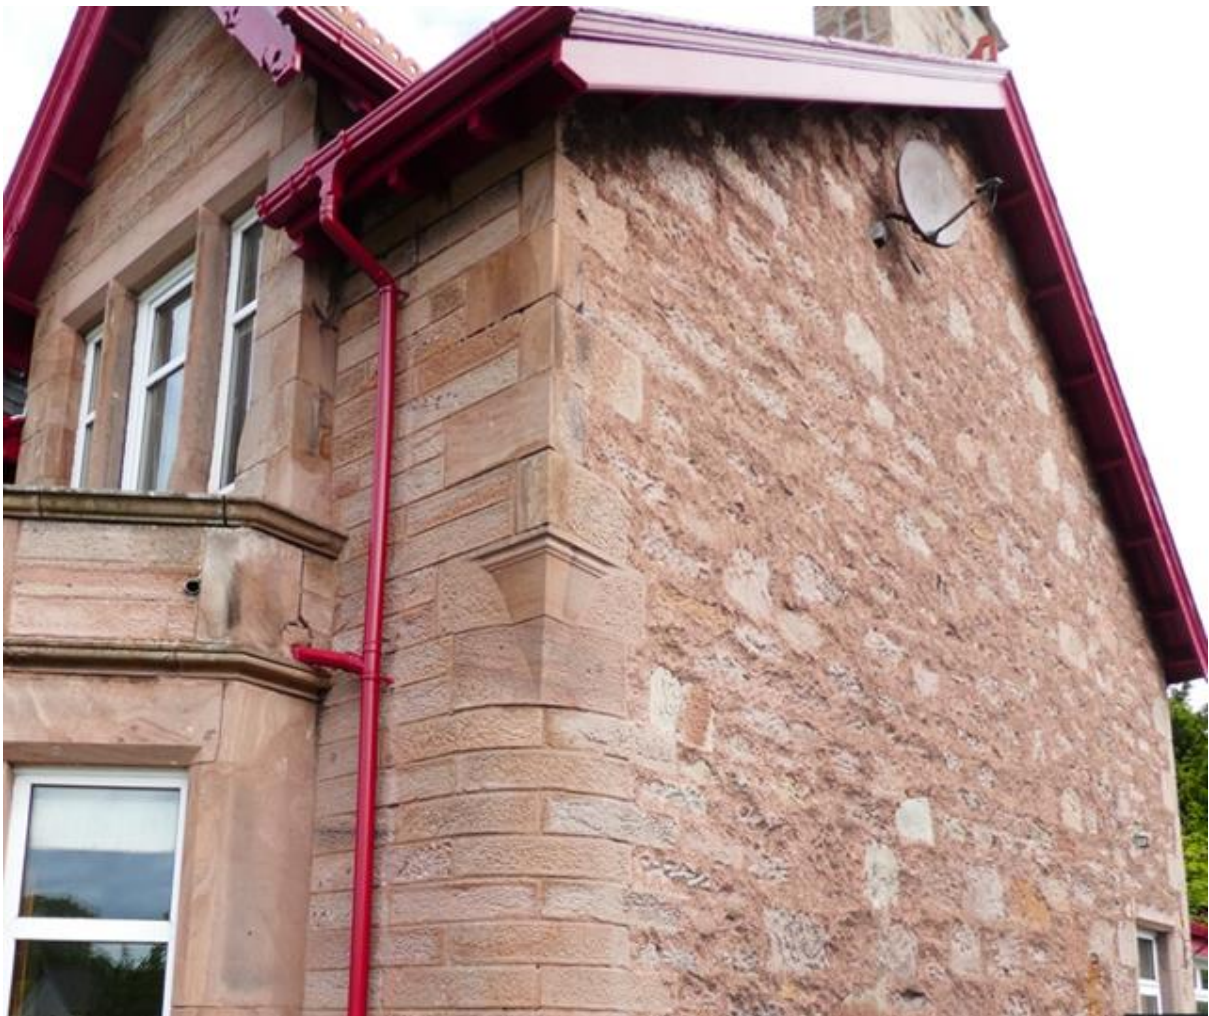
Figure 107.3. Round-to-square, ashlar front with sneck harled rubble gable.

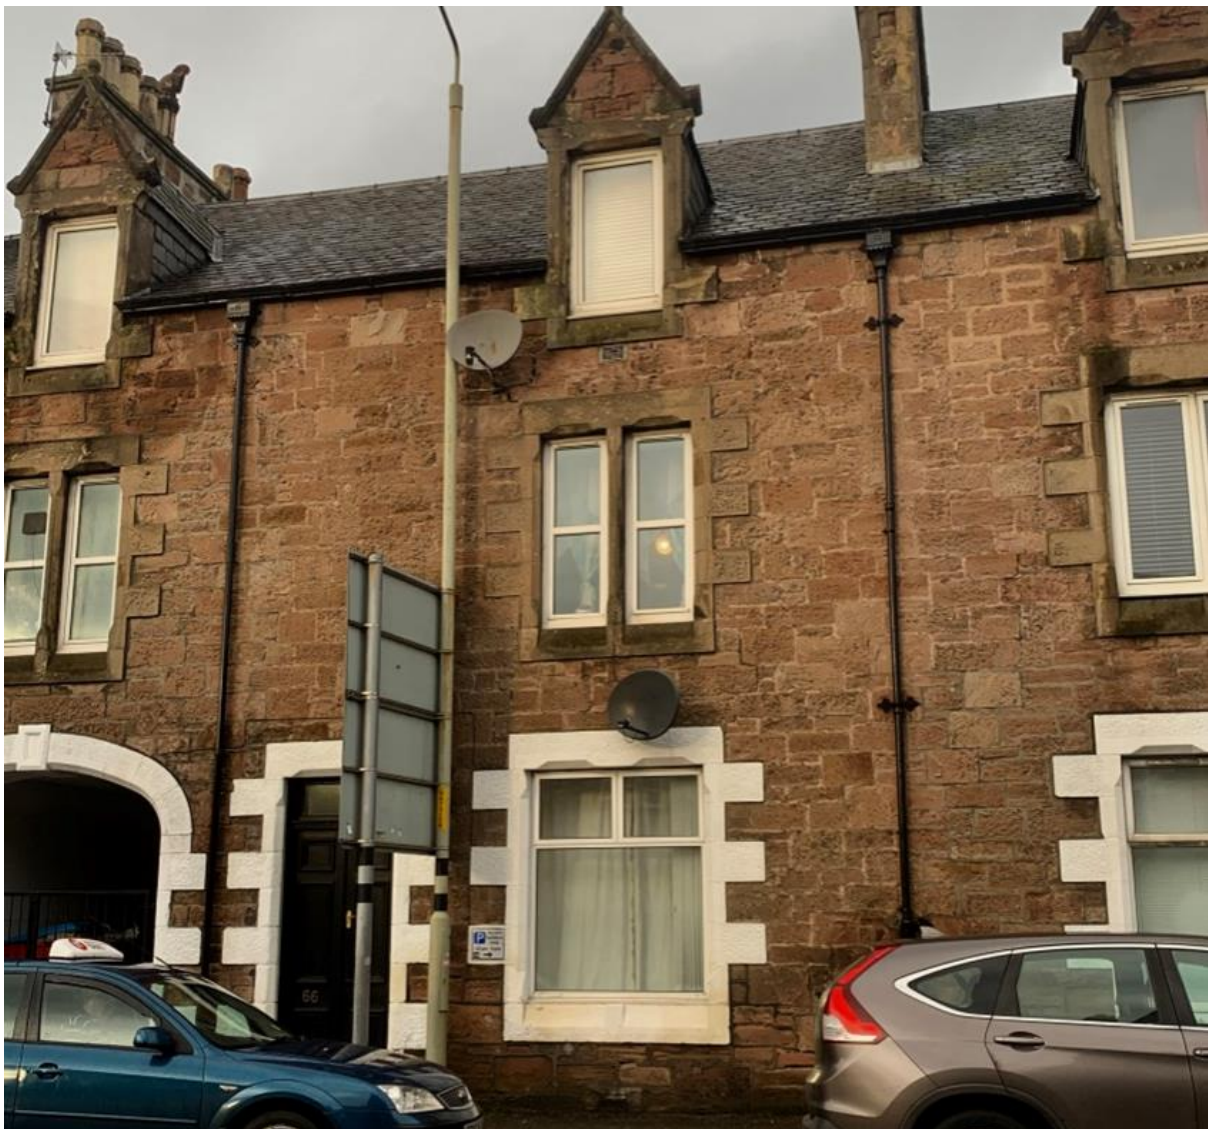
Figure 108.1. Elevation from the southeast.

Victorian mid-terrace house with buff coloured, rusticated details at the windows and doors. Otherwise, the house is generally built with red sandstone with some agglomerates (Figure 108.1). The flush finish extends well beyond the joint width with pink tinted mortar. The finish is horizontally and perpendicularly ruled (Figure 108.2). The mortar is decayed and displays evidence of salt and soot damage. The size of the aggregates are in the range of 1-6mm with a mix of rounded and angular profiles.

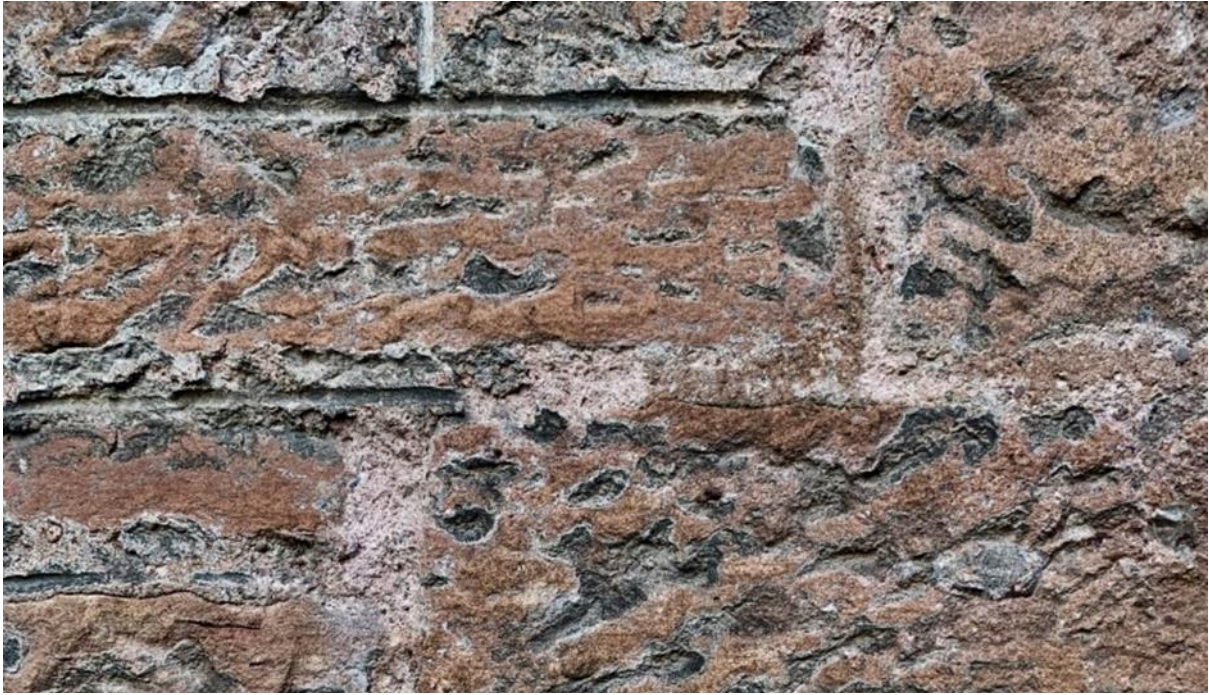
Figure 108.2. Horizontally and perpendicularly ruled flush finish.

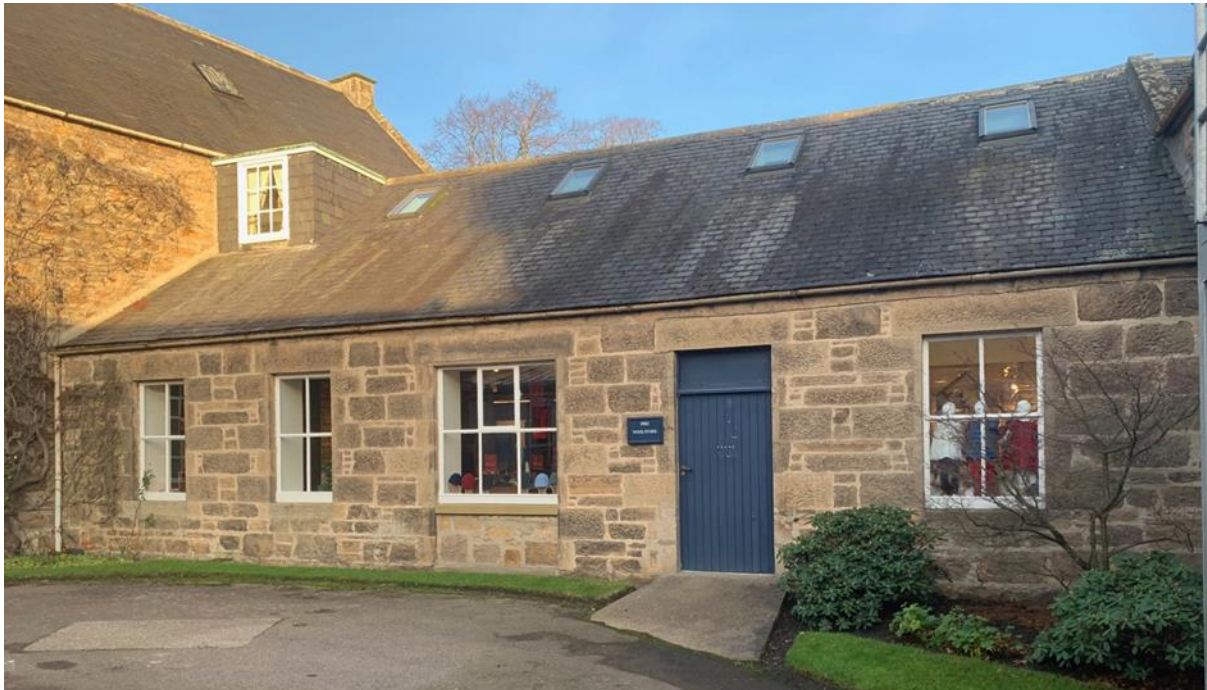
Figure 109.1. The 'Wool Store' elevation.

The complex of buildings was built in the late Georgian period but the 'Woolstore' is Victorian (Figure 109.1). Sandstone with flush 'droved' margins and broached sawn rubble. The flush finish has been horizontally ruled out. The mortar is of coarse angular gritty sand in the range of 1-7mm, (Figure 109.2).

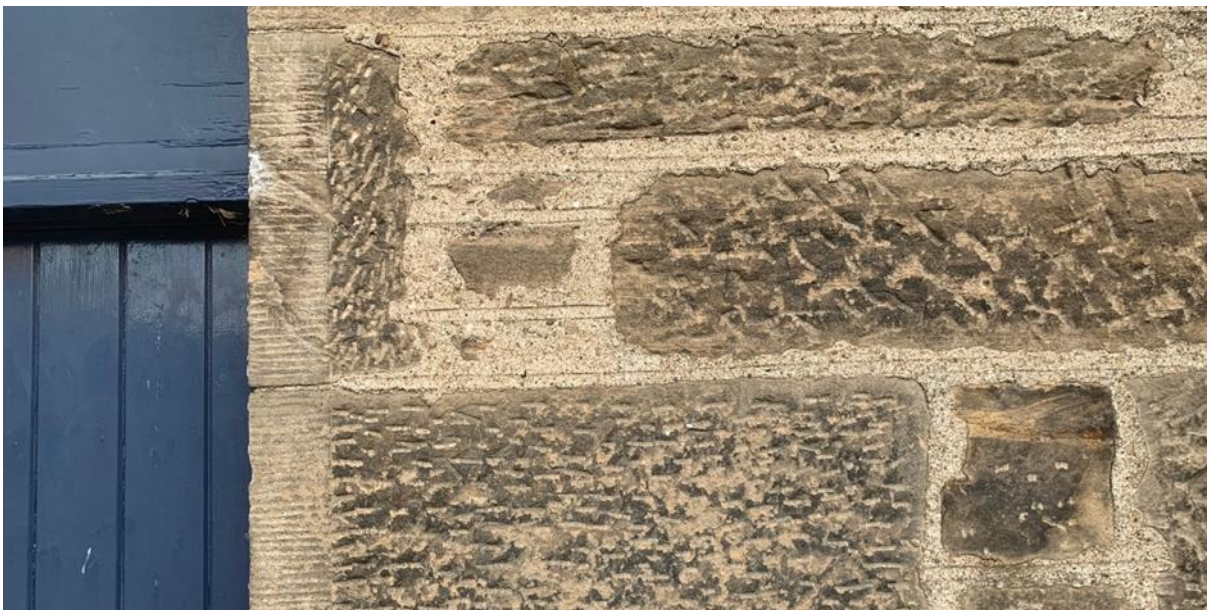
Figure 109.2. The flush finish and horizontal lining out.

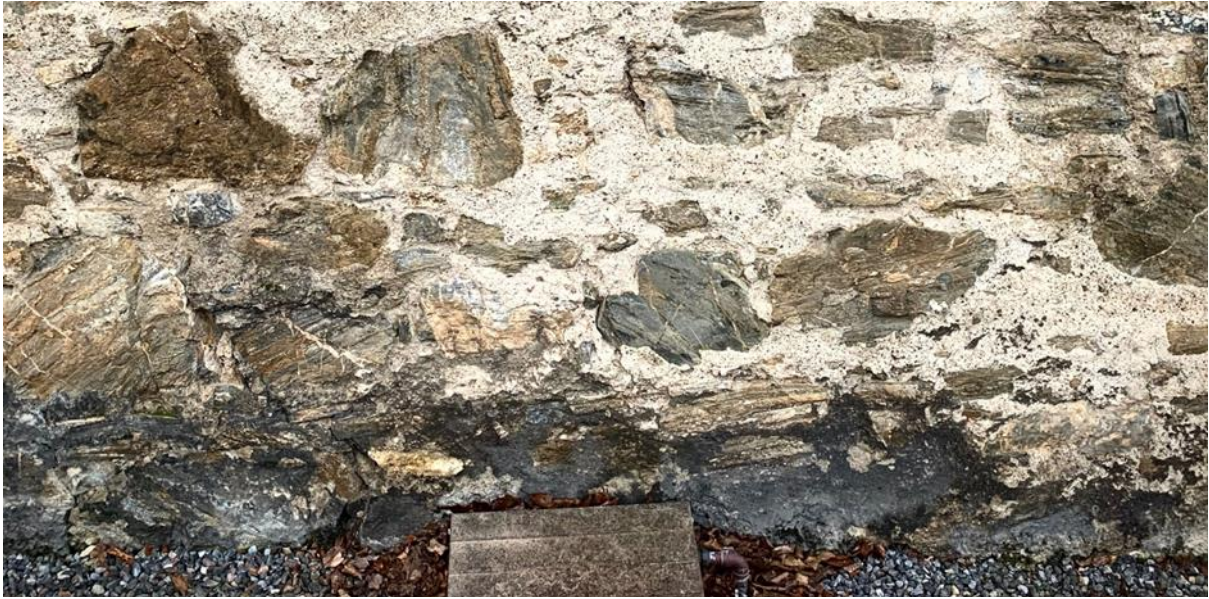
A Victorian distillery workers cottage now used as office space. The front is of sawn rubble with a random rubble gable and rear (Figure 110.1). A buff coloured sandstone ashlar bay to the front of the cottage adds to a sense of hierarchy in the finishes. The sneck harled gable (Figure 110.2) has a more formal flush finish than the front elevation (Figure 110.3). The ashlar is pointed in a fine mortar with a high binder content. All the pointing survives well except at ground level where there is some salt damage. The blackening on all the pointing is caused by a distillery related sac fungus called *Baudoinia Compniaceusis* that feeds on ethanol. The aggregates are sharp and angular, in the range of 1-20mm.

Figure 110.2. Sneck harled gable.
