TECHNICAL PAPER 33

MASONRY POINTING AND JOINT FINISHING

PART 2 - GAZETTEER

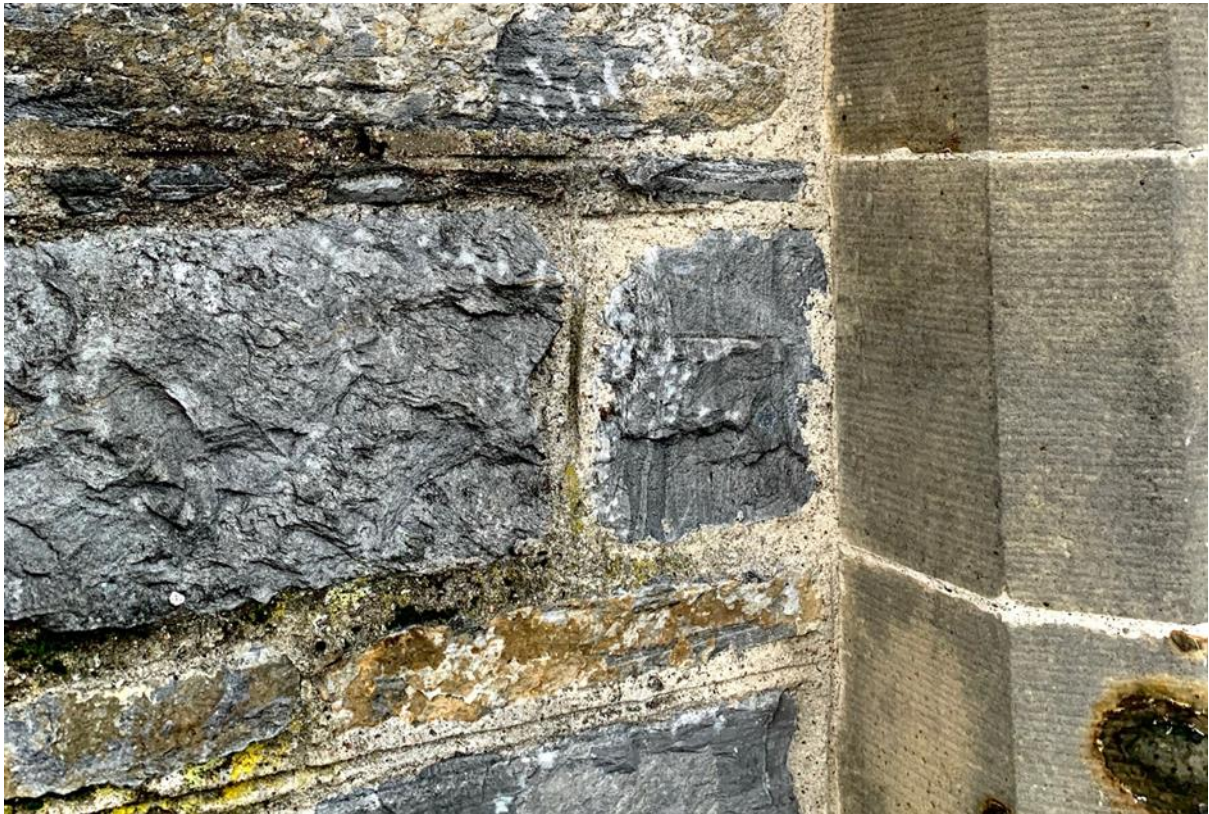
Figure 110.3. Flush finish with lining out on front elevation.

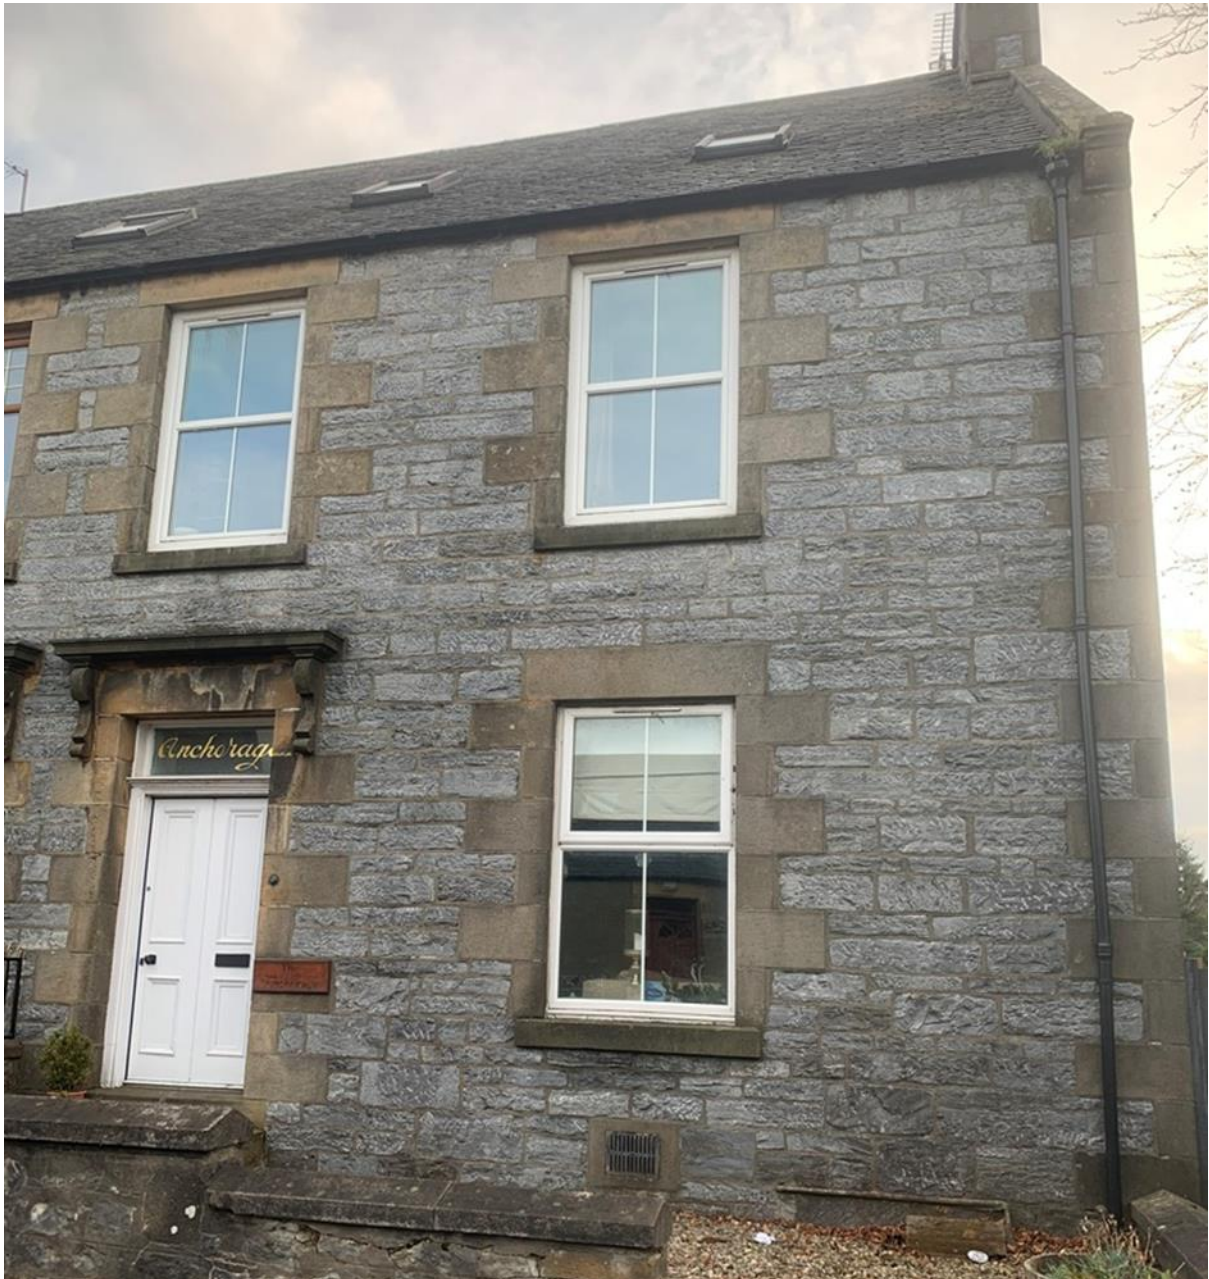
Figure 111.1. Northern elevation.

A terraced house with a sawn rubble front (Figure 111.1). This front elevation has sawn sandstone quoins on the building's corner, windows and front door. The gable is of random rubble (Figure 111.2) and the rear is finished with sneck harl. Some attempt at squaring the sneck harl has been made but (Figure 111.3) the process is inconsistent.

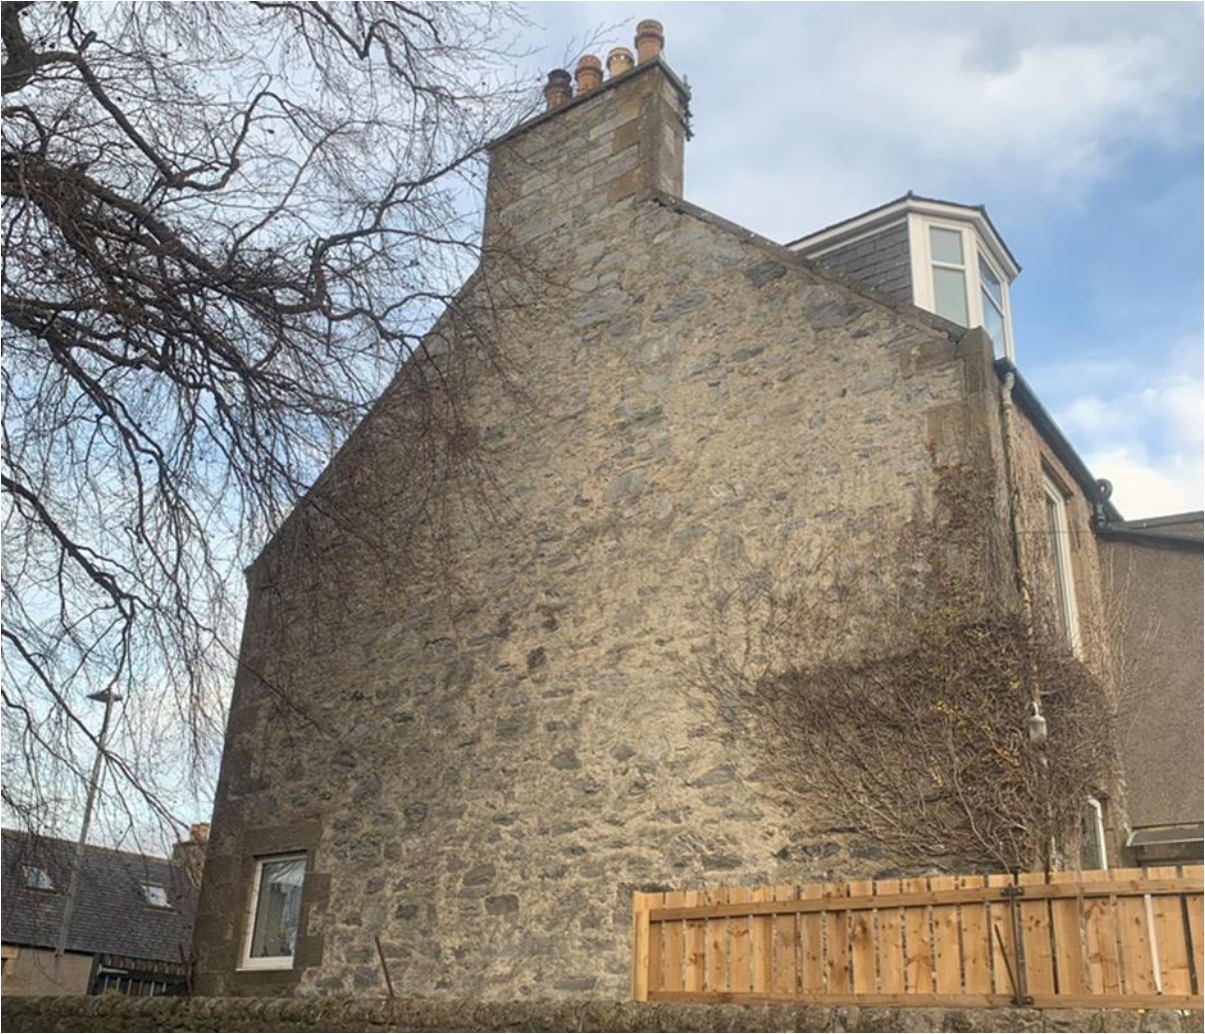
Figure 111.2. Random rubble gable with sneck harl.

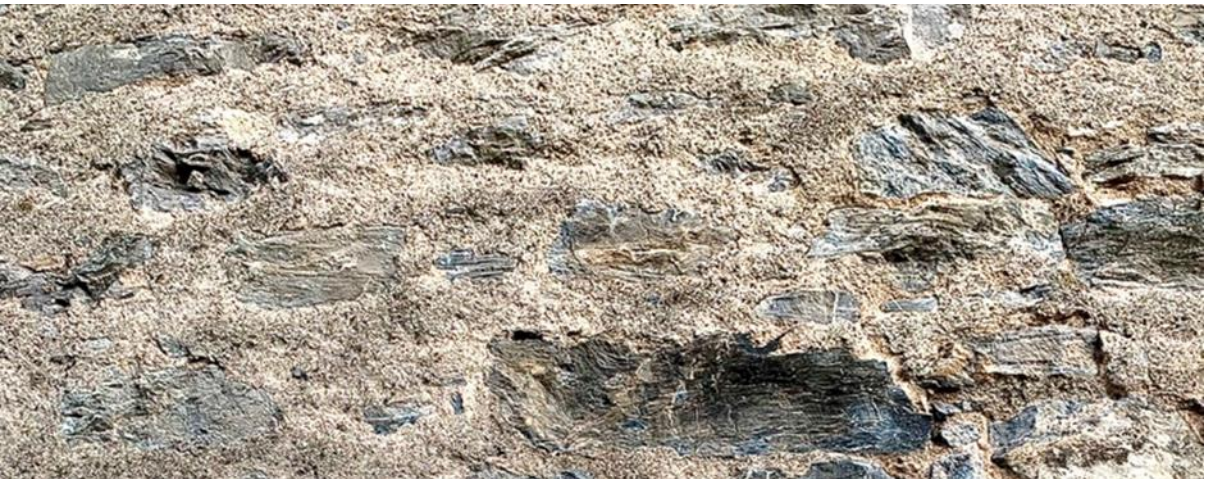
Figure 111.3. Attempt at sneck harl squaring.

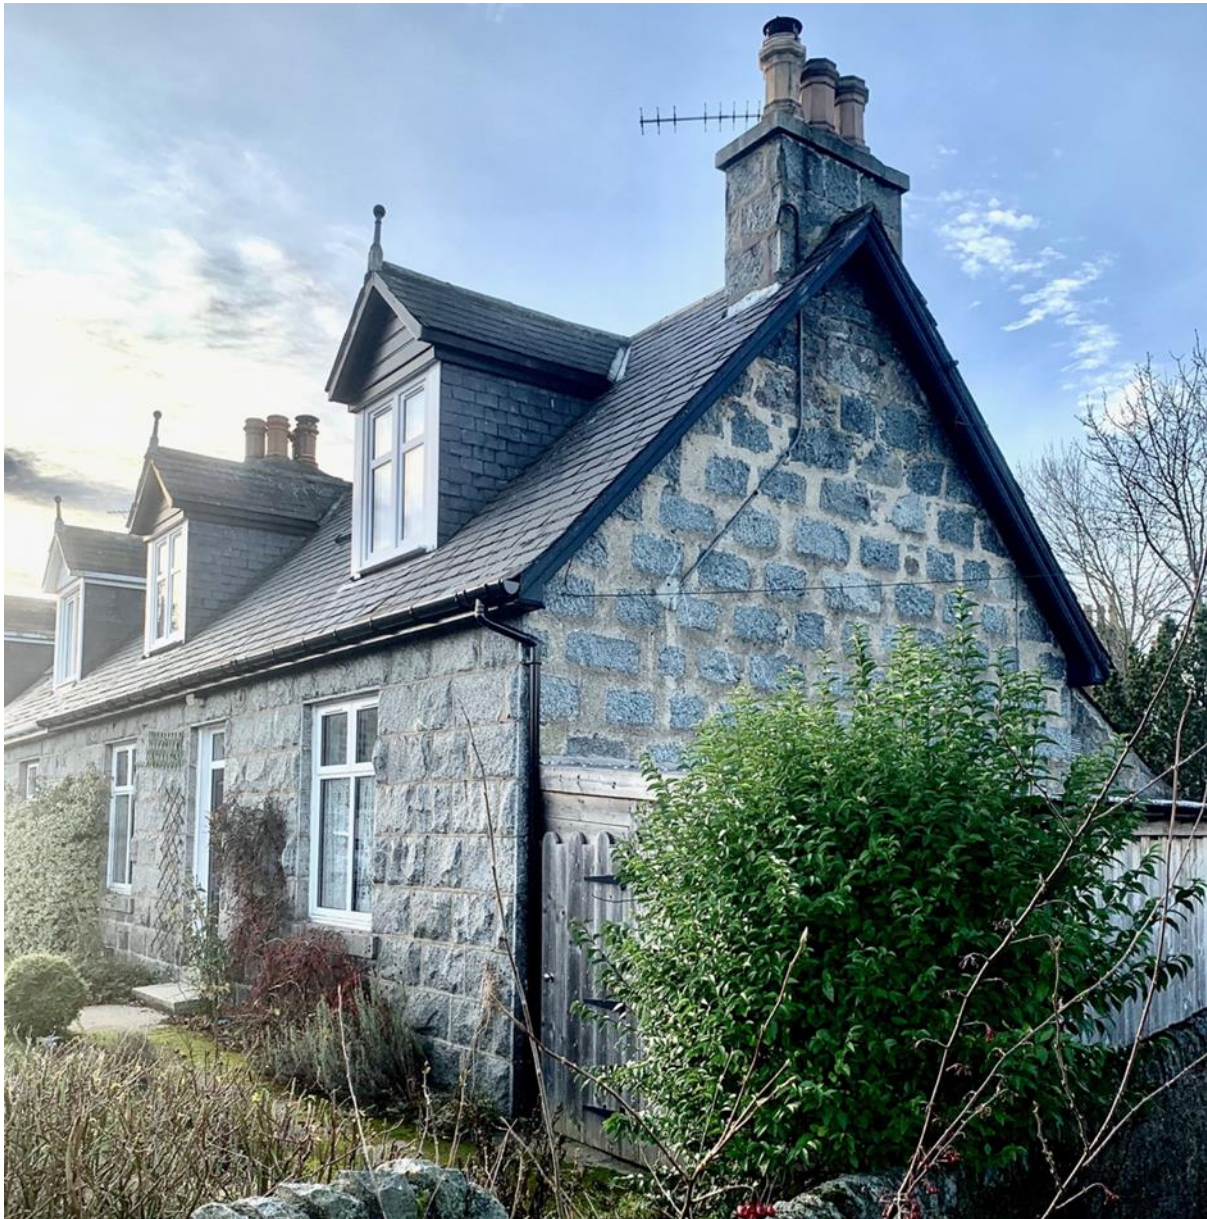
Figure 112.1. Northeastern corner of the cottage.

Small, semi-detached, Victorian granite cottage, close to the center of Alford (Figure 112.1). There are sawn granite blocks on the front elevation and more random rubble on the gable and rear (Figure 112.2). The more formal front elevation is finished with raised ribbon pointing, whilst the sides and rear have a squared sneck harl.

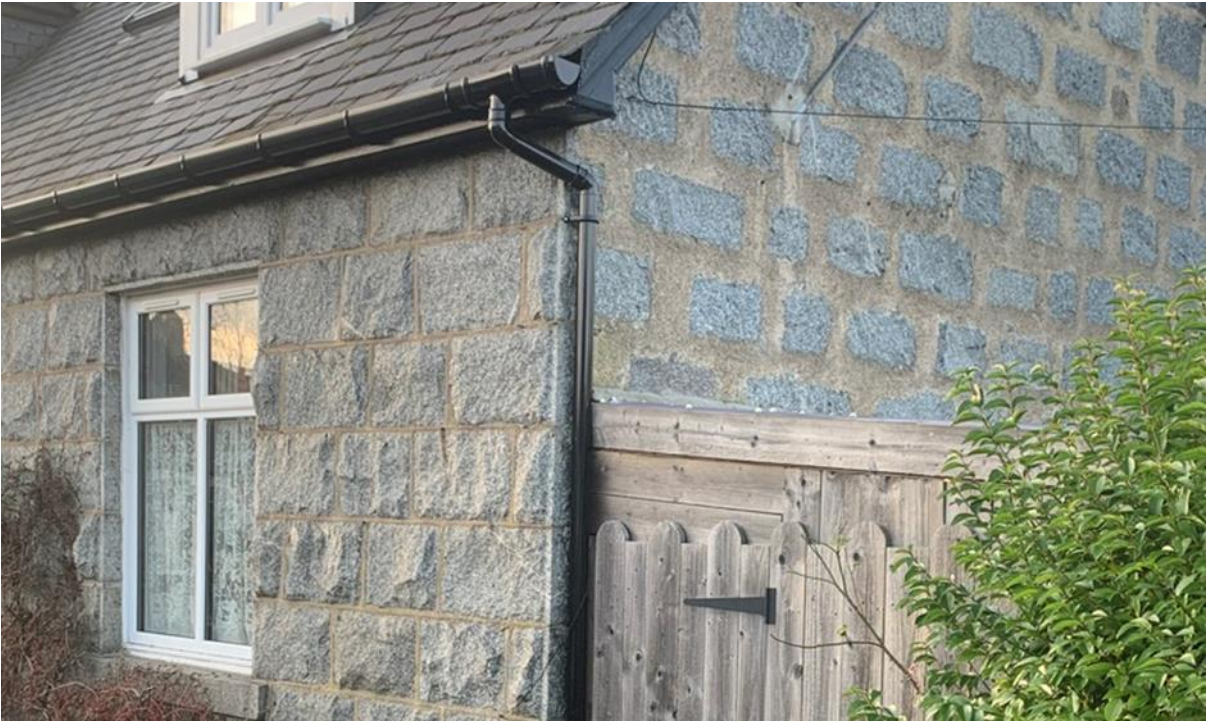
Figure 112.2. Hierarchy of finishes between front and sides.

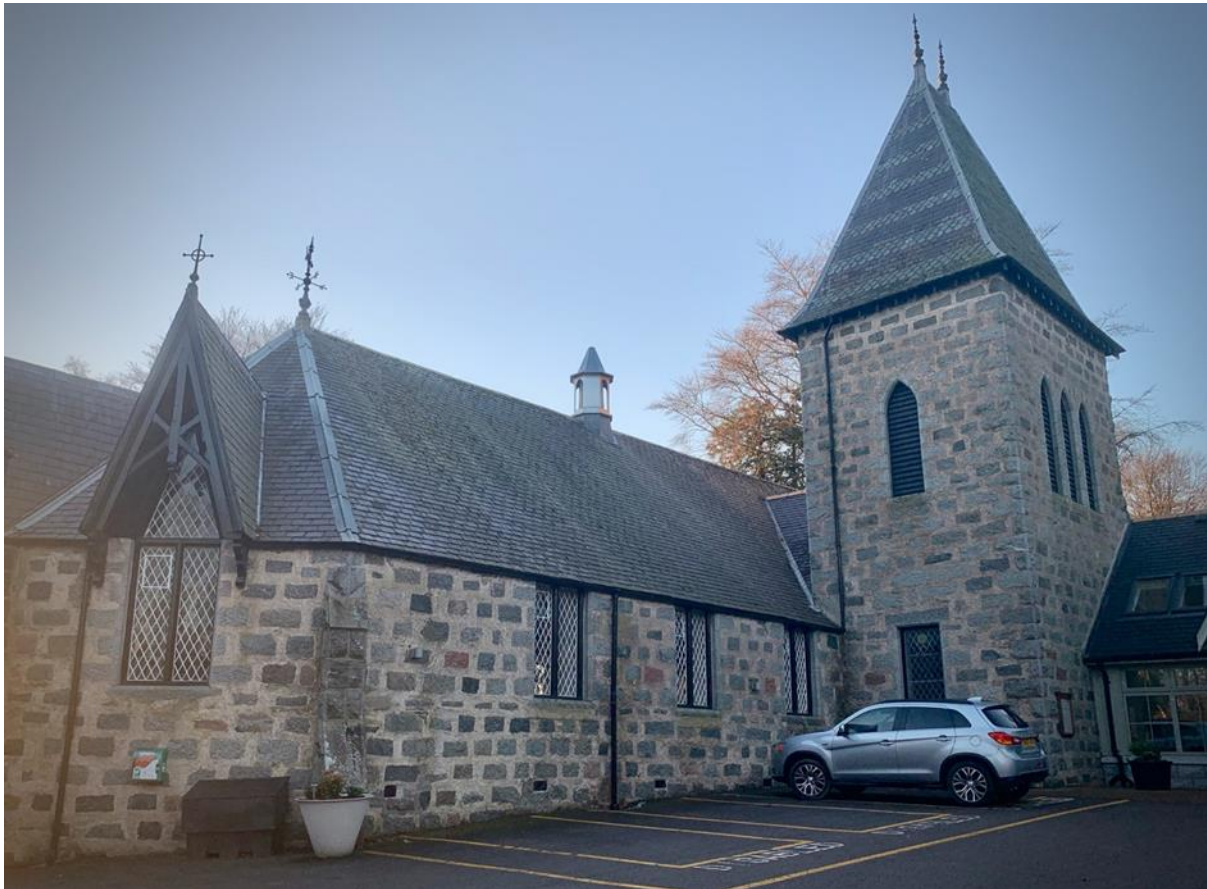
Figure 113.1. Mid Deeside Church, viewed from the east.

This distinctive church, built in stages from 1875 (Figure 113.1) retains most of its extant squared sneck harled finish. This, along with a general Bavarian feel to the architecture, represents the most complete example of a building with such a finish and a strange combination of Germanic and East Highland influences. It has a central tower with rusticated quoins that serves as a link to the new extension. The mortar survives well and is made with a coarse angular sand in the range of 1-18mm (Figure 113.2). There are many lime inclusions that, to touch, feel non-hydraulic. In one small area the sneck harl has become dislodged leaving the snecks exposed and a ghost mark of the extent to which the mortar covered the edges of the stone (Figure 113.3).

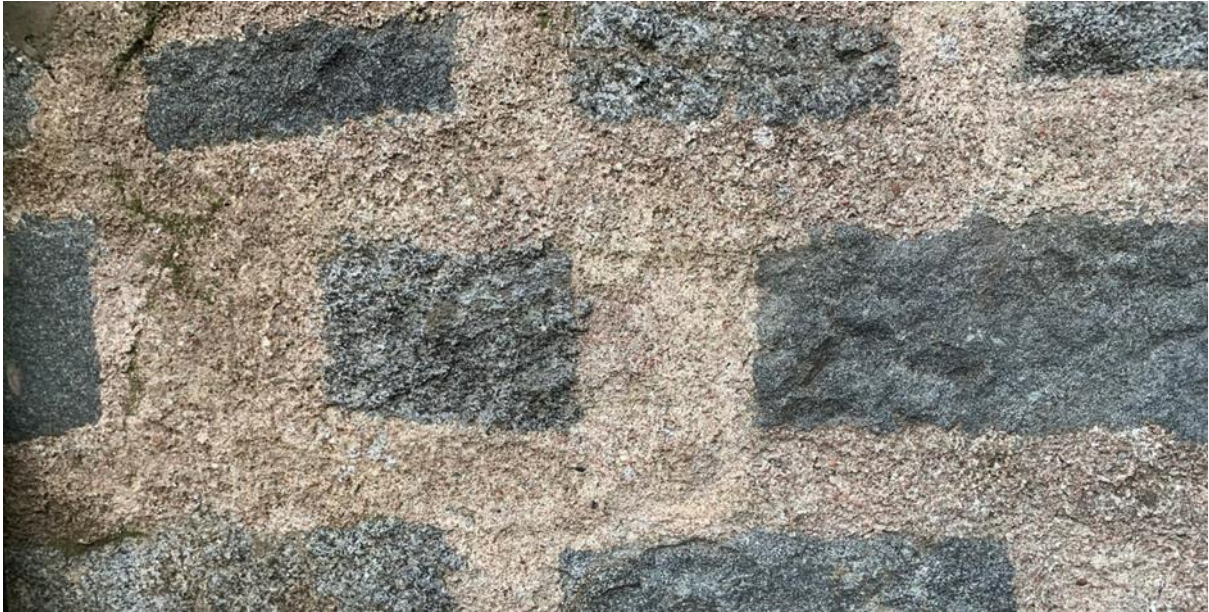
Figure 113.2. The squared sneck harl. Coarse, angular sand with lime inclusions.

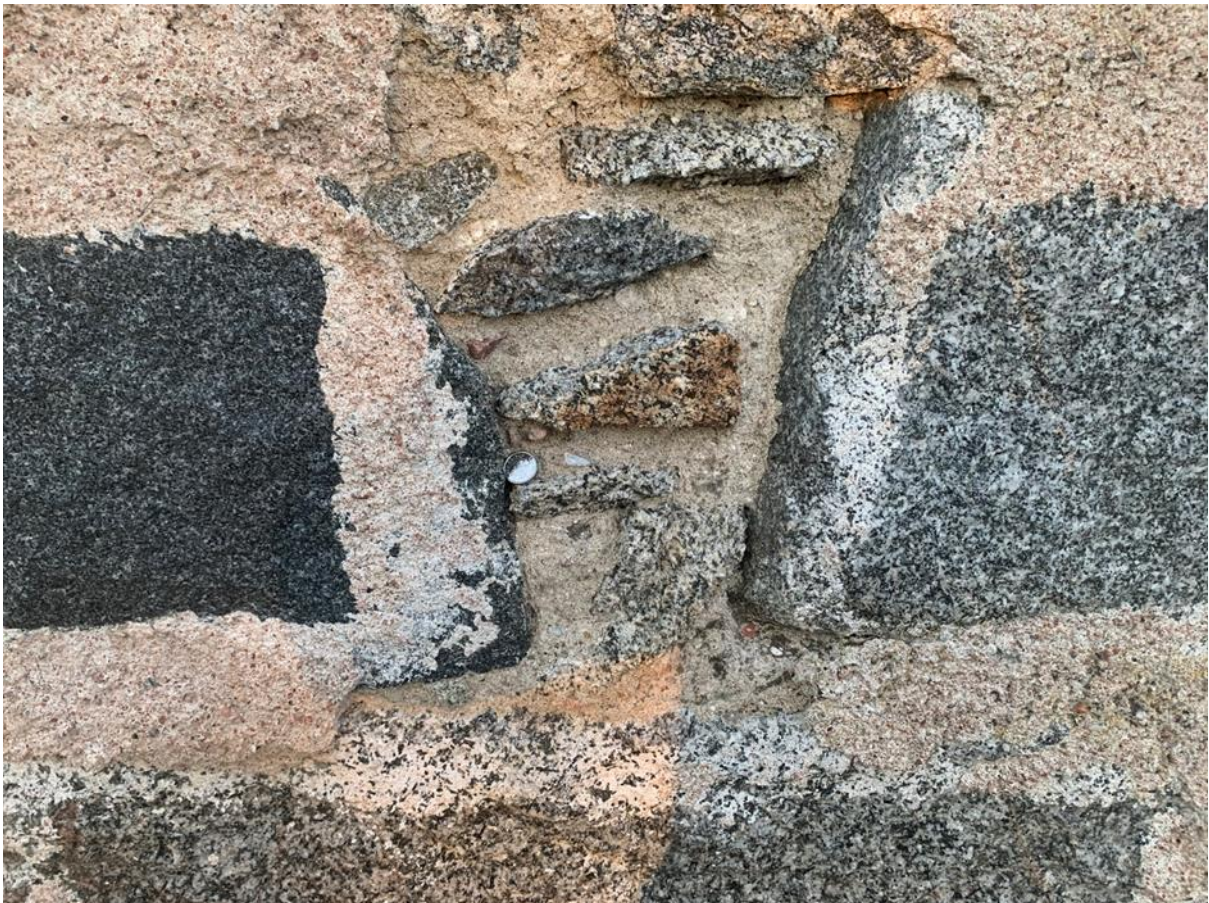
Figure 113.3. An area of pointing loss, with ghost marks of the mortar in relation to surviving sneck harl.

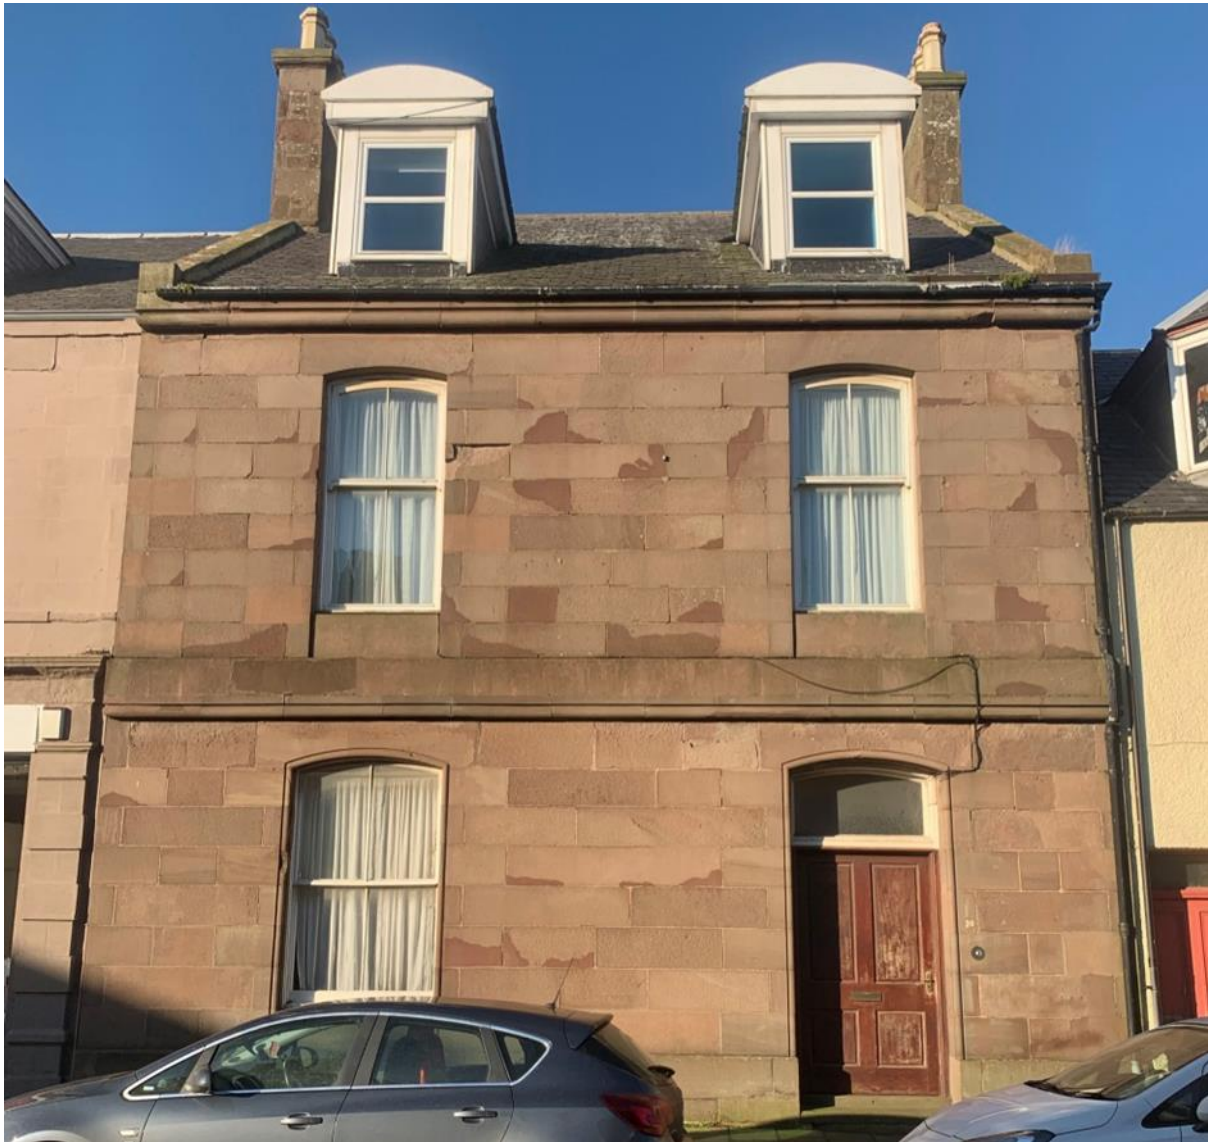
Figure 114.1. King Street, southeast elevation.

A two and half storey house (Figure 114.1) with hammered local ashlar and modest quality sandstone (Figure 114.2) with wide joints. The stone and the pointing have worn away leaving faint traces of ruling remaining. The mortar is coarse for ashlar work and results in the thick joint. It has rounded marine aggregate in the range 1-5mm with lime and shell inclusions (Figure 114.3).

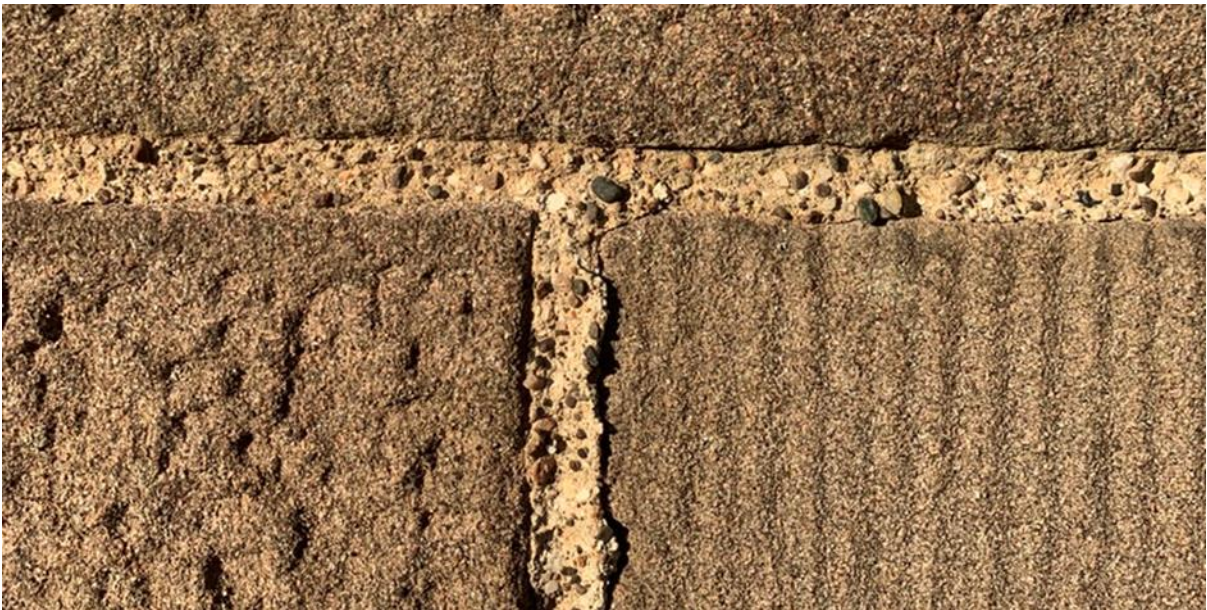
Figure 114.3. Marine aggregate.

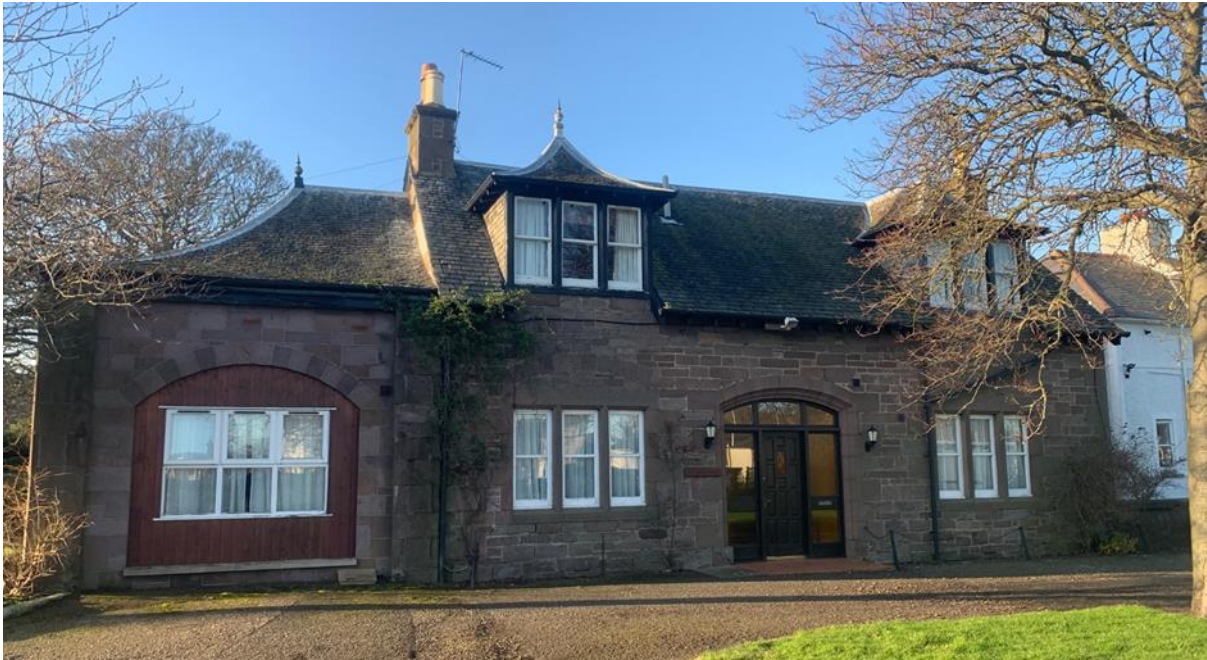
Figure 115.1. The Coach House, east elevation.

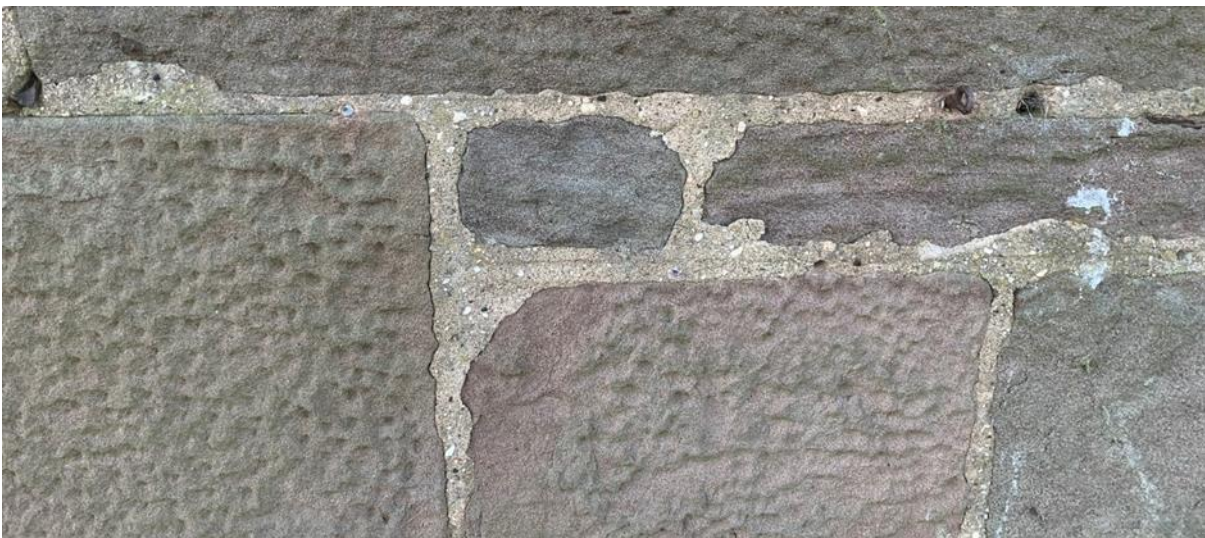
A cottage and former coach house built in the local sand and agglomerate stone in the late 19th century (Figure 115.1). The finishing is flush and ruled but only the horizontal lines were visible due to the advanced weathering of the joint and stone (Figure 115.2). The aggregates are finer than many seen locally, in the range 1-5mm. There are some lime inclusions.

Figure 115.2. Ruling out and lime inclusions.

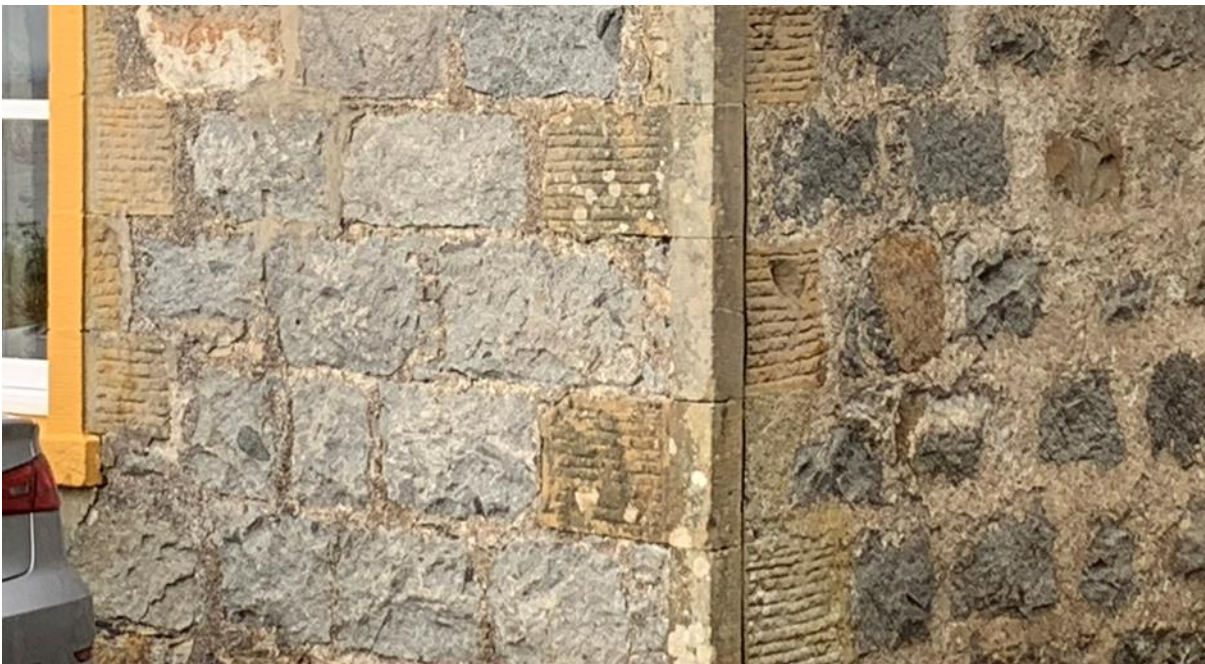
Figure 116.2. Flush pointing on the front principal elevation and sneck harl on the side.

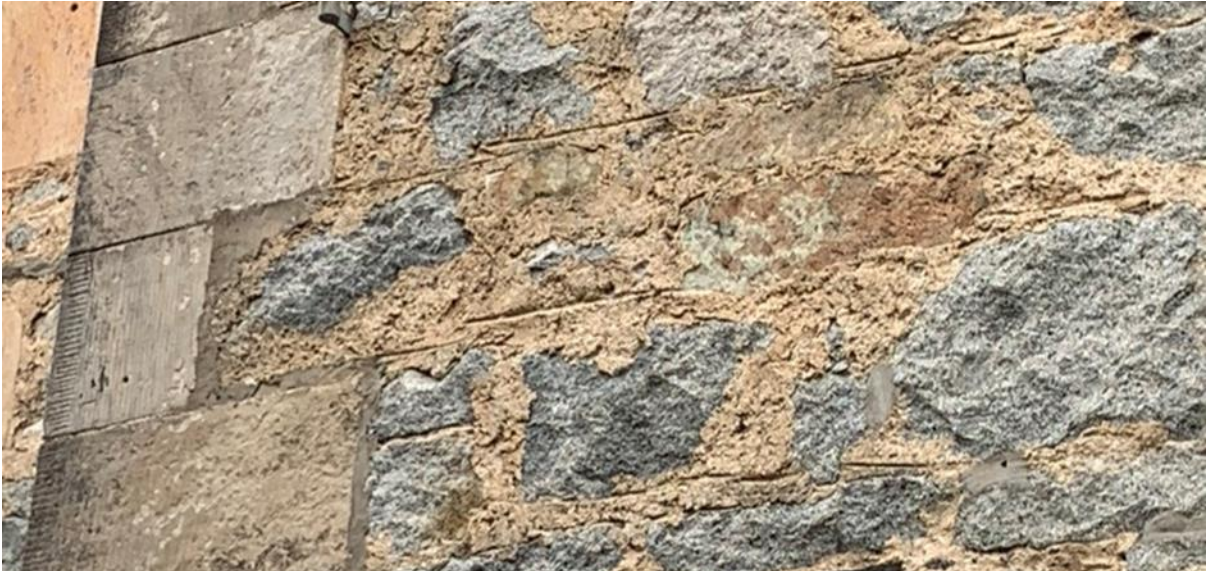
Figure 117.2. Sandstone details with full flush sneck pointed and casually ruled.

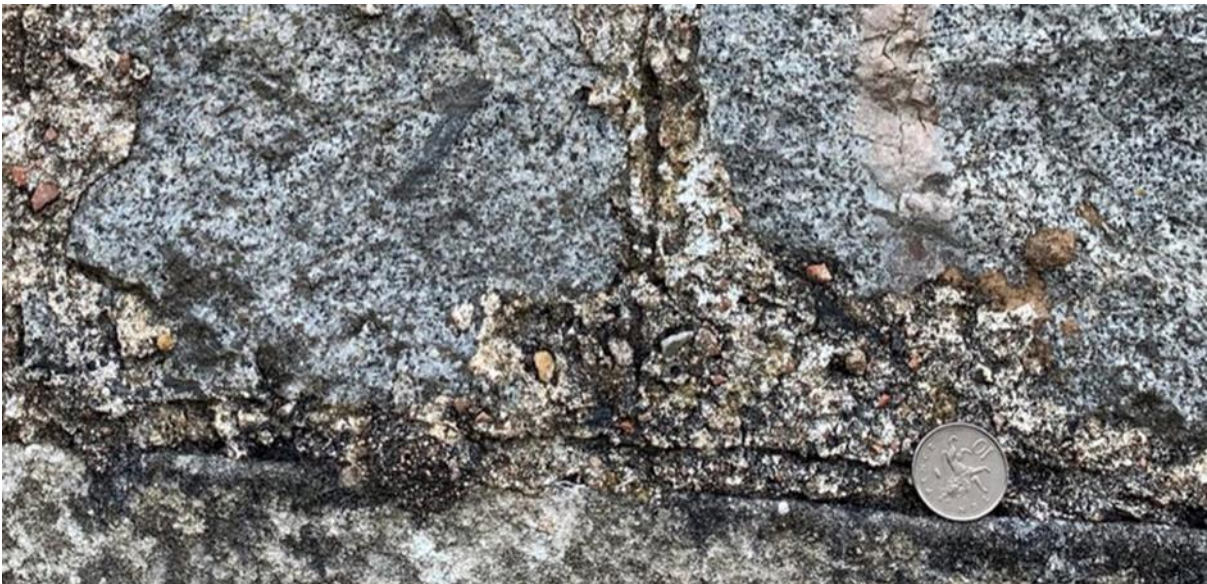
Figure 117.3. Flush pointed monochrome granite blocks with horizontal and perpendicular ruling out.

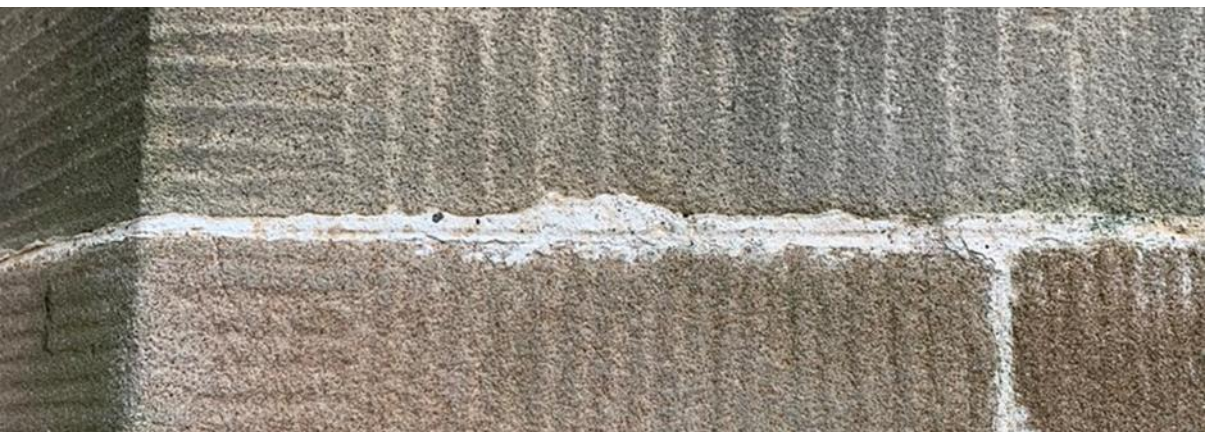
Figure 117.4. Ashlar masonry, with fine pointing, lined out.

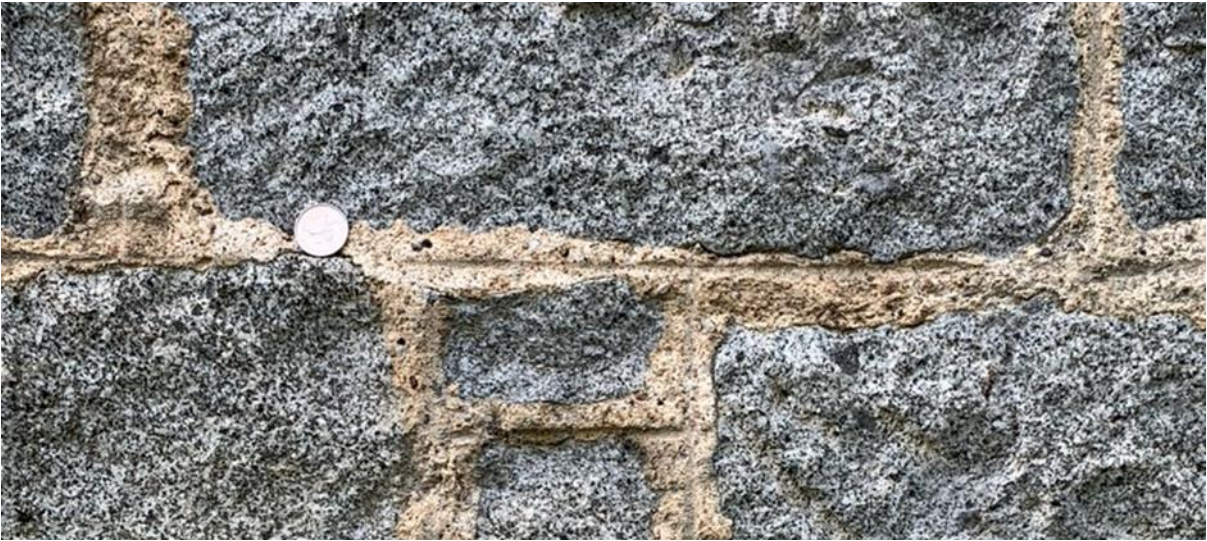
The Annex is similarly built as the main building, with monochromatic granite blocks with pinnings. The pointing is flush with the face of the stone and both horizontally and perpendicularly ruled (Figure 117.5). The ruling out is half round in profile. While this pointing is similar to the front main elevation the aggregate range is smaller.

Figure 117.5. The annex built with squared granite blocks, flushed, with both horizontal and perpendicular ruling out.

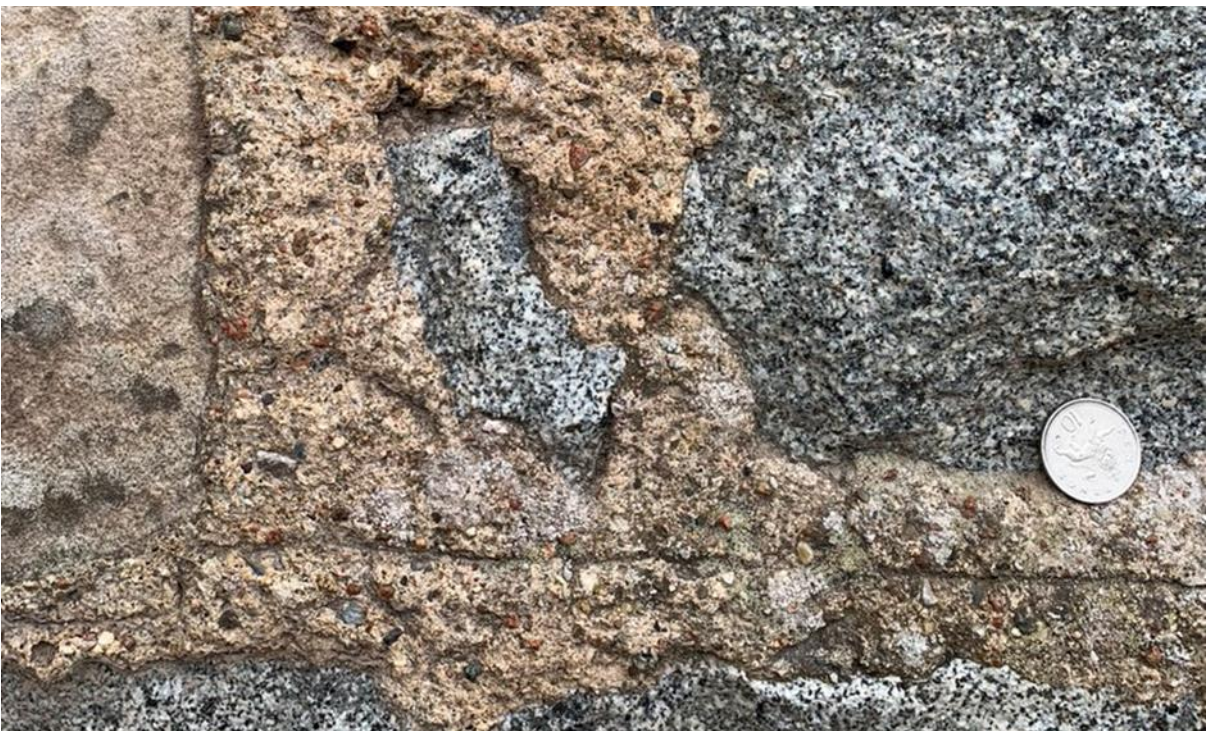
The former stable is also flush finished with informal horizontal ruling out, executed with the edge of a trowel. The aggregates are coarse and variable in the range 0.5mm - 8mm (Figure 117.6).

Figure 117.6. The former stable block pointing with informal ruling out.

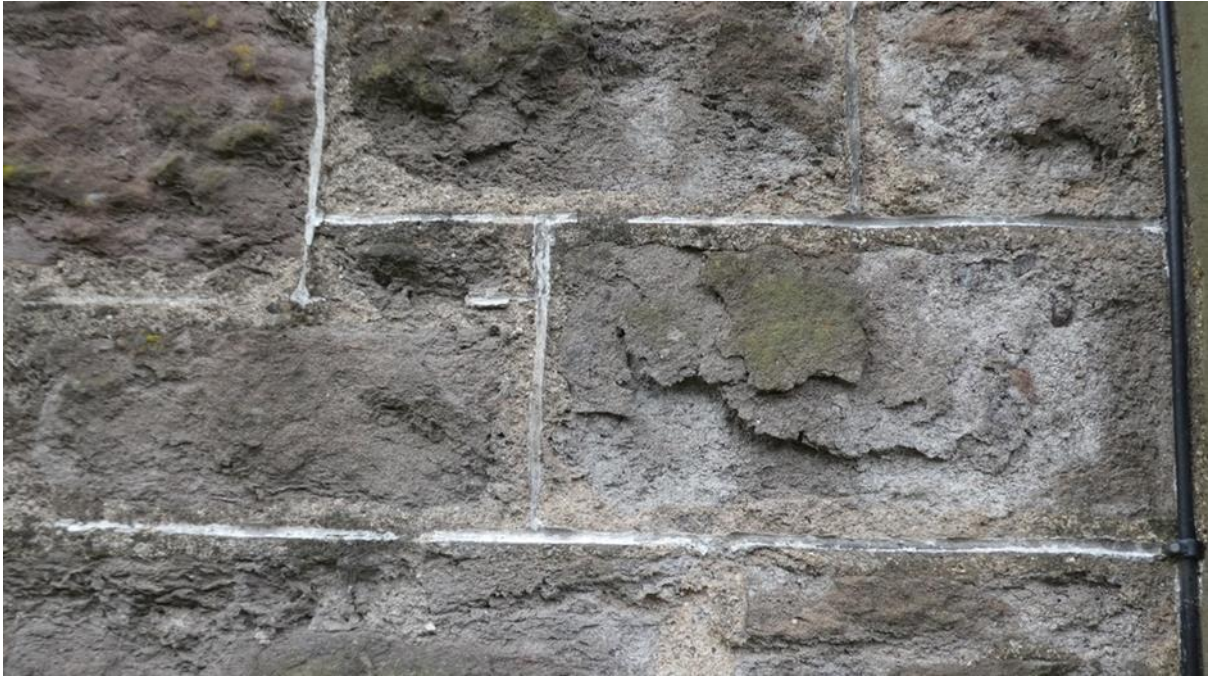
Figure 119.2. Ruling out and white lining. Stone decay evident.

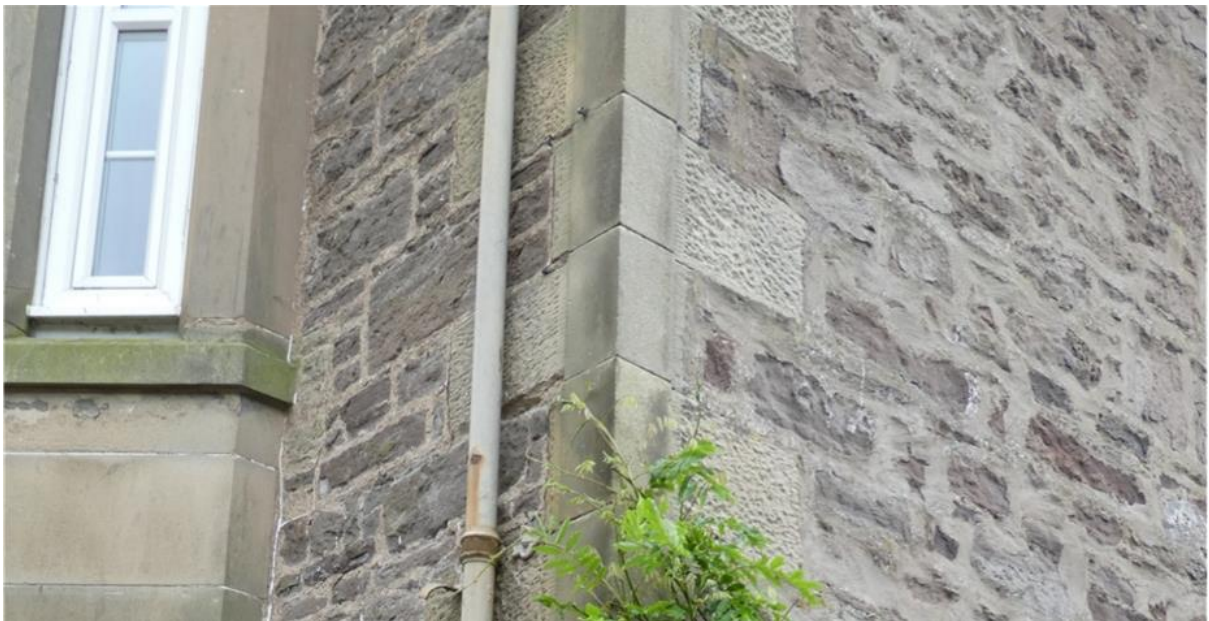
Figure 119.3. The different pointing styles between the front and gable elevations. The gable work is later cement pointing but in a traditional style.

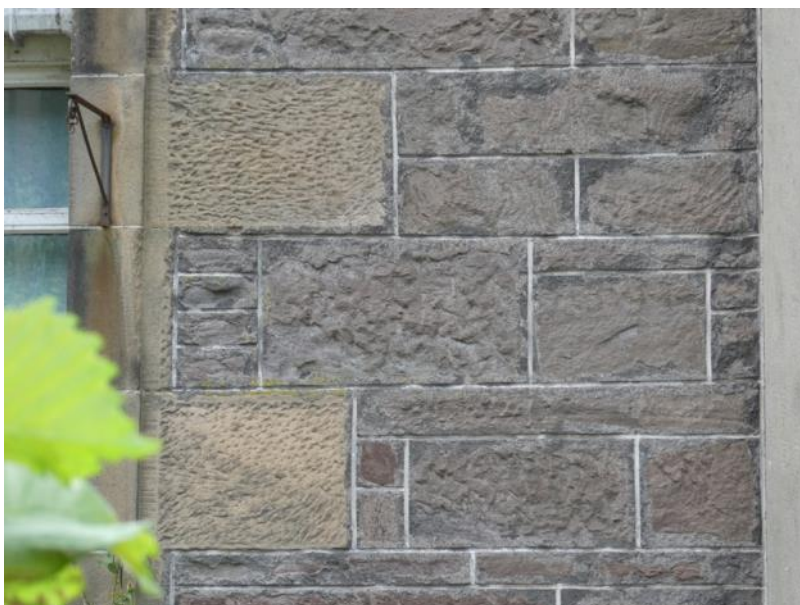
Figure 120.2. Flush pointing and ruling out with whitened lines. Note the relationship between the rubblework and the better quality masonry around the windows and doors.

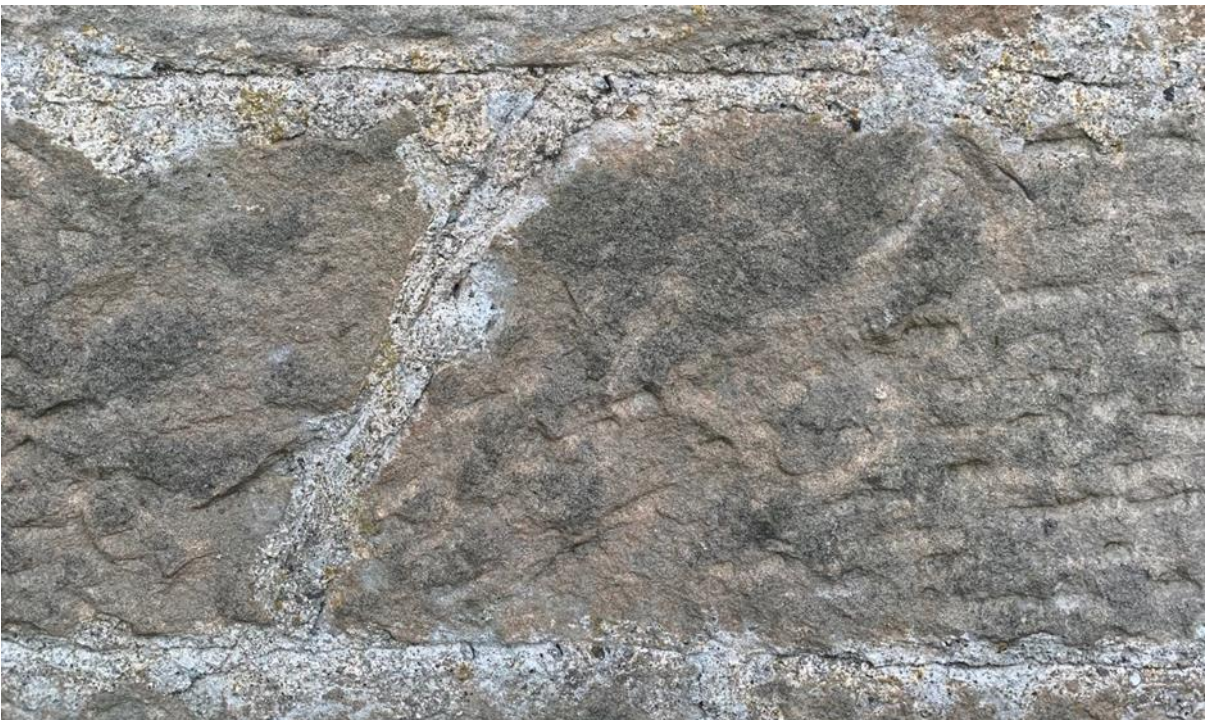
Figure 121.3. Ruling out even on angled junctions.

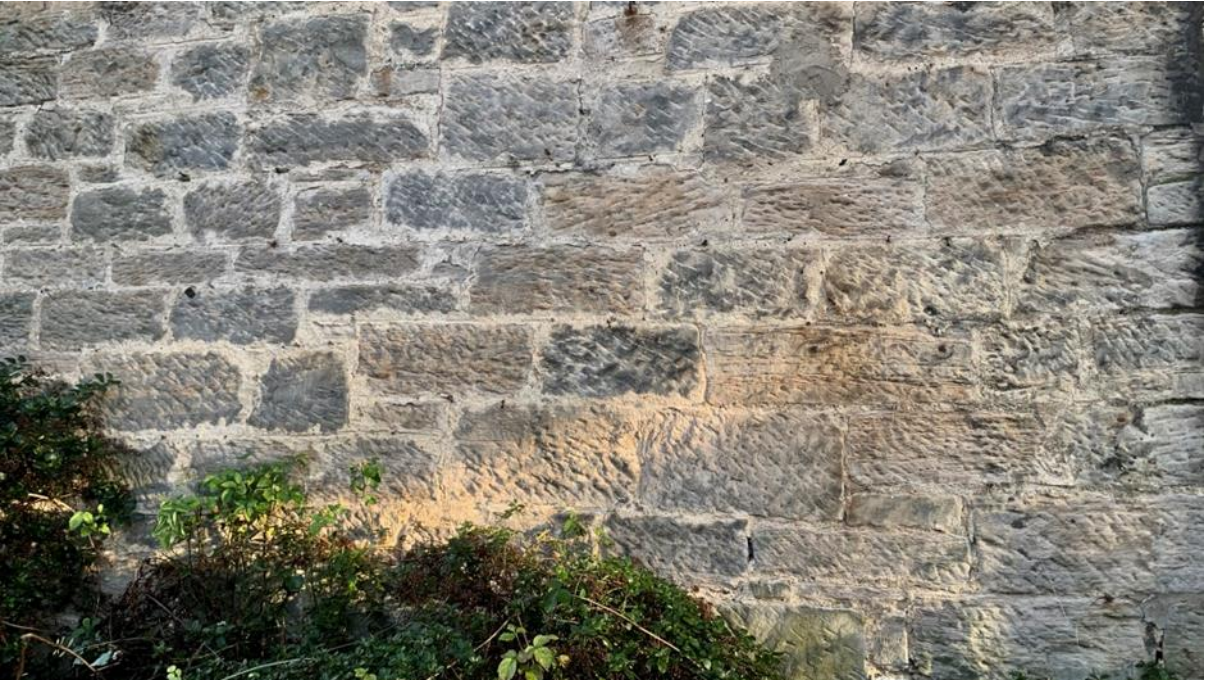
Figure 122.2. Ruled flush finish.
