TECHNICAL PAPER 33

MASONRY POINTING AND JOINT FINISHING

PART 2 - GAZETTEER

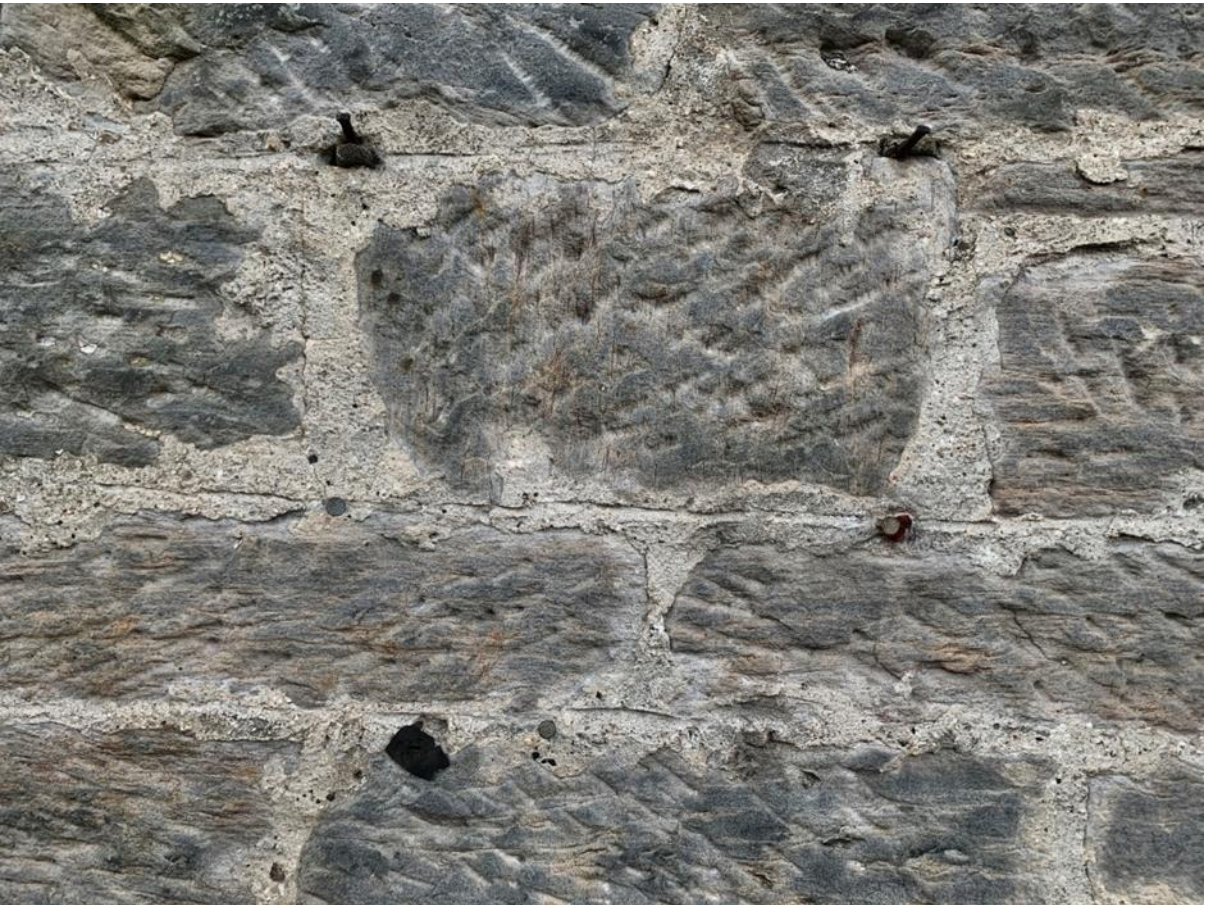
Figure 122.3. Detail of horizontal ruling as well as lime, coal and marine inclusions.

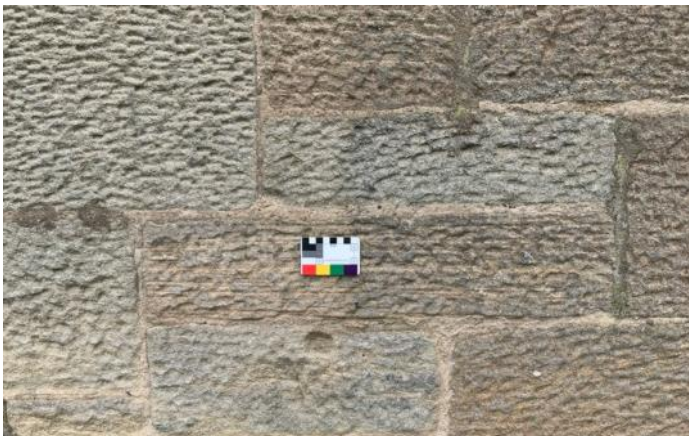
Figure 123.2. The stugged block on the main elevation showing an unmarked flush point.

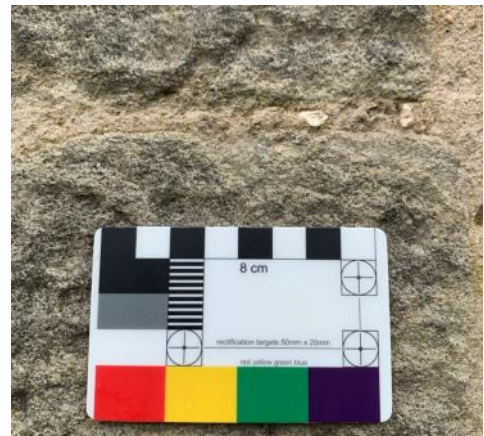
Figure 123.3. Close up of a joint showing the flush finish.

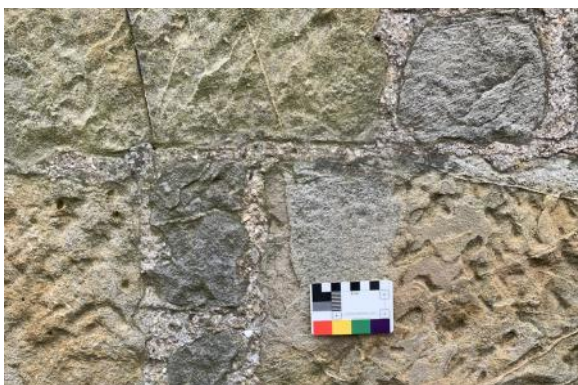
Figure 124.2. Flush pointing and horizontal ruling out.

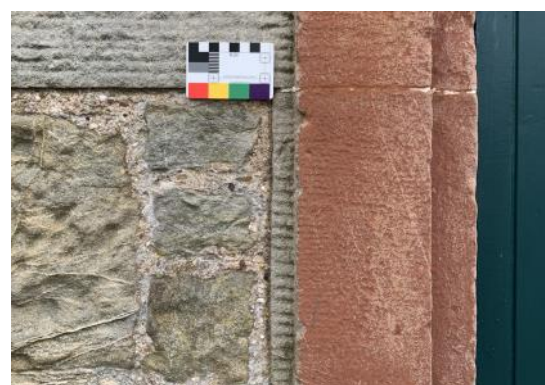
Figure 124.3. Detail of red wash with the sandstone and pointing, also showing the aggregate, coal and lime inclusions.

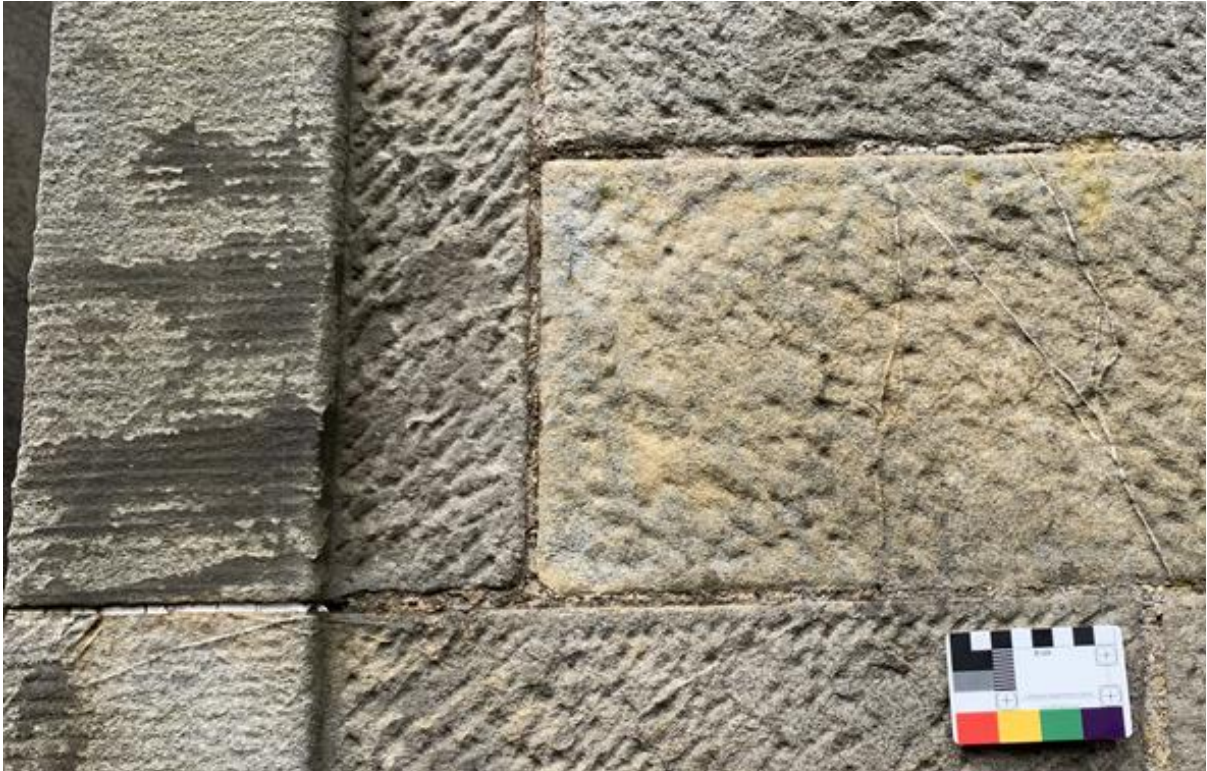
Figure 125.2. Squared ashlar blocks with coarse mortar pointing.

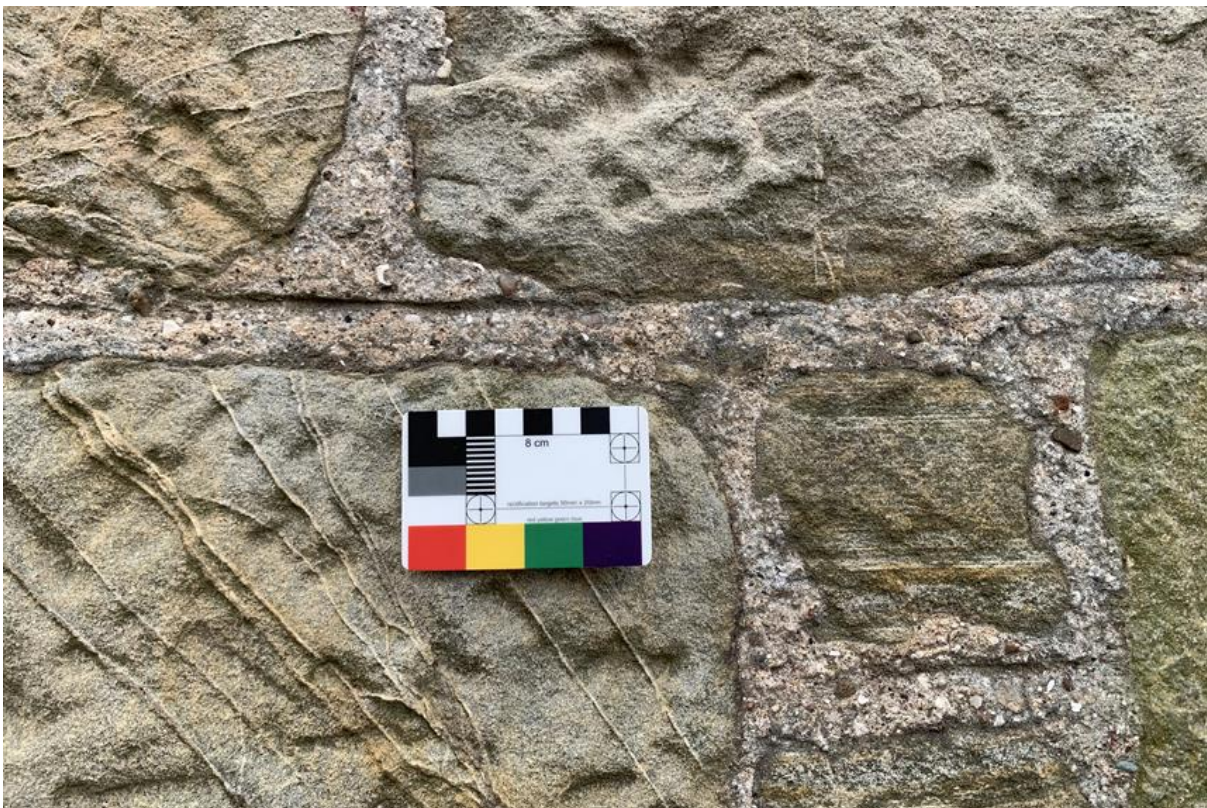
Figure 125.3. Masonry on the side elevation with rougher cut masonry blocks and a flush finish, with horizontally ruling.

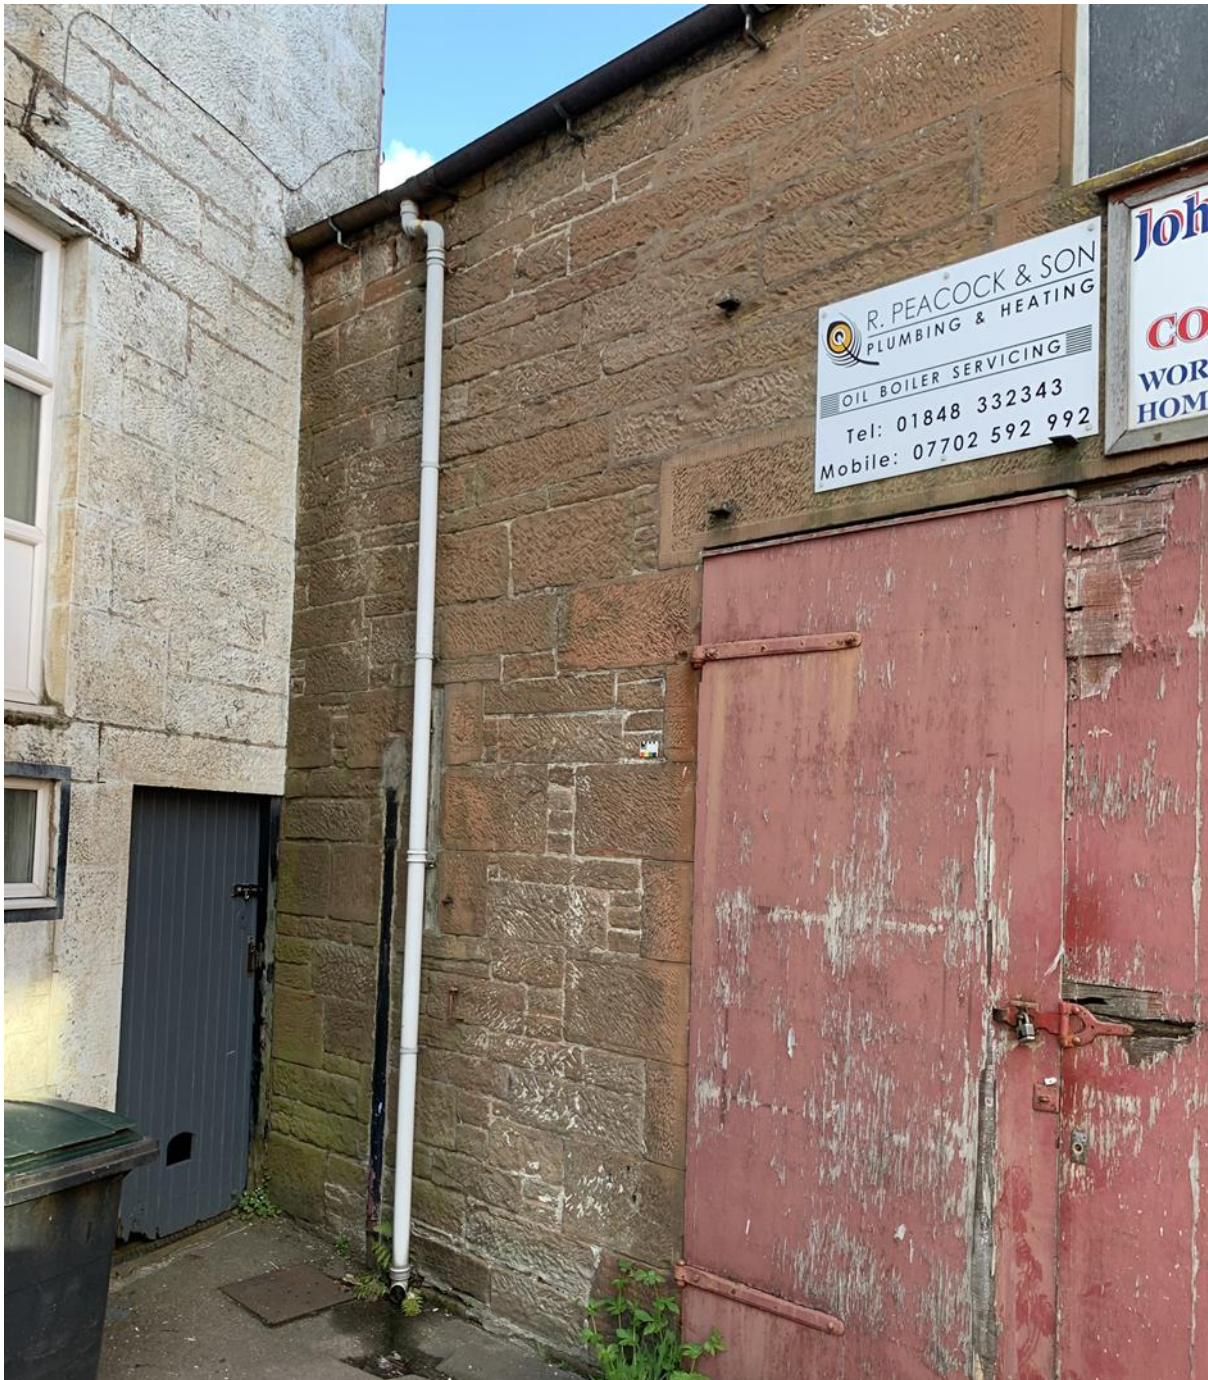
Figure 126.1. The wall of the workshop showing remains of limewash.

This 19th century workshop located in Thornhill (Figure 126.1) has weather-shot pointing and was subsequently limewashed. The wall is made of squared rubble in irregular courses. The mortar and limewash survives as fragments (Figure 126.2).

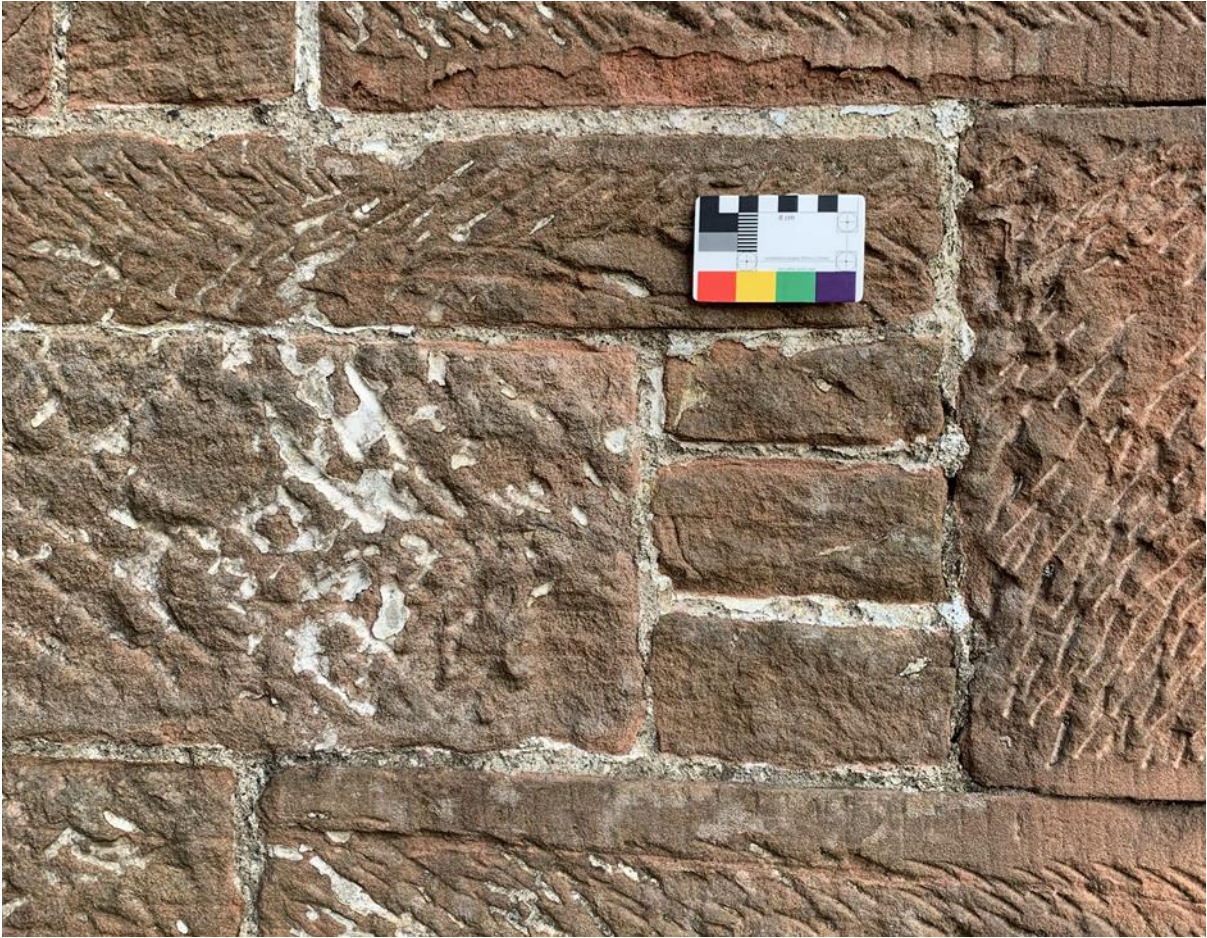
Figure 126.2. Detail of mortar with remains of limewash.

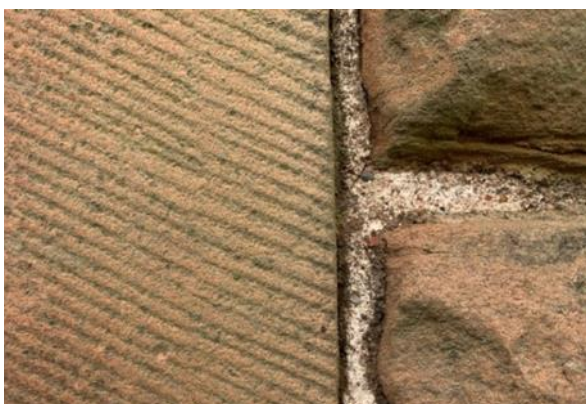
This late nineteenth century building, a former market (Figure 127.1), appeared to show a worn back mortar made with medium to fine angular aggregates with multiple lime inclusions later recessed point (Figure 127.2). However, on closer inspection behind the building sign seen on the middle right of Figure 1, it was noted that the pointing had been protected, and the sandstone blocks were once pointed with a flush lime mortar and ruled out (Figure 127.3).

Figure 127.2. The worn back lime mortar as seen on most of the building.

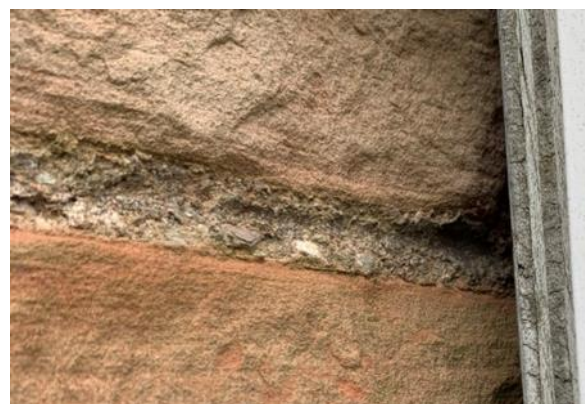
Figure 127.3. The area of protected mortar, protected and sheltered behind the sign, showing the original mortar with central lining out.

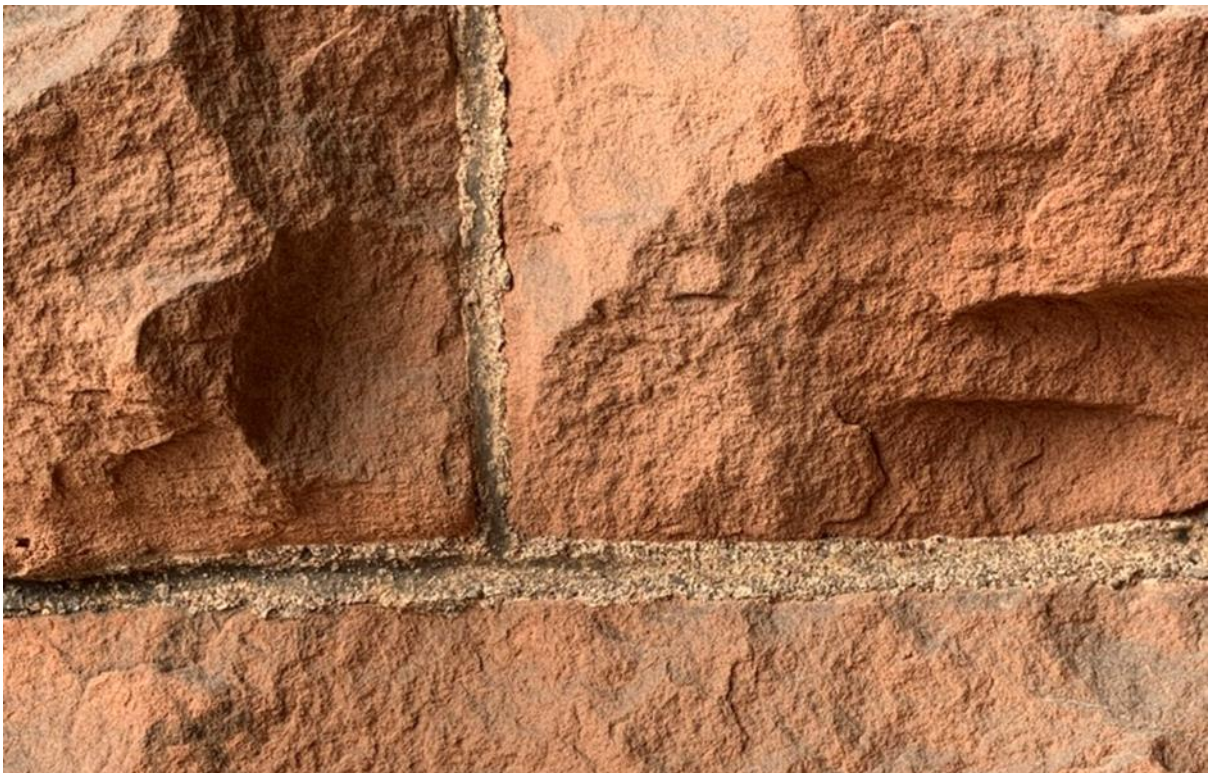
Figure 128.3. The clearer lines of what appears to be original mortar, with the lining out showing.

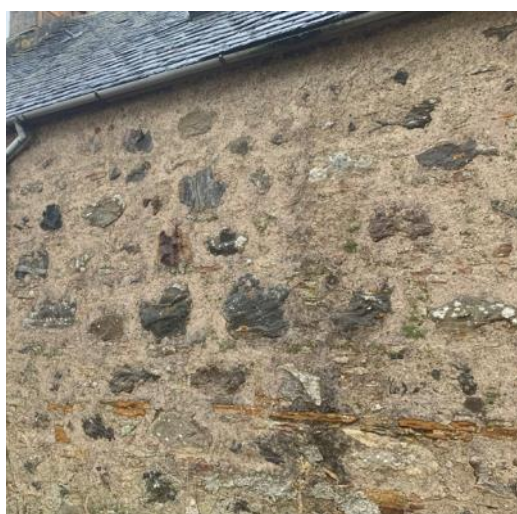
A pair of 19th century farm cottages (Figure 129.1), built with local sandstone and field stone and sneck harled (Figure 129.2). The sneck harling comprises robust thrown mortar with a sharp angular size in the range of 1-13mm (Figure 129.3). The sneck harl, though substantial in places, 'feathers' out at the door and window openings.

Figure 129.2. Rear elevation showing sneck harl and masonry.

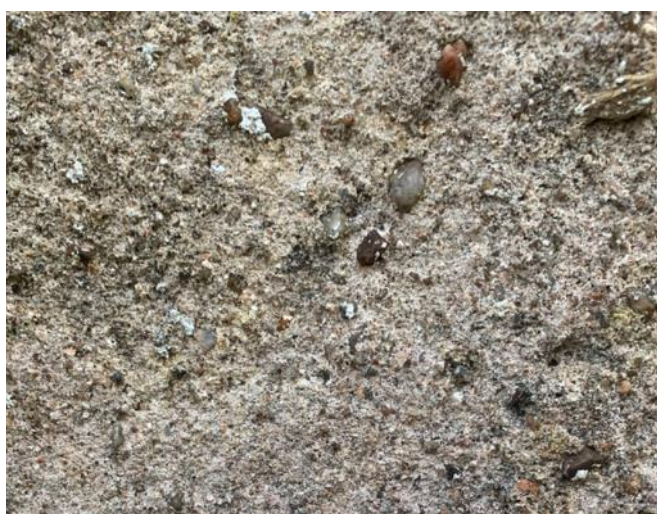
Figure 129.3. Sharp and angular mortar.

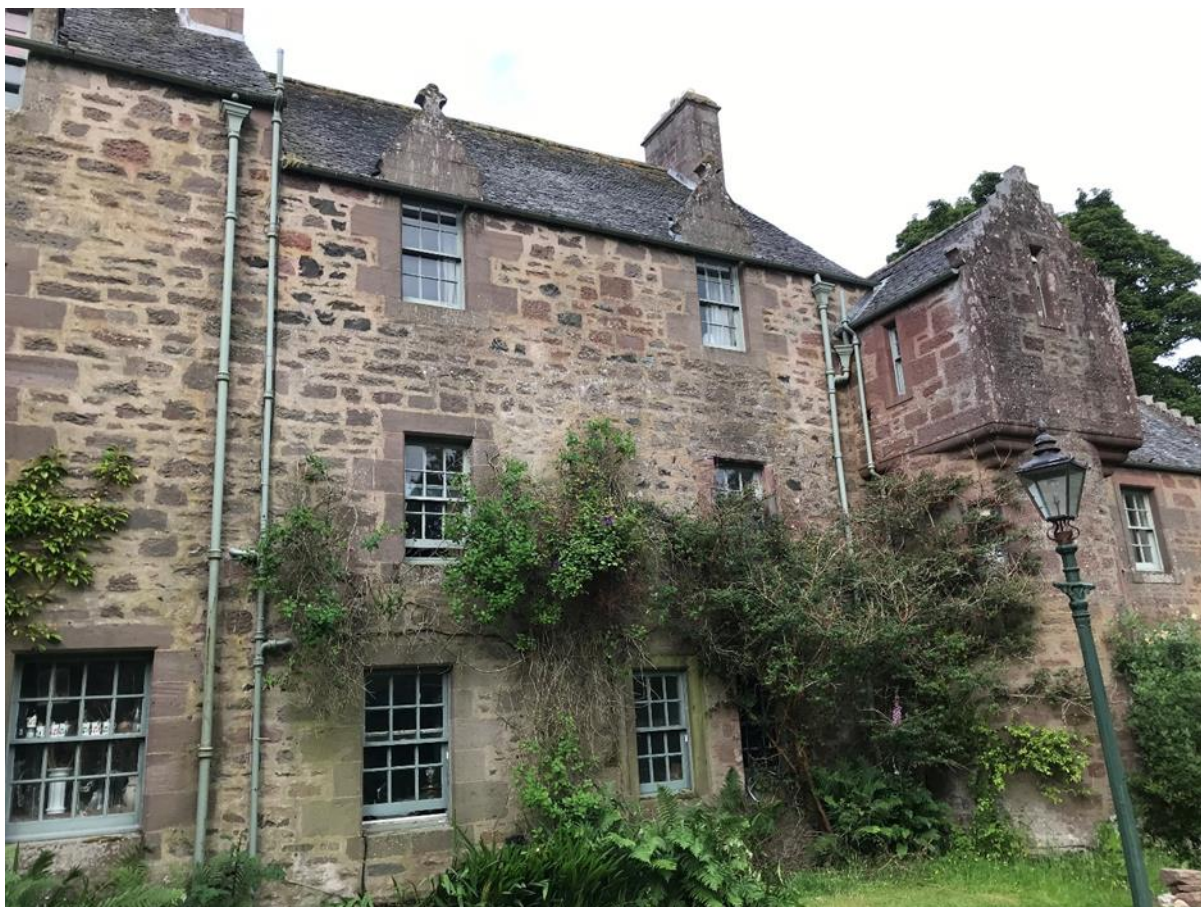
Figure 130.1. Fingask Castle, South East Elevation.

Fingask Castle is a multiperiod building dating from the 12th century, with a long history of interventions. Much of the present structure dates from the 16th century, with ranges from the 17th century and extensive re-modelling in the 19th and early 20th century. Some of these sequences can be inferred in Figure 130.1. It is the later programme of works that concern this entry. The castle was considerably extended in the 1840's, which in turn was reduced back to the earlier core in a programme of work started in 1920. This work included stone repair and replacement, reconstruction of dormers and service areas as well as repointing. Some areas retain in the rear courtyard retain the 19th century masonry finishes, with flush pointing and lining out as seen elsewhere in the gazetteer. As well as this repointing work earlier traces of limewash can be seen, probably dating from the mid or early 18th century (Figure 130.2). The 20th century work is a flush point in a weak cement-based mortar. In some areas it appears that a squared sneck finish was adopted as can be seen in Figure 130.1, top middle.

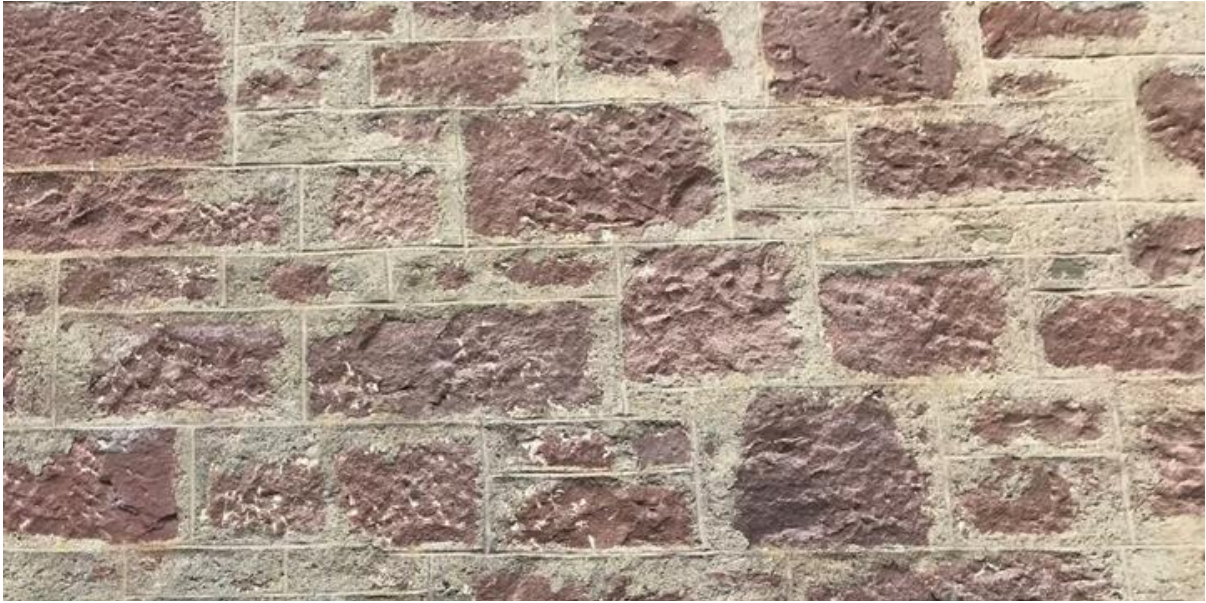
Figure 130.2. Mid 19th century masonry finishes in the rear courtyard of the castle. Note the limewash surviving in the tooling of the masonry from an earlier phase.

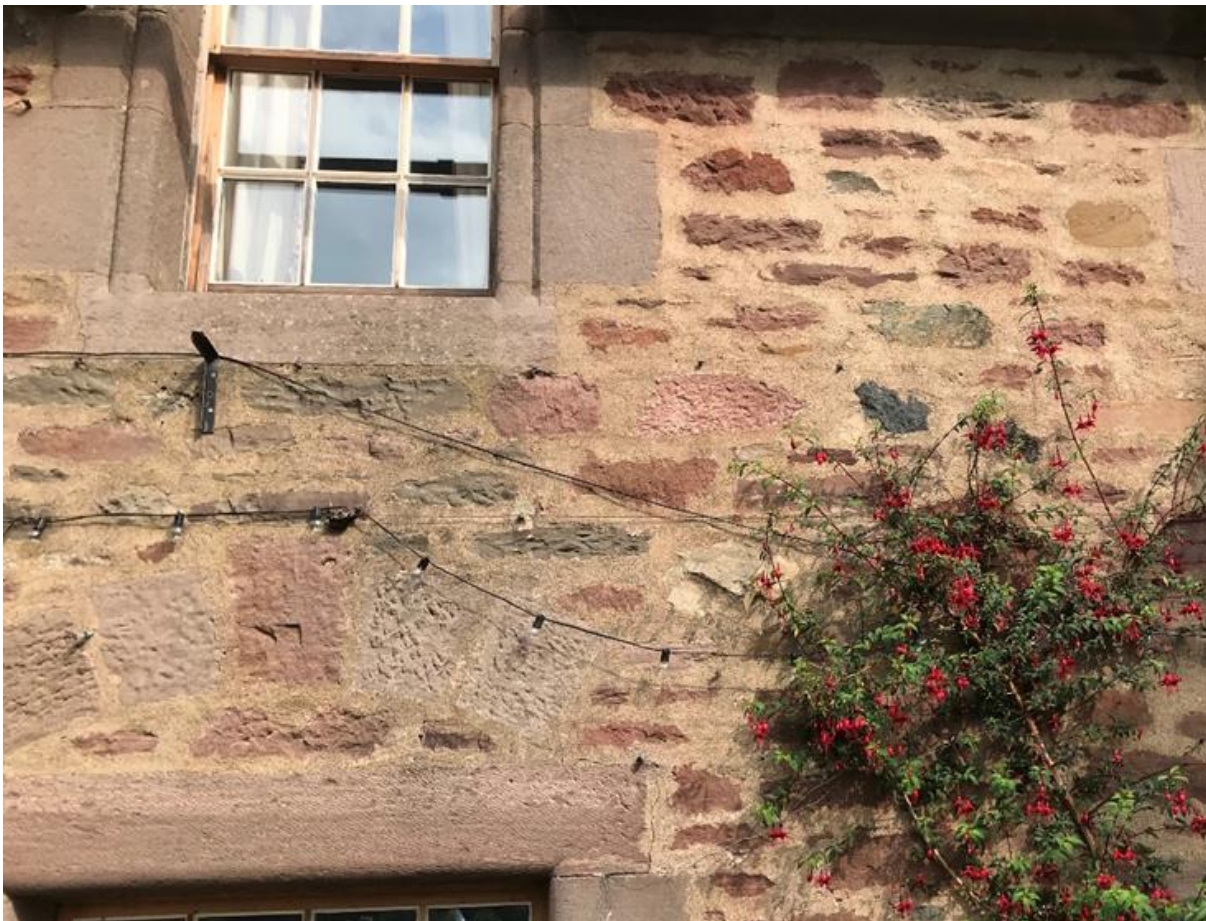
Figure 130.3. Pointing work from the 1920's on the south wall of a 17th century range. This work is flush to the masonry.
