INFORM ROOFING LEADWORK

ROOFING LEADWORK

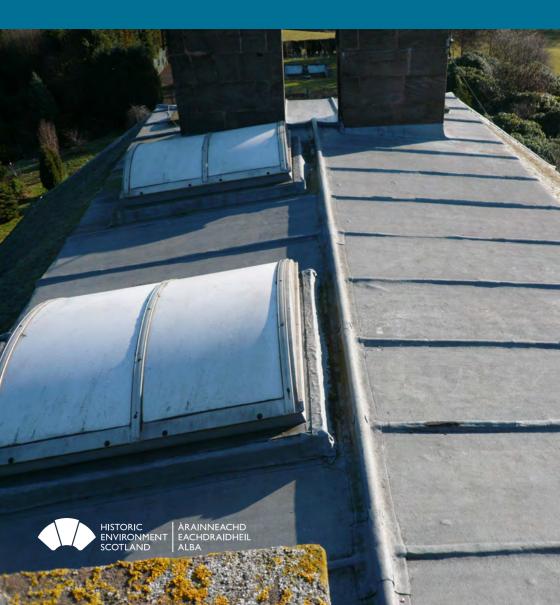
Fig. 1: Lead is used for both roof coverings, and to cover pediments, ridges and roof valleys.
