INFORM
INFORMATION FOR HISTORIC BUILDING OWNERS

Domestic Boundary Walls

Introduction

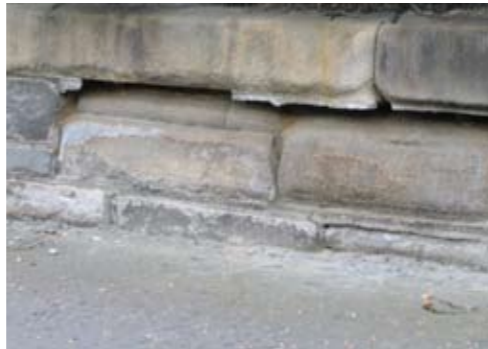
Another area where boundary walls are vulnerable to decay is in the vicinity of the wall footings - especially where there is a risk of salt being laid on adjacent roads and pavements during winter months. In these circumstances, the salt can be regularly splashed onto the stonework and this can lead to a significant breakdown of the mortar and the stone.

In recognising that it is difficult to avoid circumstances where walls are adjacent to surfaces that are routinely treated with winter salt, repairs should be carried out to both stone and joint work whenever signs of degradation are noted. If left unattended, the salt contamination can continue to decay the masonry to such an extent that it can undermine the structural stability of the wall, leading to its eventual collapse. In some cases this will mean replacing badly eroded stones to stop the process getting worse.

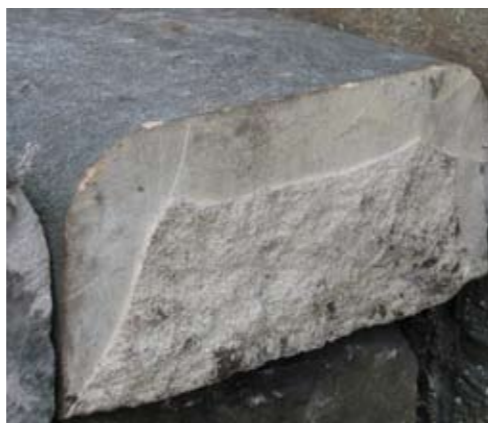
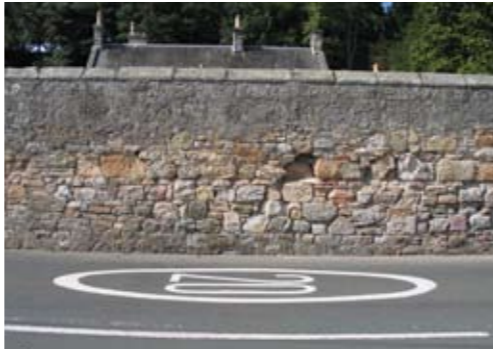
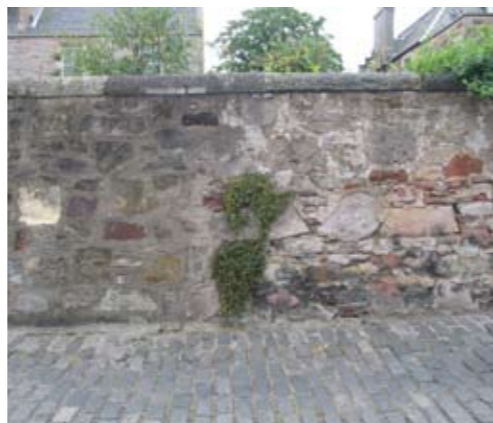
The modern technique for adjusting boundary walls frequently involves using a mechanical saw to reduce the length of some cope stones. This can leave an unsatisfactory finish as the technique also involves physically breaking the stone along the weakened lines of the mechanical saw cuts. Where cope stones require to be shortened the cut end of the stone should be carefully hand worked to match the original masons tooling.

It has also become commonplace to rebuild masonry walls in a style that does not reflect how they were originally constructed. Although the stones may be re-used in the rebuild, through lack of recognition that the stones were originally laid in horizontal courses, they now tend to be somewhat thrown together in a haphazard manner. This not only changes the appearance of the wall, it also creates a build that less strength than the original construction.

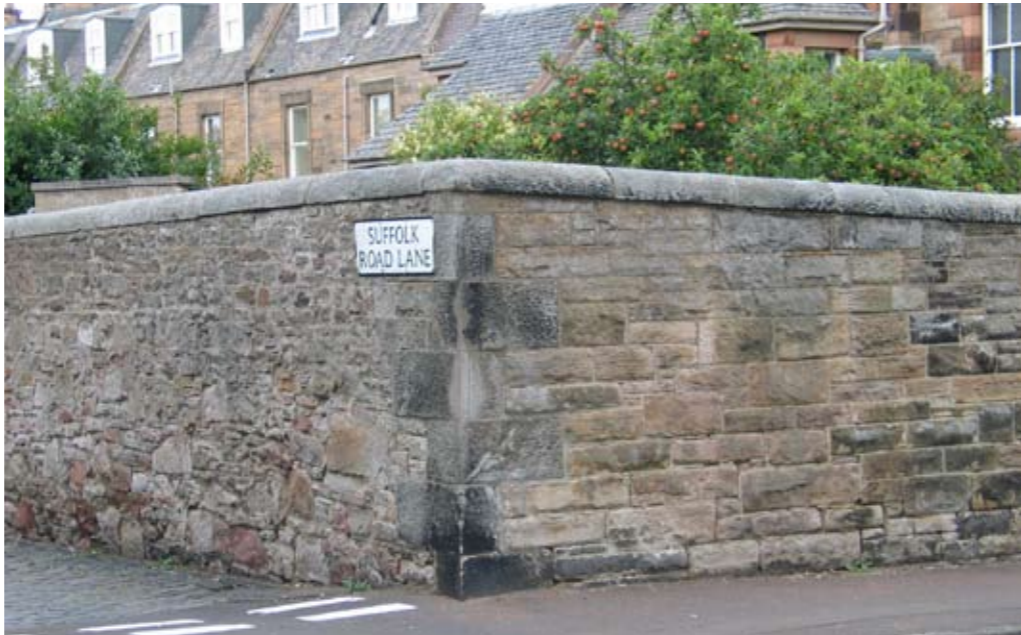
Different types of building techniques were used depending upon circumstance. For low walls, and those either fronting the property or creating the boundary with principal streets in urban areas, ashlar masonry construction was the norm. In rural areas, and in service lanes in urban locations, rubble construction was more common. Both

forms of masonry were built in distinct courses, usually with lime mortar. The ashlar build would be more finely pointed than walls built of rubble construction. Rubble tended to be “smear” or flush-pointed, with lines struck in the wet mortar to emulate fine joints.

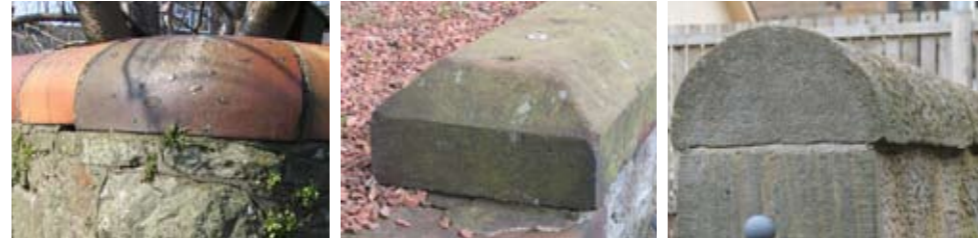
The two forms of build can often be found at the junction between the service lanes and principal streets. At the junction, the corner would be strengthened through the use of inband and outband ashlar blocks extending up the height of the wall.

To accommodate changes in the ground level between properties, cope stones may be carefully detailed to have their moulded profile curved, angled or returned in vertical steps to maintain the wall height above ground level. Occasionally, cope stones may also rise to create a lintel over doorways set within the wall. In doing so, the lintel helps stabilise the wall by providing a physical link that structurally ties the wall on either side of the doorway together.

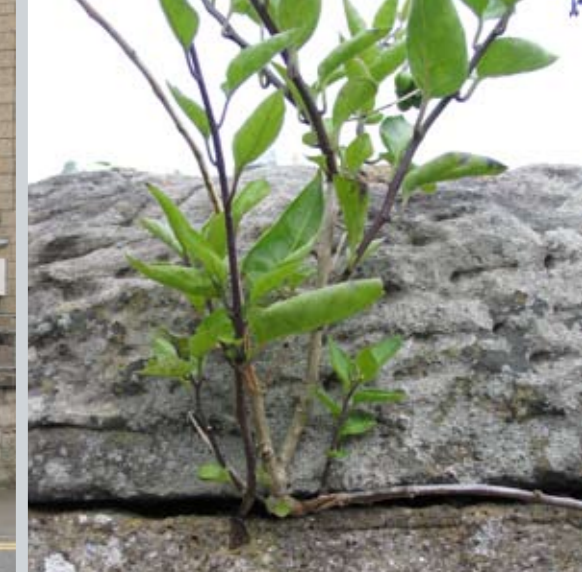
Where a wall has not been maintained, and the pointing material has become loose or dislodged, the ideal situation for the establishment of damaging plant growth has been created. Vegetation is often found growing out of the face of walls where the joints are open and this can lead to more damaging root penetration into the wall core. If this occurs below the cope the development of the roots can lever the cope stone out of place, and disrupt the pointing between the individual stones. This, in turn, can allow water to penetrate the core, nourish the roots and lead to further deterioration through encouraging the growth. Where vegetation has established itself on a boundary wall it should be quickly removed, and any open joints and beds repointed as soon as possible to prevent recolonisation. More established growths should be removed by hand weeding, ensuring that all the roots are also removed to avoid leaving potential paths for water ingress as they decay.

In situations where the growth has been left unattended for some time, and the root penetration is significant, the cope stones may

have to be up-lifted and small sections of the wall down-taken, to completely remove all the roots from the wall core prior to the wall being rebuilt. As far as possible the stones which have been removed should be replaced in their original position taking care to align with the original building courses.
