Timber Decay in Buildings

The conservation approach to treatment

Brian Ridout

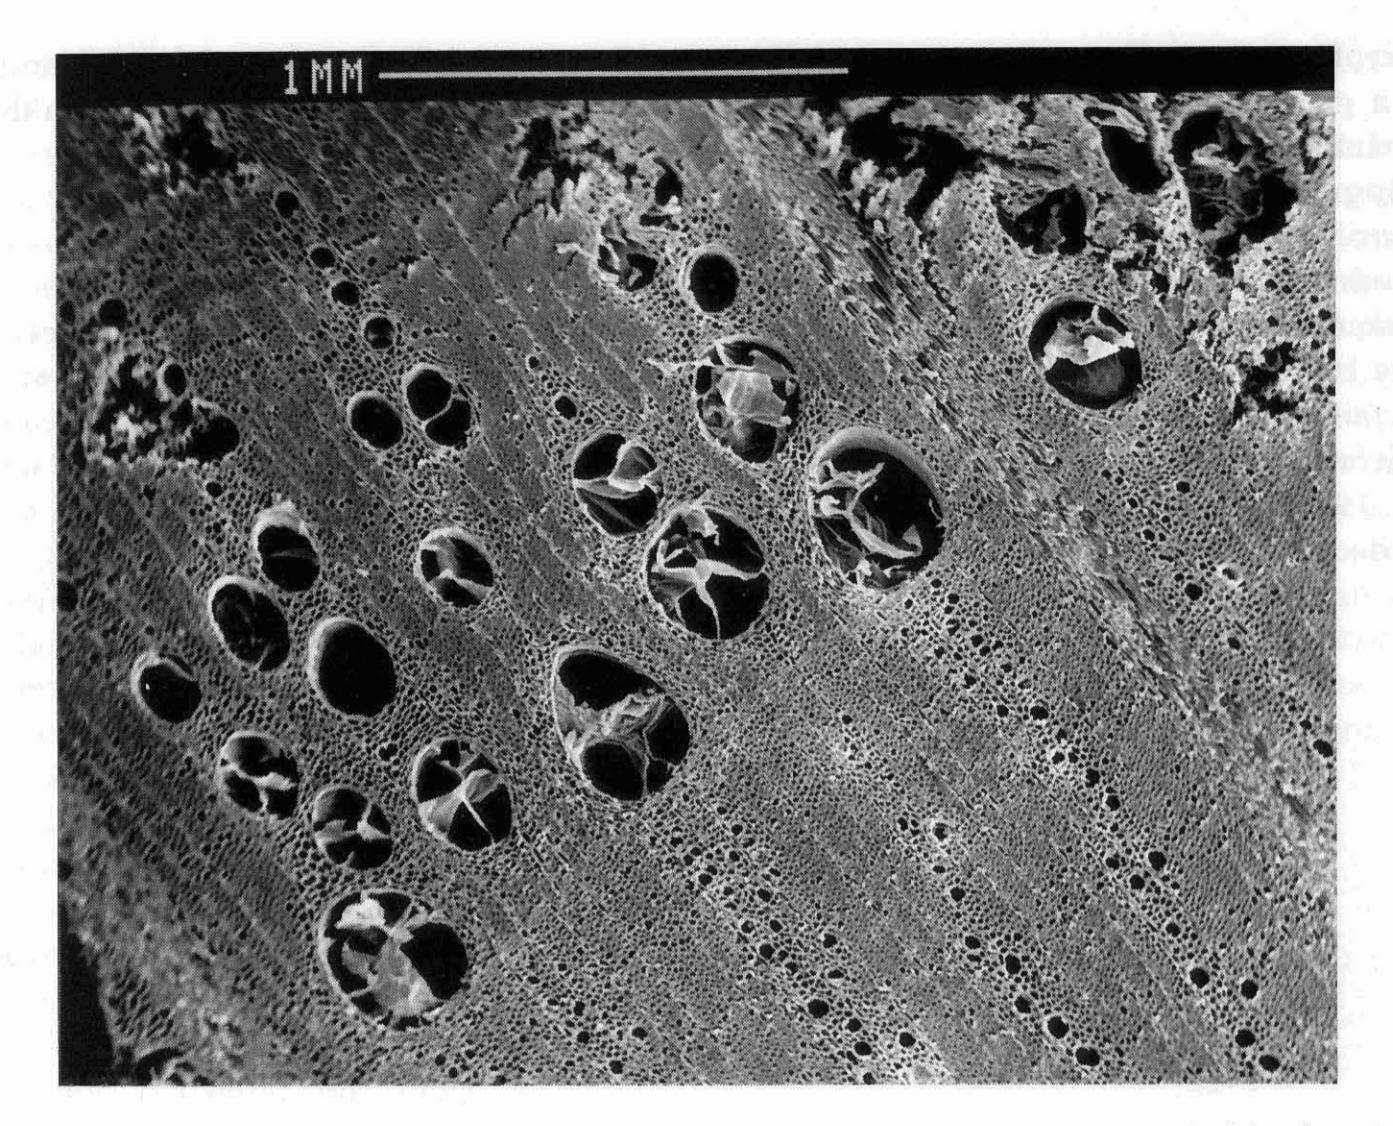
Figure 1.10 A transverse section of oak showing large earlywood vessels blocked with tyloses.

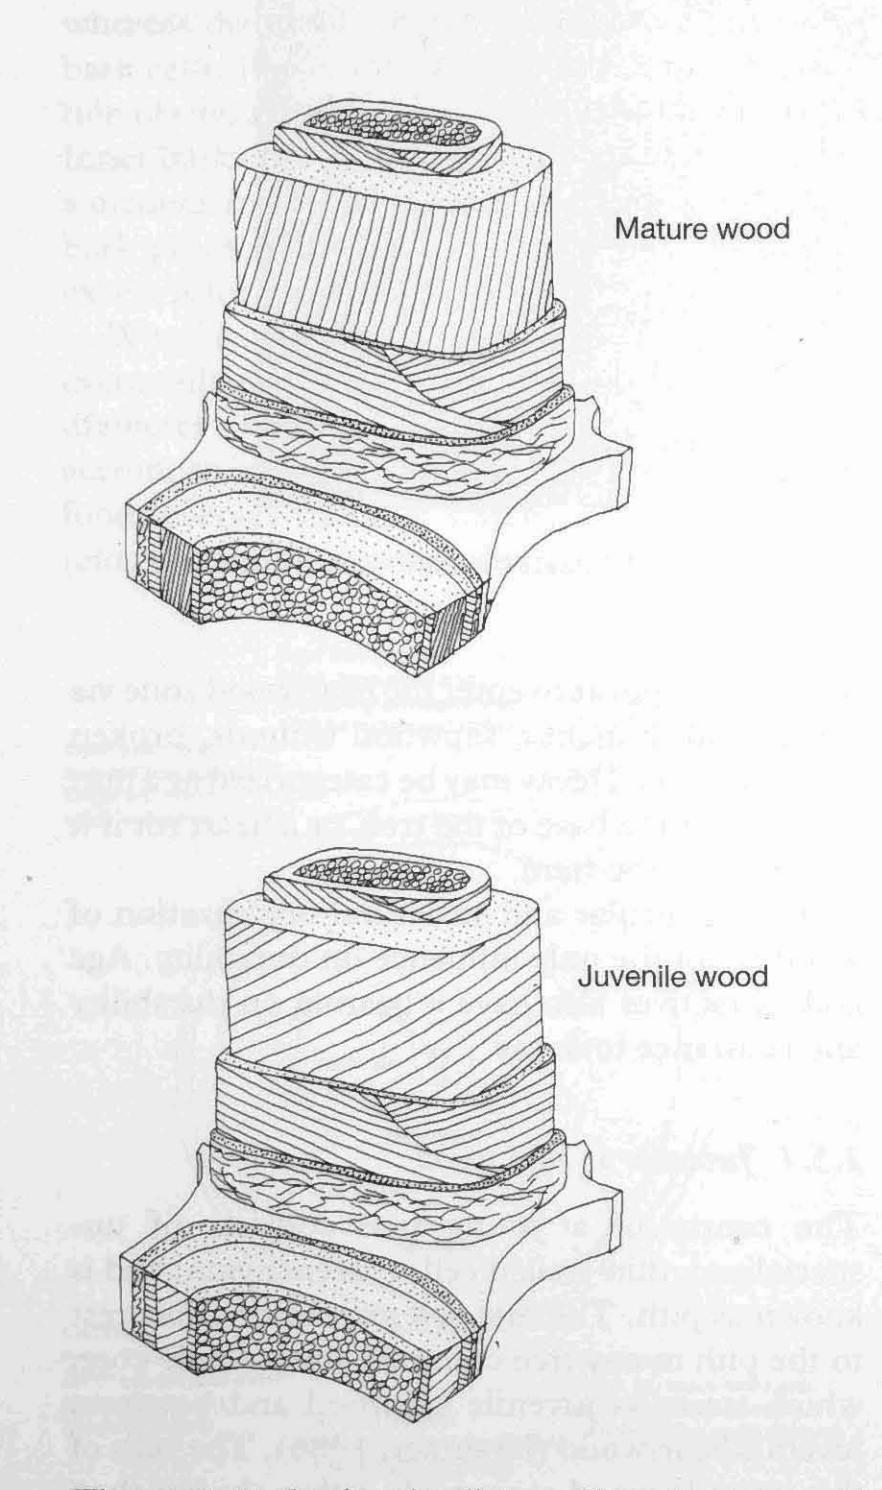
Figure 1.11 Angle of cellulose fibres in wood cell walls.

The microfibrils in the S2 layer are less crystalline and at a greater angle to the longitudinal axis (Figure 1.11). These differences are usually substantially greater in softwoods than in hardwoods. The microfibrils gradually straighten as successive years produce longer cells. Juvenile timber is therefore weaker than mature wood of the same density, and may break under load with a brash type of tension failure (Krahmer, 1986). It is also more susceptible to longitudinal shrinkage (Harris and Meylan, 1965) and will be less resistant to decay. This is because the concentration of extractives

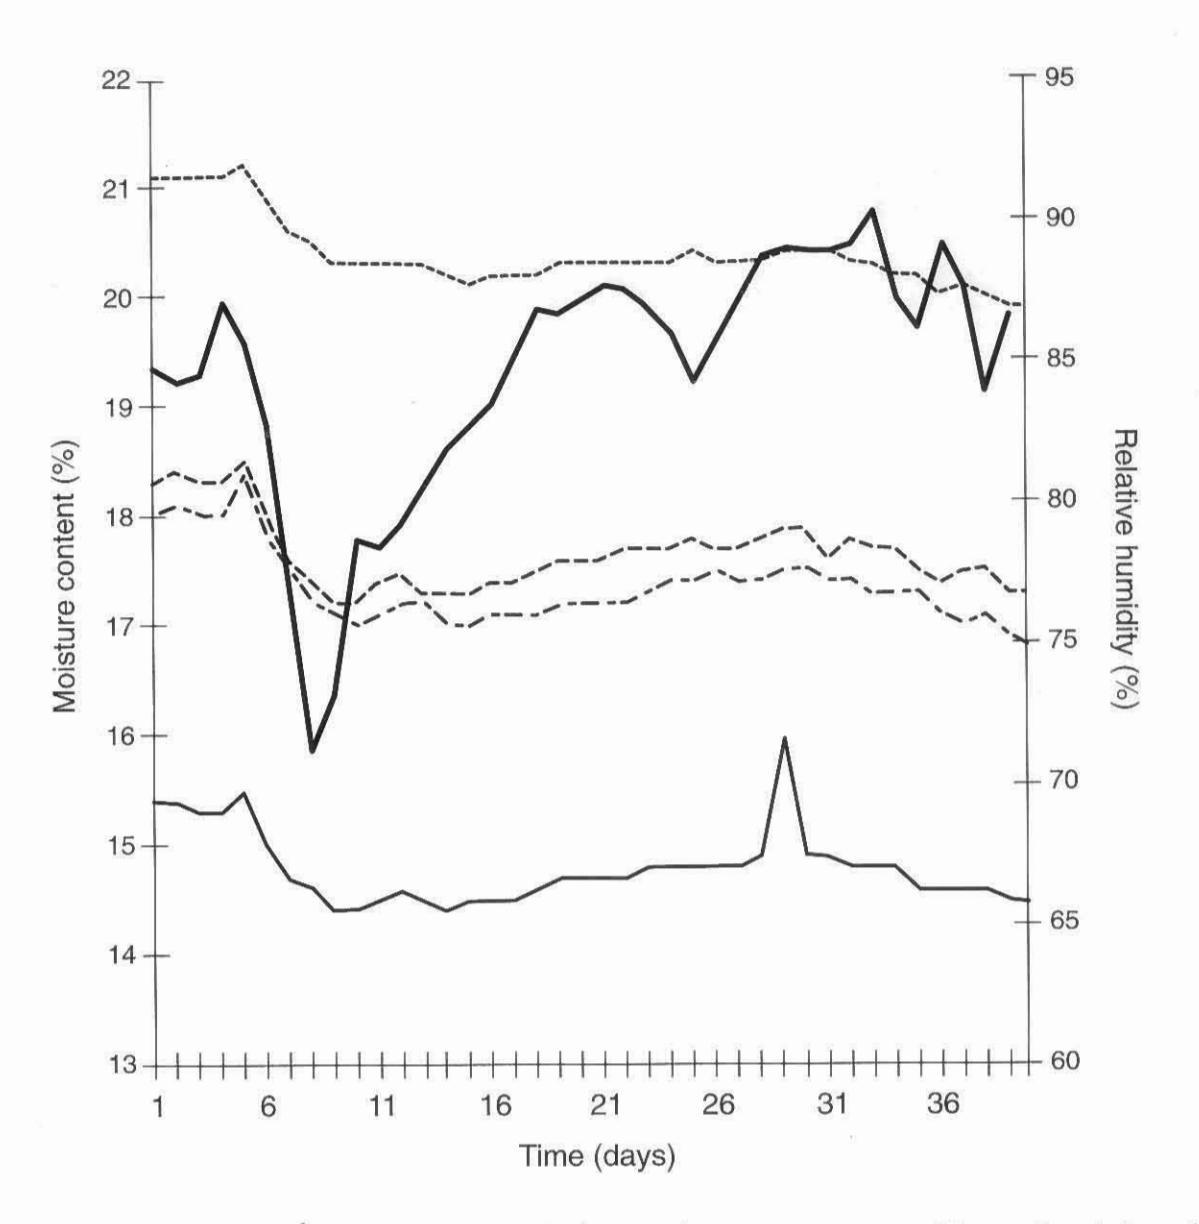
Figure 2.2 Relationship between relative humidity and timber moisture contents at 10 cm depth in oak heartwood: (----) new oak; (___) 17C oak; (_ - -) 15C oak; (_ - -) 13C oak; (___) relative humidity.

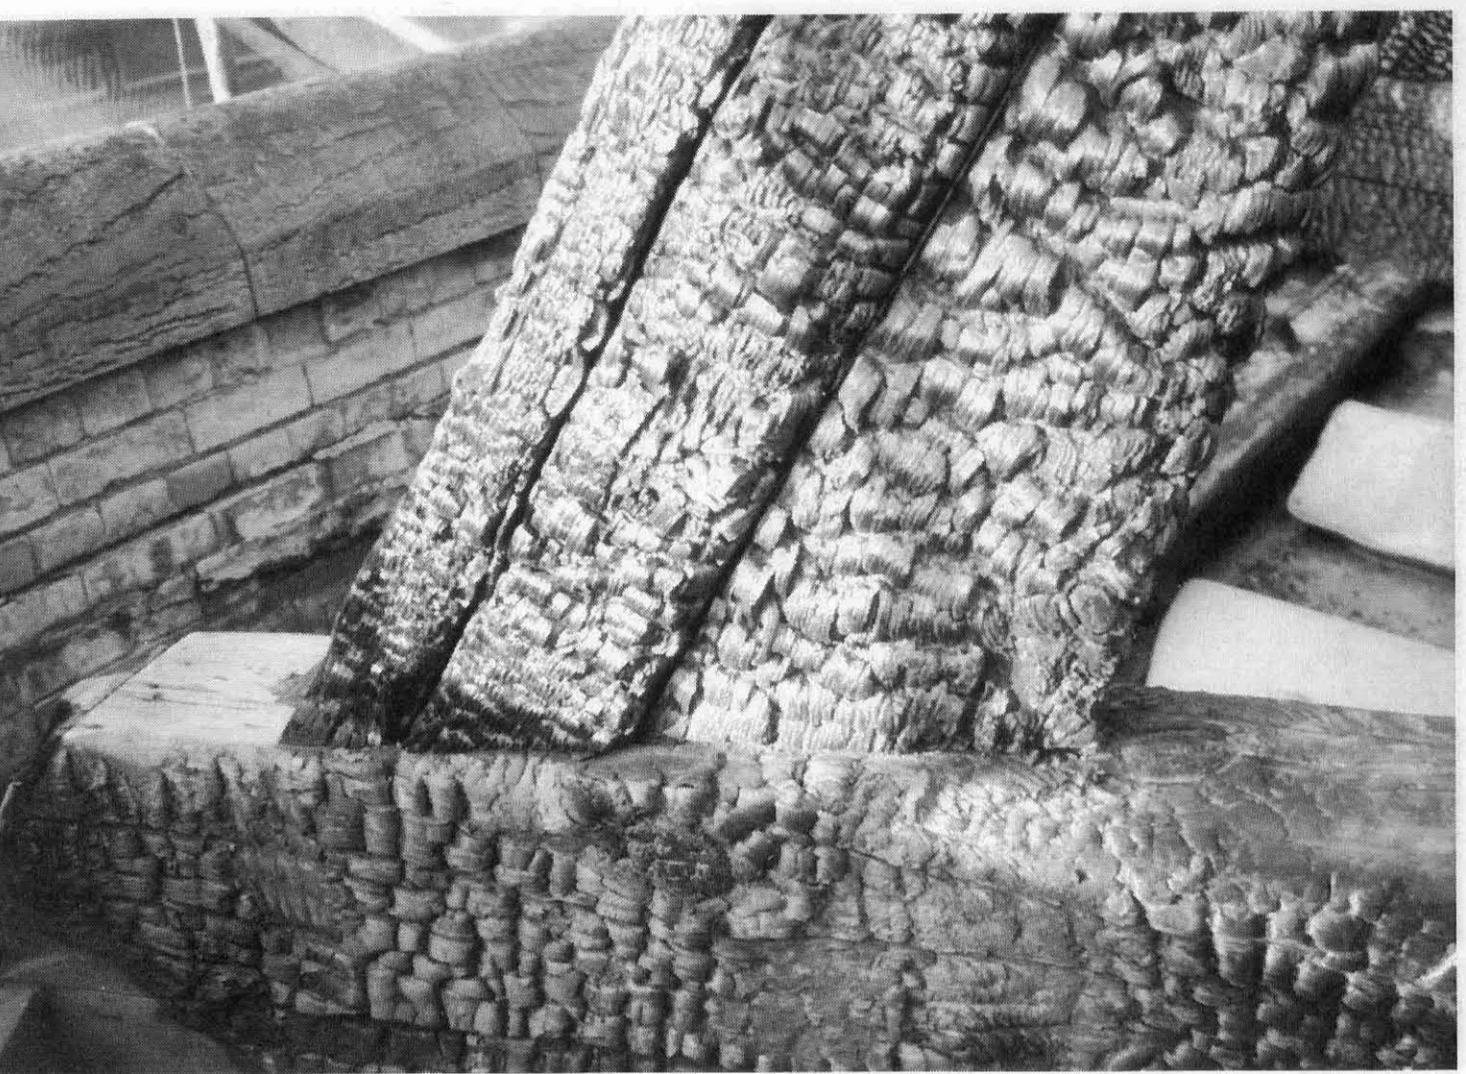
Figure 3.5 Fire damage causes a surface checking of the timber which resembles brown rot damage. This may be because the cellulose is destroyed before the lignin.

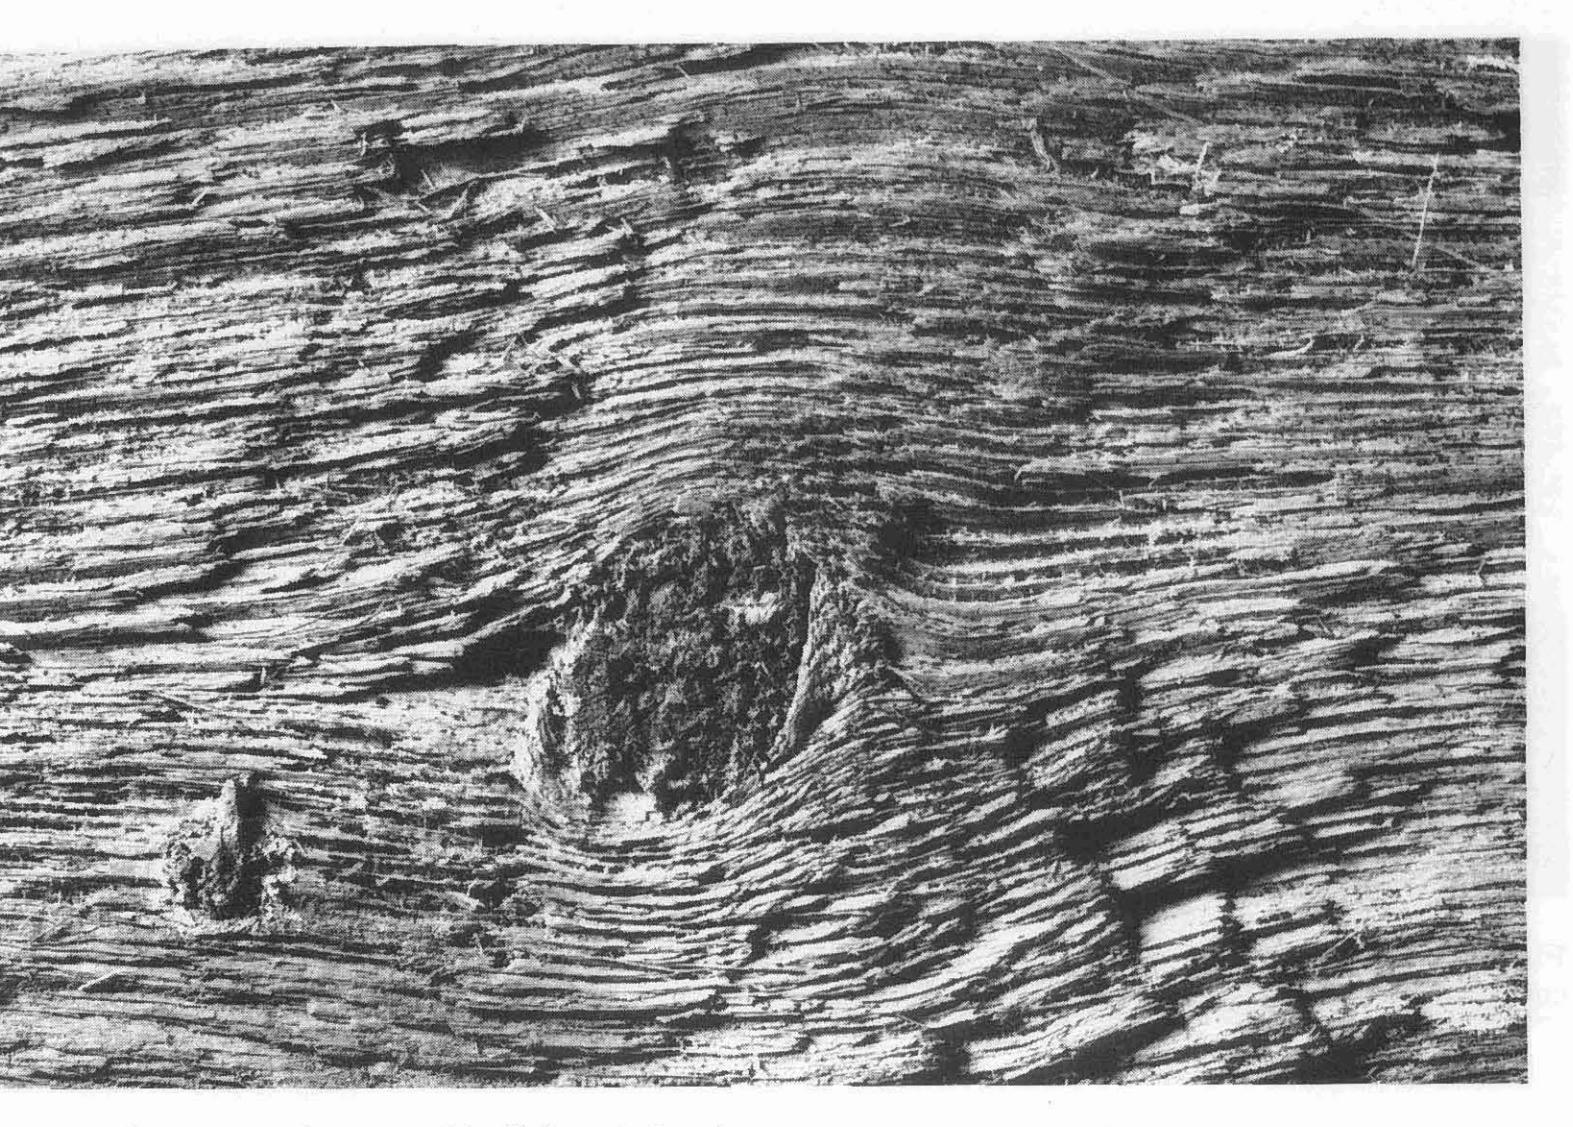
Figure 3.6 Surface erosion caused by light, wind and water.

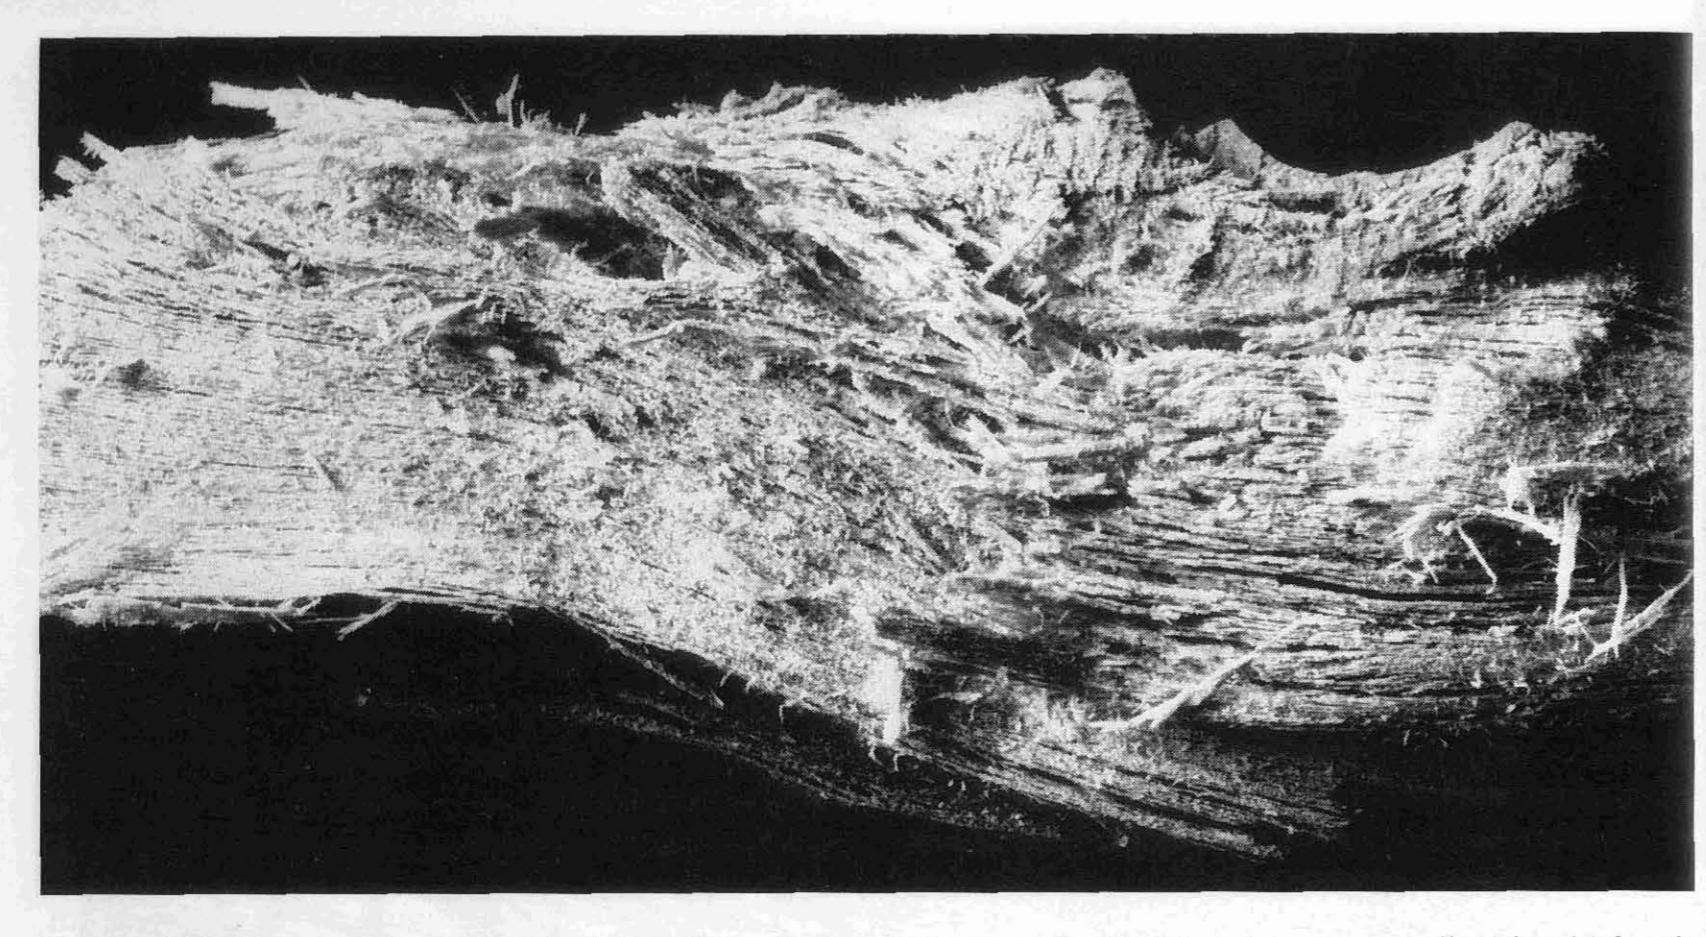
Figure 3.7 Chemical damage in the base of a wall stud that was embedded in a basement wall with a high salt concentration. The damage superficially resembles a white rot.

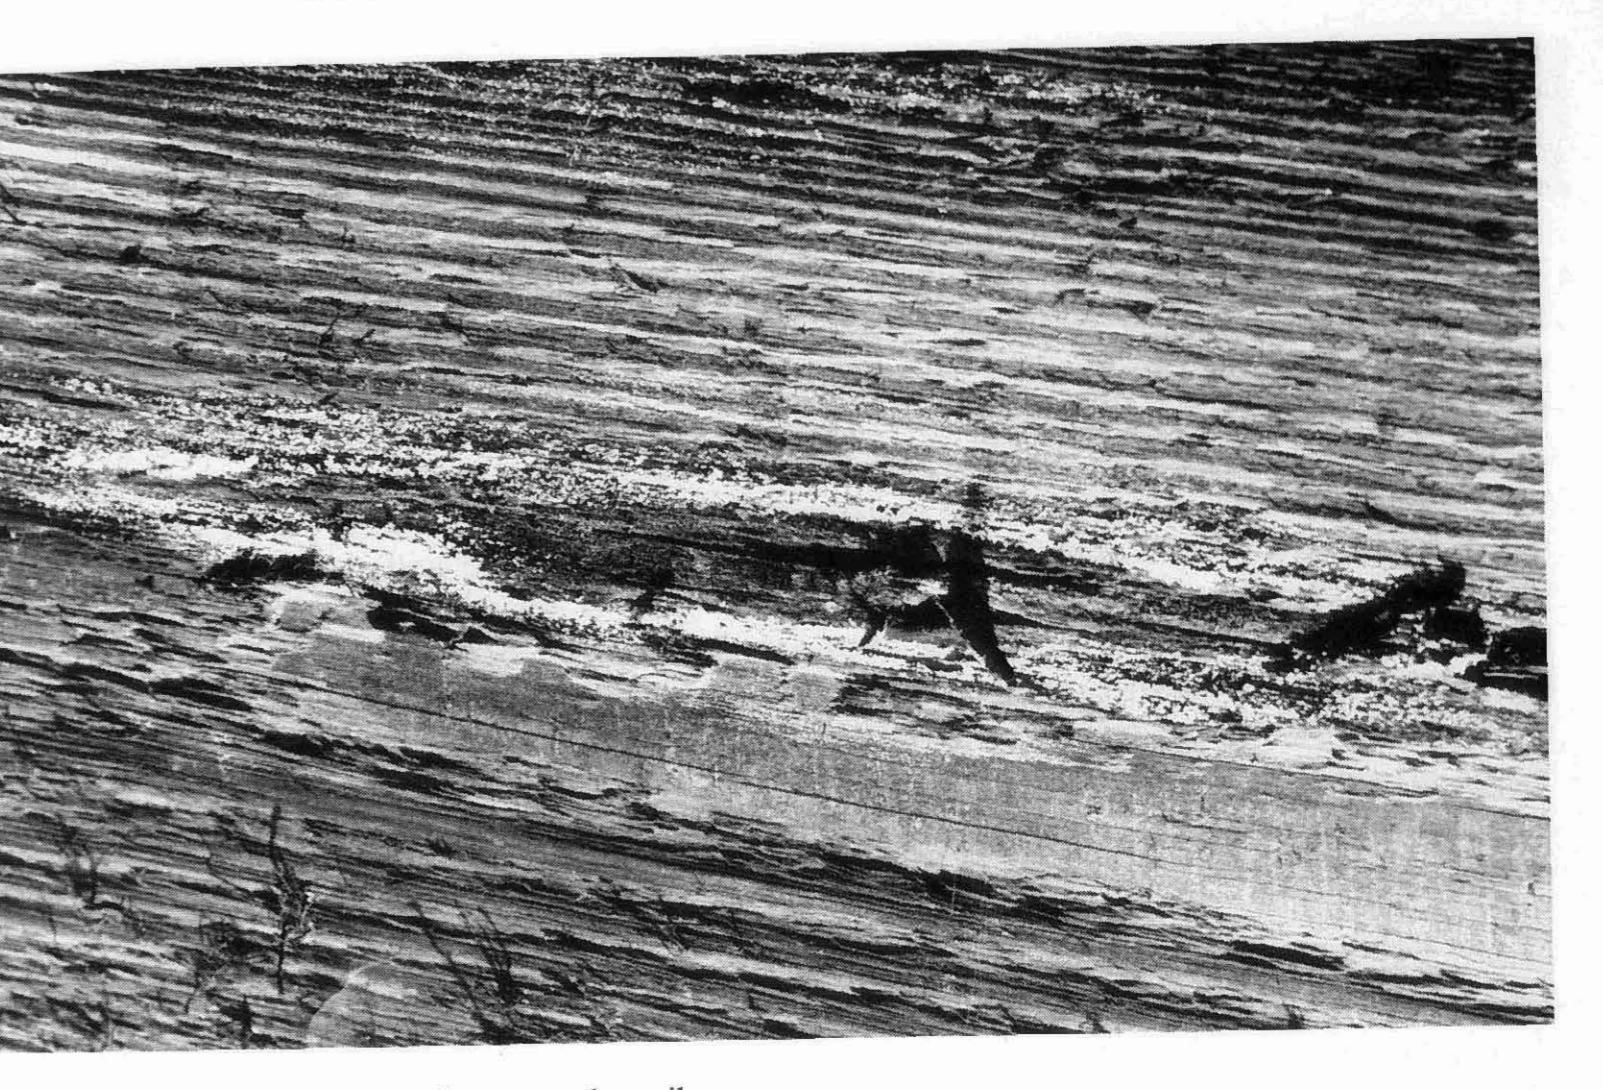
Figure 3.9 Corrosion products forming around a nail.

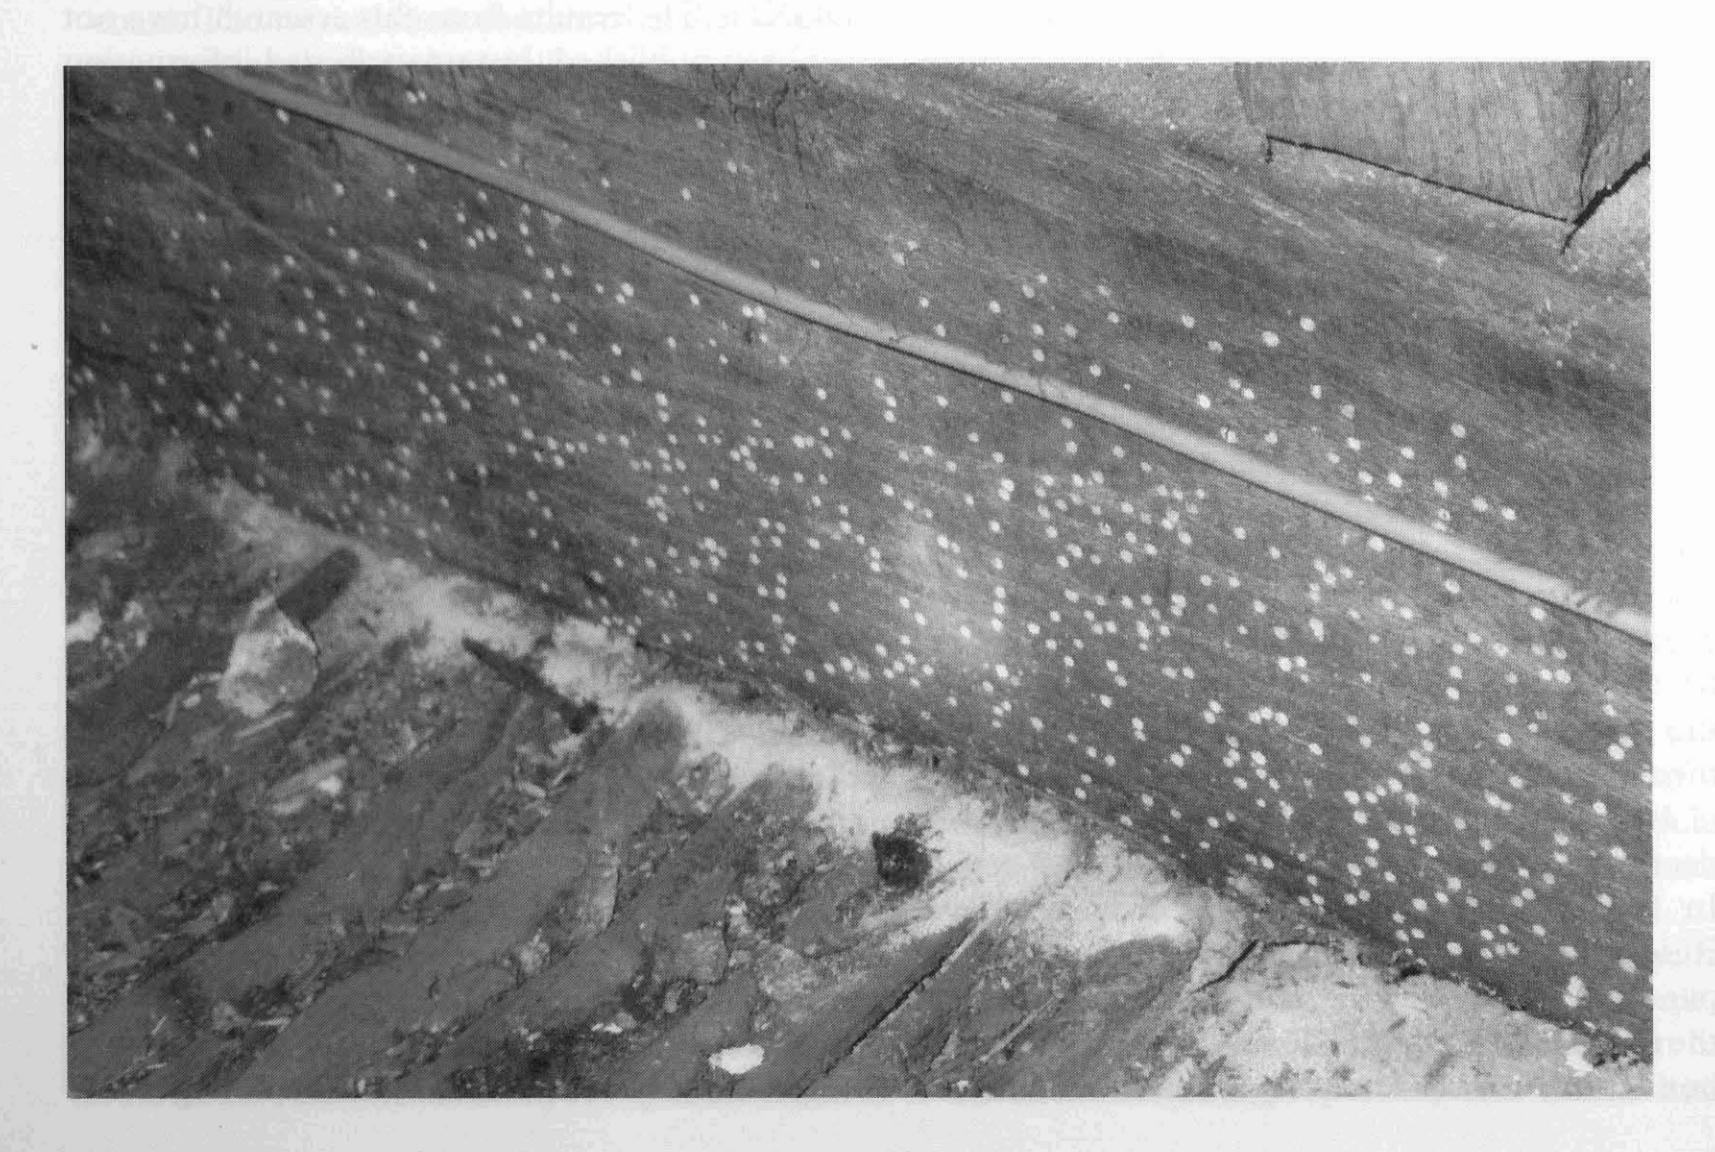
Figure 4.3 (below) Emergence holes occur all over the surface of sapwood and active infestation is shown by bore dust the colour of freshly cut timber.

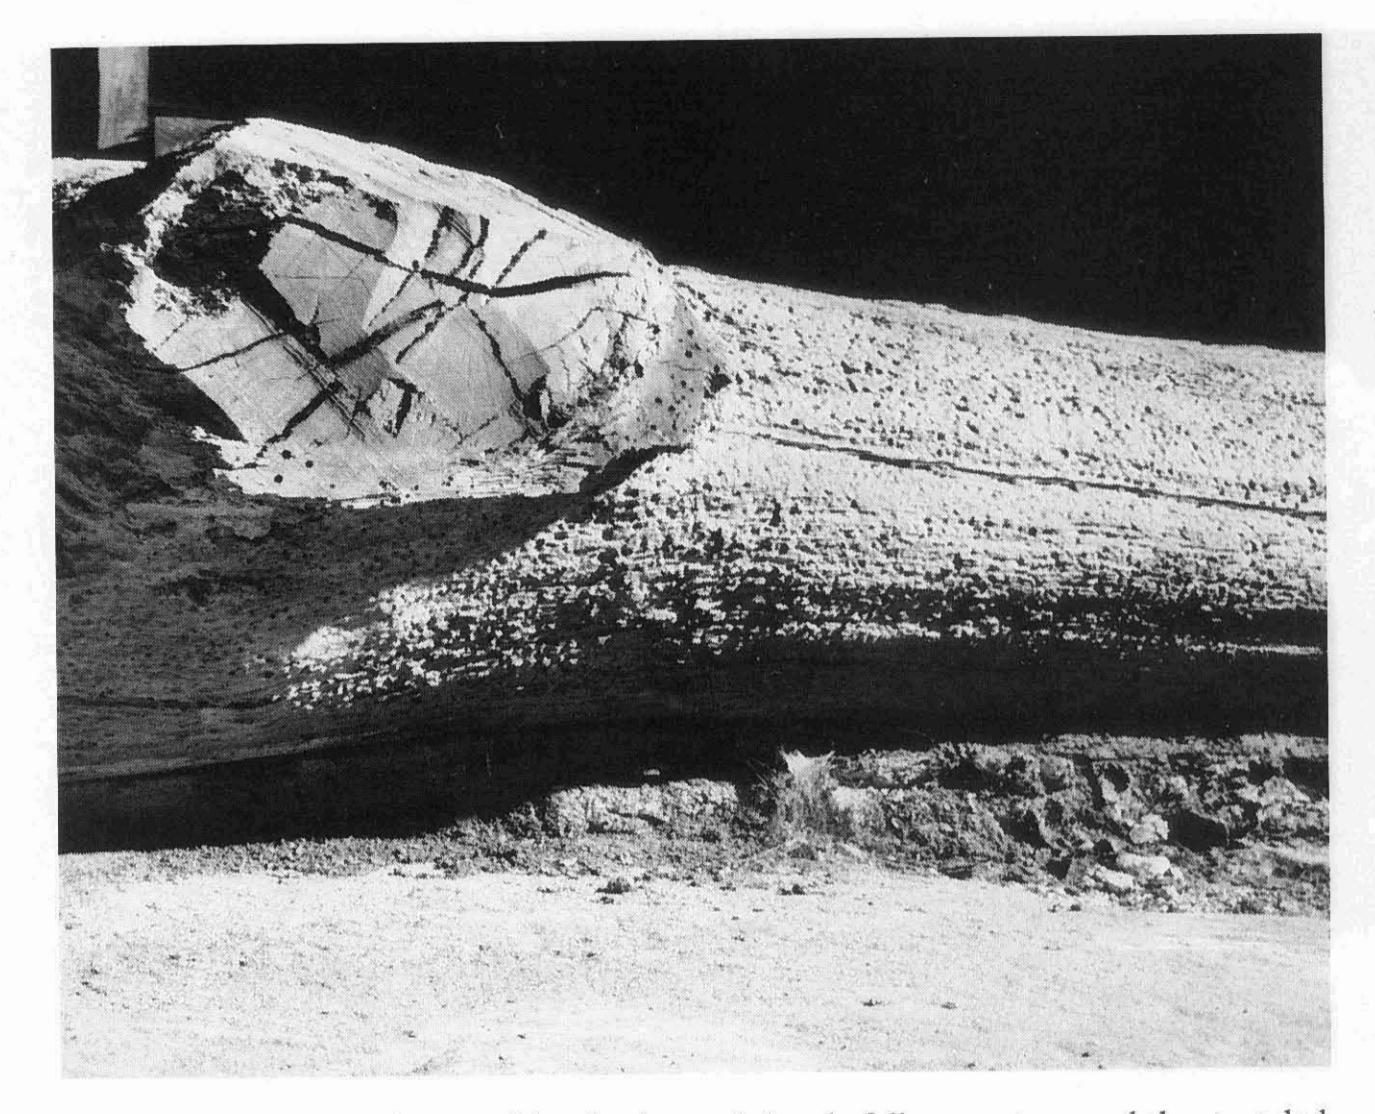
Figure 4.4 Sapwood destroyed by death watch beetle falls away to reveal the rounded heartwood surface, which is usually immune from attack unless fungus is also present.

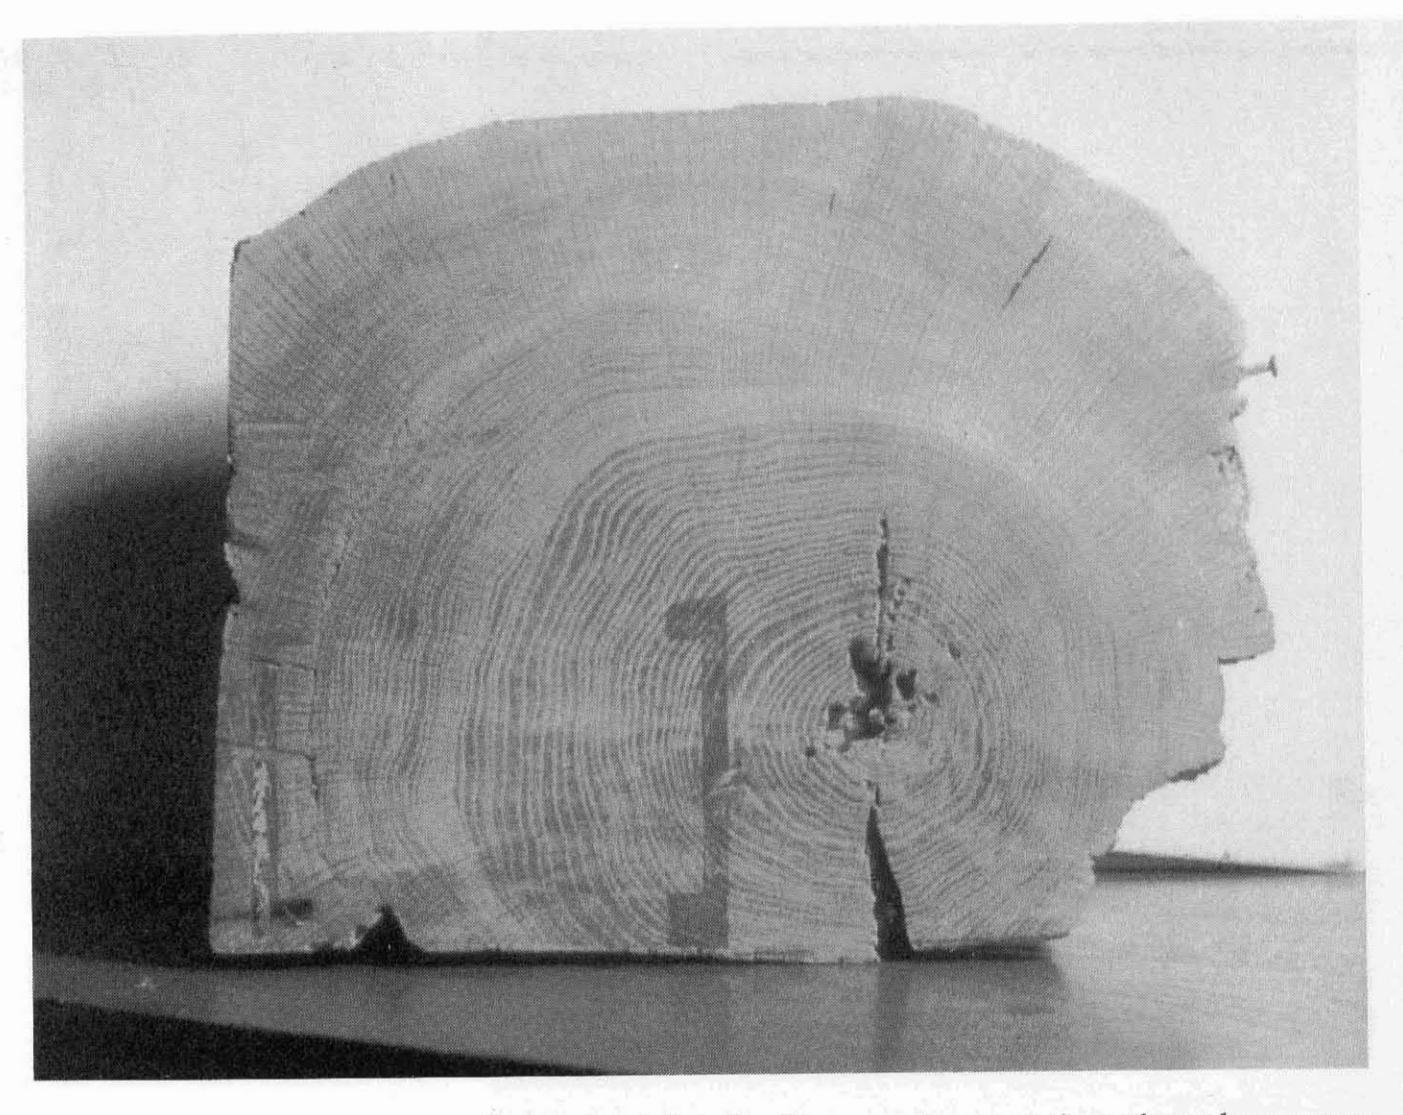
Figure 4.7 The core of the timber contains far fewer toxic extractives than the mature heartwood, and may also contain heart rots that originated in the standing tree. This zone provides a good environment for the death watch beetle.

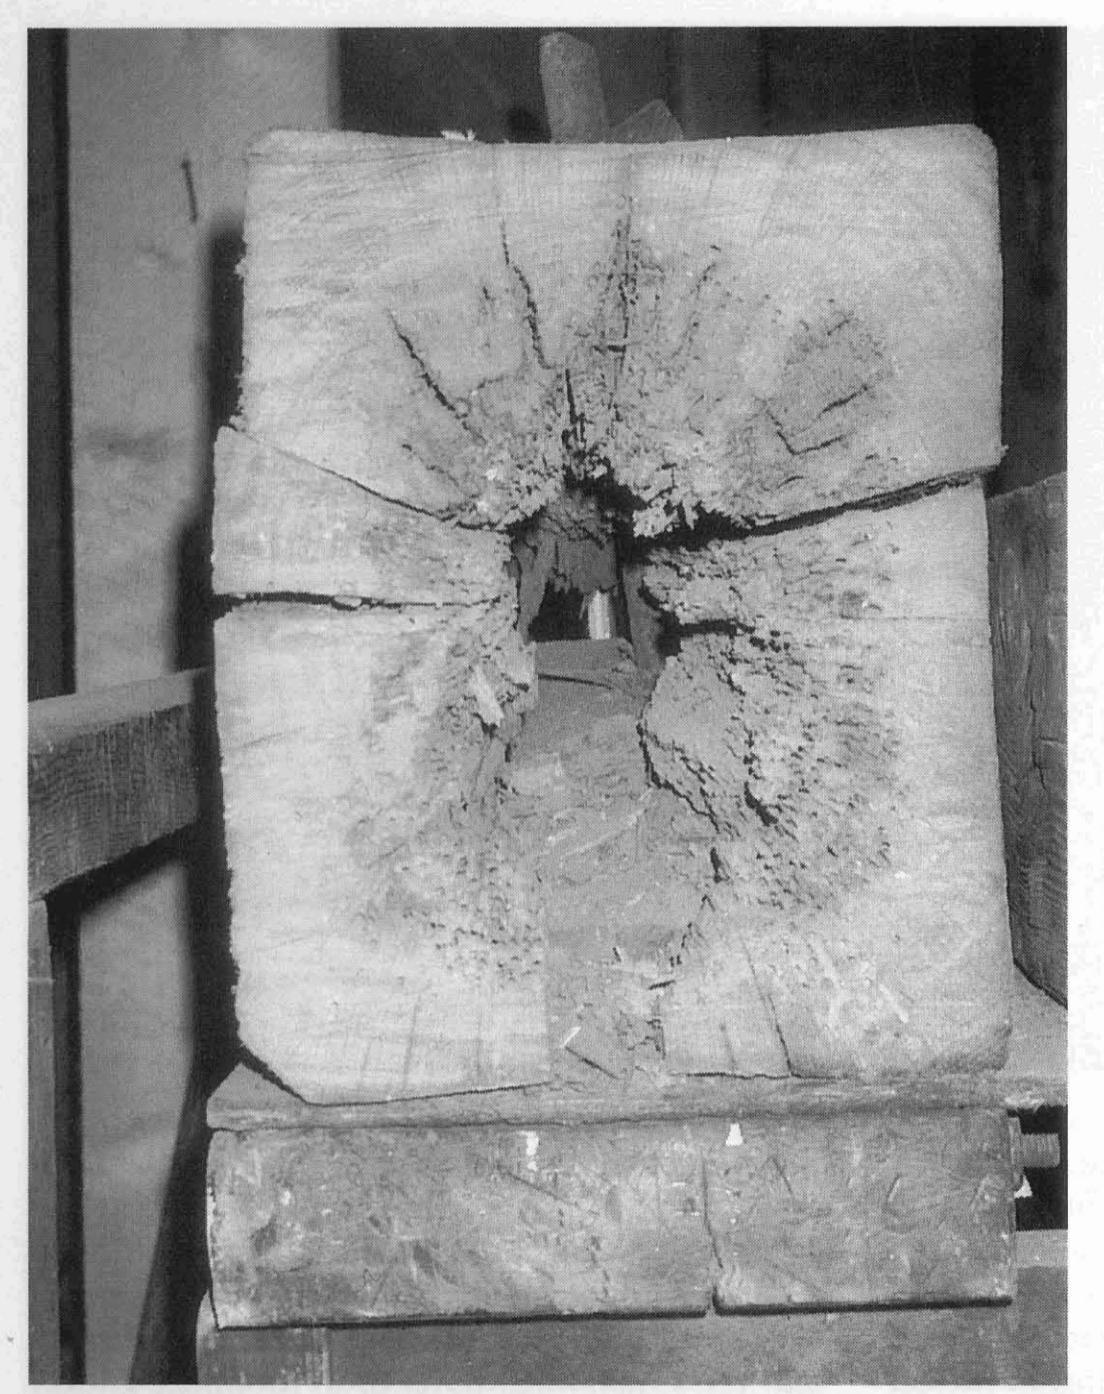
Figure 4.8 Eventually a large cavity may be found in the centre of the timber.

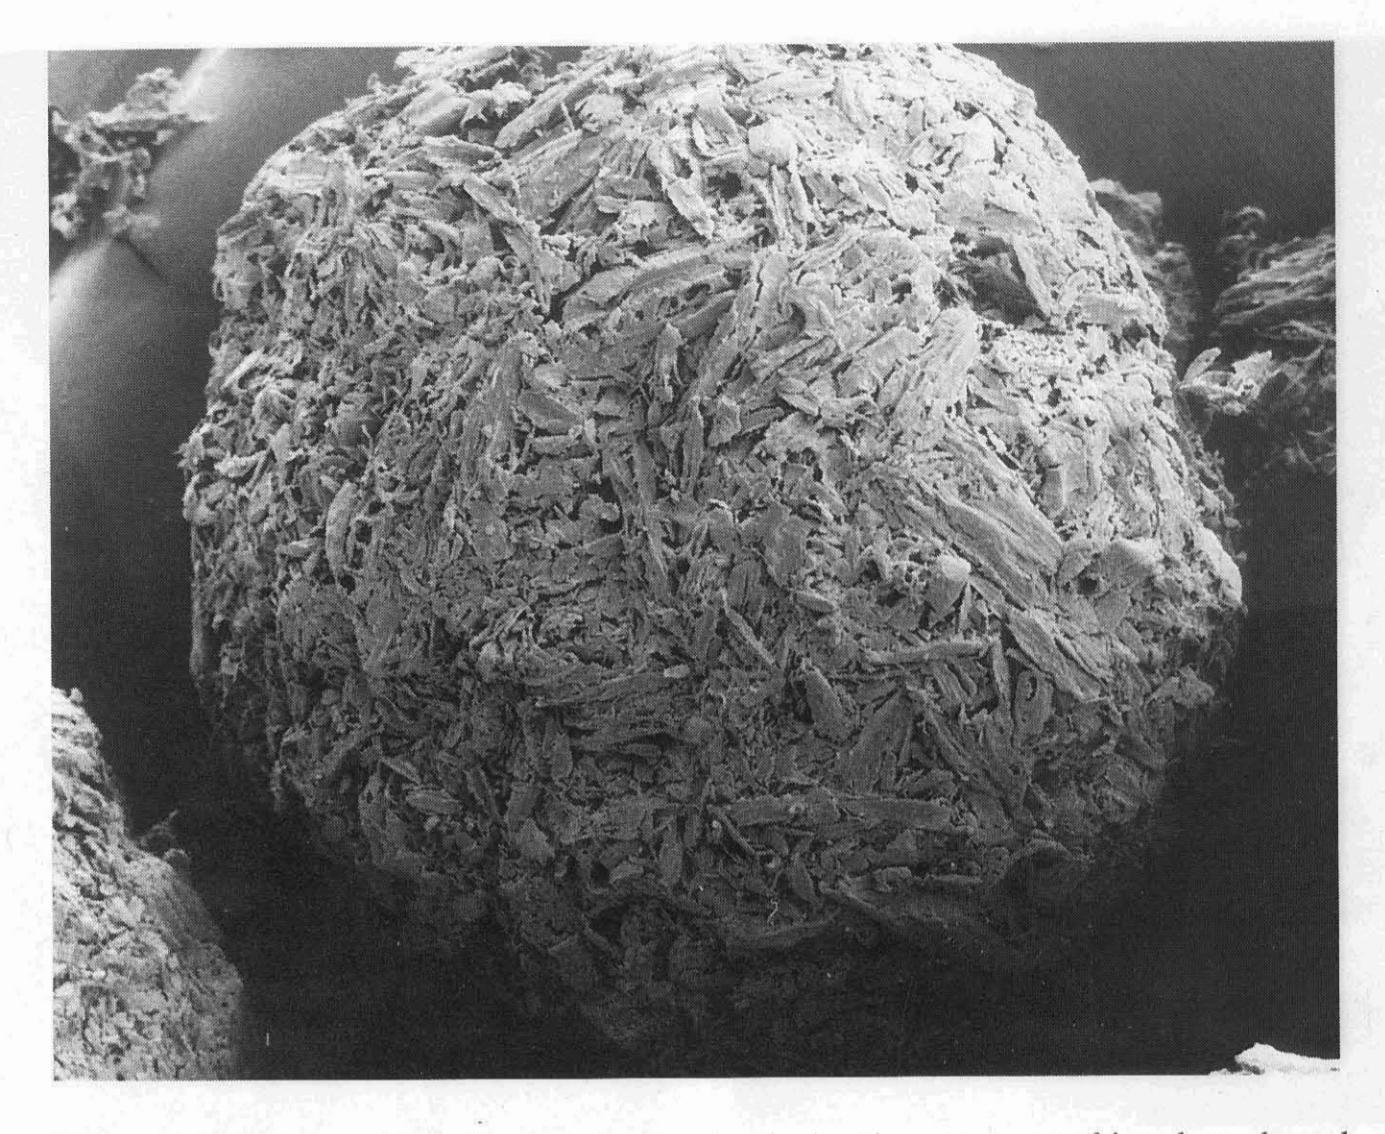
Figure 4.9 The fine timber fragments eaten by the beetle are processed into bun-shaped pellets within the insect's gut ($\times 250$).

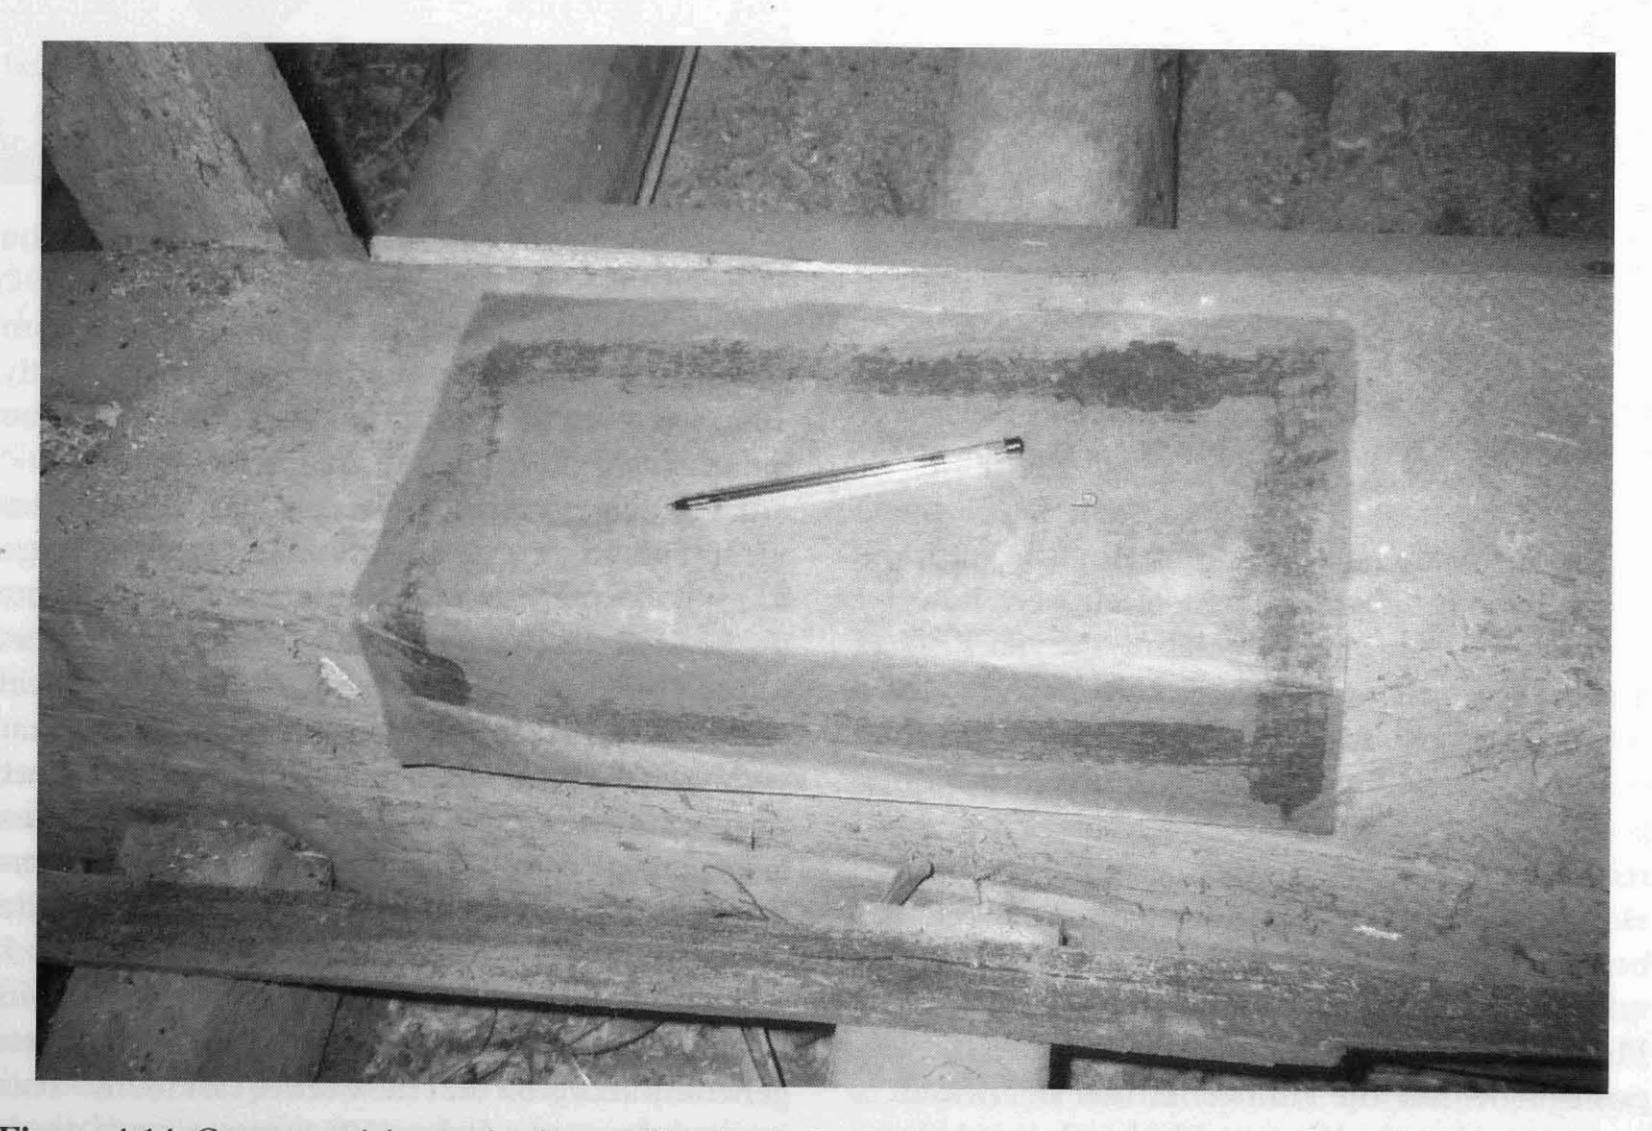
Figure 4.14 Current activity can be detected by closely fastening tissue paper over groups of flight holes. Emerging beetles will punch holes through the paper.
