Timber Decay in Buildings

The conservation approach to treatment

Brian Ridout

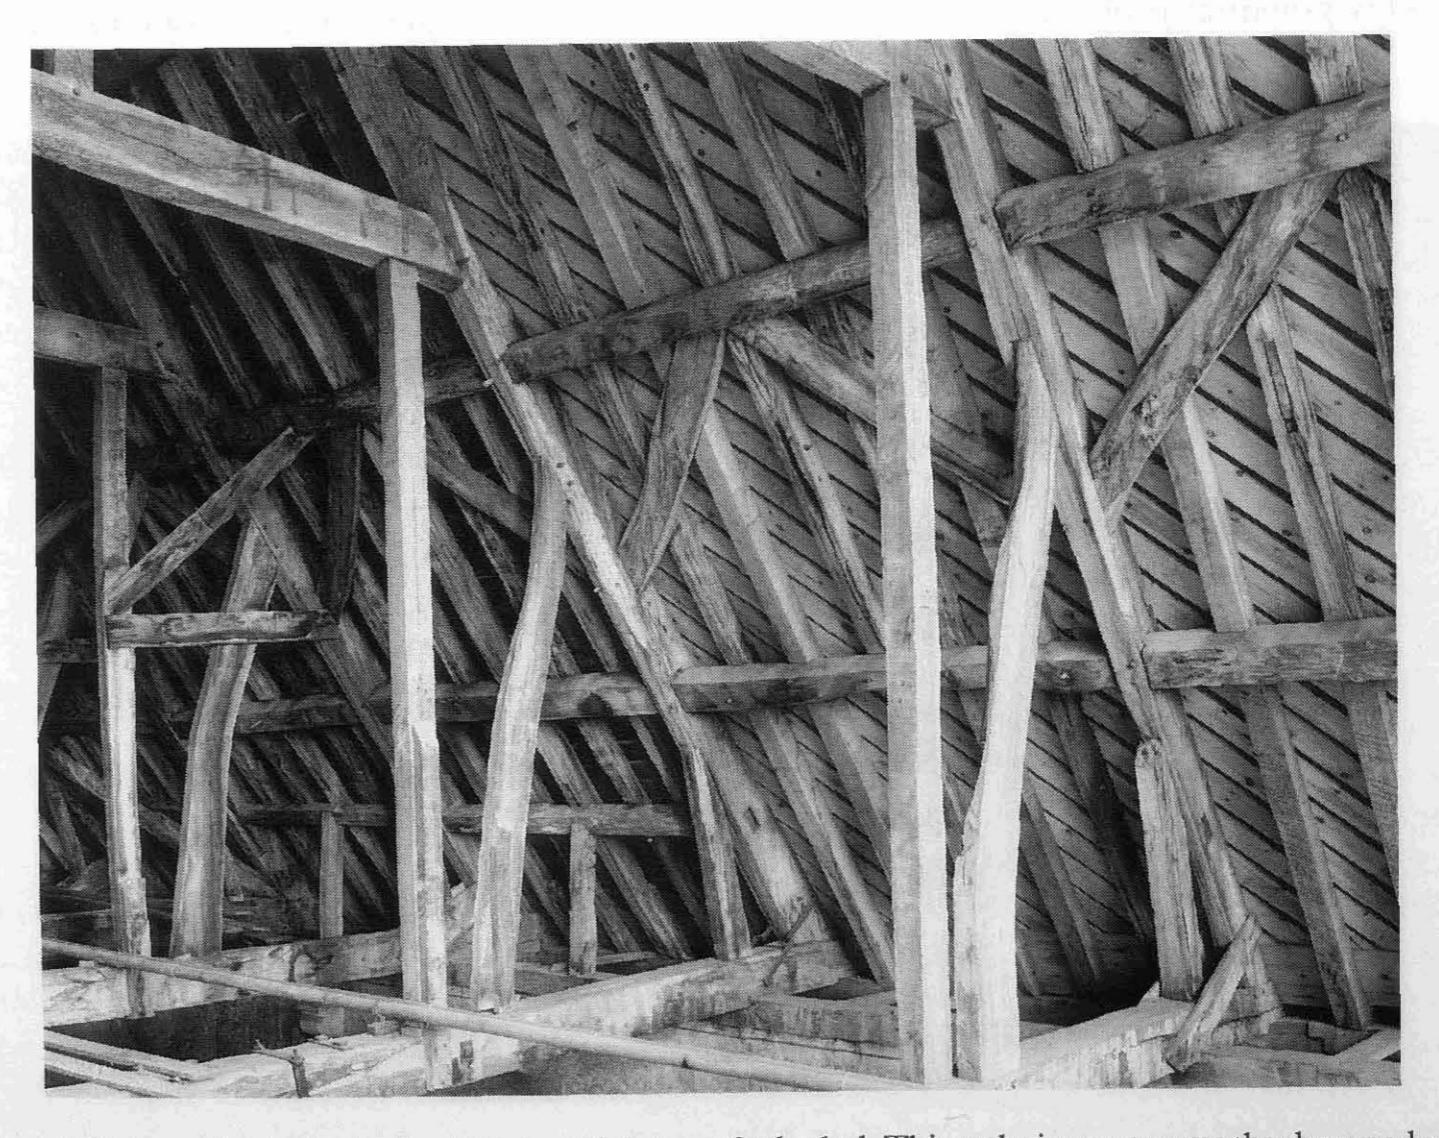
Figure 4.17 Defrassed principal rafter braces at Salisbury Cathedral. This technique removes the damaged sapwood so that the underlying heartwood can be treated. The heartwood is not, however, at risk, and will not readily accept the preservatives.

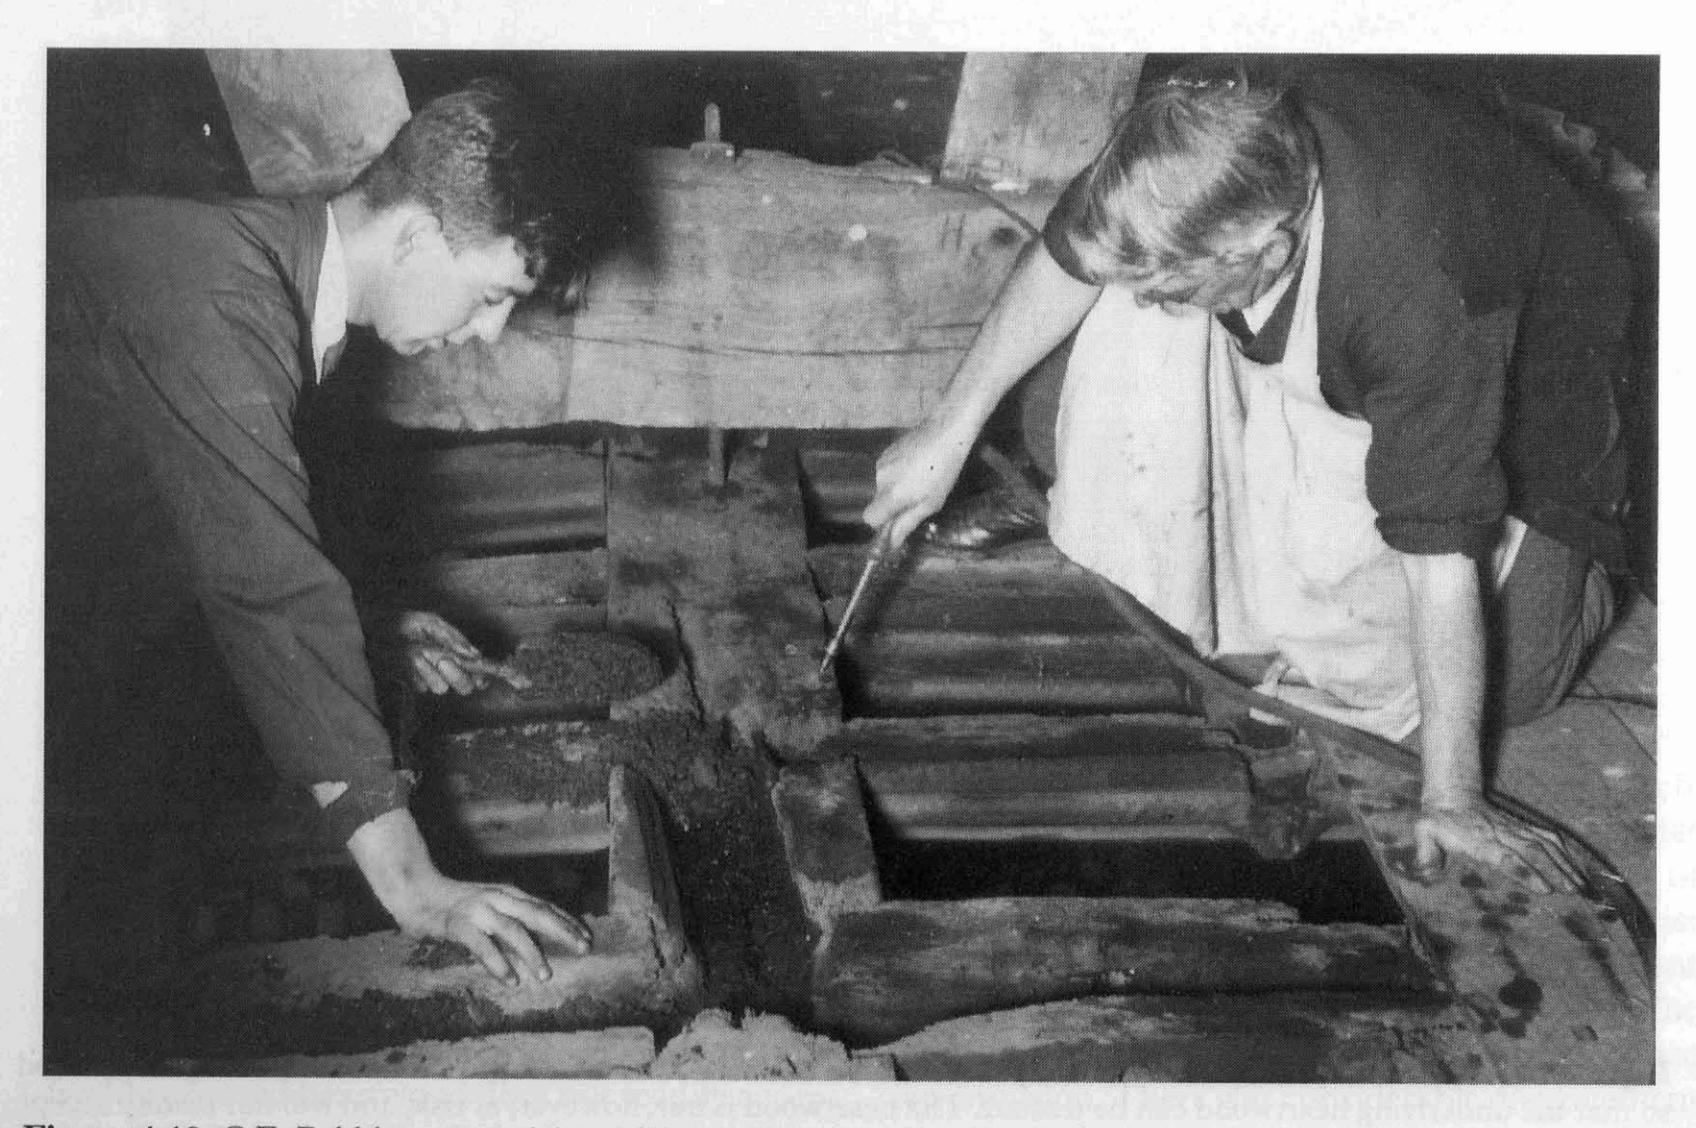
Figure 4.18 C.E. Bebbington applying a filler to timber damaged by death watch beetle (1920s).

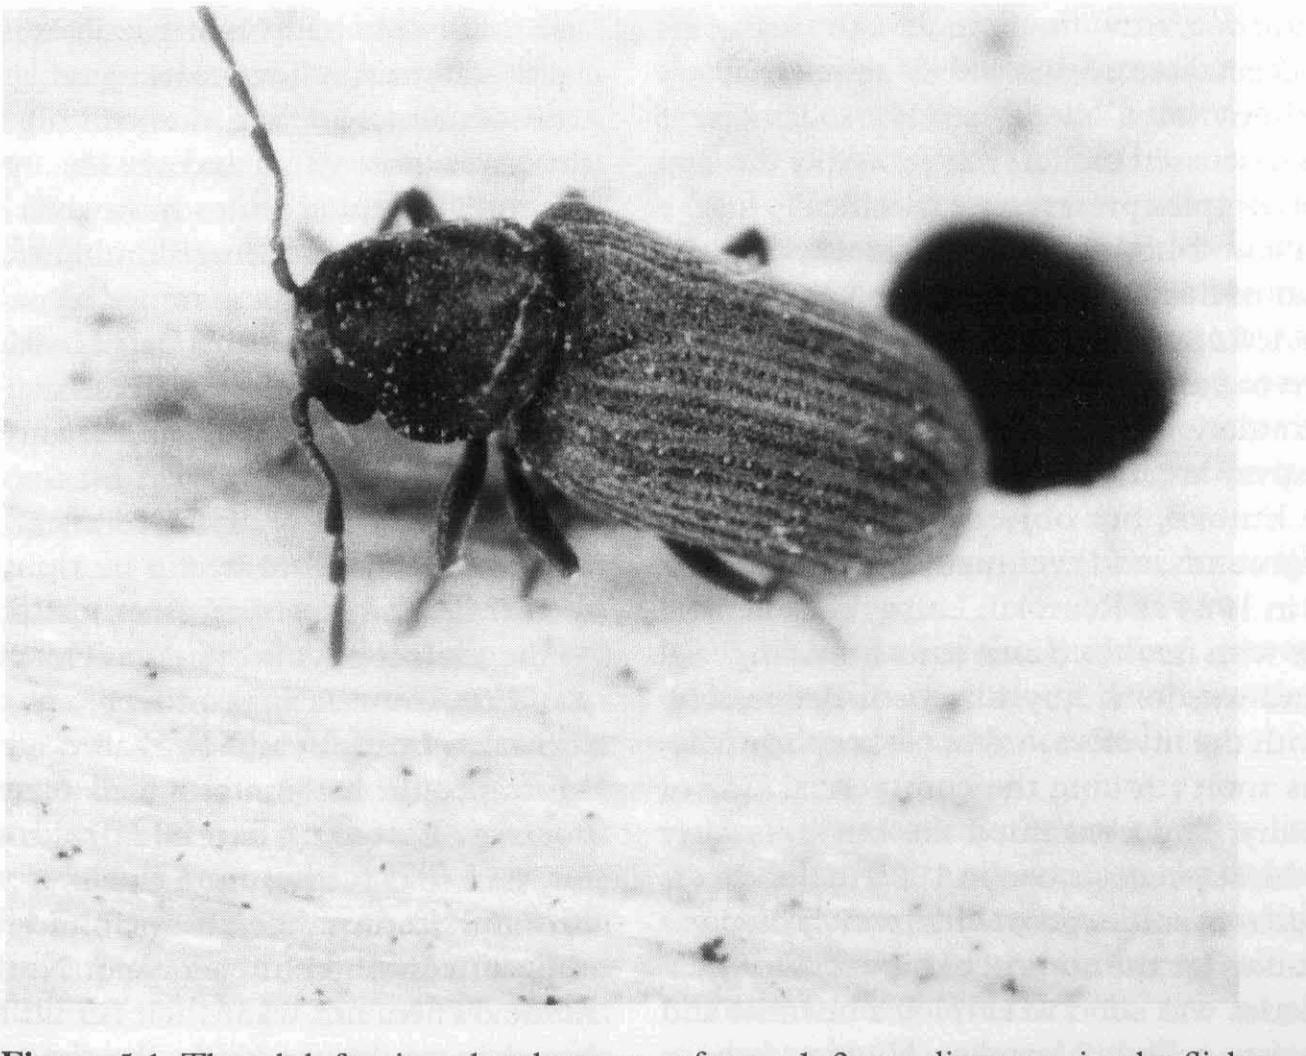
Figure 5.1 The adult furniture beetle emerges from a 1-2 mm diameter circular flight hole.

The common furniture beetle or woodworm (Figure 5.1) is indigenous to, or has been introduced into, most of the temperate world. Its similarity to the death watch beetle (X. rufovillosum) has always been recognized and in older texts it is frequently regarded as a small death watch beetle. Not until 1925 did Gahan discover that the insect does not tap, and that the name 'death watch' was misapplied.

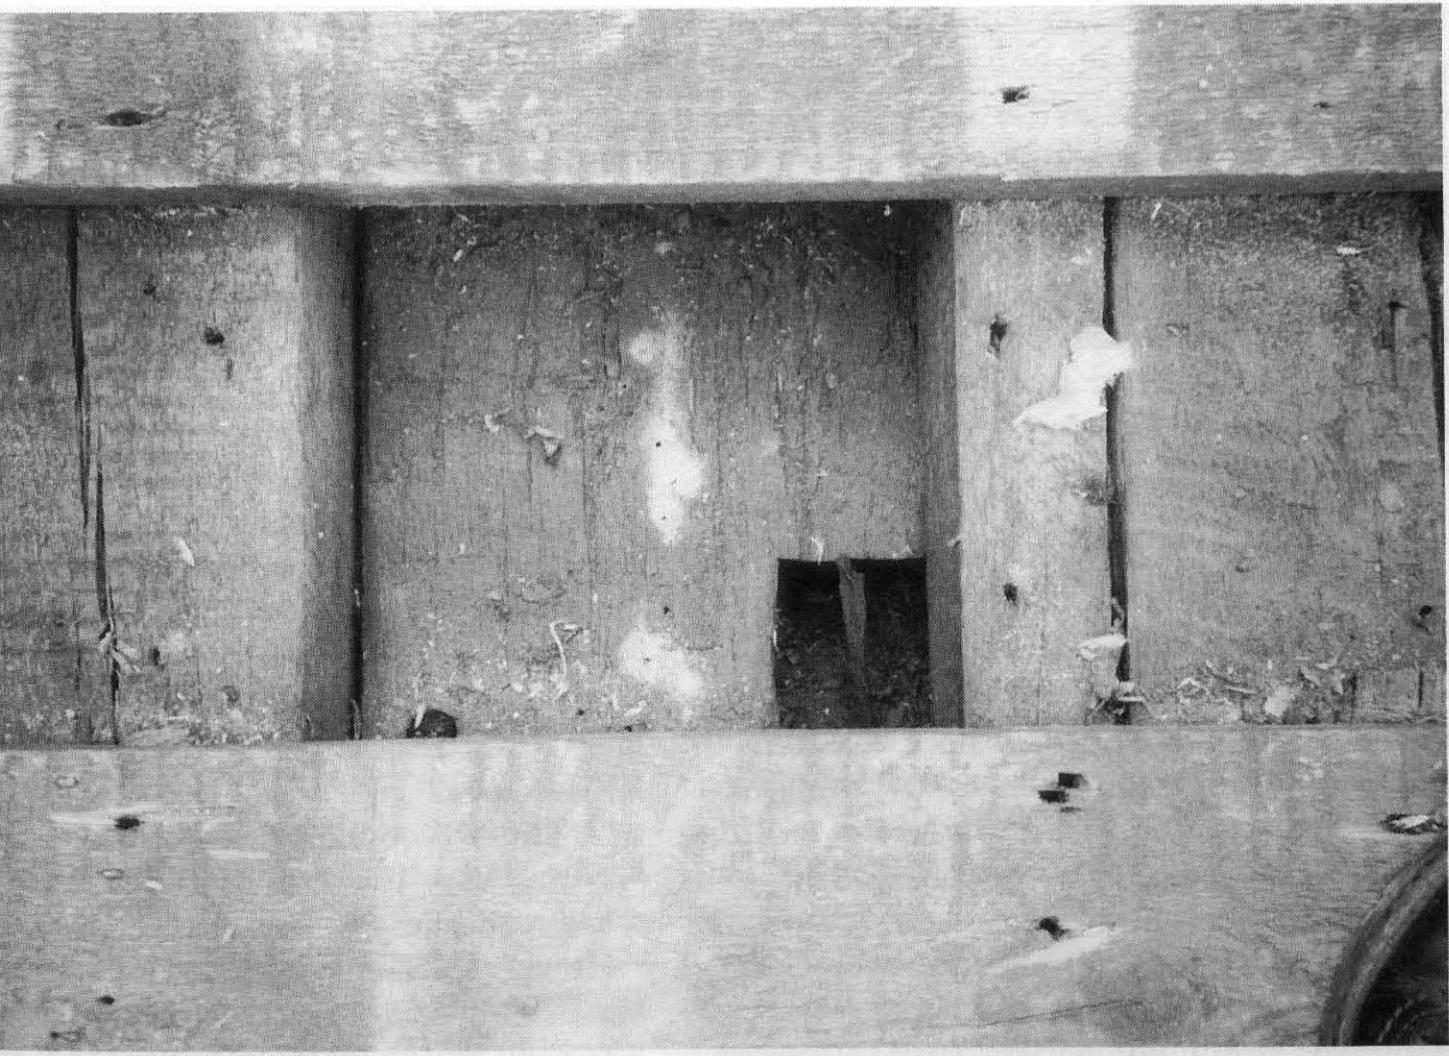
Figure 5.3 Active furniture beetle infestation is indicated by bore dust the colour of freshly cut timber trickling

Active furniture beetle can be recognized by the presence of sharp-edged holes with interiors the colour of freshly cut timber (Figure 5.3), and lemon-shaped bore dust. This is usually accompanied by dead beetles on floors and window sills. Old damage does not require treatment. In time, oxidation causes the interior of the holes to darken and the sharp edges of the flight holes are lost. If there is doubt concerning the activity of furniture beetle this can be resolved by fastening tissue paper tightly to the timber surface for a flight season, as described in Section 4.3. Active beetles will punch

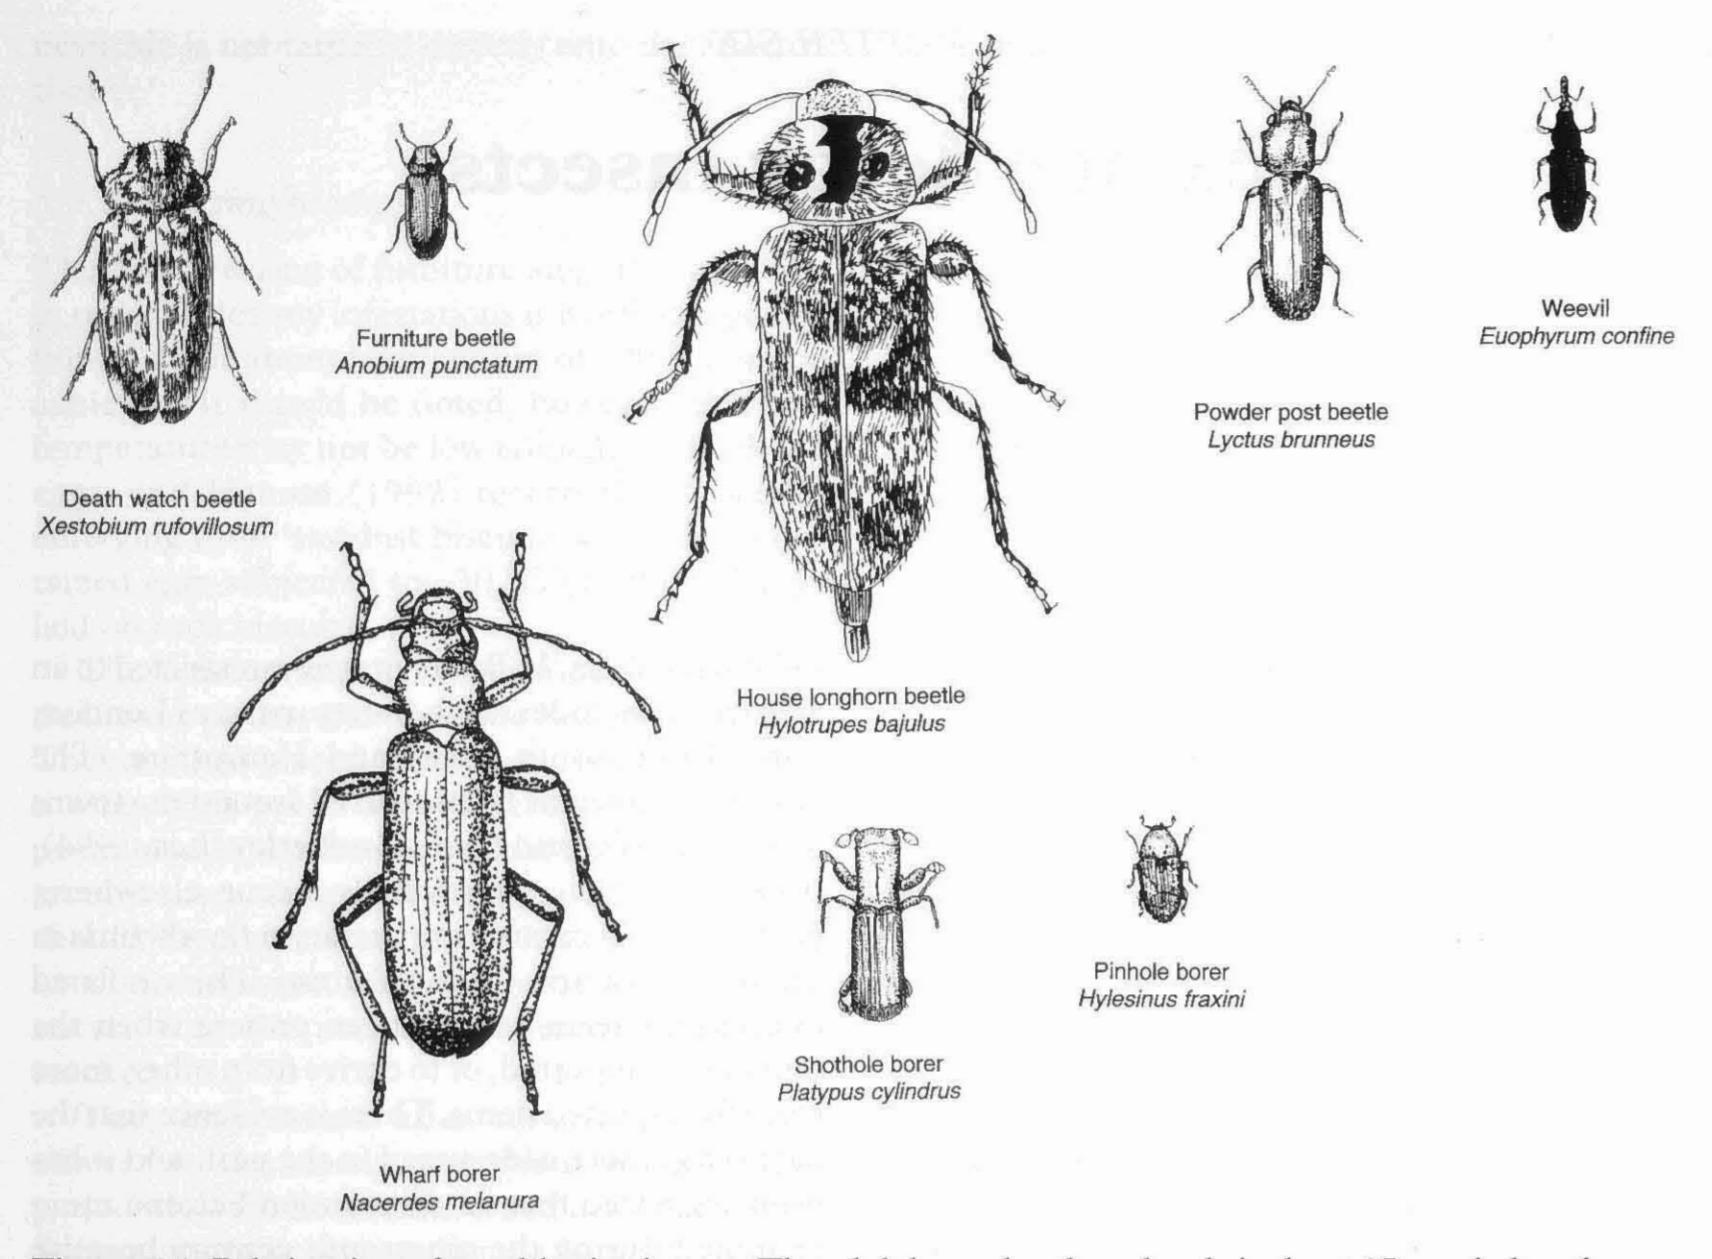
Figure 6.1 Relative sizes of wood-boring insects. The adult house longhorn beetle is about 15 mm in length.

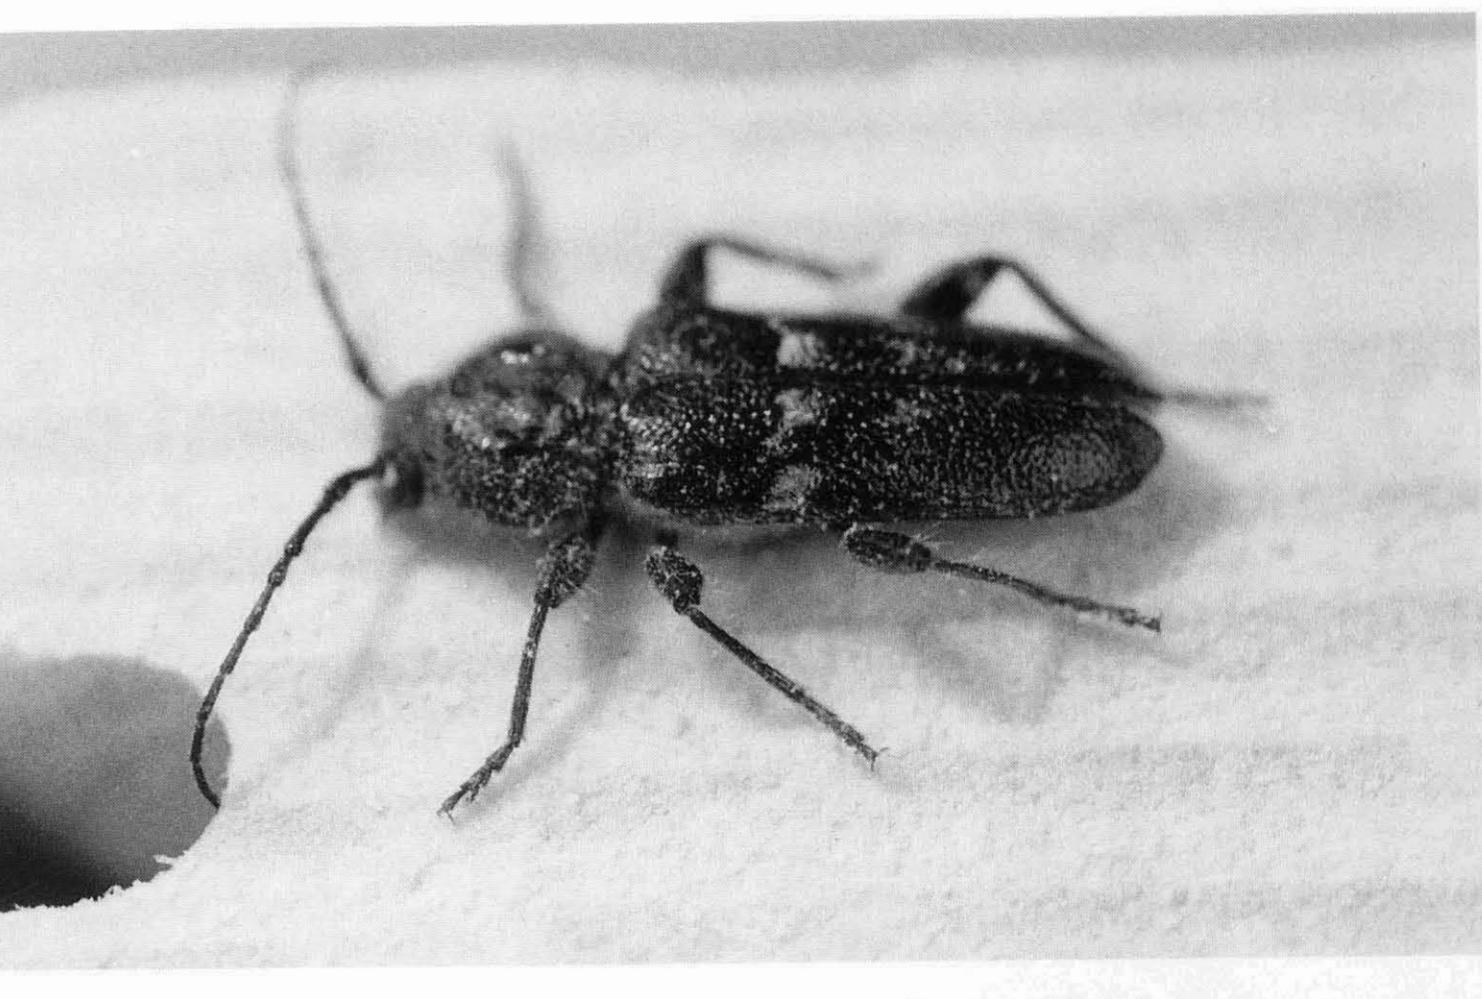
Figure 6.2 The house longhorn beetle (Hylotrupes bajulus) emerges from oval flight holes.

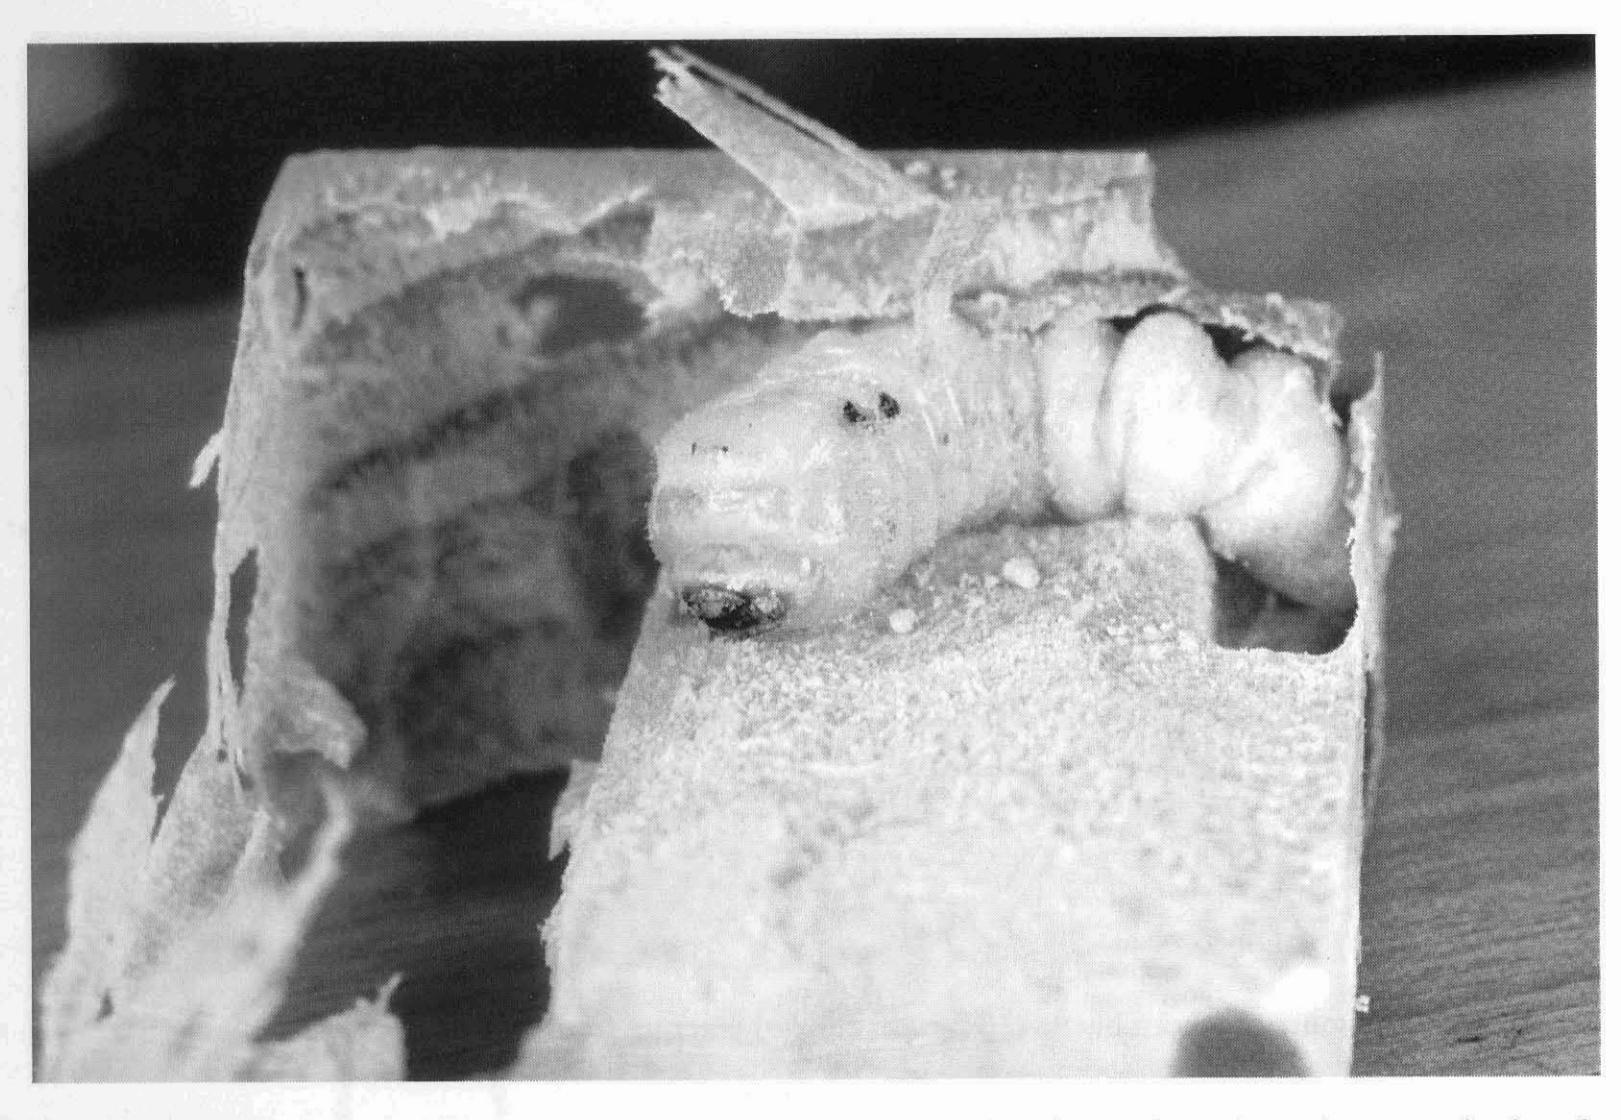
Figure 6.3 The house longhorn beetle larva feeds in the sapwood of modern softwoods, and may reach a length of 25 mm.

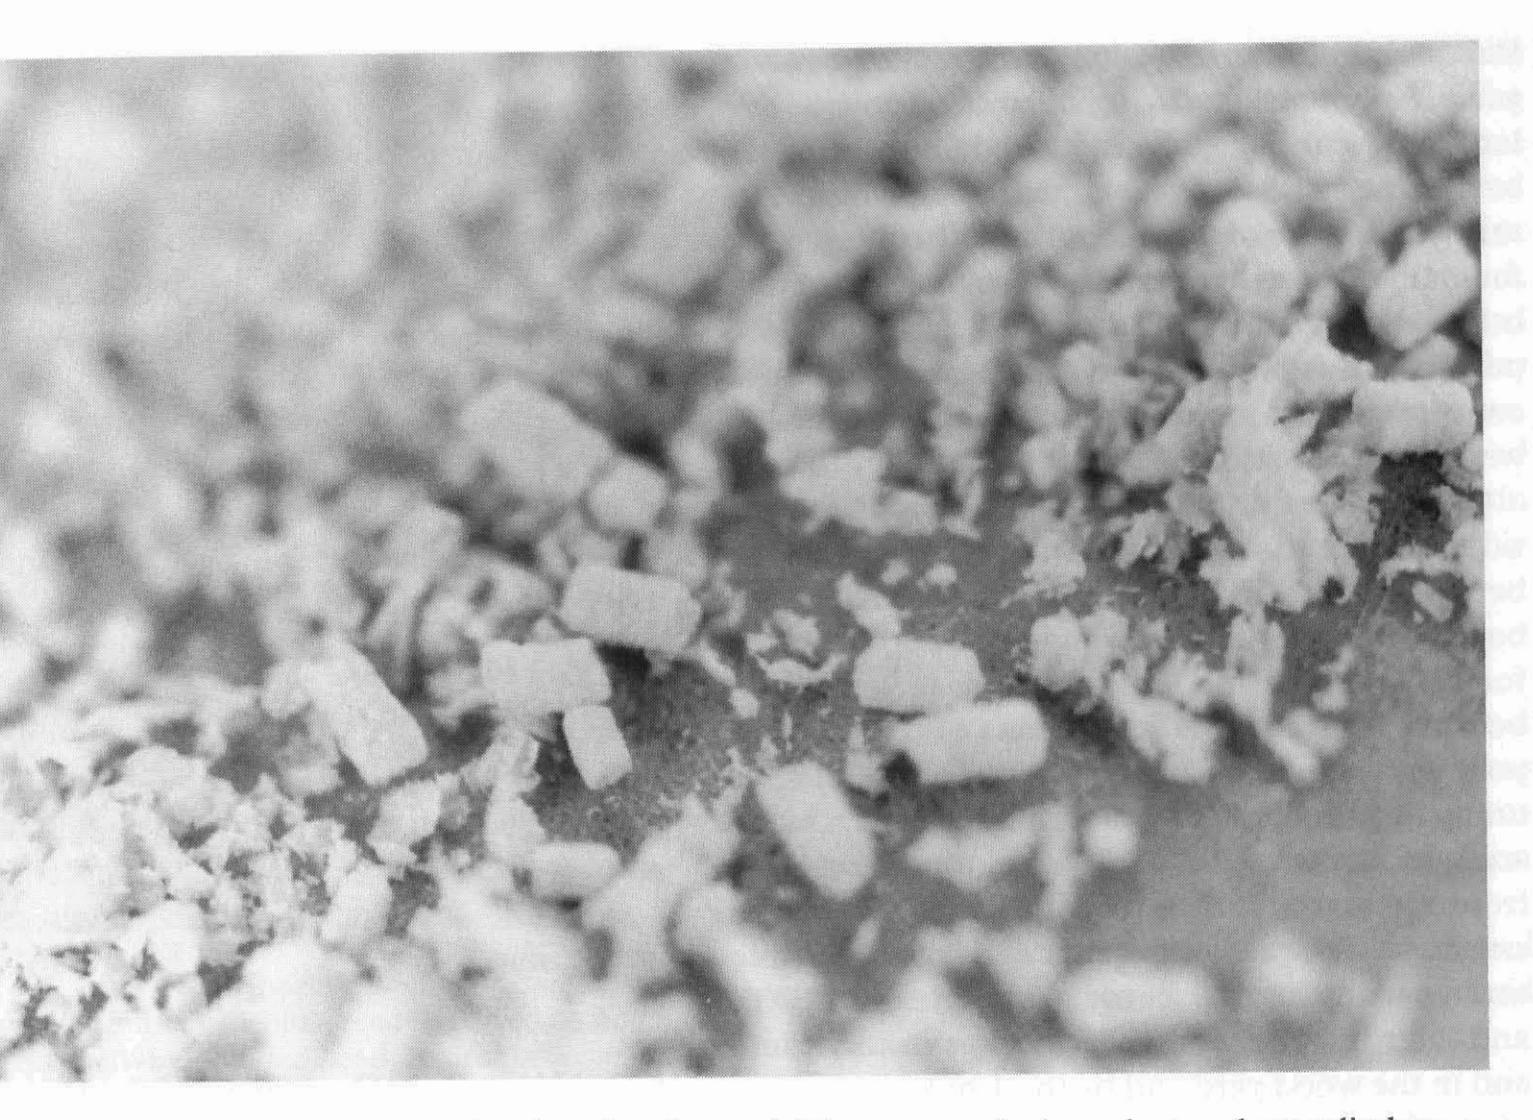
Figure 6.5 Frass pellets of the house longhorn beetle are visible amongst the bore dust as short cylinders.

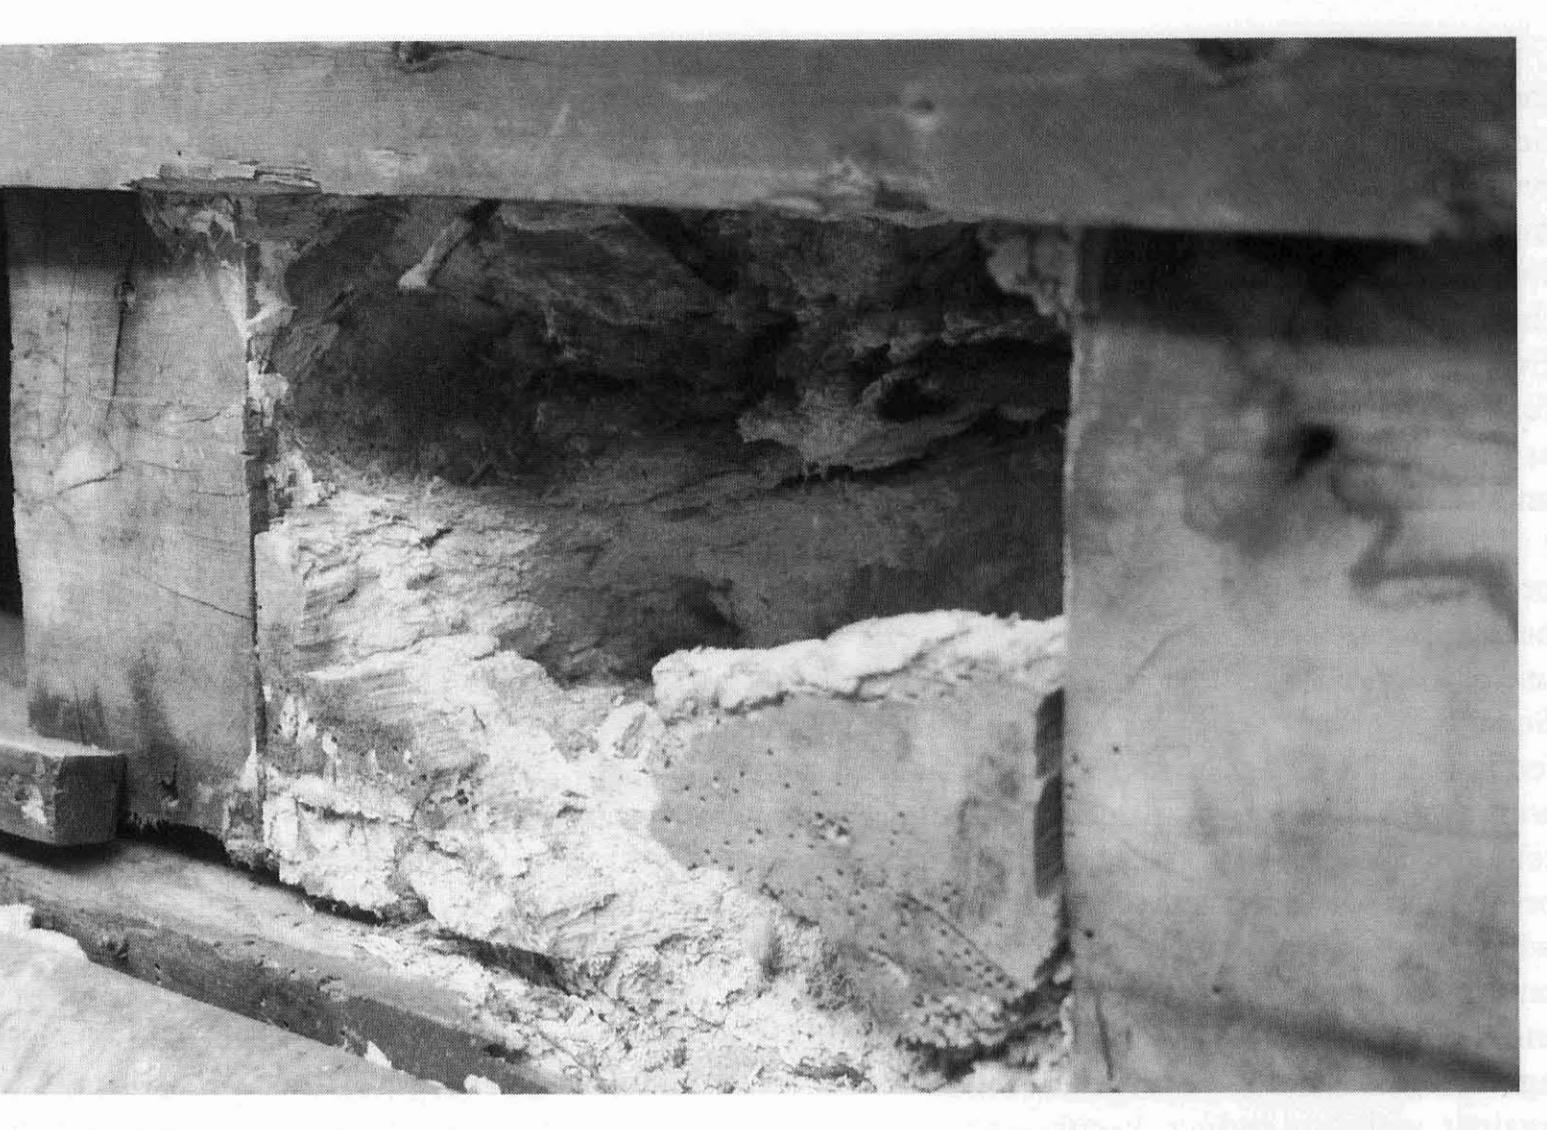
Figure 7.2 White rots are more common in hardwoods than in softwoods. They generally require more water

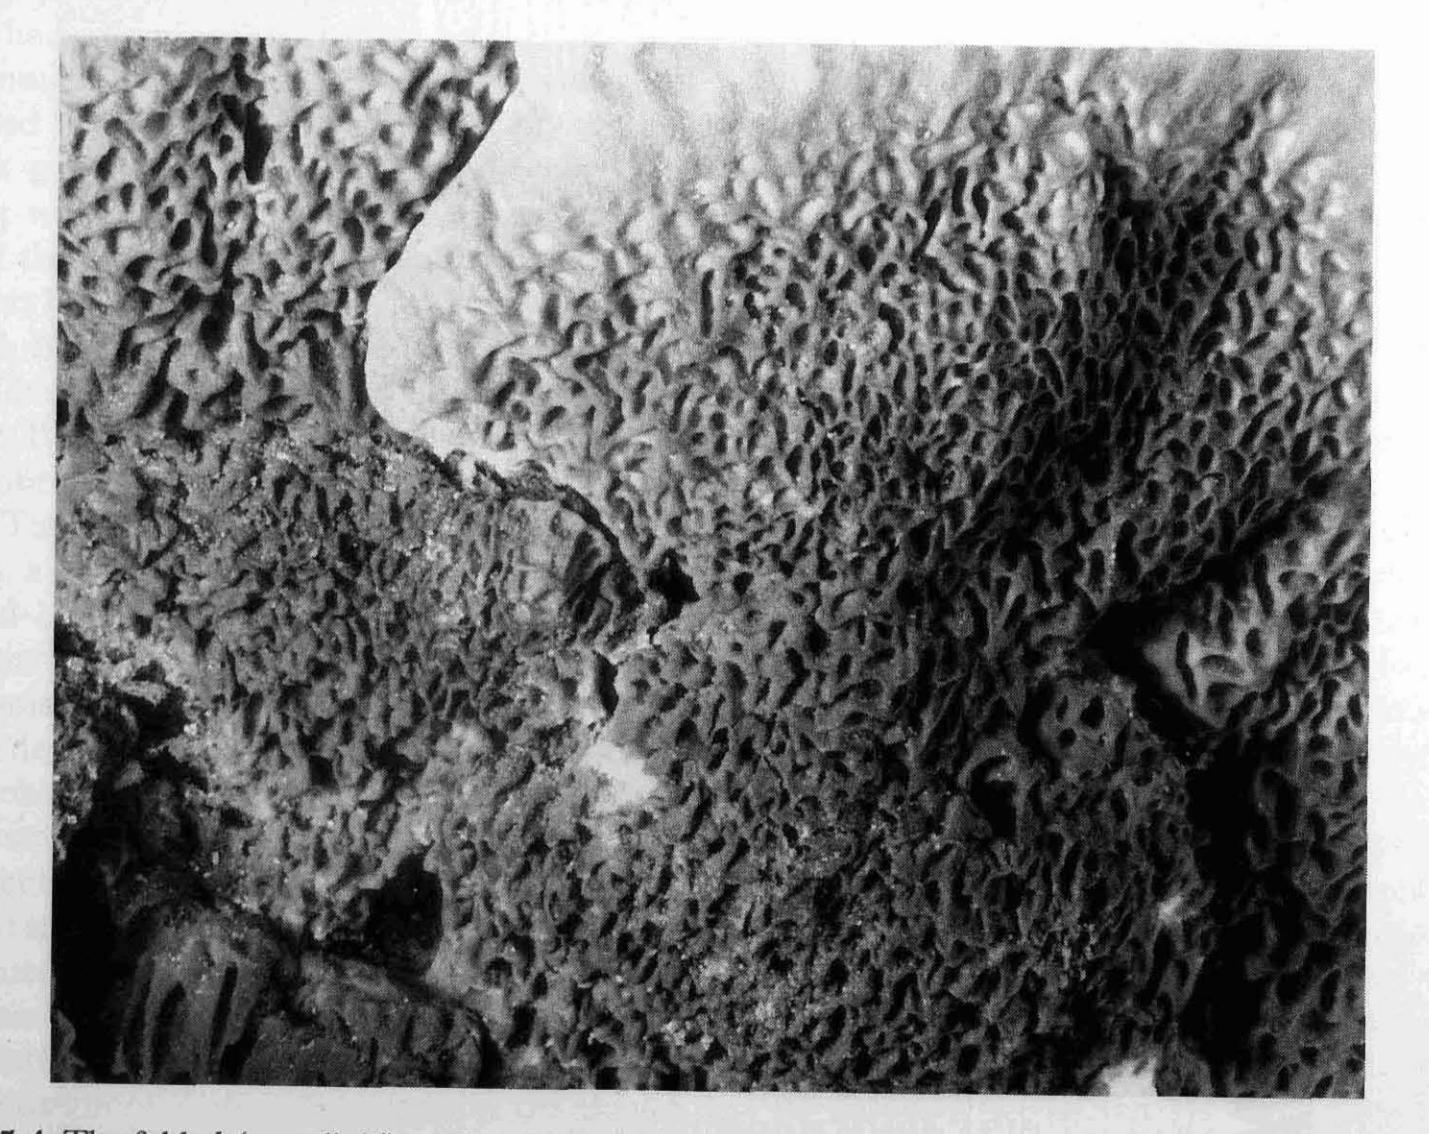
Figure 7.4 The folded (merulioid) surface of the fungus is diagnostic. It is only found in a small group of closely related fungi, of which only dry rot is commonly found in buildings.

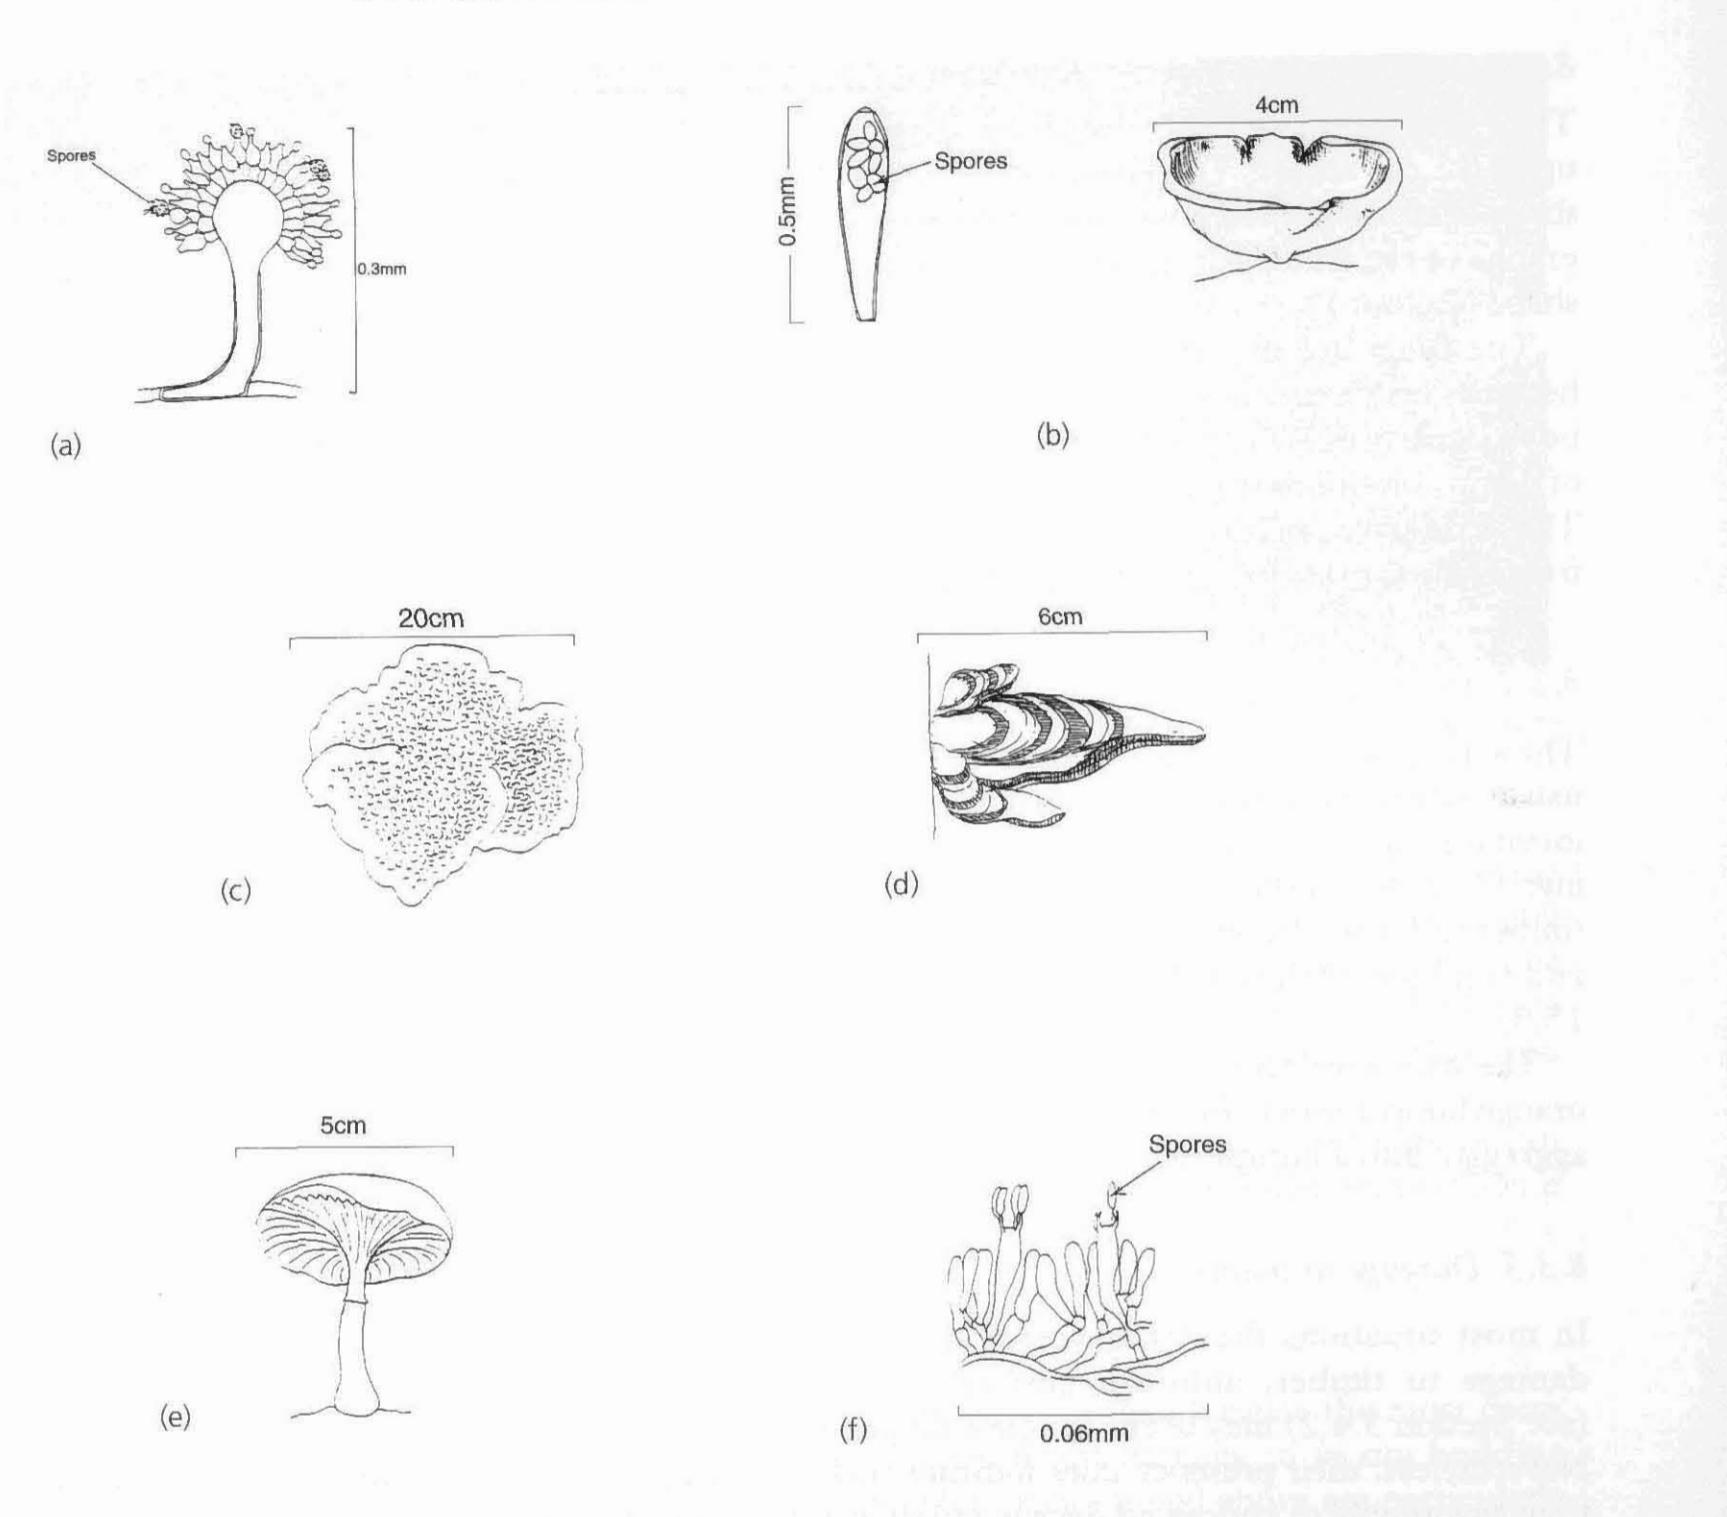
Figure 8.1 Examples of fungal fruits and their spore-producing surfaces: (a) moulds (Deuteromycetes); (b) Ascomycetes; (c) resupinate fungi; (d) pore fungi; (e) gilled fungi; (f) the spore-carrying structure for categories (c), (d) and (e).

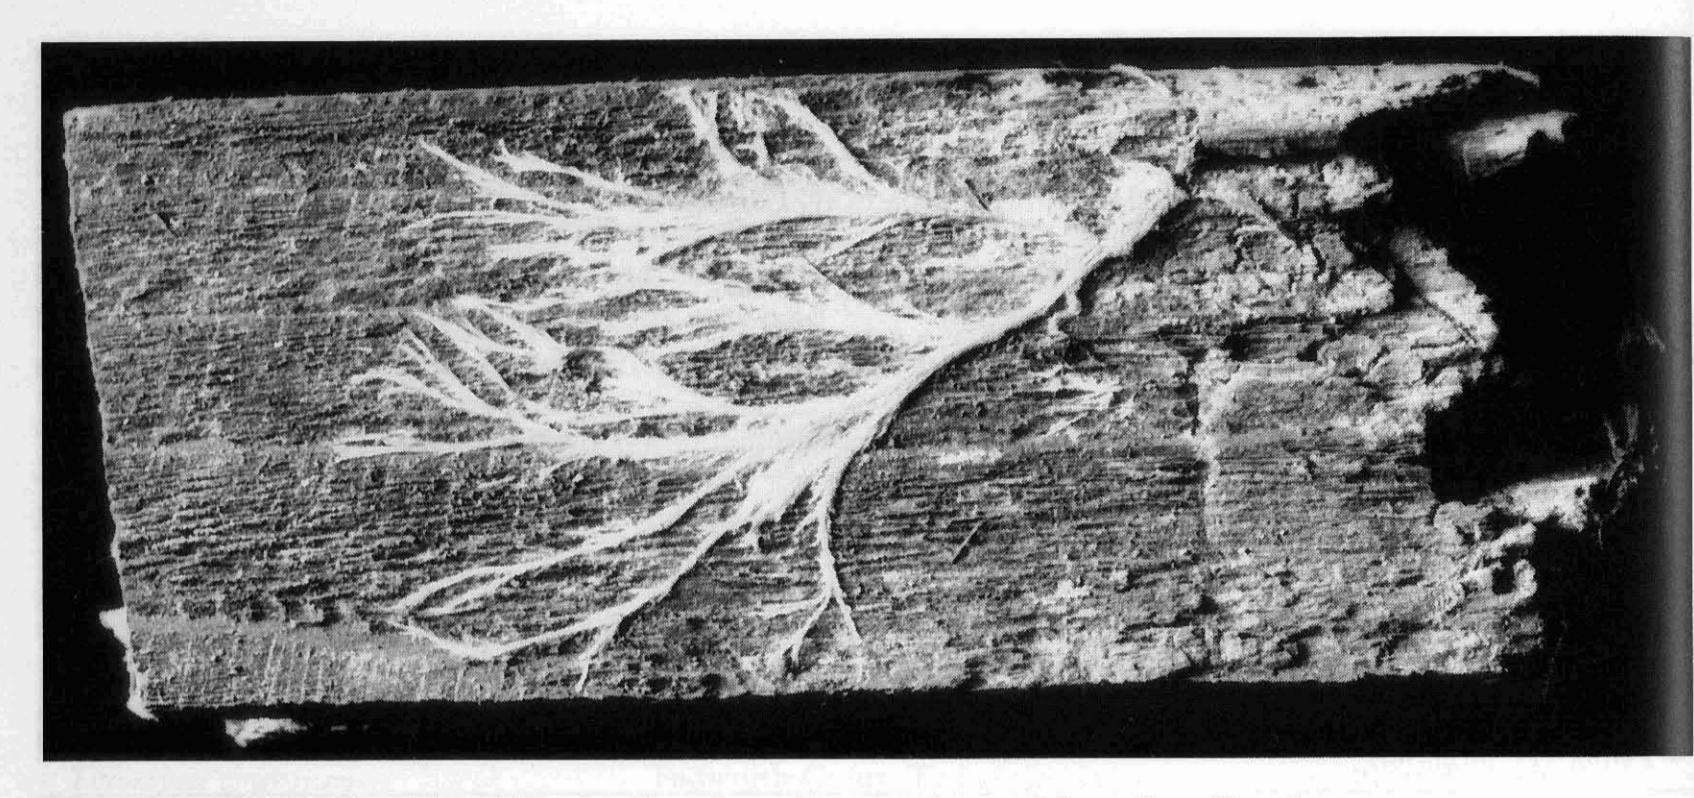
Figure 8.4 Typical fern-like white mycelium from the mine fungus (Antrodia vaillantii).
