Timber Decay in Buildings

The conservation approach to treatment

Brian Ridout

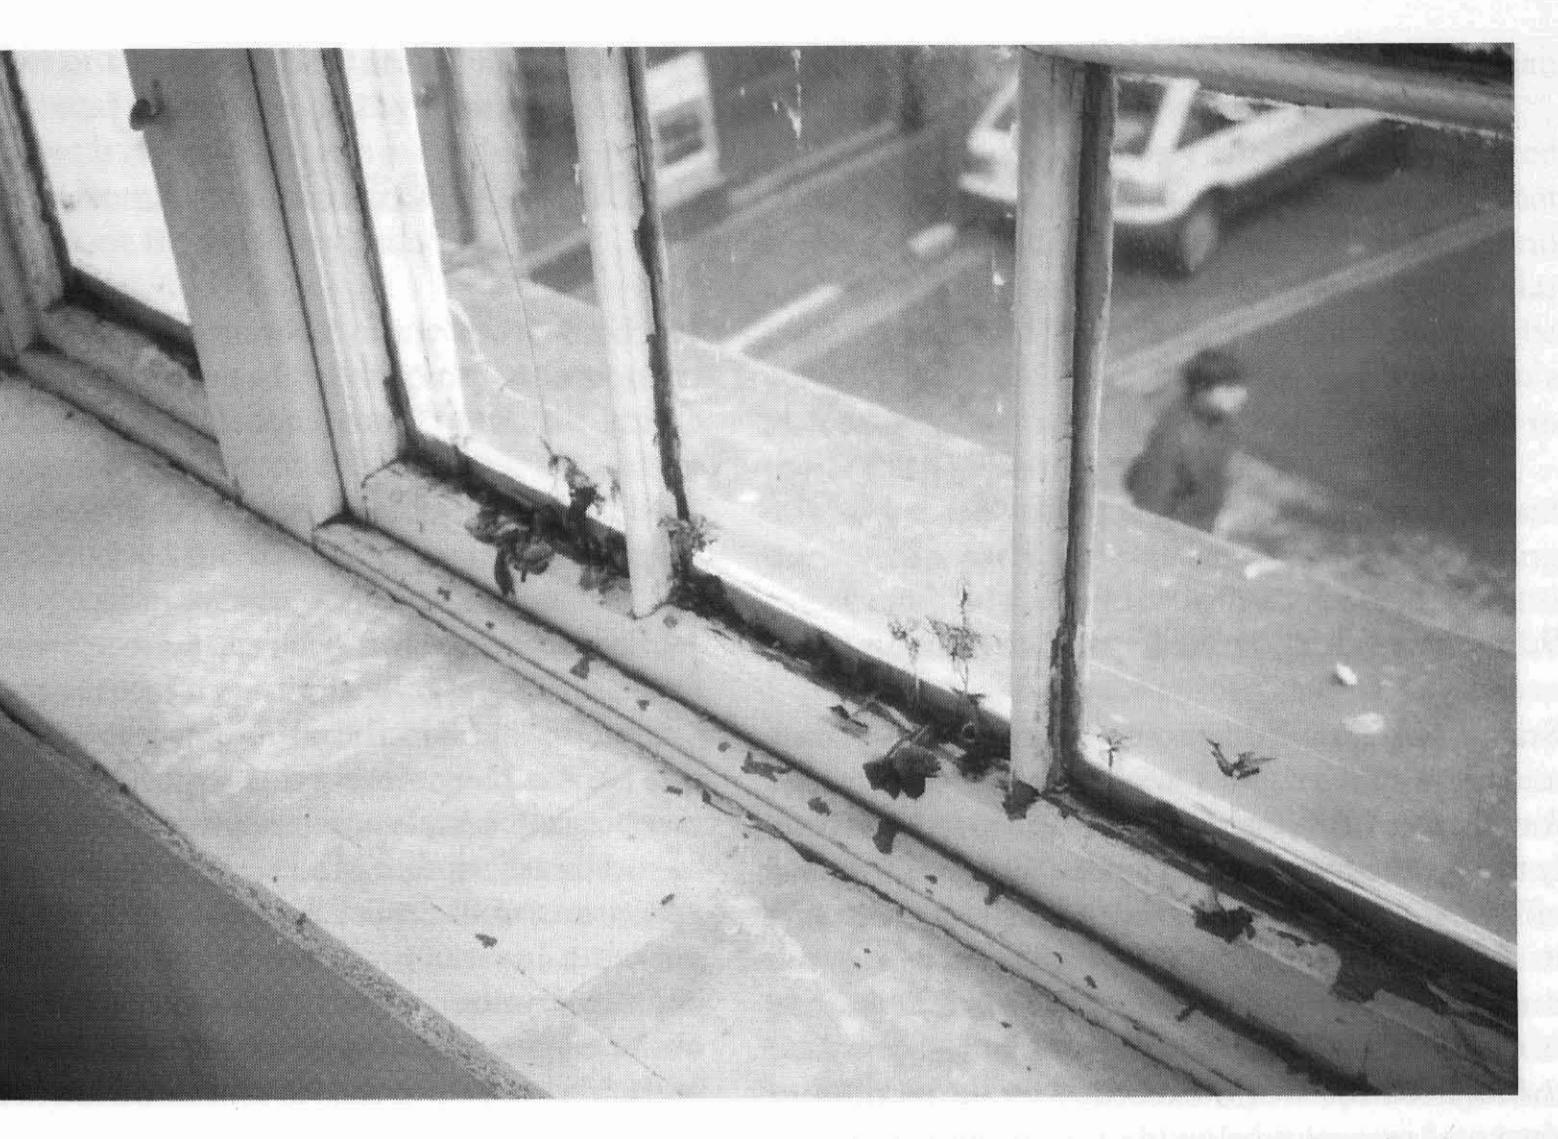
Figure 8.8 Ink cap fungus attacking a window frame. Note the old fruit bodies that have stuck to the glass.

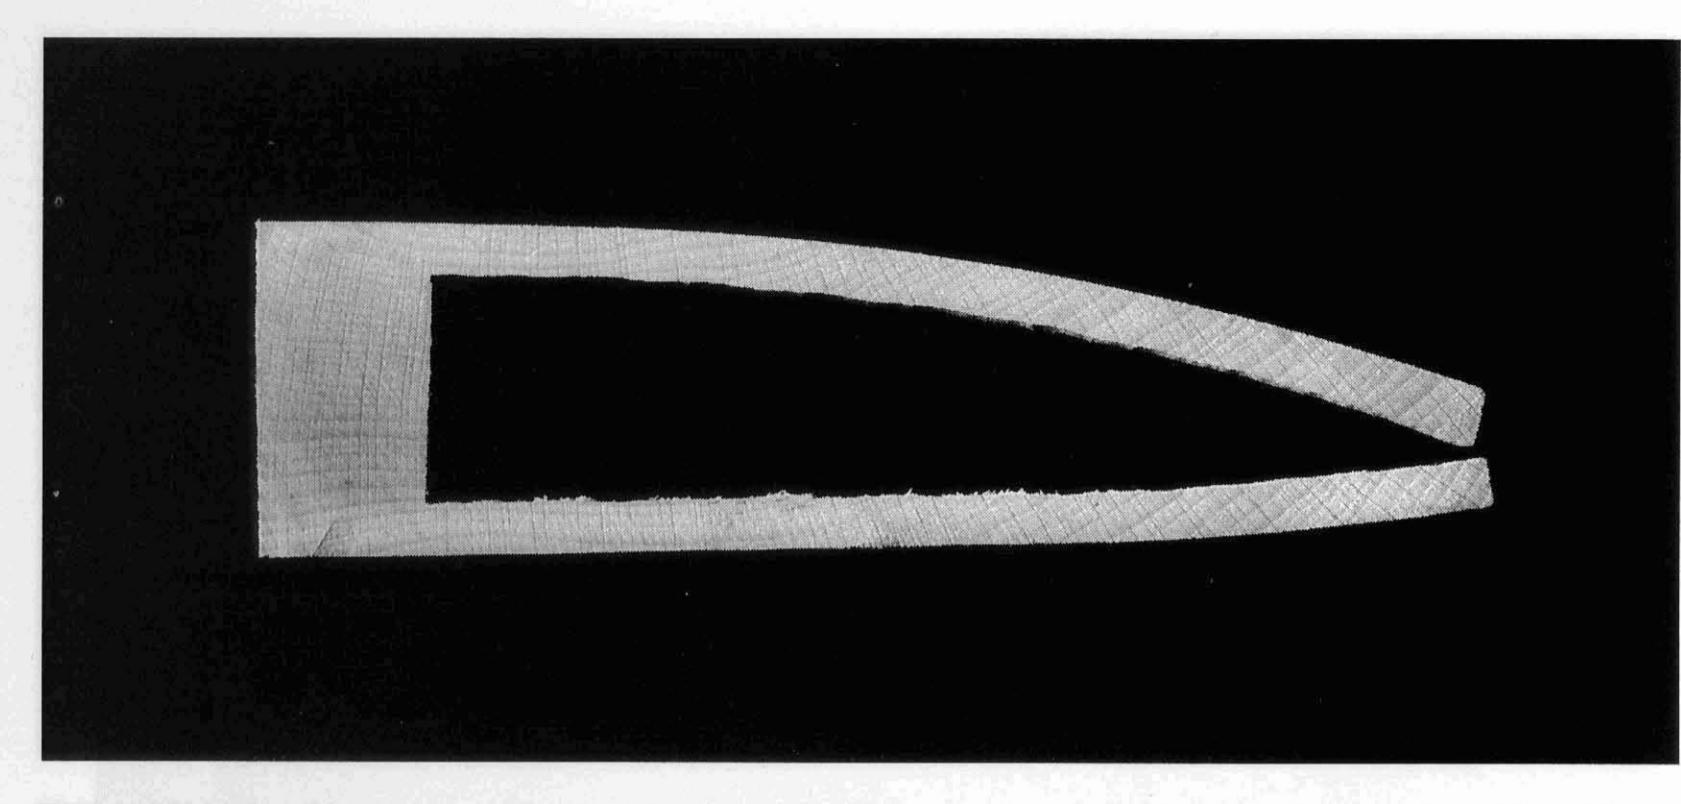
Figure 11.4 Case hardening, a kilning defect caused by the outer layers of the timber drying too rapidly while the interior is still wet. It is detected by cutting a prong from a sampling board and watching the prong for deformation.

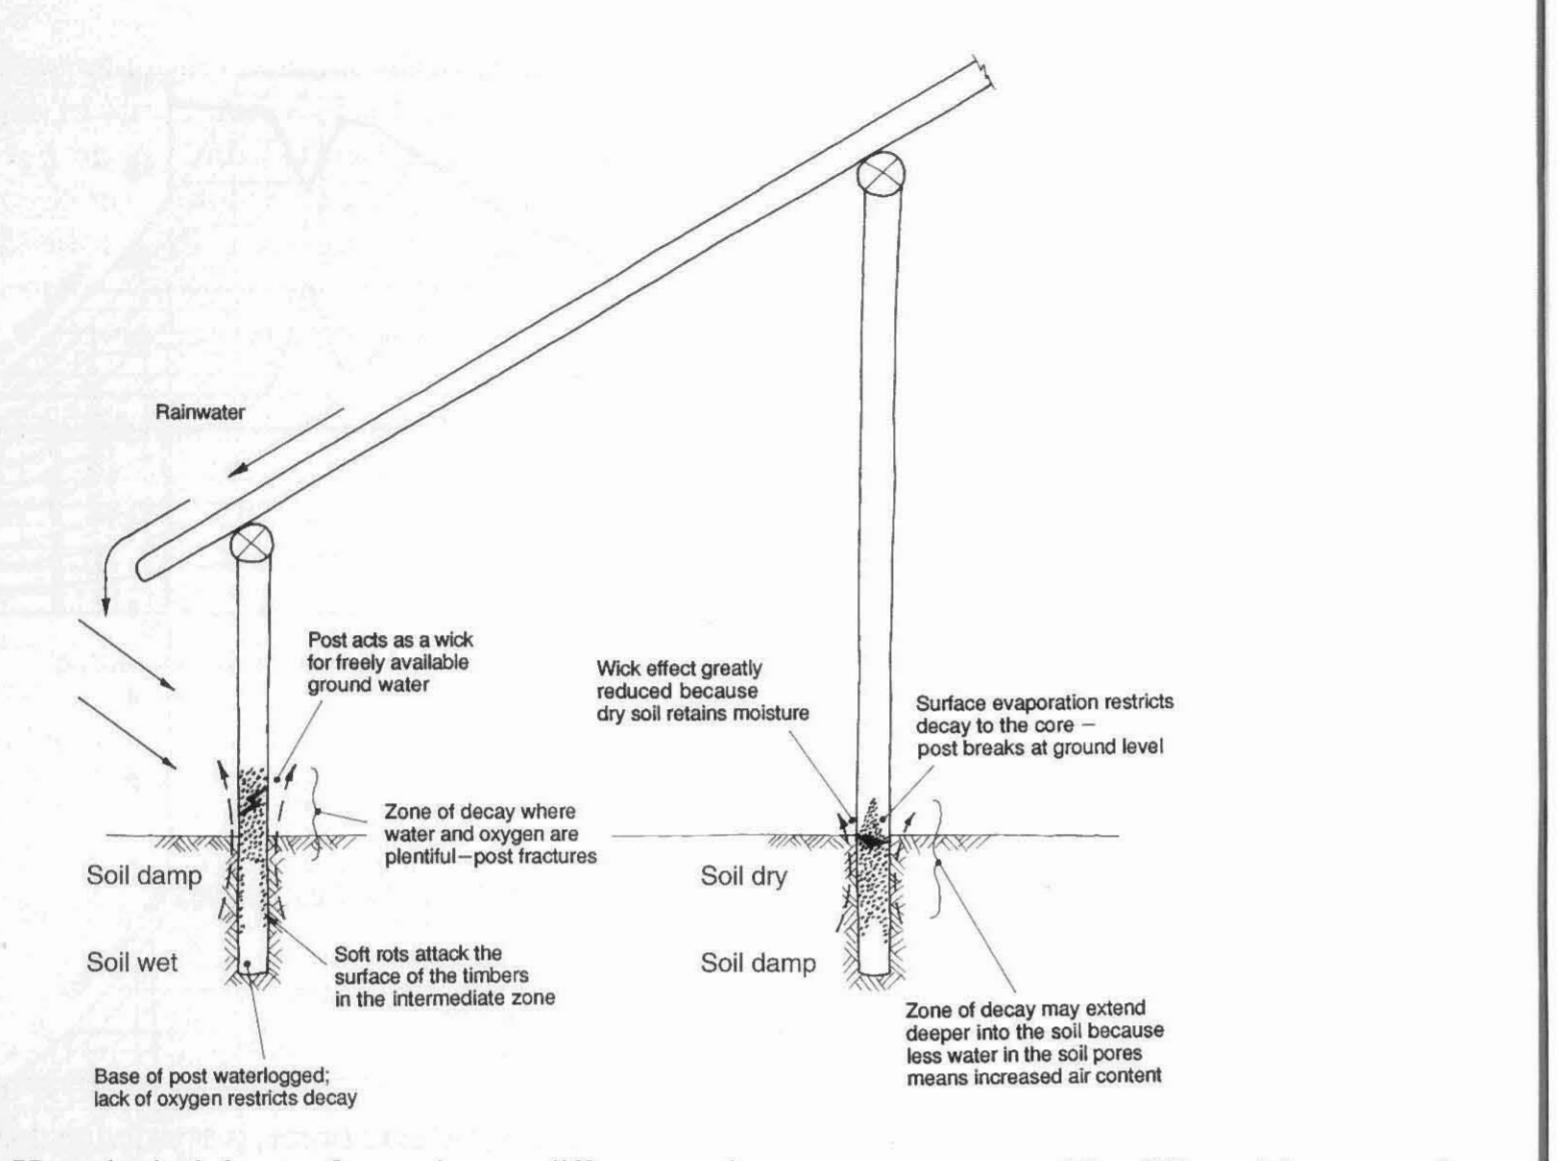
Figure 11.13 Hypothetical decay of posts in two different environments, as governed by differential water and oxygen availability.

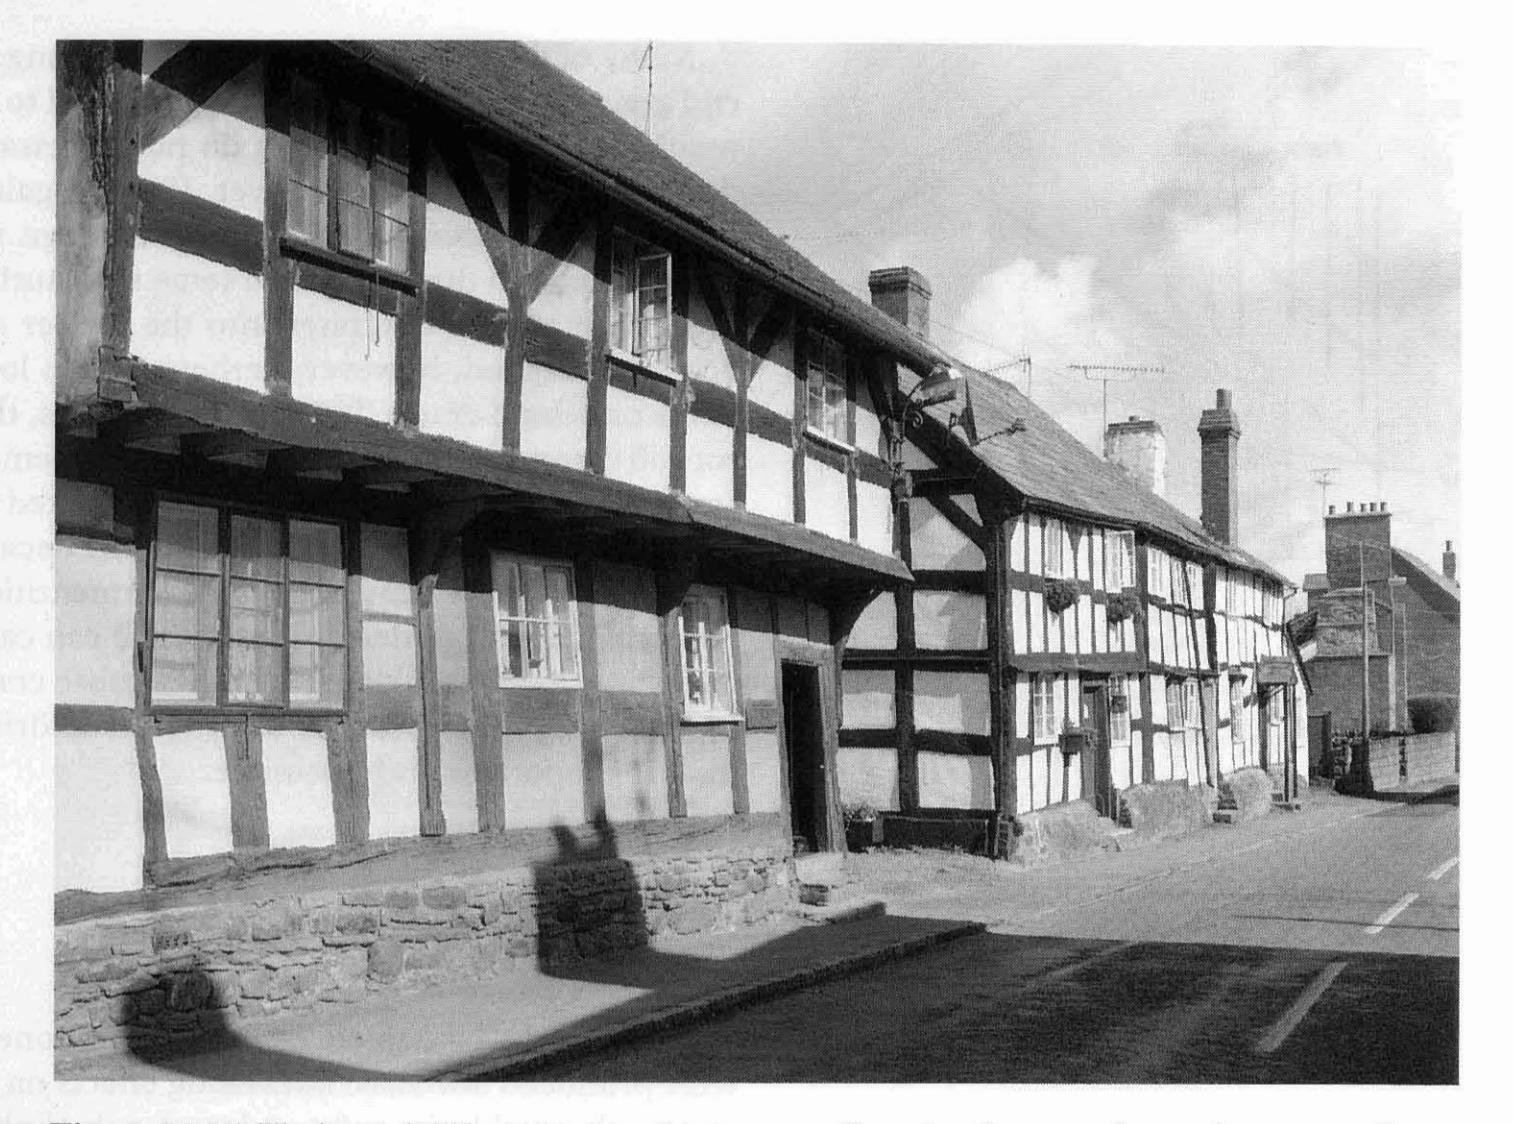
Figure 11.15 Horizontal sill beams rest on low stone walls and resist ground water because moisture absorption across the grain is limited (Pembridge, Hereford and Worcester).

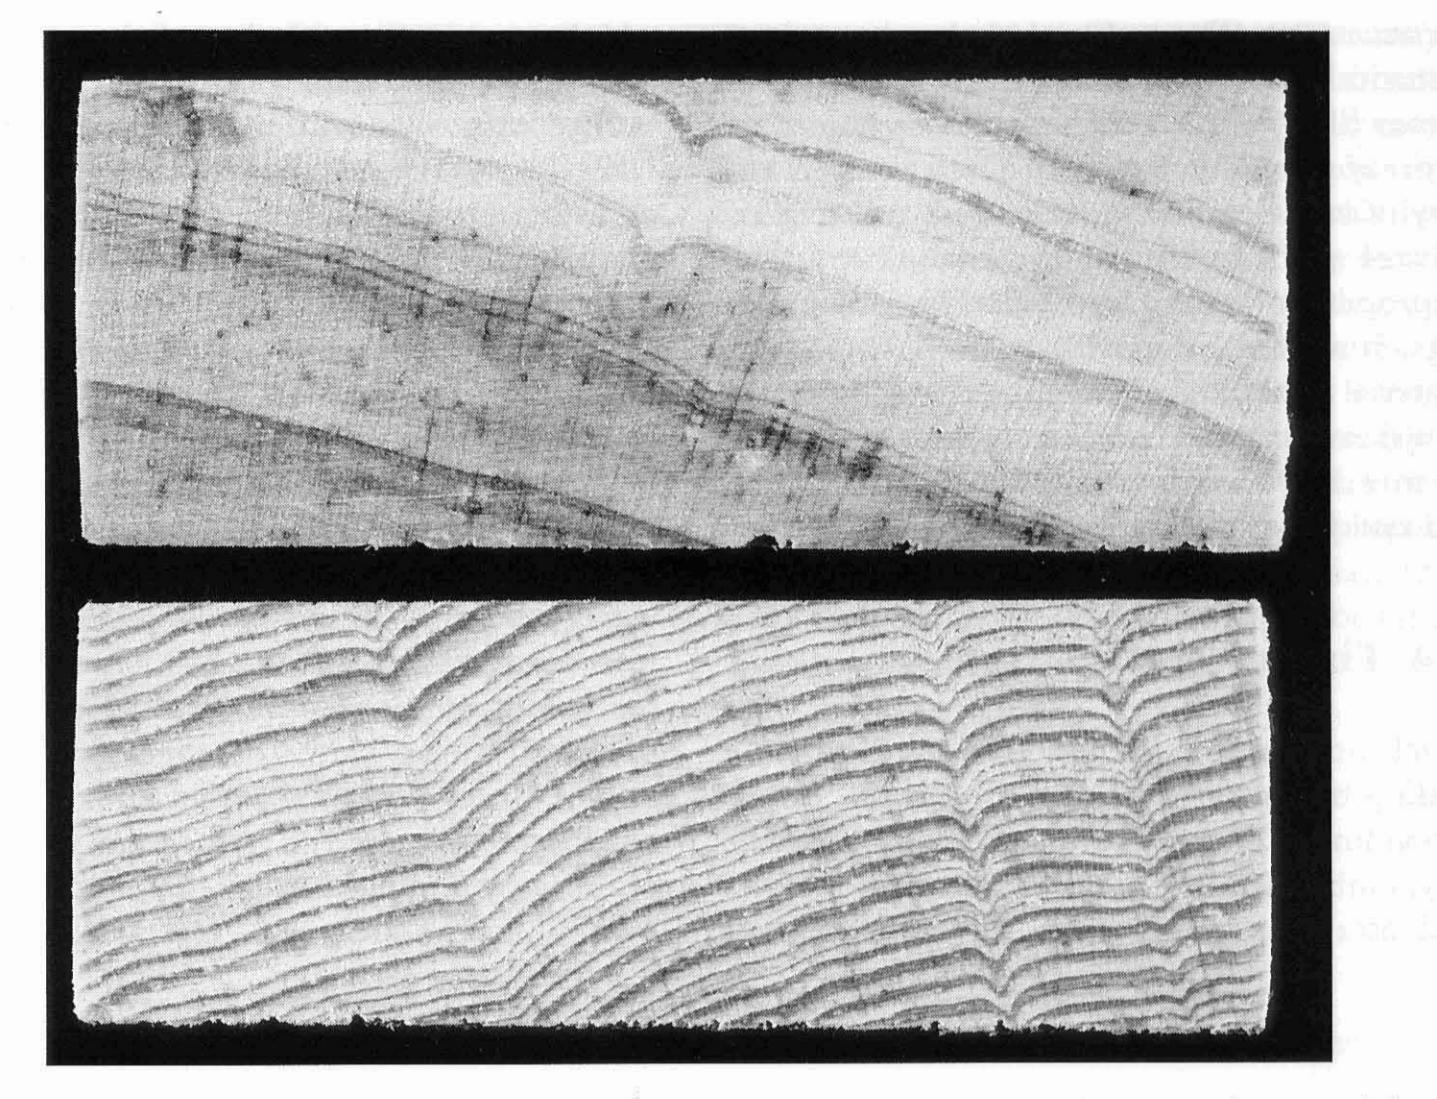
Figure 11.20 (a) Wide-ringed plantation-grown pitch pine cut from near the centre of the log. The natural durability is poor. (b) Close-ringed wild-grown pitch pine with a good natural durability.

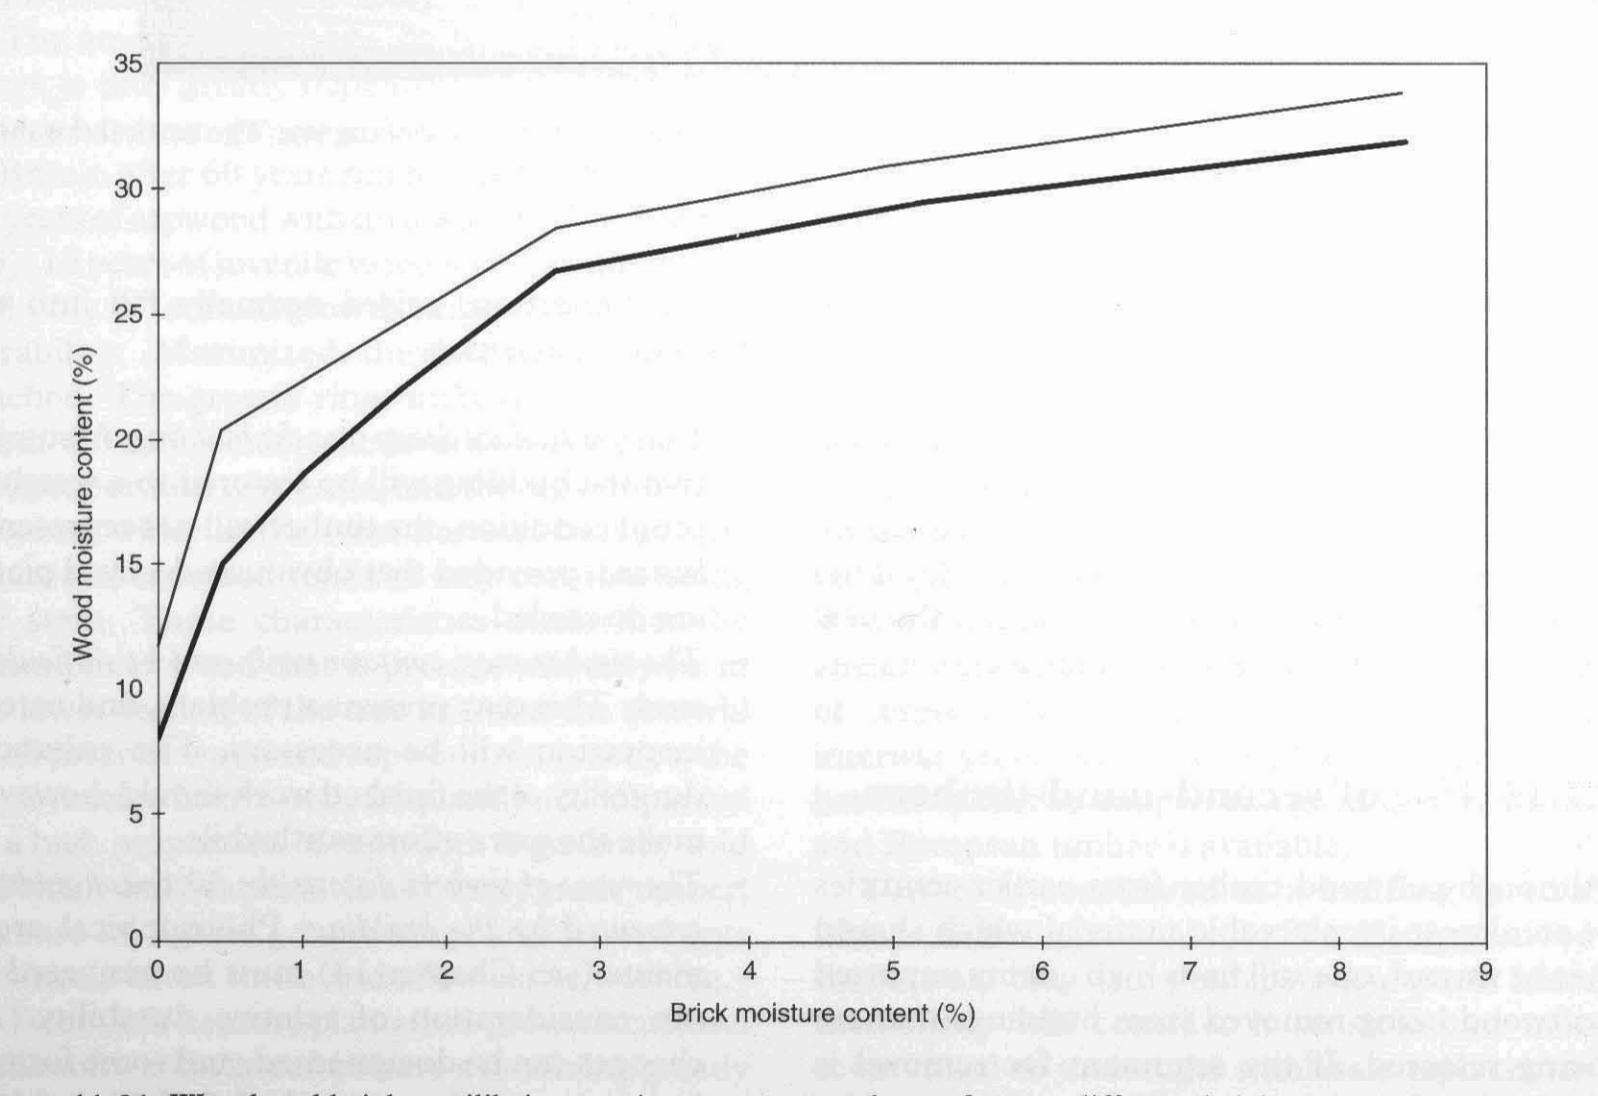
Figure 11.21 Wood and brick equilibrium moisture contents shown for two different bricks.

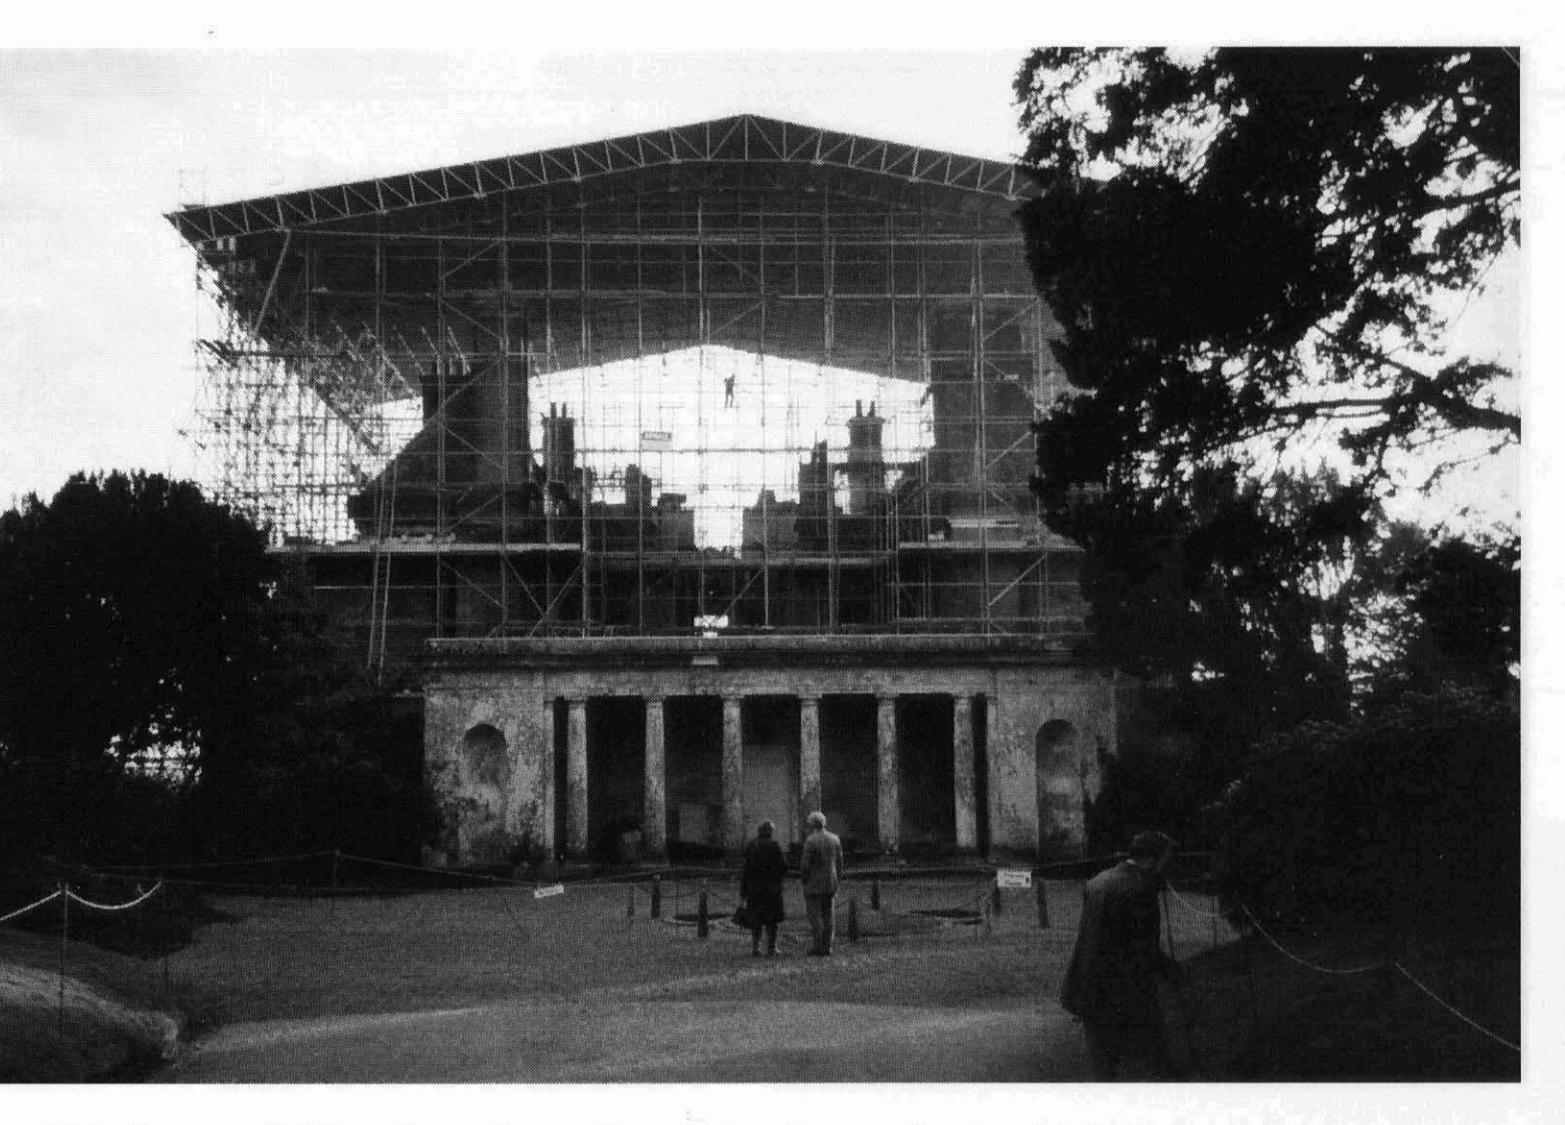
Figure 12.1 Open scaffolding allows plenty of ventilation, but may be unstable in high winds.

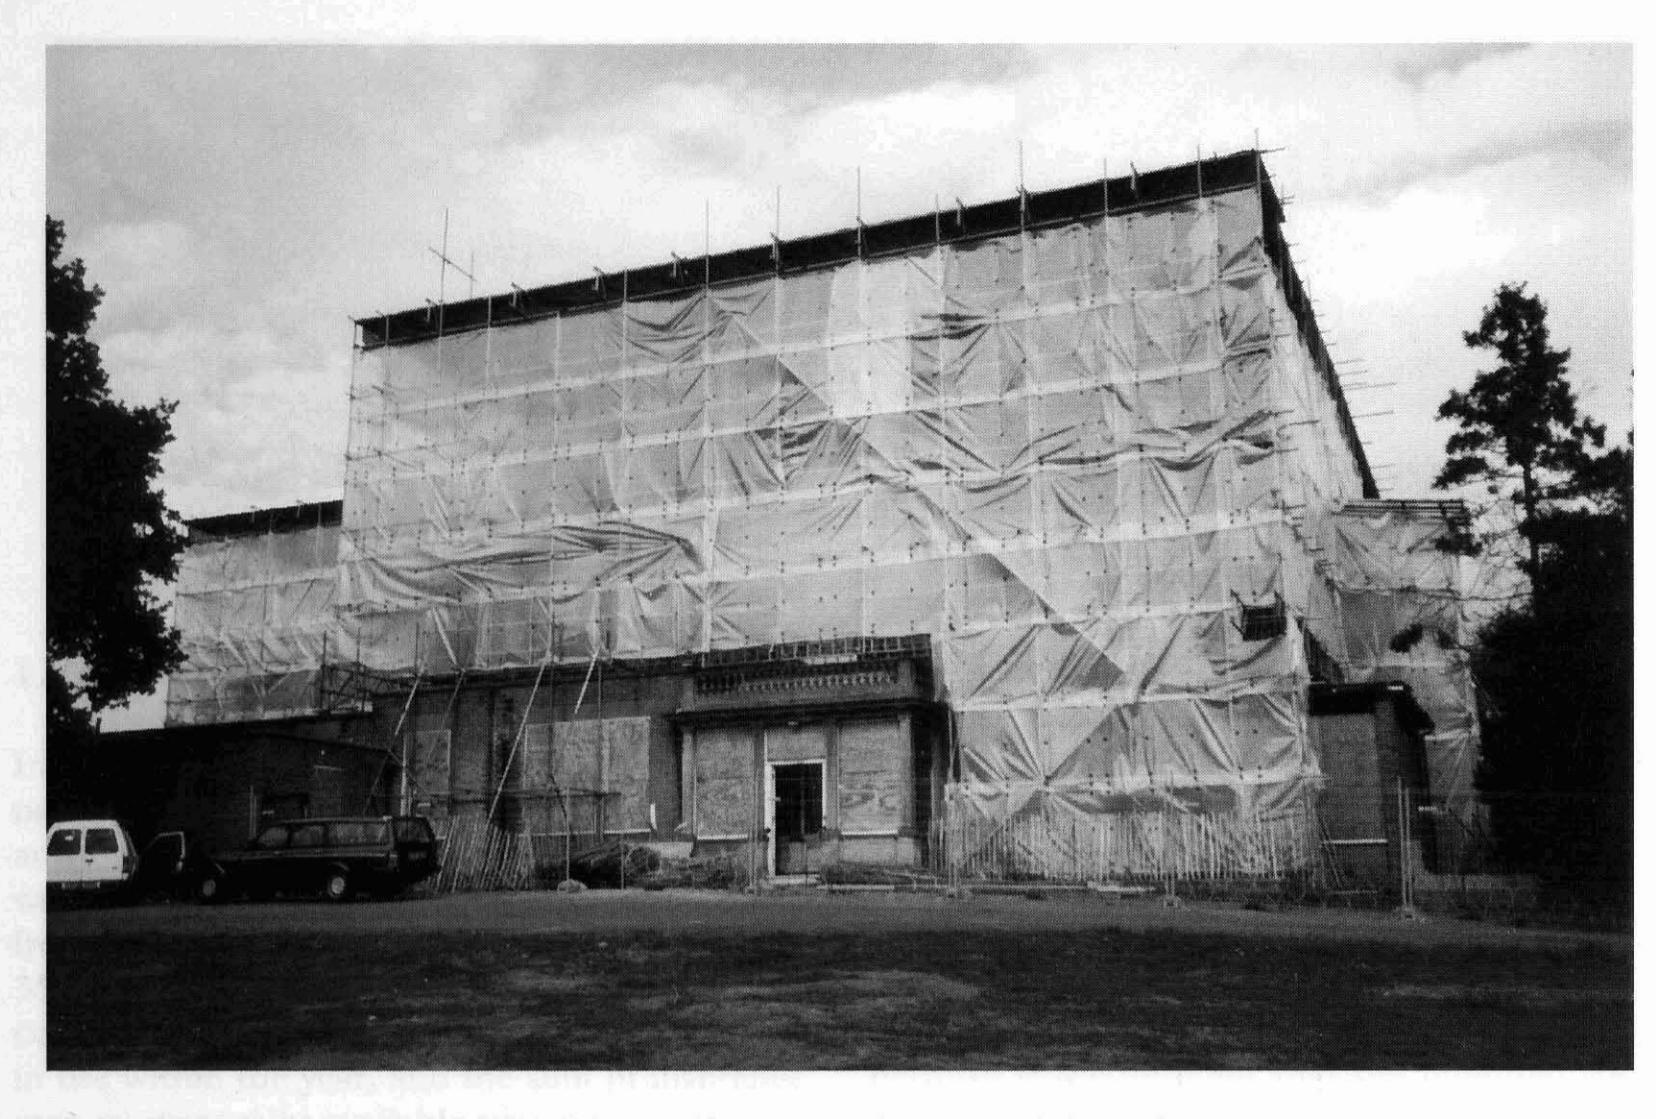
Figure 12.2 An enclosed scaffolded roof is safer, but no significant drying will occur until it is removed.

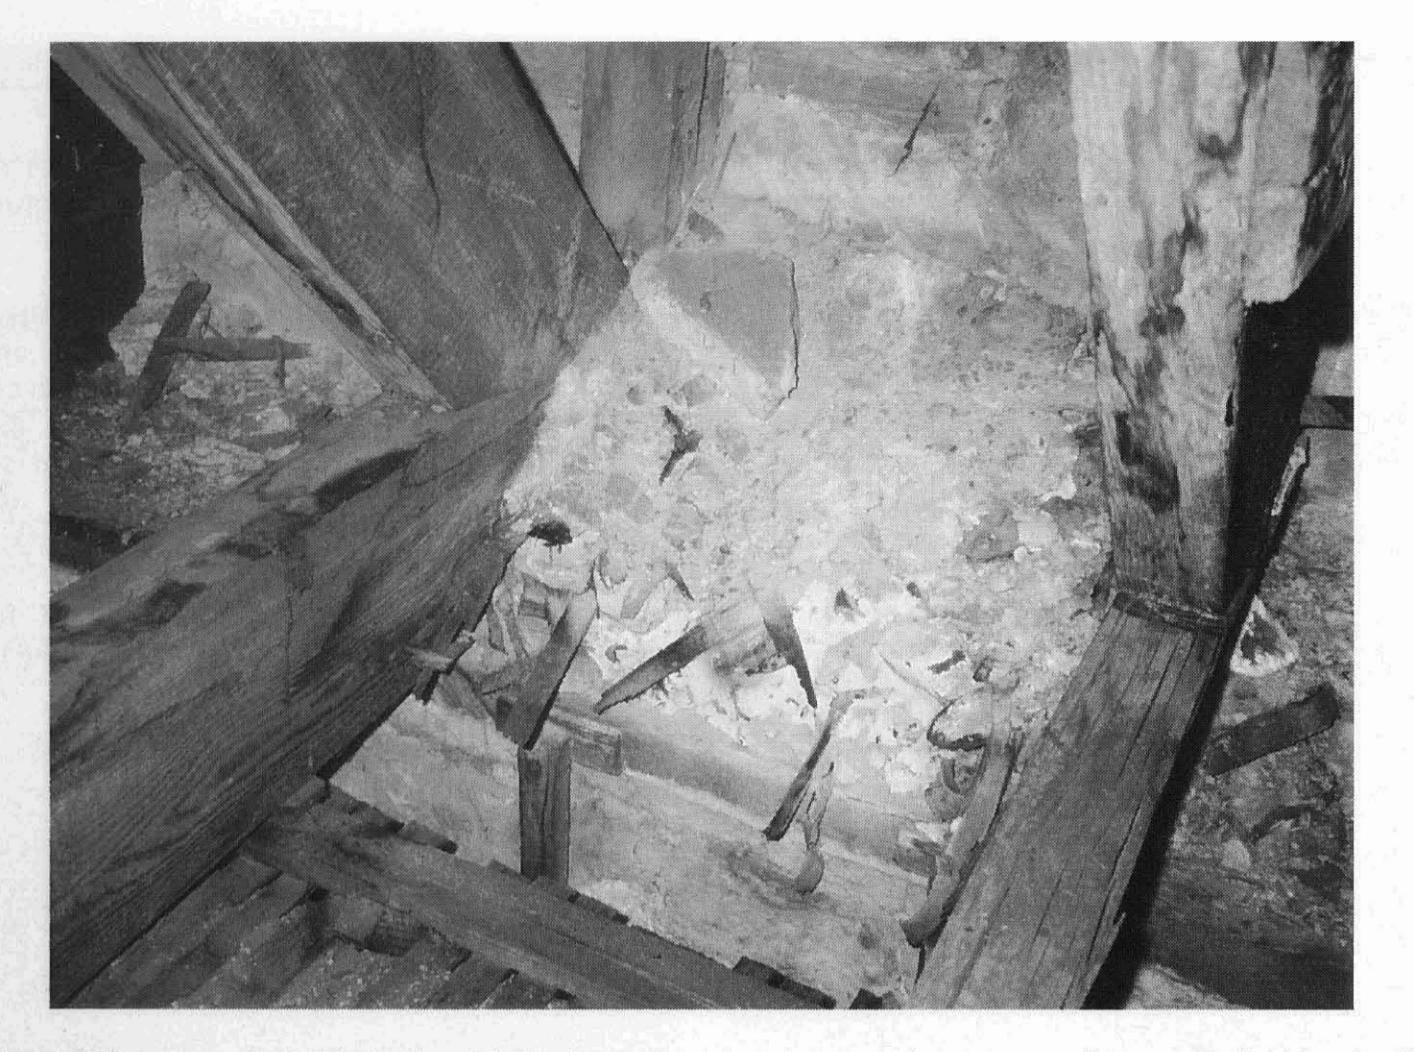
Figure 12.5 The removal of debris should also be undertaken in areas that are wet, but untouched by the fire. Here an accumulation of wet debris around a beam end has allowed dry rot to develop. Note the dry rot fruit body developing against the right-hand side of the right-hand tie beam.

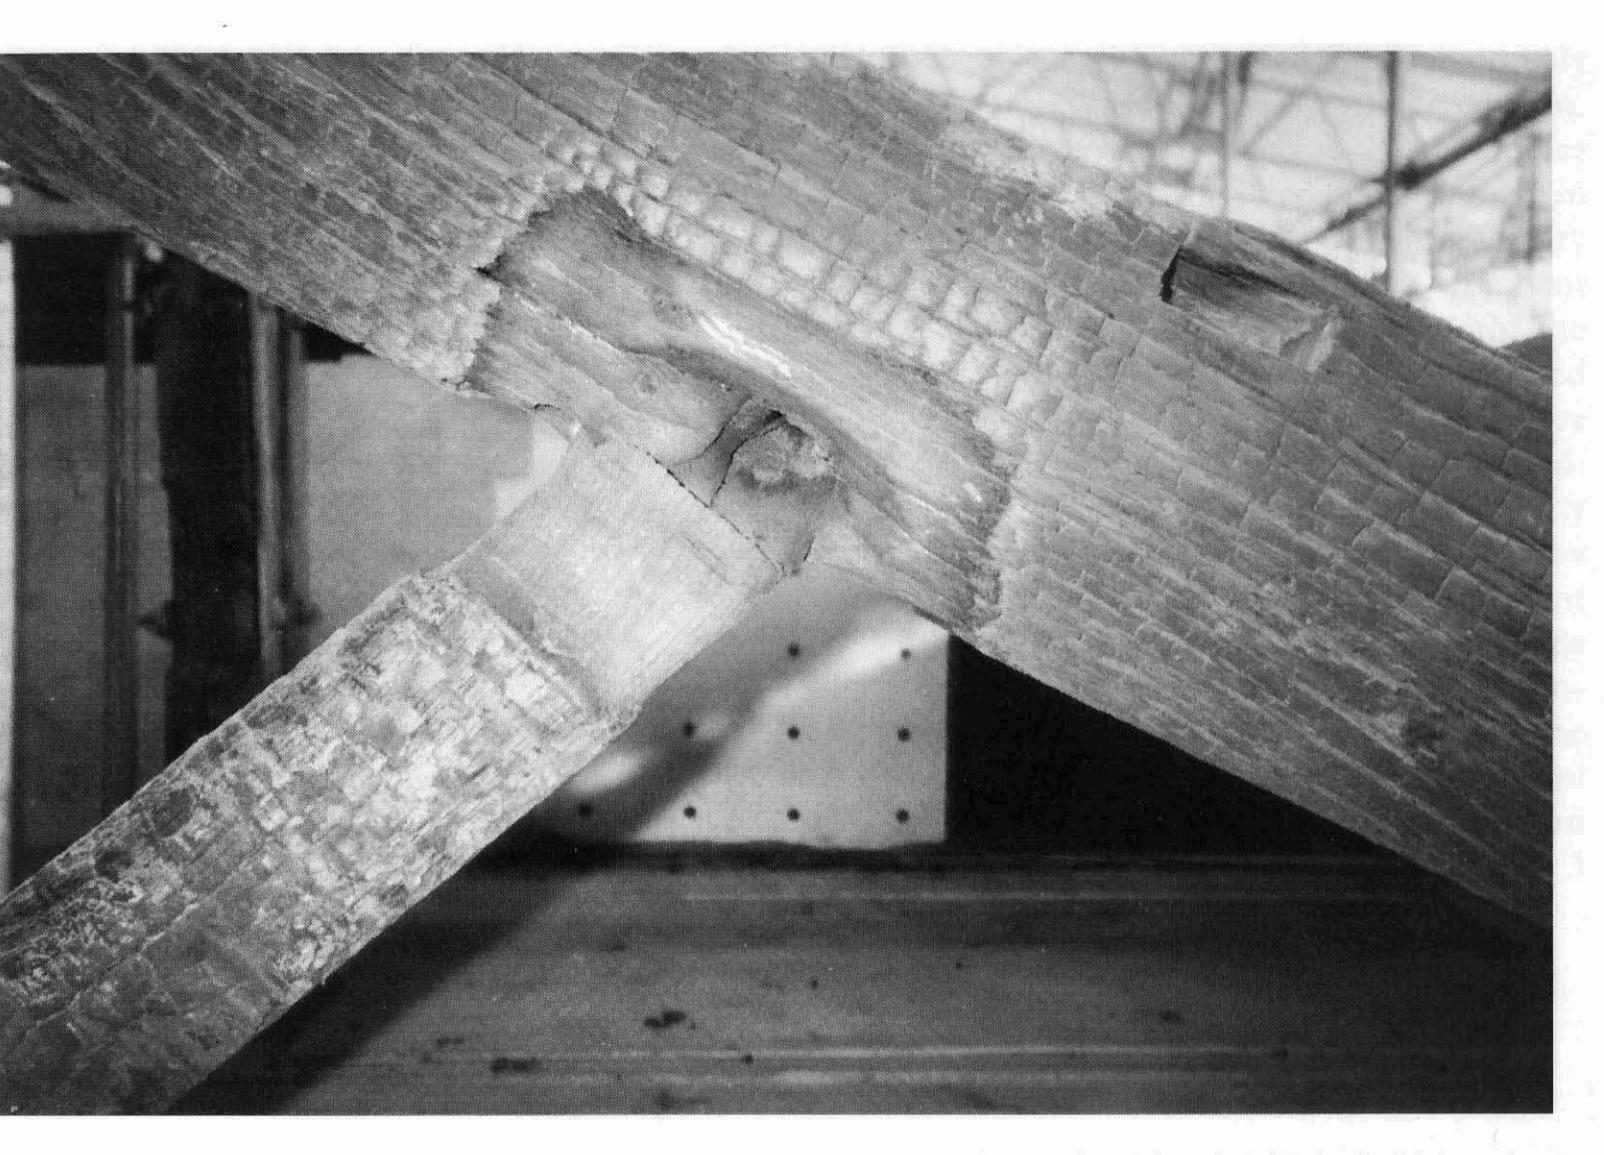
Figure 12.6 Grit blasting the charred surface from an oak truss shows that charring is shallow, but that damage is more severe at the joints.

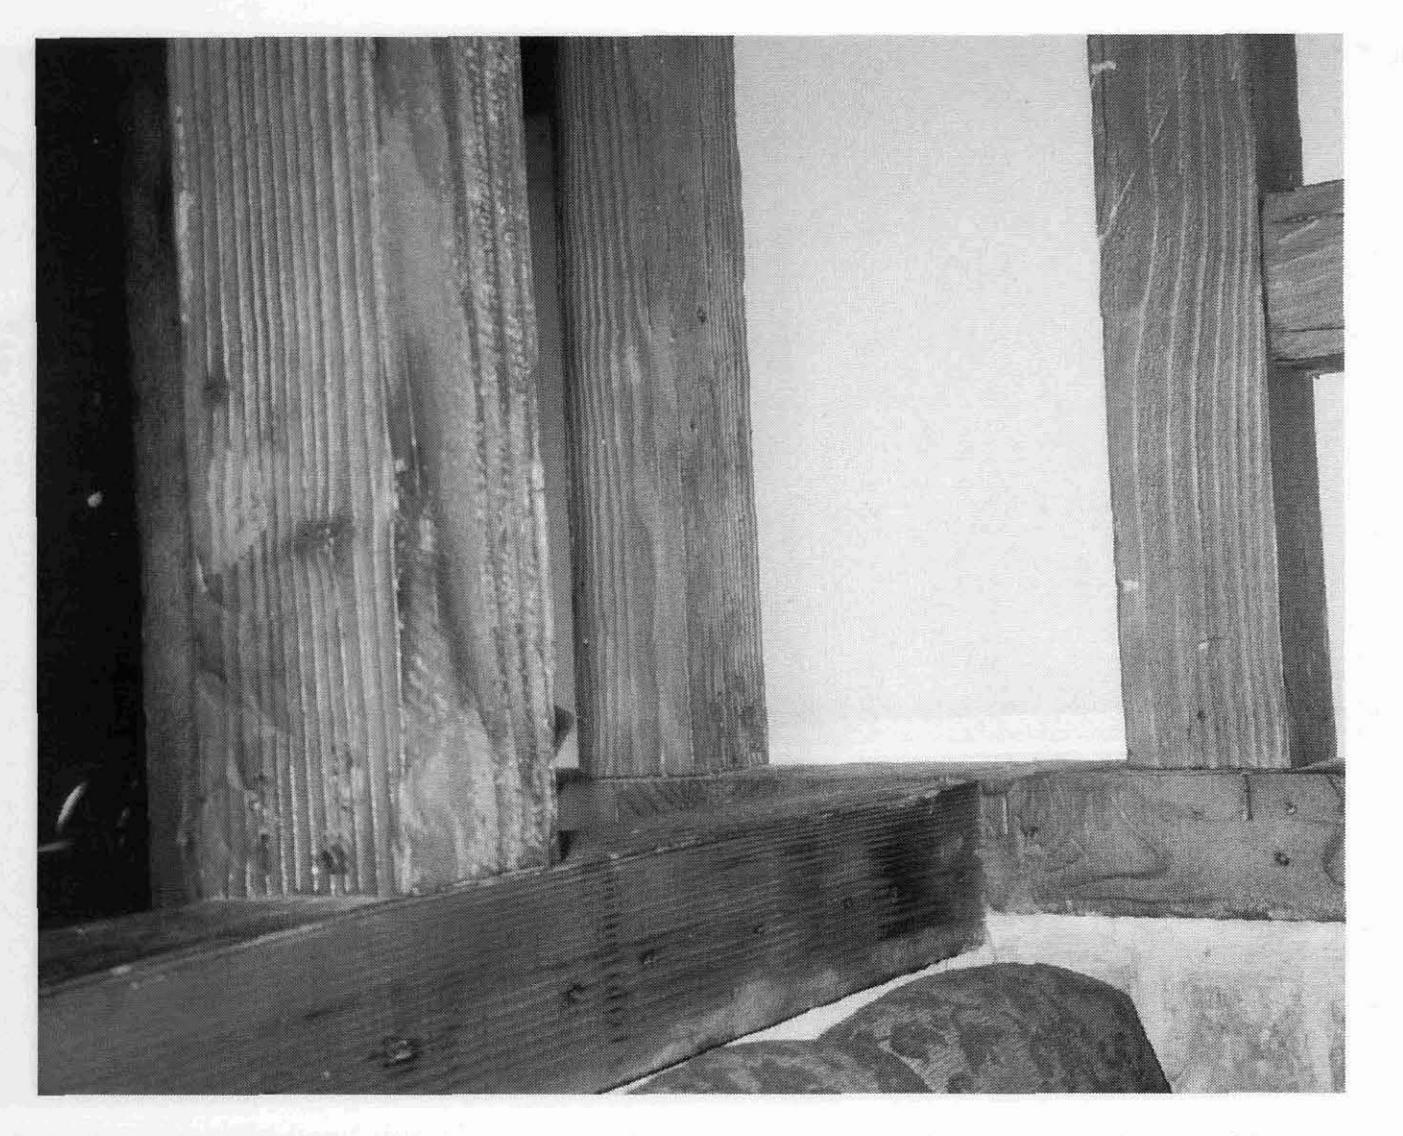
Figure 12.7 Grit blasting softwood removes the softer earlywood and leaves ridges of latewood.

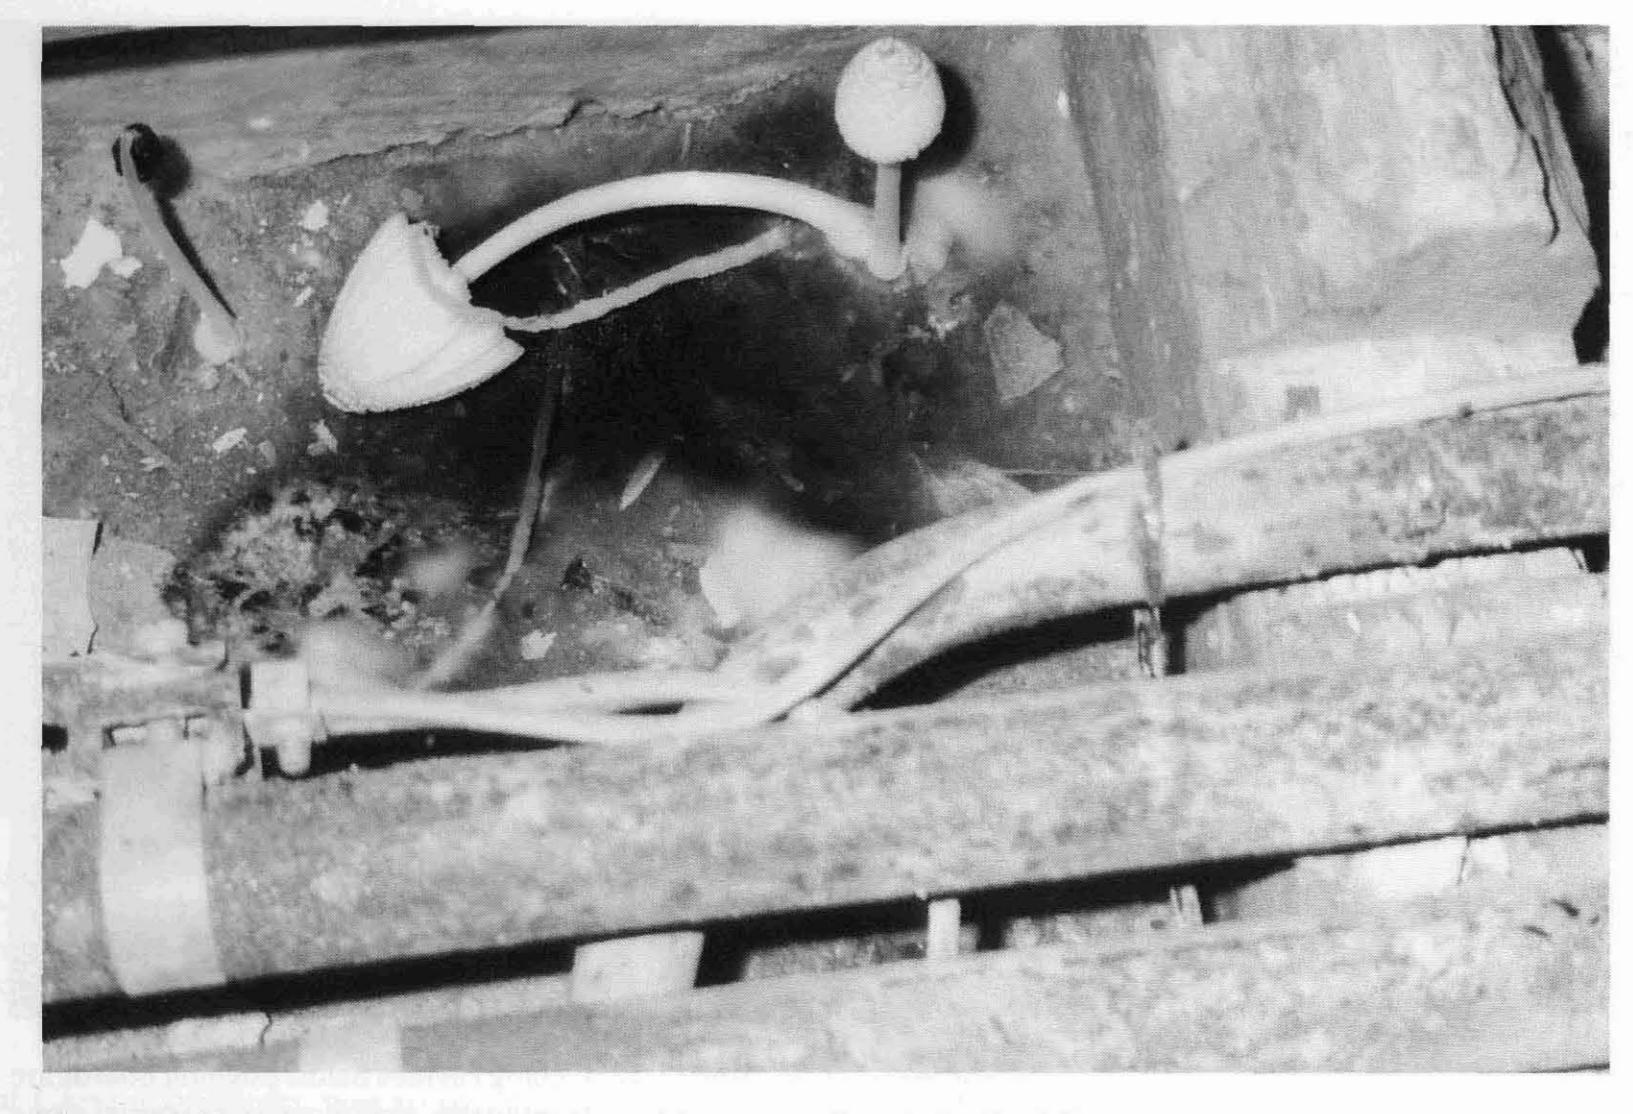
Figure 12.13 Ink cap fungi (*Coprinus* spp.) destroy ceiling laths if ceilings are not encouraged to dry. These are usually the first decay fungi to appear after a fire.

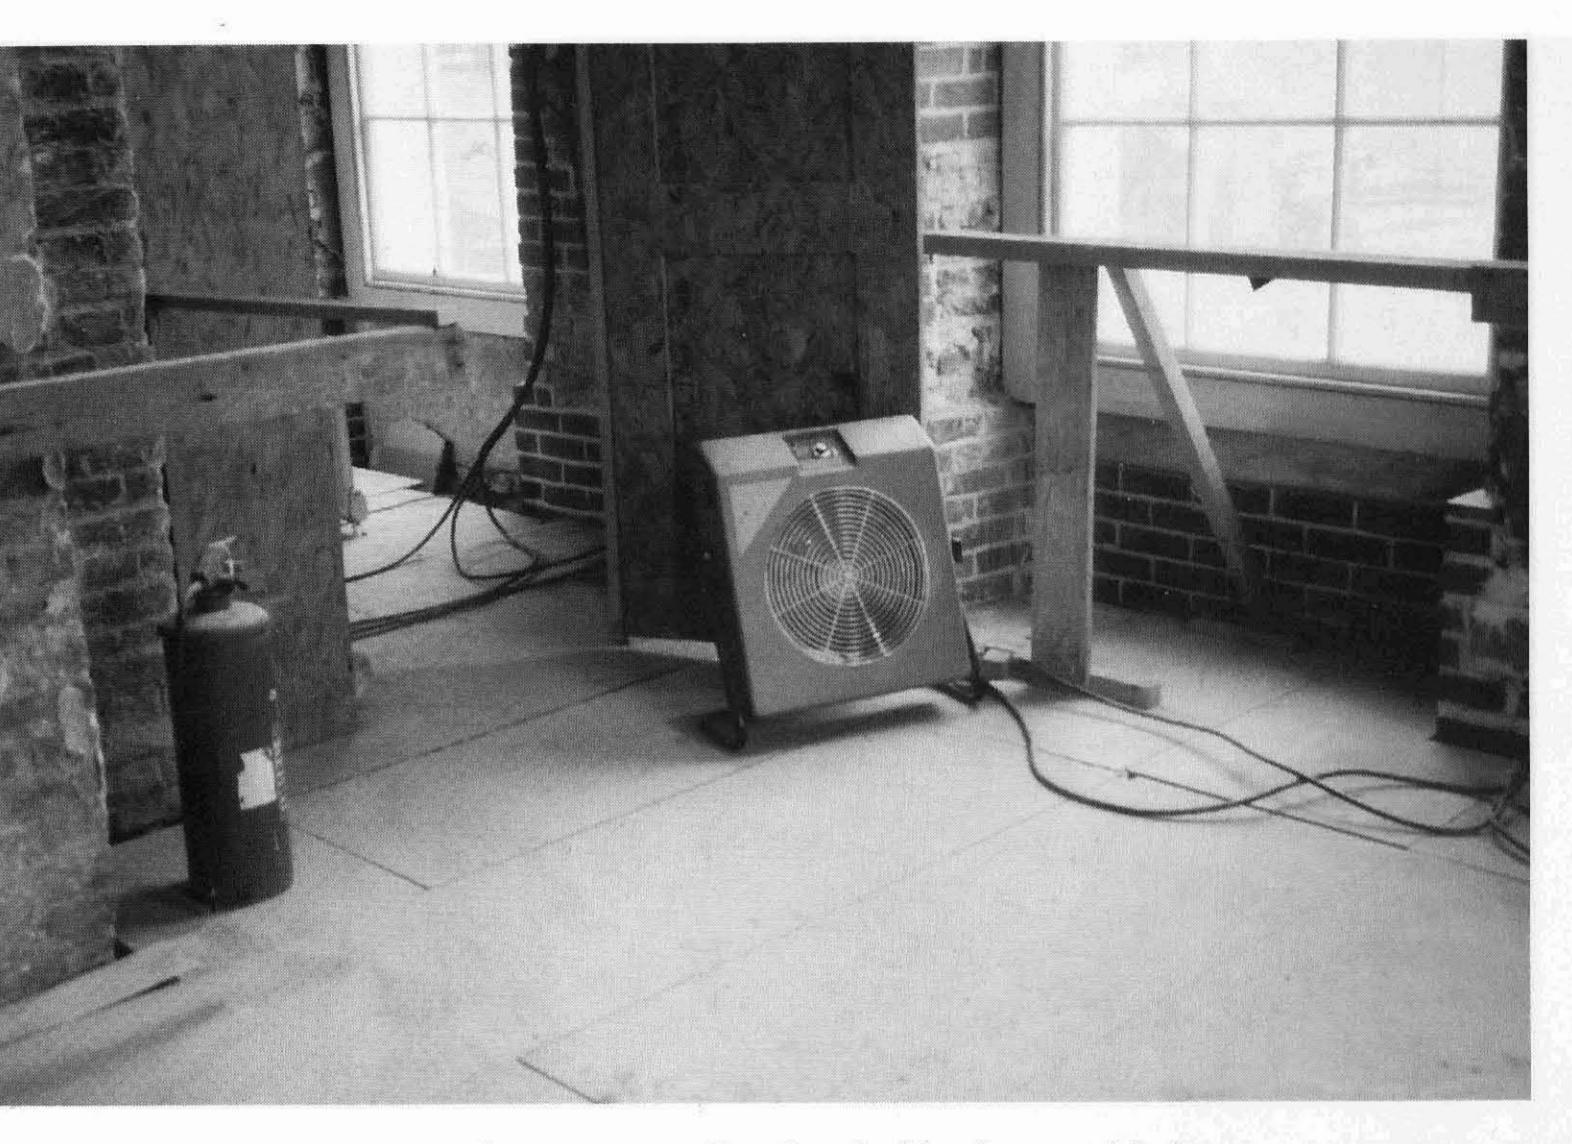
Figure 12.17 Quadrupling the air flow across a wall surface doubles the rate of drying.
