Timber Decay in Buildings

The conservation approach to treatment

Brian Ridout

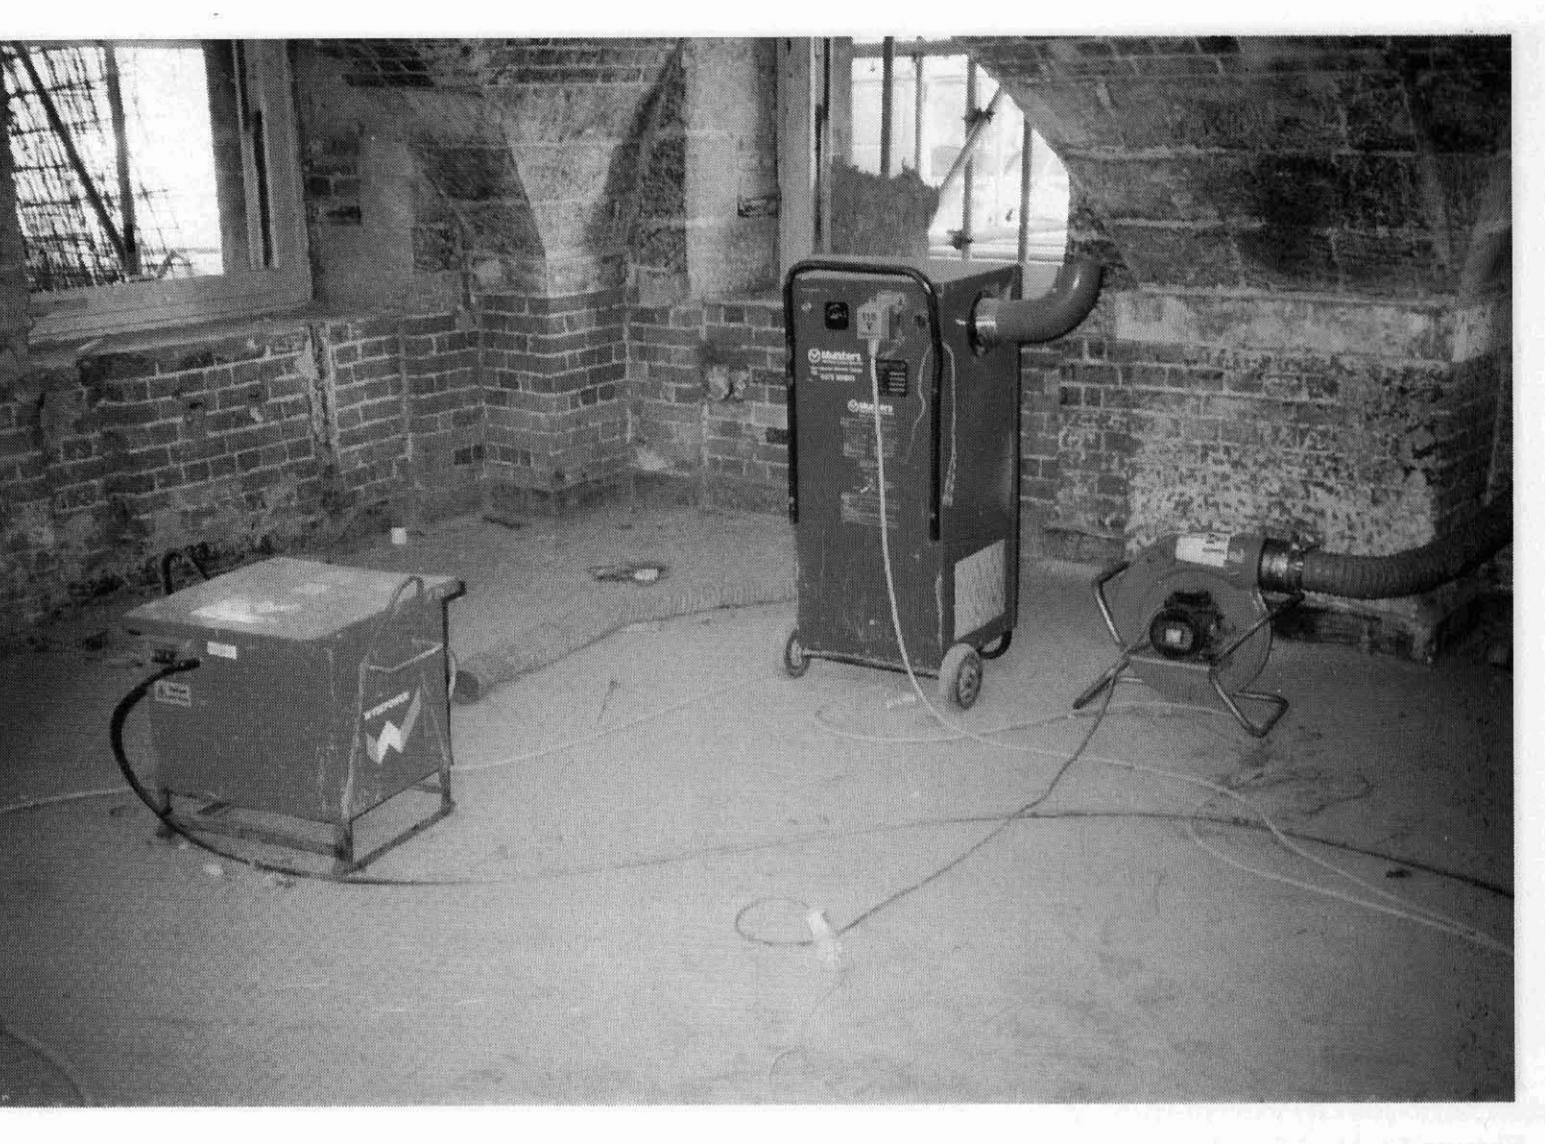
Figure 12.20 Desiccant dehumidifiers are said to perform best at lower temperatures because the desiccant holds more water. Wet air (rather than water) is produced, which relieves the problem of water accumulation, but the outlet hose needs to be vented to the exterior.

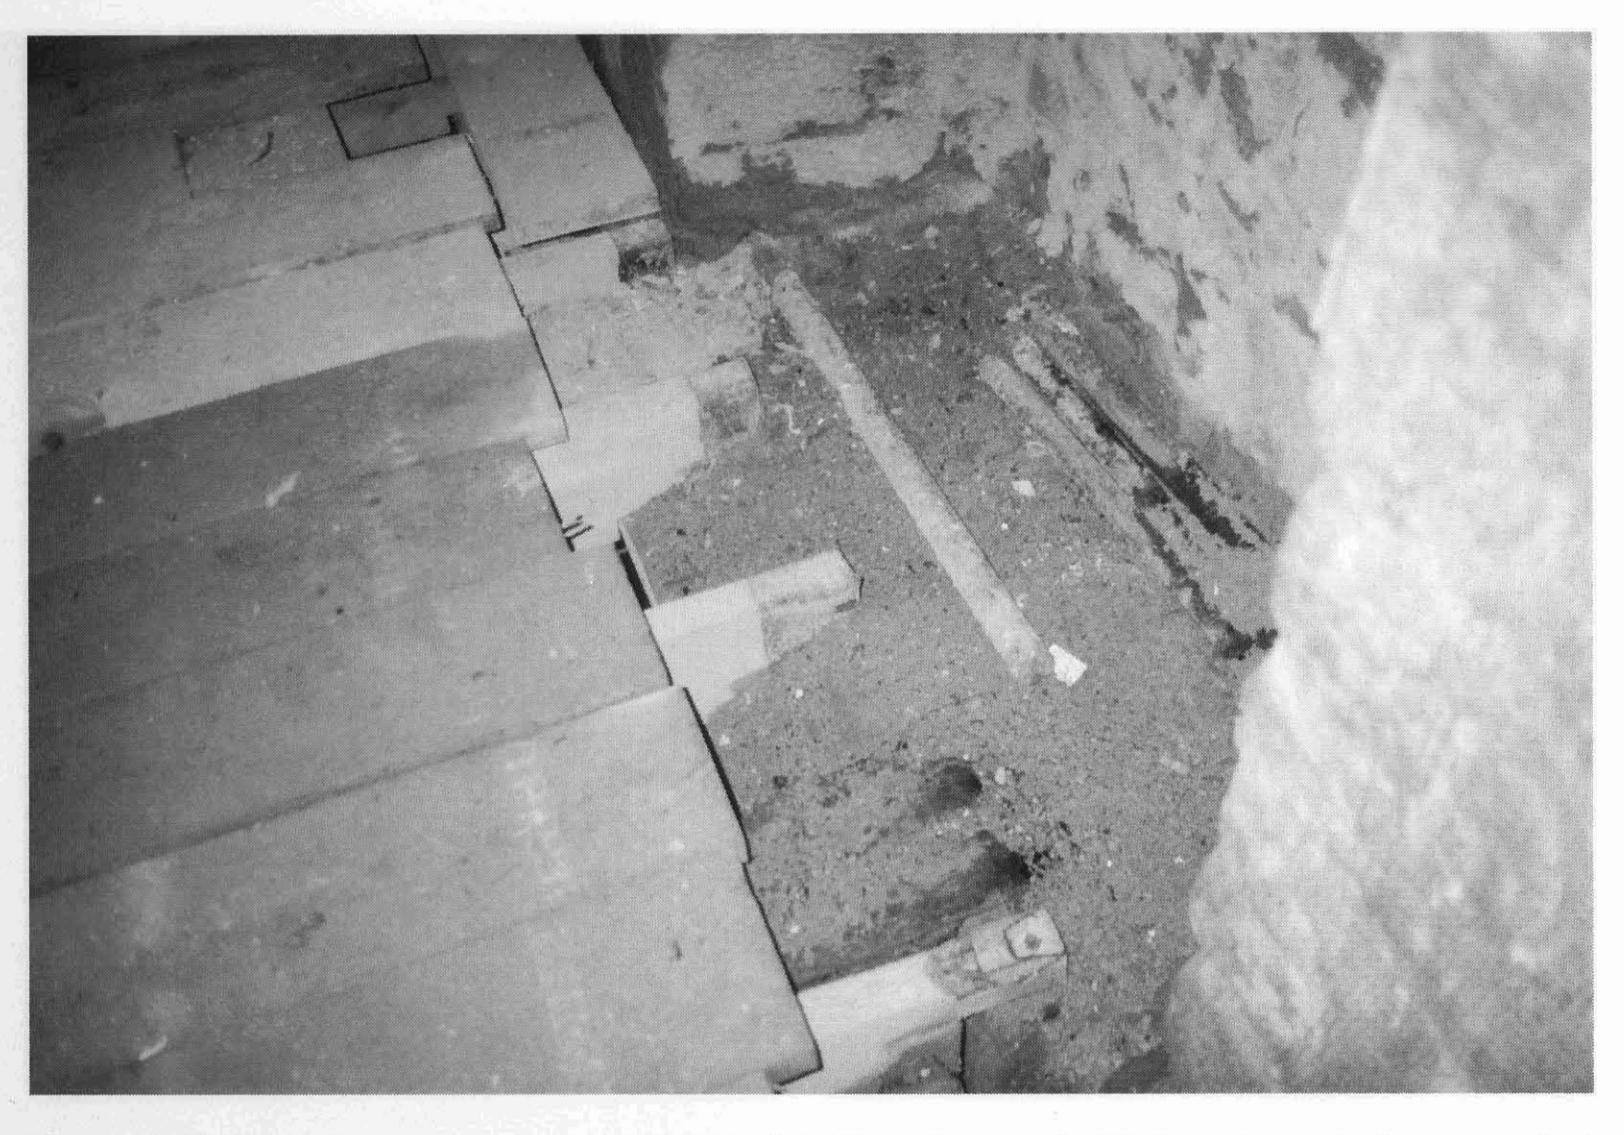
Figure 12.21 All replacement timbers should be isolated from damp walls. Vigilance is required to ensure that the barrier is not bridged by debris.

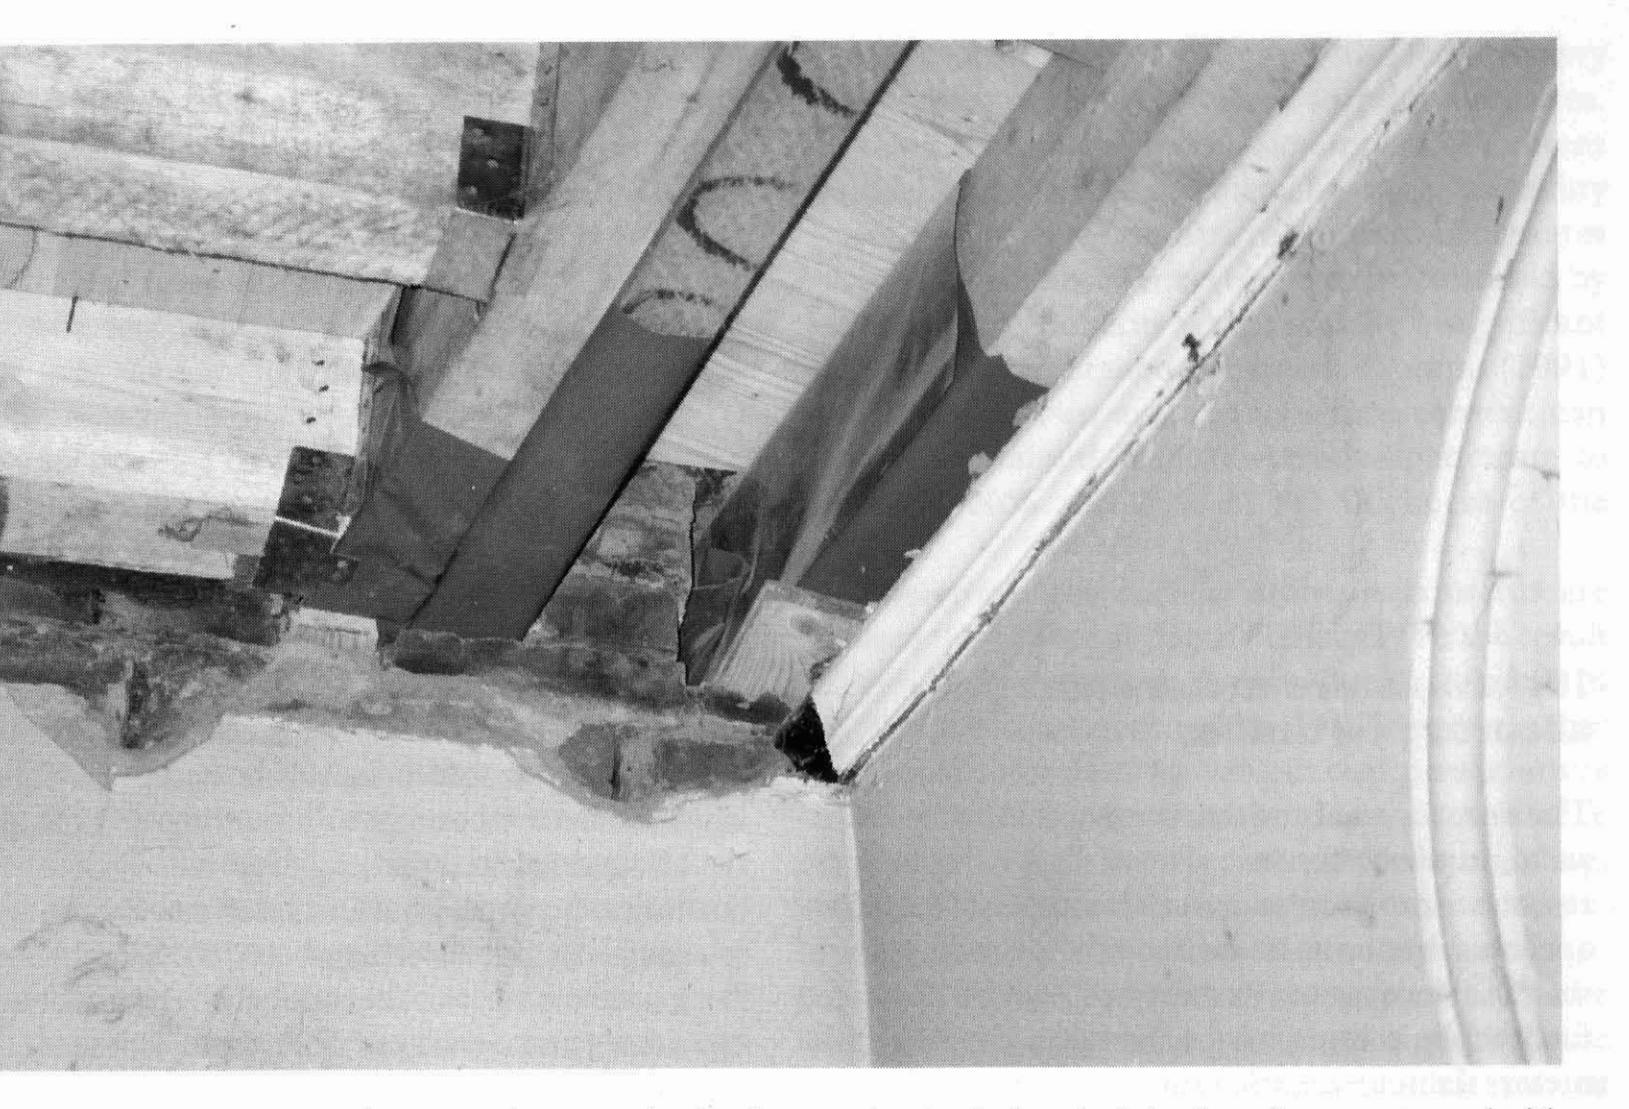
Figure 12.22 In this case the protective wrapping has been enthusiastic, but the joists have been supported with untreated wedges, which will rapidly decay in the wet wall.

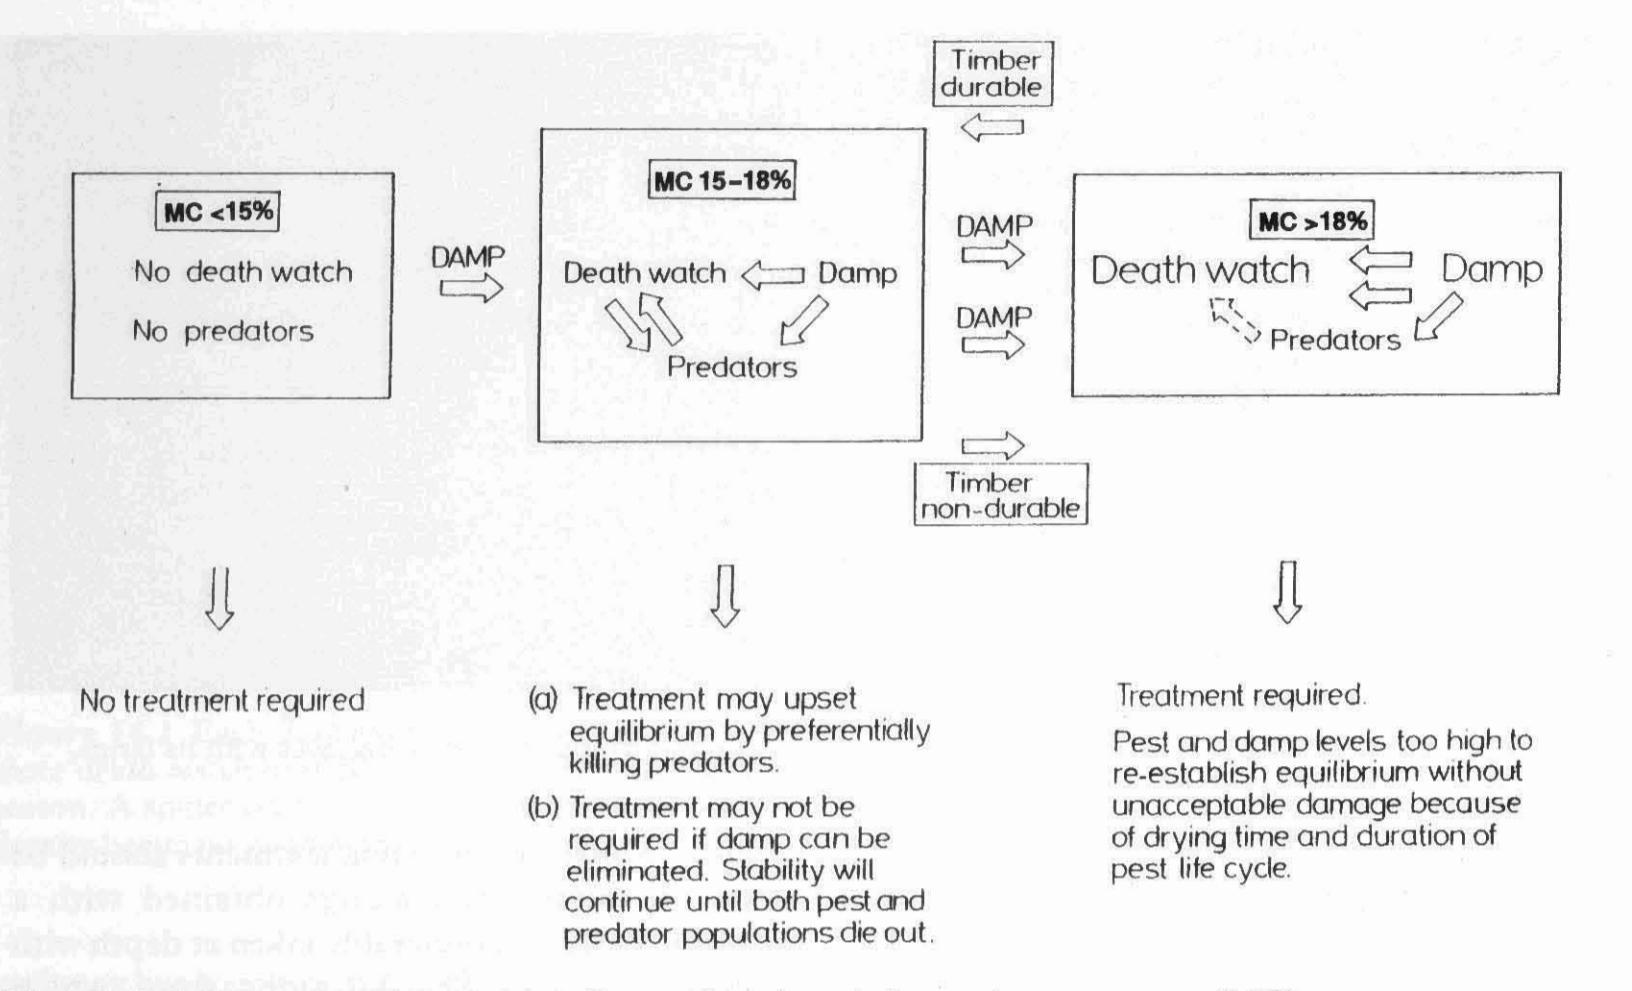
Figure 14.5 Pest and predator habitat diagram based on timber moisture contents (MC).

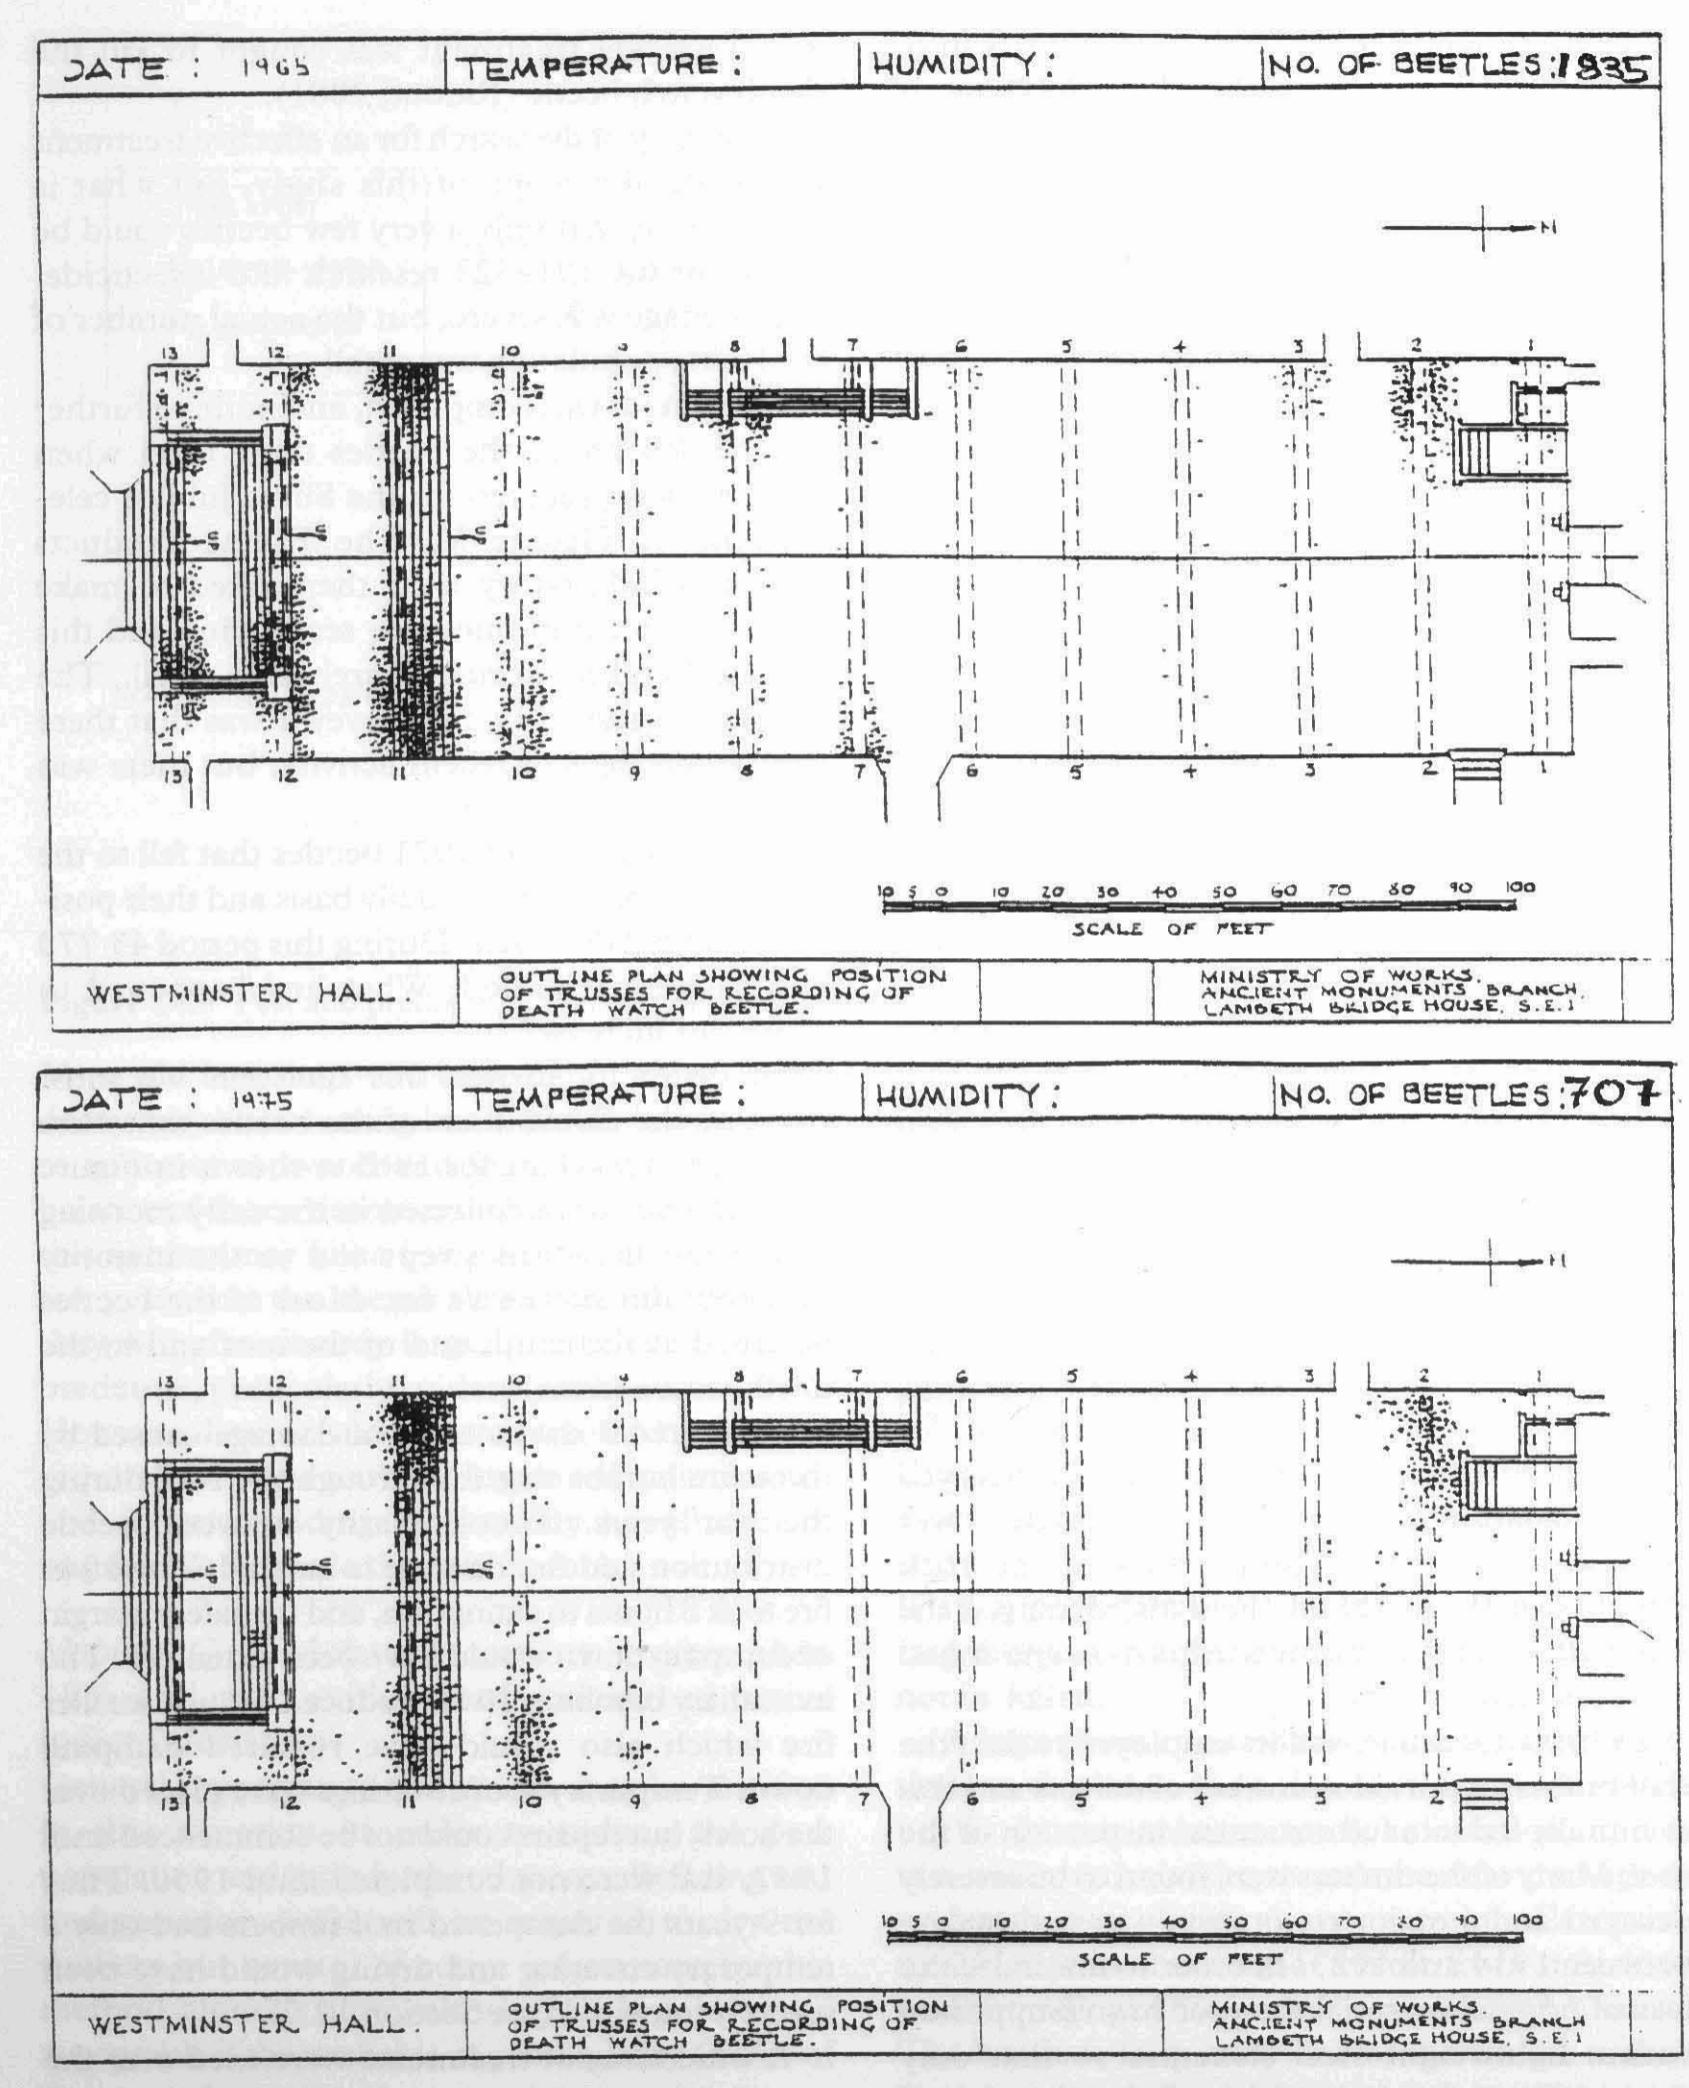
Figure 14.6 Westminster Hall: death watch beetle collection records for 1965 and 1975.

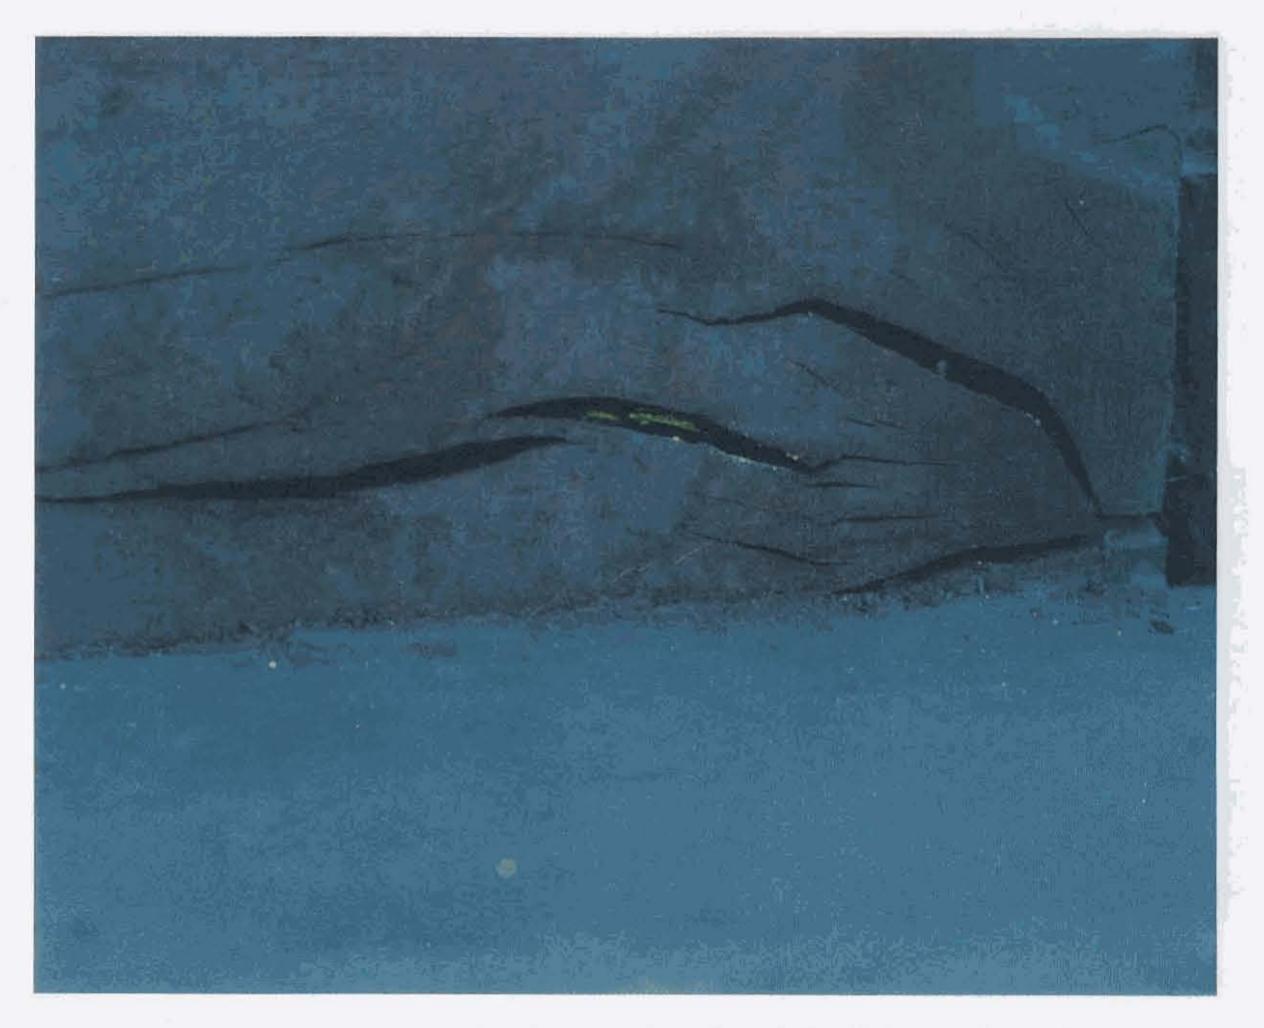
Colour Plate 1 A photograph taken under ultraviolet light to show fluorescent dust from a labelled death watch beetle that re-entered the timber via a shake.

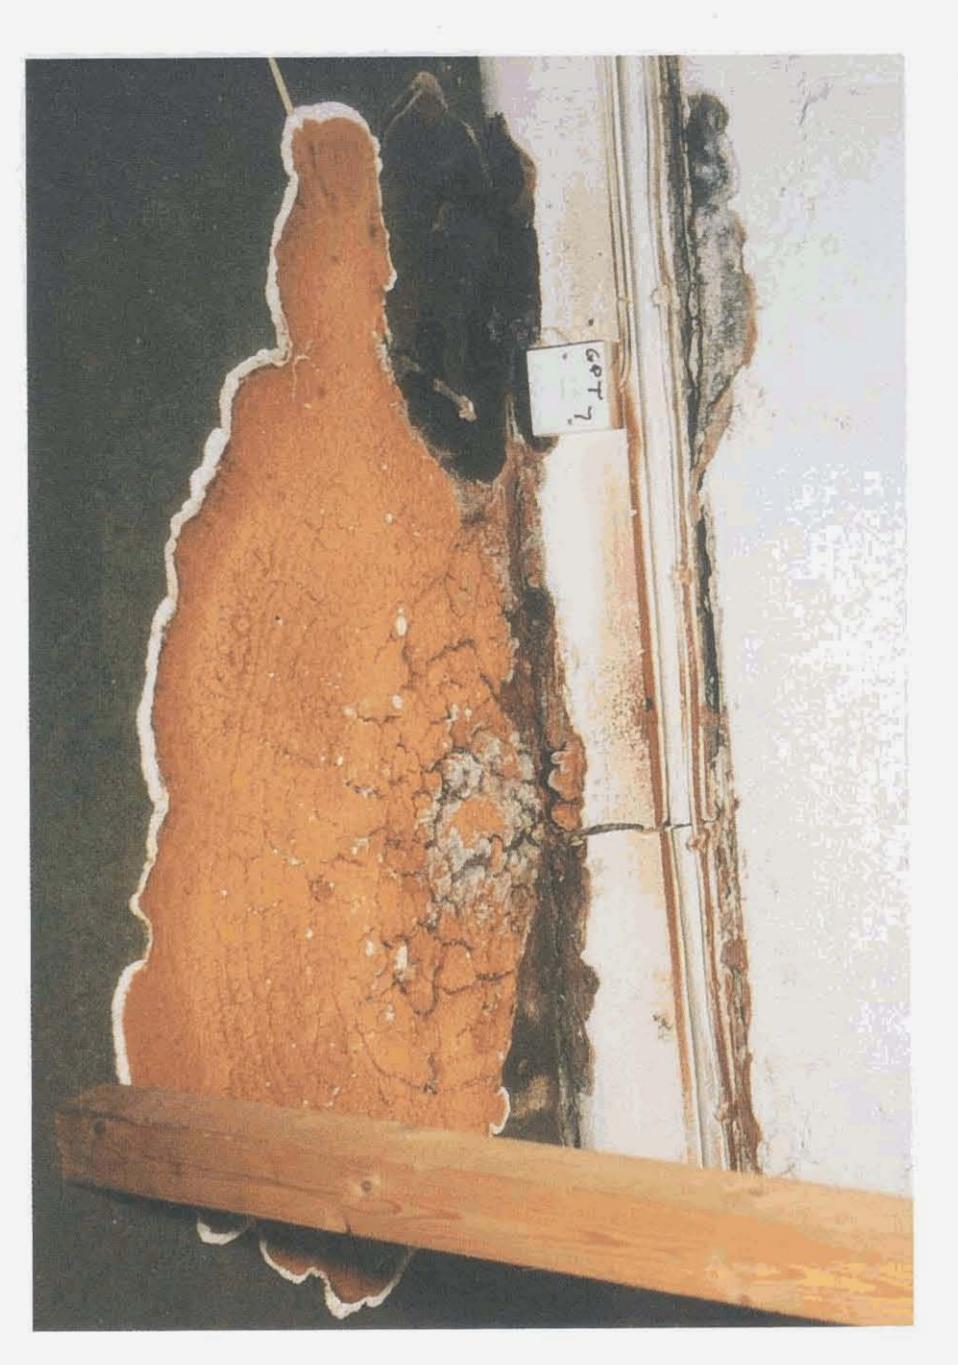
Colour Plate 3 Fresh dry rot fruits are orange, usually with a white margin. The fruit turns black and dries up after the spores are released.

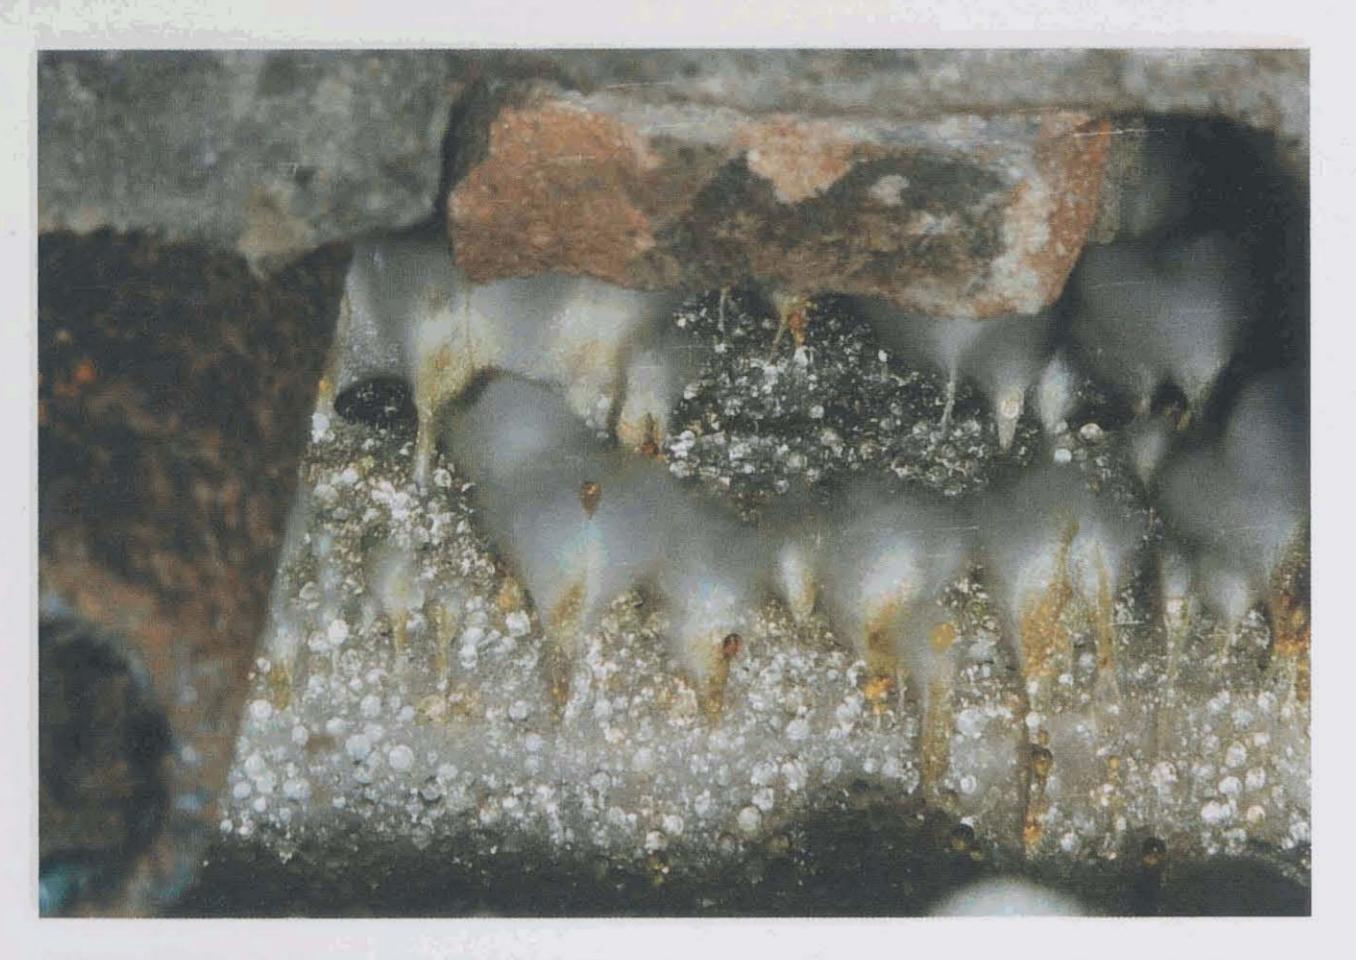
Colour Plate 9 If conditions are very humid, excessive moisture weeps from the fungus.

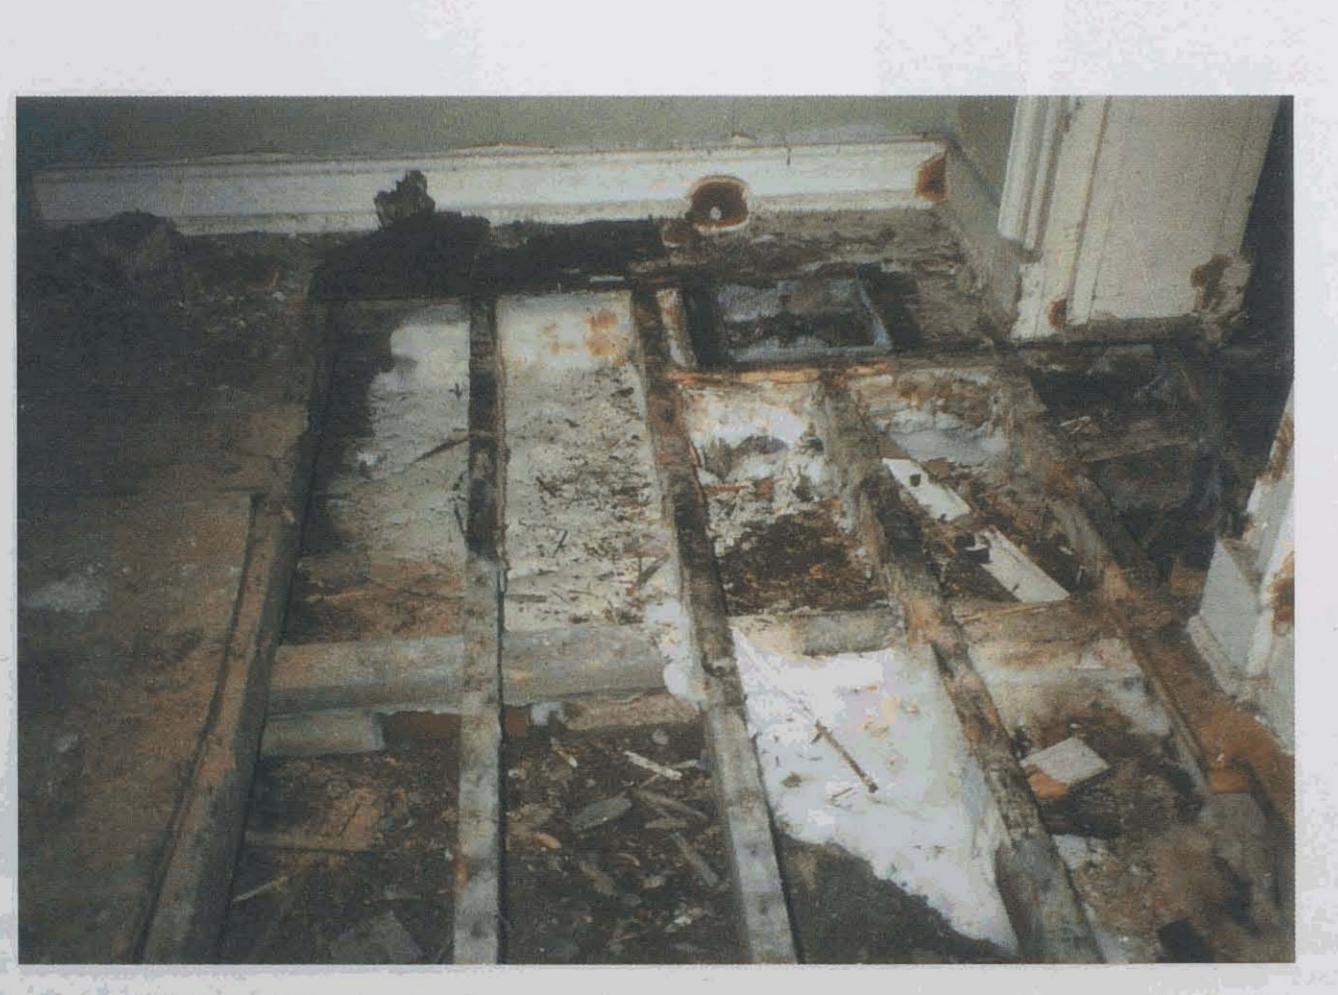
Colour Plate 10 Dry rot in a subfloor void grows in an arc around the source of moisture, which was an external downpipe.

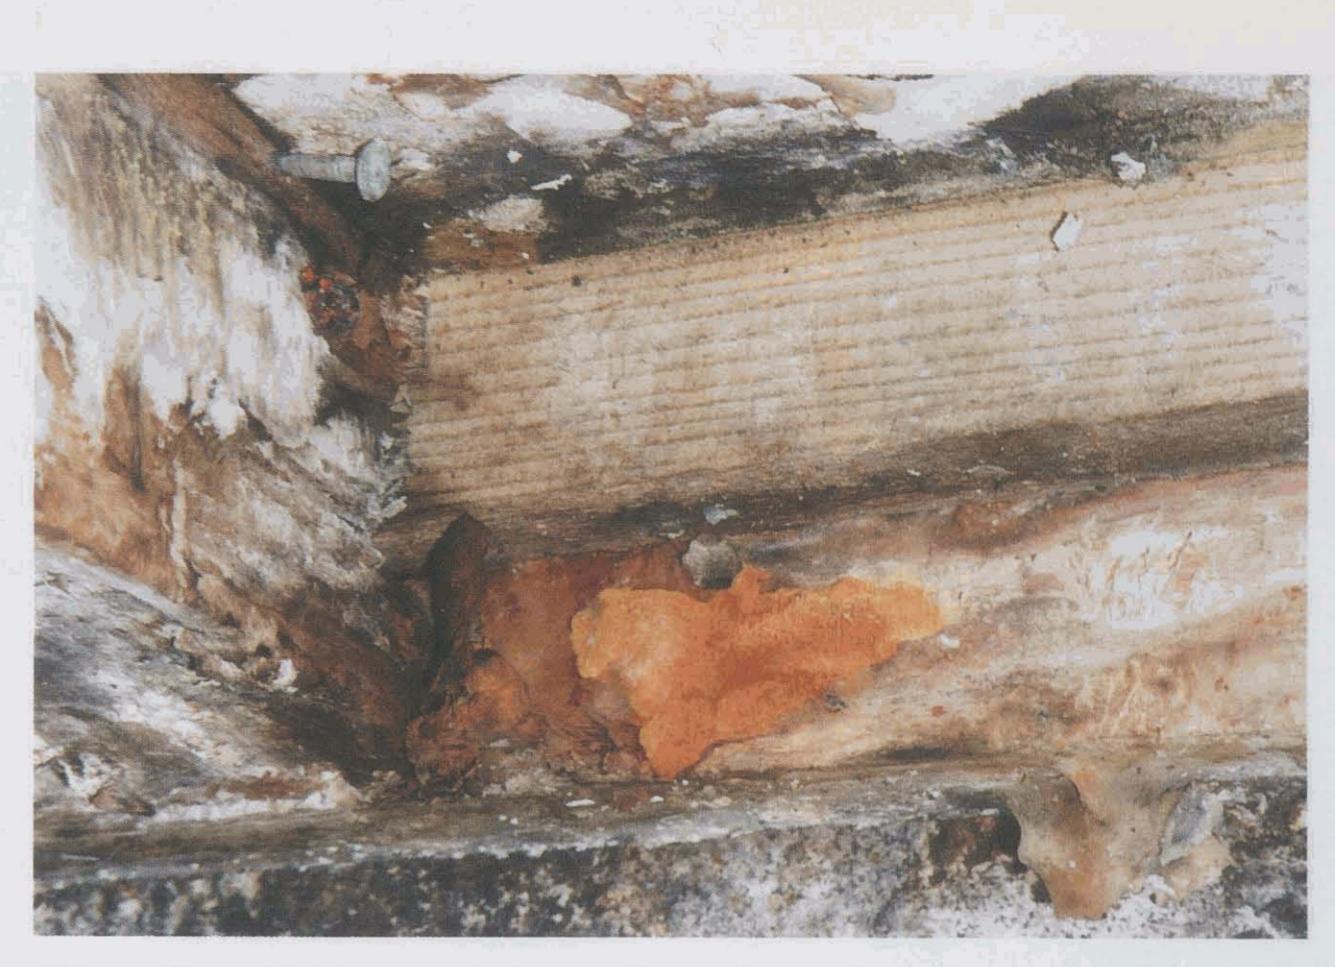
Colour Plate 17 The wet rot fungus *Gleophyllum sepiarum* has elongated pores like thick gills. It occasionally occurs in buildings and may easily be mistaken for dry rot. (See also Table 8.2.)

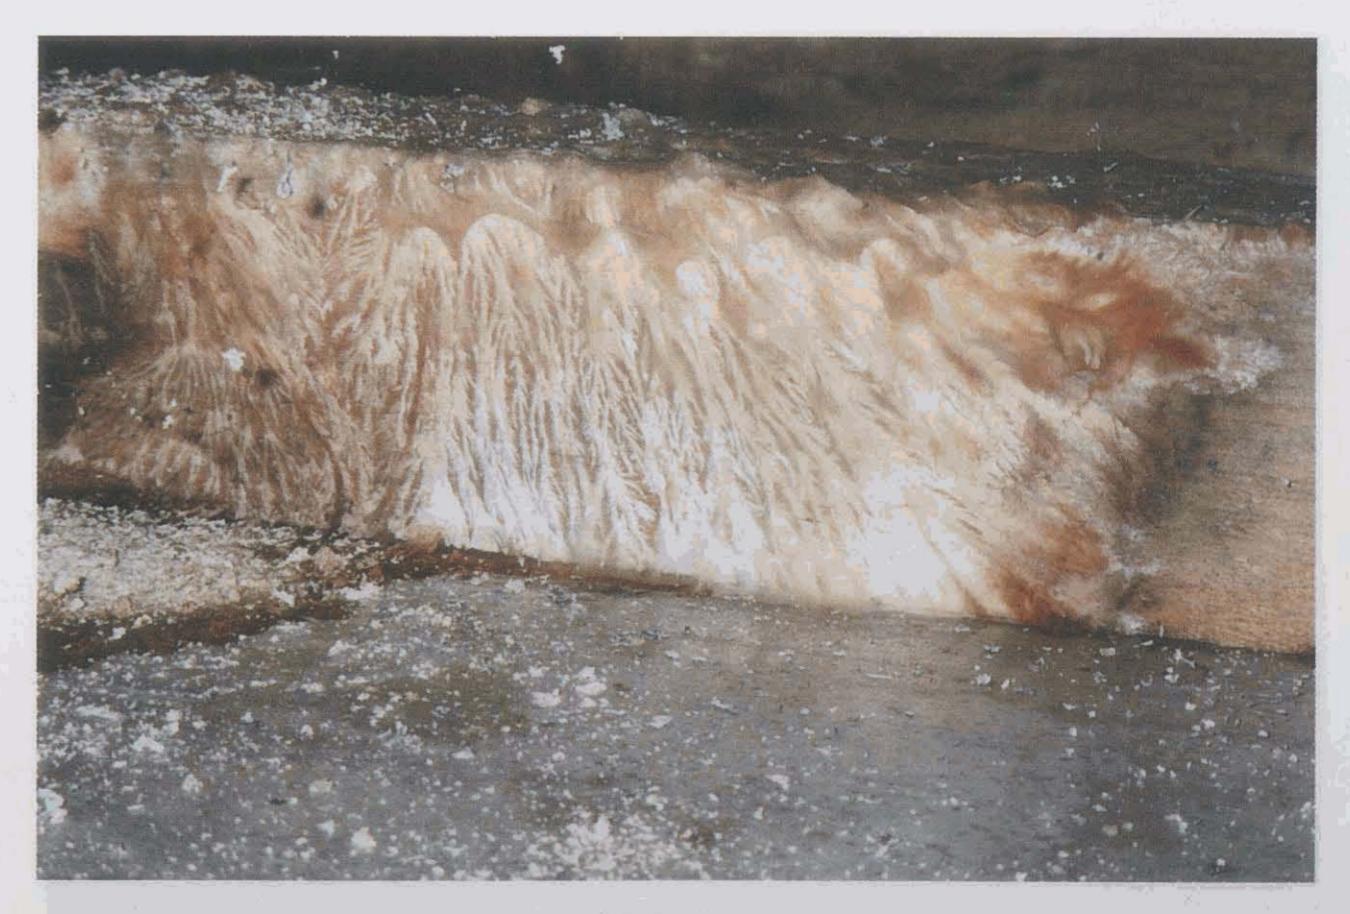
Colour Plate 18 *Gleophyllum sepiarium* is one of a wide range of fungi that may produce large amounts of visible mycelium. (See also Table 8.2.)

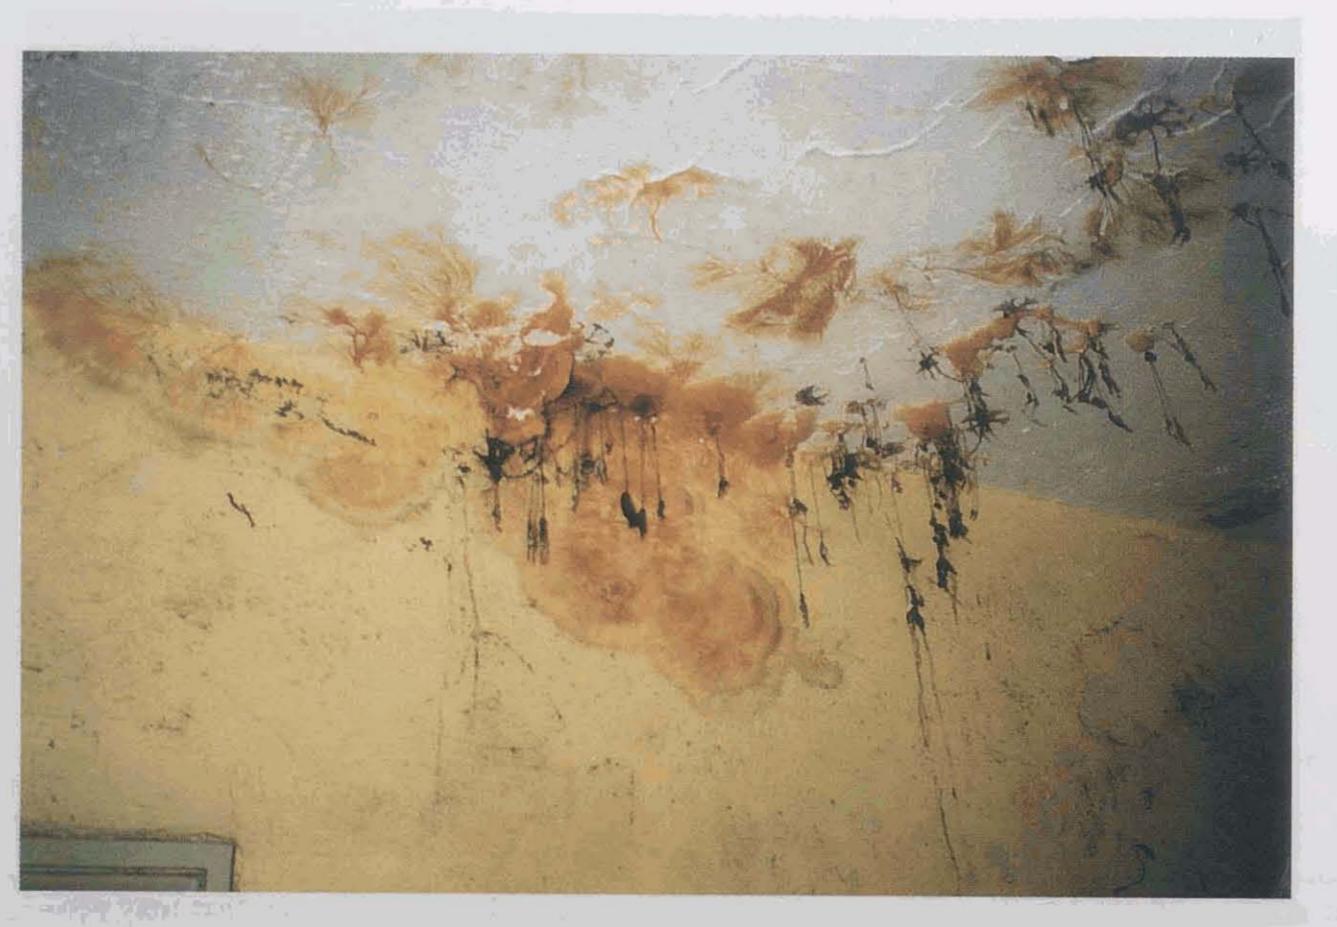
Colour Plate 21 Ginger Coprinus mycelium with the shrivelled remains of fruits.

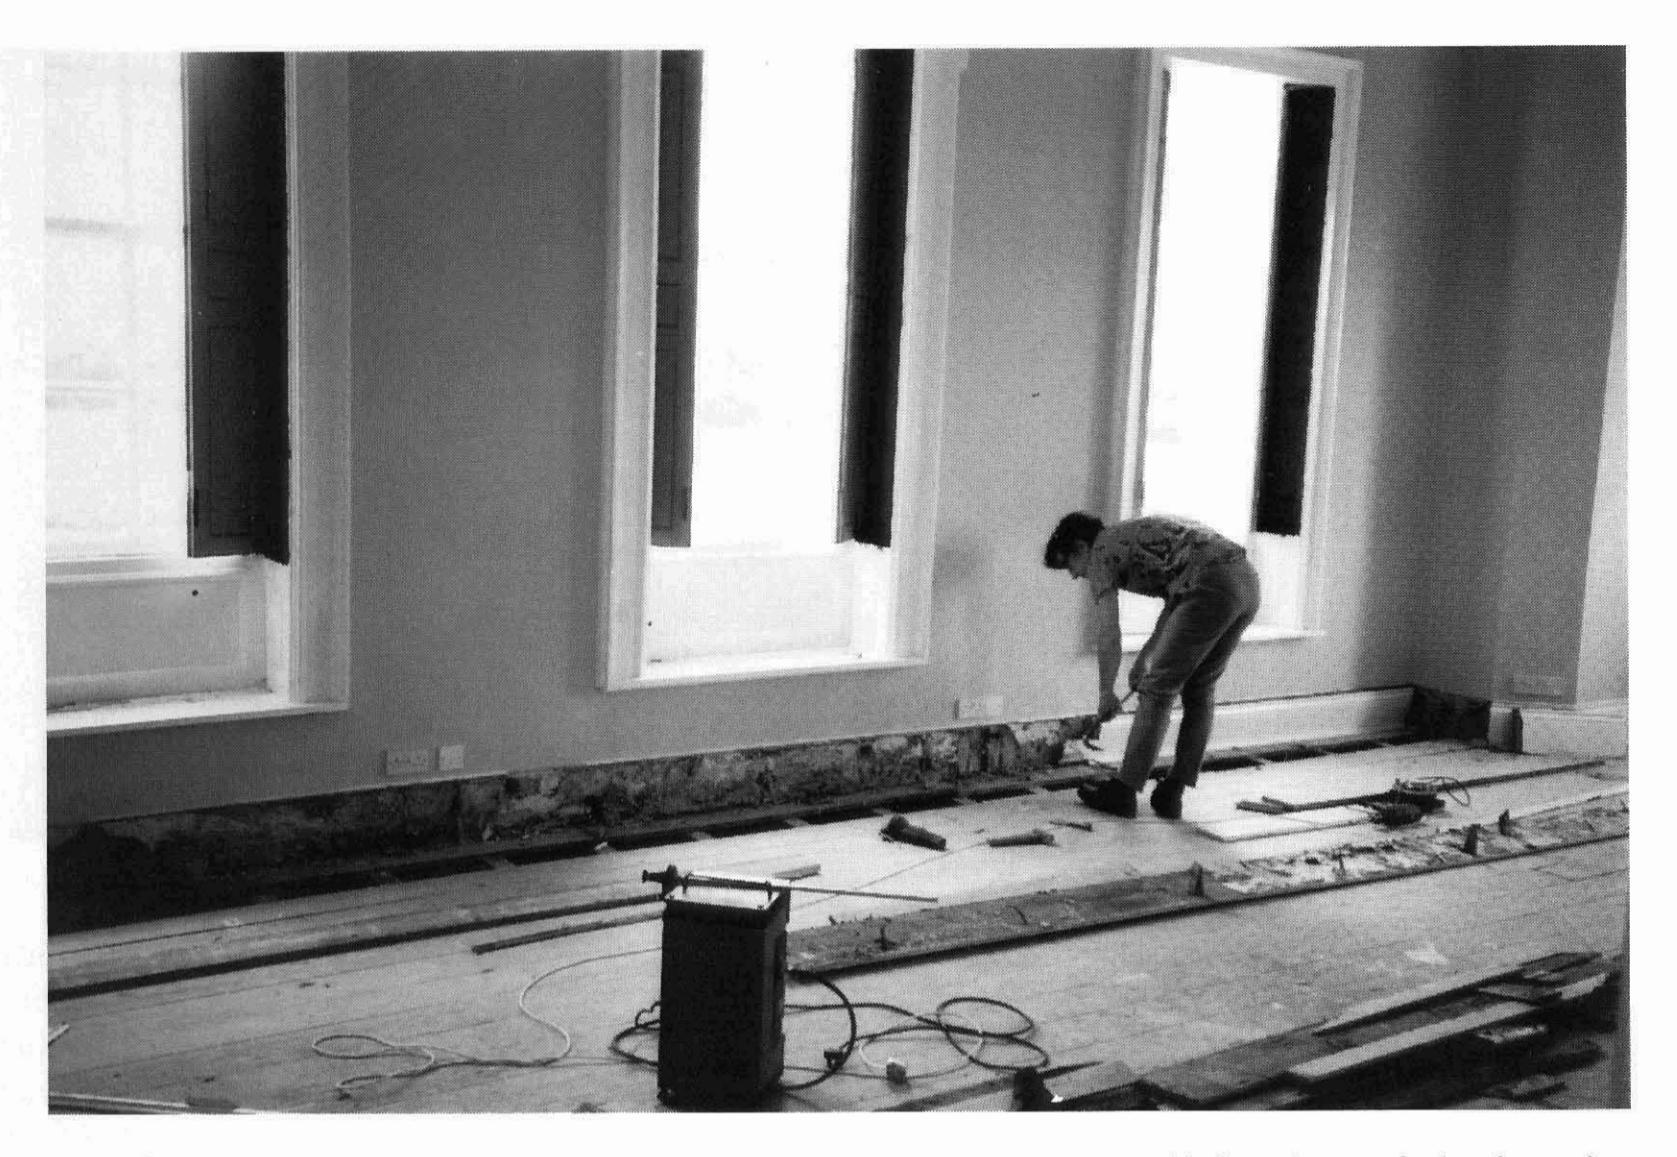
Figure B.7 Dry rot in room 3 at Walsworth Hall was able to spread along skirtings from a faulty downpipe because of exterior wall washing.

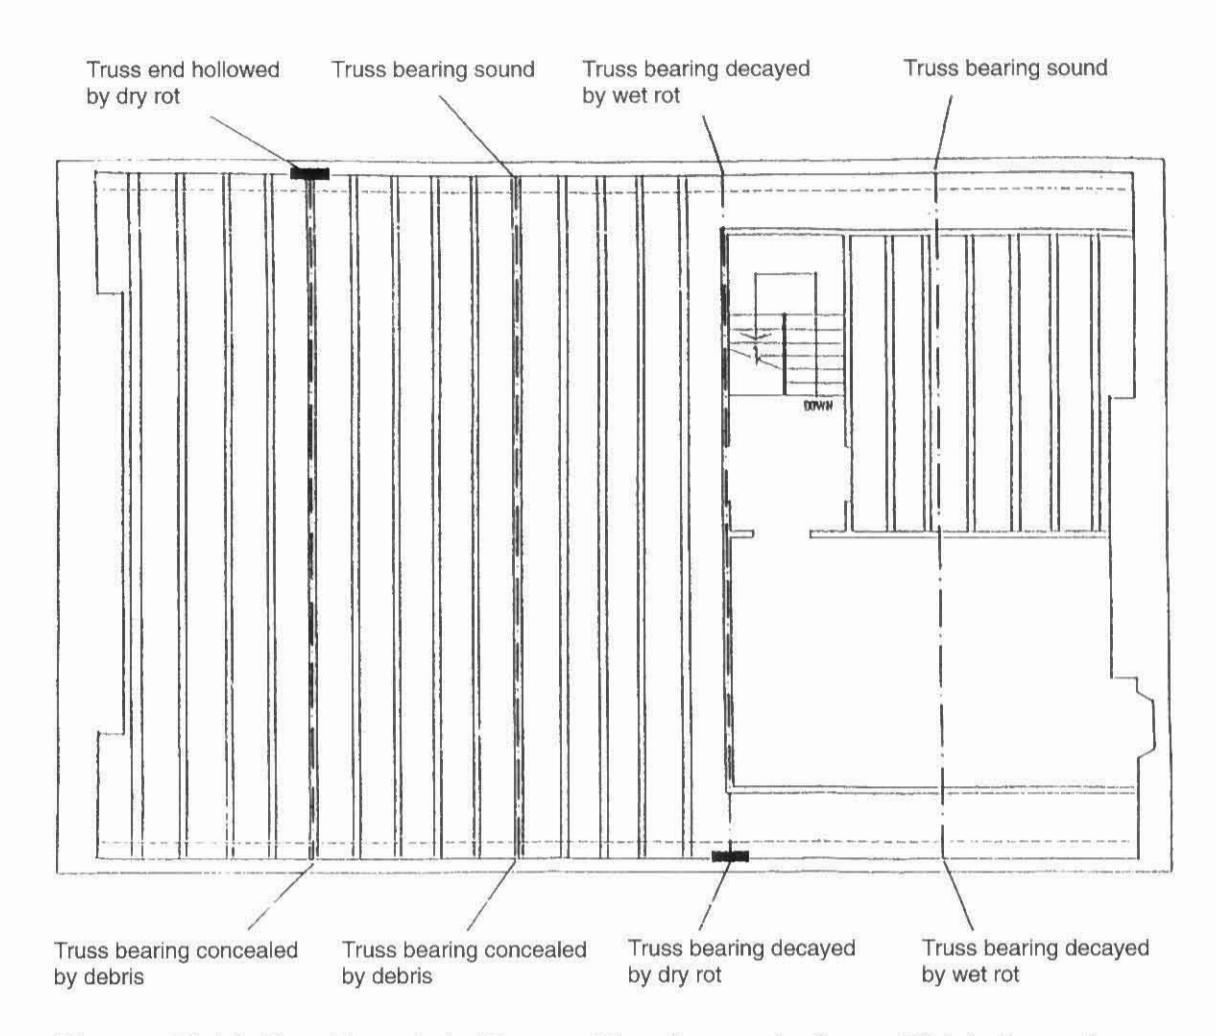
Figure B.11 Sea Captain's House, Dundee: attic floor. Thick lines show the extent of dry rot.
