Timber Decay in Buildings

The conservation approach to treatment

Brian Ridout

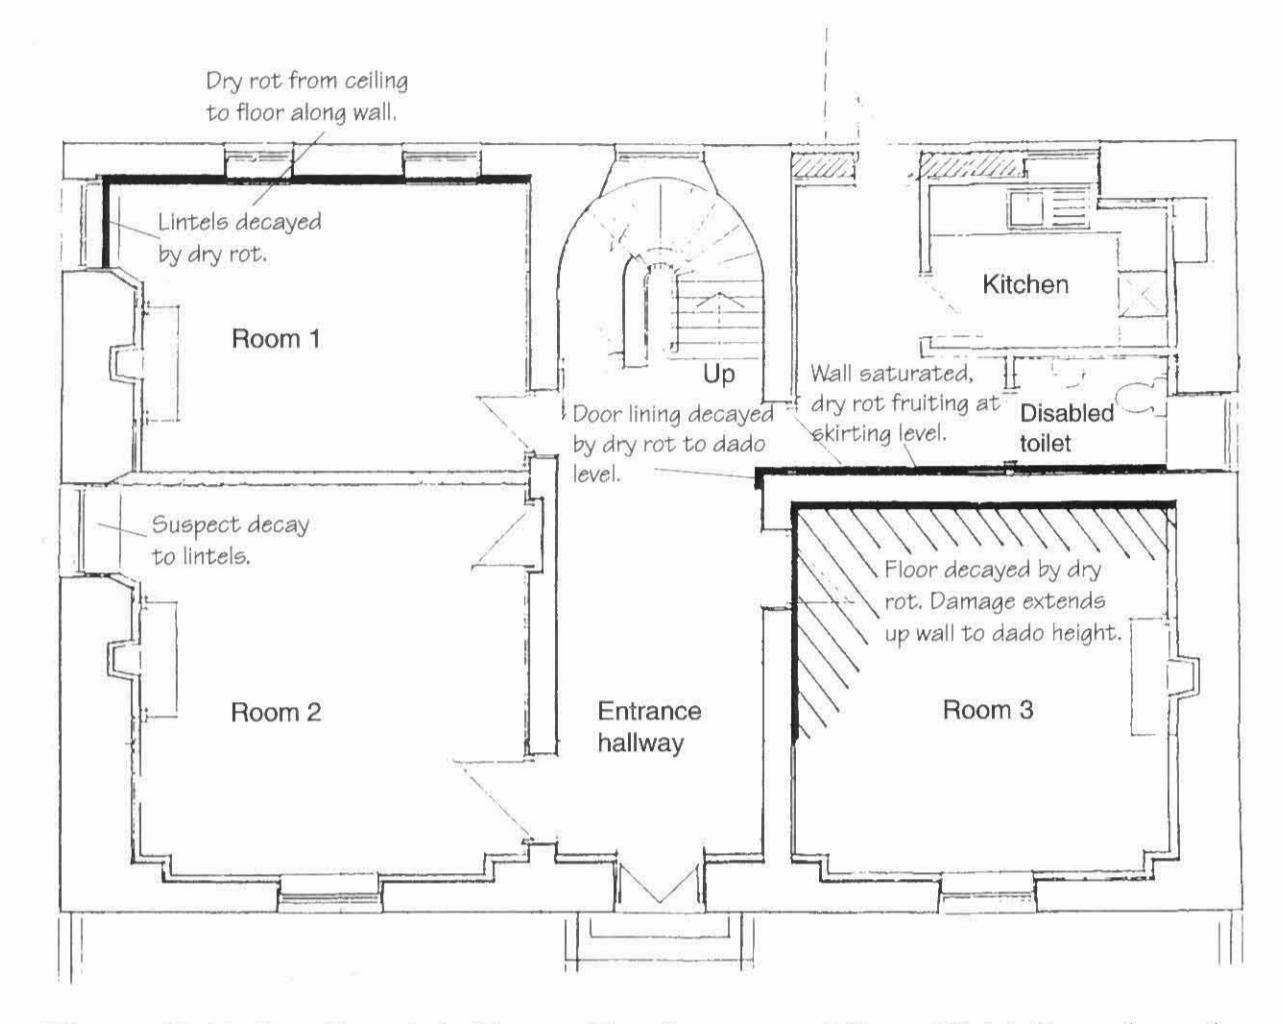
Figure B.13 Sea Captain's House, Dundee: ground floor. Thick lines show the extent of dry rot.

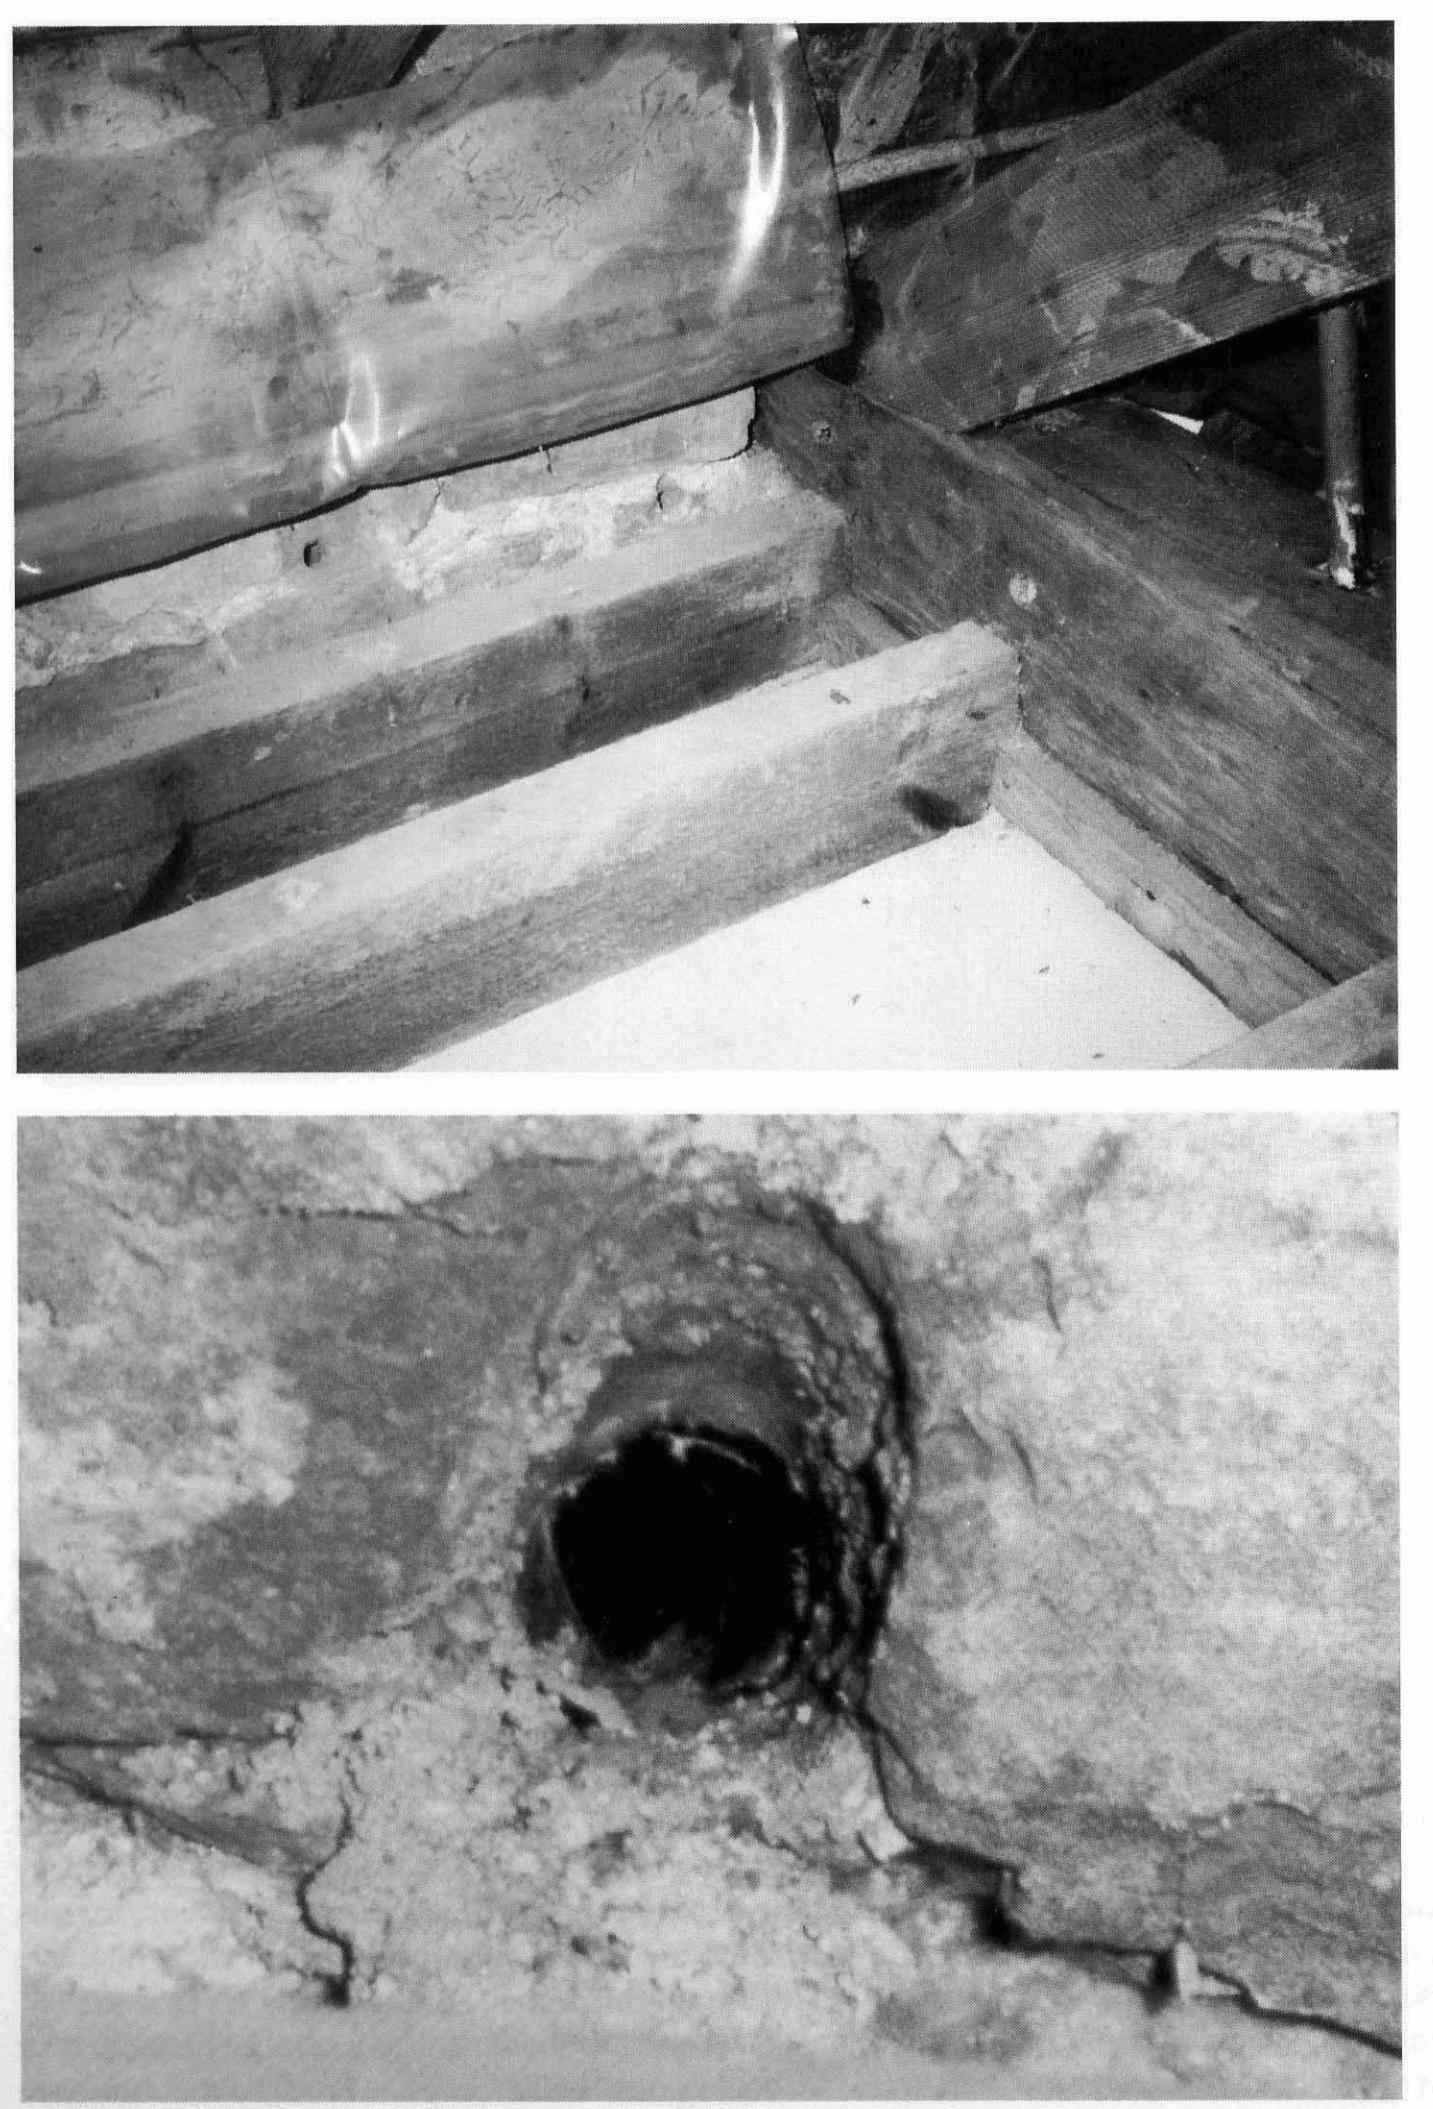
Figure B.15 Partial dry rot treatment at Lees Court, Kent. Note the irrigation holes in the wall at the tie beam.
