Short Guide

HISTORIC CONCRETE IN SCOTLAND PART 3: MAINTENANCE AND **REPAIR OF HISTORIC** CONCRETE STRUCTURES

Published by Historic Scotland, March 2014

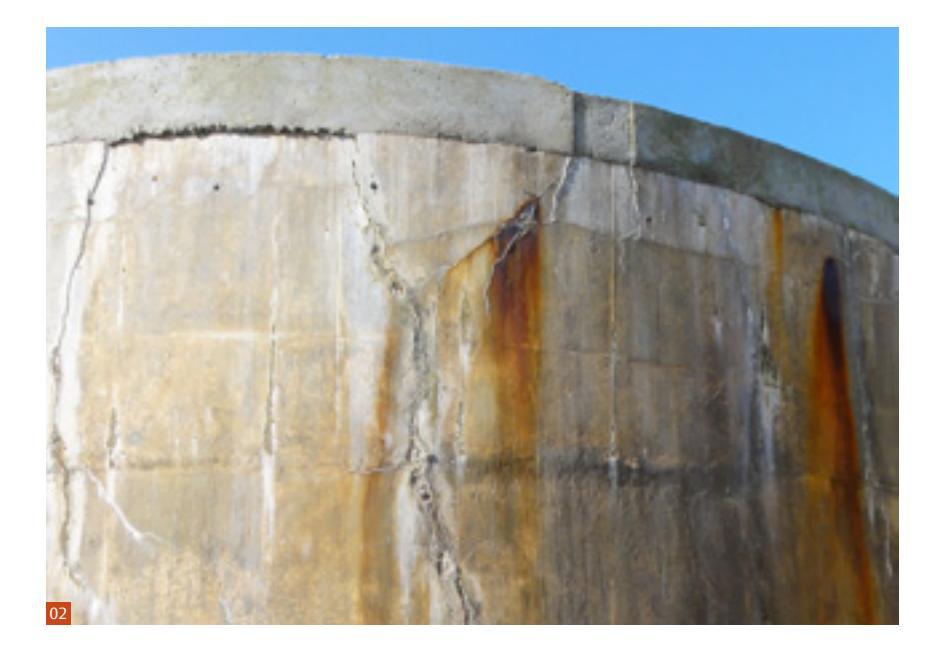
Fig. 2 Rust stains on poorly repaired historic concrete. The stains in this case may be due to the presence of ferrous metal underneath the repair.

Rust stains should be carefully investigated and analysed to determine if they are due to reinforcement corrosion, which will require special treatment and repair, or some other sources, for example iron-rich aggregate or ferrous metal fittings attached to the concrete (Fig. 2). Proprietary cleaning chemicals suitable for rust stains typically contain oxalic or phosphoric acid solutions. Deep rust stains will require chemical surface treatments using a poultice, typically diatomaceous earth containing a dilute solution of sodium citrate with glycerol (CCAA, 2008).

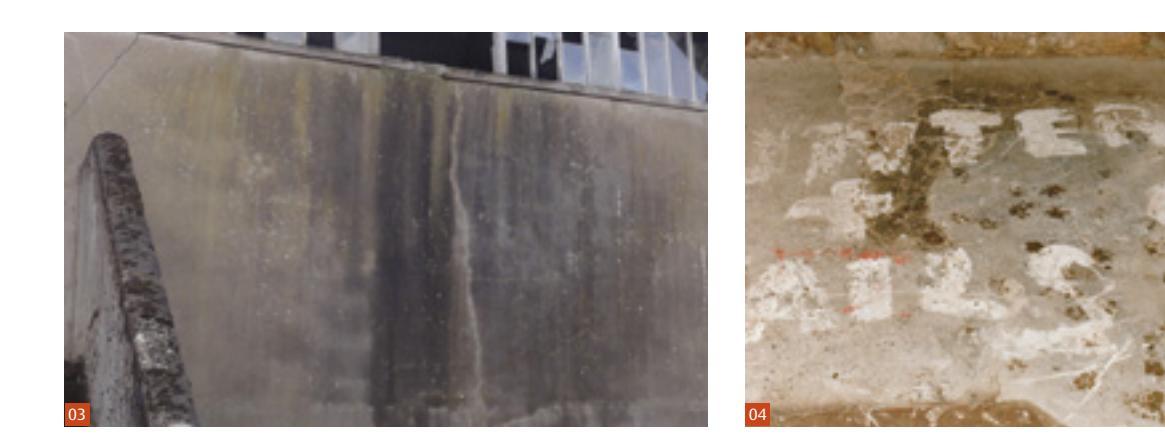
The algal growth shown in Fig. 3 is caused by water run-off due to a defective sill detail. There is no evidence of water damage or biological deterioration to the render, and it is not responsible for the shrinkage crack.

Fig. 3 The dark soiling is algal growth as a result of water run-off from a faulty sill and is unrelated to the shrinkage crack.

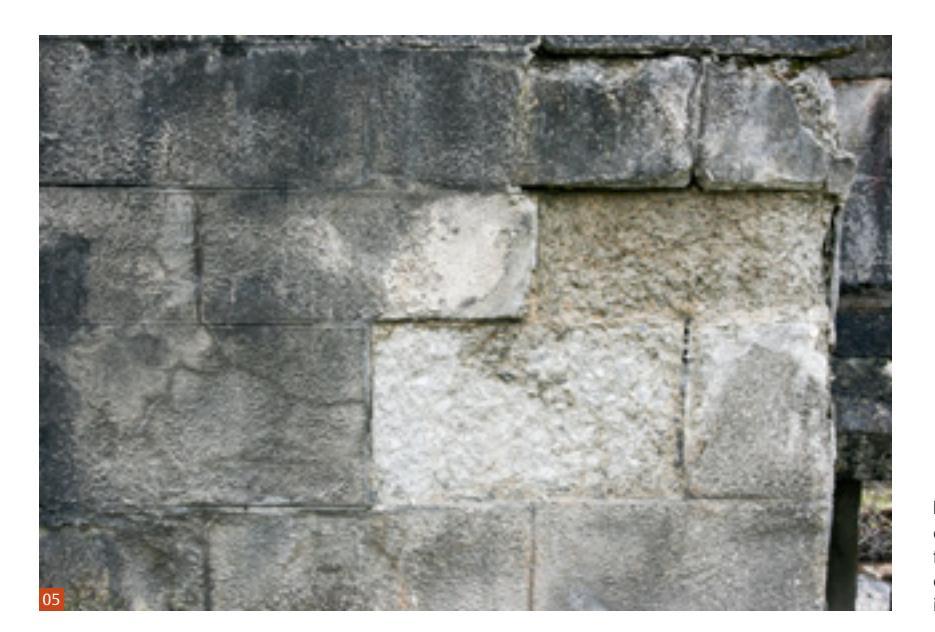
Fig. 5 Precast concrete blocks on a 1920s building suffering from delamination and severe deterioration due to salt impregnation (Category B-listed).

Efflorescence (surface salts) and cryptoflorescence (salt crystallisation within the pores) are the hydration and crystallisation of soluble salts in the presence of moisture (Fig. 5). They will only cease when the sources of moisture and/or salt have been eliminated. Sulfate or chloride contamination may occur from within the concrete itself or from external sources, such as de-icing salts, marine aerosols, ground water, soils or cleaning chemicals applied to the surface.

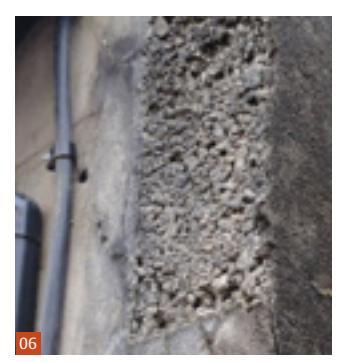
Fig. 6 Cement render coating applied to a no-fines concrete (c. 1880).

Most historic concrete buildings in Scotland appear to have flat cement-based render coatings, many of which are generally in good condition, except where cracking has taken place, usually as a result of shrinkage or embedded metal corrosion. Fig. 6 shows a cement render finish to early no-fines concrete. The rough texture and porous nature of this concrete substrate provides an excellent bond for the render. In this case, the thickness of the render is less than 10mm.

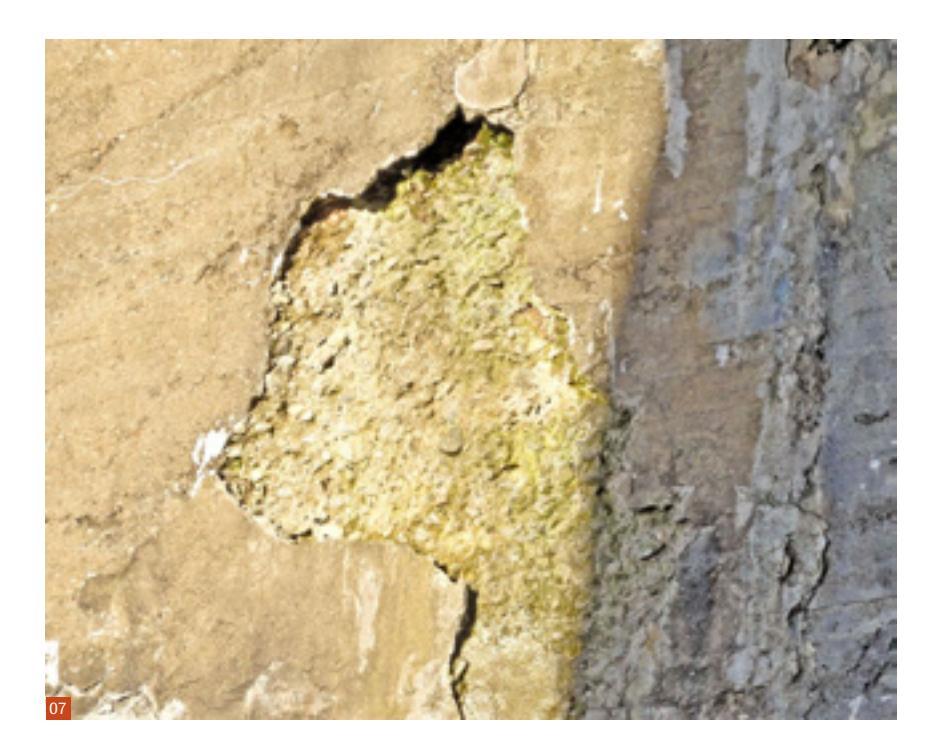
Fig. 7 Concrete deterioration as a result of water penetration through shrinkage cracks with subsequent freeze-thaw cycles causing surface disruption. A patch repair would be suitable in this case.

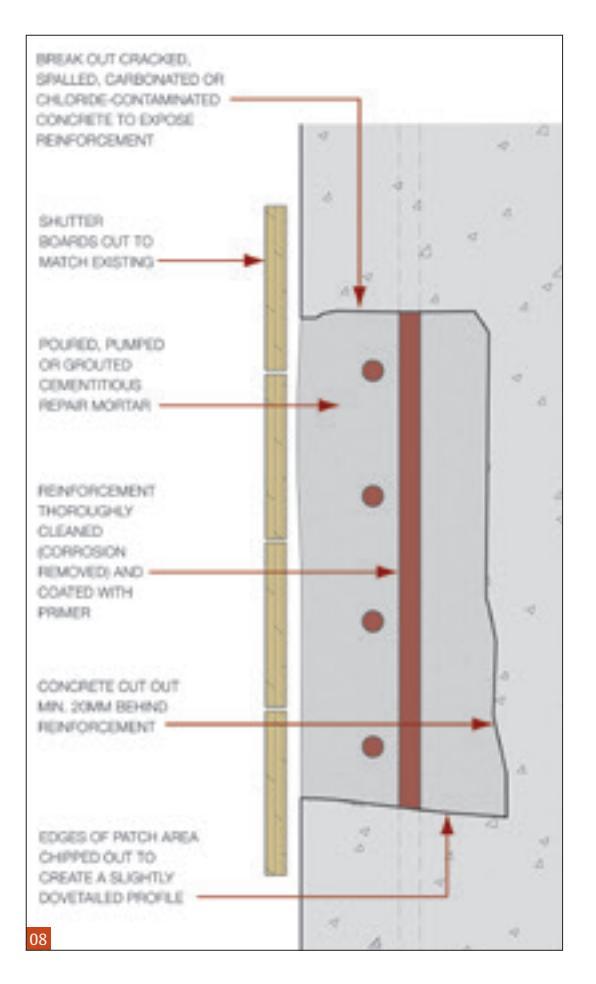
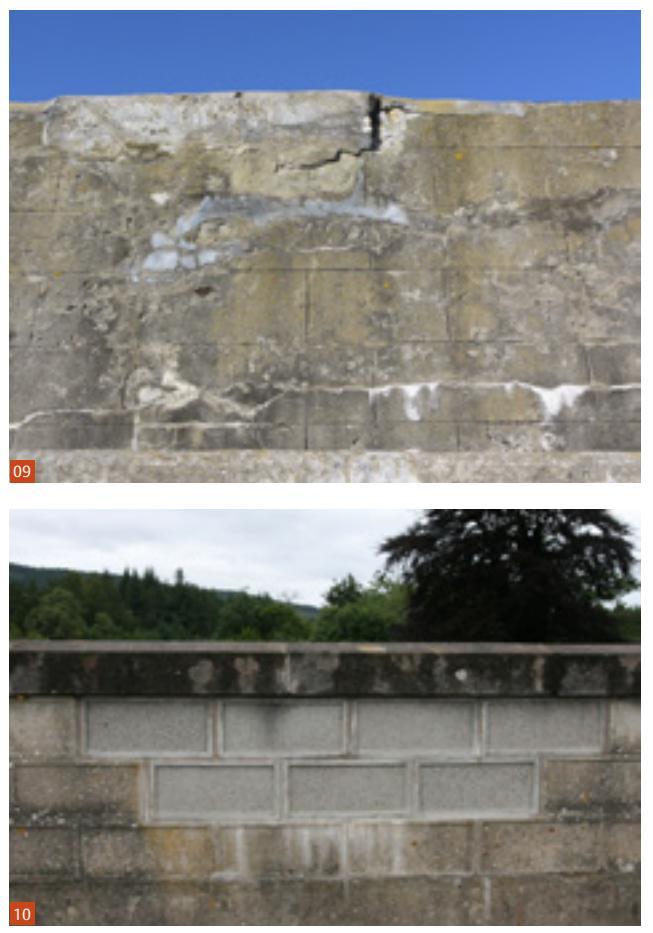
and replacement of concrete is illustrated in Fig. 8. Insufficiently detailed patch repairs can result in a poor appearance and continued decay (Fig. 9). Structural implications should be considered before carrying out any patch repairs.

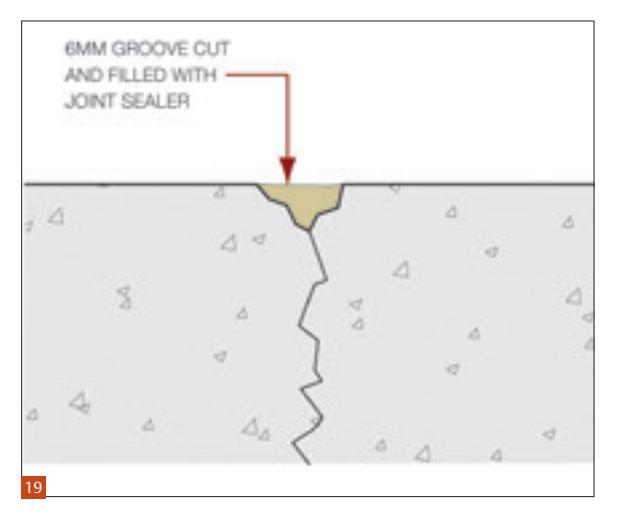
Fig. 19 Repair of cracks by routing and sealing.

Routing and sealing can be used to treat narrow and wide cracks where structural repair is not necessary. It is most suitable for flat horizontal surface cracking. The crack is widened by cutting a vertical groove of approximately 6 to 25mm depth along the surface of the crack (routing); then a sealant is placed into the clean, dry groove (Fig. 19). Typical sealants include epoxies, urethanes, silicones, polysulfides, asphaltic materials or polymer mortars. Cement grouts in this type of application should be avoided as they can have a tendency to cause further cracking. Active cracks should be repaired using a bond breaker at the base of the routed channel and a flexible sealant then placed in the channel (Fig. 20). The width of the channel is usually at least twice the depth, which permits the sealant to respond to movement of the crack. This method is quite simple compared to epoxy injection.

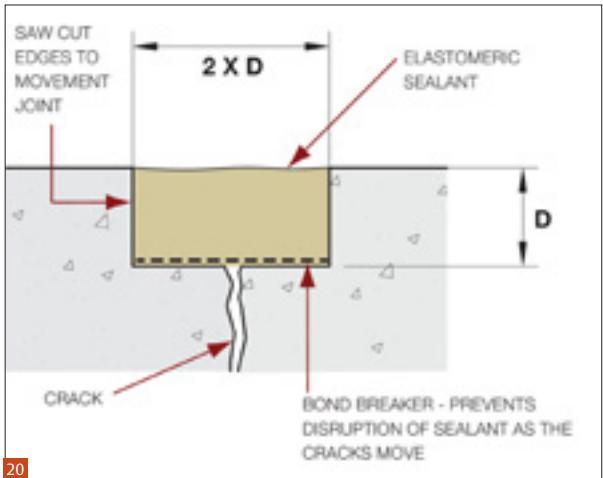
Fig. 20 Repair of active crack with bond breaker.

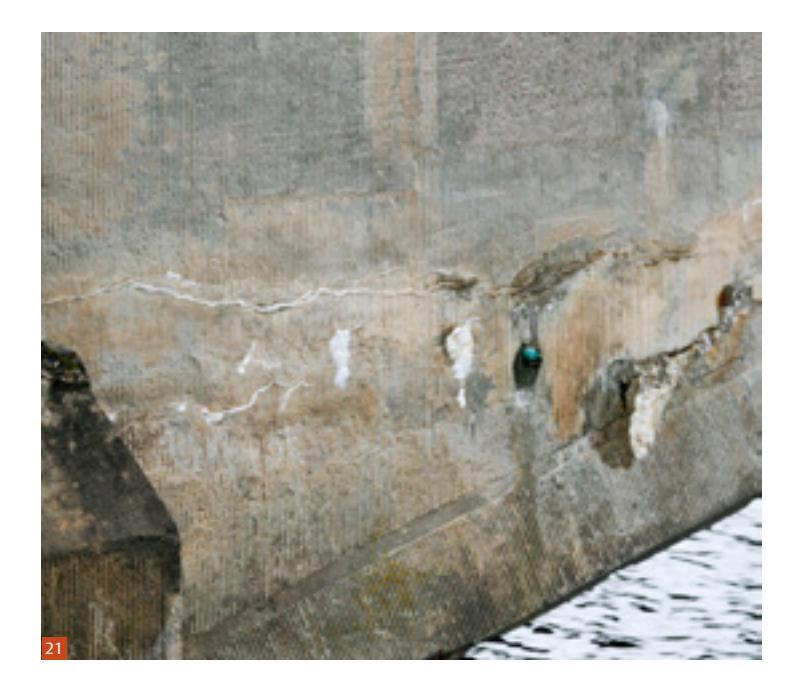
Fig. 21 Chemical grouting of cracks in a reinforced concrete bridge. Note the indication that moisture is still present within the concrete. cut to provide a slot about 25mm wide and 25mm deep, undercut at the base so that the base width is slightly wider than the surface width. The slot is cleaned and dried, and a cement-slurry bonding coat, i.e. cement and fine sand paste, or appropriate latex bonding compound is applied. Then a dry pack mortar is applied immediately which consists of one part cement to three parts suitable sand plus just enough water so that the mortar will stick together when moulded into a ball. The mortar should stand for around 30 minutes before placing to allow for shrinkage. Each layer should be compacted in 10mm thicknesses, the surface scratched before application of the next layer. In order to provide a colour match with surrounding concrete, ordinary cement may be blended with white cement if appropriate.

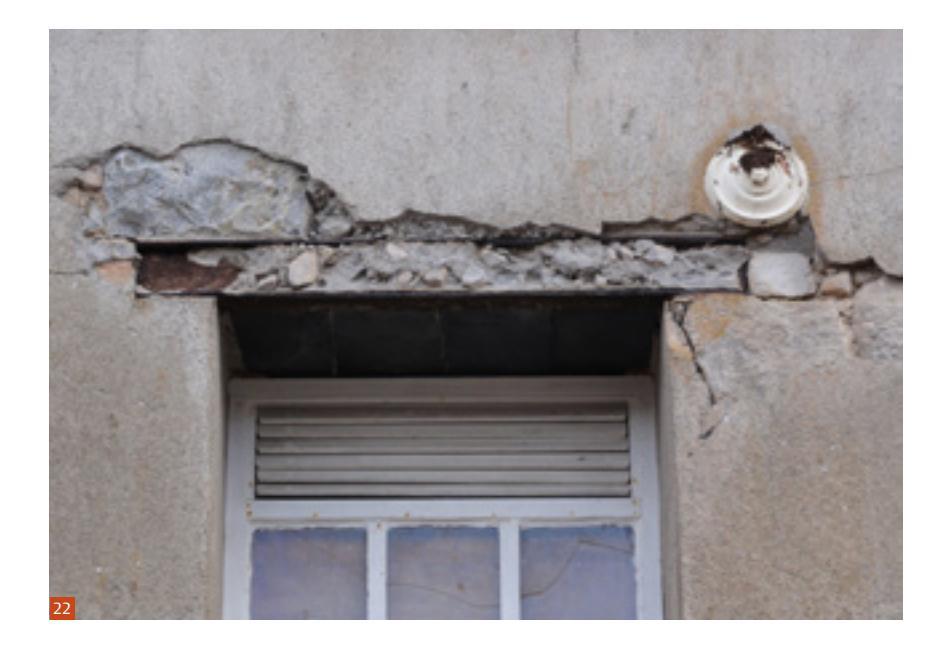
Fig. 22 Disruption to concrete from corroding and delaminating wrought iron lintel (c. 1870s).

In Scotland, there is a particular problem of corrosion of wrought iron or steel lintels over openings likely to be caused by direct water penetration through cracks, water percolation through no-fines concrete or surface condensation (Fig. 22). It is difficult to identify sound steel from wrought iron by visual inspection alone. However, the forms of corrosion are different. Wrought iron, when badly corroded, delaminates at the edges, while steel rusts on the surface and does not delaminate.

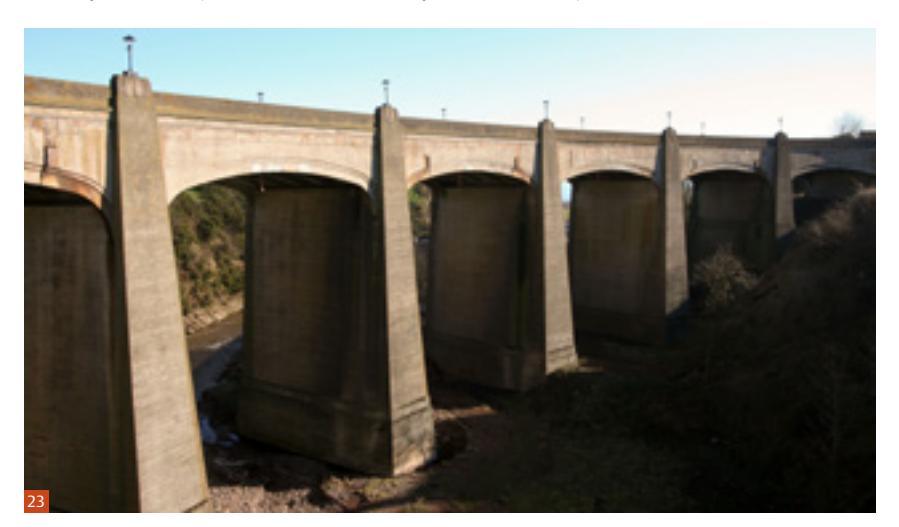
Fig. 23 Reinforced concrete Bervie Jubilee Bridge, Aberdeenshire, built 1935. Impressed-current cathode protection system used to protect the bottom section of the main supporting beams.

- 2) The *impressed-current cathodic protection system* is the most effective means of mitigating steel corrosion but is costly to install, is a permanent feature and requires continuing monitoring and maintenance. There are a number of proprietary systems available which typically work by distributing sufficient electrical current from a direct current supply to overcome continued corrosion in the structure. In some systems, small-diameter anodes are inserted into pre-drilled holes not more than 600mm apart, and a saw cut, approximately 10mm deep and 8mm wide, is made into the concrete between the holes. The anodes are then connected by a titanium wire grouted into the slots. It is difficult to install such a system without damaging the surface of the historic concrete. The system was used to protect the heavily chloride-contaminated bottom section of the main supporting beams during the refurbishment of the Bervie Jubilee Bridge, Aberdeenshire (Fig. 23) where over 8,500 discrete anodes were installed and connected to a remote monitoring system.

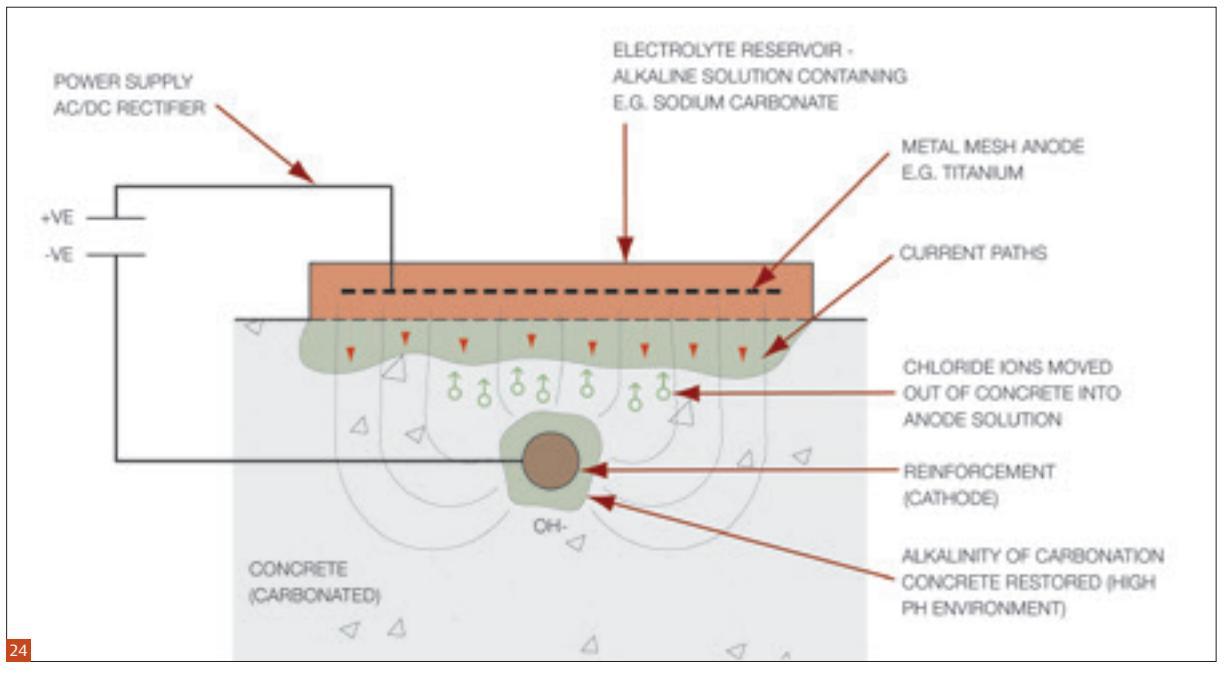
Fig. 24 Diagram illustrating chloride extraction and re-alkalisation processes.

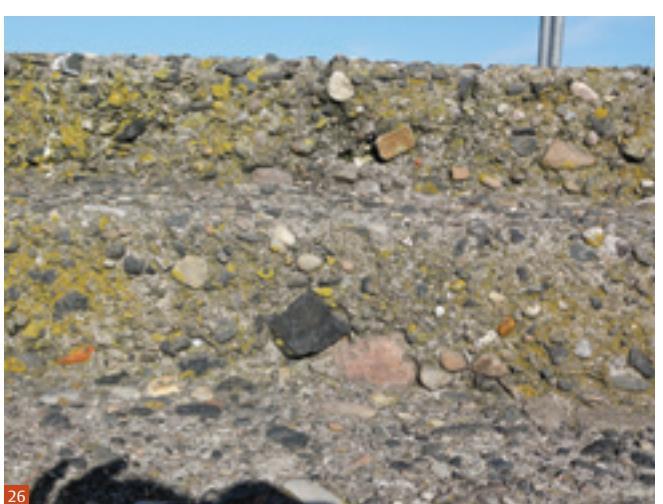
Fig. 26 Weathered steps on harbour wall. The cement matrix forming the surface has been eroded to expose the aggregate.
