HISTORIC
ENVIRONMENT
SCOTLAND

Property in Care (PIC) ID: PIC288

STATEMENT OF SIGNIFICANCE

DUN CARLOWAY

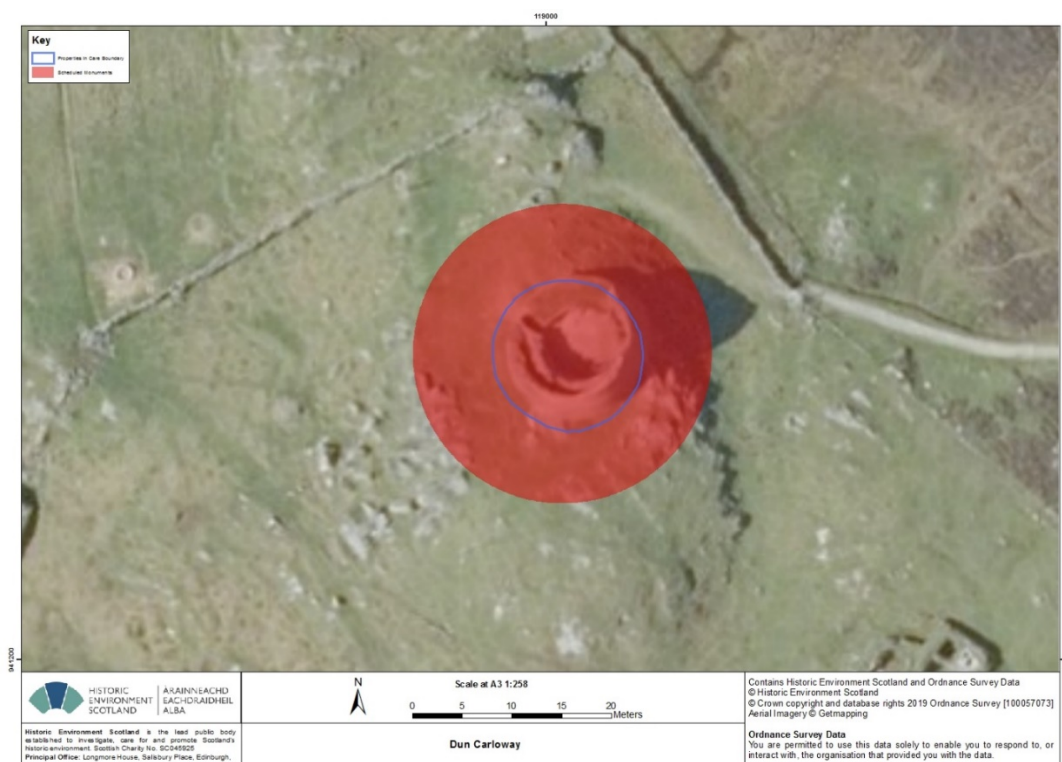
Scheduled area and Property in Care Boundary at Dun Carloway, for illustrative purposes only.

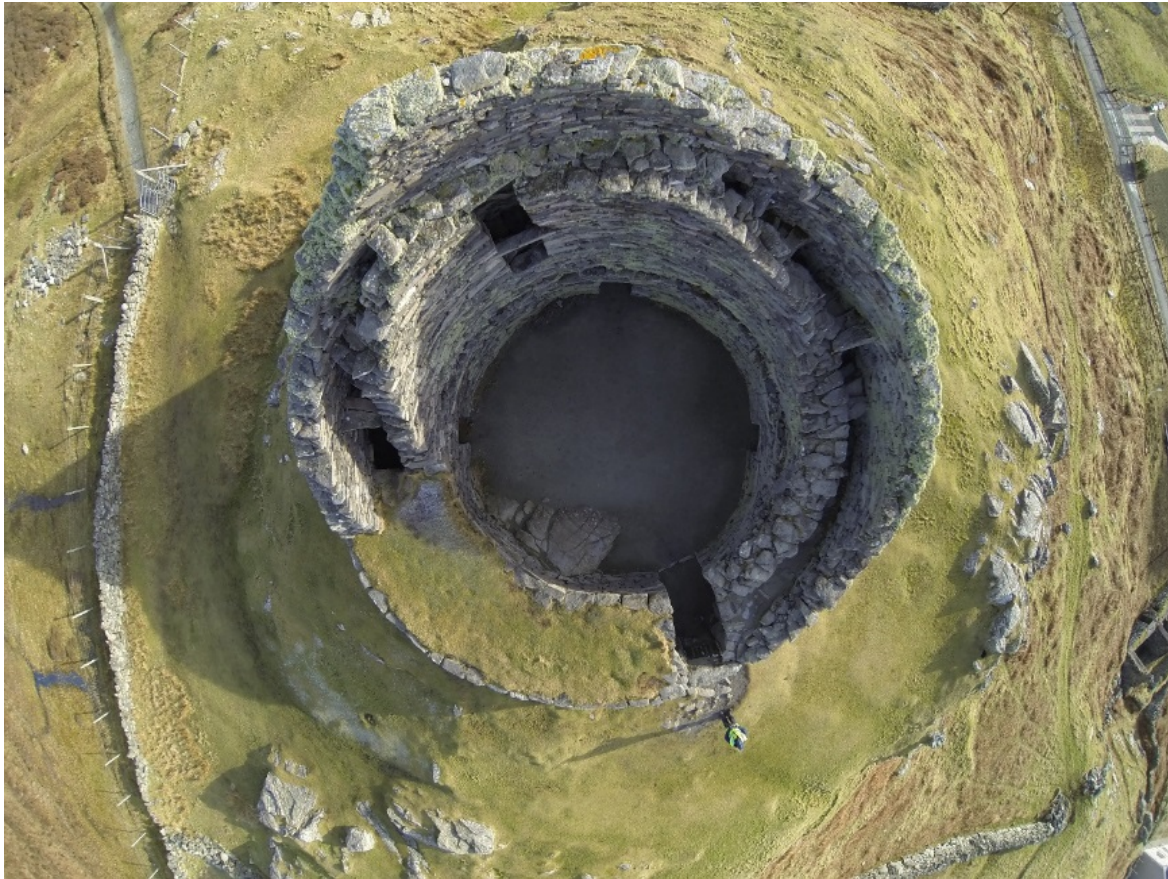
Dun Carloway close bear-vertical aerial view showing hollow wall construction.

Only the eastern portion of the broch's walls now stand above head-height, and the continuation of the internal stairway has been lost. Above the ground level, evidence survives for five continuous galleries within the thickness of the wall. Each gallery floor formed the ceiling of the gallery below, and is made of long slabs, which also serve to tie together the inner and outer skins of the wall. A vertical, elongated aperture in the internal wall-face, spanned by lintels, would have allowed light and air into the galleries.

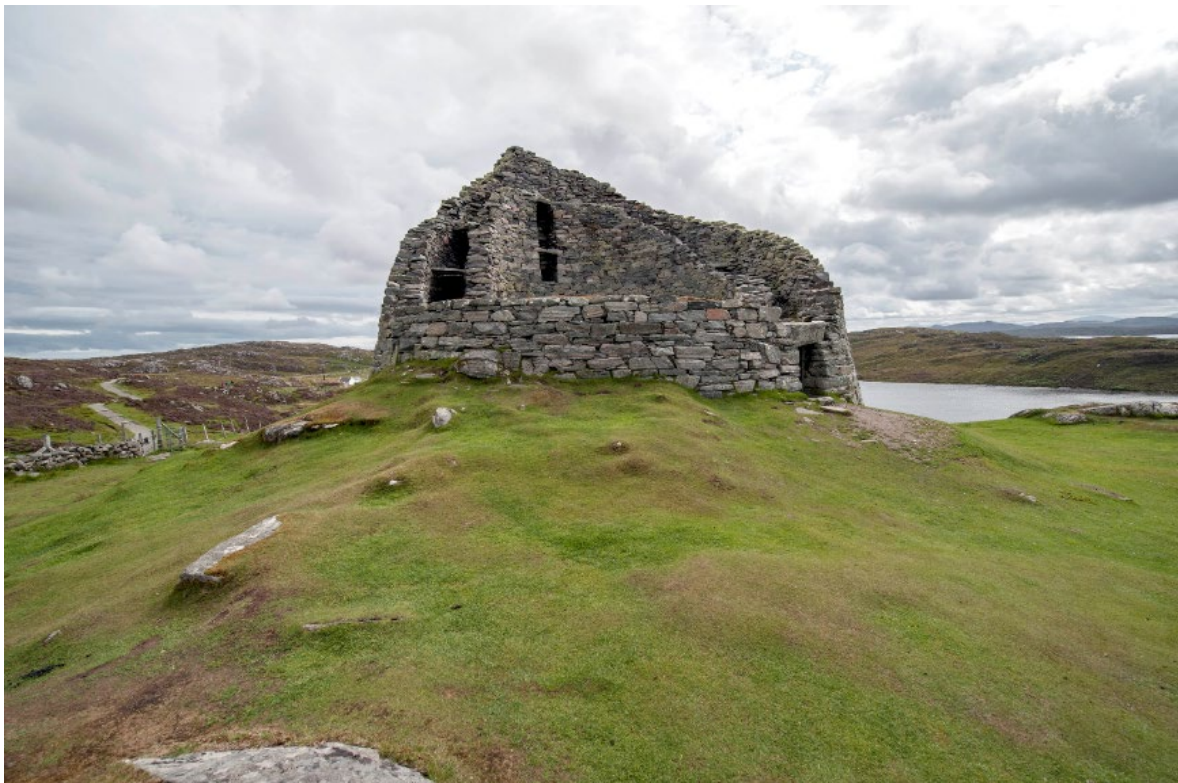
Dun Carloway from the west side showing entrance and inner wall face.
