# INFORM THATCHED ROOFS

HISTORIC ENVIRONMENT SCOTLAND | ÀRAINNEACHD | EACHDRAIDHEIL | ALBA

### THATCHED ROOFS

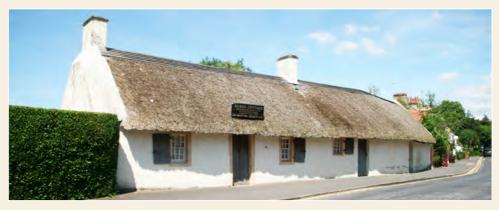
Fig. 3 Burns Cottage, Alloway, thatched in reed.

The first step when planning work is to identify the significance of the building element and what contributes to its special interest. With thatched roofs this is most often the thatching materials, the roof structure beneath, the style of thatching, and features such as fixing methods and chimney details. The building's setting and how it relates to other structures can also contribute to its significance. Any loss or alteration to an old thatched roof will normally have an impact on a building's significance. In a few cases thatched buildings may have a close historical association with people or events such as Burns Cottage in Alloway (Fig. 3) or Old Leanach Cottage in Culloden (Fig. 4), both cared for by the National Trust for Scotland.

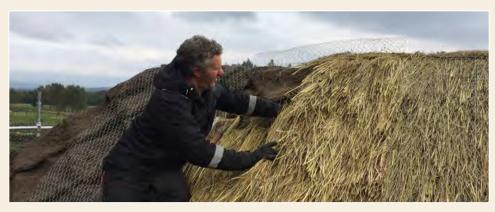
Fig. 6 Thatching a Hebridean blackhouse roof with turves under marram.

Thatched roofs typically have two layers. The base layer is formed to support the principal thatching material, prevent the thatch falling into the interior, and provide additional protection to the roof structure from water ingress. Depending on location. turves (laid grass-side down) were often used (Fig. 6) but other materials such as wattle or timber planks are also found. In Orkney, a system of straw or heather rope 'simmens' were made, and wound tightly over the roof structure to form a base for the thatching materials. The base layer is usually the oldest part of a thatched roof and can contain evidence of the building's development. It should be retained during re-thatching, but where it is disturbed there is an opportunity for recording and analysis.
