# INFORM

INFORMATION FOR HISTORIC BUILDING OWNERS

## Masonry Decay

Dealing with  
the Erosion  
of Sandstone

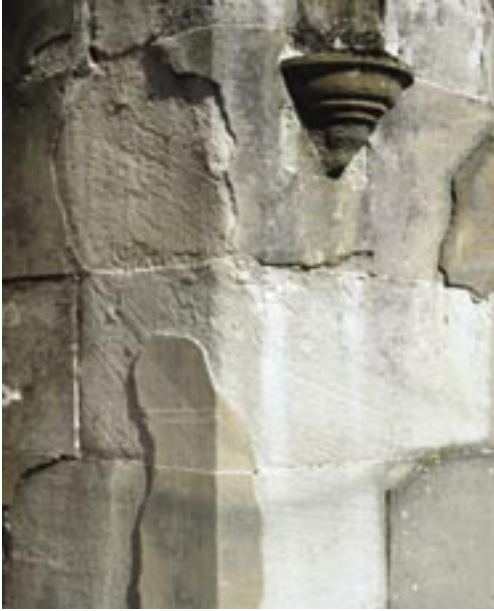
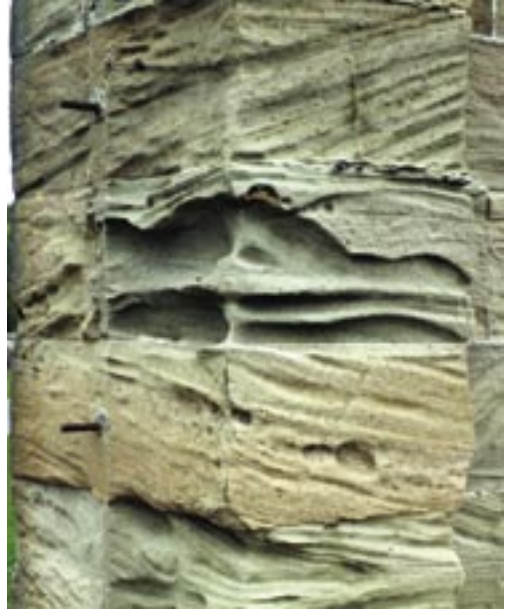
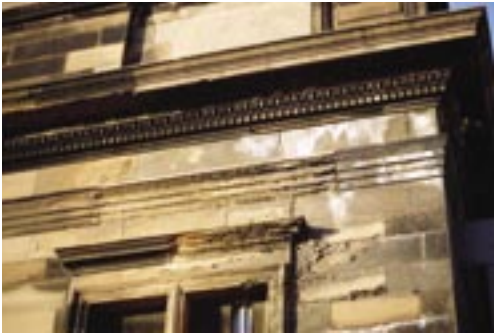
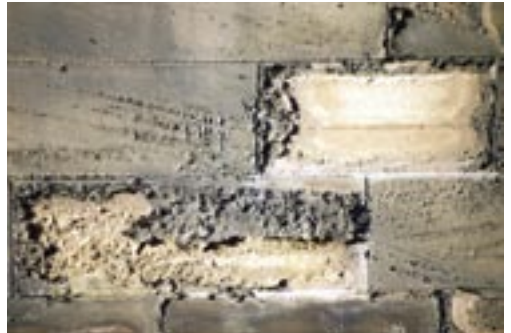
Stone decay manifests itself in many ways. This can lead to different appearances such as:

- A powdery surface of loose grains
- A separating skin (of different thicknesses)
- Penetrating holes, creating a honeycomb effect
- Open fractures crossing stones on unusual angles, or in a “starburst” effect
- Severe partial destruction of individual stones
- A white build-up of salt material on the surface
- Partial failure of projecting mouldings and carvings
- Blistered bubbles
- Deterioration of individual stones leaving the surrounding mortar standing proud
- A general blurring and loss of sharpness
- Tidemarks, water stains, and discolorations
- Wear patterns.

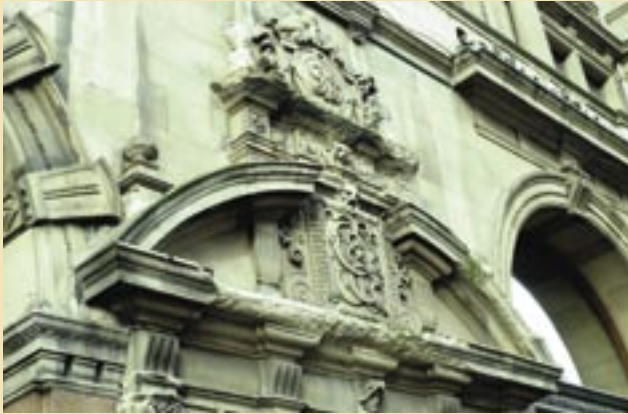
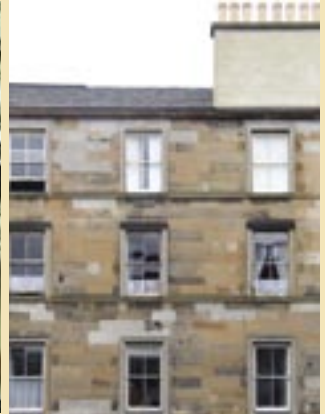
The stone cleaning problem has been compounded by the adoption of "plastic repairs" as an inappropriate maintenance technique. Here, a variety of synthetic mixtures have been spread onto the face of badly damaged stones in the misguided belief that they would improve the appearance and performance of the building. Over time the

use of these impervious “plastic” materials inevitably trapped water behind the patch. This has frequently led to the two materials failing where they were originally fixed together, and a number of incidents where the applied repair has subsequently fallen off the wall face, creating additional safety concerns. The applications of such synthetic materials are best avoided.

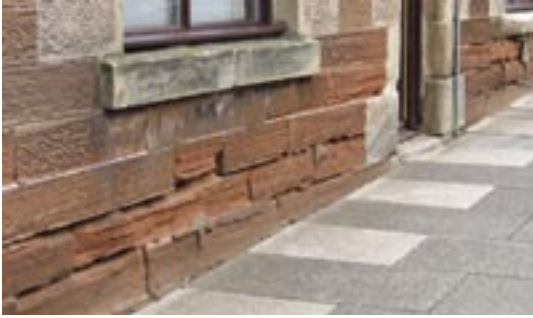
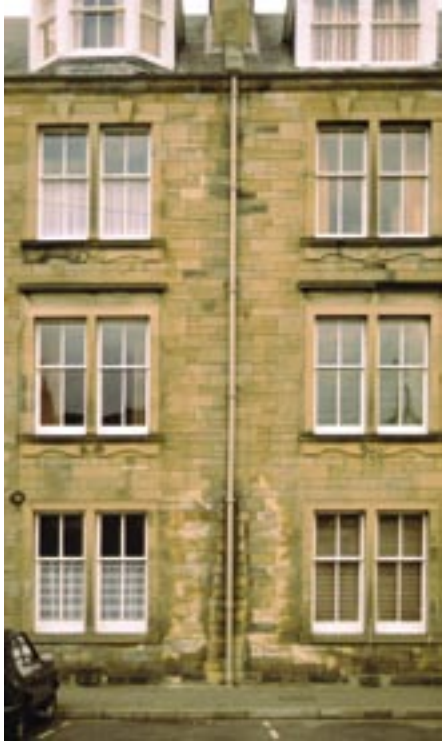
Many stone decay problems begin with the failure to maintain buildings. Splits in lead-lined parapet gutters, missing flashings, fractures in cast iron gutters and down pipes, and failed underground drainage can all lead to high volumes of water being concentrated into adjacent stonework to induce decay. It is best to avoid this risk by carrying out frequent maintenance checks, and remedying any faults or failures as soon as they are discovered. All flashings and rainwater goods should be kept in a fully functional condition, and repairs carried out as problems are identified.

Open joints between individual stones blocks should be re-pointed with an appropriate lime-based mortar. If they are left open for long periods they will encourage biological activity which will progressively encourage moss, grasses, small bushes and saplings to become established in the voids. It is best to avoid any surface growth from becoming established in the first place.
