Property in Care (PIC) ID:	PIC067
Designations:	Scheduled Monument (SM90139)
Taken into State care:	1927 (Guardianship)
Last Reviewed:	2004

STATEMENT OF SIGNIFICANCE

EILEAN MÒR

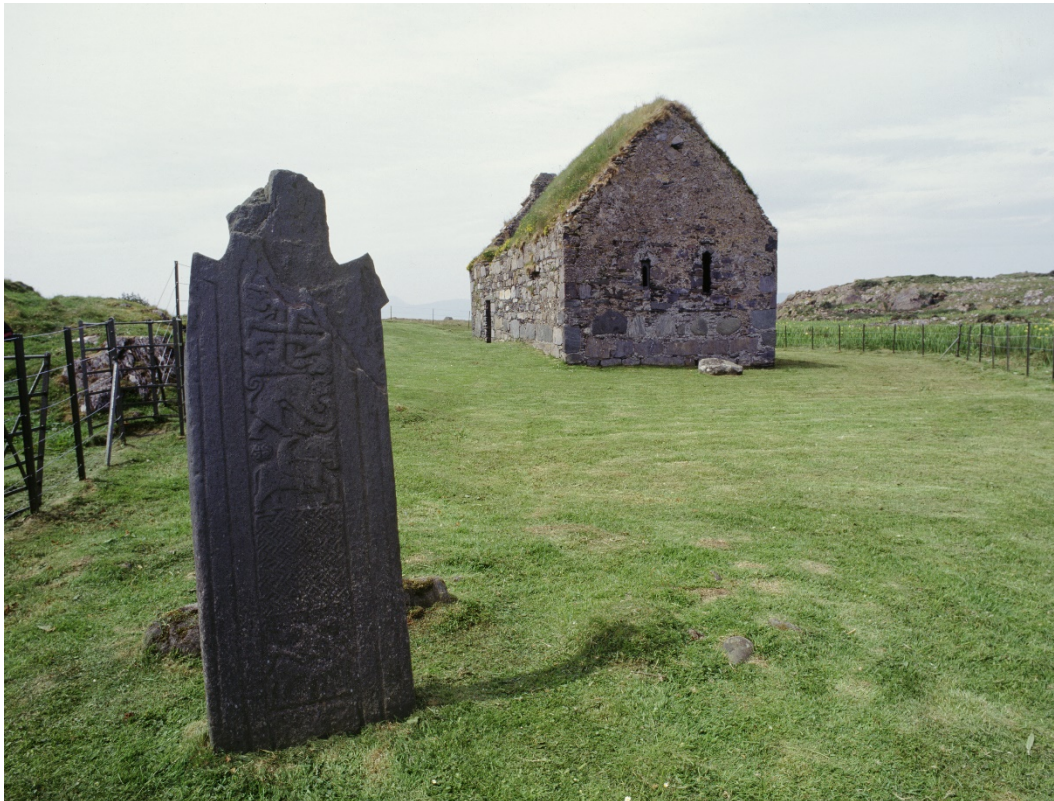
Cover image: View of 10th century cross shaft at St Cormac's Chapel on Eilean Mòr. © Crown Copyright HES.

Standing near the chapel is St Cormac's Cross, a ringed free-standing cross believed to be of 10th century date. Only the shaft and lower part of the cross-head survives, and much of the decoration on the west face is damaged. Decoration on the east face shows a pair of wrestling beak-faced monsters, a panel of key pattern, followed by three motifs that appear to lack any form of vertical demarcation. The lowest figure is a hooded rider, although the horse seems out of proportion for the small rider. Above is a large monster with a curled tail. The creature grips what appears to be a tapering snake in its maw. Both its tail and a curved crest are attached to the third motif, an interlaced group of four fantastic beasts above. The west face is bordered by broad bands of knotwork extending to the stumps of the ring, but little other decoration can be seen due to the damage mentioned above.
