### SOFT CAPPING IN SCOTLAND

The context and potential of using plants to protect masonry

> Volume 2 Case Studies

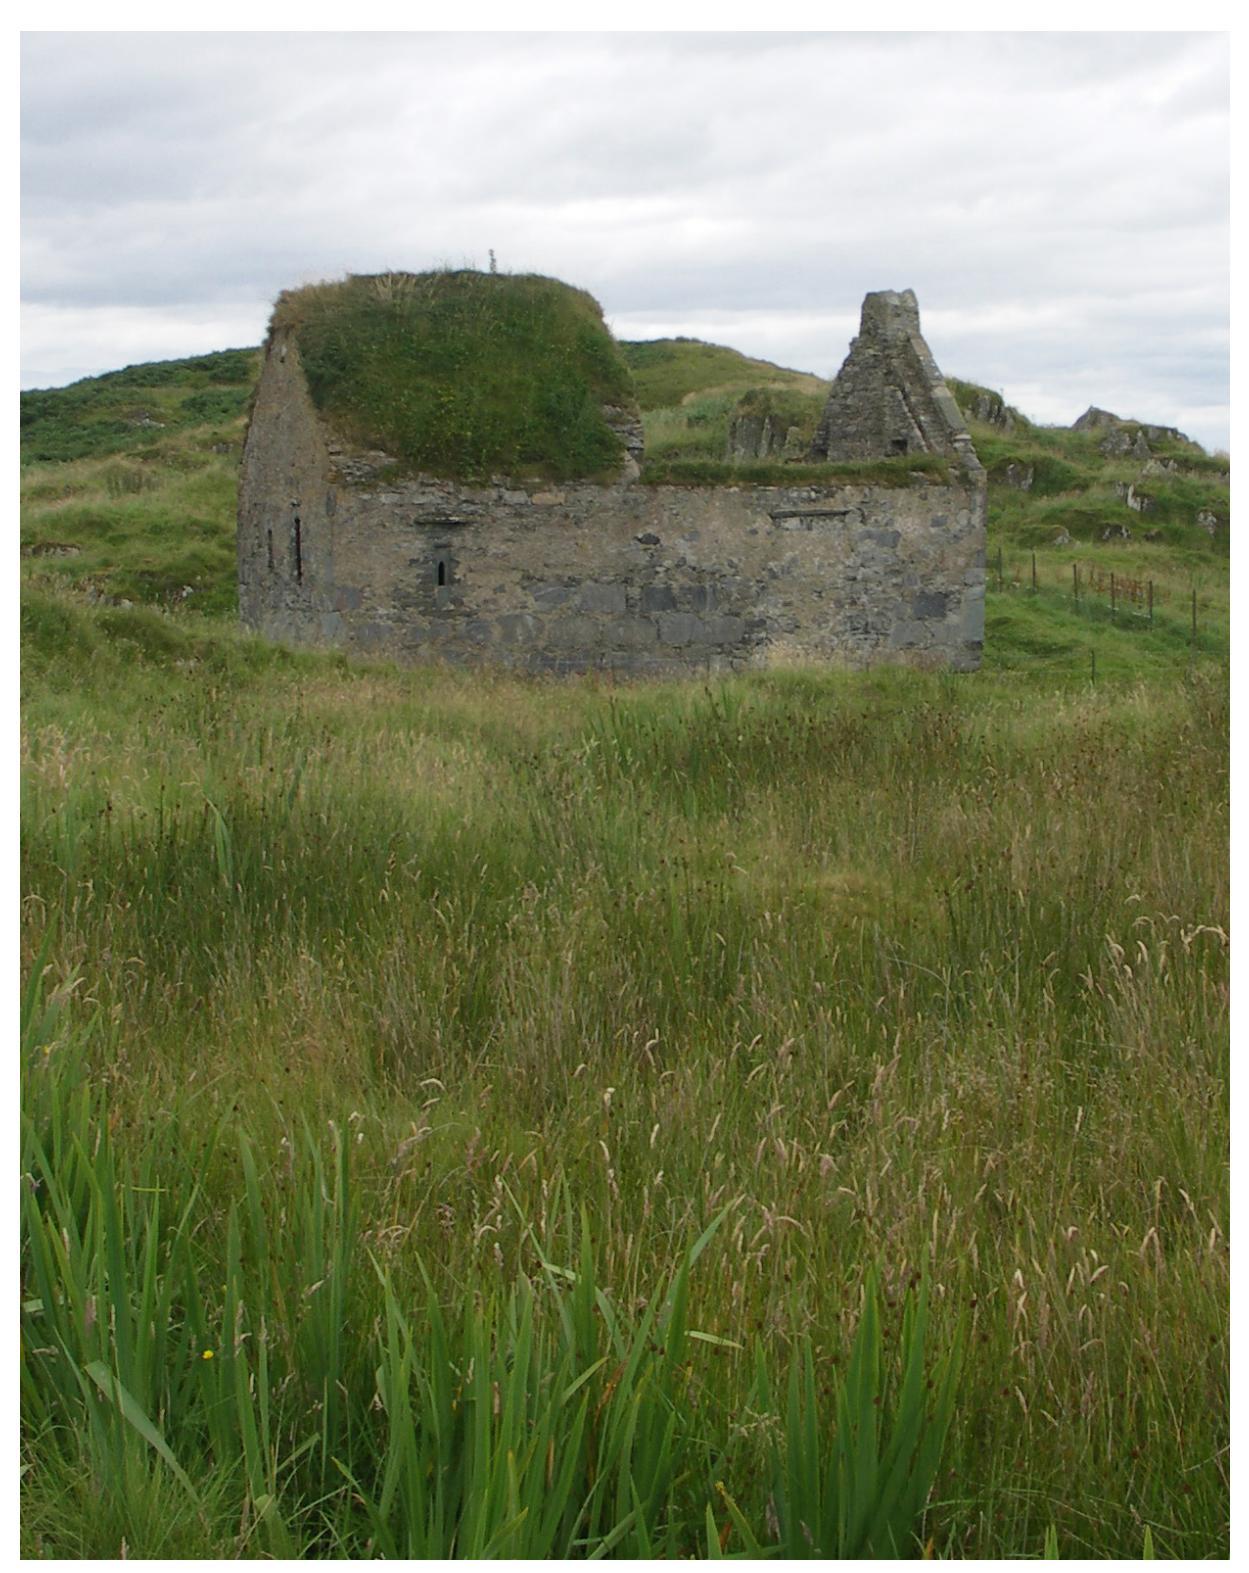
Fig. 1.1: St. Cormac's Chapel from the north, with sheltering hill behind.

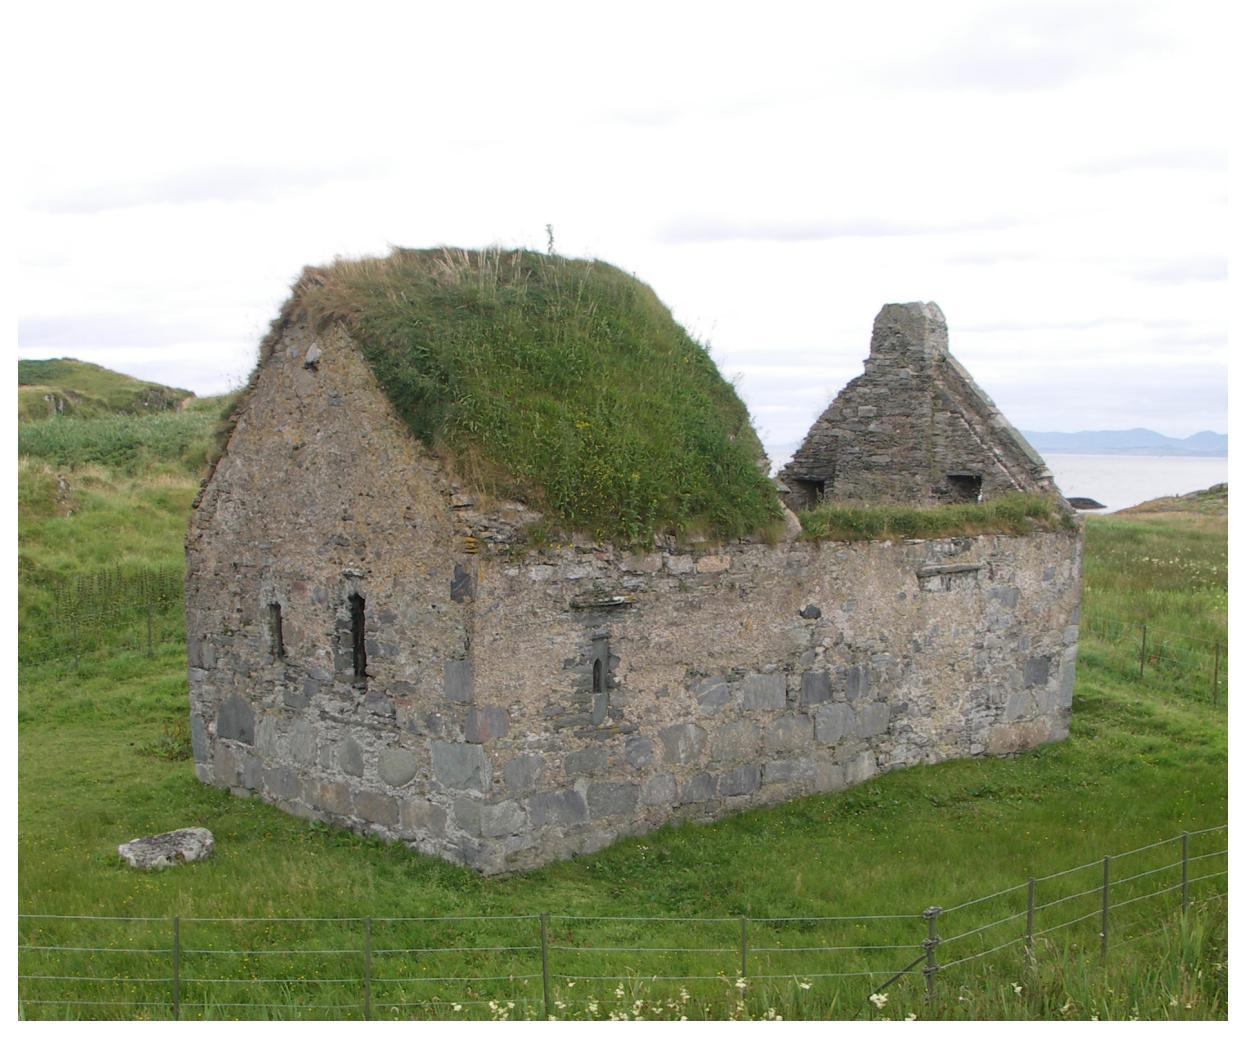
Fig. 1.2: North-east view, shelter indicated by surviving render.

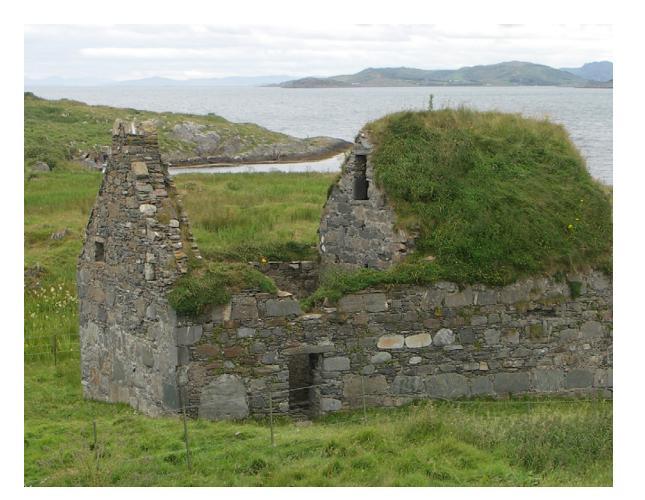
Fig. 1.3: South-west view, exposure indicated by loss of render.

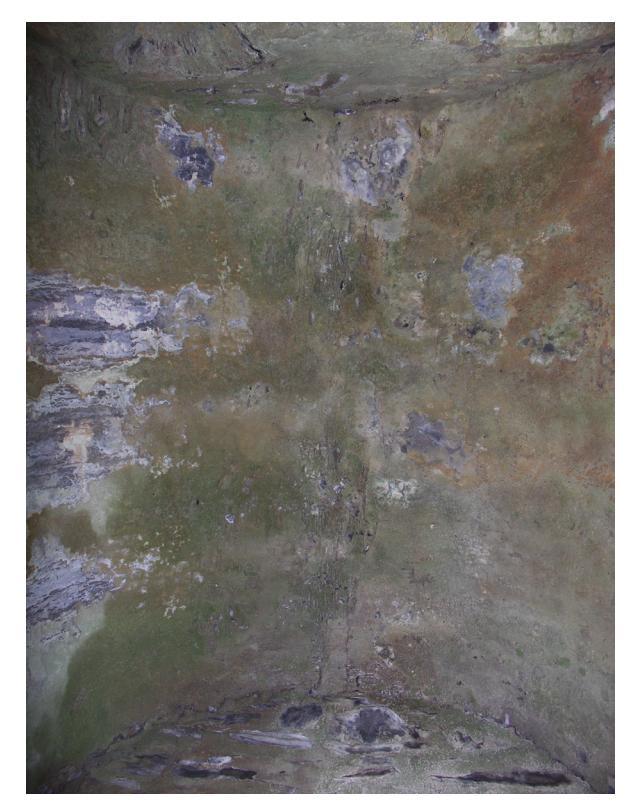
Fig. 1.5: The vault interior.

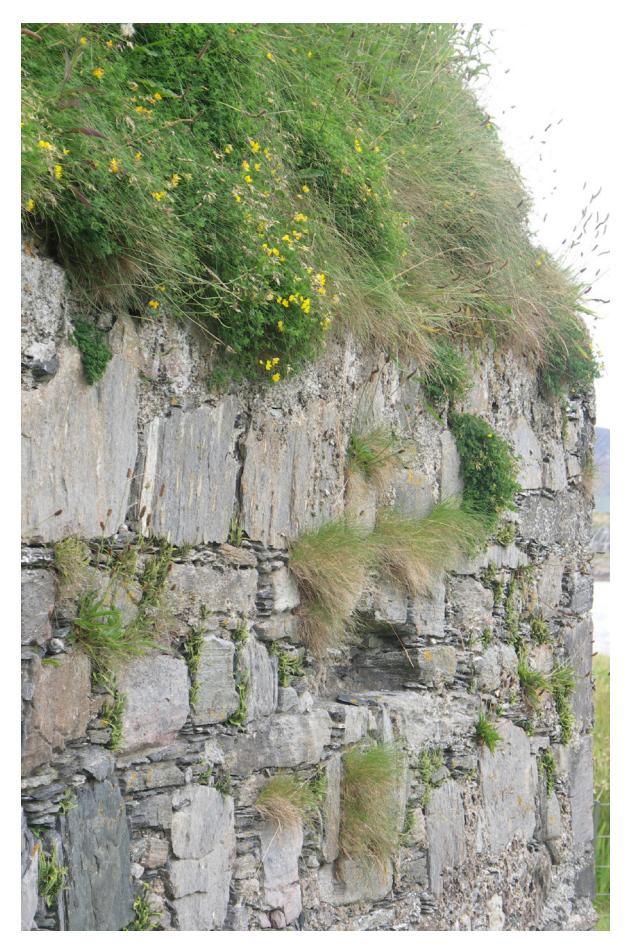
*Fig. 1.9: Edge overhang and colonisation of the south wall.*

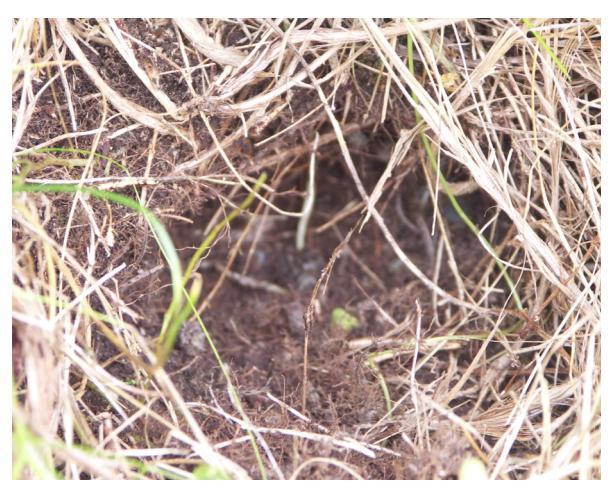
Fig. 1.6: Dense root mat and thin soil.

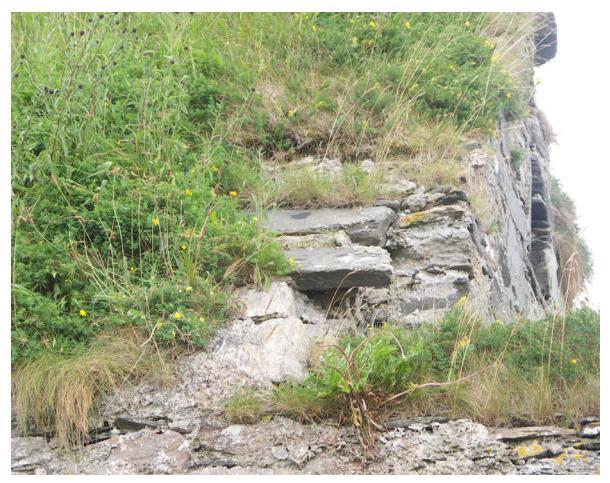
On the north side, vegetation overhung the north eaves by 0–50mm and the exposed areas of masonry at the corners were larger, approx. 1m x 1m in the north-east and 0.4m x 1m in the north-west (Fig. 1.8).						
		The vegetation at the rid vertical grading of speci Seen from the east, the v thinner at the ridge and o	ges was less lush thes, with more grass regetation clearly dieaves and thickest i	aan that further down and there app es higher up and more wildflowers isplayed a convex curve over the m n the middle (Fig. 1.10).	eared to be a lower down. asonry, being			
		There appears to be som	e blue-green algae	in the vault passage, but no signific	ant vegetation.

Fig. 1.8: Colonisation pioneered along joints, but the corners remain bare.

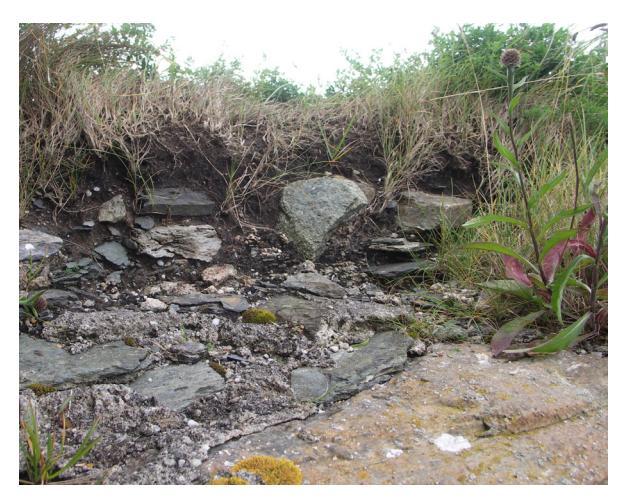
Fig. 1.12: Thicker soil layer mixes with the wallhead masonry.

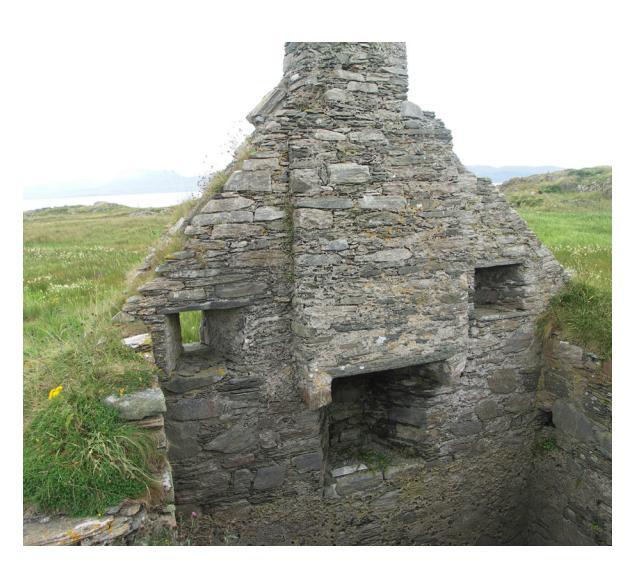
d) West Gable.						
		The south side of the gal grass in tufts up the wall On the north side, the sk adhering to the later inne	ble has skew putts, core and between ew stones are main er lining (Fig. 1.13)	but no skew stones in place. The ex the original inner face and the later ly in place and there is only some c	xposed wall has masonry lining. lead vegetation			
		The first floor chimney h plants.	nearth has one or tw	ro small shrubs, but the two window	v sills have no

Fig. 1.13: The west gable.

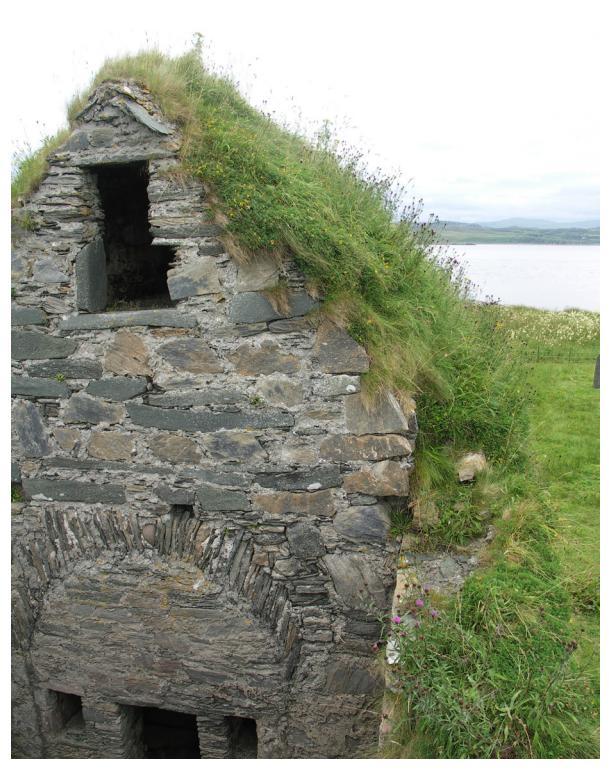
Fig. 1.11: Wind exposure on the 'sheltered' inside edge of the south wall.

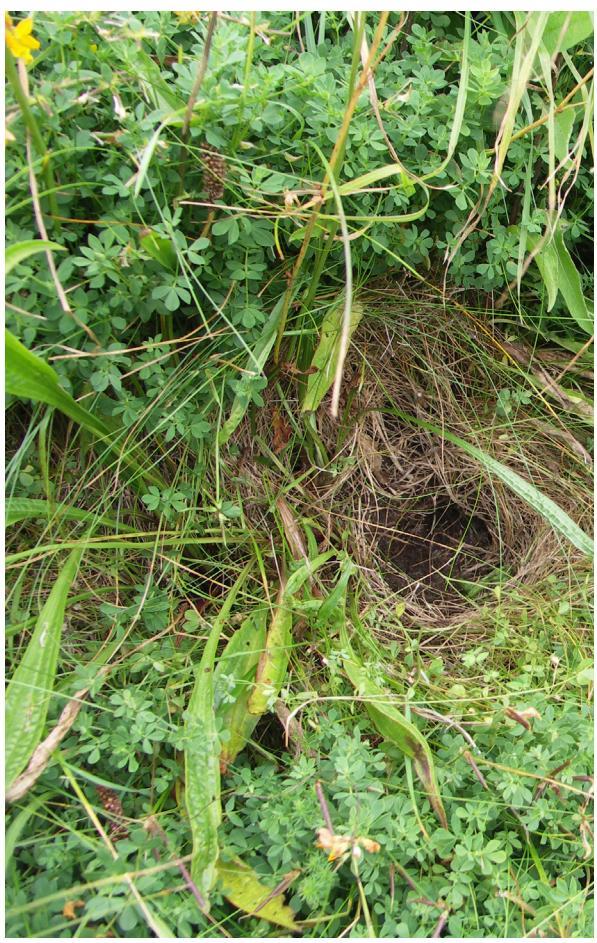
Fig 1.14: Bird's nest or burrow.

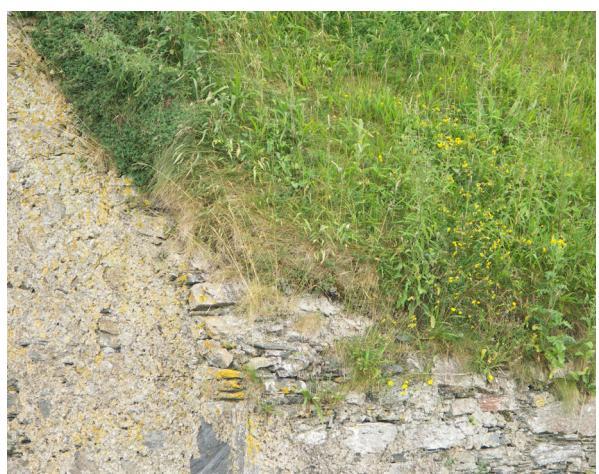
There are several small areas where vegetation has been unable to colonise, on the corners on the vault and on the wallheads, which are attributable to local focusing of the wind. The lack of plants on the narrow west gable demonstrates the importance of the shape and size of the vault roof to the establishment of vegetation.
		The mass of vault masonry will retain moisture in a way that the narrow gable cannot, sustaining the plants through periods of drought. Towards the top of the vault, where the masonry is thinner and more exposed to wind, the vegetation is thinner. That the flat wallheads have a good cover while the gable does not, indicates that the exposure of a narrow wall is not enough in itself to prevent vegetation, but that the addition of slope is sufficient.
		This capping has survived intact in no small part because of its remoteness to both visitors and maintenance teams. As such, it forms a model for similar monuments, of which there are many in Argyll with similar ecological, constructional and climatic situations. Comparisons can be made with Skipness Castle (CS35), St. Adrian's Chapel (CS36) and the Nunnery, Iona (SC28), where visitor numbers are much greater and 'maintenance' more easily effected. It can also be contrasted with the character of the natural cappings at Cessford Castle (SC2), which developed under quite different conditions.

Fig. 1.20: Wind exposure on the corners inhibits colonisation.

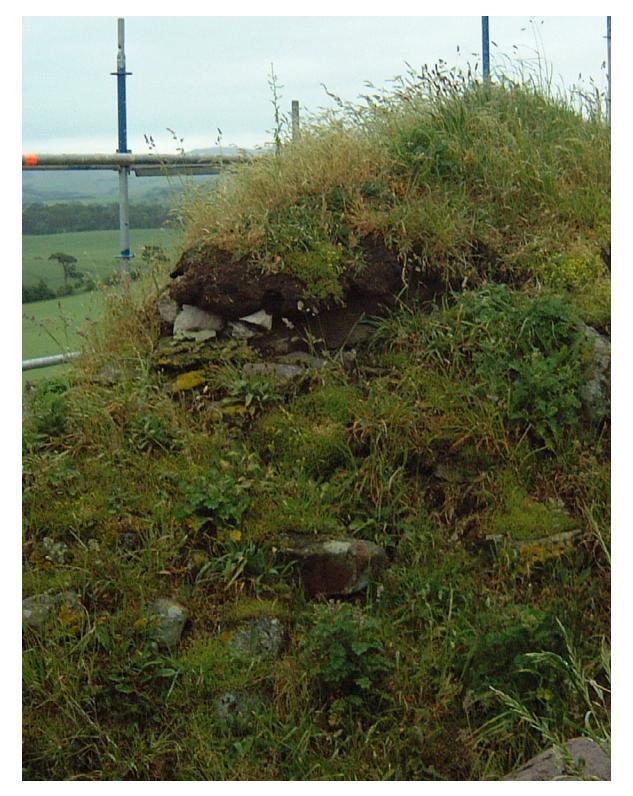
*Fig. 2.4: Thicker soils accumulate on the flatter areas, but not on significant slopes where core rubble remains exposed.*

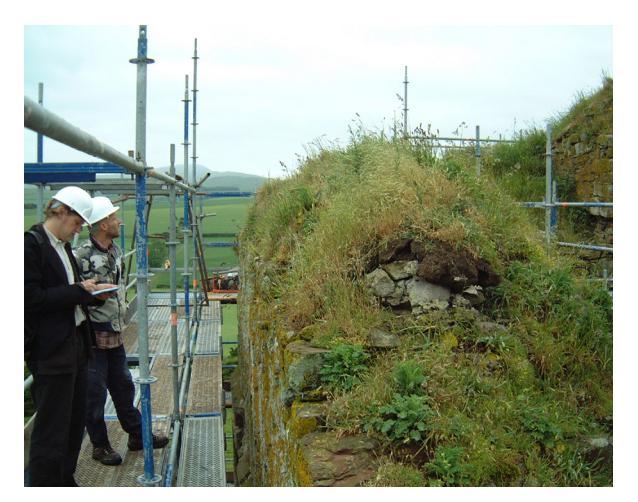
*Fig. 2.6: Where soil accumulates, the natural capping achieves a rounded profile, perhaps documenting the historic vulnerability of the edge stones to decay.*

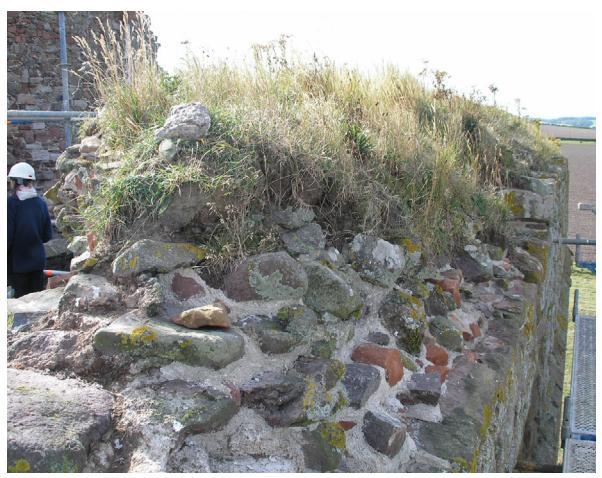
Fig. 2.7: Edge repairs leave the central capping untouched, but did not reinstate soft cappings removed to repair the edge masonry.

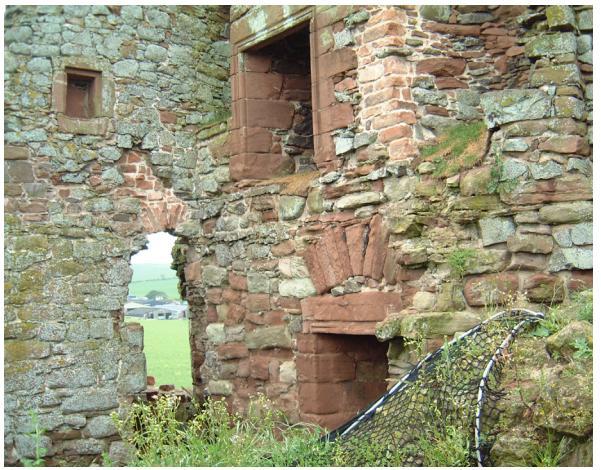
Fig. 2.9: New cappings initially died in sheltered, dry locations.

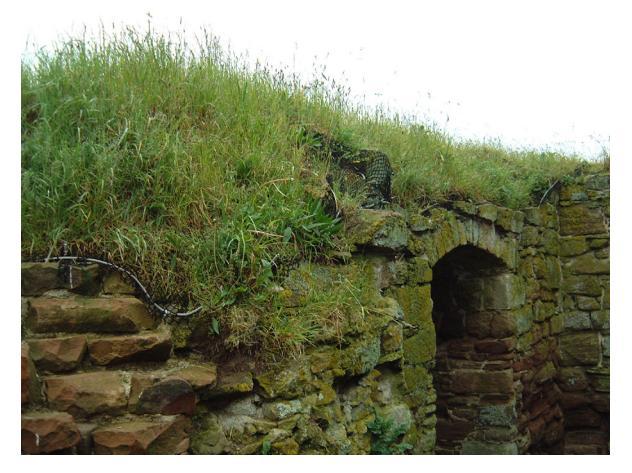
6.3	Effect of Birds:	The activities of birds may be affected by the polypropylene netting applied to the wallhead (Fig. 2.10), which has caused some bird deaths through entanglement in other cases, such a Black Castle (CS13).

*Fig. 2.10: Vegetation rapidly grew through the protective netting.*

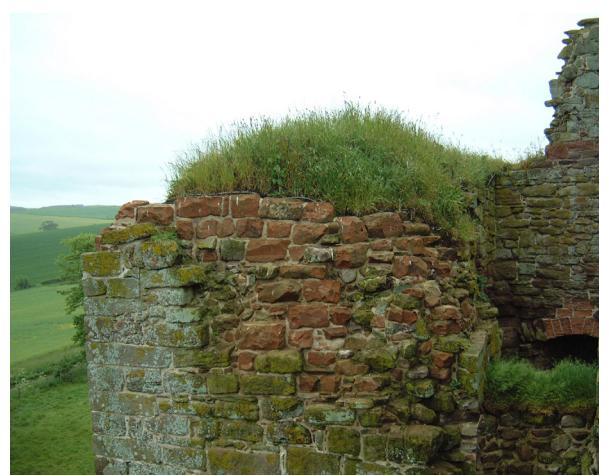
Fig. 2.11: The broad mass of a natural capping and, below right, a smaller section of new capping on a narrow wallhead, one year after works. The repaired edge masonry showing the stones natural red colour, without lichen and algae growth, indicates where natural soft cappings were removed to effect repairs.

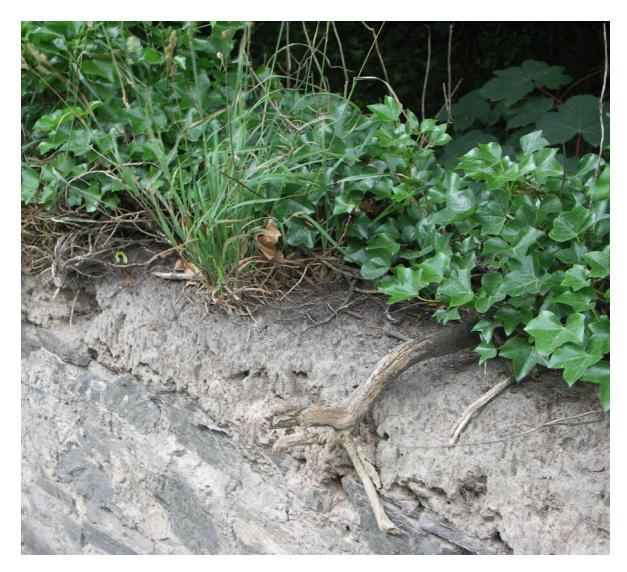
*Fig. 4.3: Wall 1, there is evidence of grass being killed by dense ivy growth, here resurgent after cutting back.*

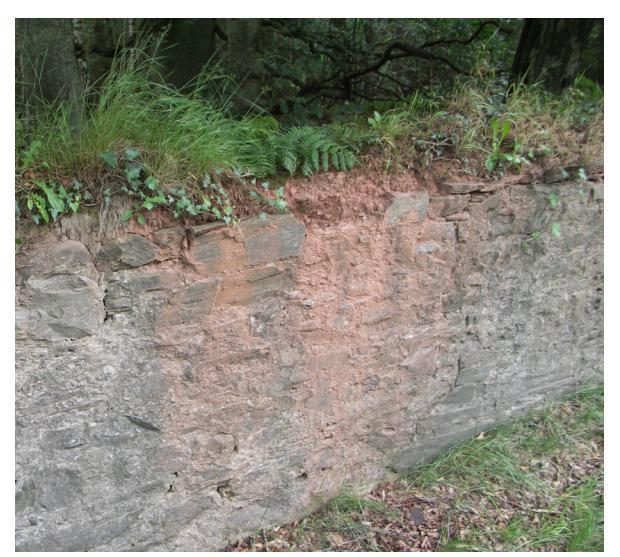
Fig. 4.4: Wall 1, where the clay soil type changes to red from grey, the soil is much more vulnerable to erosion.

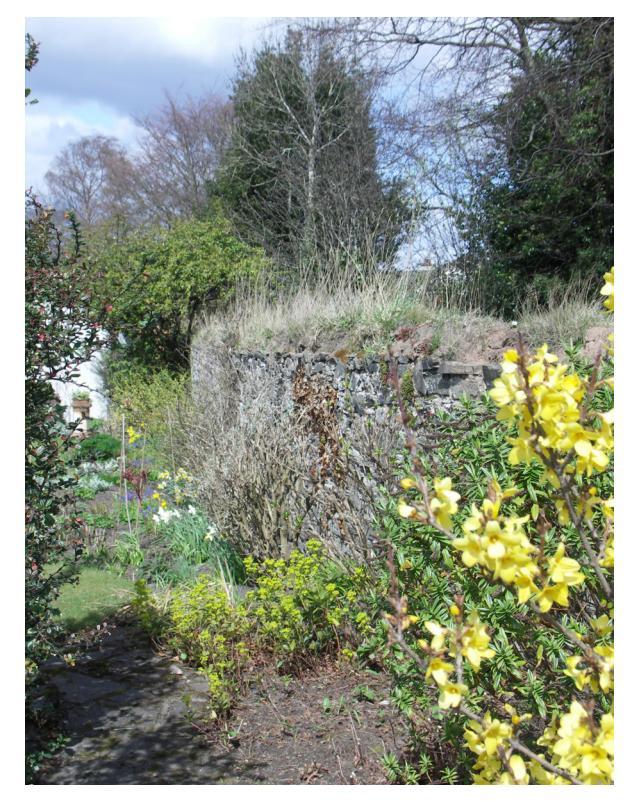
*Fig. 4.7: Wall 1, where the wall borders gardens, the caps are vulnerable to colonisation by exotic species.*

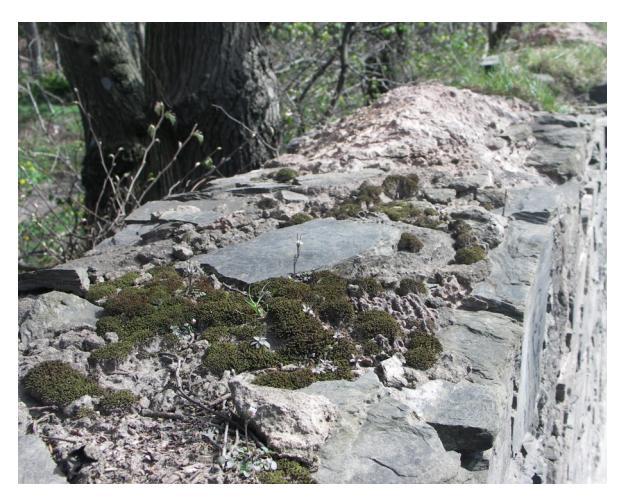
Fig. 4.6: Wall 1, there is some colonisation by mosses of dead areas, where no other species compete.

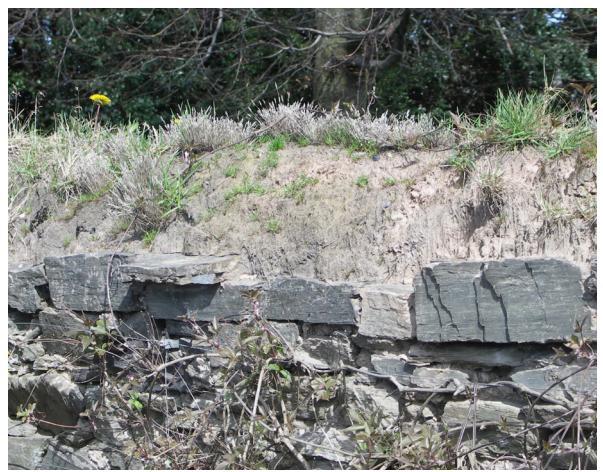
Fig. 4.8: Wall 1, High solar exposure and low rainfall seems linked to extensive grass dieback, though there is significant re-growth from seeds. Here the barest section may be associated with damage from the cut back clematis below.

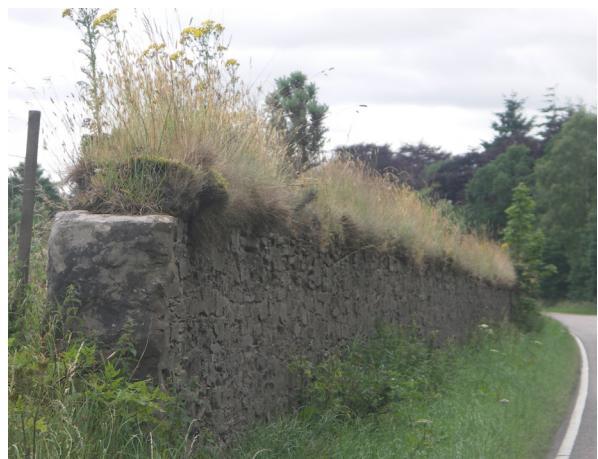
Fig. 4.9: Wall 2, general view. Although there are areas of high exposure, there is generally good plant cover and no bare areas comparable to the urban areas of Wall 1.

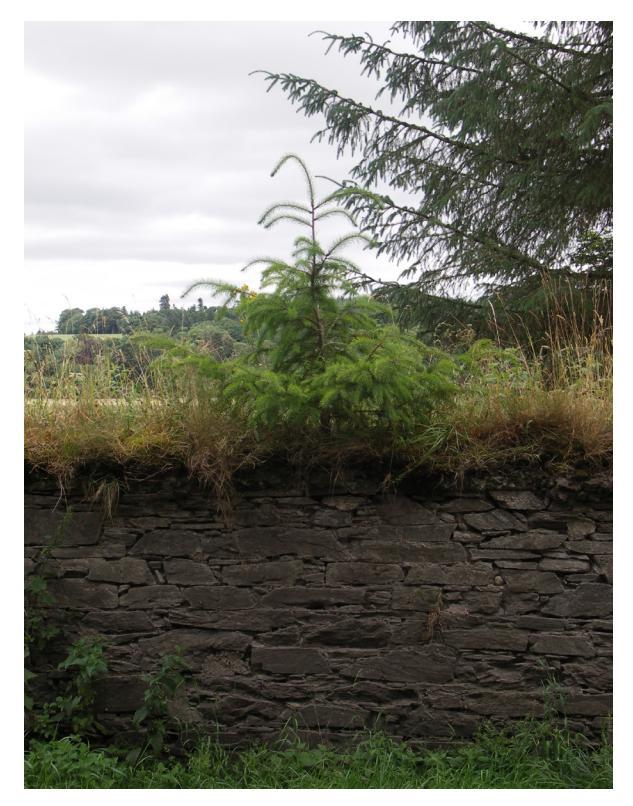
*Fig. 4.10: Wall 2, where trees are present to seed, but do not give dense cover, trees can colonise the capping.*

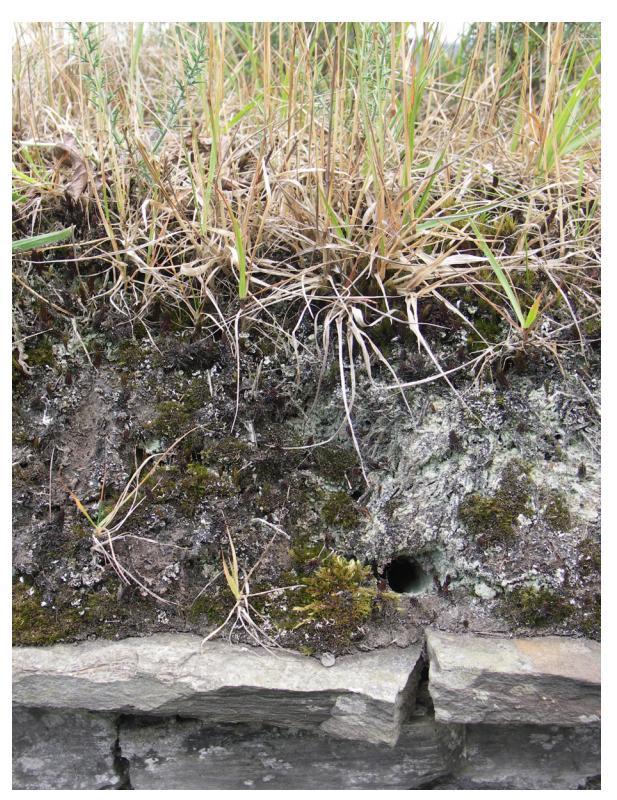
5.9	DPC:	None used			
5.10	Defining Membrane:	None used			
5.11	Fixing:	There was clear evidence of wooden pegs used as turf fastenings on Wall 2 (Fig. 4.11).

Fig. 4.11: Wall 2, the holes for the timber pegs, which originally fixed the turf caps, are still clearly visible in areas, indicating a highly durable mud mortar mix.

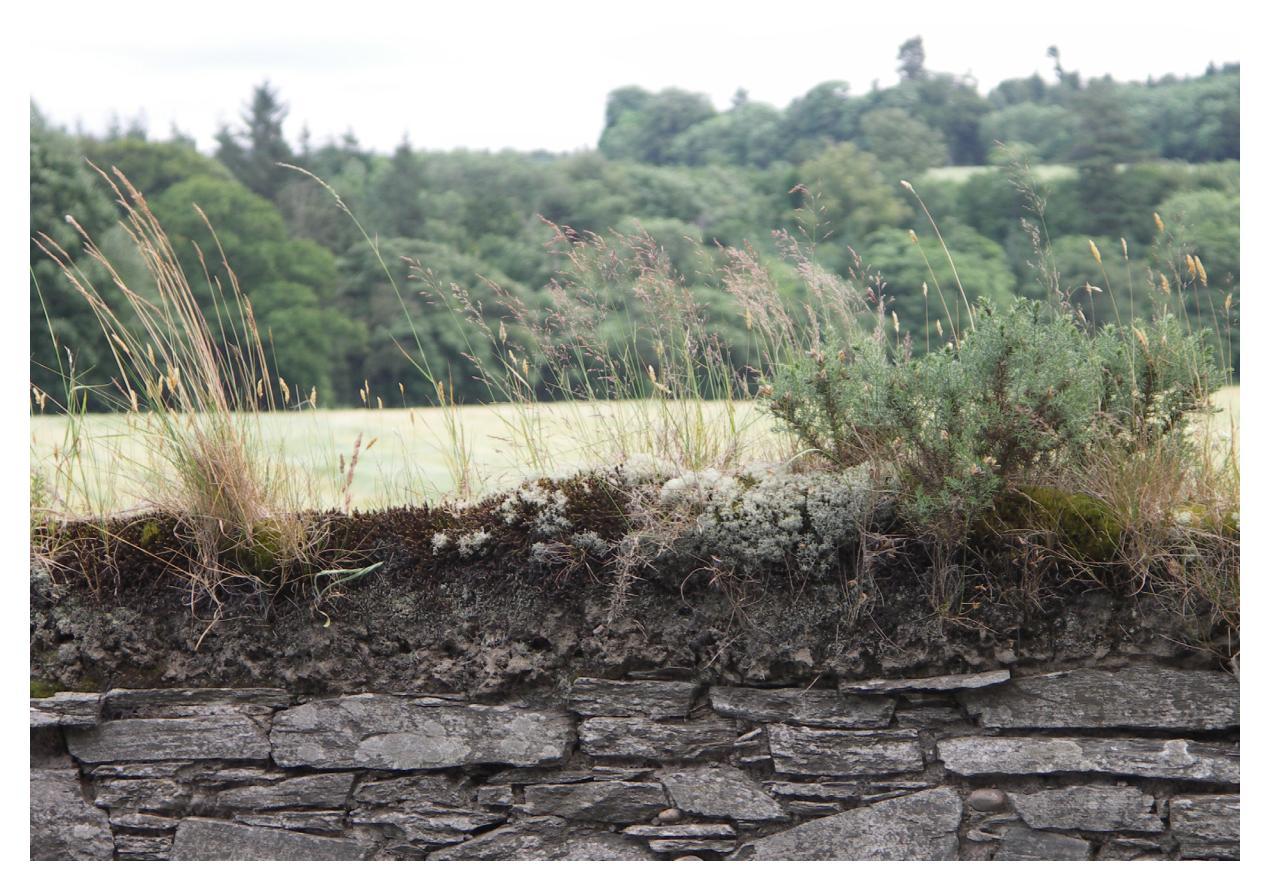
Fig. 4.12: Wall 2, exposed areas typically have a complete loss of original turf, good subsequent colonisation by moss and lichen of the top, with thin grass distribution and occasional larger plants, such as gorse.

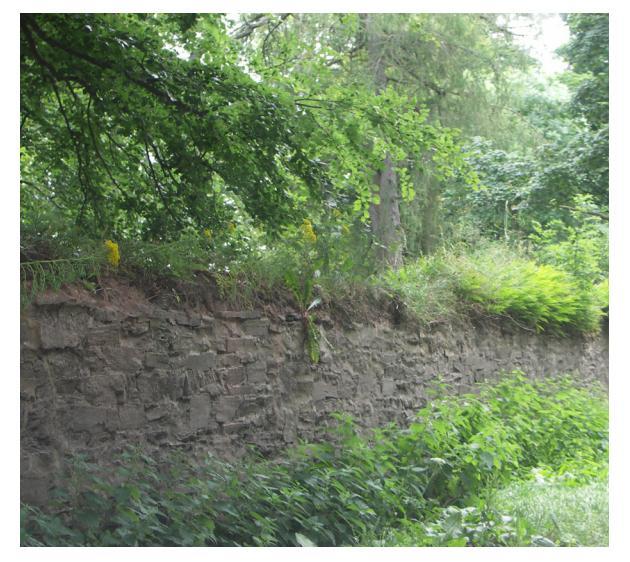
Fig. 4.13: Wall 2, in sheltered areas, there can be thick growth, though this is dramatically reduced by strong shading.

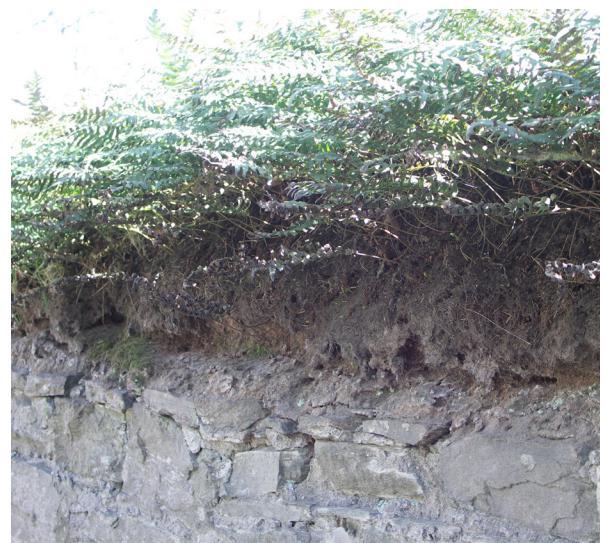
Fig. 4.14: Wall 2, dense top growth, here by ferns, often leaves the sides exposed.

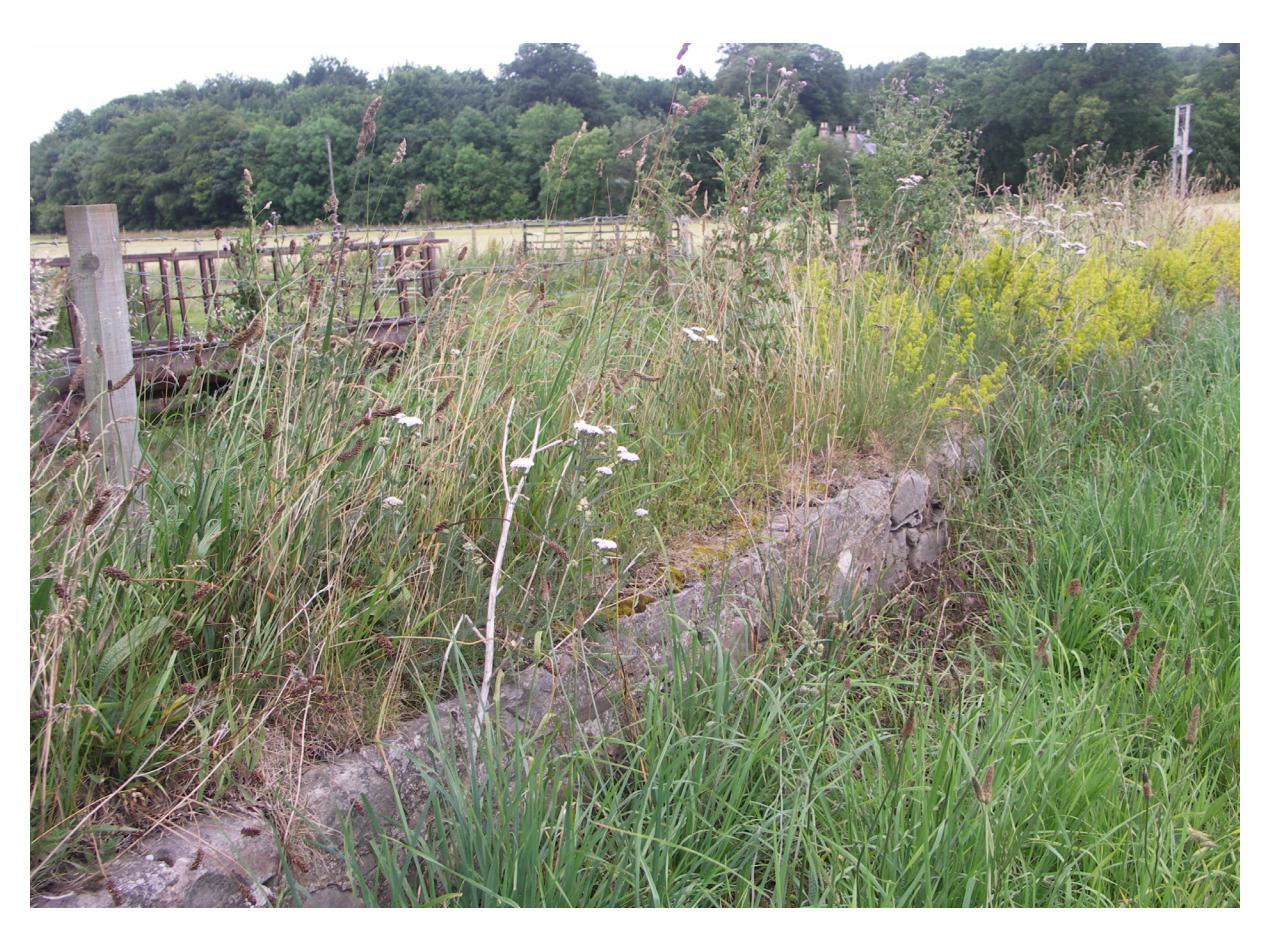
Fig. 4.15: Wall 3, growth is strong despite exposure, perhaps indicating the benefit of low height.

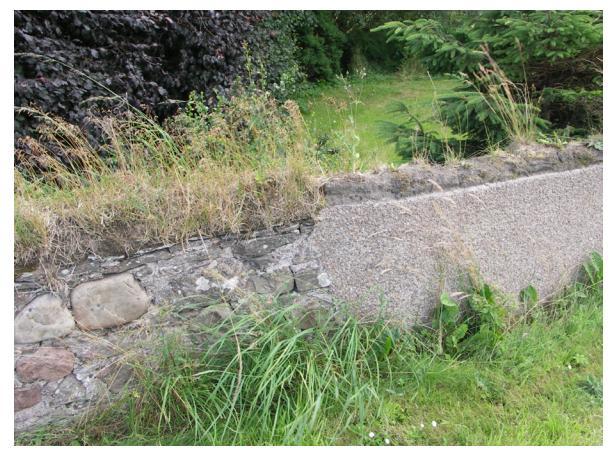
Fig.4.17: Wall 4, the relative failure of the modern soft capping over concrete block work is evident.

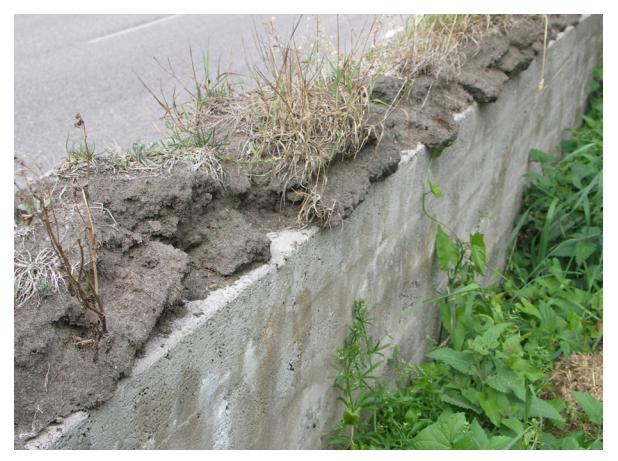
*Fig. 4.18: Wall 4, the modern capping clearly did not replicate the original turf capped mud mortar dome.*

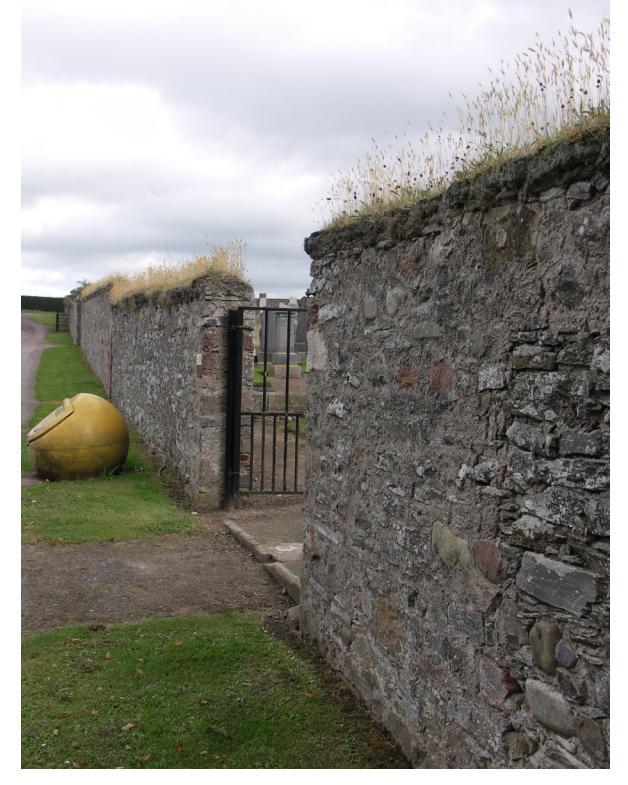
*Fig. 4.19: Wall 5, although very exposed, these caps perform well, apart from the exposed edges.*

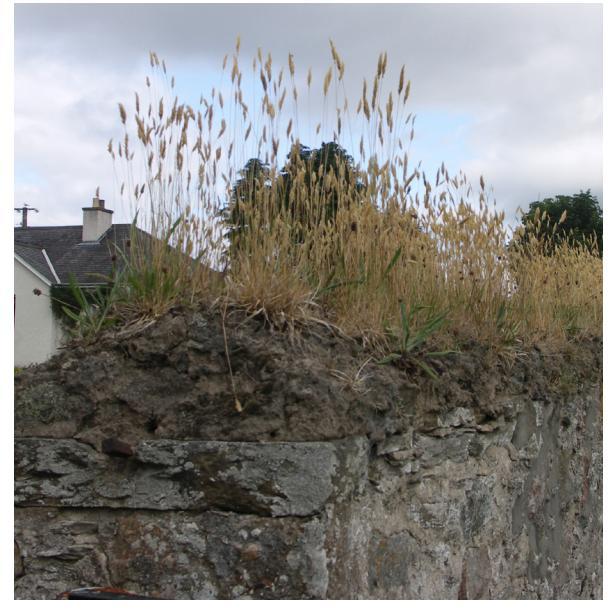
Fig. 4.20: Wall 5, the domed profile follows the vernacular of Walls 1 and 2, and seems to be following the same pattern of progressive grass dieback and colonisation by other species.

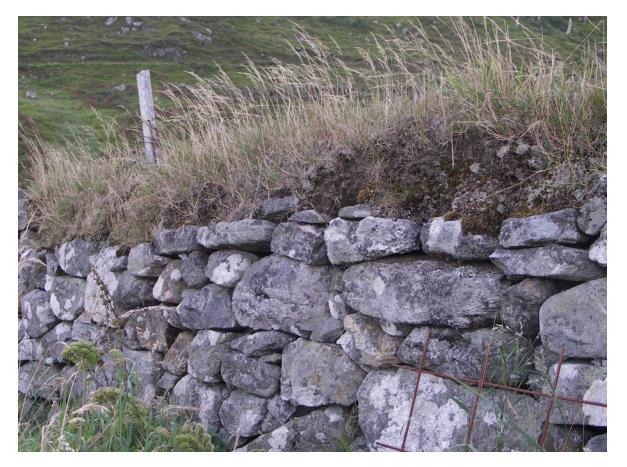
*Fig. 5.4. Some areas show a similar exposed side as at Gordon Castle (CS3).*

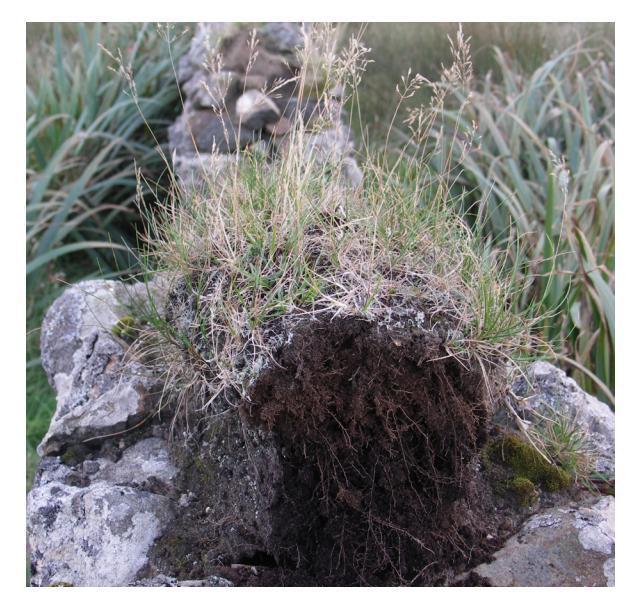
5.6	Vegetation: Source and Description	Assumed to be turf cut from the	e immediate vicinity.			
5.7	Soil: Source and Description	The soil layer is darker than the likely to be peaty or wet ground grazing land (Fig 5.6).	e soil included in the turf cap, ir d, rather than the valuable impro	nplying a different source, oved soil of the adjacent

*Fig. 5.6.* The capping has a core of dark soil beneath a thick turf.

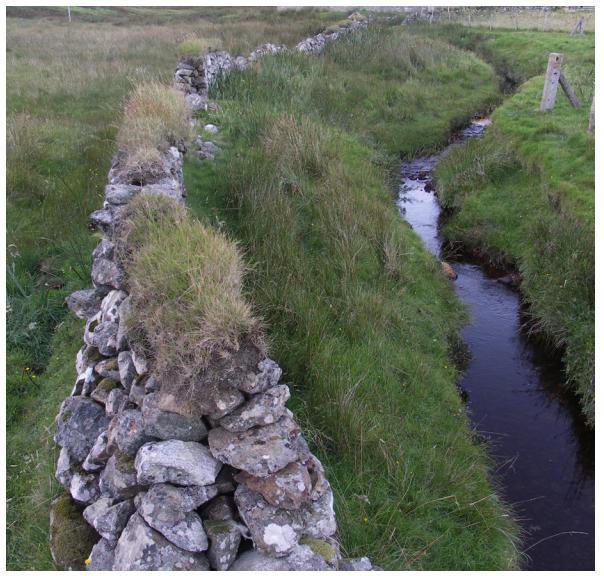
2.4	Construction and Form:	There are three secti length, located east battered faces rising elsewhere on Harris	There are three sections of rough drystone field enclosure walls, totalling over 800m in length, located east of the church and south of the road. The walls are about 1m tall and have battered faces rising to about 400mm wide (Fig. 5.7). There are other comparable examples elsewhere on Harris.			
	1

*Fig. 5.7. The caps may give some stability to the crudely constructed drystone walls*

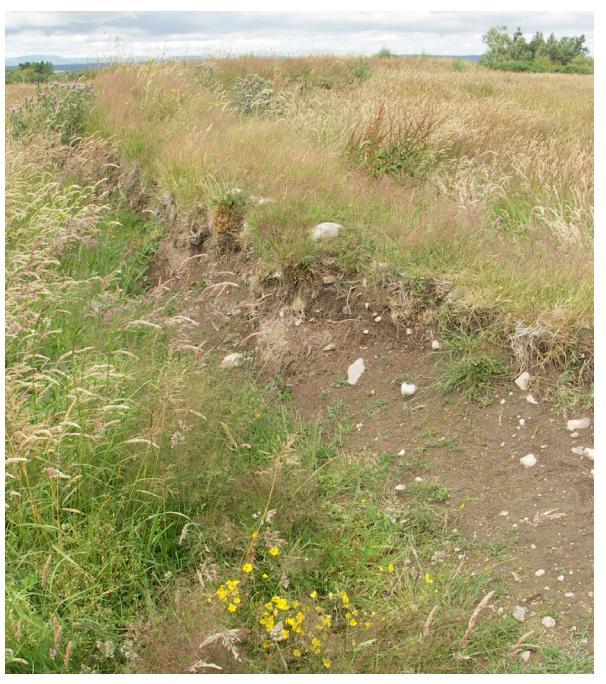
6.3	Effect of Birds:	None noted
6.4	Effect of Animals:	During construction a mole was inadvertently included in the earth core material, resulting in a series of molehills along the new wallhead. Care was thereafter taken to exclude moles from the mix, by manually rather than mechanically moving the earth.
		Grazing sheep do not seem to cause any major damage to the wall, though they are known to walk along the top of it, which could cause erosion in climbing up and contribute to path damage.
		Grazing cattle cause a great deal of damage, with several sections of wall having collapsed after being leaned on and climbed over. This initial damage is then exacerbated by wind and rain erosion (Fig. 6.7).

Fig. 6.7: Decay to the sides of an opening forced through by cattle, showing how the turf sides have degraded to lose the binding strength of its root mat, while the living roots provide some resistance to damage.

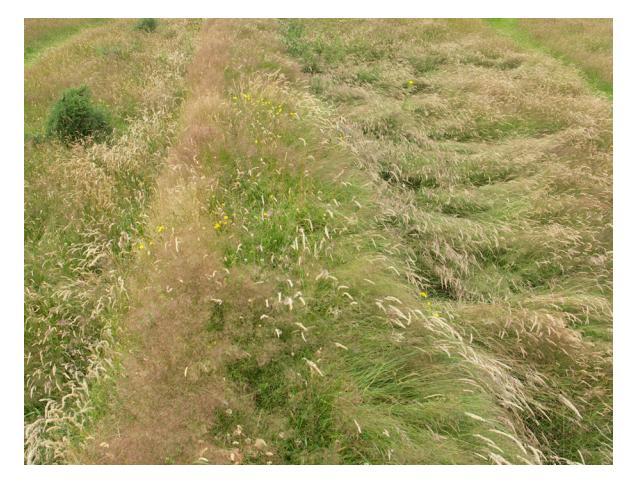
Fig. 6.8: Grass eroded by pedestrian traffic on the wallhead. Thistles and nettles grow in the sheltered areas on either side of the wall, but not in the fields generally and not on the cap.

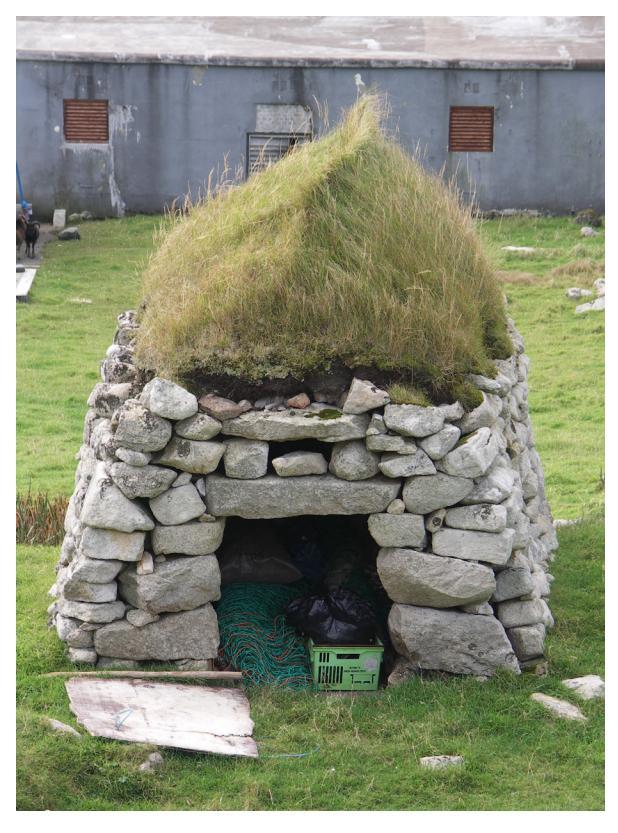
Fig. 7.3: The common 'Mohican' profile of the grass cappings. The left turf edge has stabilised back from the stone edge, implying stronger wind on that side than the right. The front edge is eroding with some moss and lichen growth. This cleit would appear to steep-sided to allow sheep to graze on top.

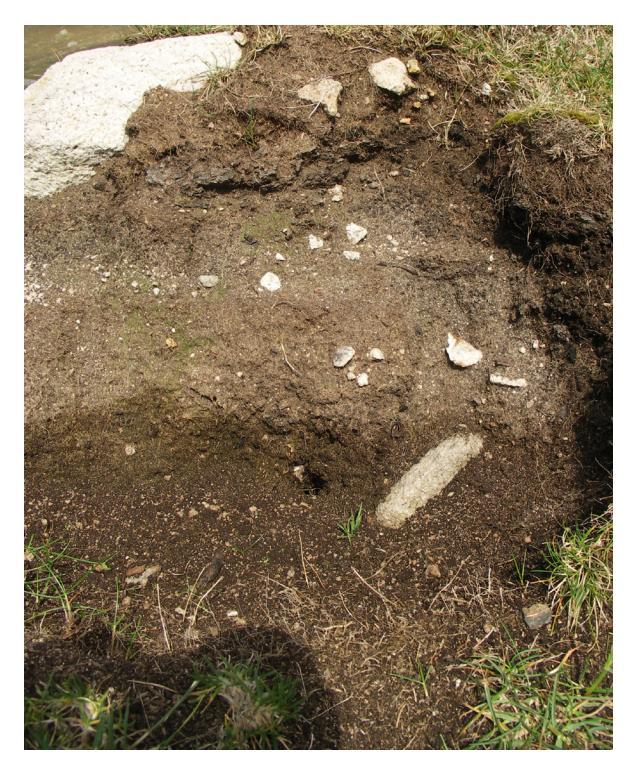
Fig. 7.7: There is apparent stratification in the soil, which might simply reflect different sources of soil, but could imply periodic repair and re-turfing.

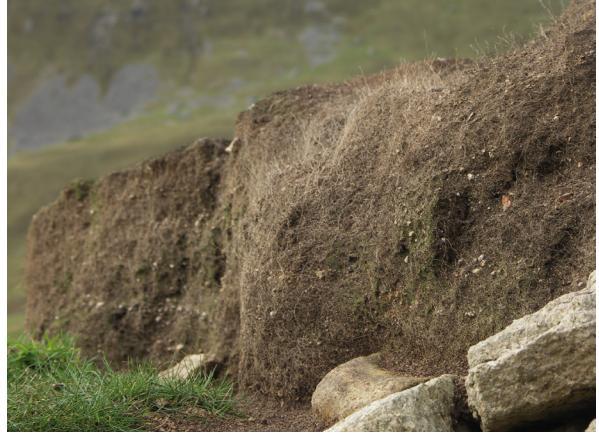
Fig. 7.8: In mature caps there is a deep penetration of fine hair roots. This binds the otherwise friable soil, retarding decay and creating an even erosion face, even when, as in this example, the turf has fully died on top. This case shows the opposite condition from a turf cap undermined by soil erosion.

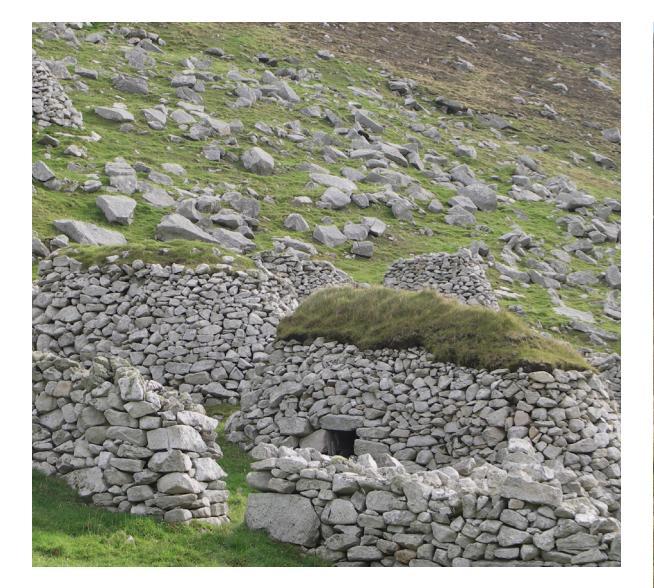
Fig. 7.13. The cleitean in the background show the characteristic pattern of progressive decay from the windward edge. This may be a very slow, but inexorable, process. However, other comparable cleits, such as the one in the foreground, are able to resist the onset of decay.
