### SOFT CAPPING IN SCOTLAND

The context and potential of using plants to protect masonry

> Volume 2 Case Studies

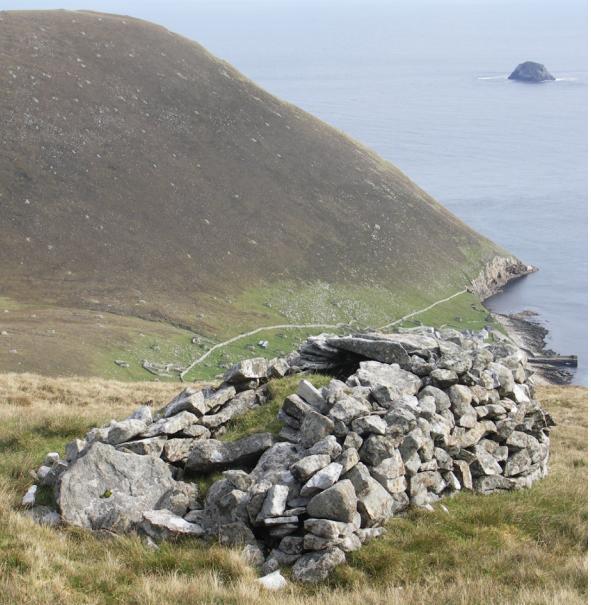
Fig. 7.14. The process of decay leads to the complete loss of vegetation and soil and the ultimate collapse of the masonry structure.

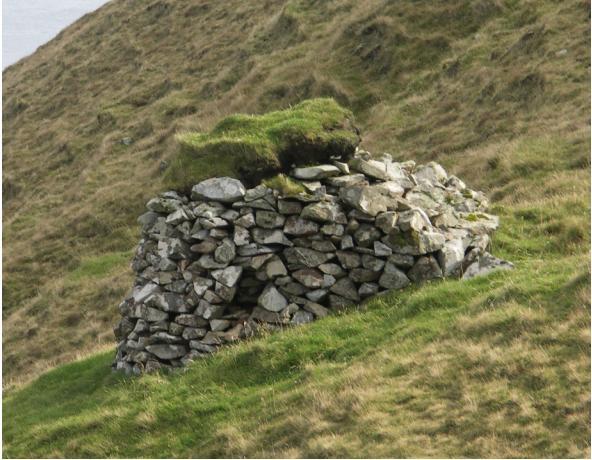
Fig. 7.16. Though cleitean usually erode from the lower face, others do not. This may relate to the local prevailing wind direction or where sheep have climbed onto the roof. Note the verdant growth on the ground around the cleit, which probably relates to the deposition of dung by sheep sheltering inside.

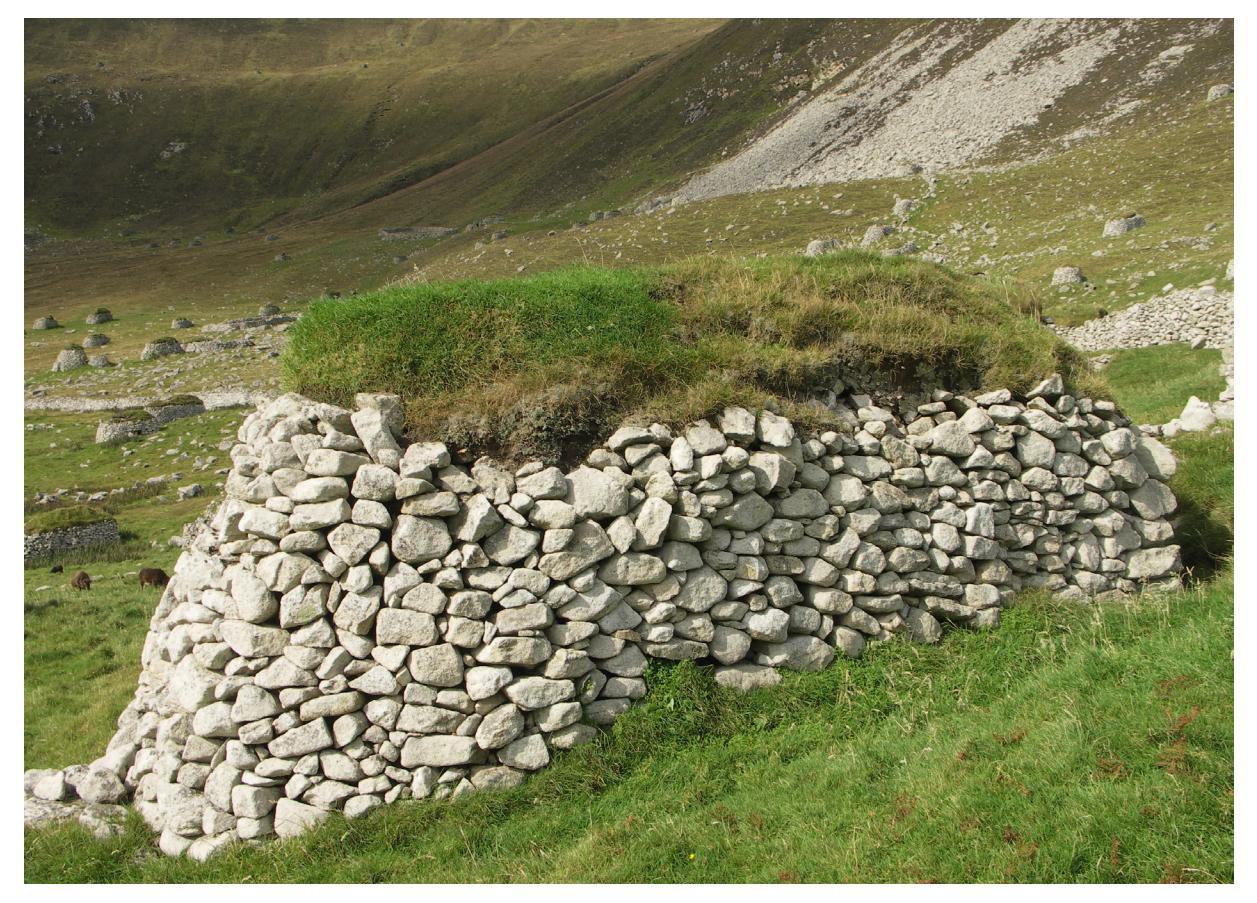
This drying shrinkage may also inhibit good rooting in of the relatively thin turf. Installation during the summer months is not ideal, being most prone to drying out before the roots become established. Although the site has a good rainfall, it also has near constant wind and high solar radiation, creating strong drying conditions in summer.		
		The post-repair watering regime alleviates this problem, though this may in some cases be counter-productive by encouraging shallow rooting rather than deep rooting which would both tie in the turf and give it a greater source area for water after watering has stopped.		
		The use of fertiliser may also create artificially benign conditions for plant growth, encouraging shallow rooted thick leaved growth during the first year, which is less robust than the deep and dense fine roots and thin leaves of the original caps. These less hardy dominant plants subsequently progressively fail in the harsher naturally prevailing conditions of subsequent years. The use of turf sourced from immediately around the cleitean would have a similar effect, as this grass is similarly lush and broad leaved thanks to the local concentration of sheep dung (Fig 7.16). The visual difference between the grass sward of the repairs and some original caps supports this theory (Figs. 7.17, 7.19 and 7.20).

Fig. 7.17: Repairs are often notable for their lush green colour.

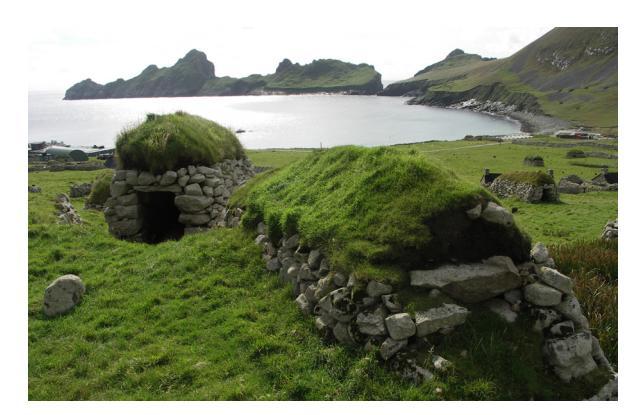
Fig. 7.20: Cleit 39, repaired one year previously.

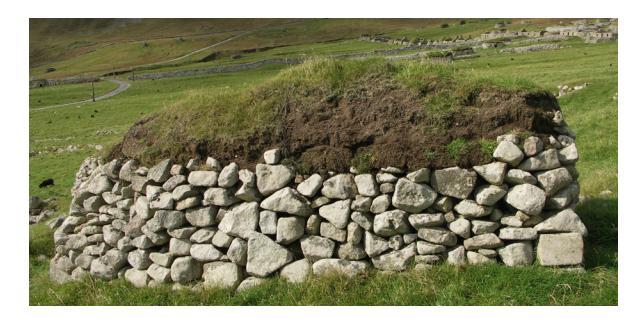
Fig. 7.22: Cleit 15, repaired four years previously showing some re-growth on areas of slow, even die-back, contrasting with the rapid failure shown in Fig.6.24.

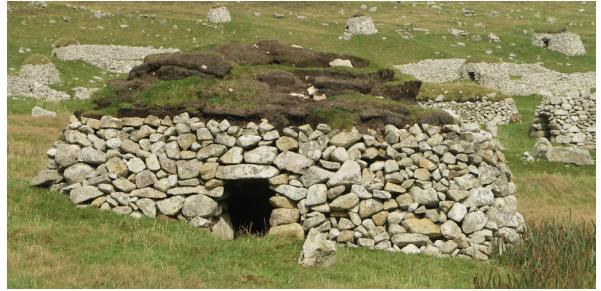
*Fig.* 7.23: *Partial failure of roof repairs, showing the how the original roof was cut back to key in.*

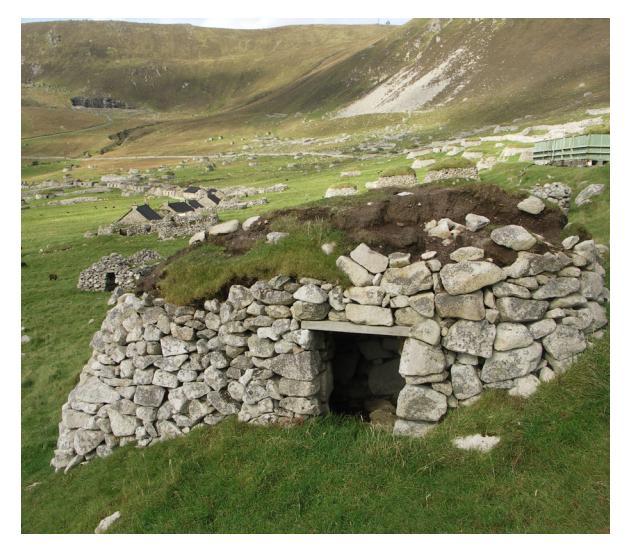
*Fig.* 7.24: *Cleit* 6, *repaired one year previously, showing turfs which have shrunk, following a failure to root in.*

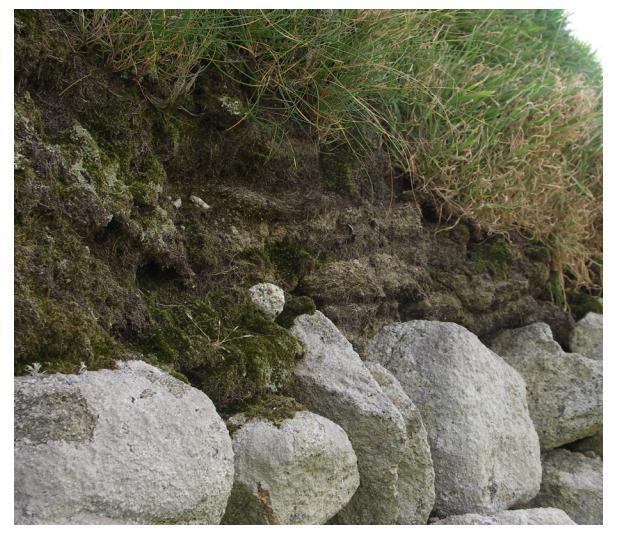
*Fig.* 7.25: Stacked turf has been used to repair some steep sides, here with partial failure.

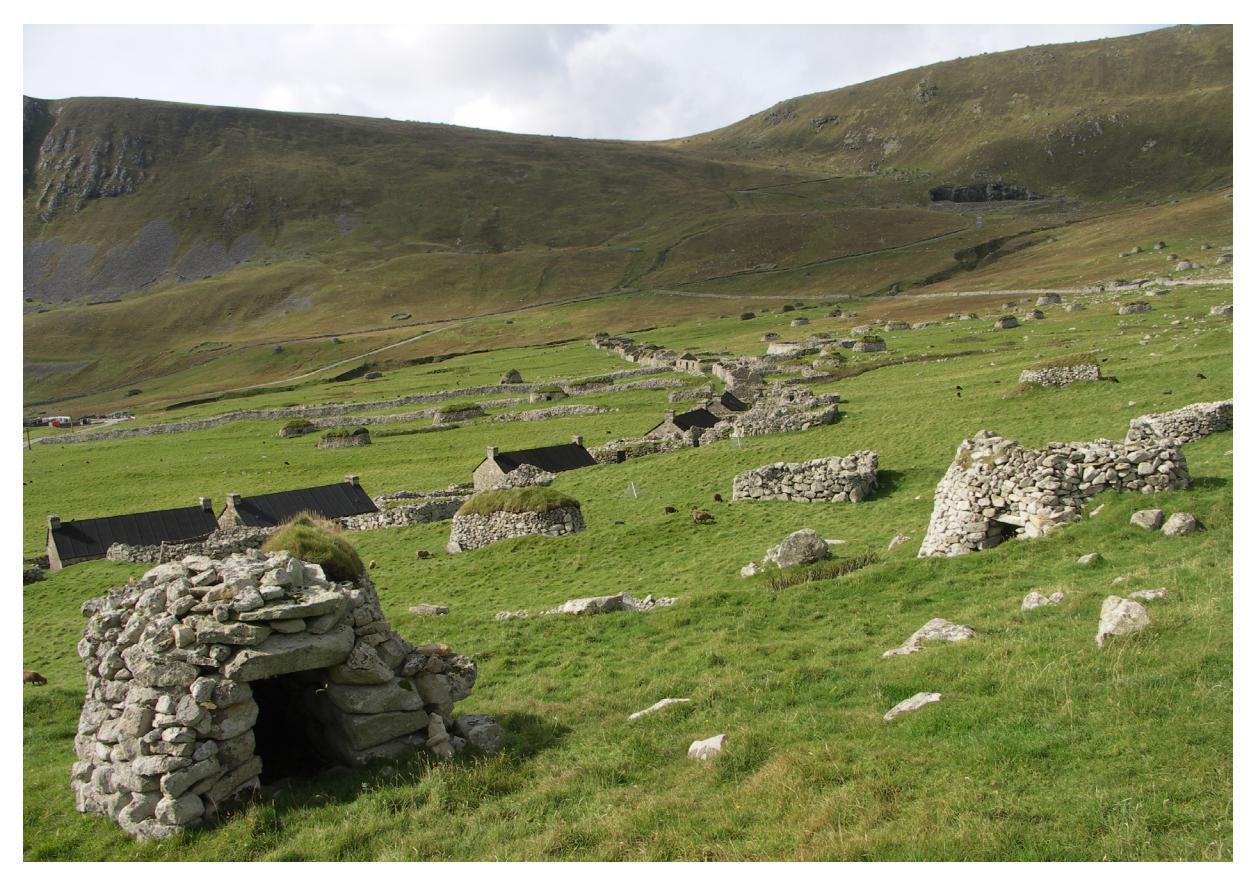
Fig. 8.2: West view. The setting is damp, but open. The north-west gable vegetation is stable against the prevailing wind.

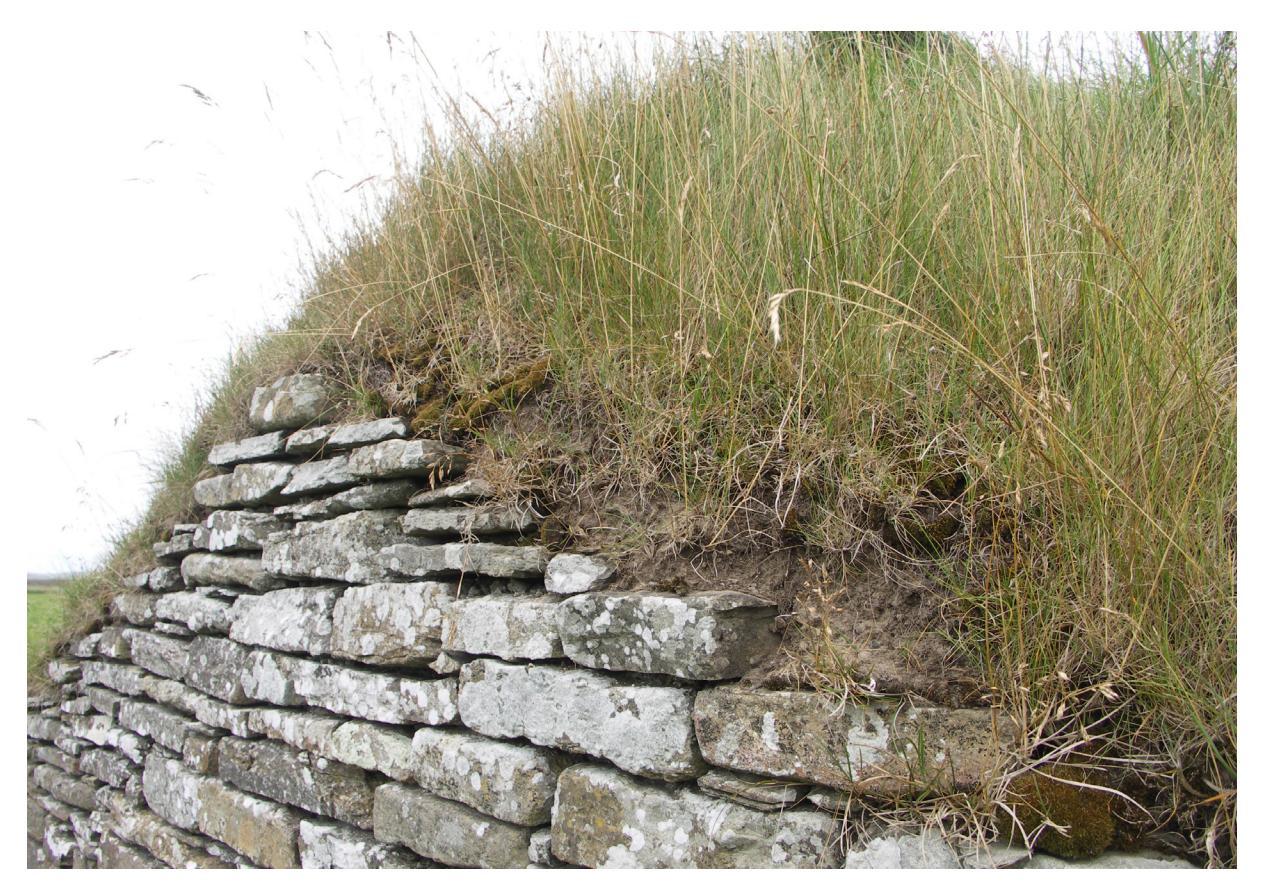
5.11	Aftercare:	None known	
5.12	Maintenance:	None	
6.0	Performance Assessment		
6.1	General Performance:	The capping seems to be performing very well, with the walls in good condition and the slabs dry on the inside. There was no evidence of delamination.	
		There was some dieback, mainly on the south-east gable, where exposed earth is apparently slowly eroding, currently ~max. 50mm from the face of the masonry wall and in line with the recessed pointing. The north-west gable had been stabilised by grasses and moss to a large extent, but the south-east gable had only been stabilised by moss about 30% (Fig. 8.3).

*Fig. 8.3:* On the south-east gable, which is apparently more sheltered, vegetation is less stable with loss of ~ 50mm.

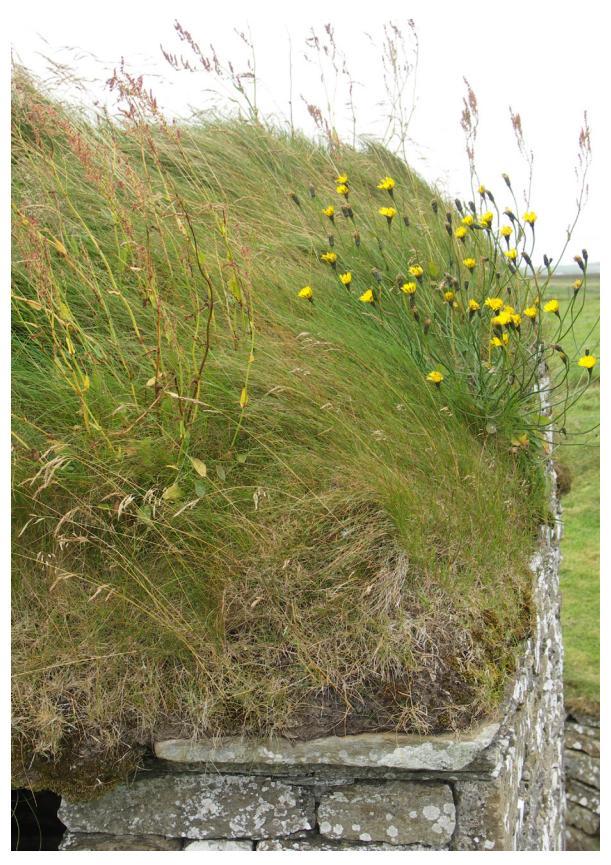
*Fig. 8.5: The most exposed west corner shows a little local decay and stabilisation by mosses.*

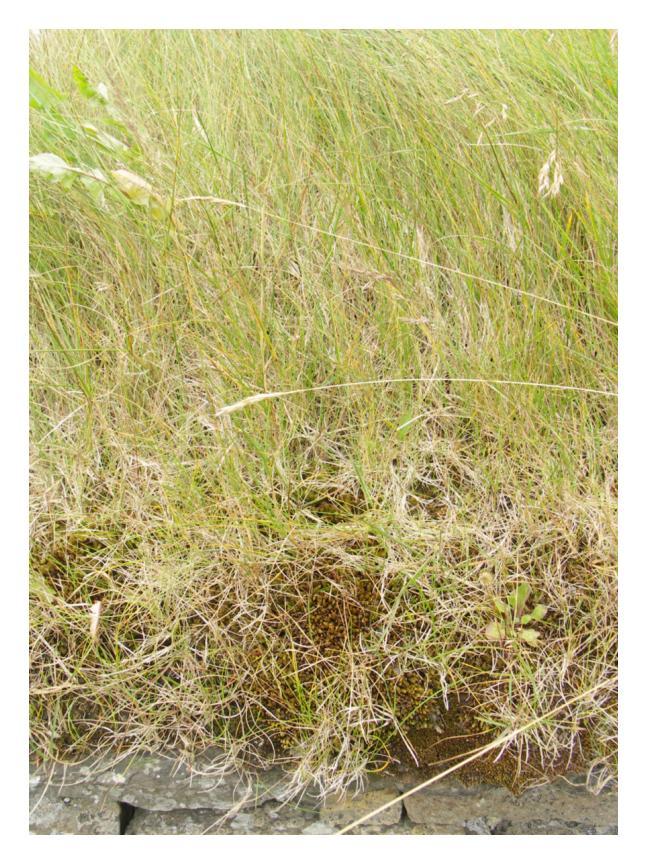
Fig. 8.6: The edges typically have a dense moss mat.

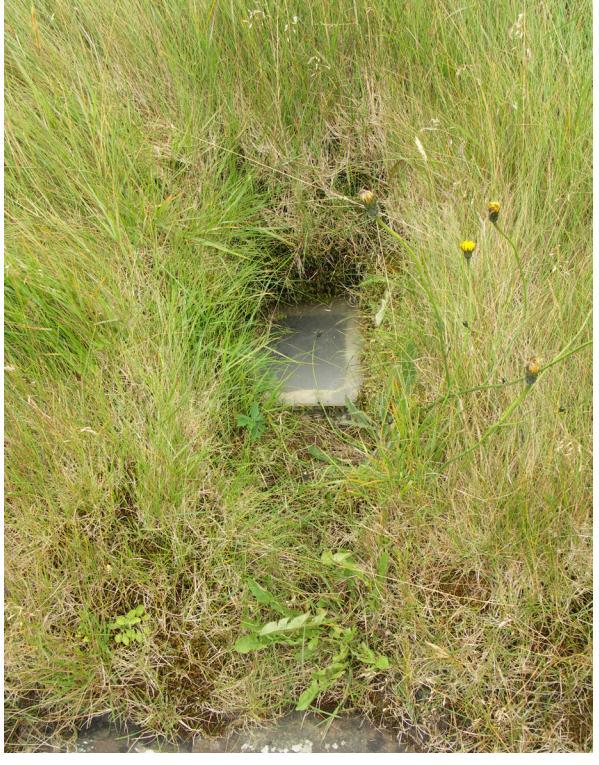
Fig. 8.7: The rooflight did not cause decay. The moss mat at the window head implies that moss growth is associated with accumulations of moisture before its drips away.

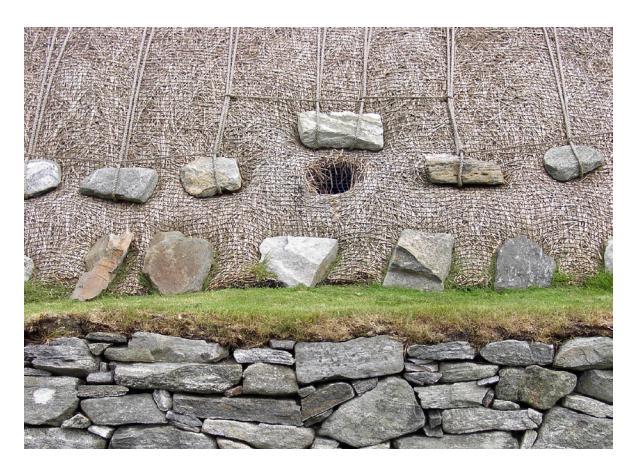
Fig. 9.5: Typical eaves condition in August, with thatched dressed over a turf upstand. The main turf remains verdant through summer with only minor edge dieback.

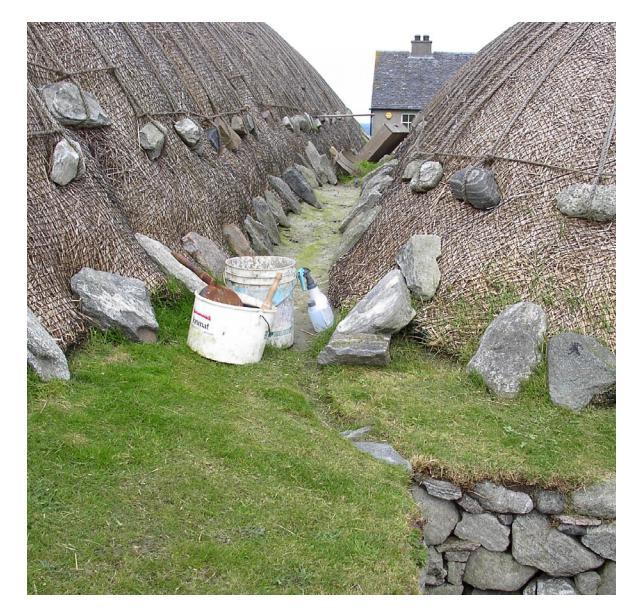
Fig. 9.6: The valley gutter during summer repairs to remove plant growth and repair cracks with clay.

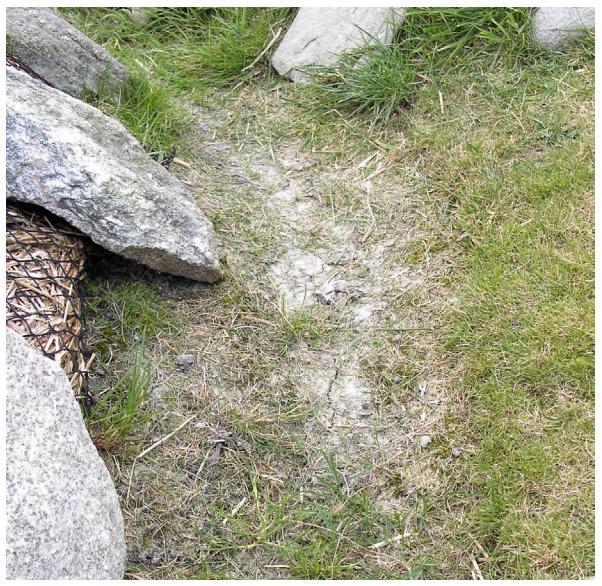
Fig. 9.7: Detail of draining end of clay gutter, with hairline cracks and colonising grass.

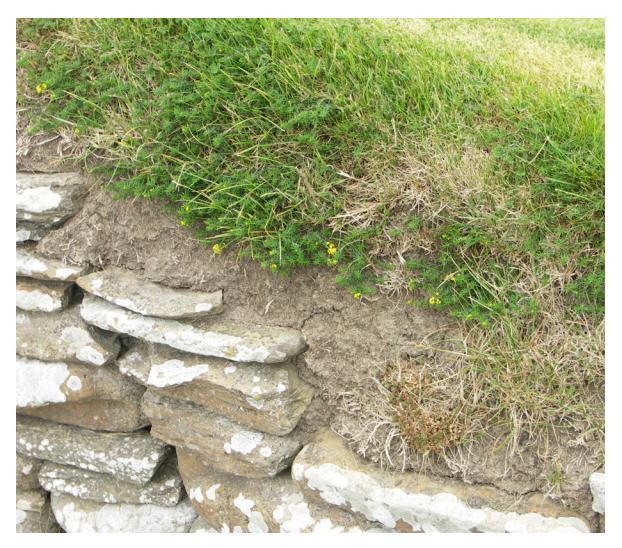
Fig. 10.5: Edge dieback of the grass is fairly common, though other species seem more resilient.

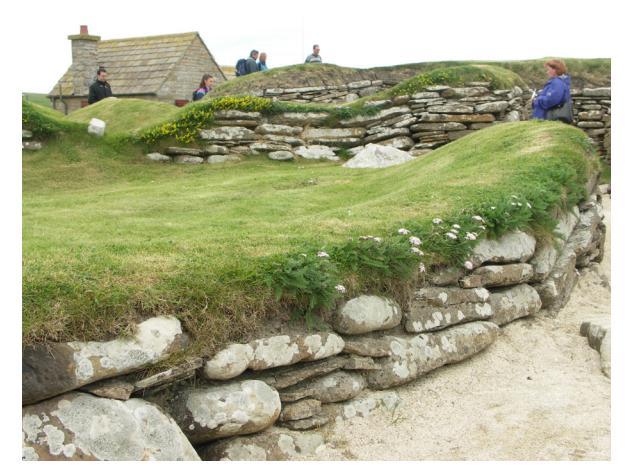
*Fig. 10.7: On edges that are not strimmed, a more diverse vegetation creates a more stable edge.*

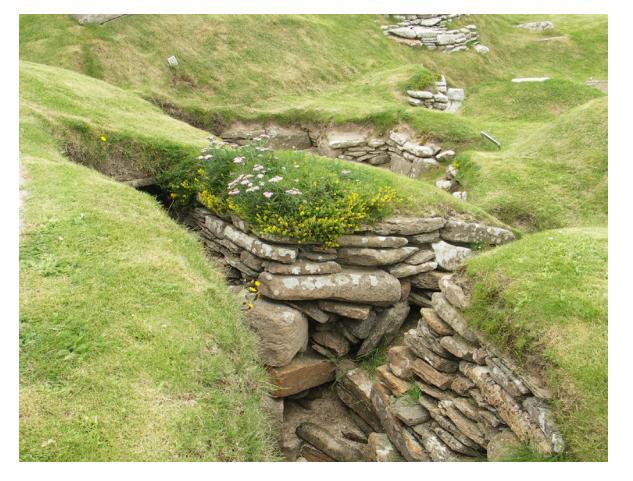
*Fig. 10.10: The complex shape of the grass surface makes cutting difficult to achieve without over-cutting in places.*

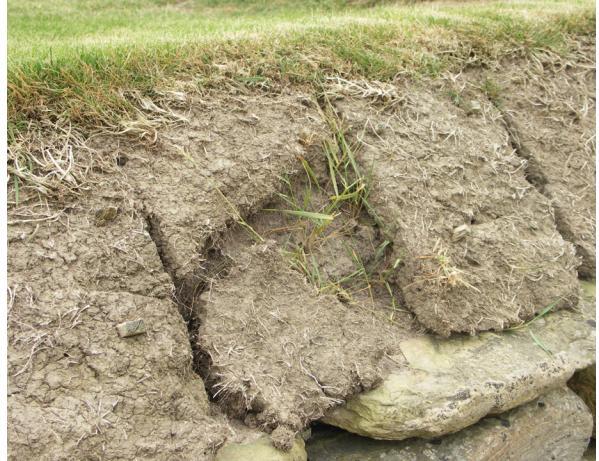
Fig. 10.11: Some of the dead repairs experience re-growth.

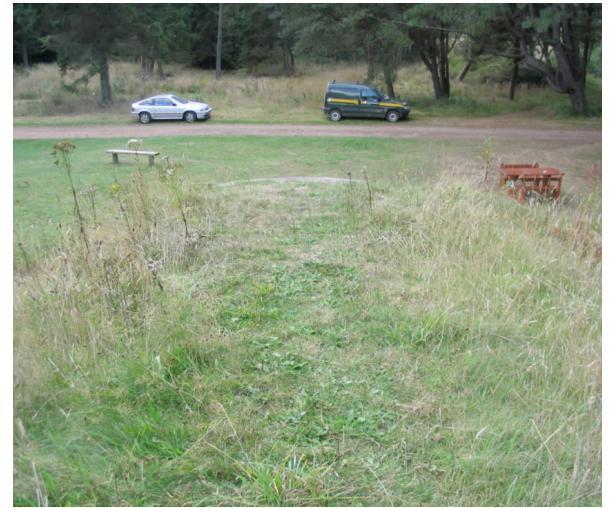
6.0	Performance Assessment	
6.1	General Performance:	The interior felt cold, even in mid summer, indicating some insulative effect from the capping. The brick vault had suffered significant leaching of lime from the mortar, though it was dry and there was no sign of water staining on the concrete floor, indicating that the lime leaching may date from the initial post construction period (Fig. 11.6). The dryness could be seasonal.
		The capping appeared lush and healthy, with vegetation growing right up to all the edges, except the south gable edge, which has been capped with cement, and onto which no grass has spread.
		There were isolated areas of severe damage caused by people climbing onto the roof (Fig. 11.10). Where this had occurred, the soil was particularly vulnerable to erosion as it was exceptionally sandy, dry and friable (Fig.11.11). The vegetation on the ridge was noticeably thinner than on the sloping sides of the vault and this appeared to be caused by people walking along it (Fig. 11.5).

Fig. 11.5: Growth on top is suppressed by foot traffic.

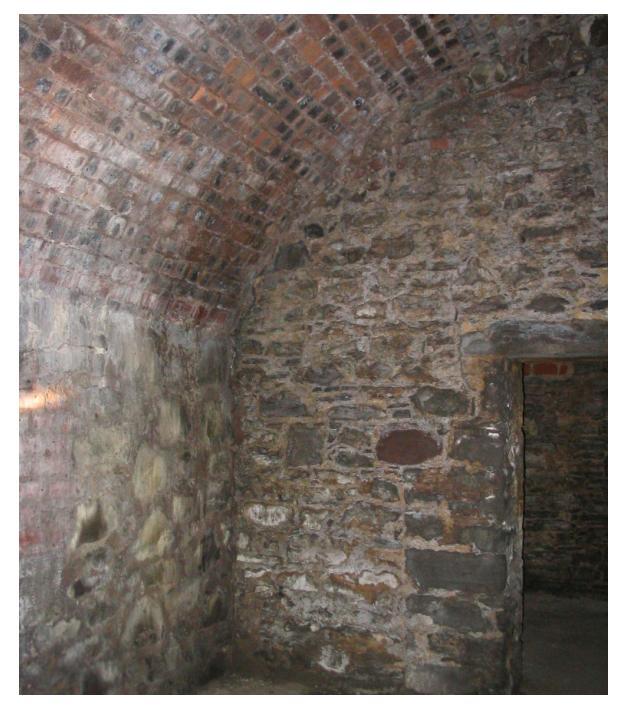
Fig. 11.6: The interior surface of the vaults appeared dry, though the brick vault especially, showed significant leached lime.

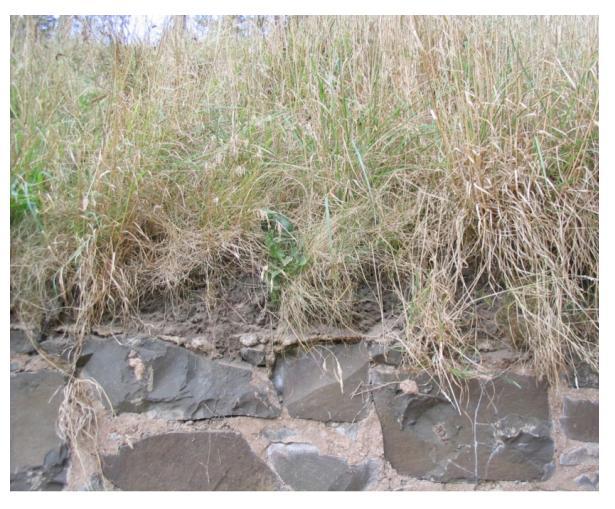
Fig. 11.9: Dryness from solar exposure on the south edge.

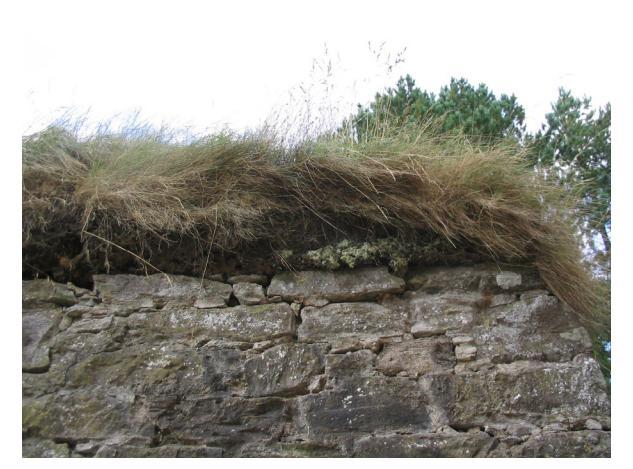
*Fig. 11.8: Typical edge, with local stabilisation by moss and lichen, indicating seasonal saturation.*

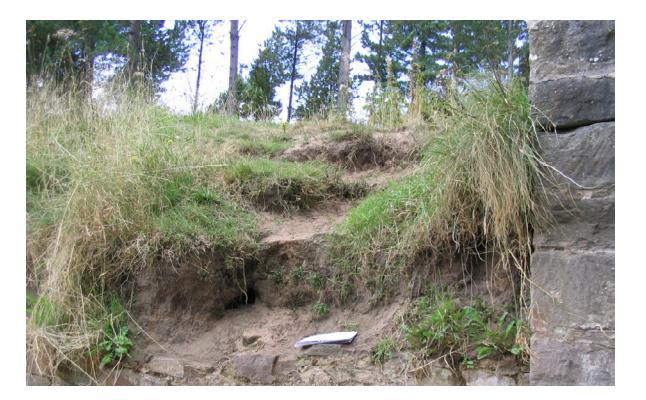
Fig. 11.10: Damage by pedestrians

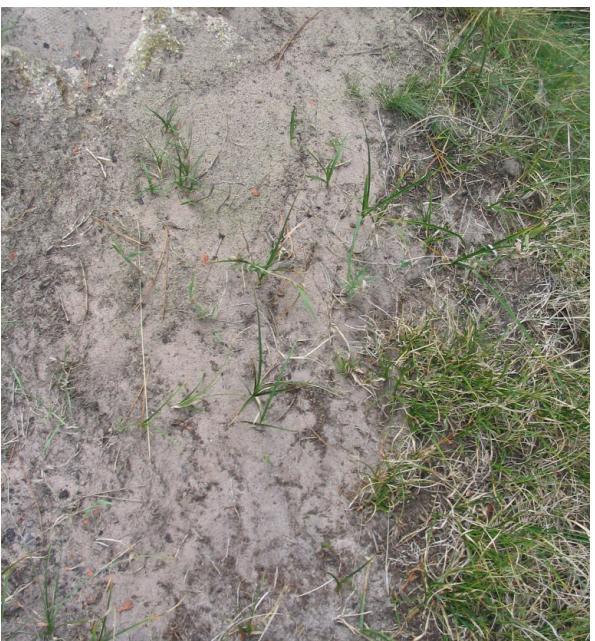
Fig. 11.11: The soil is very sandy

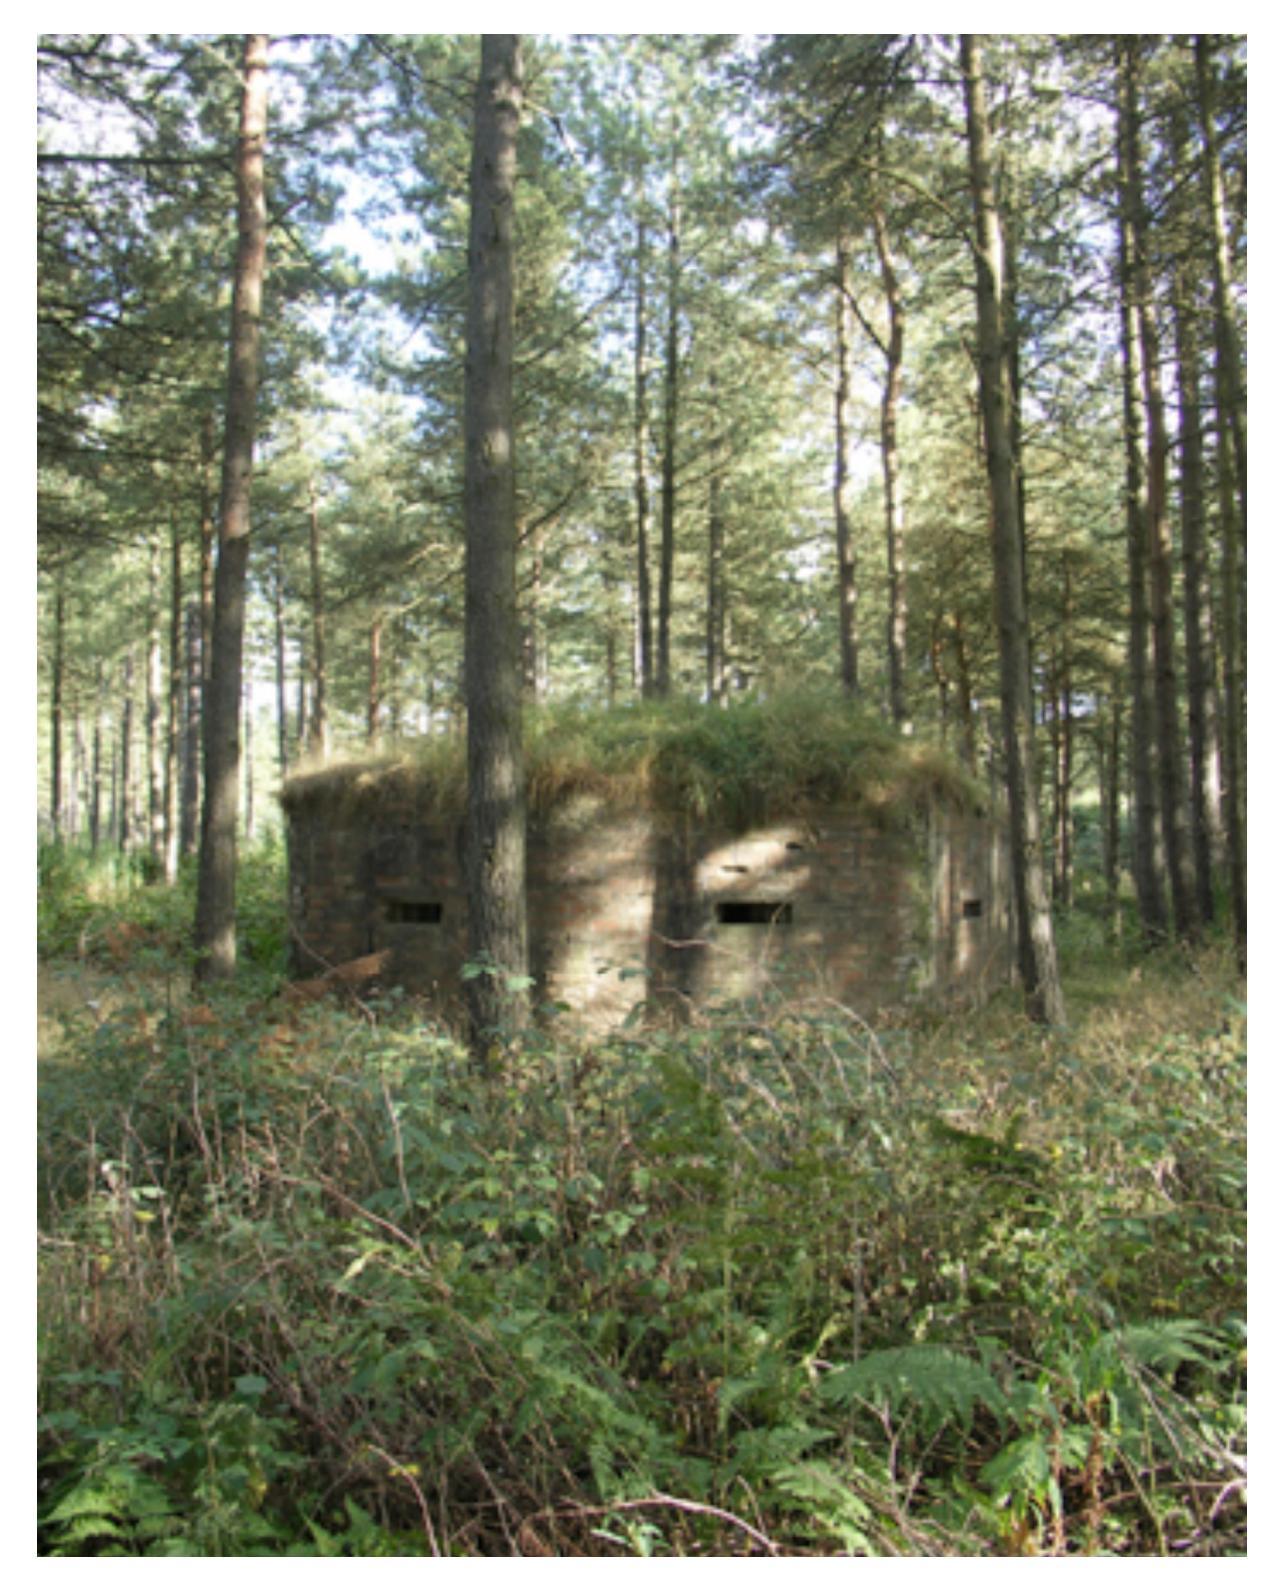
Fig. 12.1: Pillbox, Ladybank. West view, the turf camouflage remains largely in place.

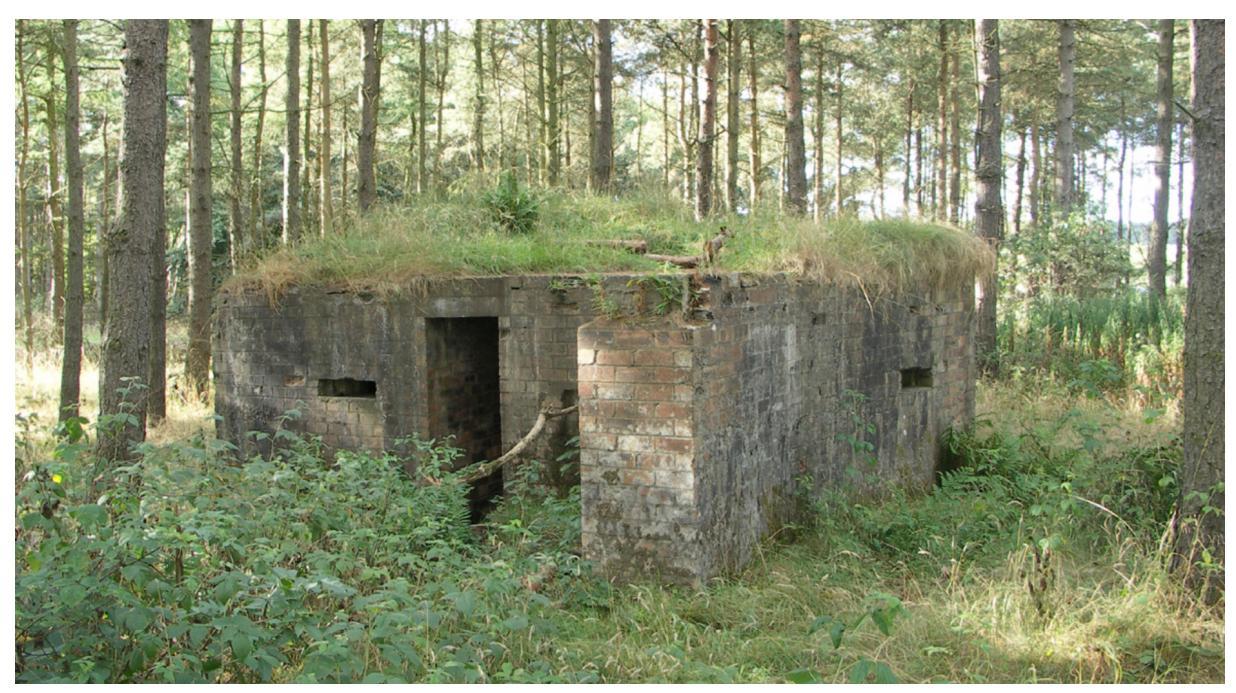
Fig. 12.2: View from the south-east. The cap is much less bio-diverse than its woodland surroundings.

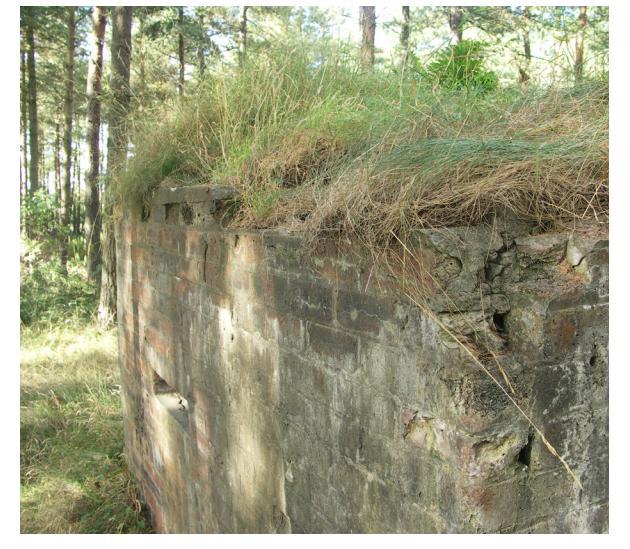
Fig. 12.4: Typical good edge protection does not extend to this corner.

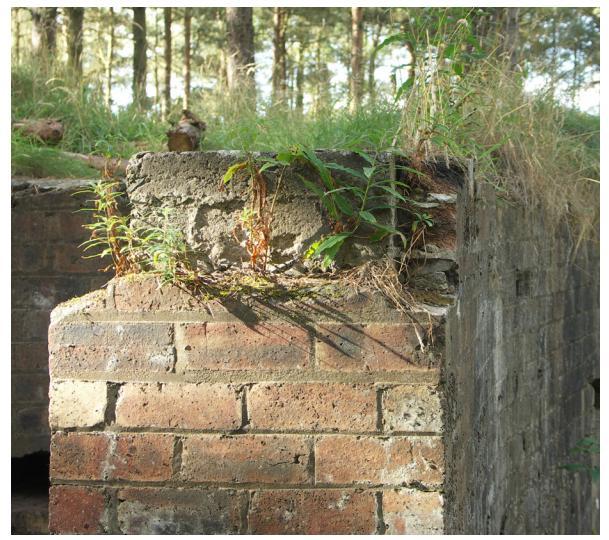
6.1	General Performance:	The capping continues to perform well as camouflage and is impeding decay of the building.			
6.1	General Performance:	The capping continues to perform well as camouflage and is impeding decay of the building. The vegetation appeared dense and healthy, with surprisingly little colonisation by woodland species, given the good depth of soil. The grass was generally dense to the edge of the roof, often projecting over the face. This protected the vulnerable exposed joint between the brick facing and concrete roof. Where this joint was not protected by turf, the crack had been colonised by ruderals and progressive decay of the brick was established (Fig. 12.5).

Fig. 12.5: Decay of the brick where there is no grass.

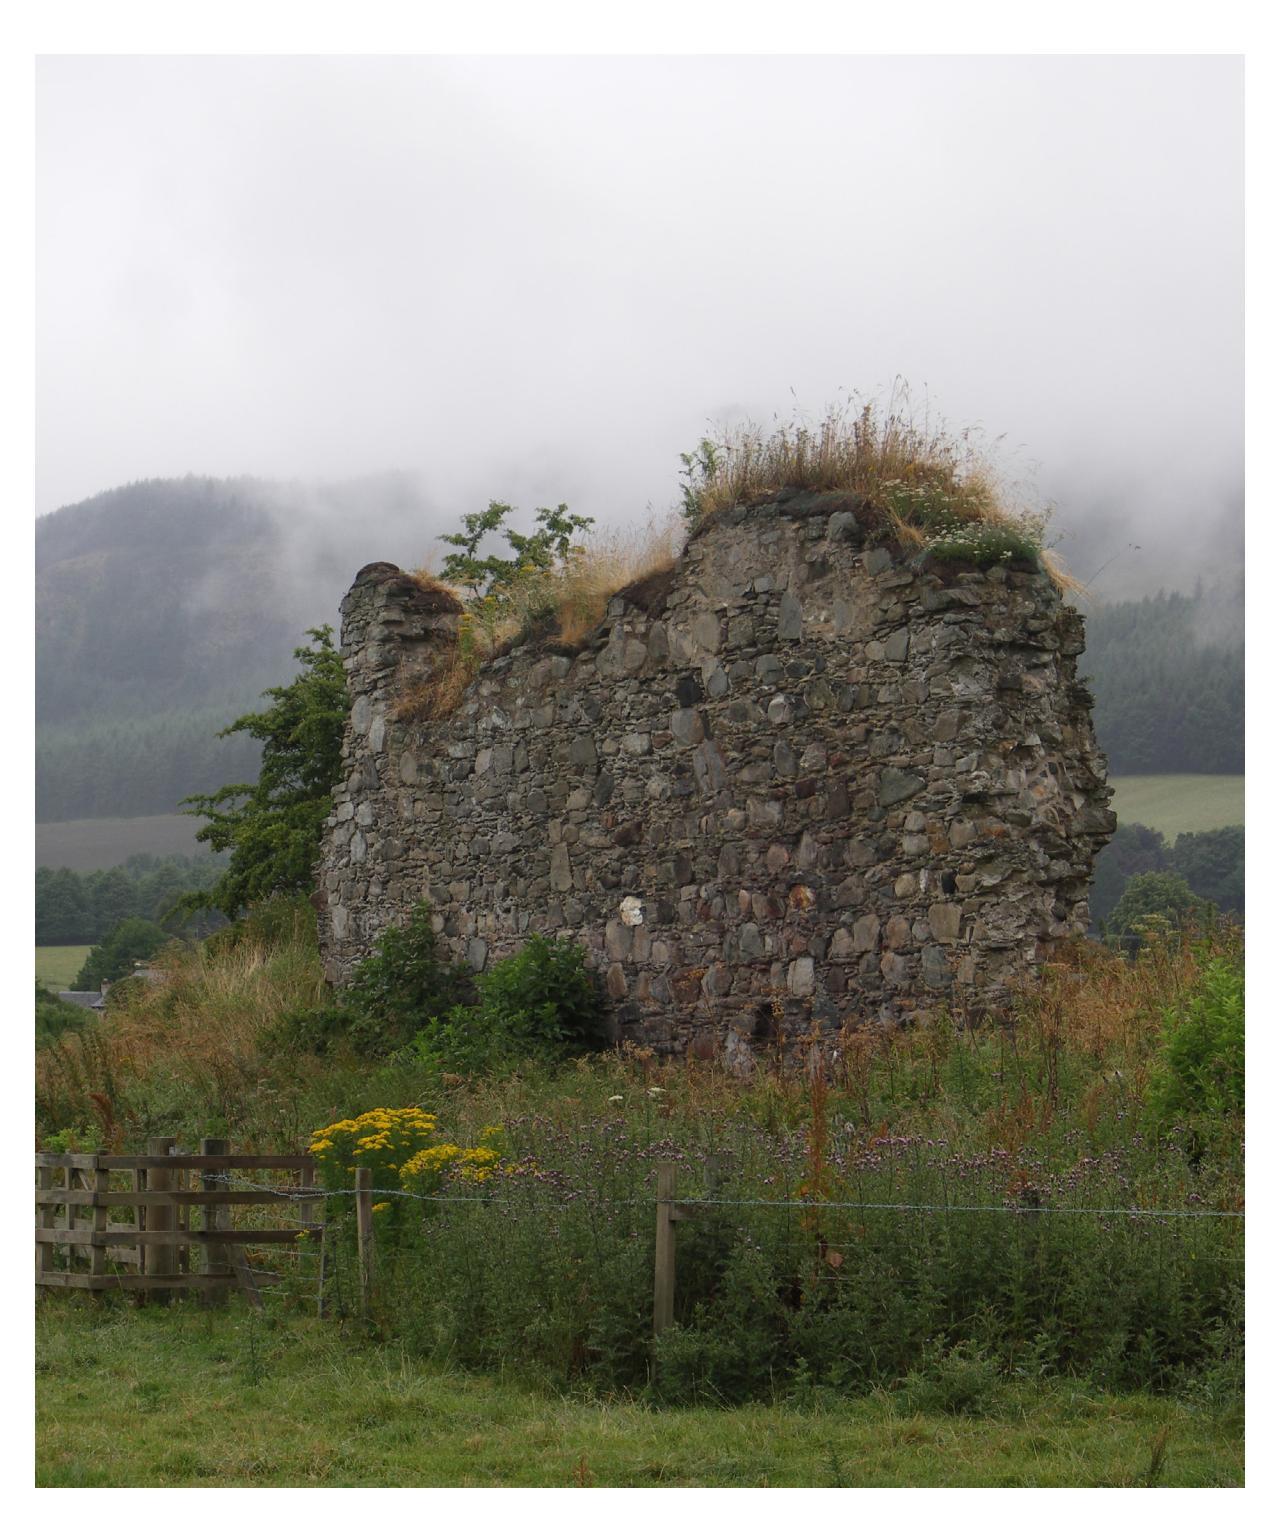
Fig. 13.1: Black Castle. The south wall, which retained the central natural vegetation, while edges were replaced with new caps. The general effect of the soft cappings is very good, being very naturalistic and appropriate to the rural landscape context. However, colonisation by tall ruderals and tree saplings, associated with the tall plant growth within the site enclosure detracts from this impression and obscures the monument.

6.4	Effect of Animals:	There was evidence of some of the lower mural vegetation being grazed by deer.
		Prior to the work being carried out the site was grazed by cattle, which helped to control the vegetation around the ruins but risked damaging the structure of the monument. After the work, the monument was fenced in without alternative maintenance provision being established and vegetation grew unchecked. This created a seed bank of undesirable species around the walls, with seasonal growth of over 1m significantly obscuring them (Fig. 13.1).

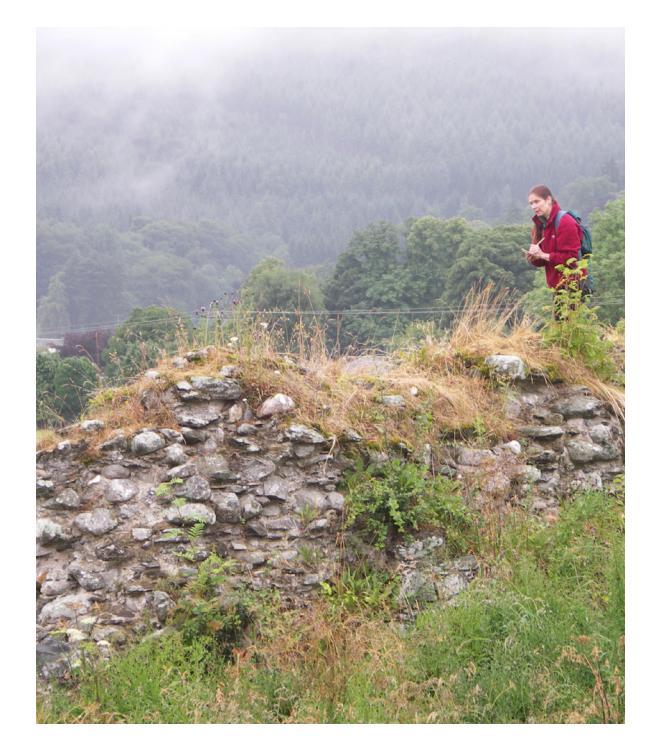
Fig. 13.5: The natural capping is thin, with few ruderals.

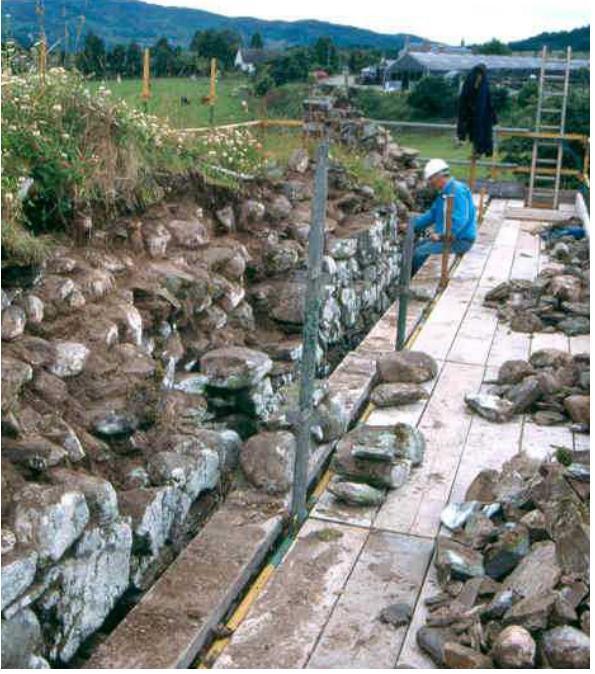
5.4	Treatment of Existing Vegetation:	One wall was assessed as having sound masonry and was not repaired, leaving undisturbed its naturally established plant cover, apart from removal of trees and tall ruderals.	
		On the three wall sections that had major repairs, a number of trees were removed, with some deeply embedded roots left in situ. A layer, ~200mm deep, of loose masonry, soil and vegetation was generally removed in order to allow consolidation of the wallheads. A large section of vegetation (about 30% of the head area), consisting of grasses and wild flowers, was left in the centre of the largest wall core to encourage colonisation of introduced turf by existing species (Fig. 13.6).

*Fig. 13.6: One side of the wall-head has been cleared of natural vegetation, in preperation for masonry consolidation.*

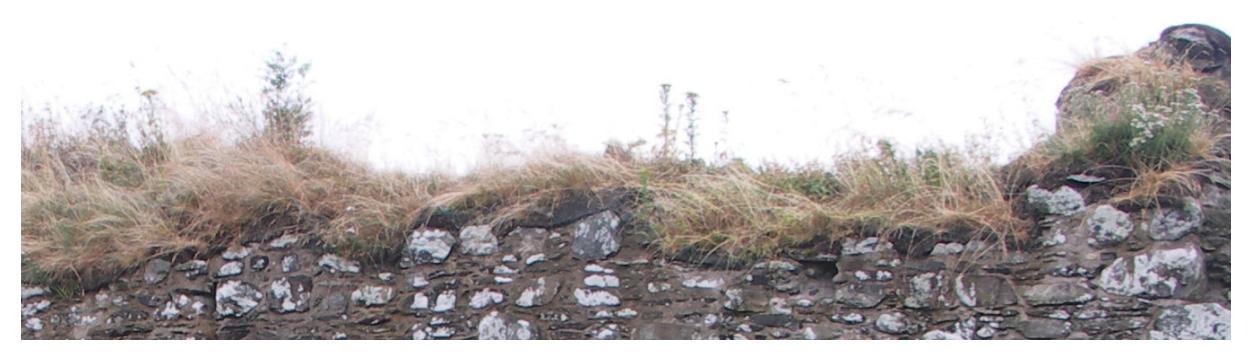
*Fig. 13.10: South wall, north side, three years after completion. Dieback on the north edges is less significant than on the south.*

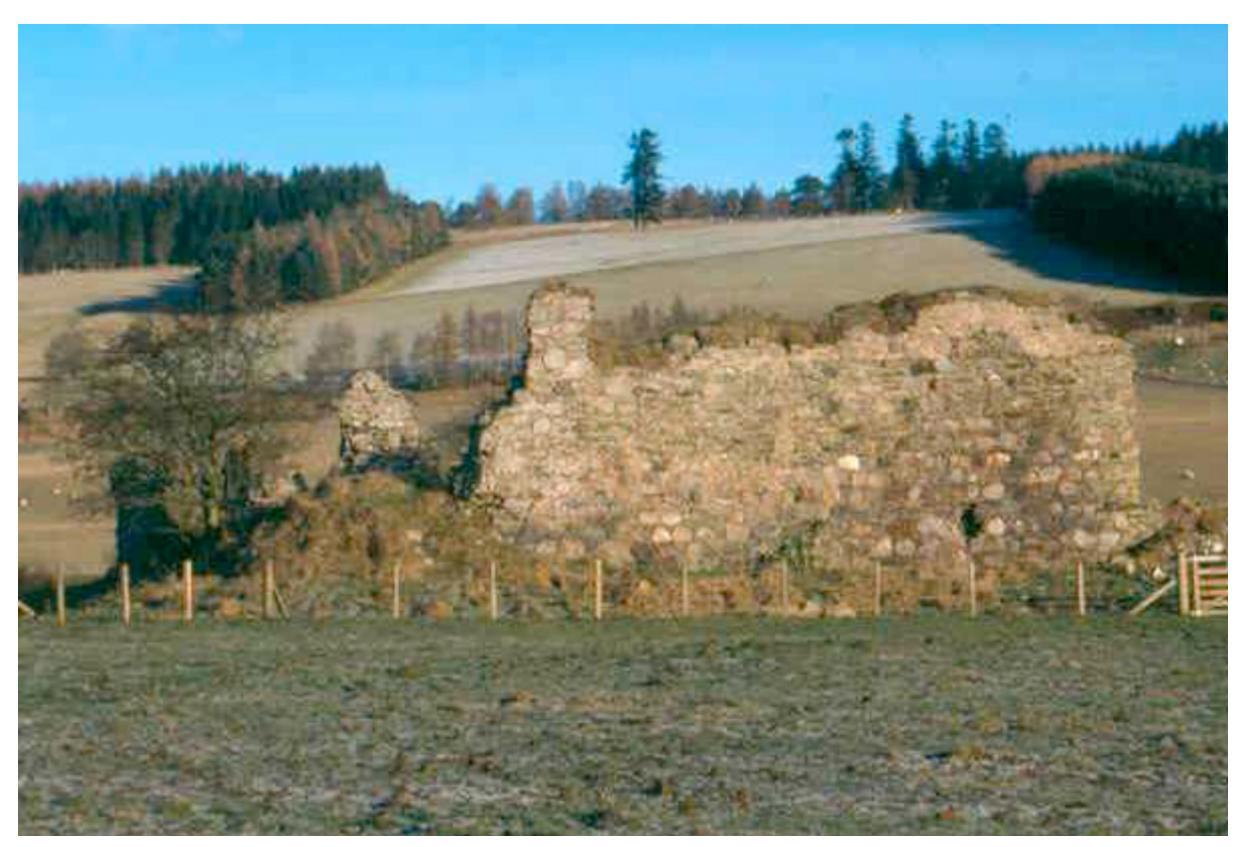
6.2	Effect of Climate:	The weeks immediately following the soft toppings work were exceptionally damp, and this may have contributed to good early rooting in. The subsequent damp winter conditions would also have prepared the vegetation for drier summer conditions.
		Photographs from the first winter (RT) indicate that the caps were less affected by frost than the surrounding ground, presumably because of their high level, and there was no indication of damage by frost (Fig. 13.11).
		Edge dieback seemed to be associated with drought conditions intensified by wind and solar exposure.

*Fig. 13.11: Photographs from the first winter indicate that the caps were less affected by frost than the surrounding ground, presumably because of their high level, and there has been no indication of damage by frost to the lime repairs.*

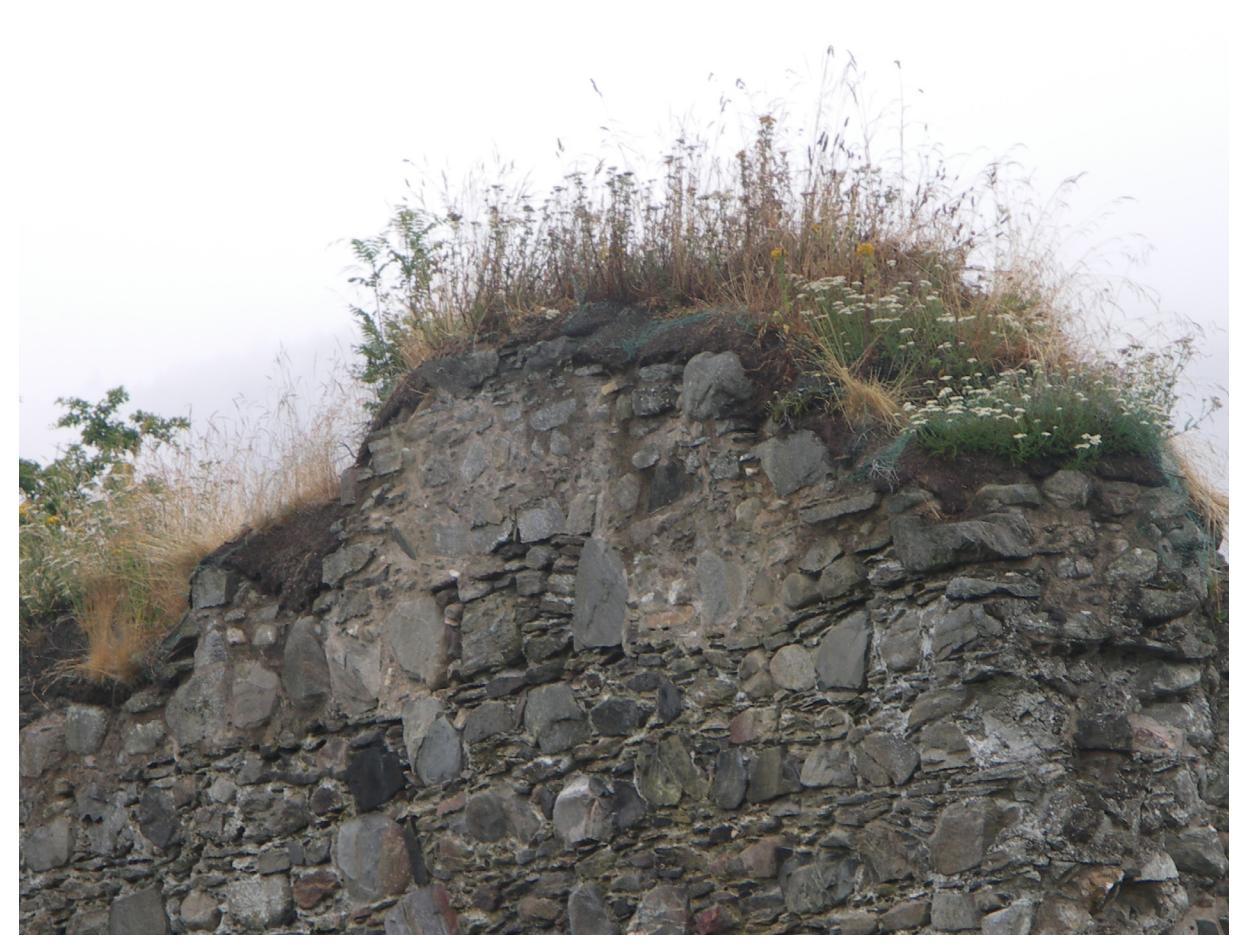
*Fig. 13.13: The core of the natural cappings were retained in situ to act as botanical reservoirs for recolonisation of the edges, in areas where these failed.*
