### SOFT CAPPING IN SCOTLAND

The context and potential of using plants to protect masonry

> Volume 2 Case Studies

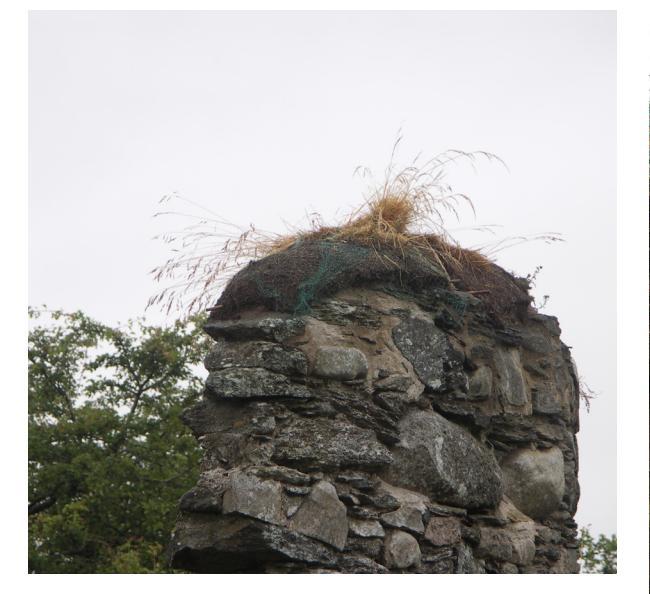
Fig. 13.14: One of the small northwest caps. Small areas of capping, such as this, are always vulnerable to drought damage.

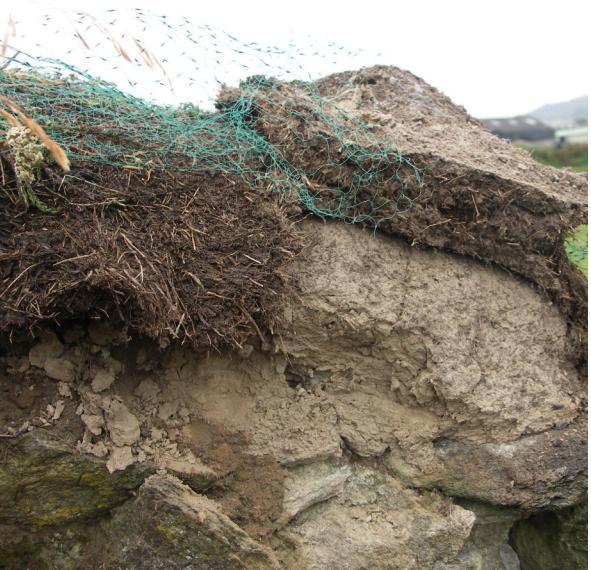
The smaller capped walls were in a similar condition, though edge dieback was more significant because of their thinner geometry. The worst conditions were found at the ends of these walls, where the turf had died completely, there was no colonisation and the clay underlayer was dry and hard (Fig. 13.15).
		The natural cappings appeared dry in places, but dieback was much less and limited to the west edge.

Fig. 13.15: Dry clay under dead turf on one of the small sections of new capping.

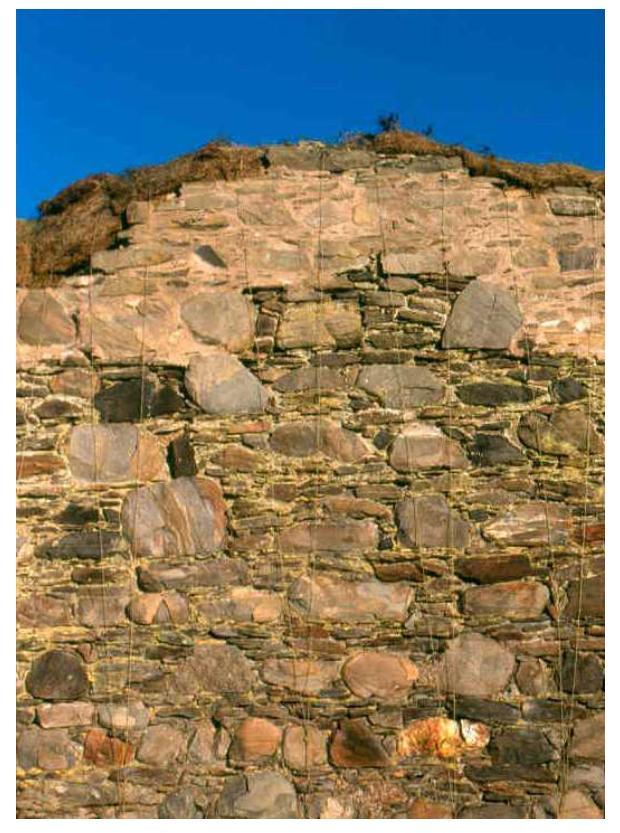
Fig. 13.16: Plastic netting was fixed with twine to timber pegs, which were located at low level so as to be easier to remove.

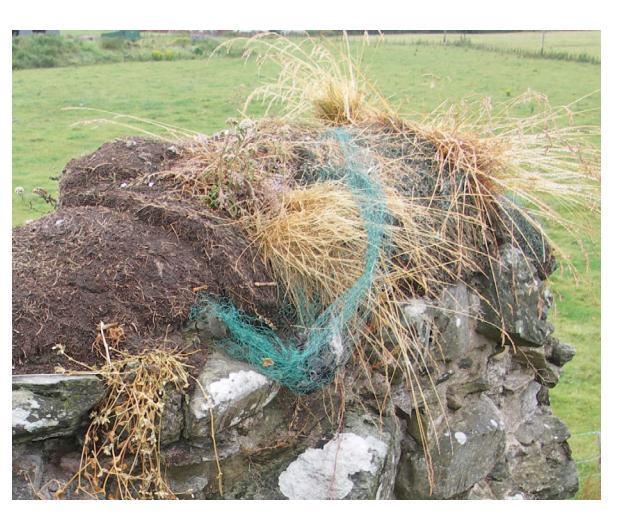
5.10	Fixing:	Large areas of capping (~75%) were fixed with twine, while smaller sections were fixed with green plastic garden netting, fastened with twine. The twine was tied to timber dooks in the wall at low level. This method of fixing was designed to prevent wind damage during the first few months of turf growth but to allow it to be removed later without the need for scaffolding (Fig. 13.16).	
		The netting was still in place and had not deteriorated after three years, though the twine had gone. The netting had become loose in places and was clearly visible on the lower walls (Fig. 13.17). Two dead birds were found, which had become trapped in the netting (Fig. 13.19).

*Fig. 13.17: Once the twine had rotted, the plastic netting loosened, trapping birds.*

The use of the newly capped wallheads for nesting or overseeing the surrounding area was terminally inhibited by the plastic netting

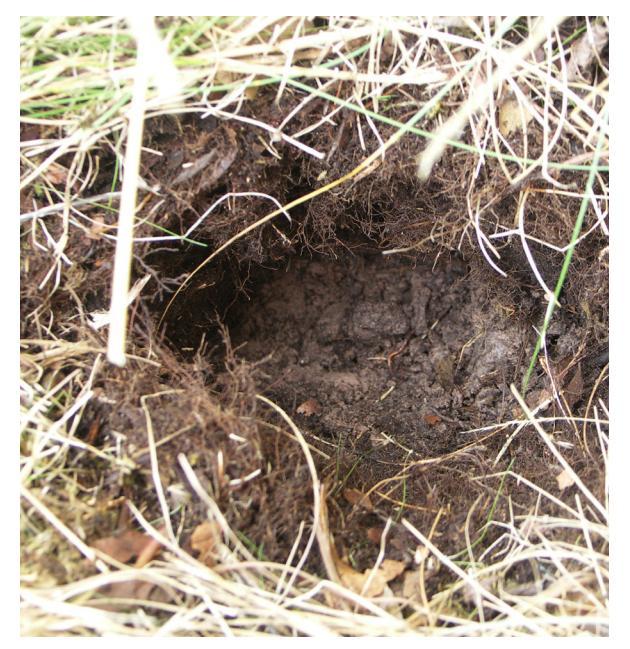
*Fig. 14.5: The clay below the turf soil was damp but firm, after a dry summer.*

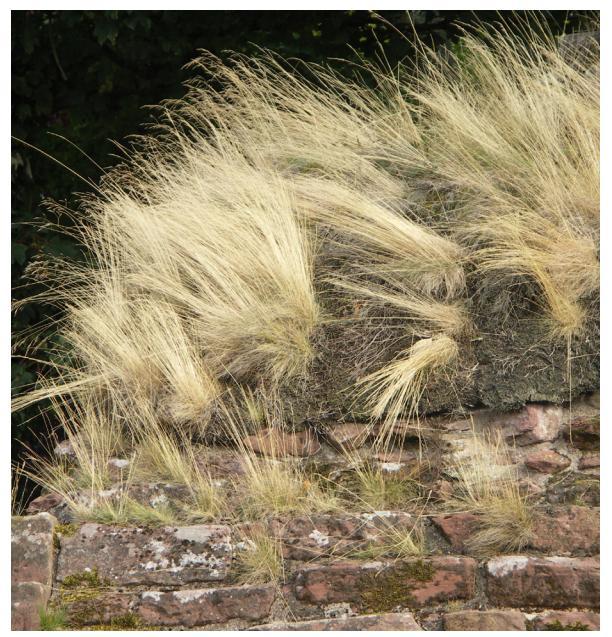
Fig.14.6: Eight years after capping, the turf joints were visible in dieback on the exposed, sloping west side, with colonisation by grasses of the masonry below.

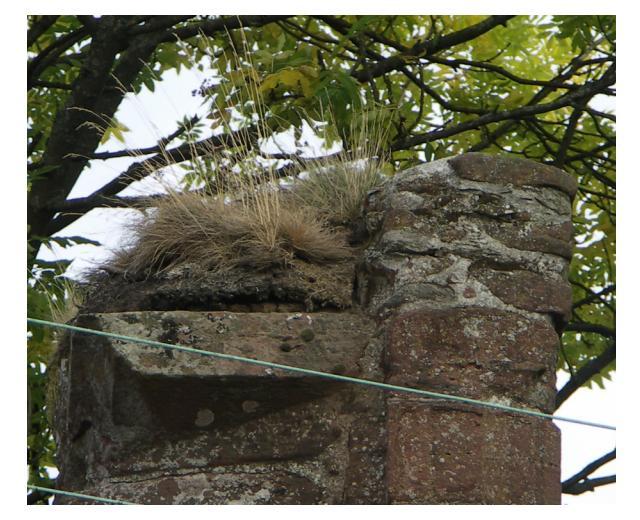
*Fig. 14.7: Eight years after capping, the grasses were still surviving on the more severe conditions of the stack top.*

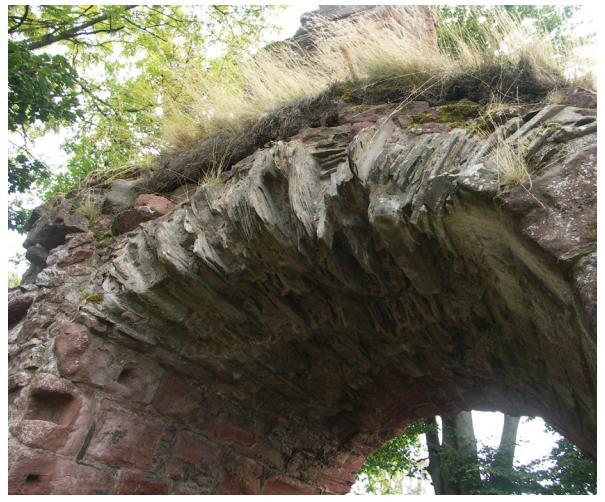
*Fig. 14.8: The edge over the vault is well established, with a pleasant grassy fringe.*

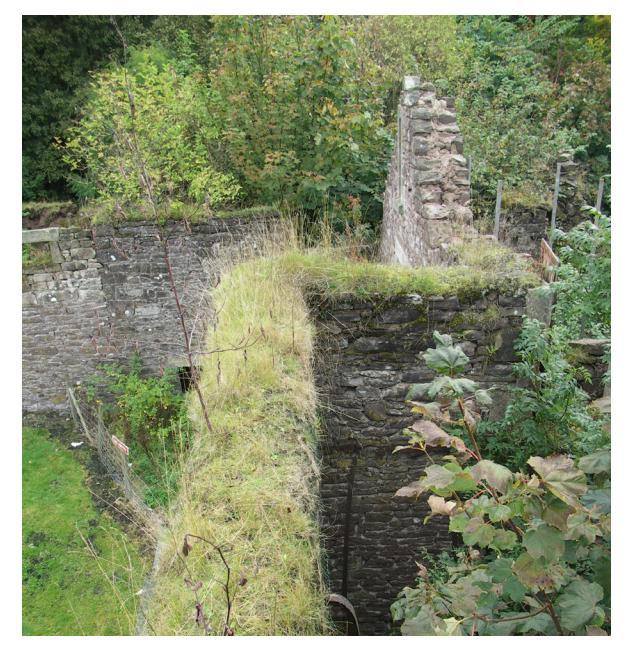
Fig.15.6 : The driest section of capping.

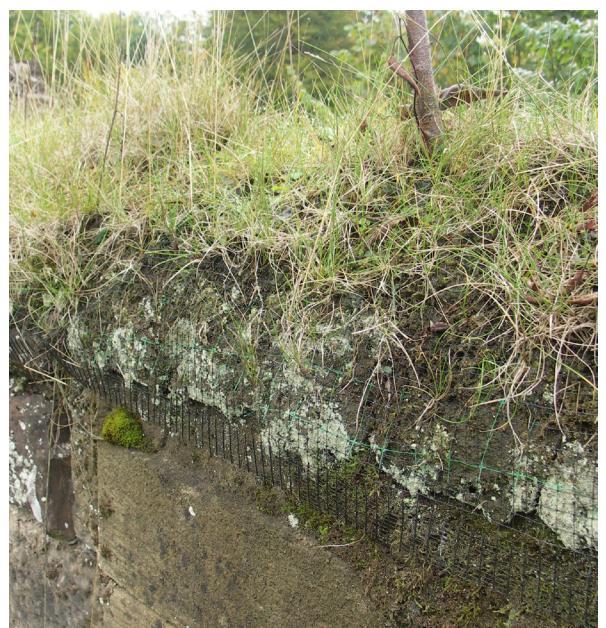
Fig.15.7 : The side has moss and lichen.

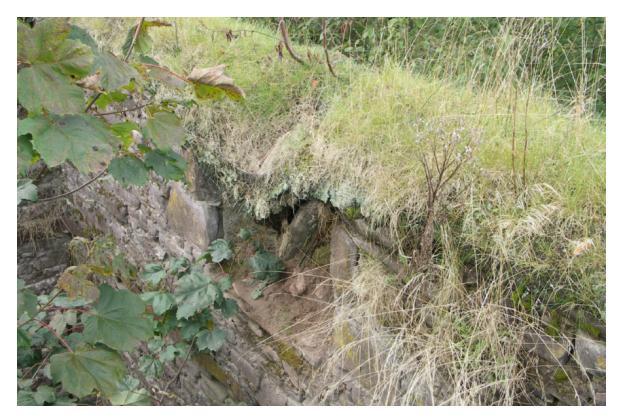
Fig.15.8: Collapsed timber lintel.

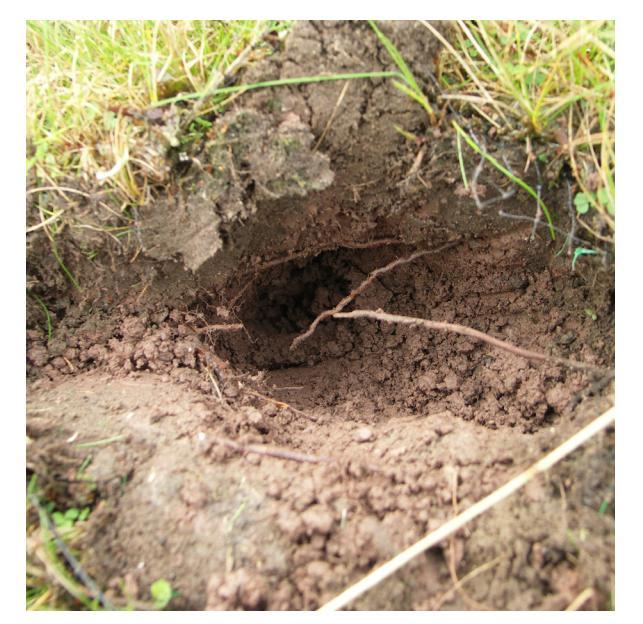
*Fig.15.10: The clay soil was much drier inside than on the surface.*

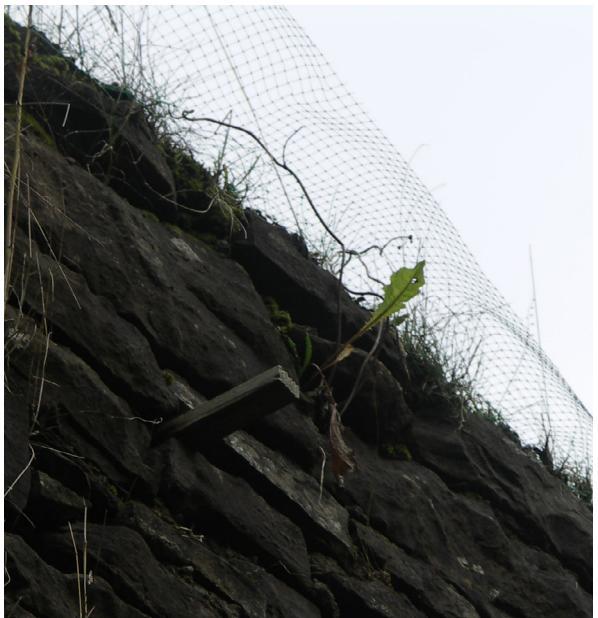
5.9	DPC:		None used						
5.10	0 Defining Membrane: None used								
5.11	Fixing:		A green, 10mm square plastic mesh was laid over the turf and fastened with twine to timber pegs and metal pins fitted into mortar joints (Fig.15.11).

Fig.15.11: Timber pegs and fine plastic mesh.

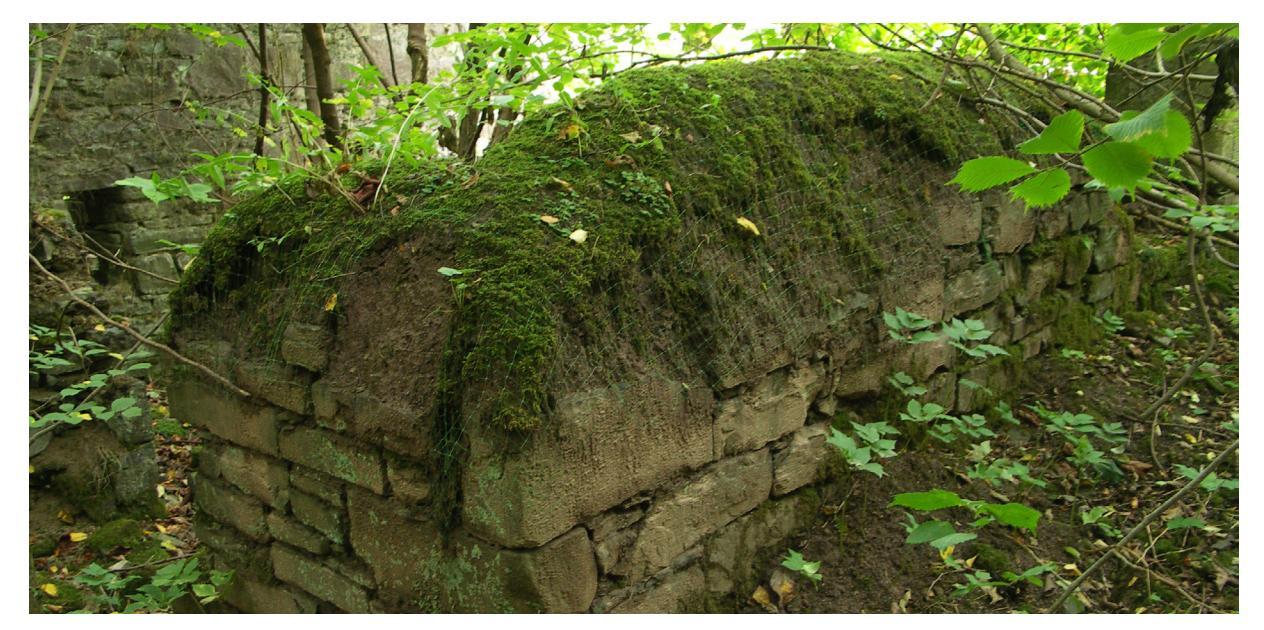
Fig.15.13: The Low East Wall.

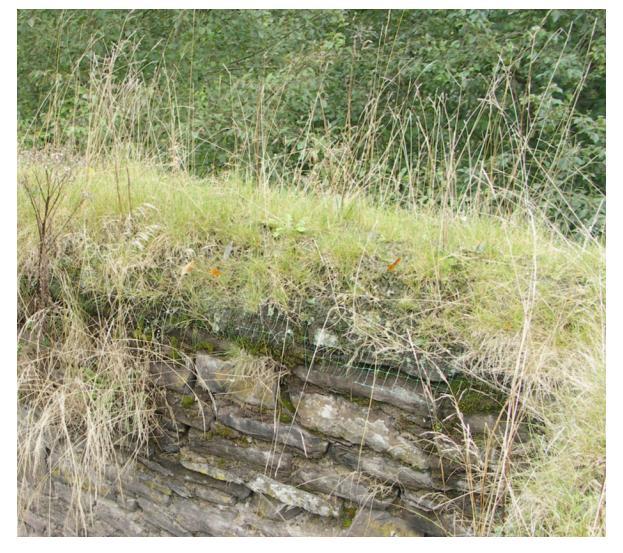
While the twine has rotted, the plastic mesh, metal pins and timber pegs remain in position. There was no evidence of the flax fibres when the clay was dug into, suggesting that they too have completely rotted.						
			The collapse of timber lintels and the staining on the masonry face (Fig. 15.14) indicate that the turf and clay layers had limited benefit as a moisture barrier to protect the wallhead masonry.						
		T fa	he soft walling has compared to the masonry walls.	letely failed	l, with remi	nants of clay re	emaining, c	on the broken inner

*Fig.15.14: The masonry for about 0.6m below the cappings is damp, with some surface staining.*

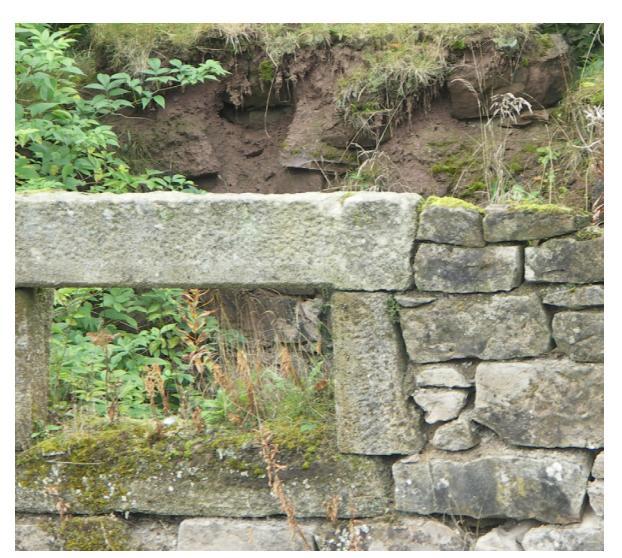
*Fig. 15.15: Clay from the soft walling test remains as a thin coating on the broken face of the outer masonry leaf.*

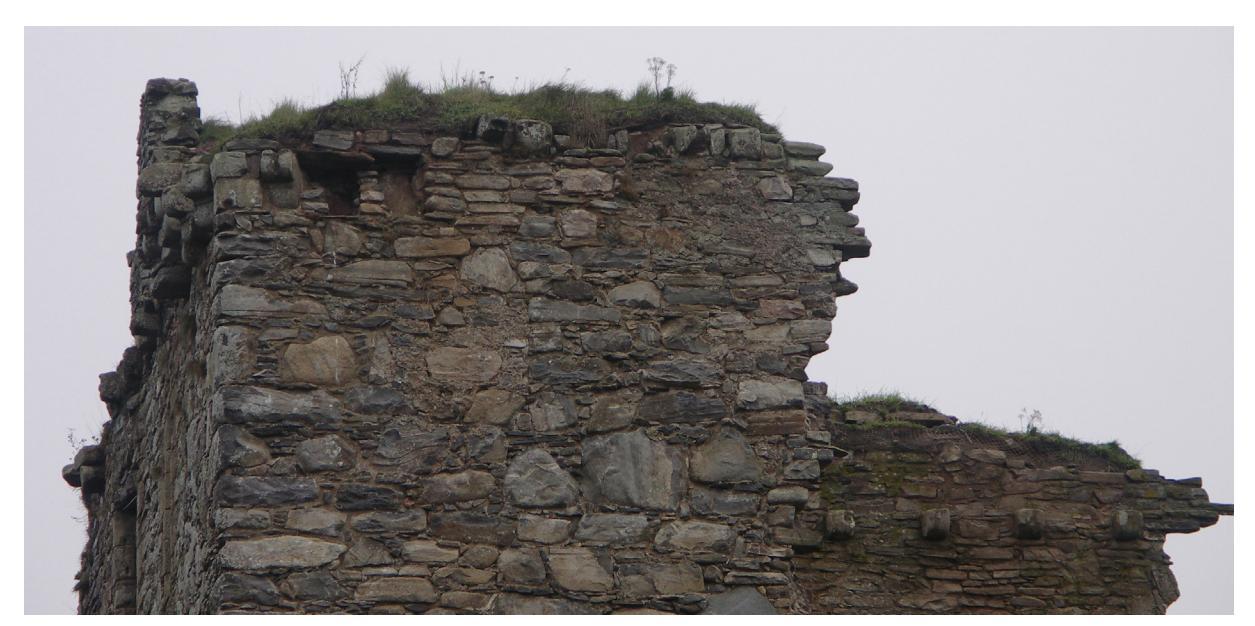
6.0	Performance Assessment	
6.1	General Performance:	The cappings have performed well in protecting the masonry from frost damage and reducing moisture ingress. The significance of the frost protection is demonstrated by the extensive damage to the lime mortar repairs that have not been soft capped (Fig. 16.6).
		There is significant edge dieback, which has resulted in extensive clay staining of the masonry face (Fig. 16.2).

Fig. 16.2 Detail of the head of the west wall.

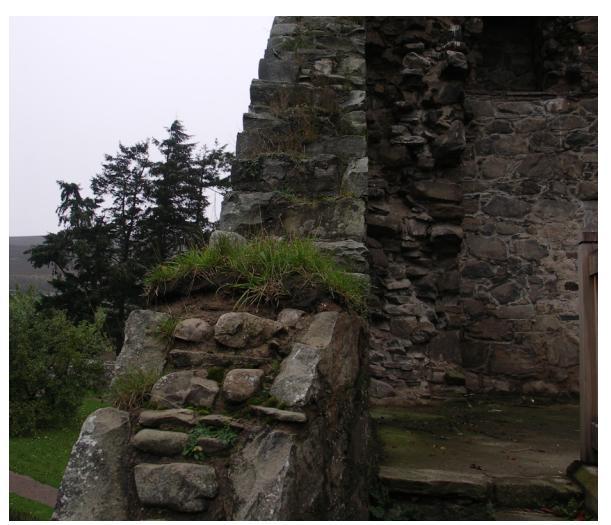
6.5	Aesthetic Performance:	The cappings are successful in giving the impression of a naturalistic ruin. Given the height of the tower, the cappings make a subtle impact overall (Fig. 16.3), though they can conceal detail locally (Fig. 16.5). The concrete floor, frost damaged lime mortar and clay staining detract from this impression.

Fig. 16.5: The capping protects but conceals the layered wall construction.

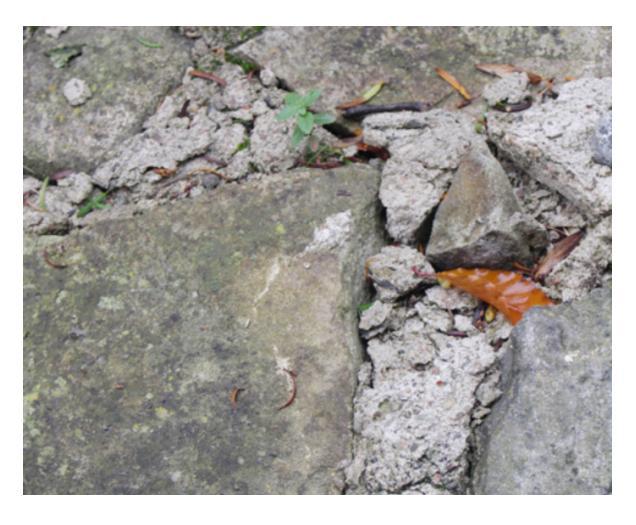
Fig. 16.6: Typical frost damage. This type of rough racking, consolidated with lime mortar but uncapped, is then open to uncontrolled colonisation by plants.

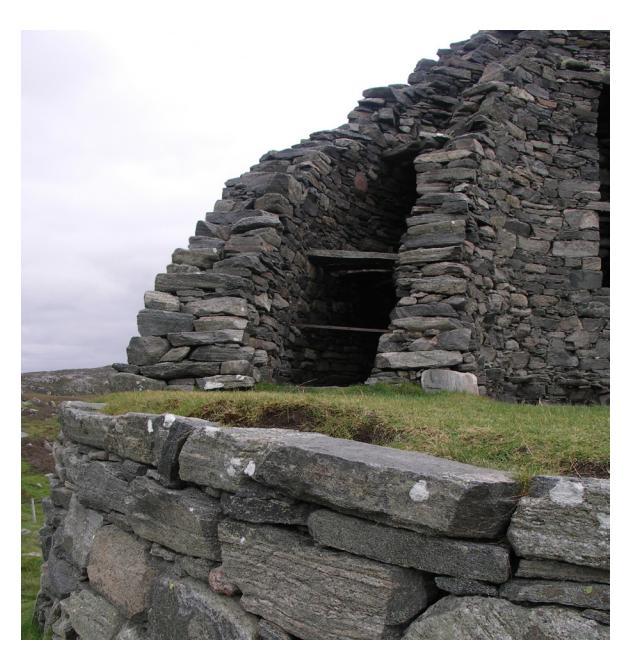
6.2	Effect of Climate:	The climate does not seem to have had a significant effect. Given the apparent longevity of the capping, the species will have adjusted to suit the conditions. The edges also present a low profile to the wind (Fig. 17.5).

Fig.17.5: Typical how profile edge, minimises wind exposure.

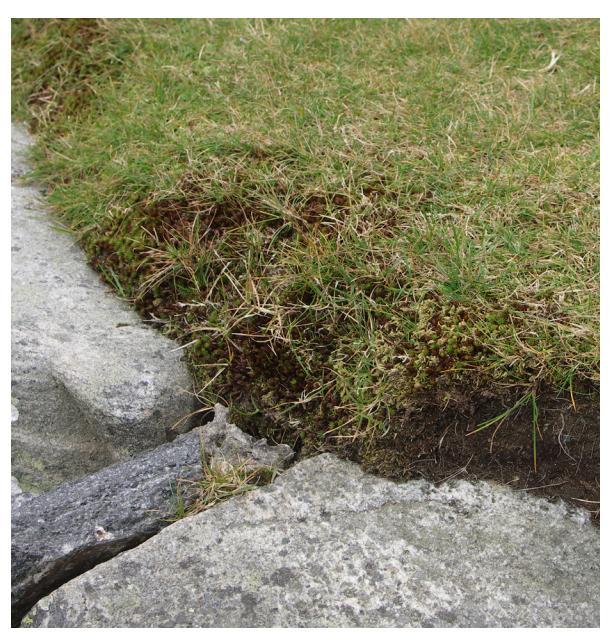
Fig.17.4: Moss growth at the edge.

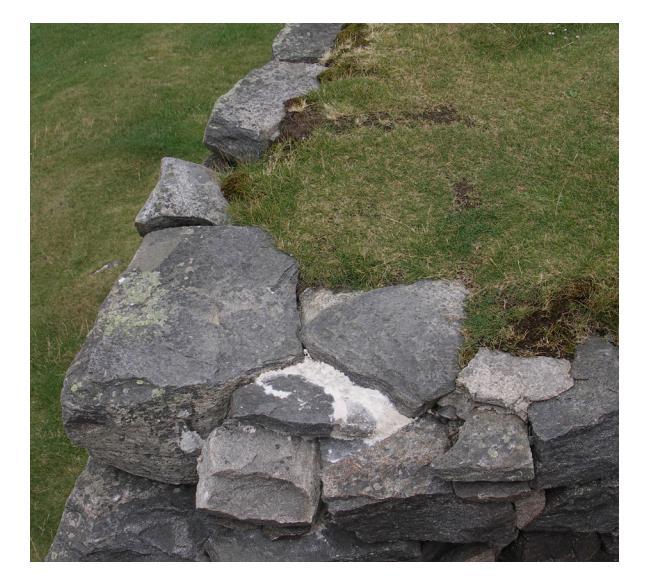
6.0	Performance Assessment		
6.1	General Performance:	The turf capping performs well in binding the unmortared masonry and protecting it from mechanical damage by visitors climbing on the wallheads; this is a significant problem. Several of the drystones have been mortared in place (Fig. 17.7), but one at high level had still been dislodged by a visitor climbing in the higher levels and was lying on the ground. The external south face of the broch has been heavily colonised by lichen (Fig. 17.9). This is likely to have been a continuous process since the construction of the broch, with much less growing on the inner face. Growth is also less on other orientations of external wall, suggesting solar exposure encourages growth. That the south wall is also the best preserved and tallest might suggest that the lichen is adding to the stability of the masonry.

*Fig.17.7: Stones are occasionally mortared in place where not bound by the turf.*

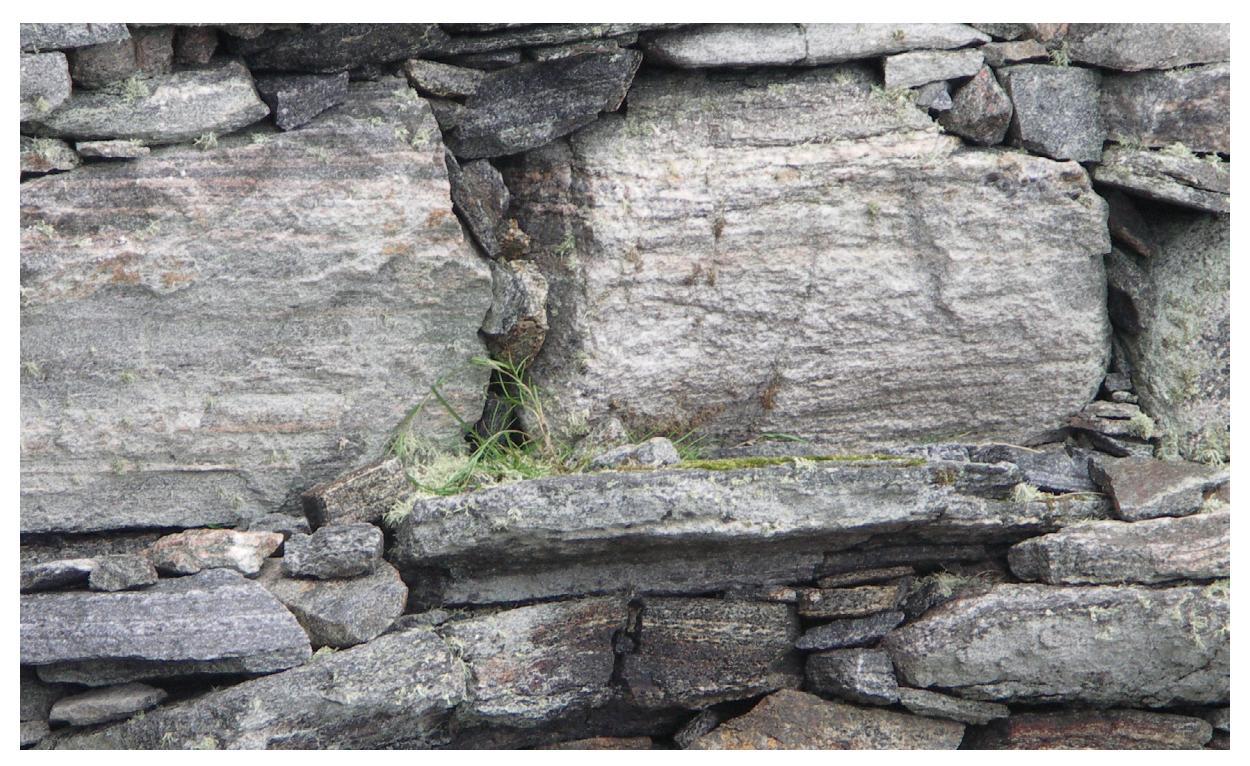
Fig.17.8: There are only rare isolated examples of colonisation of the inside drystone.

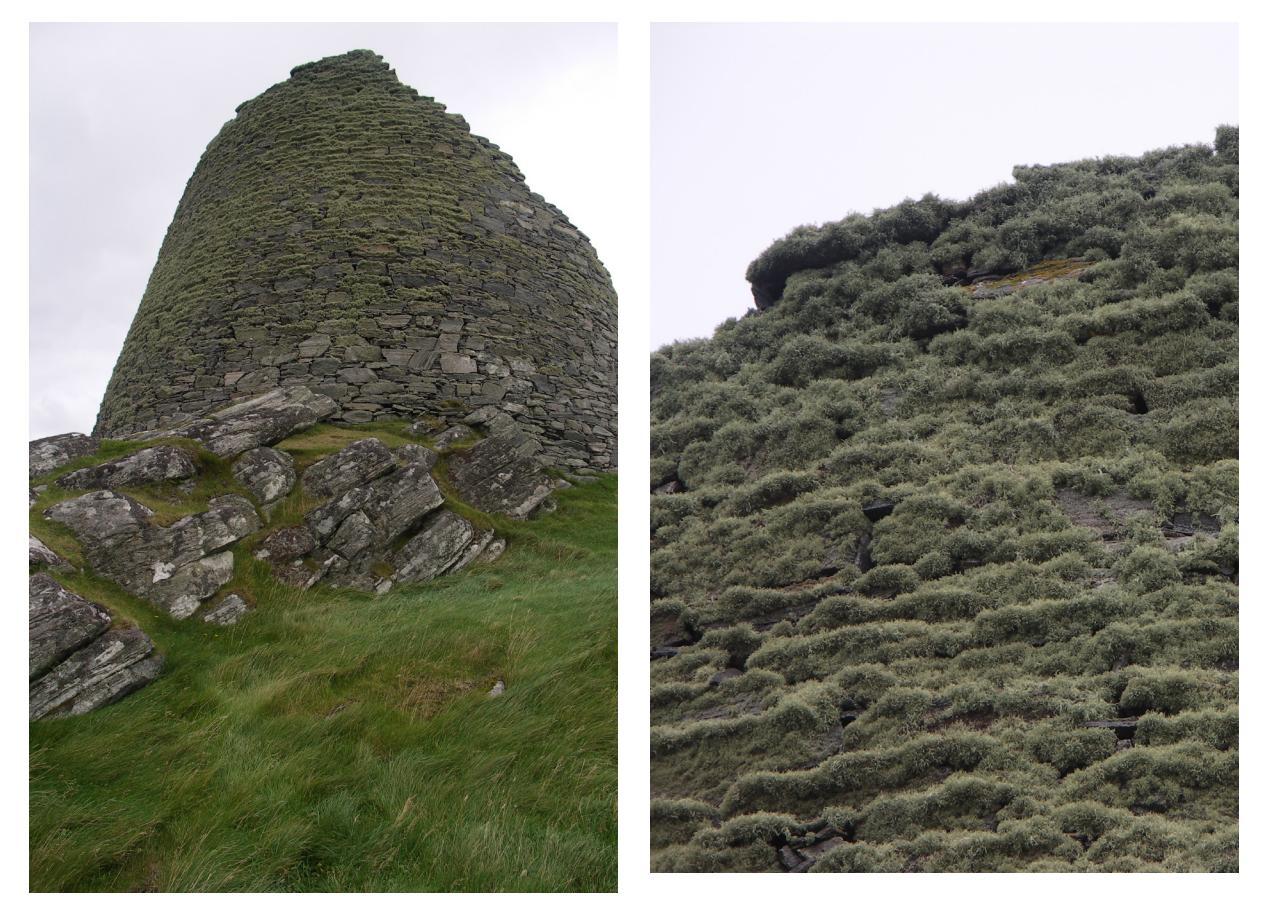
Fig.17.9: South side, with extensive colonisation by lichen.

Fig.17.10: Lichen growth may help bind the masonry.

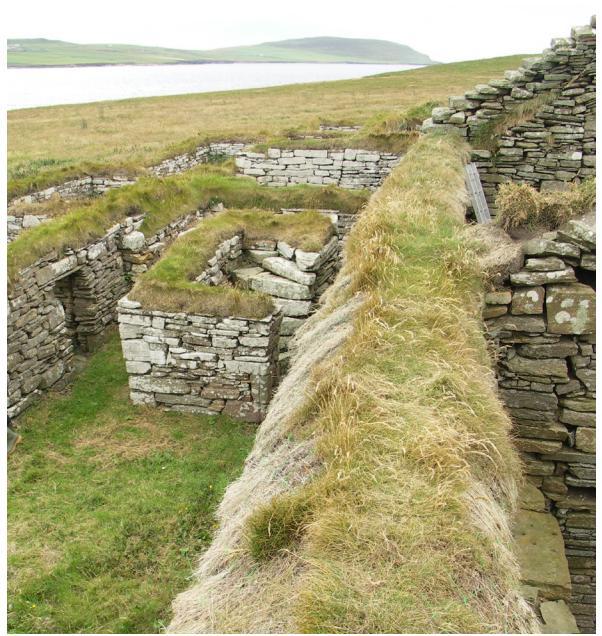
Fig. 18.5: Comparable view, 2006. The 2003 repairs in the foreground dying back to a central strip.

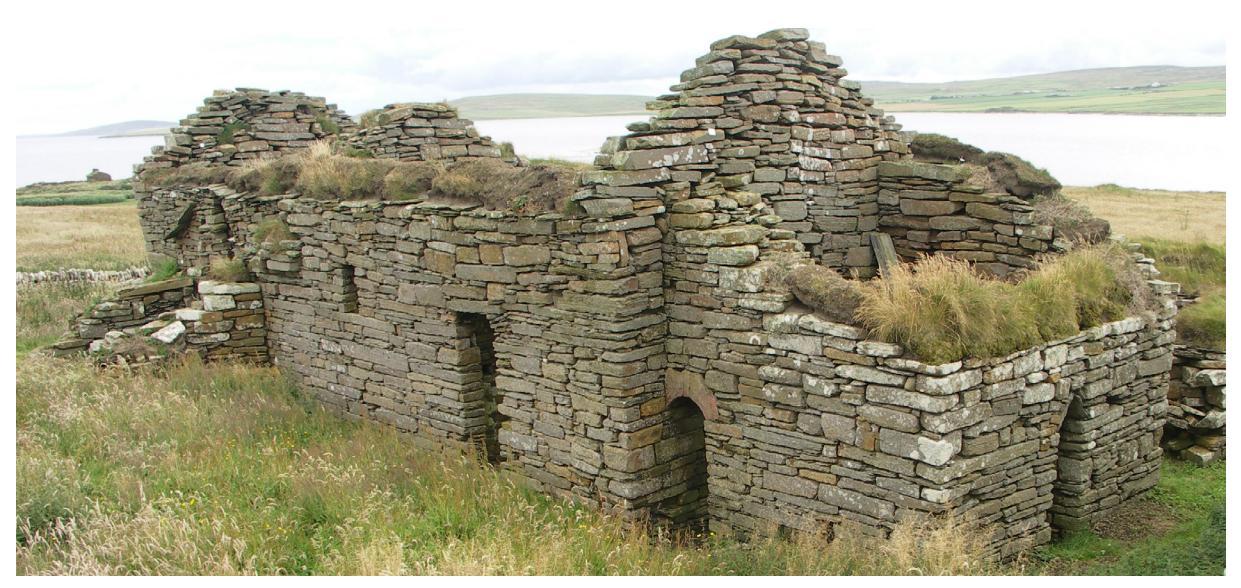
6.0	Performance Assessment	
6.1	General Performance	<i>Early Cappings: The Chapel.</i> On the chapel, there is progressive decay of the cappings, varying in degree. The severity of decay of the cappings has a direct correlation to wind exposure and wallhead incline (Fig. 18.6). The caps to the end gables have completely disappeared. Those to the west gables and internal cross-wall are in an advanced state of deterioration and the caps on the flat north and south wallheads have significant and progressive decay. There is some evidence of accelerated decay above cap stone joints.
		Much of the, presumably galvanised, chicken wire remains, which is surprising given the salt laden air (Fig. 18.8).
		The caps rise to a height of ~ 300-450mm, with the upper 50-100mm well stabilised with the grass root system. Below this there are few or no roots and there is severe undermining of the edge faces by wind erosion. The soil appears to be clay rich and must be reasonably robust to have survived such severe exposure, assuming that the edges have not been covered by vegetation for a significant period.

Fig. 18.6: The chapel from the north-west. The prevailing wind is from the right.

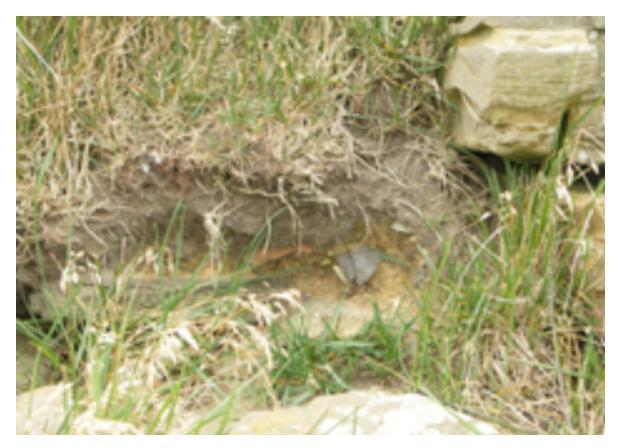
Fig. 18.7: Original clay mortar beneath the old soft cappings.

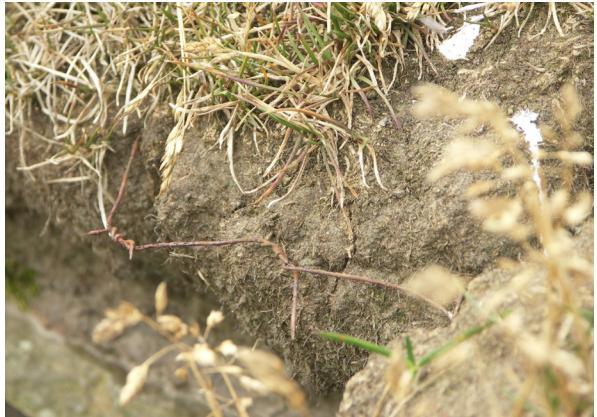
Fig. 18.8: Chicken wire survives in the old cappings.

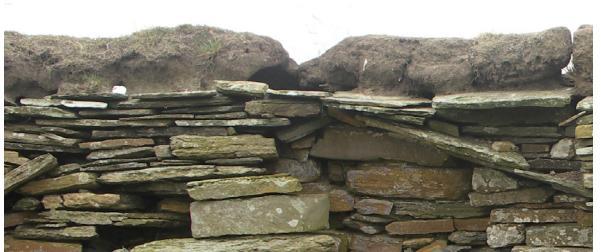
*Fig.* 18.10: *The weight of the failing old cappings still protects the stones from wind uplift.*

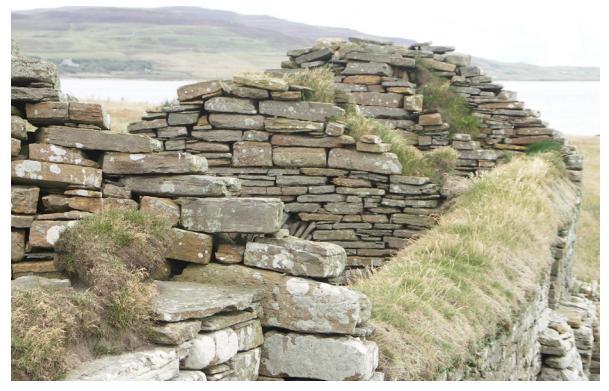
*Fig.* 18.18: *The re-capped wallhead contrasts with the decayed older cappings.*

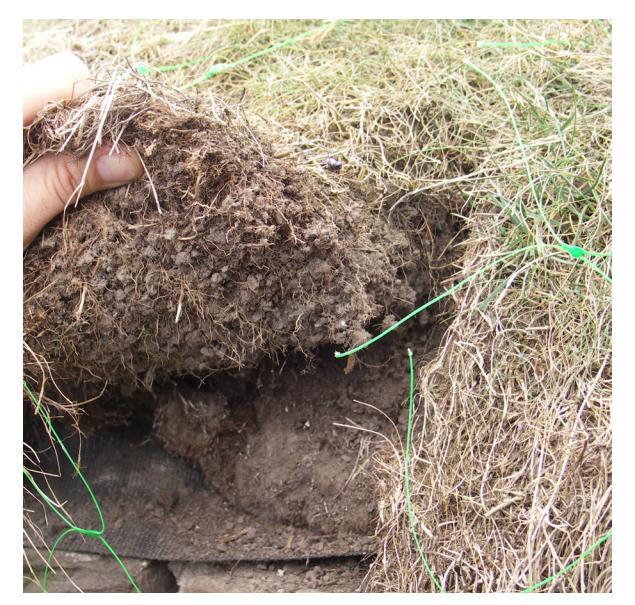
<i>Recent Cappings.</i> Both sections of repair seem to be suffering the onset of the same decay mechanisms that affected the old caps, though this had progressed more in the earlier section. The edges have failed to prosper. The older section is worse than that from 2004, with dead turf on the edges, especially the south side, and much shrinkage of joints. However, examination of the 2005 edges showed that the turf had failed to root in and the soil beneath was dry and hard (Fig. 18.19).
		The difference in plastic mesh size does not appear to be a significant factor in the success or failure of these repairs. The poorer condition of the older test may be more attributable to drier weather conditions immediately after the repairs, on a site where aftercare is not possible due to access restrictions.
		Both caps are providing the same protection that the original caps gave and this will inhibit the decay of the masonry below.

*Fig. 18.19: One year after application, the edge of the 2004 repairs had failed to root in and was dying back.*

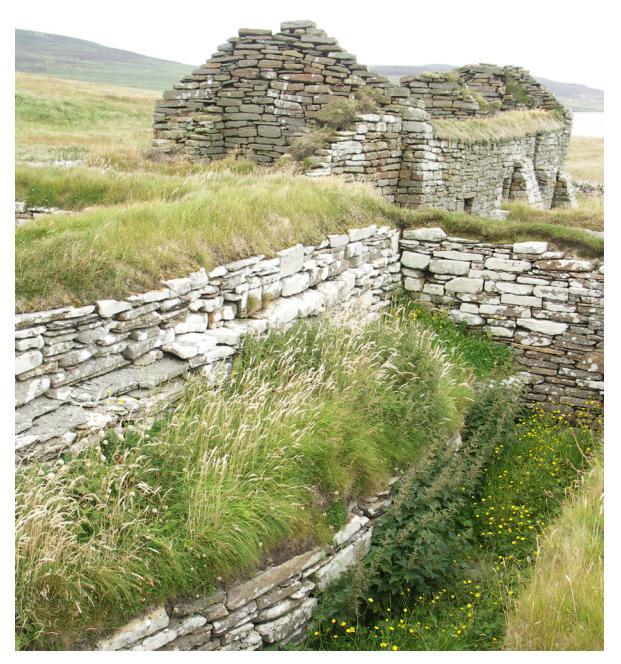
Fig. 18.21: The lower walls show dieback relating to wind exposure.

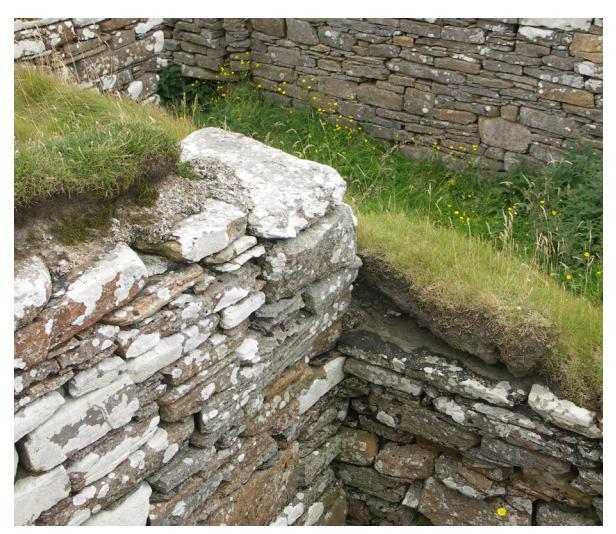
*Fig. 18.24: Local wind eddies create unpredictable patterns of decay.*

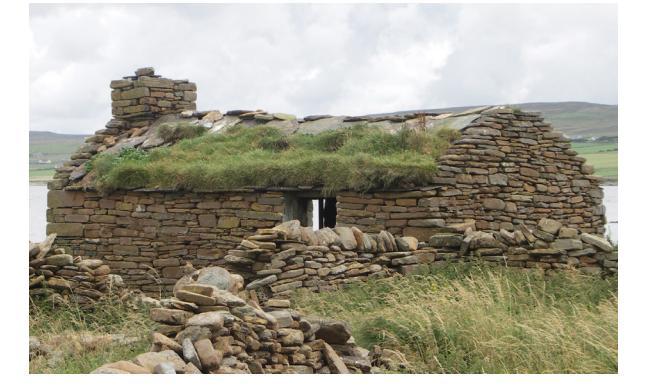
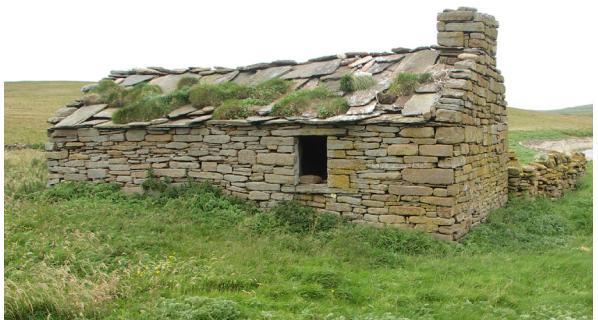
6.2	General Performance of Neighbouring Ruin	There is a nearby ruined shore-side cottage, which has a vernacular roof construction of turf on low pitched stone slabs, as described in CS8. It is assumed that this was also abandoned in the mid 19thC. The turf cap showed progressive decay from the ridge, with about 70% loss of cover on the south side and 40% on the north. This indicates that the climatic conditions are too severe for the survival of relatively large areas of exposed capping. However this represents 150 years of decay and some occasional maintenance was presumably carried out to habited buildings. Some other ruined walls to the north show only occasional colonisation by grasses and other species, indicating that the severity of the climate inhibits natural colonisation of masonry (Figs. 18.25 and 18.26). Though birds were nesting in the turf, there was no sign of direct damage.

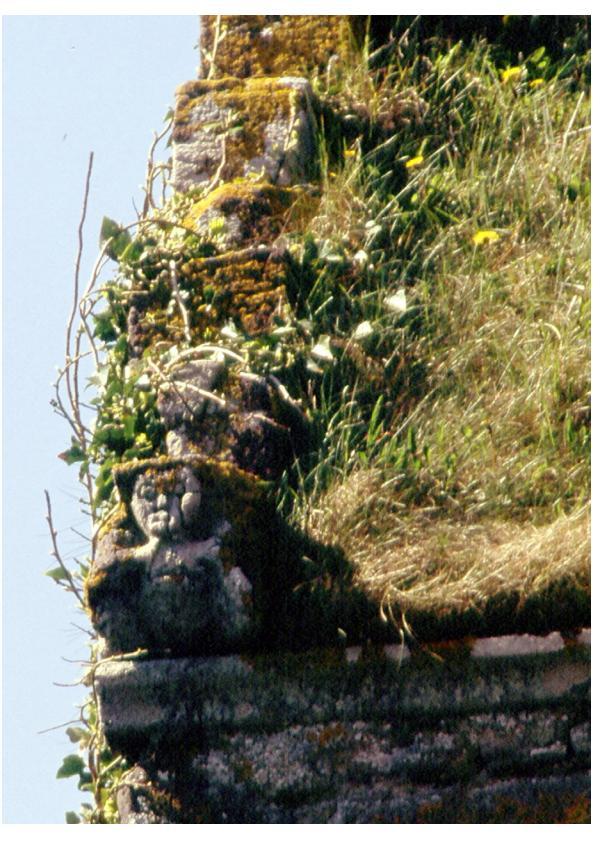
*Fig.19.3: The north-west corner prior to repairs, with ivy threatening to conceal the architectural detail.*

5.4	Treatment of Existing Vegetation:	The existing naturally established capping vegetation was fully removed, carefully stored and watered, so that it could be re-applied later. Ivy, which covered the eastern wall exterior and was patchy elsewhere, was completely removed (Fig. 19.1).

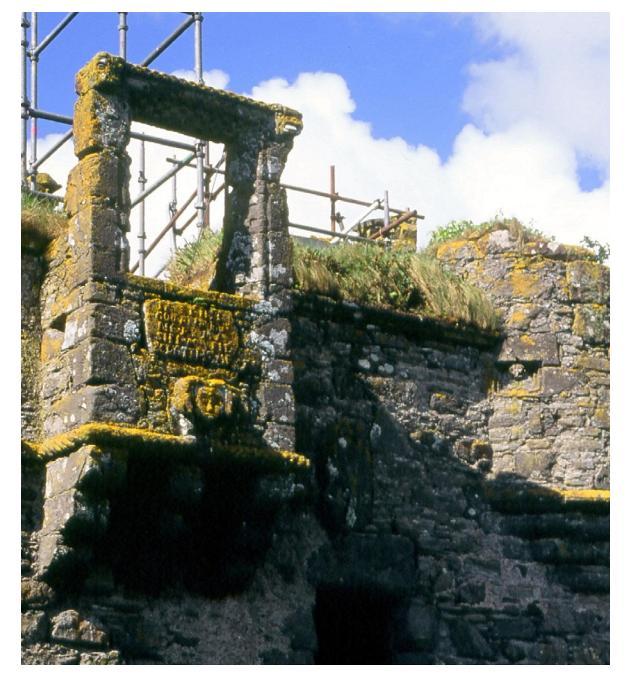
Fig.19.6: The natural turf capping gave good protection to the wallheads in exposed conditions, but left more slender masonry unprotected.

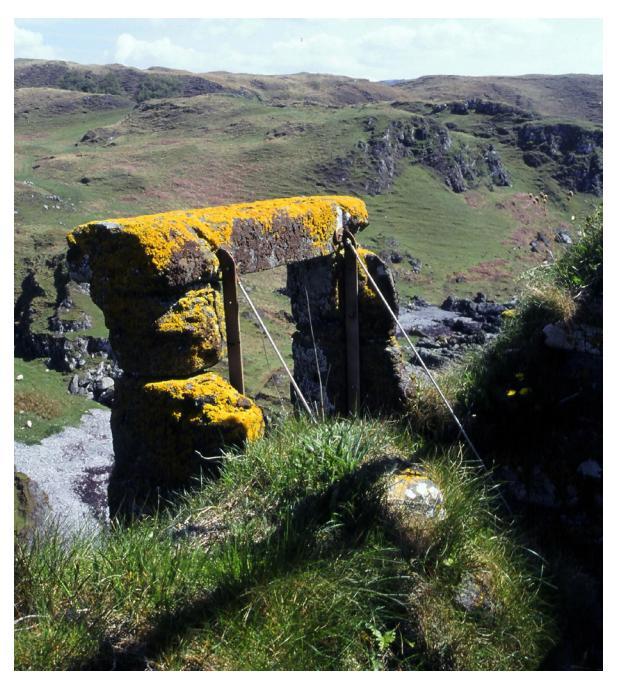
Fig.19.7: The window opening shown above, after the repairs and reinstatement of the original capping turf. This side is more sheltered than the seaward side.
### Case Study 20: HUGH MILLER'S COTTAGE, Cromarty, Ross & Cromarty

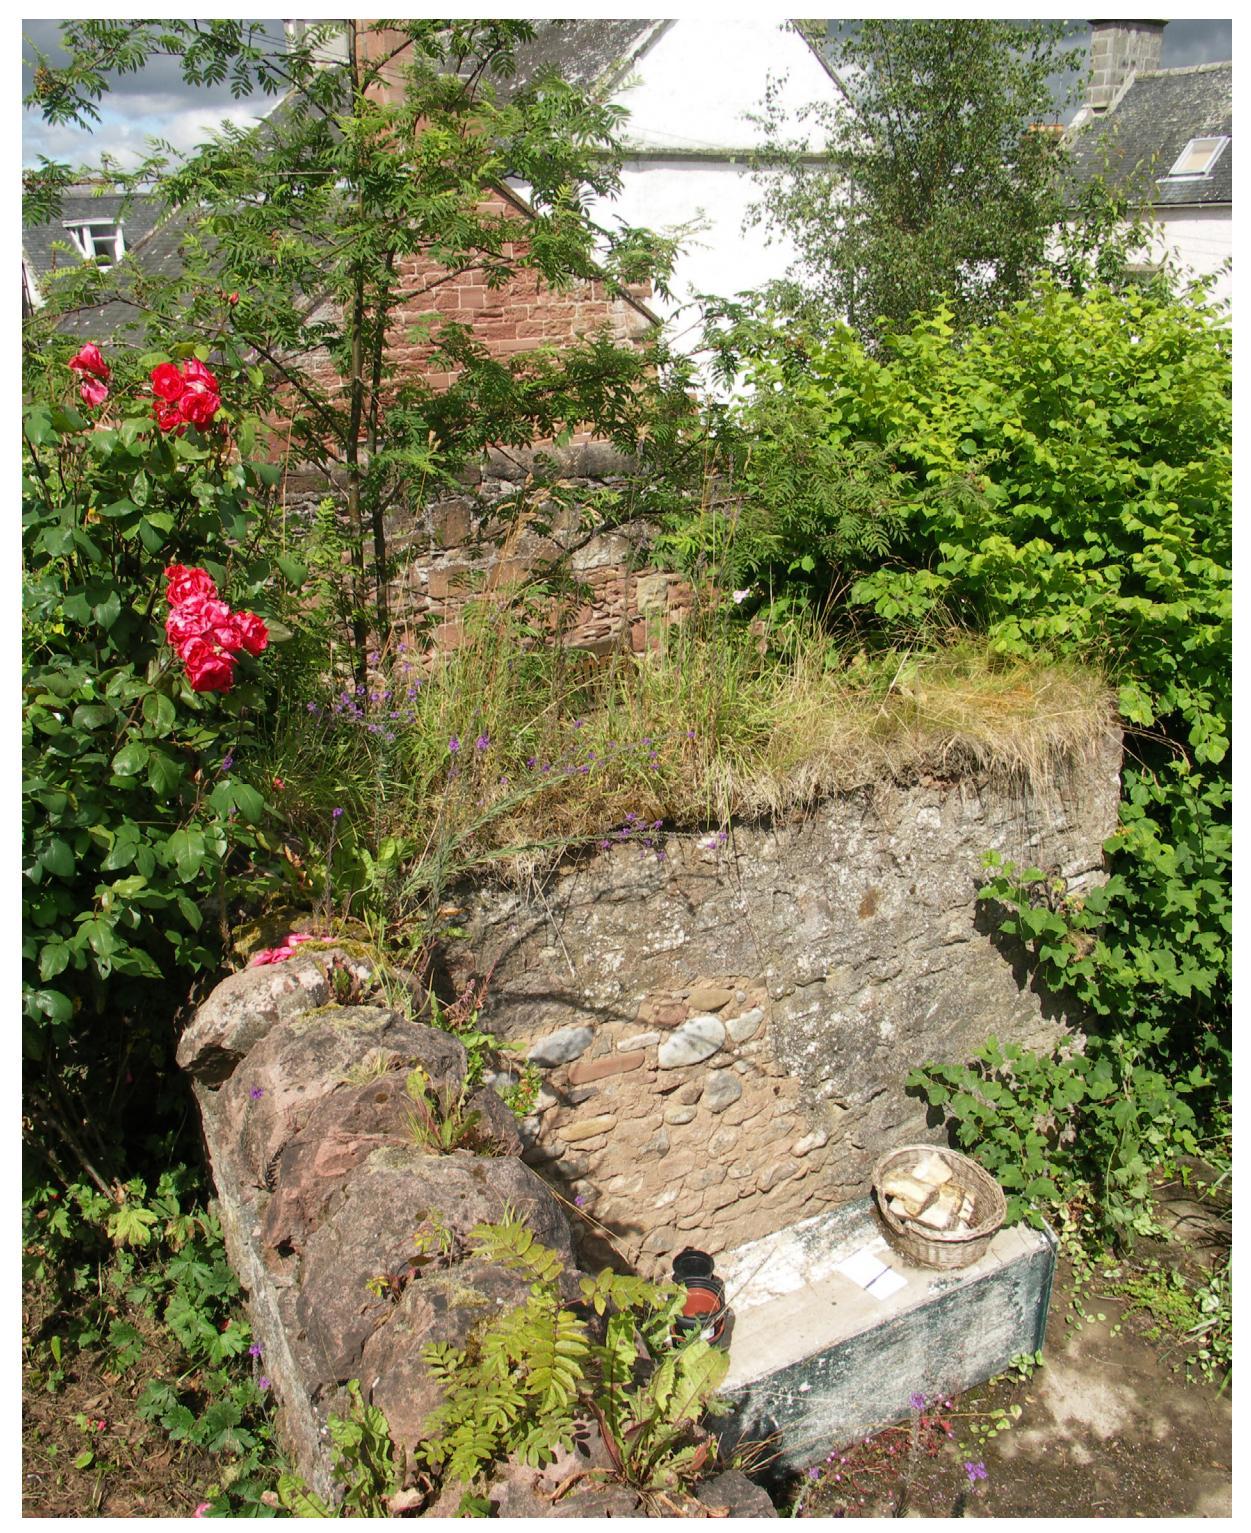
*Fig. 20.1: Garden Wall, Hugh Miller's Cottage. South-east view, five years after capping. The turf has surprisingly little colonisation by garden species and much less than the adjacent stone coped wall.*

Although the rich seed bank of the neighbouring gardens seems to have had limited effect to date, it would be wise if species such as dandelions were occasional removed. The permanent staffing of this property would make this a simple task.			
	<u>`</u>

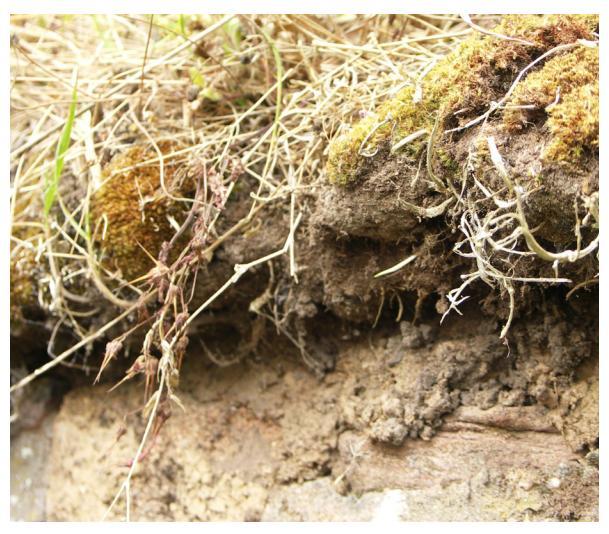
6.0	Performance Assessment	
6.1	General Performance:	The capping has survived well, and would appear to have dramatically reduced the amount of precipitation penetrating the wallhead.
		The vegetation forms a thick root mat in sandy soil, ~50mm thick, covering the layer of clay beneath, which remains quite distinct, with little root penetration. The vegetation felt damp, but the clay layer was quite dry and formed a solid cap on top of the wall, with no root penetration through into the masonry.
		The vegetation forms a significant lip, overhanging the edge by 25-30mm. However the species vary between the two sides, with the south side dominated by mosses and the shadier north side having more grasses, growing to 600mm tall (Figs 20.5 and 20.6).

Fig. 20.5: The south edge has a thick mossy overhang protecting the clay mortared masonry below.

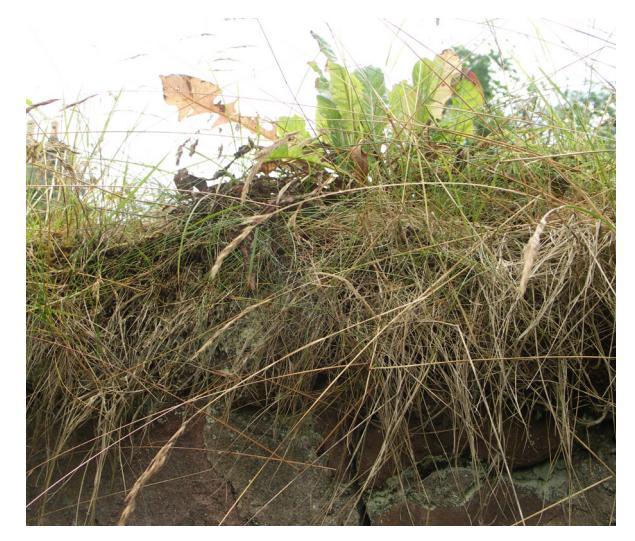
*Fig. 20.6: The north edge has a similar overhang, but containing much more grass.*

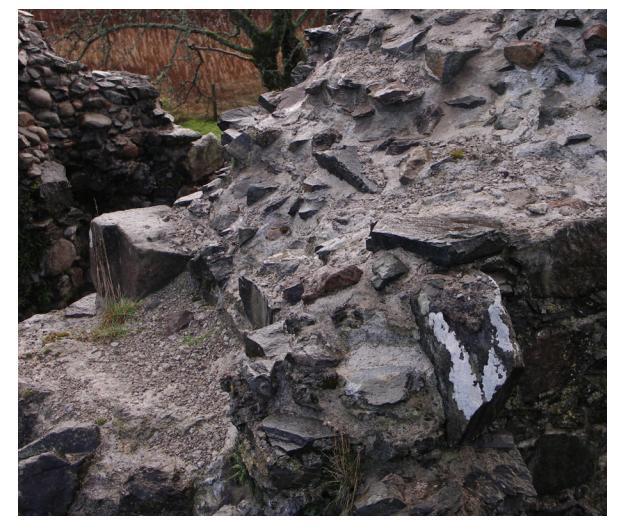
Fig. 21.4: Frost damage to lime mortared wallheads.

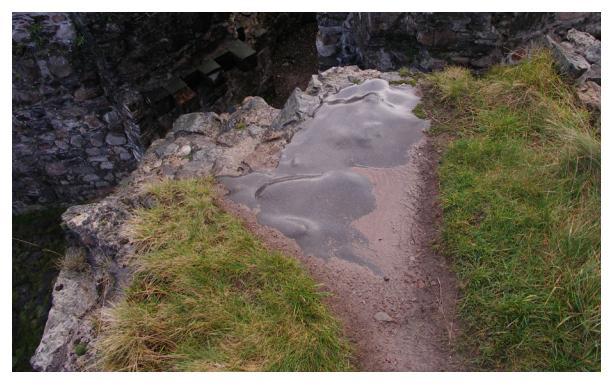
Fig. 21.13: East wall, bitumen exposed by foot traffic.

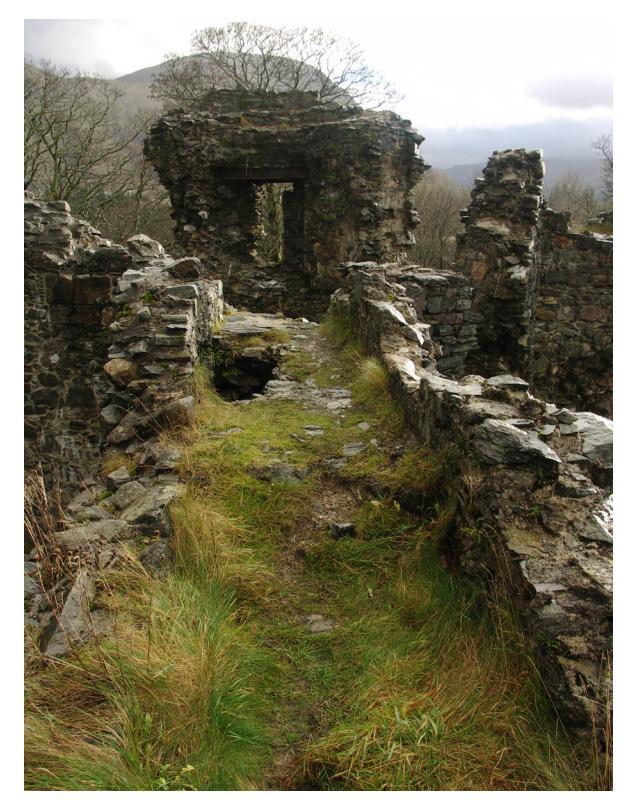
Fig 21.14: West wall, masonry exposed by foot traffic.
