### SOFT CAPPING IN SCOTLAND

The context and potential of using plants to protect masonry

> Volume 2 Case Studies

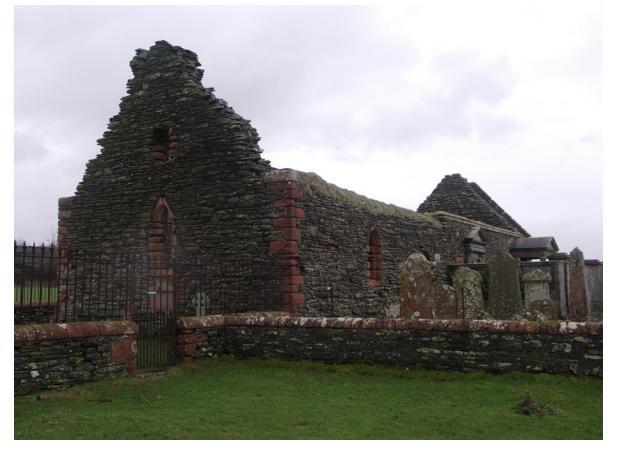
*Fig. 22.3: A view of the chapel from the south-west, 2006. The bare gable contrasts with the capped south wall.*

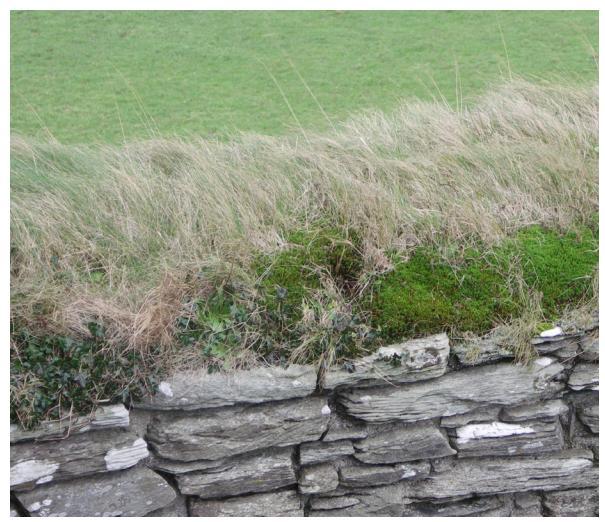
6.1	General Performance:	The natural north wallhead capping is mature, with a dense sward (Fig. 22.8). There are remnants of the ivy, but these do not seem to be prospering in the dense mass of vegetation. The cap is in good condition and seems to be protecting the underlying masonry well.

Fig. 22.8: The natural cappings have good benign species diversity.

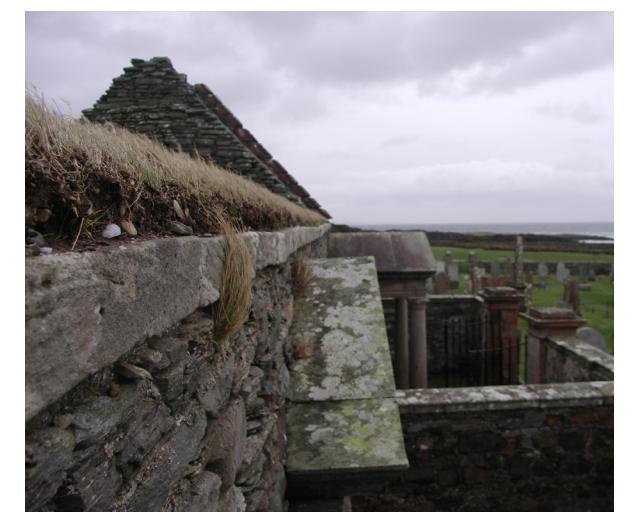
6.4	Effect of Animals:	None noted
6.3	Effect of Birds:	None noted
6.2	Effect of Climate:	The southern edges experience most exposure to wind and, combined with the fact that these are finished to an even line, this creates considerable stress on the capping edge, leading to decay away from the stone edge.
		The south-east capping is generally sound and comparable to the south-west capping, but has an unstable outer south edge (Fig. 22.11). Here, the edge sits $\sim$ 25mm back from the stone edge and is actively decaying, with exposed roots and soil $\sim$ 50mm high. The inner north edge is stable (Fig. 22.12).
		The south-west capping has taken well, forming a similar dense sward, but much less species diverse and dominated by grass, giving a very uniform appearance, reminiscent of the west wall of Skipness Castle. On the outside south edge, it sits ~50mm back from the stone edge. The capping edge is stable and mature, which suggests it may either have originally been finished to this line, or it stabilised several years ago, following initial dieback. The inner north edge is stable and finishes to the masonry edge.

*Fig.* 22.11: *The decaying south edge on the south-east capping.*

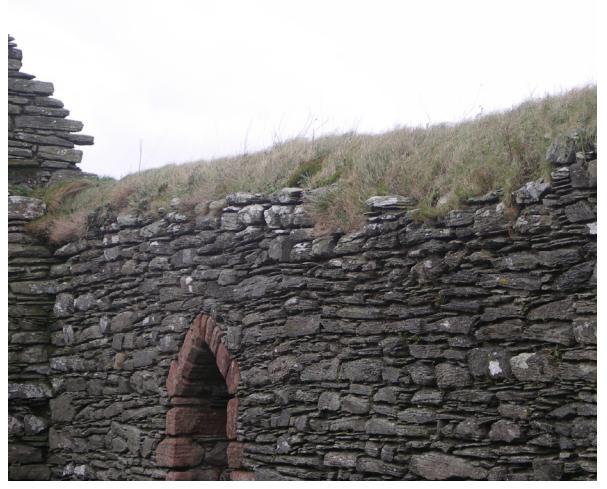
Fig. 22.12: The inner edge of the south-east capping.

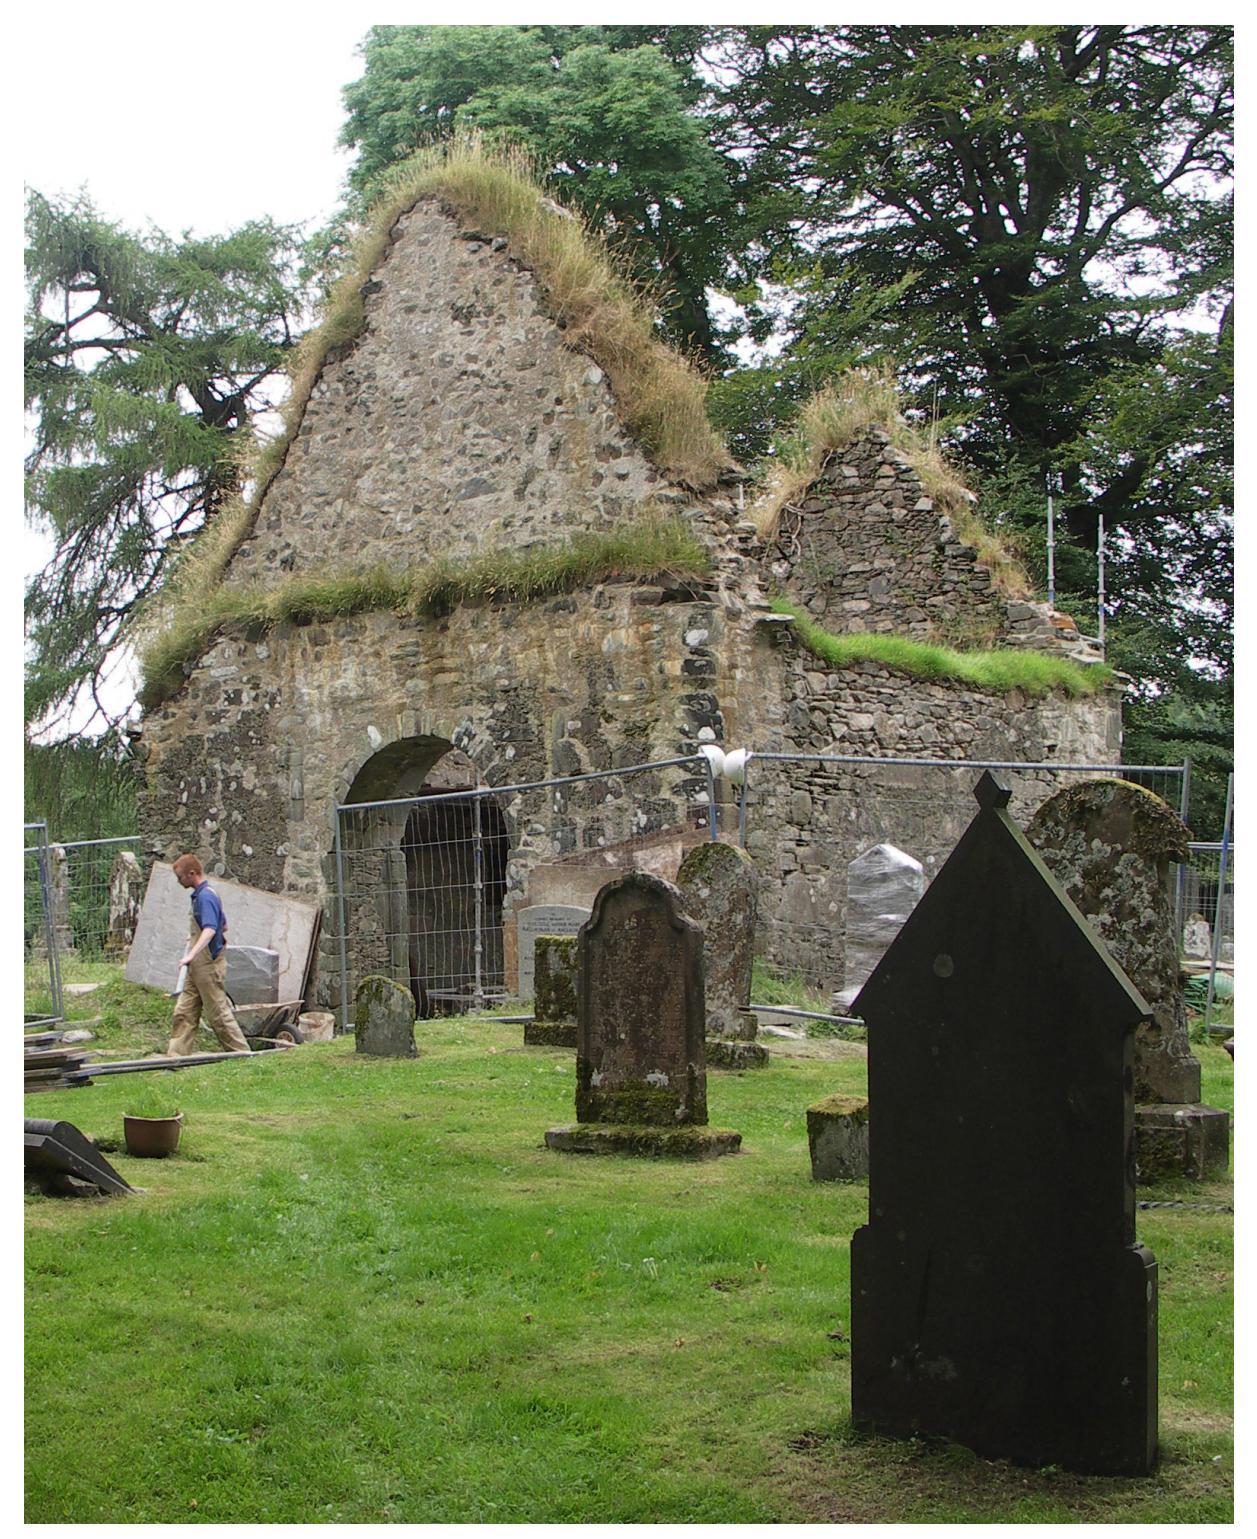
*Fig. 23.1:* South-east view. The front gable and ledge, capped the year before, show some clay staining. The rear gable is natural vegetation and the side wallhead is three months old and already rooted in.

6.5	Aesthetic Performance:	The work has been successful in preserving the appearance of a well-conserved natural ruin, despite some minor clay staining on the south wall.

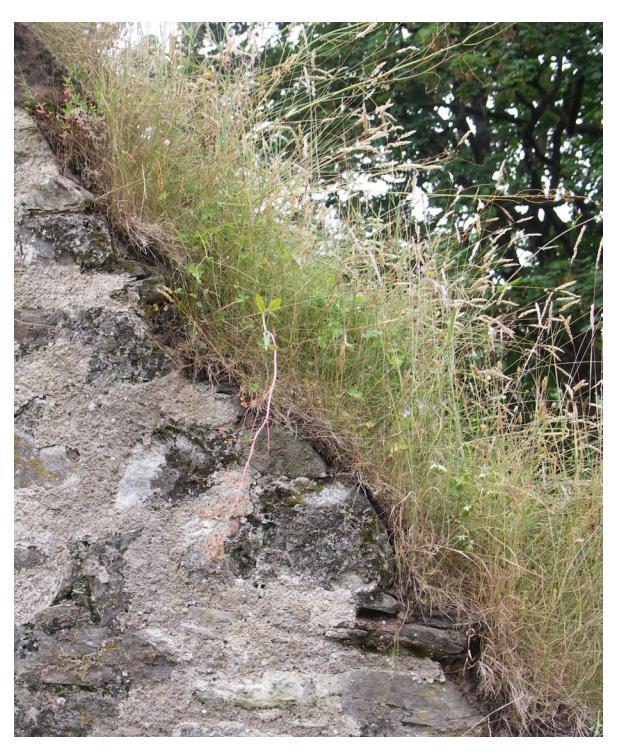
Fig. 23.4: South gable at about 60 degrees, in good condition for midsummer.

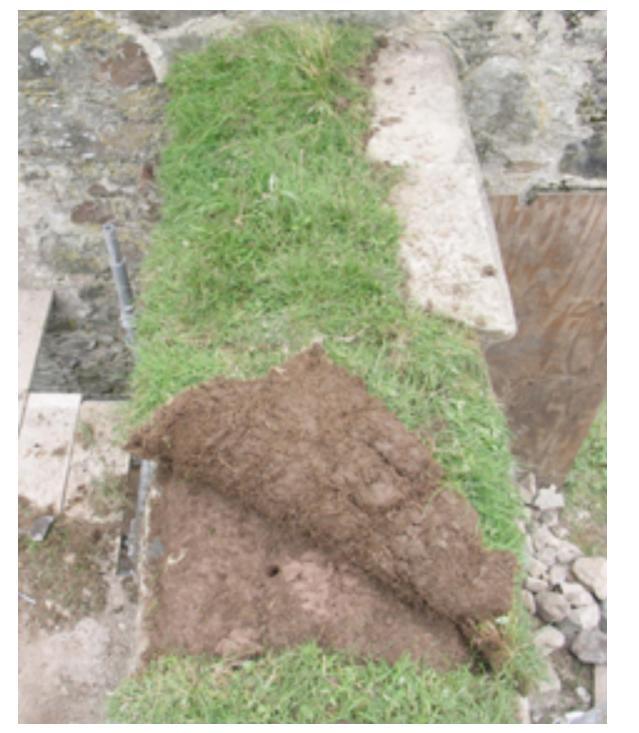
5.5	Soft Capping Technique:	1 layer of turf, ~100mm thick, pressed and pegged into 125-150mm tempered clay, which was finished 50mm from the edge (Fig. 23.5).

Fig. 23.5: Typical locally cut quality turf dressed around a surviving copestone, set onto a clay cap that is held back from the edge to avoid an exposed cut turf edge.

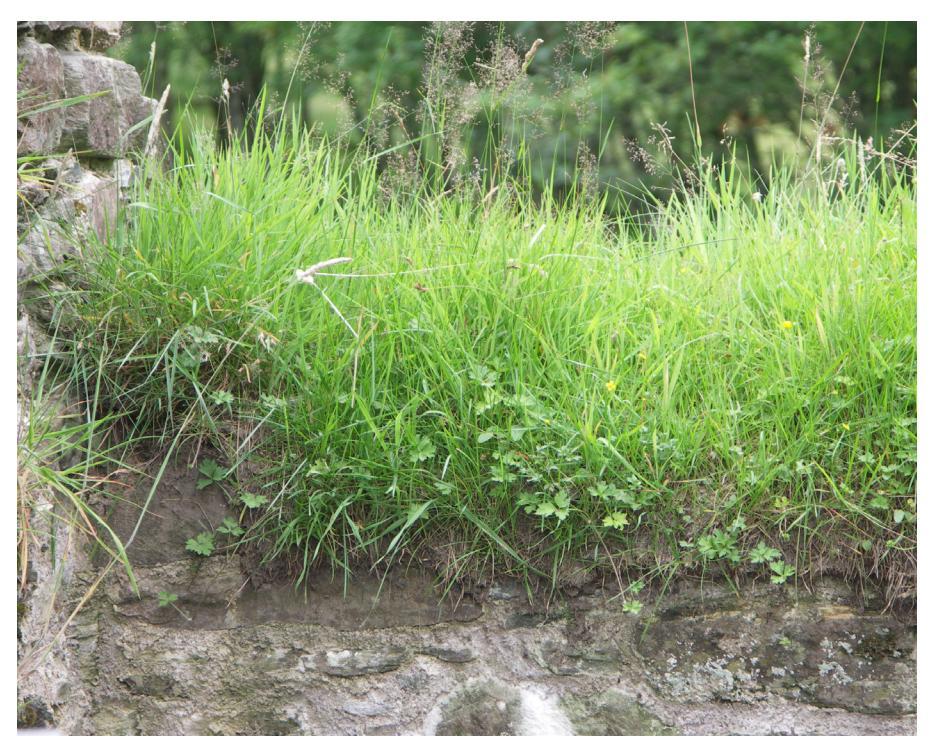
5.12	Maintenance:	None known			
6.0	Performance Assessment				
6.1	General Performance:	<ul> <li><i>The South Gable</i></li> <li>The capping had survived pretty well. The grass looked dry but alive, with growth to 300mm or so. There had been some edge dieback, mainly on the north side. There seemed to be some terracing on the steeper sections, but generally the survival on slopes up to 65 or 70 degrees was impressive (Fig. 23.4).</li> <li><i>Edge Capping at South Gable</i></li> <li>The edge capping was narrower than the wallhead capping and seemed to be in a similar condition. It had caused some clay staining to the lower masonry.</li> <li><i>The East Wall Head</i></li> <li>The capping seemed to be doing well, with lush green growth (Fig. 23.7).</li> </ul>

*Fig.* 23.7: *This turf capping was cut and fitted in April, four months before this image and has already rooted in and experienced good lush growth.*

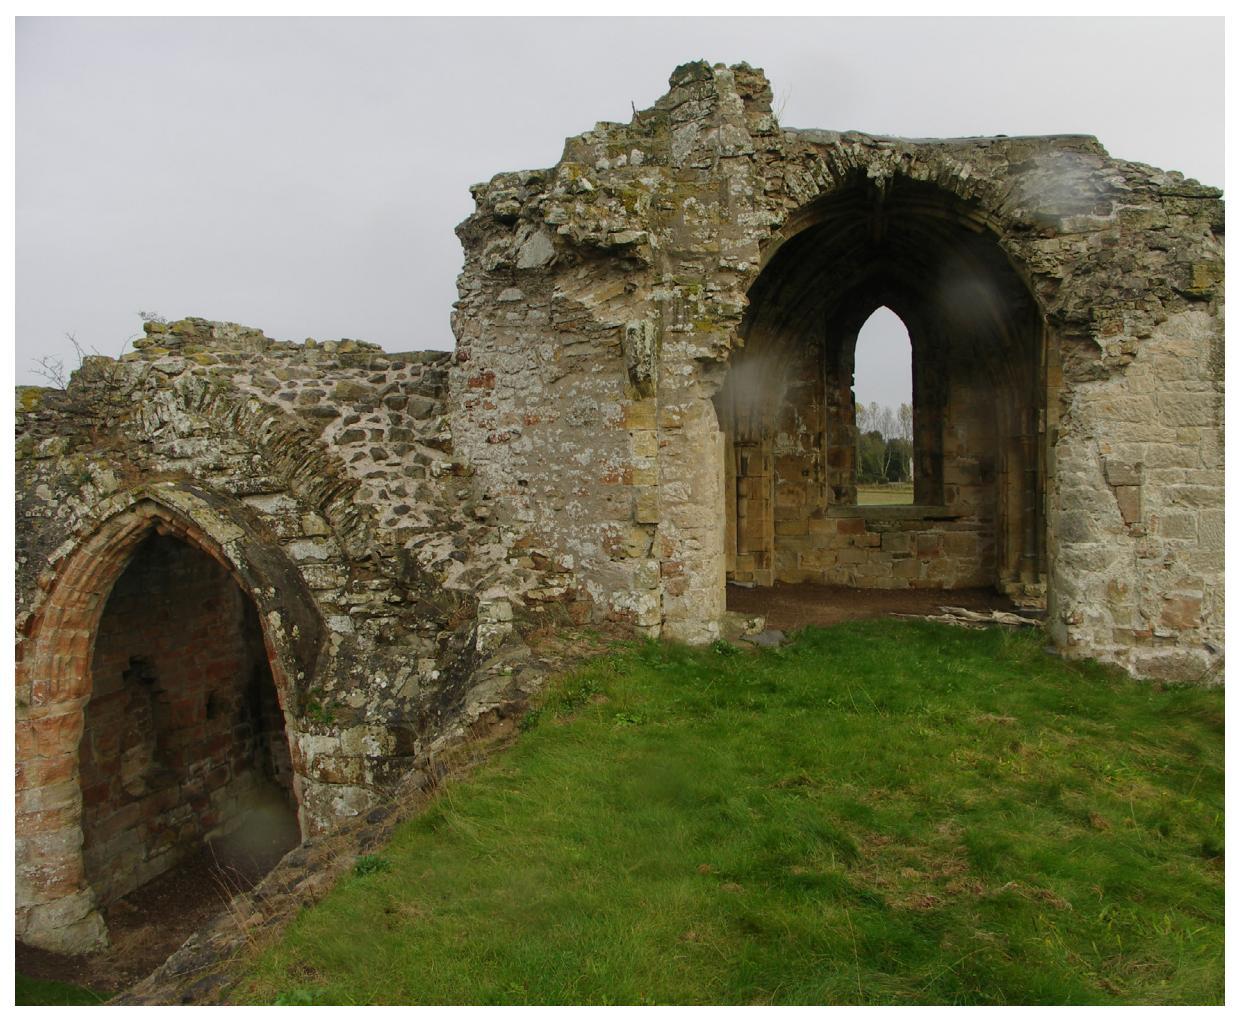
The capping is generally lush and healthy, with little evidence of colonisation by damaging plants (Fig. 24.3). This is doubtless related to the significant exclusion zone created by the mown lawns of the graveyard. The dense sward must also inhibit colonisation, as there is some evident on other exposed masonry (Fig. 24.7).				
		There is, however, severe local dieback to exposed edges. This affects the south edge of the main vault roof, where moisture is focused because of its fall, and there is considerable drying exposure from solar radiation and wind (Fig. 24.2). The edge here will suffer considerable variation between being very wet and very dry, with heat intensified by the adjacent black exposed bitumen. There has been some limited stabilisation by mosses, but the edge appears to be progressively decaying.				
		On the same roof, under the tower, there is similar edge dieback on the south, and this has been exacerbated by the attentions of the local youth who have apparently pulled away the edge vegetation and geotextile (Fig. 24.6). It should be noted that the ruin generally has suffered severe acts of vandalism. The soft capping behind this area, within the tower, has died completely, due to lack of moisture and light.

Fig. 24.3: The main roof is generally in very good condition.

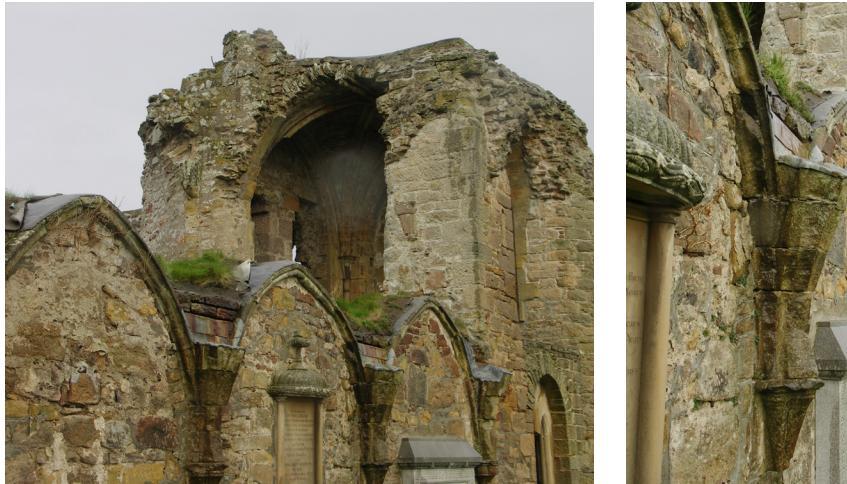
Fig. 24.4: The decay of the south edge of the main roof capping is unsightly from ground level.

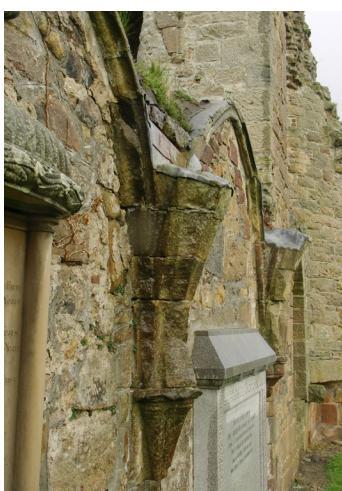
Fig. 24.5: The main roof focuses drainage onto vulnerable dressed stones.

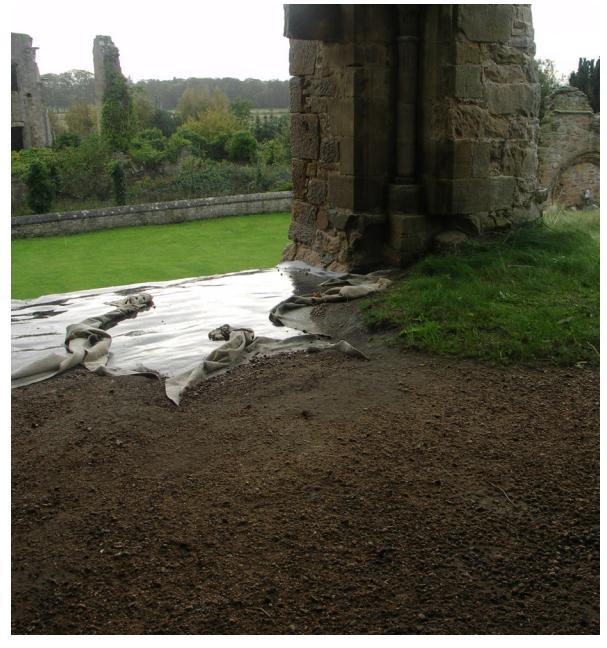
Fig. 24.6: The grass under the tower has died due to lack of rain, while the south edge has also been subjected by vandalism.

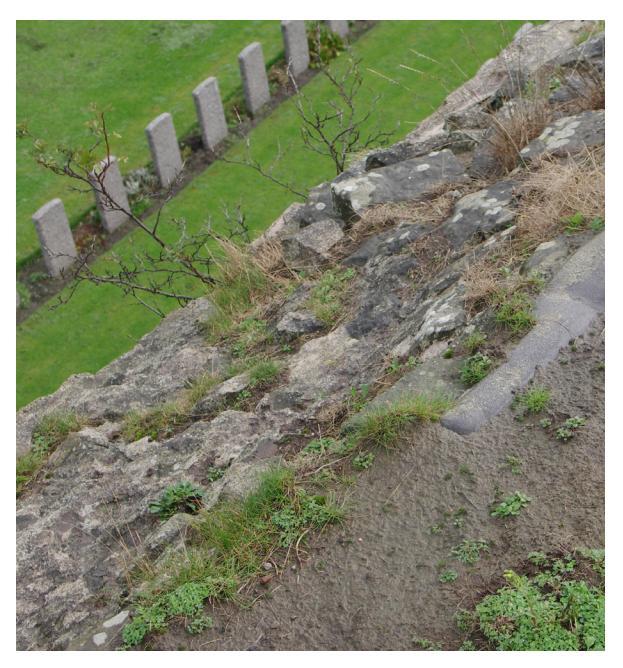
*Fig.* 24.7: *The east side of the tower capping, with some colonisation of exposed rubble.*

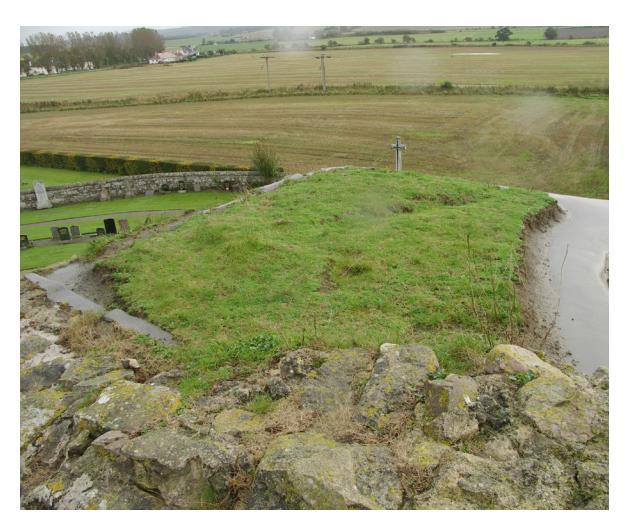
The capping to the top of the tower has suffered severe dieback to all sides, with every sign that this is progressive and caused by climatic exposure (Fig. 24.8). The greatest decay has been on the south-west side, which receives most wind, rain and sunshine.

*Fig.* 24.8: *The tower capping shows most severe decay to the south-west edge.*

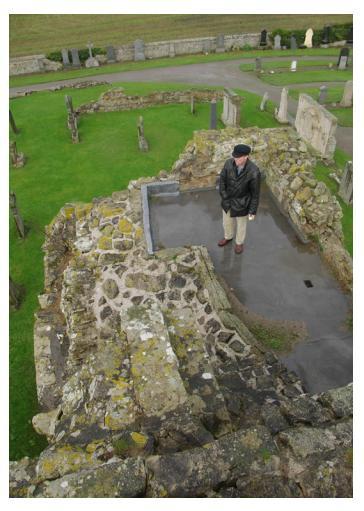
Fig. 24.9: One section where a bitumen roof is set in and has not been turf capped.

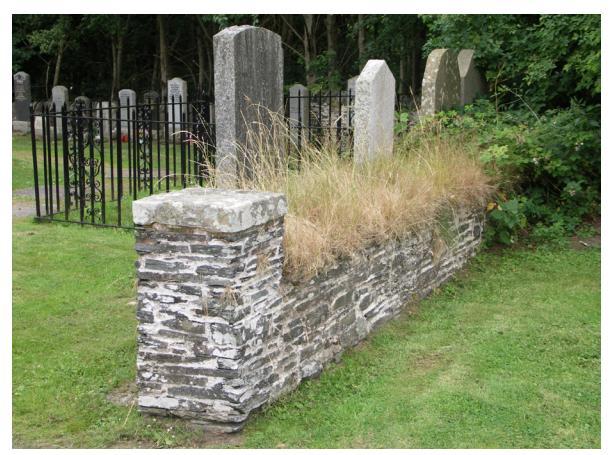
*Fig. 25.3: The south wall becomes engulfed by the surrounding woodland vegetation.*

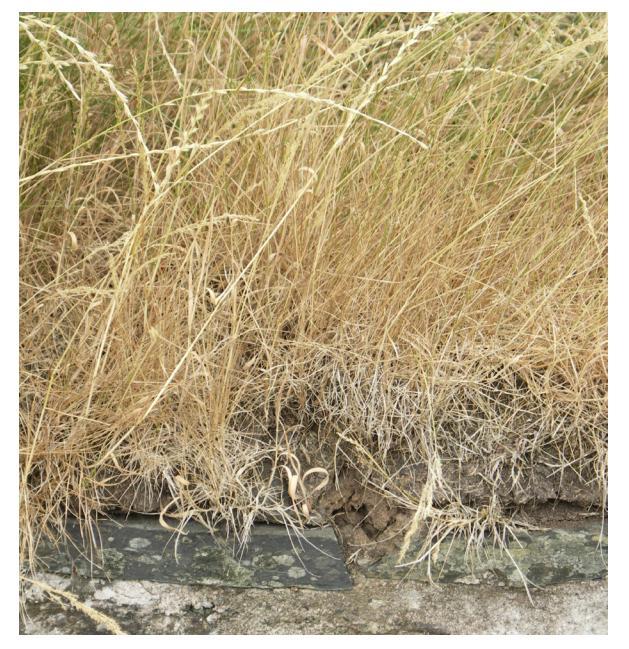
*Fig. 25.6: Edge decay seemed to be accelerated above masonry joints.*

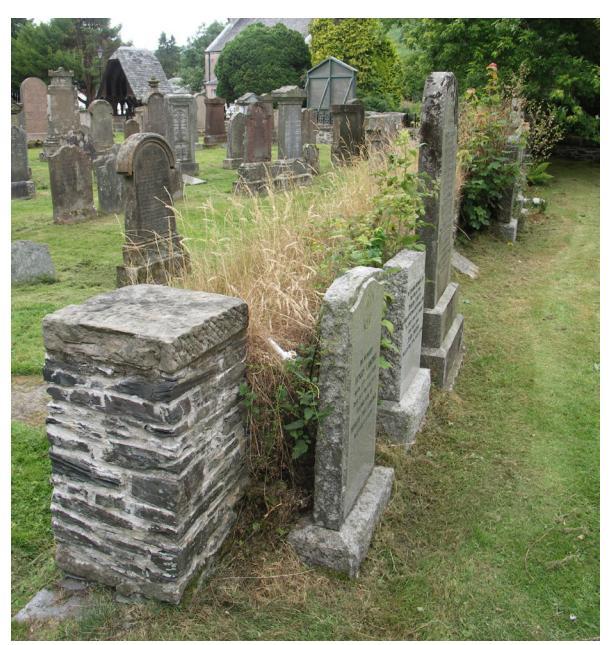
*Fig. 25.7: The turf benefited from the shelter of gravestones, but this made invasive plants difficult to control.*

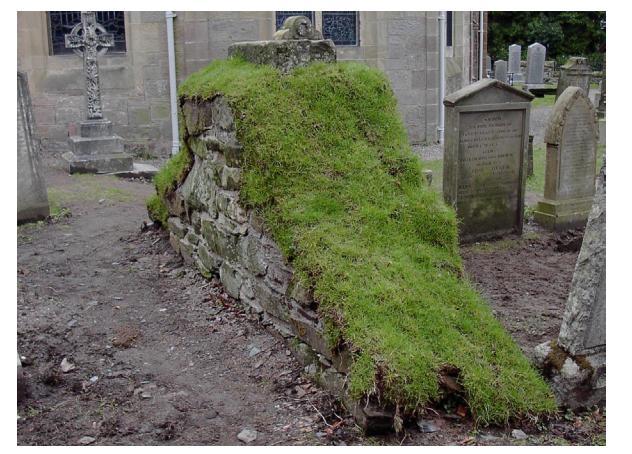
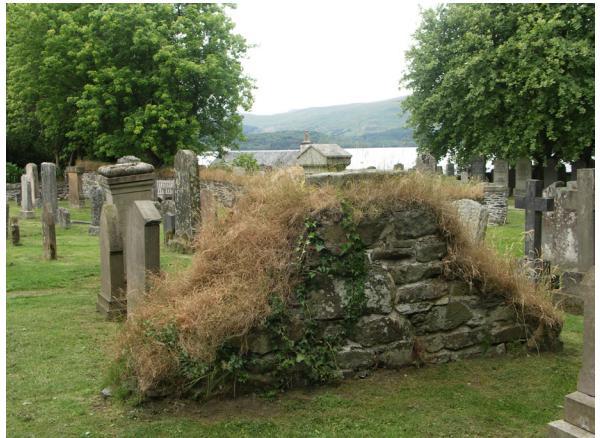
5.11	Aftercare:	None	
5.12	Maintenance:	None known	
6.0	Performance Assessment		
6.1	General Performance:	On the south-east wall, which is partly shaded, the grass forms an overhang of 10-25mm. The grass is well bonded, with no edge dieback. Brambles have invaded from the adjacent woodland, rooting into the cap (Fig. 25.3).	
		The north-west wall cap displays some edge dieback, especially on the south side, with associated decay worst above joints in the head masonry, which has left some clay staining. Where gravestones stand in front of the wall, they have protected it, allowing greater edge overhang of grass (Figs. 25.4, 5 and 6).	
		The south monument wall has some dieback at the edges, though the turf is generally well rooted into the clay layer (Figs. 25.8 and 9).	
		The north monument wall is similar, but has some grass and one dock on the south side. It also shows some clay staining. Although well rooted in, the turf at the edge has died back and the clay here is dry, hard and cracked. There is some failure of the lime pointing on the west face (Figs. 25.10 and 11).

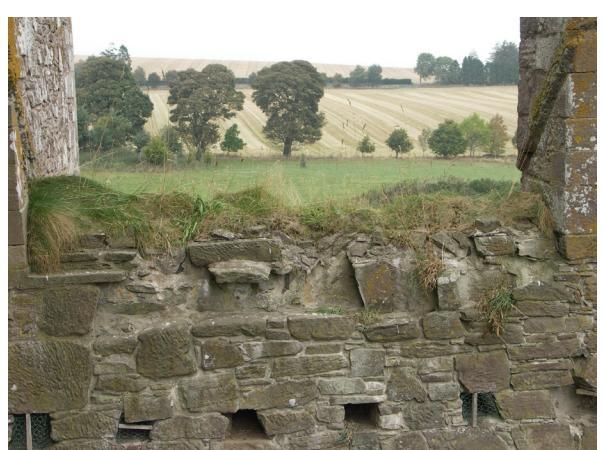
*Fig.* 26.8: *The best areas of the reinstated cappings give less protection than the original natural ones.*

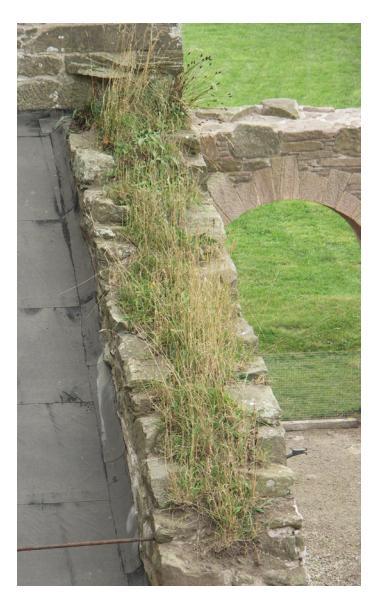
Fig. 26.9: The north gablet, edge dieback suggests there may be a central trough formed in the reconstructed masonry.

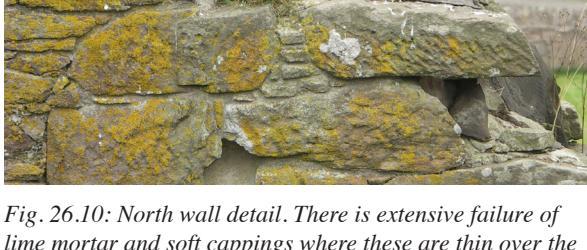
None of the caps are as lush or thick as the natural caps, though the best sections have no edge dieback. Dieback is worst on the higher and steeper sections, where the turf has completely failed and in places the mortar has fallen away, exposing the dpc (Fig. 26.10). There are some clumps of secondary growth of apparent re-colonisation of sheltered clefts.
		The <i>Internal Cross-wall</i> has a broken profile and is about 600mm thick. Fig. 26.14 from the west shows good coverage, but now the grass had retreated to the flat sheltered areas. That the photograph shows white clover flowers indicates that this capping was with ground turf.
		The <i>South Wall</i> has a consistent level profile, with a rubble inner edge, about 200mm thick, a little higher than the stepped sandstone copes that cap the outer 600mm (Figs. 26.12 and 13). The inner section has a dpc and occasional patches of turf surviving from apparently once full cover. The dressed copes have grass clumps in the more sheltered spaces. The 1990 pictures show a full lush covering, suggesting a significant depth of accumulated humus was removed during the works (Fig. 26.11).

Fig. 26.10: North wall detail. There is extensive failure of lime mortar and soft cappings where these are thin over the ledumite dpc. Some re-colonisation of sheltered niches was evident.

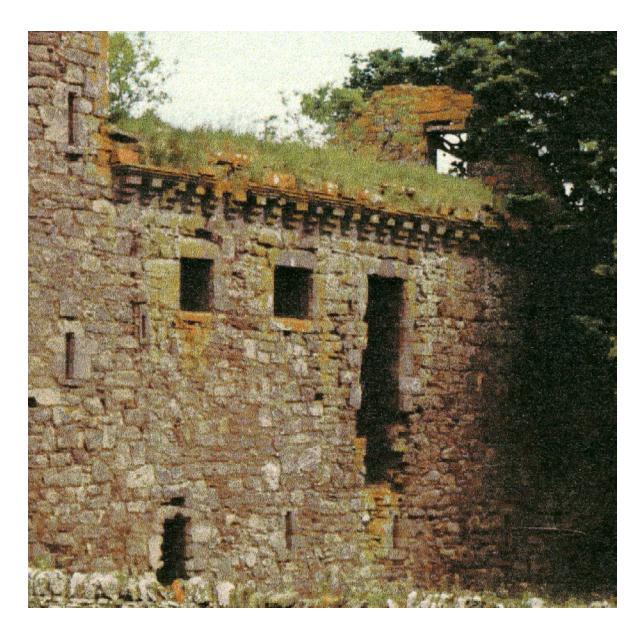
*Fig.* 26.11: South wall, June 1990, with a thick natural capping.

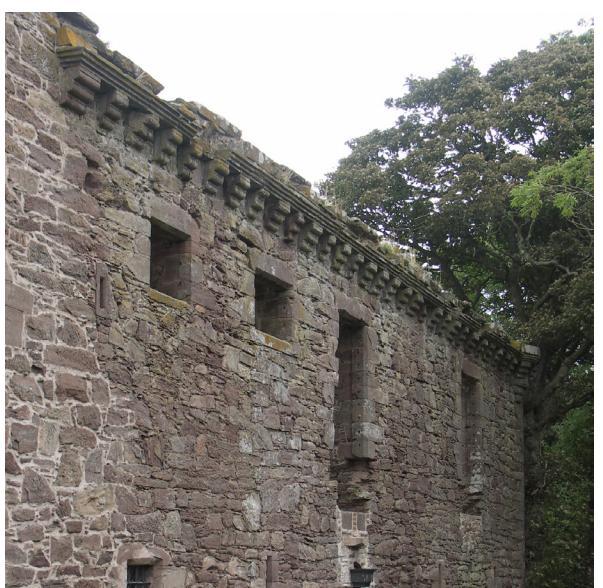
Fig. 26.12: October 2005, a much sparser cap.

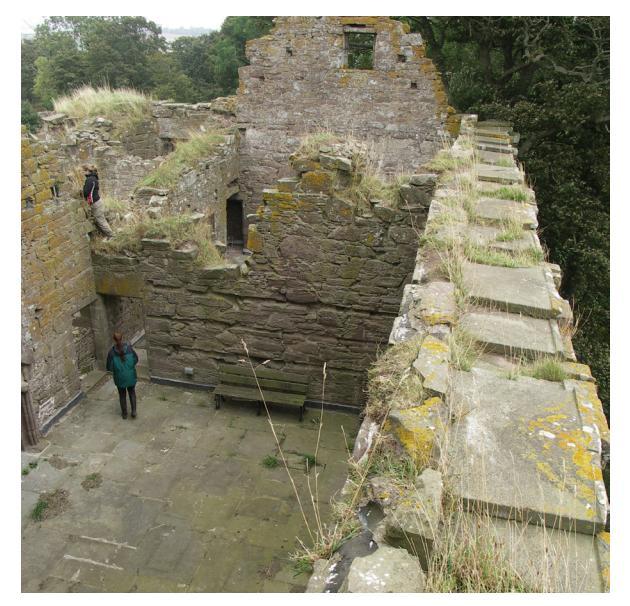
*Fig.* 26.13: *The turf has retreated to the more sheltered areas.*

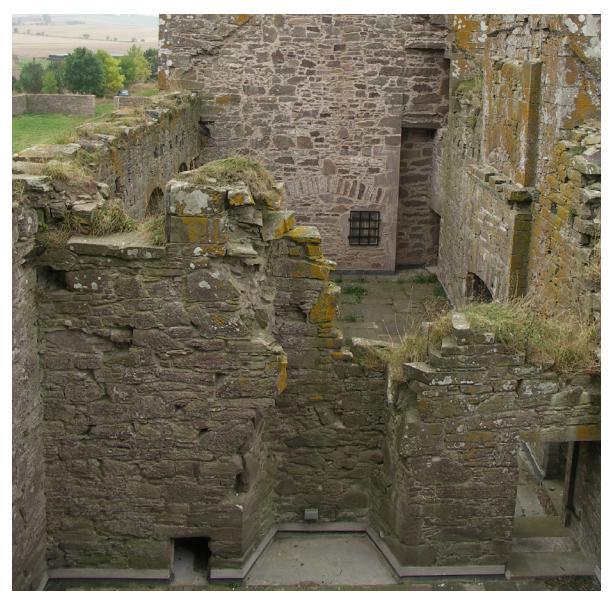
*Fig.* 26.14: *Internal cross-wall. The caps have largely failed, leaving isolated clumps in sheltered places.*

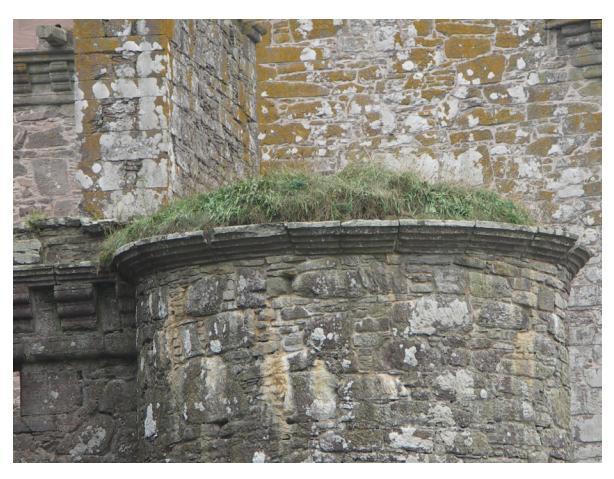
*Fig.* 26.16: *There is some sign of soil staining about 1m below the cap.*

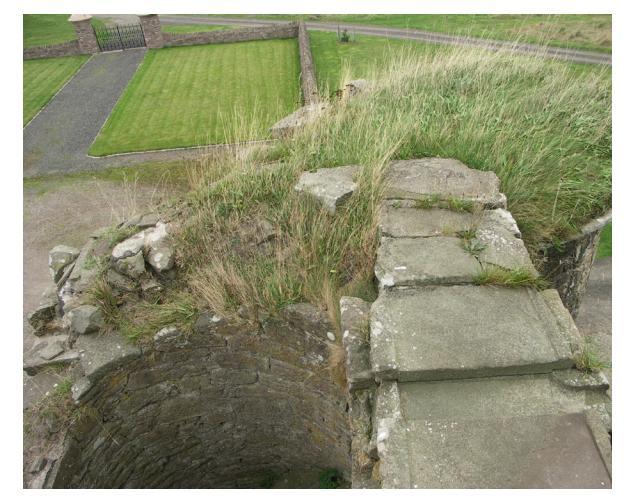
*Fig.* 26.17: *North-east tower. The turf dies away towards the narrow wallheads.*

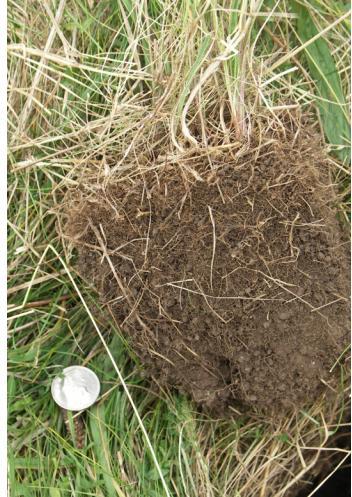
Fig. 26.18: Northeast tower. The turf has a good root system.

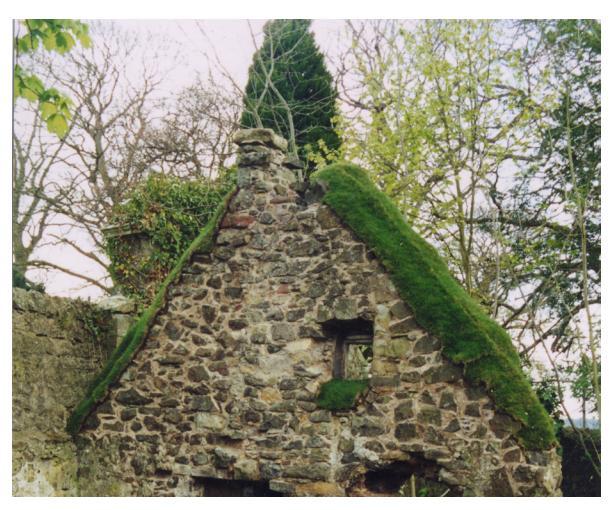
Fig. 27.3: Gable ruin after capping, note early edge dieback.

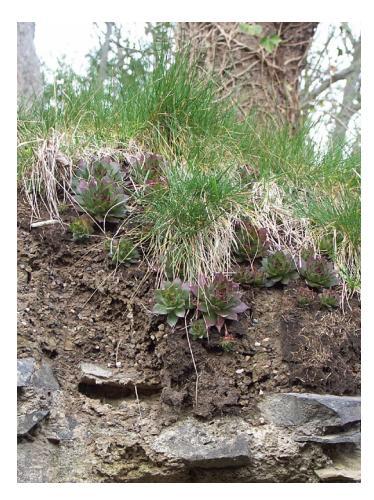
Fig. 27.10: Sempervivum fail to achieve a dense cover.

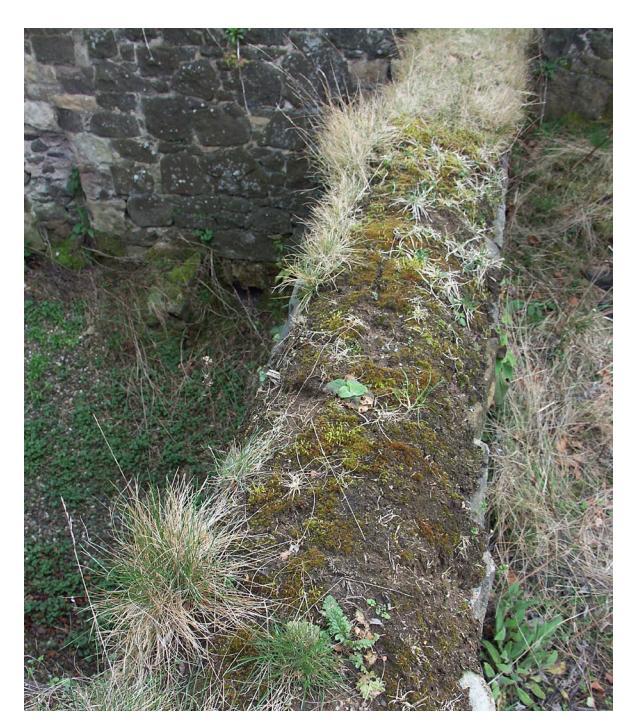
<i>Retaining walls</i> : The work on the wall was carried out in two stages in a moderately hot June and later in the following October. The earlier work was not very successful, with visible shrinkage and the turf failing to establish well, eventually becoming patchy with considerable dieback and erosion of soil. In contrast, the wall that was capped in October thrived.

Fig. 27.11: Retaining wall A, application in June.

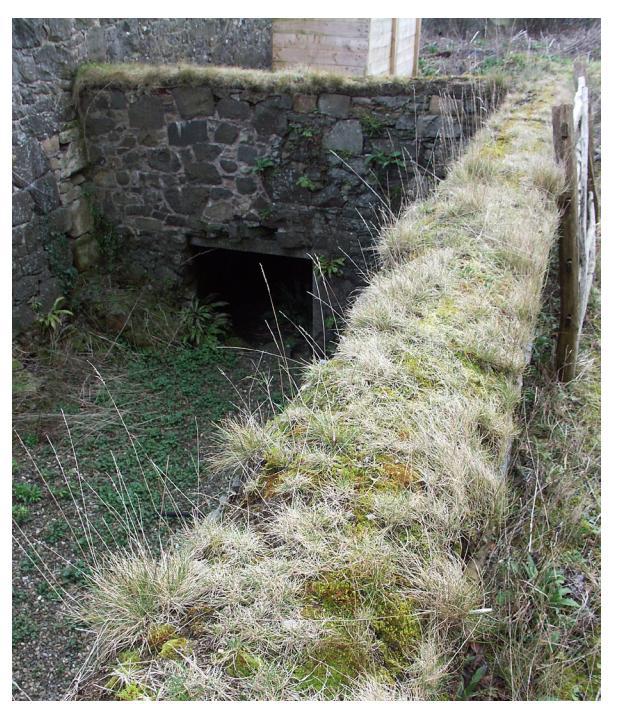
Fig. 27.12: Retaining wall B, application in October.

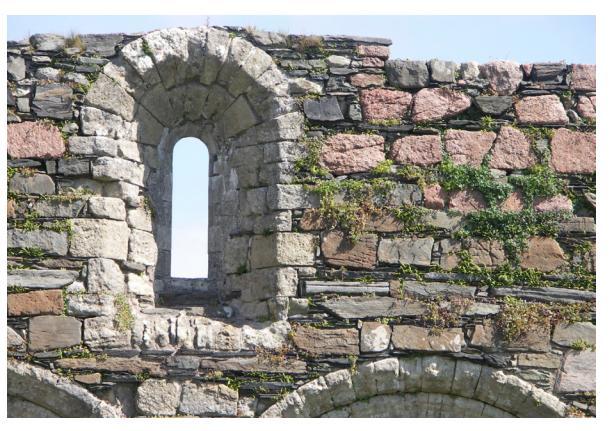
*Fig.* 28.9: *Face vegetation is undisturbed, while the cappings have been removed.*

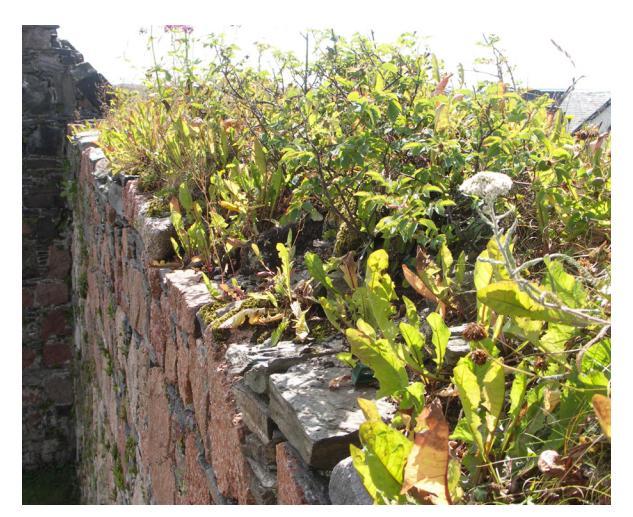
*Fig.* 28.12: *The masonry joints are exposed to wind-driven rain and root penetration.*

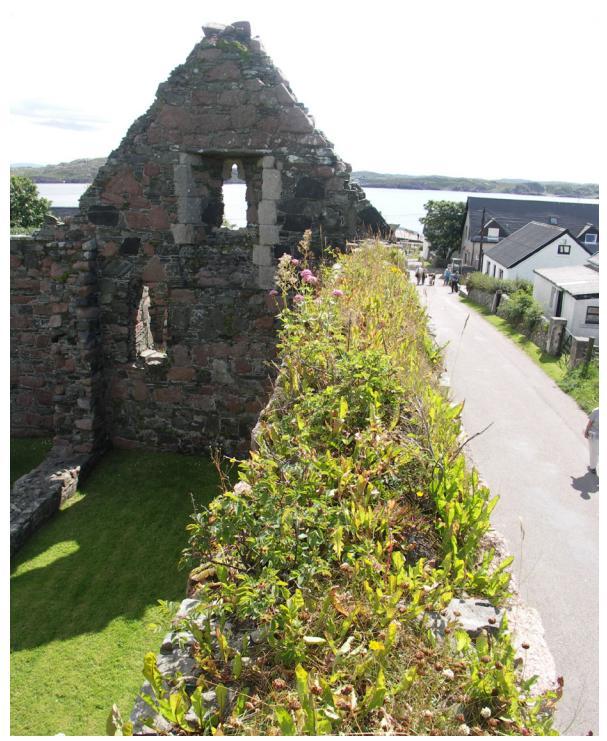
*Fig.* 28.11: The Refectory south wall. Vegetation has recolonised wallheads cleared of natural cappings, probably in the early 20th C.

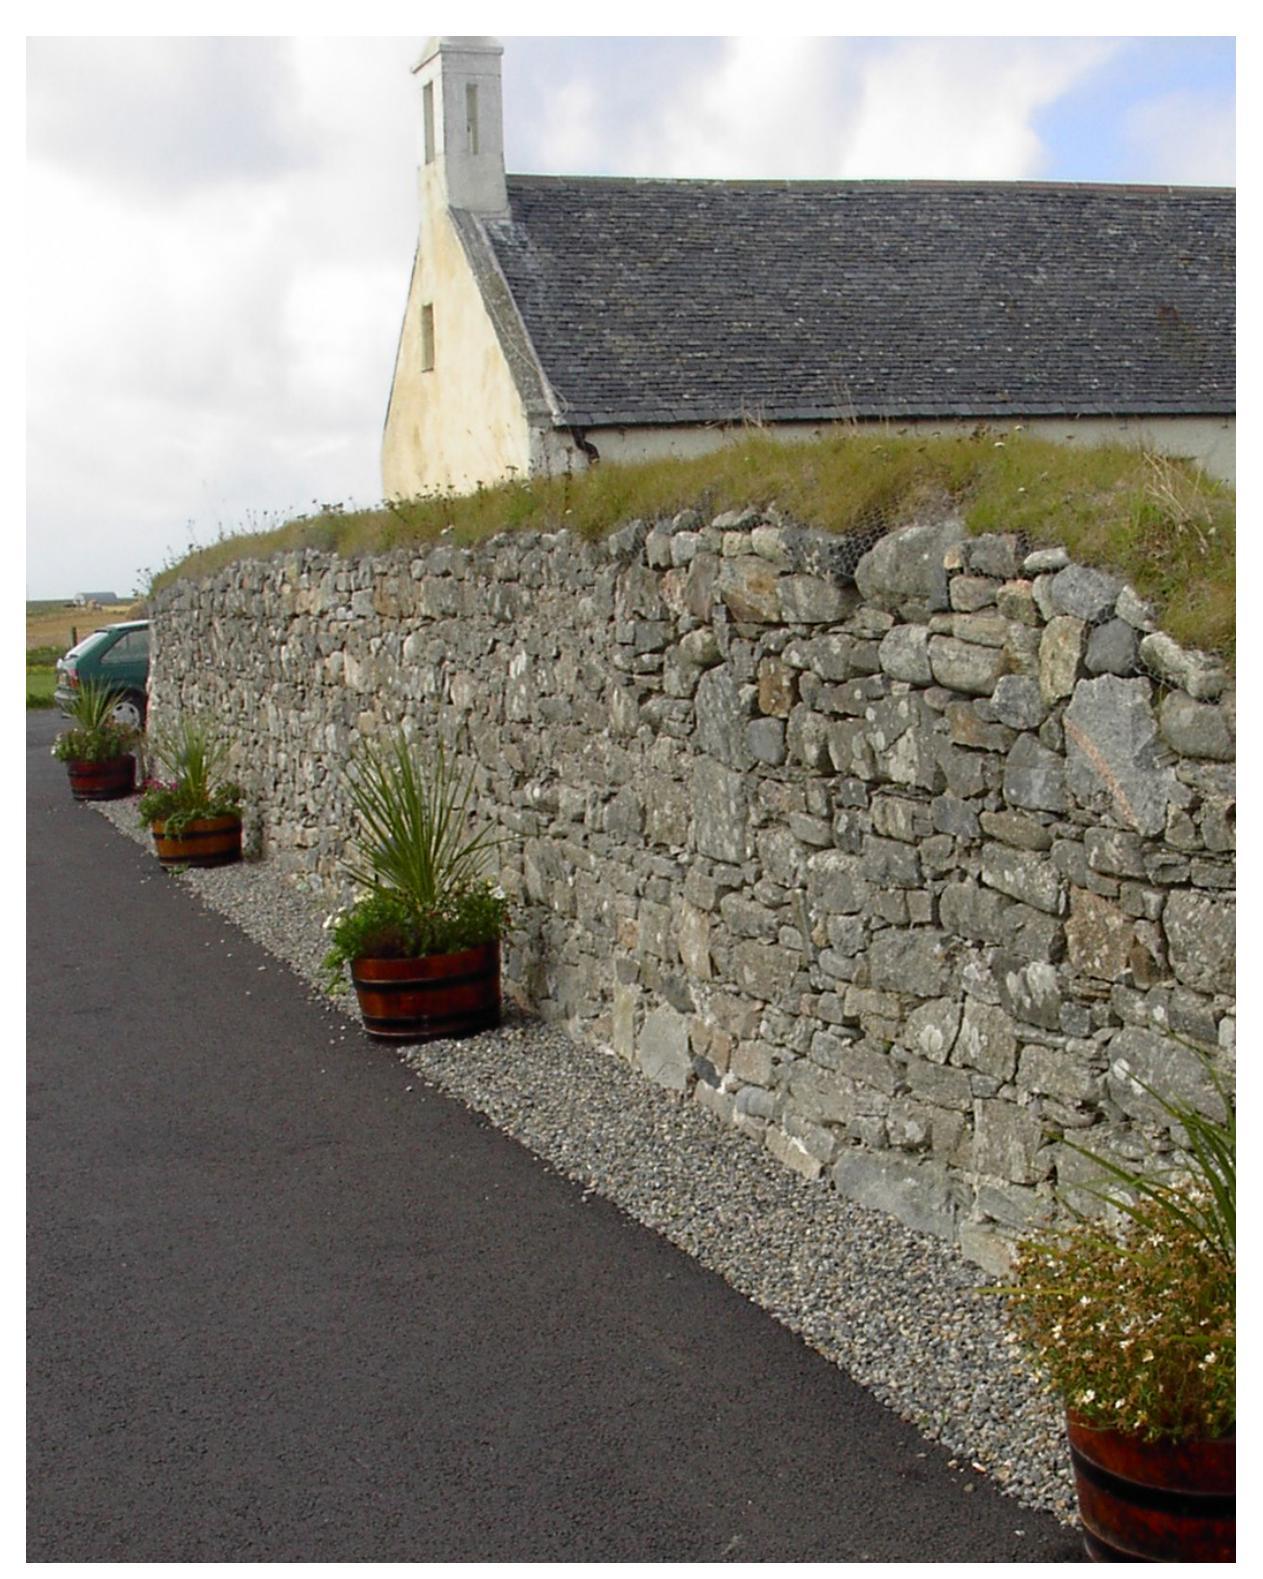
Fig. 29.1: Nunton Steadings, the west side of the wall. The capping has set naturally into the uneven wallhead.
1.0	Background							
1.1	Location:	Near the west coast of	Near the west coast of Benbecula, Western Isles

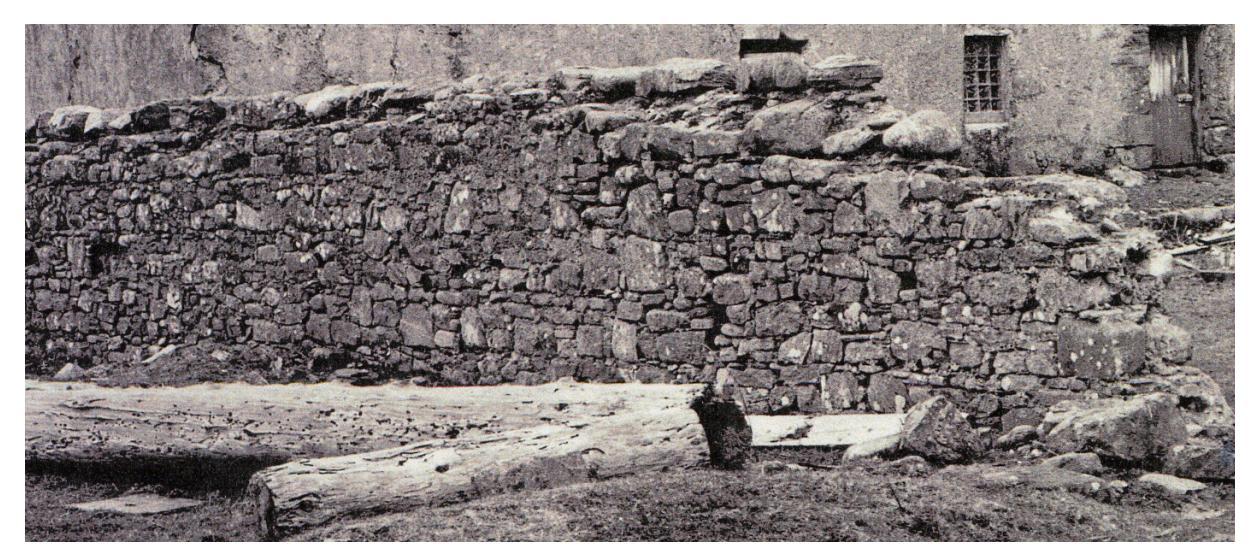
*Fig. 29.3: The wall prior to intervention, approx 1997, showing little apparent natural colonisation, though this may have been removed.*

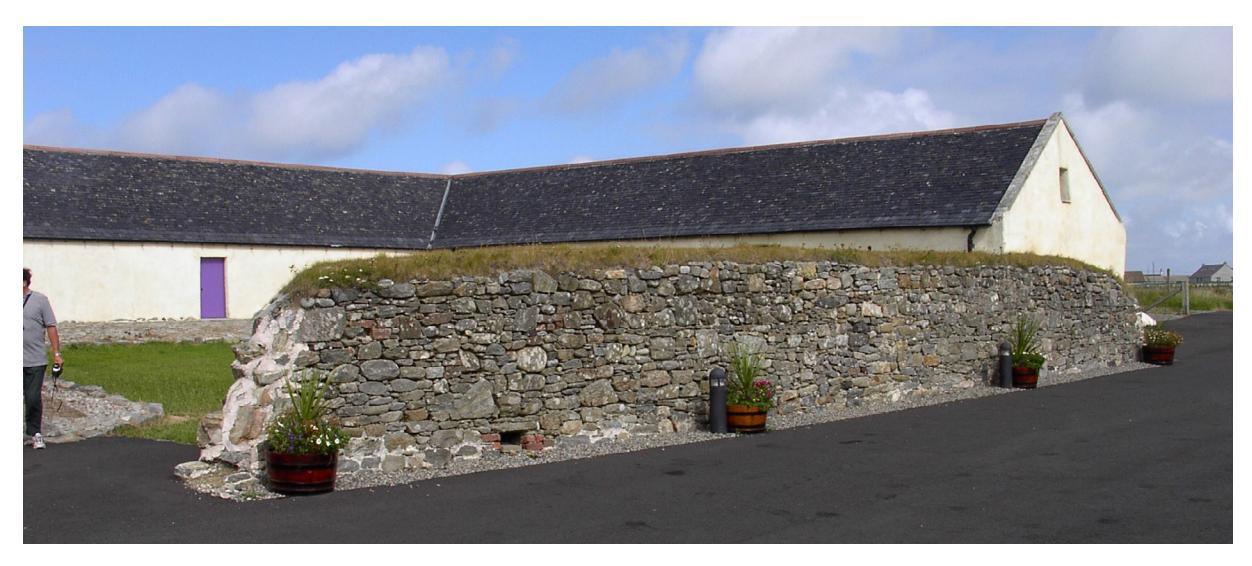
Fig. 29.4: Four years after the capping was applied, it looks healthy and natural, if somewhat lost amid tarmacadam.

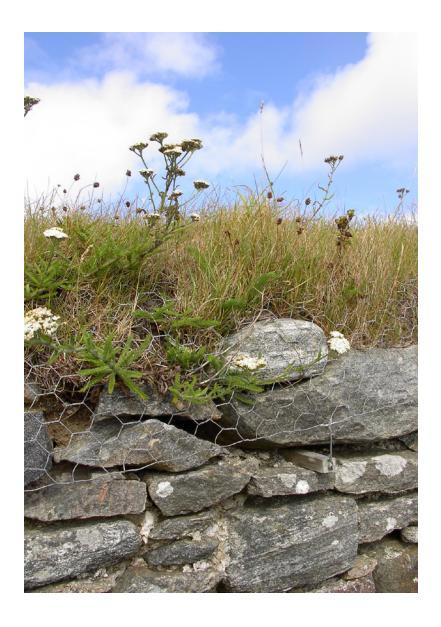
*Fig. 29.5: There is limited species diversity, related to microclimatic conditions. The caps will endure fairly strong peak drought conditions.*

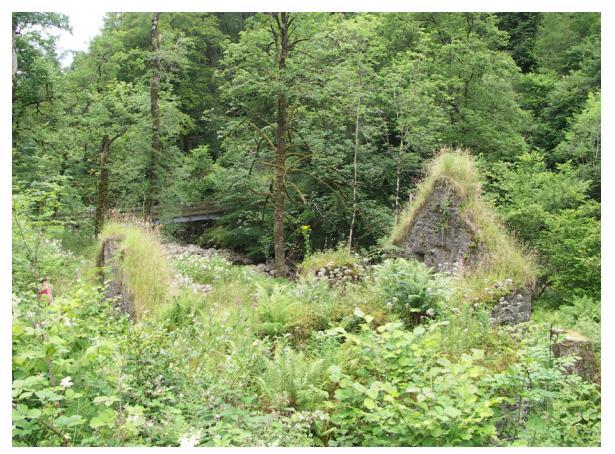
Fig. 30.5: North view, July, 2005.

The new turf caps on the main building seem better able to repel tall invasive species, such as ferns, in summer, compared to the moss-rich natural caps on the foreground walls. This allows them to be more clearly distinguished throughout the year, when the form of the naturally capped walls becomes lost in surrounding tall vegetation.

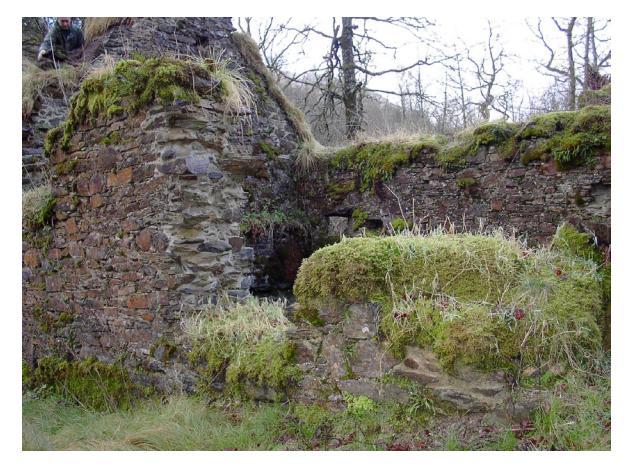
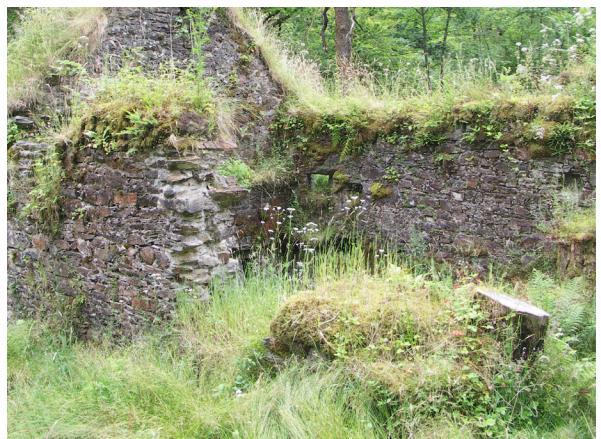
On the south lower stack, a dense carpet of moss had been lifted and re-applied during the works and this had survived well on the clay cap (Figs. 30.6 and 7). The clay had a similar consistency and there was some deep penetration of fine roots.					
		On the adjacent higher ruined walls the more biodiverse original vegetation had re- established well on the clay caps.

*Fig. 30.6: Thick moss blankets were carefully removed and later reinstated to the foreground stub.*

Fig. 30.7: The additional clay layer on the stub does not seem to have led to increased colonisation compared to the unaltered wallheads in the background.
