### SOFT CAPPING IN SCOTLAND

The context and potential of using plants to protect masonry

> Volume 2 Case Studies

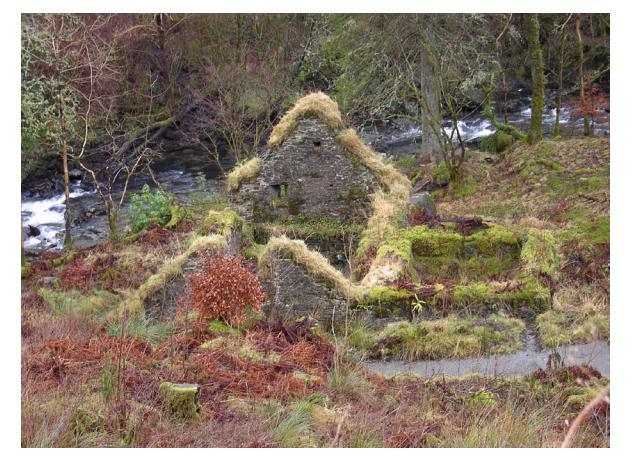
*Fig. 30.8: East view, March 2003, showing patches of failure on the west gable.*

5.12	Maintenance:		There was a maintenance colonisation by trees and r unkown.	plan established ruderals, but to w	at the time of the hat extent this ha	e work, to control as been implemen	natural ited is	
			In November 2002, the cli were repaired with two lay	ent reported pate vers of commerci	hes of dead turf al turf in March	on the west gable 2003.	and these

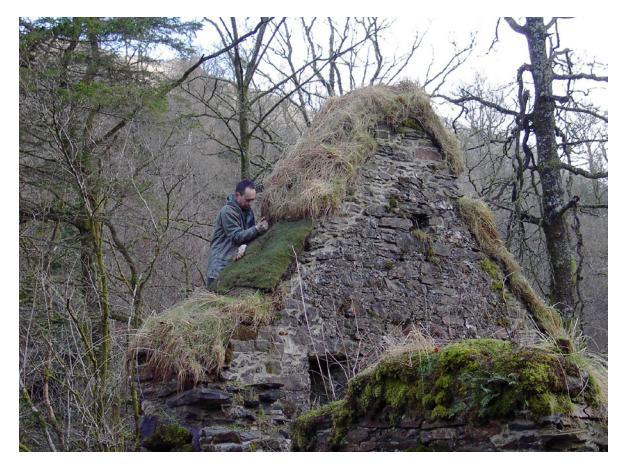
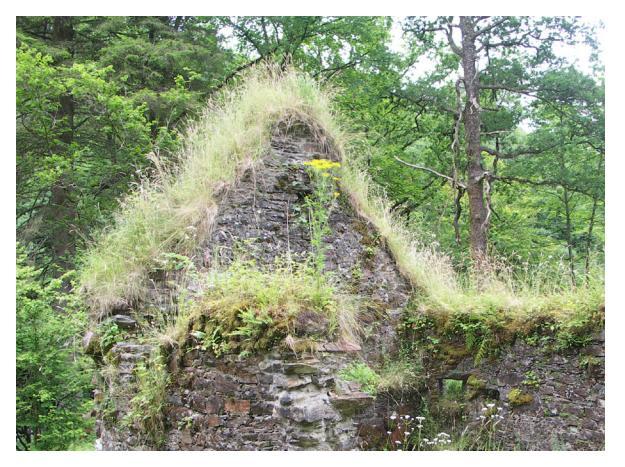
The short-term failure of a small area on the gable, the success of the subsequent repairs and the slow development of dieback on one edge confirm that narrow sloping surfaces, such as gables, present stressful conditions for vegetation where microclimate, slope and surface texture combine to affect the viability of soft caps in a manner that is difficult to predict.					
		The fact that poorer quality commercial turf succeeded and became rapidly indistinguishable shows that this, although very different from the original vegetation, can be an appropriate material under such strong colonising conditions (Figs. 30.10 and 11).

Fig. 30.10: West gable, March 2003, repairs in progress.

*Fig. 30.11: West gable, July 2005, the repairs are indistinguishable.*

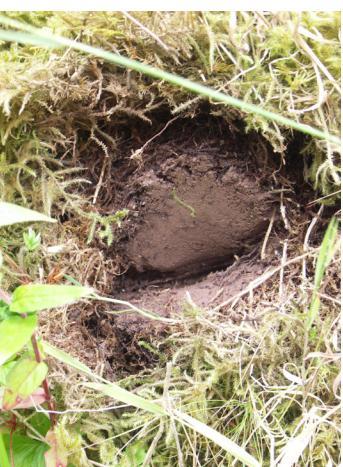
Fig. 30.13: Four years after application, the clay remained soft and malleable.

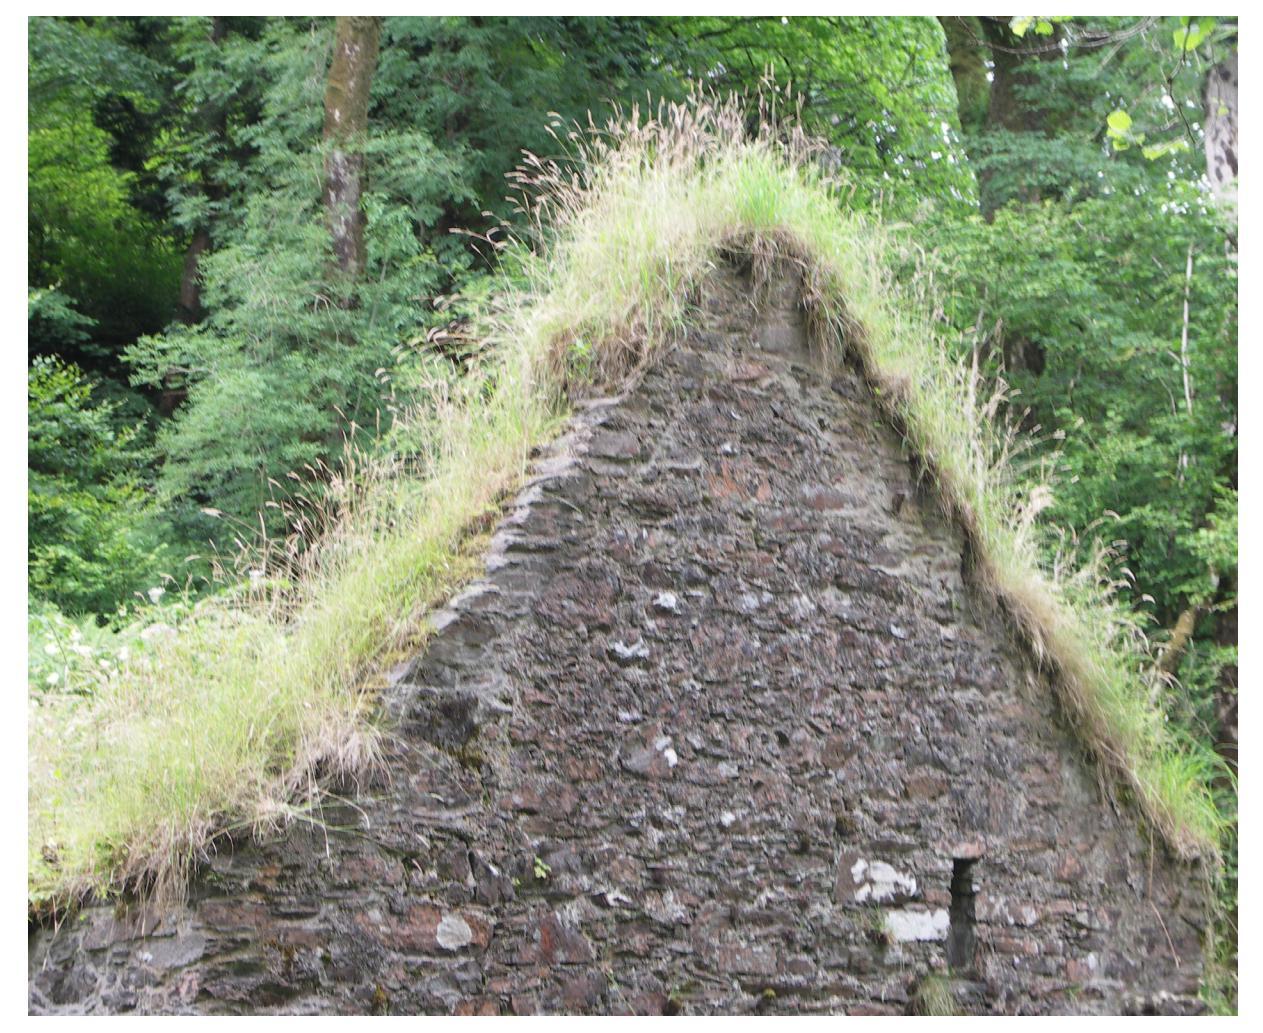
Fig. 30.14: A strip of edge dieback on the north slope of the west gable contrasts with the projecting drip provided on the south slope.

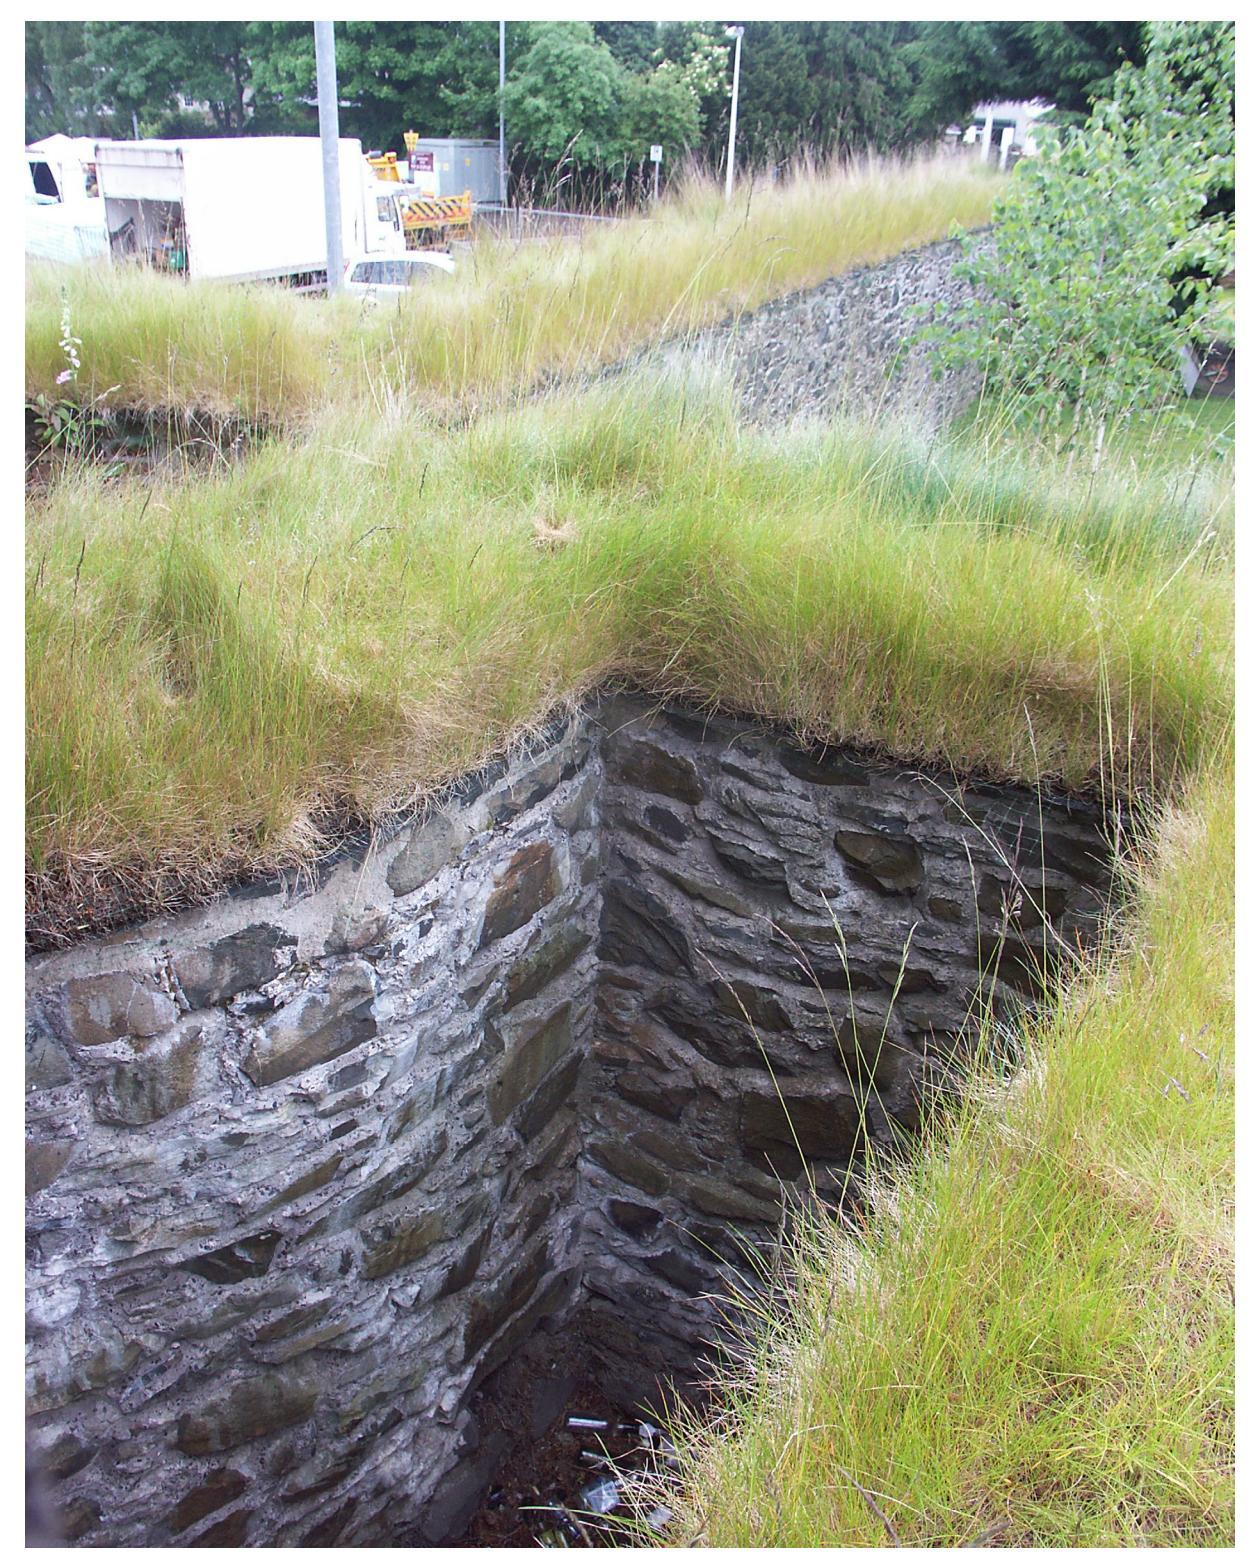
Fig. 31.1. Peebles Town Wall, north view. The cap generally maintains good cover, though in places the sward is thin.

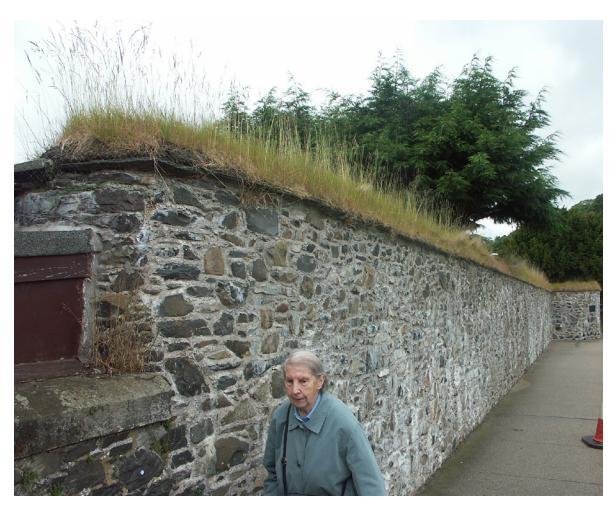
Fig. 31.5 Edge dieback was worst at the south end.

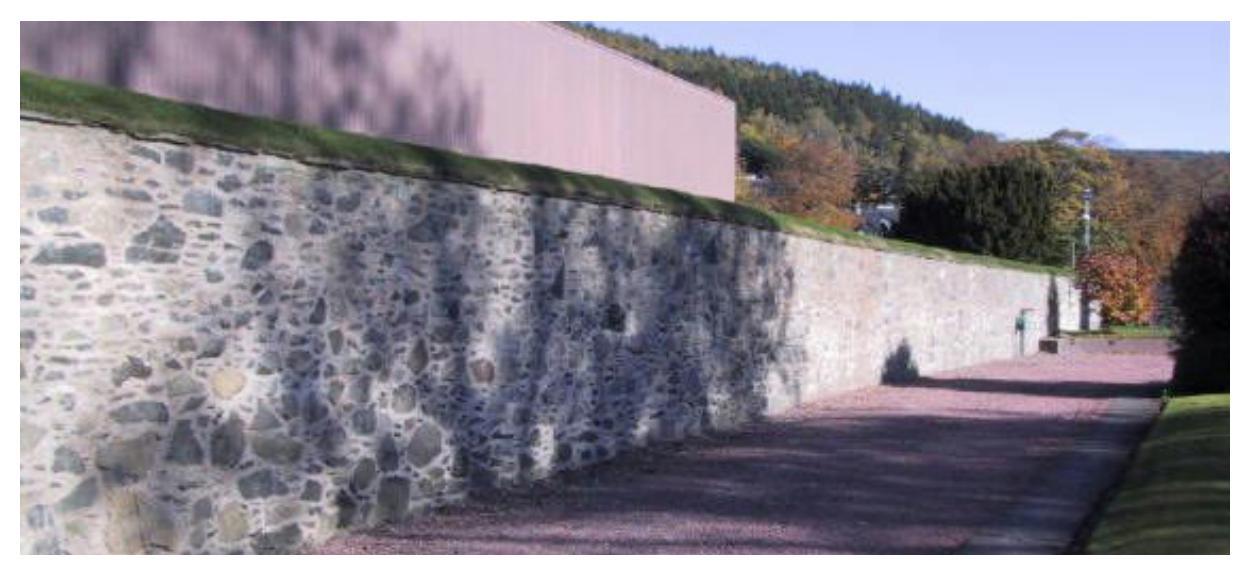
6.0	Performance Assessment					
6.1	General Performance: May 2005	Photographs from soon after completion (Fig. 31.7) show some edge dieback on the south edge of the west wall with apparently some associated clay staining, but no dieback on the north edge of the same wall.				
		The masonry was in good condition, though lime runs were extensive, up to about 600mm below the slate cap, indicating that this formed an effective dpc. There were no indications that roots had penetrated through the joints in the string course, though a few clumps appeared in cracks on the wall face.				
		The vegetation seemed to be generally in healthy condition, with the combination of complete grass cover, dense clay soil and surrounding hard landscaping strongly inhibiting colonisation from surrounding vegetation.				
		There was consistent edge dieback of 25-50mm, with the worst being at the exposed south end. There was local dieback beneath the branches of a yew tree, and comparable dieback beneath a lelandea indicated that this was from rain shadowing, rather than poisoning by dropped foliage (Fig. 31.10).

Fig. 31.7: The new capping, soon after application.

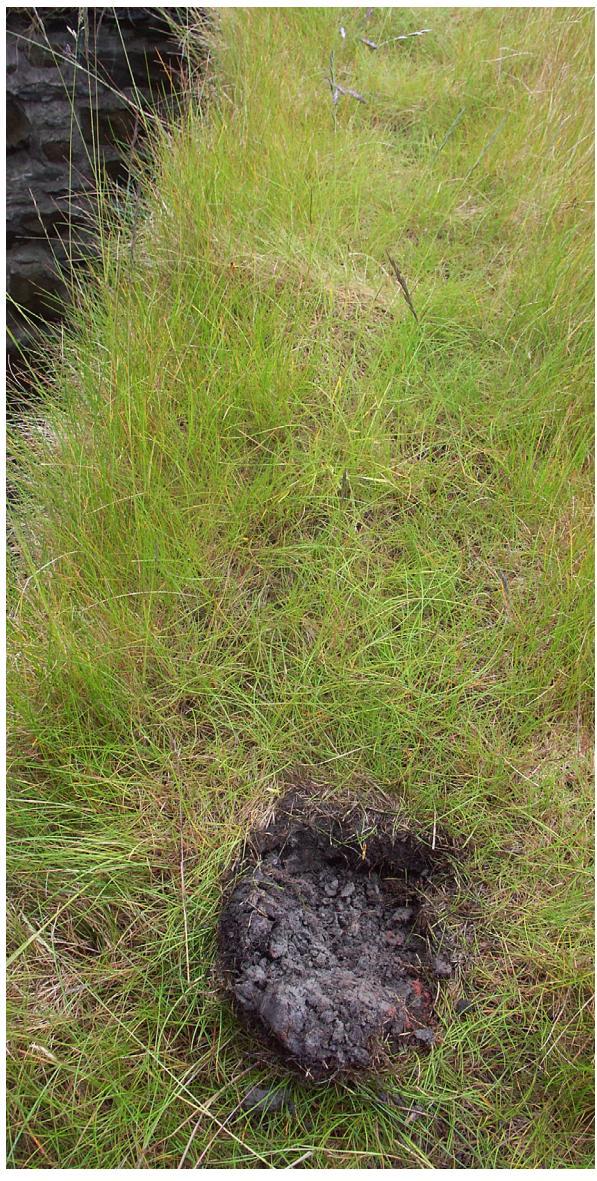
Fig. 31.9: The turf formed a thin layer, poorly rooted in.

The use of a biodegradable mesh would have improved the aesthetic success, while the inclusion of some soil from the natural capping would have assisted root penetration and aided bio-diversity through seeds, although there would be the danger of undesirable seeding. More bio-diversity through the re-use of some of the appropriate natural flora, together with a more varied profile, would have perhaps appeared more naturalistic and sat more gracefully on this ancient wall.

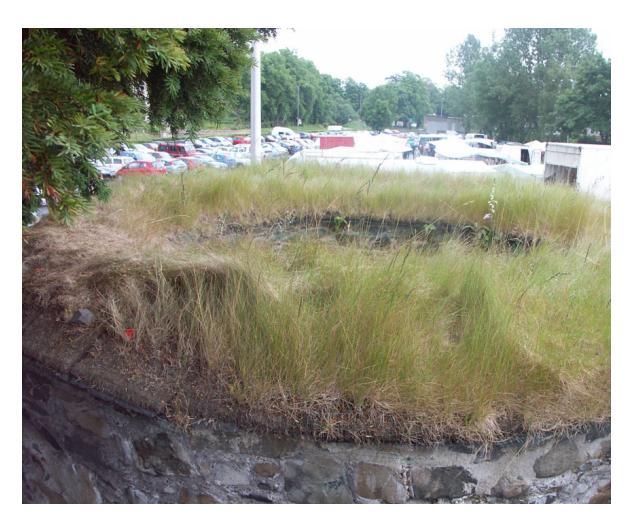
Fig. 31.10: Dieback beneath a yew tree.

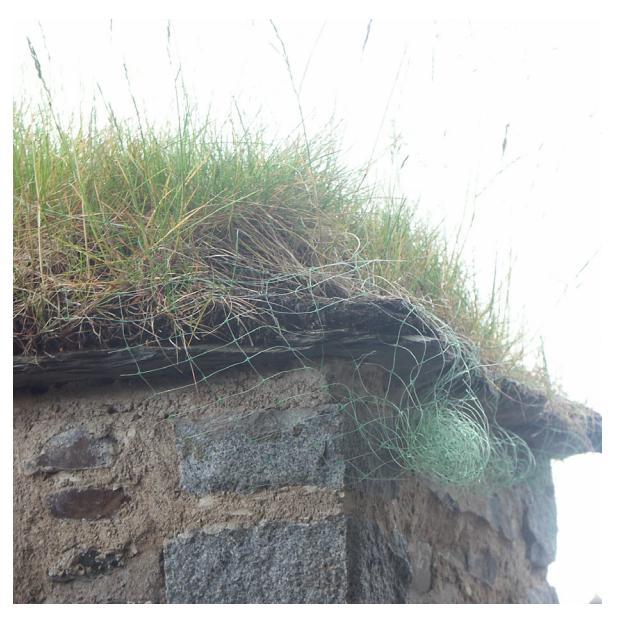
Fig. 31.11: The green plastic mesh is unsightly.

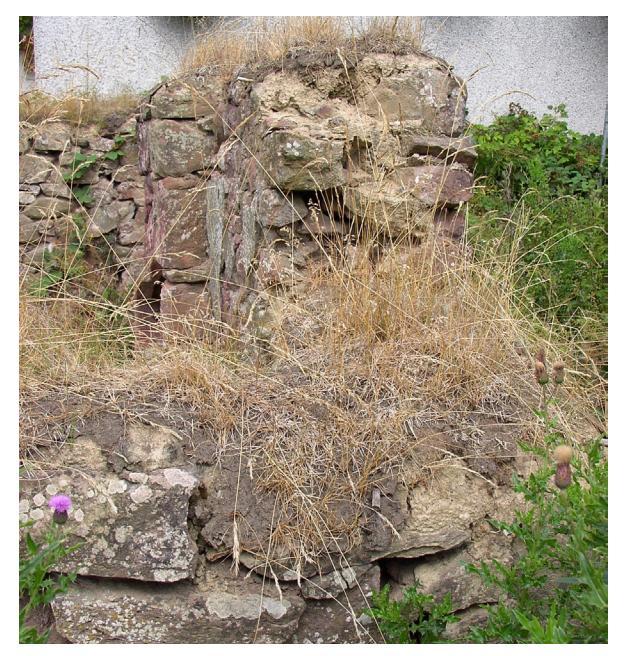
6.0	Performance Assessment				
6.1	General Performance:	The cappings performed well for their intended purpose of providing short-term protection to the walls beneath. As an emergency measure they had the benefits of retarding the decay mechanisms of thermal flux, moisture and freeze/thaw, while being fully reversible.			
		As there have been no subsequent further conservation works, the cappings have been exposed over a much longer period than was intended. In this respect, they have not proved very successful. There are large areas of failure and shrinkage, with small and steep sections of capping performing worst (Figs. 32.2 to 32.5).

*Fig. 32.2: Summer conditions with the Festuca rubra surviving, but with a dry sward.*

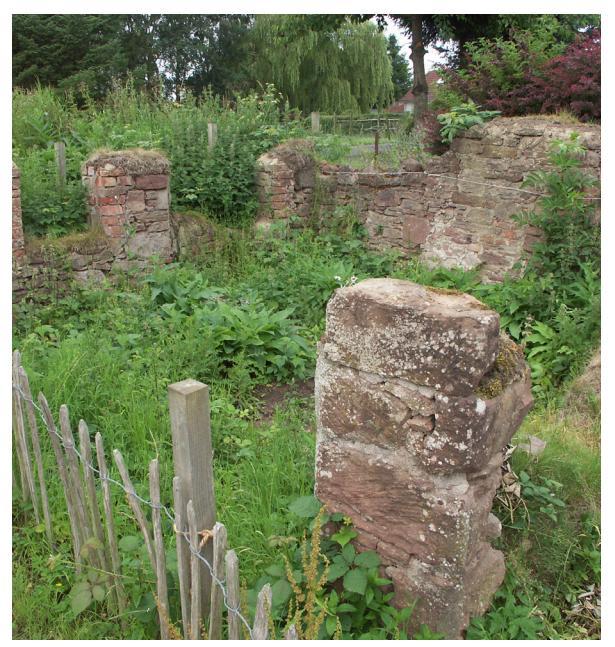
Fig. 32.3: Isolated small caps fared worst, being most vulnerable to drying out.

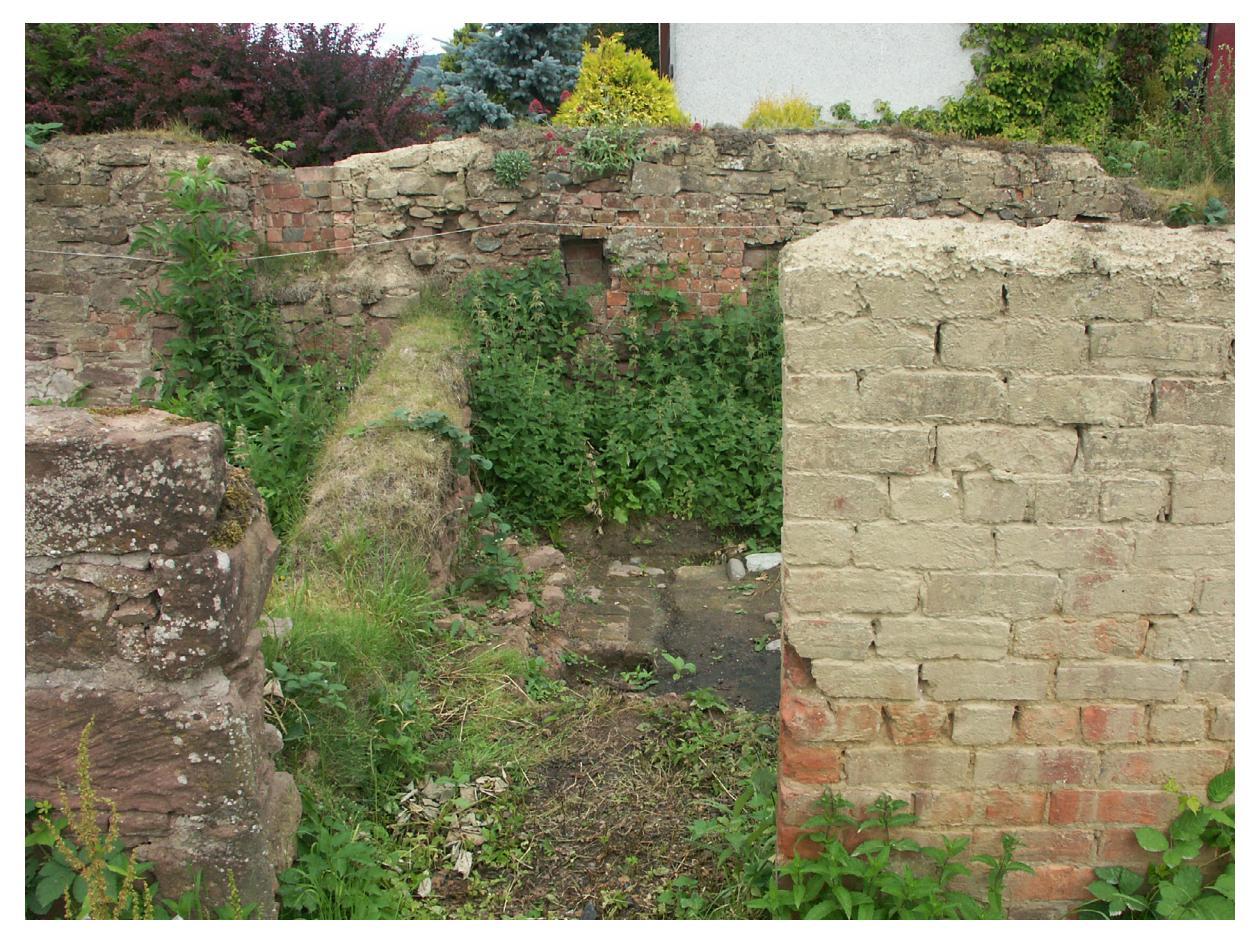
*Fig. 32.4:* The narrow brick wall caps struggled to survive, though the clay mortar caps continue to provide wallhead protection.

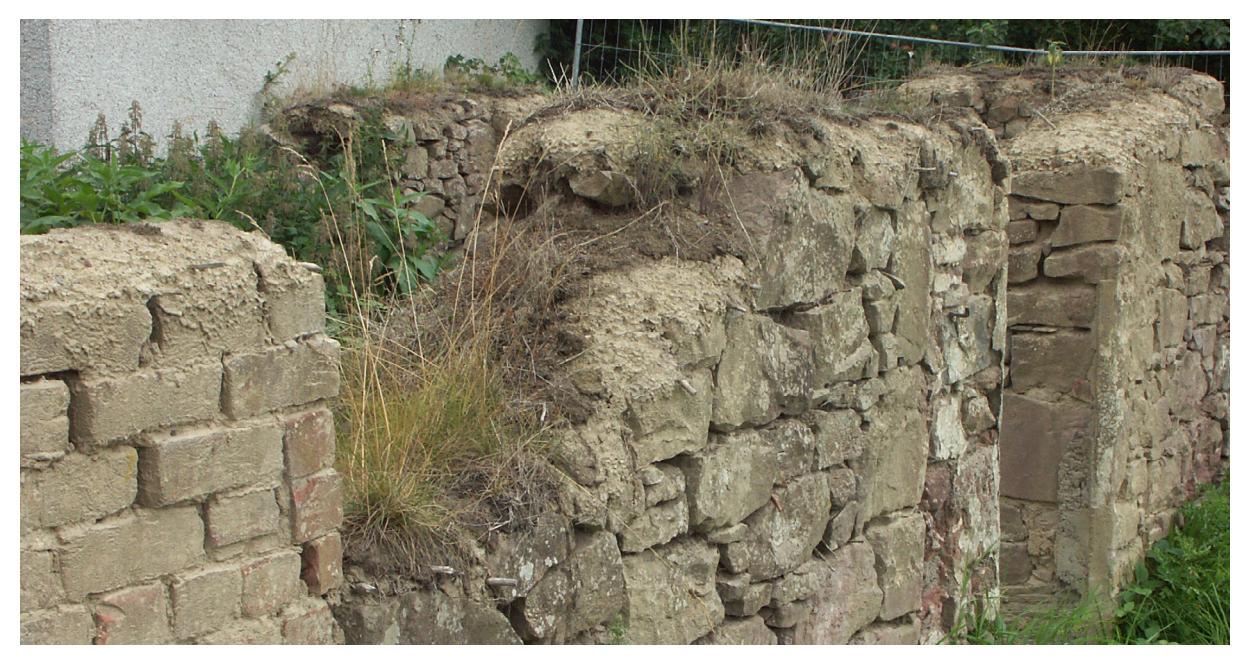
The ridge fared best on the north side, with the south suffering most dieback and shrinkage. There was a comparable correlation of performance to orientation in the wall cappings and this is clearly linked to peak solar radiation. It is notable that at sites where there is comparable low rainfall, but some shade, such as at Hugh Millar's Cottage (CS20), the caps perform much better.			
		The ridge suffered significant cracking of the clay layer, with repairs using a less clay rich mix, akin to the mix used on the wallheads, proving more resilient when the earth became exposed through plant dieback. This raises the debate of how much these clay caps can act as a moisture reservoir in dry sites, when a clay mix designed for durability, once exposed will be difficult for roots to penetrate.

*Fig. 32.5: The south facing edges were most vulnerable to drying out under the influence of solar radiation, with grass retreating to the northern sides.*

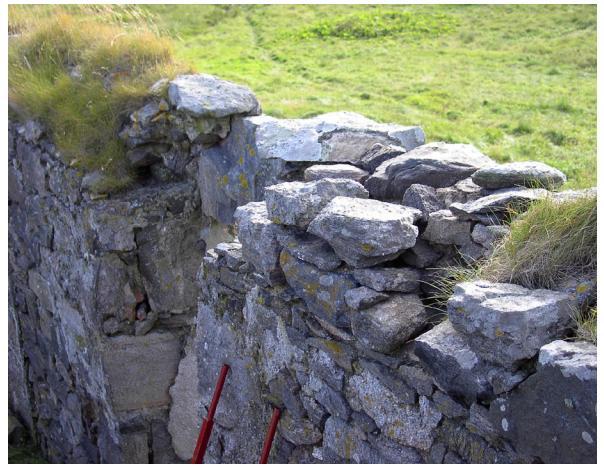
*Fig. 33.5: Removing the naturally established vegetation revealed loose masonry.*

5.3	Preliminary Repairs to Structure:	The wallheads were consolidated in lime mortar, set, as far as possible, to shed water. The flat wallheads have a complex geometry created by the many rafter end sockets. Much of the upper masonry was loose and the natural capping served to bind it (Figs. 32.4 and 5).							
		The gable wallheads had an externation face.	nal raised edge, but we	ere otherwise repaired	l to a flat sloping

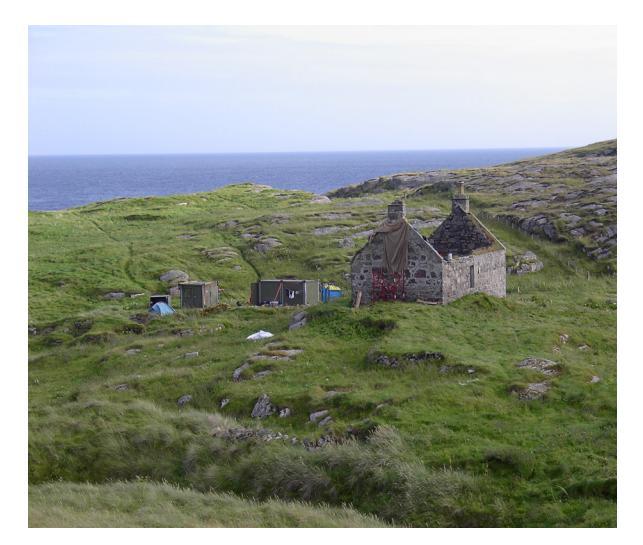
Fig. 33.6: North view, showing accommo-dation building.

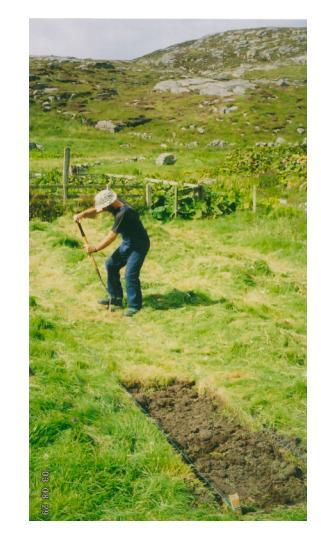
Fig. 33.8: Cutting the turf.

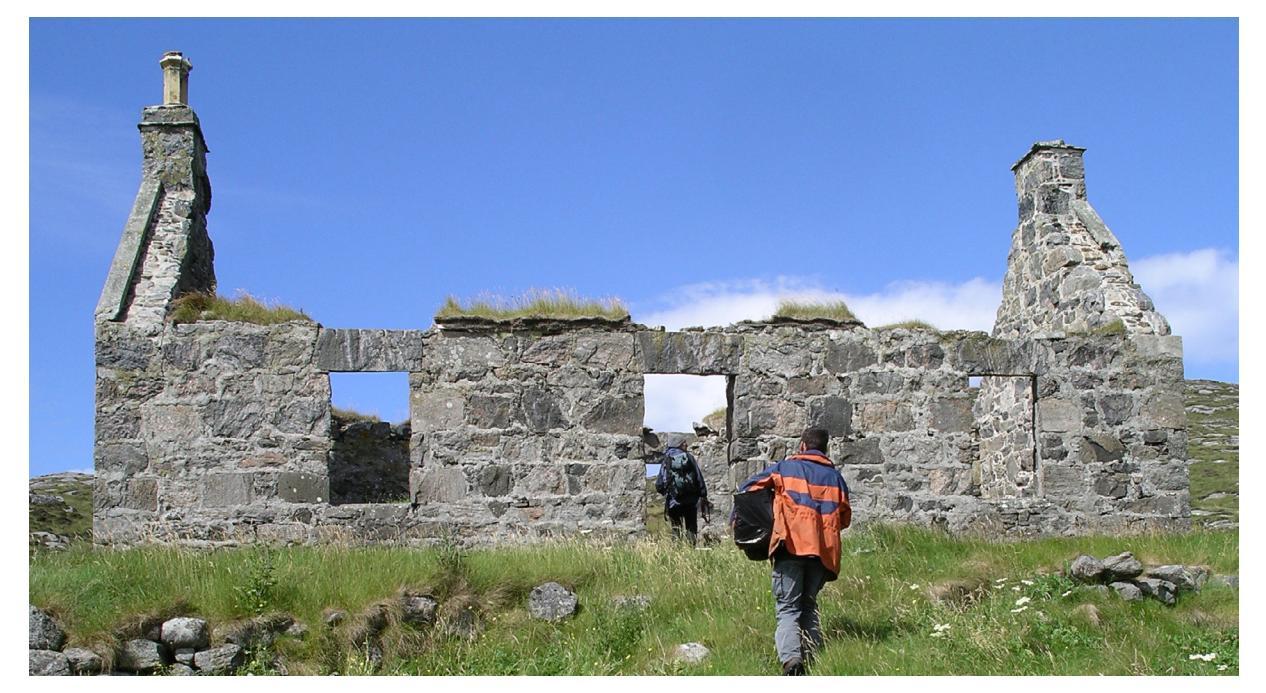
Fig. 33.12: East view two years after application, showing lost cappings on right.

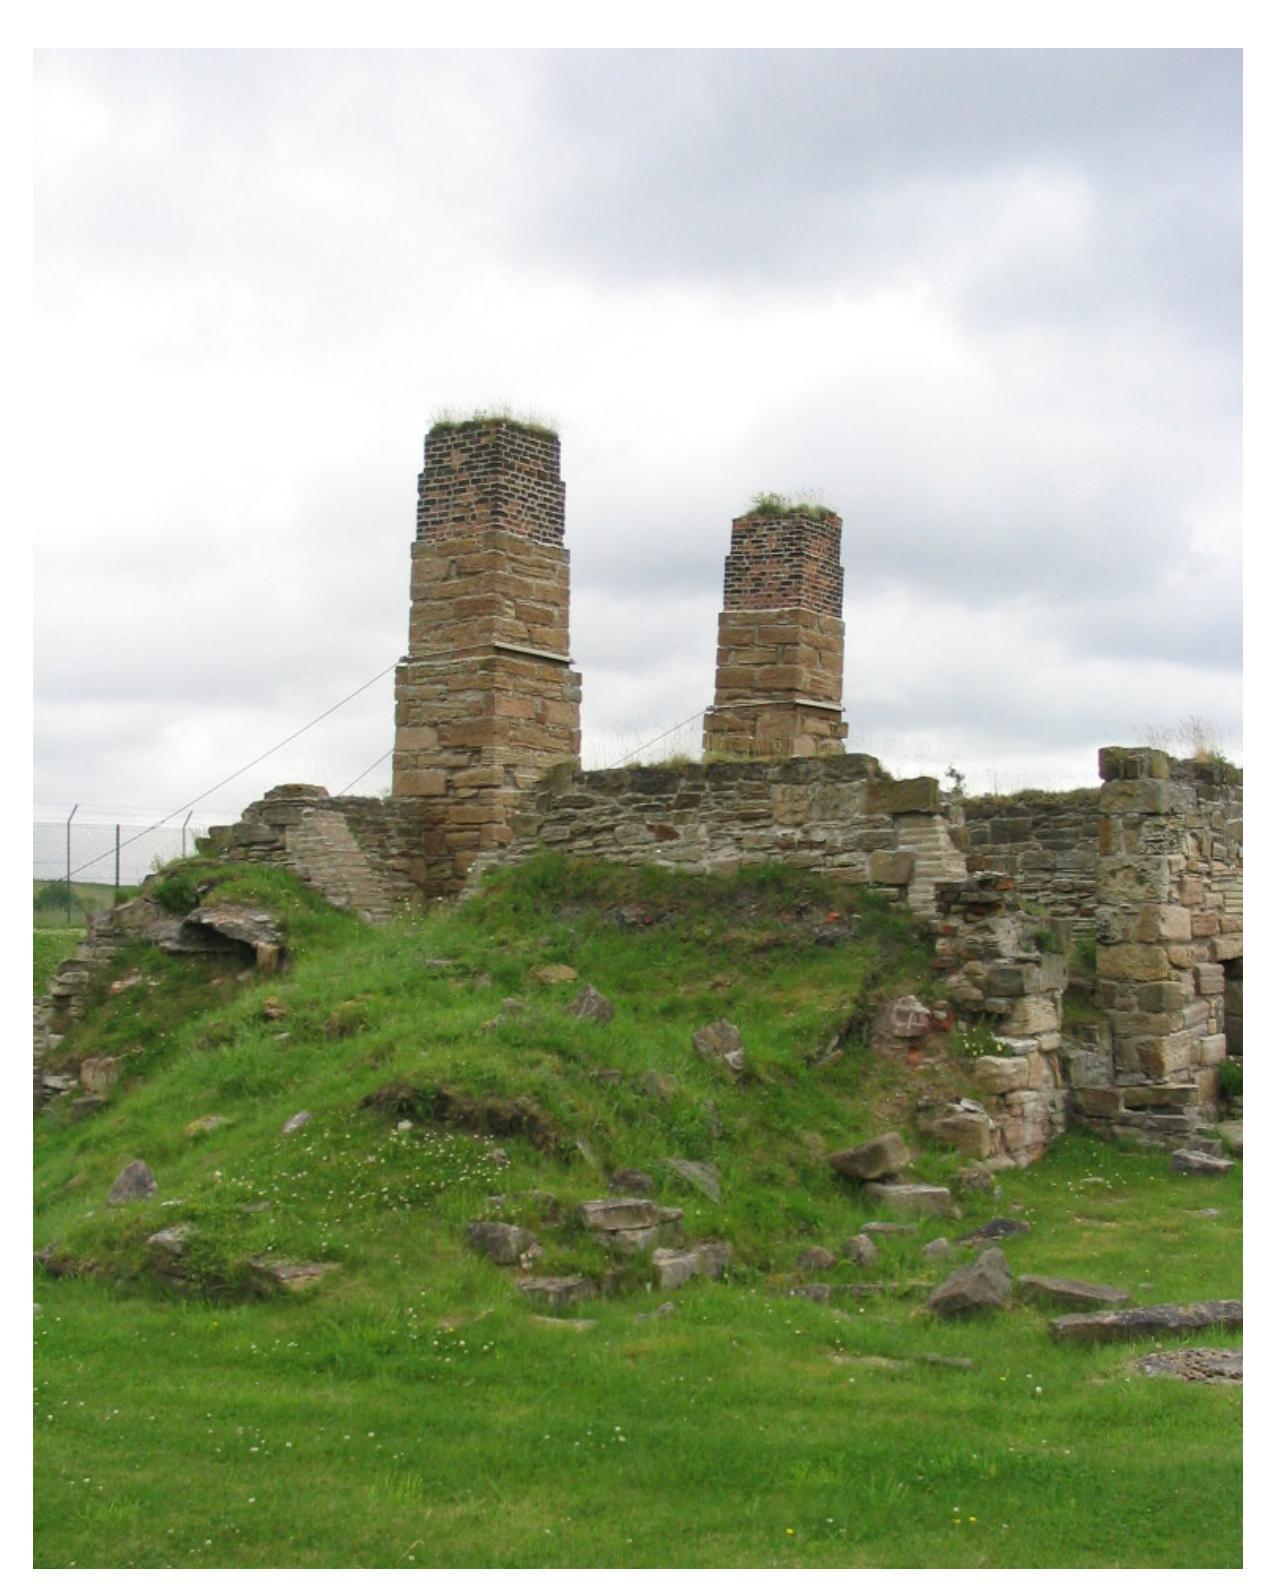
Fig. 34.1: The Salt Pan Houses. The soft cappings survive well on the chimney and wallheads.

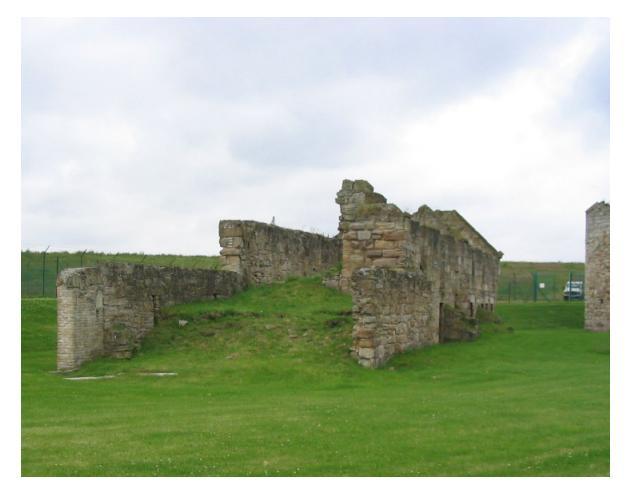
5.10	Fixing:	None used						
5.11	Aftercare:	None given						
5.12	Maintenance:	No regular maintenance						
6.0	Performance Assessment							
6.1	General Performance:	Accommodation Block: In general there has been complete failure of the capping, especially on the most exposed walls, where in some sections there is even very little earth remaining and the masonry is completely exposed. The grass growing on the wallheads is sparse and a great deal of it is yellow.						
		There is even less vegetation growing on the gable ends of the walls, and where there is growth it appears to be due to a small ledge or step in the wall, providing shelter.						
		The more sheltered north walls have a slightly denser coverage, but it is not comprehensive and a great deal of earth is exposed. There is growth on a number of internal sills.						
		<i>George Pit Engine House:</i> The vegetation on the tallest wallheads is quite sparse, however the smaller projecting walls have healthy lush vegetation growing on them. The lower walls have a well-matted root system with a variety of plants and grasses growing on them and the earth is damp.

6.2	Effect of Climate:	Wind exposure plays a large role in the condition of the cappings. The Salt Pan Houses have the most comprehensive cappings and they are the most sheltered, where as the complete failure of the capping on the Accommodation Block can be attributed to its extremely exposed position.

Fig. 34.5: The Accommodation Block.

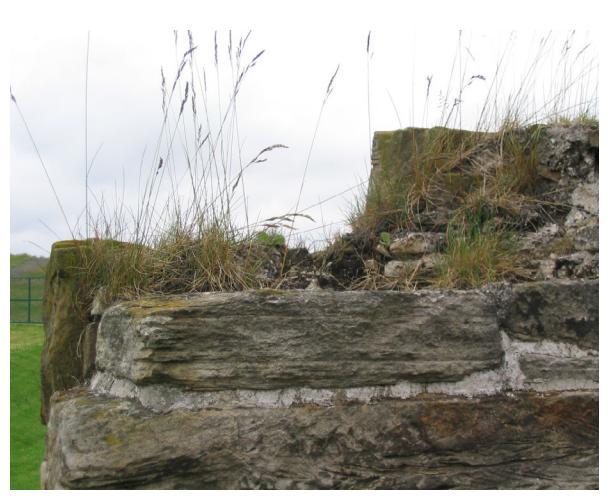
Fig. 34.6: Grass clings to locally-sheltered places.

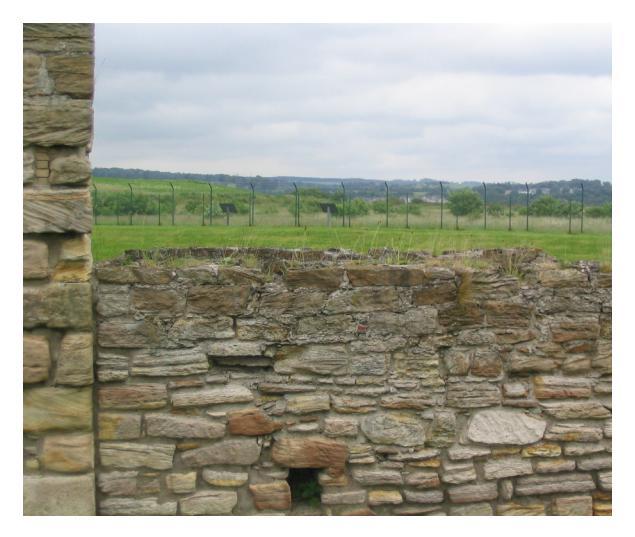
Fig. 34.7: Cover is very sparse on exposed wallheads.

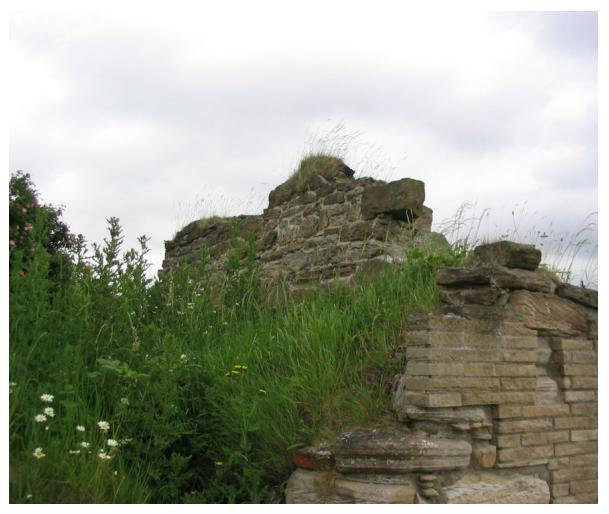
*Fig. 34.8: Inside the ruins, there is no maintenance and a profusion of plants thrive sheltered from the wind.*

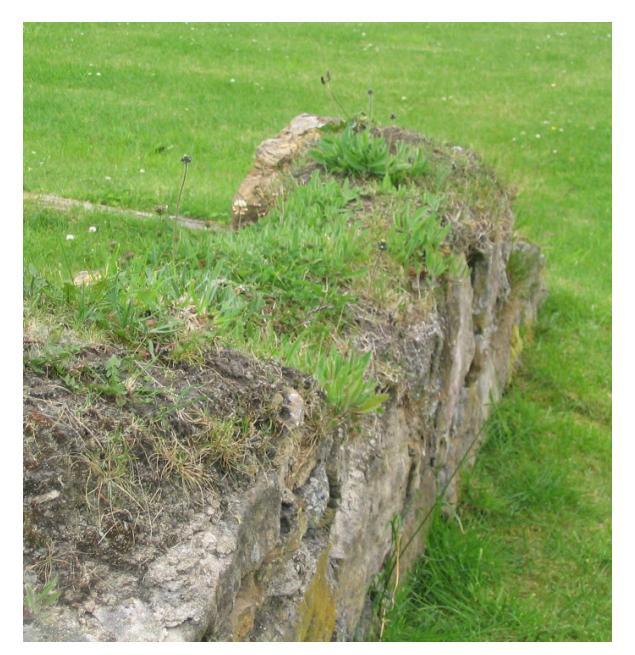
*Fig. 34.9: Low level caps show re-growth after drought dieback and possible grazing by rabbits.*

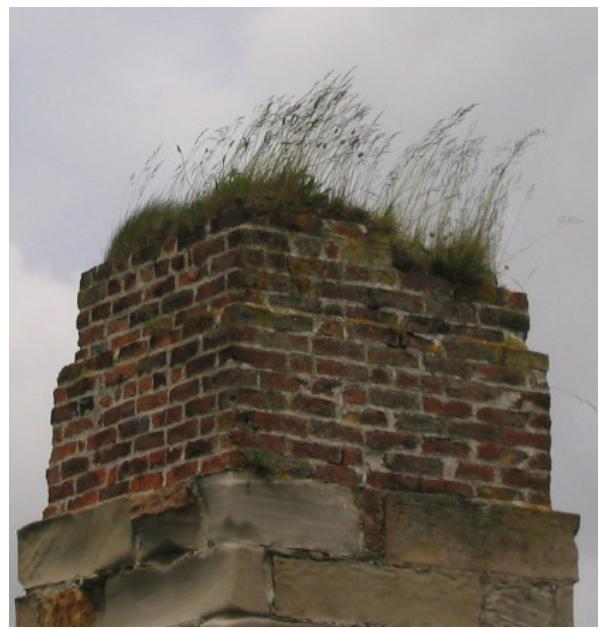
Fig. 34.10: The most exposed caps, on the chimneys, perform well.

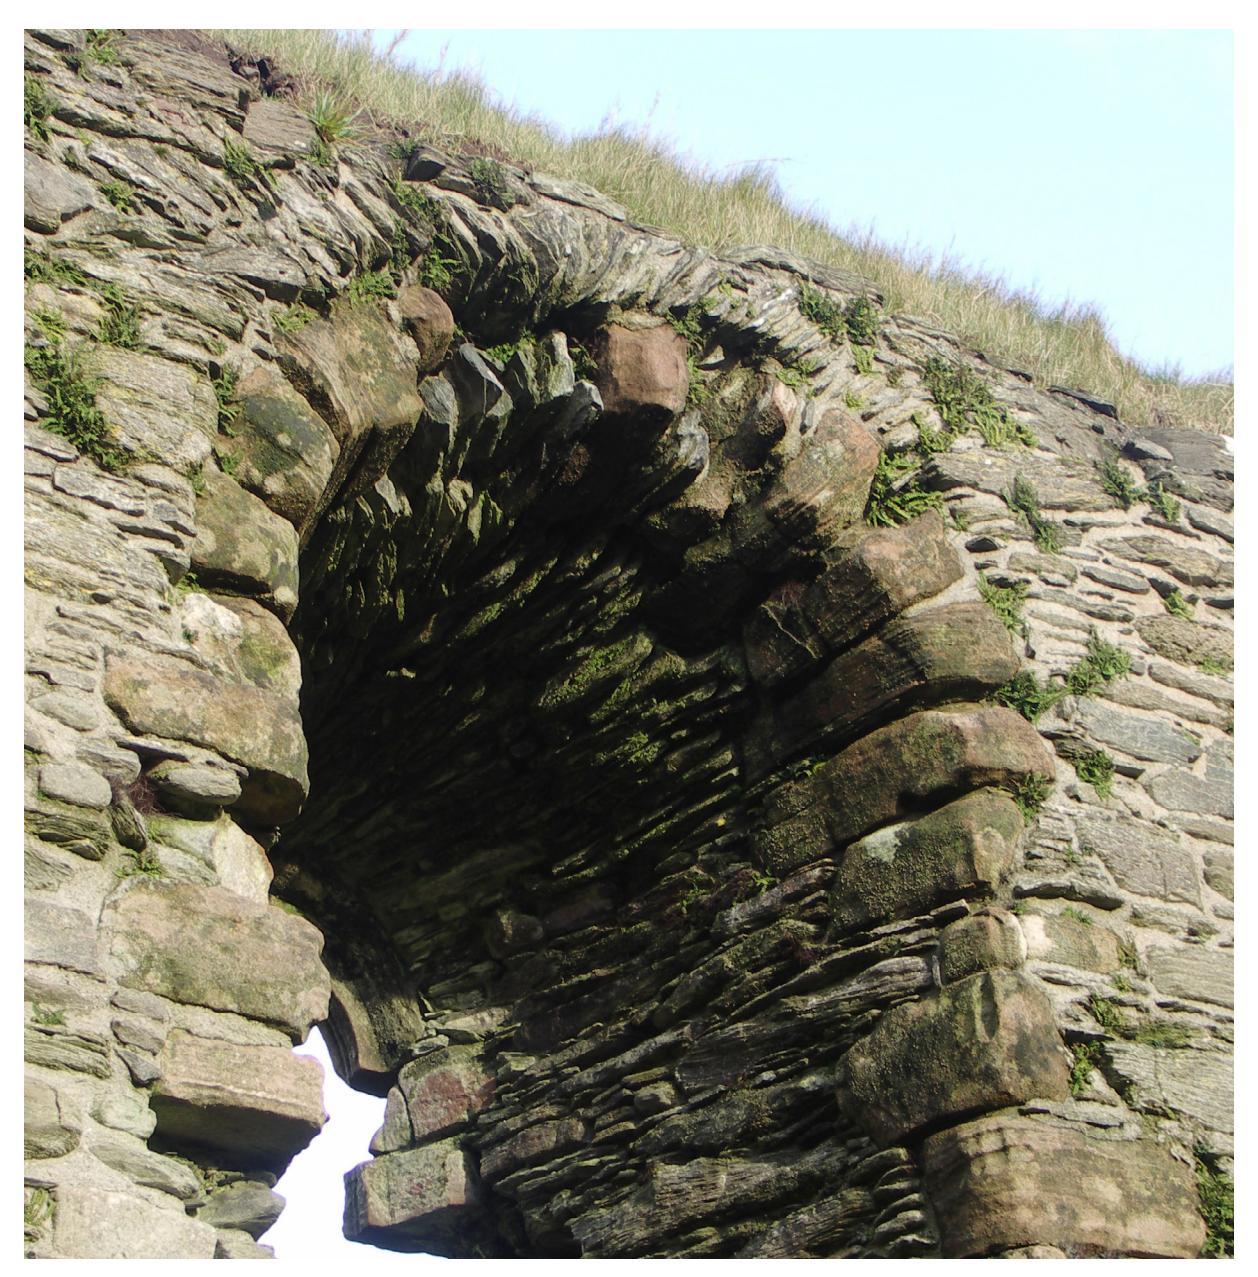
6.0	Performance Assessment		
6.1	General Performance:	The caps have performed well in reducing moisture ingress into the wallheads, with water dripping from the underside of arched openings in the walls beneath having been halted (Fig. 35.9).	
		The turf, apart from exposed edges, was well established, with a healthy dense sward and root system. The roots have not penetrated into the clay layer, which has a slightly plastic consistency (Fig. 35.10 and 13).	
		Some short-term clay staining after the works is reported. There is also minor, local, long-term clay staining where edges are not stable.	
	There is consistent evidence of edge decay, which seems to correlate with wind exposis soft cap profile, of which there is significant variation, does not seem to affect perform with a healthy sward generally away from decaying edges (Figs. 35.11 and 12).		
		There seems to be very little invasive seeding, with only occasional dandelions, etc. The exception is the decayed edges, where there are mosses some secondary grass growth and other plants. There is no evidence of trees seeding from the adjacent woodland. There has been some natural seeding onto the uncapped masonry.

Fig.35.9: Moisture reduction under arch.

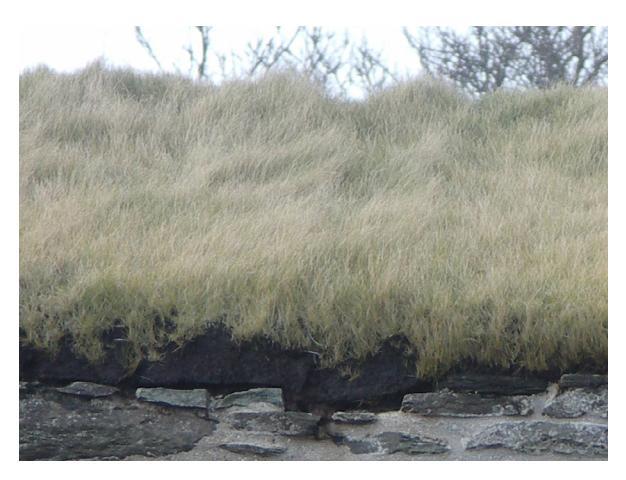
6.2	6.2 Effect of Climate: The effects of wind exposure are clearly the principal factor contributing to the the edges, which is general and progressive, and most affects the edges with g exposure. It is fairly clear that the turf dies first and then there is erosion of the with some secondary colonisation of the exposed soil by moss, grass and other successful on the more sheltered edges (Fig. 35.14).		
		It seems unlikely that these edges would dry out excessively, killing the grass, as there is a good quantity of soil and a wet climate. Heavy rainfall might cause occasional saturation of the soil, especially on the flatter wallheads.

Fig. 35.10: Edge dieback on last season's capping. The outside of this section is in the foreground of Fig. 35.11.

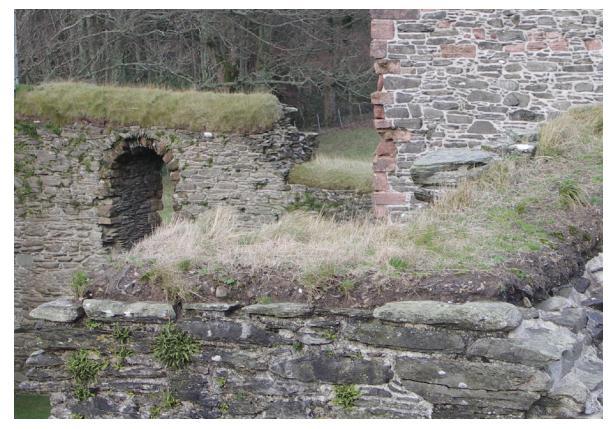
*Fig. 35.11: Variation in profile. The east wall in the foreground has a much flatter profile than the north wall in the background.*

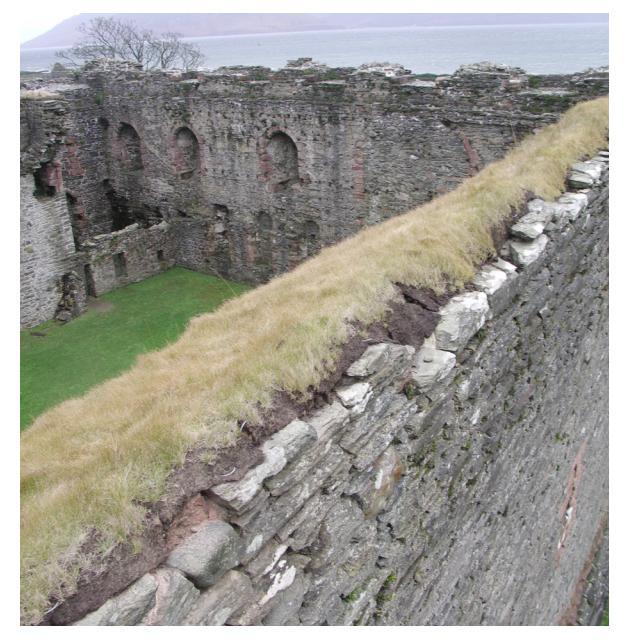
*Fig. 35.12: The west wall. The more recent work has a less stable edge than the previous years.*

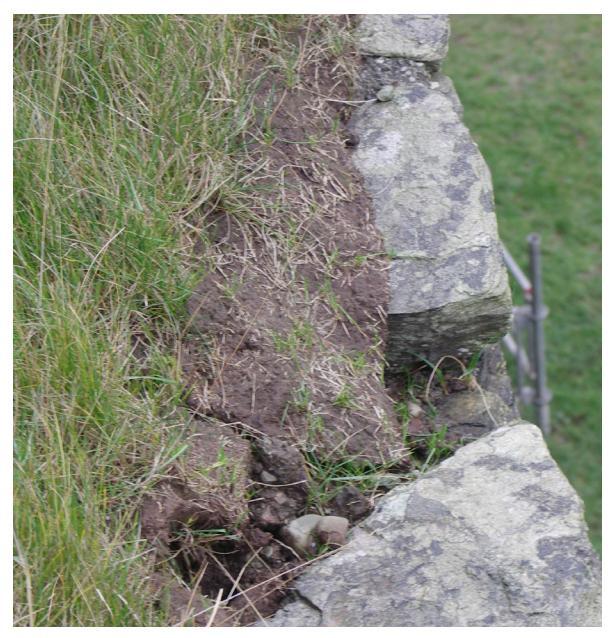
Fig. 35.13: New growth in edge dieback.

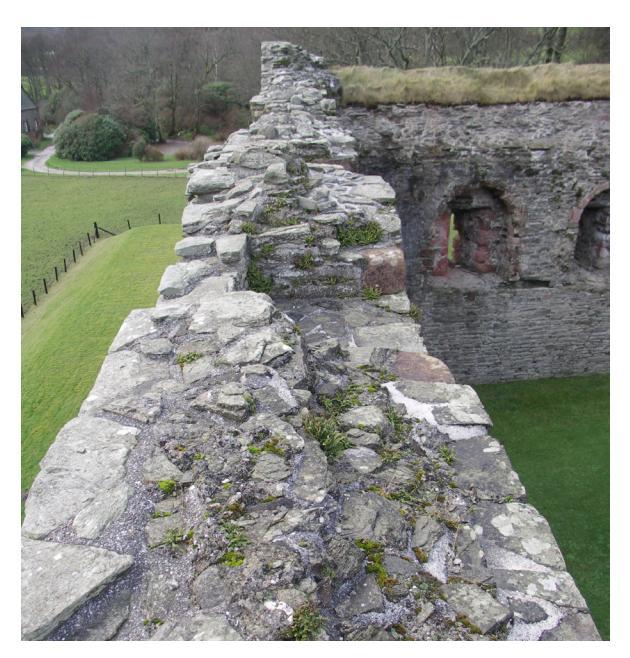
Fig. 35.14: Natural colonisation of the south wall.

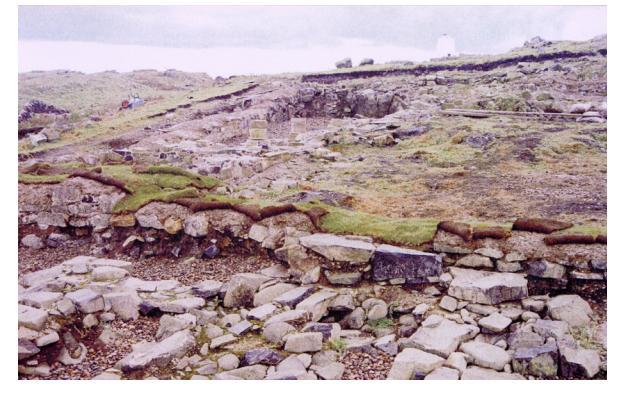
5.8	DPC:	None used		
5.9	Defining Membrane:	None used		
5.10	Fixing:	It is thought that no fixings were used. Wind, created by the helicopter used to transport materials to and from the site, partially lifted the turves from the wallhead during the works (Fig 36.4).

Fig. 36.4: Damage caused by wind from the helicopter.

The caps could have been pegged and netted against wind uplift. This would also have deterred theft by birds. The use of a better structured soil may have retained more moisture and been less susceptible to wind erosion when exposed.

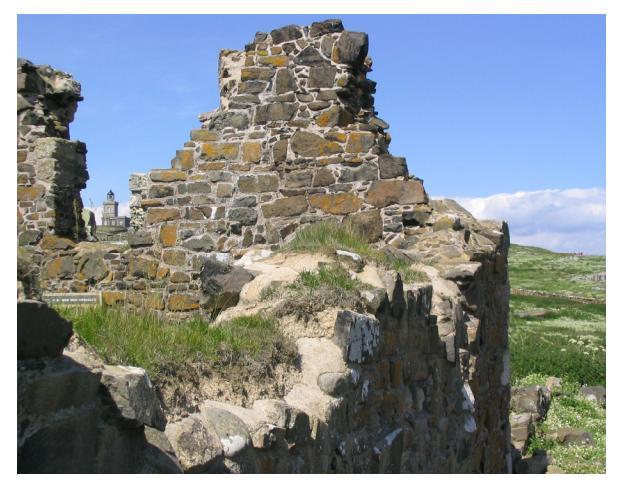
Fig. 36.6: East wall of ruined chapel. Patchy vegetation and dieback.

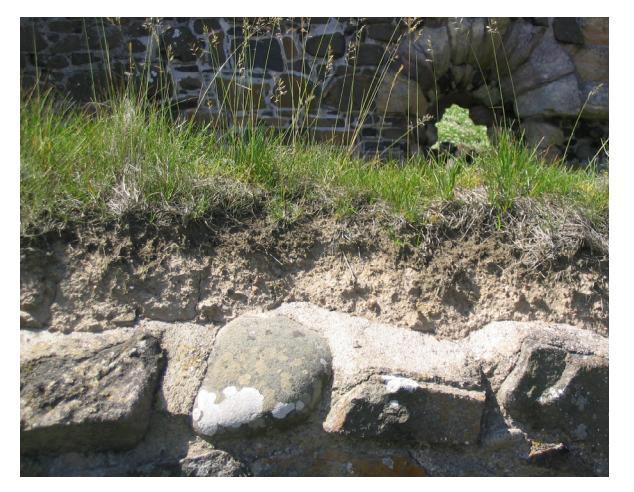
Fig. 36.8: Edge dieback on the high walls.

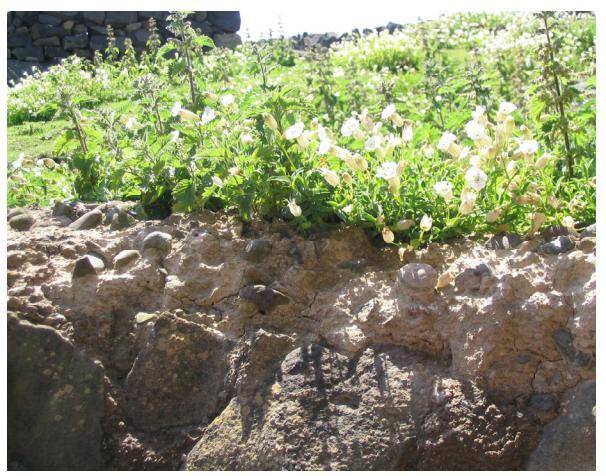
Fig. 36.9: The large pebbles are exposed by erosion.
