### SOFT CAPPING IN SCOTLAND

The context and potential of using plants to protect masonry

> Volume 2 Case Studies

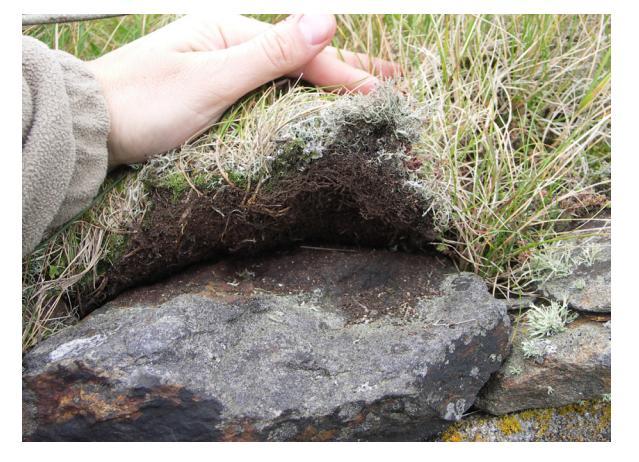
*Fig. 37.5: The old cappings all have dense root mats, which tie together the un-mortared stones, without damaging them.*

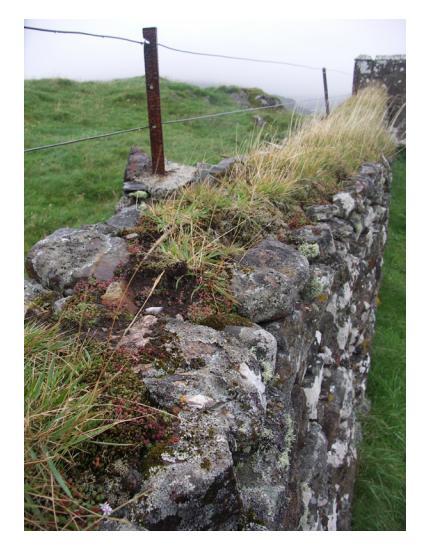
*Fig. 37.7: South wall. Some exposed caps are sparse.*

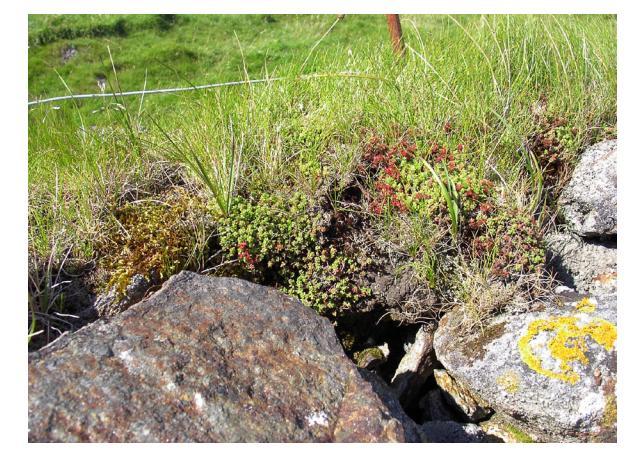
6.1	General Performance:	<i>The Old Cappings</i> The old cappings are very mature and show considerable variation, apparently relating to wind exposure, with mosses, sedums, lichens and other species all colonising where the grass struggles to survive (Figs. 37.10 and 11). The result is a dense matt giving good wallhead cover in most areas (Fig. 37.5). There is not a large amount of soil, but the root mat binds the head stones together well, contributing to their stability, while not having deep and potentially damaging tap roots that penetrate into the masonry. Relatively small areas have not sustained cappings and these seem to be associated with areas of masonry in worst condition, including partial collapse. In the best locations, the walls have a full and lush topping of predominantly grass species, with soil 125-150mm thick and cover to the edges (Figs. 37.4 and 6). One of the small enclosures within the graveyard has a rough masonry cope that has been partially colonised by plants. In the main these are sparse and ineffective, but where one corner is sheltered by a stunted tree, there is good grass cover, clearly indicating the importance of wind exposure on this site (Fig. 37.8). <i>New Cappings</i> The soft caps on the north wallhead, which was rebuilt in 2003, have had varied success, with some areas struggling and others becoming reasonably well established. There was clearly a period of initial dieback from the exposed cut edges, as well as shrinkage of the joints between the relatively small turf blocks (Fig. 37.14). The south edge commonly died back ~25mm, while the north remained to its original line.

Fig. 37.10: Sedums and mosses provide stability in exposed areas.

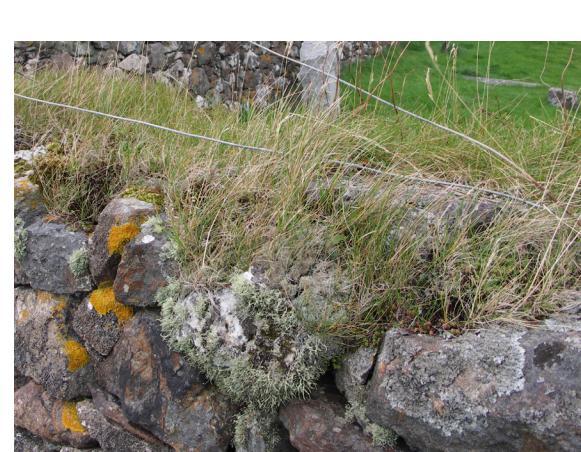
Fig. 37.11: Lichen growth can be significant.

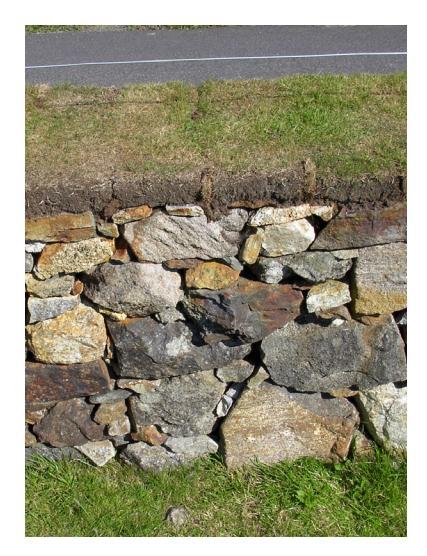
Fig. 37.14: Early dieback and joint shrinkage.

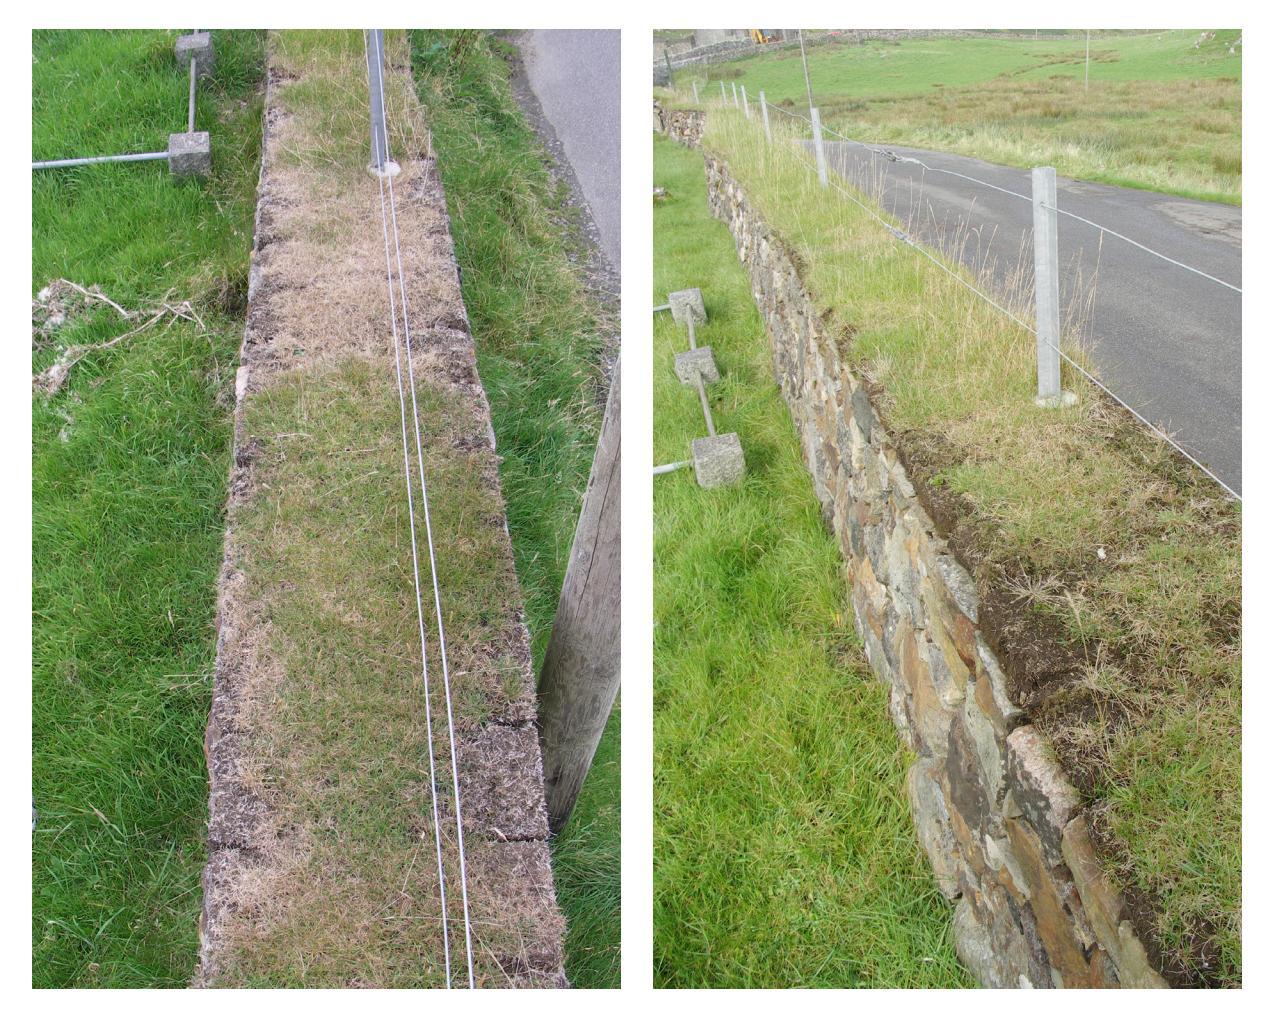
In the worst areas, the turf dies right across the wallhead. In dead areas the dense rotted turf suffered little erosion, though there was some minor association of turf edge decay with joints in the masonry below. By the third year there was evidence of new plant growth on the cut edge (Figs. 37.17 and 18).

Fig. 37.15: North wall. After two years dieback is considerable.

Fig. 37.16: North wall. After three years initial dieback seems to have stopped.

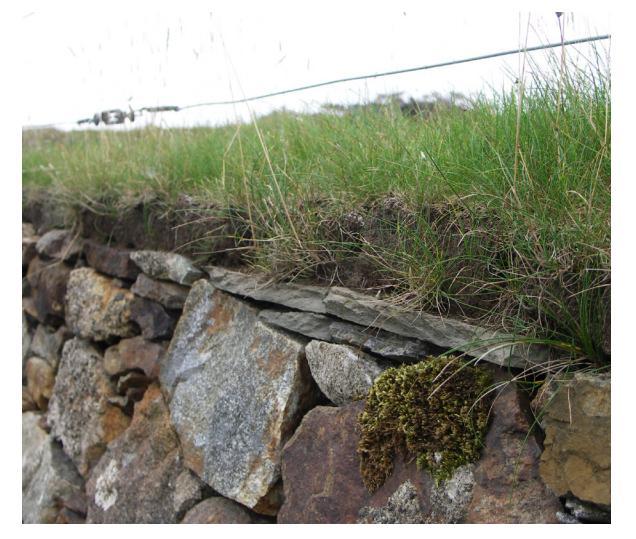
Fig. 37.17: North wall. After three years, there is some new growth from the cut edges.

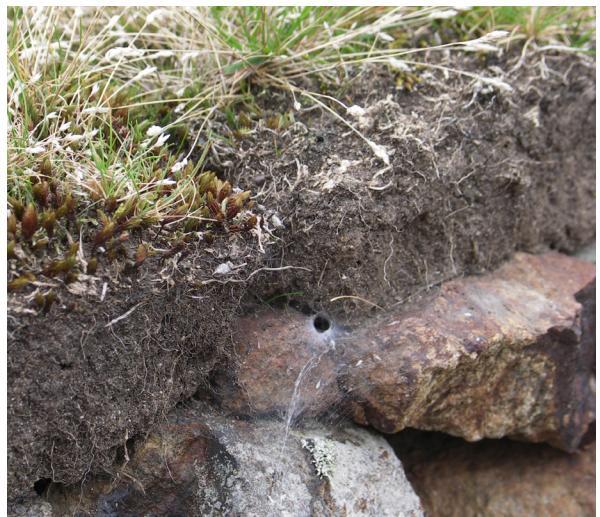
Fig. 37.18: Moss and grass colonisation helps to stabilise decay of dead areas.

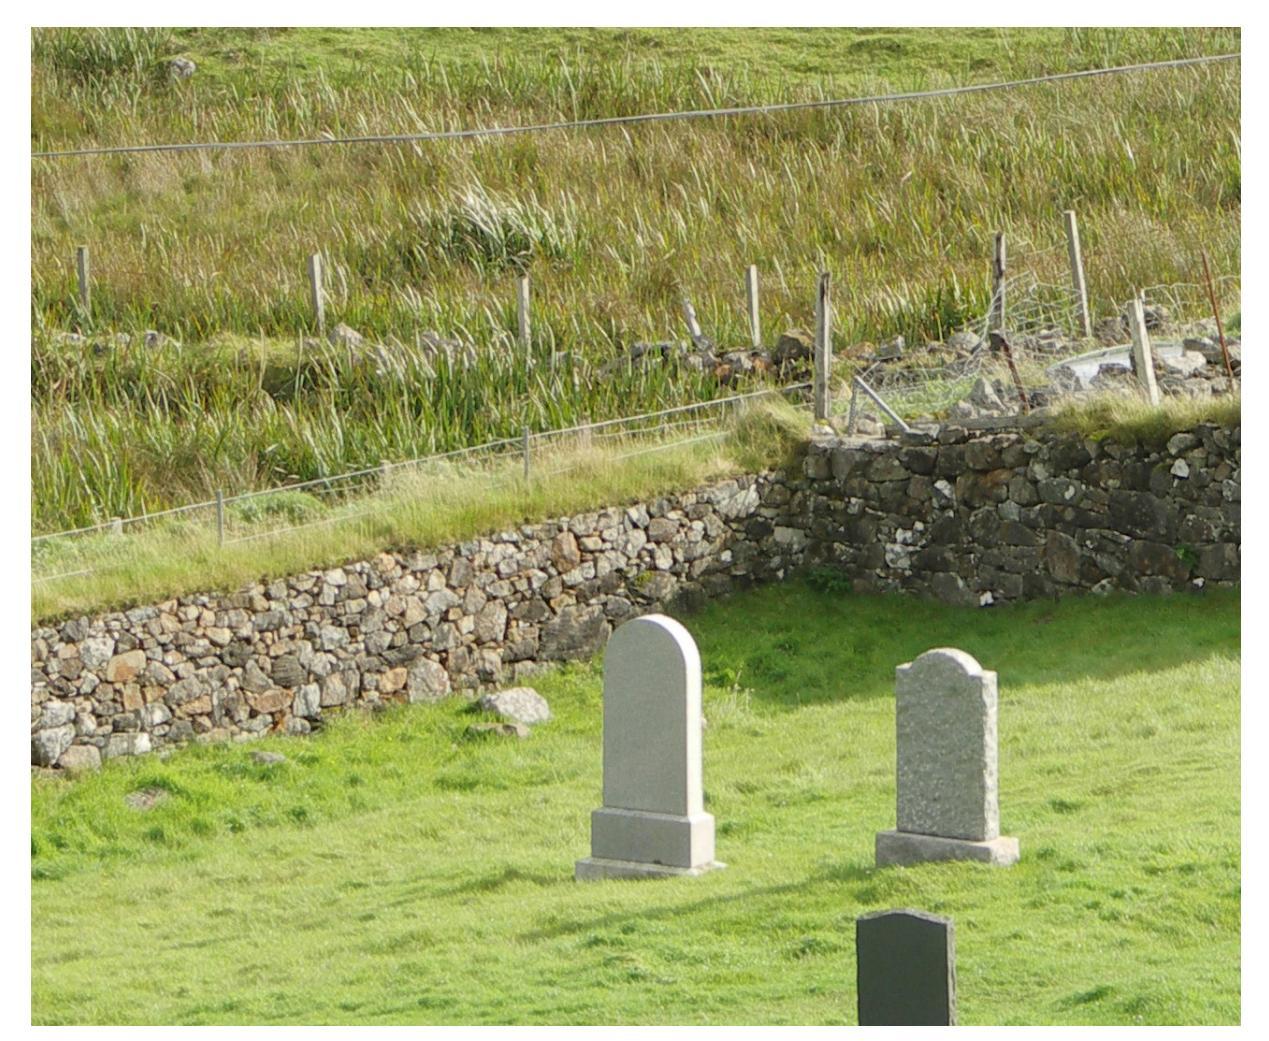
Nonetheless, in the short term the visual impression of the rebuilt walls is rather too 'tidied up' and it would be unfortunate if all the landscape character and sense of place that the old walls bring, is lost through rebuilding of all the walls.	
		One simple means of retaining some of that character through the repairs would be to re-use some of the old vegetation. The old stone is re-used to rebuild the masonry and it is logical to extend the same principle to the other walling material – the plant cap.

Fig. 37.19: North and east walls. The visual contrast between the old and reconstructed walls is significant.

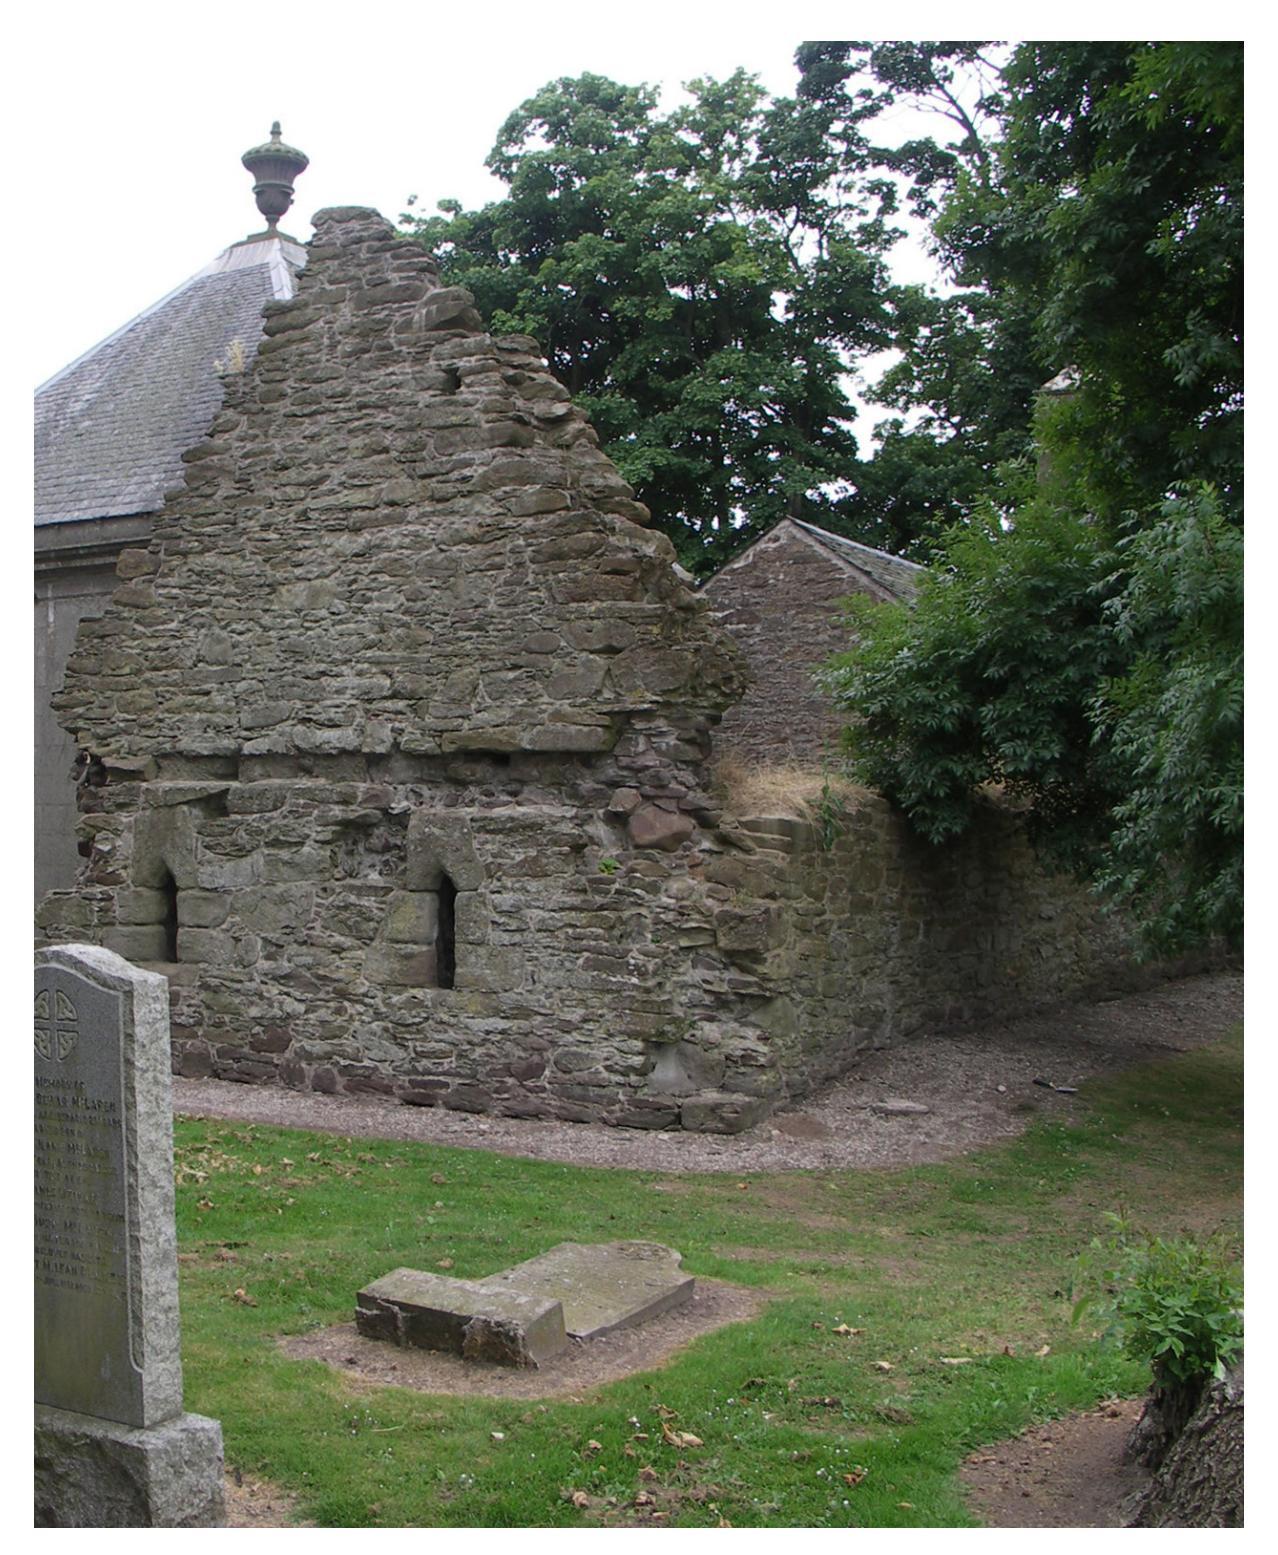
*Fig. 38.1: View from the east showing the wallhead sheltered from wind-driven rain by buildings and partially from vertical rain by trees, but exposed to high angle summer solar radiation.*

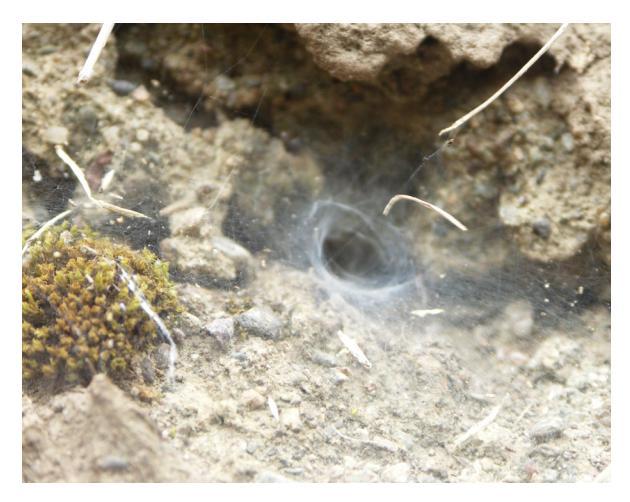
5.12	Maintenance:	No known maintenance plan.		
6.0	Performance Assessment			
6.1	General Performance:	In 2002, RL visited the site one year after application, when the turf looked well established and lush.		
		In 2005, the soft capping was in poor condition. The grass had died back completely from the sloping edges, with a strip of yellow and seemingly dead grass in the centre of the cap. In the east section even this central strip became very thin. There was also greater dieback under the tree, which may be linked to shading, rain shadowing and/or abrasion from the foliage (Fig. 38.3). However, at the ends, where it abutted gables, there was some green grass (Fig. 38.4). While the surviving grass may have been less dead than it appeared, as the site was visited in high summer, the conditions were clearly very stressed.		
		Where the vegetation had died, the exposed soil appeared to be washing away and there was staining of the masonry. The soil was crumbly, friable, very dry and sandy. In some sections, particularly on the south side, the soil has completely eroded away, exposing the clay cap, which was dry, hard and decaying at a slower rate. On the north side there had been some colonisation of the exposed soil by mosses and grasses (Fig. 38.8).

Fig. 38.8: Moss and a spider's home.

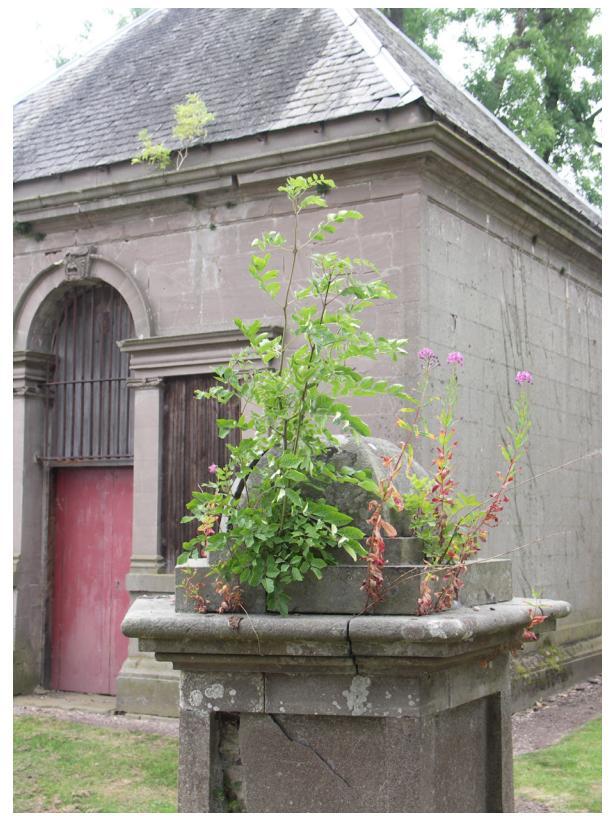
*Fig.* 38.9: Damaging colonisation nearby by trees and willow-herb.

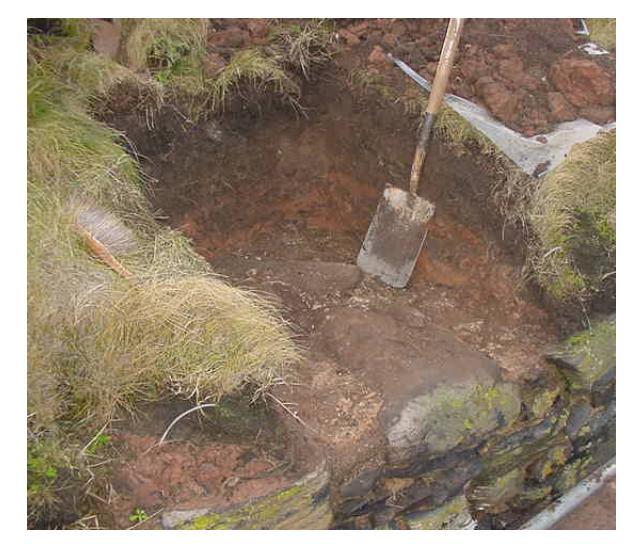
*Fig. 39.3: Section through the first capping. Note the edge cover and moss growth on the right.*

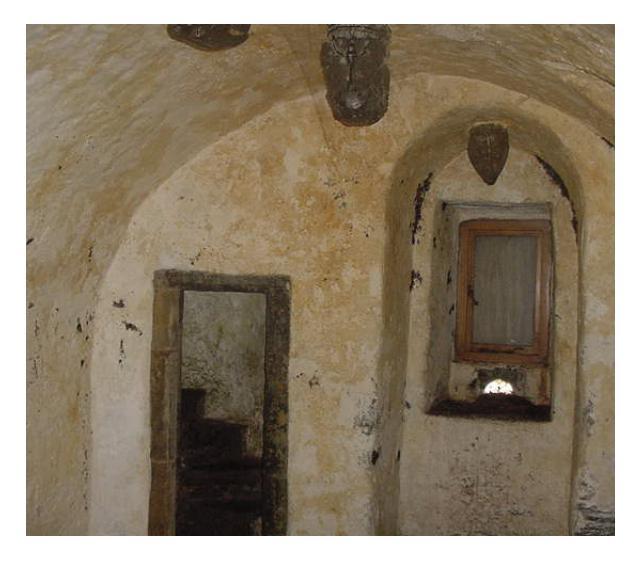
6.0	Performance Assessment		
6.1	General Performance:	<ul> <li><i>Ist Capping:</i> The clay/turf capping failed to keep the masonry waterproof, with significant ingress of water to the vault, saturating the decorative dressings and leaving extensive deposits of leached clay on the surface (Figs 37.5 and 37.6). When it was removed, it was apparent that the clay had cracked through cycles of swelling and shrinkage.</li> <li>The vegetation was apparently healthy, but may have had edge decay.</li> <li><i>2nd Capping:</i> Since the application of the second capping, the vault masonry has dried out and it seems to perform well in waterproofing the roof (Fig. 39.7). The vegetation appears generally healthy (Fig. 39.8), though there is consistent edge dieback, ~100mm, which exposes the soil beneath to erosion. Decay is worst at the corners and turf joints are clearly visible, confirming that the turf never rooted in at the edges (Fig. 39.10).</li> </ul>

*Fig. 39.5: Interior of the vault under the first capping, water staining to limewash.*

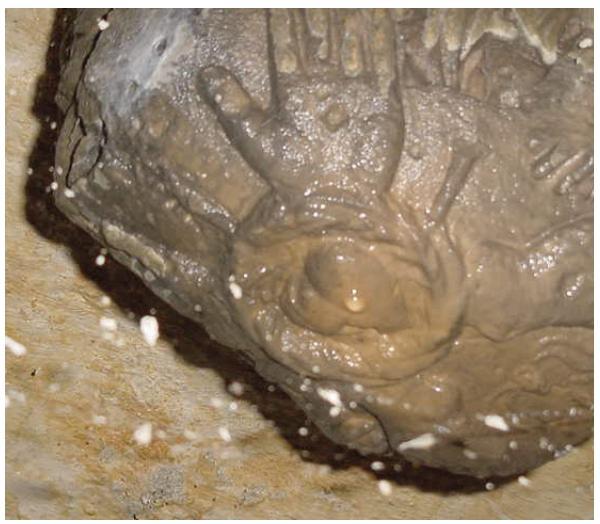
*Fig.* 39.6: Water dripping from the ceiling under the first capping.

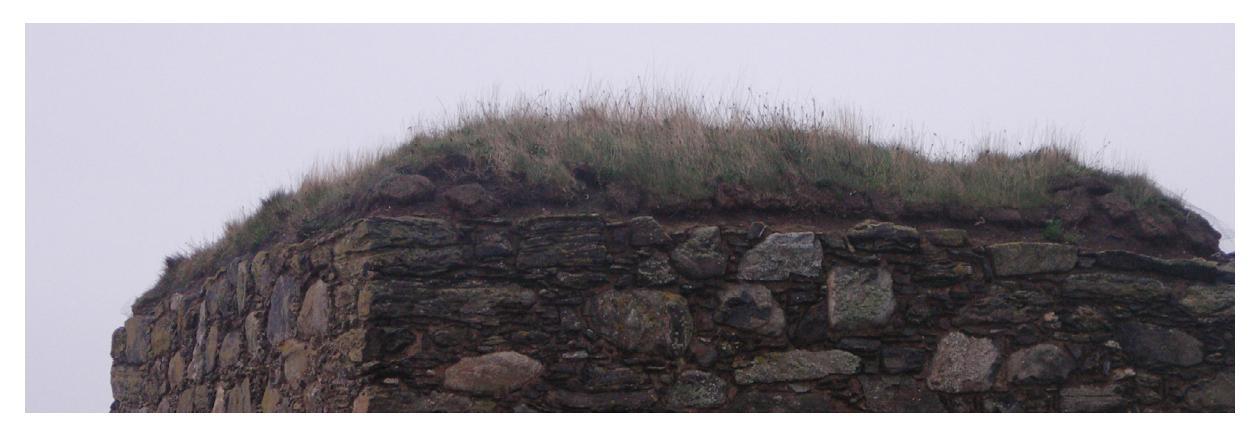
6.2	Effect of Climate:	The severity of winds, together with the low rainfall and high solar exposure, contribute to the edge dieback.	
6.3	Effect of Birds:	None noted

Fig. 39.10: Detail of edge decay.
