THE
INVESTIGATION,
REPAIR AND
CONSERVATION
OF THE
DOULTON
FOUNTAIN,
GLASGOW GREEN

2 | Case
Study

TECHNICAL
CONSERVATION
GROUP

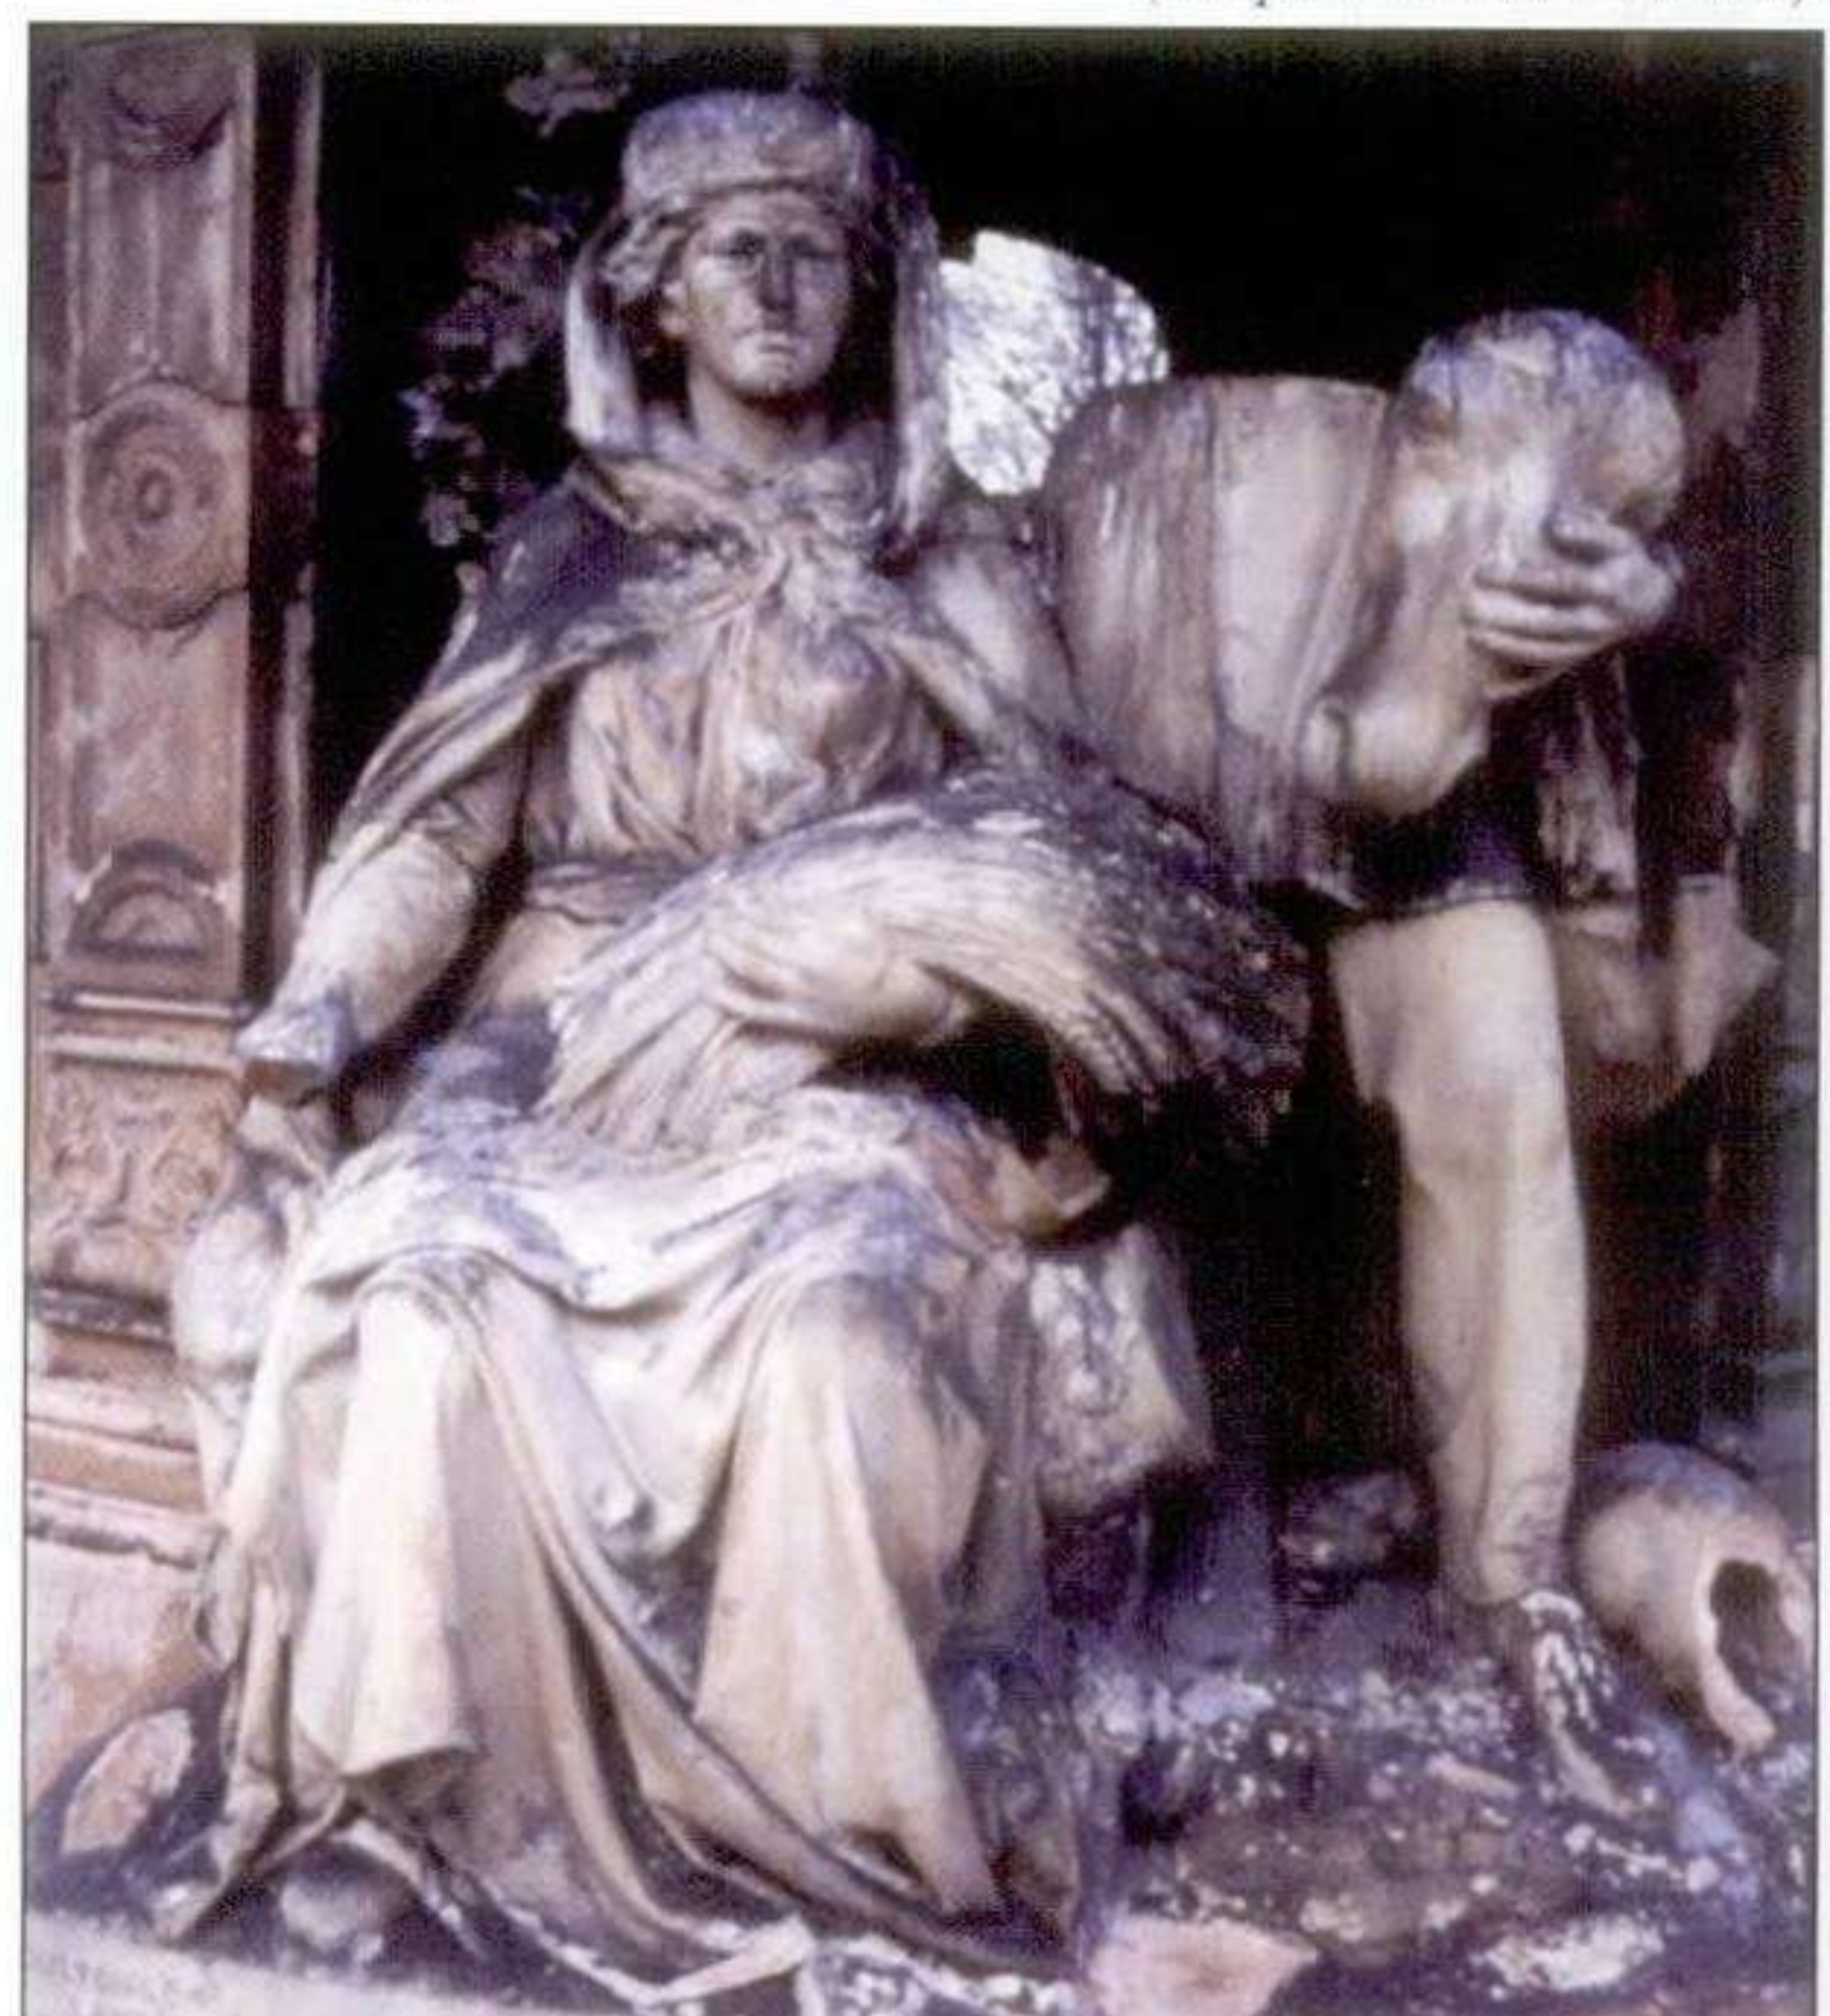
The figures after vandalism has begun (Hatherware)

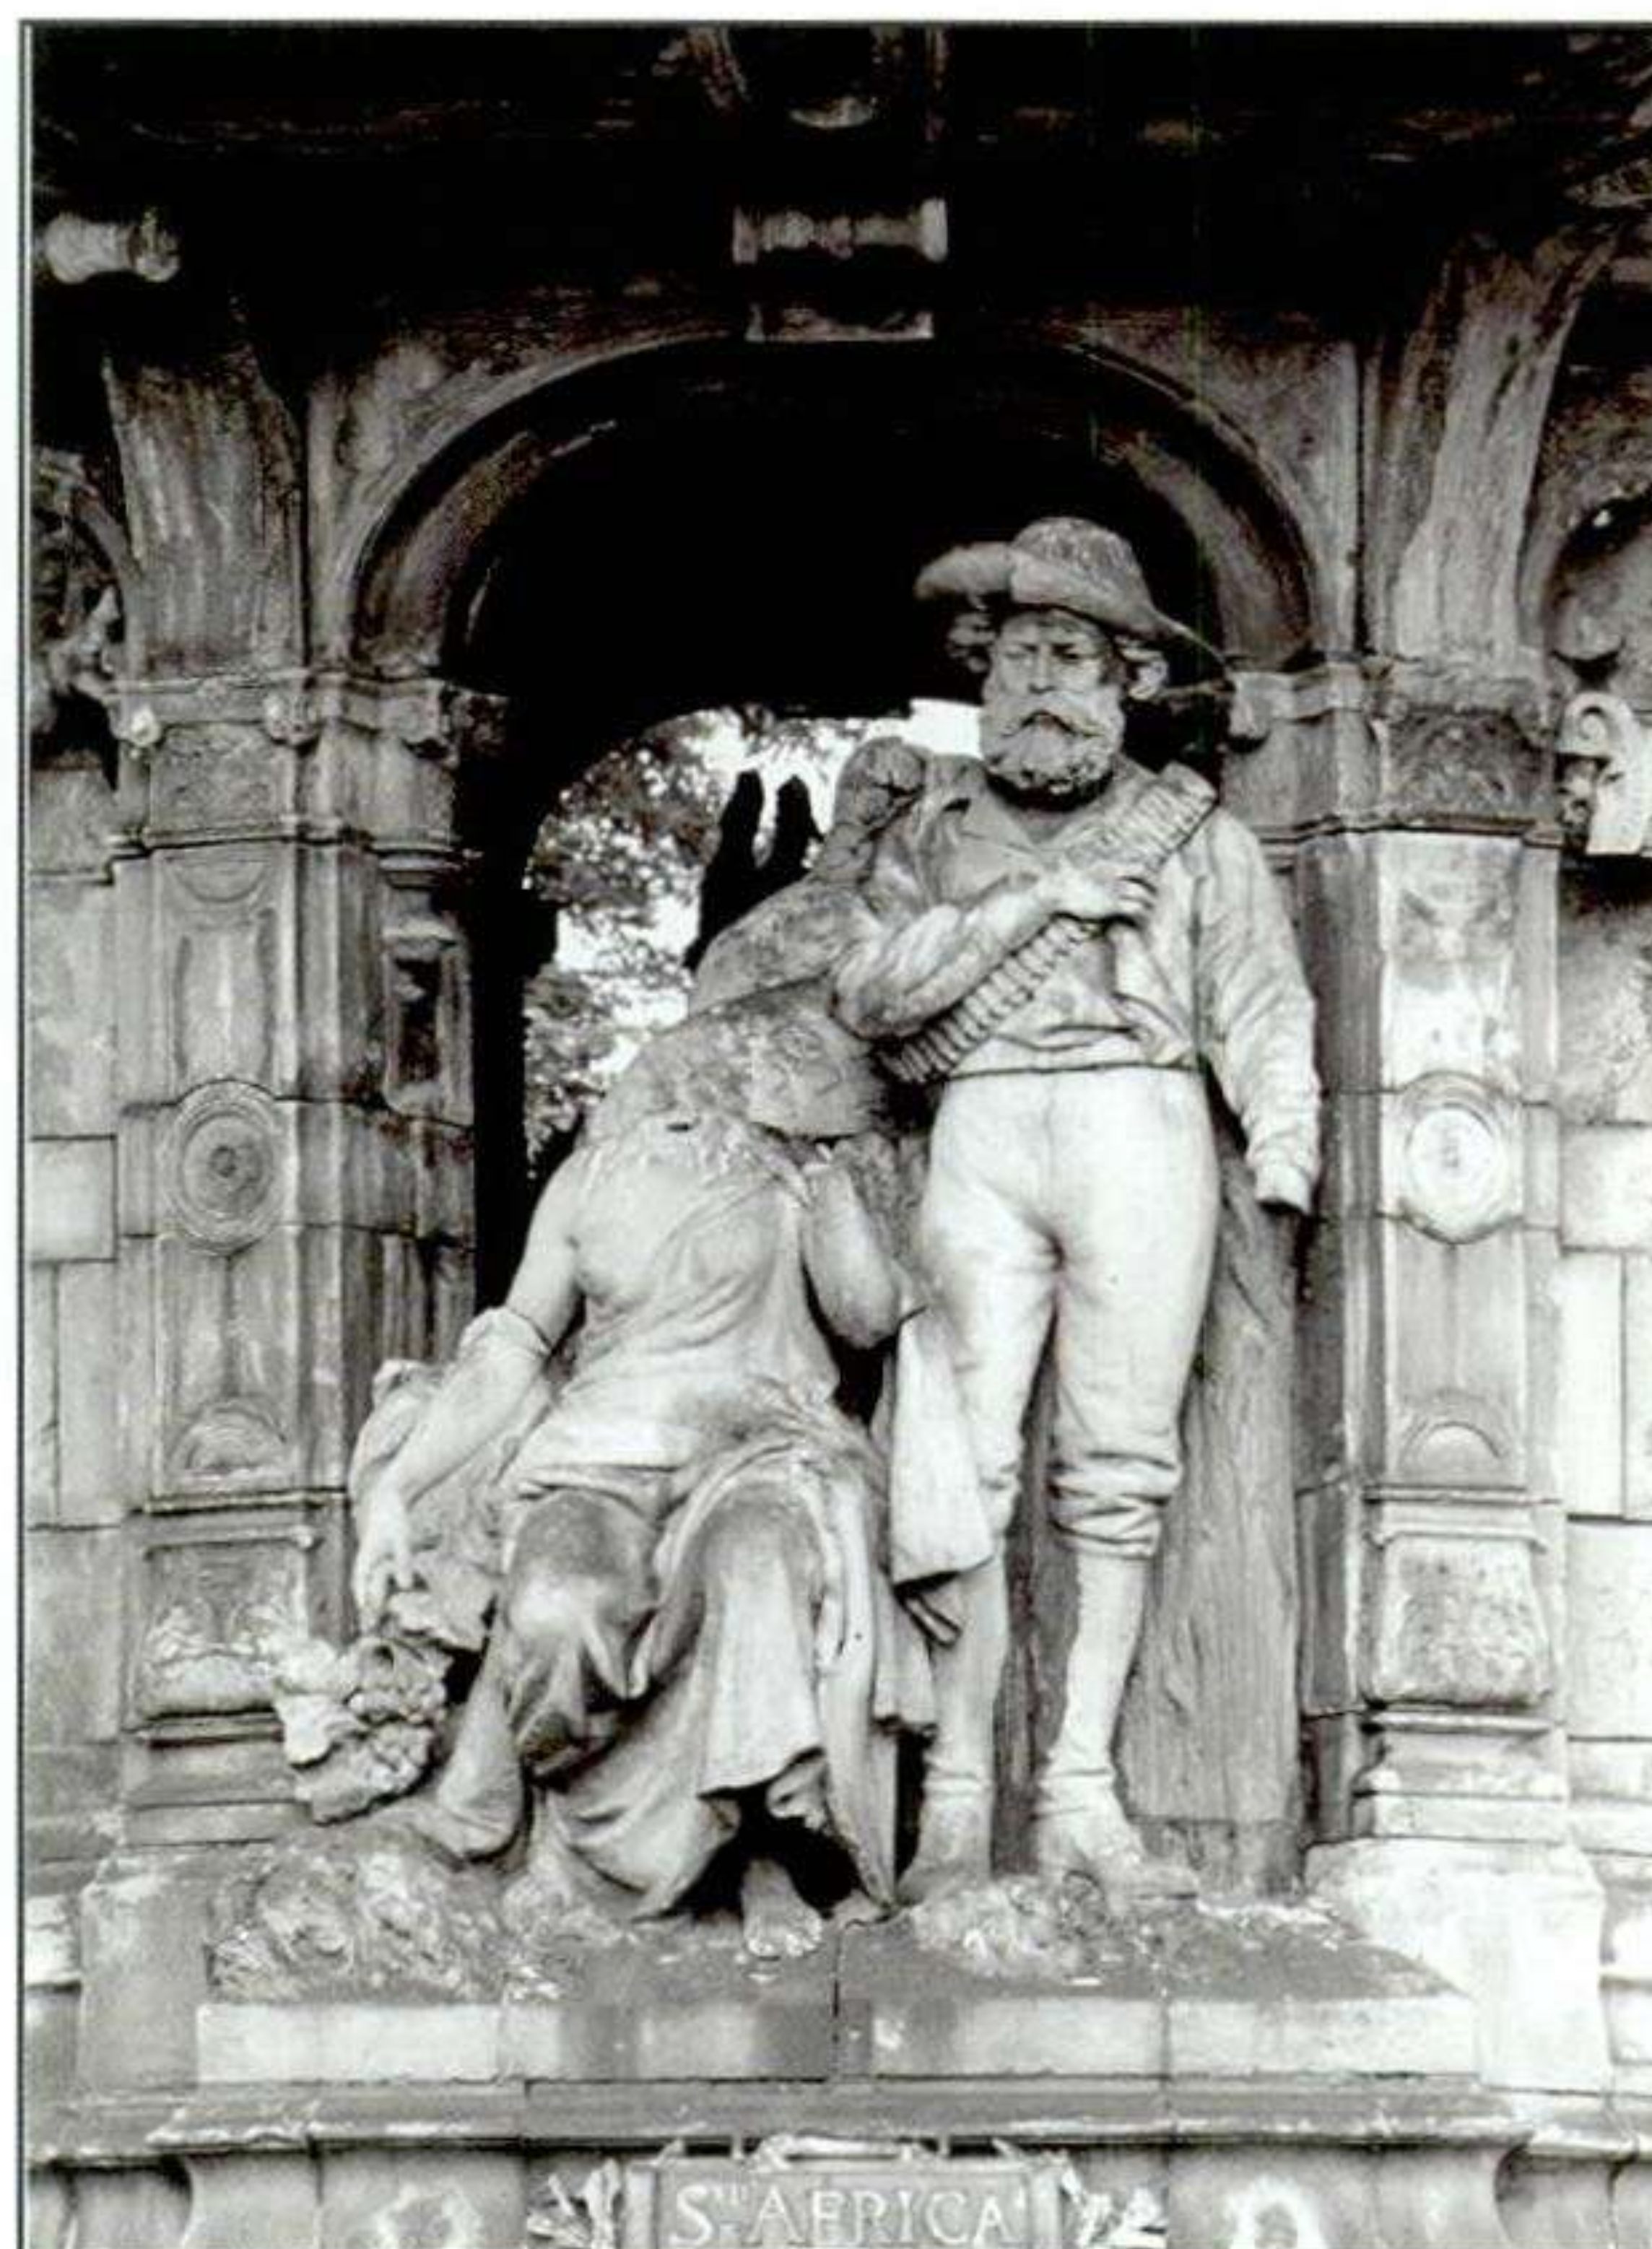
The terracotta figures in the fountain after loss of ladies head

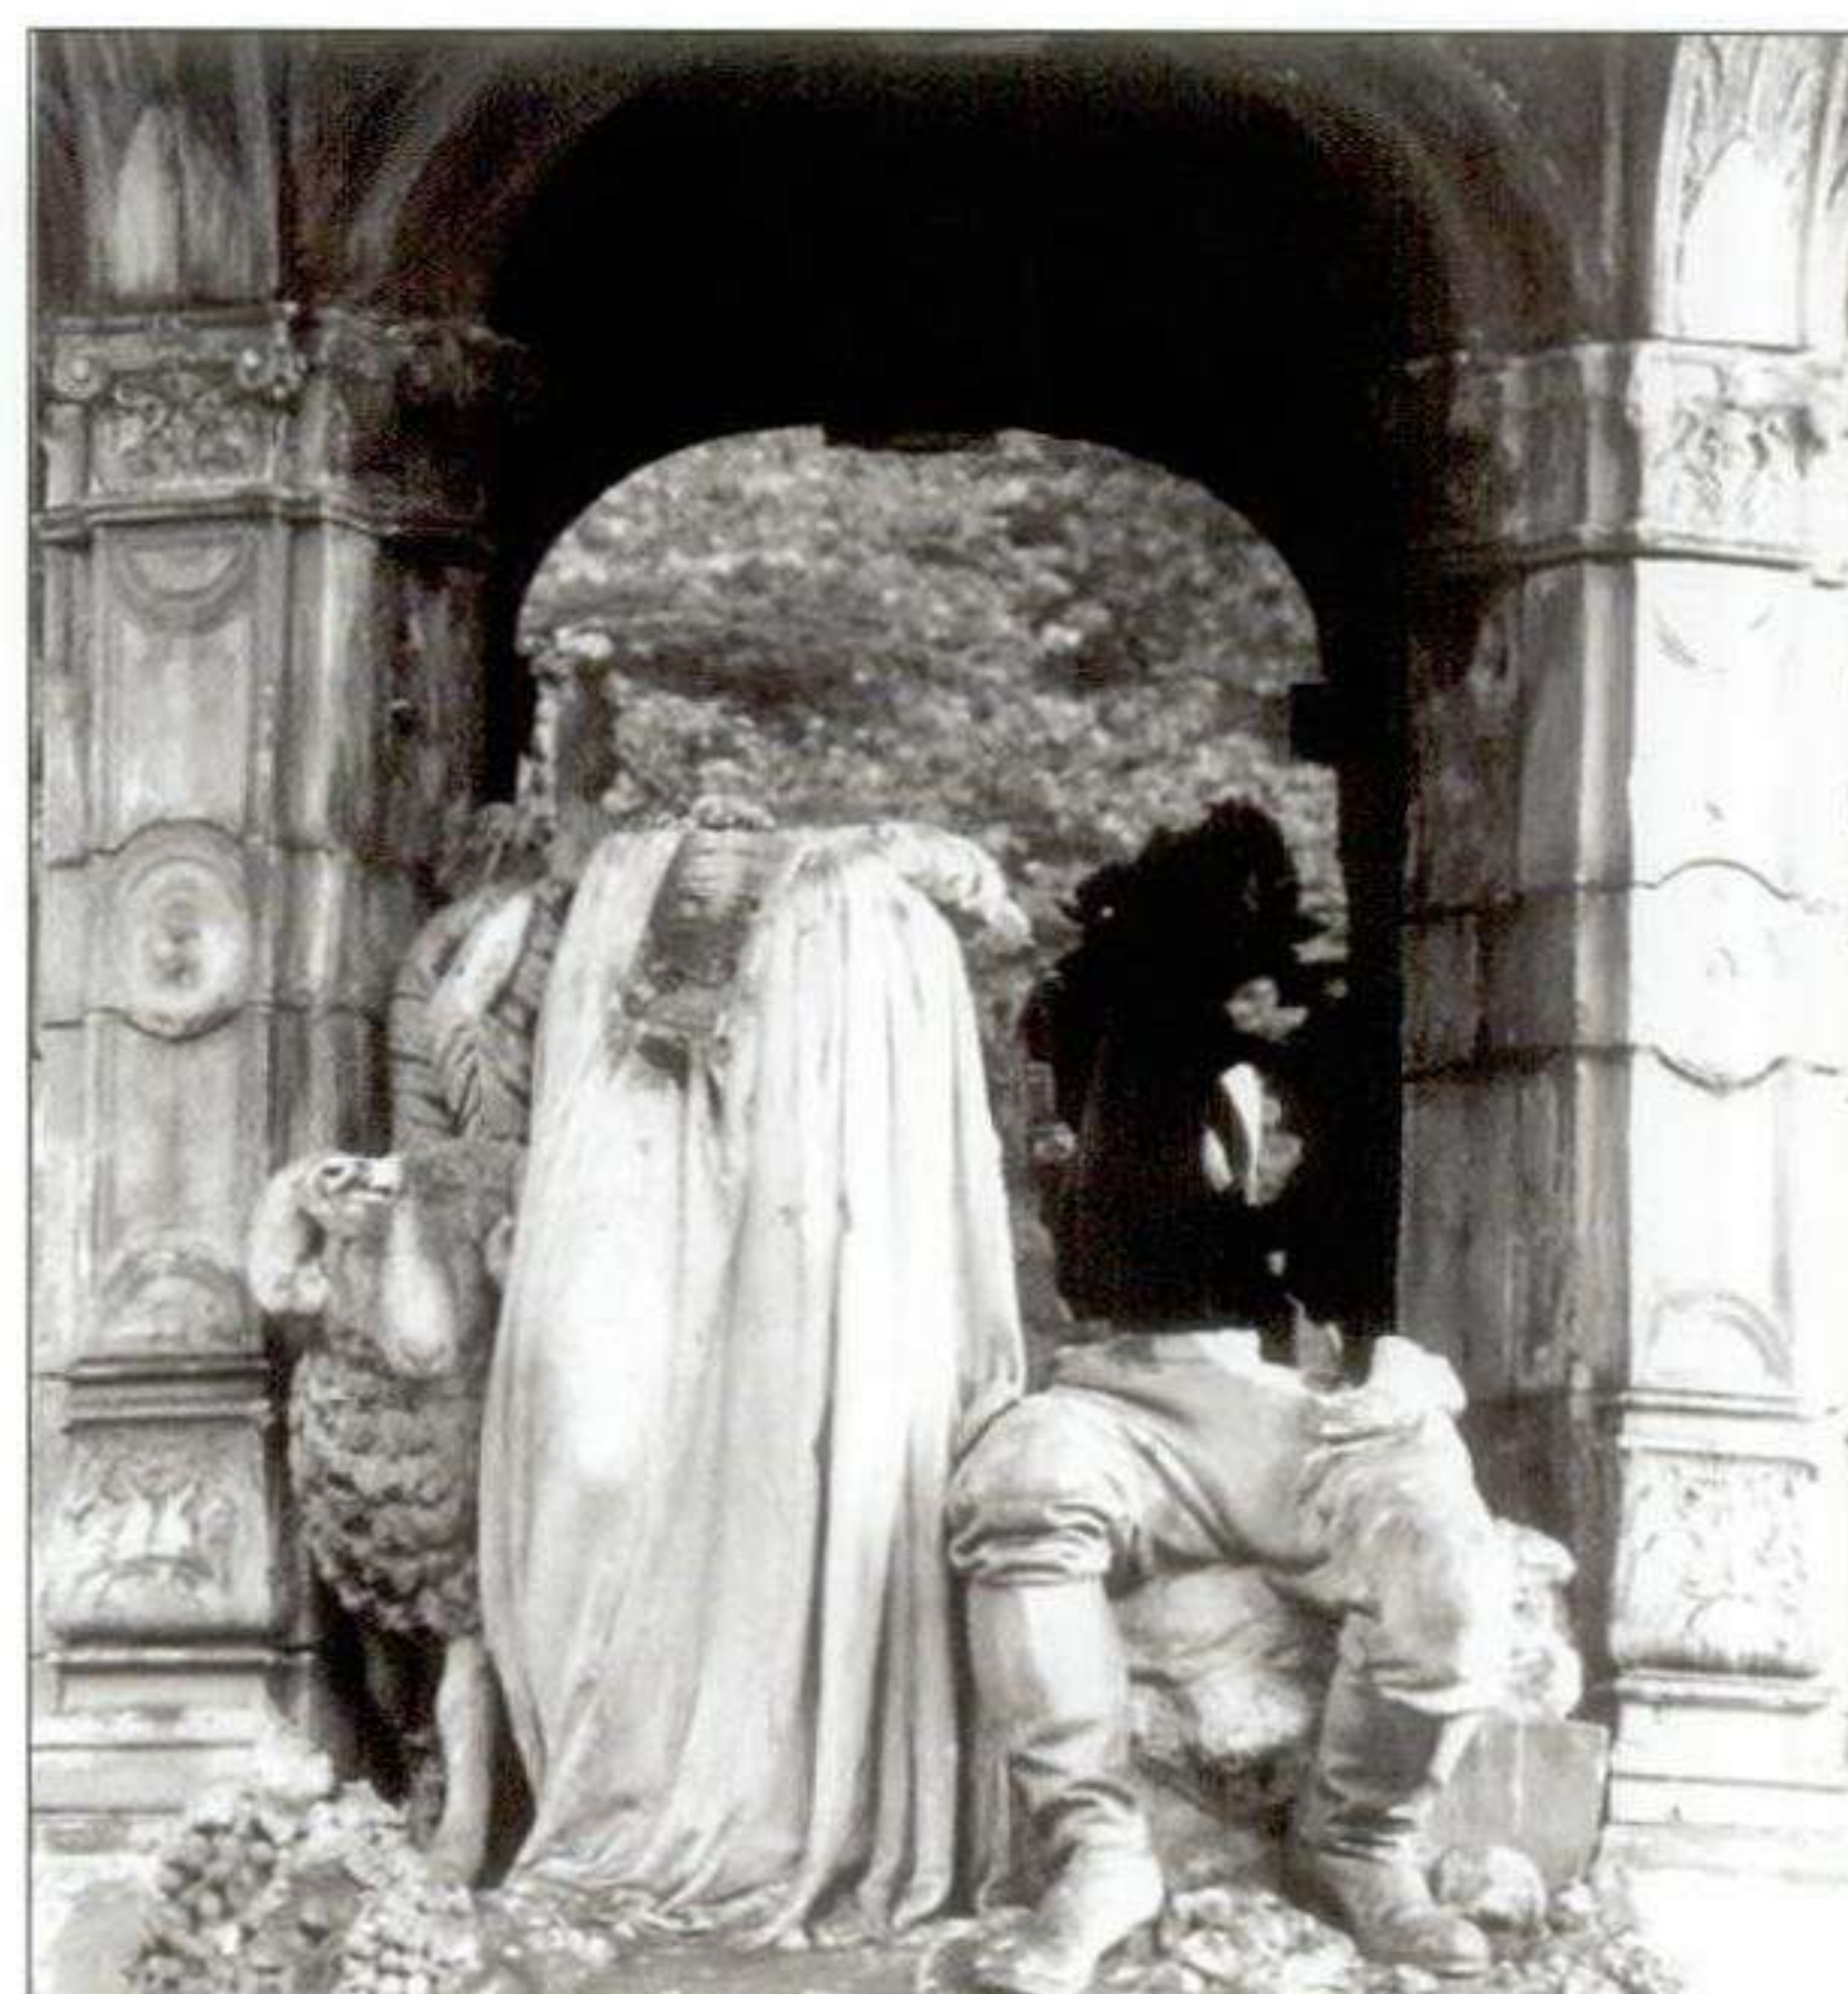
The group after loss of both torsos (People's Palace Museum, Glasgow)

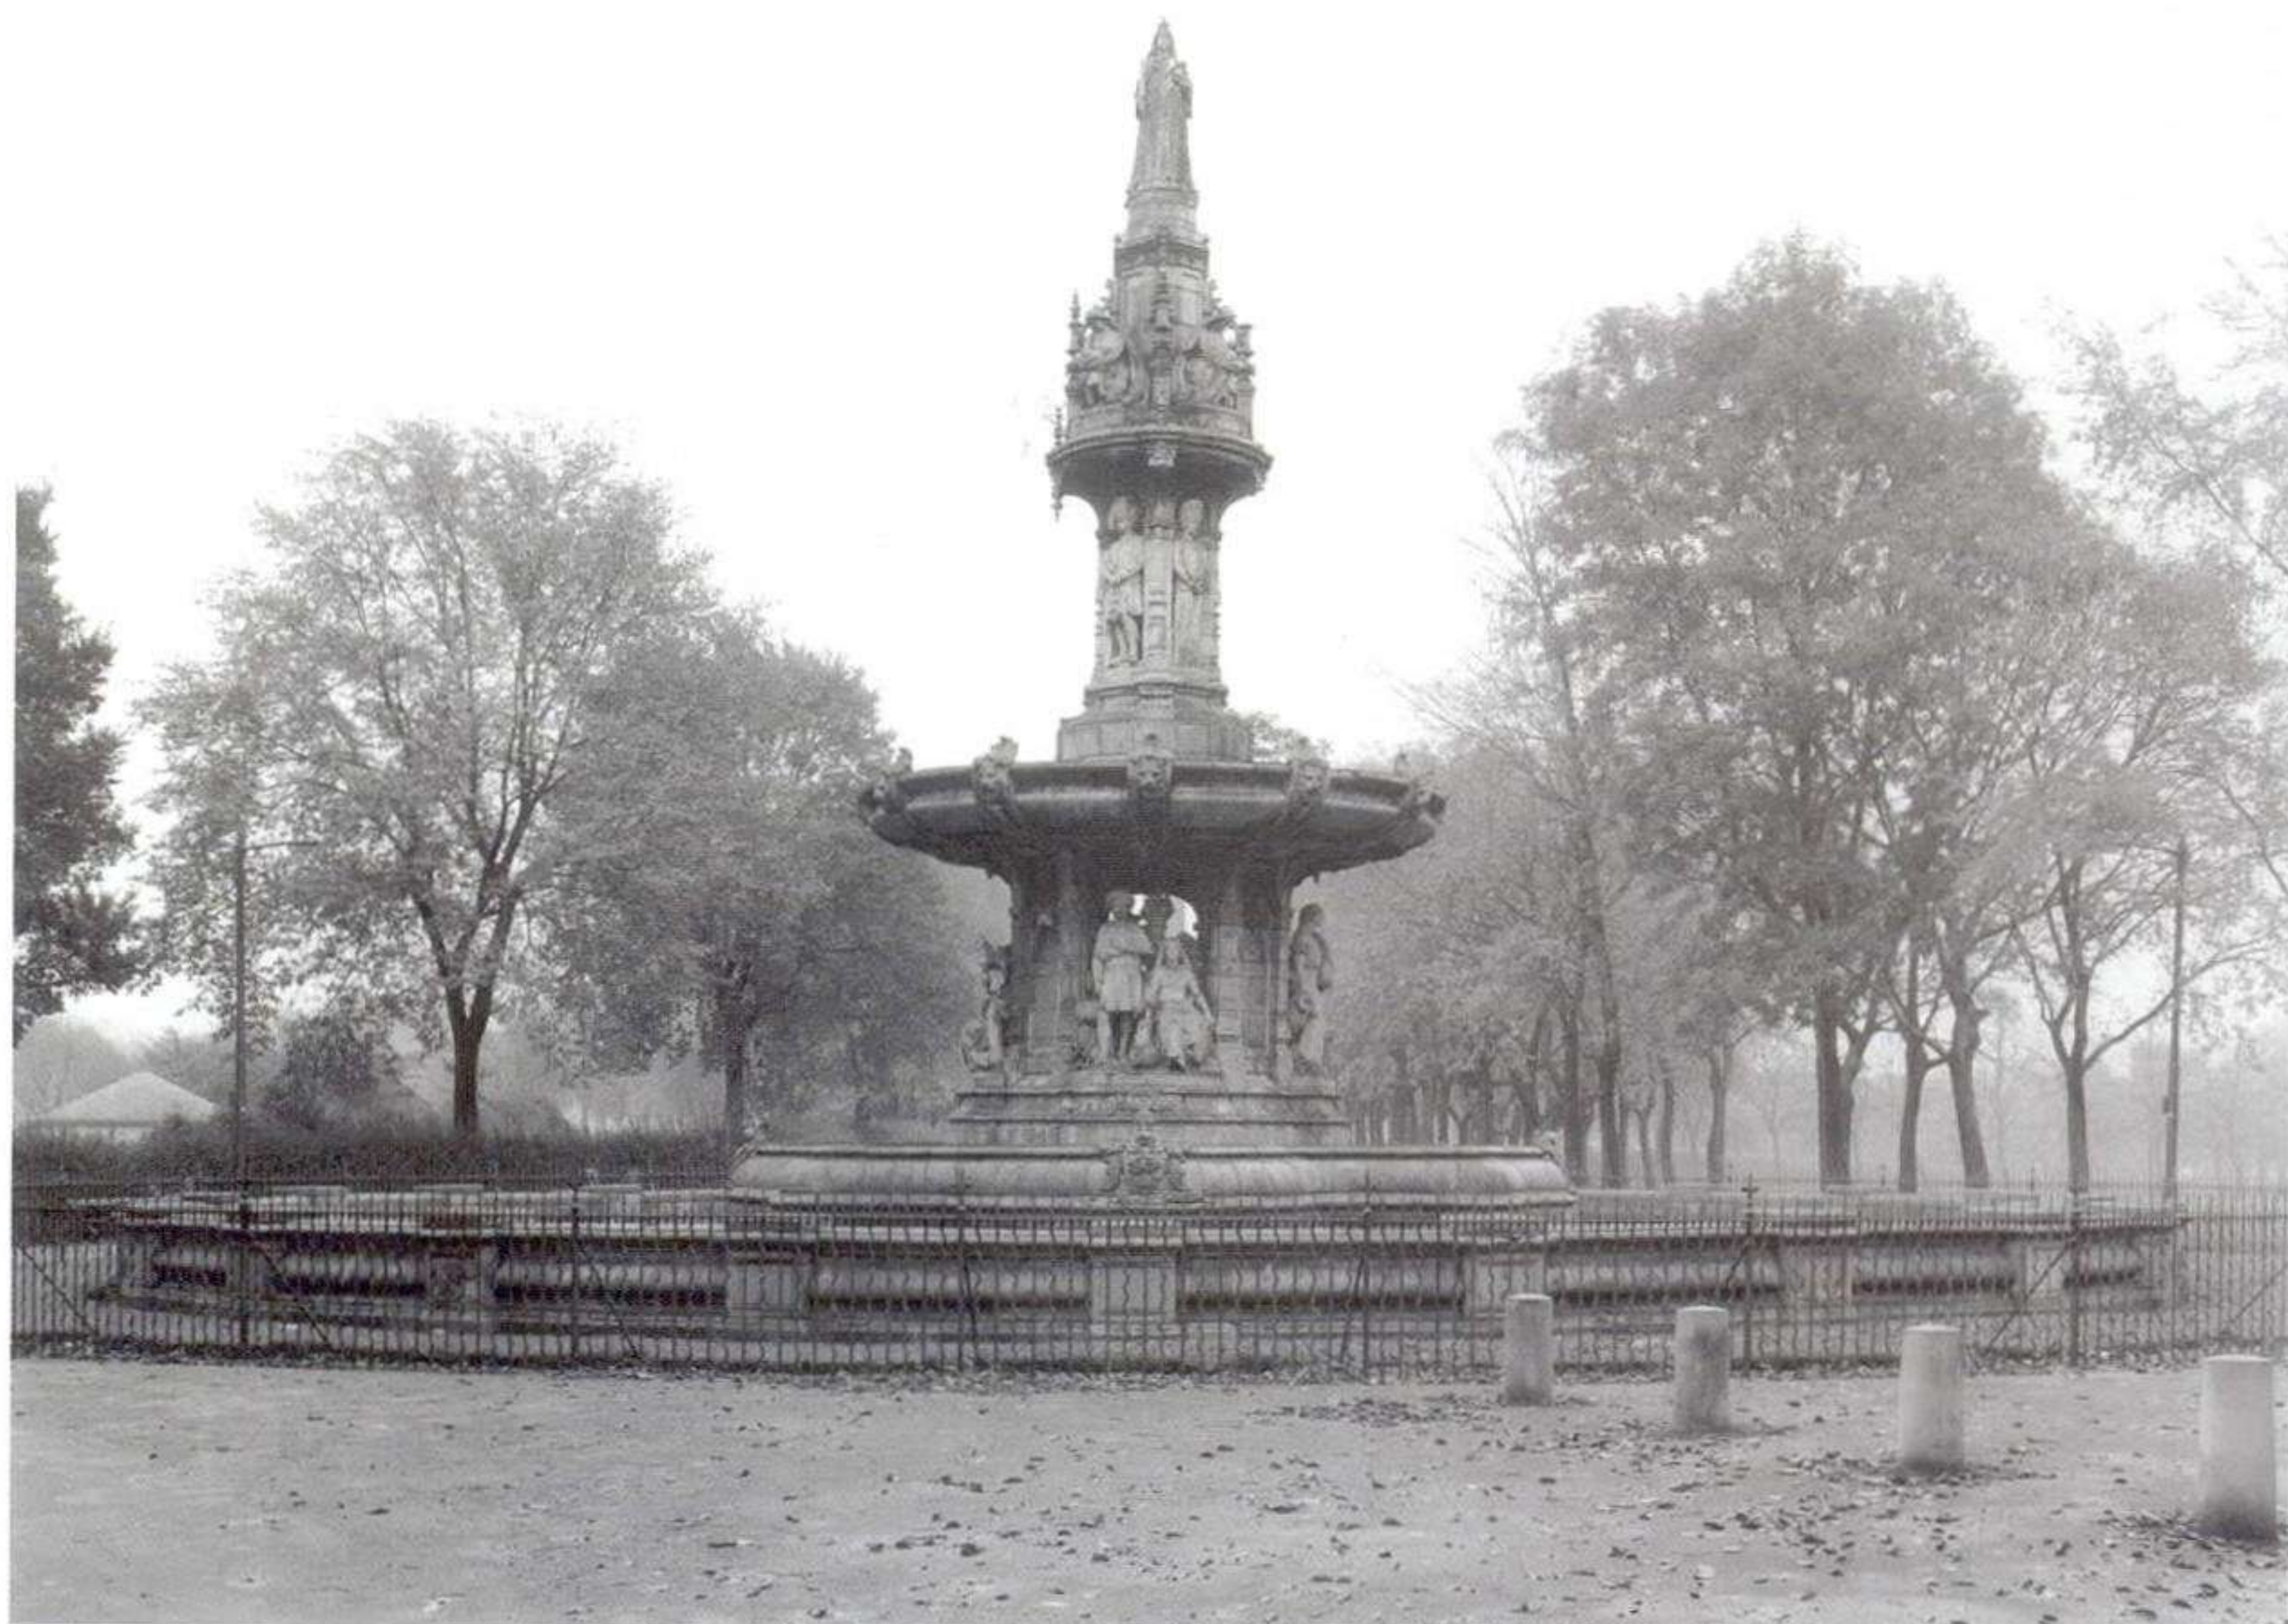
The fountain on Glasgow Green in 1986.

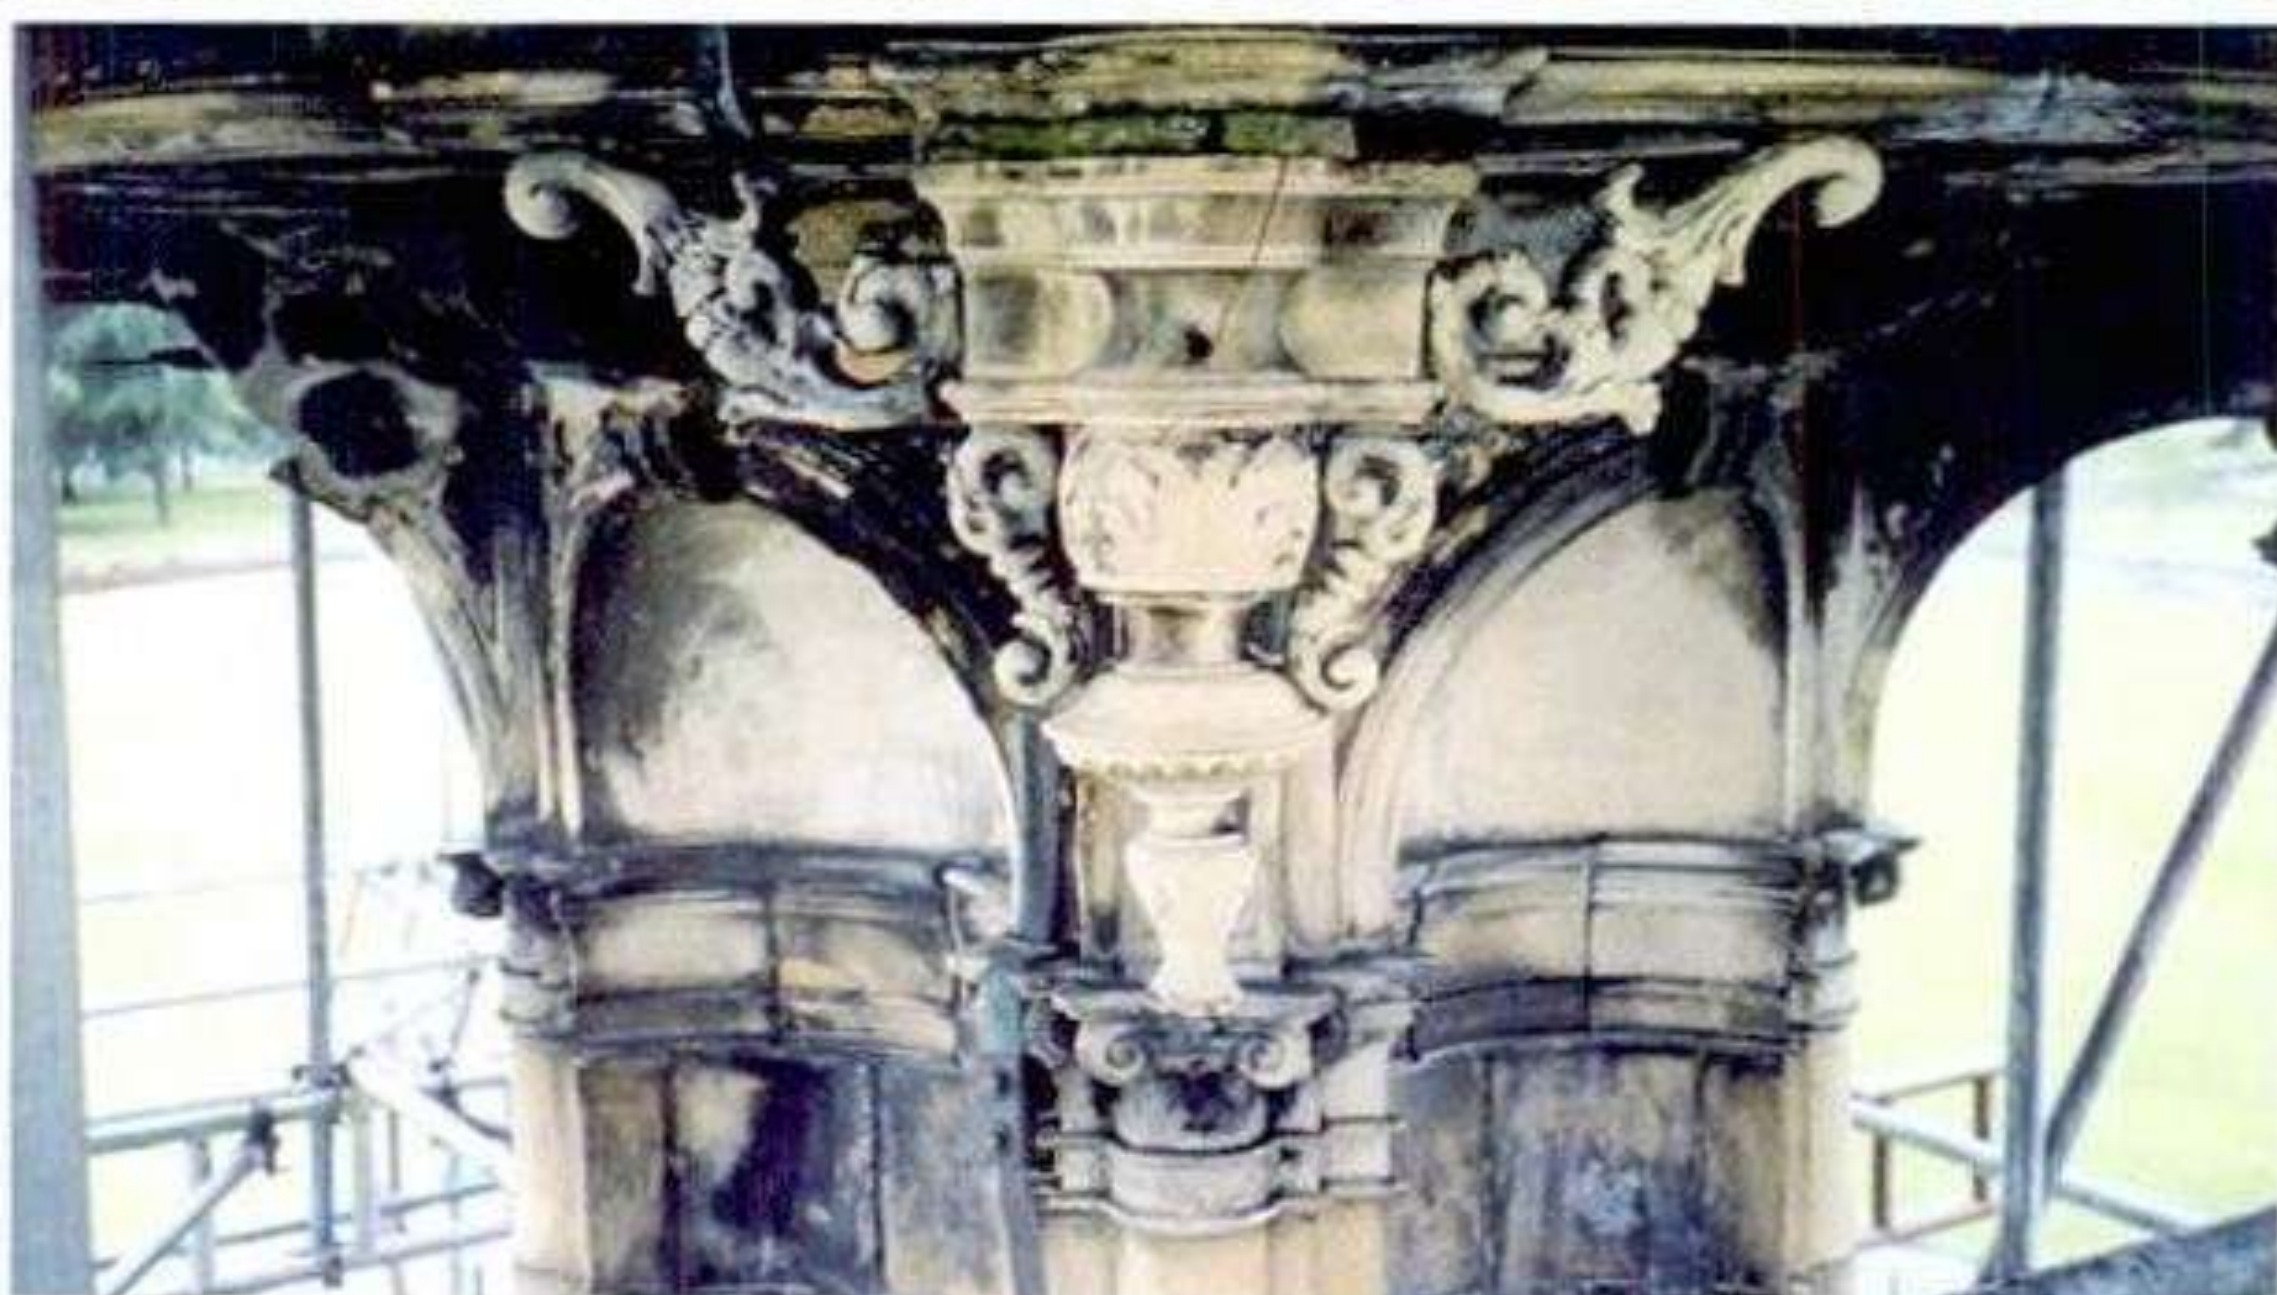
Examples of the conditions found on the Doulton Fountain at the commencement of the restoration project.

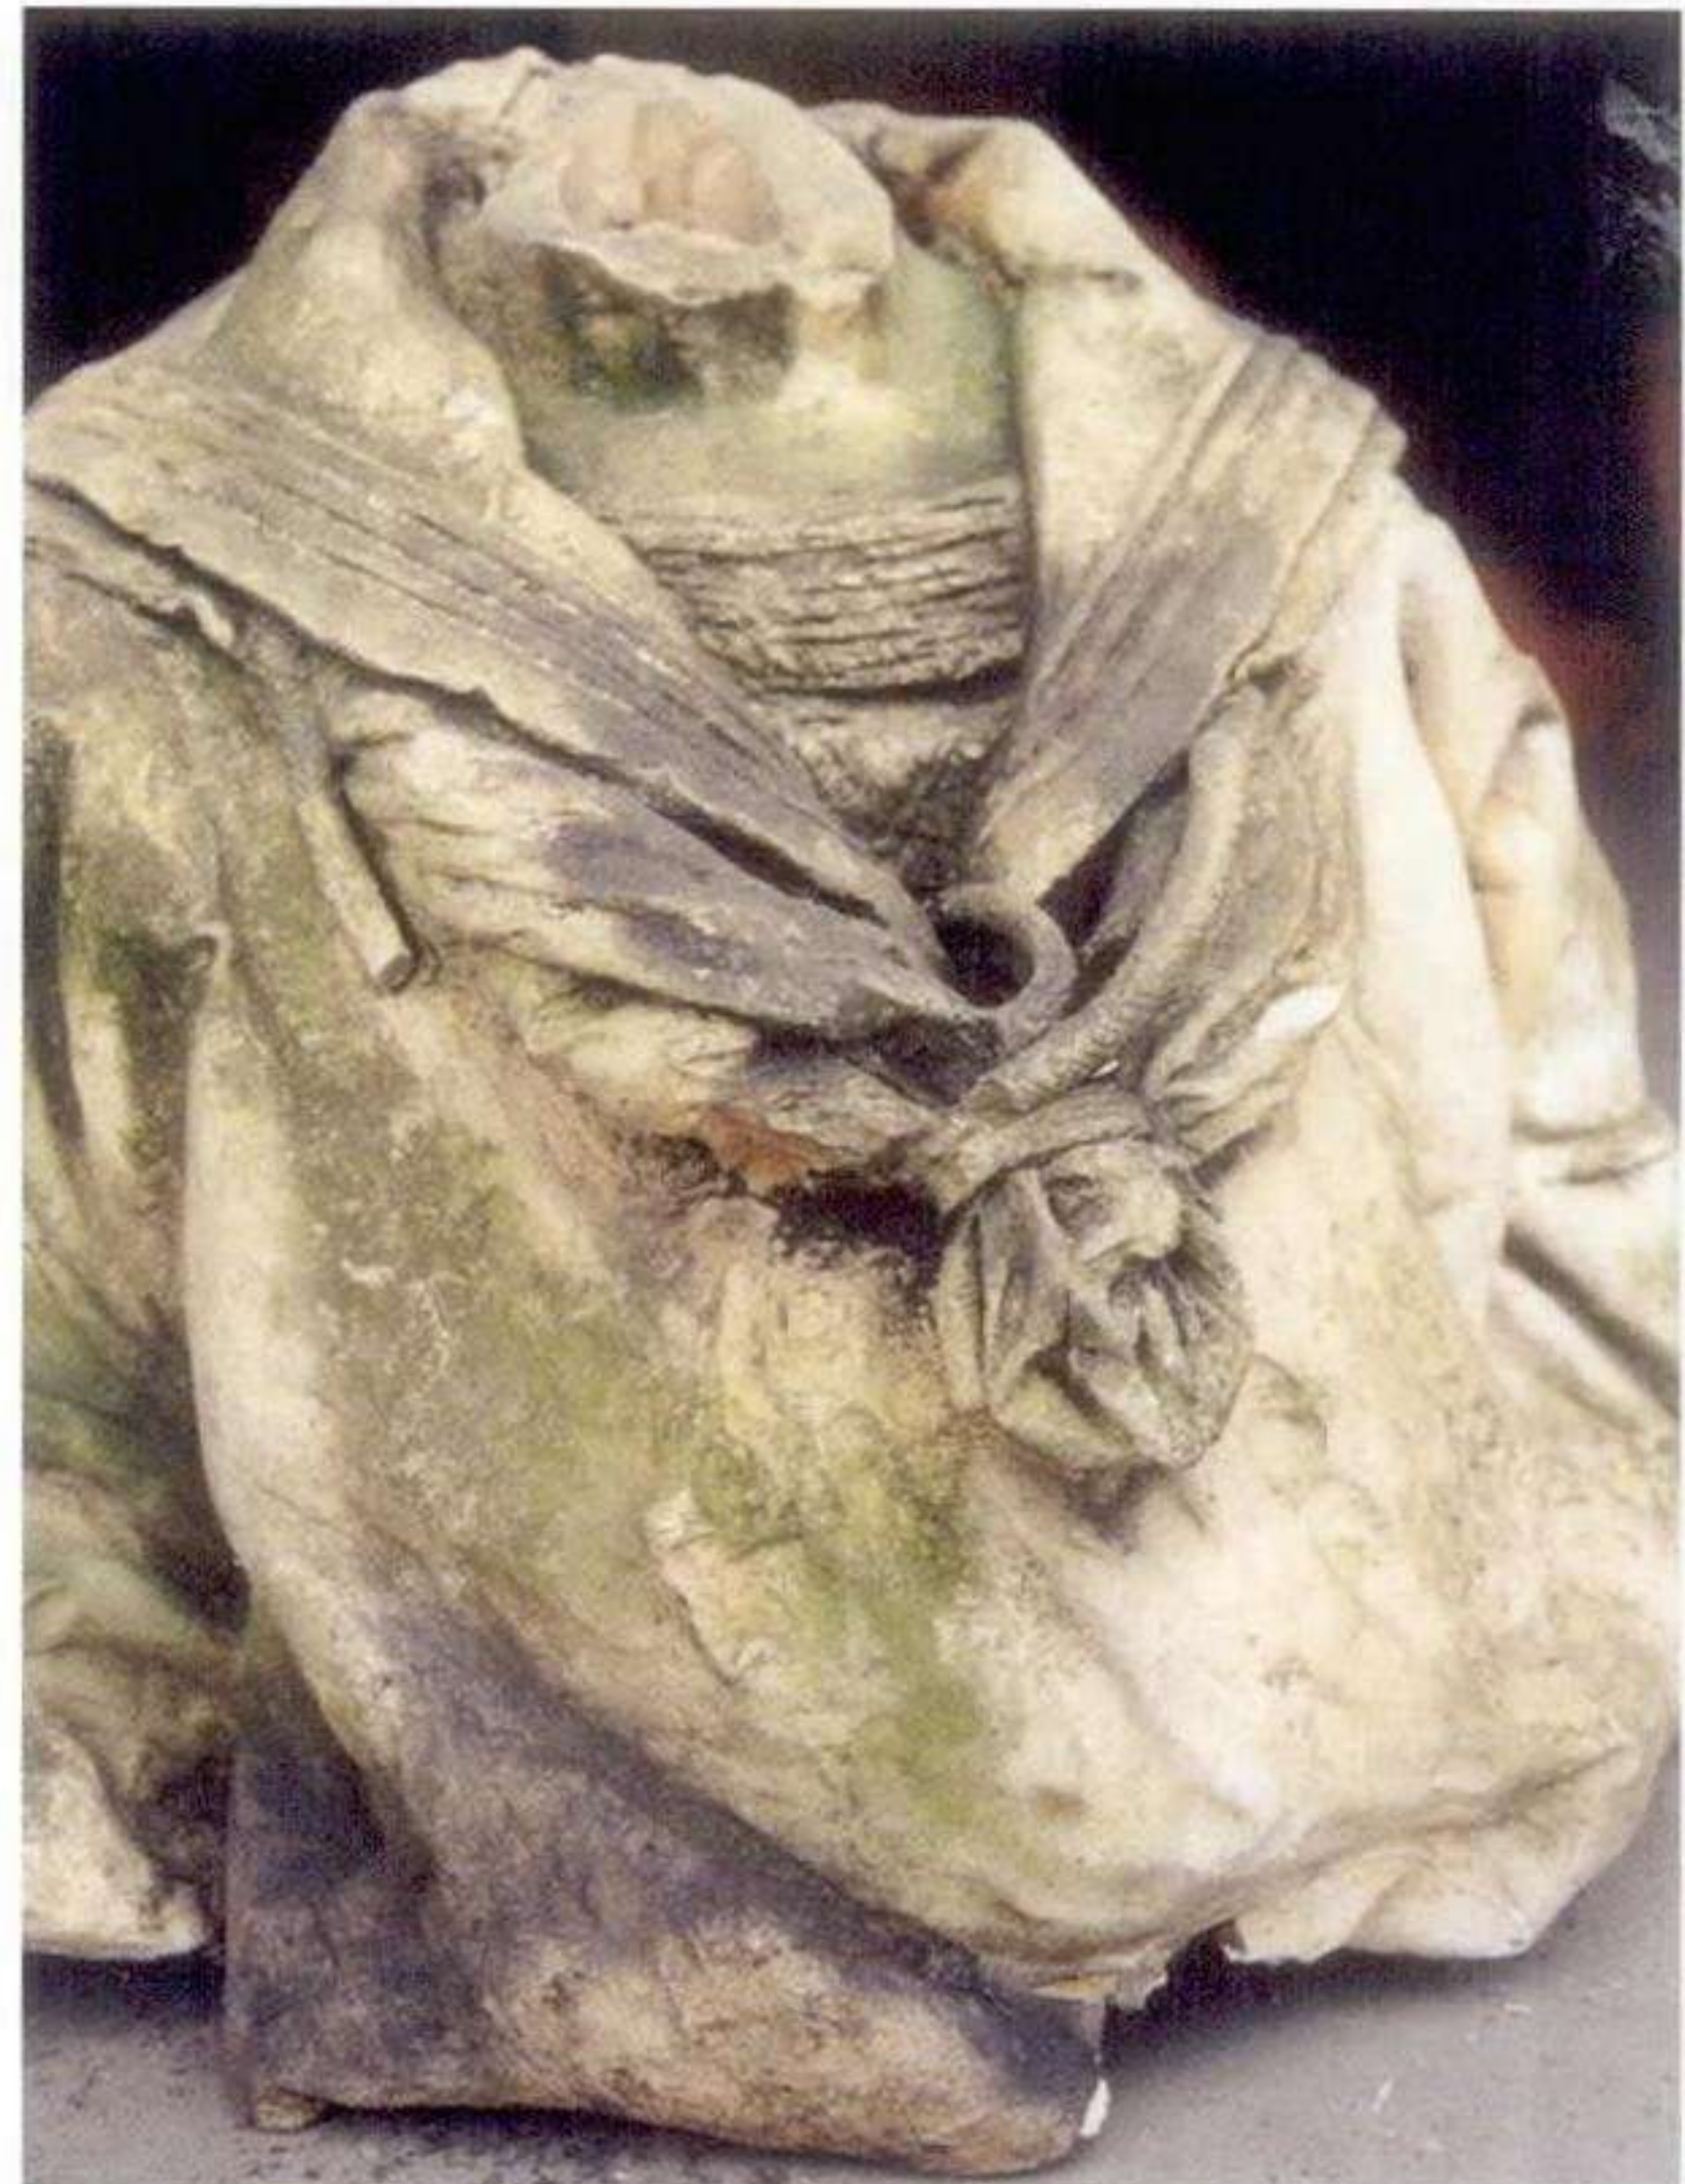
- The head of the Royal Irish Fusilier had been detached from his torso by vandals and could not be located. Localised weathering damage had taken place to his shoulders. The butt and bayonet off his gun were missing.
