THE
INVESTIGATION,
REPAIR AND
CONSERVATION
OF THE
DOULTON
FOUNTAIN,
GLASGOW GREEN

2 | Case
Study

TECHNICAL
CONSERVATION
GROUP

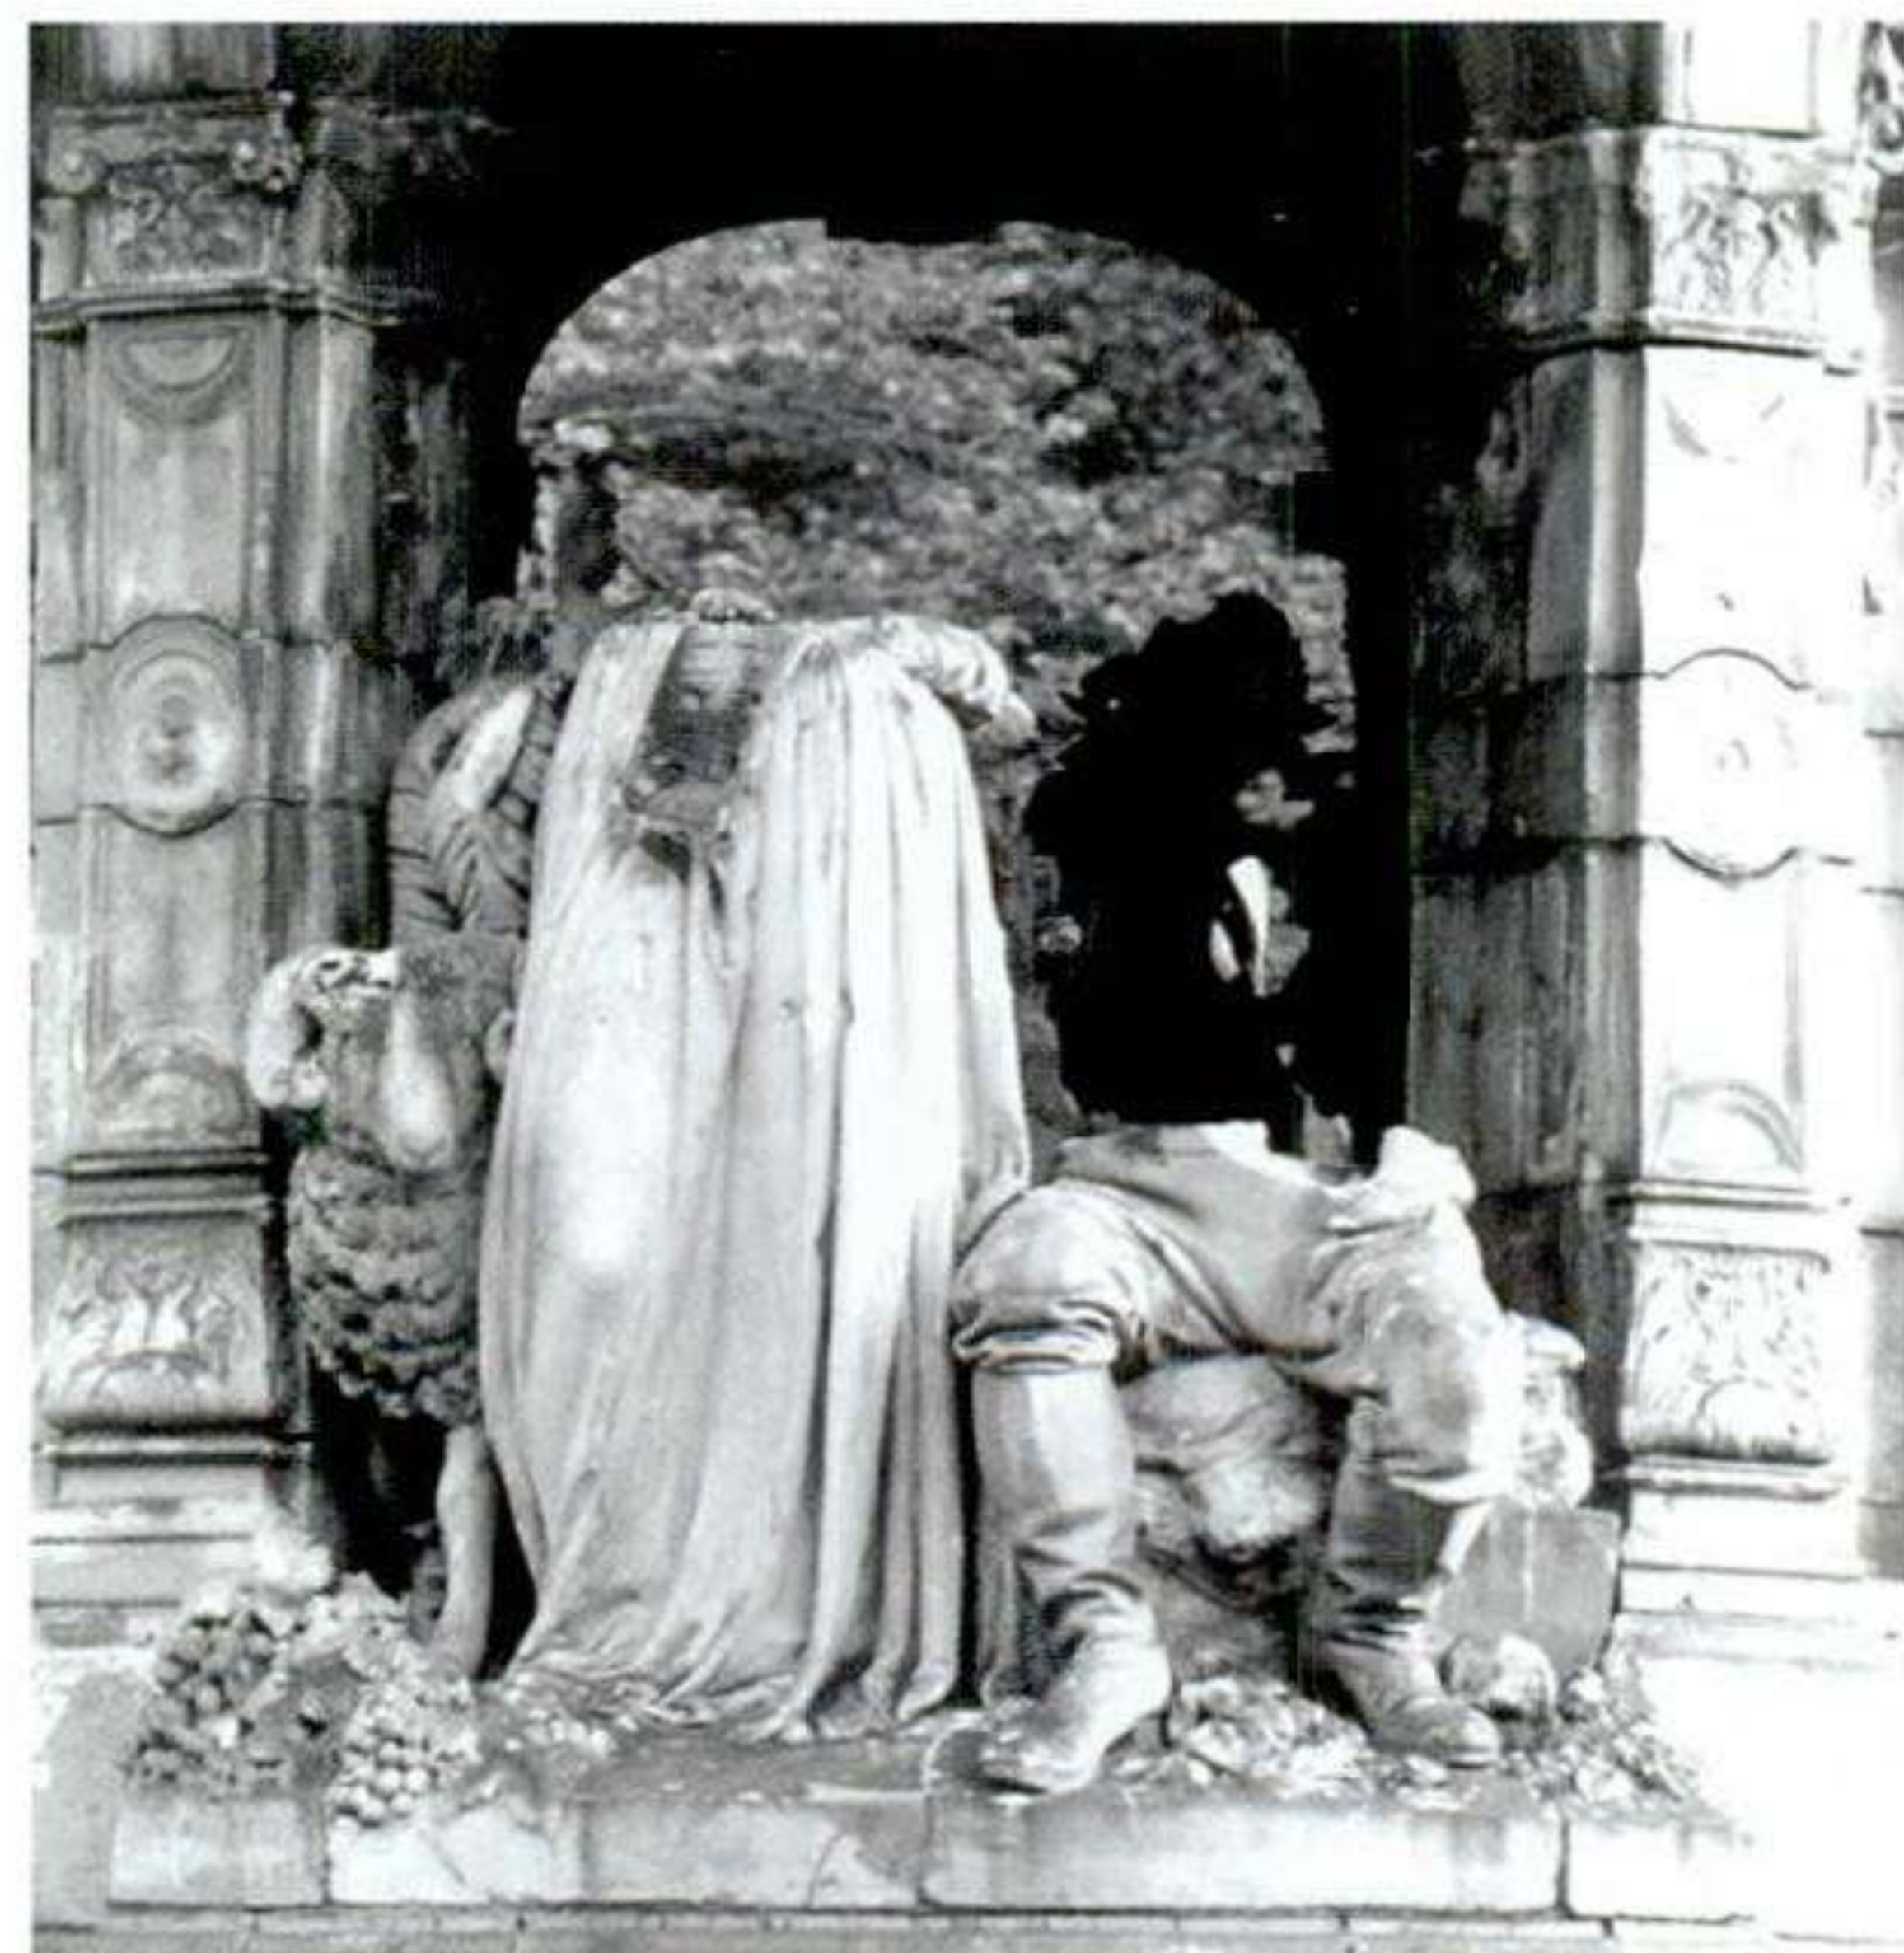
The upper half of the female figure (minus the head and right arm) had been found and retrieved from the sump behind the sculptures in July 1999. In store were the majority of the man's head and hat, the man's two arms, fragments of the woman's head, the woman's right arm, the woman's left hand the fragment of which and part of the fern from behind the man. Lost was the shaft of the man's spade.

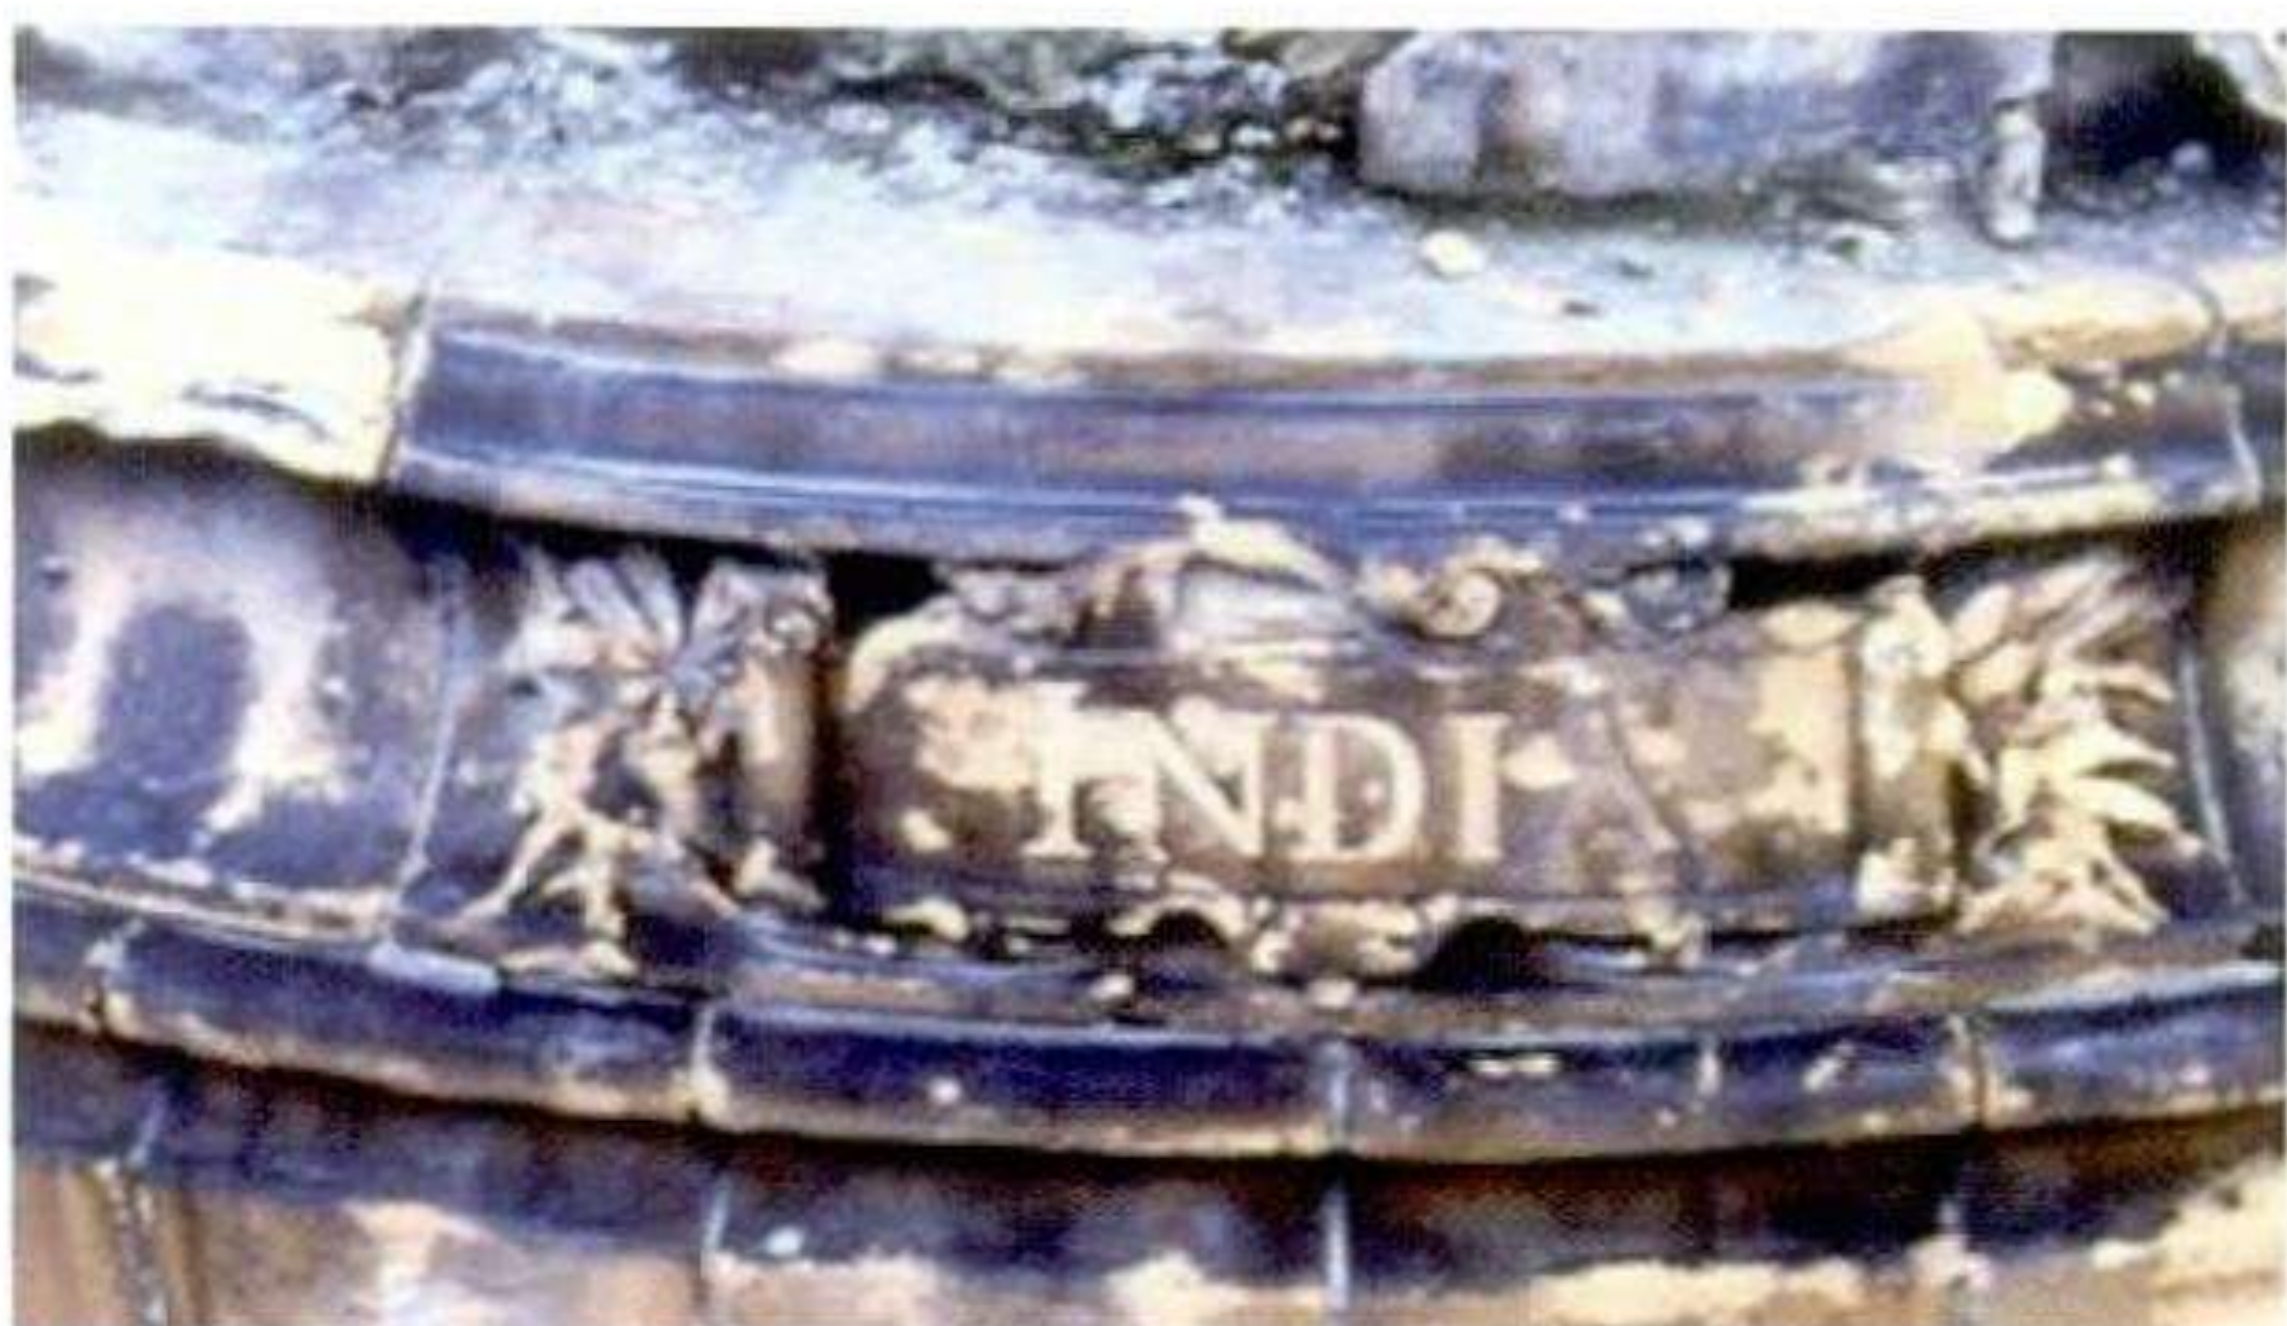
- Colonial Group Name Plaques

Beneath each colonial group was the name of the sub continent, continent or country from which they came. Although damaged, detail existed on the fountain or in the archives for these to be accurately remodelled.

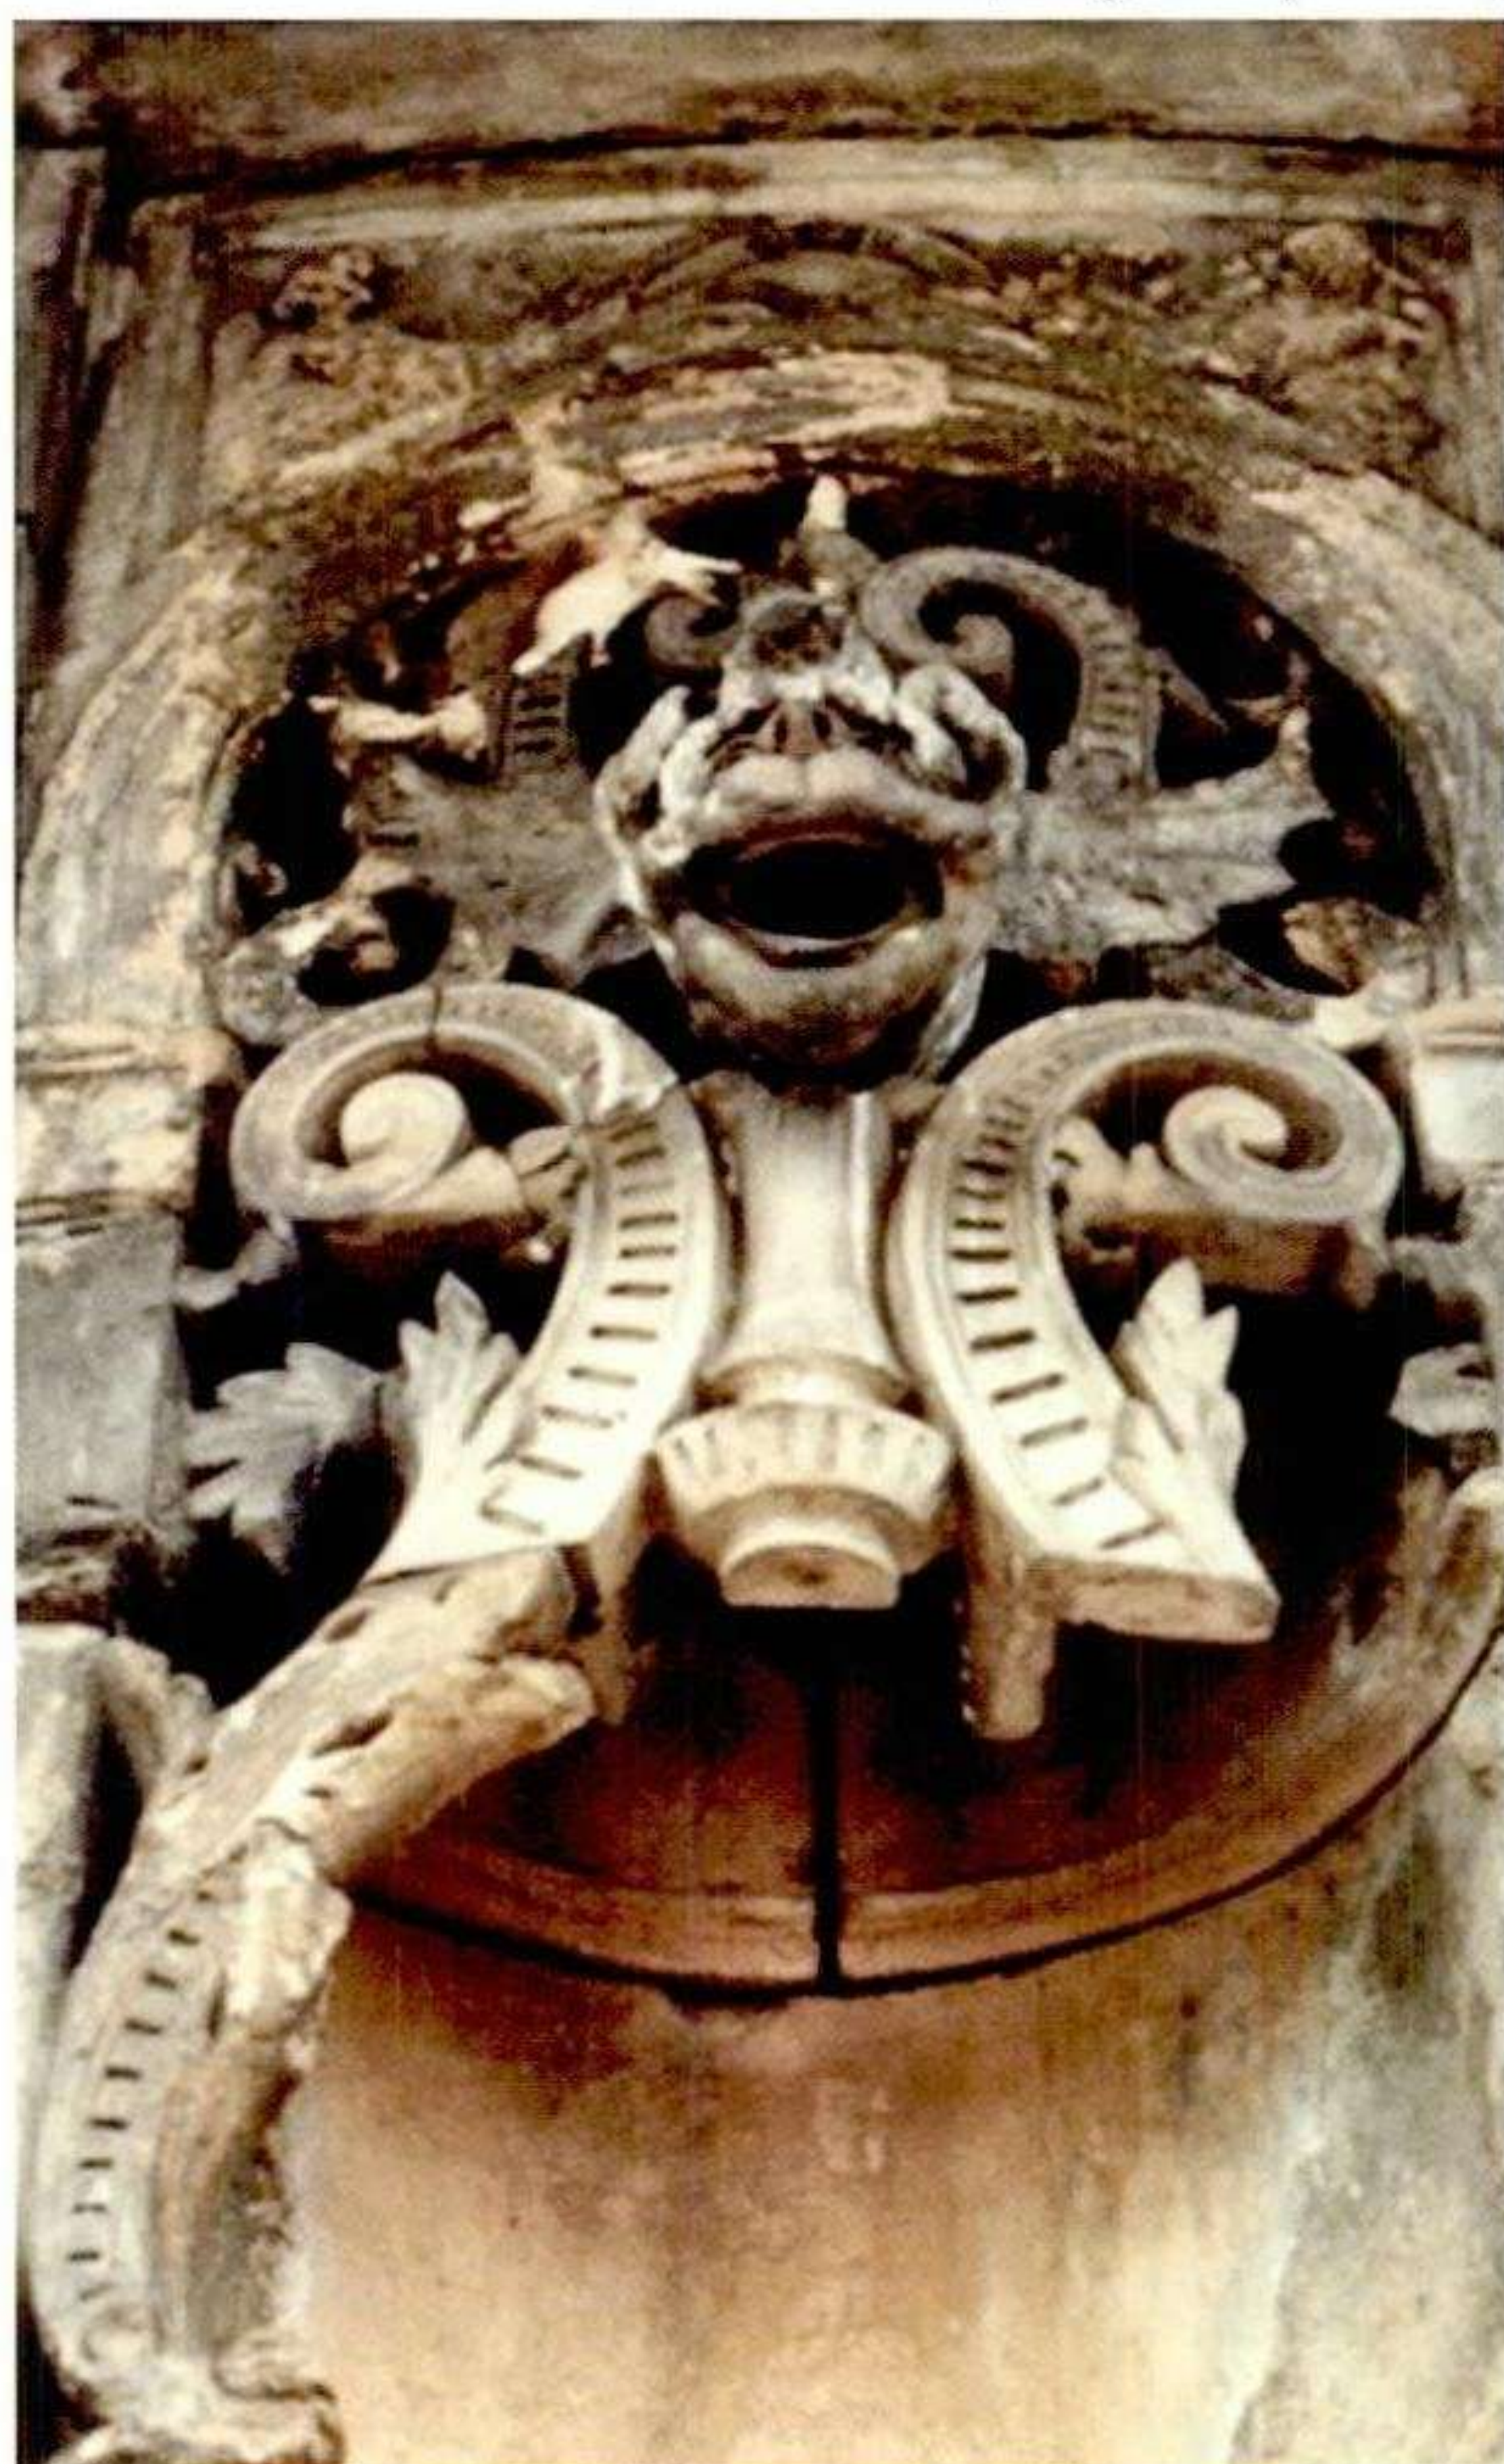
iii) The Bat-Head Niches

Between each sculptural group was a niche with tracery. The upper part of each niche contained a lyre-shaped tracery surmounted centrally by a creature that looks like a bat's head with wings. A jet of water originally exited through the mouth of the creature.

Archive photographs and photographs taken by members of the public in the 1970's and 1980's, as well as the one bat's head that remained and fragments of the tracery, provided the evidence so these elements could be accurately replicated.

Details of the bat-head niches and the inner basin wall.

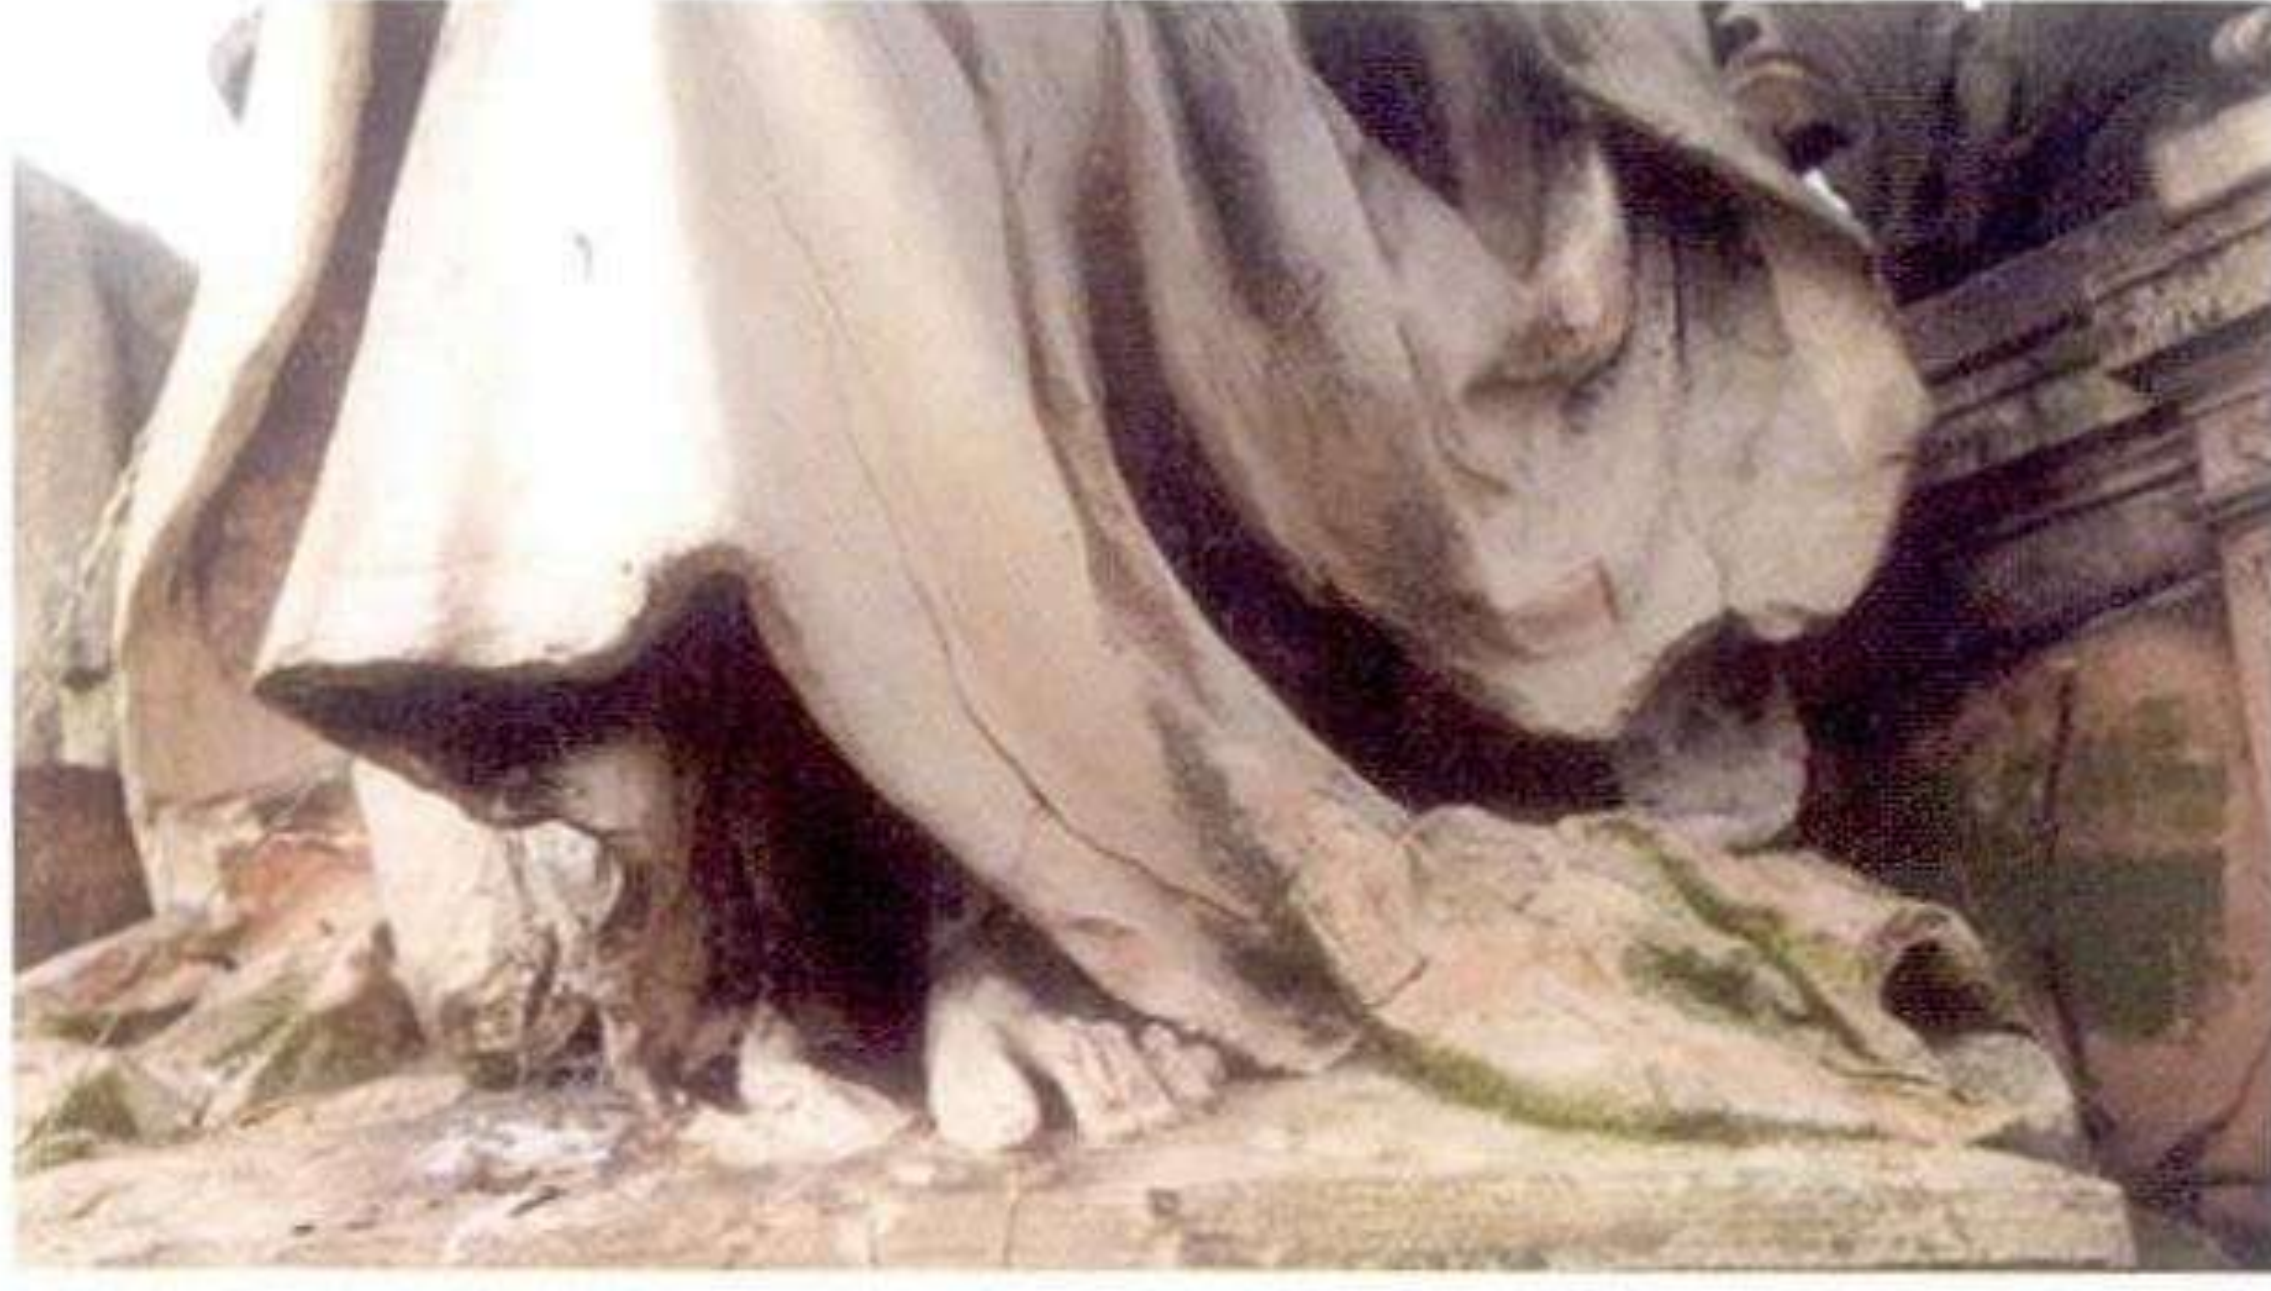
Details of the deteriorated condition of the four Water Bearers. Fracturing, delamination, frost damage and surface granulation were widespread. (All: Nicola Ashurst)

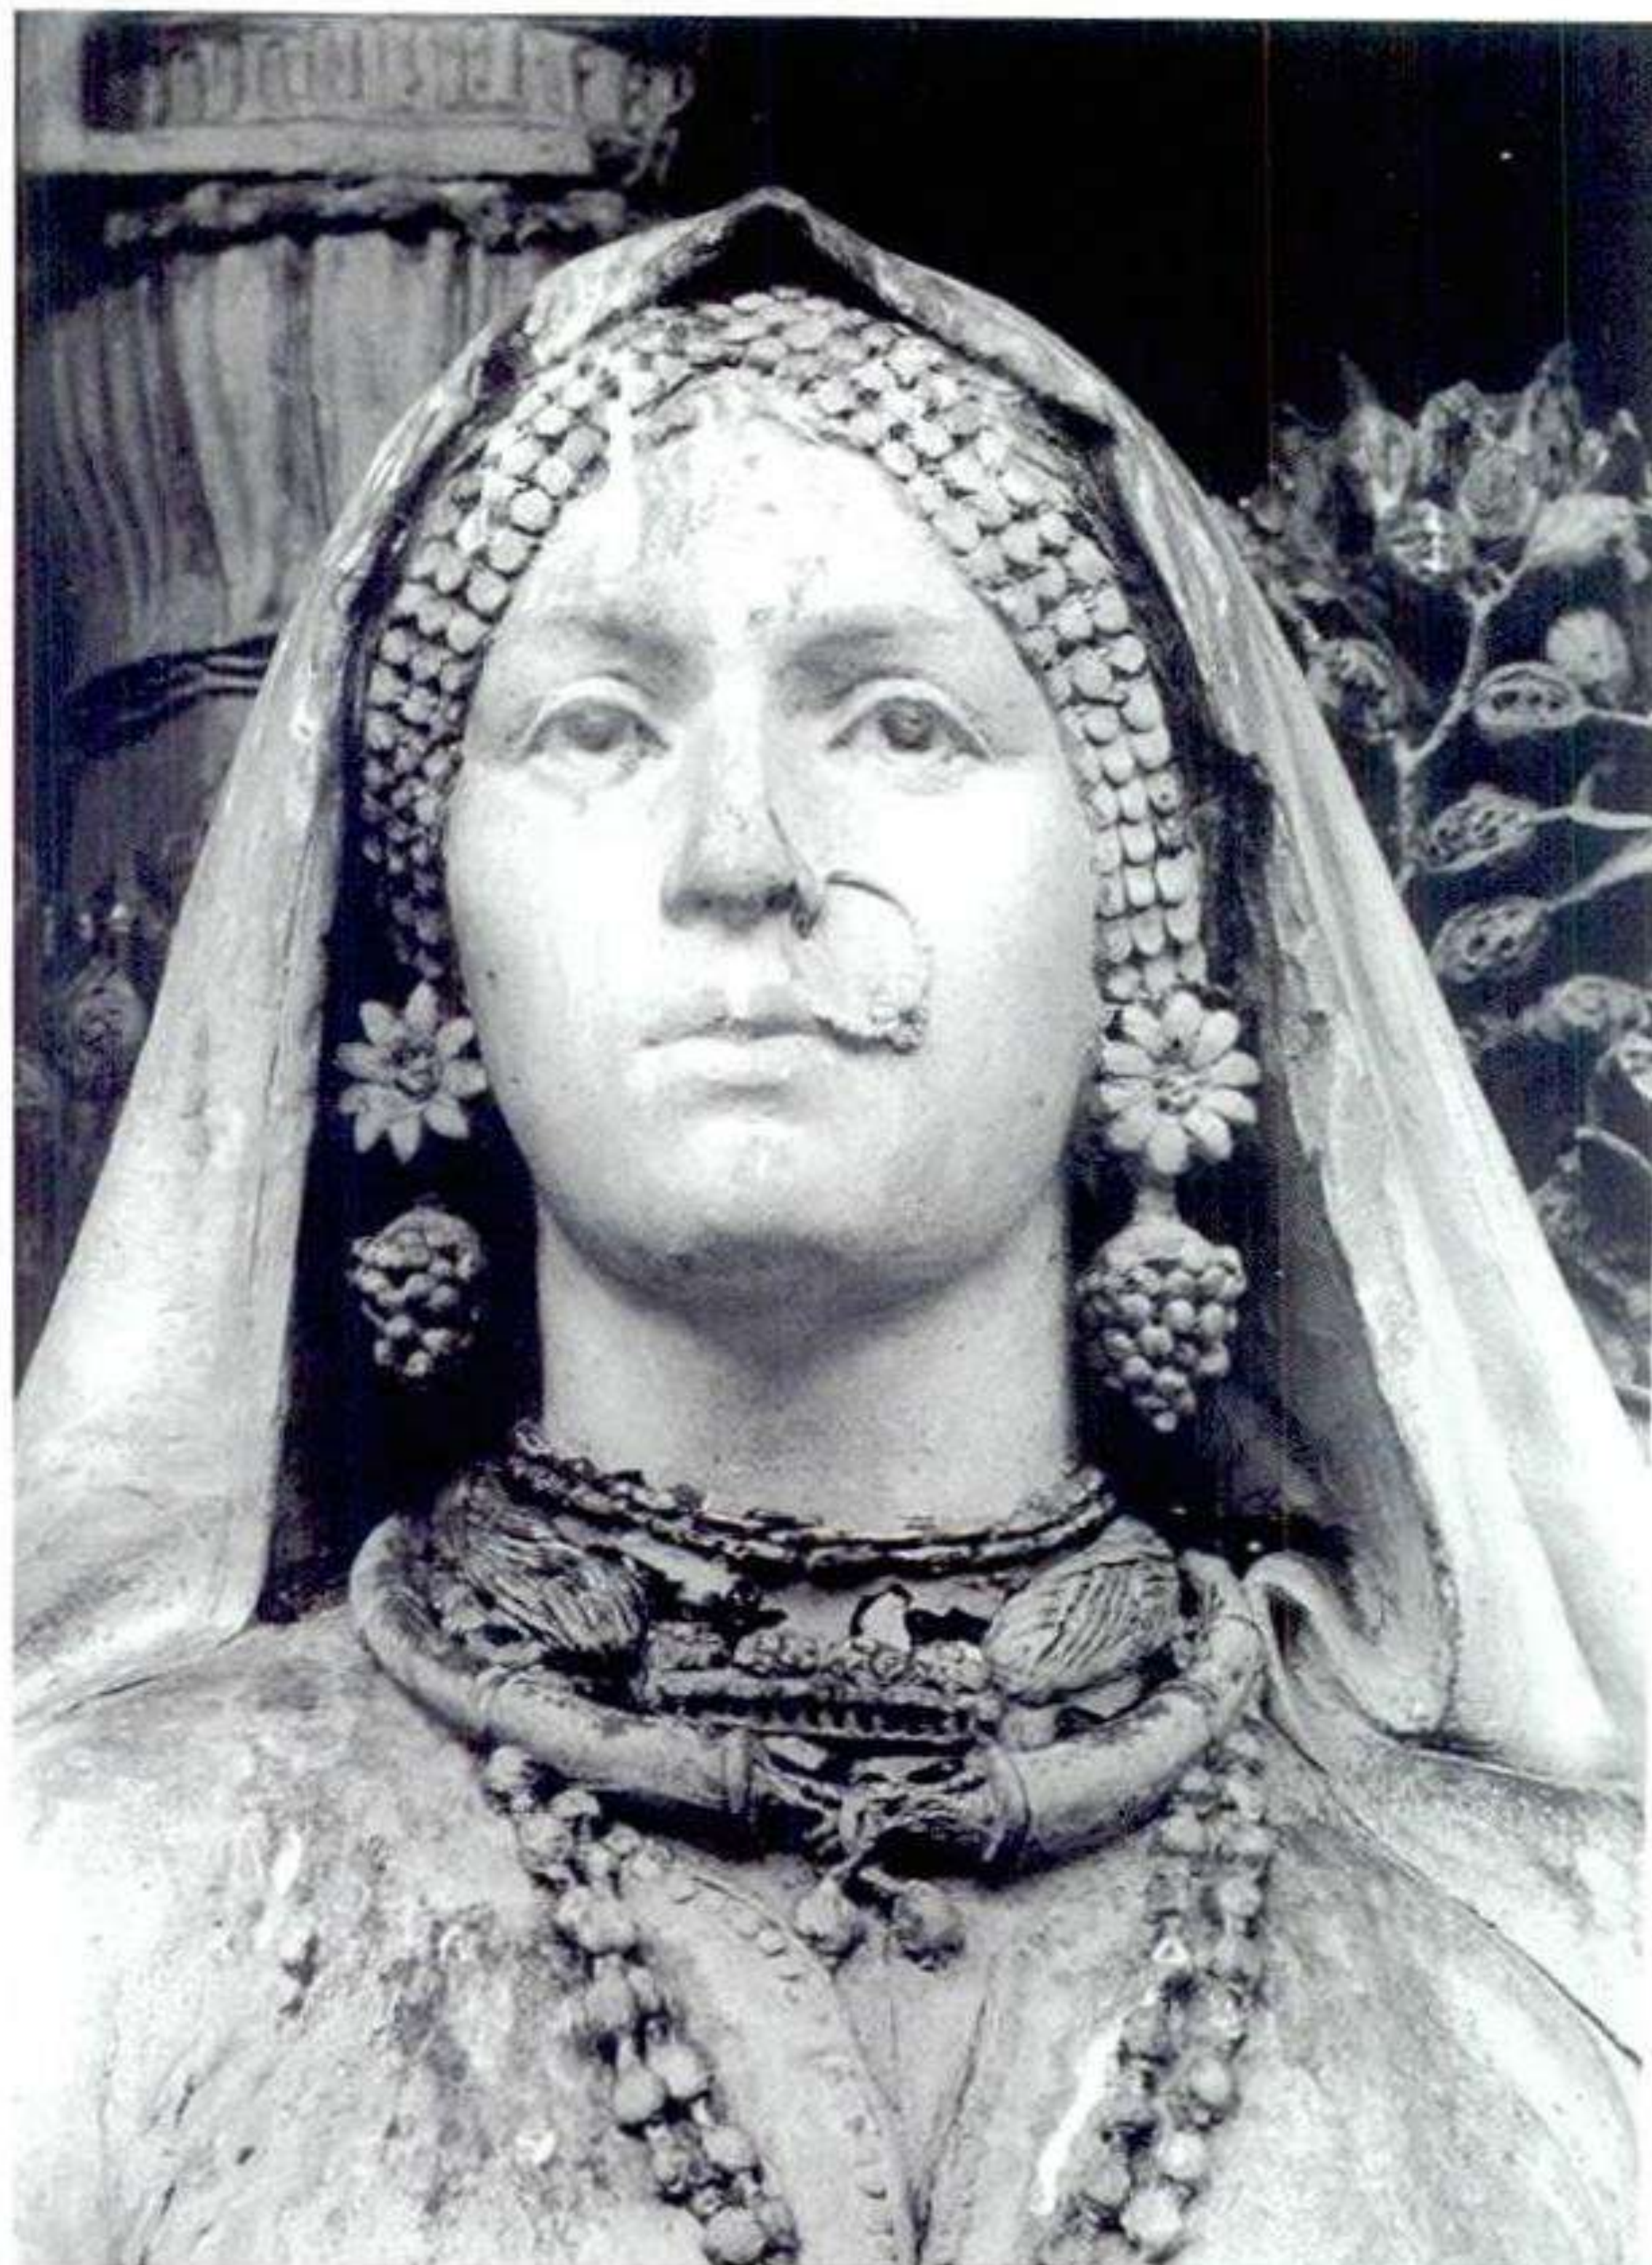
The Lady

The highly detailed original head of the Indian lady. (Cortauld Institute)

- The lady's torso remained in fragments; parts of the jewellery to her neck, right shoulder, left shoulder and the front of the dress could not be found. Most of her right arm, right torso and left arm were missing. Insufficient pieces of the original remained and very poor quality of those that did remain led to the recommendation for replacement in terracotta. It was acknowledged that this would need to rely on the archival evidence which had already been found.
- A large portion of the piece forming the lady's lap, legs and drapery was in extremely poor condition (friable, flaking and/or split). The quality of the original terracotta was not sufficiently good to provide a sound substrate for widespread localised repairs. The final recommendation was that the piece be replaced.
- The lady's head was missing and required replacement.

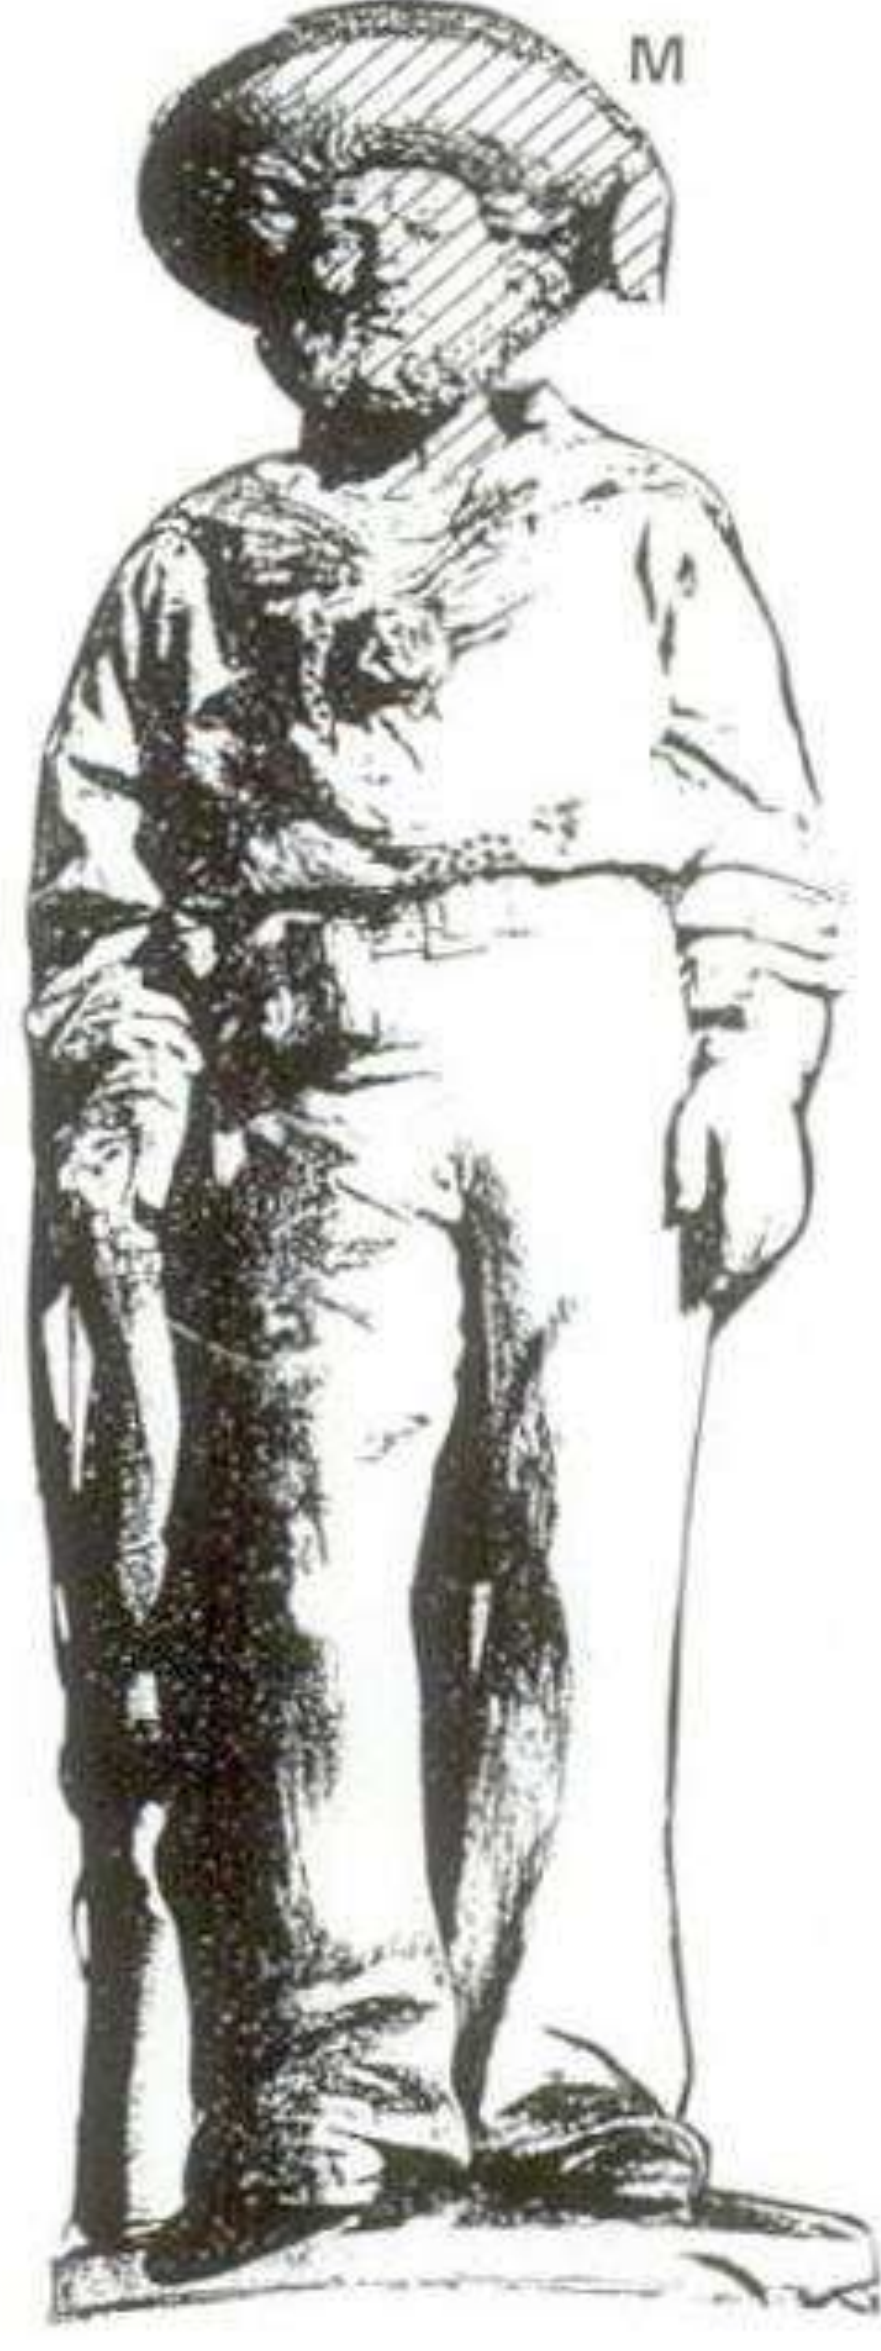
Conservation Strategies for the Military Figures. Most repair works related to missing or vandallised parts.

LEGS, BASE AND GUN:
Retain original with
minor repairs.

Replace top of gun
in terracotta.
