THE
INVESTIGATION,
REPAIR AND
CONSERVATION
OF THE
DOULTON
FOUNTAIN,
GLASGOW GREEN

2 | Case
Study

TECHNICAL
CONSERVATION
GROUP

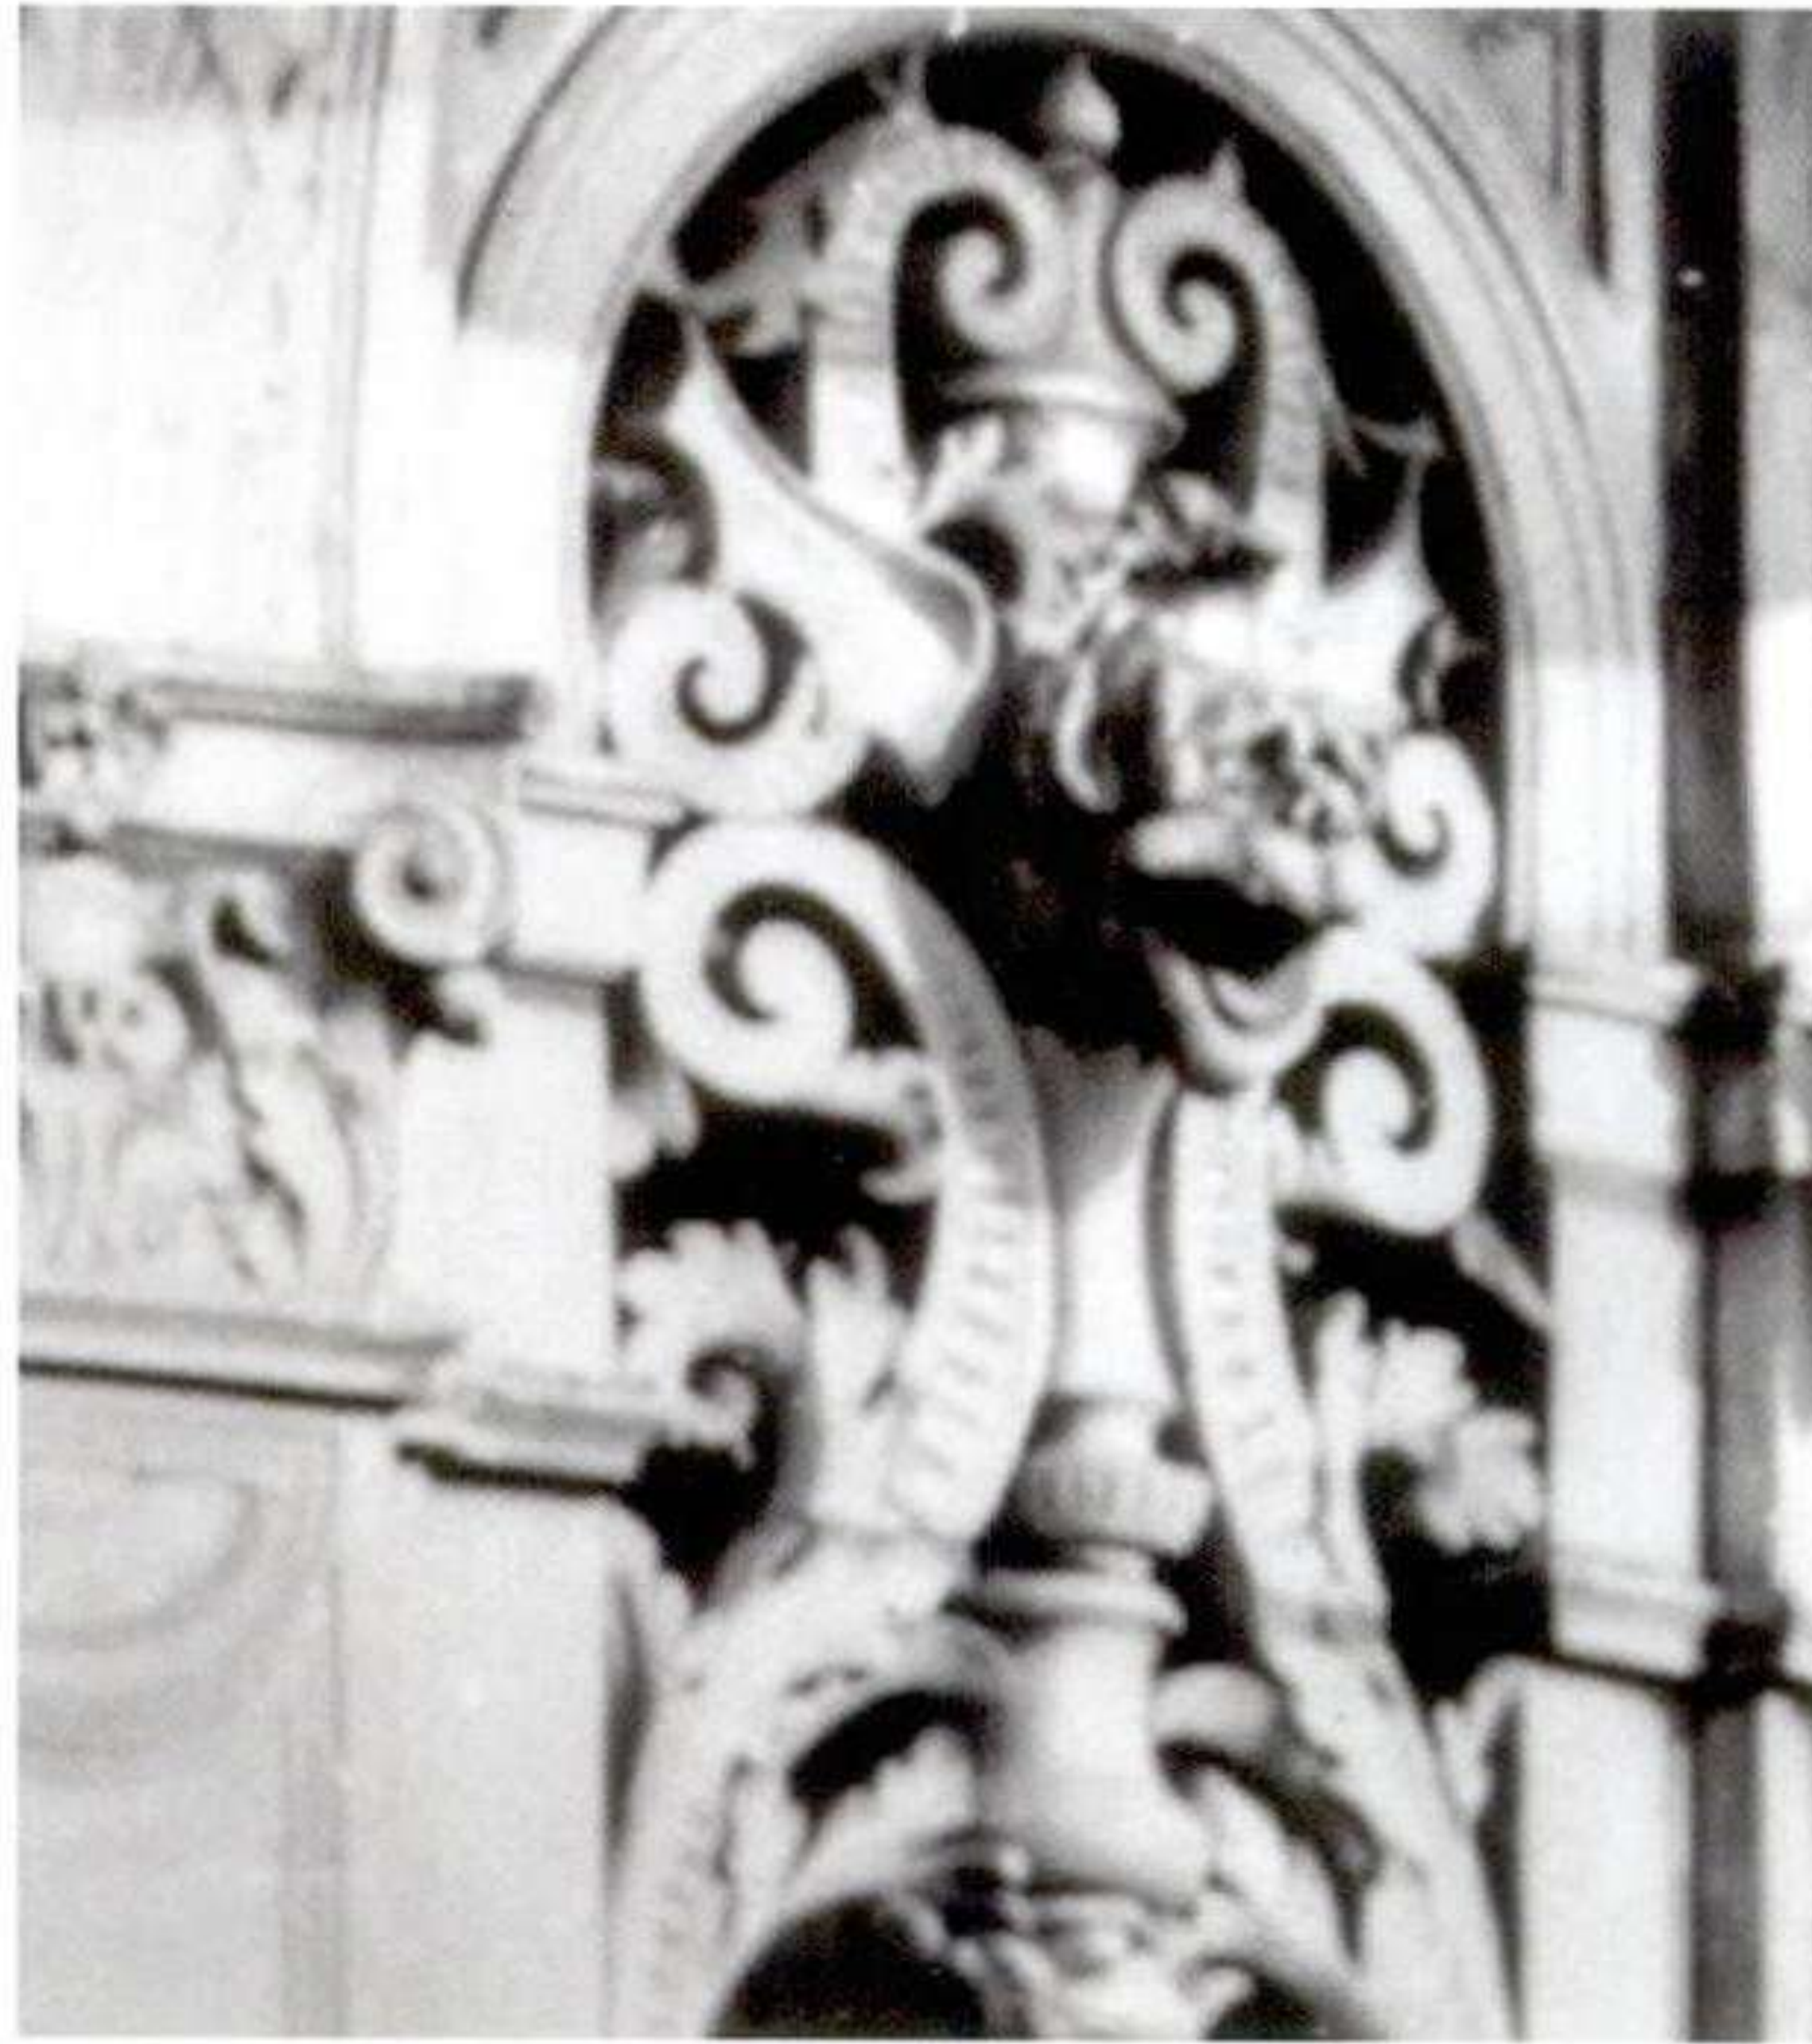
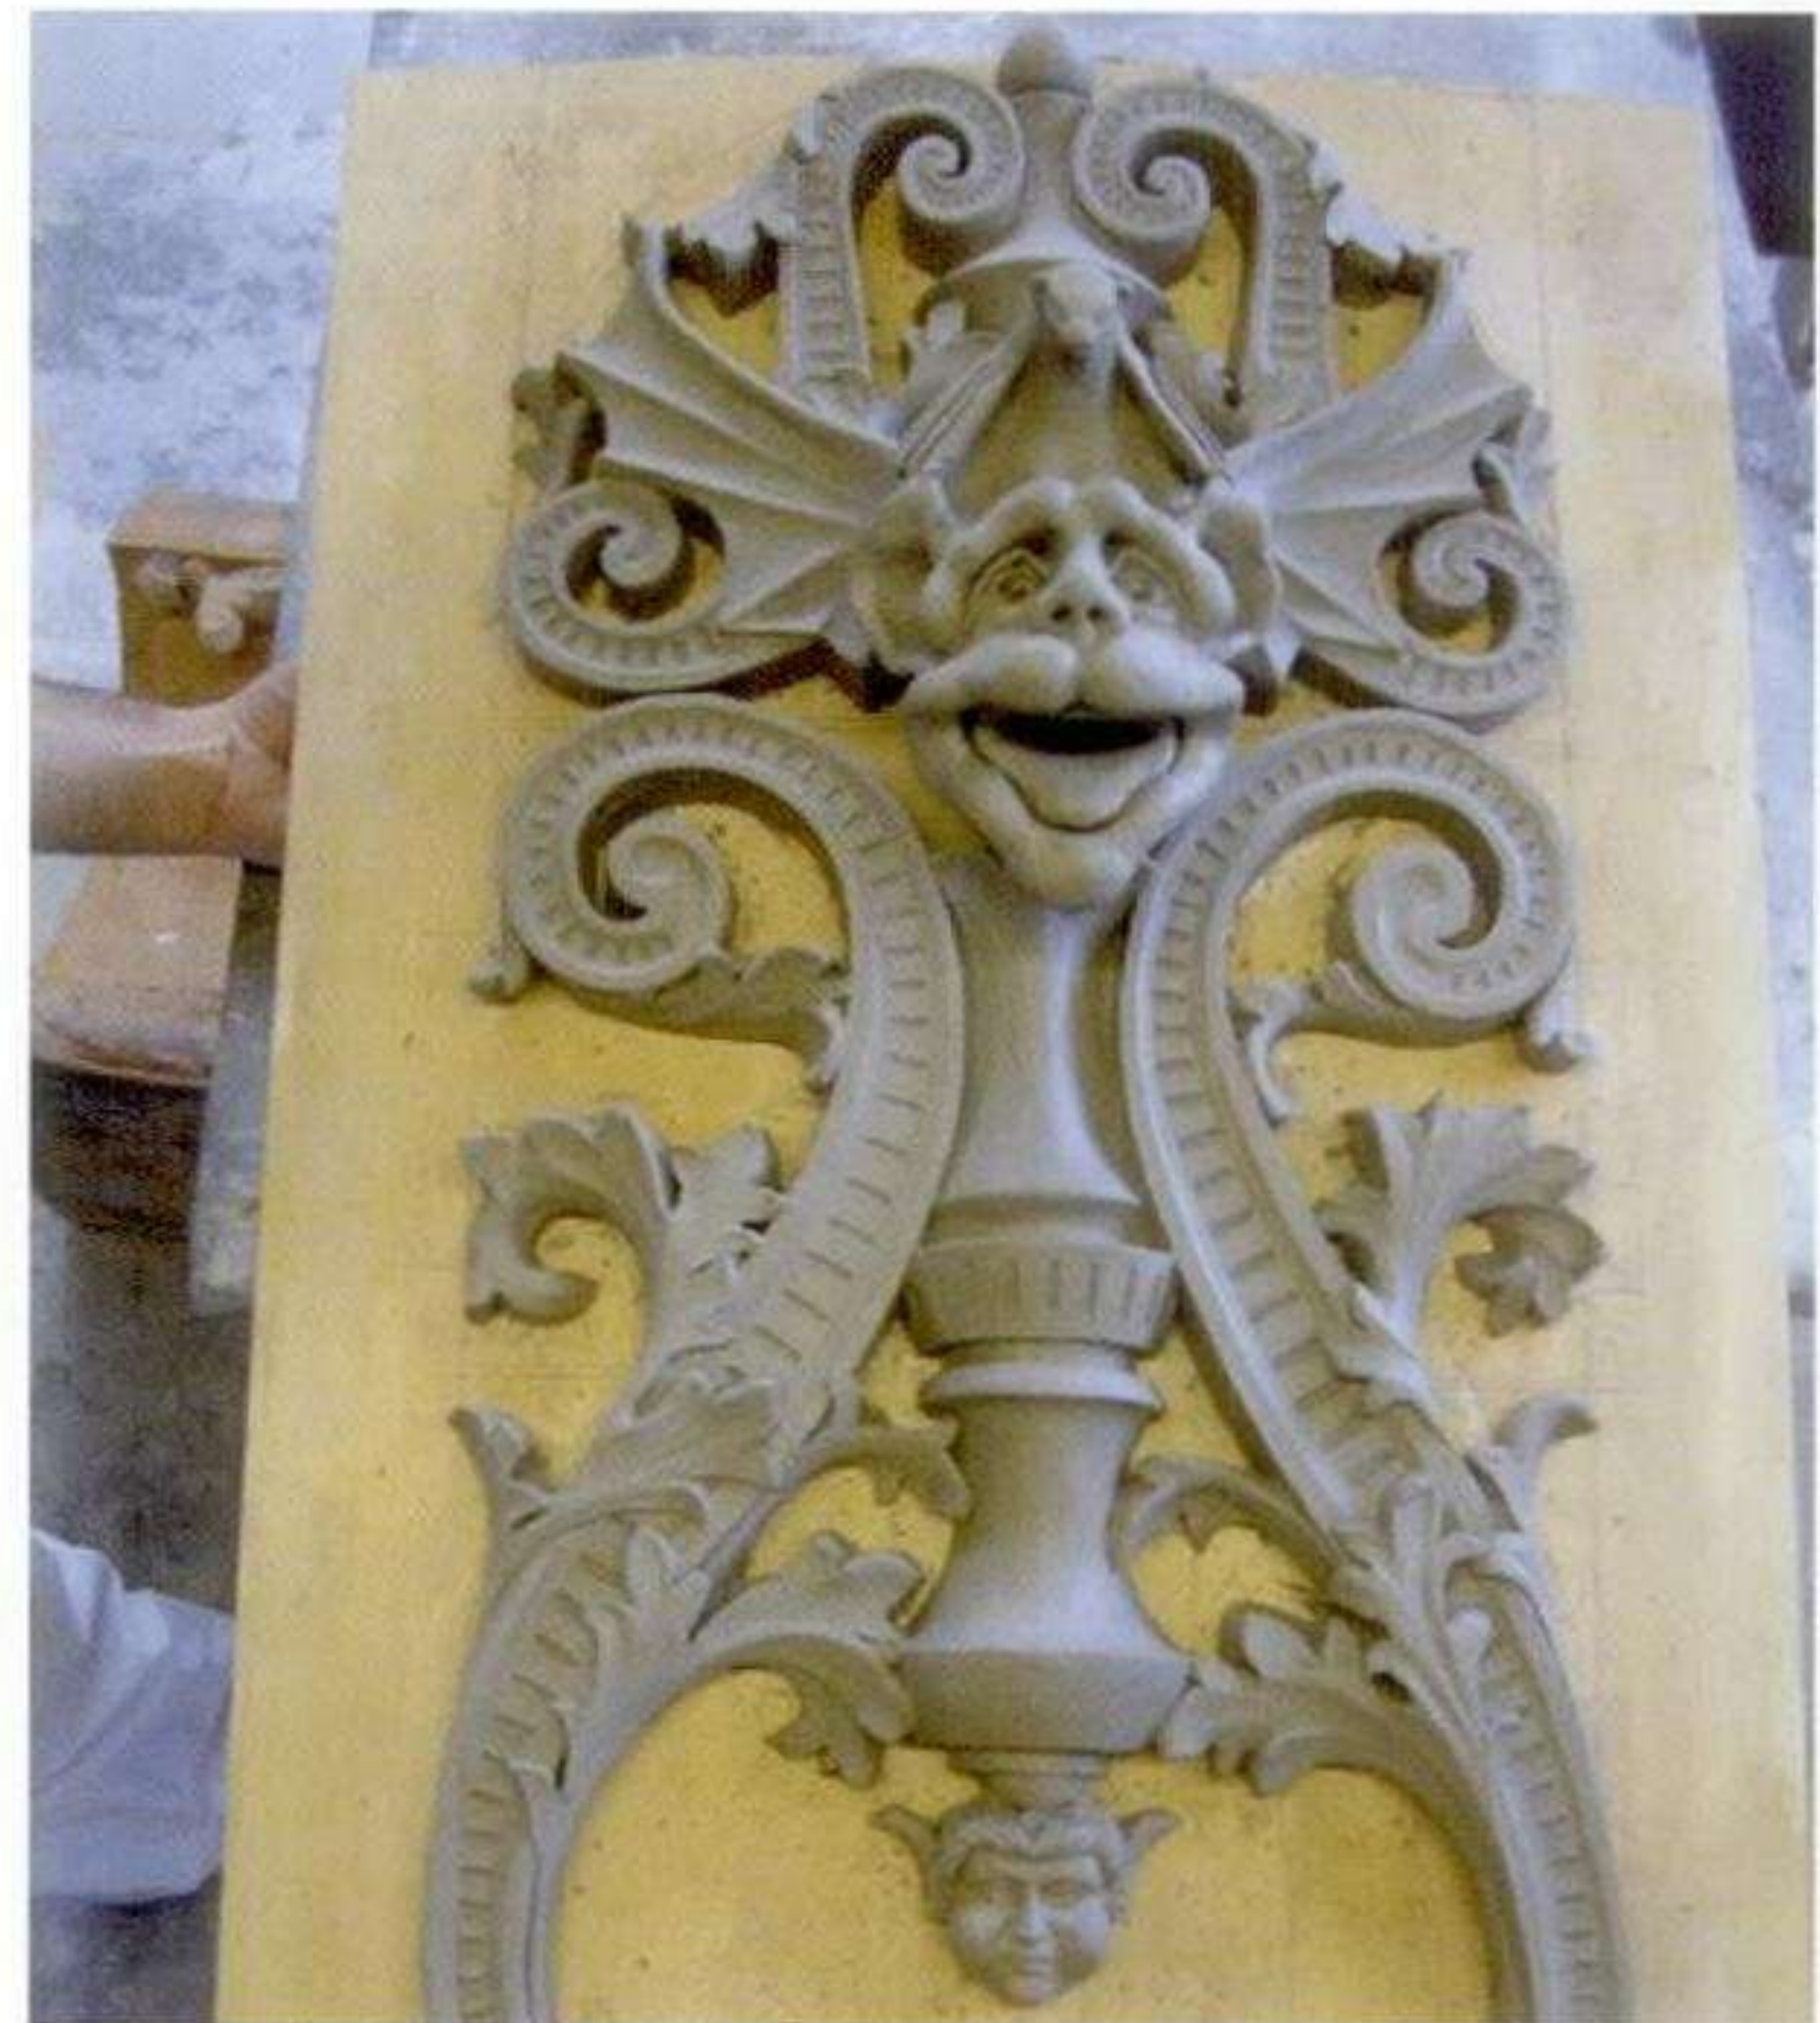
Bat's head and tracery: an early photograph of the piece intact, the approved clay sample and part of the model from which the mould

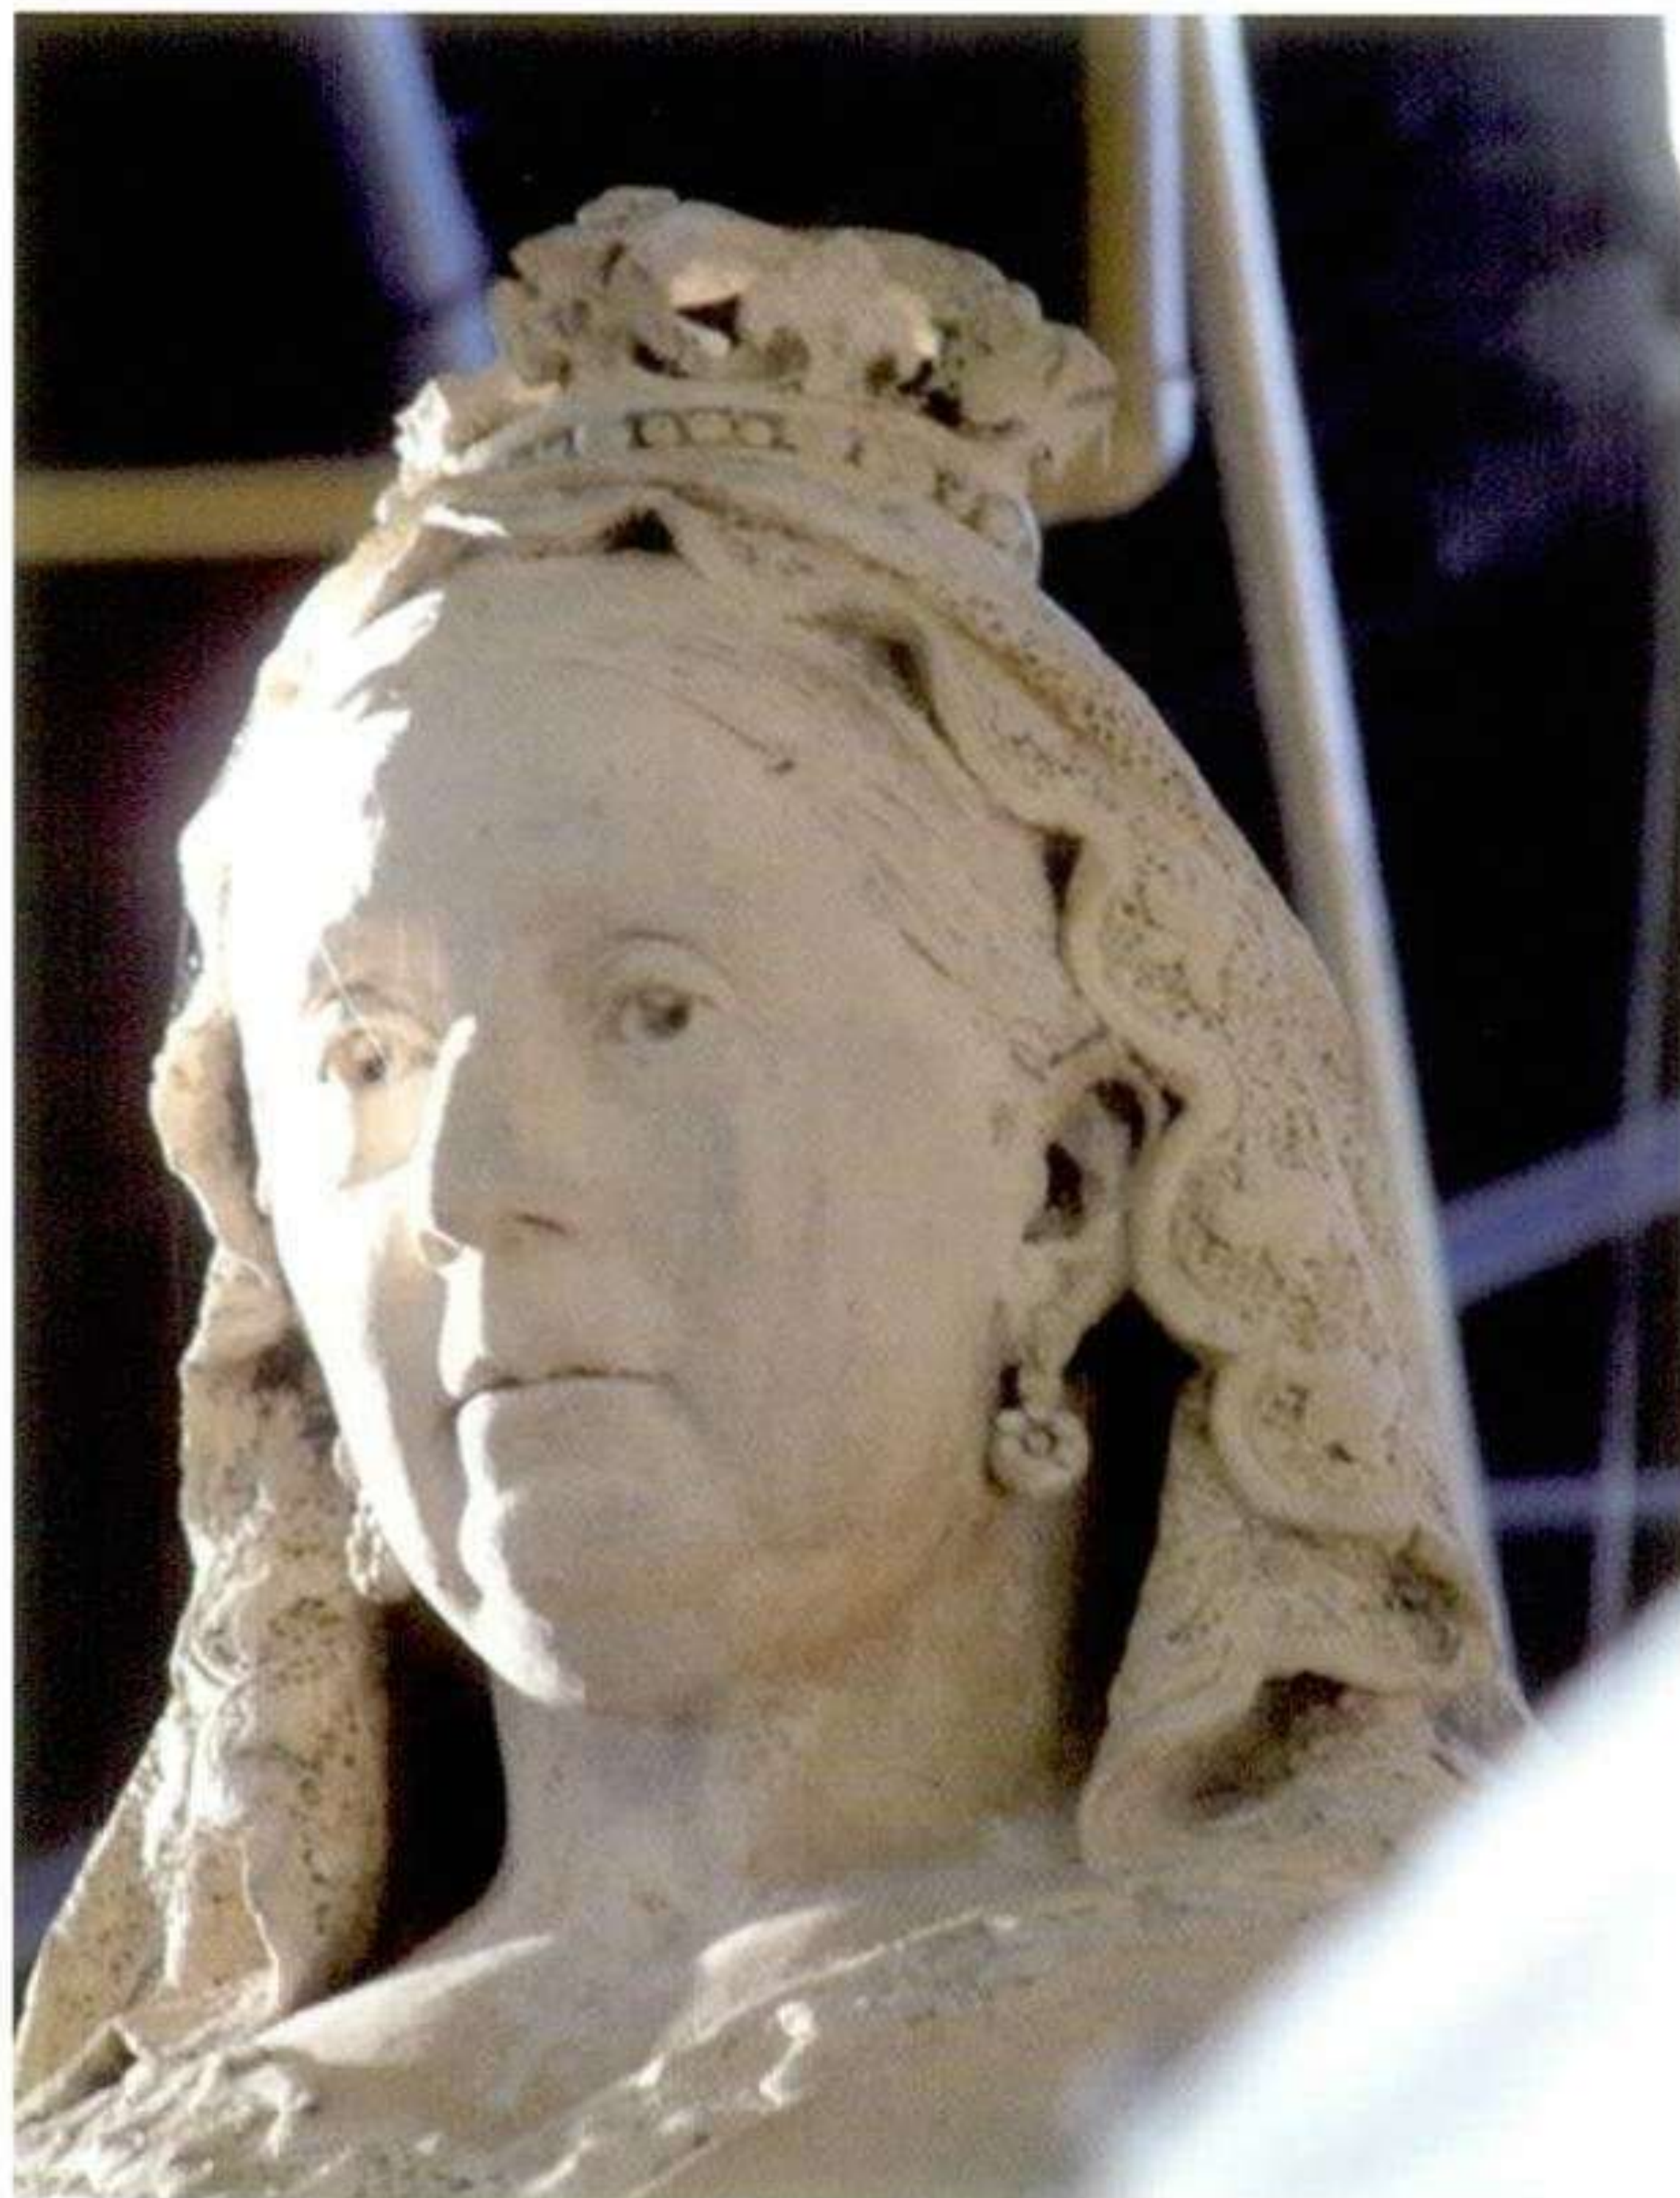
Queen Victoria's head after cleaning.

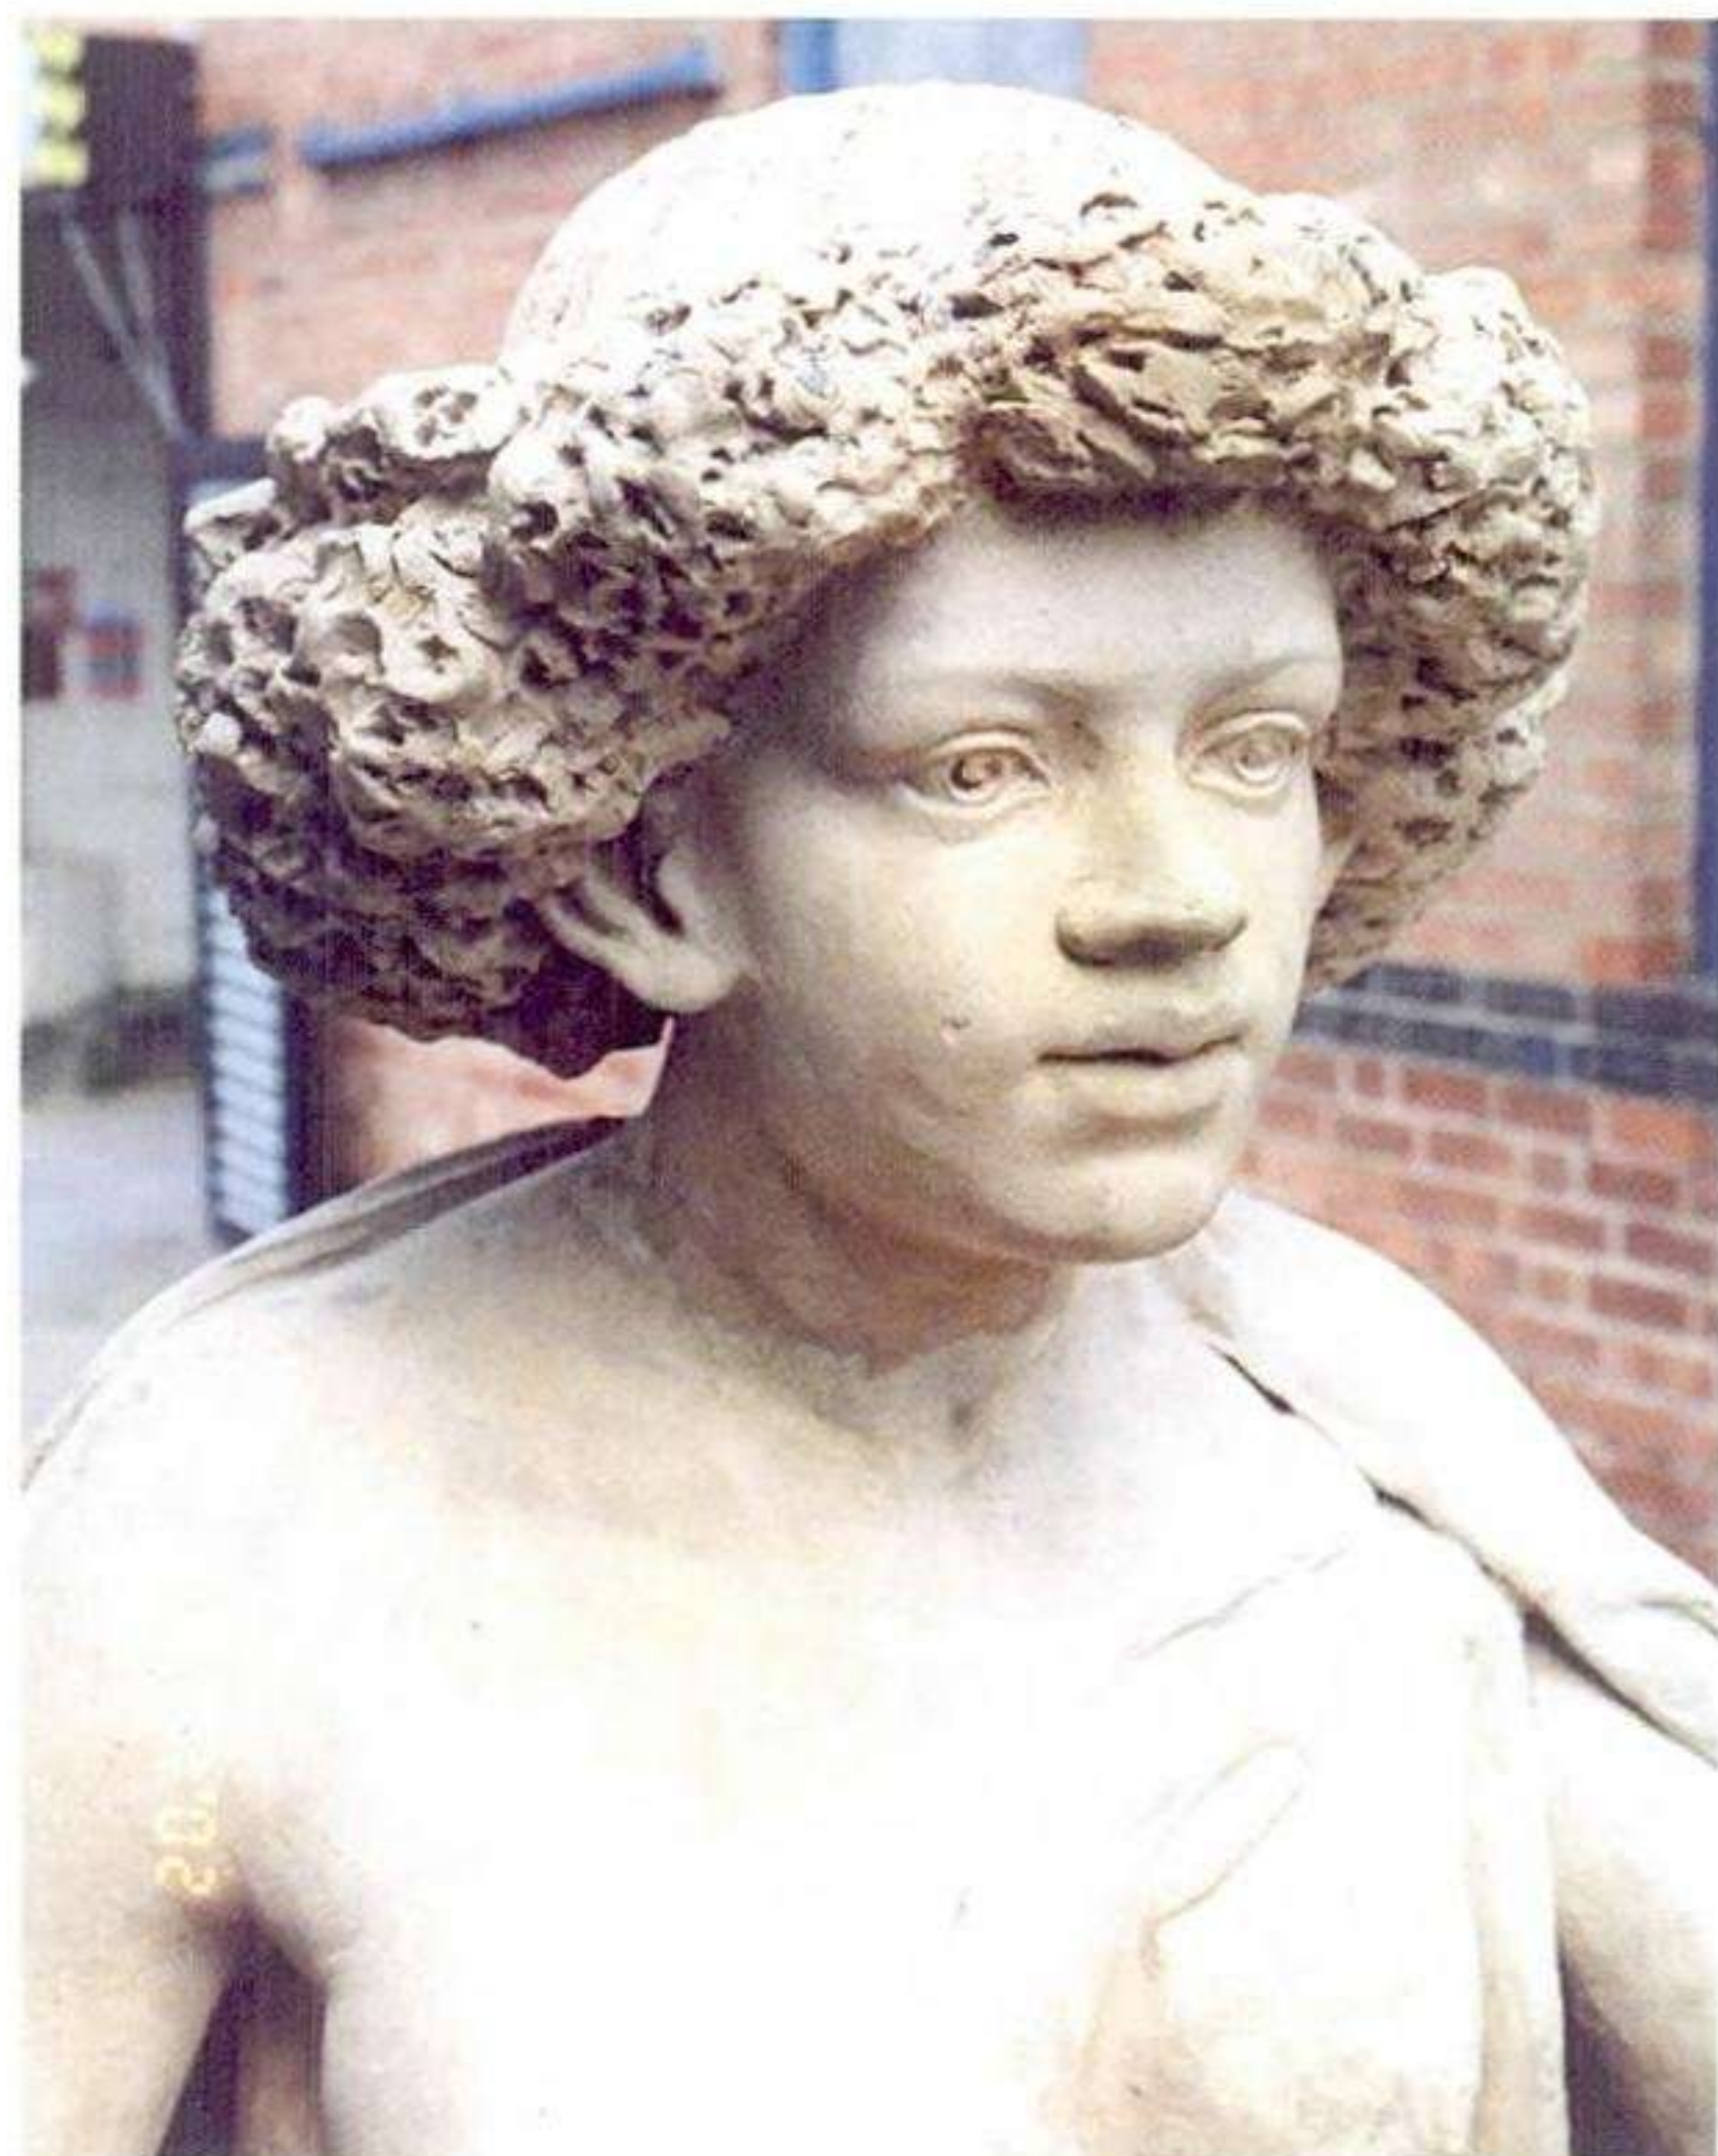
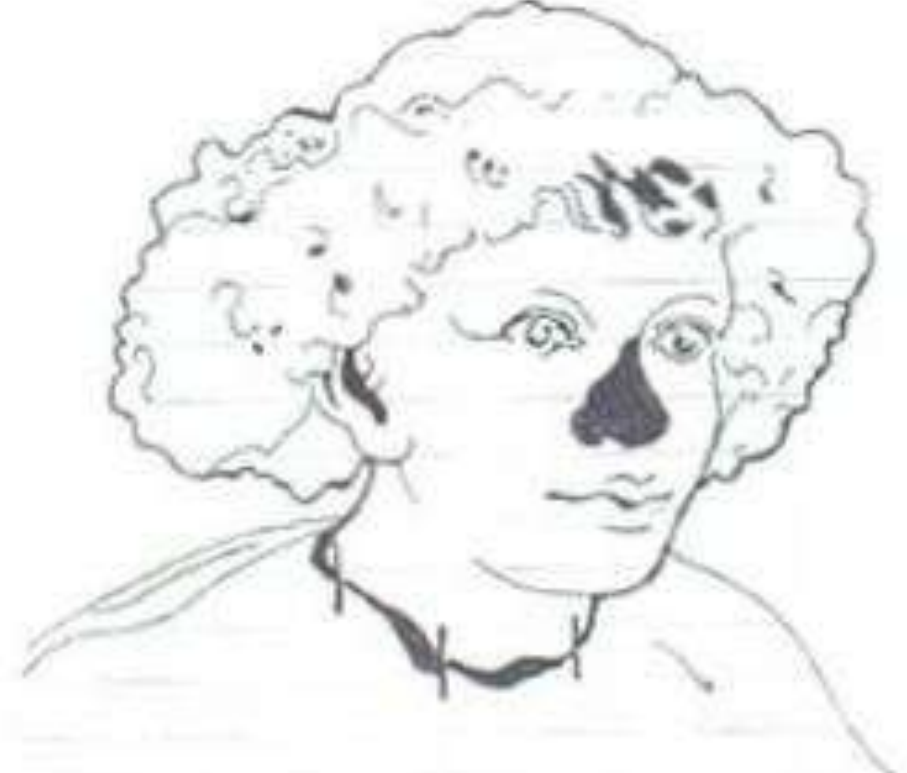
SCULPTURE: South Africa **PIECE:** Lady's head

Record of conservator's works to the head of the South African woman. Her head was reattached and minor repairs undertaken to her forehead and nose.

REPAIRS: **ADDITIONAL TO ORIGINAL SCOPE:**
SCOPE AGREED: Mortar repair and remodelling of nose and front of hair - 2 No.
Head attached to body - 3 No. pins
