THE
INVESTIGATION,
REPAIR AND
CONSERVATION
OF THE
DOULTON
FOUNTAIN,
GLASGOW GREEN

2 | Case
Study

TECHNICAL
CONSERVATION
GROUP

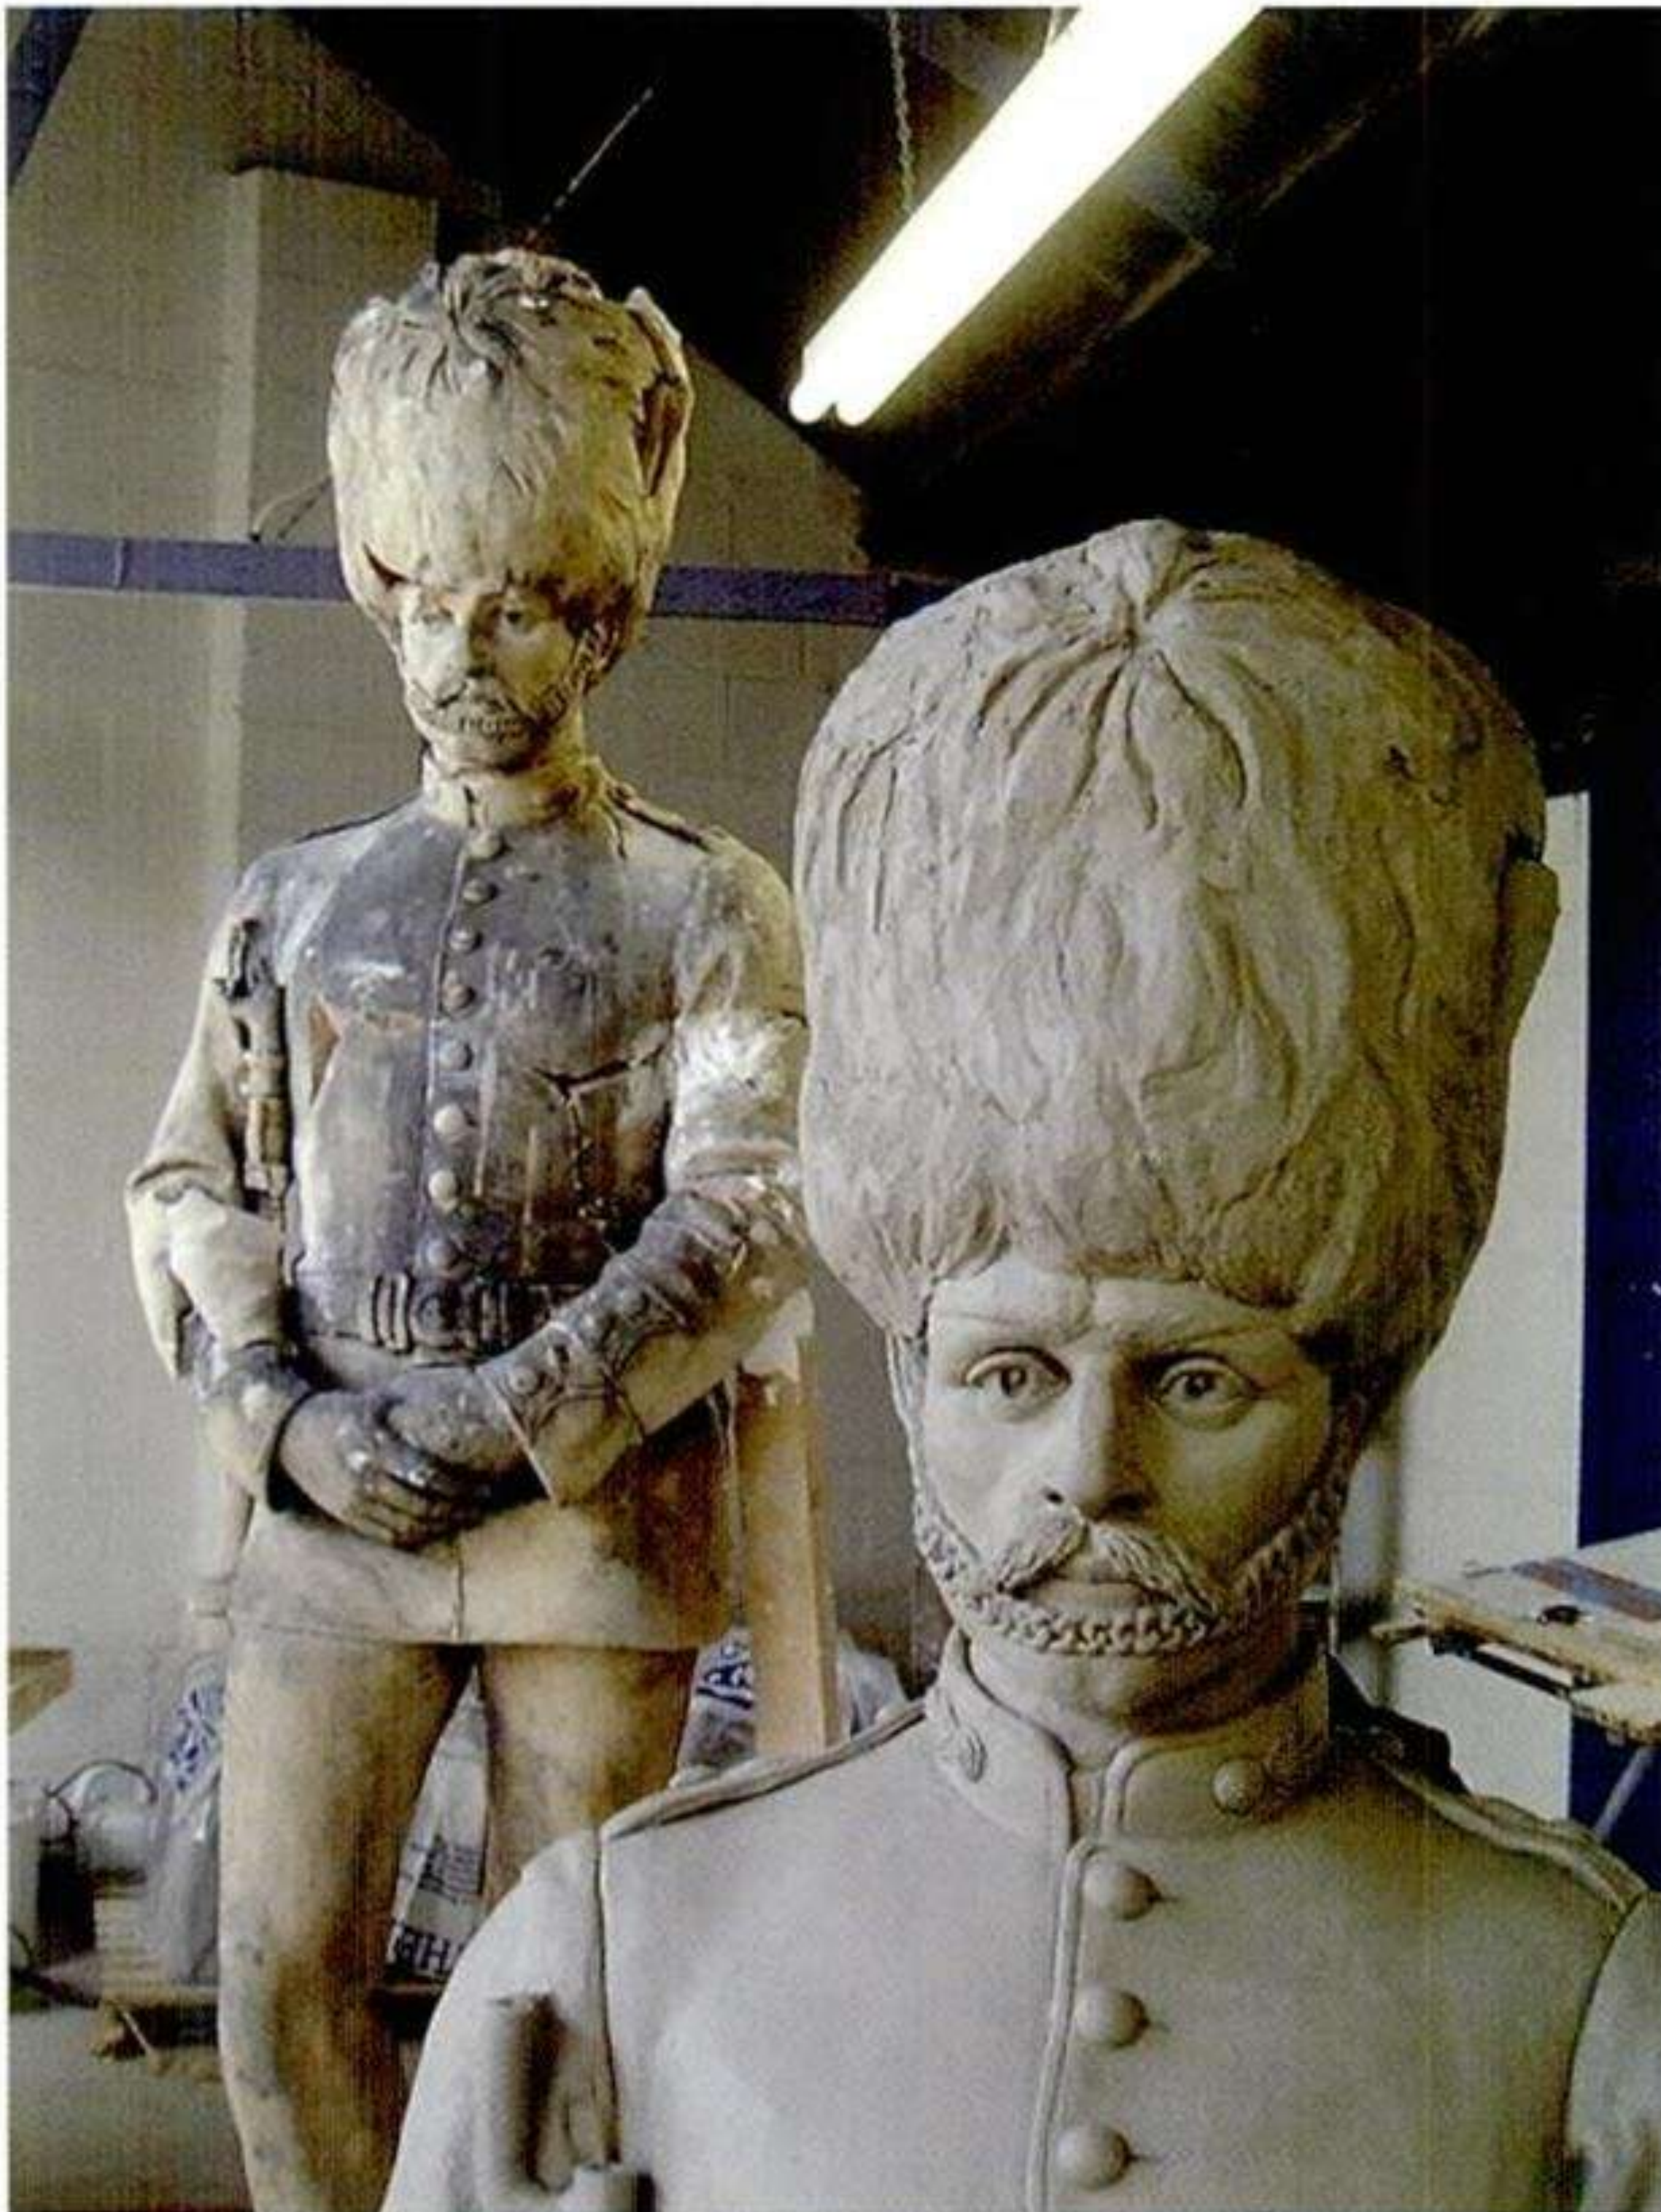
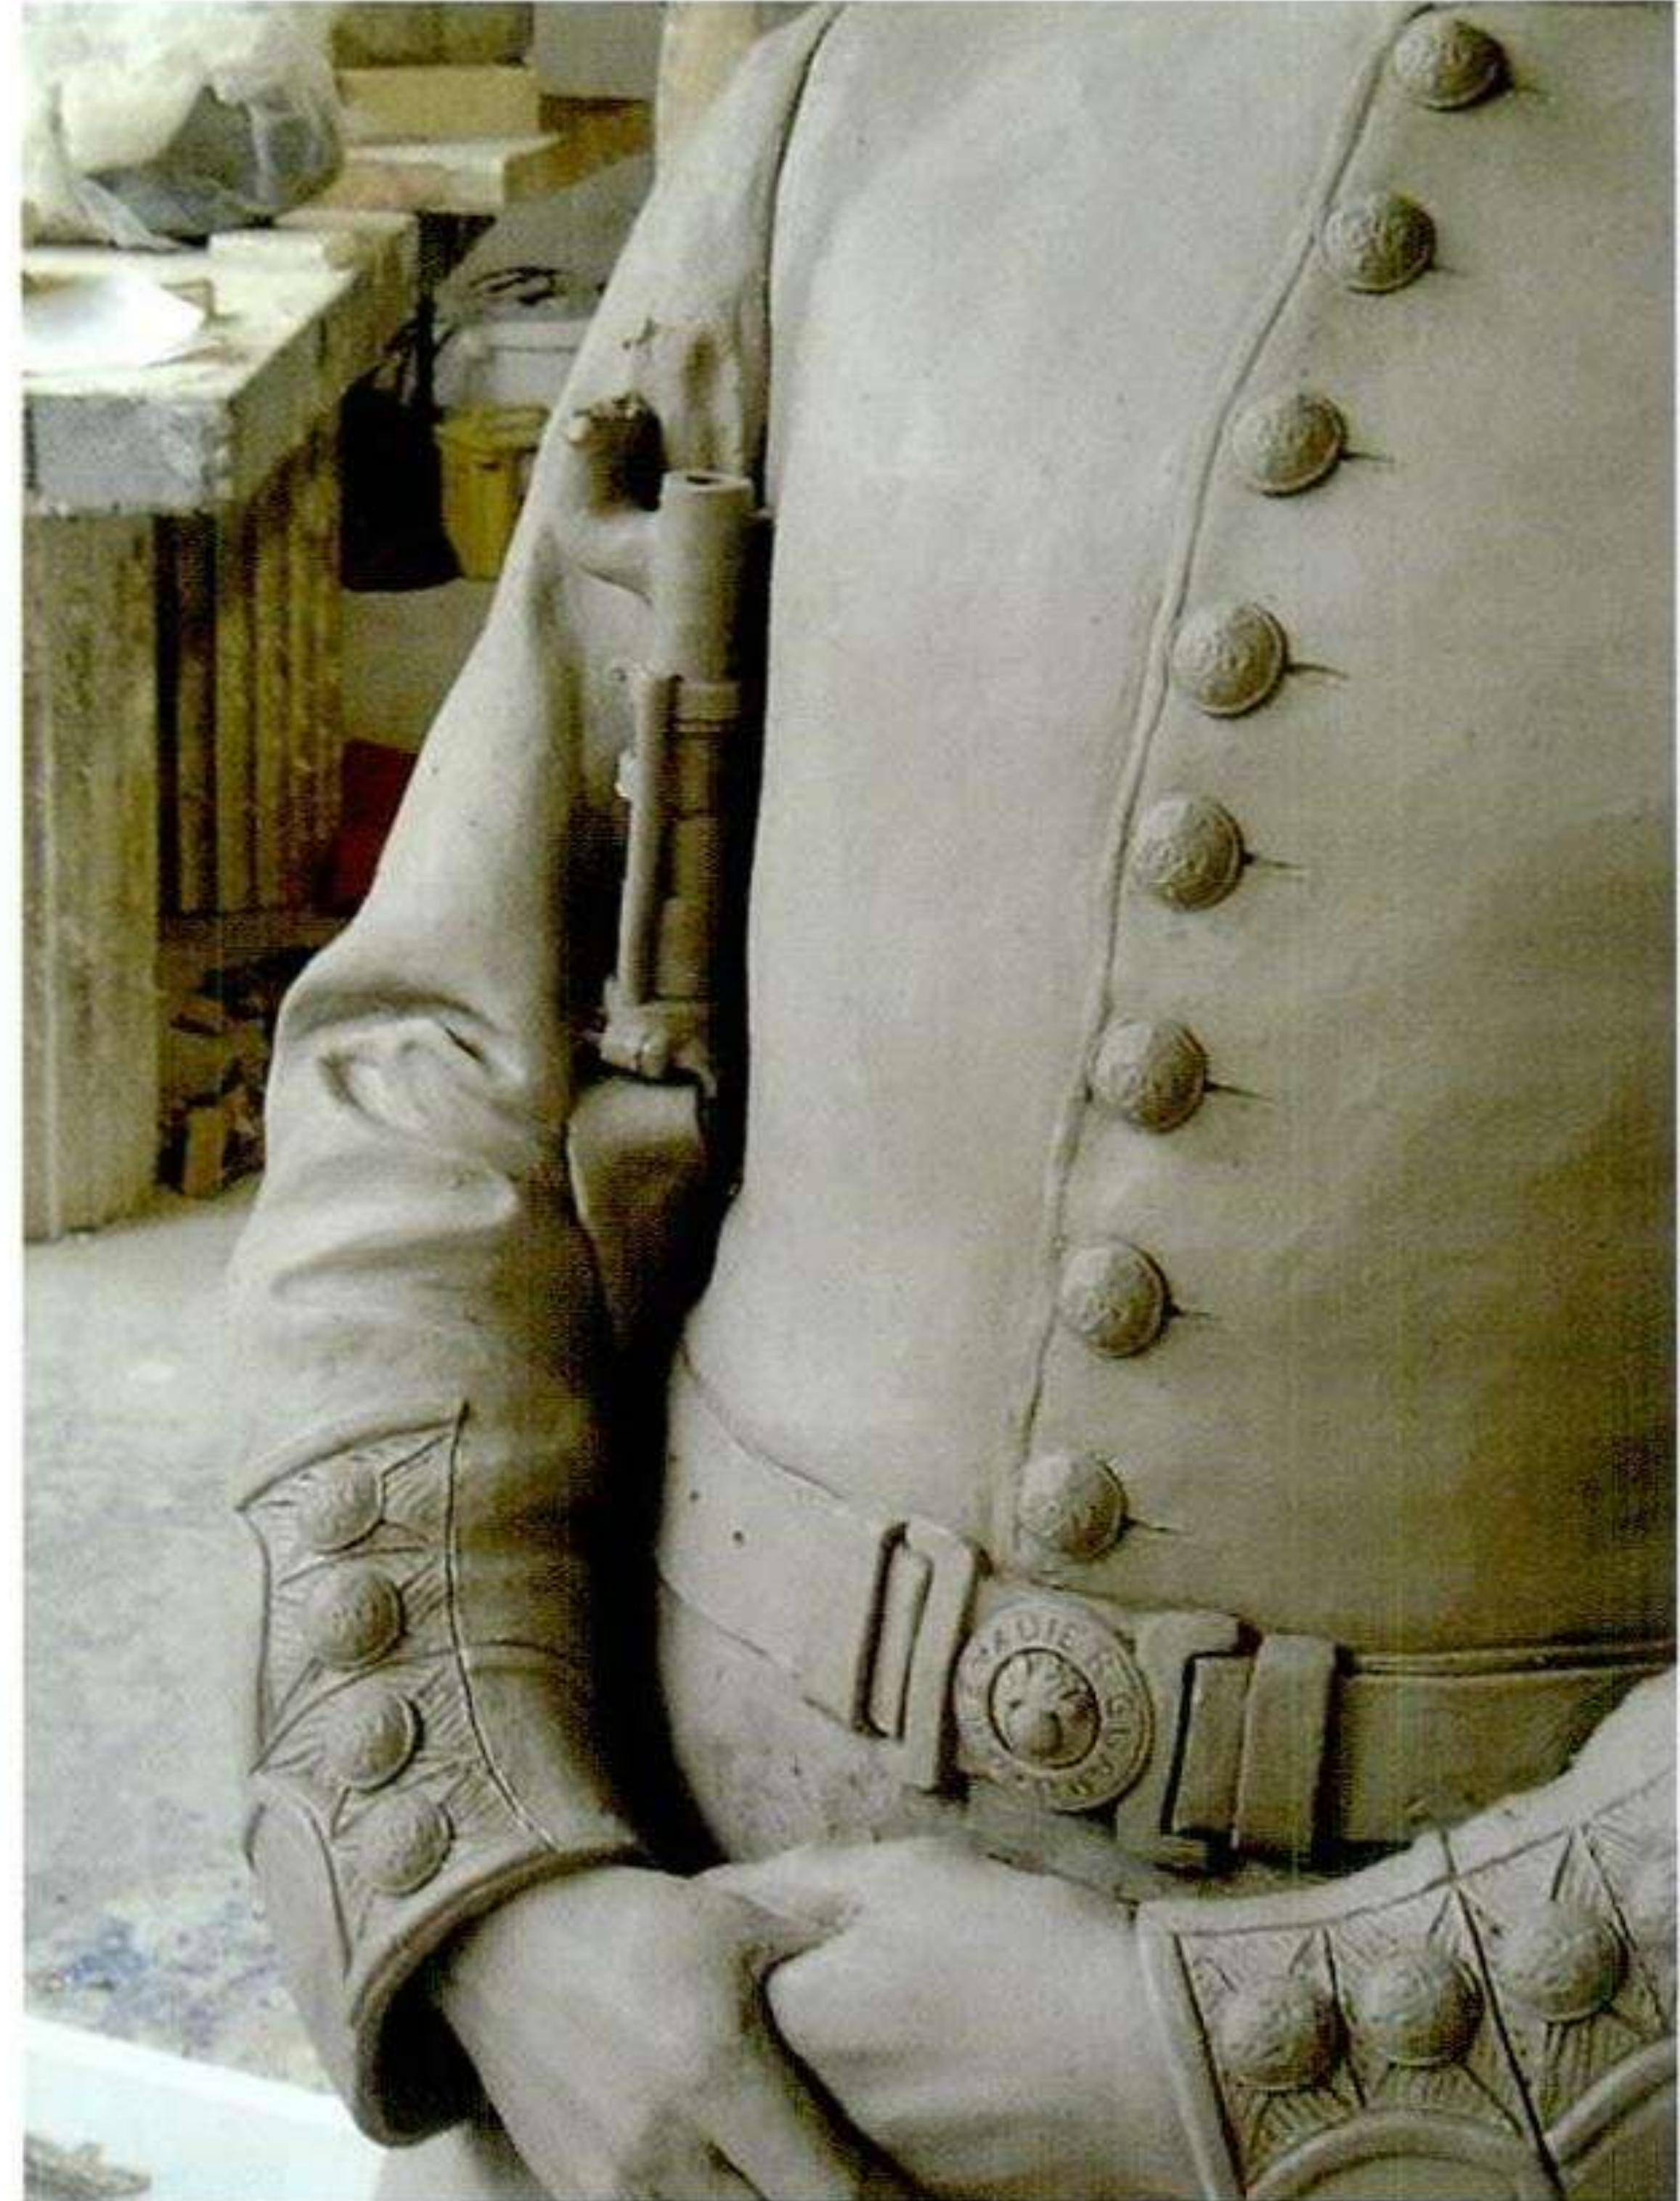
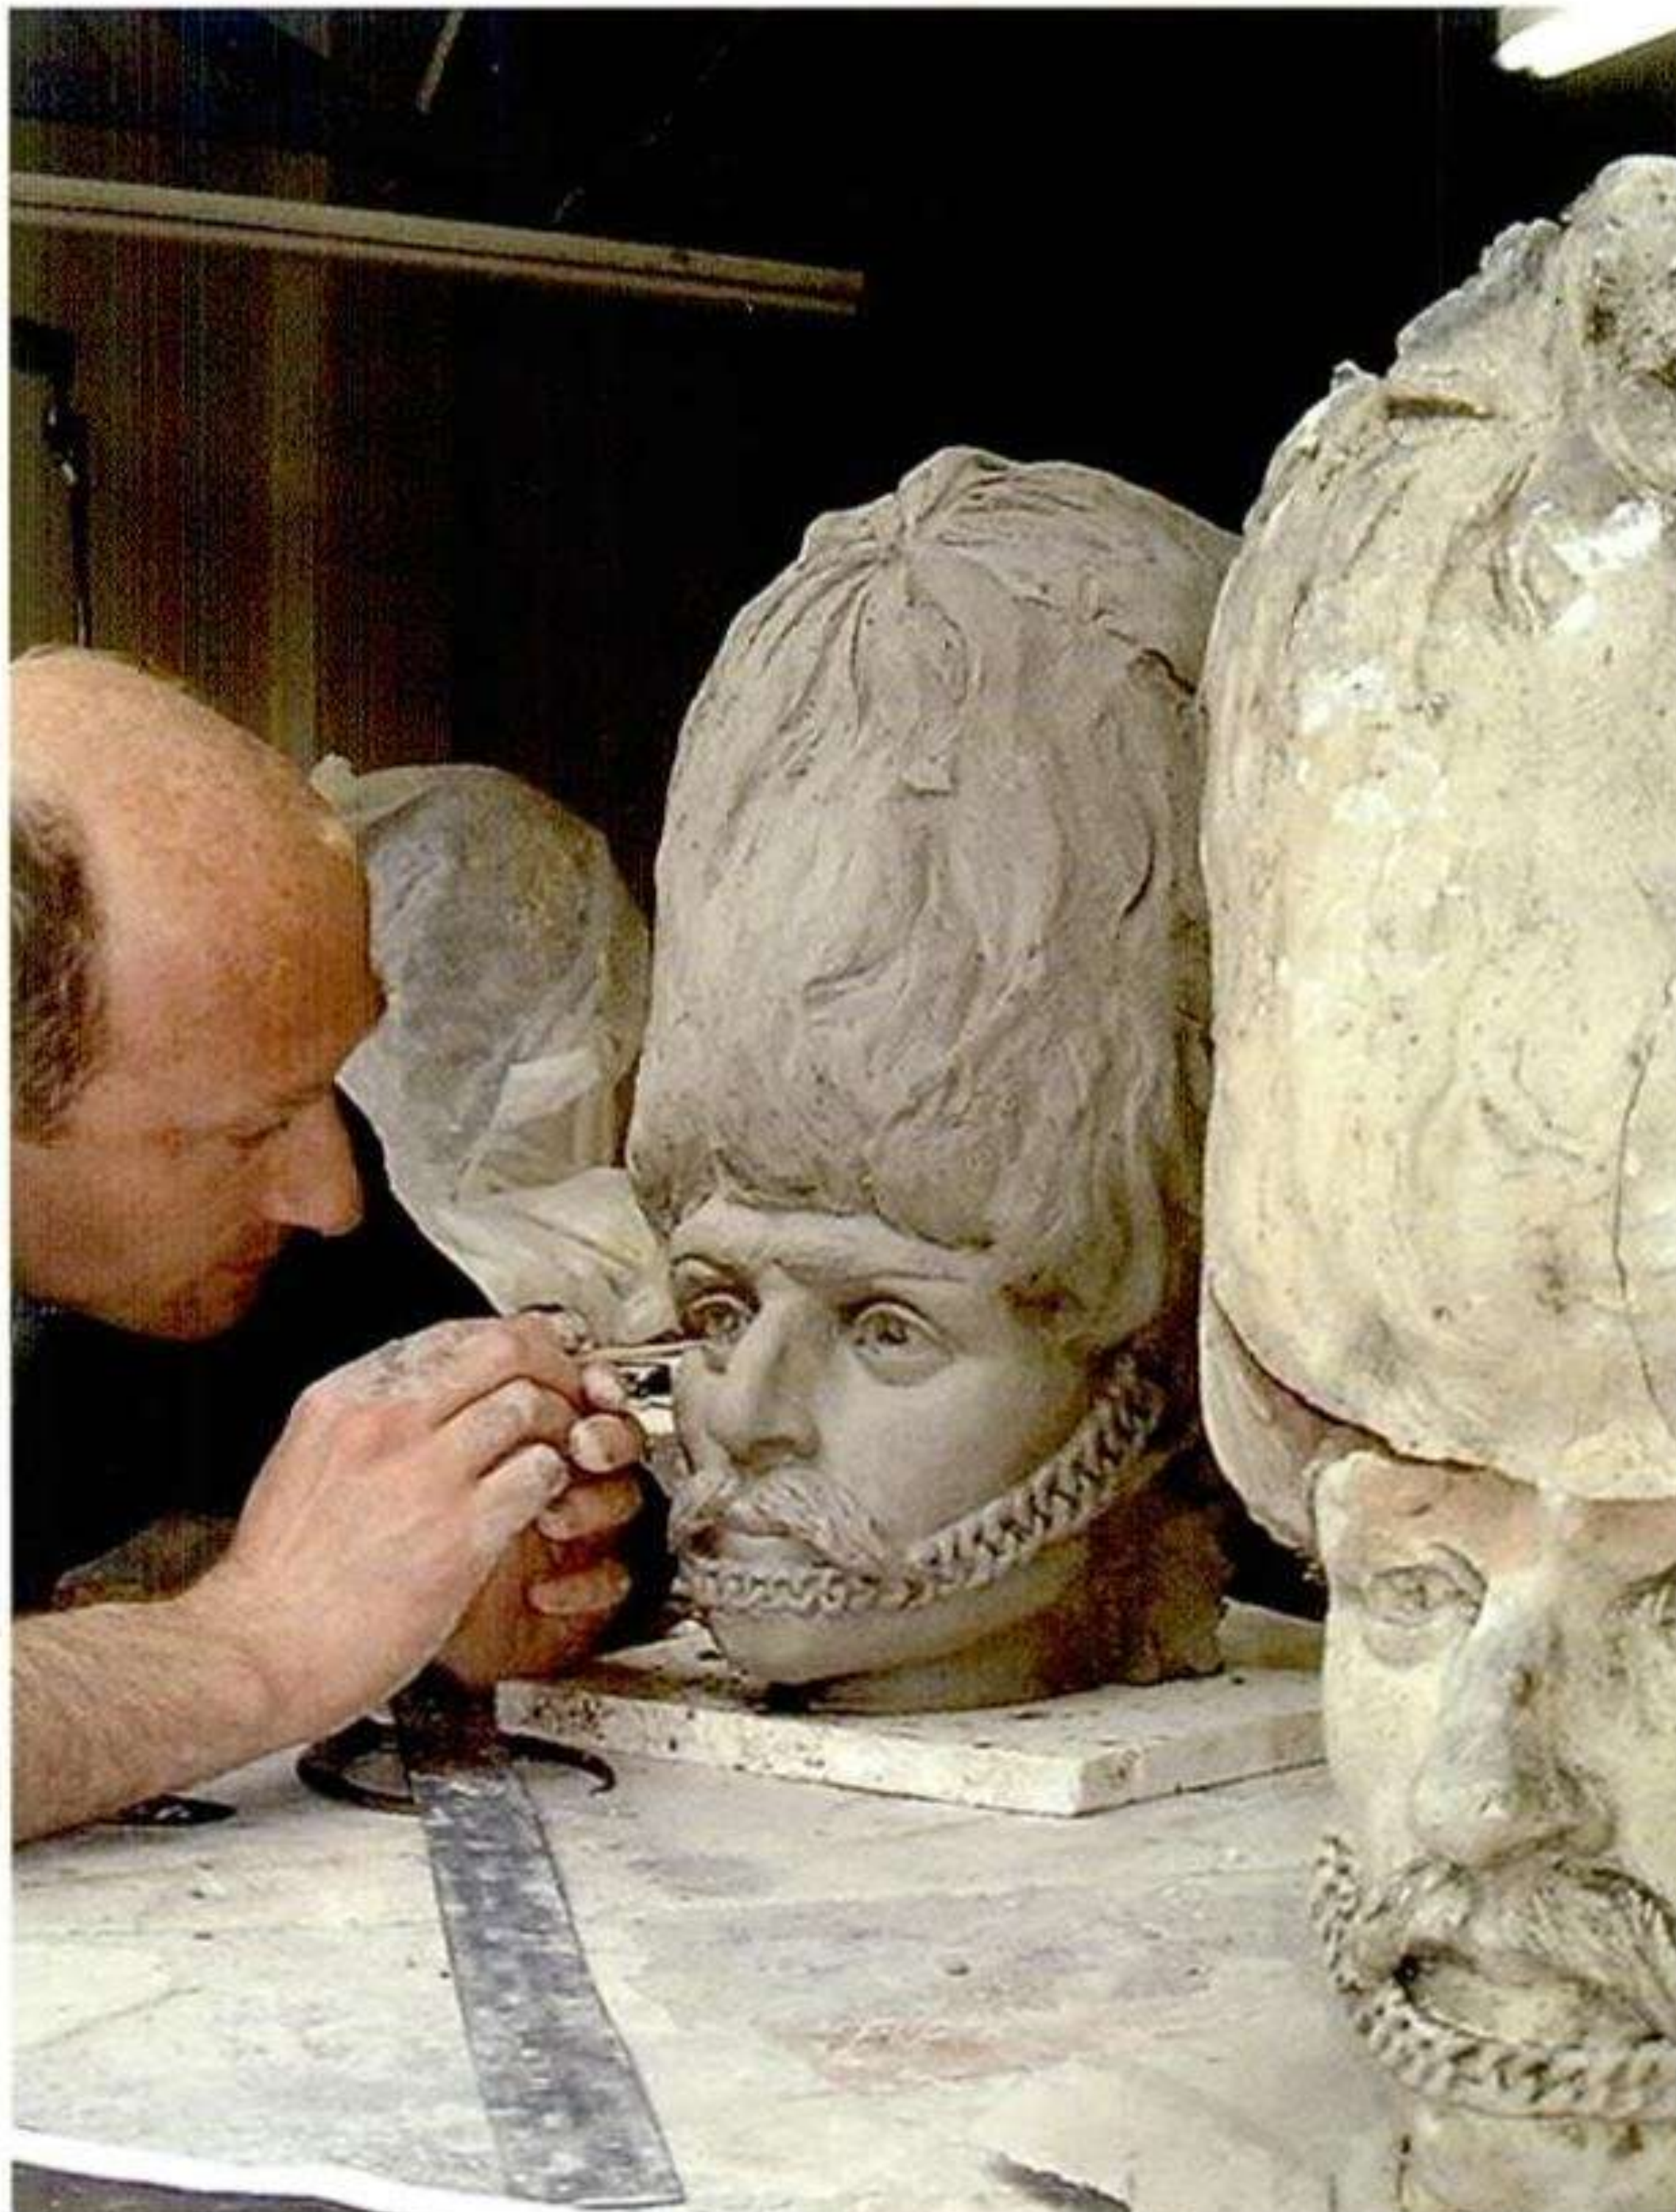
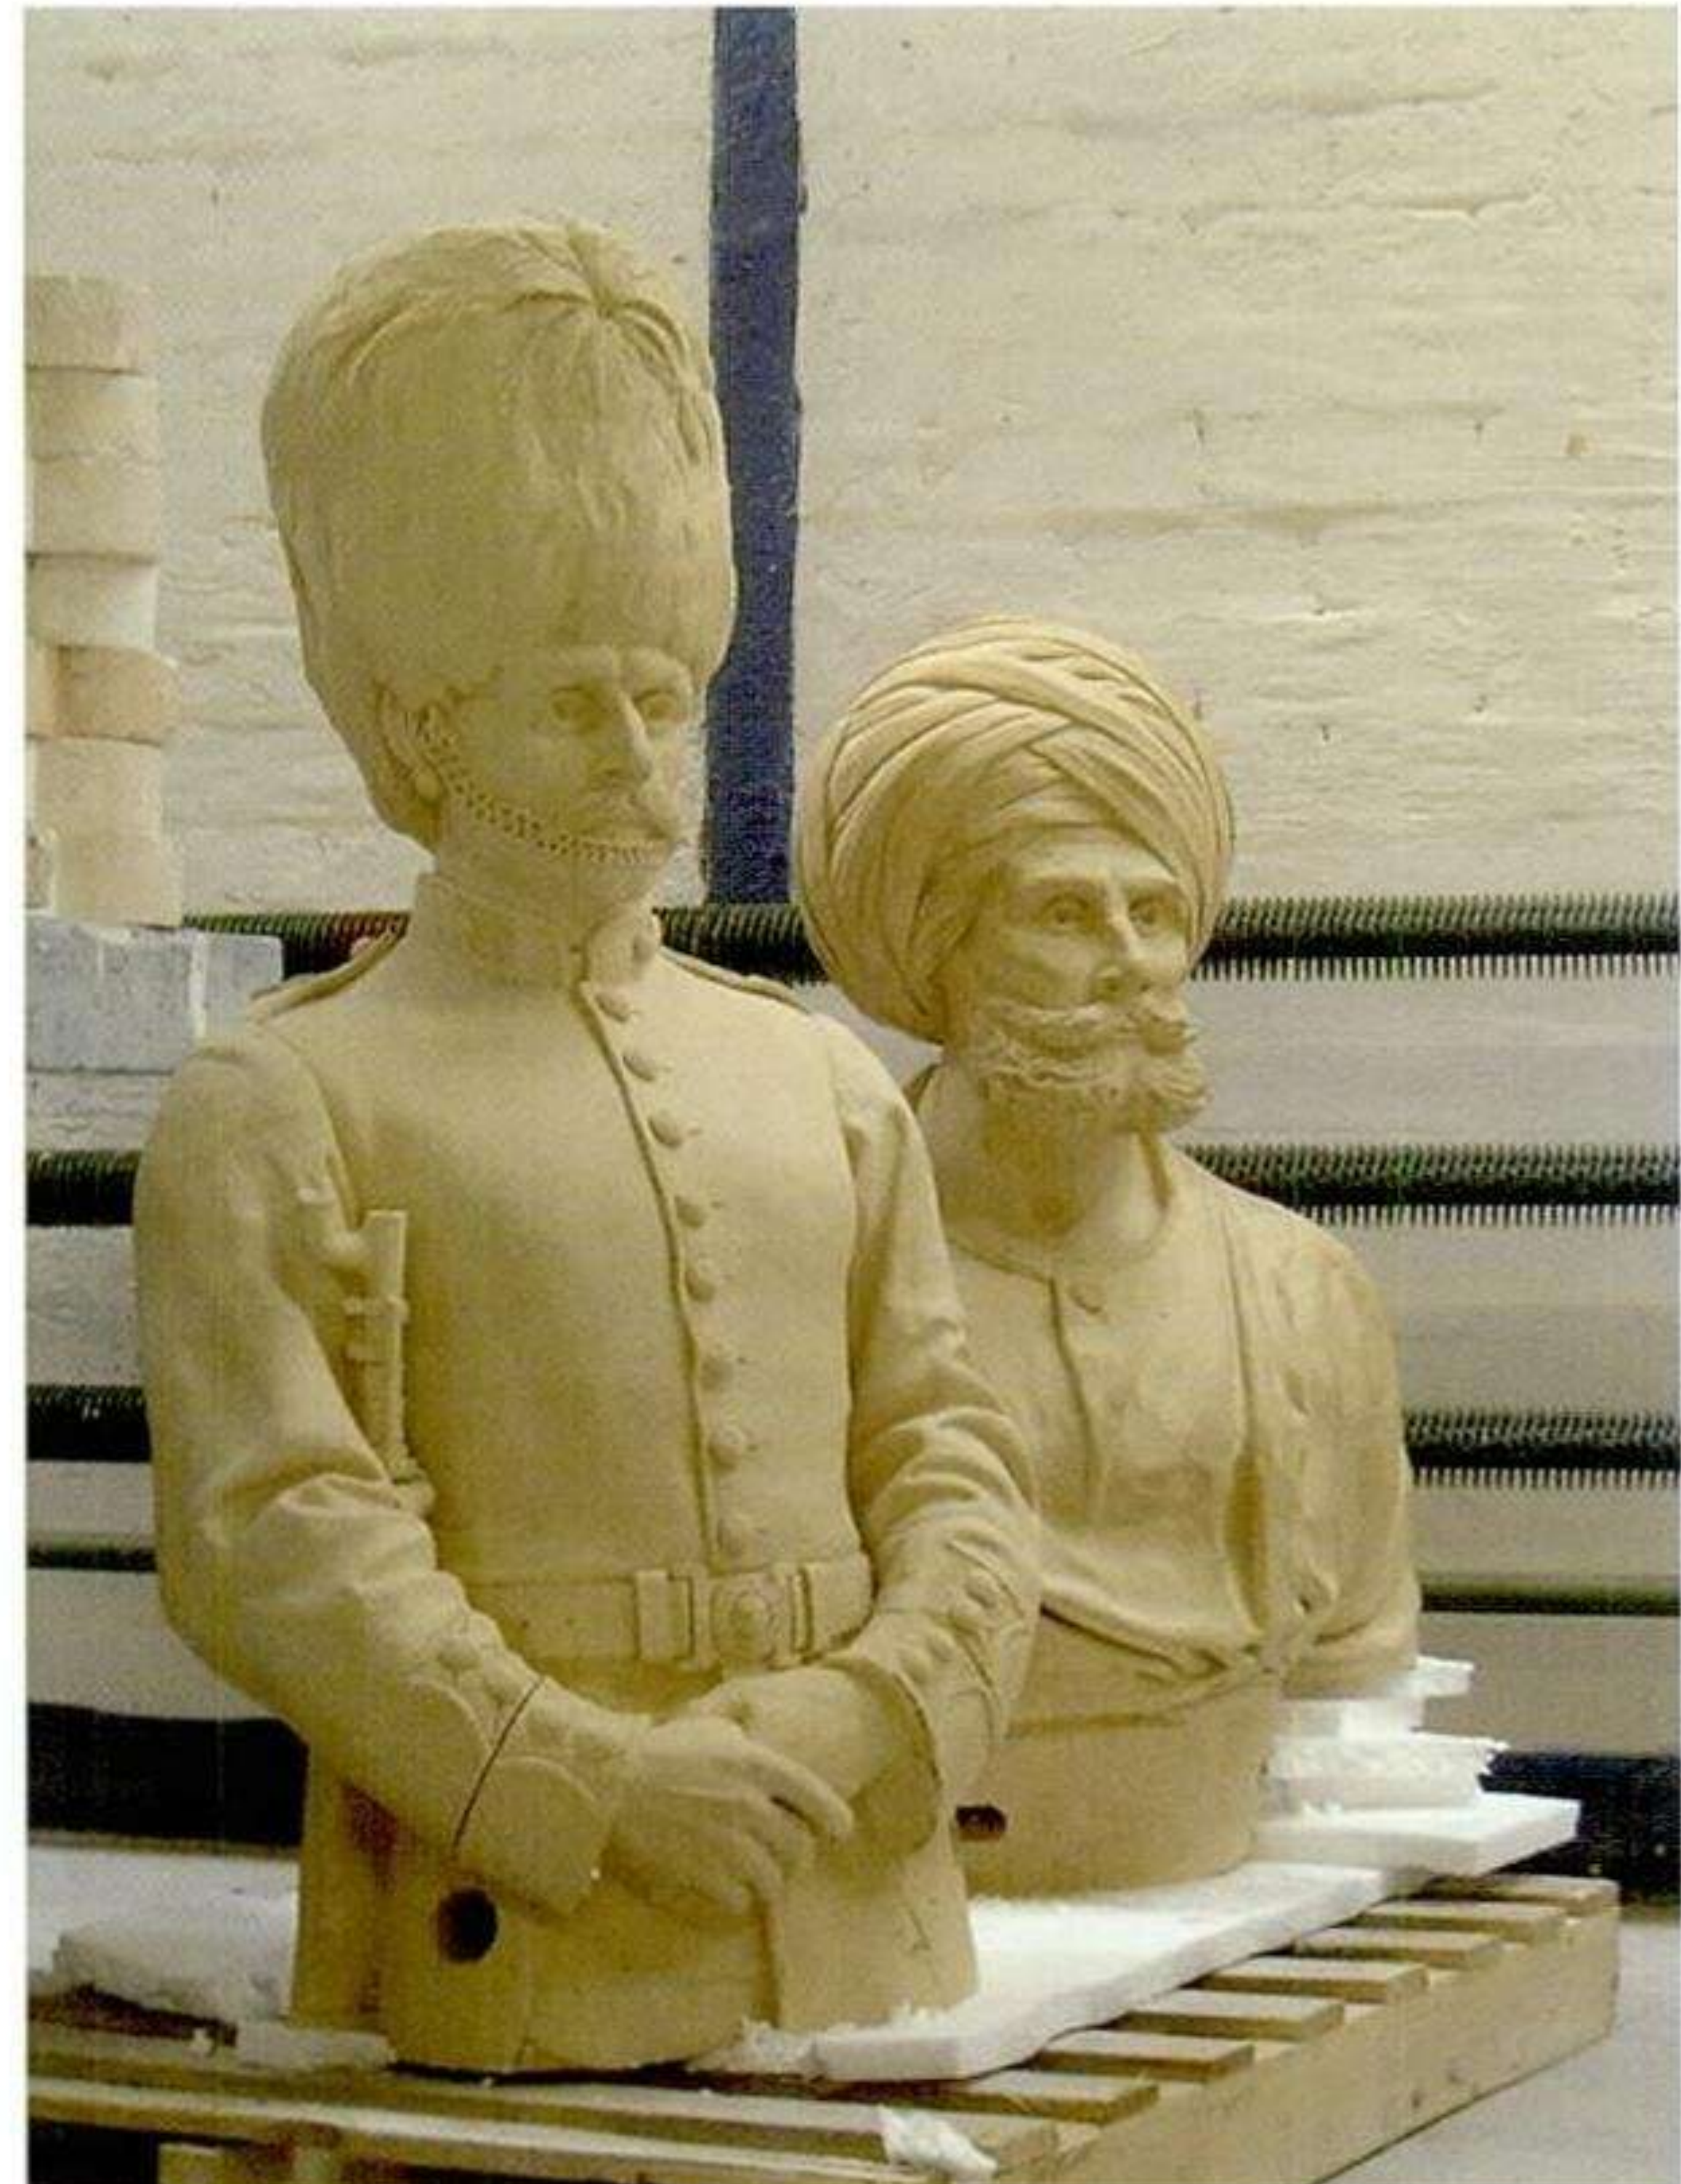
The heavily damaged head and torso of the Royal Irish Fusilier were reconstructed before the replacement piece was modelled. Evidence of the original piece was crucial when the soft clay emerged from the mould and was finished by hand.

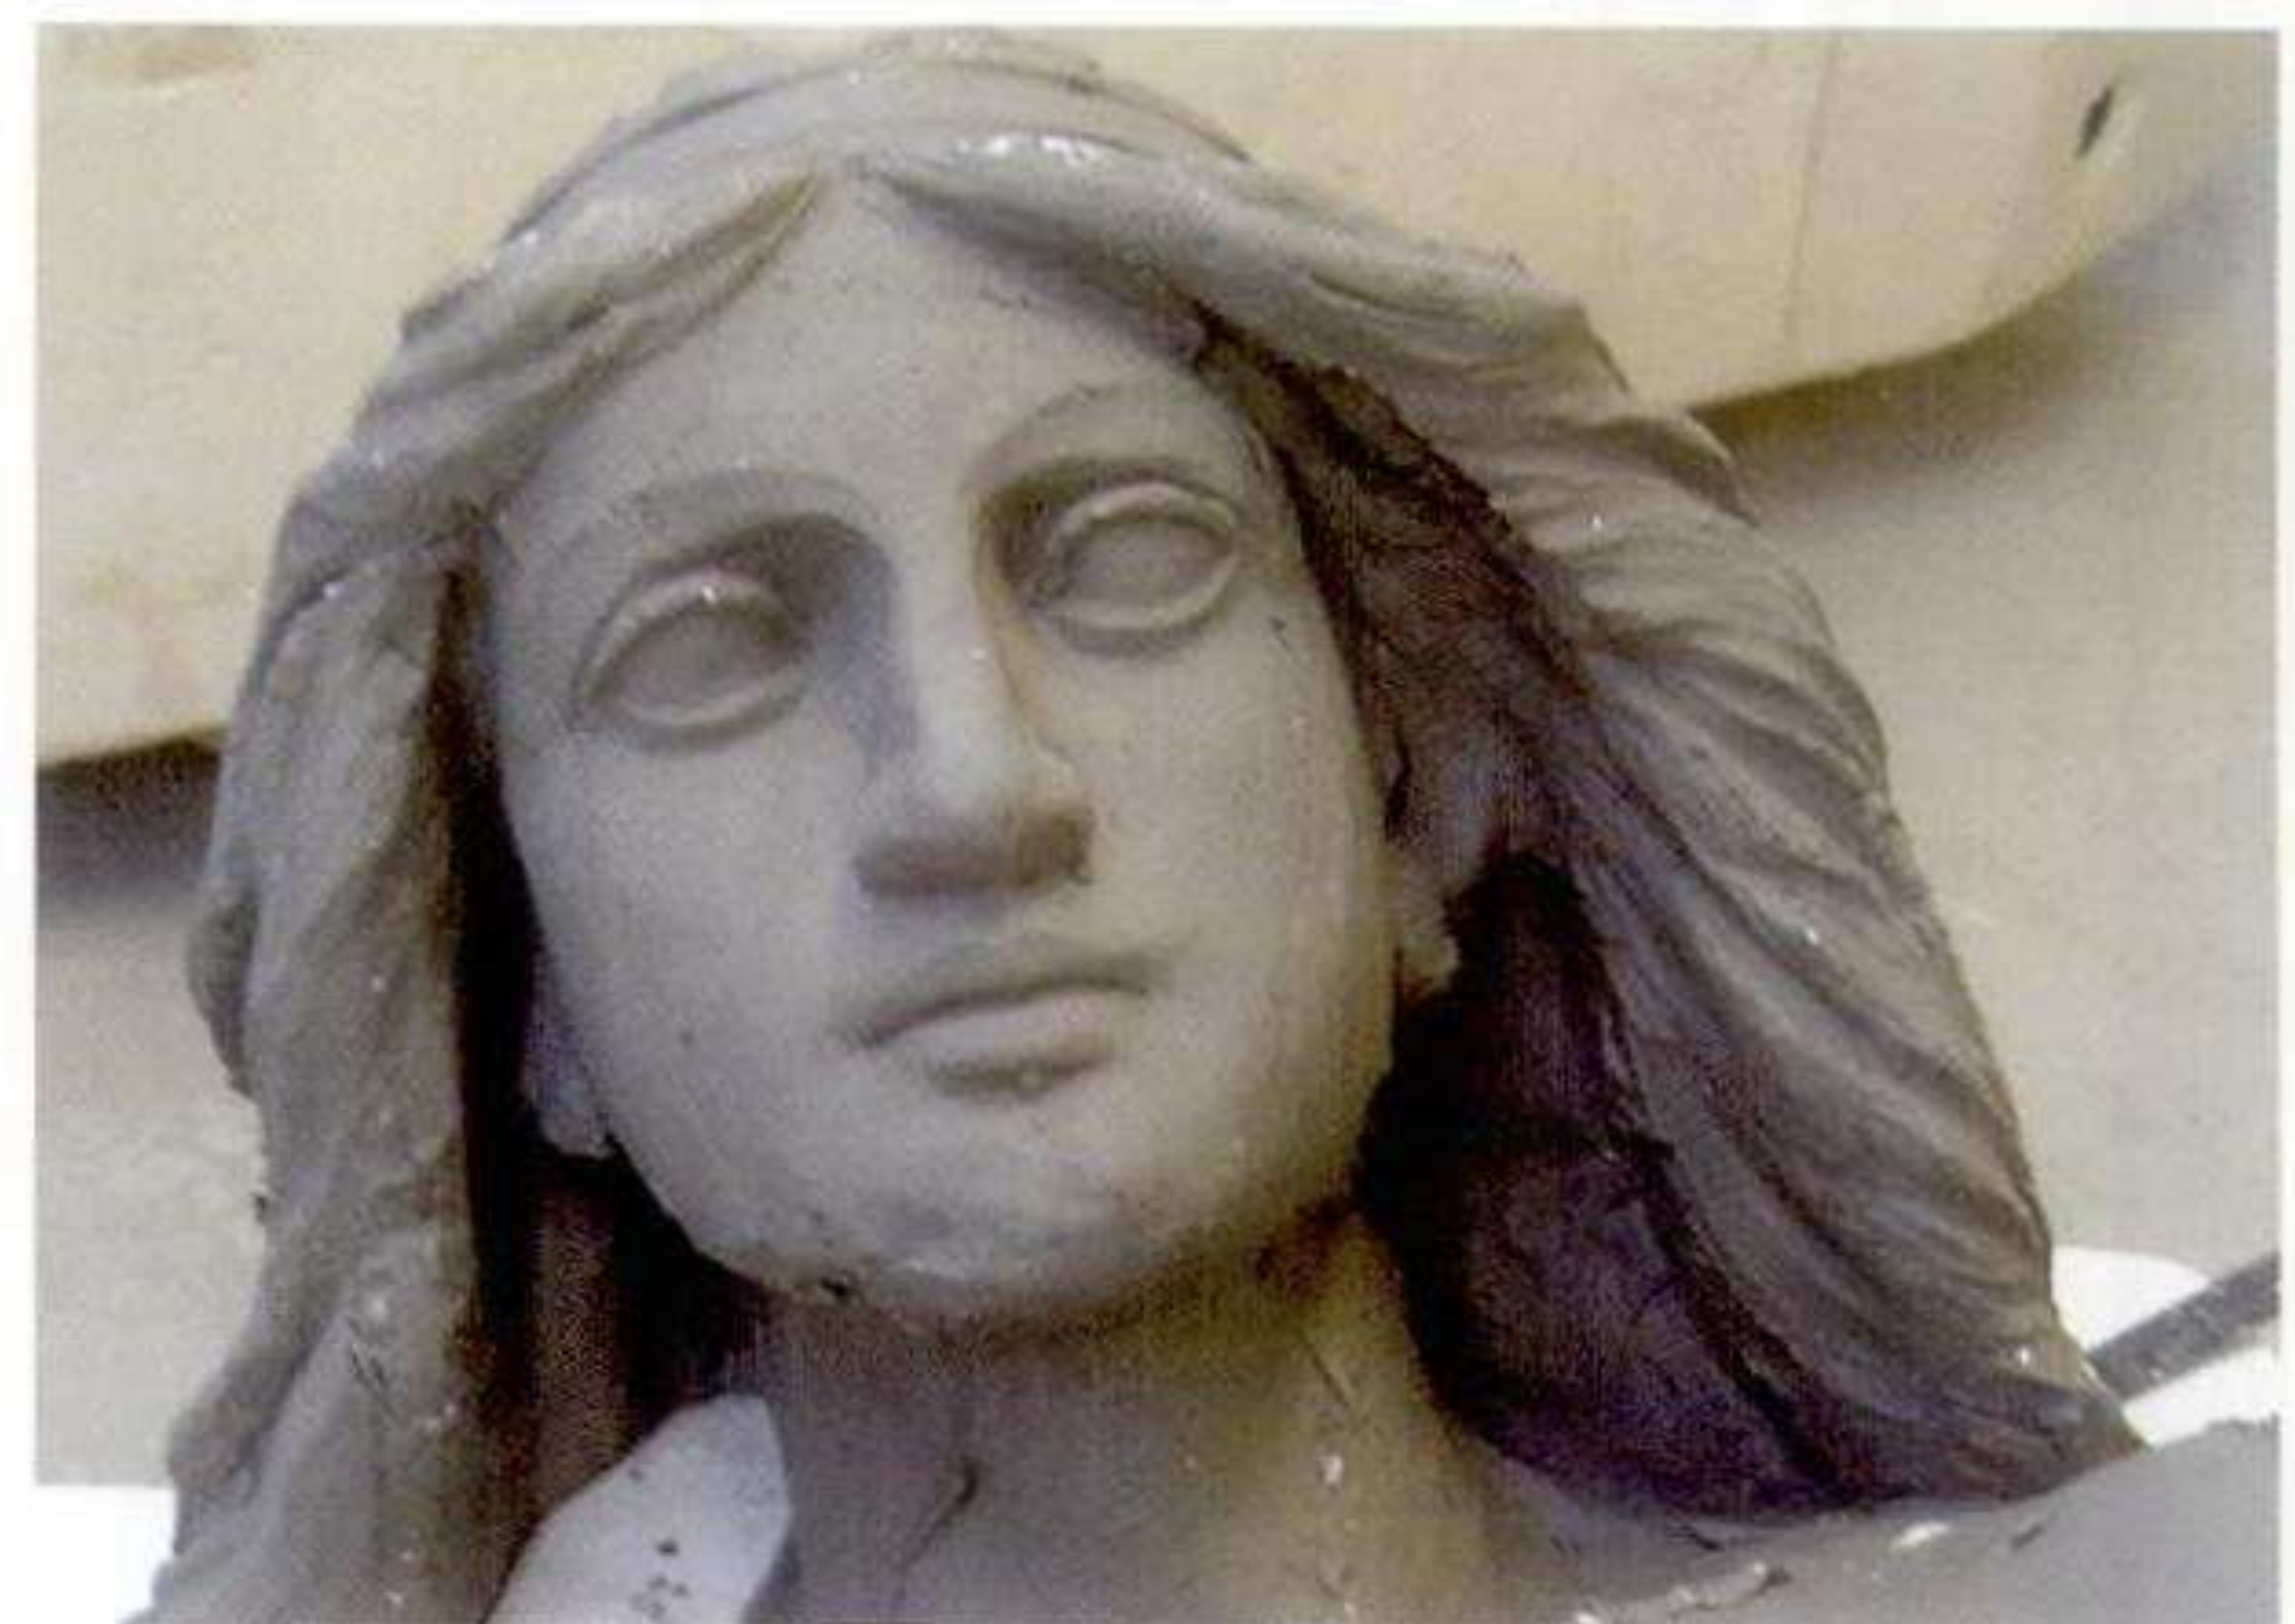
Part of the mould of one of the Water Bearers: its pressing, dismantling and the head awaiting hand finishing.

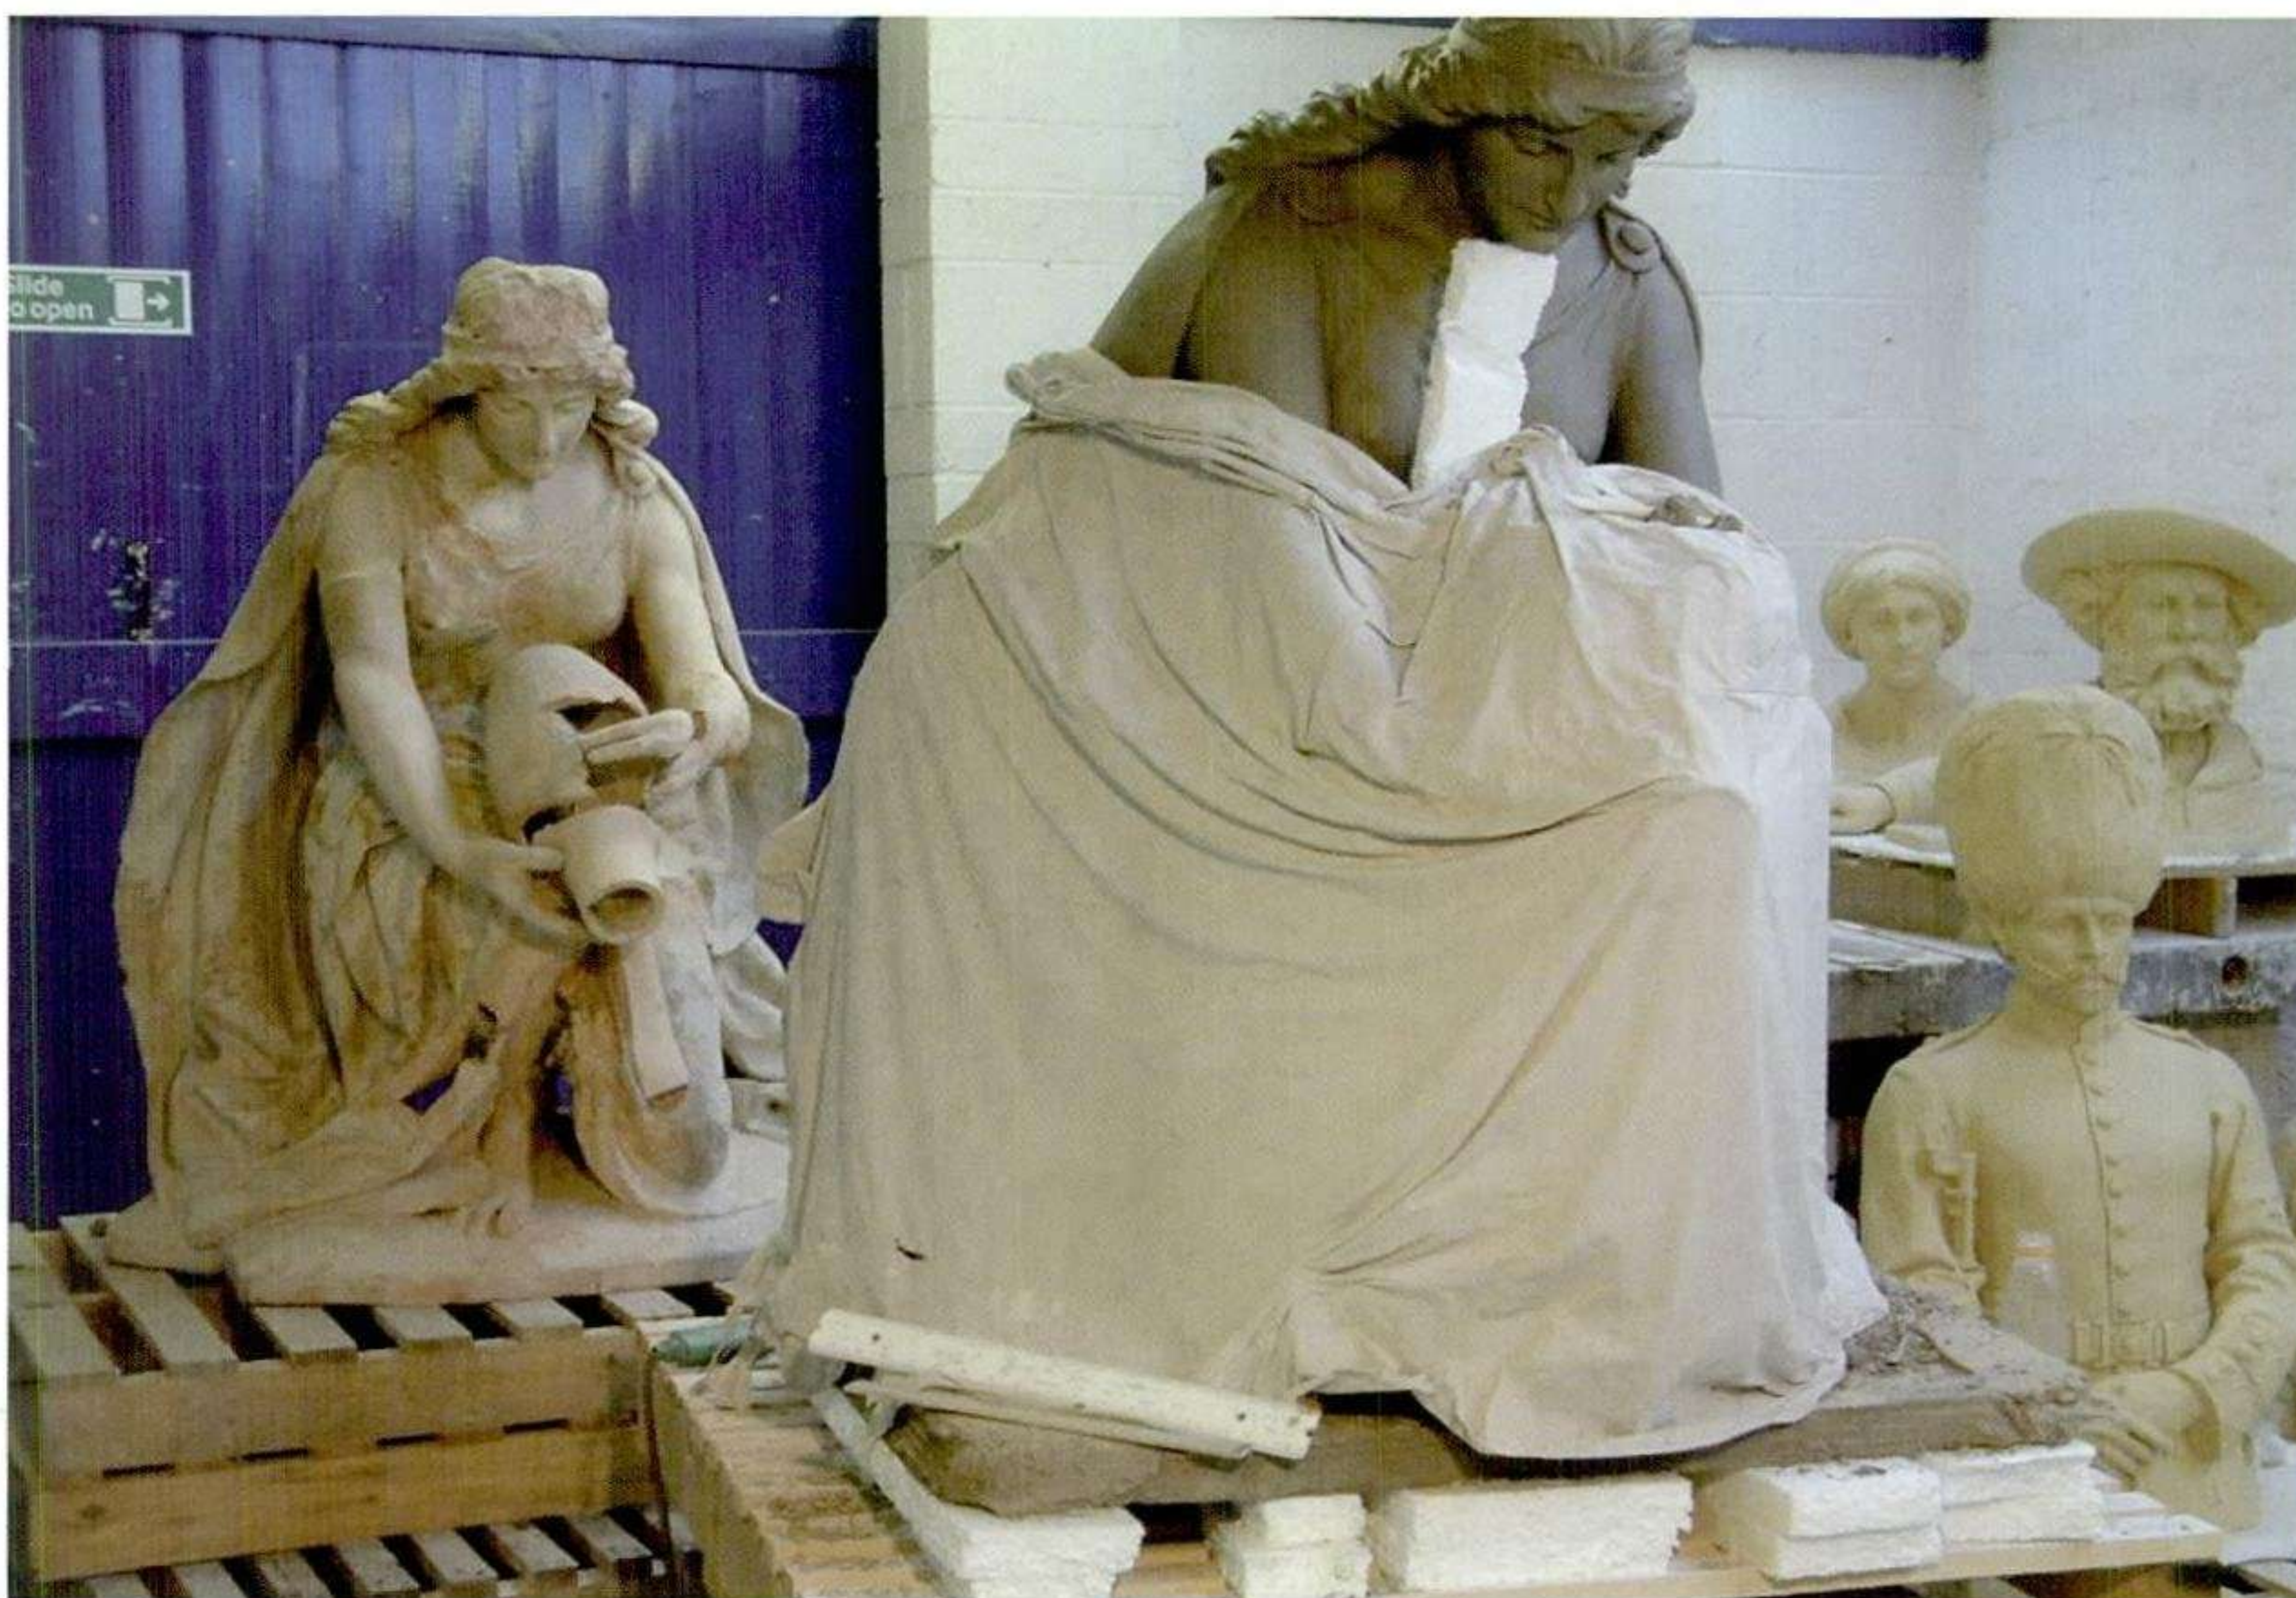
The finished figure of Water Bearer 3 covered in hessian and reclining on a support saddle, during the 8 week drying out period.
