THE
INVESTIGATION,
REPAIR AND
CONSERVATION
OF THE
DOULTON
FOUNTAIN,
GLASGOW GREEN

2 | Case
Study

TECHNICAL
CONSERVATION
GROUP

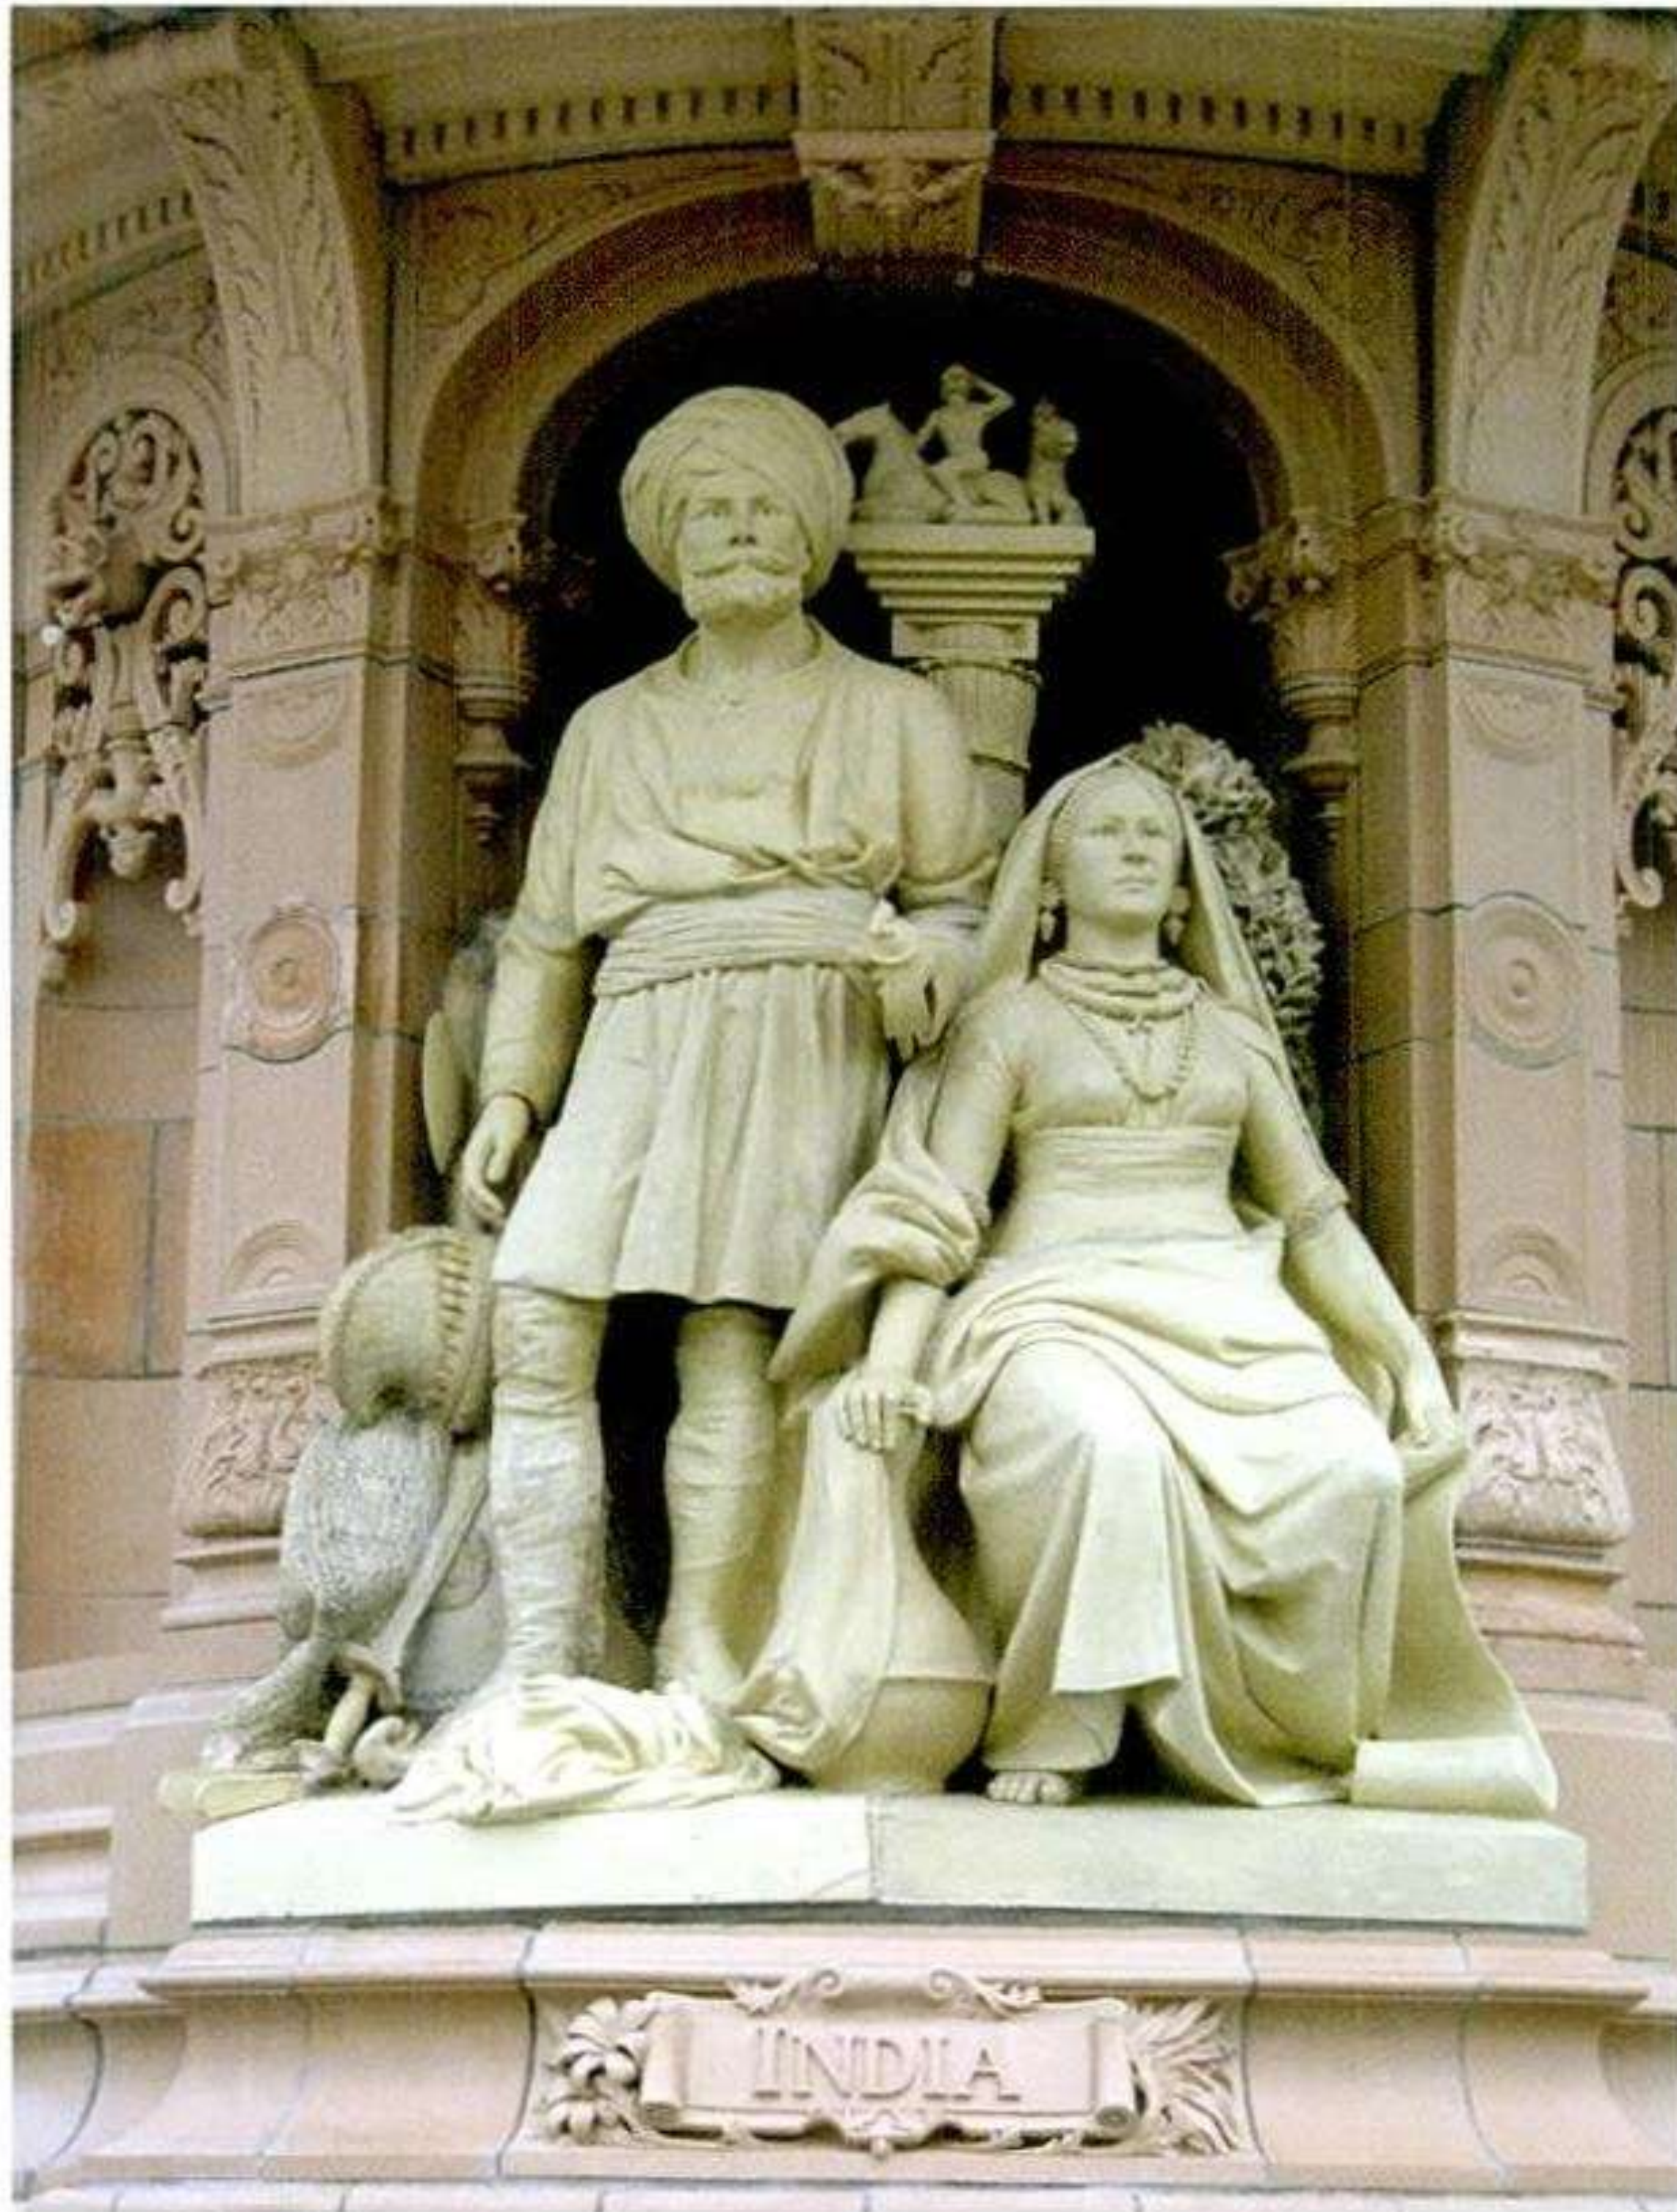
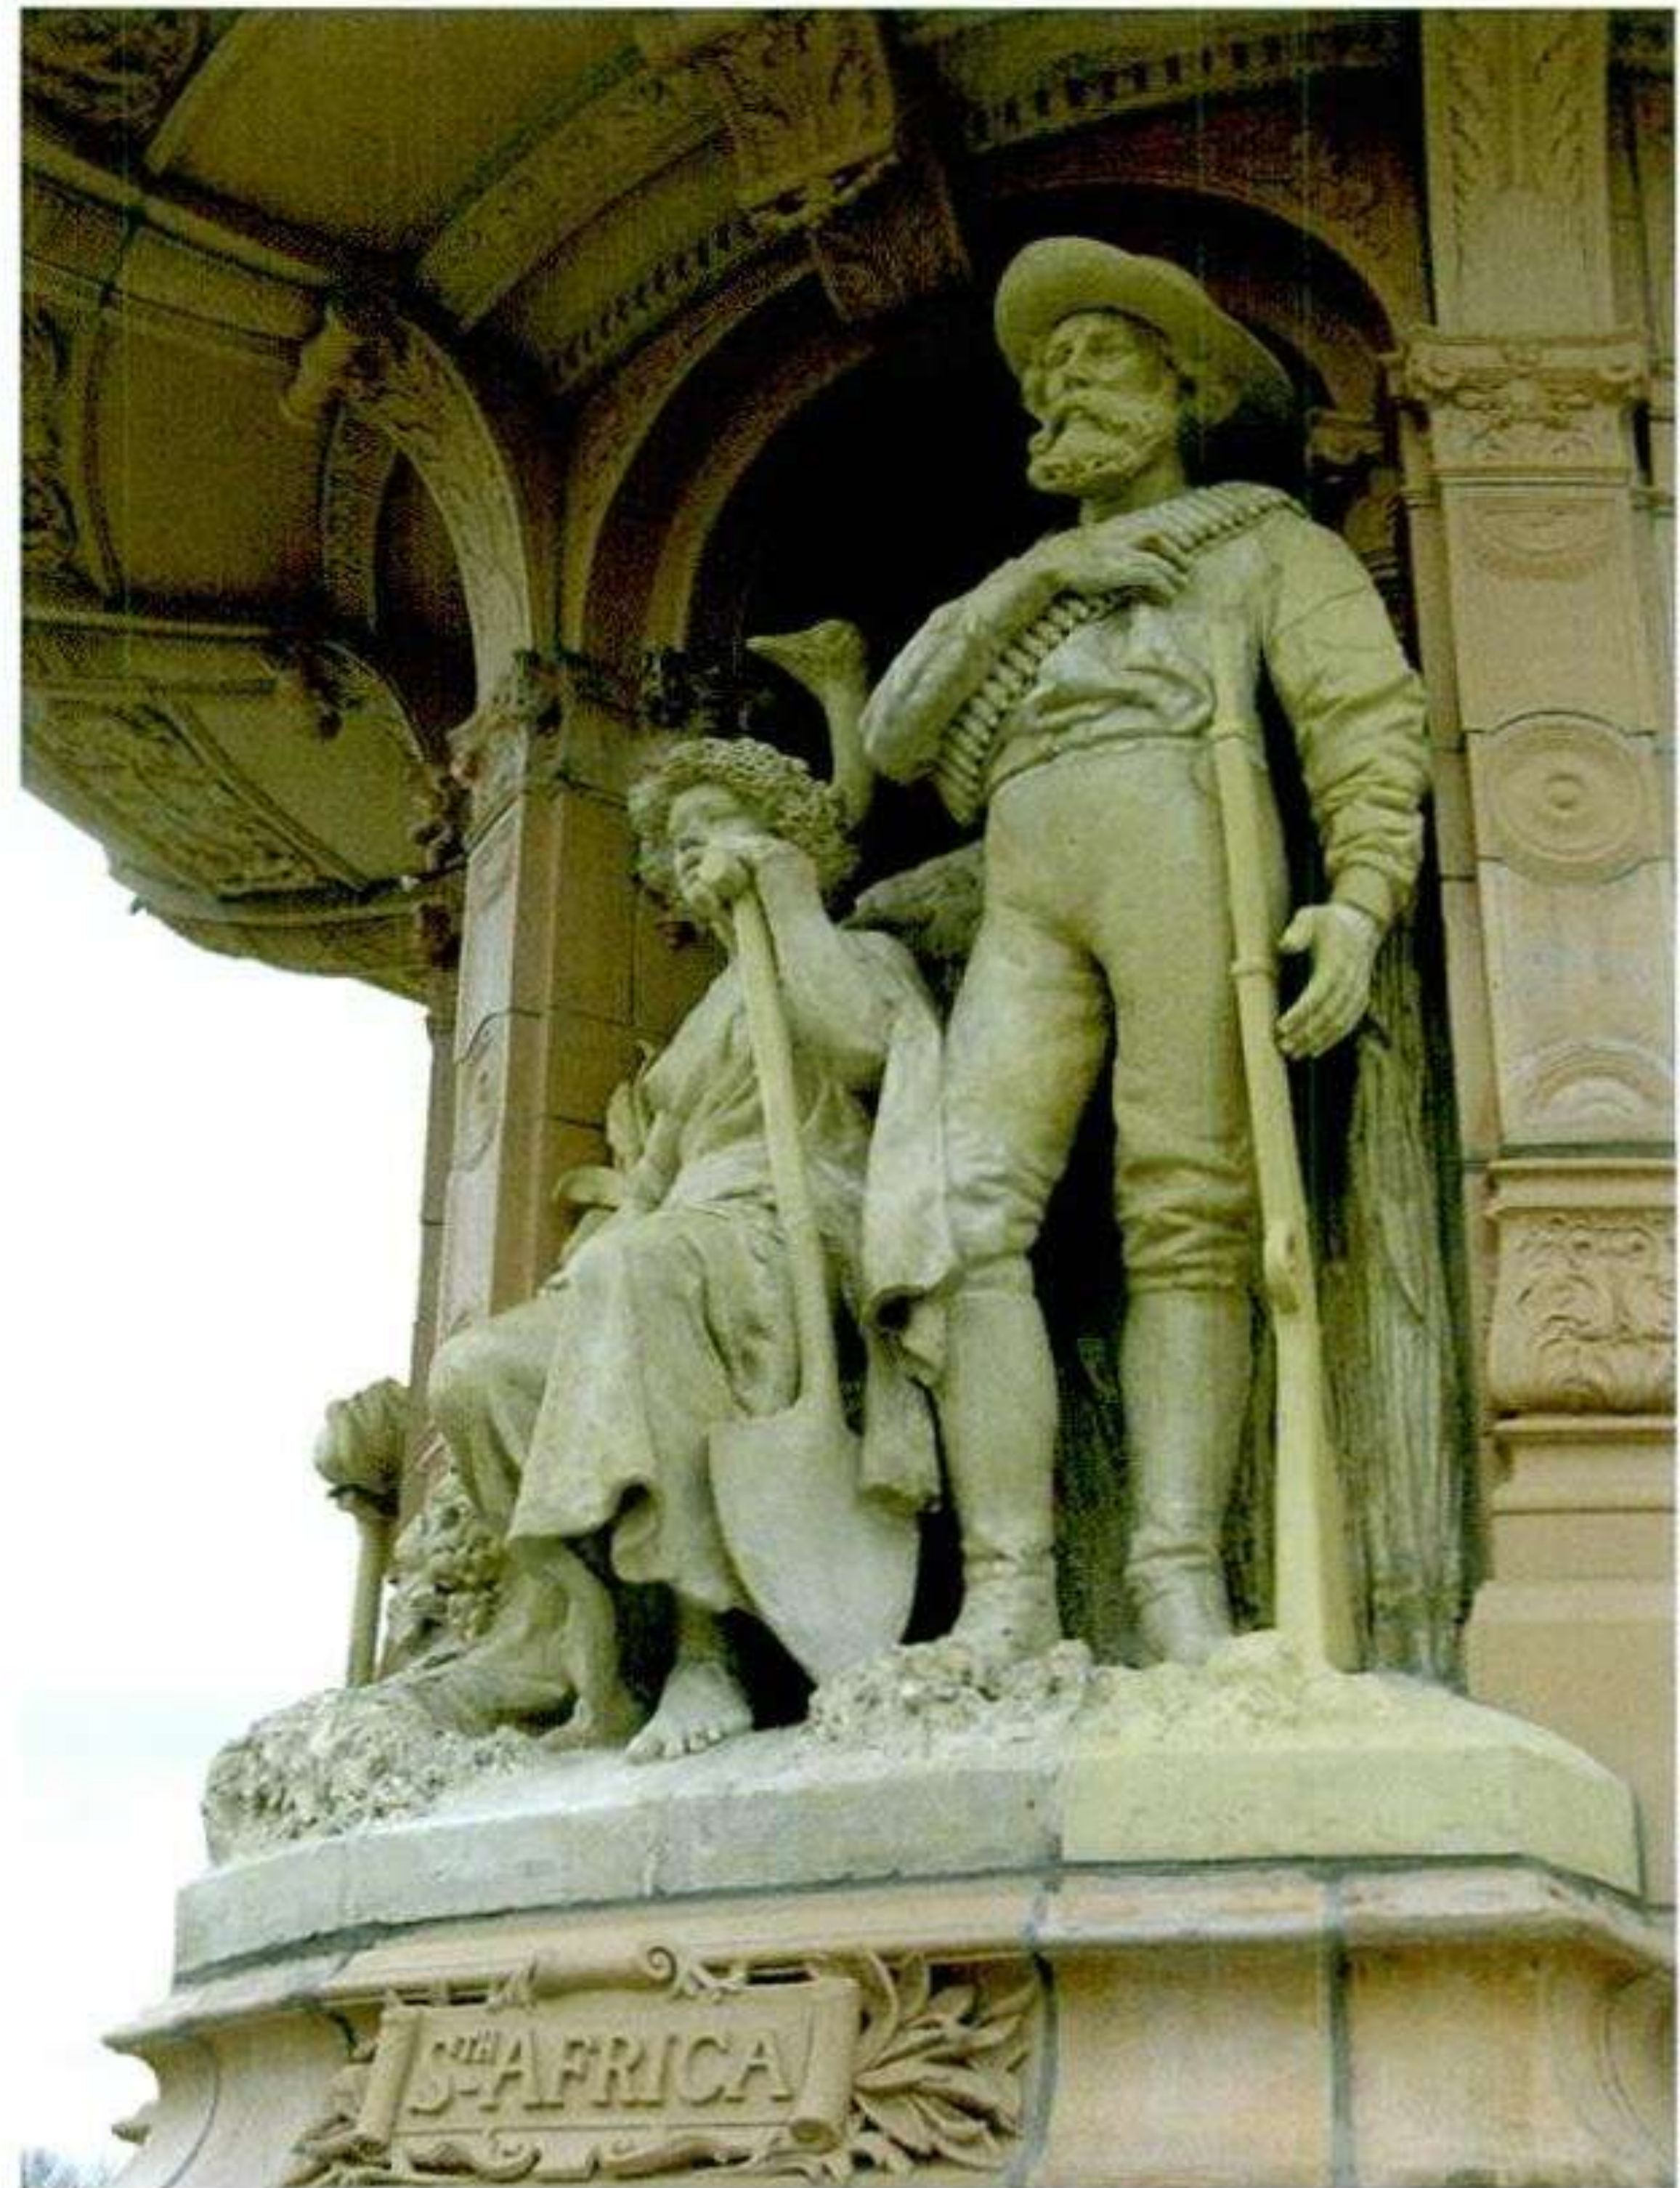
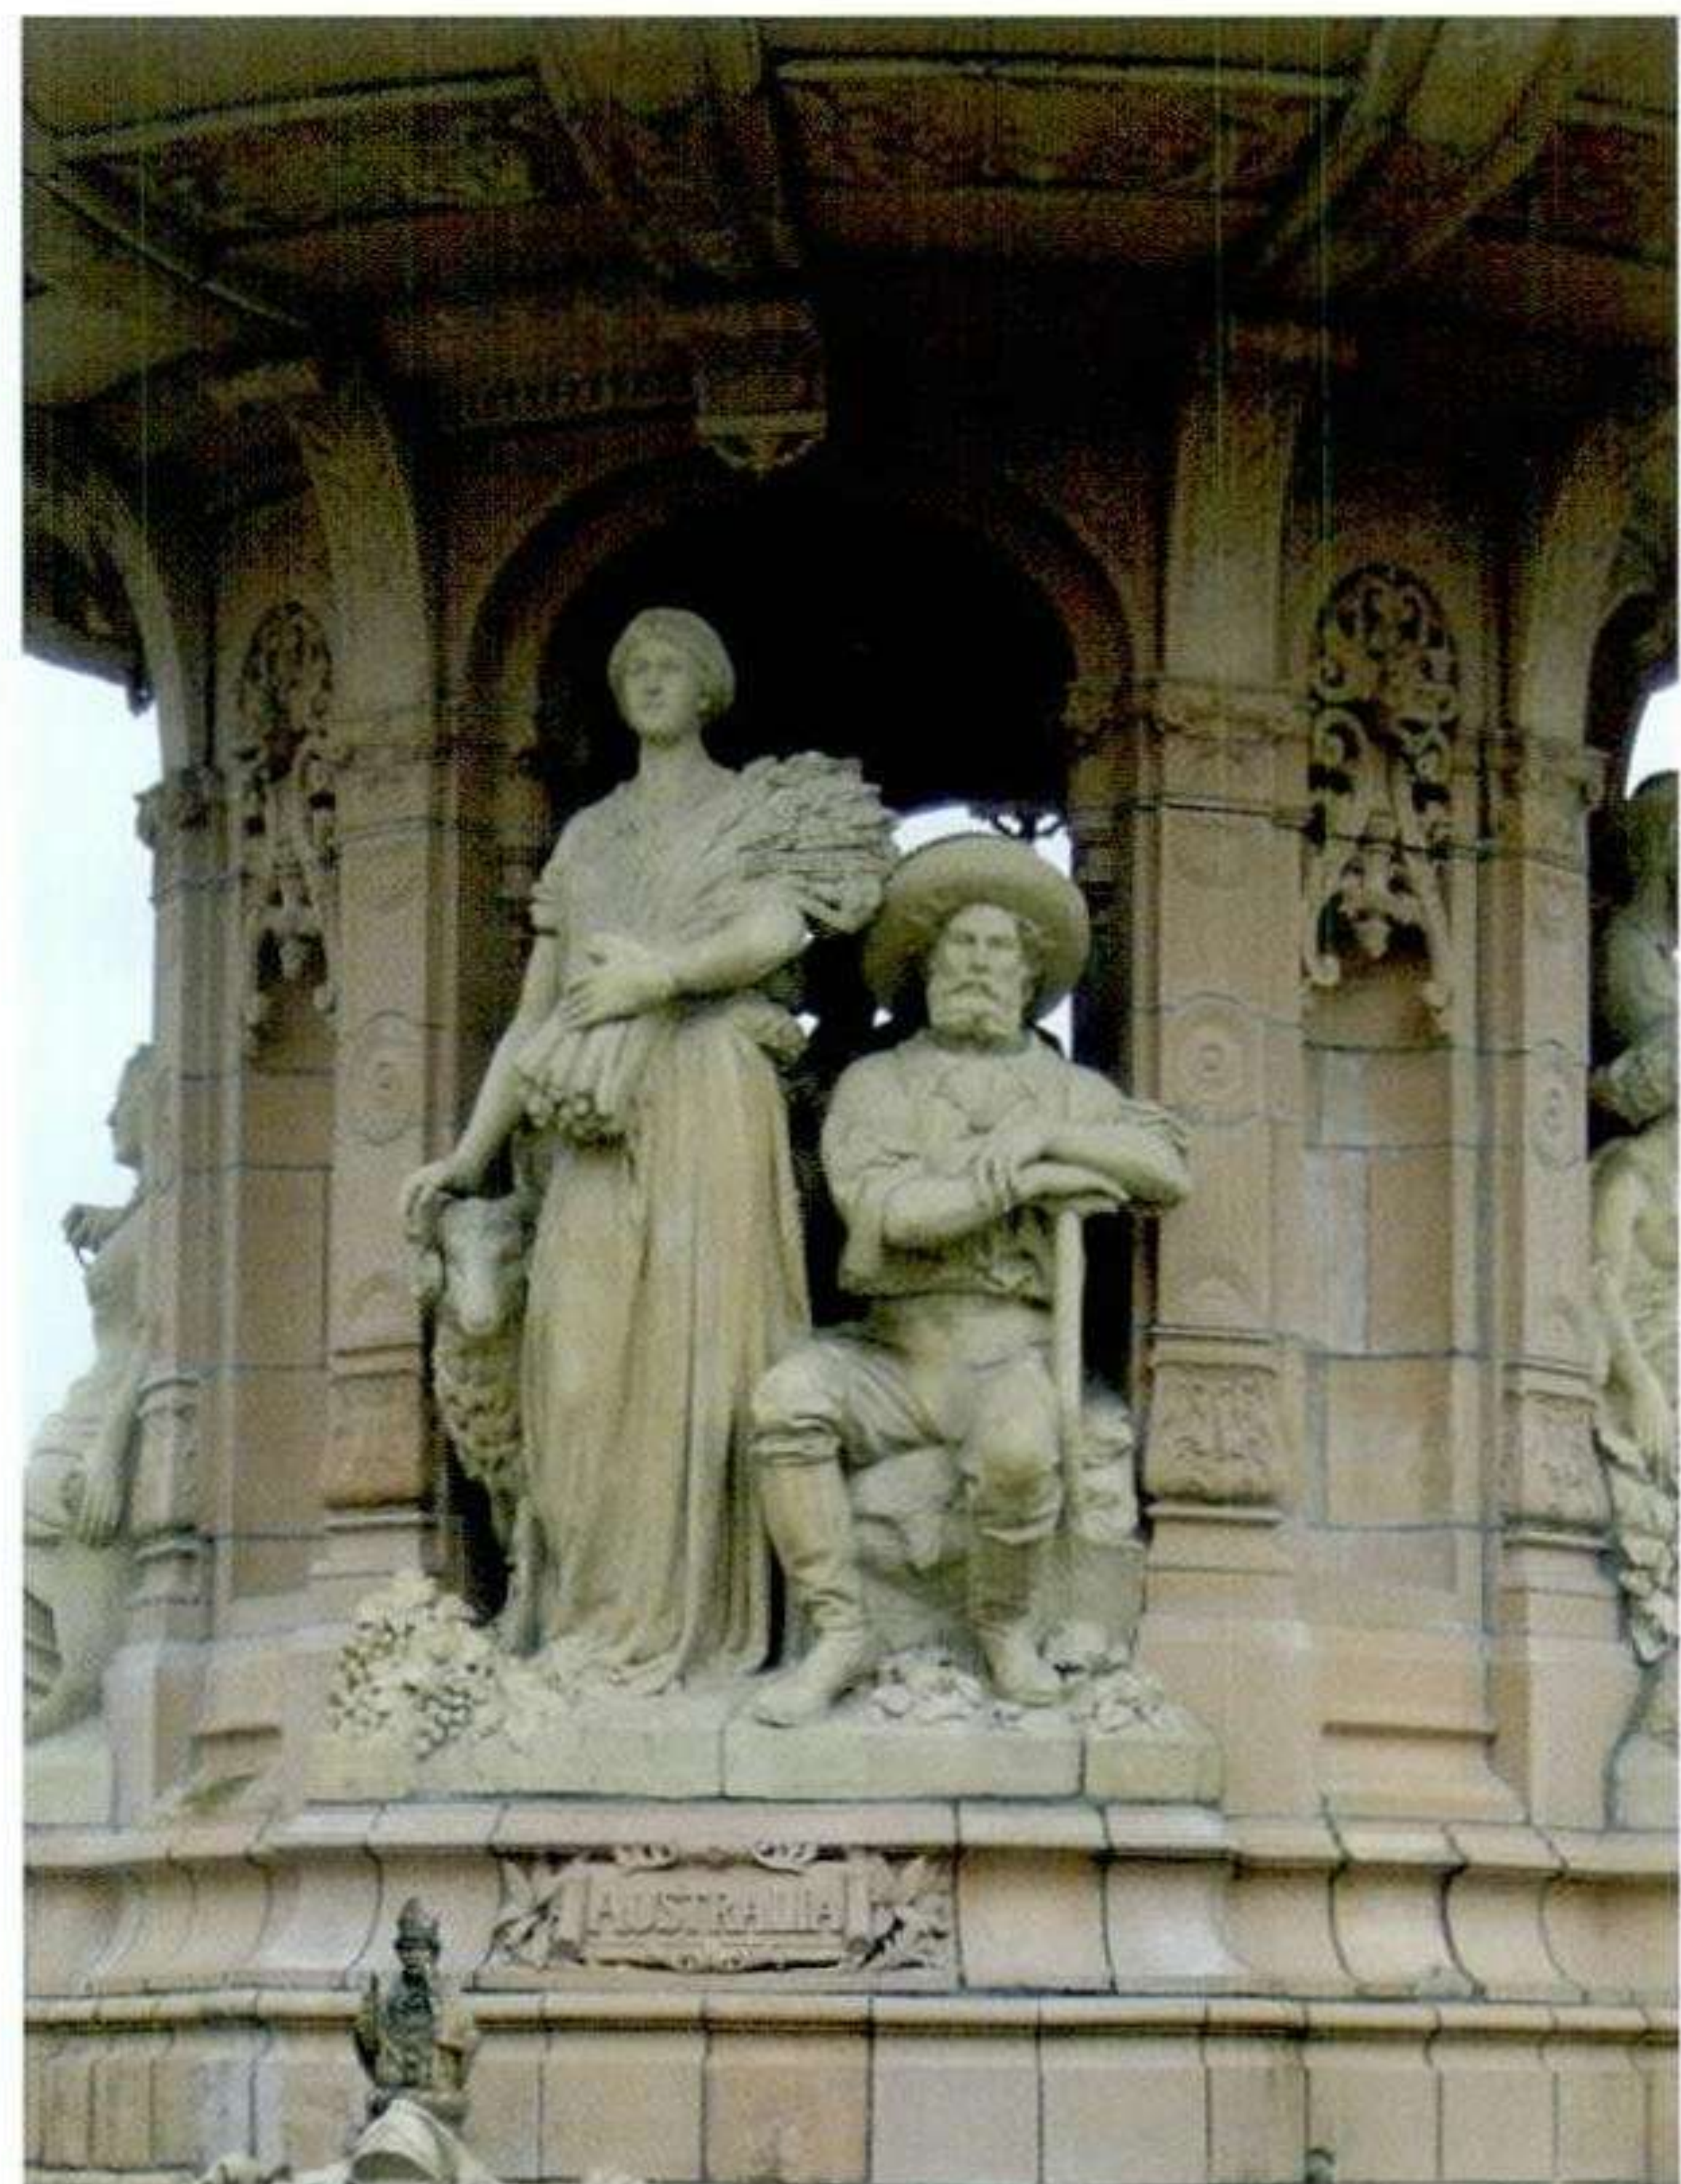
The four colonial groups, restored and conserved.
